GEOTECHNICAL & PEAT STABILITY REPORT

KNOCKSHANVO WIND FARM

Prepared for: MKO Ltd

GEOTECHNICAL & PEAT STABILITY ASSESSMENT REPORT KNOCKSHANVO WIND FARM

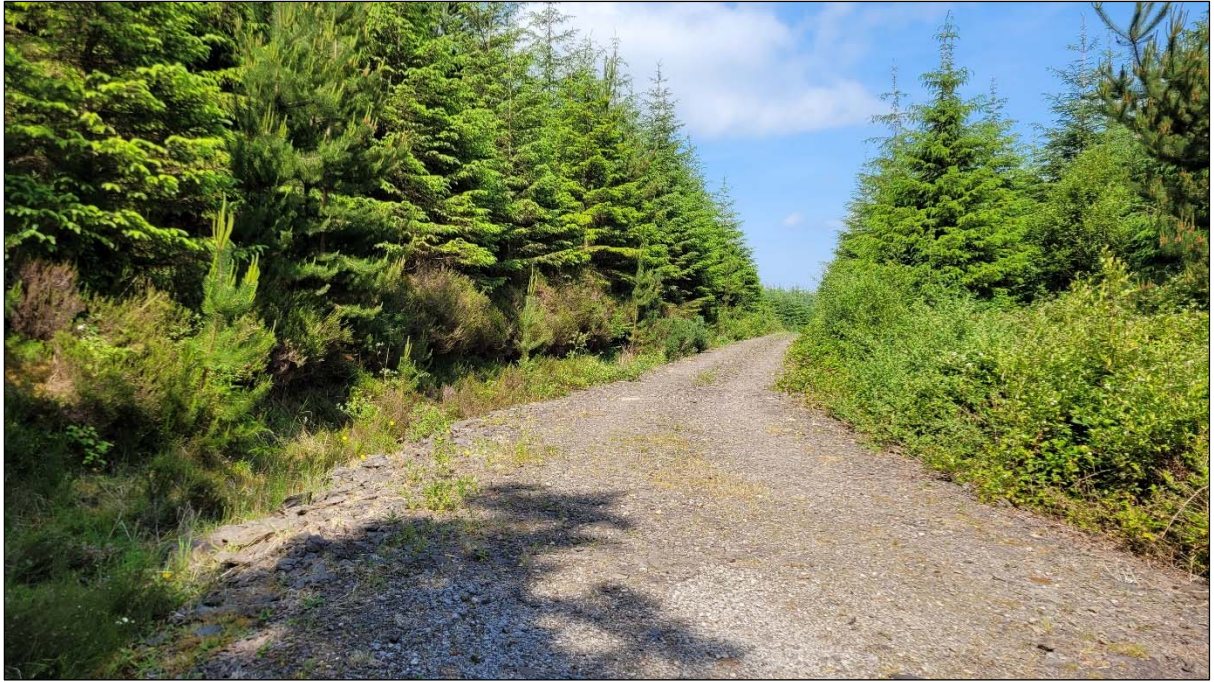
Photo 1: Example of existing access track on site

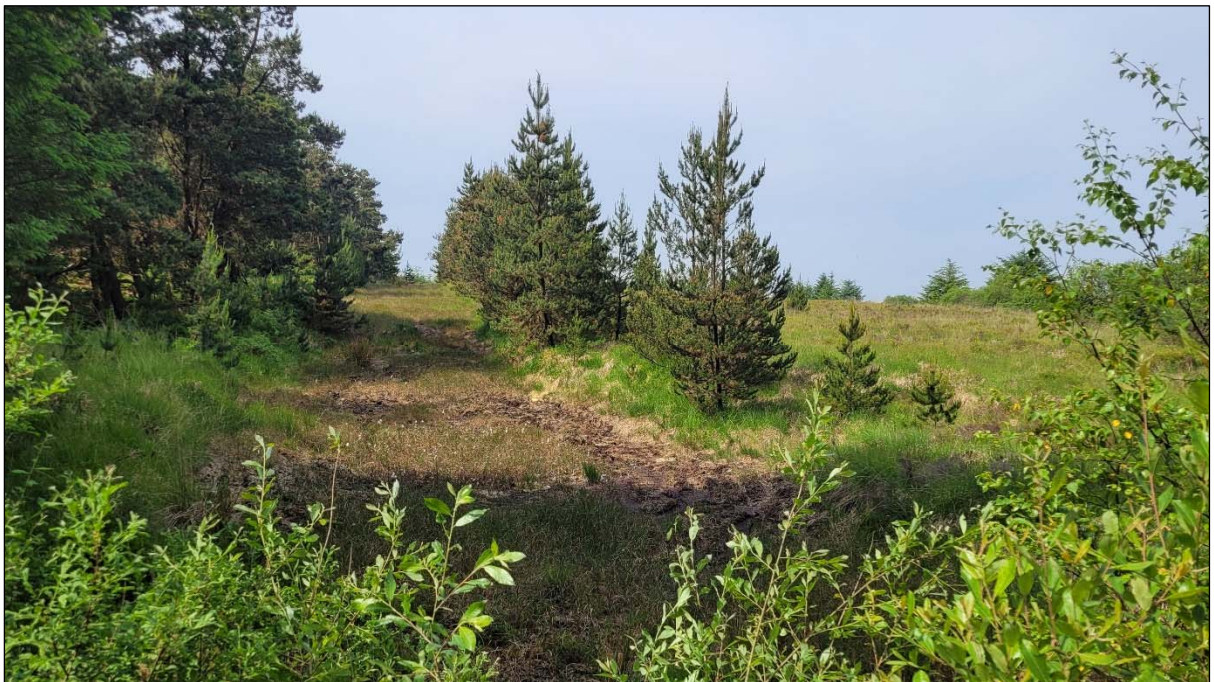
Photo 2: Route of main access track through site

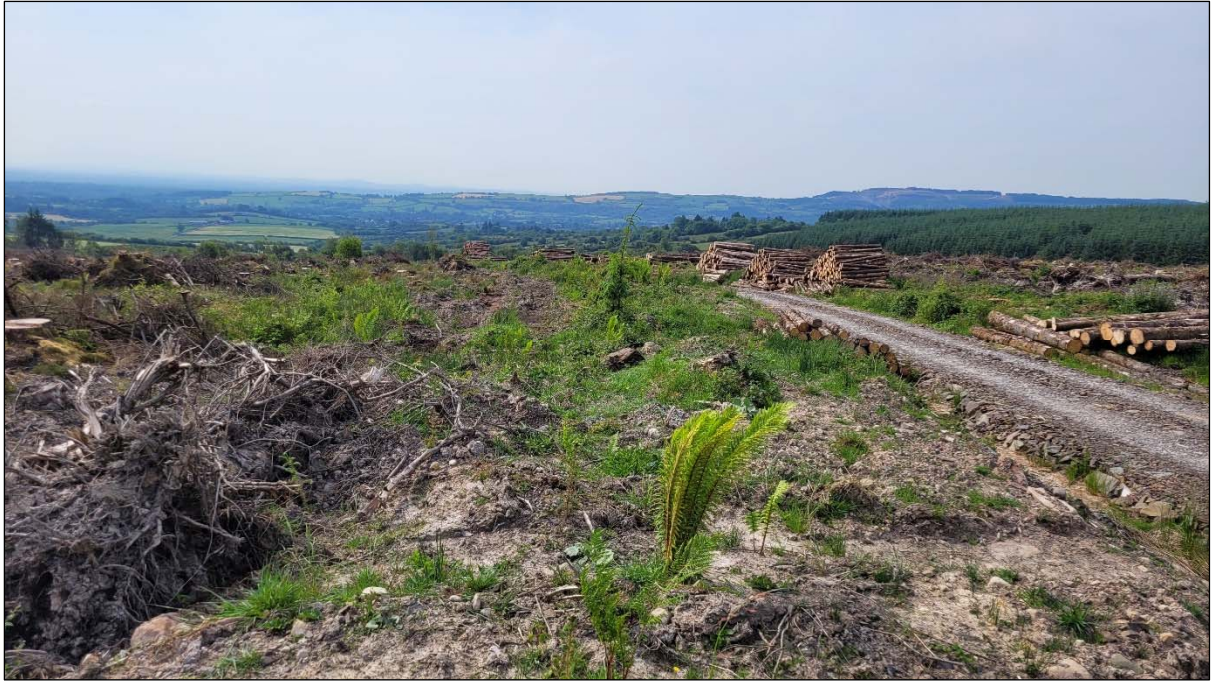
Photo 3: Ground conditions close to T7

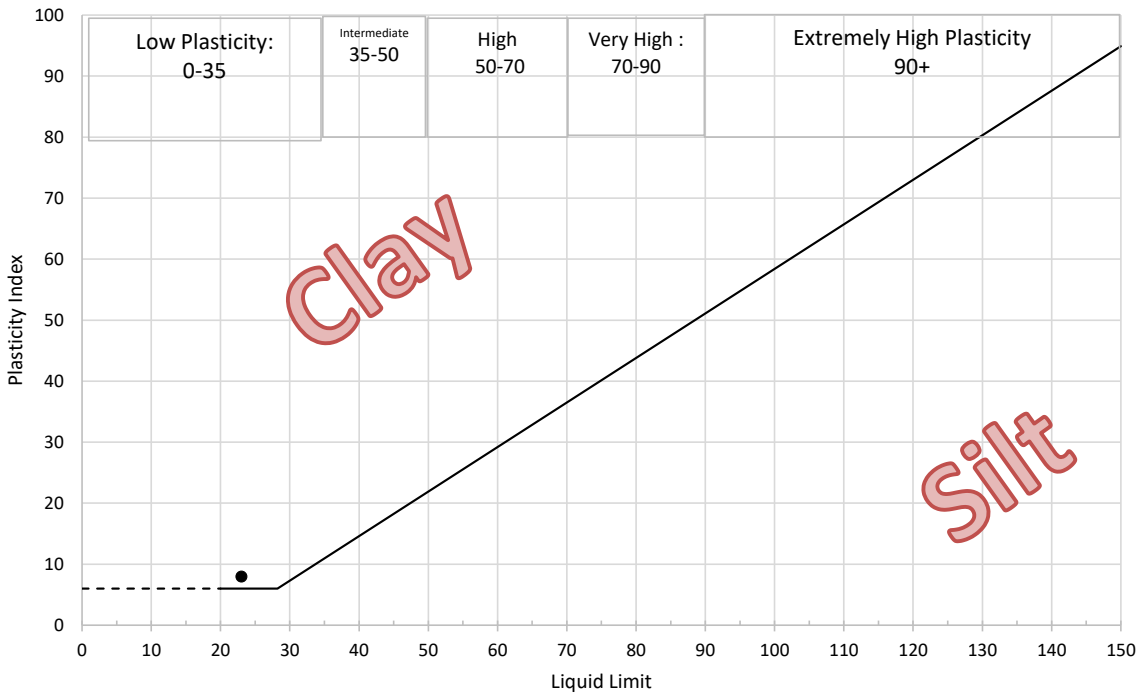
Plasticity (A-Line) Chart		Project Number
	Project Name:	Knockshanvo WF	
	Location:		2023CE103

Abreviations in the remarks column of the Classification Summary Sheet: C = Clay, M = Silt
 Plasticity abeviations: L = Low, I = Intermediate = H = High, V = Very High, E = Extremely High.
 The letter O is added to the symbol of any material containing a significant proportion of organic material.
 Chart taken from BS5930: 2010
