codling
wind park

Environmental Impact Assessment Report

Appendix 21.3 Ecological
Survey of Supratidal
habitats at Poolbeg, Dublin

Client	Tobin Engineering Ltd
Report Title	Ecological Survey of Supratidal habitats at Poolbeg, Dublin.
Job Number	JN1698
Report Status	Final
Issue Date	20/06/2024

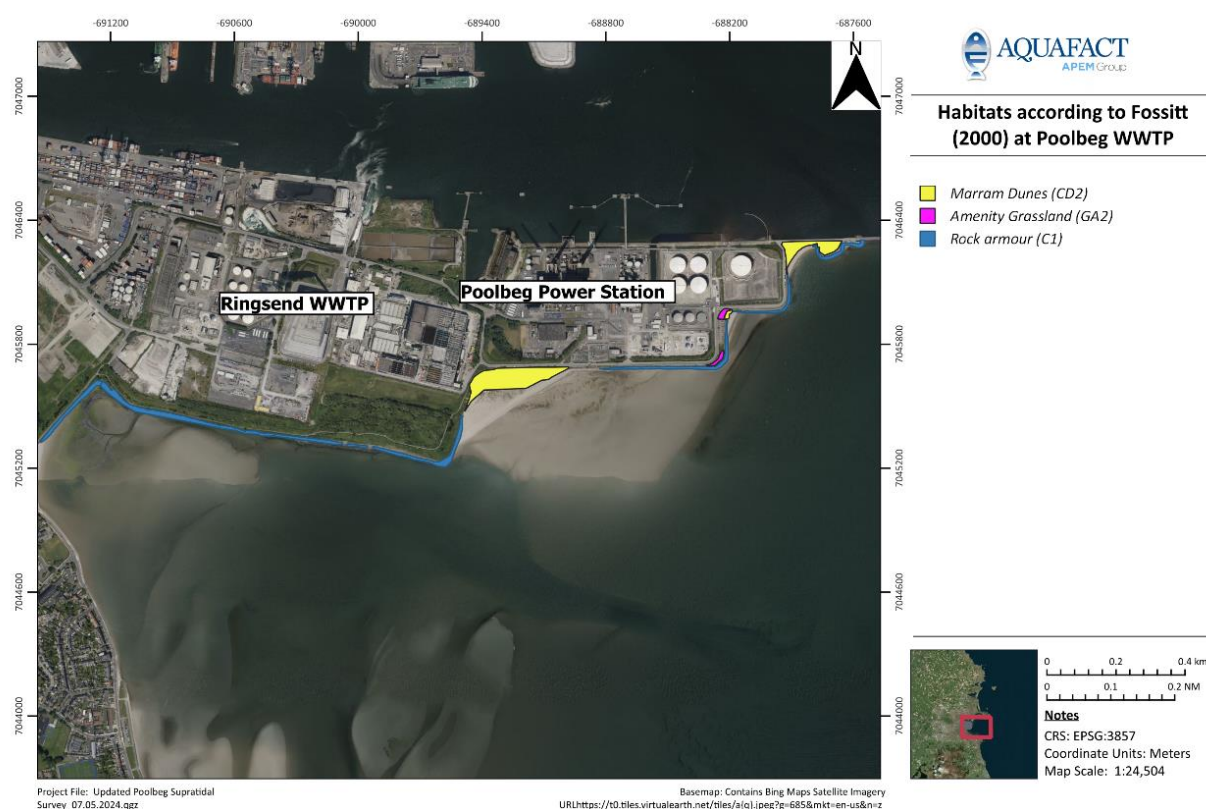
**Figure 2.1: Poolbeg habitat map.**

Biotopes recorded during the walk over surveys are mapped in **Figure 2.1** below.

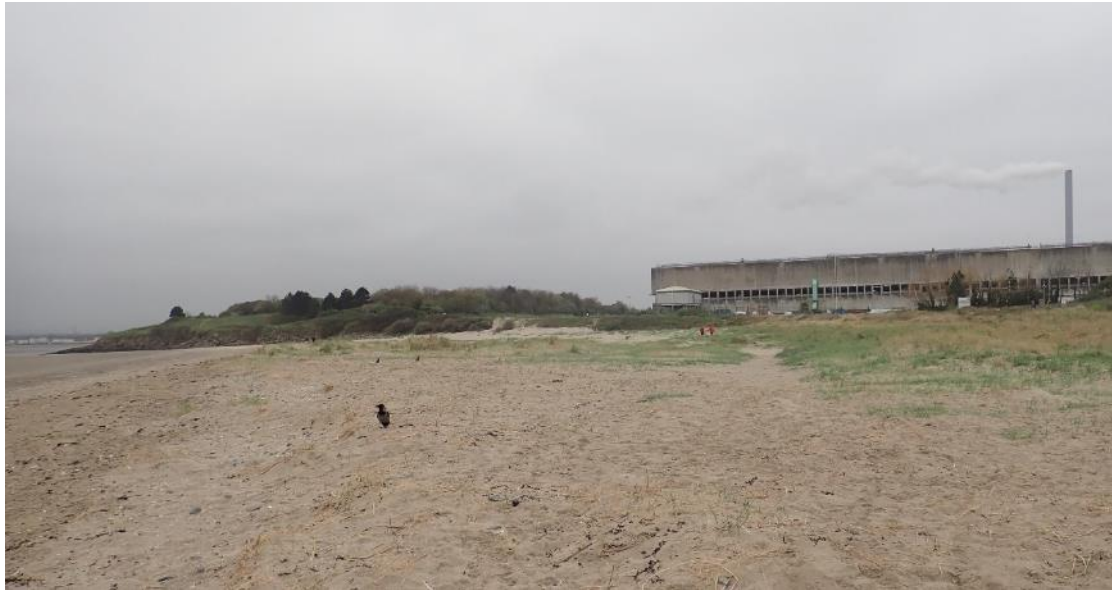
Figure 2.2: Marram dunes in the upper shore at Poolbeg Beach September 2021.

The most extensive natural supratidal habitat type is Marram dunes (CD2 *sensu* Fossitt, 2000).

Marram grass (*Ammophila arenaria*) is the dominant plant (see **Figure 2.2** and **Figure 2.3**).

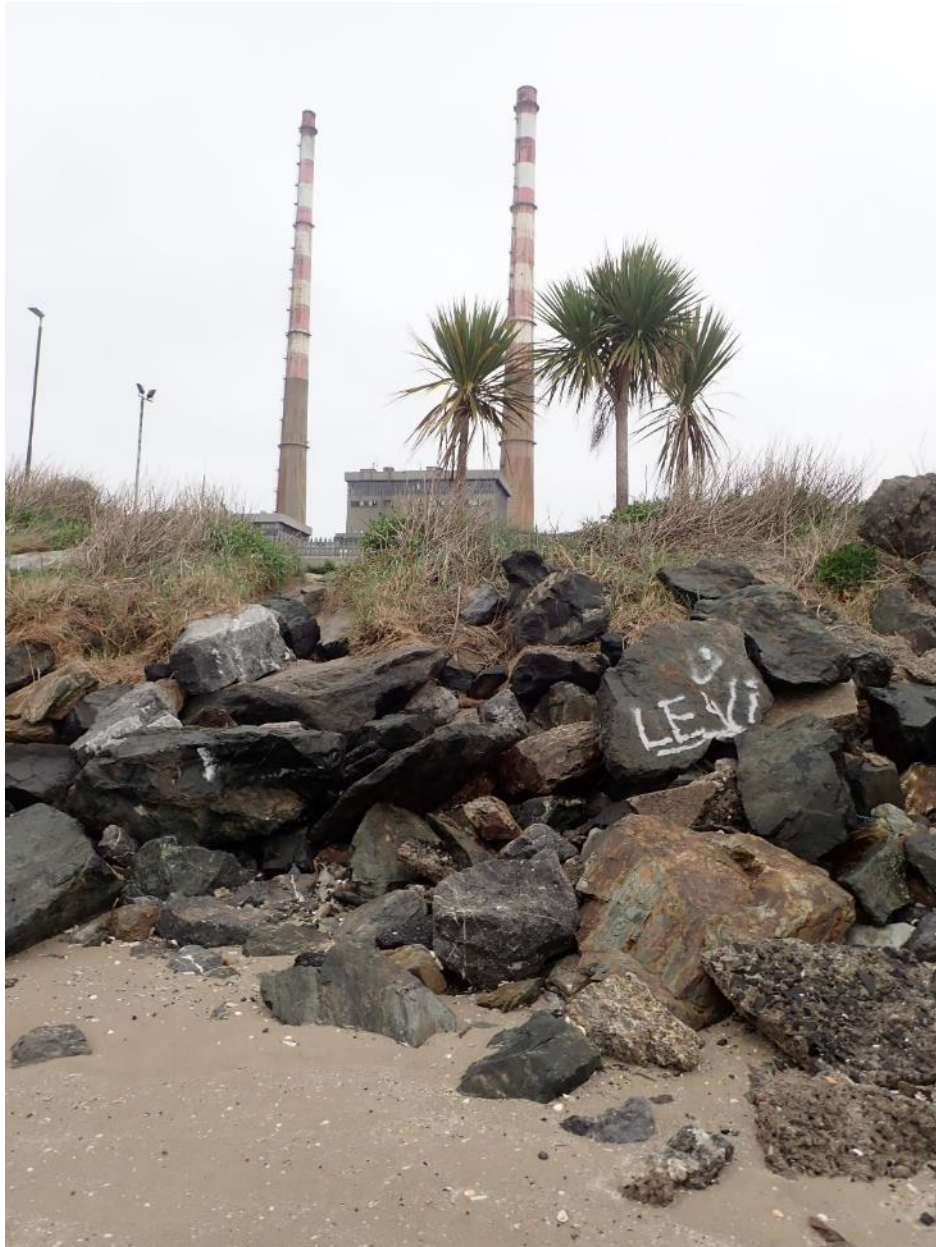
Figure 2.4: Strandline and rock armour at Poolbeg showing Marram grass and cordyline September 2021.

Cordylines, *Buddleia* and Sea Buckthorn (*Hippophae rhamnoides*) were also recorded, with the former being the most common of the two (see **Figure 2.4**, **Figure 2.5** and **Figure 2.9** below).

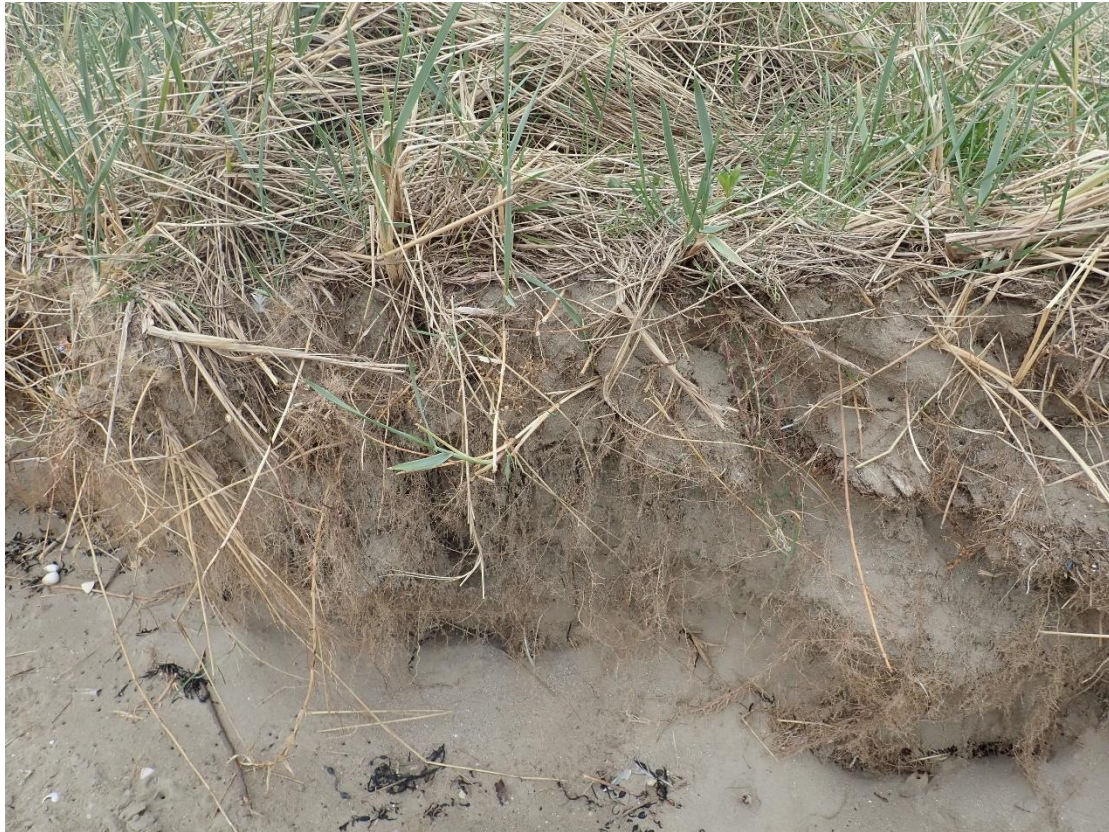
Figure 2.6: Erosion of Marram grass community at High Water near the Great South Wall Beach access September 2021.

In places, erosion of the Marram dune habitat was recorded (see **Figure 2.6** below).

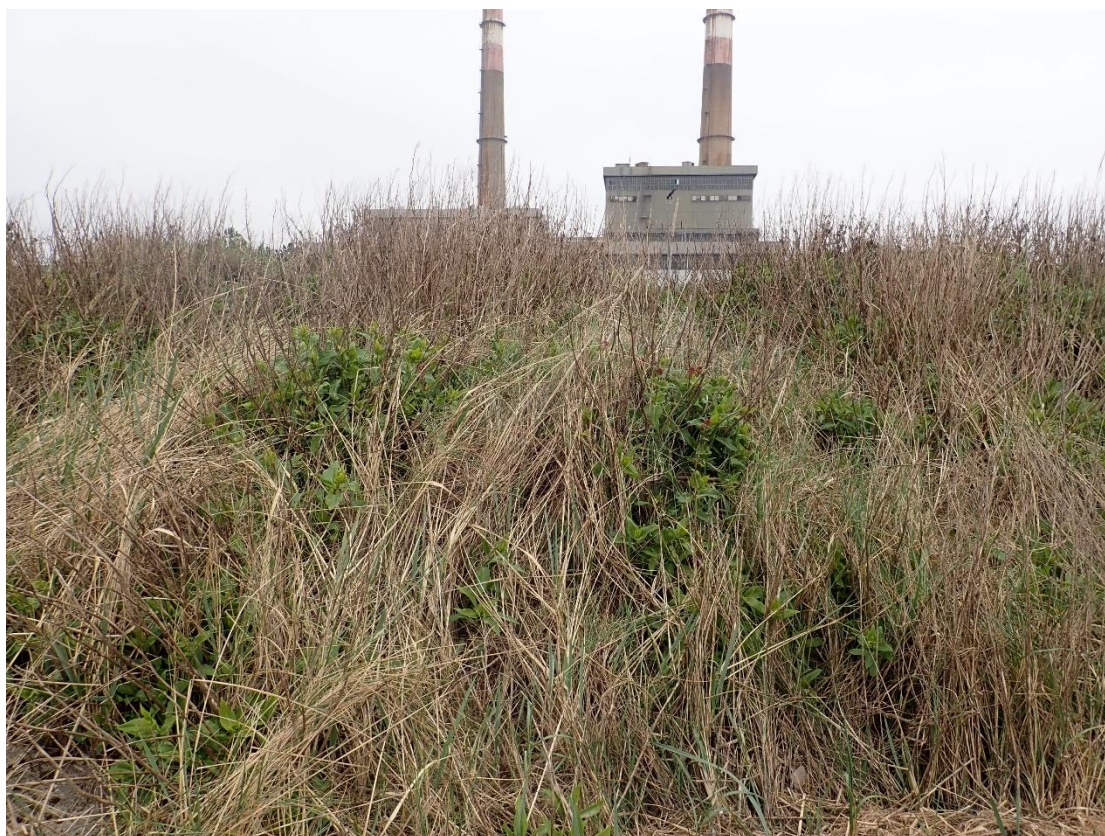
Figure 2.7: Red Valerian (*Centranthus ruber*) within Marram grass September 2021.

On both survey dates, stands of Red Valerian (*Centranthus ruber*) were widespread within the Marram dune community (see **Figure 2.7** below). Other species recorded within the Marram grass were Sea Rocket (*Cakile maritima*), Buck's-thorn plantain (*Plantago cornopus*), Sea kale (*Beta vulgaris*) and Pineapple weed (*Matricaria discoidea*).

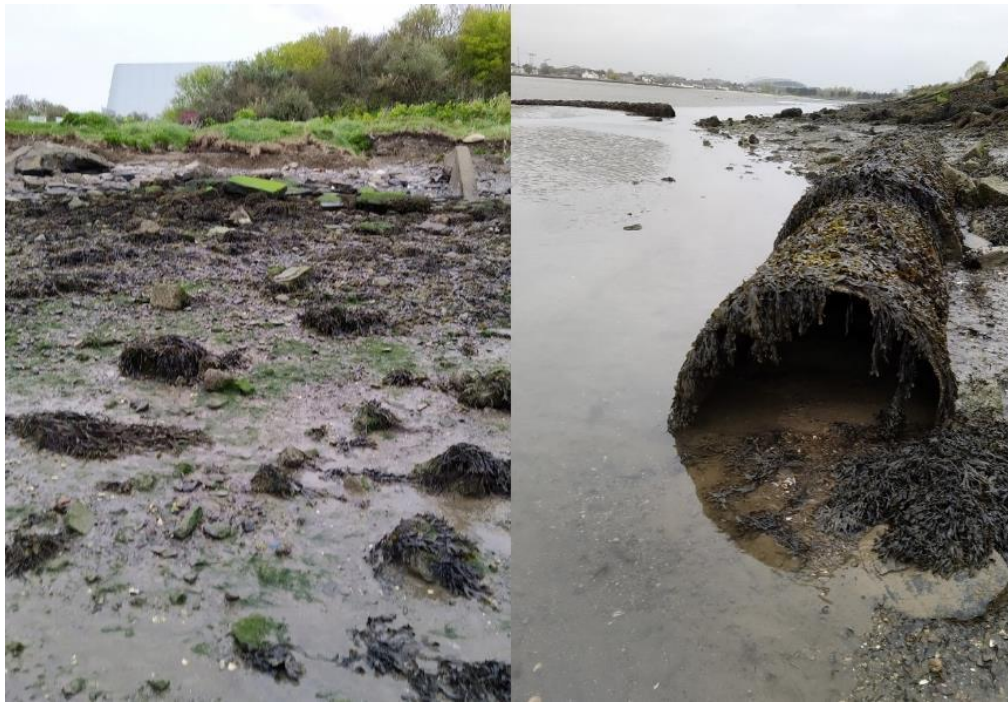
Figure 2.11: Concrete rubble and metal pipe in Irishtown Nature Park mid shore September 2021.

Besides rock armouring along the shore line, concrete and metal piping were recorded on the shore line (see Figure 2.11 below).

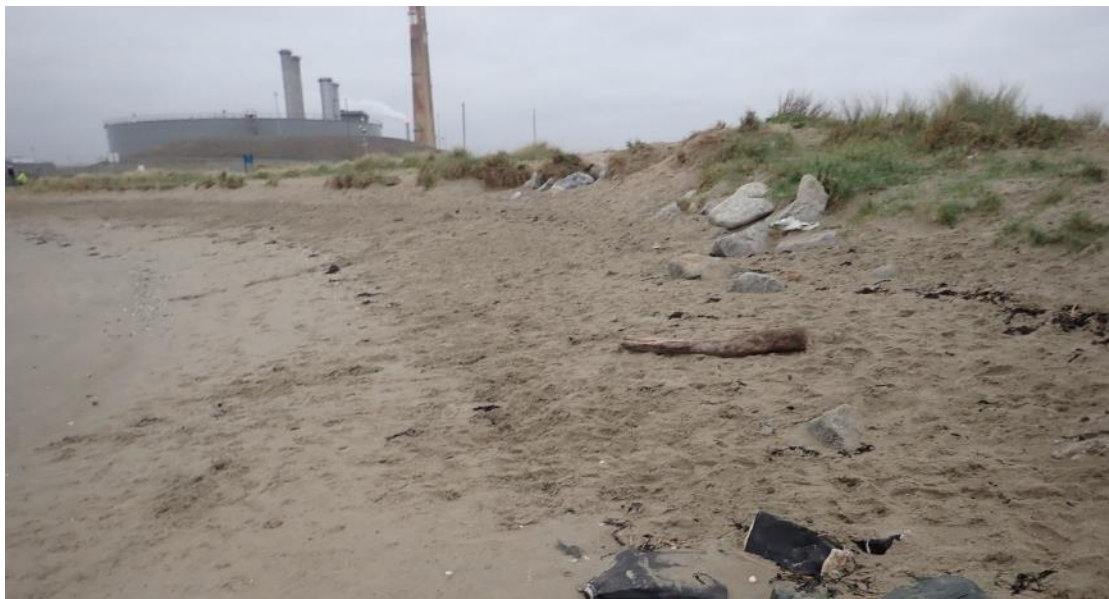
Figure 3.1: Flotsam and jetsam washed up at High Water near the Great South Wall Beach access.

Due to the impact caused by the presence of a number of non-native species in the Poolbeg area, the amount of flotsam and jetsam and general rubbish (see **Figure 3.1** below) and the high level of human disturbance (cars, walkers, dogs), the habitats recorded in the supratidal area in the vicinity of Poolbeg are not of high ecological importance. Furthermore, any temporary effects of trenching will be short term in nature and re-colonisation will occur within a short time scale.
