Peat Stability Risk Assessment Cummeennabuddoge Wind Farm

Project Title:	Cummeennabuddoge Wind Farm
Report Title:	PSRA for Cummeennabuddoge Wind Farm
Document reference:	20263-PSRA-001-03

Client:	Atmos Consulting
----------------	------------------

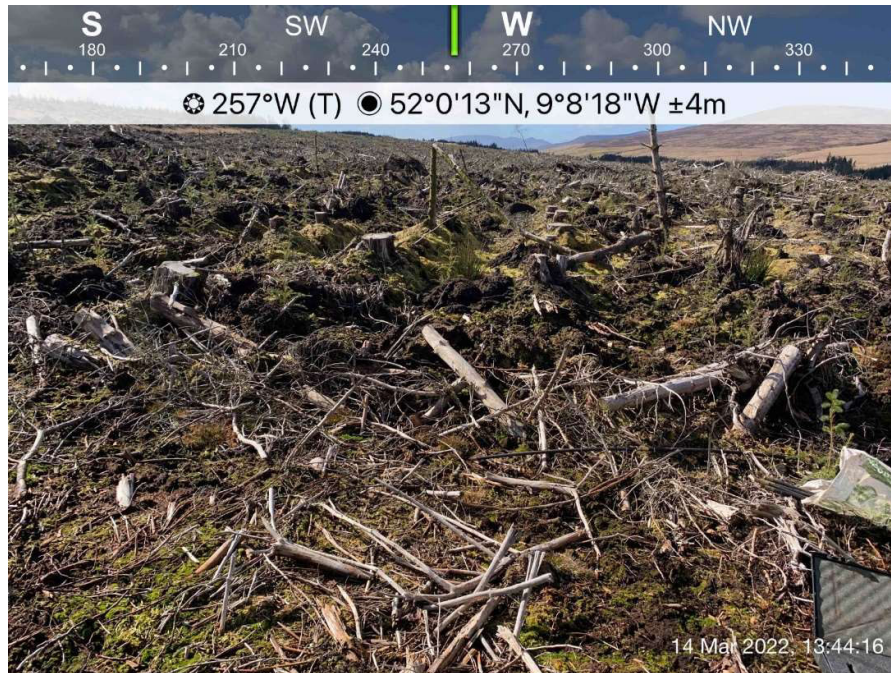
Figure 3-2: General site terrain and conditions in recently felled areas.

As part of the assessment, the project team carried out site reconnaissance. This comprised seven site visits (March 2021, June 2021, March 2022, June 2022 and October 2022) to record geomorphological features concerning the Proposed Development, peat depths and peat strength. An indication of the site conditions (forested and recently felled areas) and undulating topography are shown in Figure 3-1 and Figure 3-2.

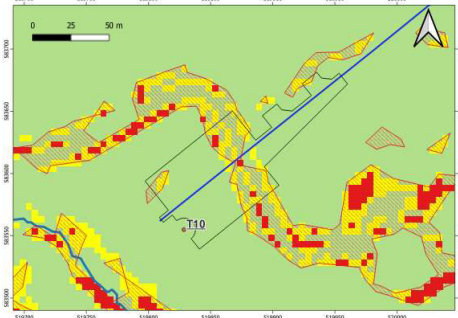
Risk and mitigation	Undrained surcharged FoS analysis
<p>The area at the hardstand for T10 suggests a FoS <1.3 with the application of a surcharge. Without the application of the surcharge indicate a FoS >1.3, indicating the natural, undisturbed slope is stable. All of the low FoS results here are caused by existing the existing cut and side cast material at the existing forestry road currently at the hardstand area. Having inspected the site during a site walkover, this is not all considered to be a true risk area. However, we recommend that the placement of peat material shall not be carried out at the northern, downslope side of the T10 turbine and hardstand area.</p>

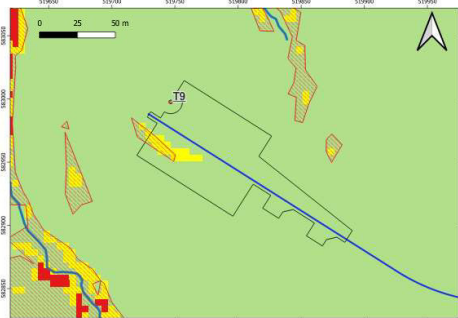
<p>The area at the hardstand for T09 suggests a FoS <1.3 in the undrained with surcharge case. The lower FoS results at this location are caused by an existing localised steep slope face and 0.45m to 0.65m of peat in the vicinity of the proposed floated blade finger area. This area will be levelled off for the construction stage. The area is also uphill of the proposed excavation area for the turbine and hardstand so any instability hazard will be mitigated out by the detail design and temporary works designer in their design of the cutting at the levelled off blade finger area.</p>

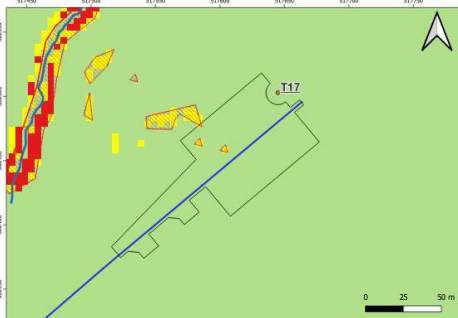
<p>The area at the hardstand for T17 suggests a FoS <1.3 in the undrained condition with the application of a surcharge. The lower FoS results here are caused by localised cutting on the peat surface due to peat harvesting or drainage of the forestry area. The peat in these areas will be excavated to a competent stratum to construct the hardstand platform, thus eliminating the hazard. The detail and temporary works design must consider these cuttings in their method statements.</p>

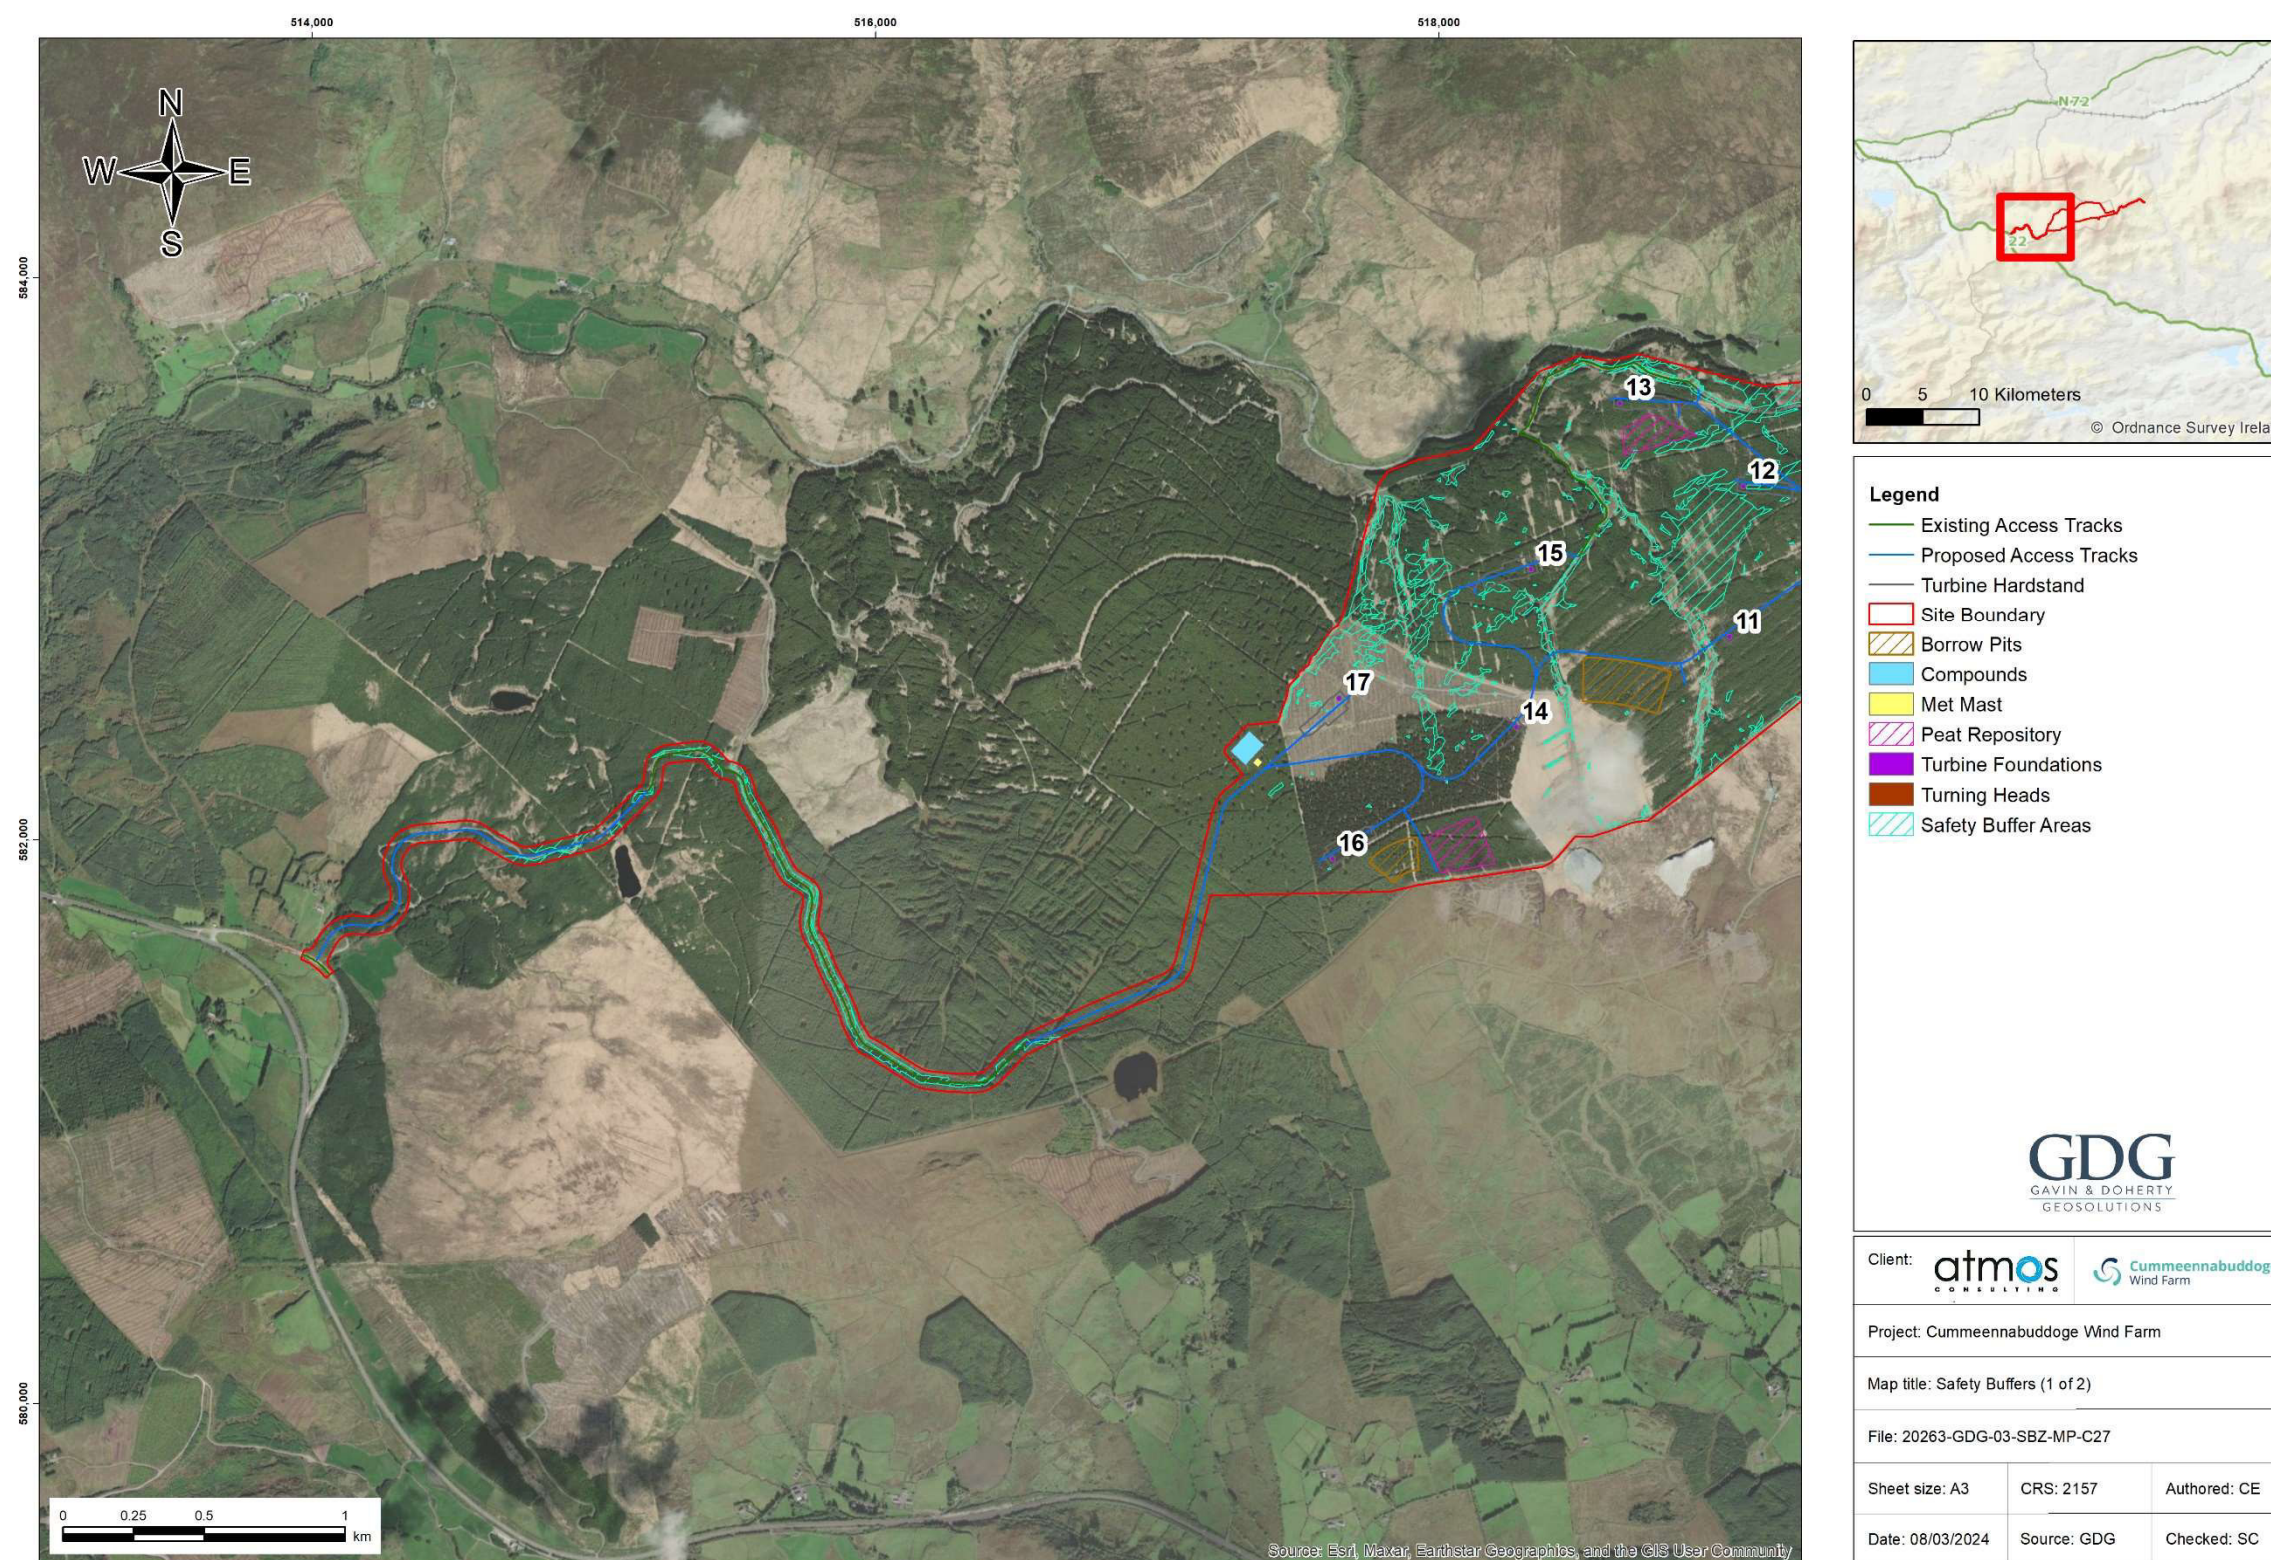
Figure L- 1: Safety buffer areas. (1 of 2)

Note: The delineation of Safety Buffers is based on the semi automated approach derived from the results of the FoS calculation, with the addition of areas identified during site walkovers and site reconnaissance outlined in Sect 4.5.
