PROJECT TITLE: CLYDAGHROE WIND FARM  
 ROUTE ASSESSMENT

DRAWING No: 20263-GDG-ZZ-XX-DR-C-0200  
 Revision: -FI -00

DRAWING TITLE: JUNCTION 1  
 LAYOUT

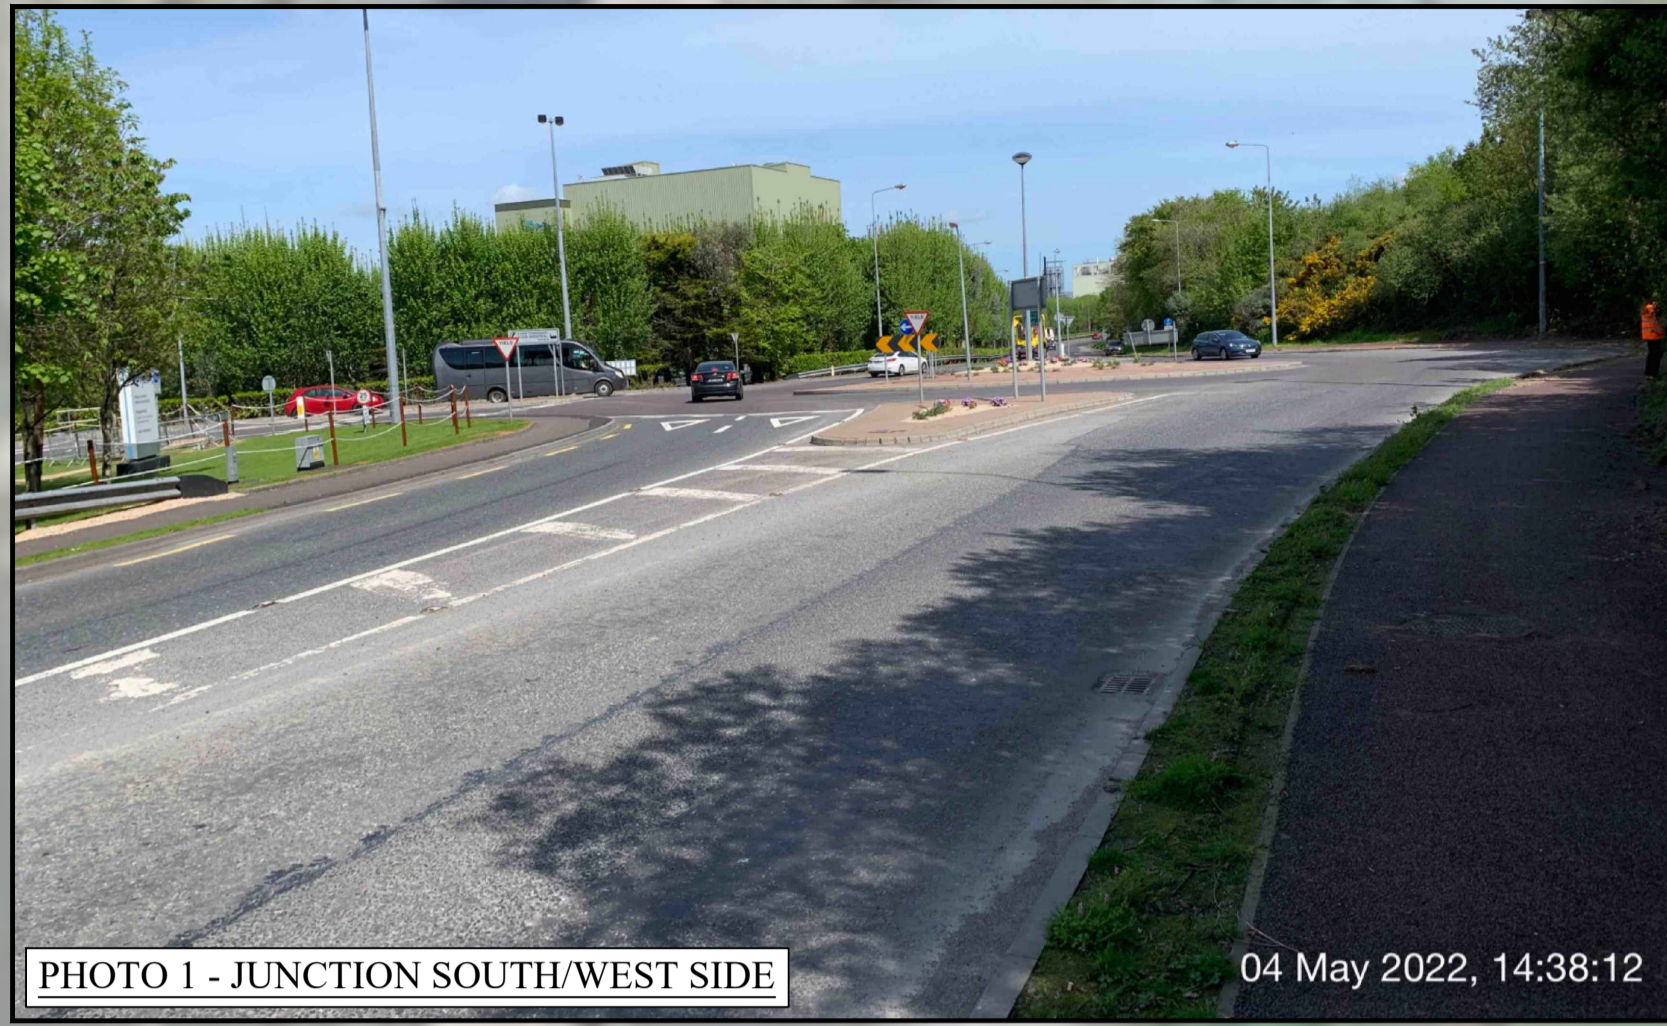
PHOTO 1 - JUNCTION SOUTH/WEST SIDE

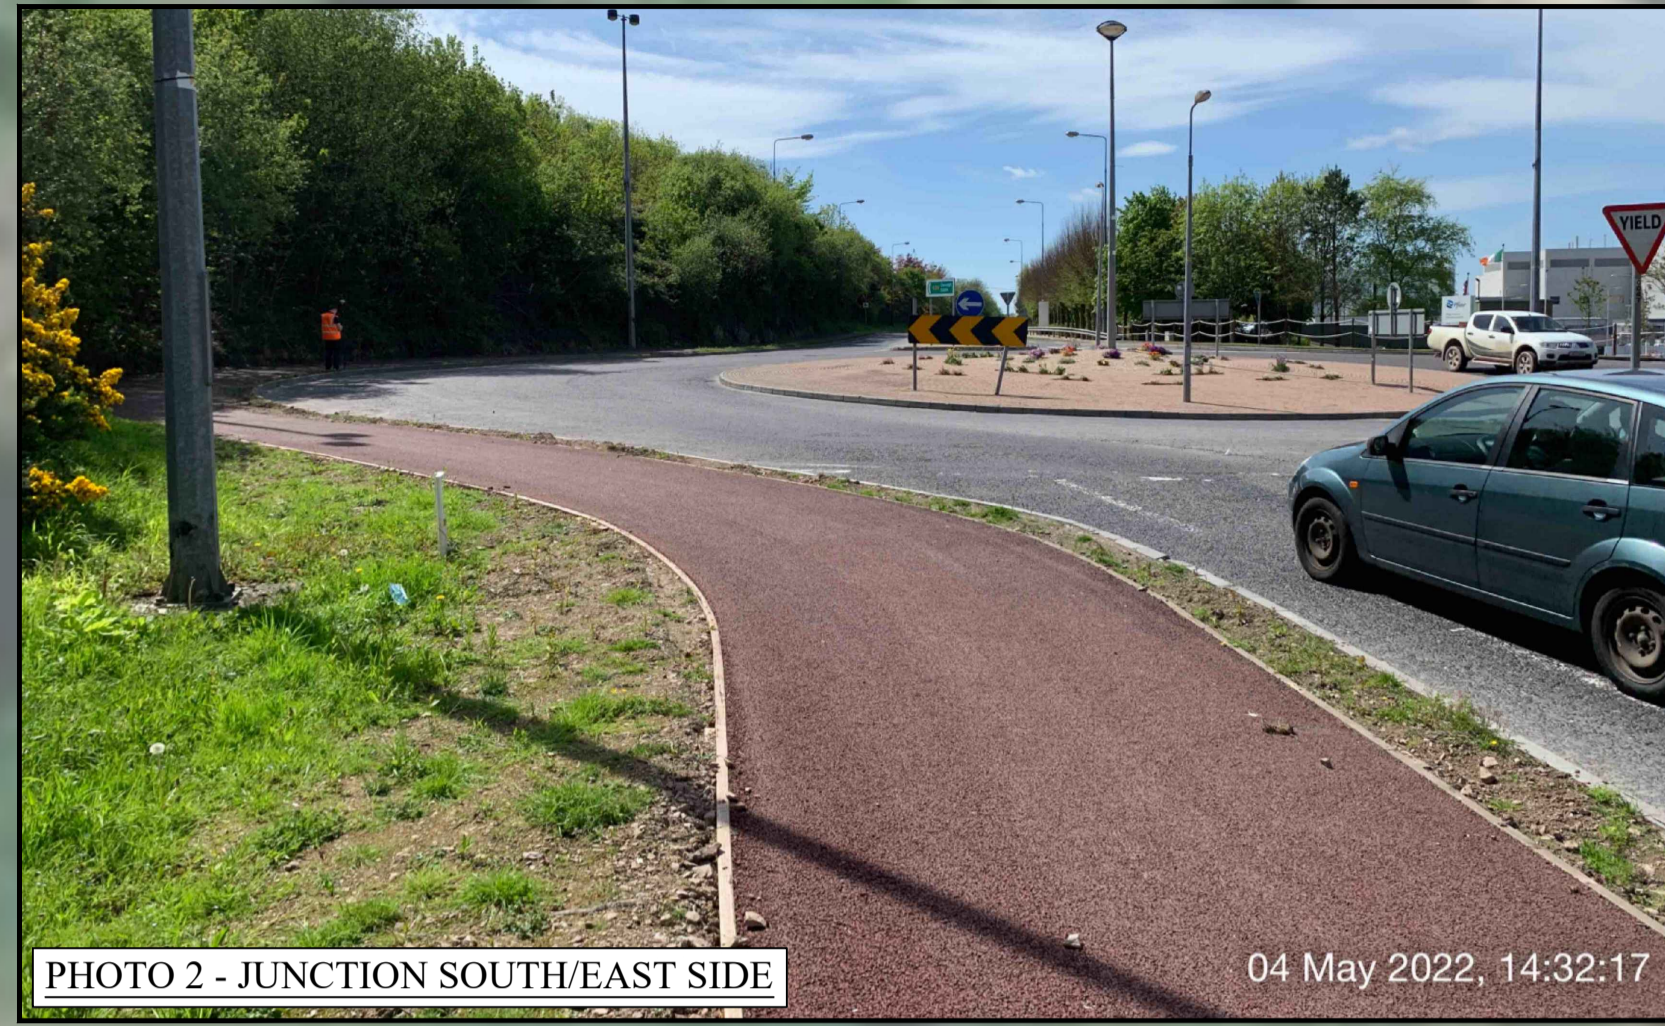
PHOTO 2 - JUNCTION SOUTH/EAST SIDE

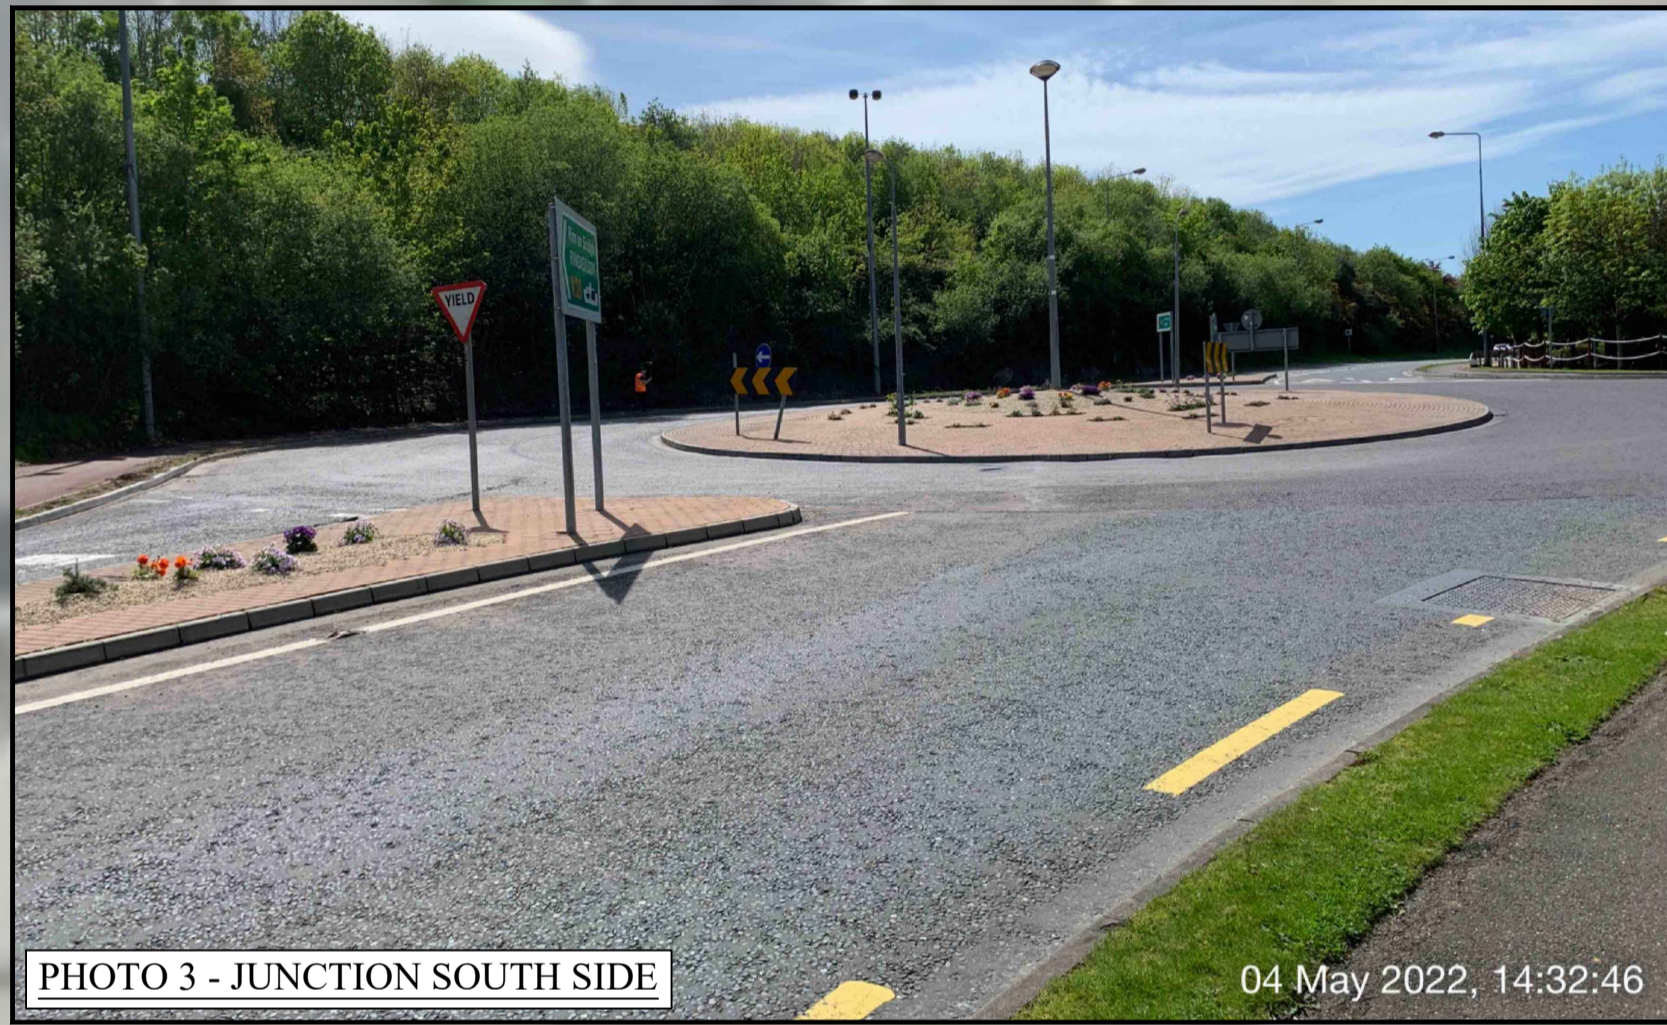
PHOTO 3 - JUNCTION SOUTH SIDE

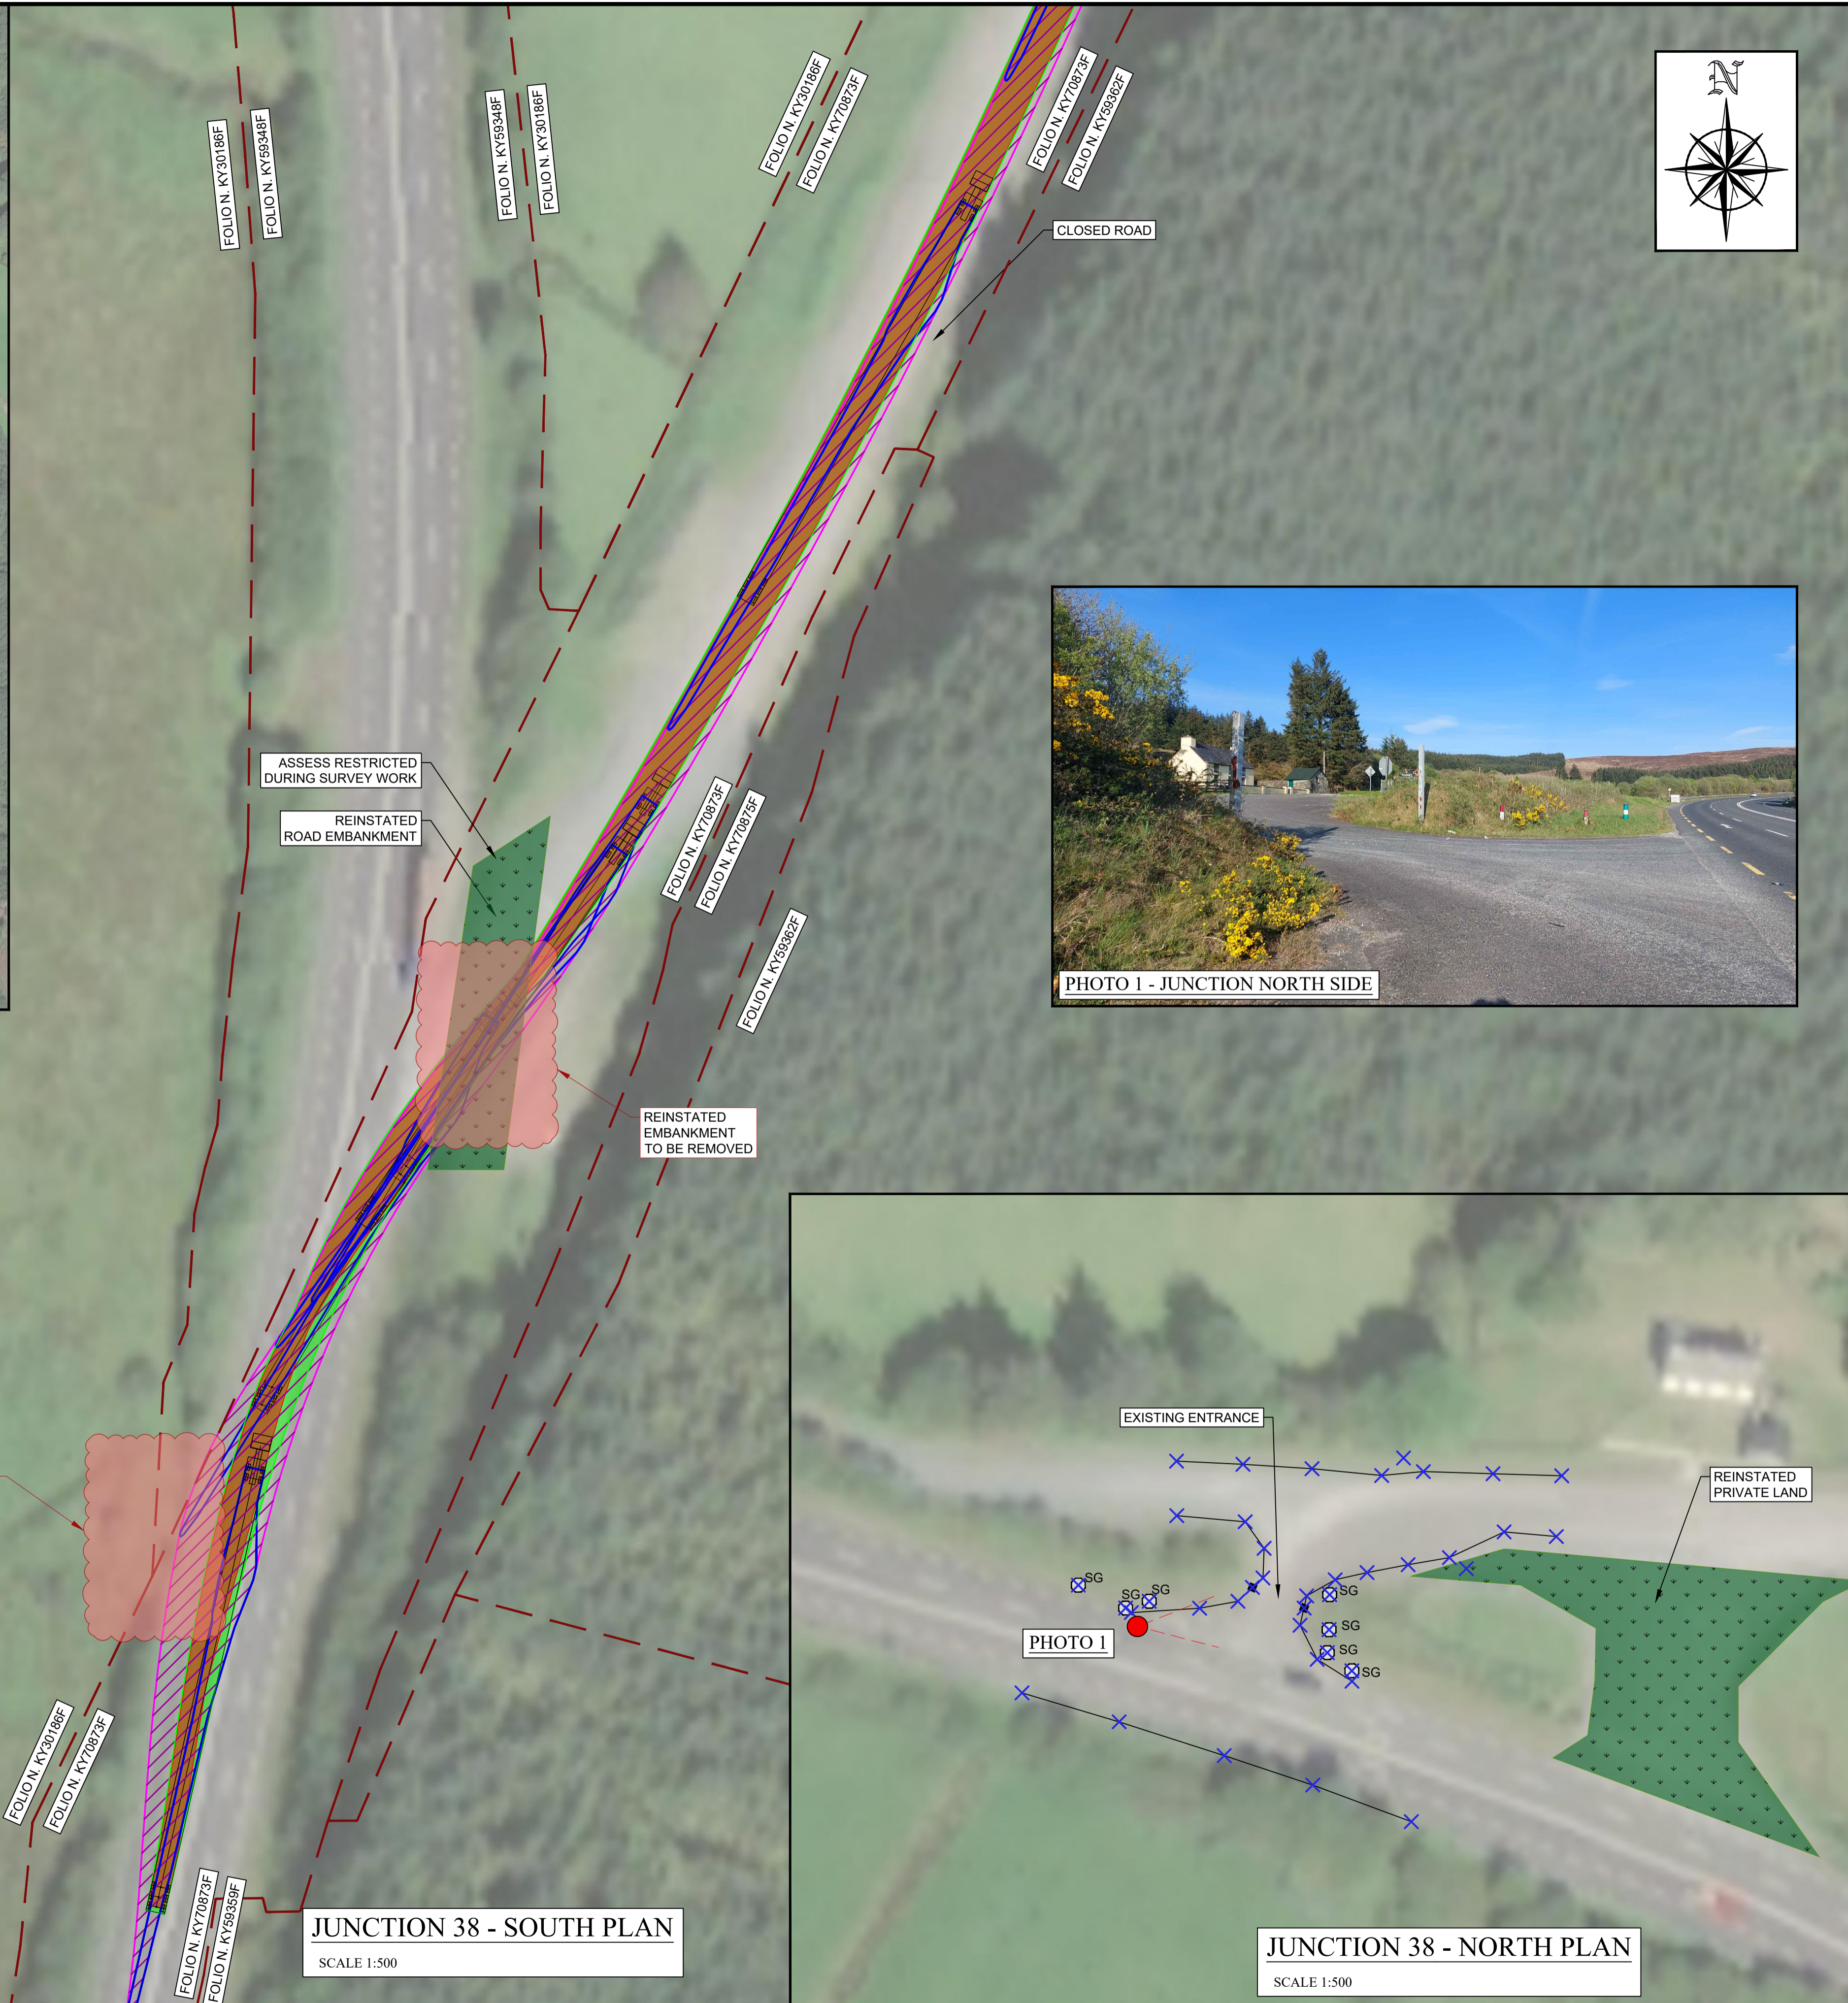
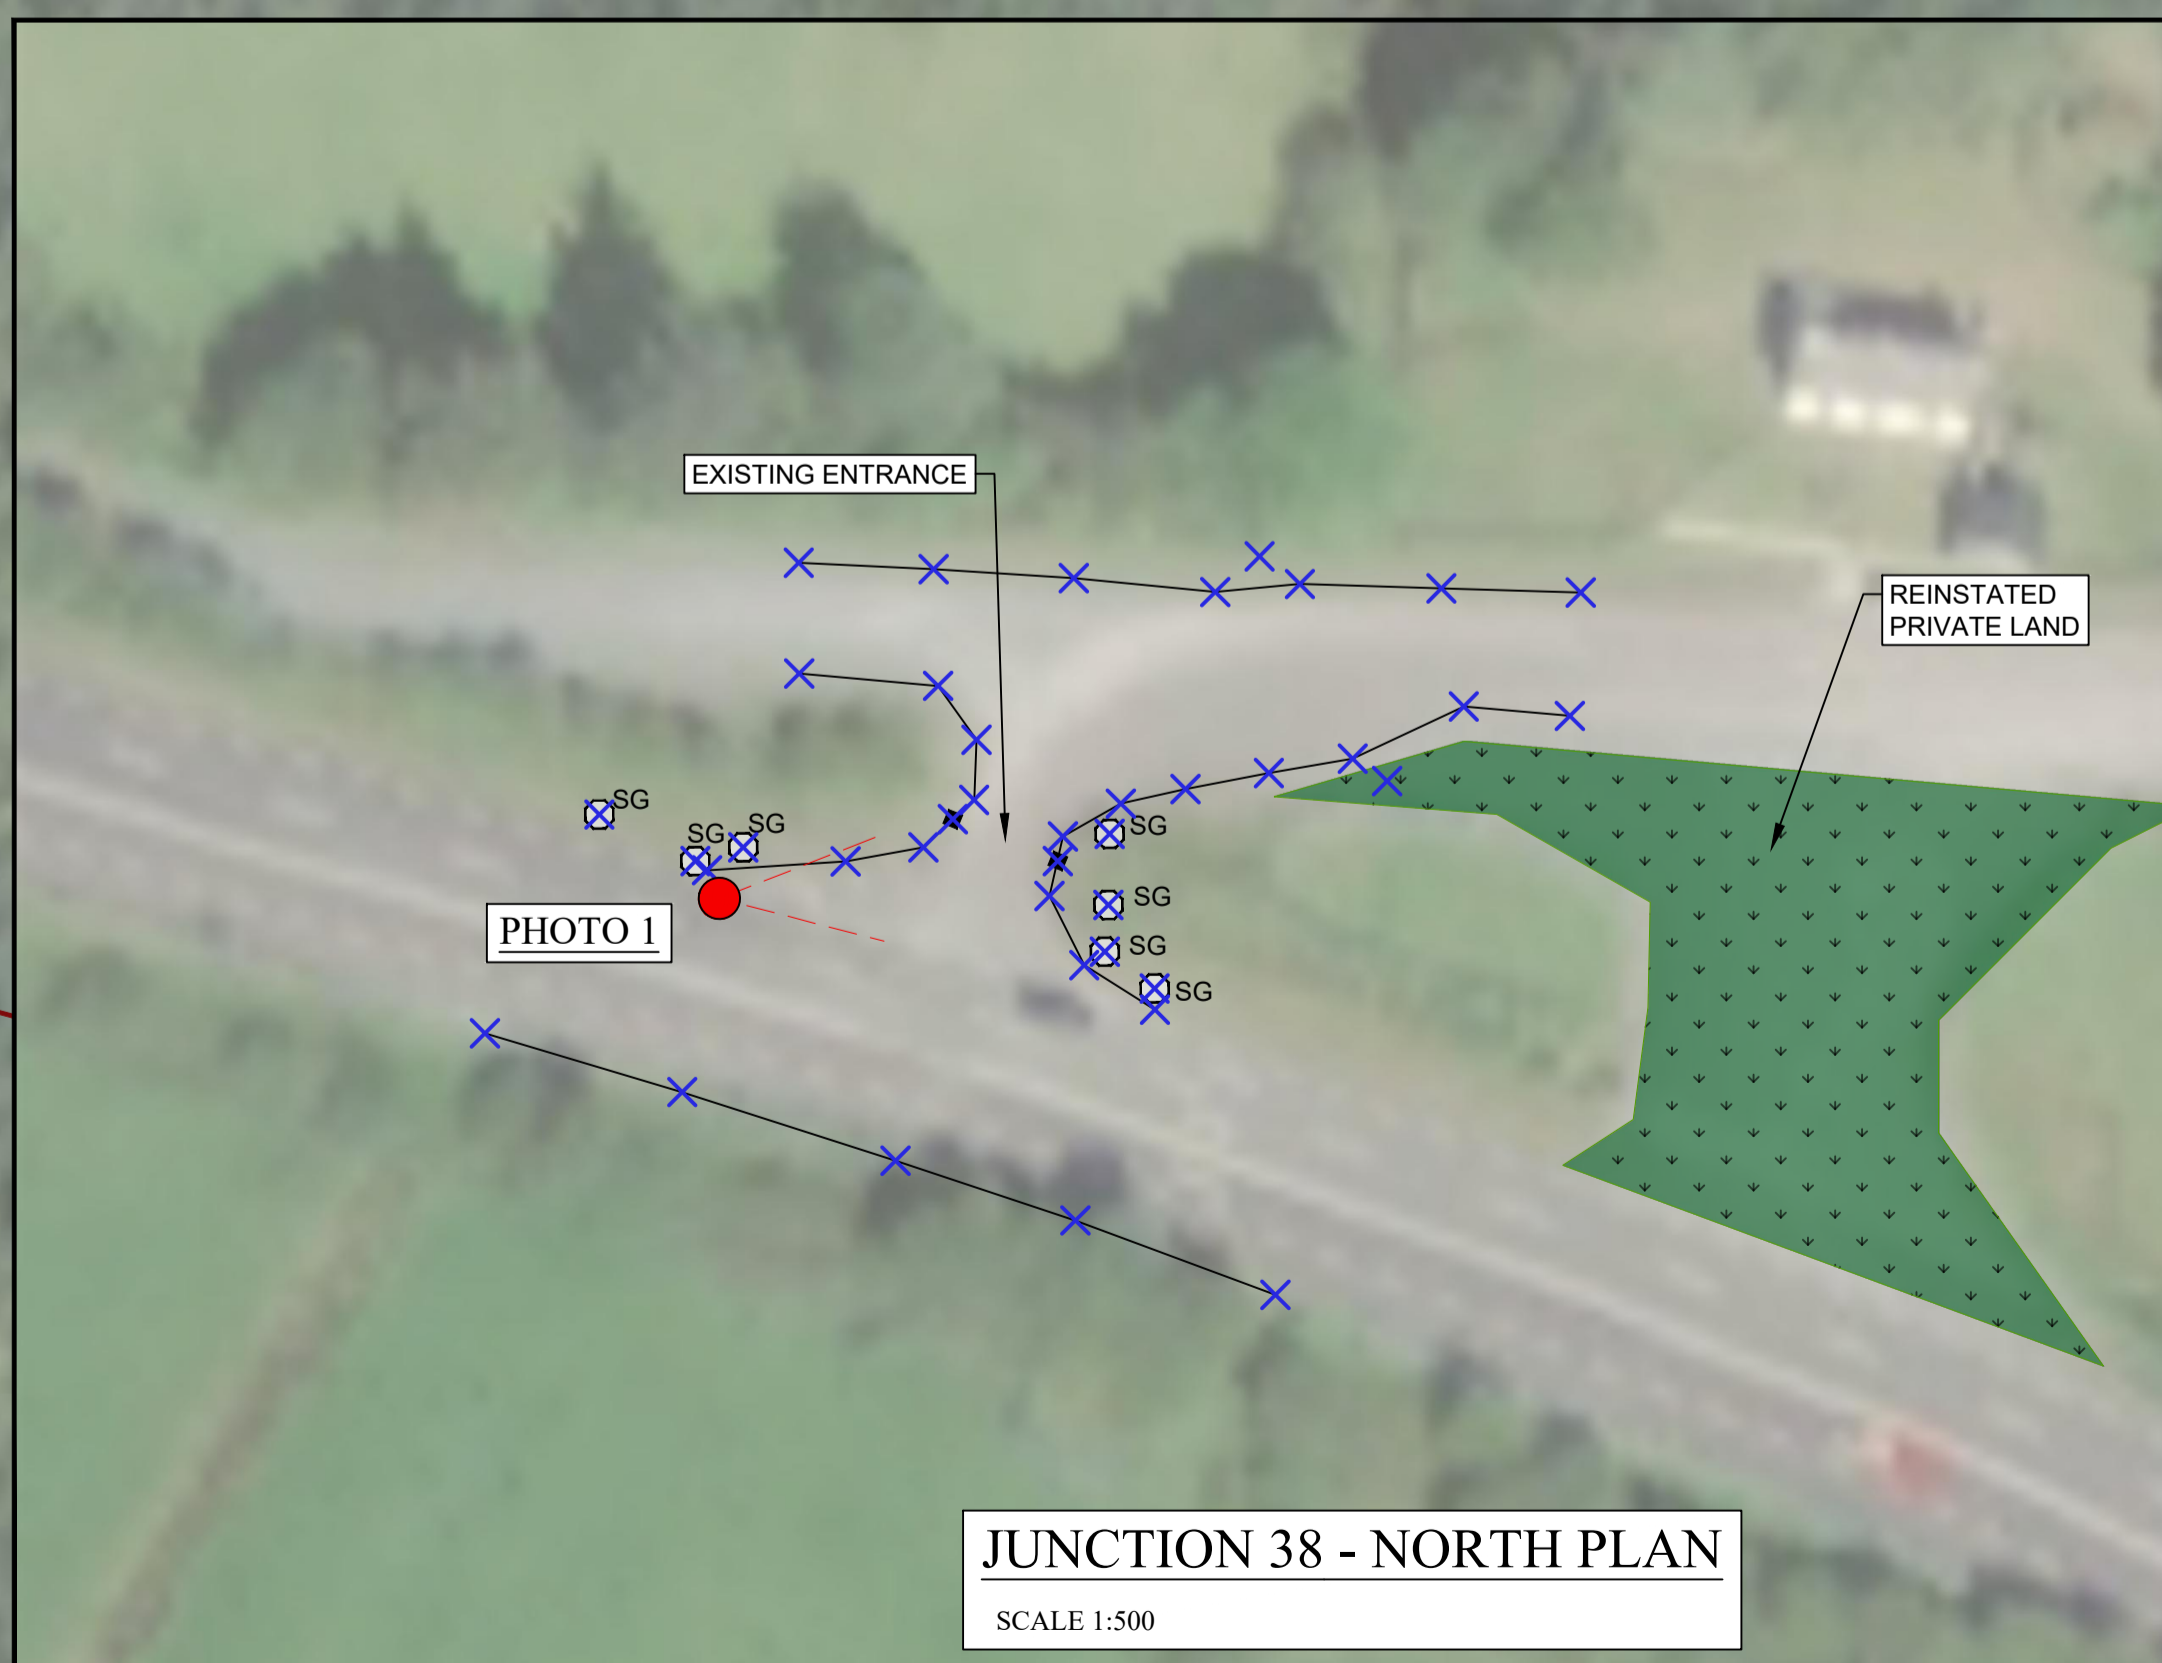
DRAWING TITLE: **JUNCTION 38 LAYOUT**

BLADE	81.1 m
LORRY	65.66 m
OVERALL LENGTH	85.71 m
MOD. SCANIA-REAR-STEERING	
OVERALL LENGTH	65.66m
OVERALL WIDTH	2.55m
OVERALL BODY HEIGHT	4.80m
MIN BODY GROUND CLEARANCE	0.37m
TRACK WIDTH	2.50m
LOCK-TO-LOCK TIME	6.00s
WALL TO WALL TURNING RADIUS	9.80m

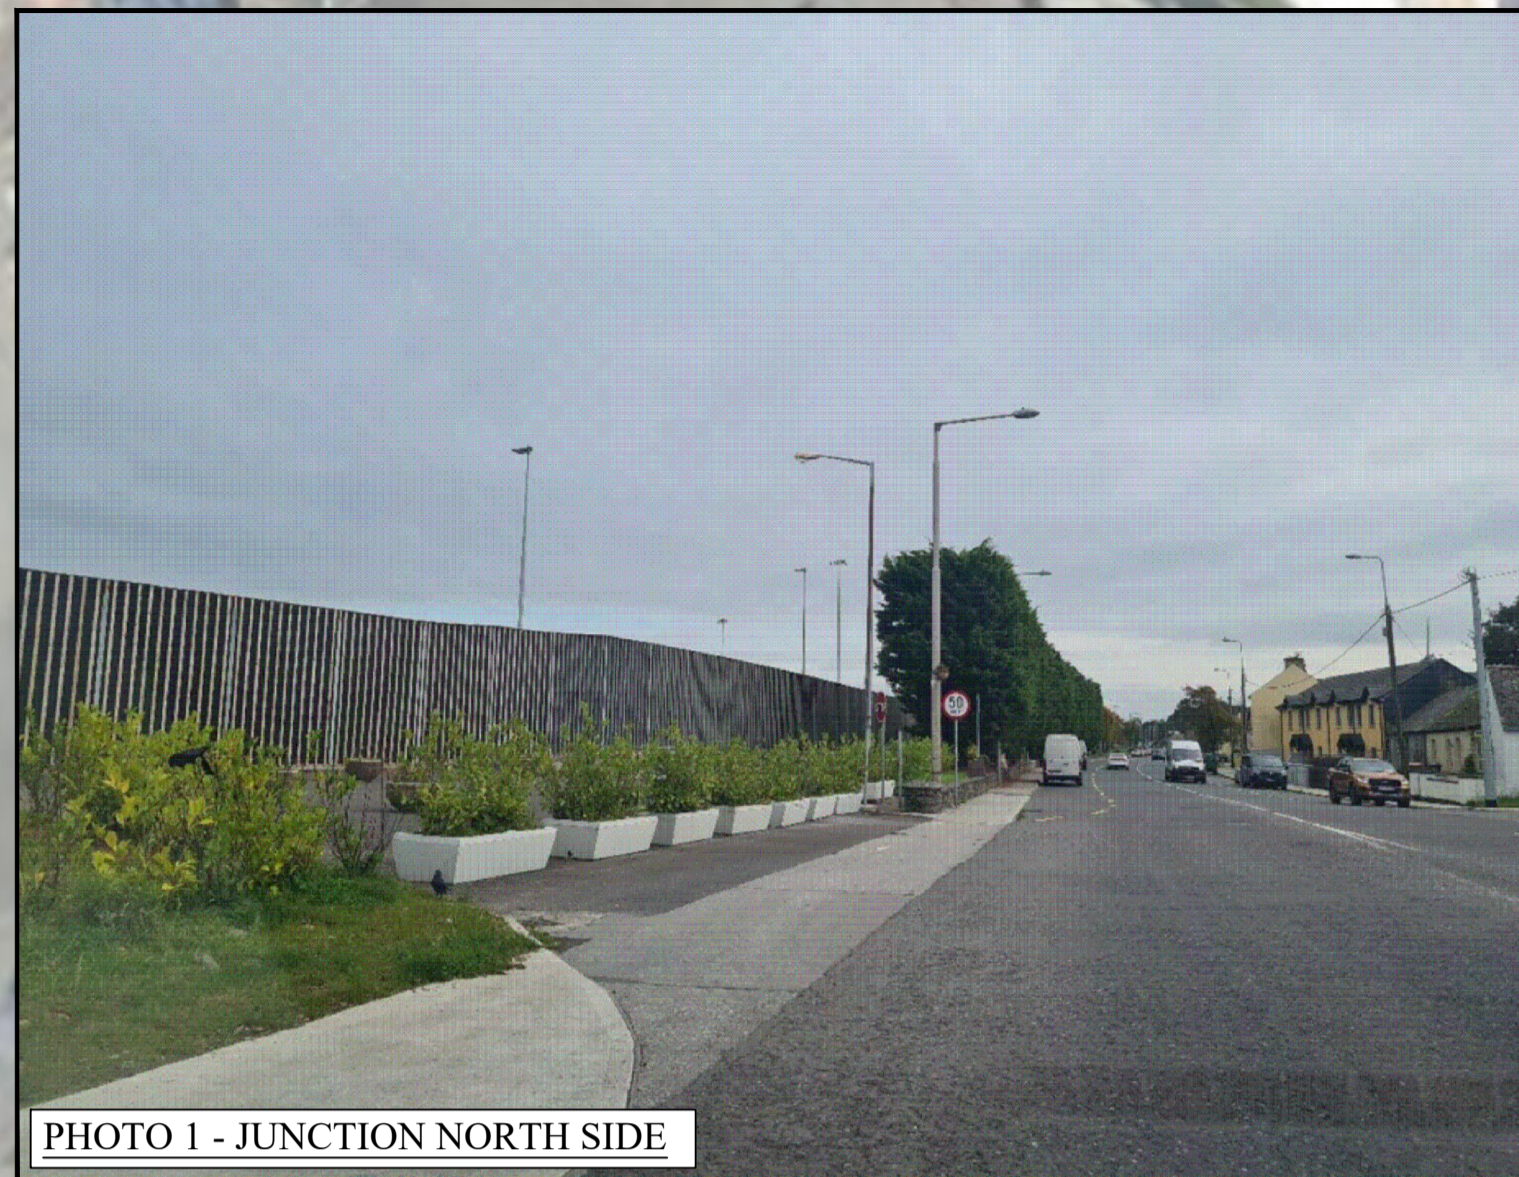
PHOTO 1 - JUNCTION NORTH SIDE
