**Re: Planning application for a 110 kilovolt electricity substation, approximately 7.5 kilometres of underground electricity line and all associated works at Moyvannan, Feamore, Lisbaun, Carrownolan, Carrowncloghan, Carrowkeeney, Ardmullan, Curraghboy, Gortnasythe, Derryglad, Eskerbaun, and Brideswell, County Roscommon**

**Ref. No. 321328**

## **Observations on planning application**

**ABP-321238-24**

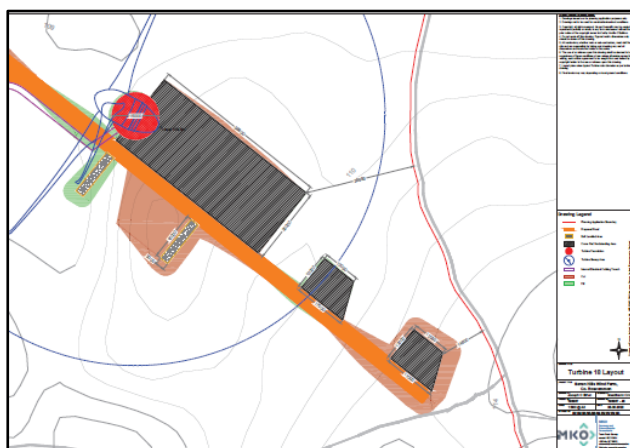
The title on this drawing is *Turbine18 layout* it shows a 15.0m base to T18 and the associated infrastructure works. The drawing is dated 03.06.2022

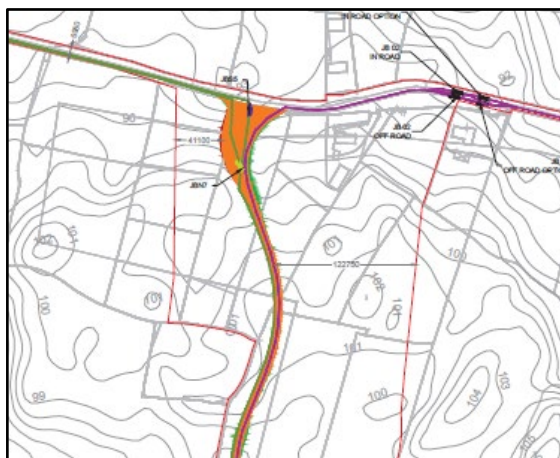
**Figure 3: Drg. No. 190907-18 (07.06.22)**

In addition the two distinct options include different site boundaries. Figure 3 shows an extract from drawing No. 190907-18 as lodged with the application on the 7<sup>th</sup> of June 2022. Figure 4 shows an extract from drawing No. 19099-18 Rev A lodged as part of the FI of the 31<sup>st</sup> of March 2023.

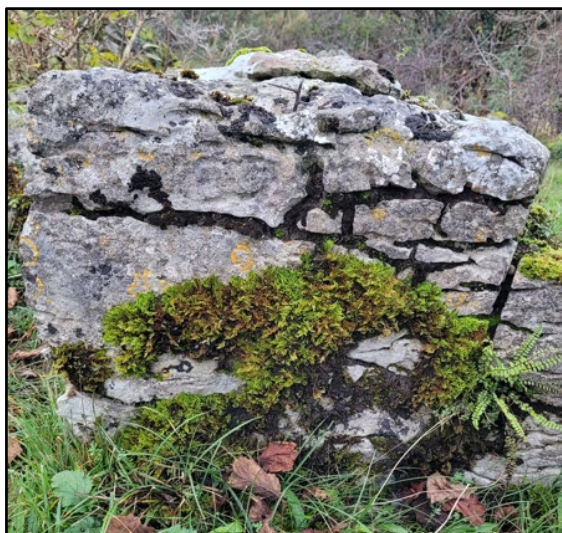
**Photo 1**

Groundwater flow in karst aquifers is three dimensional. Horizontal conduits can form at multiple levels as illustrated in Photo 1.

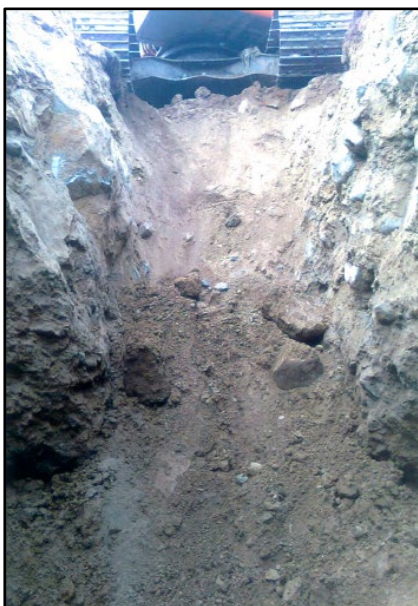
**Photo 1: Collapsed subsoil**

Photos 1 and 2 below correspond with Photos 26 and 27 as described above. The location of the conduit is shown in Figure 6.

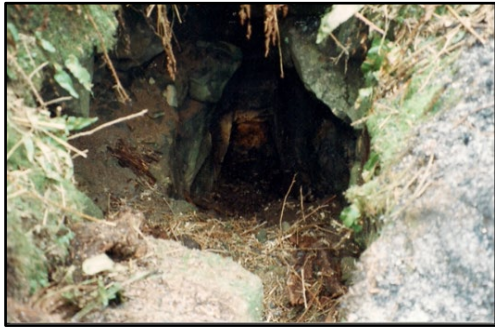
**Photo 3: Entrance to cave at T5 (1996)**

The geophysical data indicates the centre of Turbine T05 is characterised by c. 1.5m of medium dense to dense slightly clayey sandy GRAVEL/BOULDERS over very poor highly weathered/ possible karstified LIMESTONE over moderately weathered/possible karstified LIMESTONE. Depth to slightly weathered to fresh LIMESTONE is 3.0m bgl<sup>25</sup>

Since 2011 photographs 3 and 4 and explanation text have been sent to the Board on numerous occasions. They were last submitted in July 2022 as part of a submission regarding ABP-31750-22.

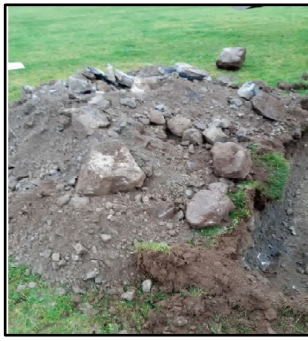
Figure 9: T5 TP02<sup>26</sup>

likely a high point of the very poor highly weathered/ possible karstified LIMESTONE as recorded in the geophysics.

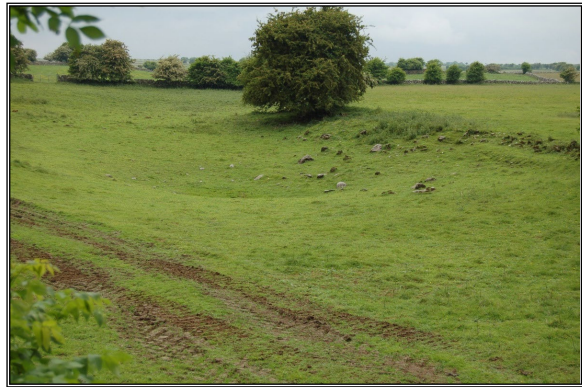
**Photo 22 (2011)**

Photo 22 is captioned " Photograph of typical (doline) present at the site and within the general area."

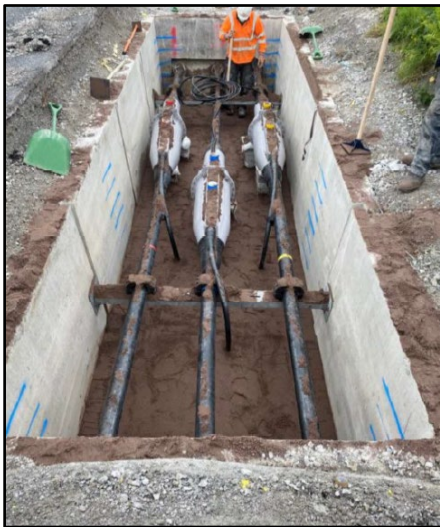
**Figure 14a: Typical Joint Bay Backfilling Procedure**

RCC Roads Dept. require the applicant to carry out full lane reinstatement on all public roads where cabling is within the carriageway.

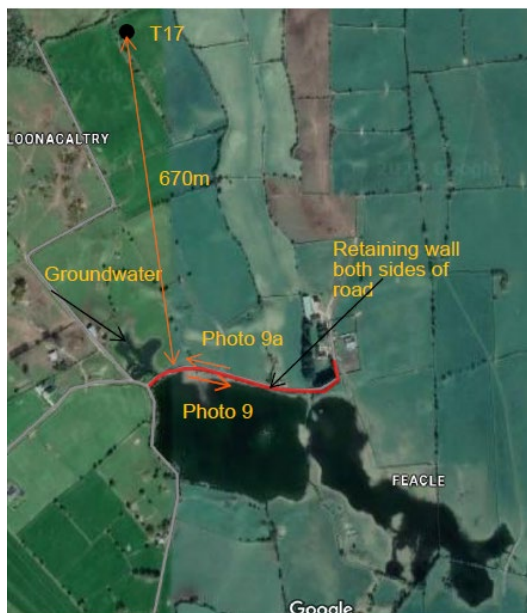
**Figure 18: Feacle Turlough April 2011**  
(Google maps)

Feacle turlough can be measured as 670m from T17 but it is an artificial measurement. In order to maintain the structural integrity and user safety of the road to the north of the turlough RCC built a retaining wall on both sides of the road. The wall artificially constrains the groundwater as shown in Figure 18 but is not always successful. Photos 9 and 9a were taken on the road in Nov. 2024 looking east and west respectively.

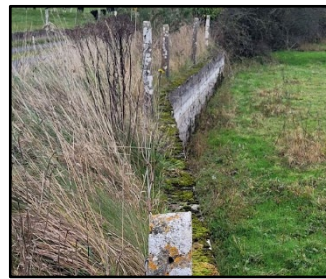
**Photo 9**

Retaining wall built by RCC to maintain structural integrity of the road and safety of users.

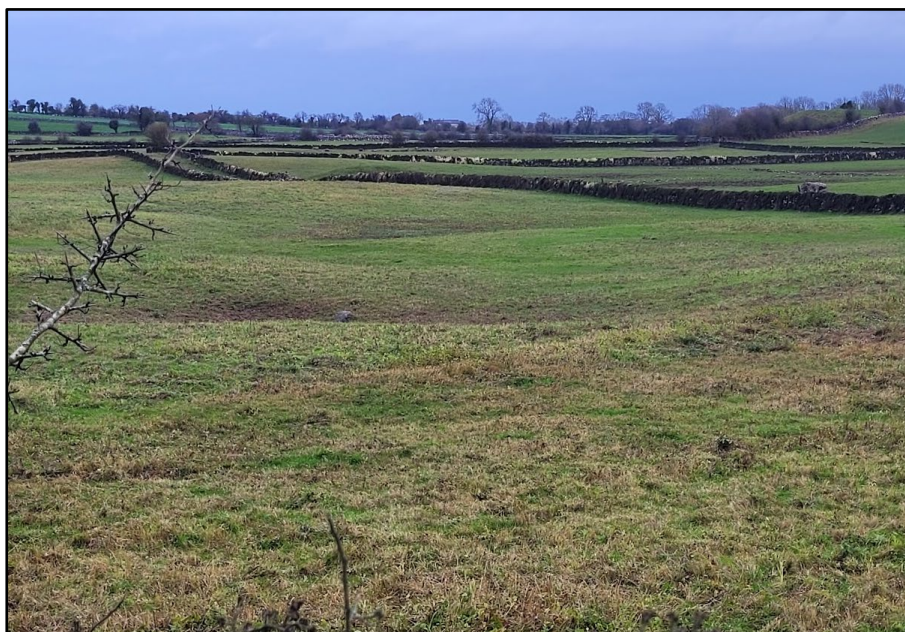
**Photo 10: Feacle turlough in Nov 2024**

Photo 10 shows Feacle turlough empty on the 25<sup>th</sup> Nov 2024. The enclosed depressions can be clearly seen. These are surface expressions of subterranean subsidence. Photo 8 shows these depressions beginning to fill from underground sources after heavy rainfall.

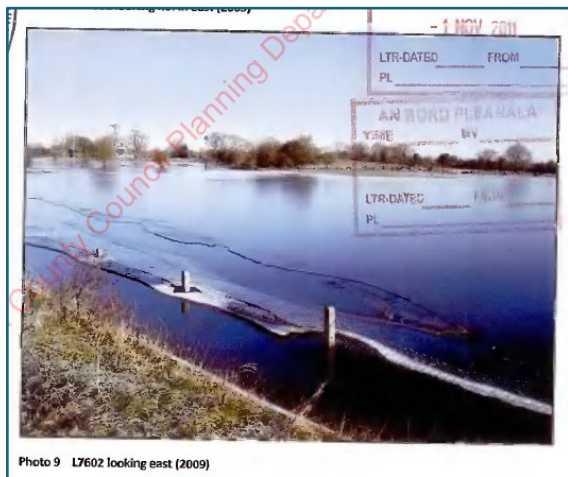
**Figure 27: L7602 looking east (2009/2010)**

Figures 27 and 28 are the photos referred to in the text. Figure 29 shows the Senior Executive report referred to in the submission.

The RCC Engineer's report states 'there has been significant flooding at this location i.e. March 2007 & Nov. - Feb 2009/10' and notes 'RCC raised this section of the road by approx. 500mm' RCC raised the road again after the 2015/2016 flood event as can be seen in Photo 9a. The raised road acts like a bund to contain and thus extend the flood waters to the east of the road.

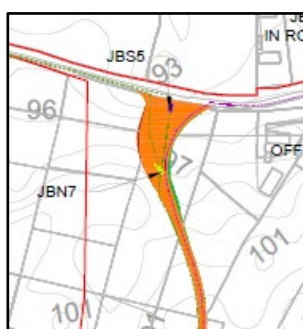
**Detail F**

Detail F shows both sets of cables joining at JBN7 and going towards the onsite substation.

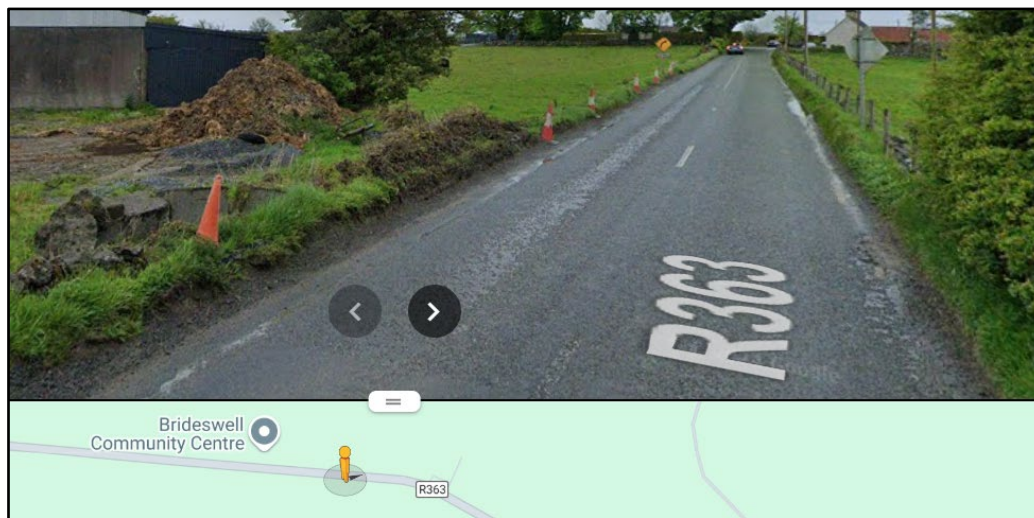
This is one of the many sections along the R363 where there is no verge, it is approx. 1.0km west of Brideswell village. At this section the road is not wide enough to accommodate heavy traffic

this resulted in damage to adjoining land and dangerous road conditions as shown in Photo 11

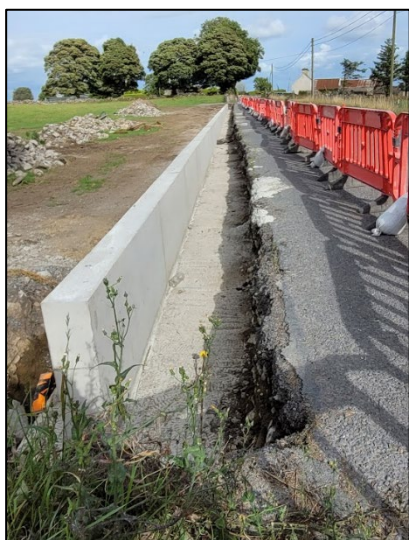
**Photo 12: Retaining wall at the R363**

In August 2024 RCC built a reinforced concrete retaining wall along this section of the R363 to preserve the structural integrity of the road and to improve the safety of the road. Photos 12 and 13 show the retaining wall and the finished wall faced with dry stone walling. RCC operated a 'stop go' system during the construction of the wall.

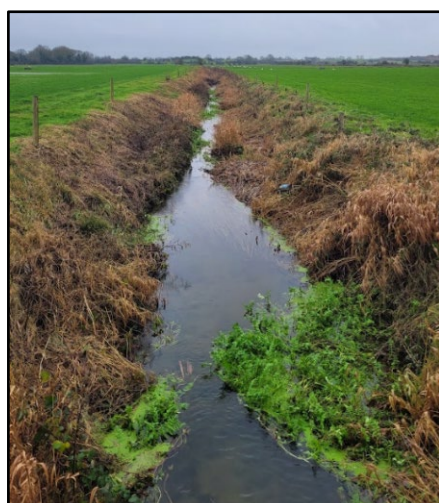
**Photo 14: Culvert at L2023 Looking SE**

At the culvert location the Cross Drain is joined by a NW arterial drain and additional drains on both sides of the SW section of the L2023.

Planning Drg. Figure 13: Directional Drilling Specification does not show these drains.

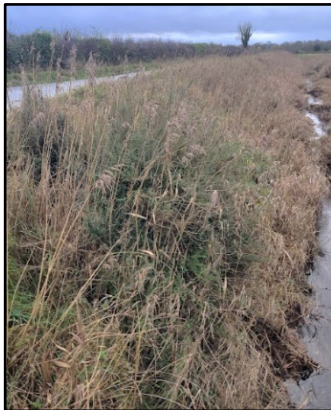
**Photo 17: At access point looking SW**

Photo 17 shows the L2023 approx. 2.0m above the water level of the Cross Drain in Nov. 2024. Photo 18 shows the culvert at an access point to a field, in the same place it was almost 150 years ago – Detail K. The L2023 along this location is single lane width approx. 3.0m wide.

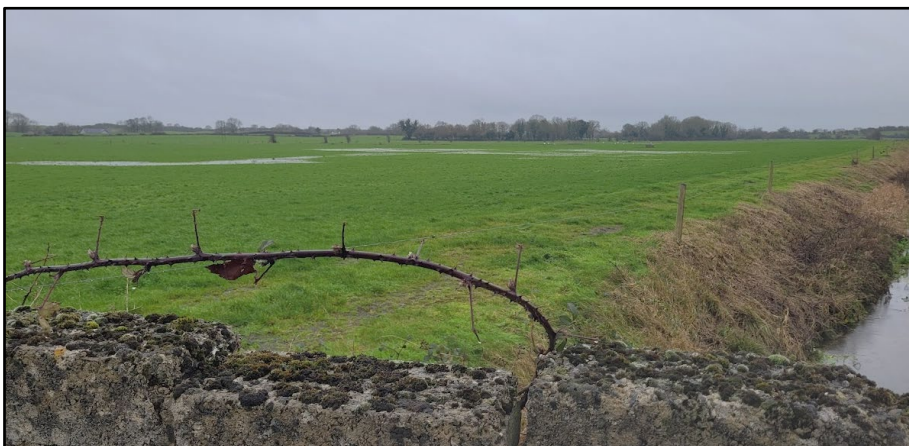
**Photo 19: Bridge on L2023 looking east (Nov 2024)**

The bridge at the L2023 is already structurally compromised as evident by the severe settlement

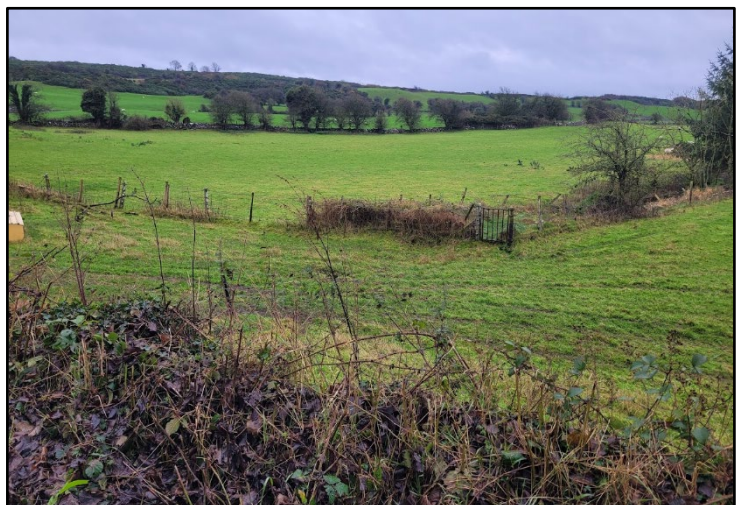
**Photo 21**

At Point A on Figure 41 the east side bank is cleared and the high ridge, which the 1996 tracer line bisects is visible in the distance—Photo 21. The spring, the source of the River Cross is approx. 850m SE of this point.

Photo 21 shows what could be considered to be the base of the valley, but it does not do the area justice. The vista has to be seen to be appreciated and understood.

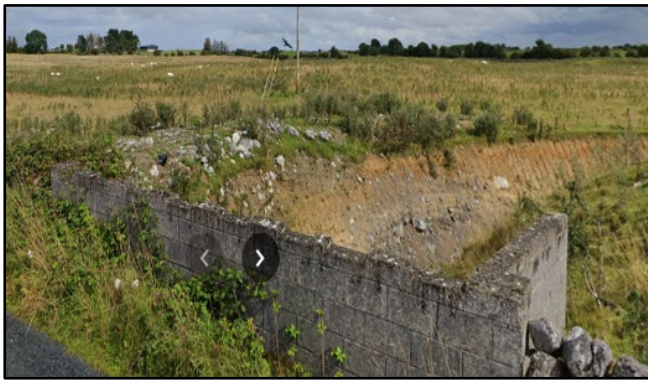
**Photo 22b: Aug. 2019 (Google maps)**

The 2019 photo shows erosion/ widening of the channel, most likely after the 2015/2016 rainfall event.

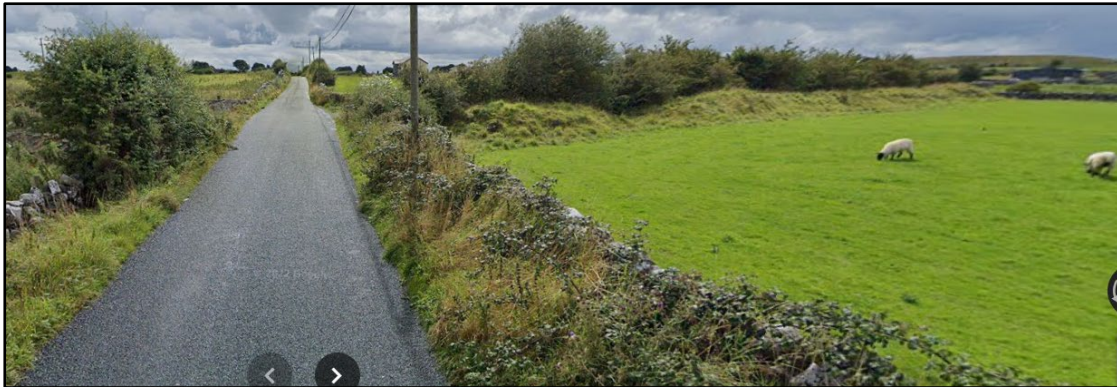
**Photo 23: The excavated material is visible on the bank Aug. 2019 (Google maps)**

Photo 23 is looking NE from the L2024 and shows the excavated material deposited along the bank.

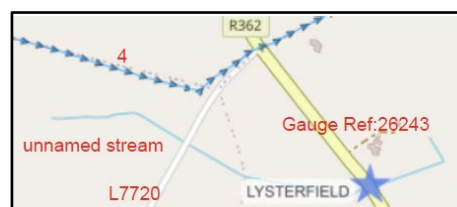
**Figure 2a: Gauge No 26243**

The EPA describes the gauges as Water level and flow gauges. Figure 2a shows gauge No. 26243 located on an unnamed water body. Figure 2b shows gauge No 26245 apparently located remote from a water body.

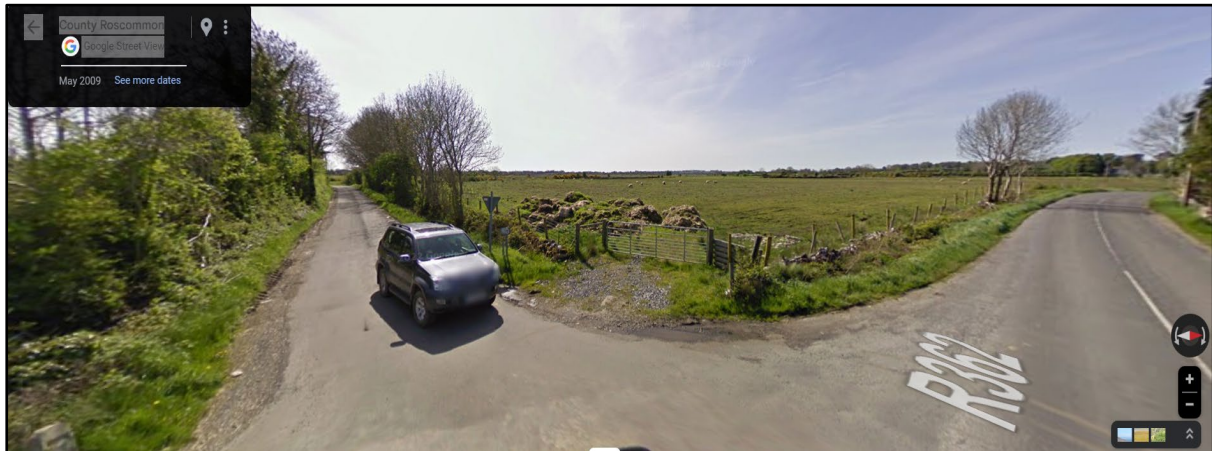
**Photo No.3: The junction of the L7720 and the R362 – May 2009**

**Stream No. 4** – Photo No. 3 is a May 2009 view (Google maps) at the junction of the R363 and the L7720. A drainage ditch is located along the righthand side of the L7720, stops at the farm gate and then continues along the lefthand side of the R362 but it is not culverted under the R362.

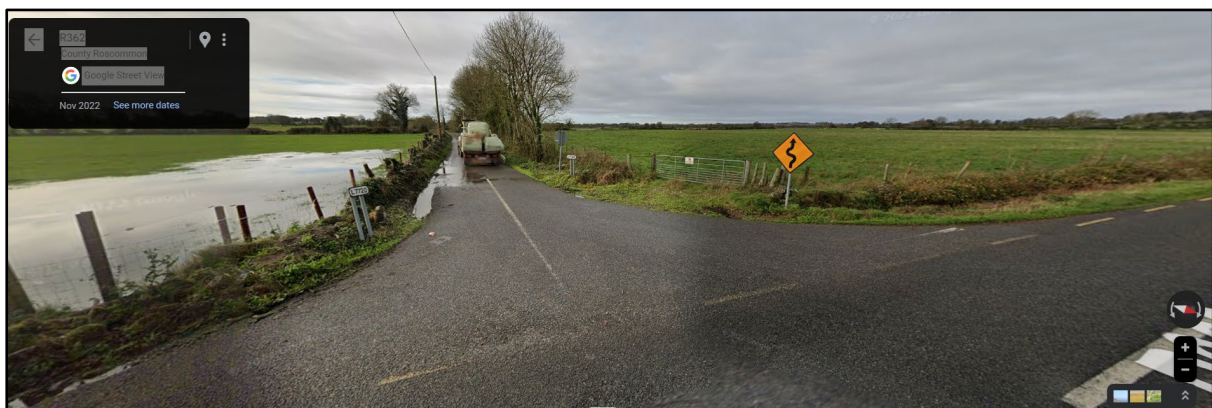
**Photo No.4: The junction of the L7720 and the R362 – Nov. 2022**

Photo No.4 is a Nov 2022 view (Google maps) at the same junction. The corner field at the junction is flooded, the groundwater has reached the centre of the L7720 and is moving towards the roadside drain.

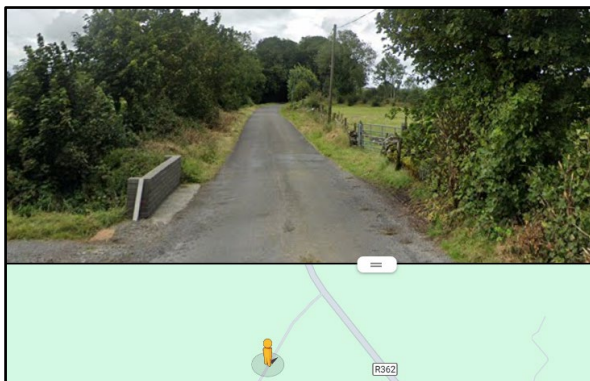
**Photo No.5 drain culverted under L7720**

**Short water feature south of stream No.4** - Photos No.5 and 6 are Aug.2019 views (Google Maps) on the L7720 and the R362 respectively. Both show a drain culverted under the road.

The OSI 25" map records artificial drains mapped along the lines of streams Nos. 3 and 4 and the unnamed stream - Figure 14. The unnamed stream on the EPA maps as described in 1.2.2 (Photos. No. 5 and 6) is a drain, field drains in Corralea discharge into it.

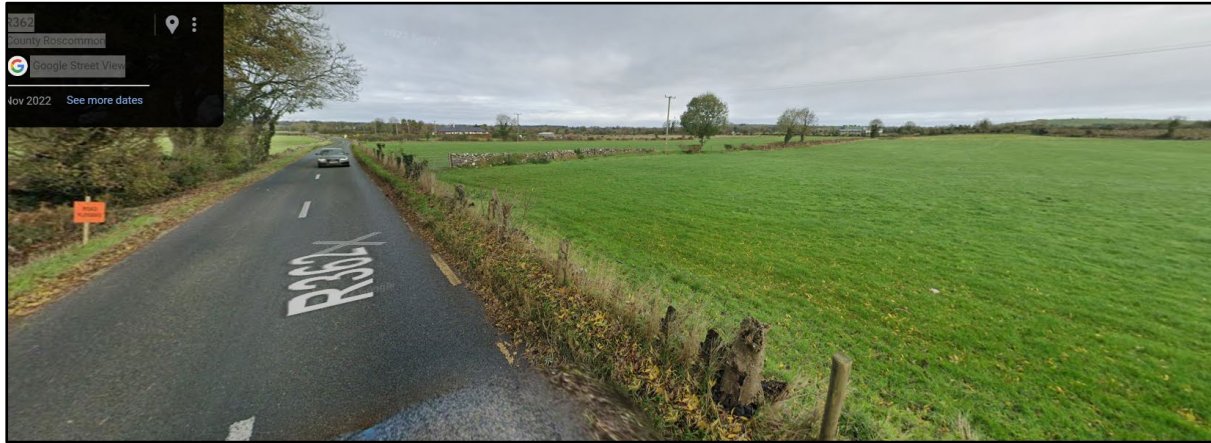
**Photo No. 10: Looking North on the R362**

**Stream No. 5 –** Photo No. 9 is a Nov.2024 view (Google maps) of a drainage ditch off the R362 Road at the same location as the EPA map. Photo No. 10 is a view (Google maps) looking north on the R362. The drain can be seen in the background adjacent to the vehicle on the road. There is a roadside drain on the left hand side of the R362, the orange sign says Road Flooded.

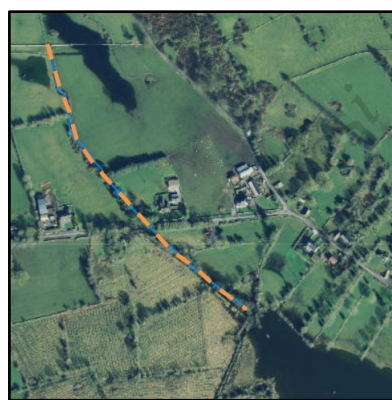
**Detail B**

Detail A shows a water feature, measured to three decimal places of an acre, on the 25" map overlain with the GSI Karst Landform feature type "Enclosed Depression". Detail B shows the line of a ditch dotted orange which may be a drain added at a later stage in attempt to drain the flood north of the L2005.

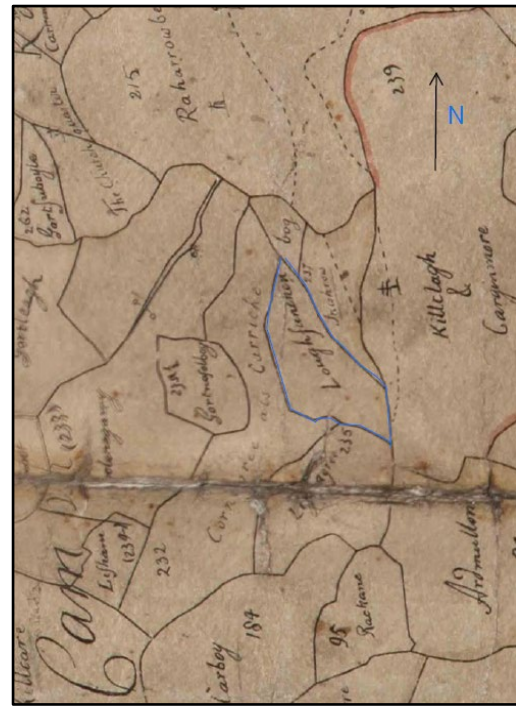
**Figure 25: Down Survey  
Lough Funshinagh outlined in blue**

If any doubt remains regarding the credentials of Lough Funshinagh, then reference to the [Down Survey](#) , Figure 24 and 25, should assuage all concerns.

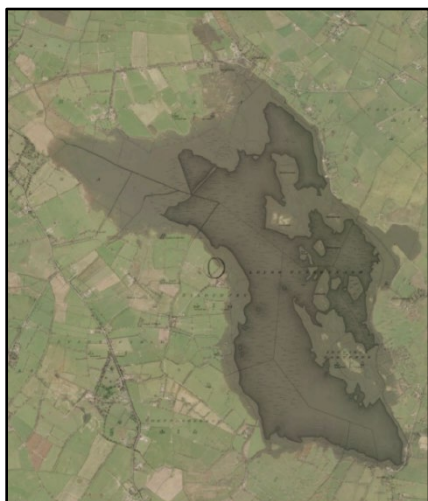
**Figure 27: OSI 6” (1830 - 1880) outline of Lough Funshinagh overlain on the ESRI World Imagery basemap. (National Library of Scotland)**

Lough Funshinagh continued to fill in the manner it always had pre the drainage works but now land drainage and flood areas, remote from the turlough, springs, sinking streams were collected in the new drains and discharged into the turlough. At the NW corner of Lough Funshinagh, the drainage network extends westward for over 3.5km. Groundwater from the moderately permeable sub soil to the west was now able to flow directly into Lough Funshinagh. Today, the drainage network continues to discharge into the turlough. When the net rate of inflow exceeds the net rate of outflow the turlough expands and floods low lying areas. The extent of the change in the turlough since 1830 can be seen in Figure 27.

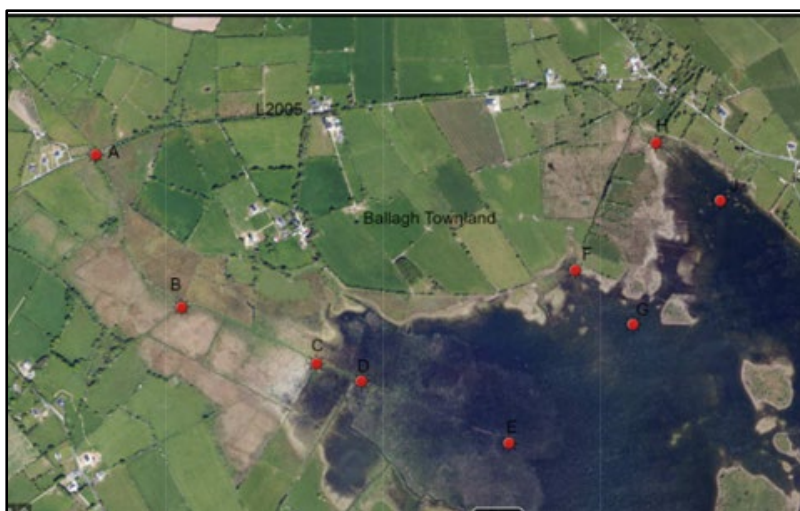
**Figure 33: OSI Digital Globe Imagery 2011 – 2013**

The 2011 – 2013 aerial photograph records that the water has receded along the line B/C, the evidence of previous flood lines is shown by the damaged areas of grassland. The NE corner hasn't receded significantly indicating lower ground in this area.

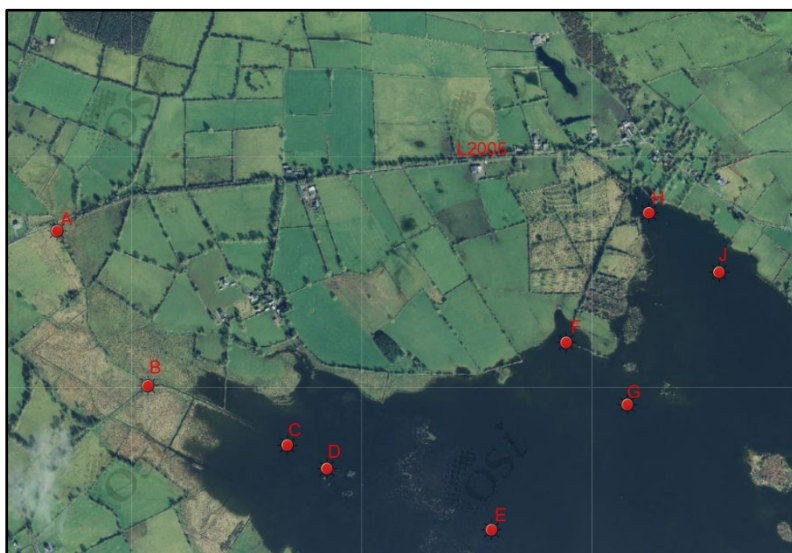
**Figure 34: OSI Digital Globe Imagery 2013 – 2018**

The 2013 - 2018 aerial photograph is almost identical to the 1995 aerial photograph.

The 1995 Imagery is shown in Figure 35. The flood extent is similar to that shown in the 2013-2018 imagery. The Google Historical Imagery 2006 is shown in Figure 36, the damaged grass areas in the NW and NE are evidence of previous flood extents.

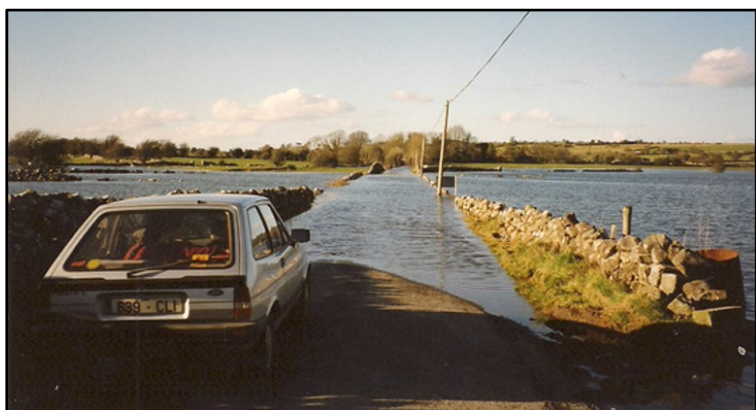
**Photograph No. 5: Dysart Turlough looking north Spring 1995**

The Dysart turlough is approx. 7.5km SW of Lough Funshinagh. The flooded turlough in 1995 is shown in photograph No.5. This photograph had been provided to RCC in 2010 and 2011. Met Eireann records for the Lecarrow station are shown in Figure 37.

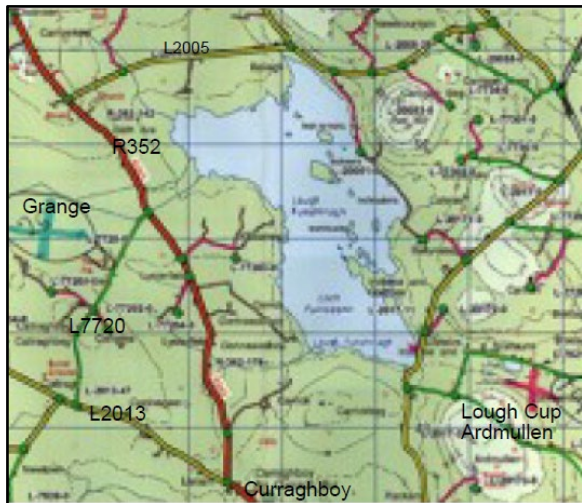
### 3. Athlone Area Engineer Meeting - Map 107.12.2004 (Appendix B)

Item 14 refers to a “small lake”, this is the waterbody known as Lough Cup and is marked with an X on the map.

Item 25 – Grange is marked with an X on the map. The extent of the area of flooding is shown in Figure 41. The flooded area is identified in the 1890 maps as “Liable to flooding”

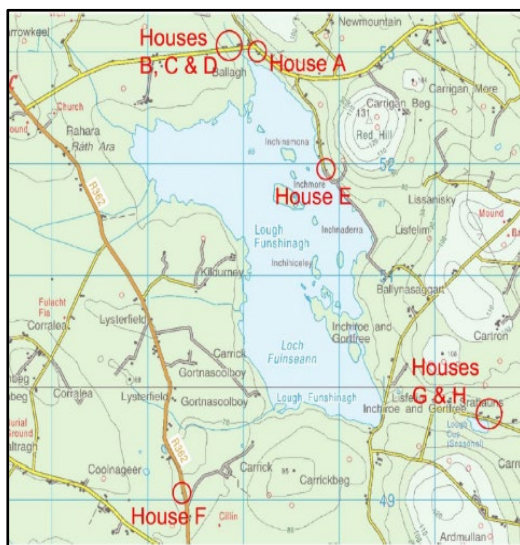
Figure 42: Figure 3 from Malachy Walsh & Partners 2021 report

A report in 2021<sup>19</sup> notes *During the 2015/2016 flood event, two houses in Ballagh near the shore of Lough Funshinagh were flooded. These are referred to as House A and House E on the map in Figure 3. Three other houses in Ballagh, Houses B, C & D were at risk of flooding with minimum freeboard above the maximum flood level. A house is Lysterfield, House F, and a section of the R362 regional road were flooded. Two houses, House G and House H and a group of farm buildings at Srahauns at Lough Cup were cut off by severe flooding of the road over an extended period. ...in the winter of 2015/2016 (when) the water reached a level of 68.25 mOD.* (emphasis added)

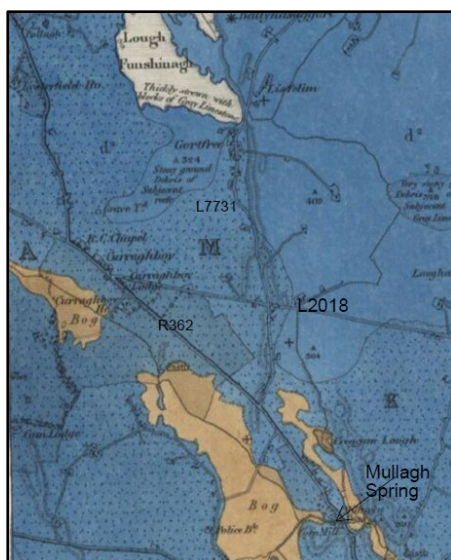
**Figure 58: BGS Sheet No. 58**

In the mid-19<sup>th</sup> century, the British Geological Survey (BGS) produced geological maps of Ireland. Figure 58 shows a section from Sheet No. 98. Memoirs were also published along with the maps.

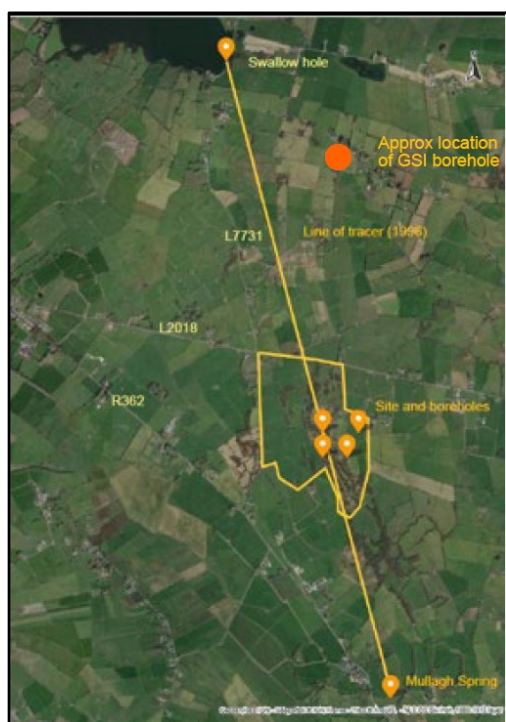
**Figure 61: Location Plan of proposed quarry**

The site location in relation to Lough Funshinagh is shown in Figure 61. The 1996 tracer test line is shown as a yellow line. A GSI borehole is approx. 1.2km SE of the swallow hole. The details from the GSI Groundwater data viewer are shown in Figure 62.

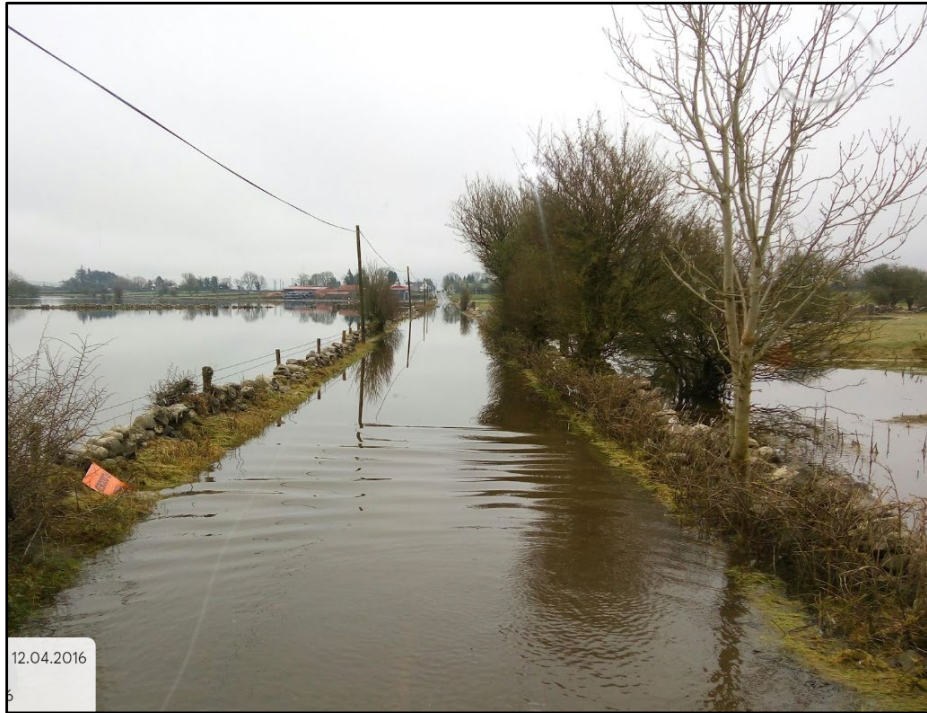
**Photo 11: The R363 flooding looking south April 2016.**

Photo 11 shows the flooded R363 leading into Dysart in April 2016. The flood was over 600m long on the R363 and too deep to wade through. It took months for the floodwater to recede. Dysart village escaped simply because the R363 and the surrounding land was low enough to accommodate the flood water. RCC's solution was to raise the road as shown in Photo 12

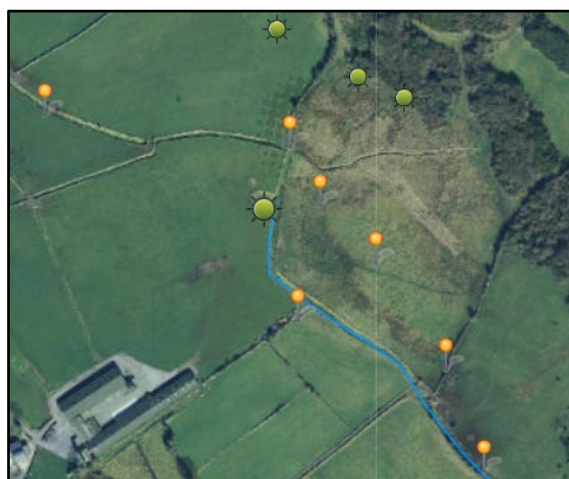
Figure 2a: (springs shown in green)

Detail B is shown in Figures 2 and 2a above, Detail C is shown in Figures 9,10 and 10a

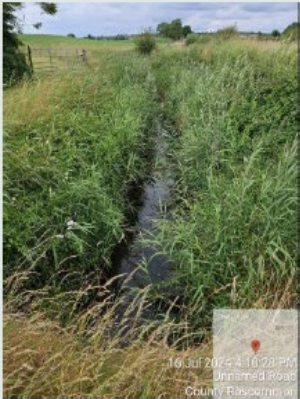
| Location | Comment | Image |
|---|---|---|
| L2023 Road Crossing | Photograph was taken from the L2023 road south of Curraghboy village. The Cross runs parallel to the road for 160 m at this point before turning 90 degrees and crossing beneath the road. Riverbed is free from growth and straight with high banks which are covered with grass and vegetation. Channel continues to be oversized for flow. | |

It is unclear how the entire Cross Drain could be mistaken for a natural watercourse. The straight lines and obtuse angles are not characteristic of a natural watercourse. It is rare to see a river running parallel to a road for 160m before turning 90 degrees. There is one or two sections which have natural characteristics usually near a spring and the drain stops and starts either side of these features. It is quite difficult to understand how a RCC staff member didn't know the geography of the area.

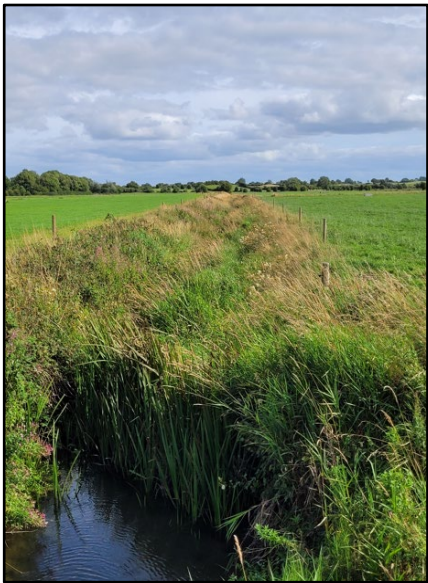
Photo No 1 was taken from the same place in August 2024. There can be no doubt that the waterbody is a drain. Walking the L2023 where the drain runs parallel to the road the grass on the drain side has the orangey burnt look of grass that is near water. Looking over the bridge where the drain turns under the road another drain can be seen joining.

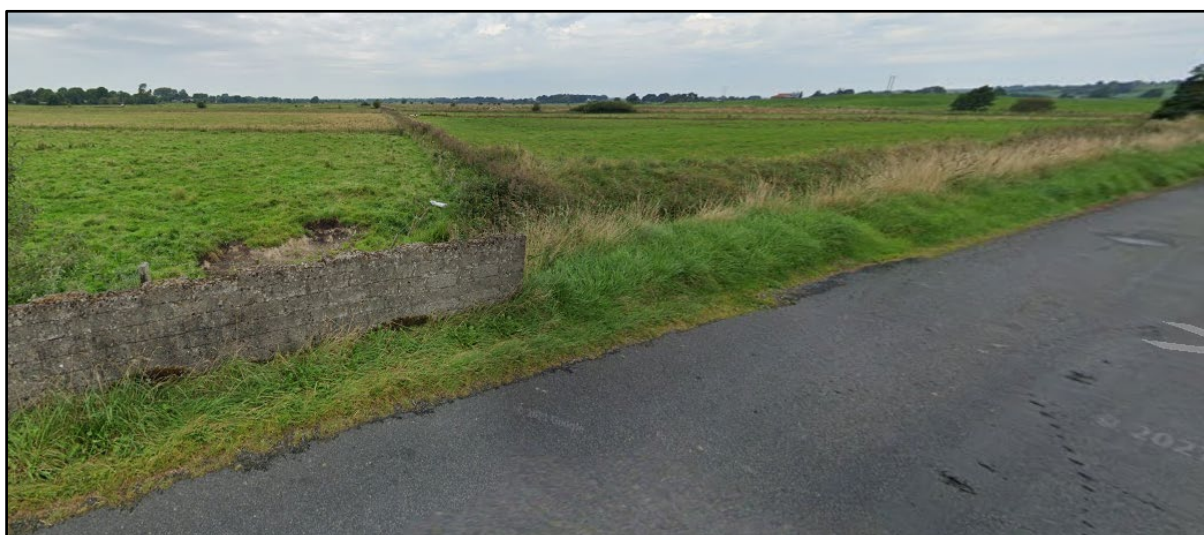
**Photo No. 2 From Bridge on L2023 looking NW**

To capture it fully a Google photograph is used – Photo No.2
