INTRODUCTION

- 5.10 The development proposal provides for the routing of all traffic to and from the proposed development along the L1157 Local Road. It also includes provision for a comprehensive road improvement scheme along the entire length of the L1157 leading up to the application site, including road widening to 6.0m everywhere along its length, with road strengthening and repair overlay and road markings where required.

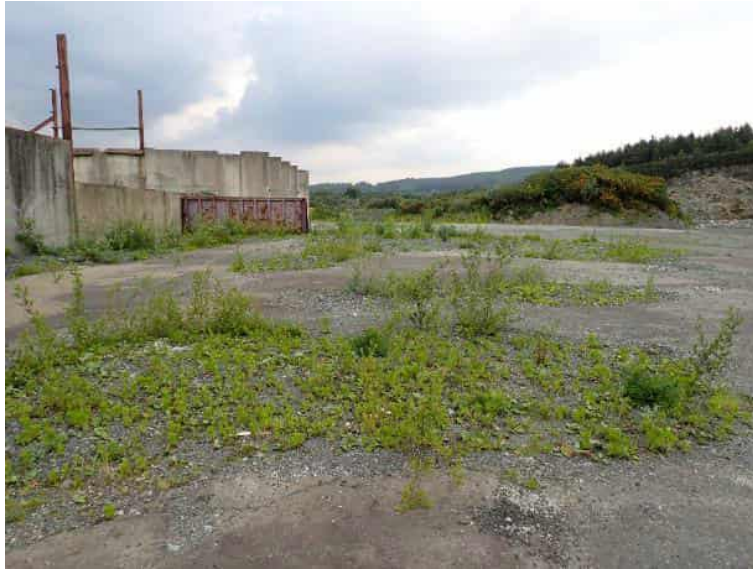
Plate 5-1
Mosaic of Recolonising Bare Ground / Hardstand Habitat in Eastern Half of Site

- 5.103 **Recolonising bare ground (ED3):** This habitat classification is used to describe areas of bare ground and gravel that have become colonised by ruderal vegetation (Plate 5.1). A high number of plant species are present within the habitat and vegetative composition is highly variable. As such, relative abundances are not considered appropriate for the species within this habitat. The following forbs were recorded in this habitat; greater plantain *Plantago major*, ribwort plantain *P. lanceolata*, red clover *Trifolium pratense*, common centaury *Centaurea erythraea*, birds foot trefoil *Lotus corniculatus*, colts foot *Tussilago farfara*, yarrow *Achillea millefolium*, dandelion *Taraxacum officinale* agg., daisy *Bellis perennis*, creeping buttercup *Ranunculus repens*, common vetch *Vicia sativa*, thyme leaf speedwell *Veronica serpyllifolia*, selfheal *Prunella vulgaris*, weld *Reseda lutea*, teasel *Dipsacus fullonum*, smooth hawkbeard *Crepis capillaris*, common hogweed *Heracleum sphondylium*, common figwort *Scrophularia auriculata*, willowherbs *Epilobium* sp., scarlet pimpernel *Anagallis arvensis*, shepherd's purse *Capsella bursa-pastoris*, procumbent pearlwort *Sagina procumbens*, lesser trefoil *Trifolium dubium*, creeping thistle *Cirsium arvense*, silverweed *Potentilla anserina*, oxeye daisy *Leucanthemum vulgare*, mouse-ear chickweed *Cerastium fontanum*, herb robert *Geranium robertianum* and smith's pepperwort *Lepidium heterophyllum*. (Plate 5-2) Some graminoids were also present and included jointed rush *Juncus articulatus*, Yorkshire fog *Holcus lanatus*, creeping bent *Agrostis stolonifera*, sweet vernal *Anthoxanthum odoratum*, ferngrass *Catapodium rigidum*. The mosses *Calliergonella cuspidatum* and *Brachythecium rutabulum* were present in the habitat. Although the habitat is quite species diverse, the habitat is considered to be of low ecological value due to the sparseness of vegetation and its inability to support a complex ecosystem. Species recorded are also all widespread and common species.

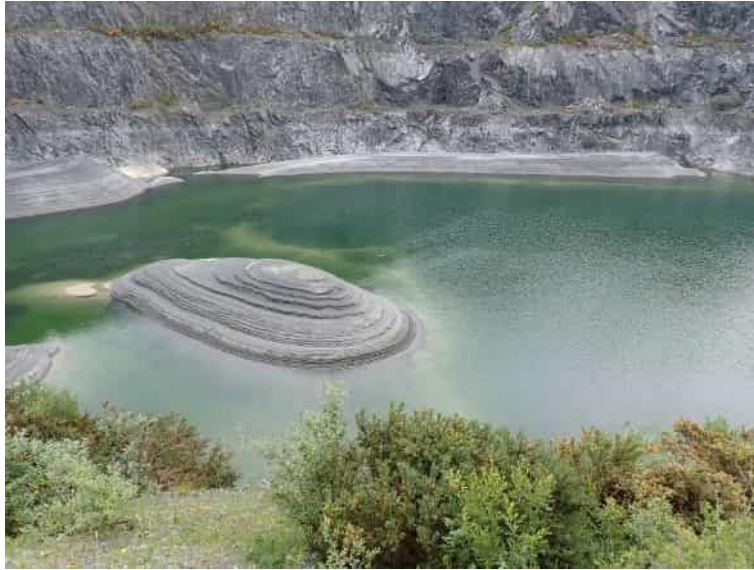
Plate 5-3
Exposed Siliceous Rock (Former Active Quarry).

- 5.104 **Exposed siliceous rock (ER1; or ED4 – Active quarry mines):** The area of open pit excavation that dominates the northeastern portion of the site is made up of this habitat and FL8 below (where the habitat is underwater). The area mapped is indicative and continues to increase in scale due to dewatering of the quarry basin (Plate 5.3). The habitat comprises exposed bedrock from historical excavations and is understood to be composed of diorite (GSI, 2024). The habitat is largely unvegetated but has some areas ED3 vegetation (described above) and WS1 scrub (described below) scattered around its edges. It is understood that a peregrine falcon nest site is present on a cliff face within this habitat. The habitat is considered to be of low to moderate ecological value.

Dewatering of the quarry basin had progressed and it was largely dry when revisited in September 2024.

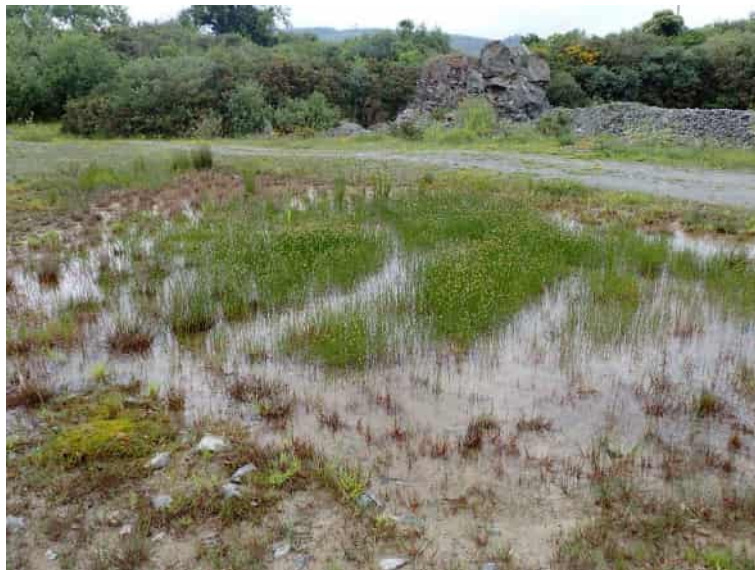
Plate 5-4
Ephemeral Pond with Tadpole Present.

- 5.105 **Mesotrophic lakes (FL4):** A small ephemeral pond was recorded in a depression within an area of gravel/hardstanding substrate in the northern end of the site (Plate 5.4). The habitat is likely to dry out in periods of drought and occurs here as a result of construction. The plant community occurring here comprises dominant common spike-rush *Eleocharis palustris*, frequent jointed rush, water crowfoot *Ranunculus* sp., occasional pondweed *Potamogeton* sp., and rare soft rush *Juncus effusus*. The bryophyte *Calliergonella cuspidatum* is frequent around the edges of the pond. The habitat is considered to be of moderate conservation value.

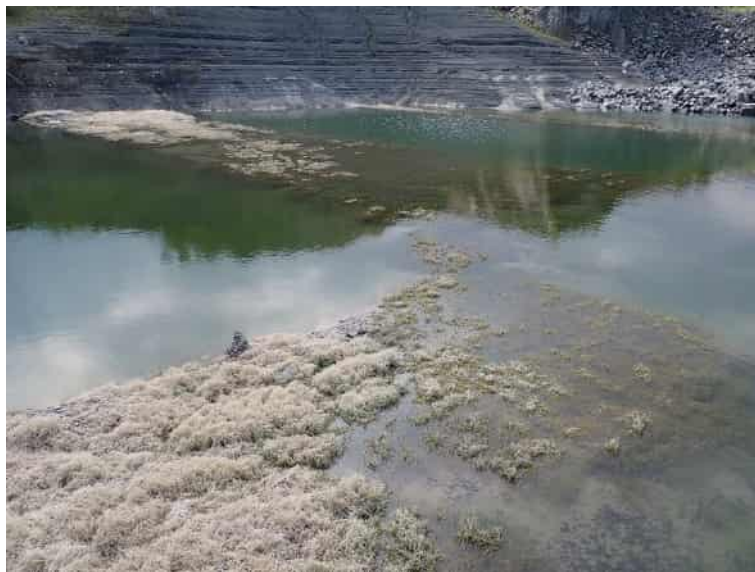
Plate 5-5
Large Area of Charophyte Vegetation.

- 5.106 **Other artificial lakes and ponds (FL8):** A large artificial water reservoir is present in the northeastern portion of the site where the quarry was historically mined. As mentioned previously, this habitat continues to decrease in extent due to it being dewatered. The edges generally have a steep incline and as such there is limited opportunity for typical freshwater benthic plants to occur. However, some stoneworts *Chara* sp. were recorded at the eastern end of the site (Plate 5.5). A number of other smaller settlement ponds are present in the western half of the site. These are generally more natural in nature with species such as broad-leaved pondweed *Potamogeton natans* being abundant, floating sweet grass *Glyceria fluitans* being frequent and water mint *Mentha aquatica* occasional. The habitat is considered to be of low conservation value as it is largely without vegetation and has an unnatural bank gradient.

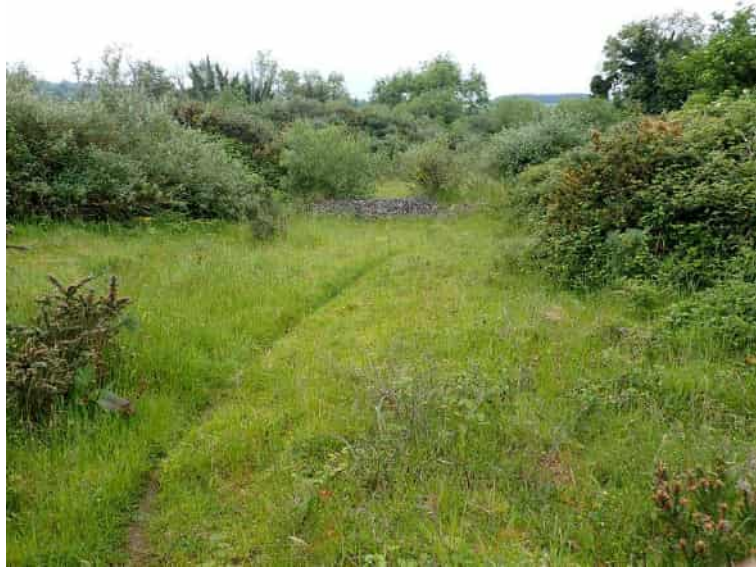
Plate 5-6
Small Area of Neutral Grassland at Northern End of Site

- 5.107 **Dry Calcareous and neutral grassland (GS1):** Small areas of semi-natural neutral grassland are present in the northwestern end of the site (Plate 5.6). This habitat seems to be occurring on what was previously bare ground habitat with a gravel substrate but has since reverted to grassland. The graminoid component of the habitat includes abundant sweet vernal grass, frequent crested dogs tail *Cynosurus cristatus*, occasional Yorkshire fog and common bent *Agrostis capillaris* with rare cocks' foot *Dactylis glomerata*. The forb component includes abundant lesser trefoil, frequent common vetch, red clover, English cinquefoil *Potentilla anglica*, occasional white clover, ribwort plantain and field forget-me-not *Myosotis arvensis*. The bryophyte *Calliergonella cuspidatum* is abundant in the habitat. The habitat is considered to be of moderate conservation value.

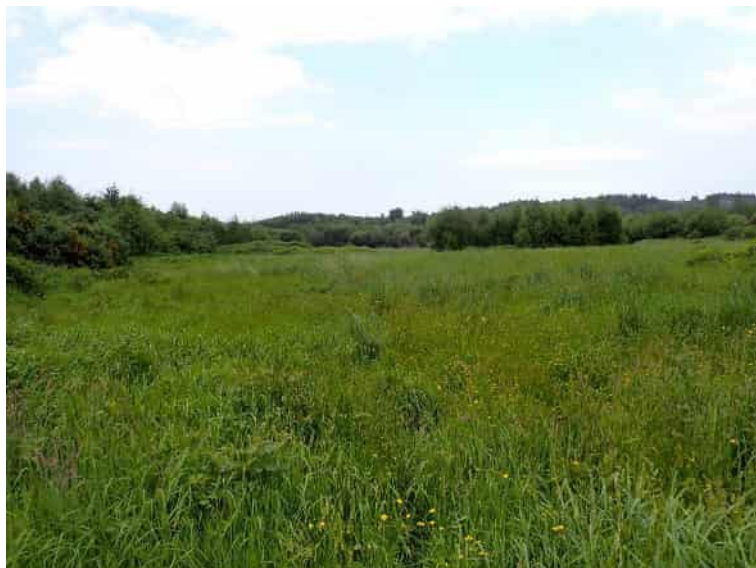
Plate 5-7
Area of Species-Poor Dry Meadow at Western End of Site

- 5.108 **Dry meadows and grassy verges (GS2):** A large area of dry meadow occurs in the western end of the site where former agricultural land has been allowed to become fallow Plate 5.7). The vegetation is very tall here (at least 1m high in places) as a result of not being managed. The graminoid component of the habitat includes abundant Yorkshire fog, frequent meadow foxtail *Alopecurus pratensis*, sweet vernal grass, and smooth meadow grass *Poa pratensis* with occasional cock's foot. The herb component includes frequent ribwort plantain, meadow buttercup *Ranunculus acris*, creeping buttercup, occasional creeping thistle, dandelion and greater birds foot trefoil *Lotus pedunculatus* with rare common hogweed. The habitat is considered to be of moderate conservation value.

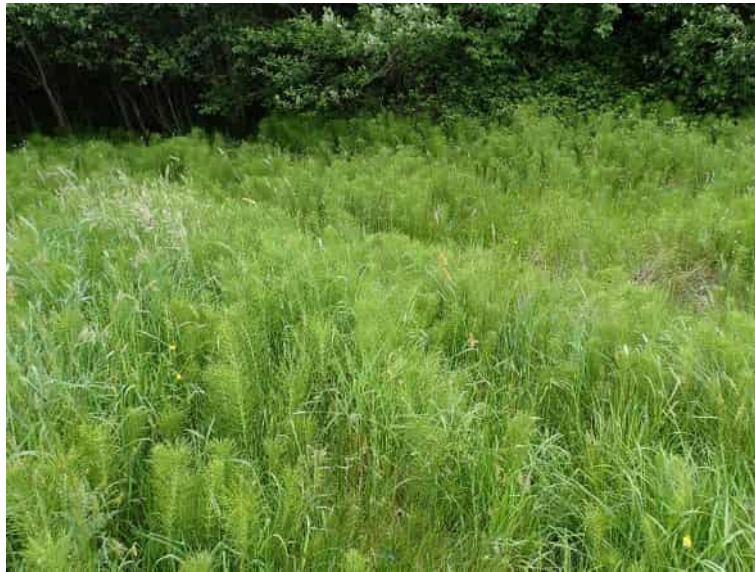
Plate 5-8
Area of Abundant Great Horsetail within Wet Grassland Habitat

- 5.109 **Wet grassland (GS4):** This habitat occurred within a few areas in the western end of the Site. The graminoid component includes abundant (to dominant) soft rush, frequent Yorkshire fog and creeping bent, occasional sweet vernal grass and compact rush *Juncus conglomeratus*, and rare common sedge *Carex nigra*, and oval sedge *C. leoporina*. Forbs present include frequent lesser spearwort *Ranunculus flammula* and creeping buttercup, occasional cuckoo flower *Cardamine pratensis*, marsh bedstraw *Galium palustre*, greater birds foot trefoil and rare common sorrel *Rumex acetosa*. A species of horsetail, great horsetail *Equisetum telmateia*, was rare in the habitat but locally abundant where it occurred (Plate 5-8). The habitat is considered to be of moderate conservation value.

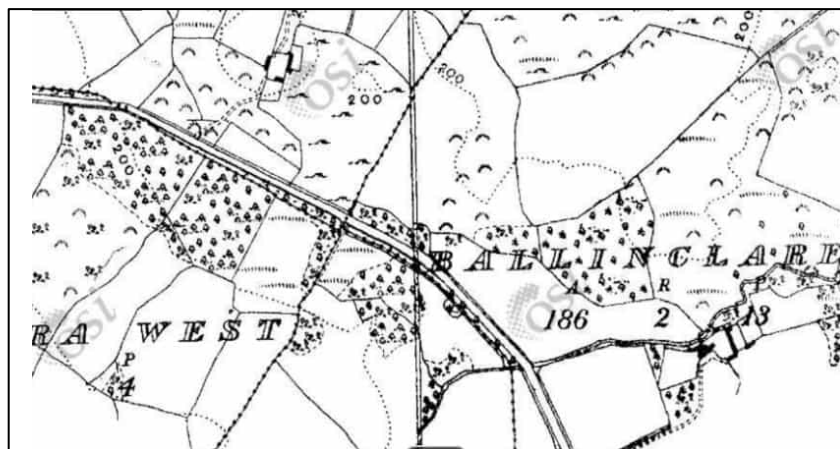
Plate 5-9
Strip of Woodland Present in 1830s, Adjacent to Road

- 5.114 **Oak-birch-holly woodland (WN1):** Along the site's southern boundary and immediately east of the entrance to the site an oak woodland part of which was present since at least the 1830's (Geohive, 2024; see Plate 5.9 below). The canopy is comprised of abundant sessile oak *Quercus petraea* with frequent beech and locally frequent grey willow in wet areas and along the southern edge of the habitat (Plate 5-10). The shrub layer includes frequent holly and rare elder, hawthorn, hazel *Corylus avellana* and rowan *Sorbus acucuparia*. It also includes the following non-native negative species; frequent cherry laurel and rare butterfly bush *Buddleja davidii* and sycamore. Cherry laurel is frequent while the other two species are rare in the shrub layer. The field layer (Plate 5-11) includes dominant ivy, frequent bramble, occasional wood sanicle *Sanicula europea*, common dog violet *Viola riviniana*, soft shield fern *Polystichum setiferum*, honeysuckle *Lonicera periclymenum*, scaly male fern and pignut. Rare selfheal *Prunella vulgaris*, false Wood-brome *Brachypodium sylvaticum*, black spleenwort *Asplenium adiantum-nigrum*, wood sorrel *Oxalis acetosella*, hard fern *Blechnum spicant* and remote sedge *Carex remota* were also recorded in the field layer. The following bryophytes were recorded in the field layer; abundant *Eurhynchium striatum*, frequent *Thuidium tamariscanum* and rare *Fissidens* sp., *Hookeria lucens* and *Atrichum undulatum*. The epiphytes *Metzgeria furcata*, *M. fruticulosa*, *Ulotia phyllantha*, *Ulotia* sp. (other species), *Microlejeuna ulicina*, *Frullania dilatata*, *Hypnum* sp., *Cryphaea heteromalla* were recorded growing on trees within the habitat. The habitat is considered to be of high conservation value.

Woodland present where WN1 habitat currently exists

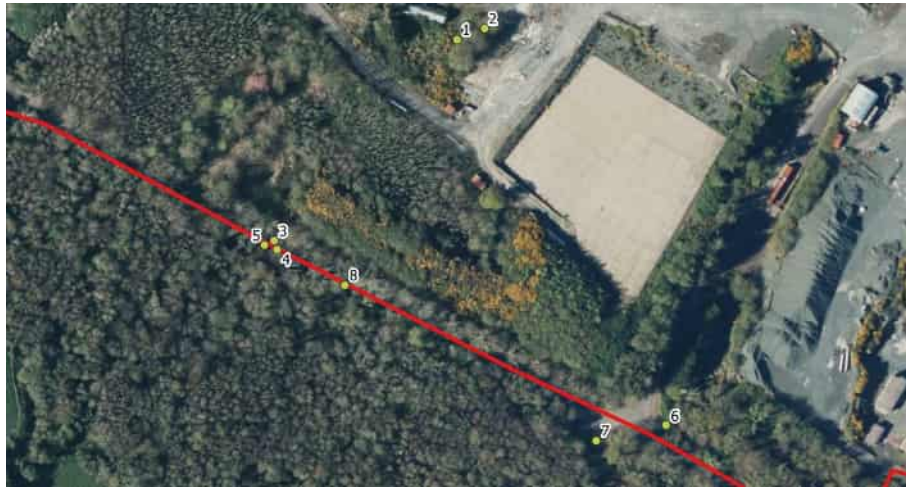
Plate 5-12
Recorded Locations of Broad-leaved Helleborine On / Adjacent to Site

(recorded in September 2024)

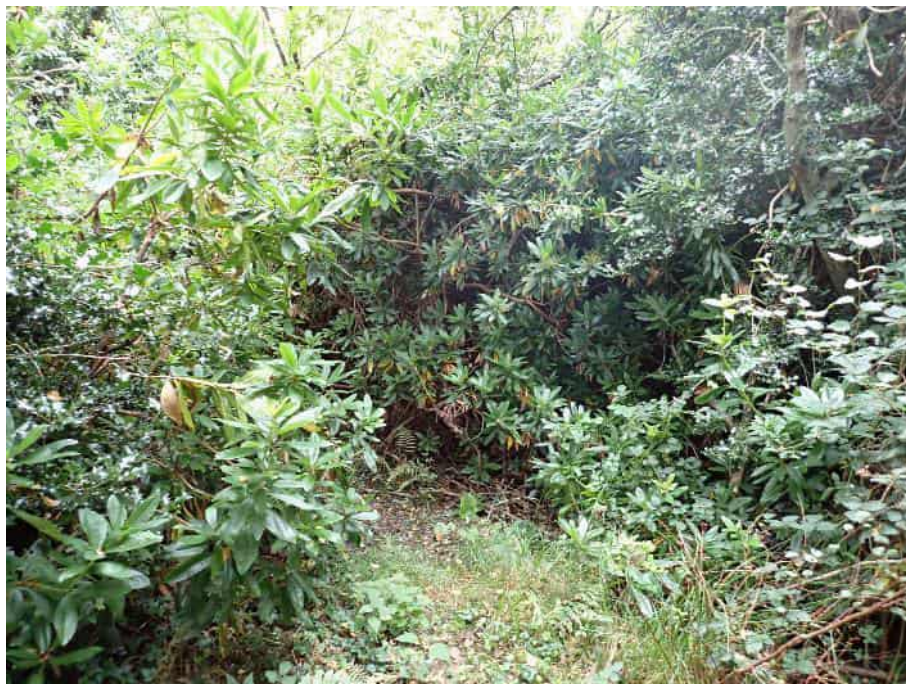
Plate 5-13
Patch of Rhododendron at Southwest of Application Site

- 5.121 A thicket of the invasive rhododendron *Rhododendron ponticum* was recorded (between T 24793 88905 and T 24833 88900) in the southwest corner of the site (see Plate 5.13, Appendix 5-D).

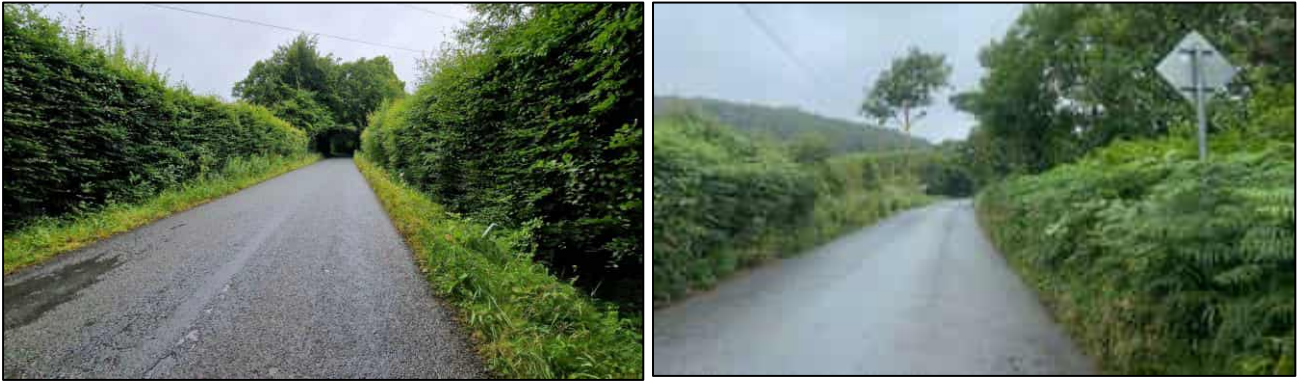
Plate 5-15
Hedgerow (WL1) Habitat

- 5.128 **Hedgerow (WL1):** This habitat type was recorded alongside the road margins primarily along the southern section of the road corridor, and consisted of frequent hawthorn, blackthorn, dog rose and bracken (Plate 5.15). A section of hedgerow, managed as a 'box hedge', was recorded along the northern section of the road corridor and included frequent beech, with occasional holly, oak, ivy and rowan (*Sorbus aucuparia*) coming through. The ecological valuation of this habitat is considered to be of local importance (higher value).

Hedgerow managed as a 'box hedge' (left) and under less management (right).

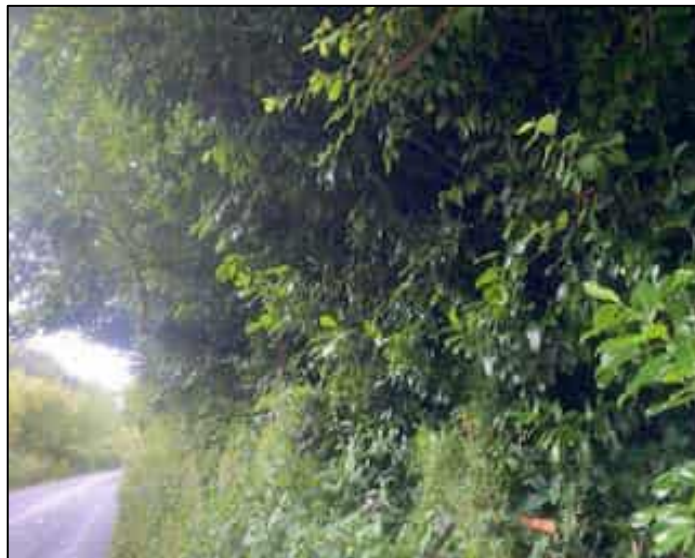
Plate 5-16
Ornamental / Non-Native Shrub (WS3) Consisting Mostly of Cherry Laurel.

- 5.129 **Ornamental/Non-Native Shrub (WS3):** This habitat type consisted of stands of cherry laurel planted on the roadside margins of private lands along the road corridor (Plate 5.16). This habitat was recorded on a number of occasions with some stands of cherry laurel more established and unmanaged than others. Other non-native species recorded occasionally include montbretia (*Crocasmia x crocosmiiflora*), snowberry, and fuchsia (*Fuchsia magellanica*). Other species recorded include dogwood (*Cornus* spp.) ragwort (*Senecio jacobaea*), ash, bramble, nettle and spurge (*Euphorbia* spp.). The ecological valuation of this habitat is considered to be of local importance (lower value).

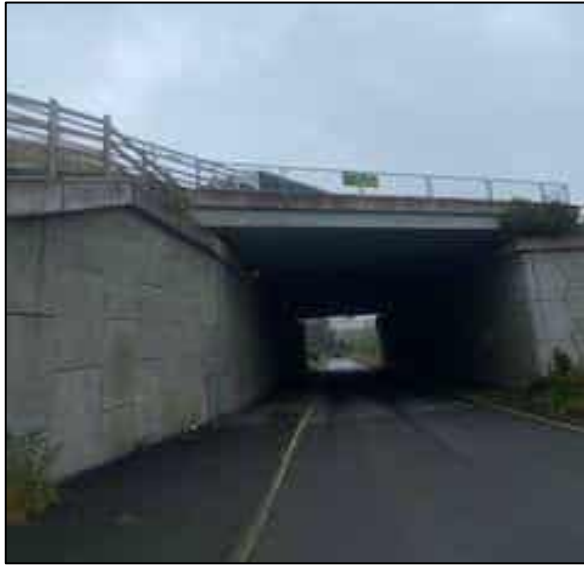
Plate 5-17
Buildings and Artificial Surfaces (BL3)

- 5.130 **Buildings and artificial surfaces (BL3):** This habitat consists of the M11 underpass under which the road corridor passes to the south. Included are pedestrian footpaths which border the road corridor as it passes beneath the M11 underpass (Plate 5.17). Few species were recorded here and were typically confined to the outer edges of the underpass. Species recorded occasionally include ragwort, herb robert, common daisy, dandelion, hawk bit (*Leontodon* spp.) and fleabane (*Pulicaria dysenterica*). The ecological valuation of this habitat is considered to be of negligible importance.

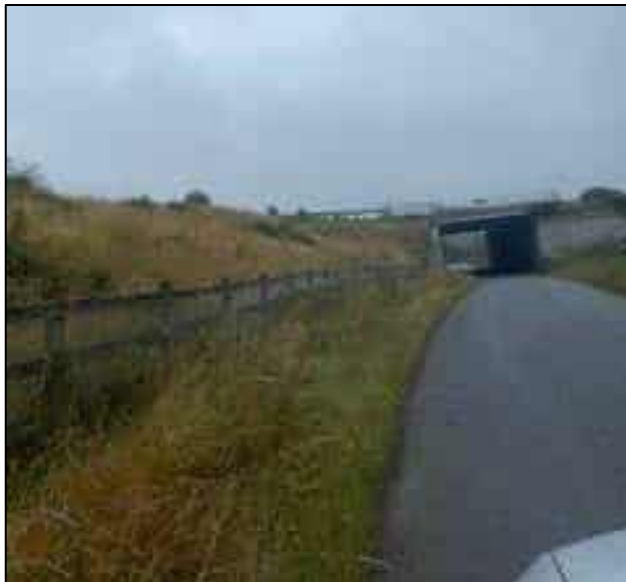
Plate 5-18
Dry Meadow and Grassy Verges along the L1157 Near M11 Underpass

- 5.131 **Dry meadows and grassy verges (GS2):** This habitat type was recorded on the approach to the M11 underpass (Plate 5.18). Species recorded included frequent cocksfoot, perennial ryegrass (*Lolium perenne*), meadow foxtail (*Alopecurus pratensis*), yorkshire fog, ragwort, bramble, nettle, cleavers, dock, common vetch, bristly oxtongue (*Helminthotheca echioides*), selfheal (*Prunella vulgaris*), dandelion, common daisy, greater birdsfoot trefoil (*Lotus pedunculatus*), common rush, creeping buttercup, coltsfoot, crested dog tail (*Cynosurus cristatus*) and hedge bindweed (*Calystegia sepium*). The ecological valuation of this habitat is considered to be of local importance (lower value).

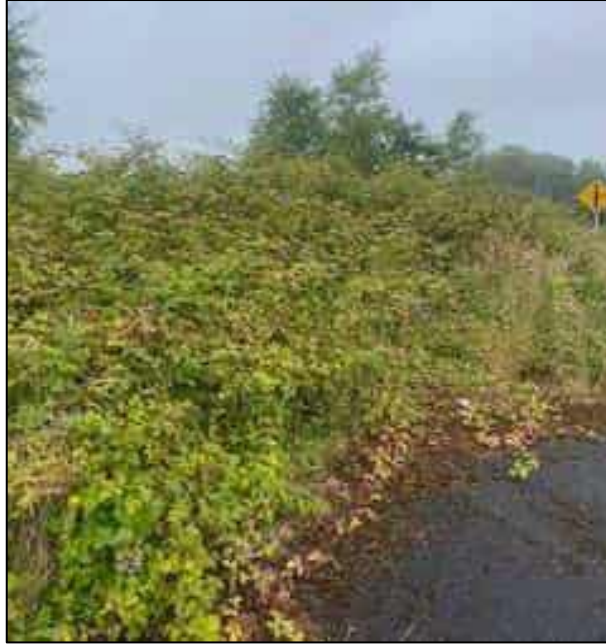
Plate 5-19
Patch of Scrub (WS1) Habitat Near M11 Underpass

- 5.132 **Scrub (WS1):** This habitat type was recorded in a small patch where the hedgerow had transitioned and expanded along the edge of farmland, encroaching on the road corridor adjacent to the M11 underpass (Plate 5.19). Species recorded included frequent bramble, gorse (*Ulex europaeus*), ribwort plantain, traveler's joy, as well as occasional dog rose, hawthorn, blackthorn, and elder. The ecological valuation of this habitat is considered to be of local importance (lower value).

Patch occurs along the south section of the road corridor

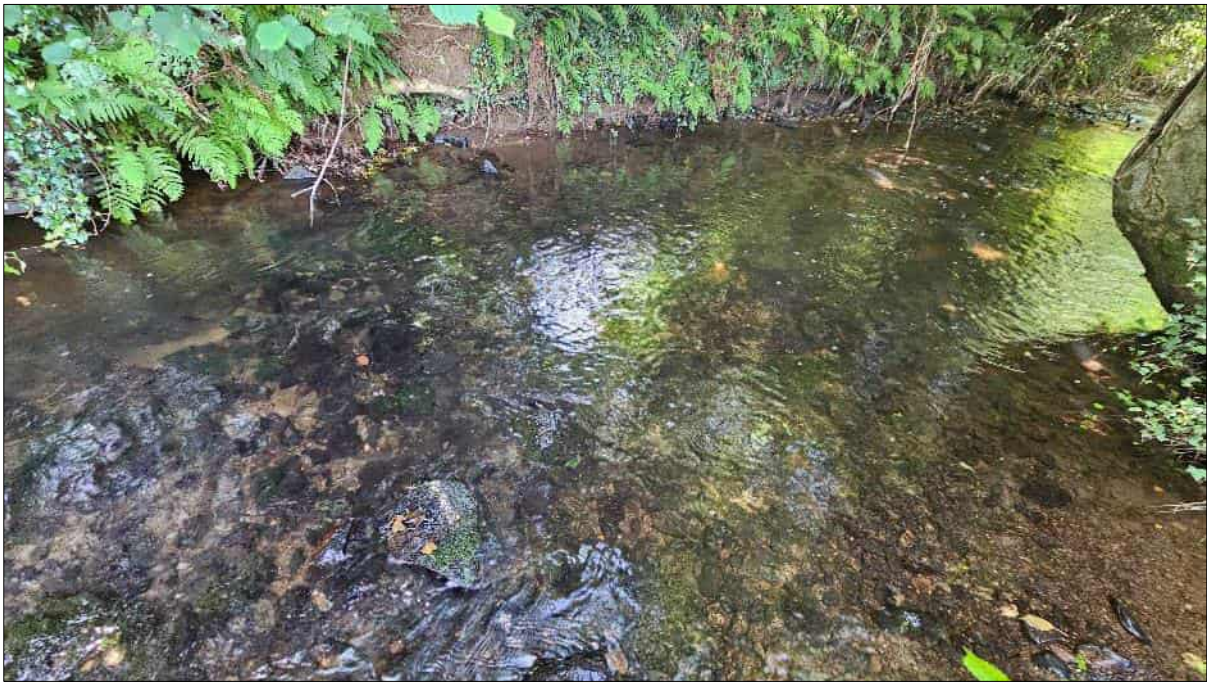
Plate 5-23
Representative Image of Site A1, Potters River Upstream of Quarry

- 5.192 **Site A1 (Potters River, Ballinclare):** was located on the Potters River (EPA code: 10P01) upstream of Ballinclare Quarry (i.e. an upstream control site). The upland eroding channel (FW1) had been historically deepened but showed good instream recovery. The river flowed over a moderate gradient in a U-shaped channel with a sinuous profile and was 4-5m wide and 0.1-0.3m deep. The profile was of slow flowing shallow riffle and glide with localised pool in bank undercuts and on meanders. The substrata were dominated by abundant boulder and cobble with mixed gravels and sand. Siltation was moderate overall with silt plumes underfoot but the majority of the substrata were unbedded. Macrophyte growth was not present due to high shading but larger substrata supported occasional *Fontinalis antipyretica* moss and abundant the *Chiloscyphus polyanthos* liverwort. The riparian areas featured mixed broad-leaved woodland (WD1) with mature ash, hazel, holly, beech and blackthorn with bramble and ivy in the understories. The site was bordered by improved grassland (GA1). Brown trout (*Salmo trutta*) (n=39) was the only fish species recorded via electro-fishing at site A1 (Chart 5-1). The river at this location was a good quality salmonid nursery given broken water sequences and a rocky bed that provided abundant refugia for good numbers of juveniles. Mixed gravels in glide and pool tailings provided good quality spawning areas. Holding habitat was moderate given the paucity of deeper pool habitat due to historical deepening/modifications. The river was of too high an energy for lamprey and no depositional soft silt areas suitable for ammocoete burial were observed. While the site had good suitability for European eel, (i.e. rocky refugia, good shading & ample depth, none were recorded. Despite some physical suitability for white-clawed crayfish, none were recorded and the species is not known from the watercourse or wider catchment. No otter signs were recorded in vicinity of the site in spite of good foraging suitability. Biological water quality, based on Q-sampling, was calculated as Q3-4 (moderate status) (Appendix 5-F). No macro-invertebrate species of conservation value greater than 'least concern', according to national red lists, were recorded via Q-sampling.

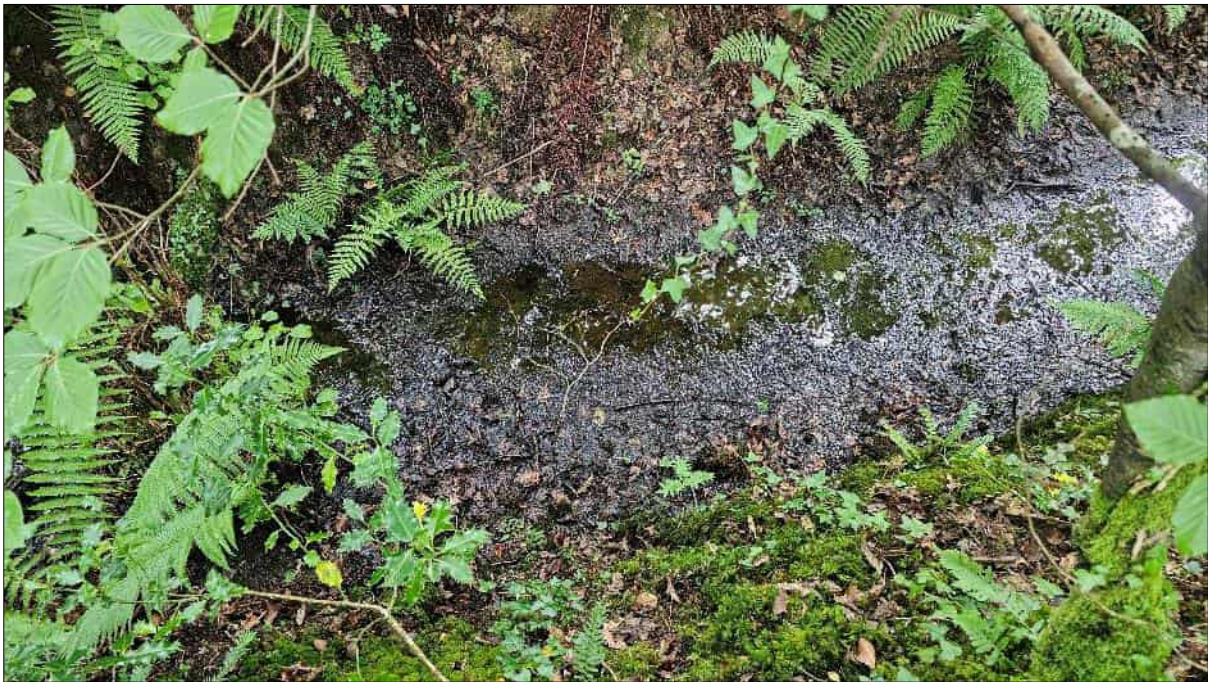
Plate 5-26
Representative Image of Site B1 on Ballinclare Stream

- 5.194 **Site B1 (Ballinclare Stream, Carrigmore):** Site B1 was located on the uppermost reaches of the Ballinclare Stream (unmapped by the EPA) along the southern site boundary. The lowland depositing stream (FW2) had been historically realigned along the local road and quarry site boundary, resulting in a U-shaped channel that was 1m wide with 0.5-1m high banks. The stream suffered from low summer water levels at the time of survey, with near imperceptible flows and a depth of 0.05m. The stream was likely ephemeral at this location. The heavily modified bed was composed of silt/mud, exposed clay and abundant leaf litter. The site did not support macrophytes or aquatic bryophytes due to high shading shade and ephemeral flows. The stream flowed through mature plantation woodland (WS2) with scattered mature oak, ash and beech and scrubby understories. No fish were recorded via electro-fishing at site B1. The modified channel was not of fisheries value or high aquatic value given poor flows and evident seasonality. It was also too shallow to be of value to amphibians given the absence of ponding water and macrophyte vegetation. For the same reasons it was not of value to white-clawed crayfish and the species was not recorded (not known from the watercourse or wider catchment). No otter signs were recorded in vicinity of the site. Biological water quality, based on Q-sampling, was calculated as Q4 (good status) (Appendix 5-F). However, it should be noted that this was a tentative rating given poor flows and an absence of suitable riffle areas for sampling (Toner *et al.*, 2005). No macro-invertebrate species of conservation value greater than 'least concern', according to national red lists, were recorded via Q-sampling.

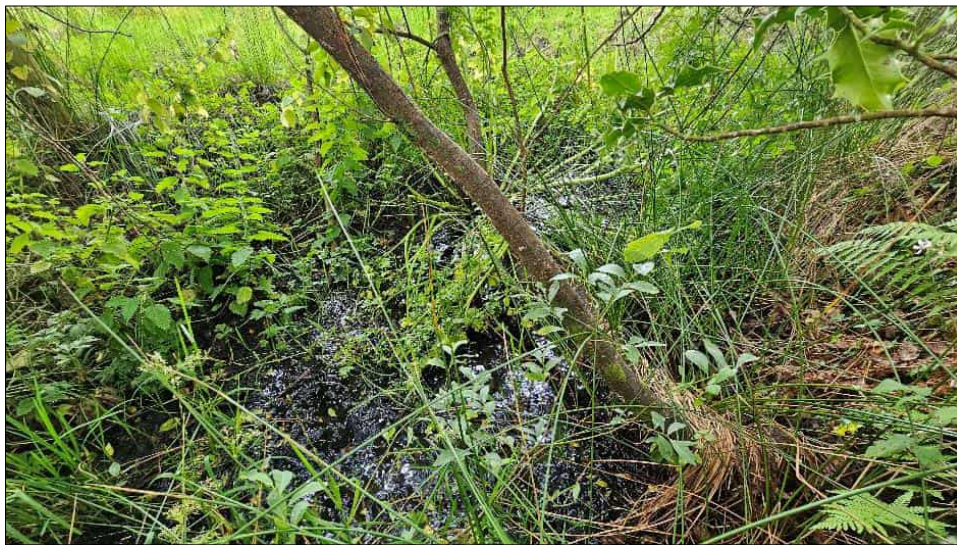
Plate 5-28
Representative Image Site B2 on Ballinclare Stream

- 5.195 **Site B2 (Ballinclare Stream, Ballinclare):** Site B2 was located on the Ballinclare Stream (unmapped by the EPA) along the southern site boundary, approximately 450m downstream of site B1. As per upstream, the lowland depositing stream (FW2) had been extensively realigned and modified historically and flowed parallel to the local road. The U-shaped channel was 1-1.5m wide and typically 0.05m deep with no visible flows and intermittent pools of water. The bed was composed of anoxic silt and abundant leaf litter. The heavily shaded channel supported occasional common clubrush (*Schoenoplectus lacustris*) and hemlock water dropwort (*Oenanthe crocata*) with frequent floating common duckweed (*Lemna minor*). The riparian areas supported mature oak and beech with scattered grey willow (*Salix cinerea* sp. *oleifolia*). The understories supported golden-scale male fern (*Dryopteris affinis*), Enchanter's-nightshade (*Circaea lutetiana*), remote sedge (*Carex remota*), wild angelica, bramble, ivy, hogweed, and honeysuckle (*Lonicera periclymenum*). No fish were recorded via electro-fishing at site B2. The modified channel was not of fisheries value given poor flows and evident seasonality. However, the channel had some low suitability for smooth newt given the presence of ponding water with a low cover of macrophytes. A low density of newt efts (juveniles, $n=2$) was recorded via sweep netting. The site was unsuitable for white-clawed crayfish and the species was not recorded (not known from the watercourse or wider catchment). No other signs were recorded in vicinity of the site. Biological water quality, based on Q-sampling, was calculated as Q2-3 (poor status) (Appendix 5-F). However, it should be noted that this was a tentative rating given poor flows and an absence of suitable riffle areas for sampling (Toner et al., 2005). No macro-invertebrate species of conservation value greater than 'least concern', according to national red lists, were recorded via Q-sampling.

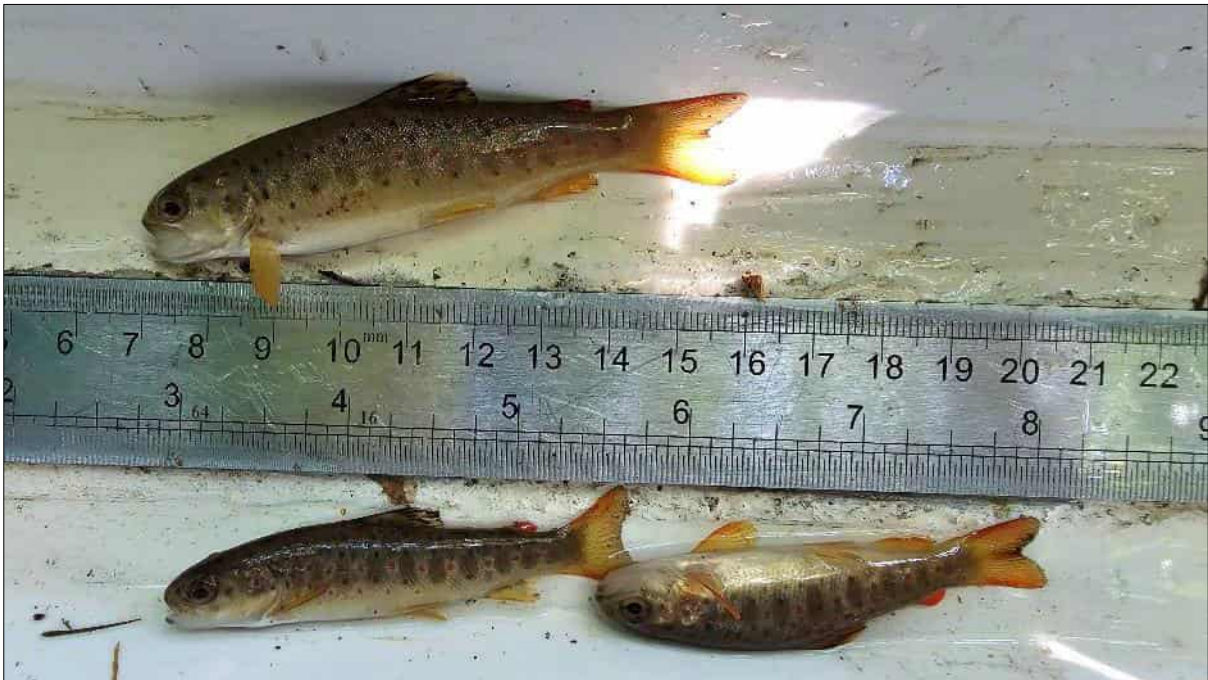
Plate 5-32
Representative Image of Site C2 on Ballinameesda Lower Stream

- 5.208 Site B2 on the Ballinclare Stream and both sites C1 and C2 on the Ballinameesda Lower Stream achieved Q2-3 or Q3 (poor status) water quality based on an absence of group A species, low numbers or an absence of group B species and a dominance of group C or D species such as the mayfly *Baetis rhodani*, freshwater shrimp (*Gammarus duebeni*), New Zealand mud snail (*Potamopyrgus antipodarum*) and hoglouse (*Asellus aquaticus*) (Appendix 5-F). It should be noted that the Q-rating for site B2 is tentative only given the absence of suitable riffle areas for sampling in the heavily modified channel (as per Toner *et al.*, 2005).

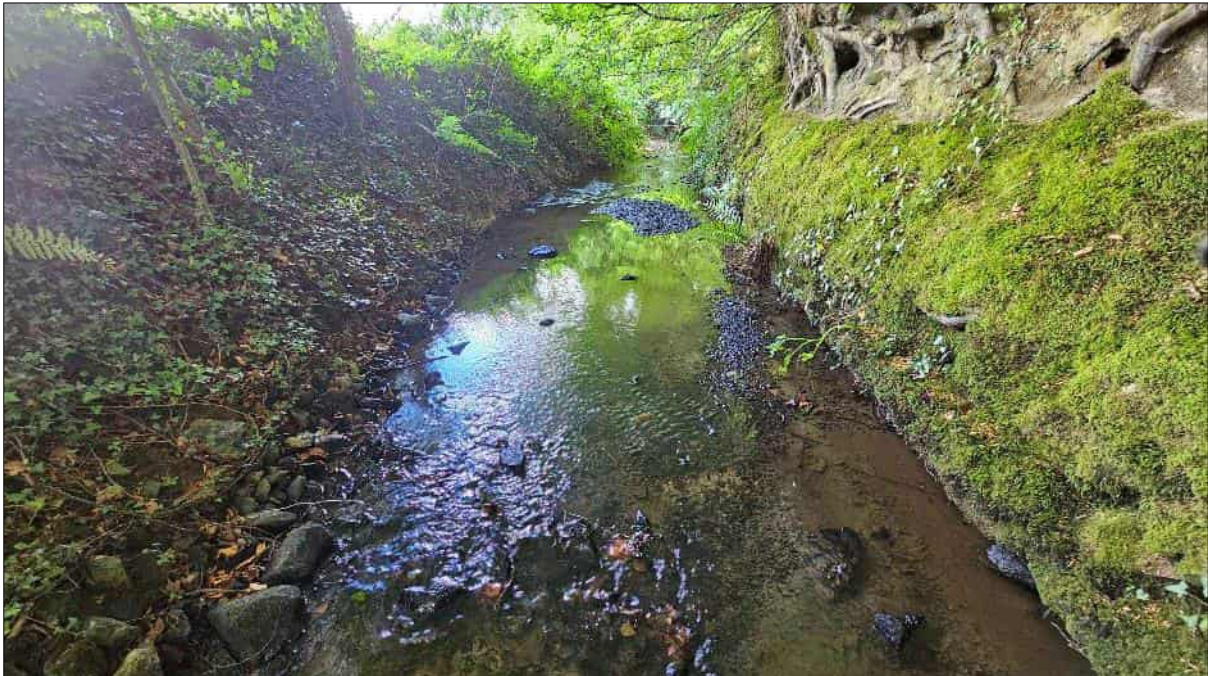
5.197 **Site C2 (Ballinameesda Lower Stream, Ballinclare):** Site C2 was located on the Ballinameesda Lower Stream (10B74) approximately 75m downstream of the Ballinclare Stream confluence. As per upstream, the lowland depositing stream (FW2) had been historically straightened and deepened, resulting in a U-shaped channel with 2-2.5m high banks. The stream was 2m wide and 0.1-0.15m deep with a profile of slow-flowing shallow riffle and glide and only very localised shallow pool. The substrata comprised occasional bedrock and angular small boulder with heavily bedded mixed gravels and silt. Siltation was very high with much of the gravels covered in silt with very heavy infiltration (large silt plumes) but deposits were shallower in depth compared with upstream (i.e. more superficial silt). Although macrophytes were absent from the site due to high shading, high siltation and high turbidity, the site did support occasional *Rhynchostegium riparioides* moss. The banks supported trailing *Thamnobryum alopercum* with occasional *Conocephalum salebrosum* on the lower splash zone. The riparian areas supported mature beech, holly and cherry laurel with ivy in the understories. The site was bordered by semi-improved grassland (GA1) with narrow borders. Brown trout ($n=24$), lamprey (*Lampetra* sp.) ($n=15$) and European eel ($n=1$) were recorded via electro-fishing at site C2 (Chart 5-4). Whilst juveniles were present in low densities, the site was considered a poor-quality salmonid nursery due to poor flows and gross siltation. Although some moderate quality spawning habitat existed locally in hard areas of bed it was compromised by high rates of siltation and colmation. The quality of holding habitat was poor given the paucity of pool habitat. The soft organic rich-silt albeit more compacted and superficial in nature than upstream, provided a moderate quality nursery habitat for lamprey ammocoetes with a medium density recorded (up to 8 per m^2). As with salmonids, the spawning capacity of the site was significantly reduced due to siltation. The site had some low value as an eel nursery (i.e. silt burial areas and localised shallow pools) with a single adult recorded. Poor flows and a paucity of deeper pool reduced the overall suitability for the species. Suitability for white-clawed crayfish was poor and none were recorded (species is not known from the watercourse or wider catchment). No otter signs were recorded in vicinity of the site. Biological water quality, based on Q-sampling, was calculated as Q3 (poor status) (Appendix 5-F). No macro-invertebrate species of conservation value greater than 'least concern', according to national red lists, were recorded via Q-sampling.

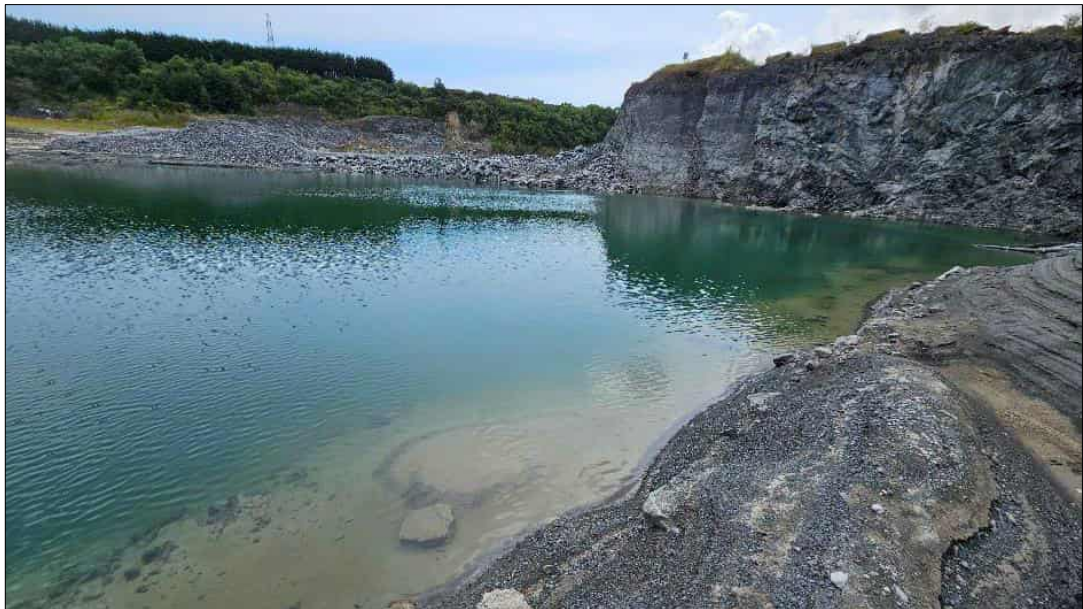
Plate 5-33
Representative Image of Quarry Void at Ballinclare Quarry

- 5.198 **Site L1 (Ballinclare Quarry void):** Site L1 was **located** at the void of Ballinclare Quarry. Since extraction and production activities were suspended in 2016, the floor of the quarry had been flooded with surface water run-off and limited groundwater ingress (SLR, 2021). The void covered a surface area of c.7ha although it was being actively drawn down at the time of the survey. The void was predominately

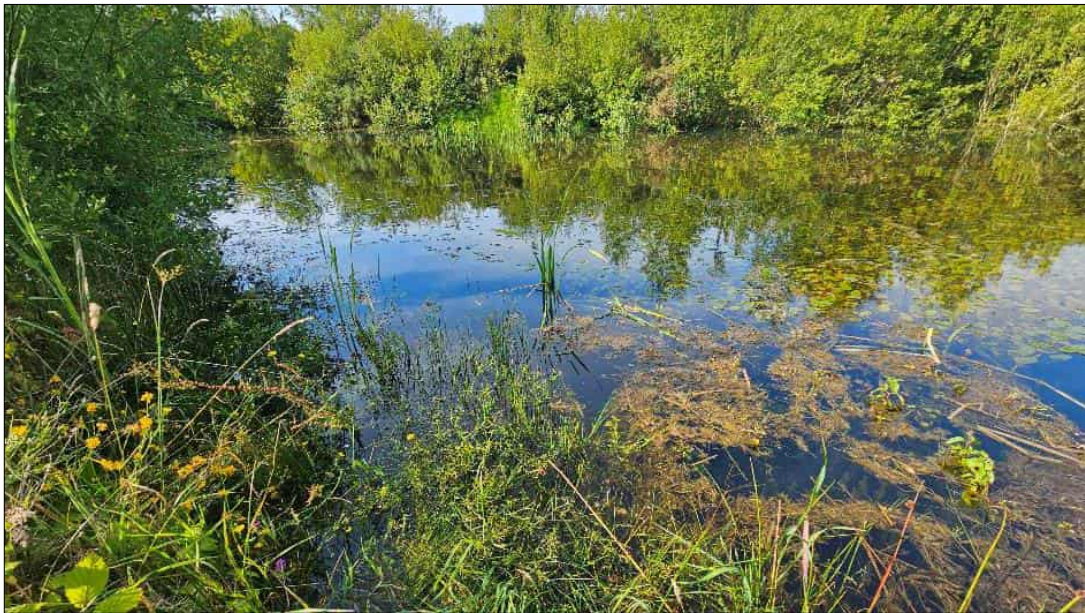
Plate 5-35
Representative Image of Pond Site P2

- 5.200 **Site P2 (Pond, Ballinclare Quarry):** Site P2 was located at in the second stage of a series of settlement ponds in the western part of the site, adjacent to site P1. The rectangular pond was 0.06ha in size and 1-2.5m deep with clear water. The pond had steep marginal slopes grading into a deep central basin with a bed of soft silt. The pond supported a very high coverage of broad-leaved pondweed with occasional spiked-water milfoil. The littorals also supported occasional branched-bur-reed (*Sparganium erectum*), water-horsetail, lesser spearwort (*Ranunculus flammula*) and water mint. The pond was fringed by dense growth of grey willow, downy birch, gorse, bramble and rushes. Site P2 was not of significant fisheries value with no fish populations observed during the survey. No European eel or white-clawed crayfish eDNA were detected (Table 5.18). However, the pond supported smooth newt with a low density of efts (juveniles) recorded via sweep sampling. No otter signs were recorded in vicinity of the site. No macro-invertebrate species of conservation value greater than 'least concern', according to national red lists, were recorded via sweep sampling. The community was dominated by Coenagrionidae damselflies (Appendix 5-F).

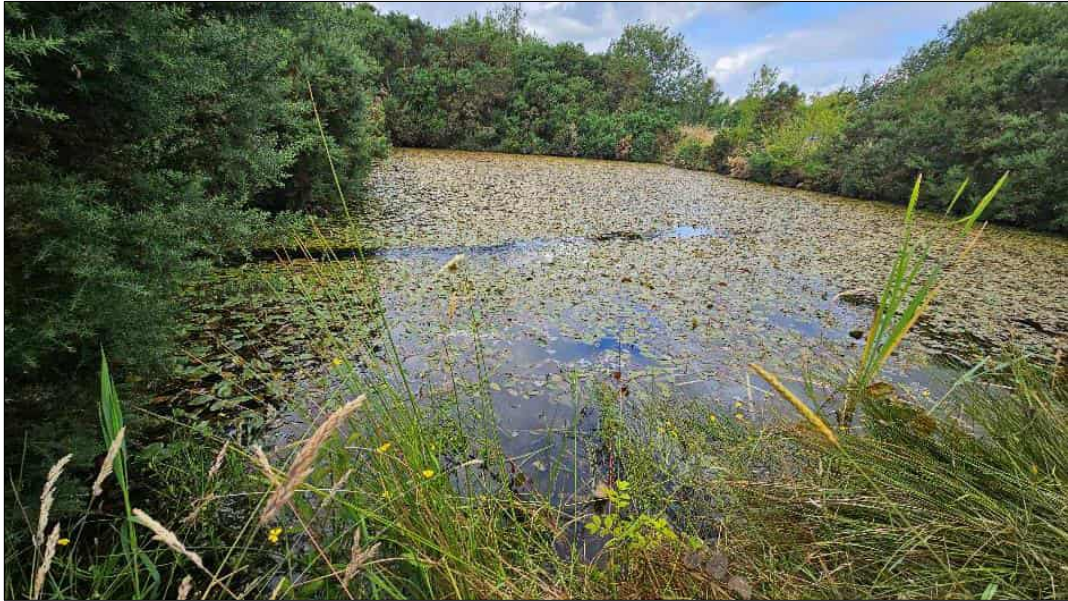
Plate 5-36
Representative Image of Pond Site P3

- 5.201 **Site P3 (Pond, Ballinclare Quarry):** Site P3 was third in the series of settlement ponds in the western part of the site, adjacent to sites P4 and P5. The rectangular pond was 0.07ha in size and 2-2.5m deep with clear water. This was the largest settlement pond on site. The pond had very steep marginal slopes grading into a deep central basin with a bed of soft silt and abundant decaying floc in suspension. As with other nearby ponds, the site supported a very high coverage of broad-leaved pondweed. The pond also supported occasional bulrush, lesser spearwort, water mint, spiked water-milfoil, small pondweed and blue water speedwell (*Veronica anagallis-aquatica*). The pond was fringed by very dense scrub dominated by gorse with occasional downy birch and grey willow. Site P3 was not of significant fisheries value with no fish populations observed during the survey. However, European eel were detected via eDNA sampling (Table 5.18). However, the pond supported smooth newt with a low density of efts (juveniles) recorded via sweep sampling. No other signs were recorded in vicinity of the site. No macro-invertebrate species of conservation value greater than 'least concern', according to national red lists, were recorded via sweep sampling. The community was dominated by Coenagrionidae damselflies (Appendix 5.F).

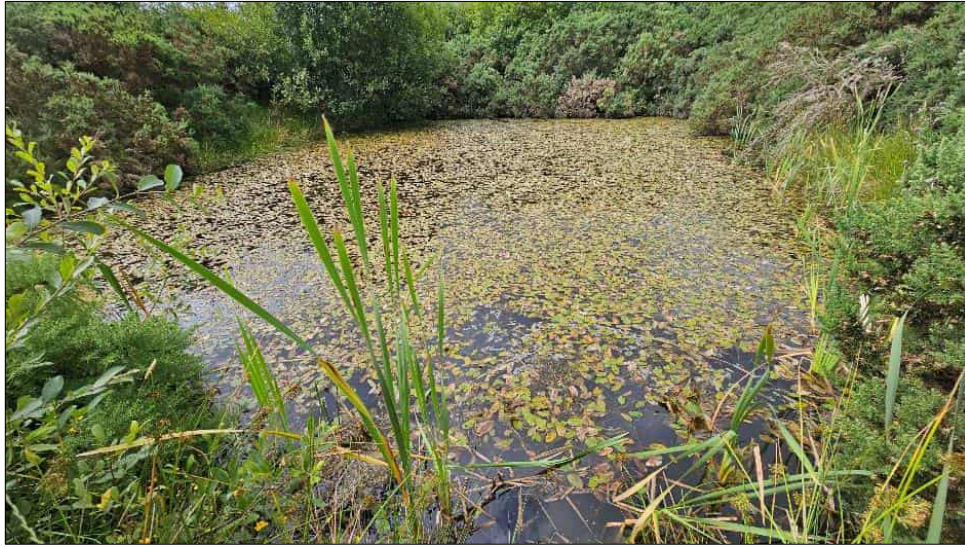
Plate 5-37
Representative Image of Pond Site P4

- 5.202 **Site P4 (Pond, Ballinclare Quarry):** Site P4 was the fourth in the series of settlement ponds in the western part of the site, between ponds P3 and P5. The small elliptical pond was 0.03ha in size and 2-2.5m deep with clear water. The pond had very steep marginal slopes grading into a deep central basin with a bed of soft silt and abundant decaying floc in suspension. The pond supported a very high coverage of broad-leaved pondweed with rare bulrush and small pondweed. Lesser spearwort was occasional in the margins. The pond was fringed by very dense scrub dominated by gorse and bramble with occasional grey willow. Site P4 was not of significant fisheries value with no fish populations observed during the survey. However, European eel were detected via eDNA sampling (Table 5.18). However, the pond supported smooth newt with a low density of efts (juveniles) recorded via sweep sampling. No otter signs were recorded in vicinity of the site. No macro-invertebrate species of conservation value greater than 'least concern', according to national red lists, were recorded via sweep sampling. The community was dominated by Coenagrionidae damselflies and wandering snail (Appendix 5-F).

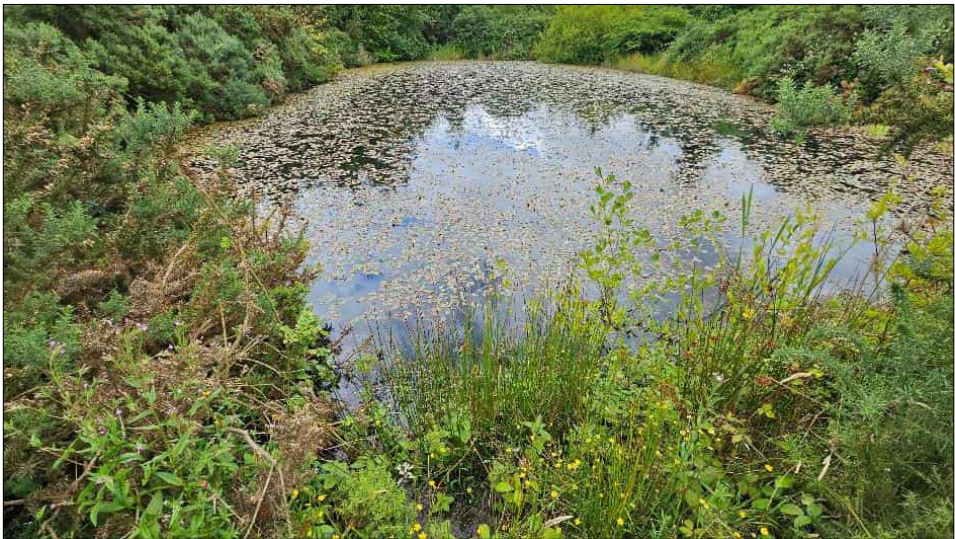
Plate 5-38
Representative Image of Pond Site P5

- 5.203 Site P5 (Pond, Ballinclare Quarry):** Site P5 was the final settlement pond in the series of five ponds. The small elliptical pond was 0.025ha in size and 2-3m deep with clear water. The pond fed a heavily modified drainage tributary of the Potters River via an outfall. The pond had very steep marginal slopes grading into a deep central basin with a bed of soft silt and abundant decaying floc² in suspension. The pond supported a very high coverage of broad-leaved pondweed with branched bur-reed, bulrush (*Typha latifolia*), fennel pondweed (*Stuckenia pectinata*), small pondweed (*Potamogeton berchtoldii*) and spiked-watermilfoil all recorded as rare. Lesser spearwort and wild angelica were occasional in the margins. The pond was fringed by dense scrub dominated by gorse and bramble with occasional grey willow and buddleja (*Buddleja davidii*). Site P5 was not of significant fisheries value with no fish populations observed during the survey. No European eel or white-clawed crayfish eDNA was detected (Table 5.18). However, the pond supported smooth newt with a low density of efts (juveniles) recorded via sweep sampling. No otter signs were recorded in vicinity of the site. No macro-invertebrate species of conservation value greater than 'least concern', according to national red lists, were recorded via sweep sampling. The community was dominated by Coenagrionidae damselflies (Appendix 5-F).

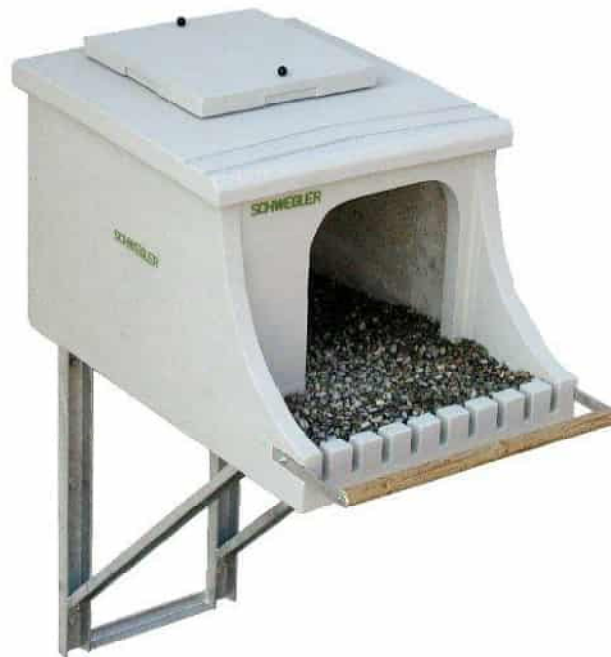
Plate 5-39
Peregrine Falcon Nest-Box

- 5.392 **Peregrine Falcon nesting box/ledge:** A permanent nesting box or ledge for Peregrine Falcon will be installed on the cliff-face that is to be retained post closure. It will be installed outside of the bird breeding season at a location chosen by and under the supervision of the ECoW. The ledge will be weatherproof and a camera mount will be provided to enable the nest-site to be easily monitored by NPWS. The ledge will be similar in design to that shown in Plate 5.39.
