INTRODUCTION

- 5.10 The development proposal provides for the routing of all traffic to and from the proposed development along the L1157 Local Road. It also includes provision for a comprehensive road improvement scheme along the entire length of the L1157 leading up to the application site, including road widening to 6.0m everywhere along its length, with road strengthening and repair overlay and road markings where required.

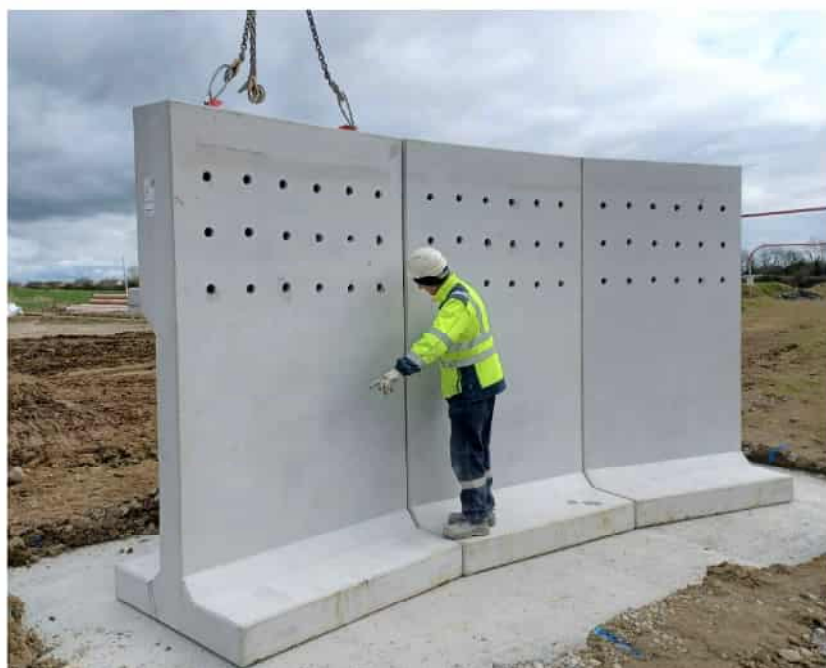
Plate 5-40
Pre-cast Sand Martin Nesting Wall

- 5.393 **Artificial Sand Martin colony:** An artificial Sand Martin nesting colony will be installed on-site at a location near the settlement ponds, or constructed wetland area. The award-winning design of the OPW precast Sand Martin wall from the Templemore Flood Relief Scheme will be adopted (see Plate 5.40). The walls are designed to stop predator access with the thickened stem and small entrance hole for the birds. The cavities within the wall widen out towards the rear for the nesting area, with removable caps fitted in the rear so that a bed of sand can be placed inside and to facilitate maintenance and monitoring.

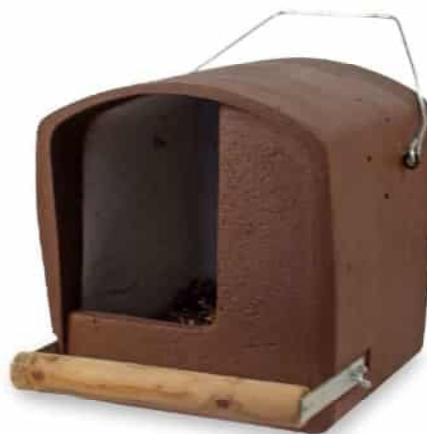
Plate 5-41
Woodcrete Kestrel Nest Box

- 5.396 **Bird and Bat boxes:** To encourage nesting birds and roosting bats at the site a selection of bird nest boxes and bat boxes will be erected at the site. The boxes will be weather resistant (woodcrete/recycled plastic) and the designs and erection locations will be chosen by a suitably qualified ecologist and these will be erected under the supervision of the ECoW. A total of 50 bird and 50 bat boxes will be erected at the site. Nest box design will include boxes suitable for Kestrel (Plate 5.41) and Barn Owl (Plate 5.42). Bat boxes will include pole mounted designs for areas where suitable trees are unavailable and also a large winter hibernation box. These bird and bat boxes will be monitored annually by a suitably qualified ecologist and any boxes lost or damaged will be repaired or replaced throughout the operational lifetime of the project.

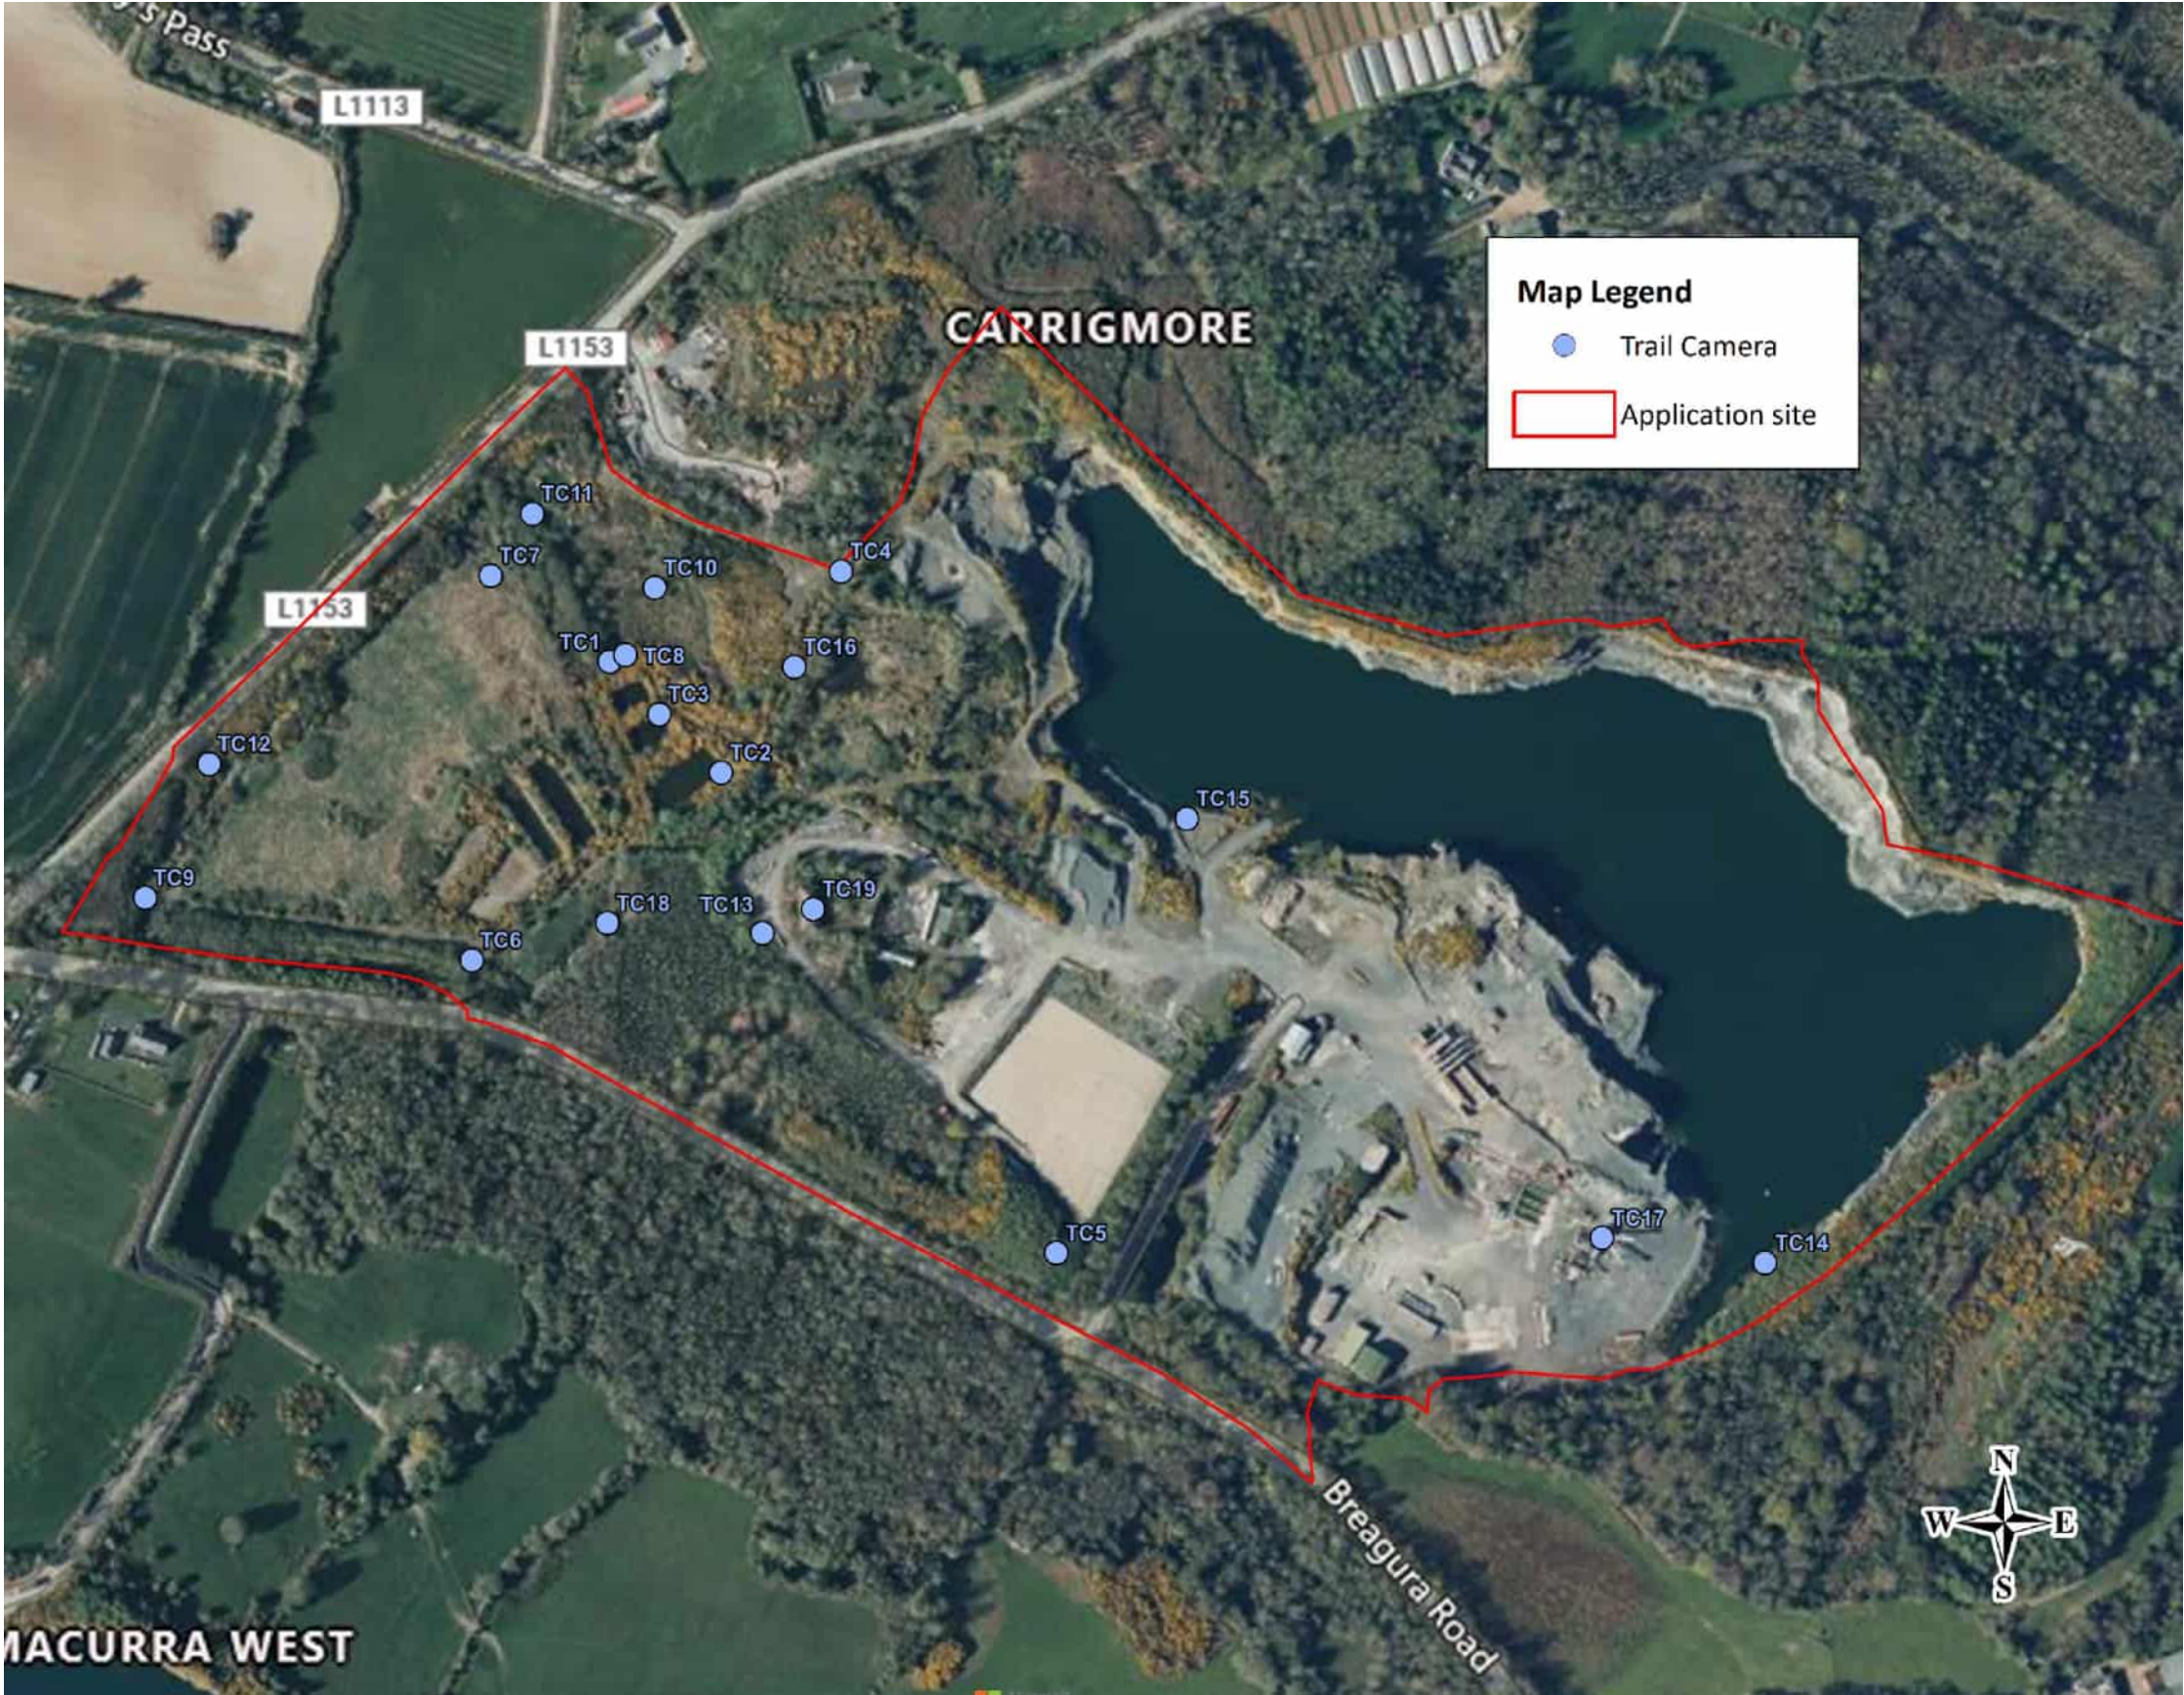
Drawing Title
TRAIL CAMERA LOCATIONS

- 5.55 Trail cameras were deployed at a total of 19 locations from record mammal activity in the study area (Figure 5-2). These trail cameras ('camera traps') are small camera units that are left in situ to record mammals (and birds) that pass close to the deployment locations. When analysing the trail camera record records the first photo in a sequence is identified and counts as an 'observation'. To minimise inflating the number of 'observations' of a particular individual that stays close to the camera for a prolonged period, consecutive photos of a particular species are

- 5.53 Non-volant mammal field surveys comprised walkovers and long-term deployment of multiple wildlife trail cameras at locations throughout the application site (Figure 5-2). The dates and duration(s) of deployment of trail cameras at each location is summarised in Table 5.2. Direct and photographic data were supplemented by casual records made in the course of other terrestrial field surveys (e.g. night-time active bat surveys,). Walkovers of the site to record signs of non-volant mammals were carried out over several days were carried out on dates described in Table 5.1. This includes walkovers of the main haul route along the L1157.

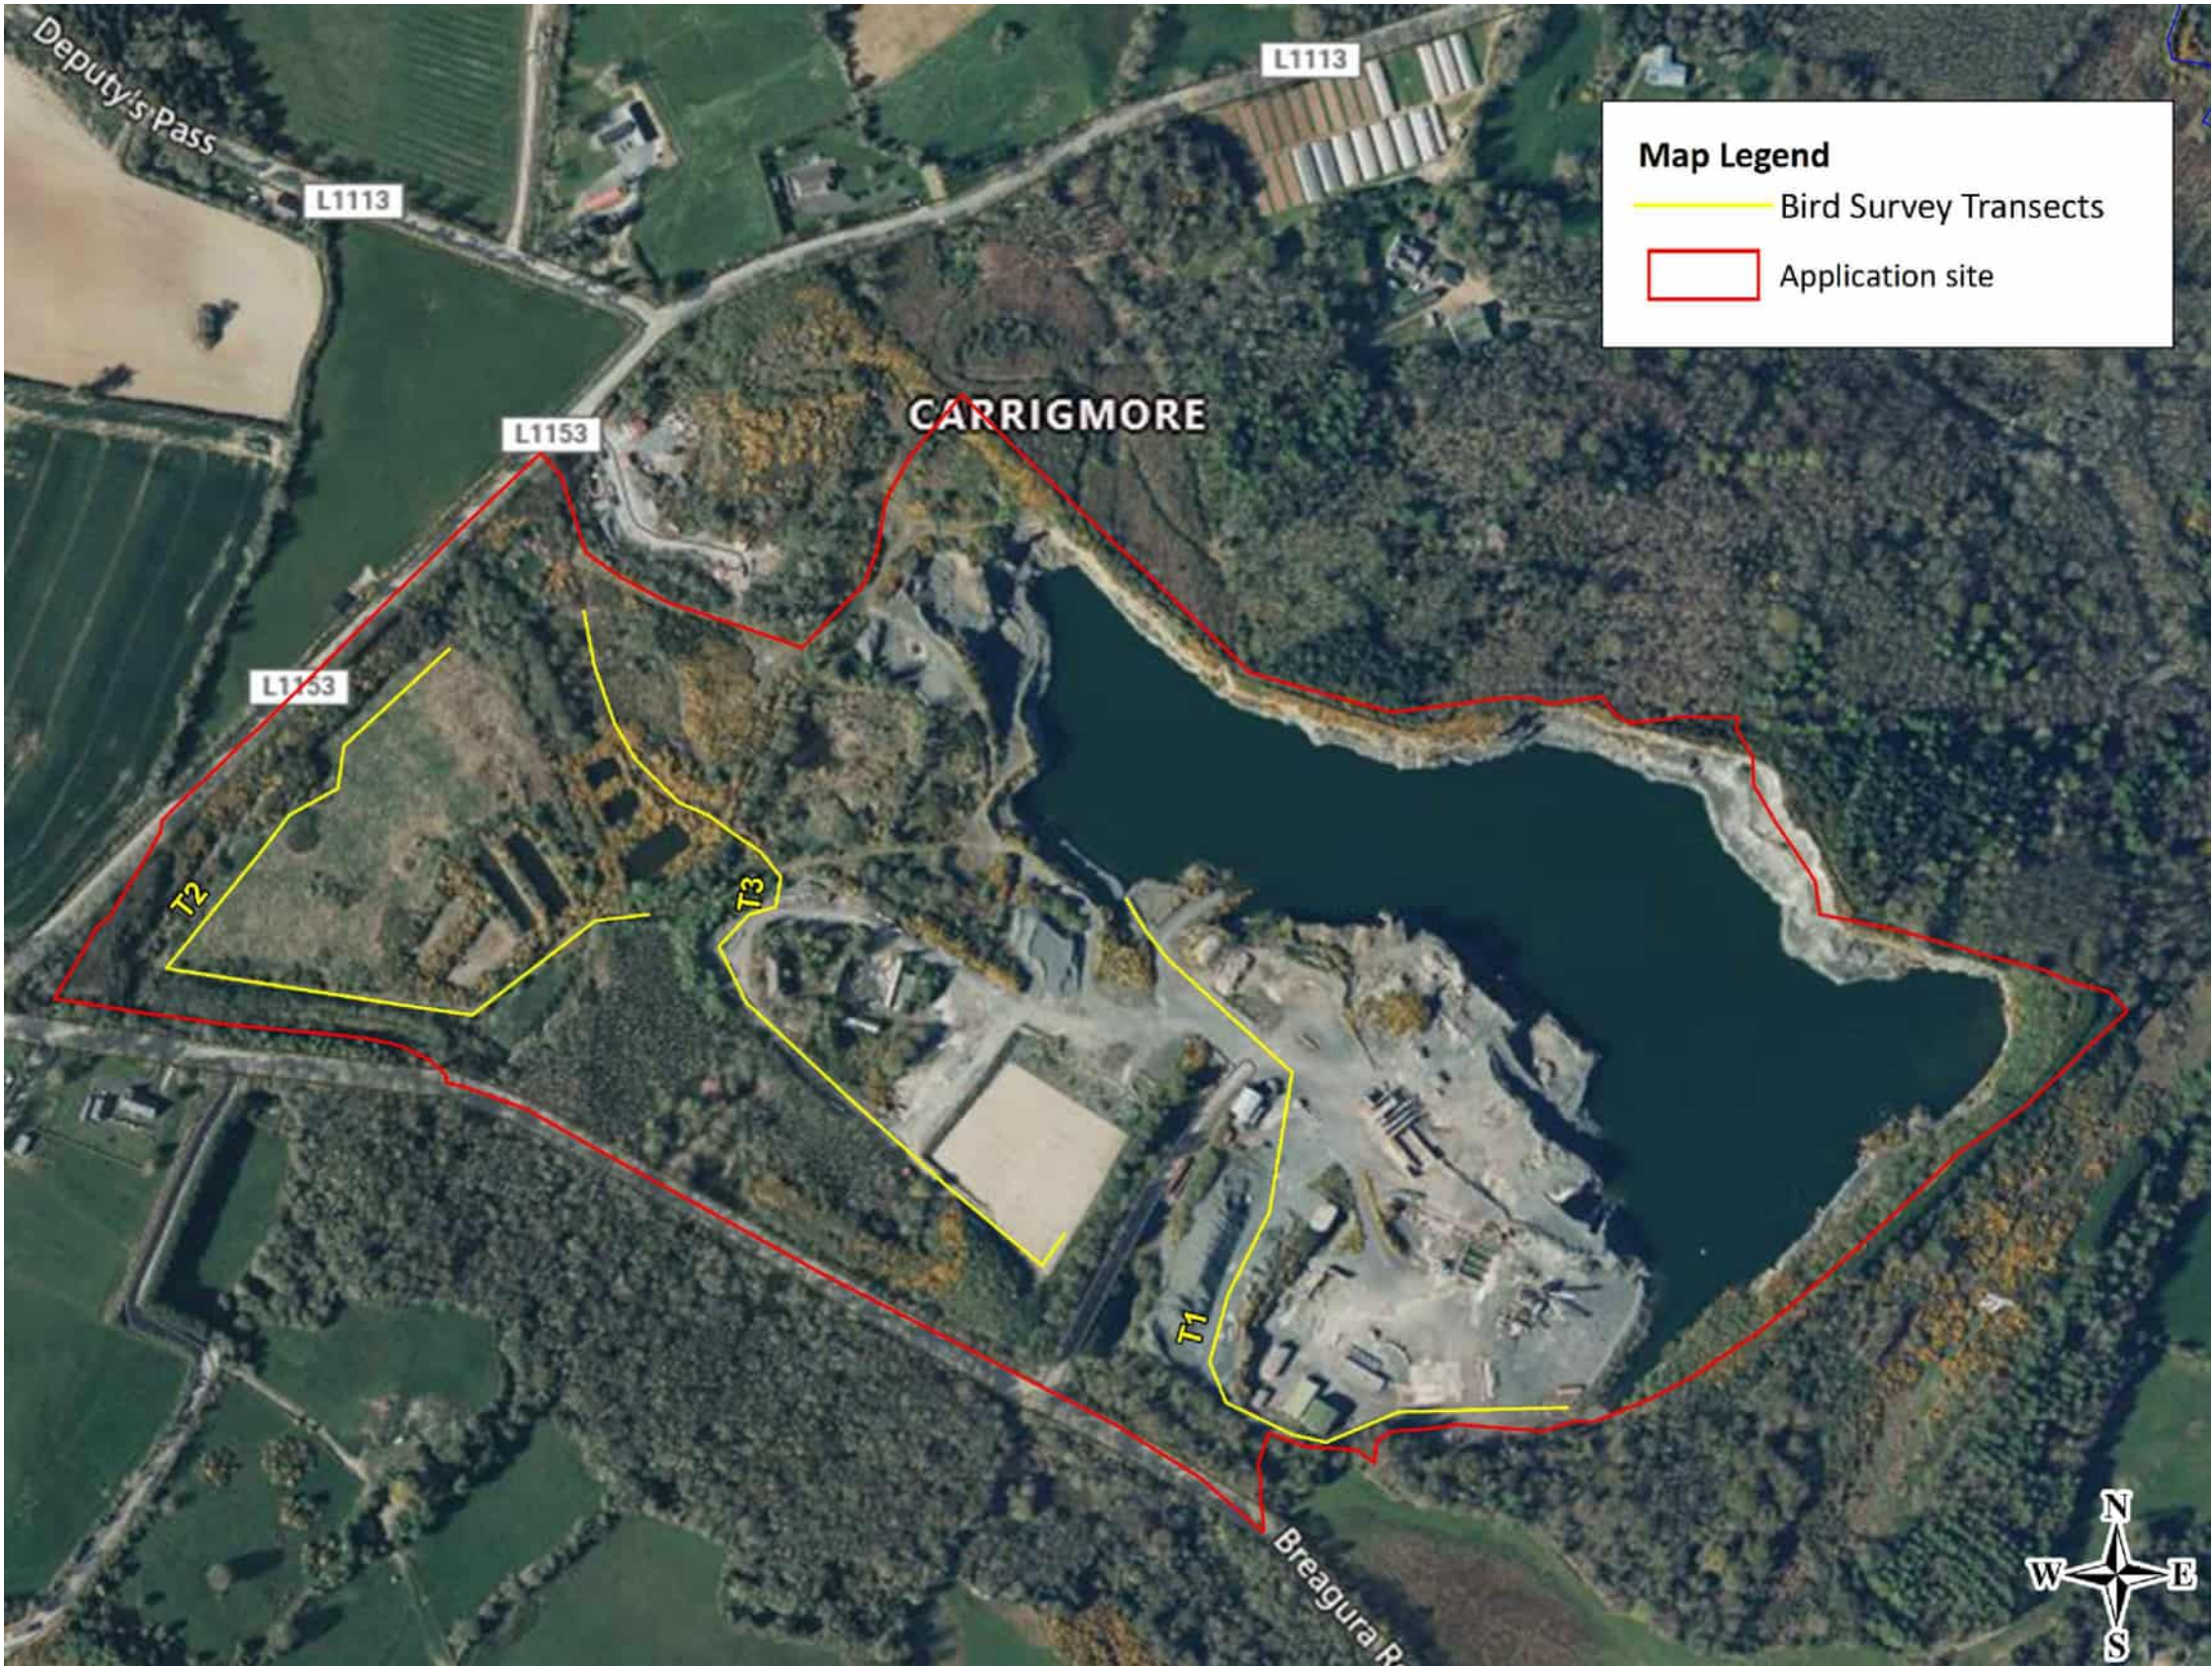
Scale 1:4,000	@ A3	SLR Project No. 065366.00001	
Designed GF	Drawn GF	Checked GF	Authorised GF
Date 10/24	Date 10/24	Date 10/24	Date 10/24
Drawing Number FIGURE 5-5			Rev. 1

- 5.69 Figure 5-5 shows the location of three transects used to record the bird community present at the site in winter and in the bird breeding season. Figure 5-6 shows the location of three Point Count locations used to assess the general breeding bird community present along the L1157 towards the junction with the R772.
