## **APPENDIX 6-2**

**BAT SURVEY REPORT  
(INCLUDING APPENDICES)**

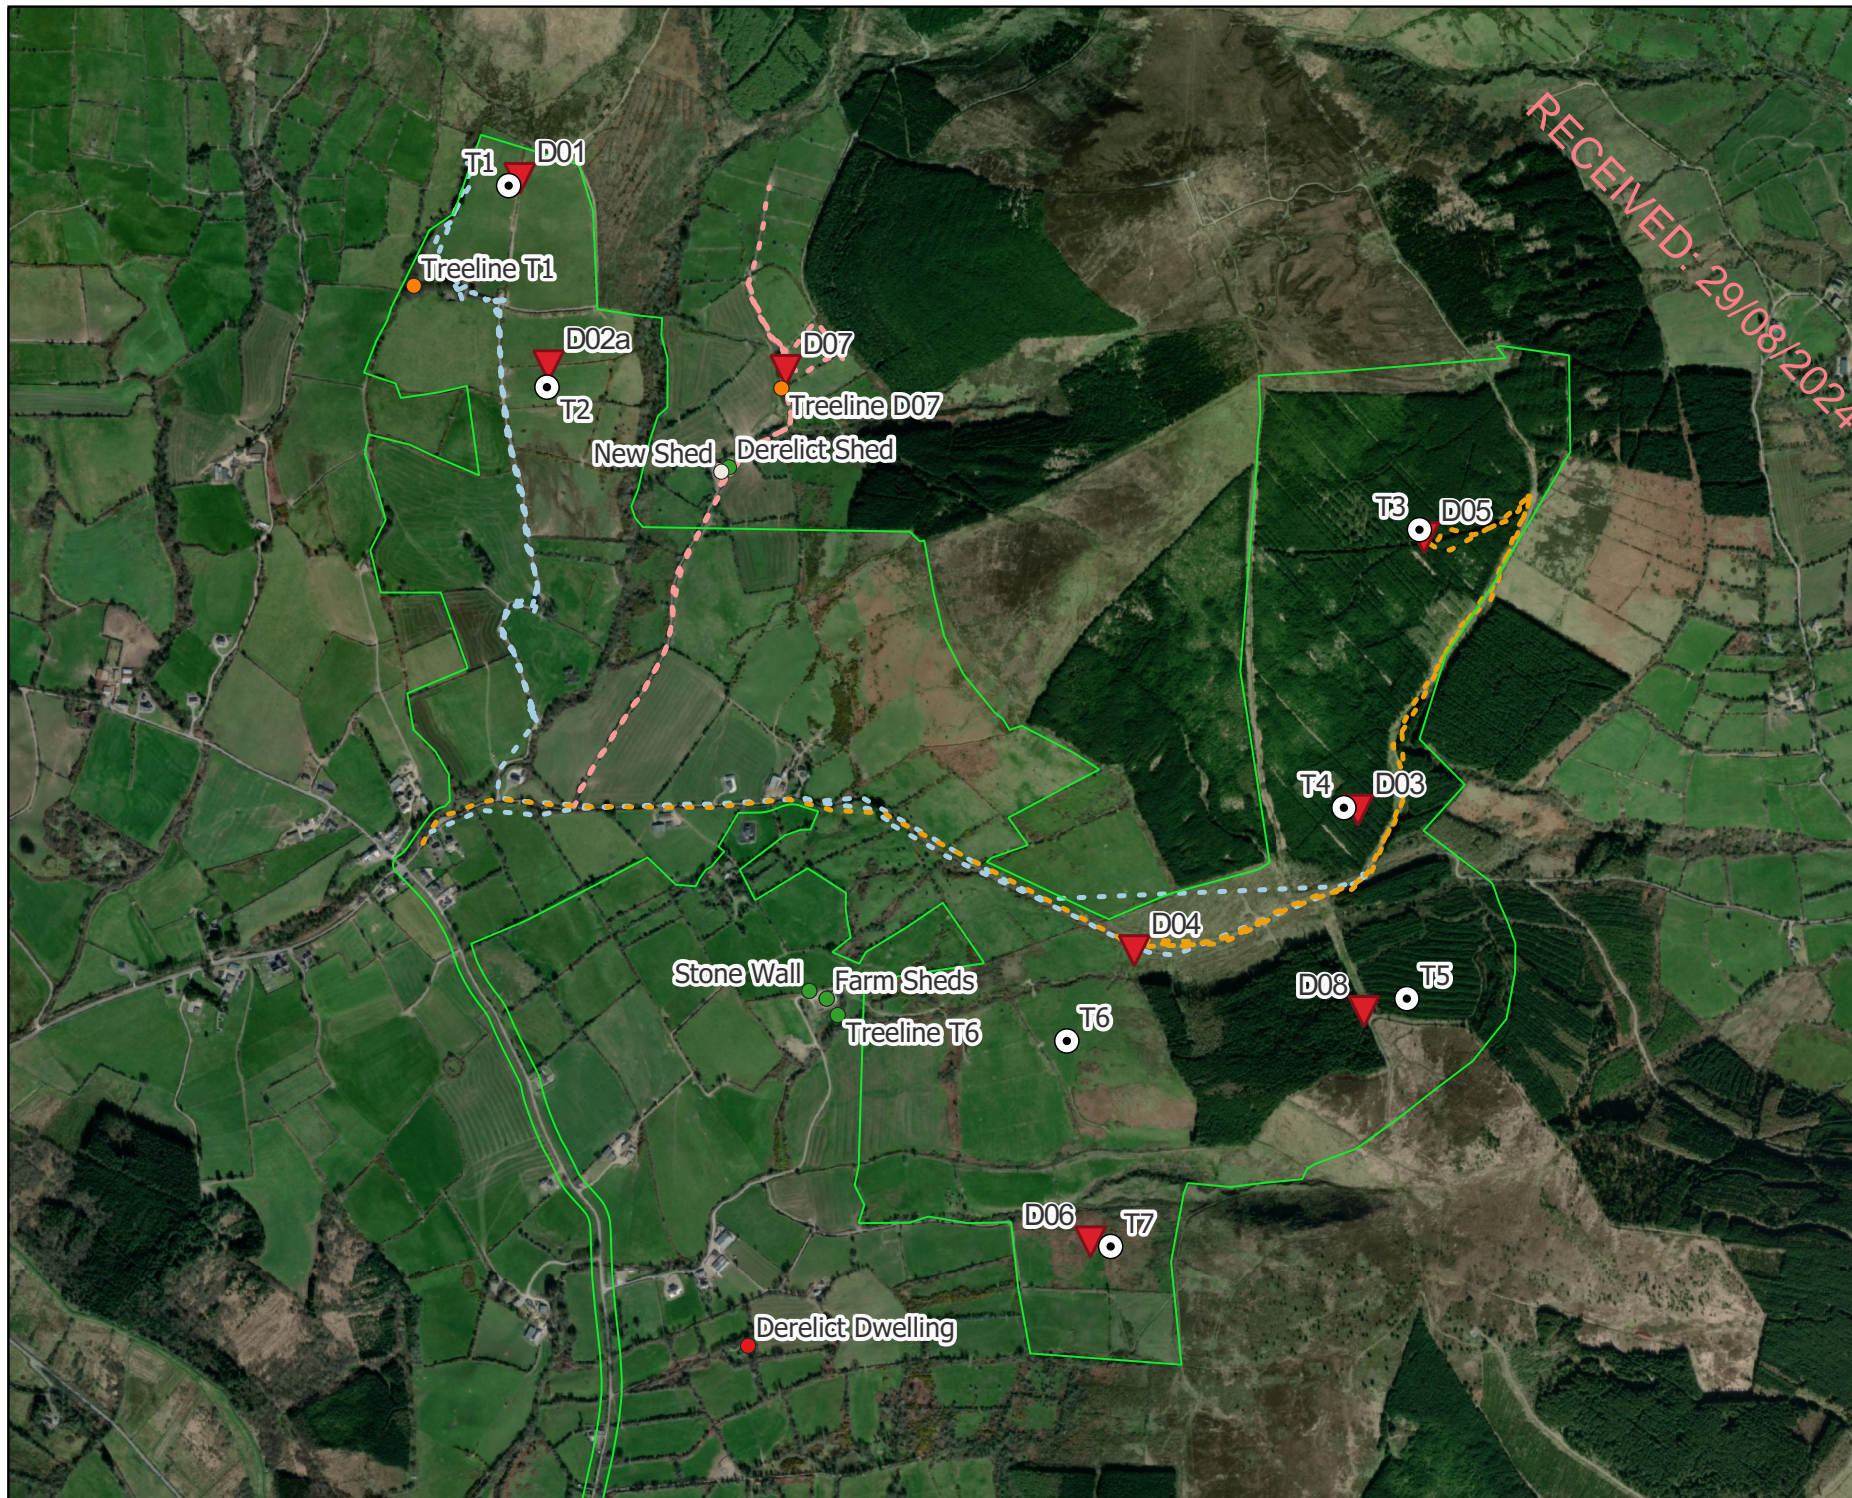
- EIAR Site Boundary
- Proposed Turbine Layout
- Static Detector Locations
- Spring Transect 11.05.2022
- Summer Transect 02.08.2022
- Autumn Transect 21.09.2022
- PRFs Inspected**
  - High
  - Low
  - Moderate
  - Negligible

Keyhole felling will be required where turbines are proposed in areas of forestry within the site. This involves only felling an area required to construct the turbine and associated infrastructure thus creating open areas, within the forest, around proposed turbines (IWEA, 2012). The 'keyhole' size is typically 50m from turbine blade tip to forestry edge, and these keyhole areas remain open during the wind farm lifetime. Further details on proposed key-hole locations can be found in Chapter 4 of the EIAR. Where keyholing is proposed, detectors were located along nearby forestry edge to more closely reflect the likely post-construction habitat (NatureScot, 2021). Detector D04 was not located at the exact proposed turbine location (T6) as the integrity of the equipment and safety of surveyors could not be guaranteed due to bulls and cattle being present. Static detector locations are described in Table 3-3 and presented in Figure 3-1.

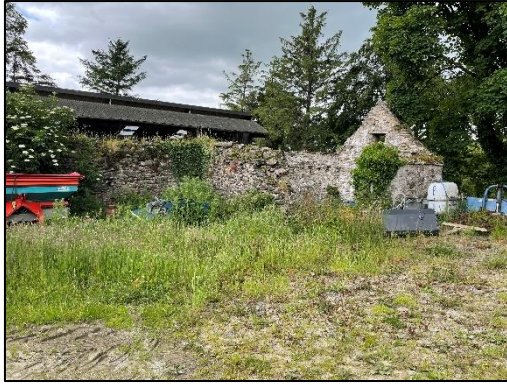
Plate 4-1 Derelict shed's north-eastern aspect. New shed behind it.

One of the PRF structures identified was a derelict stone shed with a broken-down corrugated roof located in the vicinity of newly built farm buildings (IG Ref: R 62688 73403, Plate 4-1 Plate 4-2). The structure is located approximately 408m east of proposed turbine T2. No evidence of roosting bats was found within the derelict shed, however a small number of gaps suitable for crevice dwelling bats was identified. It was assigned a *Low* roosting potential. The shed was subject to a dusk emergence survey on 24<sup>th</sup> August 2022, as detailed in Section 4.4.1. A newly built shed located in its proximity was assigned *Negligible* roosting potential.

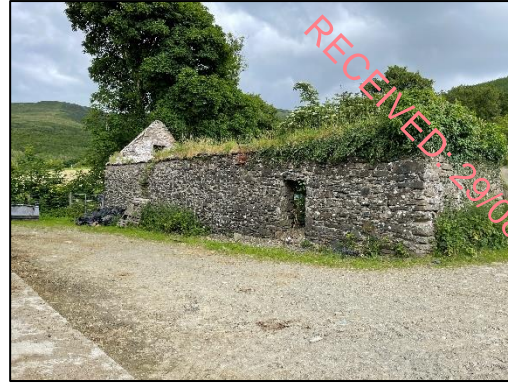
Plate 4-2 Derelict shed's north-western aspect.

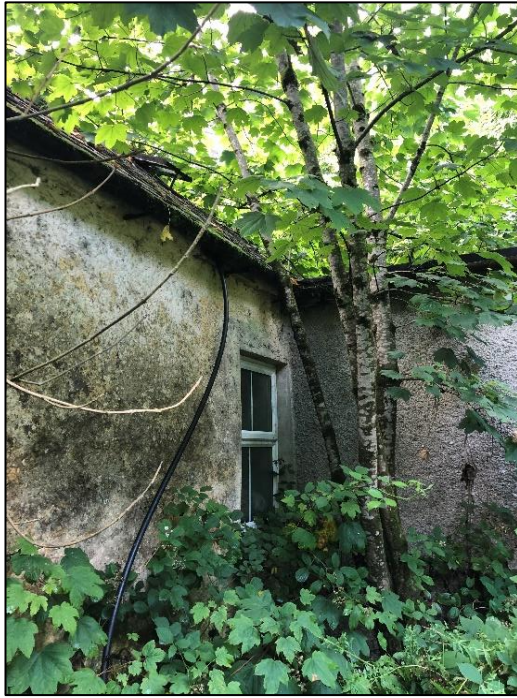
Plate 4-3 Back of derelict dwelling with large gaps along fascia.

An exterior inspection of the structure was carried out on 5<sup>th</sup> May 2022. No evidence of roosting bats was found, however suitable access points were identified along the fascia as well as within gaps in the roof slates and via open windows. On 5<sup>th</sup> May, no interior access to the dwelling was granted to surveyors. The interior of the derelict outbuildings was inspected, where health and safety allowed it. The outbuildings consisted of a lean-to shed to the north of the dwelling and a separate stone milking parlour. Both were in advanced state of dereliction, with broken down corrugated roofs and vegetation overgrowth throughout. They were both assigned *Moderate* roosting potential. The house was subject to a dusk emergence survey on the same night.

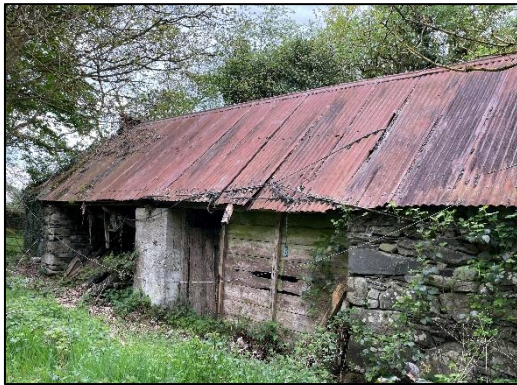
Plate 4-4 Lean-to derelict shed.

Two dusk emergence surveys were carried out at the derelict house located 710m west of proposed turbine T6. During the first survey, one lesser horseshoe bat was observed potentially emerging from the structure from the lean-to shed. Leisler's bats and soprano and common pipistrelles were also recorded foraging within the farmyard by both surveyors, which were located at the front and back of the house. Another dusk emergence, which was carried out in August following the interior inspection of the house, found lesser horseshoe bats emerging from a large gap in the fascia at the back of the house. A small number of bats, comprising 3 to 5 individuals, was observed. The bats continued foraging along the surrounding treeline for the remainder of the survey. No other species was observed emerging, however activity by Leisler's bats and soprano and common pipistrelles was recorded.

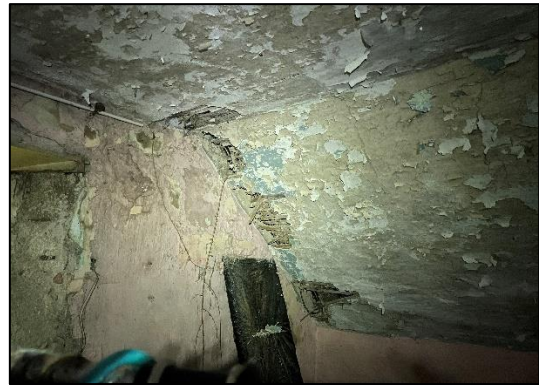
Plate 4-6 Interior of dwelling with exposed attic space.

An interior inspection of the dwelling was carried out on 24<sup>th</sup> August 2022. The structure was built in the early 1900s and subsequently extended and renovated. It comprised two floors with two rooms each and a mezzanine bathroom extension. All floors were covered with discarded clothing and other materials, but most areas of the house were accessible for inspection. A small attic space was present along the roof apex, but was not accessible for inspection. A significant number of bat droppings was identified in one room of the second floor, under gaps in the ceiling opened into the attic apex and scattered within the room. Scattered droppings and some urine splashes were also found in the rest of the dwelling, in minor concentrations. No other evidence of bat use was found. Mustelid droppings of various sizes, possibly belonging to stoat and pine marten, were also identified in the dwelling. The house was assigned a *High* roosting potential. A second emergence survey was carried out on the same night and the dwelling was confirmed as a Lesser Horseshoe bat roost.

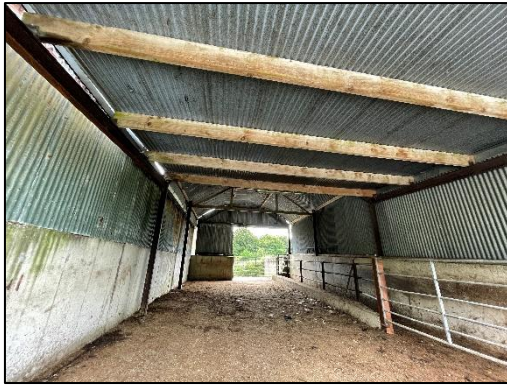
Plate 4-7 Farm shed with *Negligible* potential

The third structure identified is a cluster of four farm sheds located within the same land ownership as turbine T6 and is located approximately 490m west of the proposed turbine (IG Ref: R 62886 72346). The sheds were all open corrugated sheds in use by cattle (Plate 4-7). No suitable roosting spaces were identified within the sheds, and they were assigned a *Negligible* roosting potential. A stone wall partially overgrown by ivy was also present outside the sheds (Plate 4-8). The wall was well-pointed and any gaps identified were considered too shallow to host roosting bats. The stone wall was assigned a *Low* potential due to the dense ivy cover, which could provide opportunistic shelter. No evidence of bat use such as droppings or grease marks were identified.

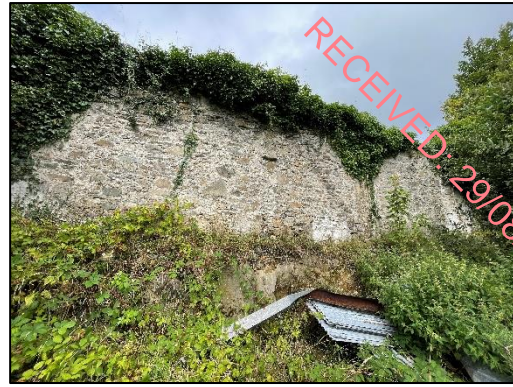
Plate 4-8 Stone wall with *Low* potential

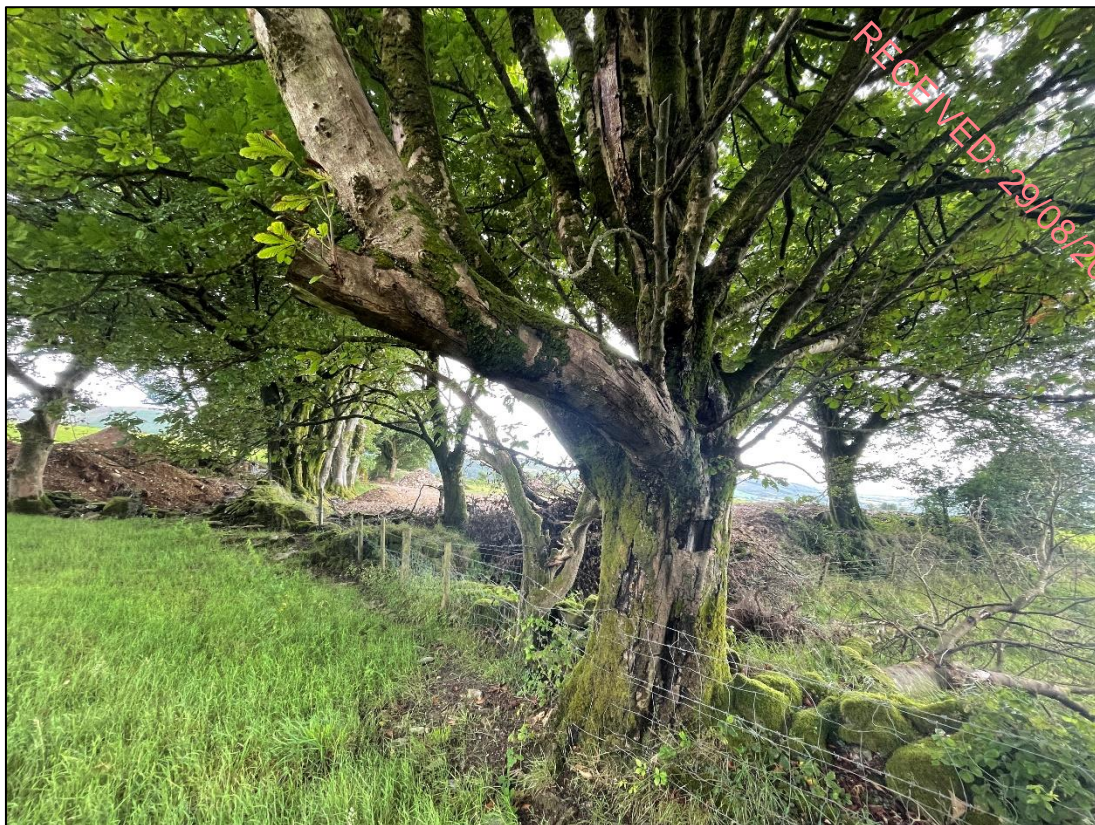
Plate 4-9 Moderate potential tree located south of proposed turbine T1

- A mature treeline located approximately 200m south-west of proposed turbine T1, with *Low* to *Moderate* potential (IG Ref: R 62085 73754). The treeline also includes conifer trees with *Negligible* potential.
- A mature treeline with *Moderate* potential, approximately 120m long, located in proximity of a preliminary turbine location which was subsequently dropped at design stage due to existing constraints (IG Ref: R 62798 73568). The treeline is close to detector D07.
- A number of deciduous trees with *Low* potential surrounding the farm shed located west of proposed turbine T6 (IG Ref: R 62833 72340).

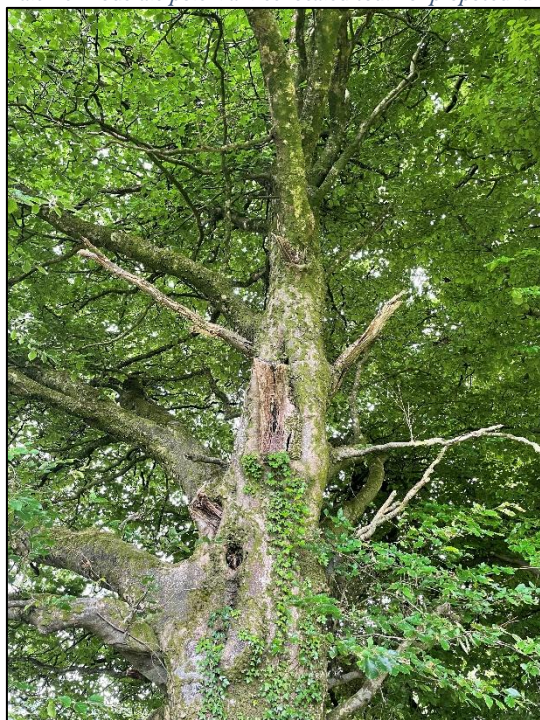
Plate 4-10 Moderate potential tree located outside of the Proposed Wind Farm .

Where a potential for impact on the trees as a result of the Proposed Project was identified (i.e. felling), the trees were subject to further assessment, as described in Section 4.4.1 below.

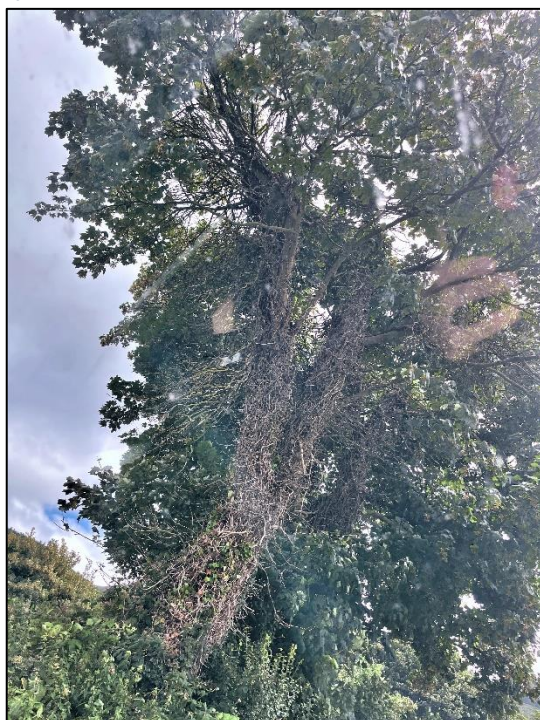
Plate 4-11 Low potential tree located west of proposed T6, outside of the Proposed Wind Farm .

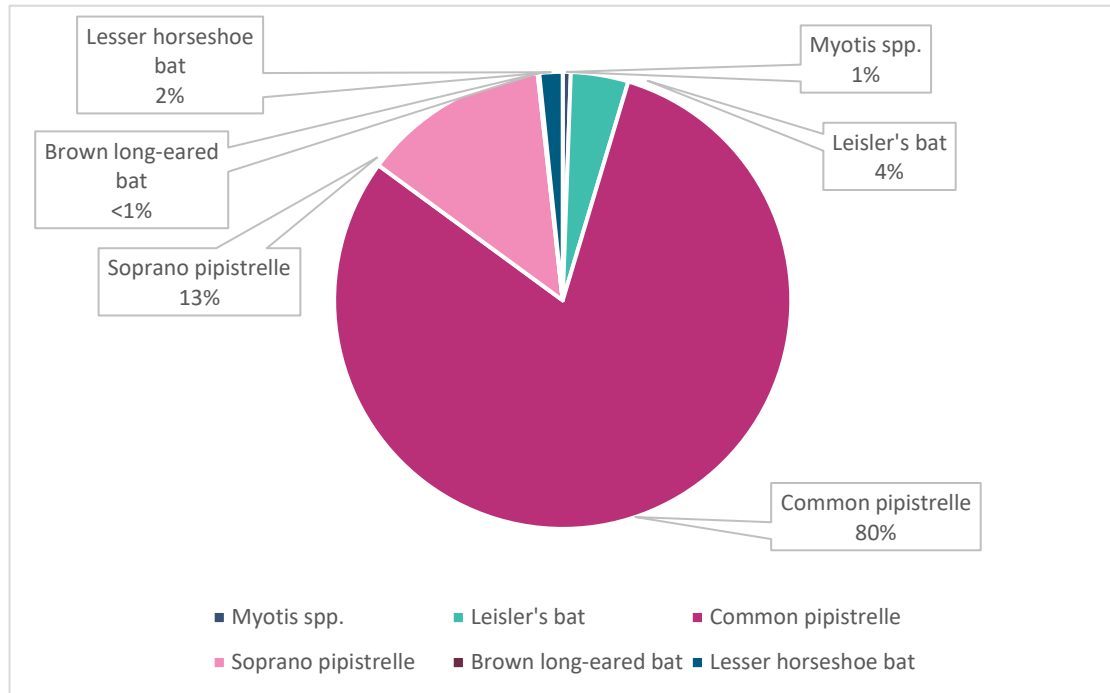
Plate 4-12. Species composition recorded during manual activity surveys.

Manual bat activity surveys took place in the Spring, Summer, and Autumn of 2022. Bat activity was recorded on all surveys, with a total of 1,768 bat passes (Plate 4-12). Common pipistrelle (n=1,422) was the species recorded most frequently, followed by soprano pipistrelle (n=233), Leisler's bat (n=72), and lesser horseshoe bat (n=29). *Myotis* spp. (n=10) and brown long-eared bat (n=2) were recorded in low numbers. The following sections detail the results of emergence/re-entry surveys and transect surveys carried out throughout 2022.

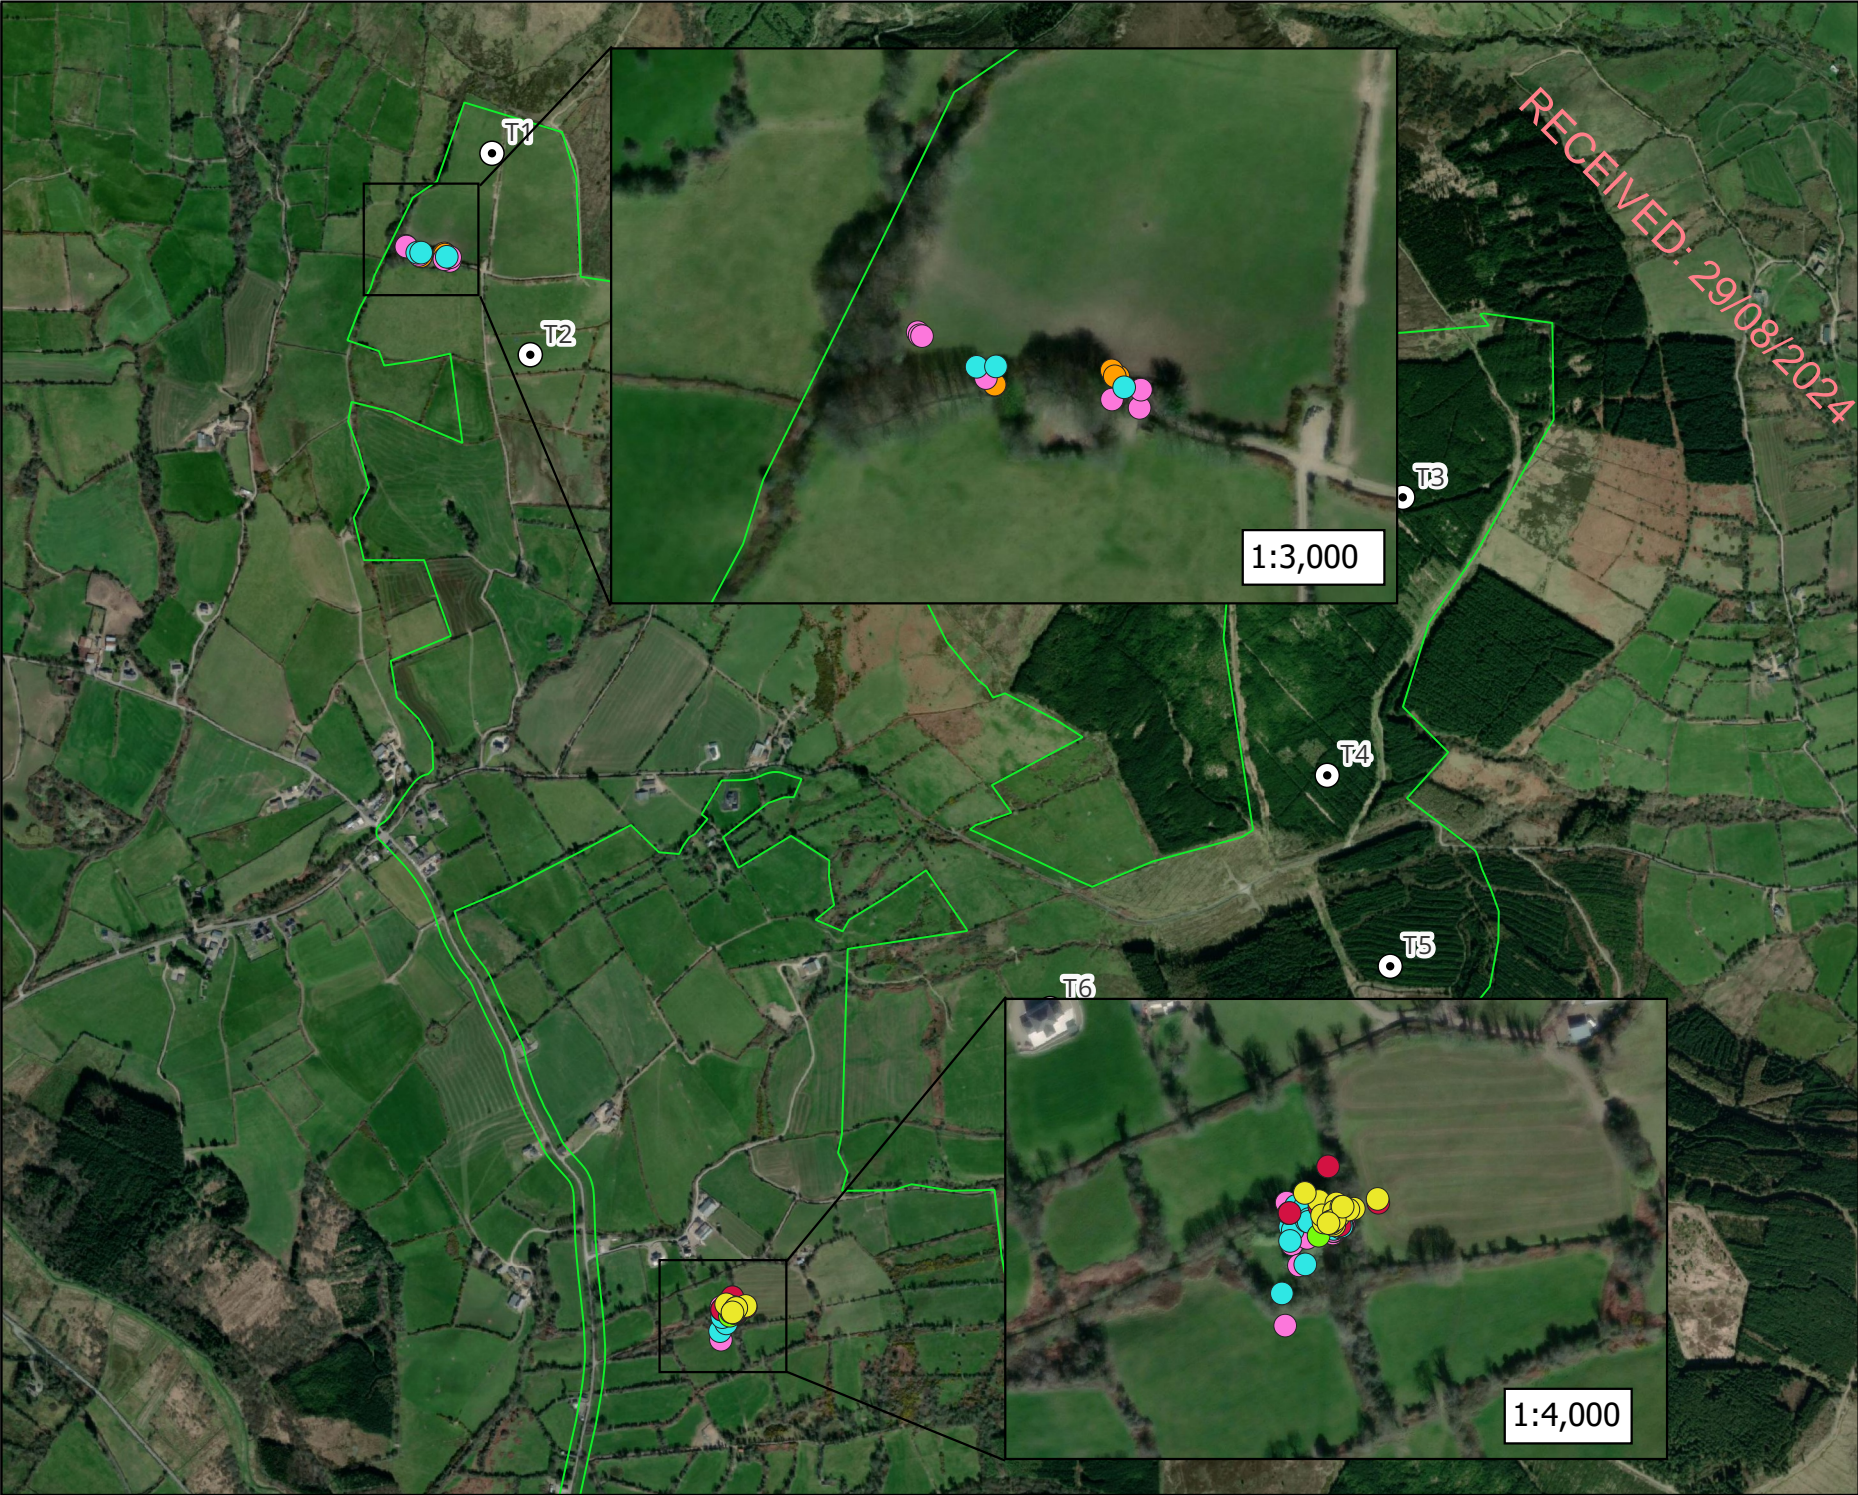
- EIAR Site Boundary
- Proposed Turbine Layout
- Dusk 24.08.22 & Dawn 25.08.22 Results
- Myotis spp.
- Leisler's bat
- Common pipistrelle
- Soprano pipistrelle
- Brown long-eared bat
- Lesser horseshoe bat

Two surveys were carried out along the treeline comprising mature deciduous trees located approximately 200m southwest of proposed turbine T1. During the dawn re-entry survey carried out in August, bats were observed foraging around the trees and primarily commuting west. Activity stopped approximately 40 minutes prior to dawn, no bats were observed returning to the trees for roosting. During the dusk emergence survey carried out in September, activity started early after sunset, with bats observed coming from the south-western corner of the treeline. No roost was identified however it was considered likely for the PRFs present within the trees to be used as transitional roosting spaces. Species recorded during the surveys at these locations were Leisler's bats, common and soprano pipistrelles.

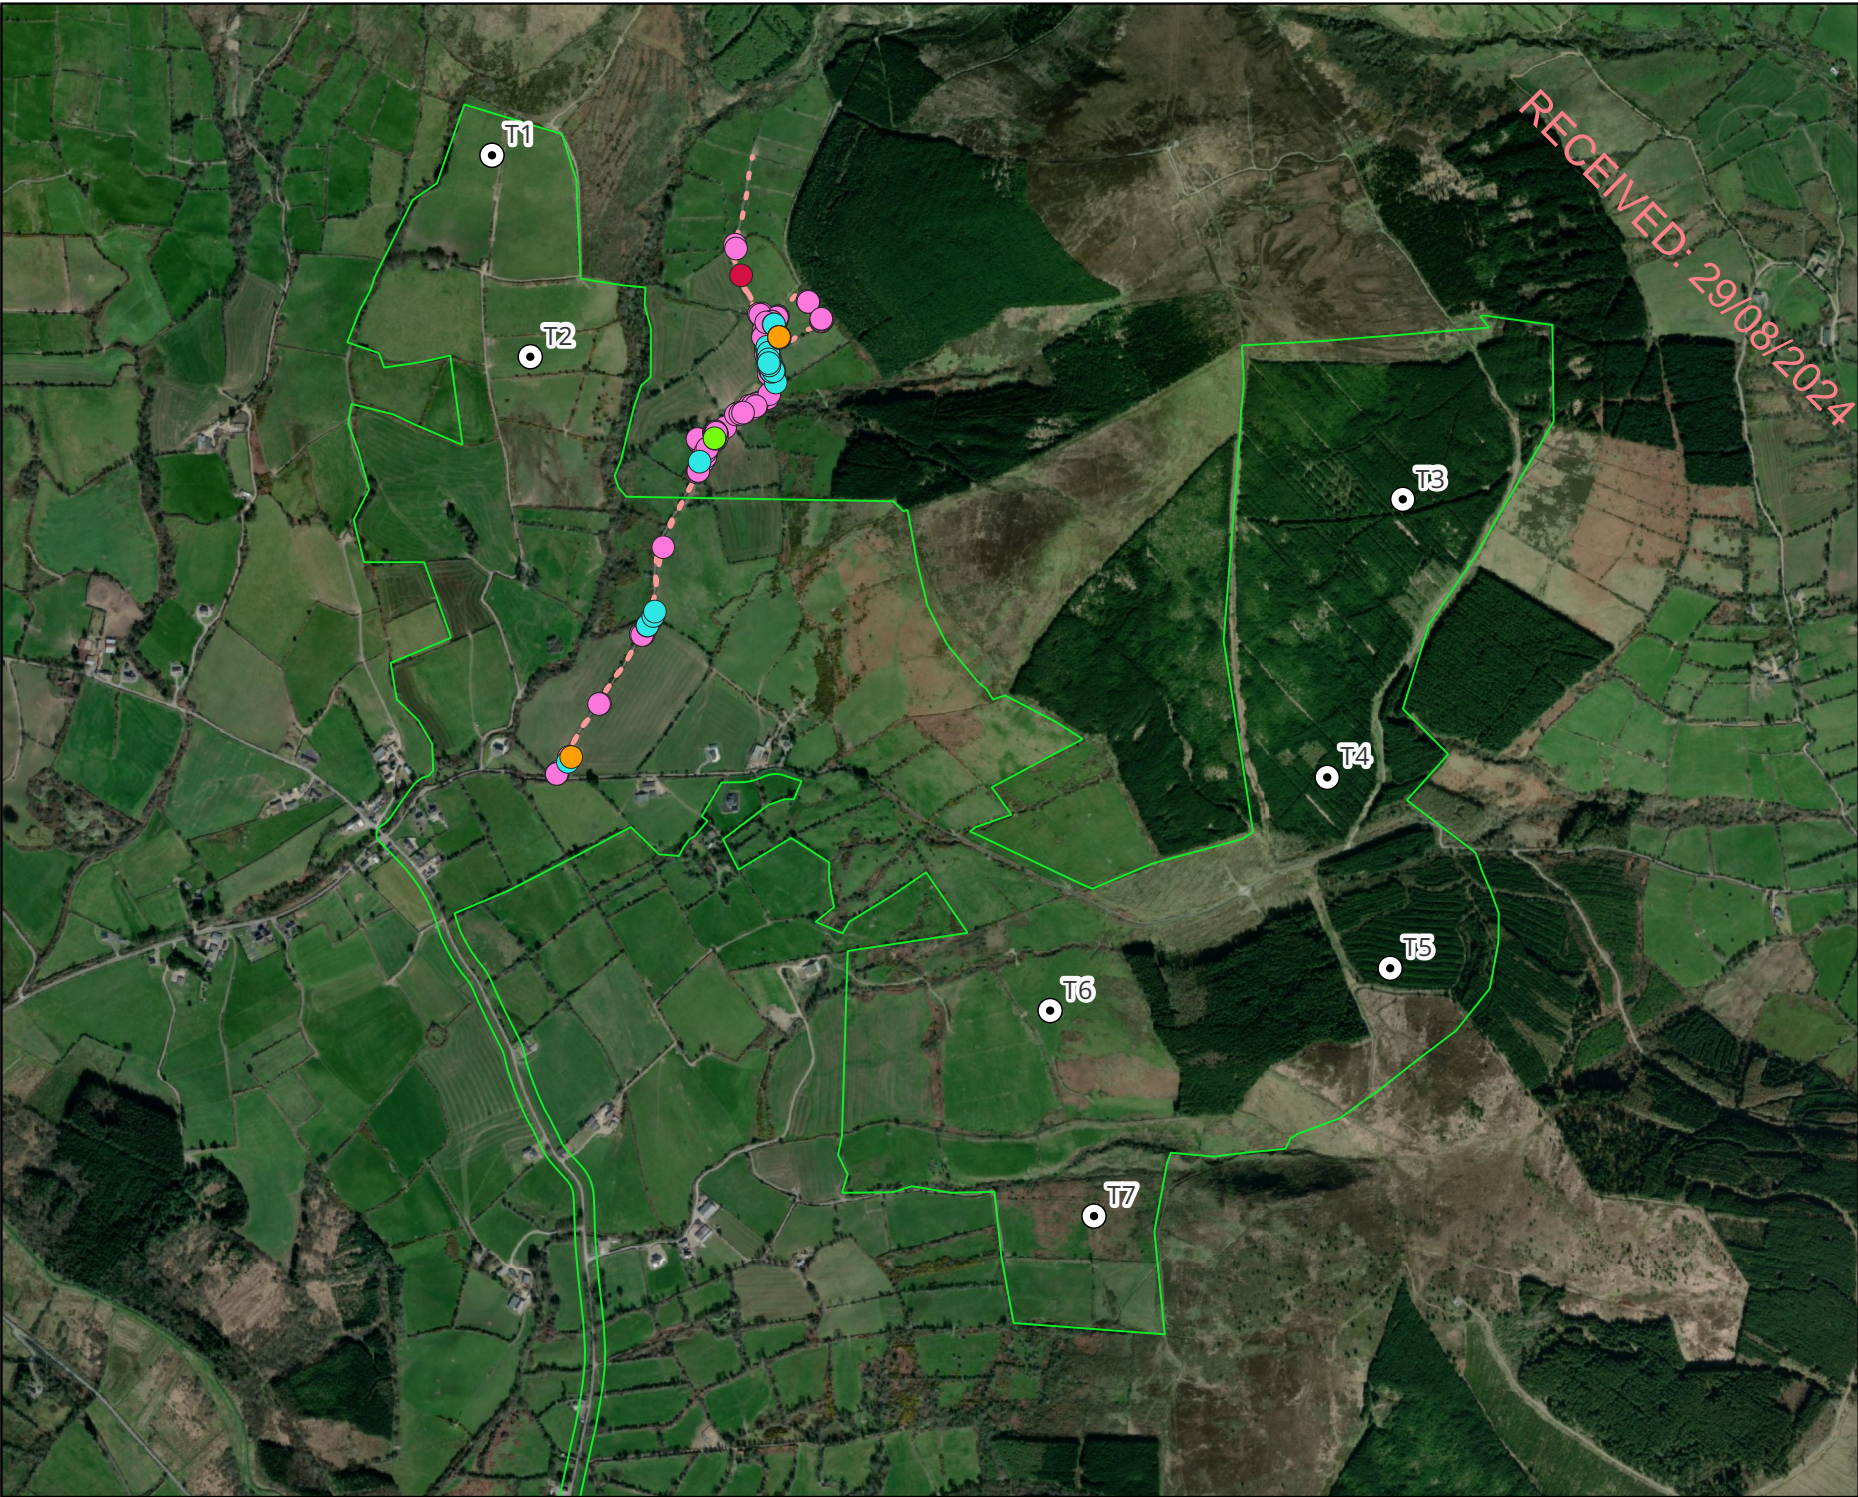
Drawn By	Checked By
NS	SF
Project No. 220245	Drawing No. Fig. 4-3
Scale 1:15,000	Date 2024-04-12

- EIAR Site Boundary
- Proposed Turbine Layout
- - - Transect 02.08.2022
- Transect Results 02.08.2022
  - Myotis spp.
  - Leisler's bat
  - Common pipistrelle
  - Soprano pipistrelle
  - Brown long-eared bat

Figure 4-2 to Figure 4-4 present the spatial distribution of bat activity across the manual activity surveys at the Proposed Wind Farm site.

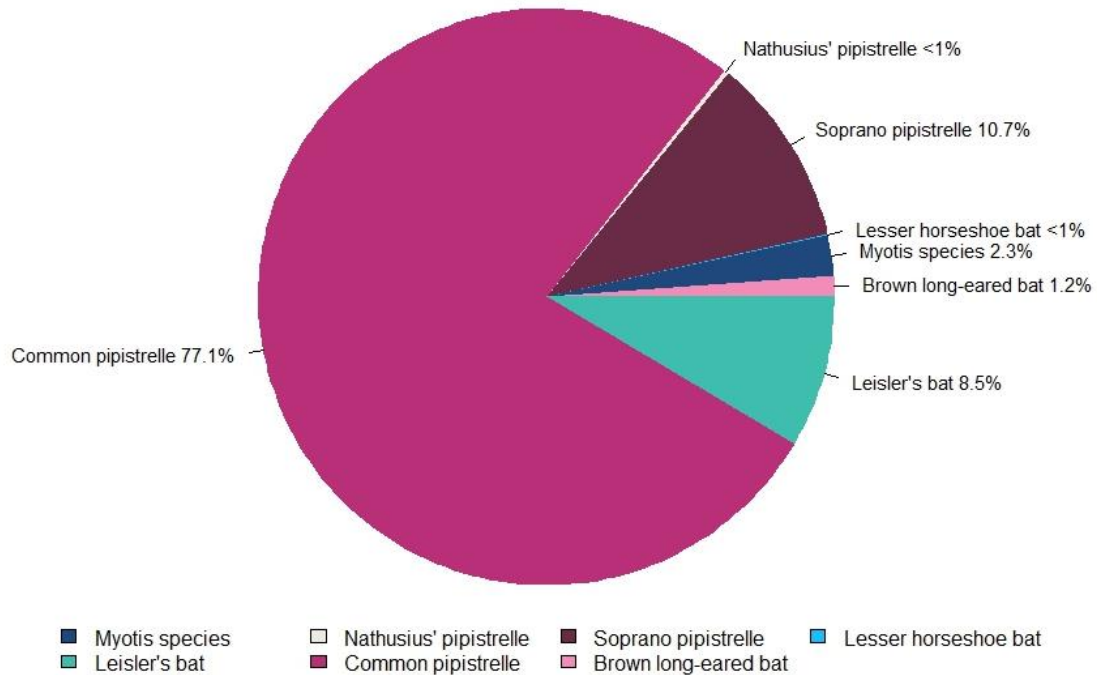
Plate 4-13 Static Detector Surveys: Species Composition Across All Deployments 2022

In total, 75,245 bat passes were recorded across all deployments. In general, common pipistrelle (n=58,020) occurred most frequently, soprano pipistrelle (n=8,035), Leisler's bat (n=6,400), *Myotis* spp. (n=1,707) and brown long-eared bat (n=877) were significantly less. Few instances of Nathusius' pipistrelle (n=156) and lesser horseshoe bat (n=50) were also recorded. Plate 4-13 presents species composition across all ground-level static detectors.

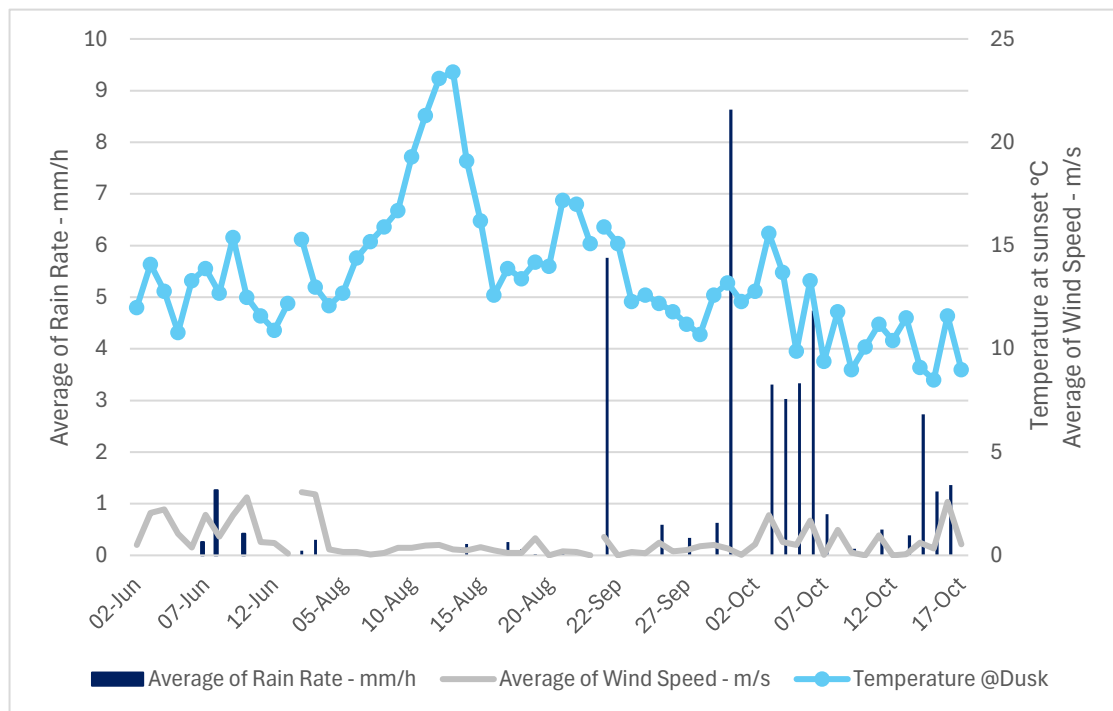
Plate 4-16 Weather Conditions recorded in 2022.

Weather conditions (rainfall, windspeed and temperature) at night during deployments 2022 are presented below (Plate 4-16). Autumn had the highest level of rainfall.

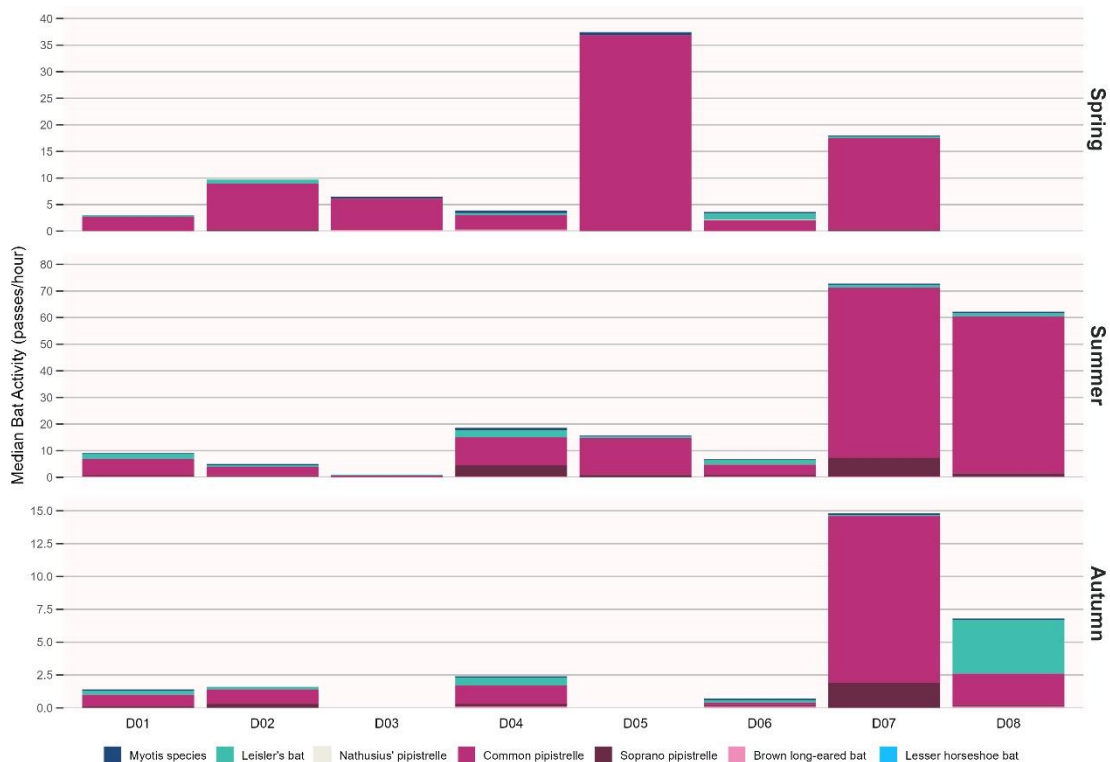
Plate 4-17 Median bat activity per detector across the seasons 2022 with different y-axis. There was no Detector D08 deployed in Spring.

Median bat passes per detector was used to assess the level of activity per location and per season. The plates below illustrate the median bat passes per detector across the seasons with varied y-axis (Plate 4-17) and same y-axis (Plate 4-18) allowing for comparison. It should be noted that a median of zero does not necessarily mean that there was no bat activity recorded at the location.

In summer, species composition by location tended to have a higher proportion of median soprano pipistrelles activity. D07 and D08 tended to have the highest median bat activity of the season (*median* D07 = 72.75 *bpph*; *median* D08 = 62.2 *bpph*). In comparison to spring, D05 median bat activity tended to reduce while D07 it tended to increase. *Myotis* spp. reached their highest median bat activity across the three seasons at D04.

In autumn, the median bat activity tended to be lower than in spring and summer. The lowest median values was calculated at D03 and D05 where both detectors median equalled zero for all bat species. The highest proportion of Leisler's bats per detector across the three seasons was recorded at D08 in Autumn.

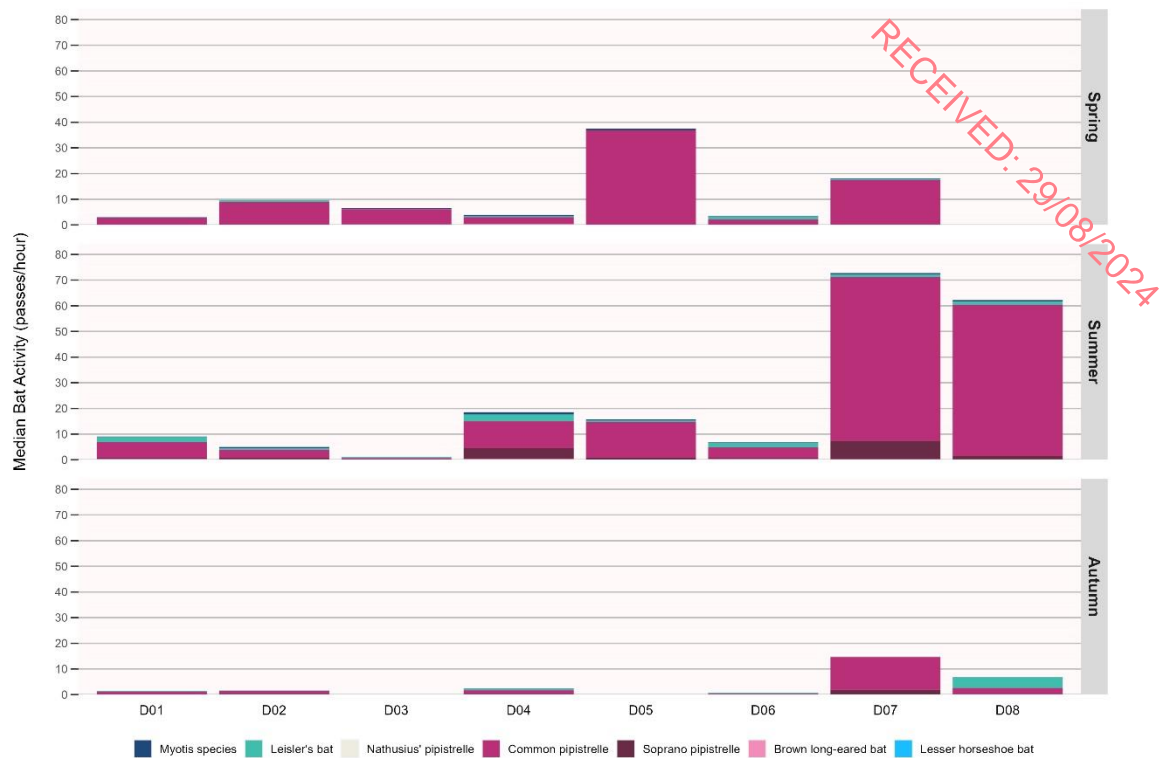
Plate 4-18 Median bat activity per detector across the seasons 2022 with same y-axis allowing for comparisons. There was no Detector D08 deployed in Spring.

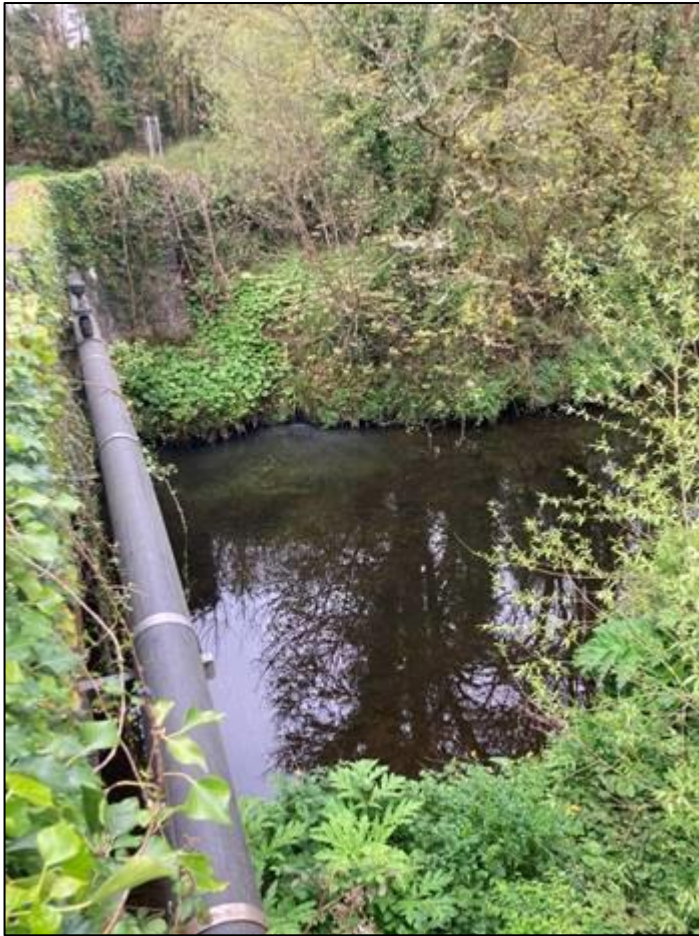
Plate 5-1 Bridge 1 existing ducted services.

Horizontal Directional Drilling (HDD) is proposed for Bridge 3 and ducting on deck is proposed for Bridge 2, as such no loss of roosting habitat is anticipated. Bridge 1 will be equipped with a stainless steel pipe fixture which will run in conjunction with other existing services (Plate 5-1), to limit aquatic works and the spread of existing invasive species. The bridge was identified as having roosting potential however roosting features were identified within the arch and not the sides of the structure. No potential damage or loss of roosting habitat is anticipated. A potential for temporary disturbance during works was identified and will be mitigated as described in section 6.2.3.
