**GEOTECHNICAL AND PEAT
STABILITY ASSESSMENT
REPORT**

Lackareagh Wind Farm
Geotechnical and Peat Stability Assessment Report

13 August 2024

Person responsible	Manasvi Srivastava, Liam Power
Company	AFRY Ireland Limited
Address	The Hyde Building, The Park, Carrickmines, Dublin 18, Ireland
E-mail	manasvi.srivastava@afry.com , Liam.power@afry.com
Project Number	ICPR1268
Revision Number	REV I
Date	August 2024

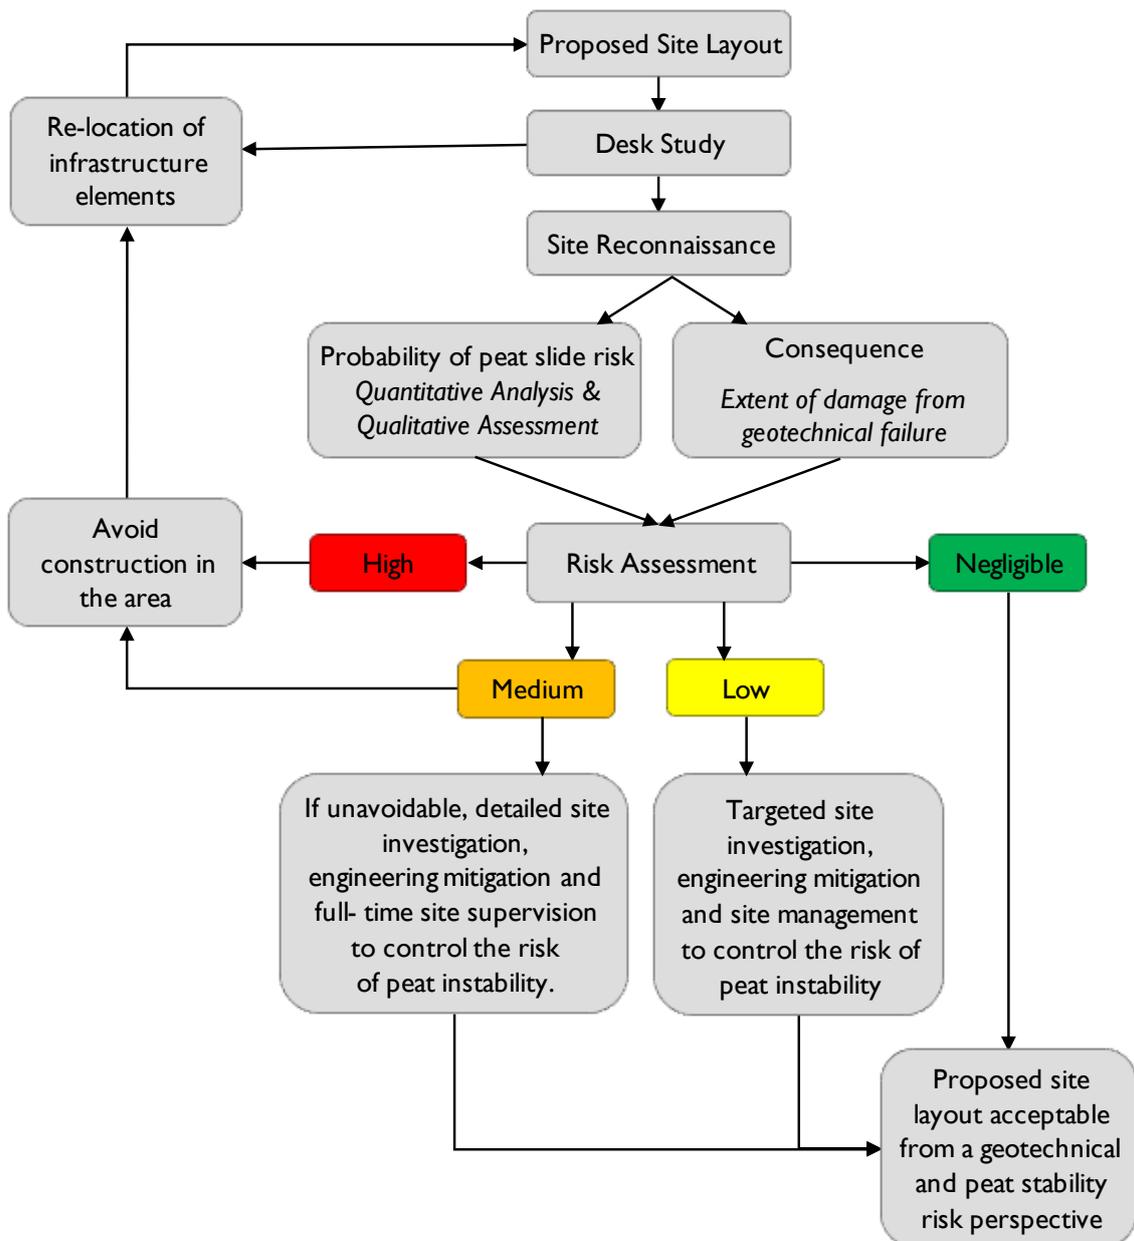
Figure 1: Peat Stability Risk Assessment Methodology

Figure 1 shows a workflow diagram showing the general methodology for the PSRA.

The methodology followed is set out below:

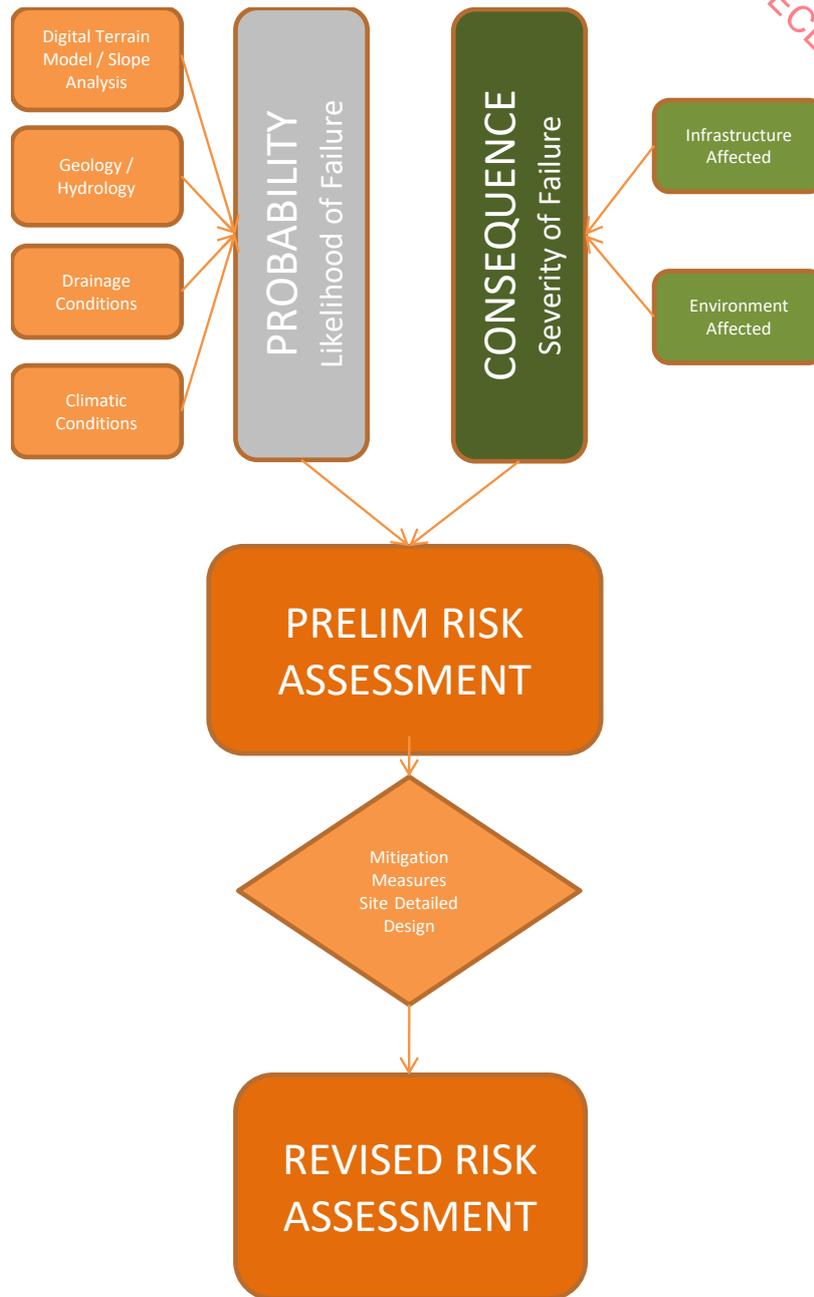
Figure 5: Revised Risk Assessment Process

It is proposed that site infrastructure identified with a Negligible or Low risk from a landslide (or other geotechnical failure) perspective would not have any further consideration within this report.

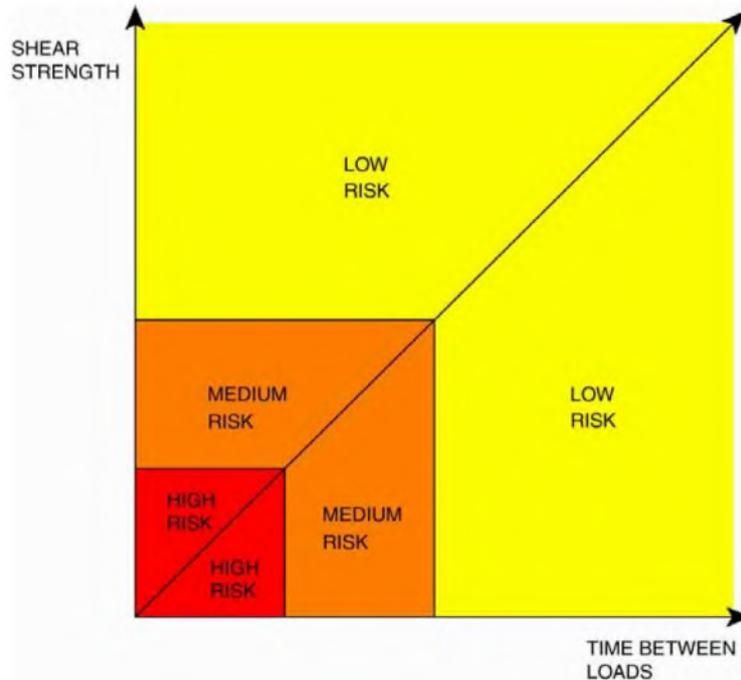
Figure 6: Graph showing relationship between shear strength and time between loads (MacCulloch 2006)

If visual monitoring shows deterioration in the four elements listed above, the time interval between loading will be increased in order to decrease the risk (Figure 6 below).

The graph shown in Figure 4 above indicates that reducing the time between deliveries would increase the risk of peat failure. However, increasing the time between the loads allows the pore water pressure to dissipate into the adjoining peat, thus reducing the risk.

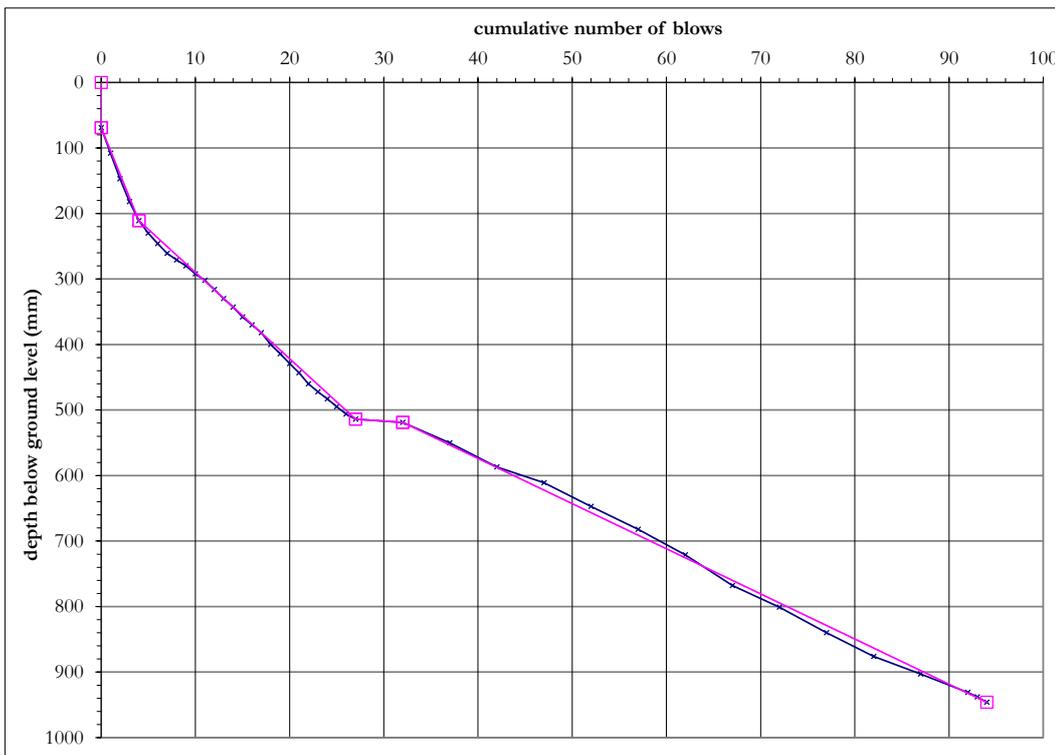
Surface preparation	Description of surface material at test depth
N/A	TOPSOIL

top / base of layer (mm)	mm/ blow	CBR (%)
0	N/A	N/A
69		
69	36	6.9
211		
211	13	20
514		
514	1	>100
519		
519	6.9	39
946

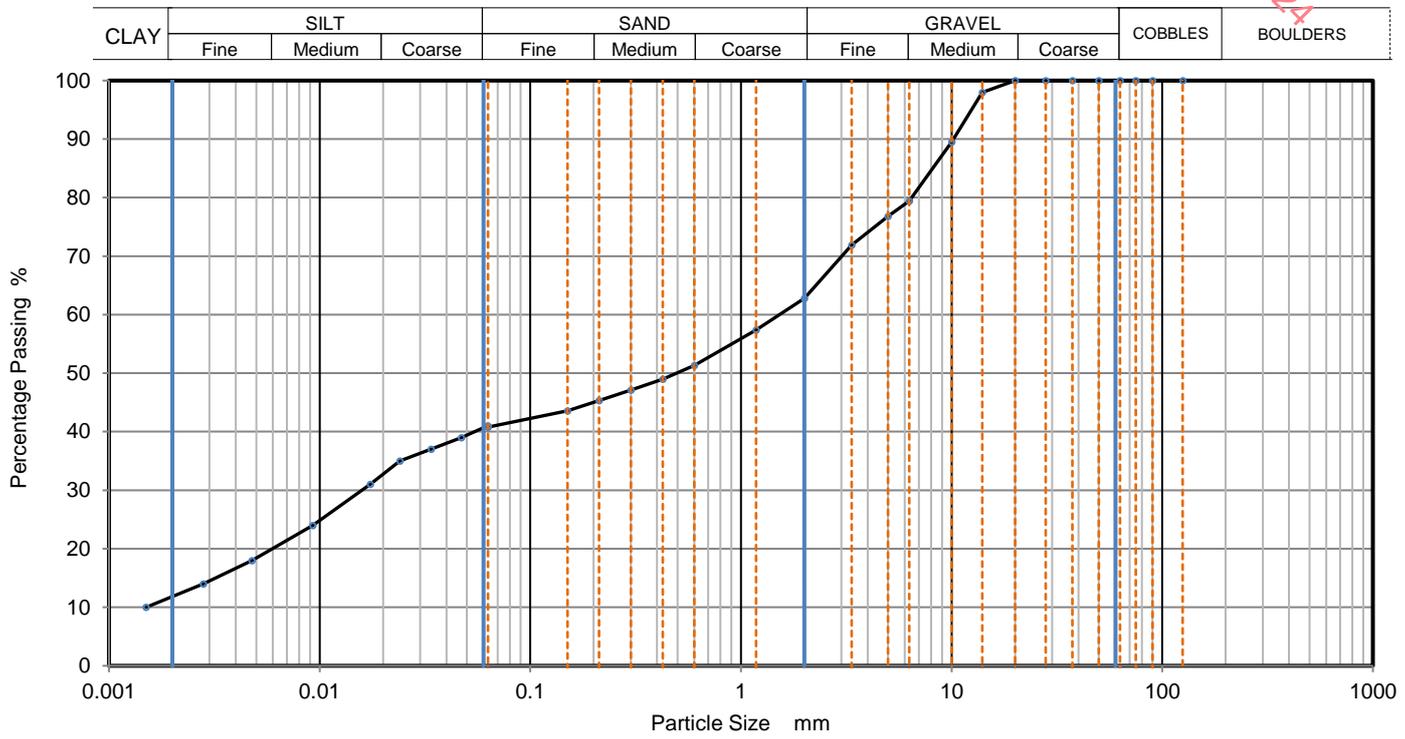
Site Name	Lackareagh Wind Farm		
Specimen Description	Brown sandy slightly gravelly clayey SILT.		
Specimen Reference	2	Specimen Depth	1.5 m
Test Method	BS1377:Part 2:1990, clauses 9.2 and 9.5

Sieving		Sedimentation	
Particle Size mm	% Passing	Particle Size mm	% Passing
125	100	0.06289	41
90	100	0.04710	39
75	100	0.03379	37
63	100	0.02406	35
50	100	0.01737	31
37.5	100	0.00926	24
28	100	0.00477	18
20	100	0.00281	14
14	98	0.00150	10
10	90		
6.3	79		
5	77		
3.35	72		
2	63		
1.18	57		
0.6	51		
0.425	49	Particle density (assumed)	
0.3	47	2.65 Mg/m3	
0.212	45		
0.15	44		
0.063	41

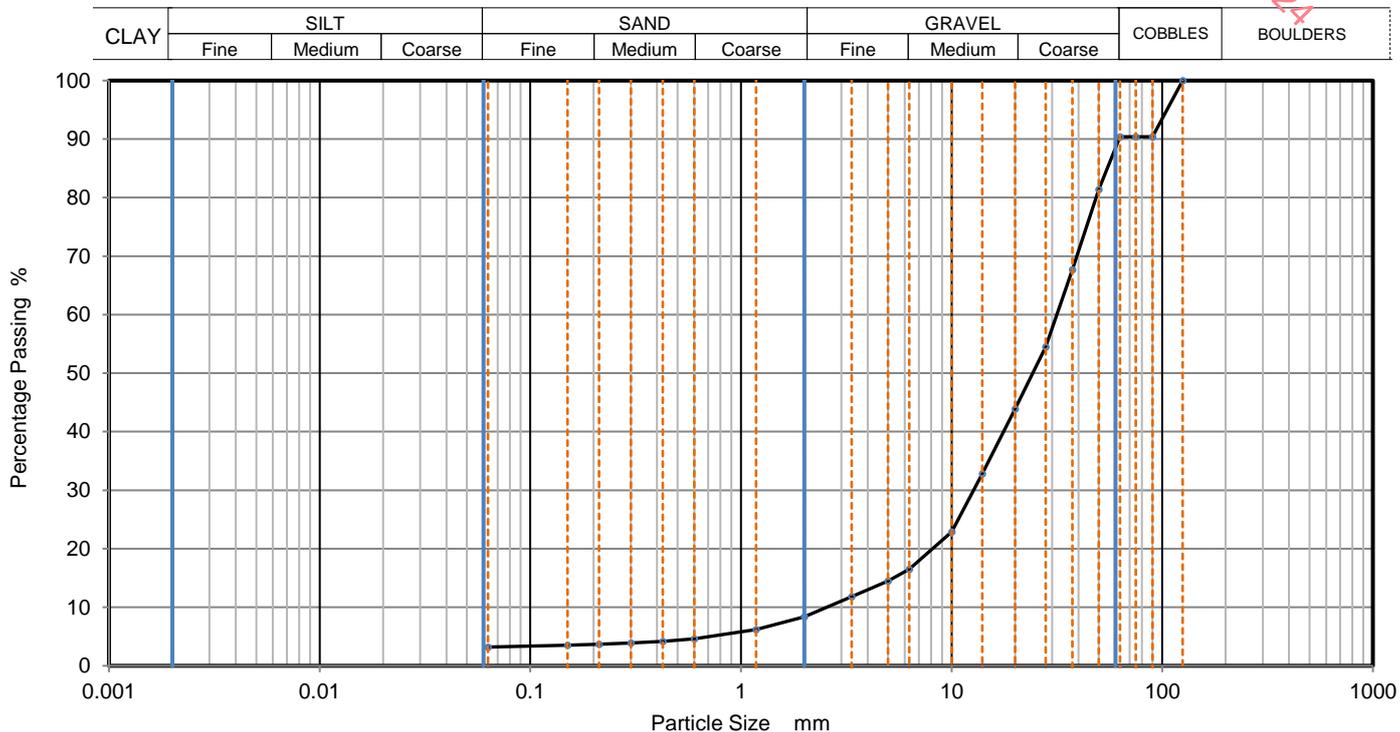
Site Name	Lackareagh Wind Farm		
Specimen Description	Brown slightly sandy slightly clayey subangular fine to coarse GRAVEL.		
Specimen Reference	2	Specimen Depth	1.6 m
Test Method	BS1377:Part 2:1990, clause 9.2

Sieving		Sedimentation	
Particle Size mm	% Passing	Particle Size mm	% Passing
125	100		
90	90		
75	90		
63	90		
50	81		
37.5	68		
28	55		
20	44		
14	33		
10	23		
6.3	17		
5	15		
3.35	12		
2	8		
1.18	6		
0.6	5		
0.425	4		
0.3	4		
0.212	4		
0.15	4		
0.063	3

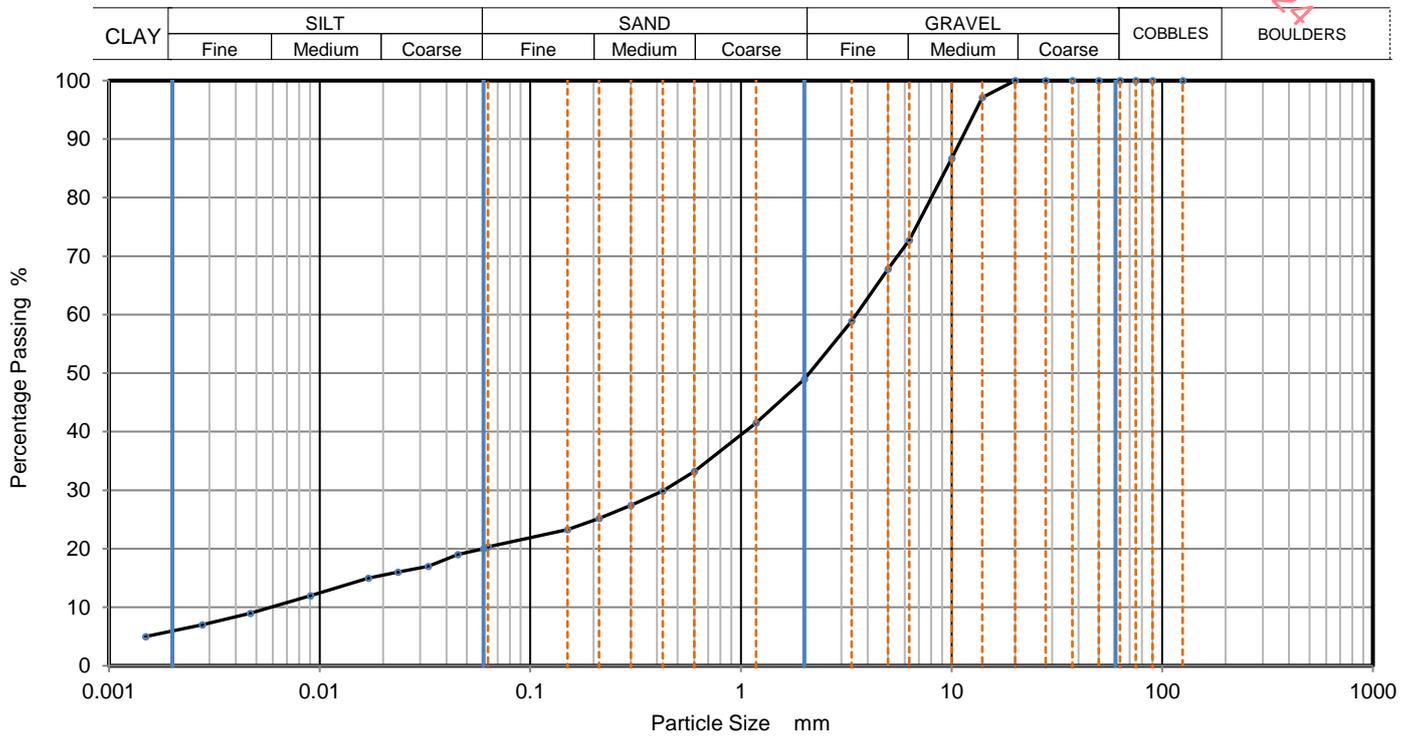
Site Name	Lackareagh Wind Farm		
Specimen Description	Brown sandy slightly gravelly clayey SILT.		
Specimen Reference	4	Specimen Depth	1 m
Test Method	BS1377:Part 2:1990, clauses 9.2 and 9.5

Sieving		Sedimentation	
Particle Size mm	% Passing	Particle Size mm	% Passing
125	100	0.06003	20
90	100	0.04536	19
75	100	0.03282	17
63	100	0.02355	16
50	100	0.01701	15
37.5	100	0.00903	12
28	100	0.00469	9
20	100	0.00277	7
14	97	0.00149	5
10	87		
6.3	73		
5	68		
3.35	59		
2	49		
1.18	42		
0.6	33		
0.425	30	Particle density (assumed) 2.65 Mg/m3	
0.3	27		
0.212	25		
0.15	23		
0.063	20

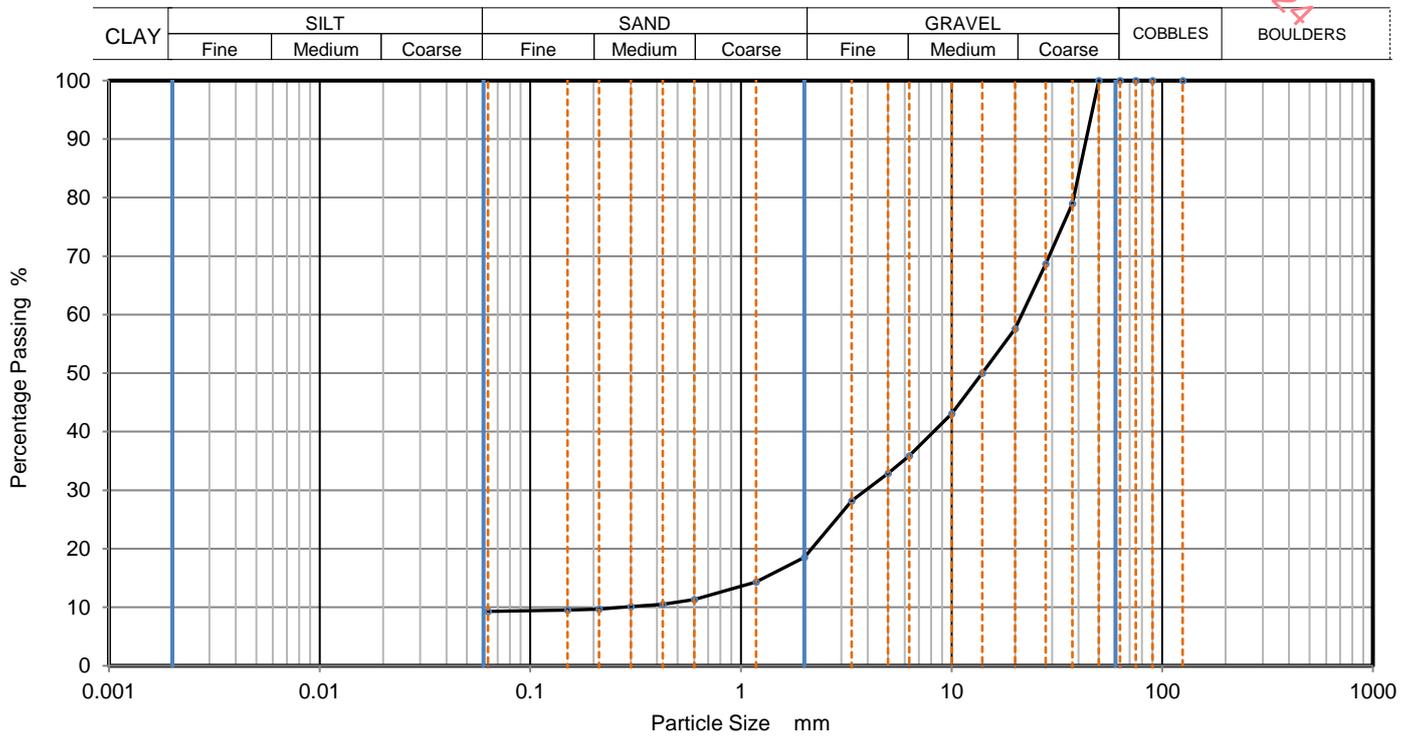
Site Name	Lackareagh Wind Farm		
Specimen Description	Brown gravelly slightly clayey fine to coarse SAND.		
Specimen Reference	2	Specimen Depth	2 m
Test Method	BS1377:Part 2:1990, clause 9.2

Sieving		Sedimentation	
Particle Size mm	% Passing	Particle Size mm	% Passing
125	100		
90	100		
75	100		
63	100		
50	100		
37.5	79		
28	69		
20	58		
14	50		
10	43		
6.3	36		
5	33		
3.35	28		
2	19		
1.18	14		
0.6	11		
0.425	11		
0.3	10		
0.212	10		
0.15	10		
0.063	9

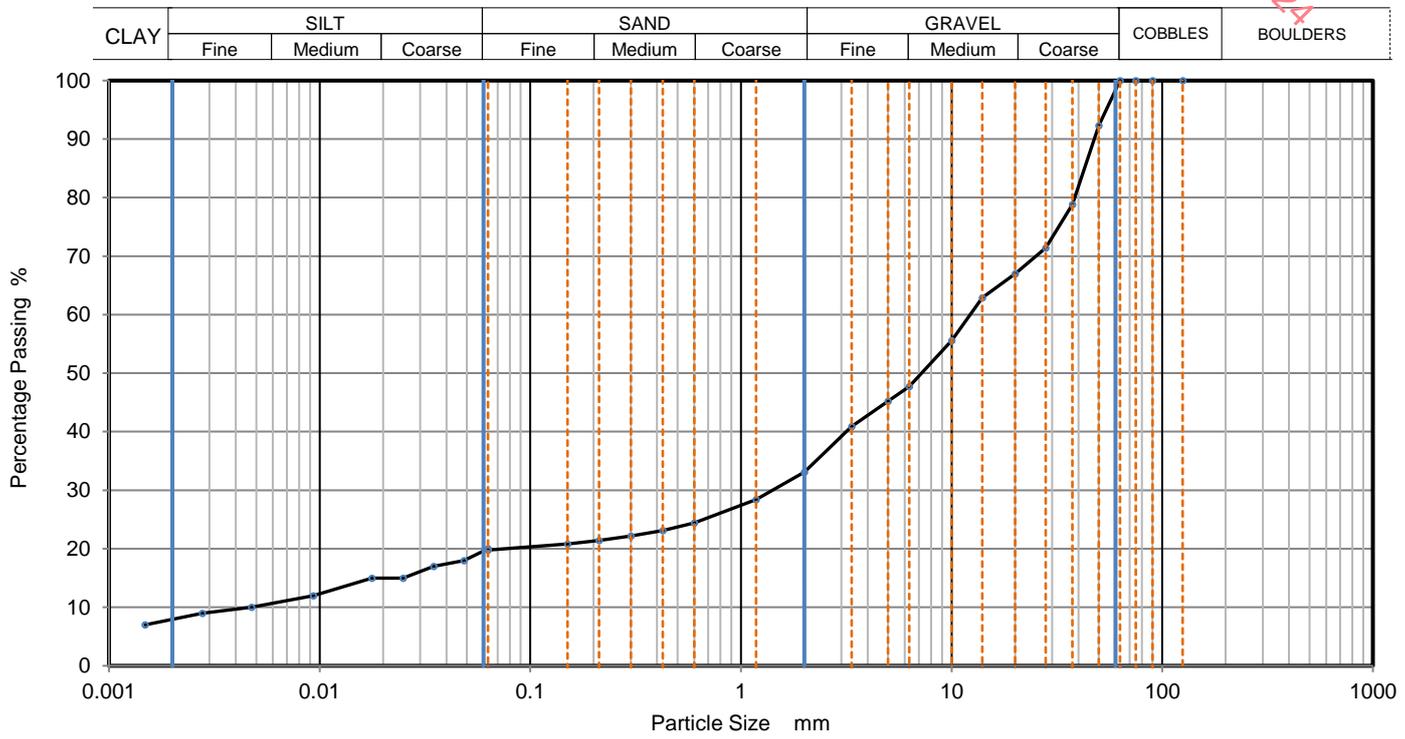
Site Name	Lackareagh Wind Farm		
Specimen Description	Brown sandy gravelly silty CLAY.		
Specimen Reference	2	Specimen Depth	1 m
Test Method	BS1377:Part 2:1990, clauses 9.2 and 9.5

Sieving		Sedimentation	
Particle Size mm	% Passing	Particle Size mm	% Passing
125	100	0.06300	20
90	100	0.04846	18
75	100	0.03473	17
63	100	0.02489	15
50	92	0.01771	15
37.5	79	0.00932	12
28	71	0.00475	10
20	67	0.00277	9
14	63	0.00148	7
10	56		
6.3	48		
5	45		
3.35	41		
2	33		
1.18	28		
0.6	24	Particle density (assumed) 2.65 Mg/m ³	
0.425	23		
0.3	22		
0.212	21		
0.15	21		
0.063	20

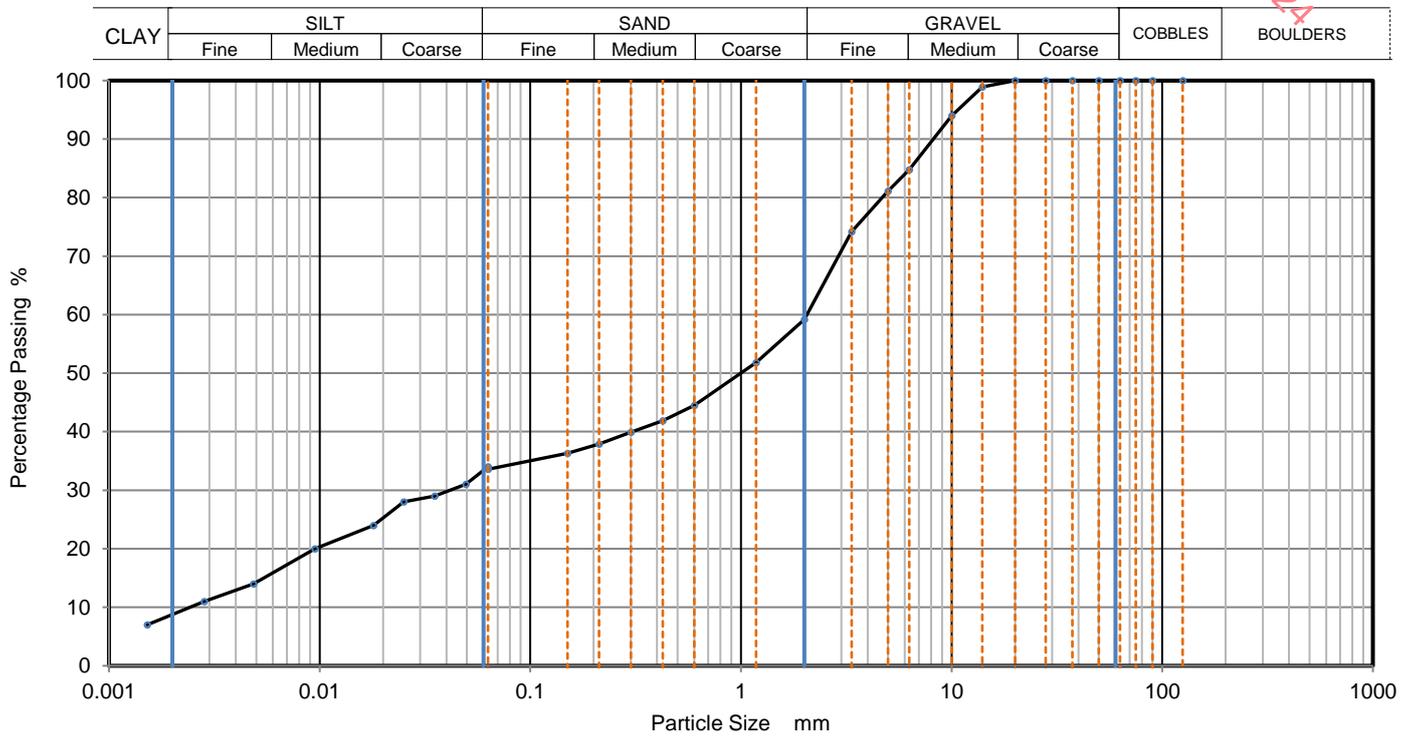
Site Name	Lackareagh Wind Farm		
Specimen Description	Brown sandy gravelly silty CLAY.		
Specimen Reference	2	Specimen Depth	1.5 m
Test Method	BS1377:Part 2:1990, clauses 9.2 and 9.5

Sieving		Sedimentation	
Particle Size mm	% Passing	Particle Size mm	% Passing
125	100	0.06300	34
90	100	0.04945	31
75	100	0.03519	29
63	100	0.02505	28
50	100	0.01805	24
37.5	100	0.00949	20
28	100	0.00486	14
20	100	0.00284	11
14	99	0.00152	7
10	94		
6.3	85		
5	81		
3.35	74		
2	59		
1.18	52		
0.6	45		
0.425	42	Particle density (assumed)	
0.3	40	2.65 Mg/m3	
0.212	38		
0.15	36		
0.063	34

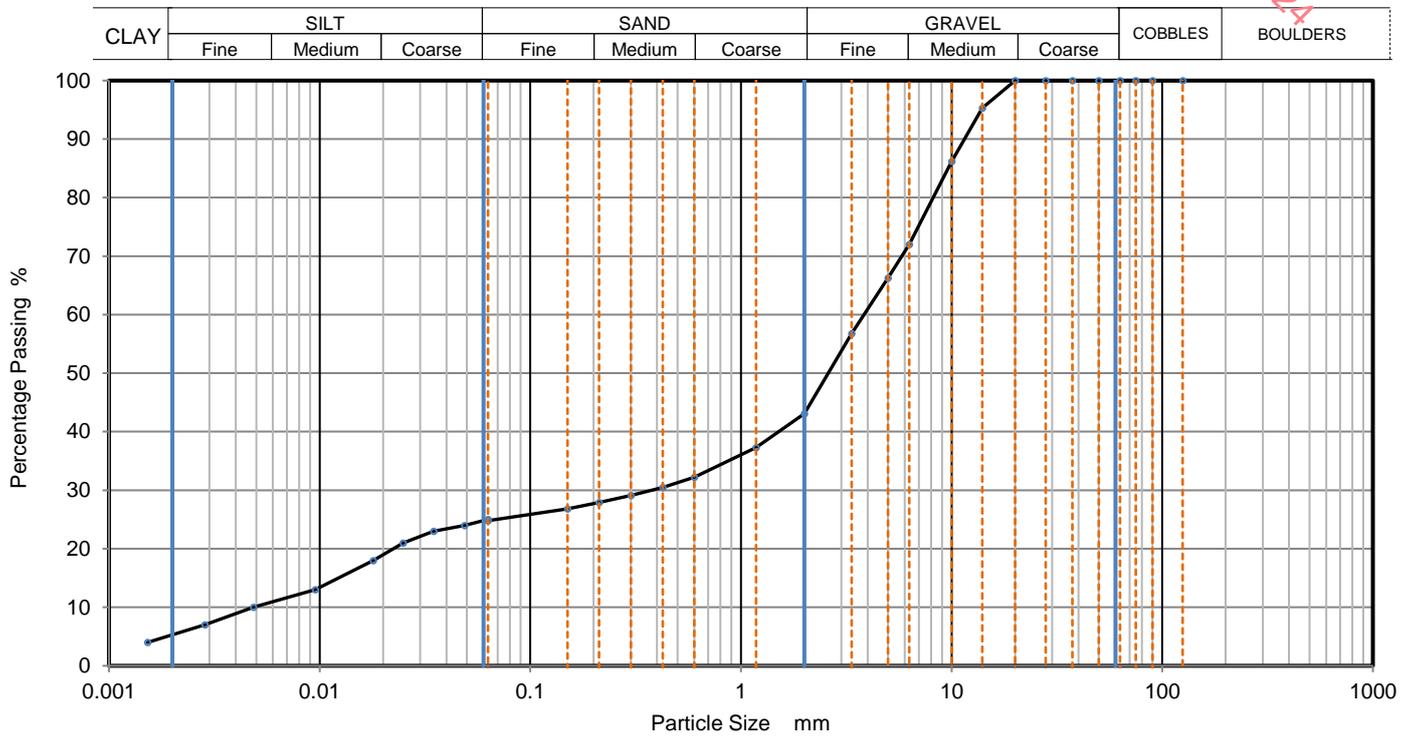
Site Name	Lackareagh Wind Farm		
Specimen Description	Brown sandy slightly gravelly silty CLAY.		
Specimen Reference	2	Specimen Depth	0.5 m
Test Method	BS1377:Part 2:1990, clauses 9.2 and 9.5

Sieving		Sedimentation	
Particle Size mm	% Passing	Particle Size mm	% Passing
125	100	0.06300	25
90	100	0.04879	24
75	100	0.03473	23
63	100	0.02489	21
50	100	0.01794	18
37.5	100	0.00955	13
28	100	0.00486	10
20	100	0.00285	7
14	95	0.00153	4
10	86		
6.3	72		
5	66		
3.35	57		
2	43		
1.18	37		
0.6	32		
0.425	31	Particle density (assumed) 2.65 Mg/m ³	
0.3	29		
0.212	28		
0.15	27		
0.063	25

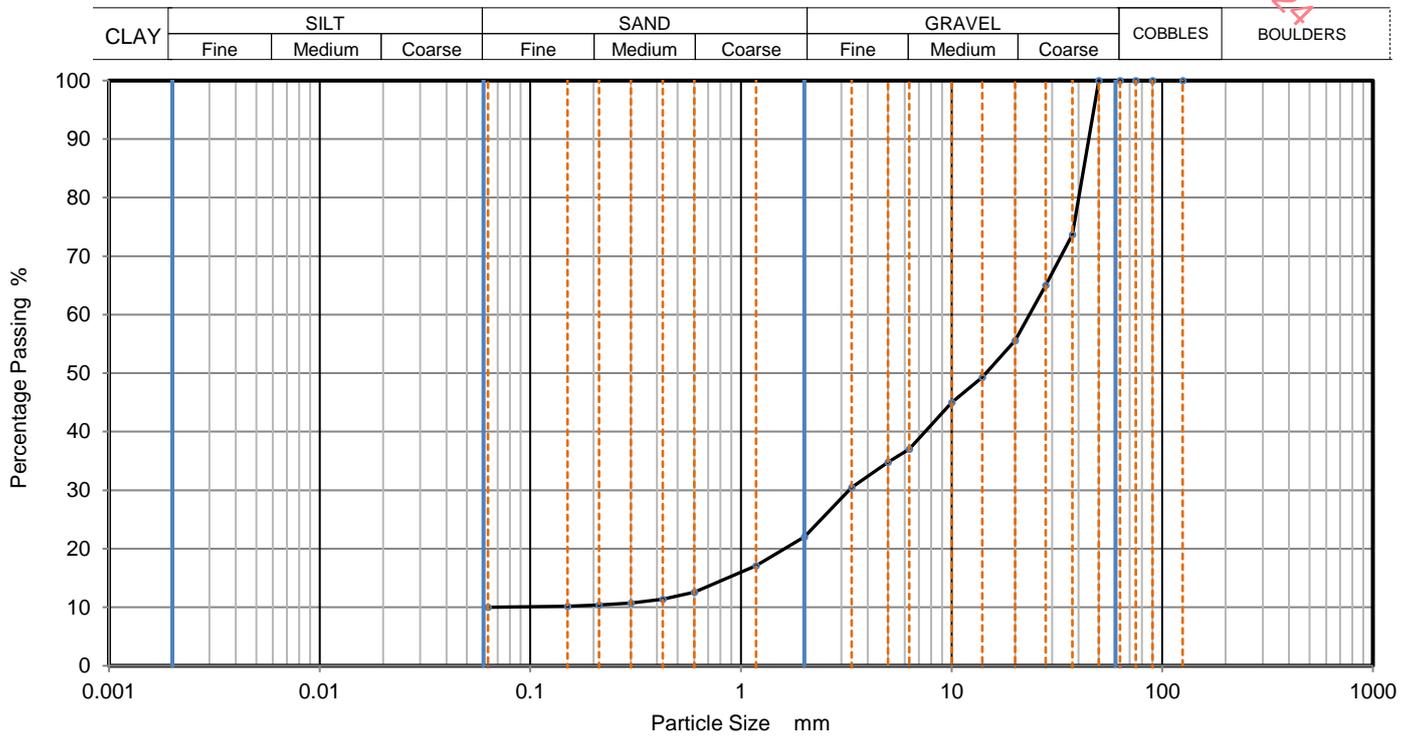
Site Name	Lackareagh Wind Farm		
Specimen Description	Brown gravelly clayey fine to coarse SAND.		
Specimen Reference	2	Specimen Depth	1.5 m
Test Method	BS1377:Part 2:1990, clause 9.2

Sieving		Sedimentation	
Particle Size mm	% Passing	Particle Size mm	% Passing
125	100		
90	100		
75	100		
63	100		
50	100		
37.5	74		
28	65		
20	56		
14	49		
10	45		
6.3	37		
5	35		
3.35	31		
2	22		
1.18	17		
0.6	13		
0.425	11		
0.3	11		
0.212	10		
0.15	10		
0.063	10
