# EIAR – Volume 3 Appendices

**Final Report**

This report relates to the Castleconnell Flood Relief Scheme commissioned by Limerick City and County Council, on behalf of the Office of Public Works. Conor O'Neill and Bernadette O'Connell of JBA Consulting compiled this report, which was prepared by the competent experts listed in Table 1-1 of Chapter 1 of the EIAR, Volume II.

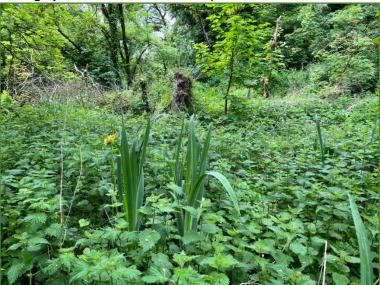
Photograph 2. Woodland with affinity to 'Alluvial woodland' but with a canopy of non-native tree species

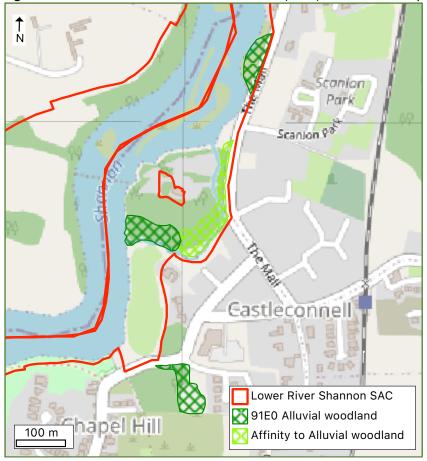
Figure 1.0. Location of Annex I alluvial woodland (91E0) within the survey area

The site was visited with JBA ecologist Hannah Mulcahy in mid-May 2022. Areas of potential Annex I (priority) habitat were surveyed by walk-over survey. Three areas of **Alluvial woodland (91E0)** were recorded. These are shown on Figure 1. These had a canopy and ground flora dominated by native species typical of alluvial woodland. A detailed 20m x 20m plot was recorded in the northern section (Photograph 1) and 16 positive indicator species for 91E0 were recorded (a minimum of 6 is required for this habitat to pass a condition assessment). In addition, one area of woodland was recorded that was considered to have 'affinity' to alluvial woodland (Figure 1, Photograph 2). This had a canopy dominated by non-native, non-alluvial woodland species (e.g. Sycamore *Acer pseudoplatanus* and Beech *Fagus sylvatica*), but the ground flora had a number of alluvial woodland positive indicator species. Although it is not considered to be an example of alluvial woodland, it is located within the SAC boundary and is sensitive wetland habitat.

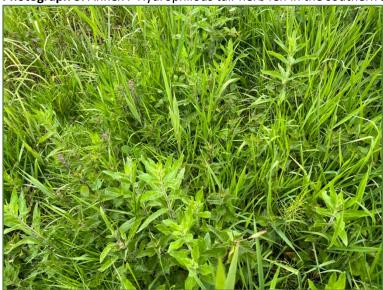
Photograph 3. Annex I 'Hydrophilous tall-herb fen in the southern section of the survey area

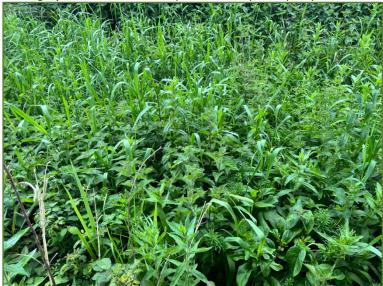
Photograph 4. Tall-herb swamp with affinity to 'Hydrophilous tall-herb fen'

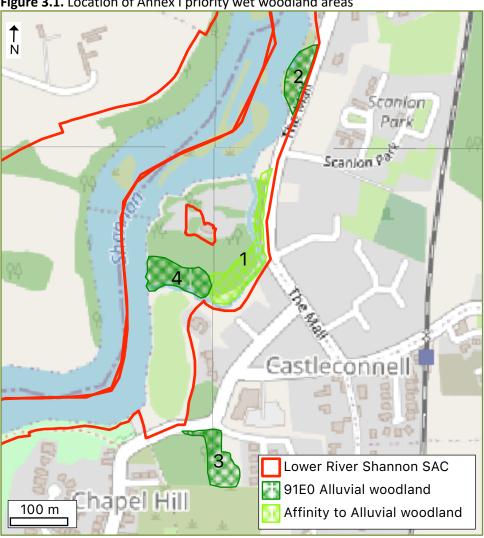
Figure 3.1. Location of Annex I priority wet woodland areas

Three areas of Annex I priority **Alluvial woodland (91E0)** were recorded (Areas 2, 3 and 4; Figure 3.1). These had a canopy and ground flora dominated by native species typical of alluvial woodland. In addition, one area of woodland (Area 1; Figure 3.1) was considered to have 'affinity' to alluvial woodland, but had a canopy dominated by non-native, non-alluvial woodland species. The key features and Annex I assessment of the four woodland areas are shown in Tables 3.1 and 3.2.

Three areas of Annex I priority alluvial woodland [91E0\*] were recorded (Figure 3.1, Tables 3.1 and 3.2).

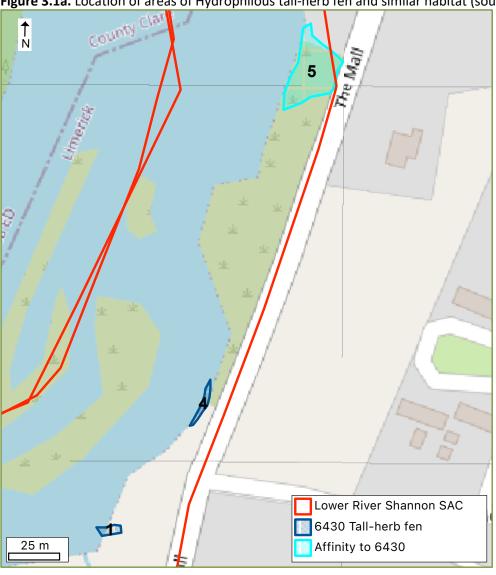
Figure 3.1a. Location of areas of Hydrophilous tall-herb fen and similar habitat (southern area)

Four areas of Annex I Hydrophilous tall-herb fen (Figure 3.1) were identified. In addition there were three areas that had some affinity to Annex I Hydrophilous tall-herb fen, but did not have sufficient cover or number of positive indicator species. The key features and Annex I assessment of the seven wetland areas are shown in Tables 3.1 and 3.2.

Four areas of Annex I Hydrophilous tall-herb fen [6430] were recorded (Figure 3.1, Tables 3.1 and 3.2).

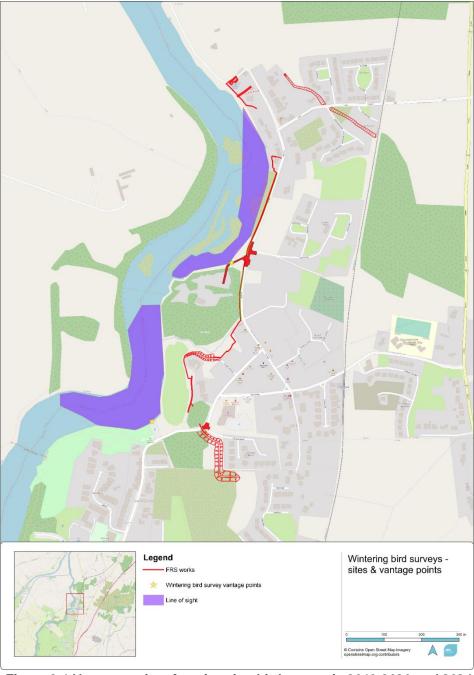
Figure 8-1 Vantage points for wintering bird survey in 2019-2020 and 2024

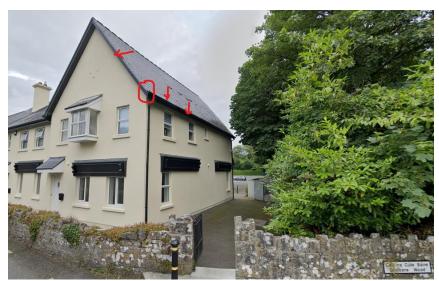
Figure 8-3 Roost of 20-40 Pipistrelles emerging from building in Coolbane Meadows
Table 8-6 Bats recorded by Anabat Walkabout Detector during 20th July 2020 transect

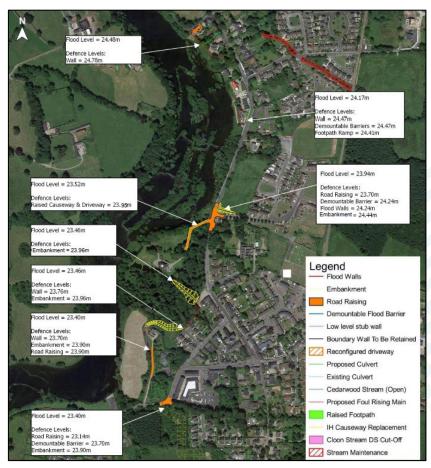
Figure 2-1 Image taken from Drawing for Option 1

- New flood walls & ancillary works to the northern properties on Elvers Road;
- Road raising (and demountable barrier Options 1 & 3) north of the Scanlon Park entrance;
- New flood defence wall along the Mall Road from Mall House to Island House;
- Road raising and demountable barrier or raising of the causeway at the Island House Entrance;
- New flood defence wall from Island House to the rear of Maher's pub;
- New flood embankment to the north-west of Meadowbrook estate;
- Road raising and demountable barrier at the Coolbane Woods junction;
- New flood embankment on the south side of the Coolbane Wood access road.

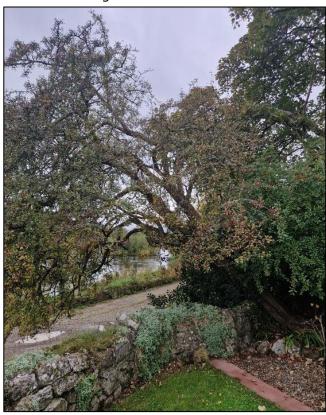
6.1.2 It has been specifically indicated by residents, that the retention of T036 a hawthorn in the rear amenity area of Mall House on Elvers Road, is desired. However, the tree is noted to be significantly leaning and is resting on a current boundary/ retaining wall. It is not considered that its retention is viable by transplanting, or other tree protection mitigation. If retention is to occur this would require a redesign of the flood wall location or a design solution that is outside of the scope of this report.

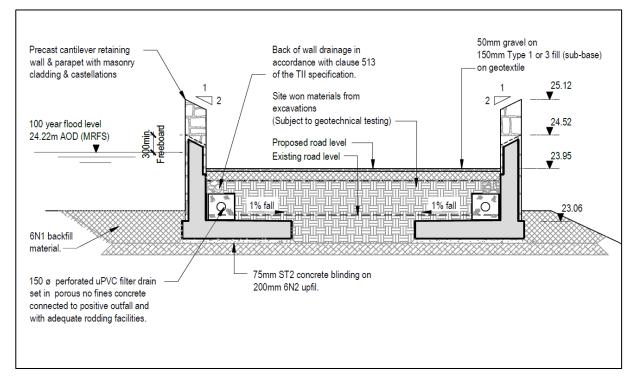
Figure 7-1 Design of Parapet along driveway of Island House, design taken from drawing 1904-JBB-XX-XX-DR-S-00008

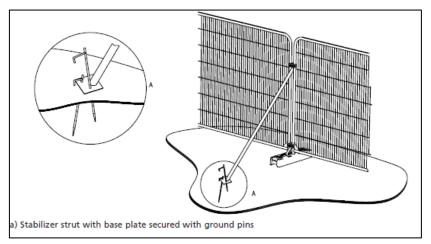
Figure 9-1 An Example of an 'above-ground stabilizing system'

- 9.3.2 At this time Root investigation works Tree Numbers T015, T017, T018, T031, T032, T033 has been recommended to consider the viability of installing a new culvert within proximity of these mature beech trees. Until this has been undertaken or if it is confirmed that the removal of these four trees is acceptable, no tree protection measures (fencing or ground protection) has been specified within proximity of these trees.
- 9.3.3 Due to the variation and change between soft ground and hard standing locations, in numerous locations, an 'Above-ground stabilizing system' braced Heras fencing has been proposed as a reasonable approach to the protection of trees throughout the works.

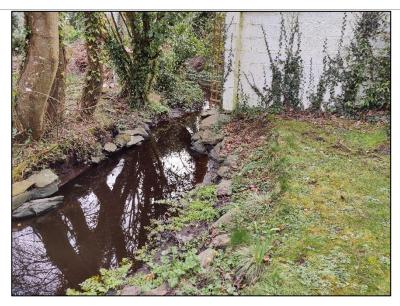
Stone lining Cedarwood Stream

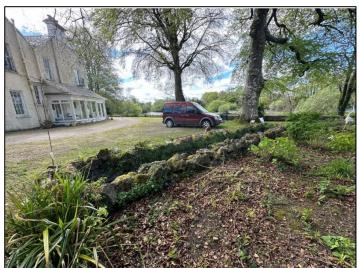
Open culvert (CH3) within the garden and mature trees

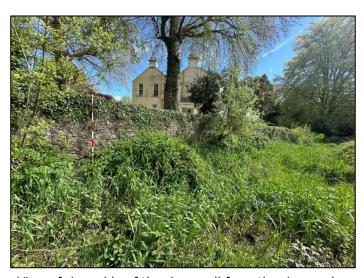
View of river side of the river wall from the rivers edge

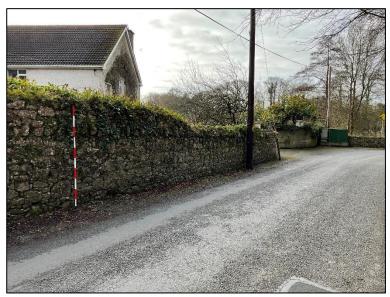
Stone wall where new entrance to Rivergrove B&B will be located

Reference no.	CH1
Legal Status	N/A
Other Designations	N/A
Location	Lacka
Site Type	Boundary wall
ITM	566051, 663365
	The boundary wall of Rivergrove B&B is part of the original boundary wall of Grange House (RPS 1075). It comprises of roughly coursed stone measuring approximately 2 in height with the top course comprising stones on their sides. Approximately 19m of wall survives at this location, with breaches having been made previously to access Rivergrove B&B and the adjoining property.
Description	Although no longer associated with Grange House which is not visible from this location, this wall forms part of the character of the Spa-well and Worldsend ACA, being one of a number of stone walls which flank the road at this location.
	It is proposed to create a c. 6.5m breach in this wall to accommodate a new entrance to Rivergrove B&B. A new river wall will also remove a surviving corner section of the river wall.

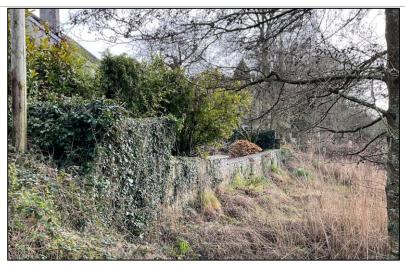
River wall to be replaced the wall is of modern construction while the corner is of rubble stone and part of the former Grange House property boundary

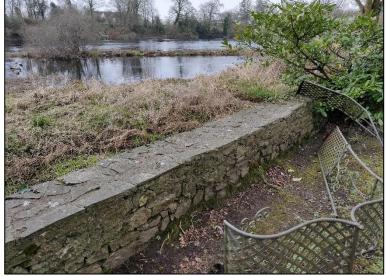
Stone wall to be replaced at Grange House

Reference no.	CH2
Legal Status	N/A
Other Designations	N/A
Location	Lacka
Site Type	River wall
ITM	566051, 663365
Description	A river wall along the bank of the River Shannon is part of the original boundary of Grange House. It follows the old river bank and the original course of the Lacka townland boundary. The ground is terraced at this location so that the wall appears higher on the river side than on the landward side where it measures approximately 0.4m high and is constructed from roughly course limestone. It is proposed to demolish this wall and replace it with a flood wall.
Sources	www.osi.ie; Google Street View

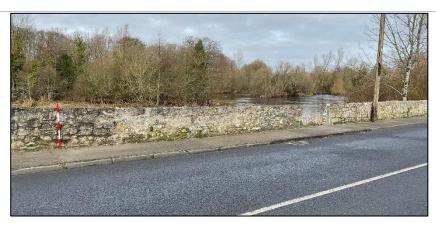
Reference no.	CH6
Legal Status	N/A
Other Designations	N/A
Location	Cloon and Commons
Site Type	River wall
ITM	566097, 662915
Description	A stone wall extends along the west side of The Mall (north of Island House) which follows the old river bank and the original course of the Cloon and Commons townland boundary. On the east side it measures approximately 1m high, with a drop on the river (west) side of the wall where it measures up to 2m high. It is of coursed stone on the north end and of random rubble construction elsewhere with evidence of rebuilding on the south end.
Sources	www.osi.ie

Stone wall with rebuilding evident

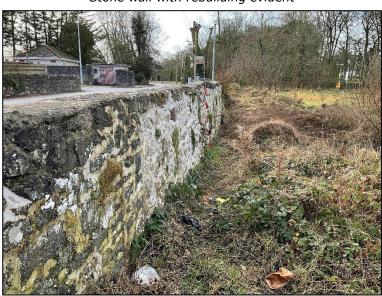
Stone wall with rebuilding evident

Reference no.	CH8
Legal Status	N/A
Other Designations	N/A
Location	Cloon and Commons
Site Type	Stone wall
ITM	566073, 662794
Description	Within the Village Core ACA, a stone wall extends along the west side of The Mall (south of Island House) which follows the old river bank and the original course of the Cloon and Commons townland boundary. It measures approximately 0.6-1m high comprises a combination of roughly coursed and random rubble construction. A memorial plaque to Tom O'Shea is inserted into the wall on the south end. It is proposed to remove this entire section of wall and to construct a new flood wall.
Sources	www.osi.ie

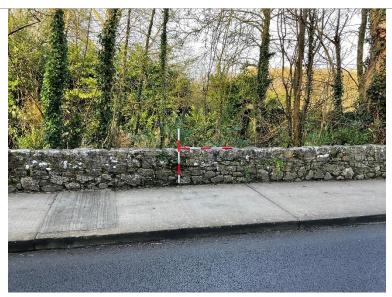
Stone wall

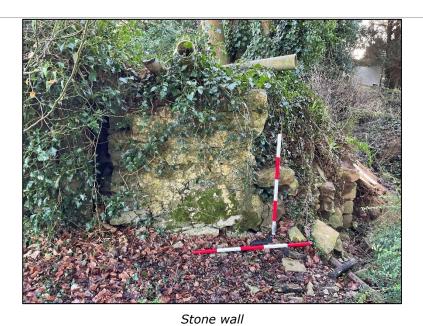
Reference no.	CH10
Legal Status	N/A
Other Designations	N/A
Location	Coolbane
Site Type	Stone wall
ITM	566067, 662670
Description	To the rear of Island View House and Maher's Pub a section of stone wall marks the Island House property boundary. This wall appears to be the remains of a structure which is depicted on the First Edition 6-inch OS map at the end of the long garden associated with Island View House.
Sources	www.osi.ie
Images	CH10 on First Edition 6-inch OS map

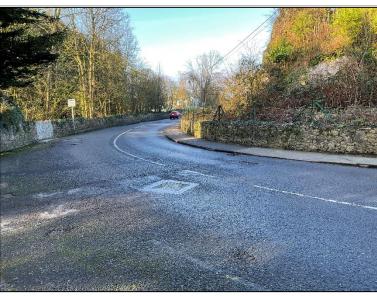
Reference no.	CH13
Legal Status	N/A
Other Designations	N/A
Location	Coolbane
Site Type	Stone walls
ITM	565973, 662434
Description	A rubble-built stone wall runs for approximately 204m along the south side of Chapel Hill. At the Coolbane Woods junction where road raising is proposed, this wall measures approximately 1m in height and includes a rebuilt section which is braced by a concrete abutment on the south side.
Sources	www.osi.ie

Stone wall

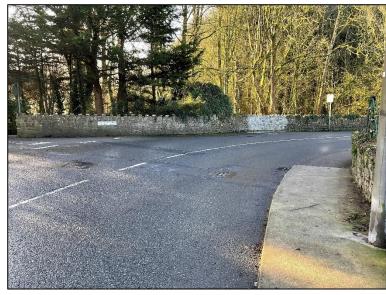
Stone wall with rebuilt section evident

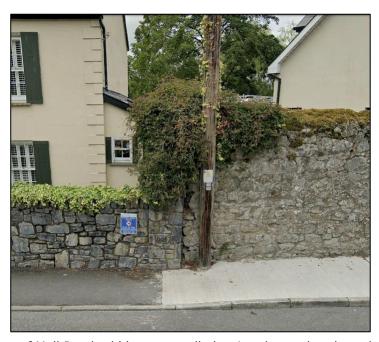
Reference no.	CH4
Legal Status	N/A
Other Designations	N/A
Location	Cloon and Commons
Site Type	Stone wall
ITM	566189, 663192
Description	A high stone wall which extends along the west side of the Mall in the Spa-well and Worldsend ACA. It extends for a distance of 82m and up to 3m high and is composed of roughly coursed limestone. The remnants of the gable end of a building is preserved in a portion of this wall, with a post wall box (RPS 5057) set into it on the northern end. It is not shown on the First Edition 6-inch map of 1844 but is indicated on 25-inch map of 1901.
Sources	N/a
Images	Stone wall on The Mall

Connection of Mall Road rubble stone wall abutting the modern boundary wall of Mall House

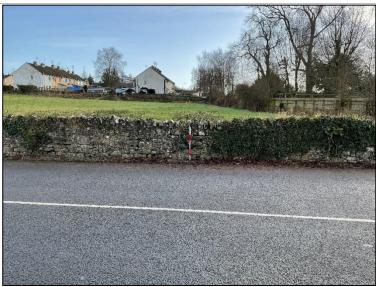
Reference no.	CH7
Legal Status	N/A
Other Designations	N/A
Location	Cloon & Commons
Site Type	Stone wall
ITM	566111, 662923
Description	Roughly coursed stone wall approximately 1.2m high on east side of The Mall at Scanlon Park junction.
Sources	www.osi.ie

Stone wall
Approx Distance from FRS Measure	On the opposite side of the road from the Mall Road North Measure

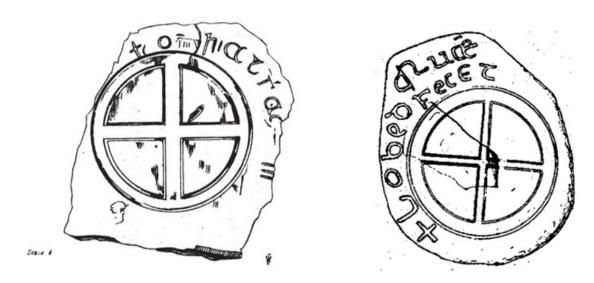
Two cross slabs are incorporated into the fabric of the church. LI001-004002 was built into the west wall of the church. The slab measures 0.60m by 0.55m and carved with a plain encircled cross with an initial small cross and mostly illegible text overhead (Crawford 1912, 240). It was drawn by Wakeman in 1840 (Figure 6). The text was read by Macalister (1949, 98) as being a latin inscription of 'LOBED FECET CRUCE[M]'. More recently in 2001, Okasha and Forsyth (185–7) could find no evidence to justify Macalisters reading of the slab due to the bad weathered conditions.

Figure 6: Drawing of two cross slabs are incorporated into the fabric of the church

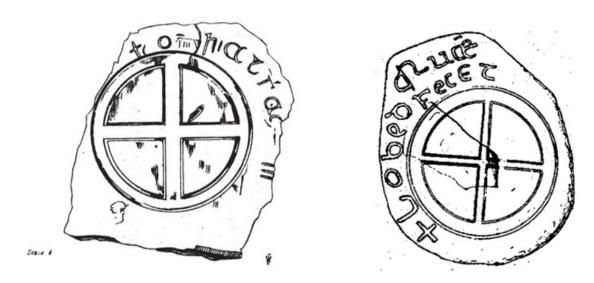
Two cross slabs are incorporated into the fabric of the church. LI001-004002 was built into the west wall of the church. The slab measures 0.60m by 0.55m and carved with a plain encircled cross with an initial small cross and mostly illegible text overhead (Crawford 1912, 240). It was drawn by Wakeman in 1840 (Figure 6). The text was read by Macalister (1949, 98) as being a latin inscription of 'LOBED FECET CRUCE[M]'. More recently in 2001, Okasha and Forsyth (185–7) could find no evidence to justify Macalisters reading of the slab due to the bad weathered conditions.

Figure 6: Drawing of two cross slabs are incorporated into the fabric of the church

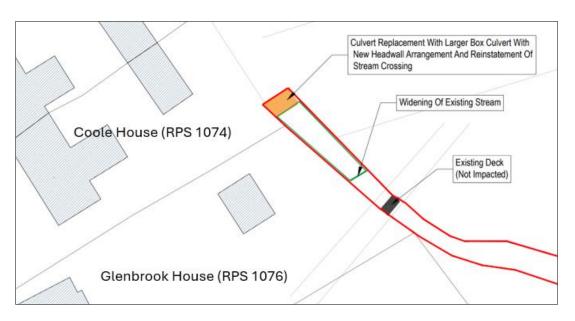
The proposed works to Cedarwood Stream is concentrated to the rear of Coole House (RPS 1074) and Glenbrook House (RPS 1076) where it is proposed to widen the existing stream for 15m and to replace the existing culvert/footbridge with a larger box culvert with a new headwall arrangement (Figure 3). The proposed culvert will be wider and deeper below the stream bed to prevent erosion and undercutting, and to reintroduce a natural sediment movement through the culvert.

Figure 3 Proposed works to the rear of Coole (RPS 1074) and Glenbrook (RPS 1076)

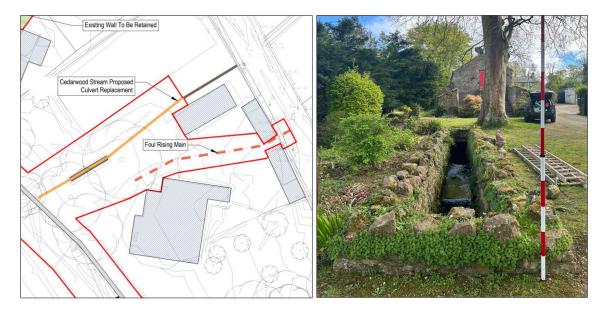
Figure 4 Grange House (RPS 1075),

At the time of the survey, it was also proposed to replace a 40m section of an open culvert along the Cedarwood Stream at Grange House (RPS 1075) to its discharge into the River Shannon (Figure 4). The open stone culvert is associated with a mid-19th century former mill building located on the left bank of the river to the rear of the property (Plate 1).

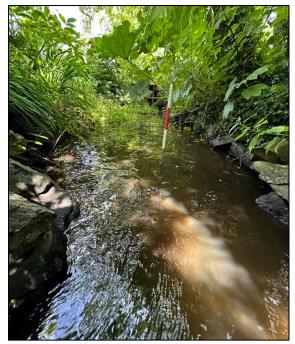
Where the stream enters the property of Coole House (ITM: 566178.96, 663386.61, 0m baseline for the survey), the river is at its widest (1.78m) and deepest point (c.40cm) (Plate 2). The stream bed comprises gravel and silt deposits. The banks on both sides comprised of clay reinforced at their base with loose rubble stone boulders. The left bank (LB) had a sloping side and measured 0.60m high, whilst the right bank (RB) was almost vertical measuring 0.53m high (measured from the river bed).

Plate 2 View downstream where the Cedarwood stream enters Coole House

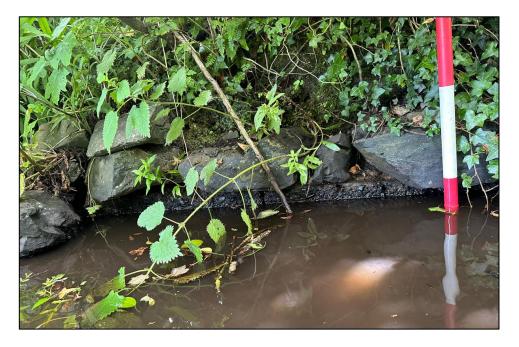
Approximately 6m upstream from the survey baseline, on the right bank, just above the water level a concrete plinth is revealed beneath the rubble stone and bank structure (Plate 3).

Plate 3 Concrete plinth beneath the rubble stone and earthen bank (R.B view)

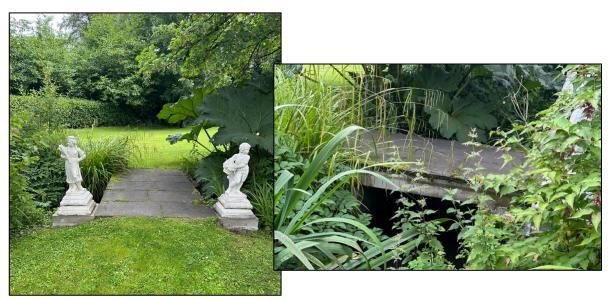
This plinth continued upstream and ran beneath a modern square headed concrete footbridge which provides access to a garden area east of the stream (Plate 4). The simple footbridge (located 0.7m upstream survey baseline, ITM 566203.26, 663342.47), spans a narrow 1.28m wide section of the river. The bridge comprises a square headed bridge structure comprised a concrete deck (measuring 1.65m wide), with a stone paving slab surface, with concrete abutments constructed

in front of the clay banks. This will be retained as part of the FRS measure. The river widens to 1.33m immediately downstream of the foot bridge.

Plate 4 Concrete footbridge in Glenbrook House

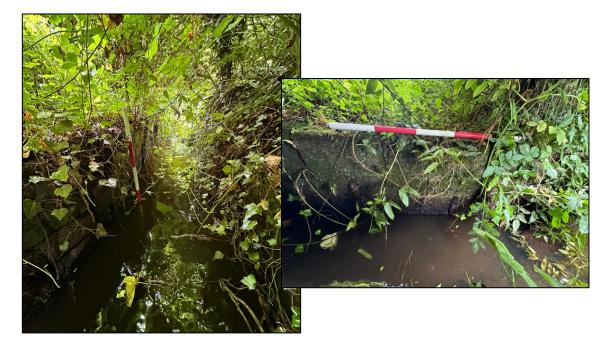
At 20m from the baseline, there is 2m high concrete walls align the river, confining the stream to just 0.65m in width, and 0.15m high. The walls on the right bank are leaning into the stream (Plate 5 and Plate 6). These walls may have formed the abutments of a former footbridge or an effort to curtail the stream.

Plate 5 View upstream of the walls defining the narrow section of the stream
Plate 6 Concrete plinth beneath the rubble stone and earthen bank (R.B)

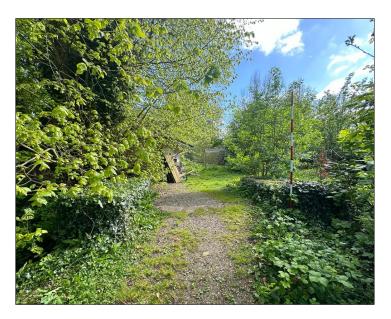
Approximately 3m inside the boundary of Coole House, there is a pedestrian bridge that is 0.45m in length and 0.76m in width. The bridge deck is covered in gravel and is flanked by walls made of rubblestone that are 0.50 meters in height. The walls are capped with large limestone slabs. The parapets are covered in dense ivy growth (Plate 7).

Plate 7 Bridge over Cedarwood Stream in Coole House

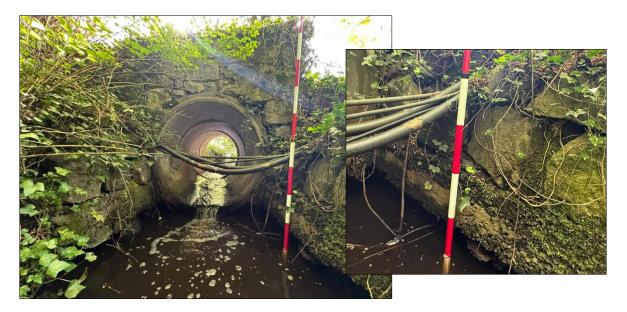
Beneath the bridge a concrete pipe measuring 1.30m in external diameter, the bridge parapet above is c 0.75m. The pipe is underpinned with concrete at the base and the river bank walls of rubble stone (measuring c. 1.50m) are also founded on a coarse gravel aggregate concrete footing (Plate 8). The riverbed in this location is deep silt deposited from the pipe above.

Plate 8 Pipe culvert at Coole House, view upstream, note the concrete plinth beneath the rubble stone and earthen bank to the right of the photo. Insert: detail of the concrete footing.

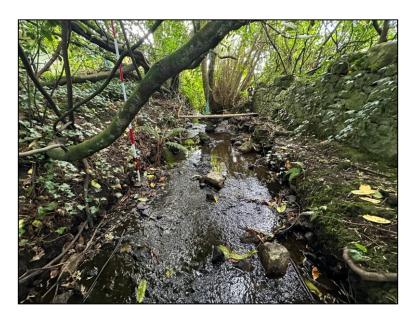
From this point, the stream widens to a width of 2.35m and becomes shallower, measuring only 0.10m in depth. The stream bottom is of well sorted stone and gravel. On the right bank, there is a wall that stretches approximately 10.8m. The wall is about 1m high and is located on a flat earthen river bank approximately 0.80 centimetres wide. The left bank has a sloping dark brown silty clay bank covered in vegetation which is about 1.30m from the ground level of the adjacent field. This bank is covered with loose rubble stone and has roots from mature beech trees that are deeply embedded. The tree roots have disrupted the clay, revealing shards of construction slate and redbrick.

Plate 9 View upstream of the stream in Coole House just beyond the culvert (outside the proposed works area)

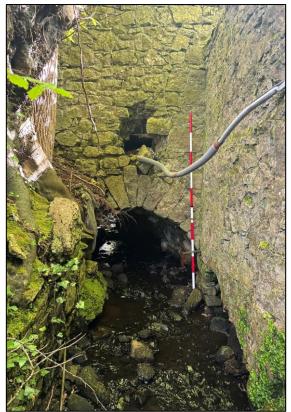
The stream is culverted beneath the Lacka Road and beneath the northern boundary of Grange House which comprises a high rubble stone wall. The stream flows through a single arched culvert c. 1m high and 1.40m wide, with voussoirs of 0.60m high, a rubble stone wall and a mill building from the abutments for the structure. Approximately 0.35m above the arch there is an opening in the spandrel wall for the road surface drain above (Plate 10).

Plate 10 Culvert and eastern boundary wall of Grange House beneath the Lacka road. Note square opening is for the road surface runoff

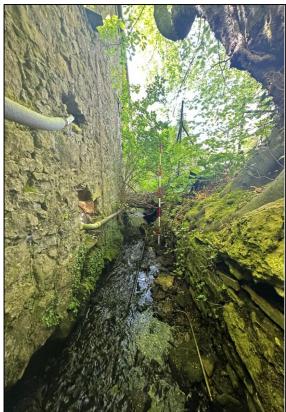
The right bank comprises a vertical rubble stone wall c. 1.20m high, large tree roots are woven into its structure undermining it in places (Plate 11).

Plate 11 View downstream of the river bound by the mill building on the left bank, and rubble stone wall on right bank.

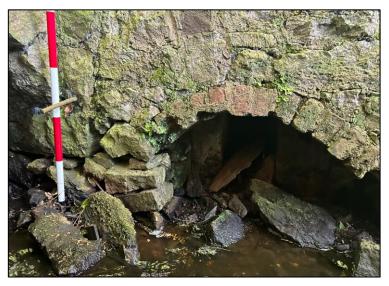
The wall of a two-storey mill building runs parallel to the river on the left bank. There is a red brick arched culvert at river level. It appears to be obstructed and dry. Except for two windows on the upper level, the wall is featureless (Plate 12).

Plate 12 Red brick arch culvert from beneath the mill building

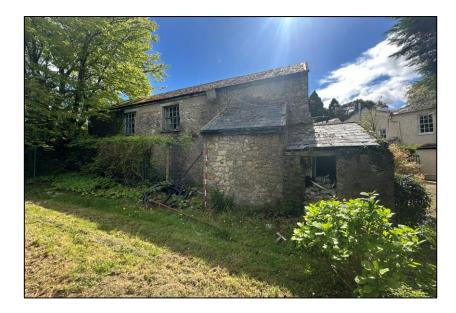
The stream is then crossed by a large limestone flag forming a platform and continues beneath two single storey lean-to structures attached to the mill building one of which may have functioned as a wheel house (Plate 13).

Plate 13 Northern (rear/riverside)façade of the mill building (Grange House to the rear right-hand side.)

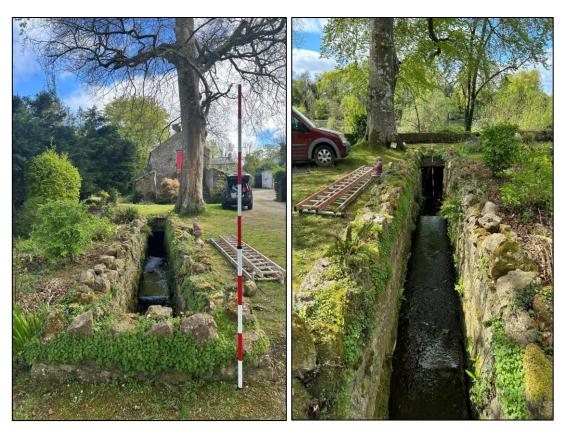
The stream continues west beneath the garden and reemerges in an open stone lined culvert surrounded by a decorative low wall (Plate 14, Plate 15). It comprises of rubble side walls and limestone slabs c.1m wide and 0.07m thick. The culvert descends in c. 20cm stages downstream to a drop of 1.6m where it is then once again covered by the garden surface and runs beneath the river wall that forms the western boundary of the property.

Plate 14 View upstream from the western end of the culvert with the mill building in the background

Plate 15 View downstream from the west end of the culvert towards the river wall and the Shannon outlet

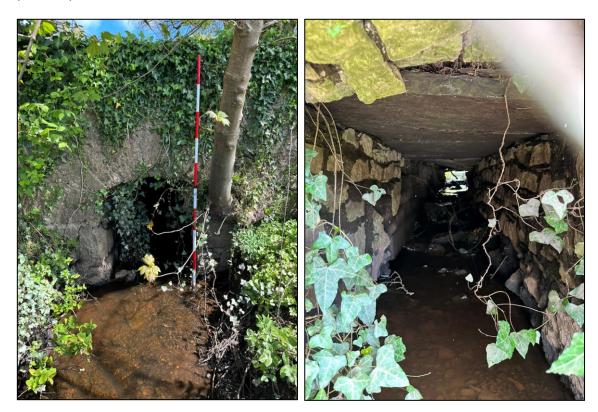
The river discharges into the River Shannon through a masonry arch outlet (Plate 16), a view under the culvert shows that large limestone slabs form the roof of the culvert with rubble stone walls (Plate 17).

Plate 16 View of the outlet of the Cedarwood Stream into the River Shannon
Plate 17 Detail of the interior of the culvert/outlet looking upstream

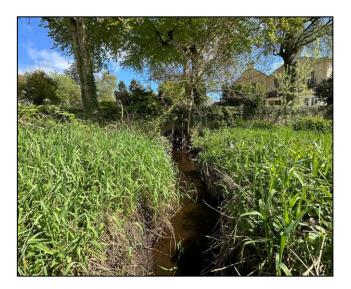
There is a build-up of silt and gravel at the outlet and the stream cuts through the soft riverine mud and silts into the River Shannon (Plate 18).

Plate 18 View downstream from the west end of the culvert towards the river wall and the Shannon outlet

The metal detector targets picked up identified modern pieces of metal and pipes which were visible in the water or partially covered by the silt/gravels. The metal detector was rendered ineffective in Grange House section of the survey due to a distortion caused by a long metal pipe embedded in the stream along the right bank. Rare occurrences of 19<sup>th</sup> century bottles, and broken plant pots and a firelighter were found in the stream section behind Coole and Glenbrook house. However, where the stream discharges into the River Shannon more frequent occurrences of glass, bottles, jars pottery and rare occurrences of butchered animal bone, also dating to the 19<sup>th</sup> century, were found partially buried in the silt and gravels. These finds demonstrate that artefacts can be washed downstream even with obstructions such as the stone lined culvert at Grange (Plate 18).

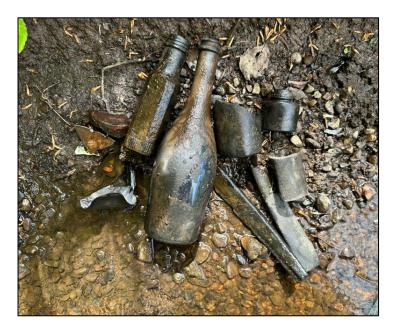
Plate 19 Some of the finds identified at the Cedarwood Stream outlet

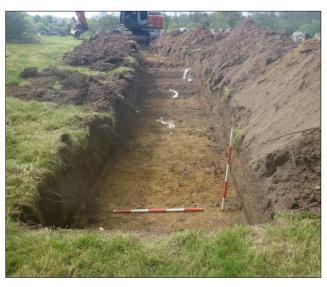
Plate 3 Trench 1, view towards the southwest

No features, soils or finds of archaeological potential was identified in Trench 1. The testing confirms that Coolbane house was founded on a knoll of dry land on the edge of the river.

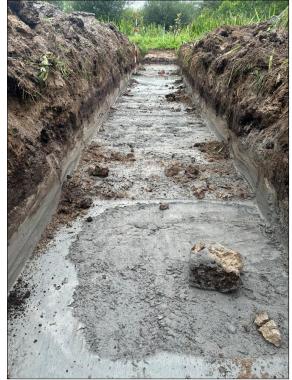
Test trench 2 revealed dynamic riverine environment, with the identification of alluvial deposits indicating occurrences of flooding, deposition and periods of standing water (Plates 5 and 6). These well sorted deposits were to be expected in the floodplain of the River Shannon which lies a close distance to the northwest. The peat layer in the area tested was shallow (0.25m thick), the anaerobic environment of peat would have the potential to preserve organic features and artefacts, however the layer it did not contain any inclusions of note (such as timbers or worked wood/leather etc. of any kind).

Plate 5 View looking east along Trench 2
Plate 6 Profile of Trench 2

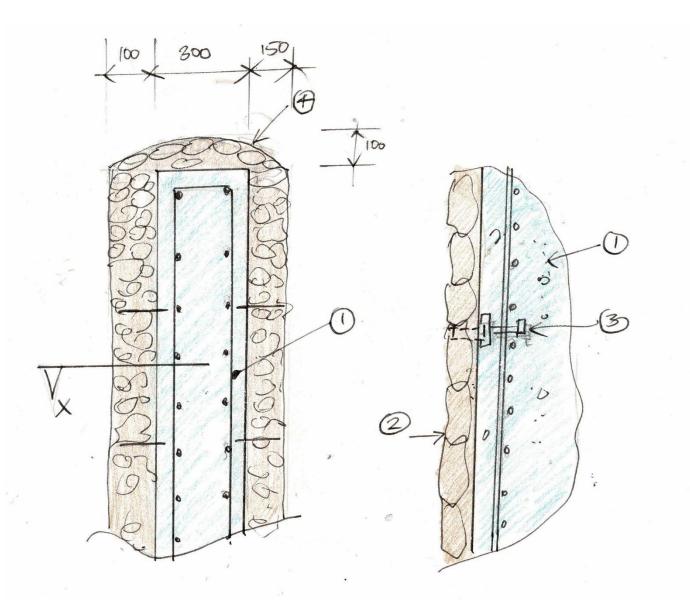
Sketch SA 202413/CR2 New flood relief wall cladding and capping
