## **Appendix 6C**

### **AQUATICS**

## **Appendix 6.C Aquatic Assessment Results**

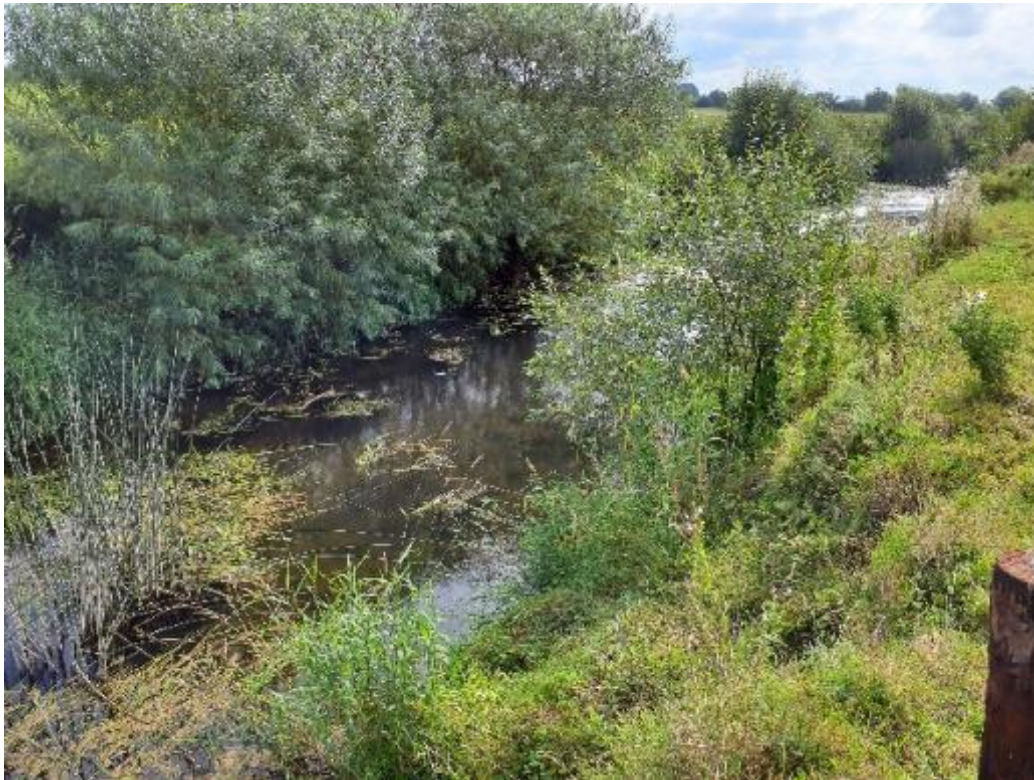
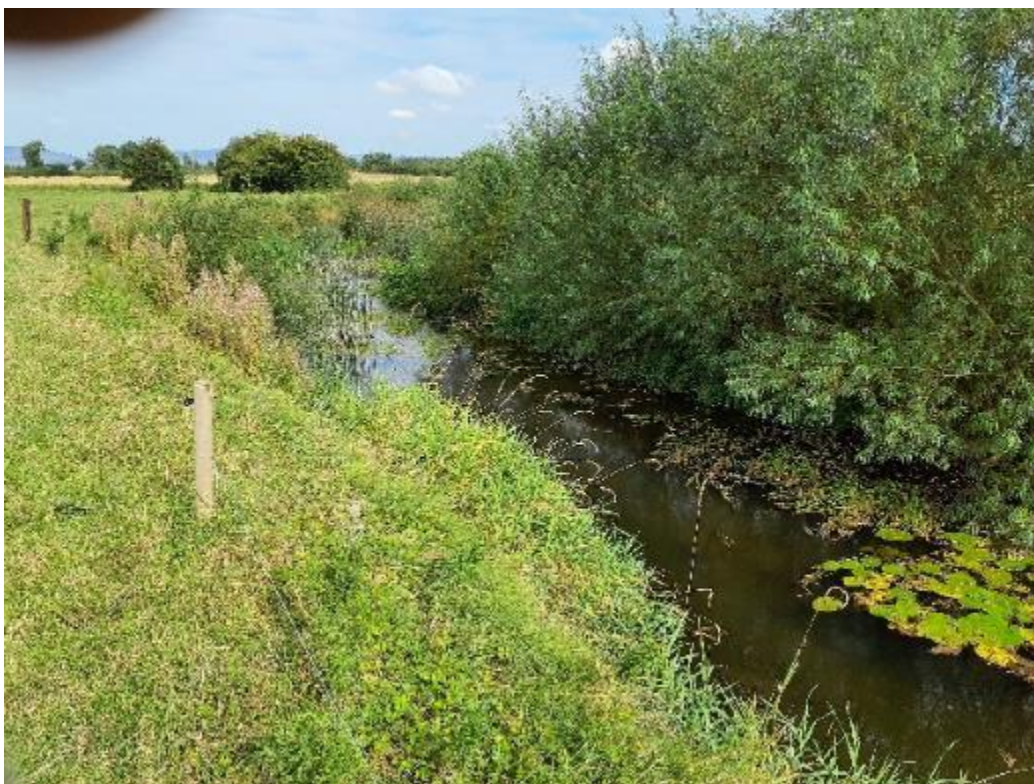
Figure 1: WQ1 in the River Suir

Figure 1 and Figure 2 show the condition of the River Suir for the first sampling point (WQ1). This sample point had group C indicator species present, which are tolerant of pollutants in the water. This sample point scored a Q

value of Q3, which means the water quality is poor. The Water Framework Directive (WFD) status of this sample point is poor.

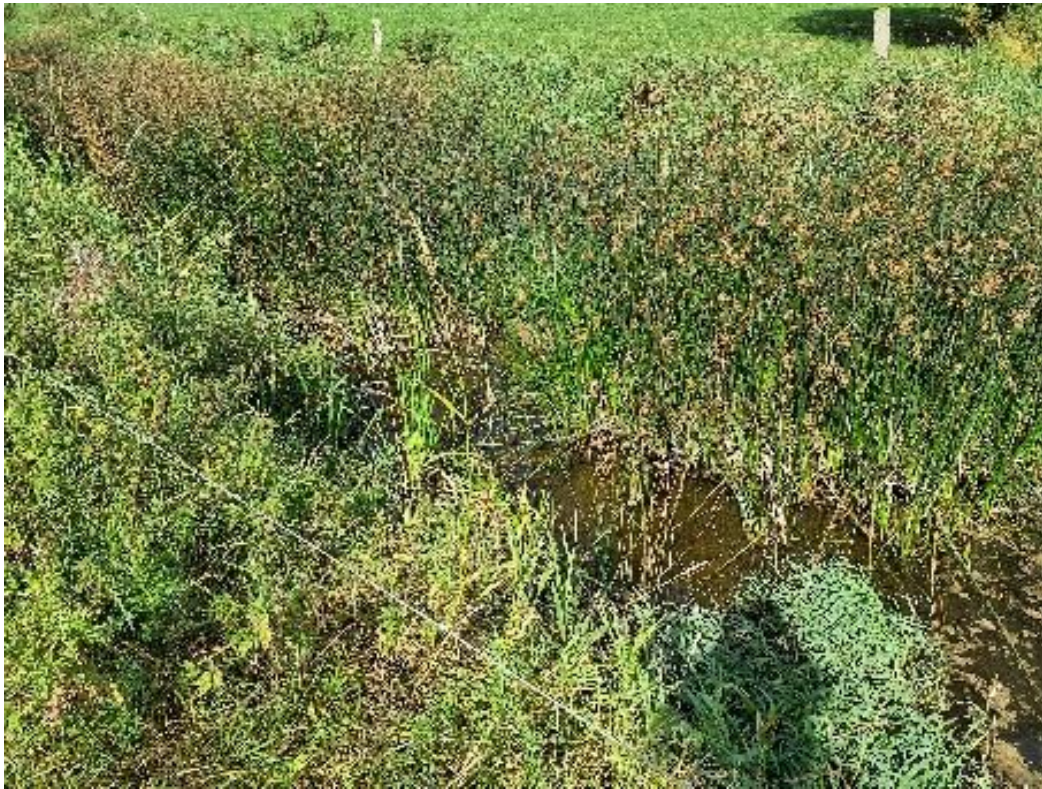
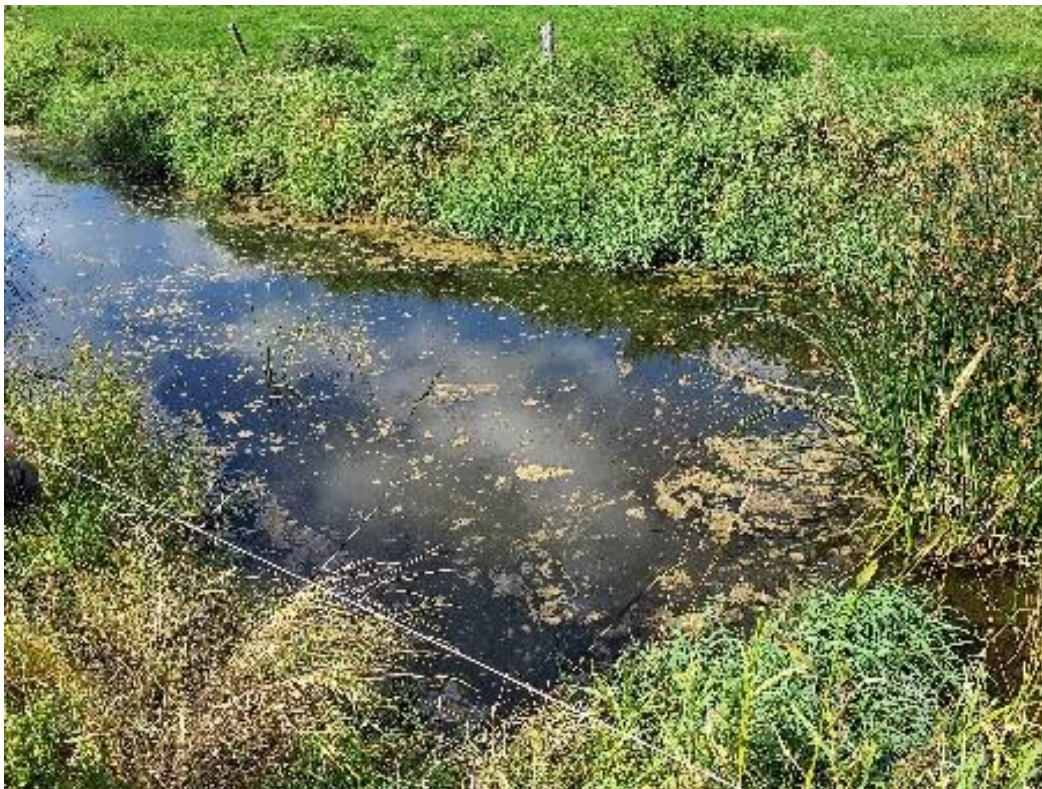
Figure 3: WQ2 in the River Suir

Figure 3 and Figure 4 show the condition of the River Suir for the second sampling point (WQ2). This sample point had no indicator species group, Q value or WFD status assigned as the kick sampling survey could not be completed. The substrate was too soft, and there was no suitable kick sampling habitat. Figure 5 shows the surveyor setting the crayfish trap in the River Suir at WQ2 sample point.

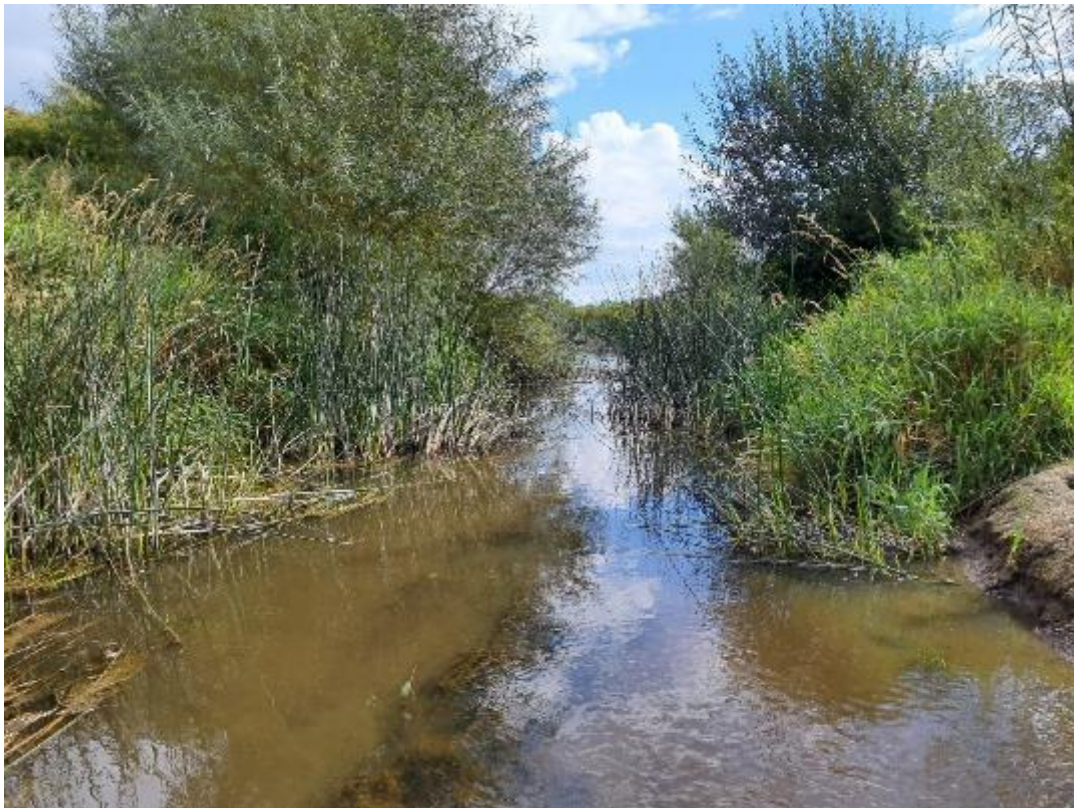
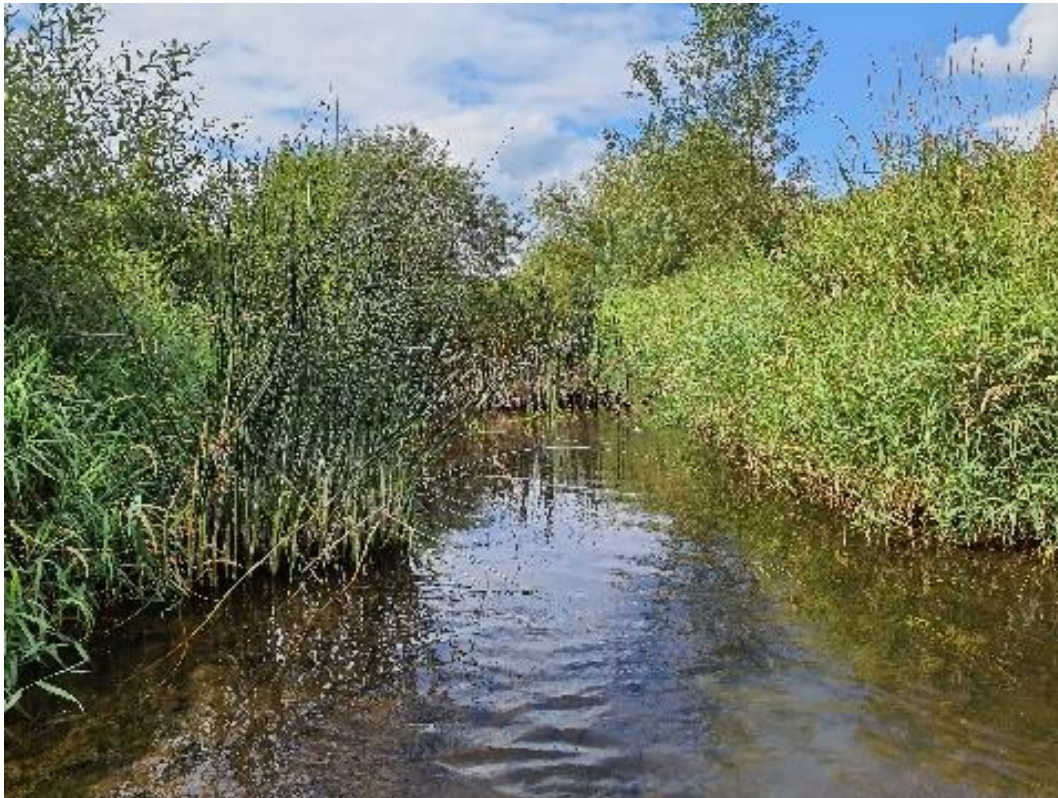
Figure 6: WQ3 in the River Suir

Figure 6 and Figure 7 show the condition of the River Suir for WQ3 sampling point. This sample point had group B indicator species present, which are sensitive of pollutants in the water. This sample point scored a Q value of

Q3-4, which means the water quality is moderate. The Water Framework Directive (WFD) status of this sample point is moderate. Figure 8 shows the surveyor setting the crayfish trap in the River Suir at WQ3 sample point.

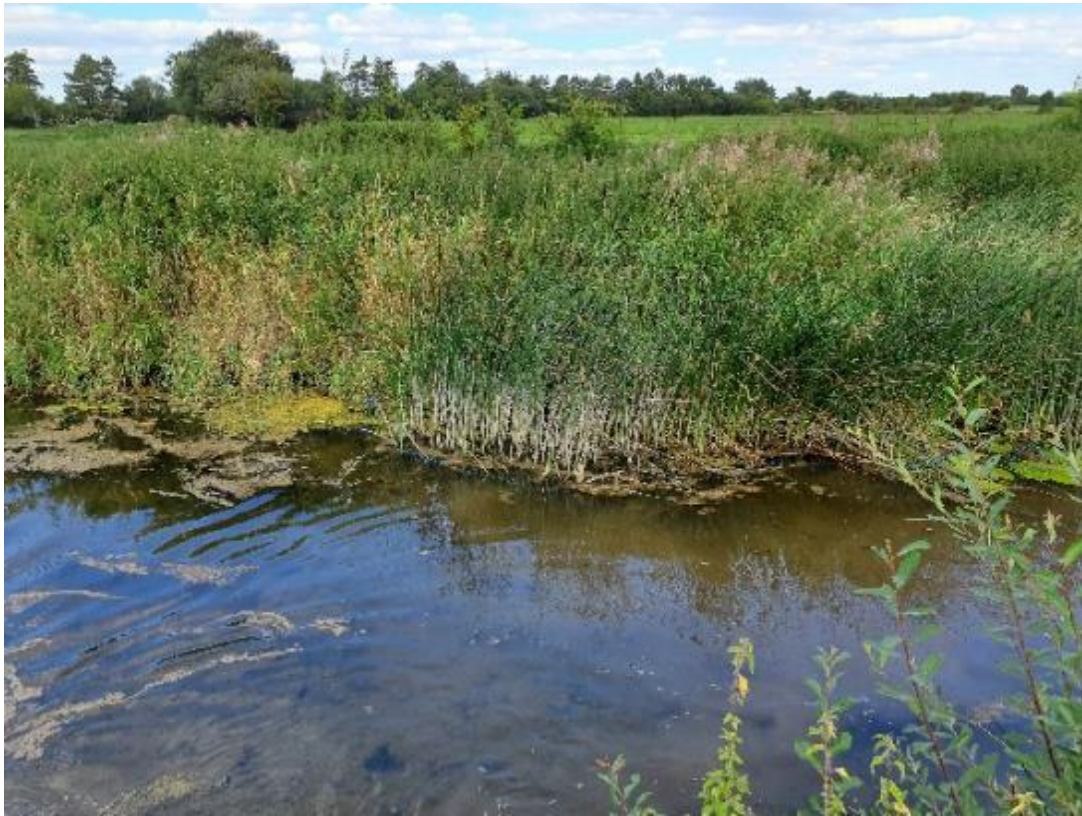
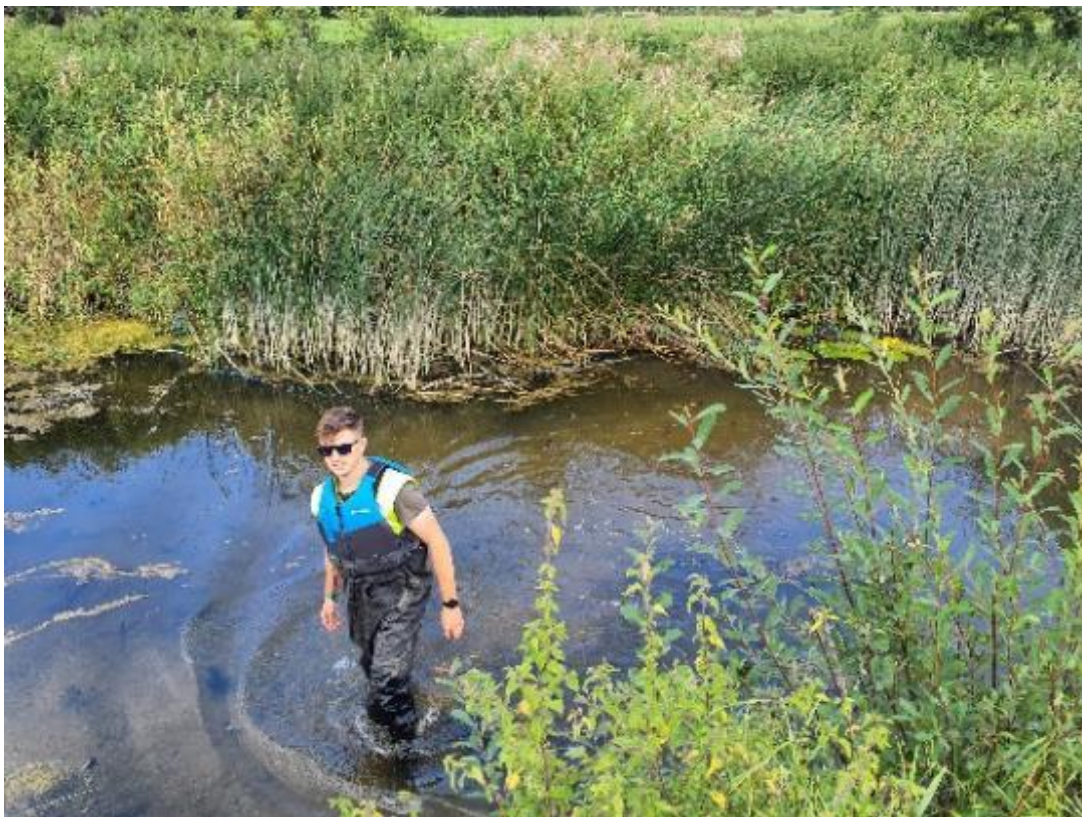
Figure 9: WQ4 in the River Suir

**Figure 9 and Figure 10** show the condition of the River Suir for WQ4 sampling point. This sample point had group C indicator species present, which are tolerant of pollutants in the water. This sample point scored a Q value of Q3, which means the water quality is moderate. The Water Framework Directive (WFD) status of this sample point is poor.

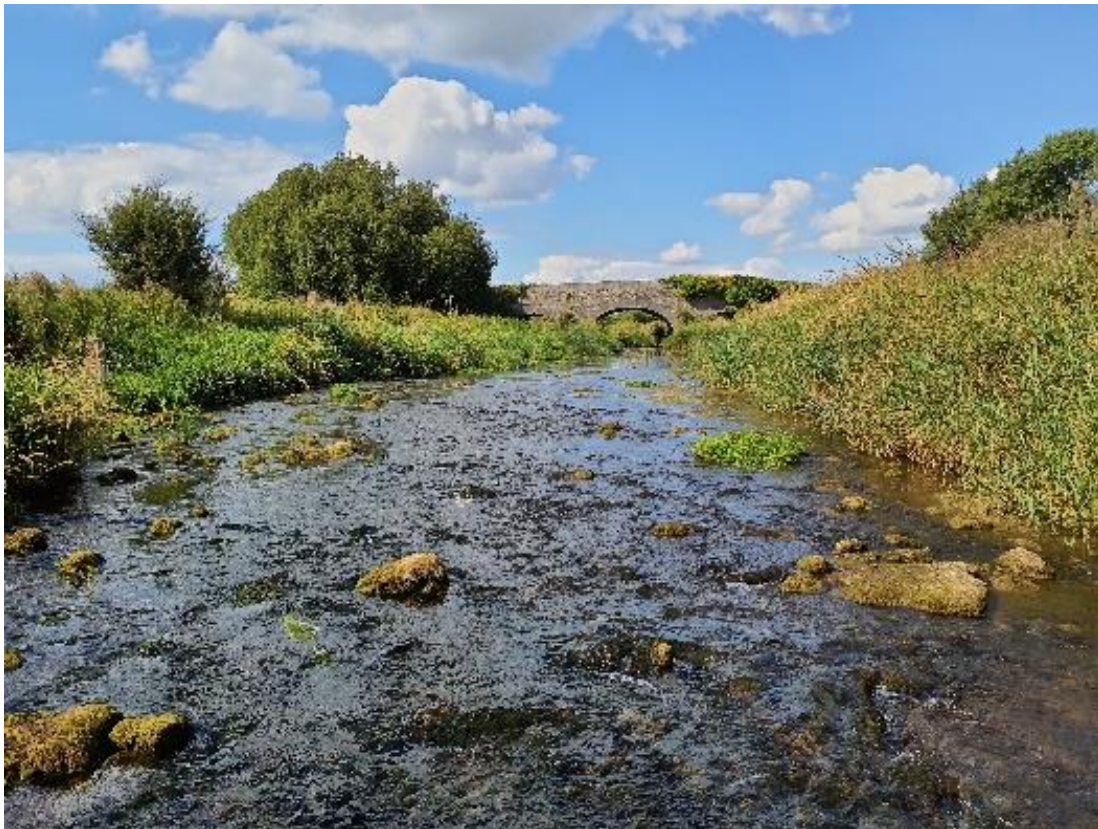
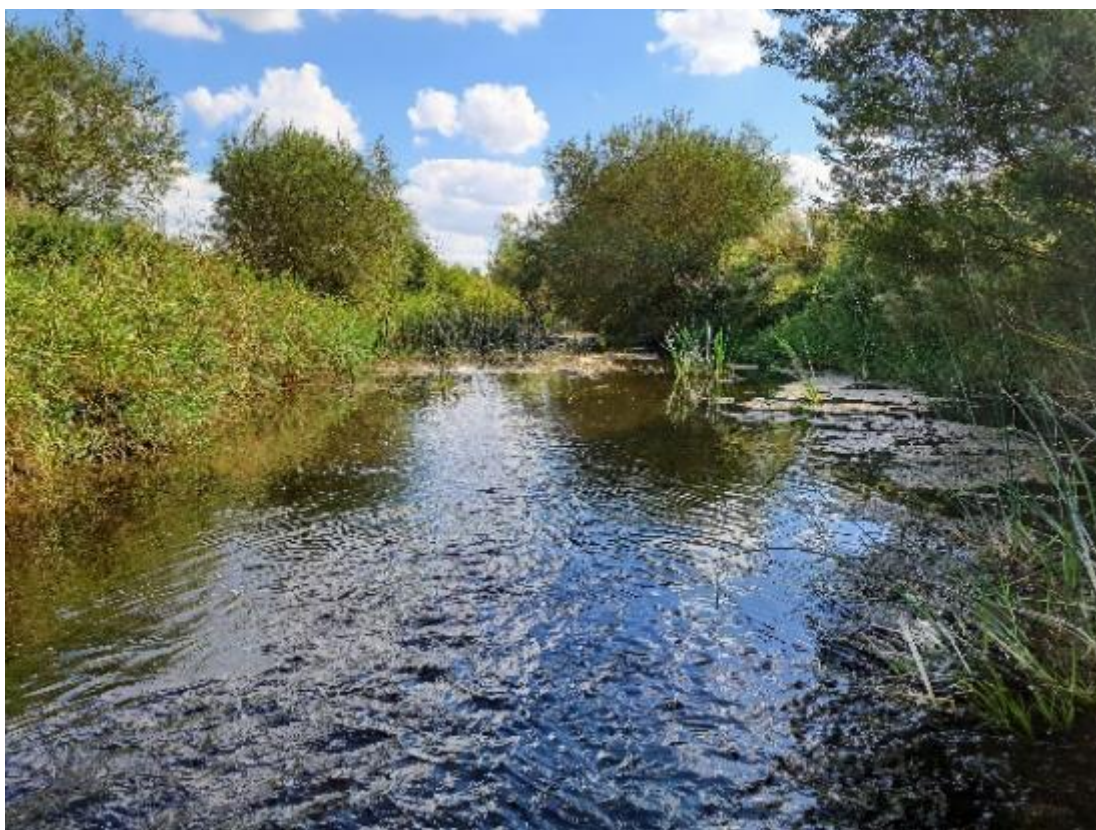
Figure 11: WQ5 in the River Suir

Figure 11 and Figure 12 show the condition of the River Suir for WQ5 sampling point. This sample point had group B indicator species present, which are sensitive of pollutants in the water. This sample point scored a Q value of Q3-4, which means the water quality is moderate. The Water Framework Directive (WFD) status of this sample point is moderate.

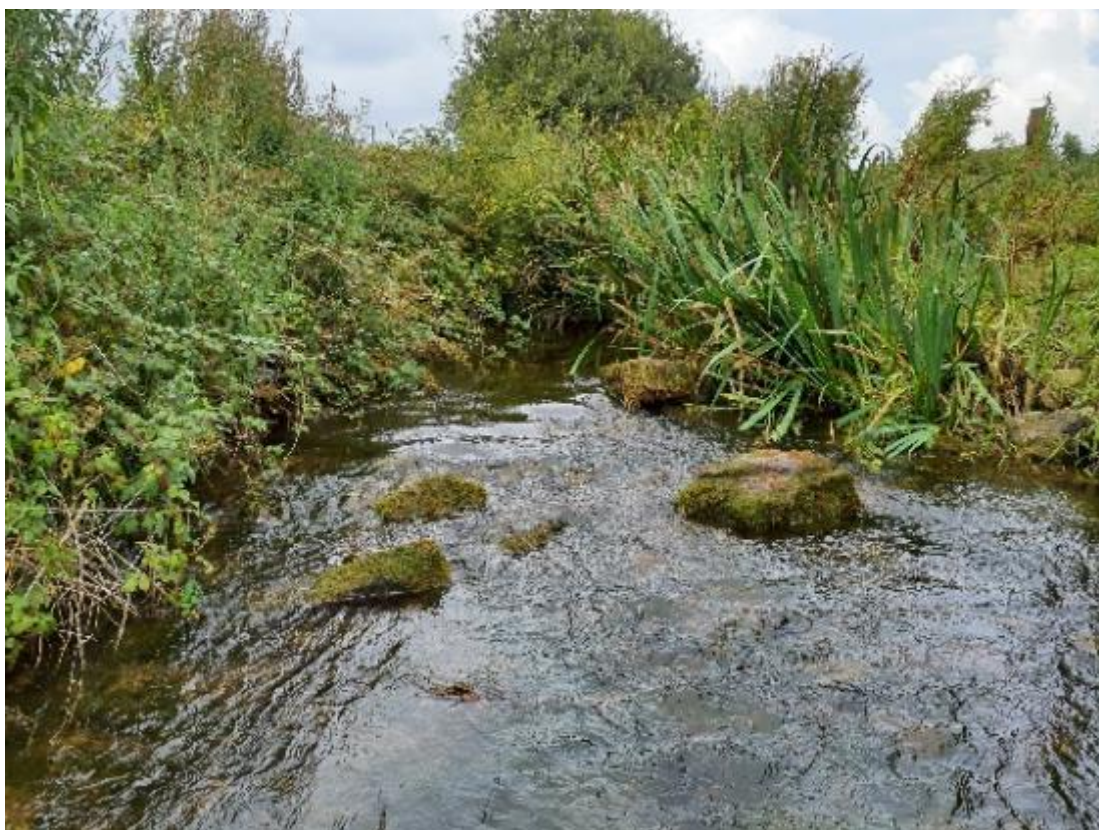
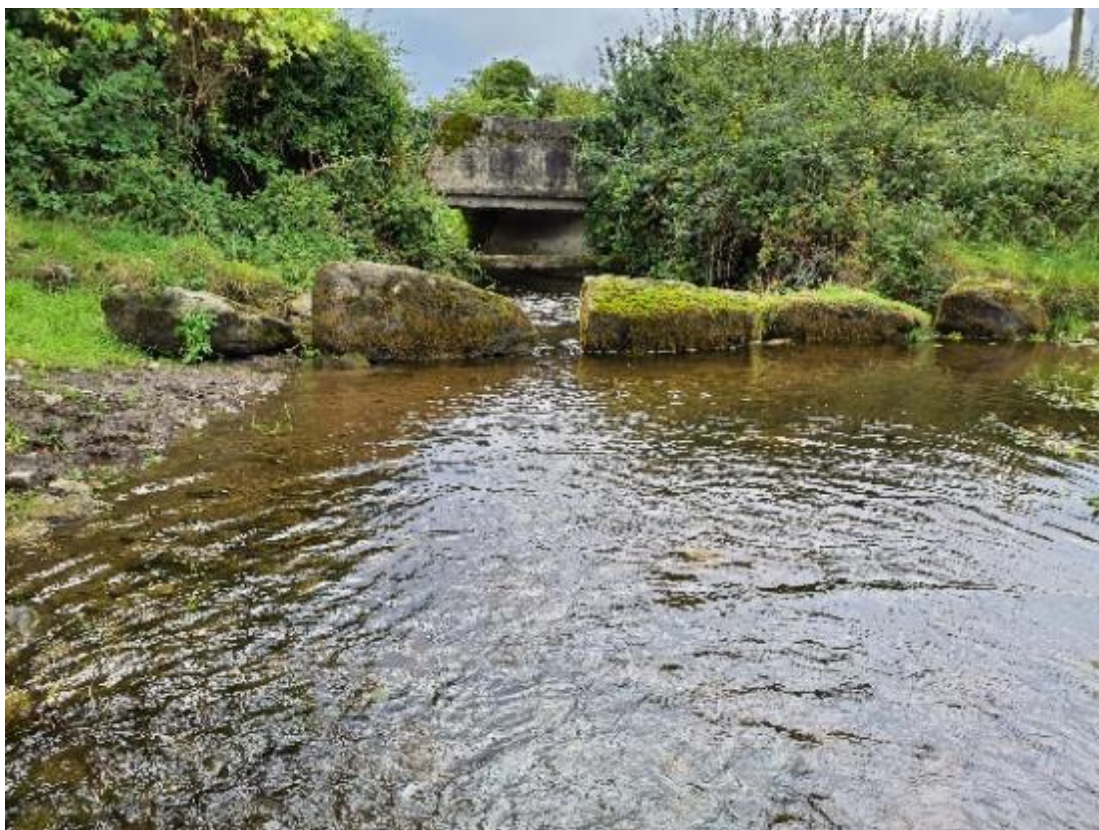
Figure 13: WQ6 in the Rossesstown River

Figure 13 and Figure 14 show the condition of the Rossesstown River for WQ6 sampling point. This sample point had group C indicator species present, which are tolerant of pollutants in the water. This sample point scored a Q

value of Q3, which means the water quality is poor. The Water Framework Directive (WFD) status of this sample point is poor.

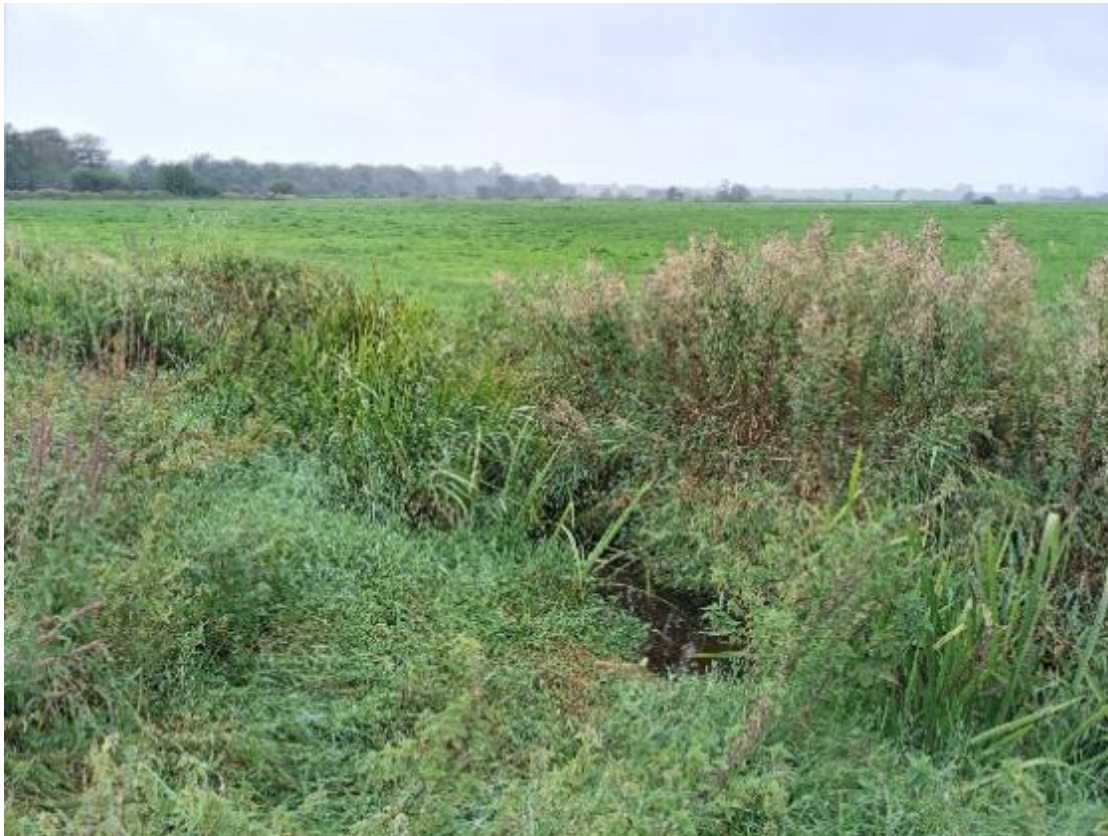
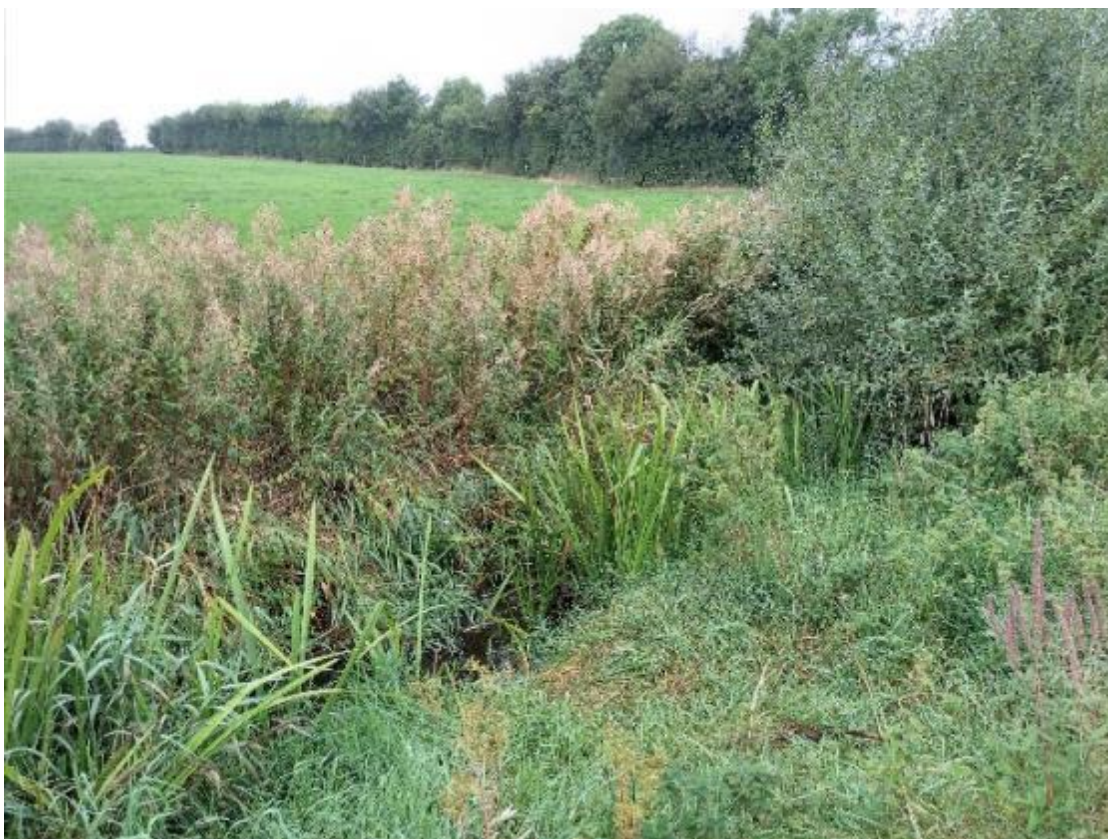
Figure 15: WQ7 in the Rossesstown River

Figure 15 and Figure 16 show the condition of the Rossestown River for WQ6 sampling point. This sample point had group C indicator species present, which are tolerant of pollutants in the water. This sample point scored a Q value of Q3, which means the water quality is moderate. The Water Framework Directive (WFD) status of this sample point is poor.

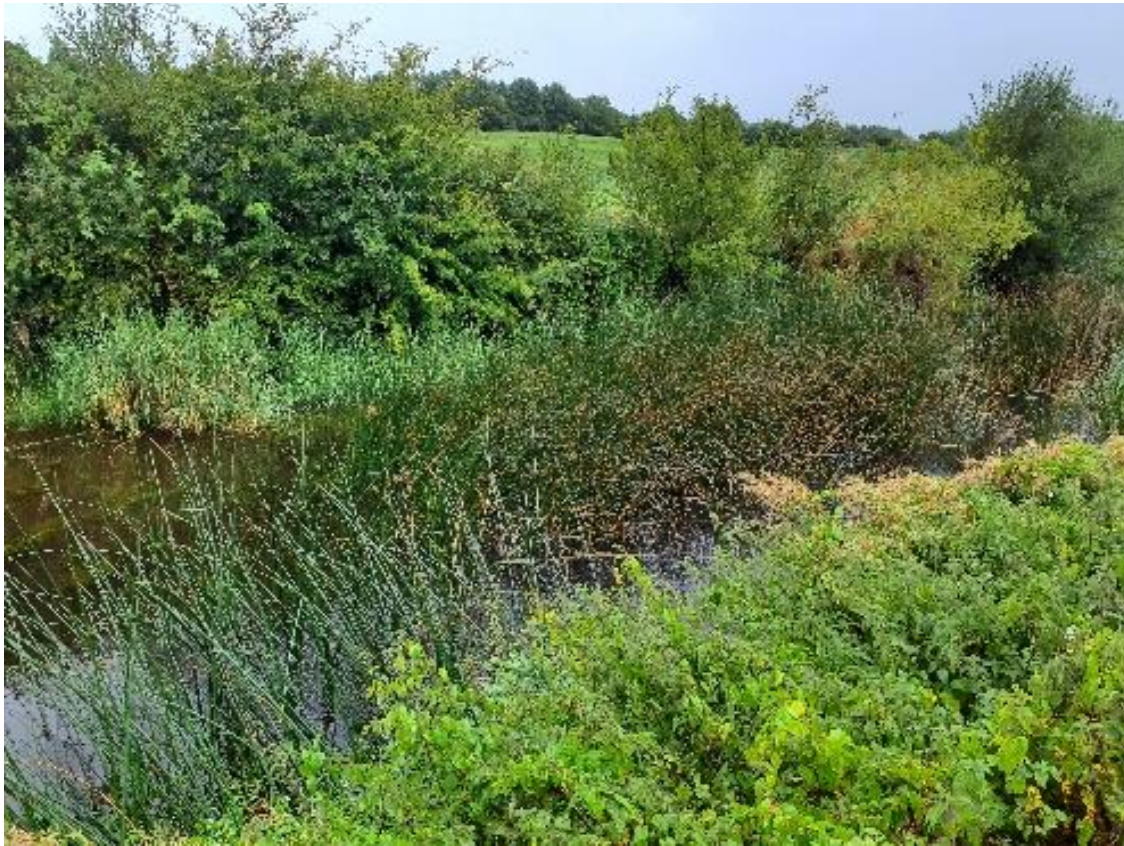
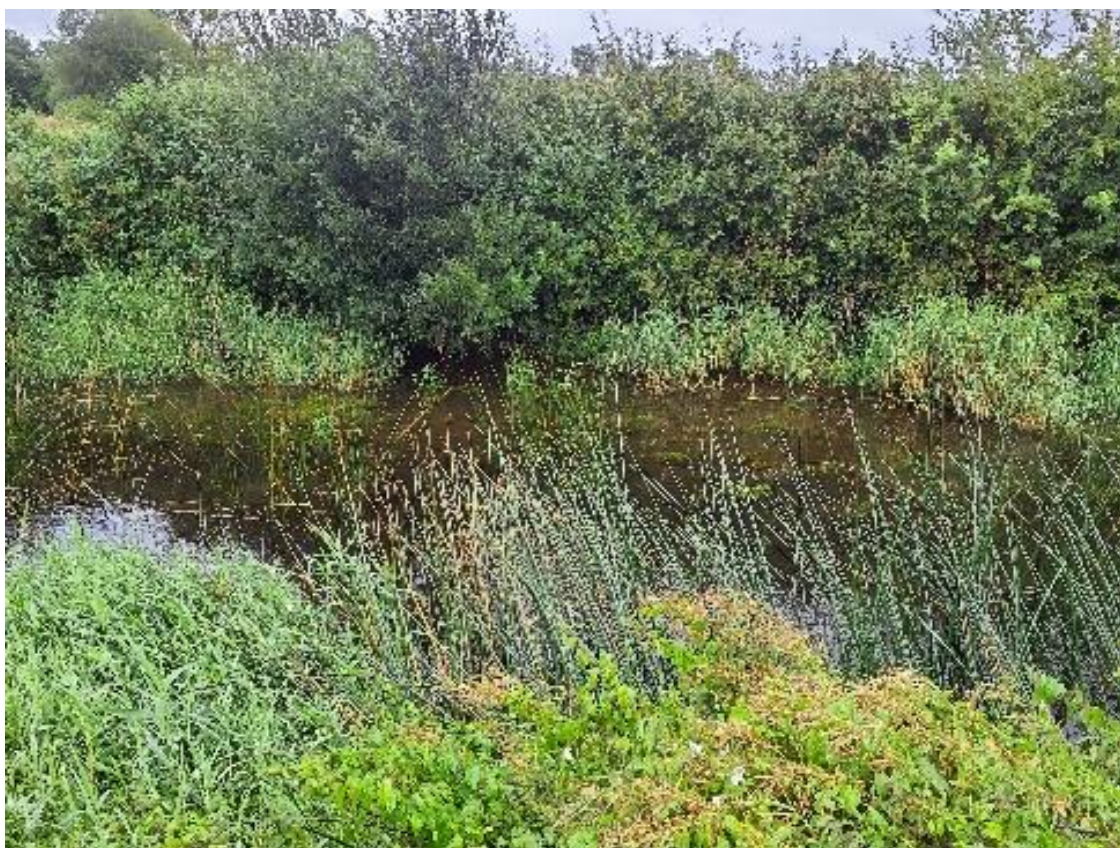
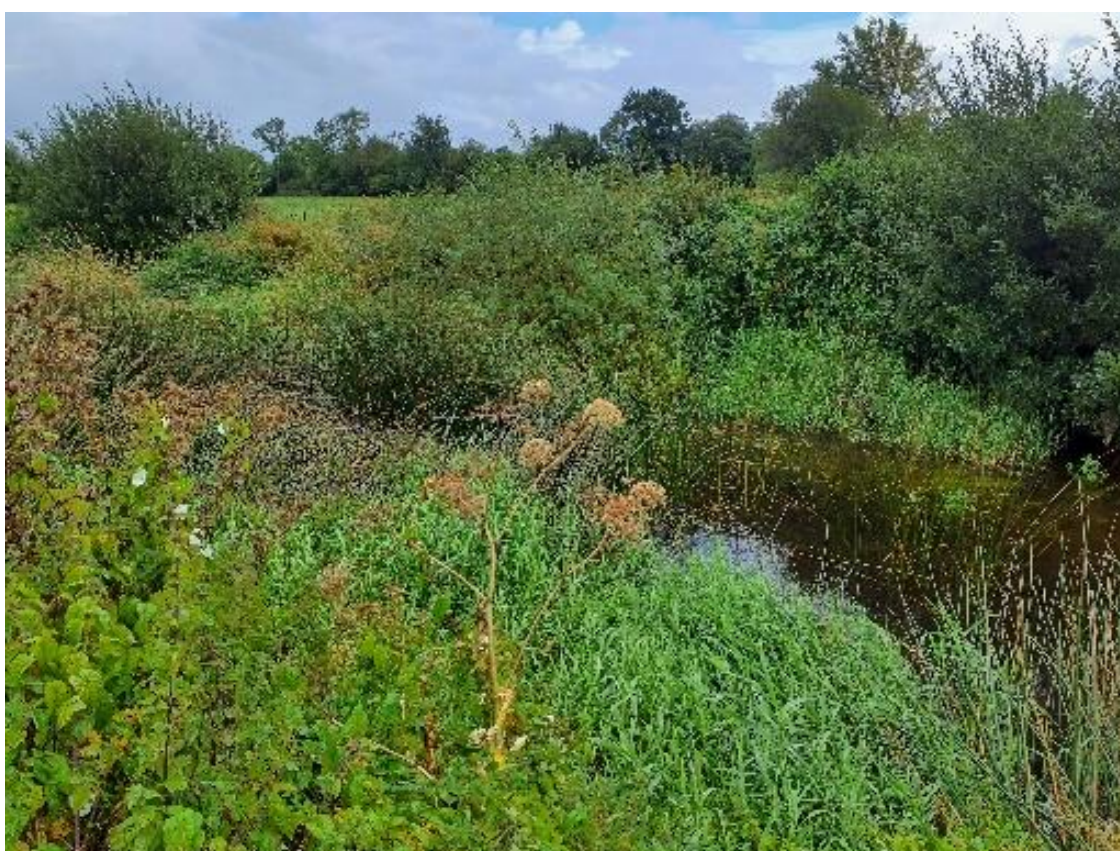
Figure 17: WQ8 in the River Suir

Figure 17, Figure 18 and Figure 19 show the condition of the River Suir for WQ8 sampling point. This sample point had group B indicator species present, which are sensitive of pollutants in the water. This sample point scored a Q value of Q3-4, which means the water quality is moderate. The Water Framework Directive (WFD) status of this sample point is moderate.

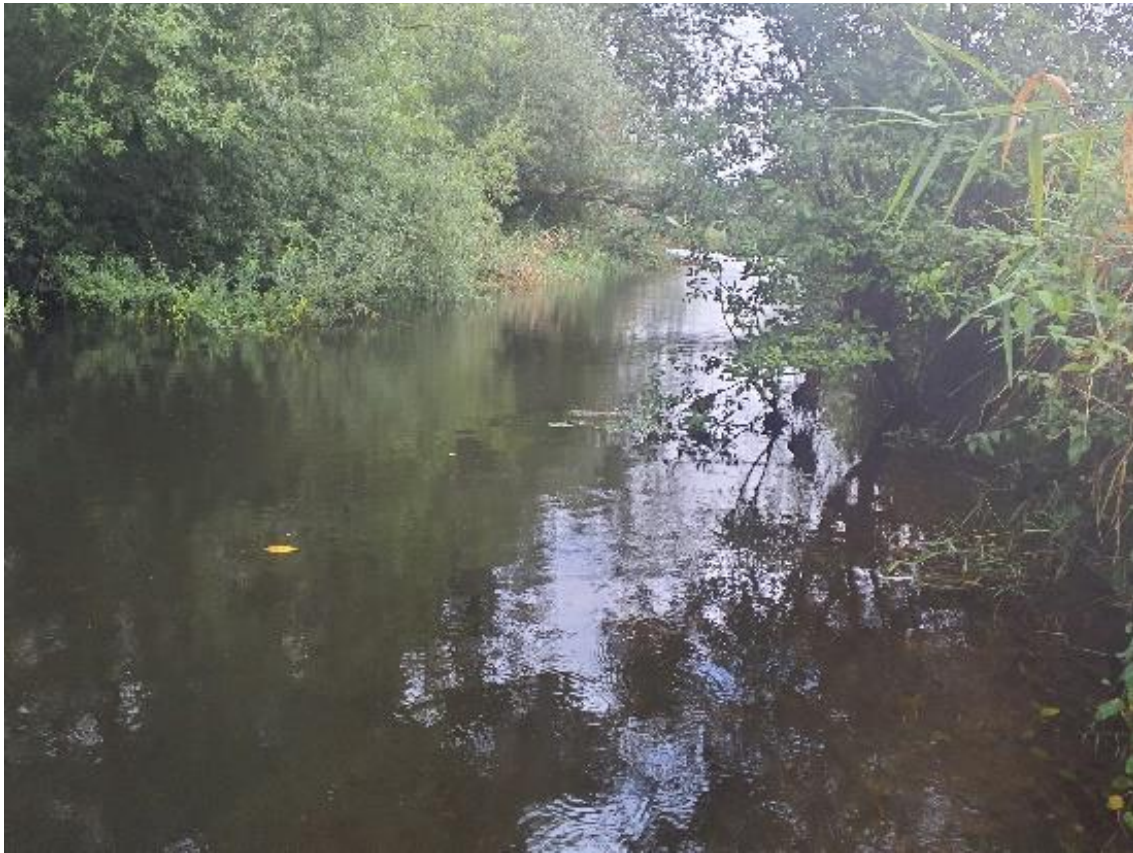
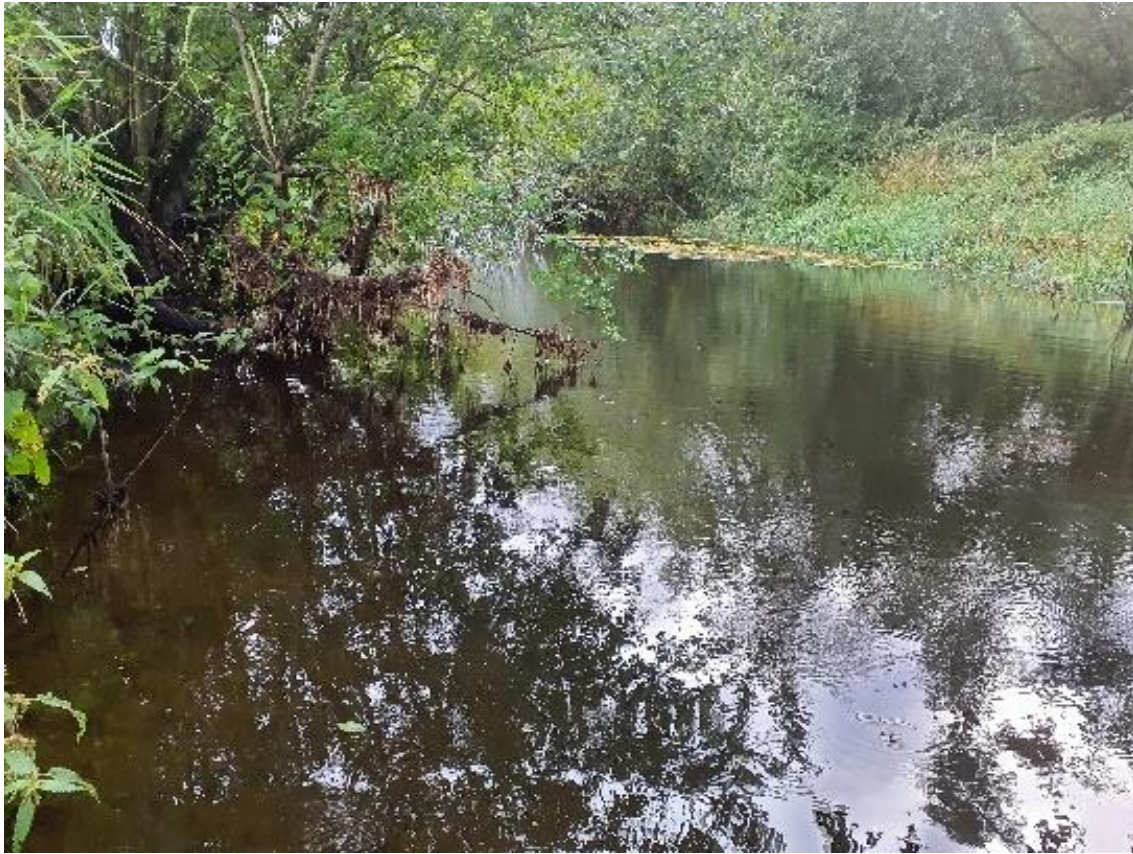
Figure 20: WQ9 in the River Suir

Figure 20 and Figure 21 show the condition of the River Suir for WQ9 sampling point. This sample point had group C indicator species present, which are tolerant of pollutants in the water. This sample point scored a Q value of Q3, which means the water quality is poor. The Water Framework Directive (WFD) status of this sample point is poor.

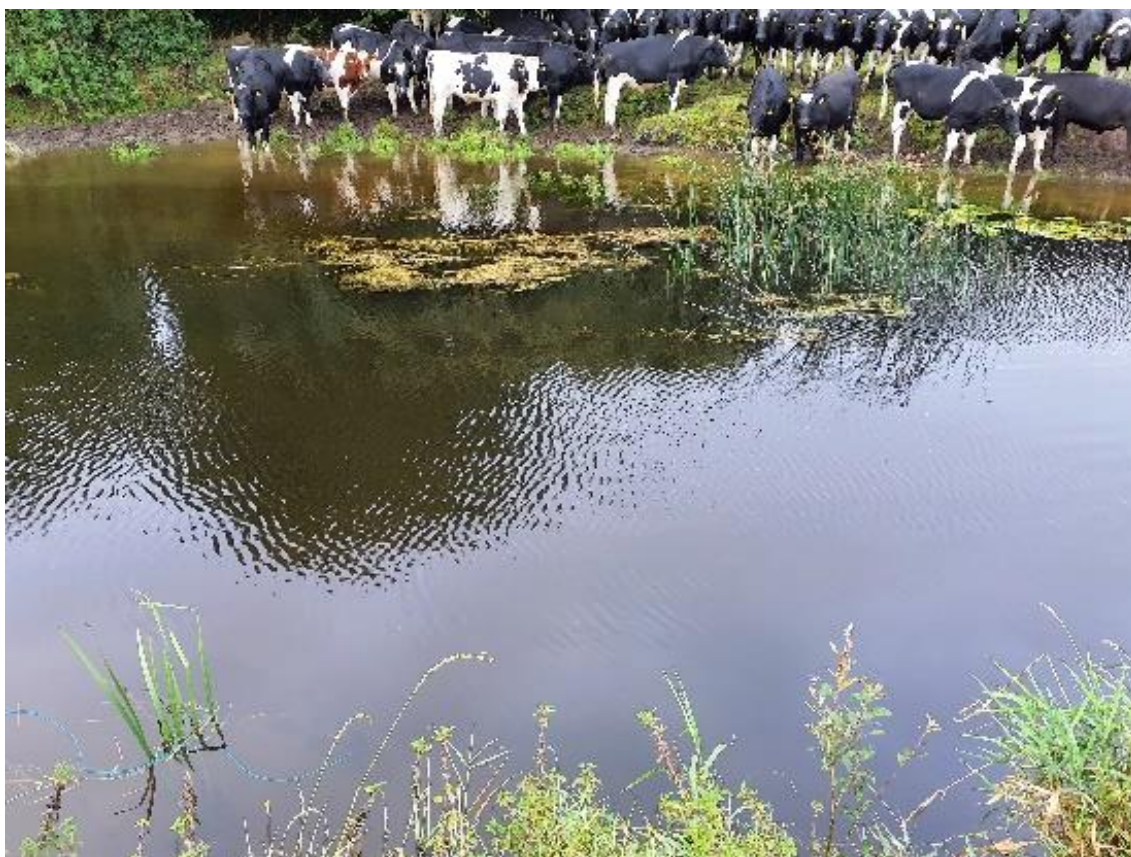
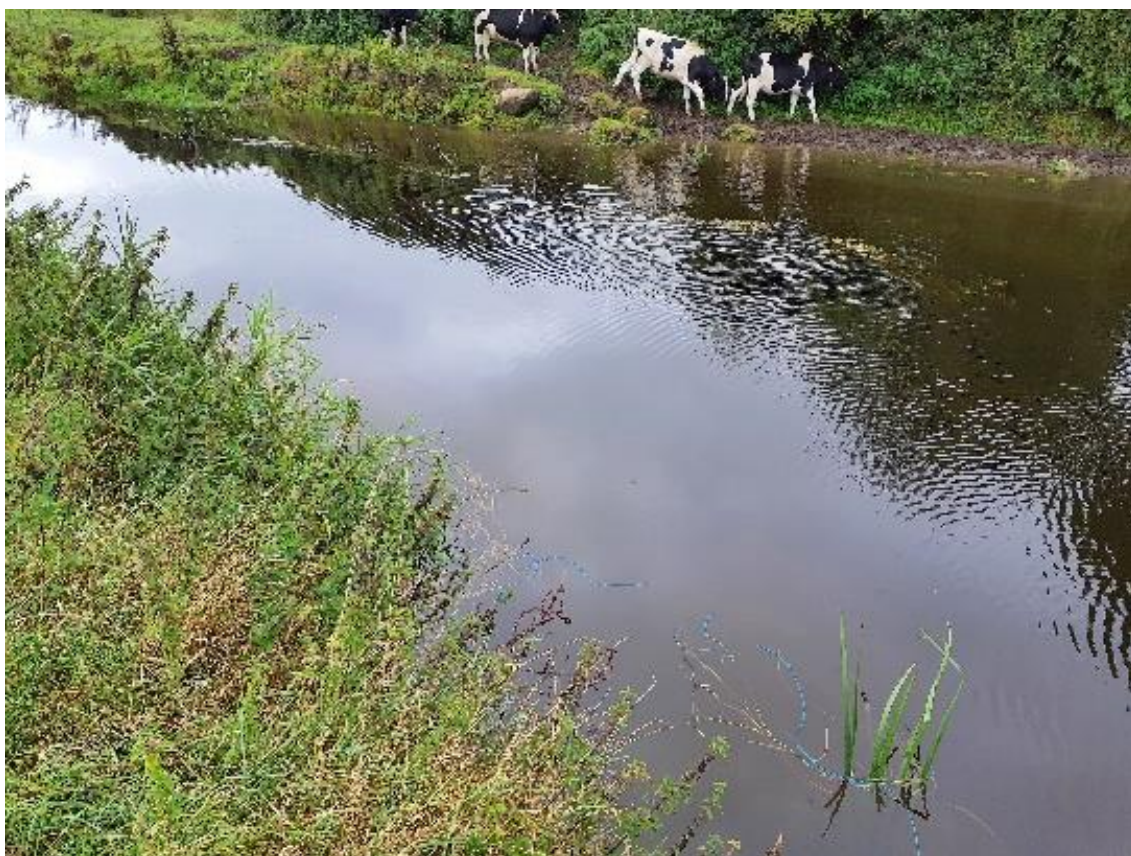
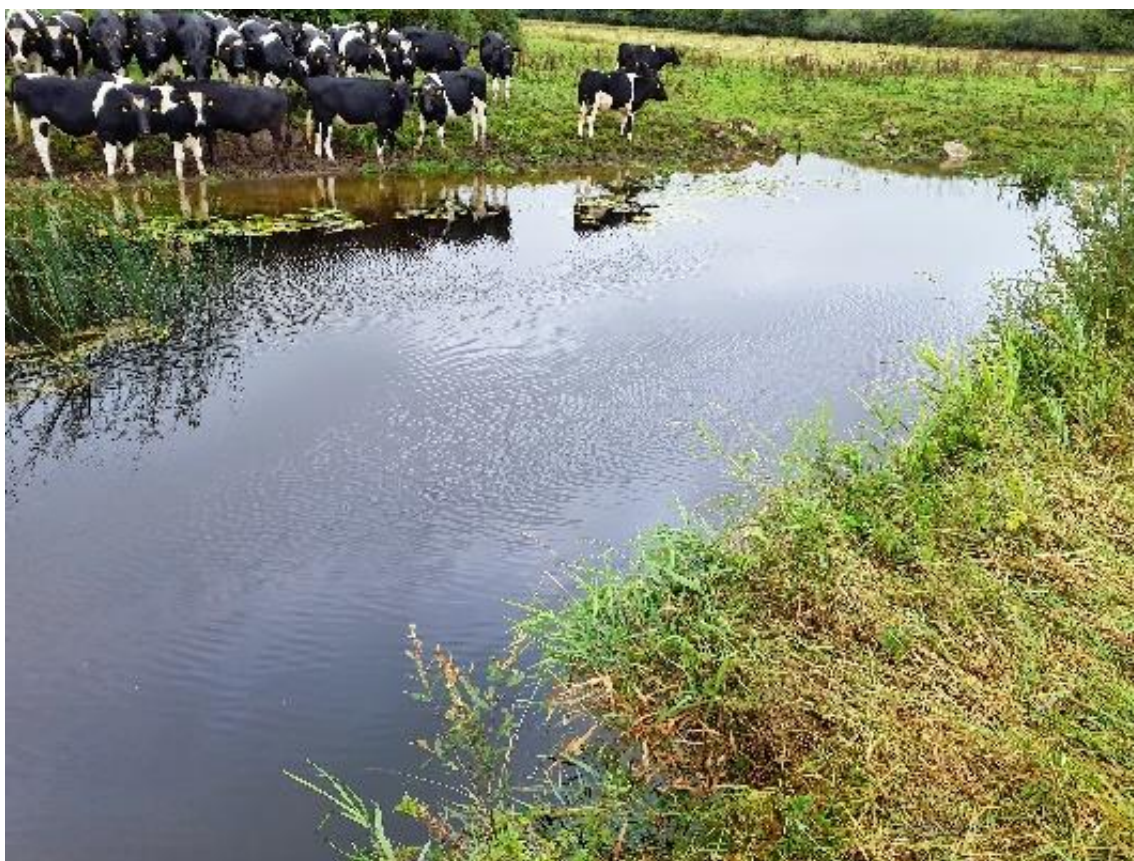
Figure 22: WQ10 in the River Suir

Figure 22, Figure 23 and Figure 24 show the condition of the River Suir for WQ10 sampling point. This sample point had group C indicator species present, which are tolerant of pollutants in the water. This sample point scored a Q value of Q3, which means the water quality is poor. The Water Framework Directive (WFD) status of this sample point is poor.

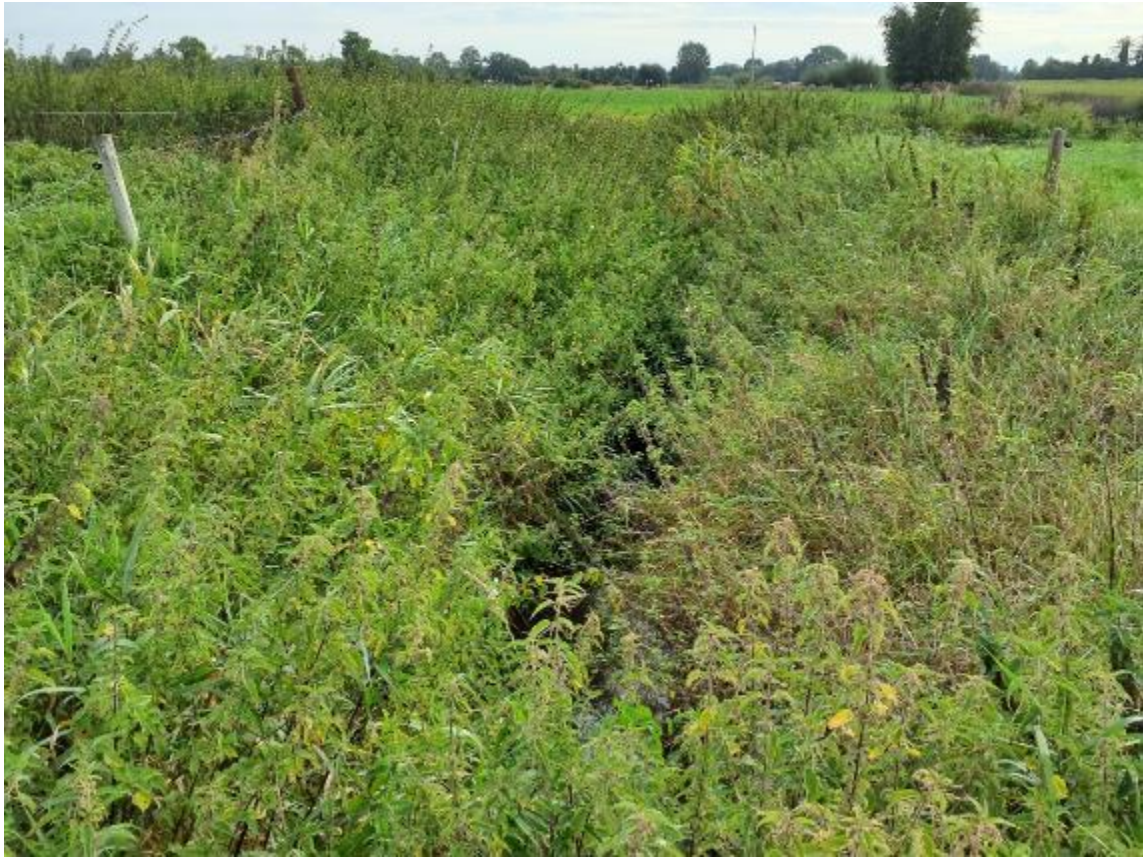
Figure 25: An inaccessible sample point

Figure 25 shows the sample point for Kilkillahara. This sample point was inaccessible, and no surveys were completed here.
