# Ground Investigations Ireland

## Scart Mountain-Broemountain

### Tobin Consulting Engineers

## Ground Investigation Report

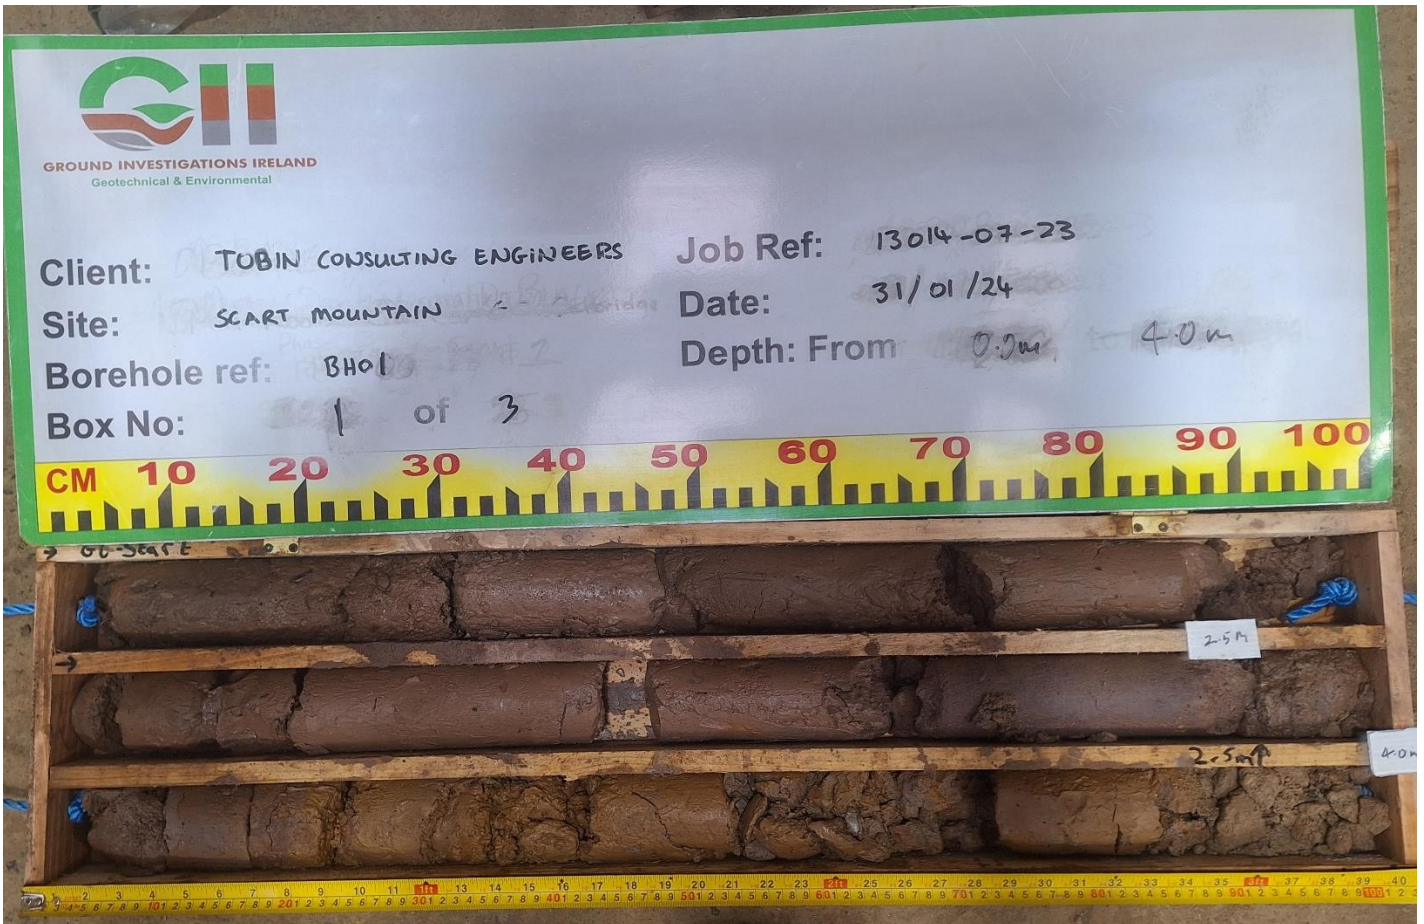
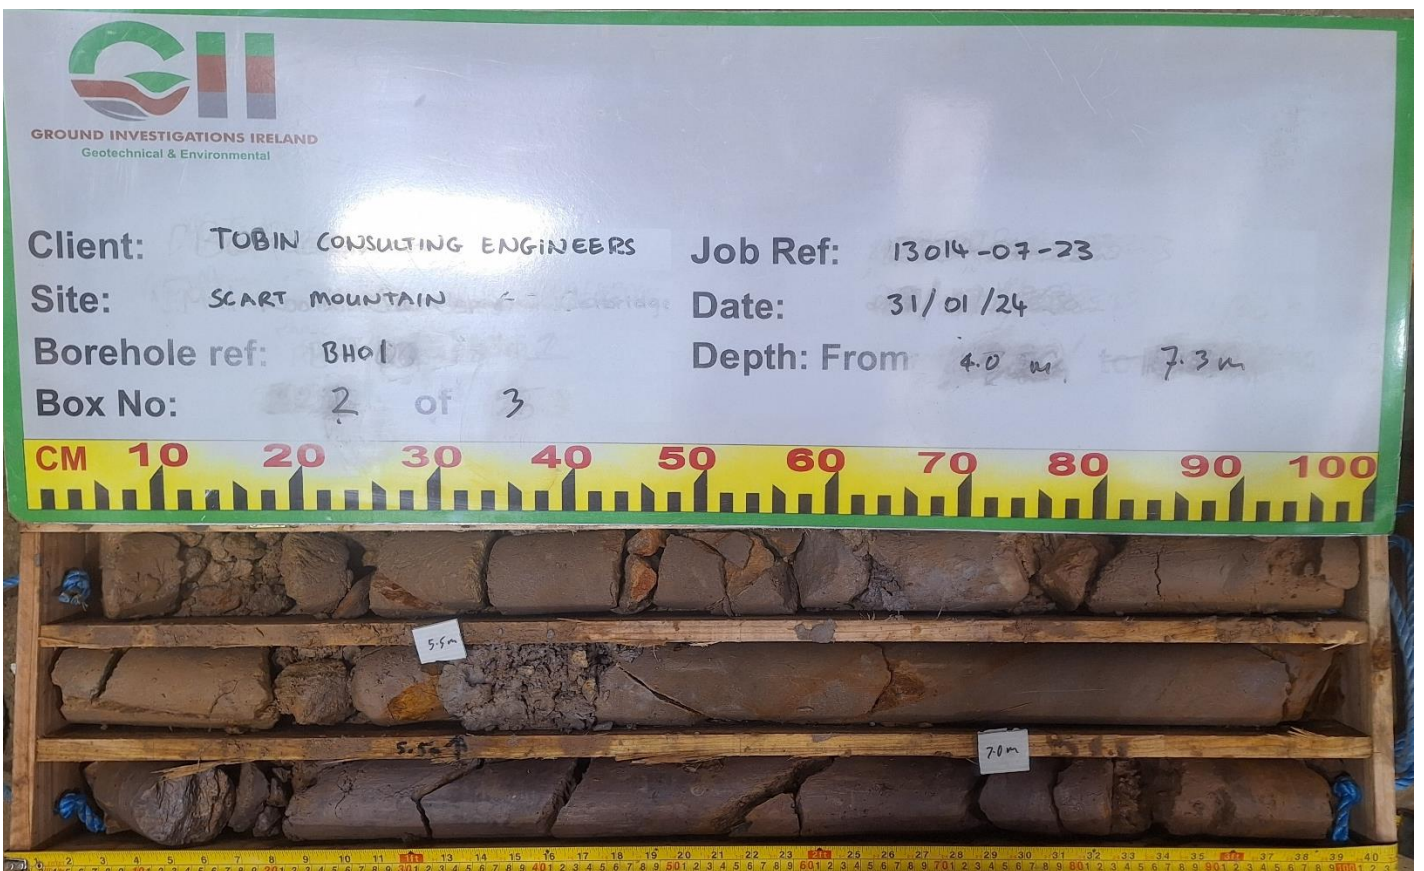
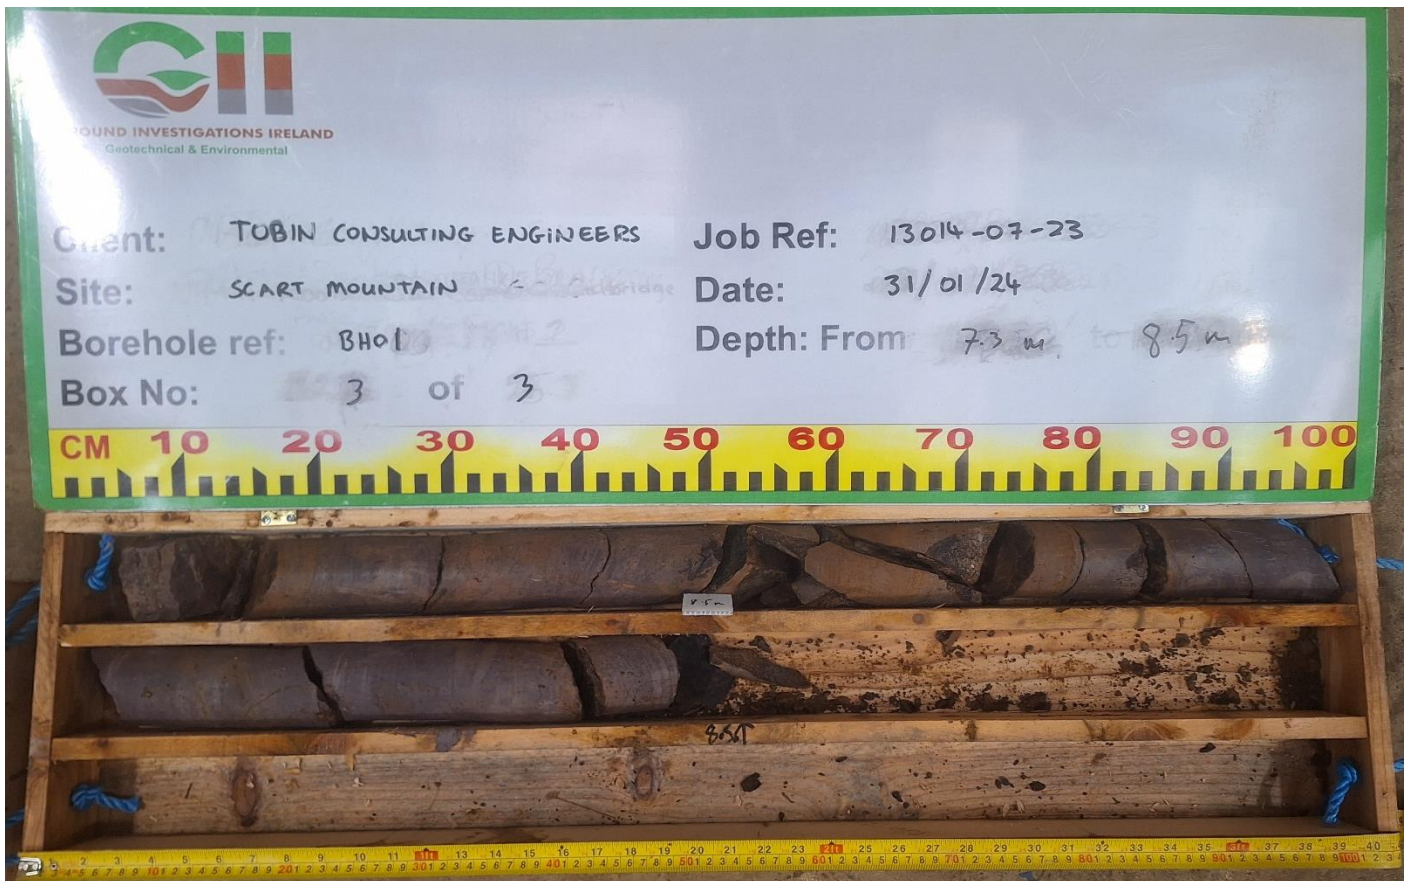
BH01

4.00-4.45	31										
5.50	60				7,13/19,21,10 SPT(C) N=50		(3.00)				
5.50-5.95											
7.00	100	73	57	13		160.85	7.00	Weak to medium strong thinly to thickly laminated greyish brown fine to medium SANDSTONE. Slightly to moderately weathered. 7.0m - 8.0m BGL Two fracture sets. F1: Very closey to closely spaced 0-20 degrees planar rough, tight to open with occasional clay smear. F2: Closely spaced 60-80 degrees planar rough, incipient to open with a clay smear.

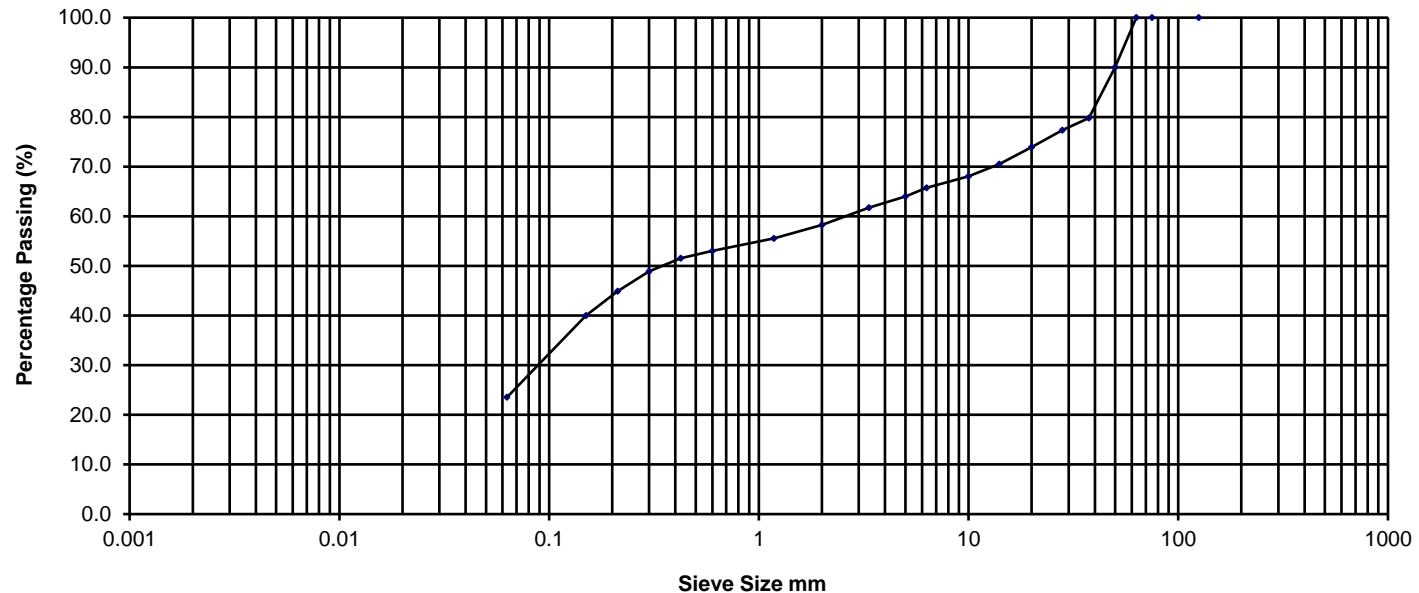
## Determination of Particle Size Distribution

Clay	Fine	Medium	Coarse	Fine	Medium	Coarse	Fine	Medium	Coarse	Cobbles	Boulder
	Silt			Sand			Gravel			0.0	0.0
	23.5			34.7			41.8

The geotechnical testing carried out on soil samples recovered generally confirm the descriptions on the logs with the primary constituent of the cohesive deposits found to be a CLAY of low to intermediate plasticity. The Particle Size Distribution tests confirm that generally the cohesive deposits are well-graded with percentages of sands and gravels ranging between 4.80% and 50.8% generally with fines contents of 23.5% to 50.8%.

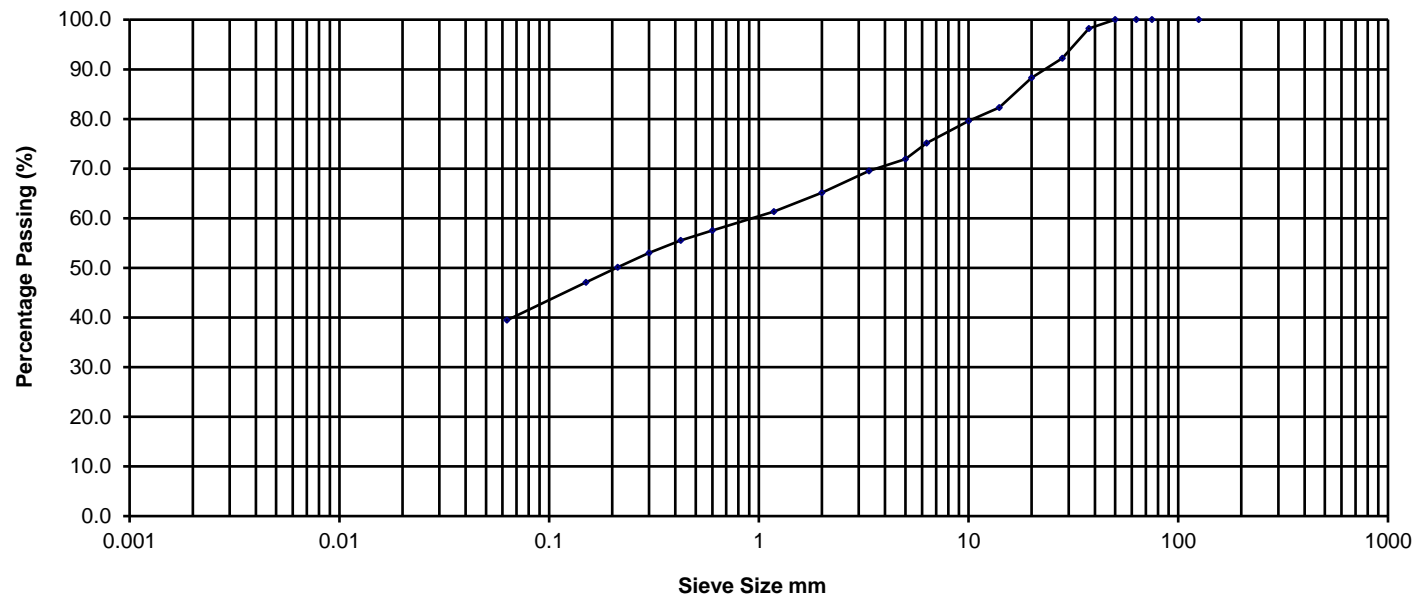
## Determination of Particle Size Distribution

Clay	Fine	Medium	Coarse	Fine	Medium	Coarse	Fine	Medium	Coarse	Cobbles	Boulder
	Silt			Sand			Gravel				
	39.5			25.7			34.9			0.0	0.0

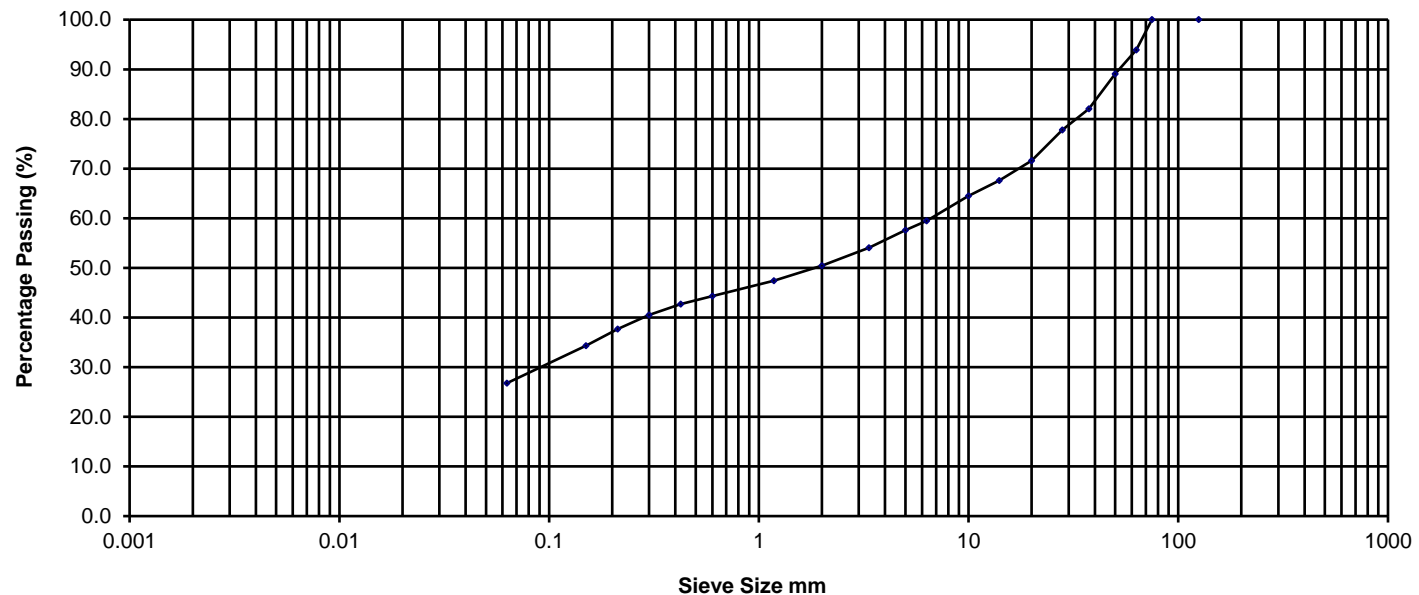
## Determination of Particle Size Distribution

Clay	Fine	Medium	Coarse	Fine	Medium	Coarse	Fine	Medium	Coarse	Cobbles	Boulder
	Silt			Sand			Gravel				
	26.8			23.7			43.5			6.1	0.0

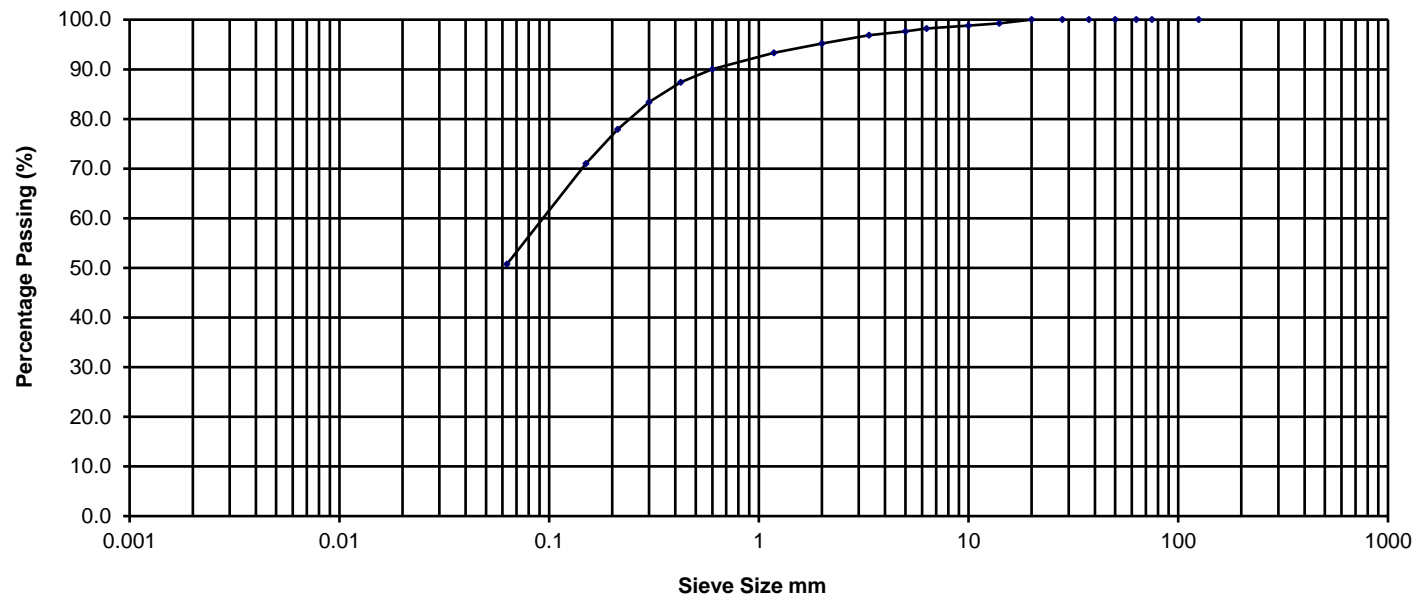
## Determination of Particle Size Distribution

Clay	Fine	Medium	Coarse	Fine	Medium	Coarse	Fine	Medium	Coarse	Cobbles	Boulder
	Silt			Sand			Gravel			0.0	0.0
	50.8			44.4			4.8

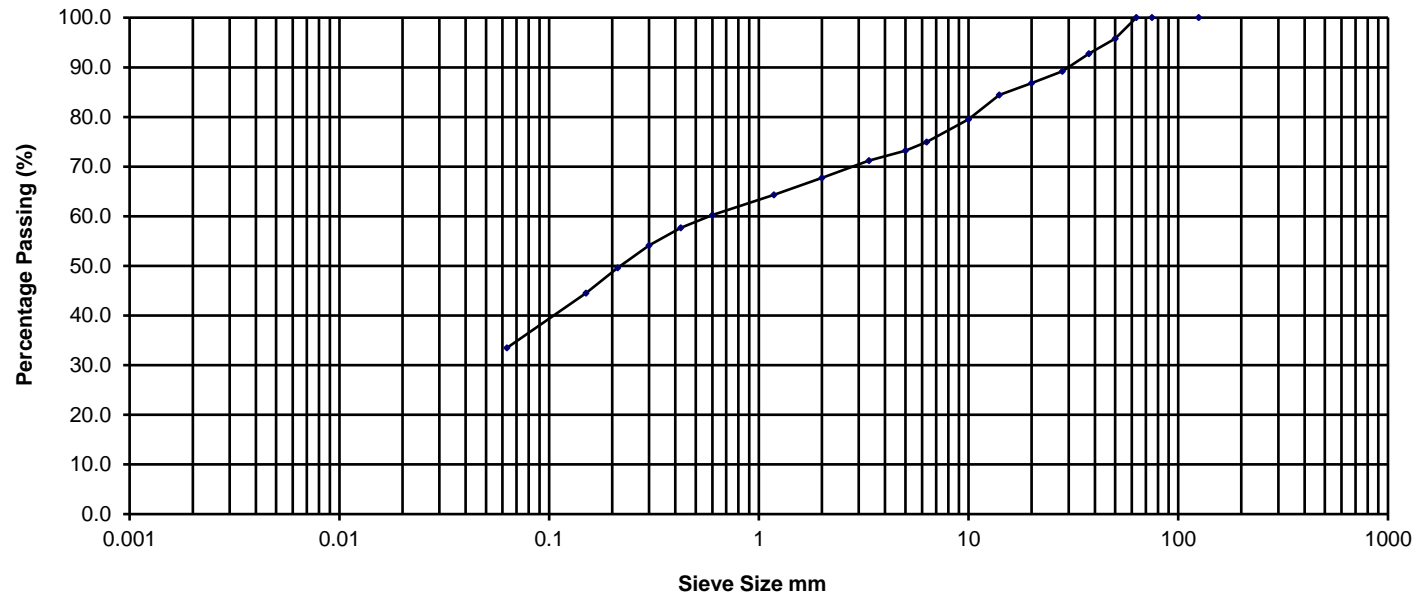
## Determination of Particle Size Distribution

Clay	Fine	Medium	Coarse	Fine	Medium	Coarse	Fine	Medium	Coarse	Cobbles	Boulder
	Silt			Sand			Gravel			0.0	0.0
	33.5			34.3			32.3

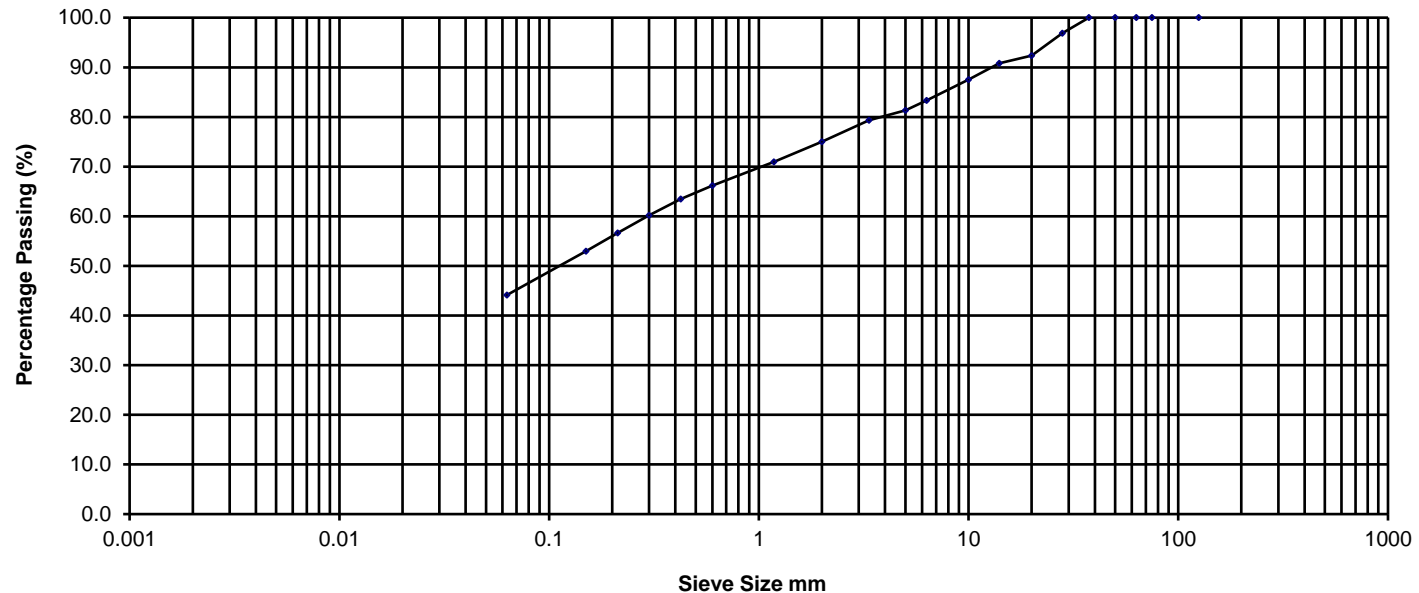
## Determination of Particle Size Distribution

Clay	Fine	Medium	Coarse	Fine	Medium	Coarse	Fine	Medium	Coarse	Cobbles	Boulder
	Silt			Sand			Gravel			0.0	0.0
	44.1			30.9			25.0

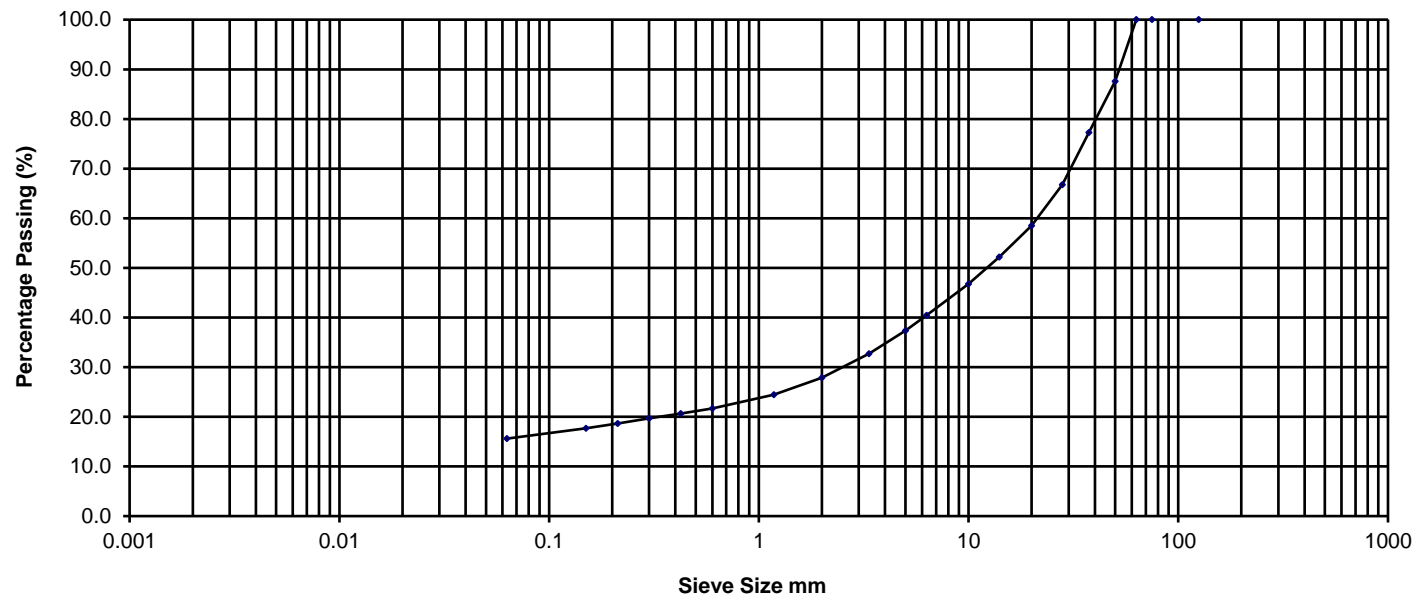
## Determination of Particle Size Distribution

Clay	Fine	Medium	Coarse	Fine	Medium	Coarse	Fine	Medium	Coarse	Cobbles	Boulder
	Silt			Sand			Gravel			0.0	0.0
	15.6			12.3			72.1

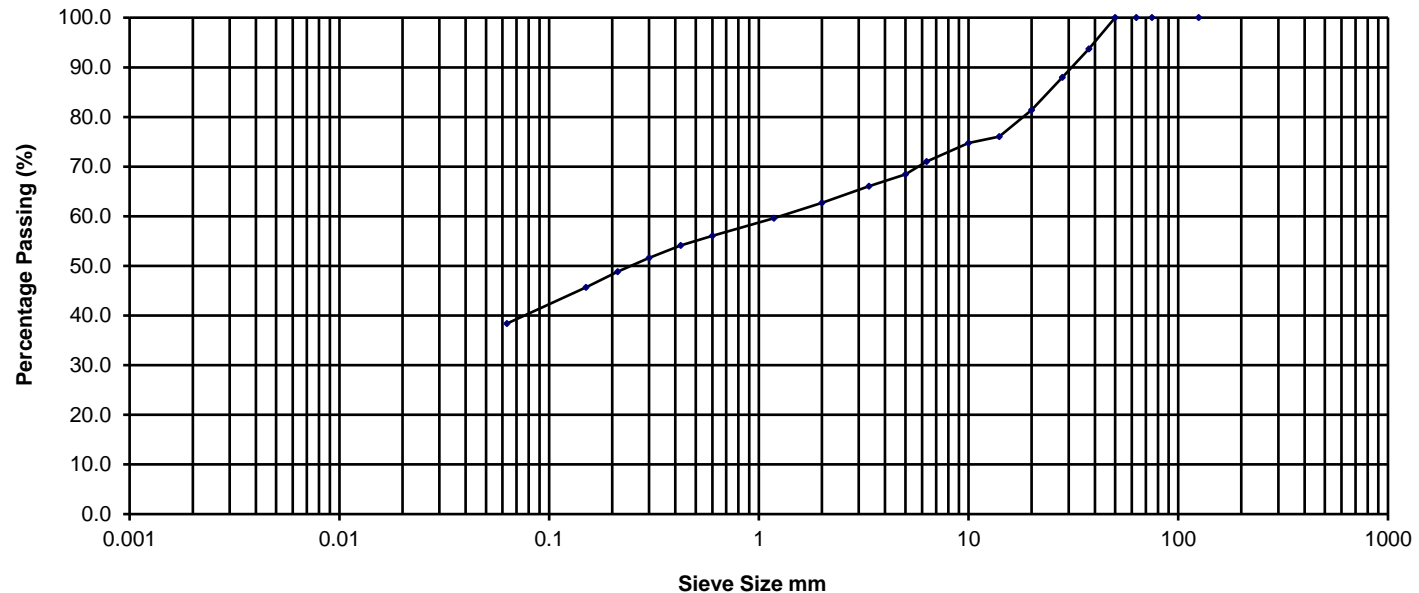
## Determination of Particle Size Distribution

Clay	Fine	Medium	Coarse	Fine	Medium	Coarse	Fine	Medium	Coarse	Cobbles	Boulder
	Silt			Sand			Gravel				
	38.4			24.3			37.3			0.0	0.0

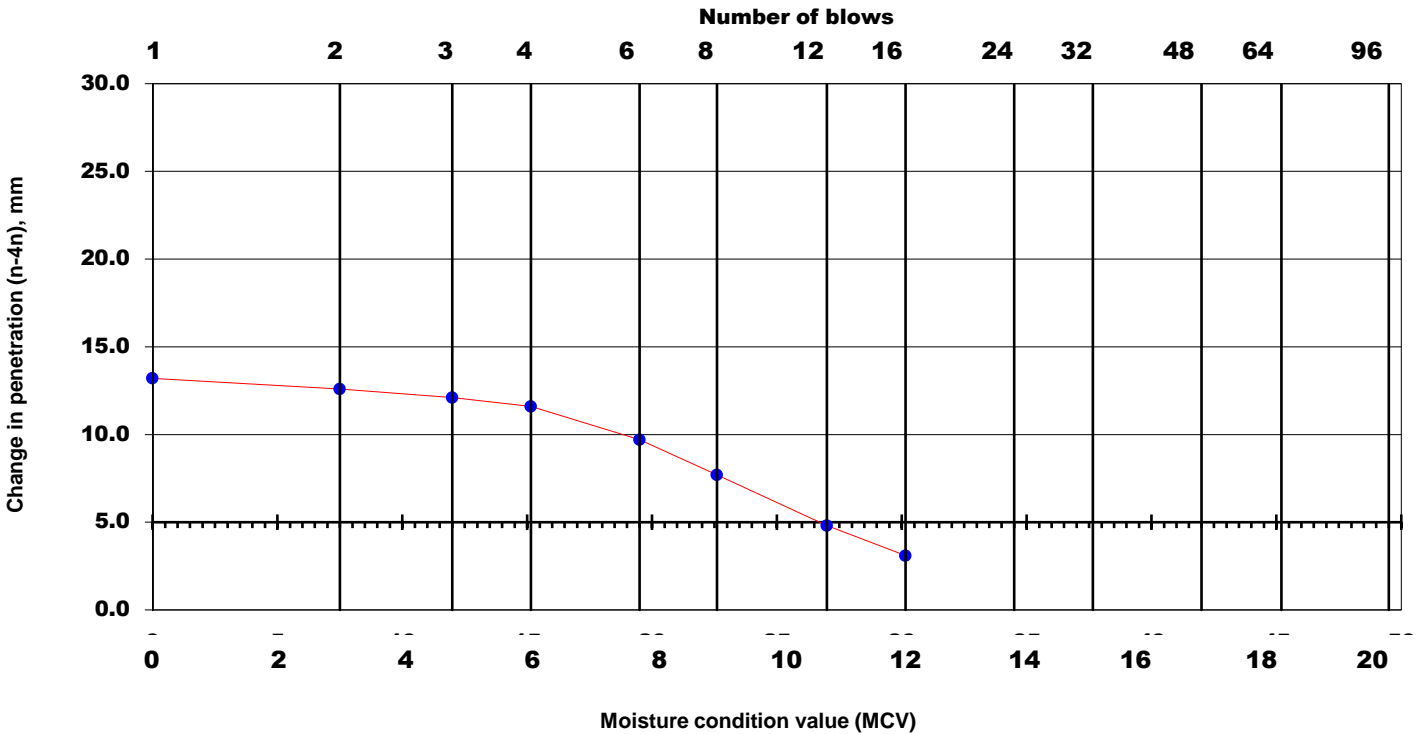
SINGLE POINT MOISTURE CONDITION VALUE TEST

Single sample mass	
Initial sample mass	1605 g
Moisture content	11.7 %
Dry mass	1437.0 g
Mass retained on 20mm sieve	g 23.6 %

MCV 10.8 Natural

Total number of blows n	Penetration or protrusion mm	Change in penetration n to 4n mm
1	66.6	13.2
2	59.6	12.6
3	55.8	12.1
4	53.4	11.6
6	49.4	9.7
8	47.0	7.7
12	43.7	4.8
16	41.8	3.1
24	39.7	
32	39.3	
48	38.9	
64	38.7	
96		
128		
192		
256

The Moisture Content Value (MCV) testing on a single sample yielded a result of 10.80 for the cohesive deposits in TP12 at 2.0m BGL indicative of a stiff cohesive deposit. TP15 at 2.0m BLG had a MCV relationship test carried out, which indicates a good MCV of 13.1 reducing to below 7 at a moisture content in excess of 17%. MCV results of 7% to 8% are considered marginal while MCV results of 8 or higher are considered acceptable.

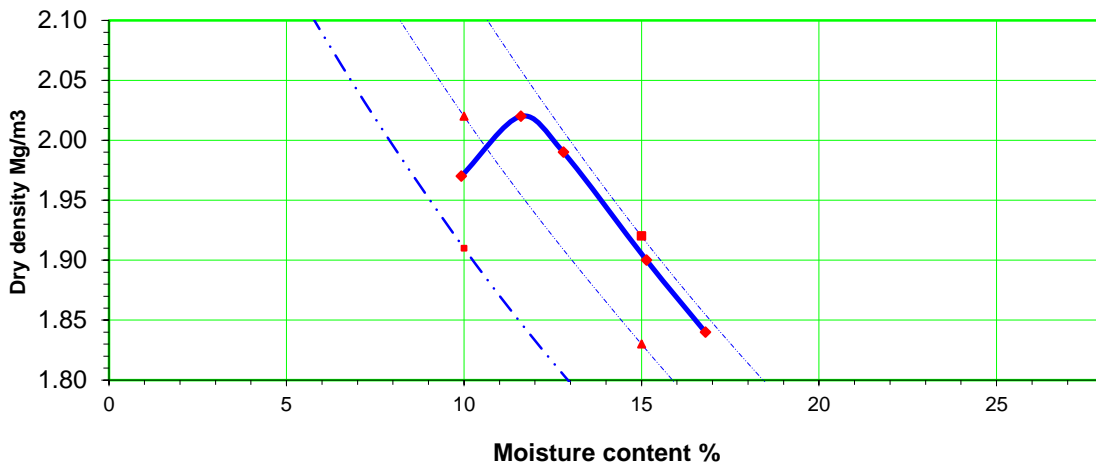
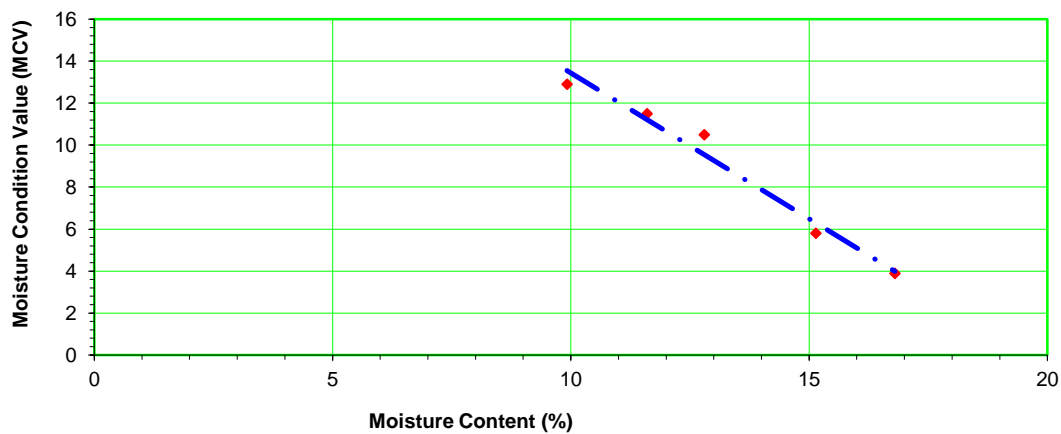
# Determination of dry density / moisture content relationship

Optimum Moisture Content 11.6 %

Moisture Content %	Dry Density Mg/m3	MCV
9.92	1.97	12.90
11.60	2.02	11.50
12.80	1.99	10.50
15.14	1.90	5.80
16.80	1.84	3.90

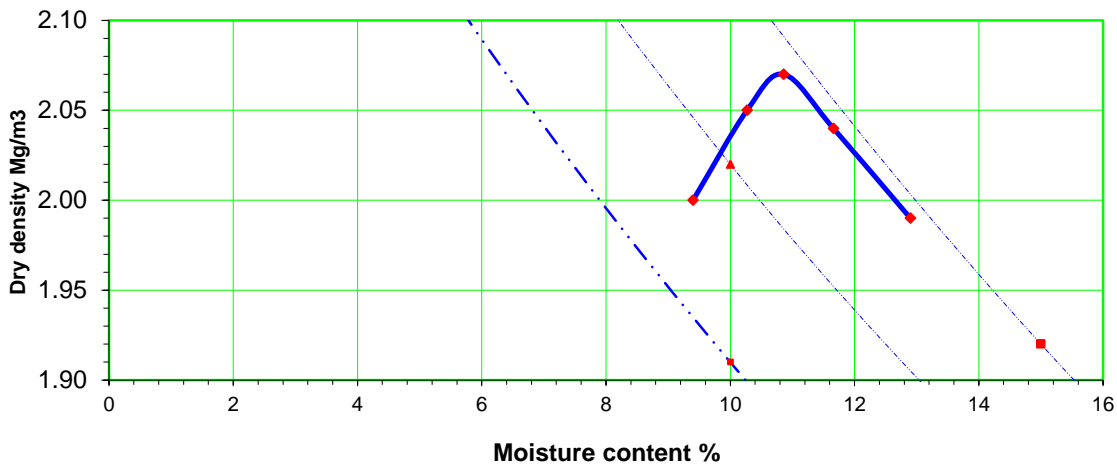
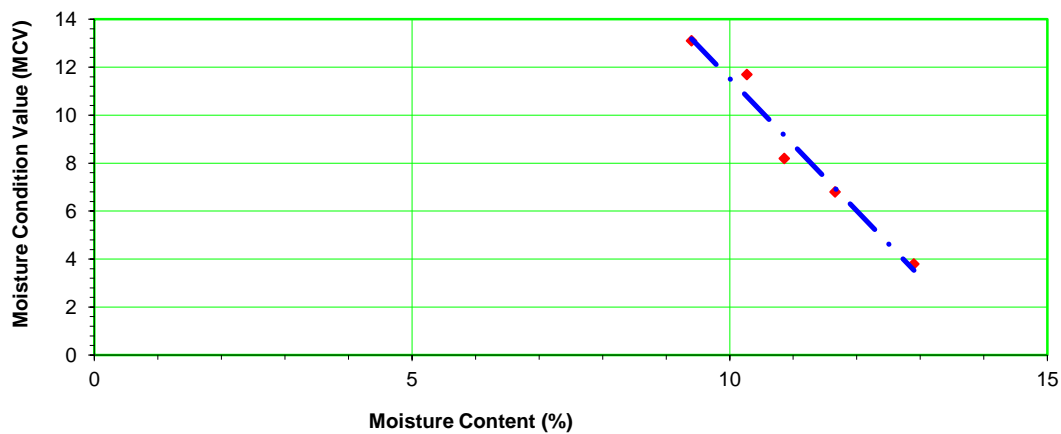
**Determination of dry density / moisture content relationship**  
**BS 1377: Part 4: 1990 : Clause 3.4**

NM  TL  Ltd		Project: Scart Mountain-Broemountain				Job No		NMTL3686			
						Trial Pit No.		TP25			
						Sample No.		B			
Operator Dk		Checked Nc		Approved Bc		14/12/2023		Depth		2.00m

Soil description: **Brown/red slightly sandy slightly gravelly SILT/CLAY.**  
 Optimum Moisture Content 10.9 %  
 Maximum Dry density 2.05 Mg/m3

Moisture Content %	Dry Density Mg/m3	MCV
9.40	2.00	13.10
10.27	2.05	11.70
10.86	2.07	8.20
11.66	2.04	6.80
12.90	1.99	3.80
