FuturEnergy Ireland
Scart Mountain Wind Farm
Aquatic Ecology Survey Report

Document Control Sheet	
Document Reference	11303_ Aquatic Ecology Survey Report
Client:	FuturEnergy Ireland
Project Reference	11303

Title: **Figure 2-1: Watercourses and Aquatic Survey Sites within the Study Area of the Proposed Development**

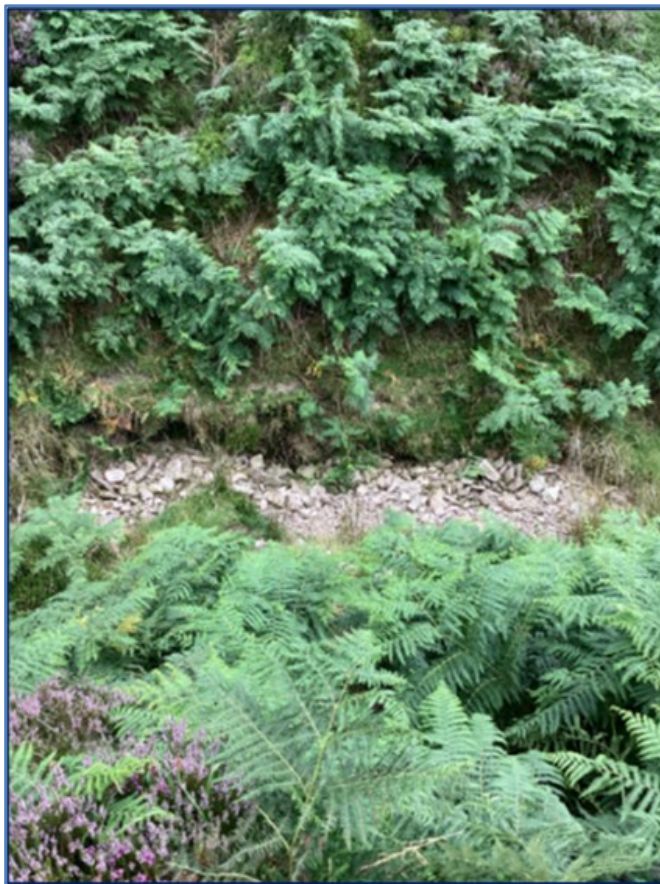
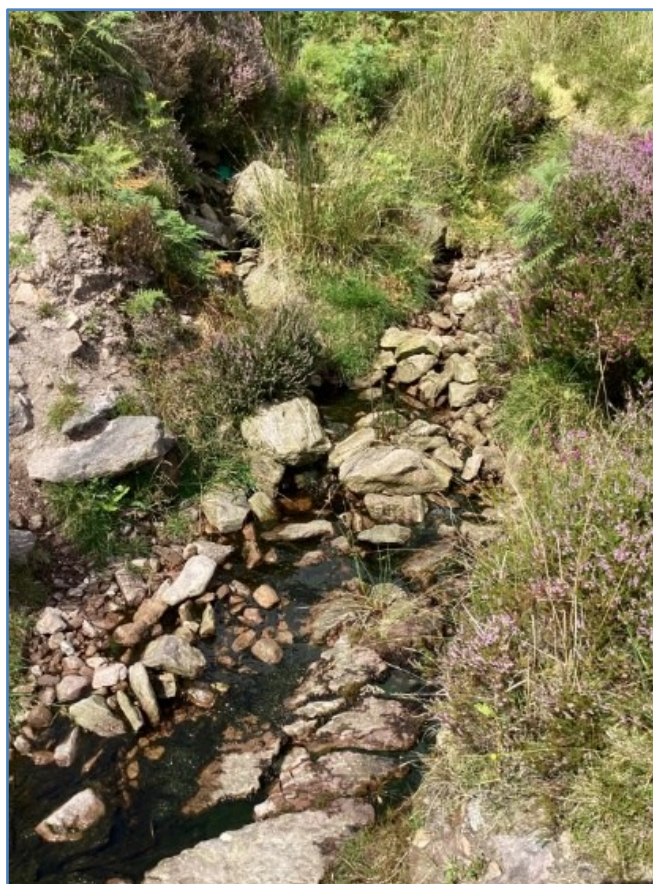
Plate C- 1: Site 1 on the Left, Dried Out, Site 2 on the Right, Heavy Presence of Filamentous Algae.

Site 2 showed evidence of enrichment from forestry and animals due to the presence of algae. The water was also slightly peat stained. The water quality at this site was of poor quality reflected by the dominance of Chironomids present in the sample, these represent Class C moderately pollution tolerant species. Overall, Site 2 scored an SSRS rating of 8.8 indicating it is not at risk of failing to achieve the 'good' water quality status goals of the WFD. Site 2 is evaluated as Q3, indicating moderately polluted water.

Site 1-4, located on the Glennafallia_010 northwest of the site. Water levels were very low due to recent high temperatures. Site 1 was completely dry due to the recent heat wave and therefore no sampling was undertaken at this site. At site 2, there was evidence of enrichment from forestry and animals due to the presence of algae. The water was also slightly peat stained. The water quality was poor and reflected by the dominance of Chironomids present in the sample, these represent Class C moderately pollution tolerant species. There was one species of stonefly present, *Leuctra* sp. Which is a Class A species. Overall, this site scored an SSRS rating of 8.8 indicating it is not at risk. The results indicate to represent a Q3, indicating moderately polluted water.

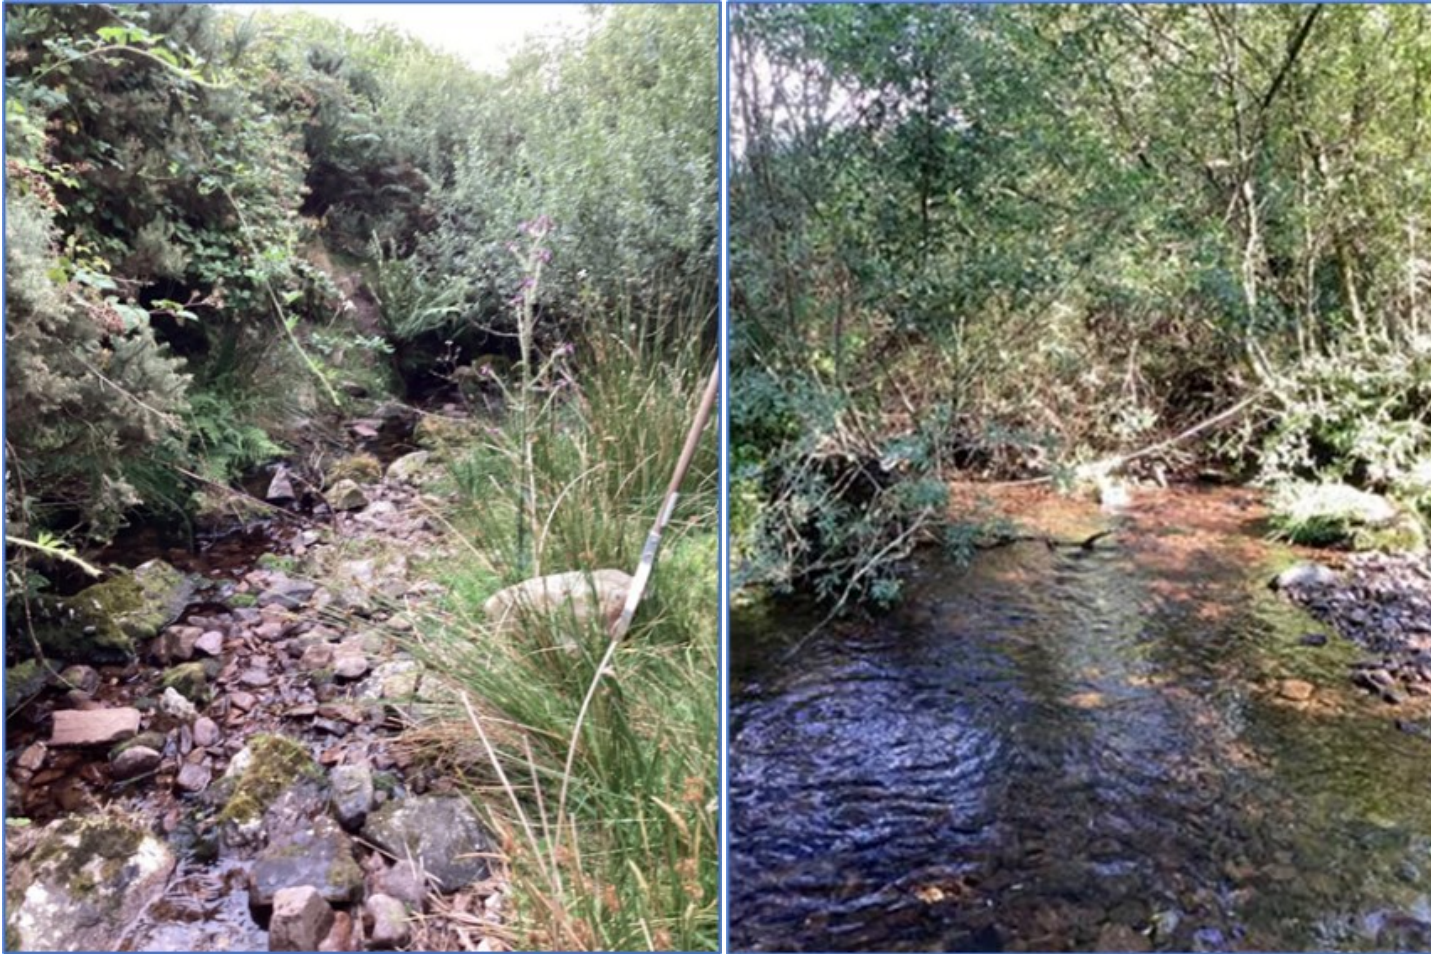
Plate C- 2: Site 3, on the Left, a 1st Order Stream and Site 4, on the Right, a 2nd Order Stream. These Run South of the Site, Outside of the Proposed Project.

The furthest upstream sample on this river was Site 3. The composition of this sample had low numbers of pollution intolerant class A and B invertebrates and a dominance of class C invertebrates (more pollution tolerant). The class A invertebrates included, one stonefly species, a single specimen of *Nemurella picteti*. The more pollution tolerant class C was found in higher numbers, including Mayfly species *Caenis luctuosa*, caddis fly species *Rhyacophila dorsalis*, *Philopotamus montanus* and *Odontoceium albicorne* and one species of Elmidae and *Gammarus pulex*. The dominance of Class C species within the sample indicates the sample is representative of Q3-Q4 slightly polluted site. This site scored an SSRS rating of 6.4 indicating it is at risk.

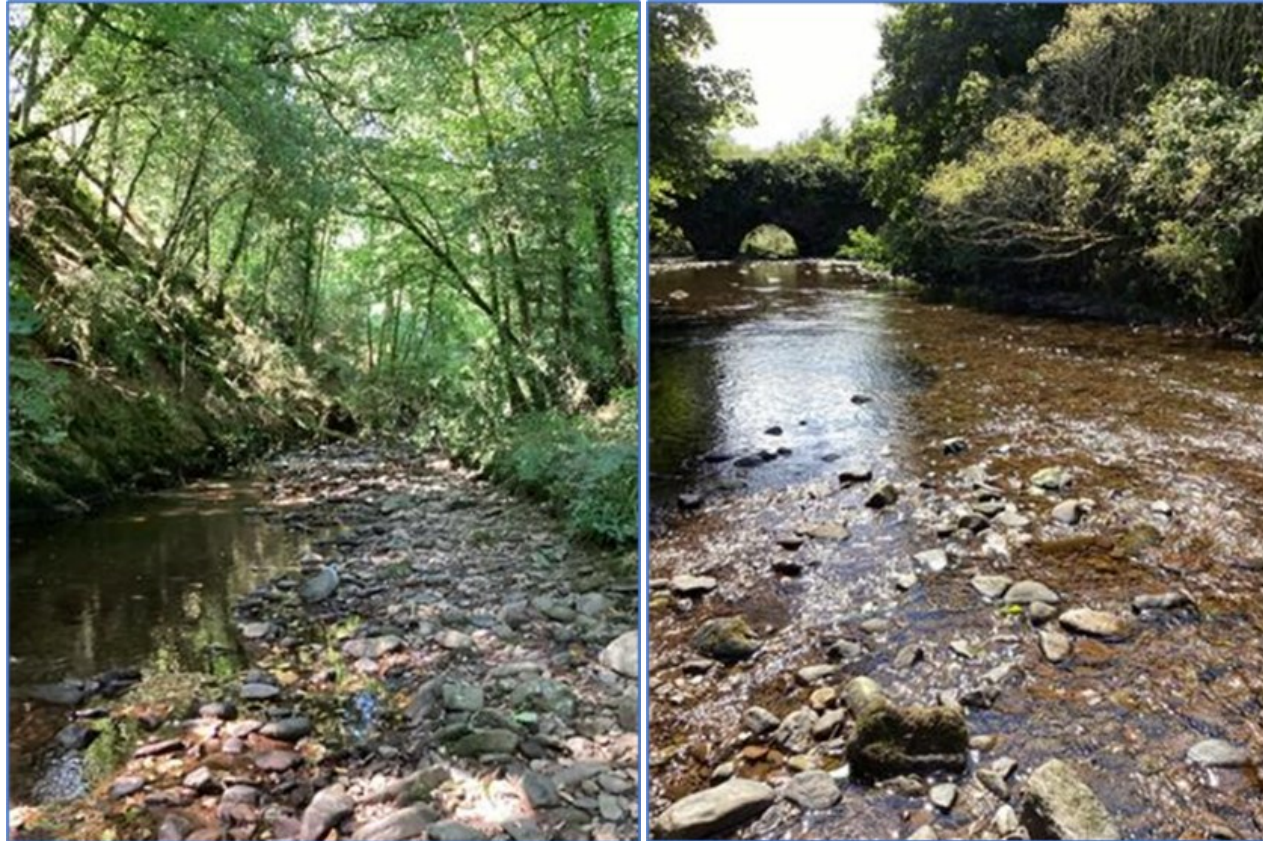
Plate C- 3: Site 6, on the Left and Site 7 on the Right. These 3rd Order Rivers Contain Nursery Habitat for Salmonid Parr and Holding Pools Suitable for Young Salmonids.

There was spawning gravels and holding pools present in some of the watercourses surveyed which also providing limited salmonid nursery habitat, namely Site 6, 7, 15 and 18. The fast-flowing high gradient nature of watercourses in the study area provided unsuitable conditions for lamprey larvae, which require soft substrates into which they can burrow.

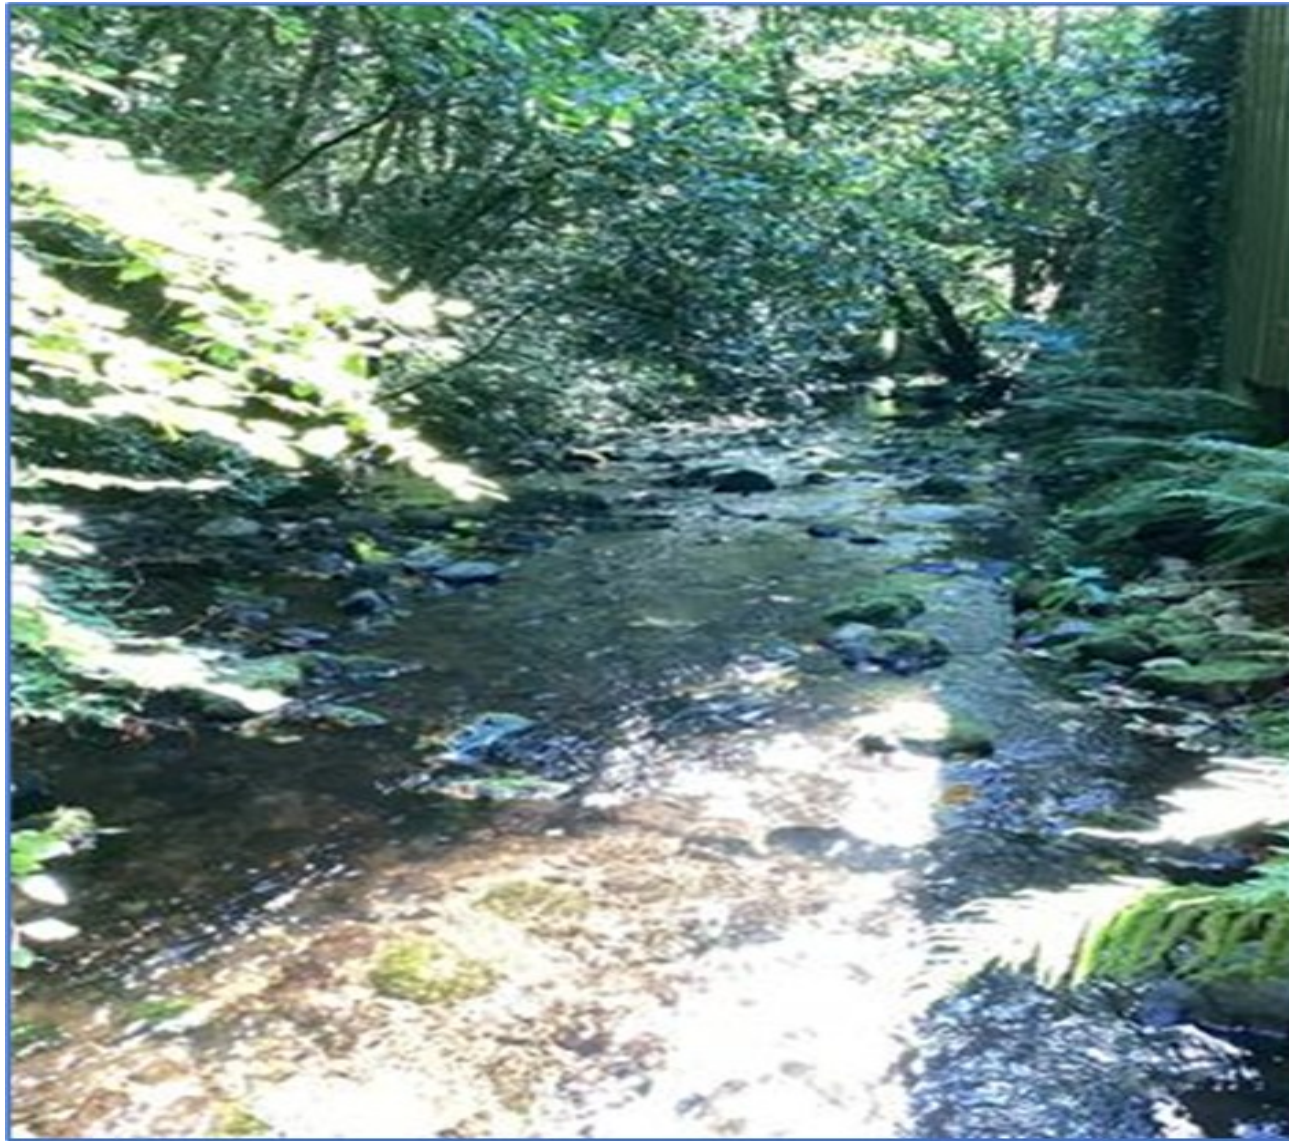
Plate C- 1: Site 5 on the Monavugga River Containing Spawning Gravels.

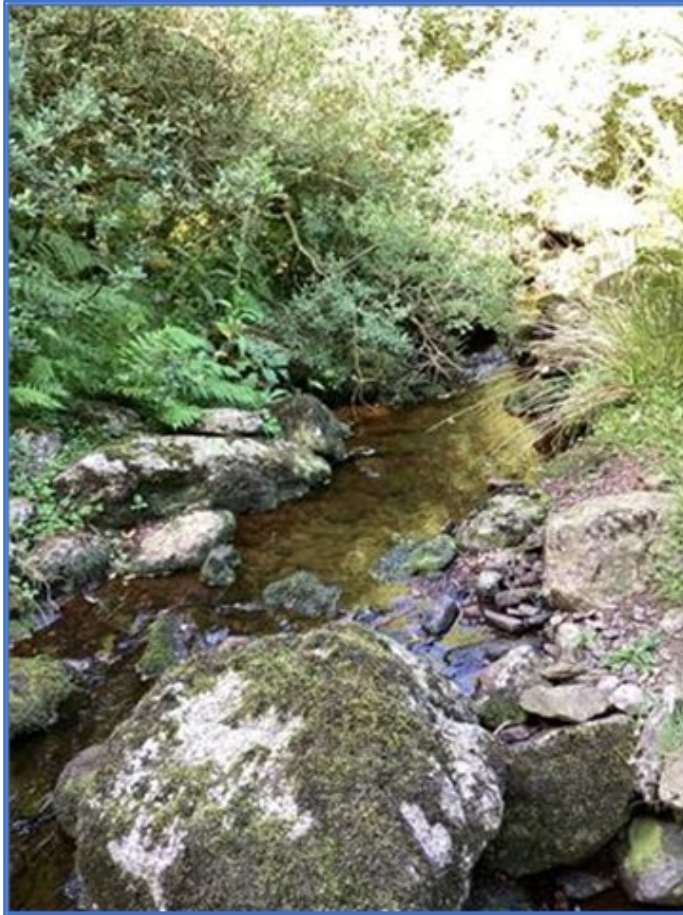
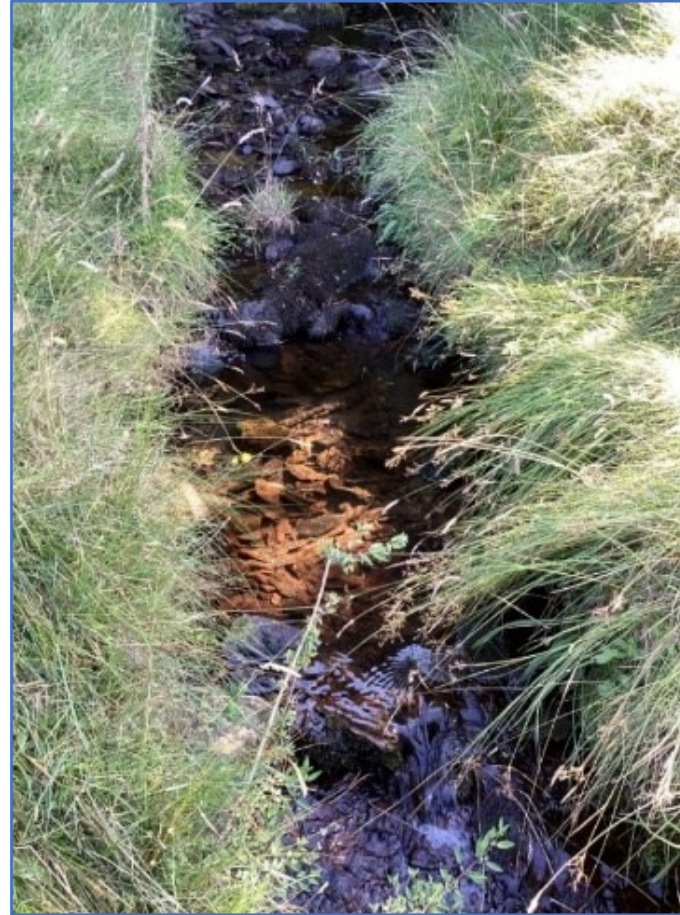
Plate C- 2: Site 8, a 1st Order Stream Containing Shallow Holding Pools for Trout on the Left and Site 9, a Narrow Straight 1st Order Stream With Limited Spawning Gravels for Salmonids on the Right.

Site 8 sample contained invertebrate species of Class A and Class B and Class C category. During kick sampling at site 8, a young brown trout parr (4cm in length) was caught in the net (see **Error! Reference source not found.**). The biological water quality evaluation for Site 8 is Q4 unpolluted site. This site scored an SSRS rating of 8 indicating it is probably not at risk.

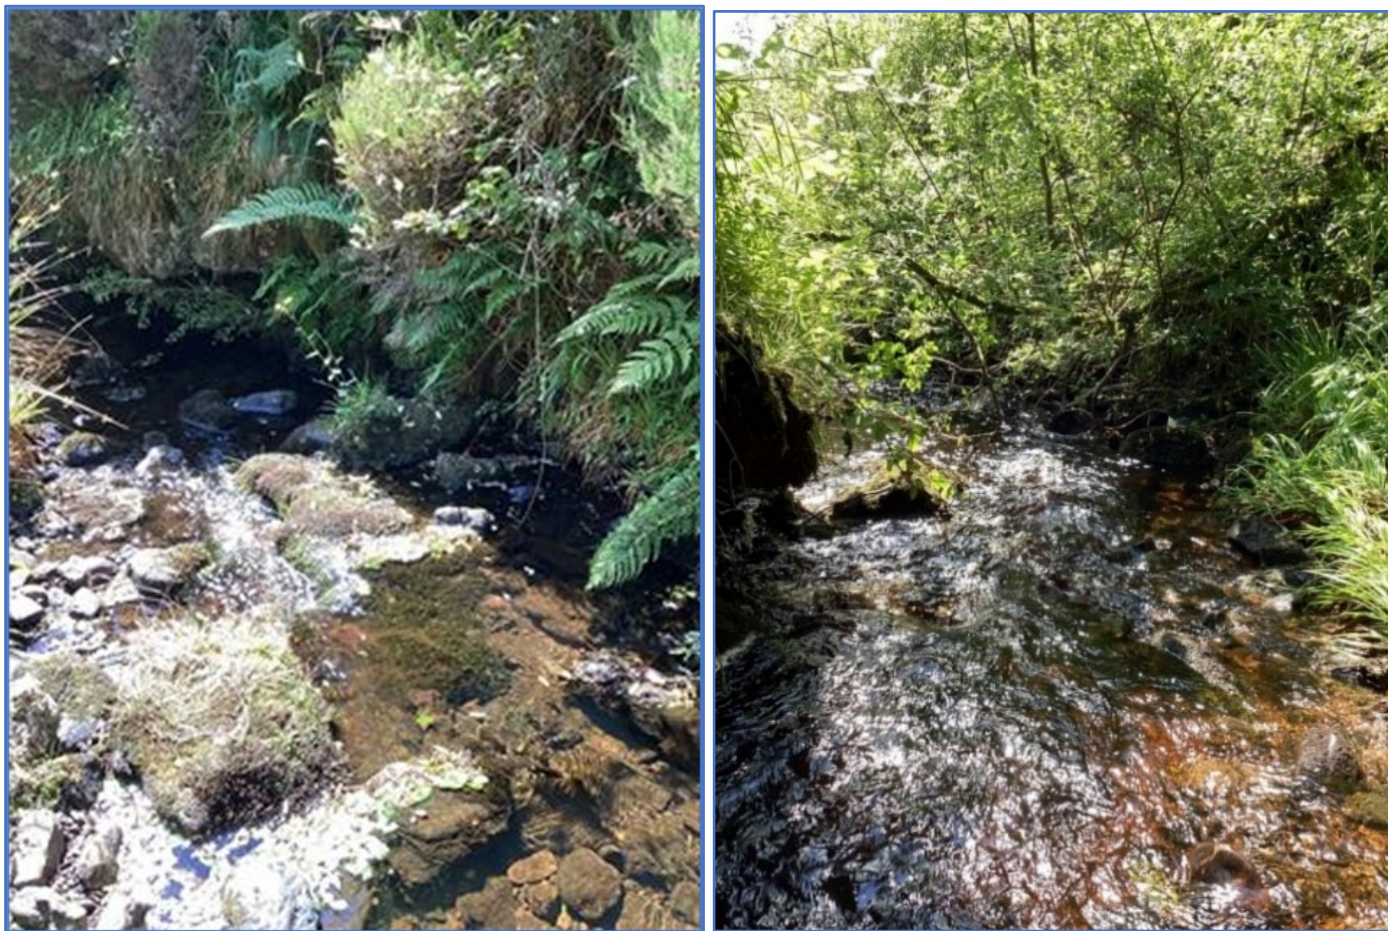
Plate C- 3: Site 10 and Site 19 on the Glenshelane River, a Fast Steep Gradient 2nd Order Stream Dominated by Boulders.

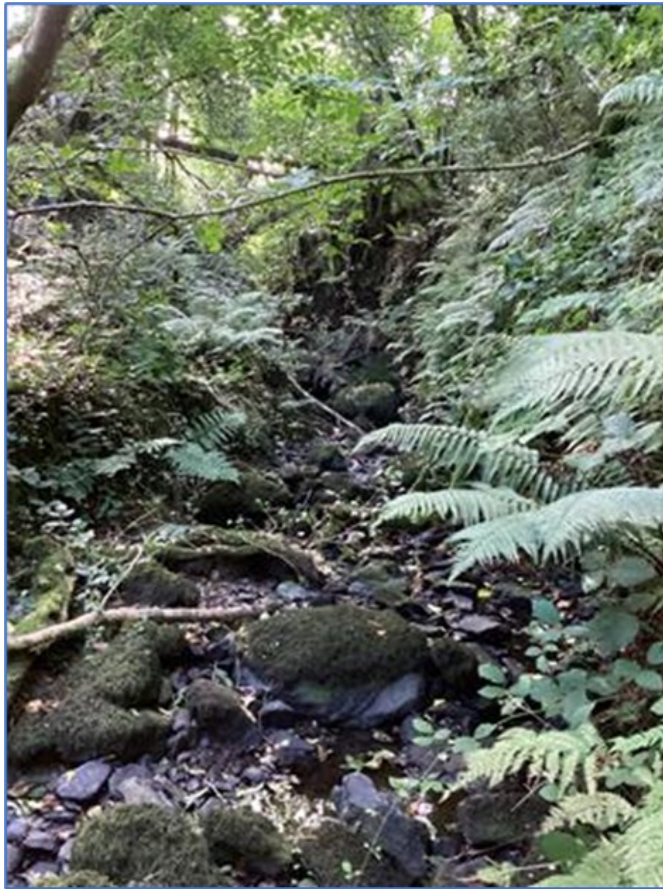
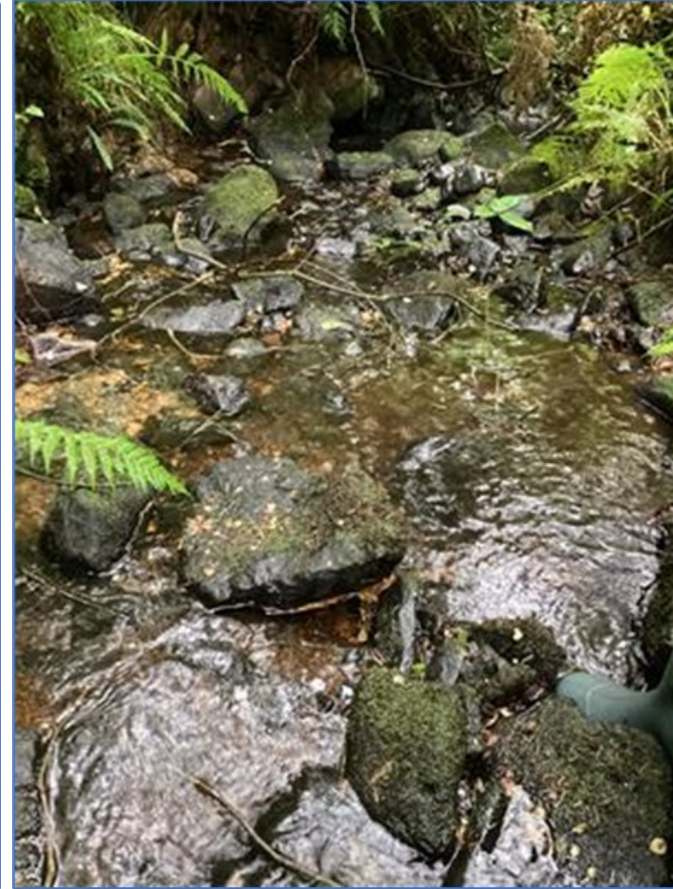
Plate C- 4: Site 11 on the Left, a Tributary of the Glenshelane River That is Prone to Drying Out and Site 12 on the Right, With Limited Spawning Habitat Present for Salmonids.

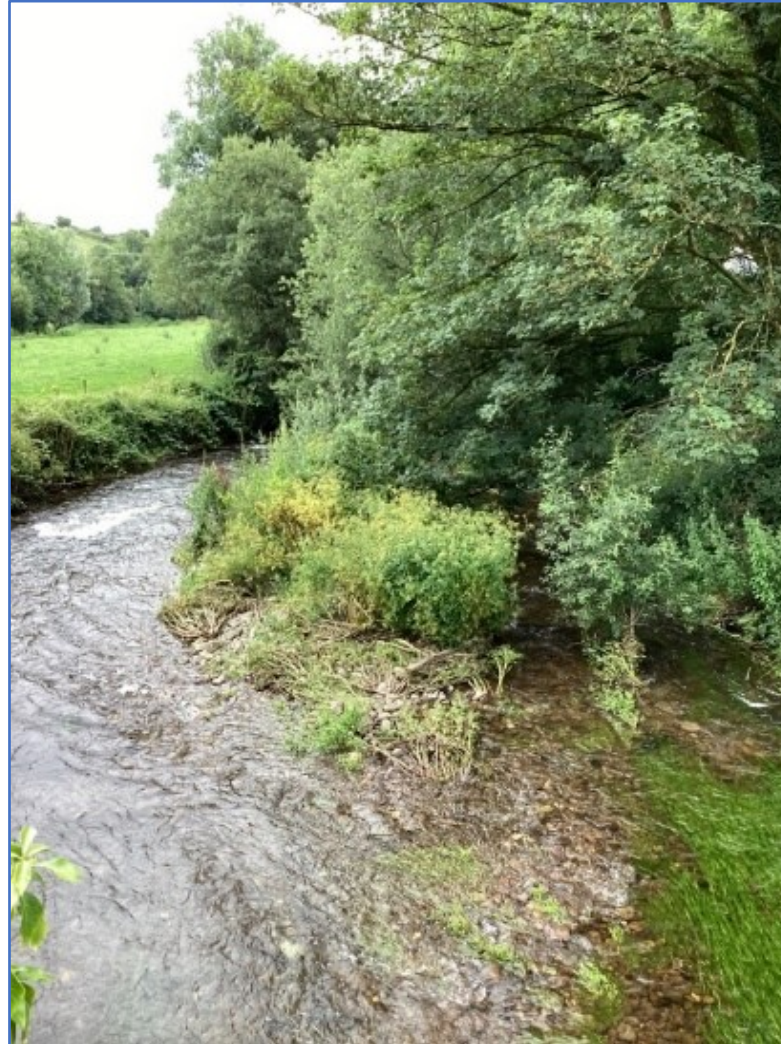
Plate C- 5: Site 21, Located Outside the Proposed Project, This 3rd Order River Contains Ideal Spawning and Nursery Habitat for Salmonids and Spawning and Silt Habitat for Lamprey.

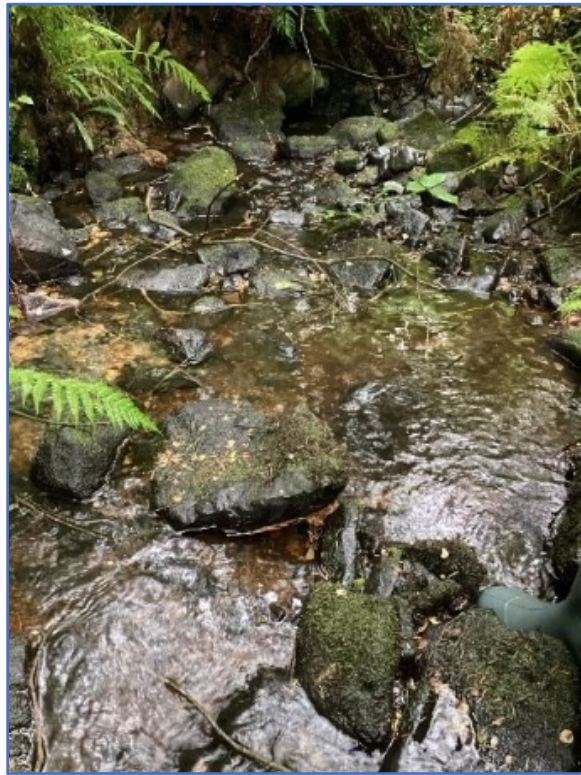
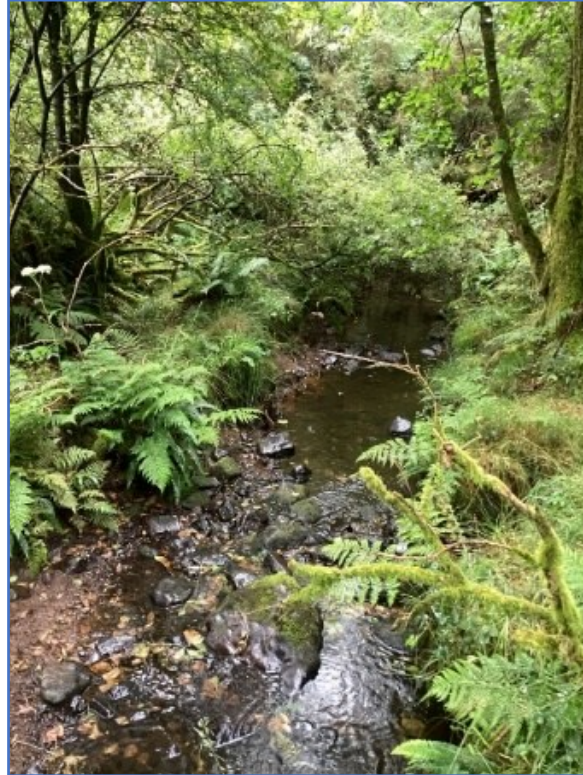
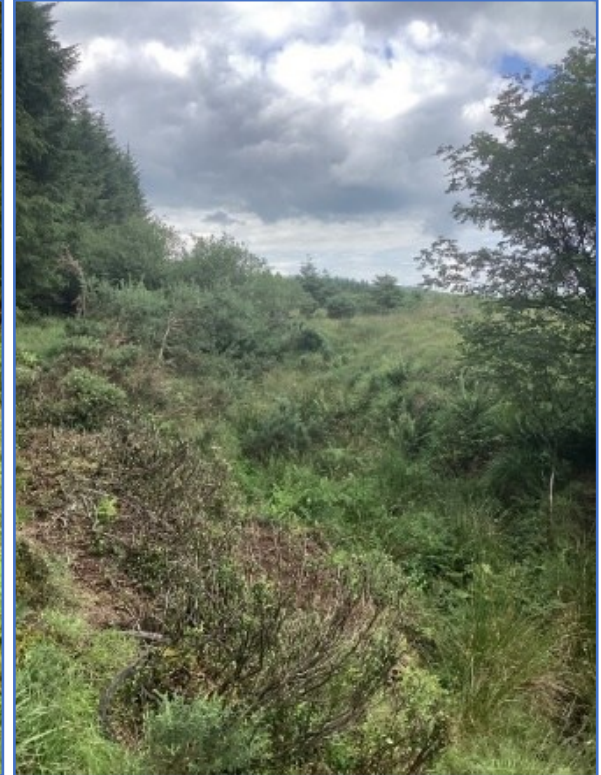
Plate C- 6: First Order Streams at Site 13, 14 and 22 on the Finisk River, Flowing on the Boundary of a Sitka Plantation.

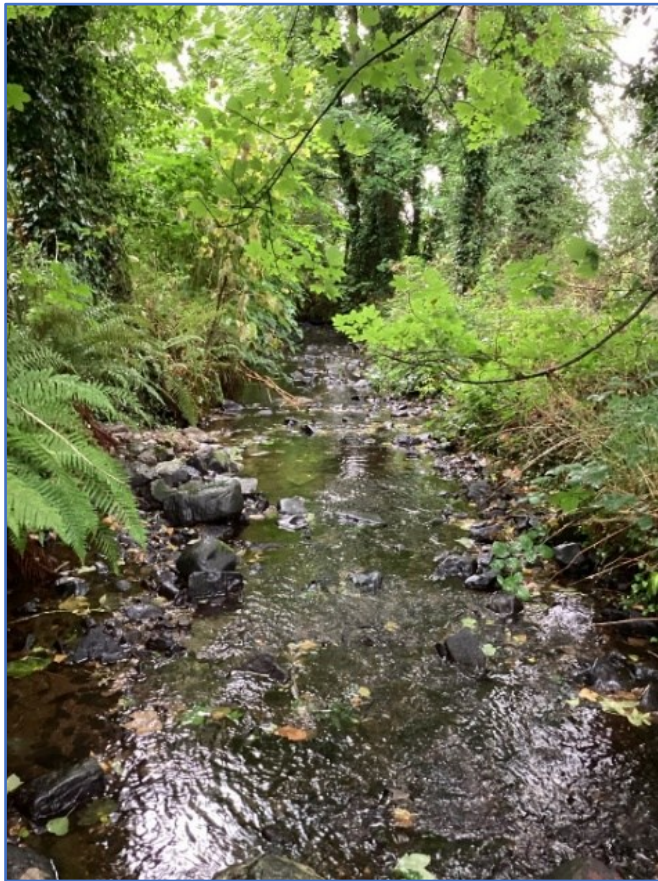
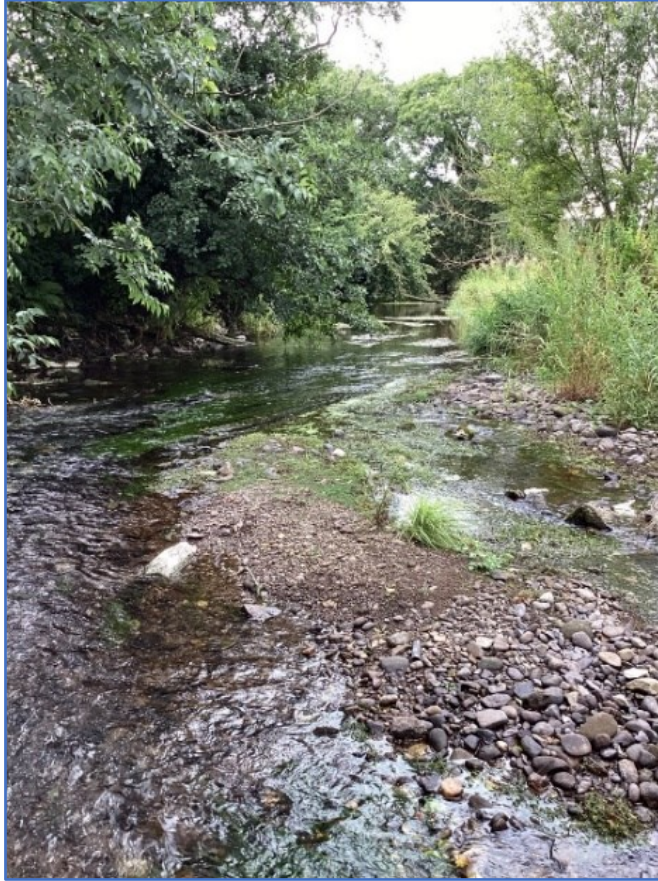
Plate C- 7: Salmonid Spawning and Nursery Habitat Present at Site 15, on the Left and Site 18 on the Right of the Finisk River Downstream of the Proposed Project

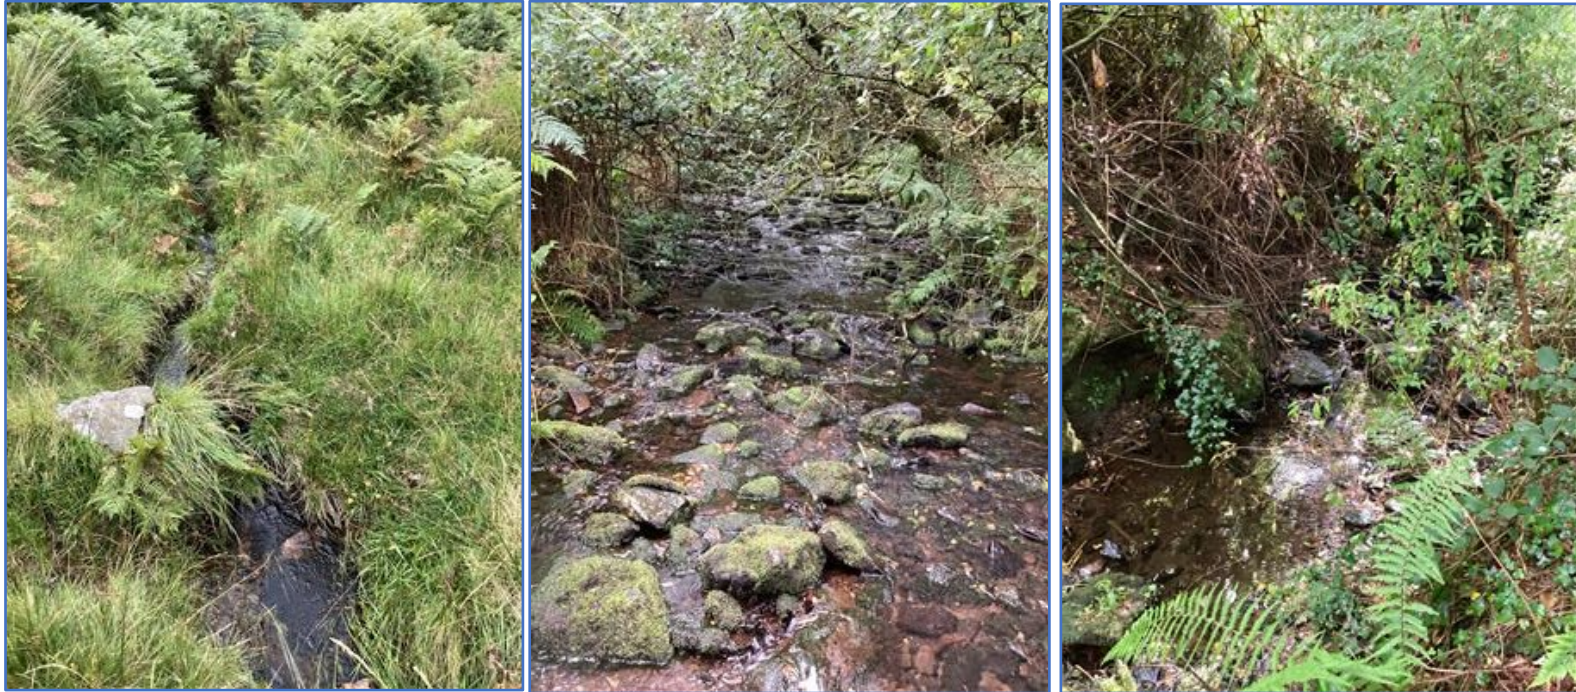
Plate C- 8: Site 20 on the Left is a peat stained 1st Order Stream Lacking Salmonid Habitat. Site 16, Centre, is a Fast-Flowing 2nd Order Stream Containing Adequate Salmonid Spawning Habitat. Site 17, Right, Lacking Holding Habitat for Fish.

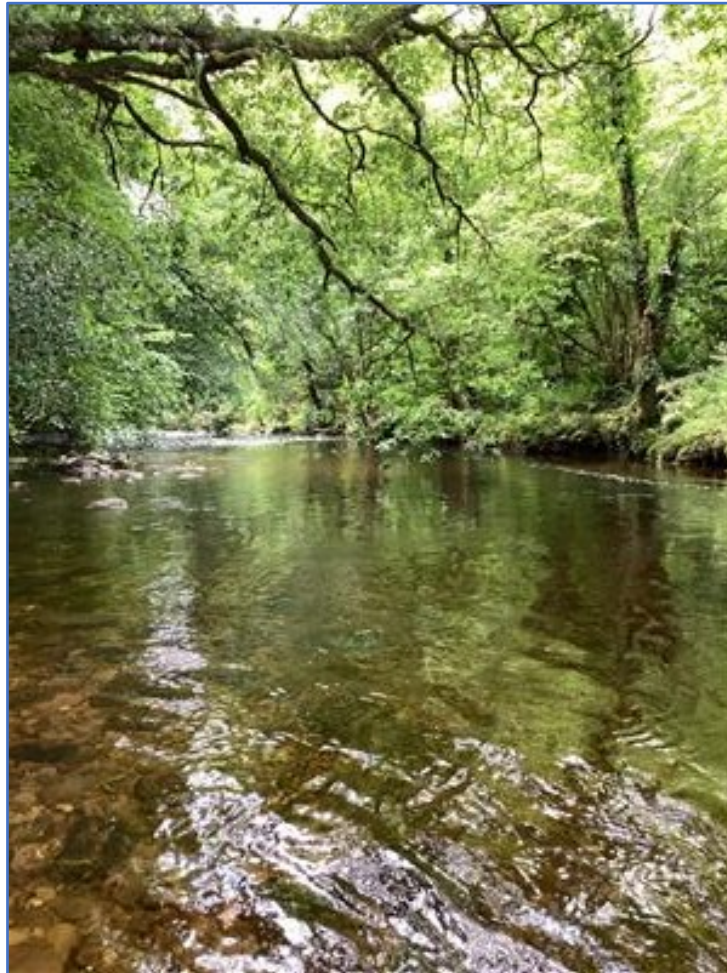
Plate C- 9: The Colligan River, Sampled at Site 23. This 4th Order River Contained Ideal Spawning and Nursery Habitat for Salmonids.

Site 23 is located on the Colligan River, where the proposed directional drilling will take place for the proposed GCR. This river contained heterogeneous fluvial habitat and provides ideal rearing conditions for salmonids and is known to be a very good sea trout river. There was no evidence of pollution and the water was very clean at the time of surveying. Its substrate is

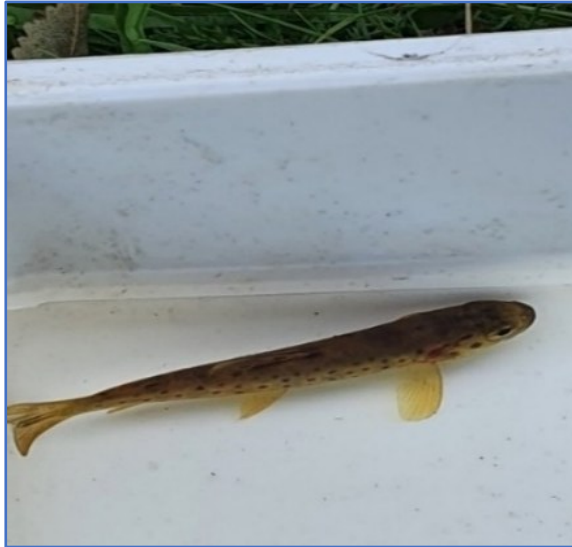
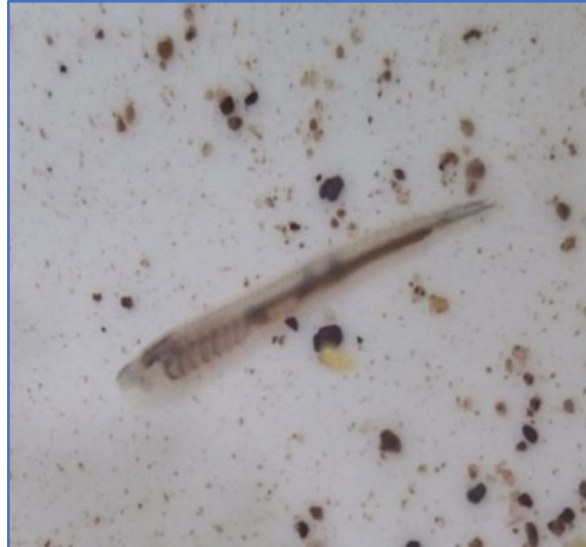
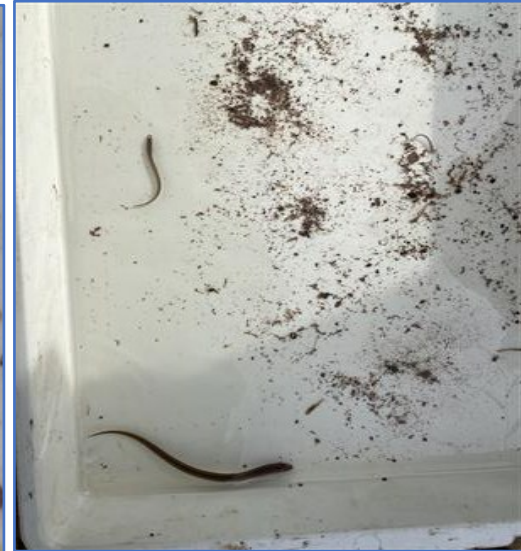
Plate C- 10: Brown Trout Parr Recorded at Site 8 on the Glenshelane River, (Left Photo). Lamprey Ammocetes Recorded at Site 18, (Centre Photo), and Site 21 on the Finisk River, (Right Photo).

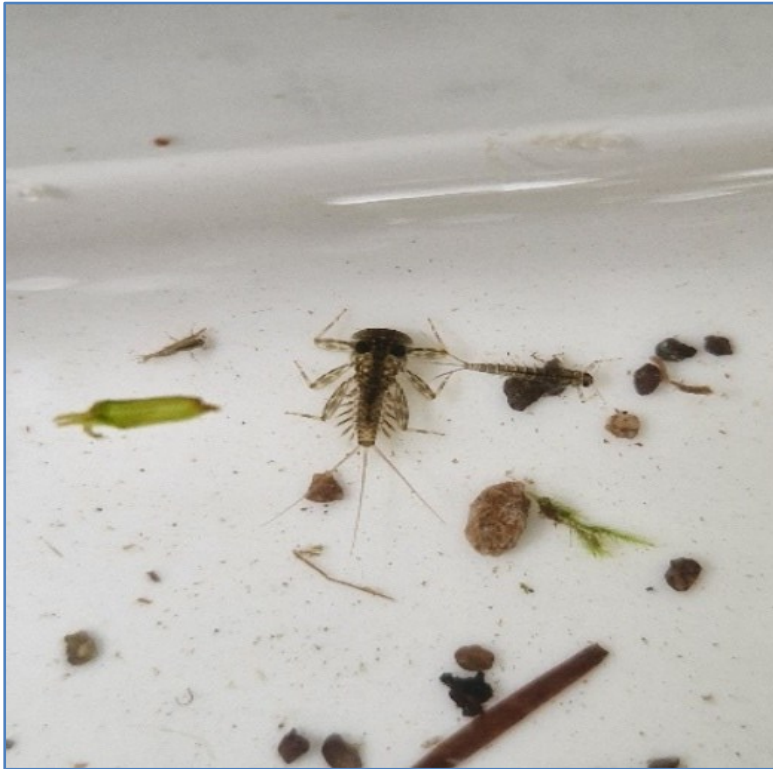
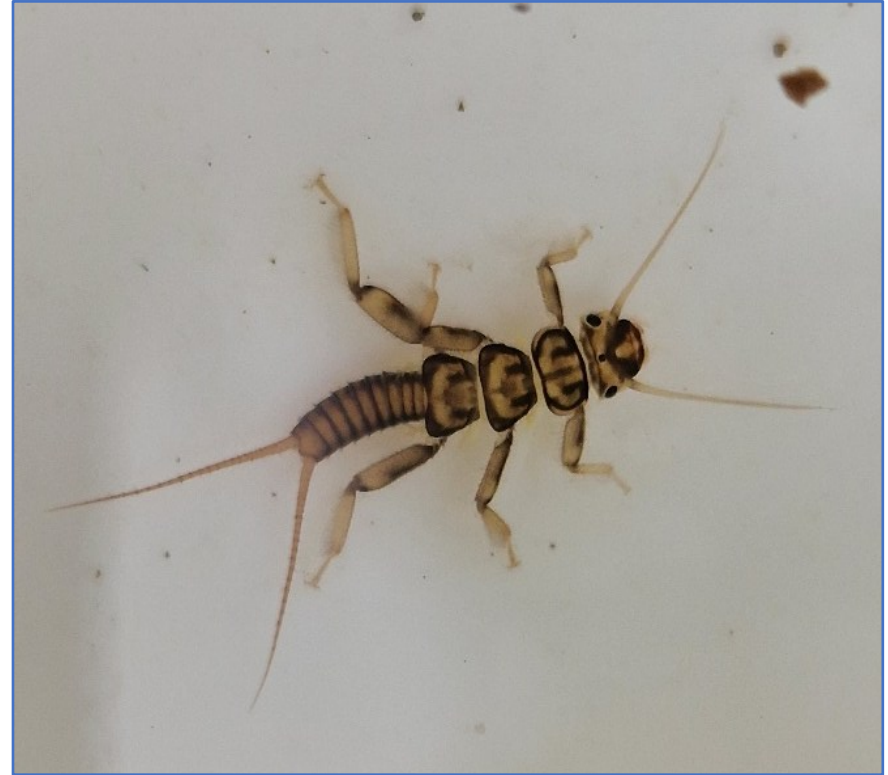
Plate D- 1: Larva of the Ephemeroptera / mayfly *Ecdyonurus* sp. at Site 4 on the Glennafallia River (Left Photo). Larva of the Stonefly (Plecoptera) *Perla bipunctate* at Site 21 on the Finisk River (Right Photo).
