# **APPENDIX 10.1**

## **NRA CRITERIA FOR RATING THE MAGNITUDE AND SIGNIFICANCE OF IMPACTS AT EIA STAGE**

### **VOLUME III**

#### **APPENDICES TO ENVIRONMENTAL IMPACT ASSESSMENT REPORT**

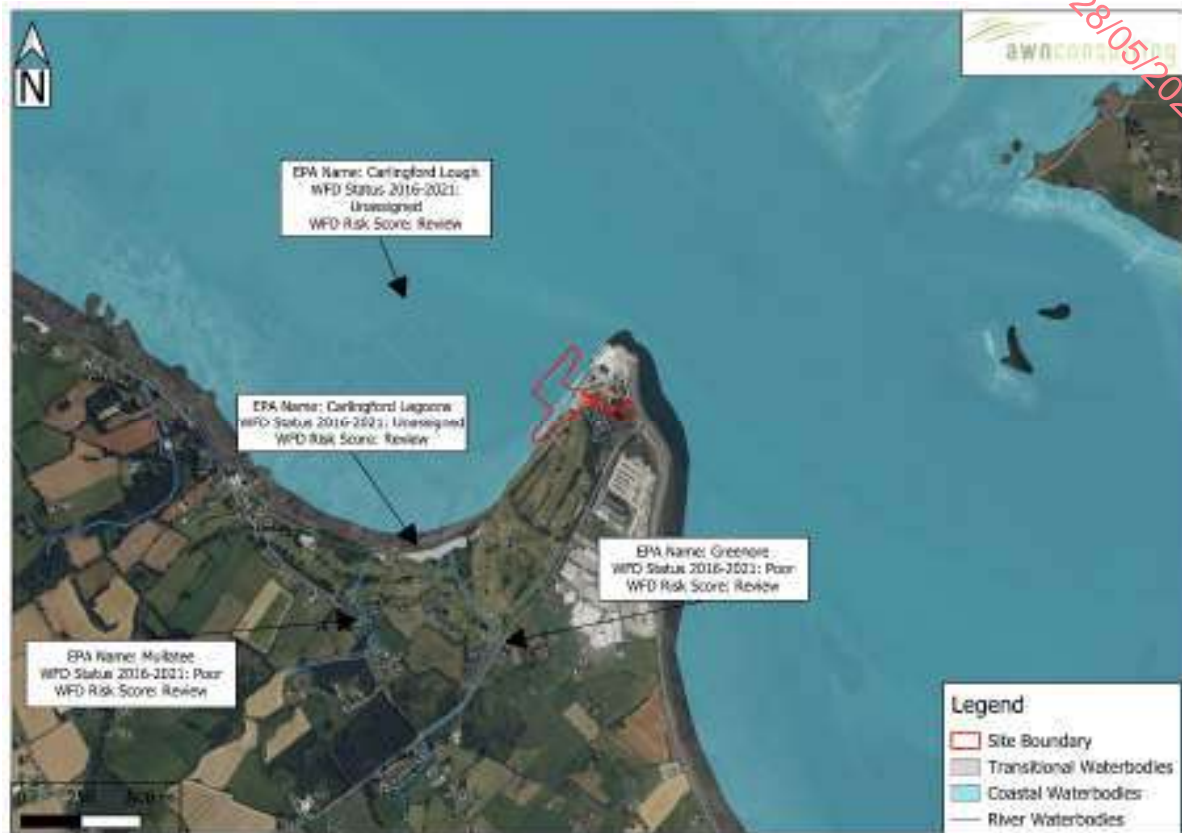
**Figure 1.1** Site Location with Hydrological Environment

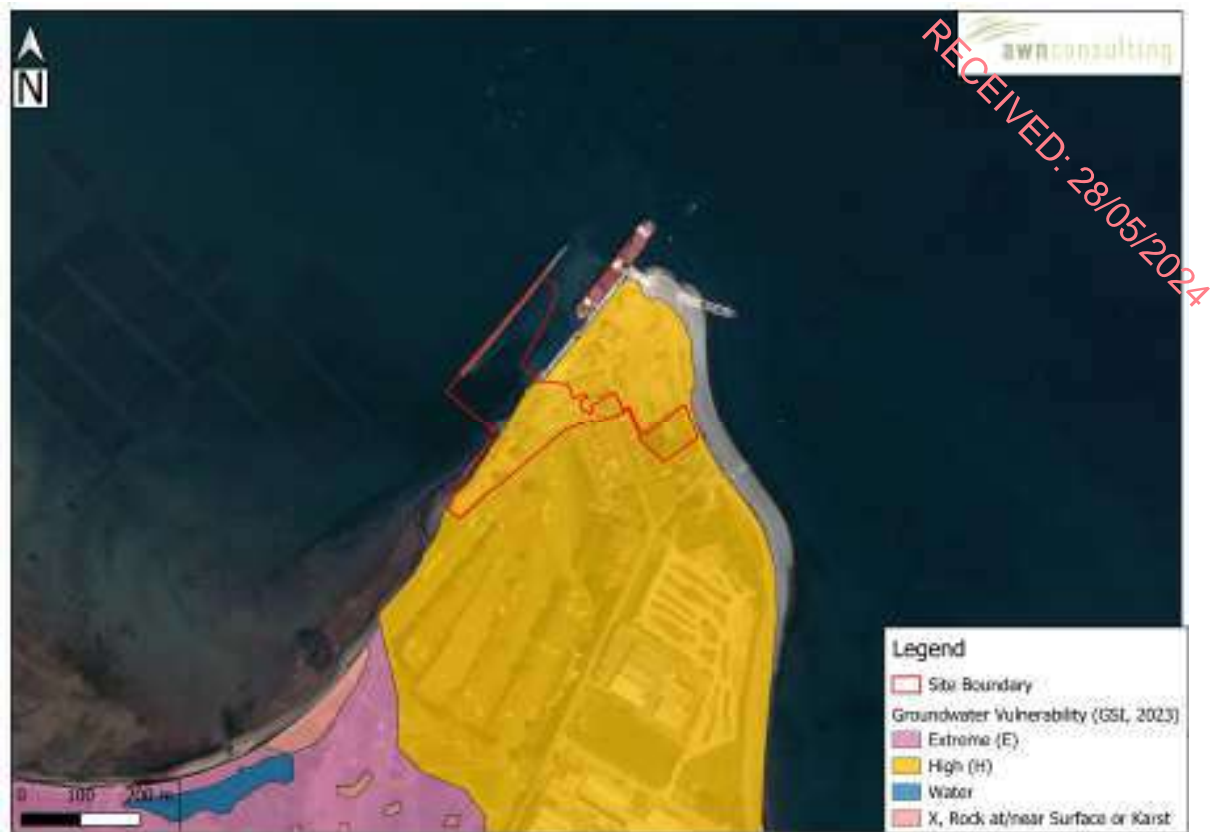
**Figure 2.1**      *Aquifer Vulnerability*

Aquifer vulnerability is a term used to represent the intrinsic geological and hydrological characteristics that determine the ease with which groundwater may be contaminated generally by human activities. The GSI (2023) guidance presently classifies the bedrock aquifer in the region of the subject site as having '*High*' vulnerability which indicates a general overburden depth potential greater than 3m, suggesting a moderate to good natural protection of the aquifer by high permeability marine gravel and sands. The aquifer vulnerability class in the region of the site is presented as Figure 2.1 below.

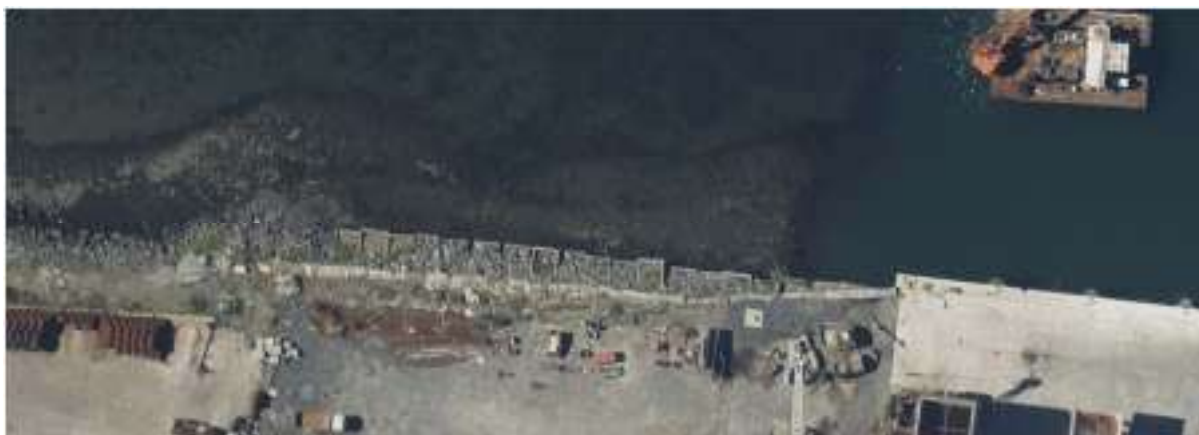
Figure 6 Coast land showing caissons

The coastal port development area is a narrow strip of land approximately 150 metres by 5 metres consisting of recently developed quay wall, older concrete caissons, a pitched sea wall made of cut limestone cobbles. Over time topsoil has arrived windblown and stemming from decayed coastal vegetation. They have also been partially infilled with clean stone. The following species have been observed in small patches or as one or two specimens in and along the edge of the caisson area, particularly where decaying nitrogenous vegetation slips in cracks and crevices along the track and stone bank and give opportunity: *Plantago maritima*, *Beta vulgaris*, *Aster tripolium*, *Malva sylvestris*, *Matricaria discoidea*, *Cochlearia officinalis*, *Tripleurospermum maritimum*, *Senecio squalidus*, *Erysimum* sp and *Geranium robertianum* along with one example of *Reseda luteola*. *Crambe maritima*, *Suaeda maritima* and *Honkenya peploides* were absent. This habitat may therefore be classified as Sea Walls Piers & Jetties (CC1).

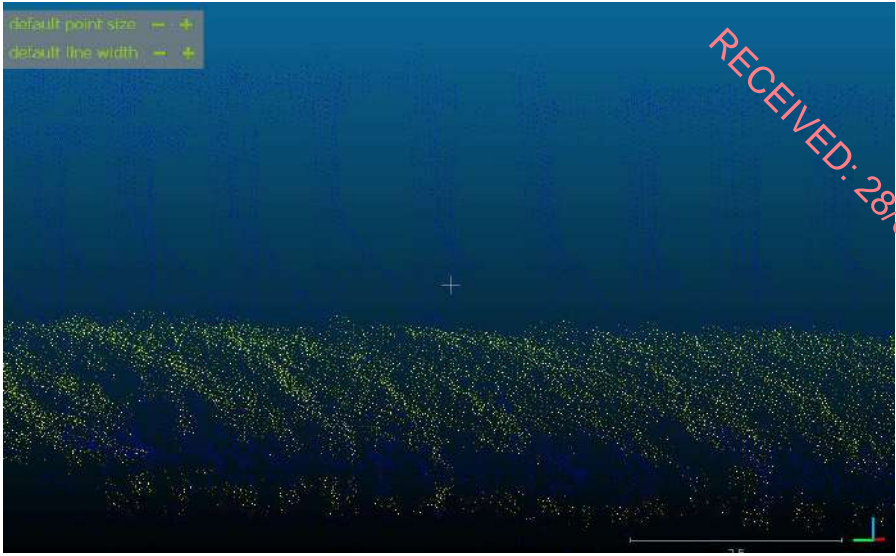
<p>Detail from point cloud showing close-up isometric view detail looking north along breakwater.</p>
<b>Proximity to development</b>	Within Greenore Port directly adjacent to O&M facility project area
<b>Likely Impacts</b>	Repair works to rock armour base of the breakwater feature may be required. Works may include addition of rock armour where there are gaps or localised settlement, and reconstruction or reinforcement of the toe.
<b>Recommended Mitigation</b>	<p>Avoid all impacts to the superstructure during design, construction, operation and decommissioning.</p> <p>Dredging design in vicinity will need to ensure that the breakwater is not undermined. Dredging should seek to retrieve fallen timbers from the superstructure.</p> <p>Consider rehabilitation of breakwater to celebrate the nineteenth-century origins of the Port.</p>

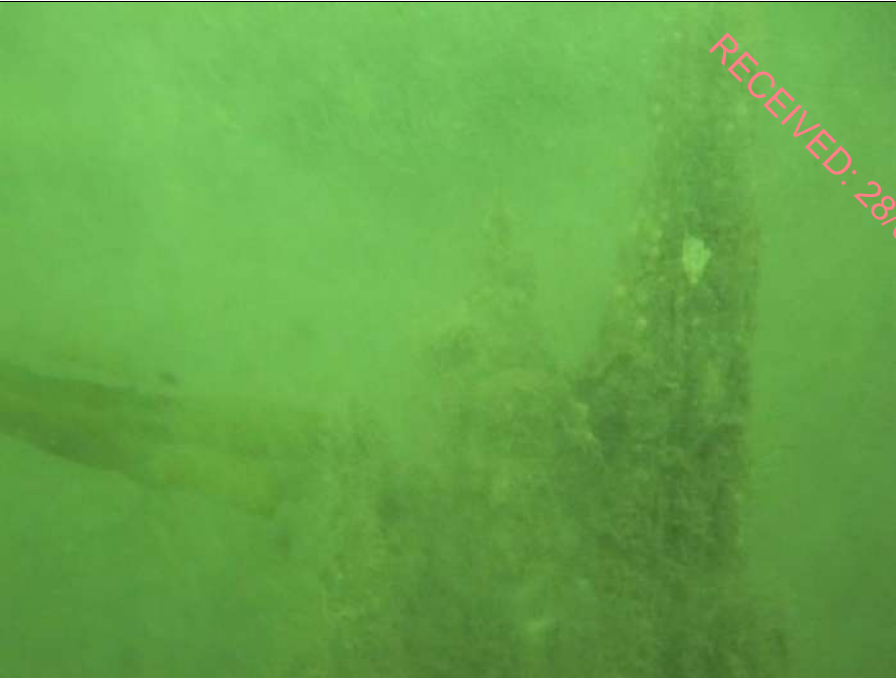
<p data-bbox="408 857 1307 913">View showing example of the eroded tips of timbers associated with the timber shuttering observed at the south end of Berth 2.</p>
<b>Proximity to development</b>	Within Greenore Port but outside O&M facility project area
<b>Likely Impacts</b>	None
<b>Recommended Mitigation</b>	None
