APPENDIX 10.1

NRA CRITERIA FOR RATING THE MAGNITUDE AND SIGNIFICANCE OF IMPACTS AT EIA STAGE

VOLUME III

APPENDICES TO ENVIRONMENTAL IMPACT ASSESSMENT REPORT

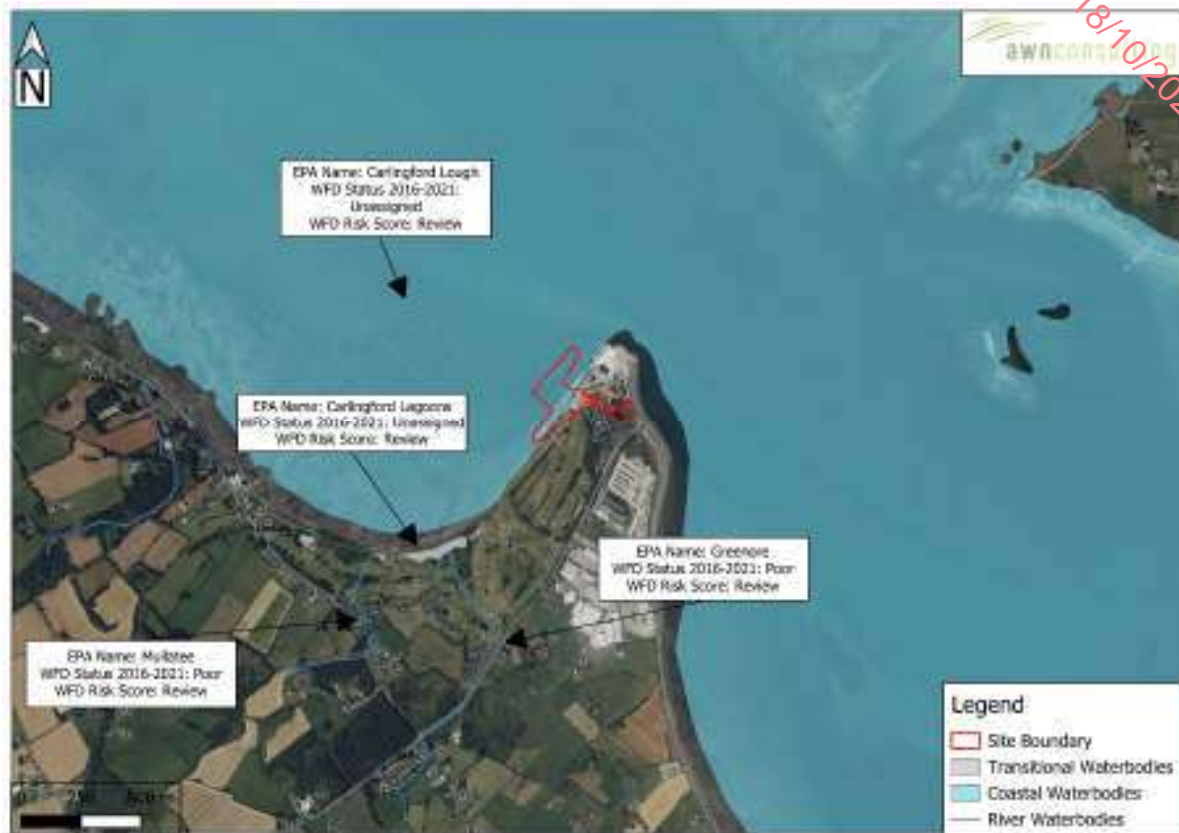
Figure 1.1 Site Location with Hydrological Environment

Currently, there is a direct hydrological linkage between the proposed development sites and these sites through the existing stormwater drainage network, which outfalls into the Carlingford Lough. In addition, foul water from the site is eventually treated in

Carlingford Lough hosts Natura 2000 Sites (refer to Figure 1.1 and Figure 1.2 below) and there is a direct spatial overlap with the SPA and SAC.

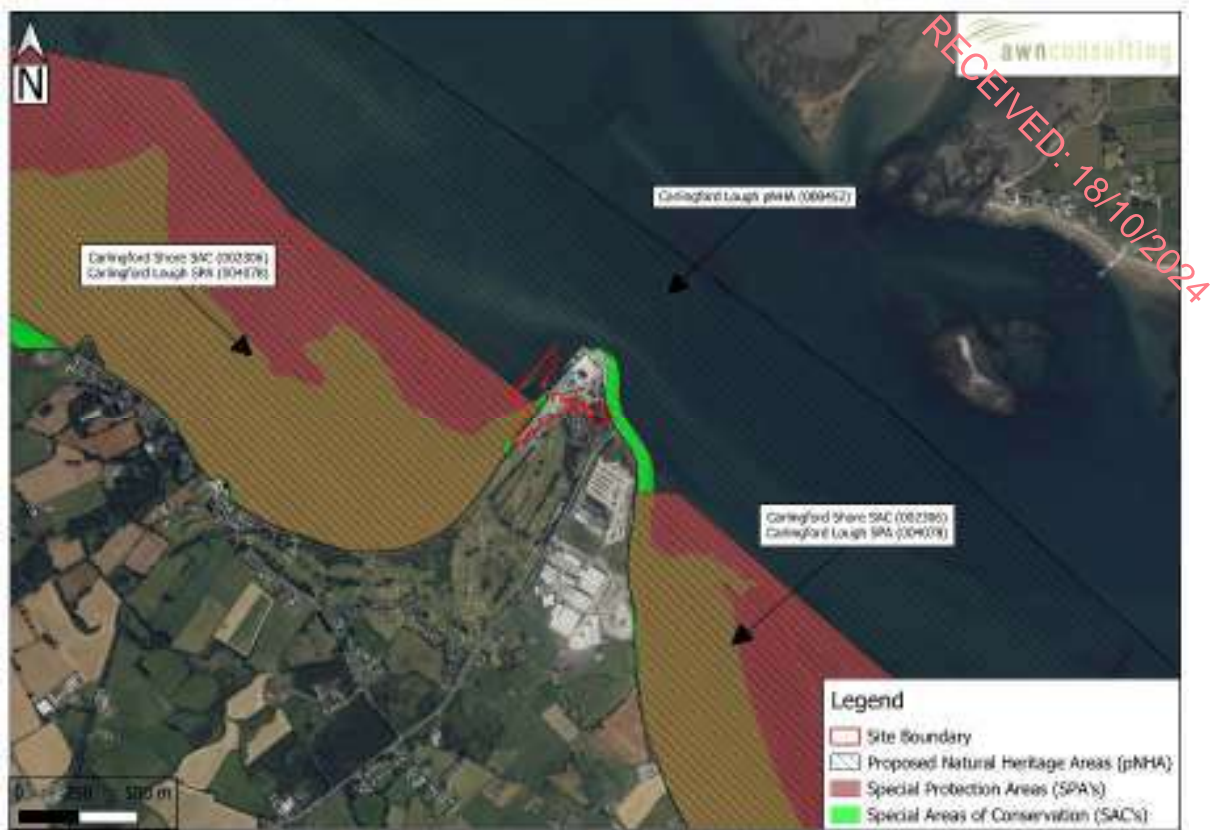
Figure 1.2 Site Location with Natura 2000 Sites

Dundalk WWTP, which in turn discharges into Dundalk Bay, which also hosts Natura 2000 sites (Dundalk Bay SAC/SPA).

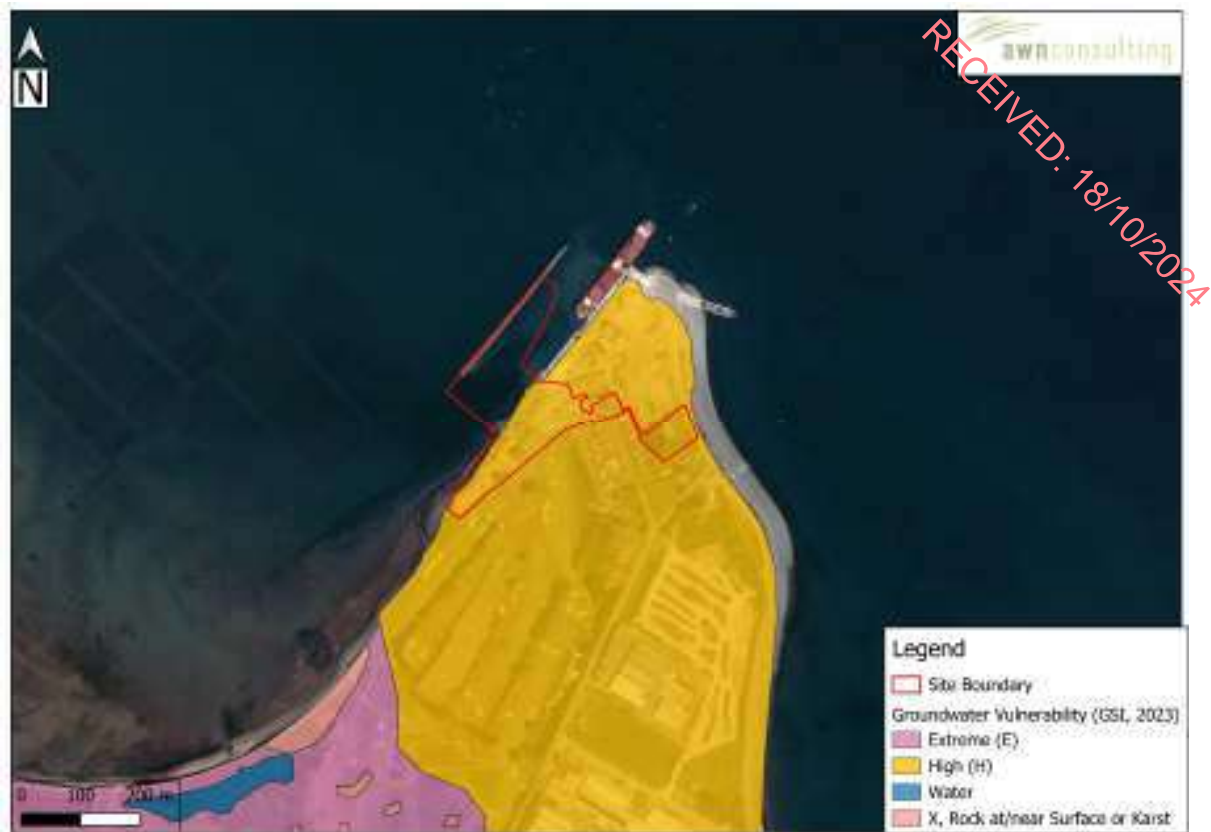
Figure 2.1 *Aquifer Vulnerability*

Aquifer vulnerability is a term used to represent the intrinsic geological and hydrological characteristics that determine the ease with which groundwater may be contaminated generally by human activities. The GSI (2023) guidance presently classifies the bedrock aquifer in the region of the subject site as having '*High*' vulnerability which indicates a general overburden depth potential greater than 3m, suggesting a moderate to good natural protection of the aquifer by high permeability marine gravel and sands. The aquifer vulnerability class in the region of the site is presented as Figure 2.1 below.

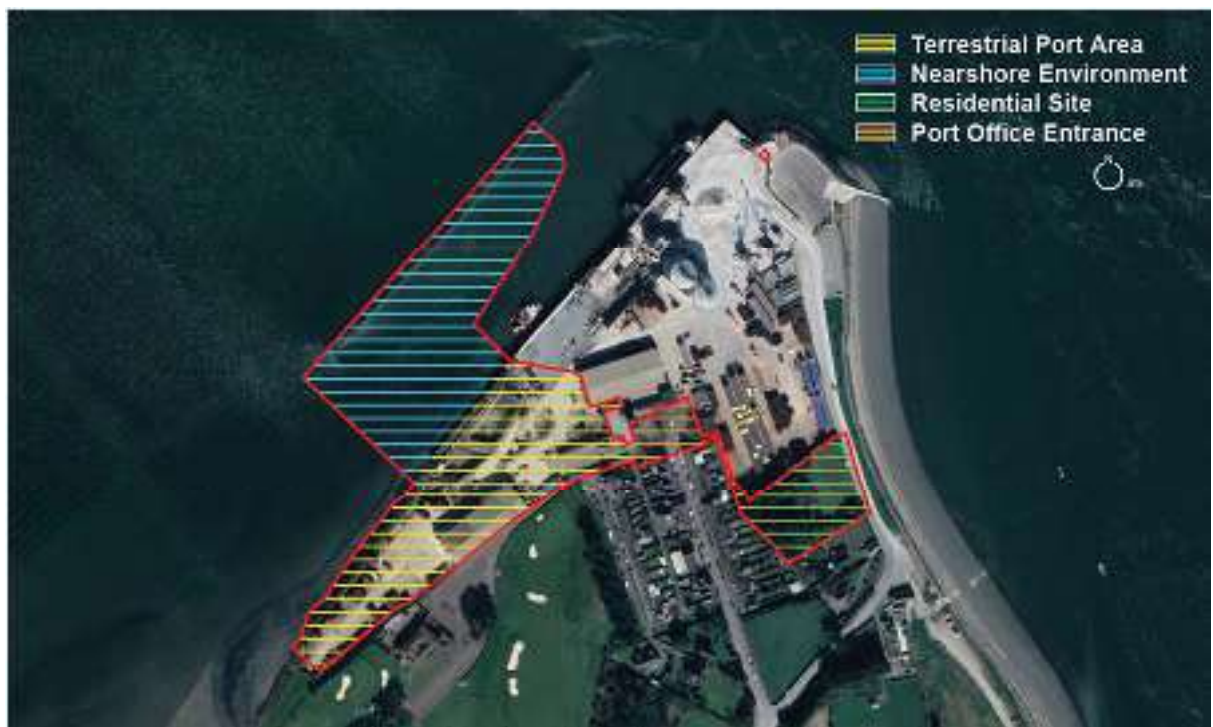
Figure 1.1 Proposed Development Plots/Character Areas

1. 'Terrestrial Port Area', (c.1.9ha) which includes, a port commodity warehouse (former Open Hydro building), hardstanding areas, remnant wall associated with the pre-existing 'engine room', and a communications mast.
2. 'Nearshore Environment' (c.2.3ha) encompassing part of Carlingford Lough and an existing caisson quay wall, known as 'Berth 3'.
3. 'Residential Site' (c. 0.5ha) a greenfield site with a single-storey unoccupied residential dwelling with frontage to the R175, Shore Road.
4. 'Port Office Entrance' (c. 0.18ha) encompassing a portion of the existing office building, known as the 'Seafarers room', hardstanding and parking area to the front of the port office with pockets of green space, that front Euston Street.

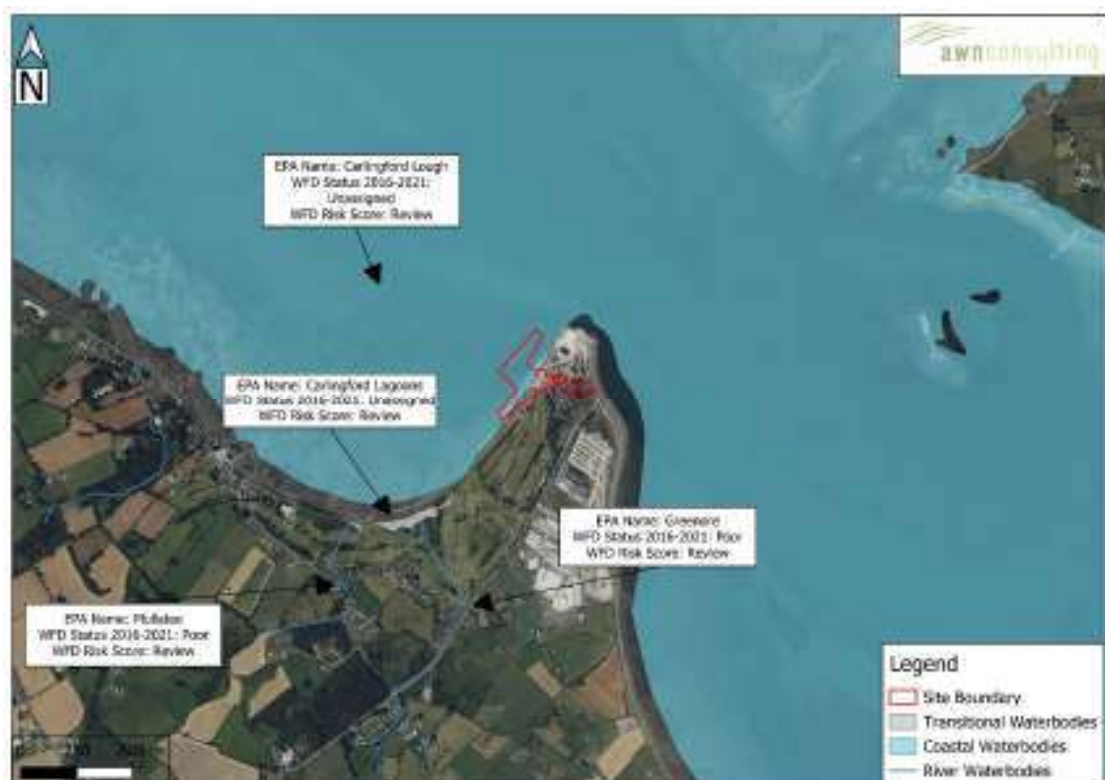
Figure 3.1 Site Location and Hydrological Environment

Carlingford Lough hosts Natura 2000 Sites (refer to Figure 3.1 and Figure 3.2 below). Currently there is a direct hydrological linkage between the proposed development sites and these sites through the existing stormwater drainage network which outfalls into the Carlingford Lough.

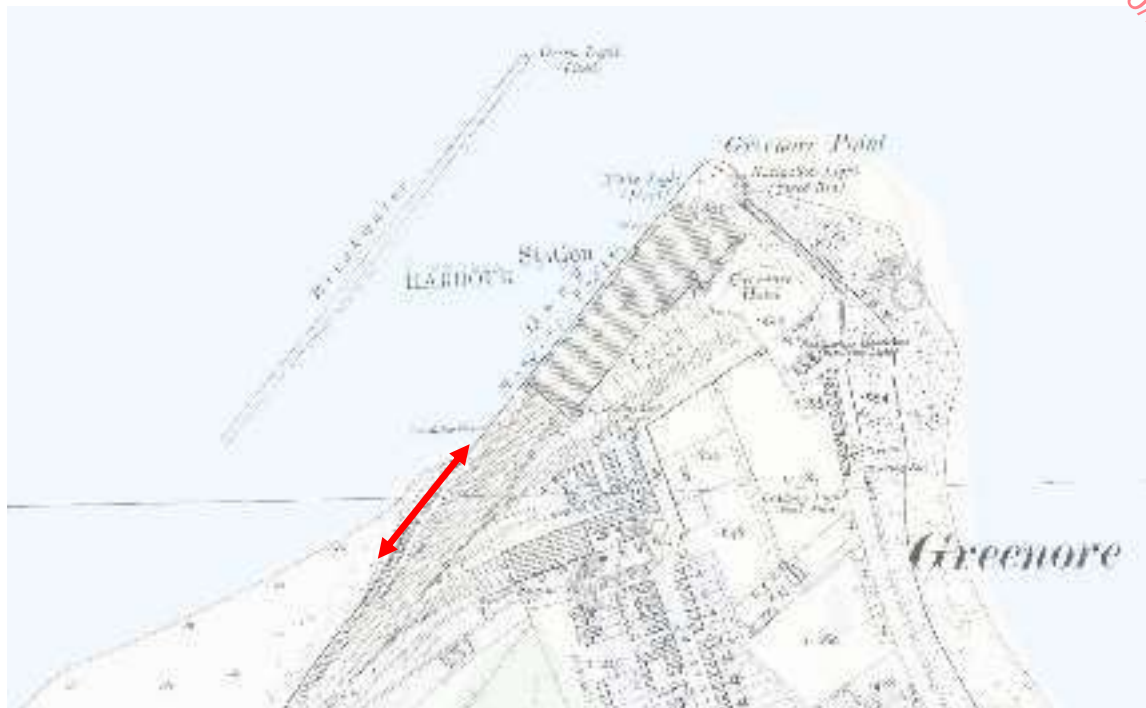
Figure 4 Detail of port circa 1888 showing present location of caissons

A large travelling crane was located immediately to the north of the present location of the caissons. A limestone block pitched quay wall was located where the caissons are now.

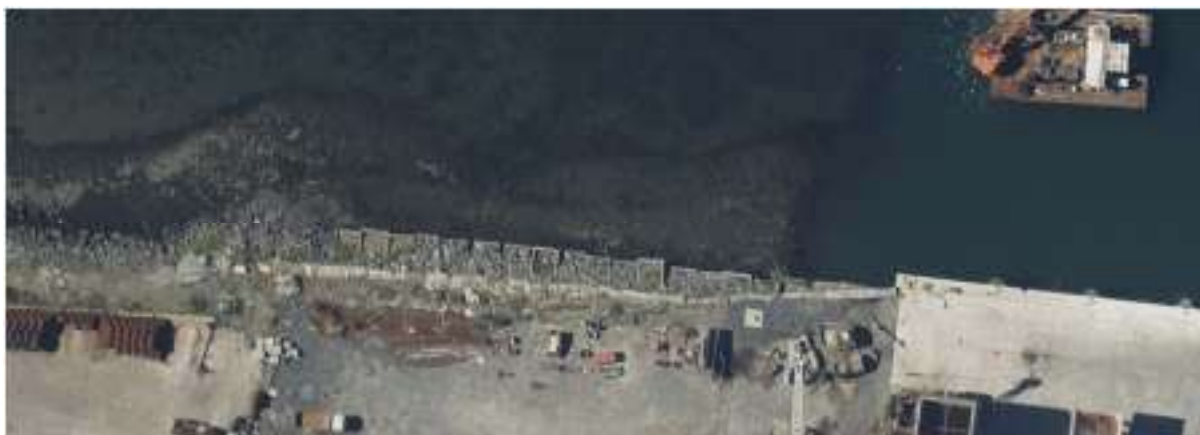
Figure 6 Coast land showing caissons

The coastal port development area is a narrow strip of land approximately 150 metres by 5 metres consisting of recently developed quay wall, older concrete caissons, a pitched sea wall made of cut limestone cobbles. Over time topsoil has arrived windblown and stemming from decayed coastal vegetation. They have also been partially infilled with clean stone. The following species have been observed in small patches or as one or two specimens in and along the edge of the caisson area, particularly where decaying nitrogenous vegetation slips in cracks and crevices along the track and stone bank and give opportunity: *Plantago maritima*, *Beta vulgaris*, *Aster tripolium*, *Malva sylvestris*, *Matricaria discoidea*, *Cochlearia officinalis*, *Tripleurospermum maritimum*, *Senecio squalidus*, *Erysimum* sp and *Geranium robertianum* along with one example of *Reseda luteola*. *Crambe maritima*, *Suaeda maritima* and *Honkenya peploides* were absent. This habitat may therefore be classified as Sea Walls Piers & Jetties (CC1).

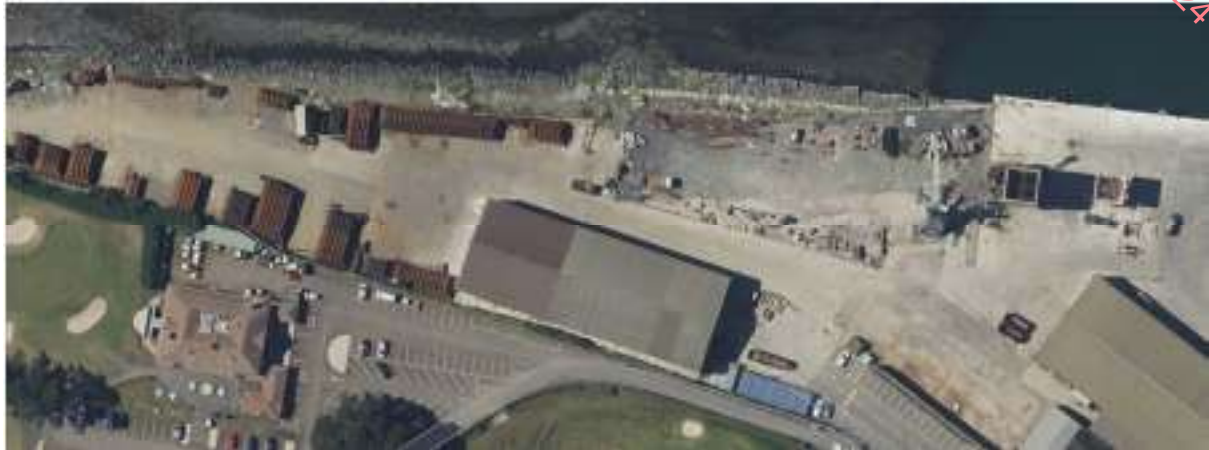
Figure 8 Hard standing area with warehouse and steel storage

Further inland the development area consists of hard standing, a currently used as an animal feed store, some remnant walls and tarmac carpark. These areas consist of concrete hard standing and man-made structures and are as such bereft of vegetation. Much of the area between the warehouse and the quay is currently used for the storage of steel coil and mesh.

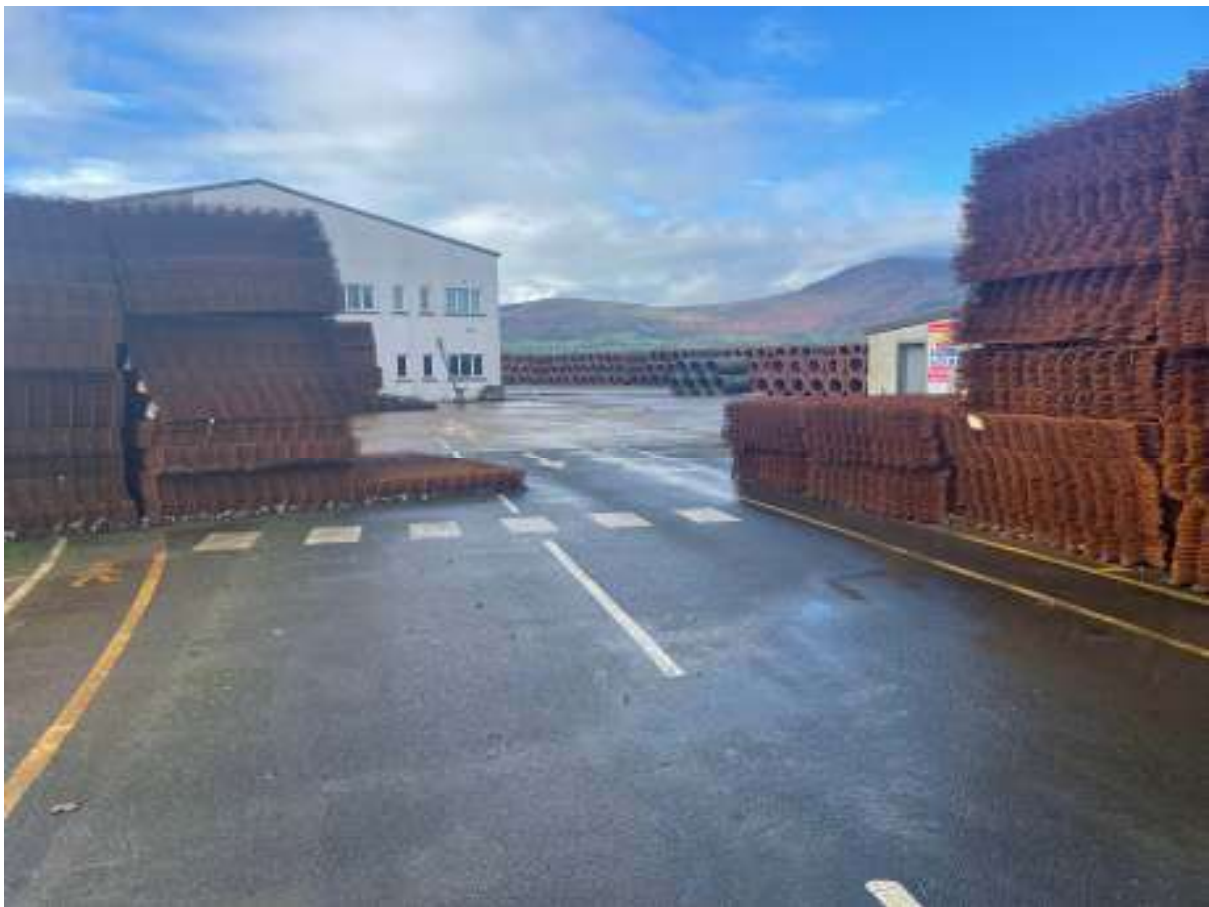
Figure 9 Hard standing, steel storage and openhydro building

This area may be classified as buildings and artificial surfaces - BL3.

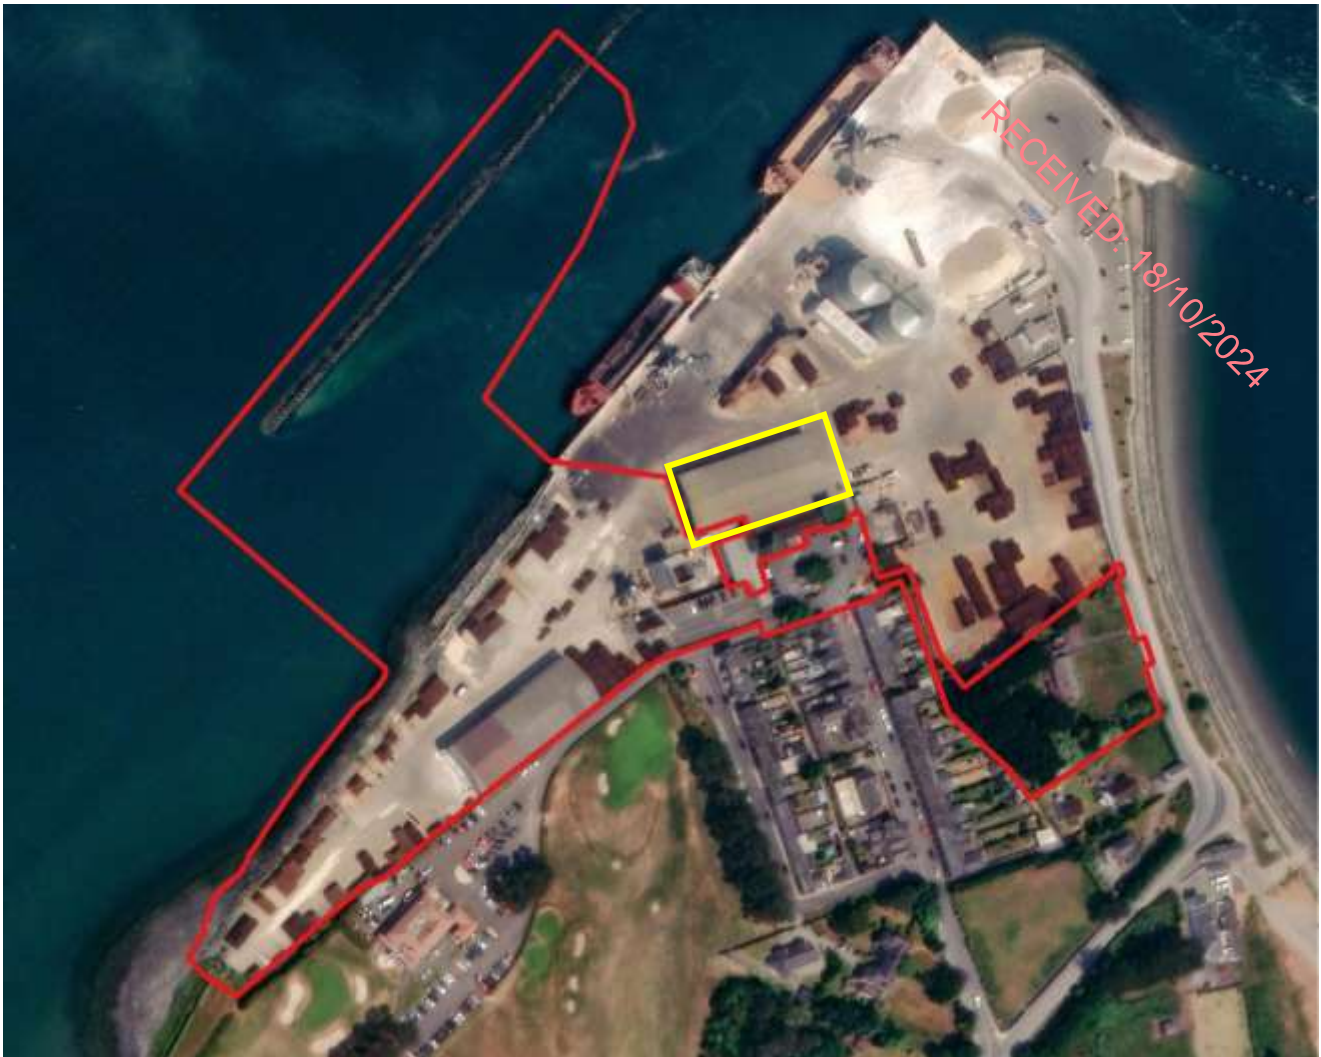
In 2024, a single Soprano Pipistrelle (*Pipistrellus pygmaeus*) was noted foraging near equipment storage building adjacent to the north boundary of the proposed development site, within the port area. No bats were observed emerging from onsite trees or buildings within or proximate to the subject site. Activity was restricted to within this port area storage shed. No activity was recorded within the grain storage building (former open hydro) proposed for removal, the remaining port area, or residential site.

Figure 9. Equipment storage building where individual Soprano Pipistrelle was observed foraging (yellow).

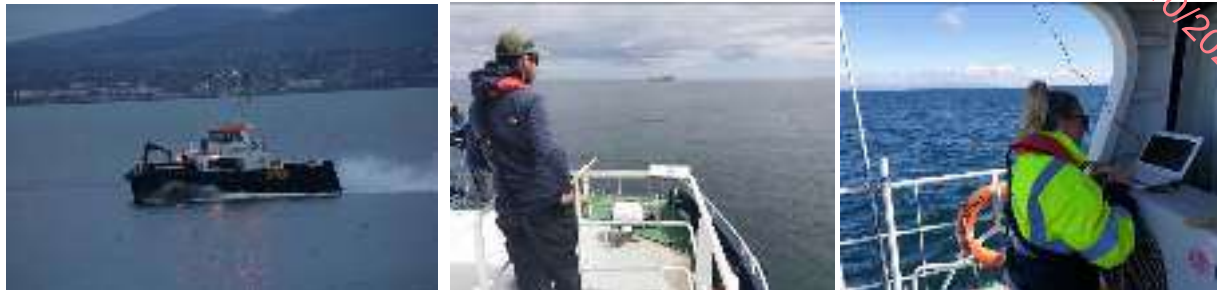
Figure 2. *MV Fastnet Petrel* used for line-transect surveys off Oriel

The vessel used for each survey was the *MV Fastnet Petrel*, provided by Fastnet Shipping Ltd. *MV Fastnet Petrel* is an 18M DNV Classed Windfarm Service and Survey Support Vessel (Figure 2). The vessel proved to be excellent, providing fast passage to the start of each track-line, stability and an observation platform height of 4m above the waterline.

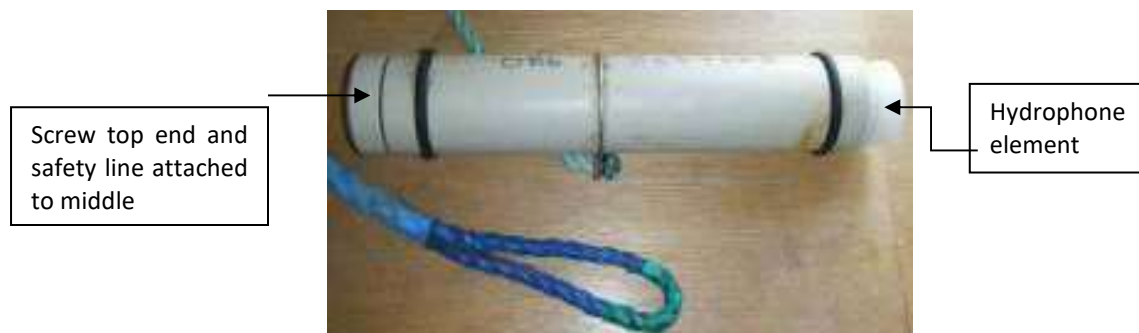
Figure 3.2: C-POD unit by Chelonia Ltd

The C-POD is a fully automated, static acoustic monitoring system which can detect porpoises, dolphins and other toothed whales by recognising echolocation click trains these animals make in order to detect their prey, orientate

themselves and interact with one another (Figure 3.2). These units are designed and manufactured by Chelonia Ltd and they are the only commercially available instruments with click train recognition software which produces fully automated, accurate data on the behaviour and identification of odontocetes (see www.chelonia.co.uk). A single C-POD can monitor both porpoise and dolphins simultaneously through identifying characteristic click parameters which can be assigned to either harbour porpoise or dolphin species. Once deployed at sea, C-PODs operate in a passive mode and are constantly listening for tonal clicks within a frequency range of 20 to 160 kHz. When a tonal click is detected, the C-POD records the time of occurrence, centre frequency, intensity, duration, bandwidth and frequency of the click. Internally, the C-POD is equipped with a Secure Digital (SD) flash card, and all data are stored on this card. Dedicated software, C-POD.exe, provided by the manufacturer, and is used to process the data from the SD card when connected to a PC via a card-reader. This allows for the extraction of data files under pre-determined parameters as set by the user. Additionally, the C-POD also records temperature over its deployment duration. It must be noted that the C-POD does not record actual sound files, only information about the tonal clicks it detects.

The C-POD detector is a sound pressure level detector with a threshold of 1Pa peak to peak at 130 kHz, with the frequency response shown below (Figure 3.2, 3.3, www.chelonia.co.uk). An estimated detection distance of $797.6\text{m} \pm 61\text{m}$ (75% of groups recorded <400m) for C-PODs and bottlenose dolphins was generated in the Shannon Estuary, while distances estimates of $441\text{m} \pm 42\text{m}$ (92% <400m) were generated for the harbour porpoise in Galway Bay (O'Brien *et al*, 2013).

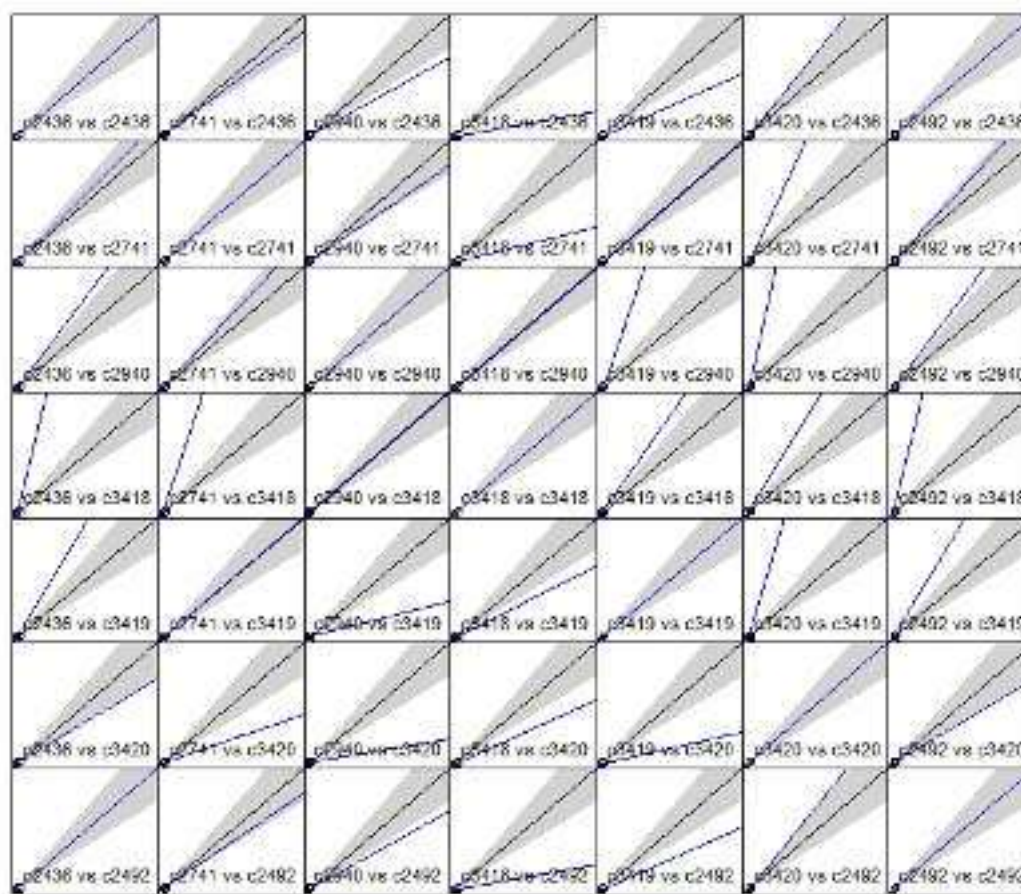
Figure 4.1: Orthogonal regression plot of C-POD comparisons in calibration trial (June-July 2019), in blue, with a null model where each unit performs exactly the same, in black and an acceptable error margin of $\pm 20\%$, in grey from Calibration trials, June-July 2019.

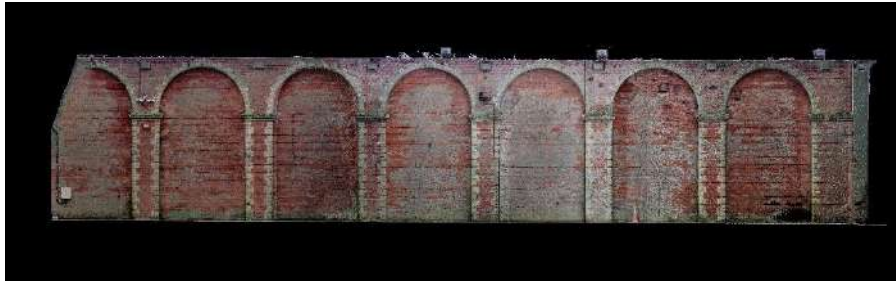
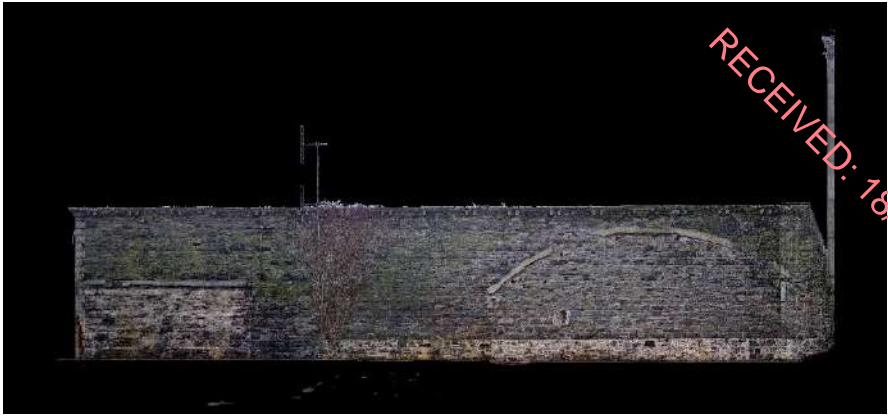
<p>Point Cloud survey showing north-facing façade completed separately for the port.</p> </div>

<p>Point Cloud survey showing south-facing façade completed separately for the port.</p>
Proximity to development	Within Greenore Port but outside O&M facility project area
Likely Impacts	None
Recommended Mitigation	Retain as protected structure

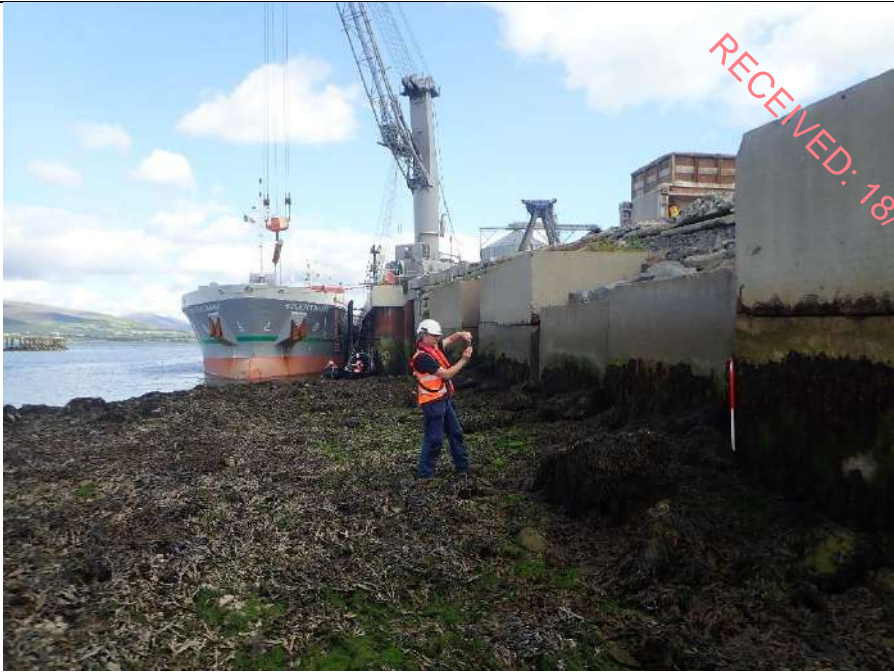
<p data-bbox="408 853 1003 880">Foreshore image where it is intended to extend Berth 3.</p>
Proximity to development	Within O&M facility project area
Likely Impacts	Capital dredging, marine piling
Recommended Mitigation	Archaeological monitoring of seabed impacts

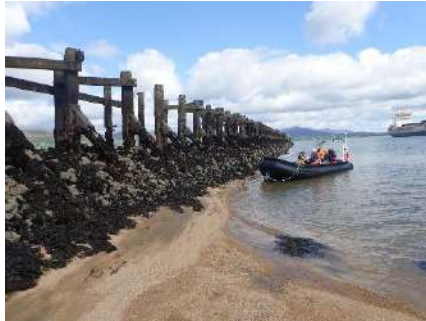
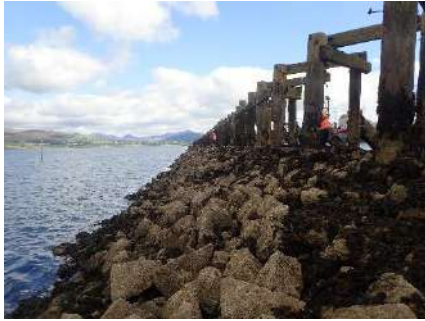
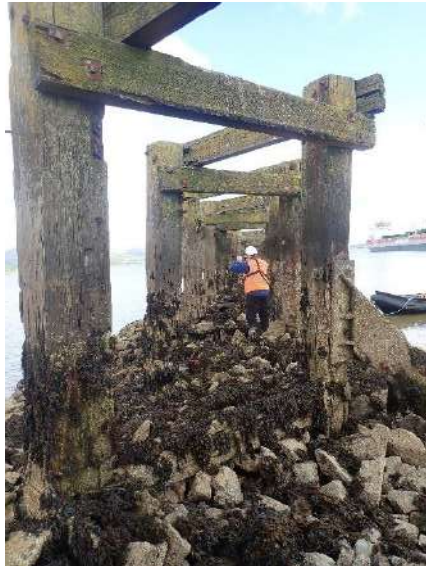
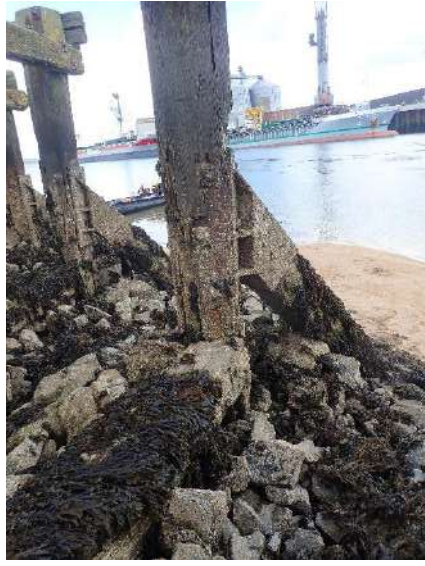
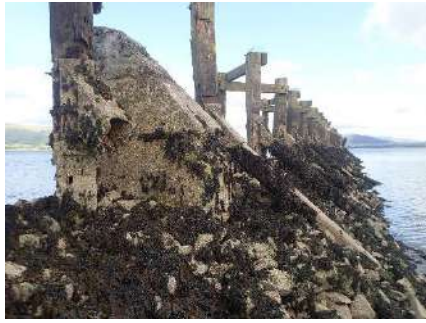
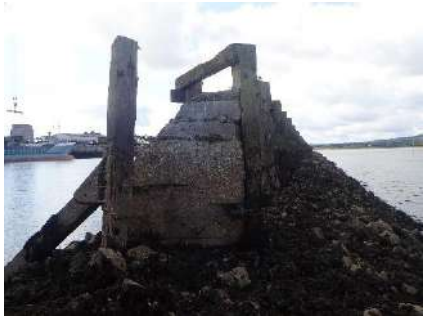
Reference	Site Name	Site Type	ITM Easting	ITM Northing
ADCO 02	Breakwater	Breakwater	722086	811024
Description	<p>The breakwater has two principal elements, comprising an openwork timber superstructure and a rubble rock armour base.</p> <p>The timber superstructure is formed of two lines of square-sectioned timber piles that are staggered to create a zig-zag linear formation which runs the length of the breakwater. The two lines of timber are braced by a series of cross beams which form lintels at the top of the feature and also lower down where the rubble mound buries the base of the piles. The vertical piles are cut with simple scarf joints to receive the lintels, which are then fixed to the piles with iron bolts. A series of timbers also brace the vertical piles as buttresses set at 45-degree angles, and these are fixed to the piles by means of steel plates. The buttress timbers are only seen on the east-facing side of the breakwater, facing the quay. Two of the timber braces have fallen away and lie on the seabed off its east-facing side.</p> <p>A series of steel beams fixed to the west-facing side of the breakwater at its north end appear to serve a similar bracing purpose but they are probably a later addition as they are not continued along the length of the breakwater.</p> <p>A poured concrete pier is located at the centrepiece of the breakwater's length. The pier rises almost to the same height as the timber piles. It appears to have functioned as a central anchor point.</p> <p>The remains of a metal pole fitted with a circular grid lies off the north end of the breakwater on its west-facing side. This appears to have been a navigation aid that has fallen down, and may be the remnants of the Green Light fixture, or a version thereof, recorded on the historic OS map (Figure 3).</p> <p>The base of the piles are not visible as the base of the breakwater has a mound of granite rubble that offers rock-armoured protection to the feature. The rubble mound measures c. 1 m high above current seabed level and extends in width just beyond the visible extent of the timberwork above. There</p>

<p>are no obvious set stones forming a wall line and the rubble mound is substantial.</p> <p>A point cloud survey completed separately for the port has recorded the primary elements of the breakwater, stopping short of surveying the seabed on the west-facing side. Based on the point cloud, the breakwater measures 285m long and is not entirely straight but retains a slight bend; the piles are exposed to a height of 6m at the north end, and 3m at the south end. The rock armour base reaches 4m wide consistently along its length.</p>	
Image/s

<p>View looking north along east-facing side.</p>

<p>View looking north along west-facing side.</p>

<p>View looking north through breakwater.</p>

<p>View looking east at timber buttressing.</p>

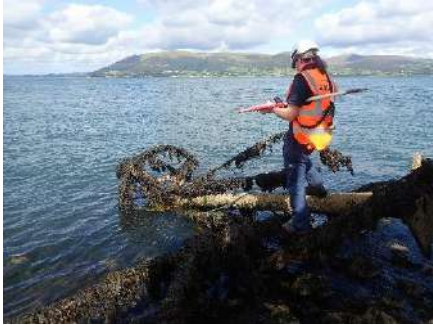
<p>View of collapsed navigation aid.</p>

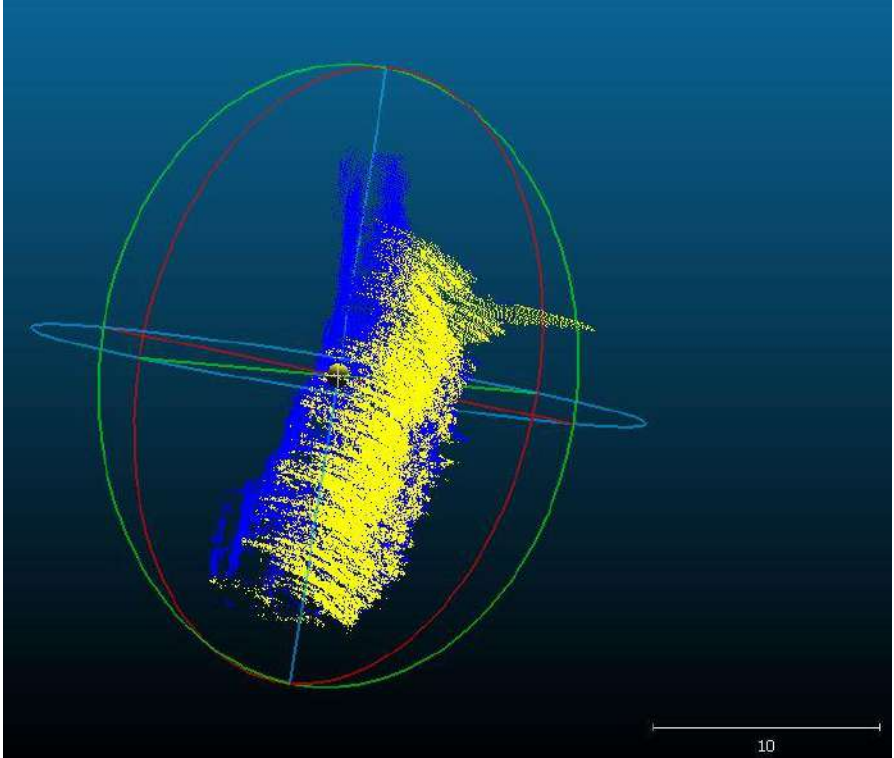
<p>Detail from point cloud showing Bird's Eye perspective looking north along breakwater length. Blue elements are the standing piles; yellow elements is the rock armour foundation.</p>

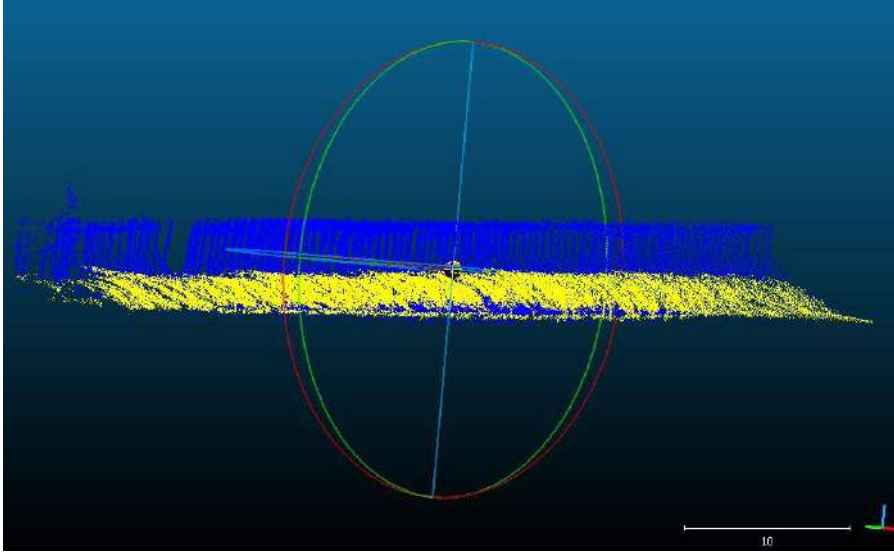
<p>Detail from point cloud showing isometric view along breakwater from south to north.</p>

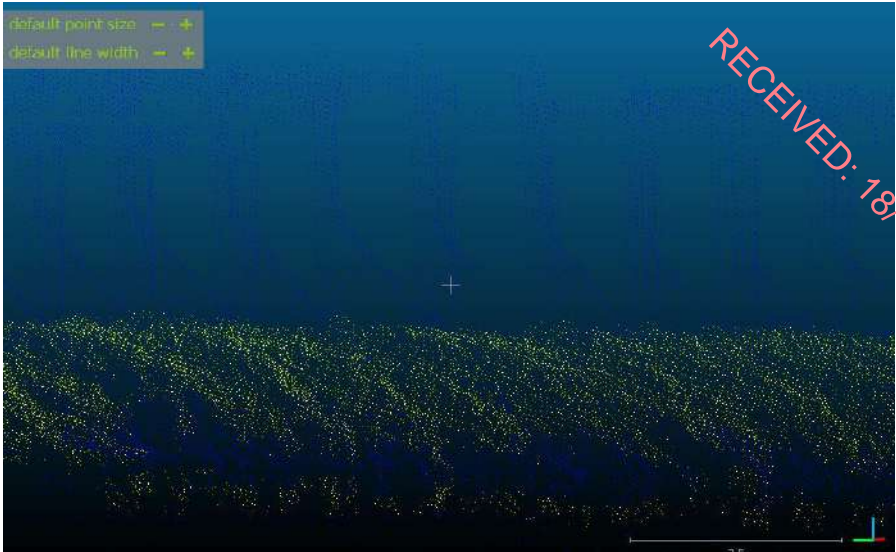
<p>Detail from point cloud showing close-up isometric view detail looking north along breakwater.</p>
Proximity to development	Within Greenore Port directly adjacent to O&M facility project area
Likely Impacts	Repair works to rock armour base of the breakwater feature may be required. Works may include addition of rock armour where there are gaps or localised settlement, and reconstruction or reinforcement of the toe.
Recommended Mitigation	<p>Avoid all impacts to the superstructure during design, construction, operation and decommissioning.</p> <p>Dredging design in vicinity will need to ensure that the breakwater is not undermined. Dredging should seek to retrieve fallen timbers from the superstructure.</p> <p>Consider rehabilitation of breakwater to celebrate the nineteenth-century origins of the Port.</p>

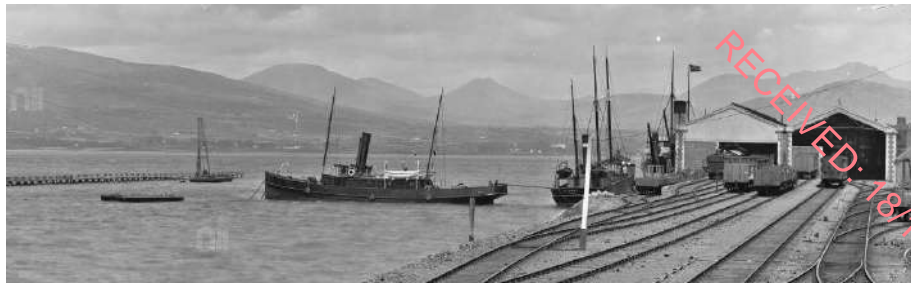
Reference	Site Name	Site Type	ITM Easting	ITM Northing
ADCO 03	Quay	Quay	718129	734913
Description	<p>The stone-built quay was well-constructed, made up of cut stone blocks, laid in courses where the stones mask the formal courses by being of different sizes. At regular intervals, there are pairs of projecting jamb stones to capture and secure in place vertical timber fenders.</p> <p>The base of the quay wall was covered in silt and cobble for the most part, but the most southerly section featured a glacis embrasure built at its base to act as a rock armoured defence against erosion. The feature was curved in plan view and served to deflect scour from the base of the quay wall.</p> <p>The sub-tidal element was covered in a loose shingle and cobble when inspected in 2017. The only feature observed was a line of vertically-set timber uprights that formed a line of shuttering located some 10 m out from the quay wall. It is understood that the timberwork would have served as part of the quay's construction. The timbers were set edge-to-edge and many featured eroded tops, where the top surface is sheared off at an acute angle, perhaps from previous cutting action.</p> <p>The stone quay is now buried under the modern combi wall that was constructed on Berths 1 and 2.</p>

Historic photograph of Greenore quayside looking north, showing the railhead.
Source: National Library of Ireland, Robert French, 1841-1917.

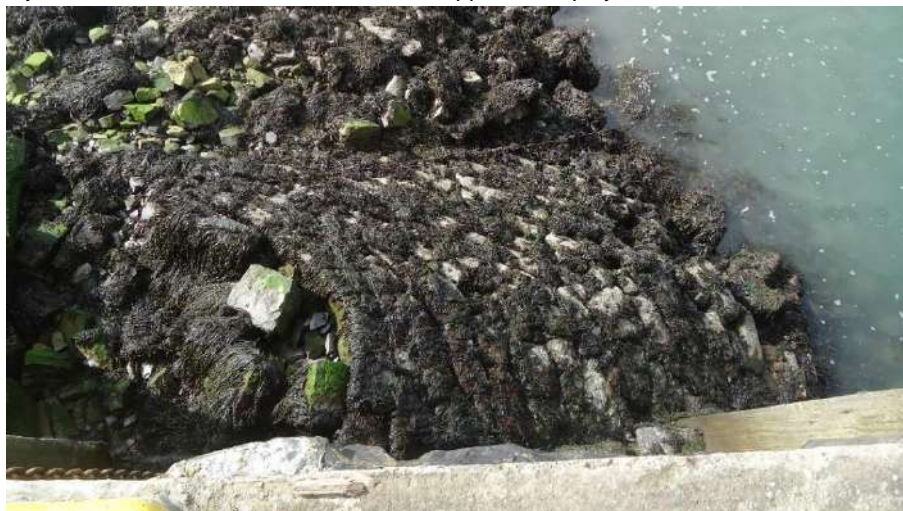
View along the façade of the stone-built quay in 2017, showing the cut stone blocks and the projecting jamb stones in the upper level spaced at regular intervals to secure the vertically-set timbers used as fenders. The uppermost layer of concrete was a later addition to support that quayside cranes in use.

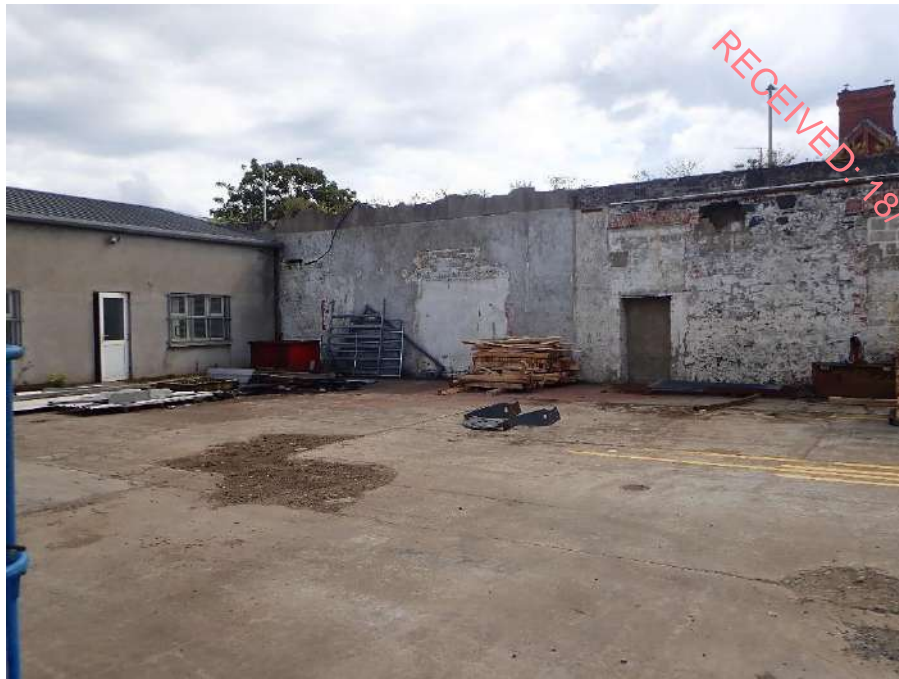
Engine Shed wall, east end, view from north.

Reference	Site Name	Site Type	ITM Easting	ITM Northing
ADCO 04	Engine Shed	Wall	722213	810881
Description	Wall length representing the southern long wall of the former Engine Shed recorded on the OS 1890-1900 historic map. The wall retains a series of architectural features, including a fractured wall end, six blocked-up window ope and one blocked-up doorway ope. It currently serves as a boundary between the operational area of the port to the north and Port car parking to the south.

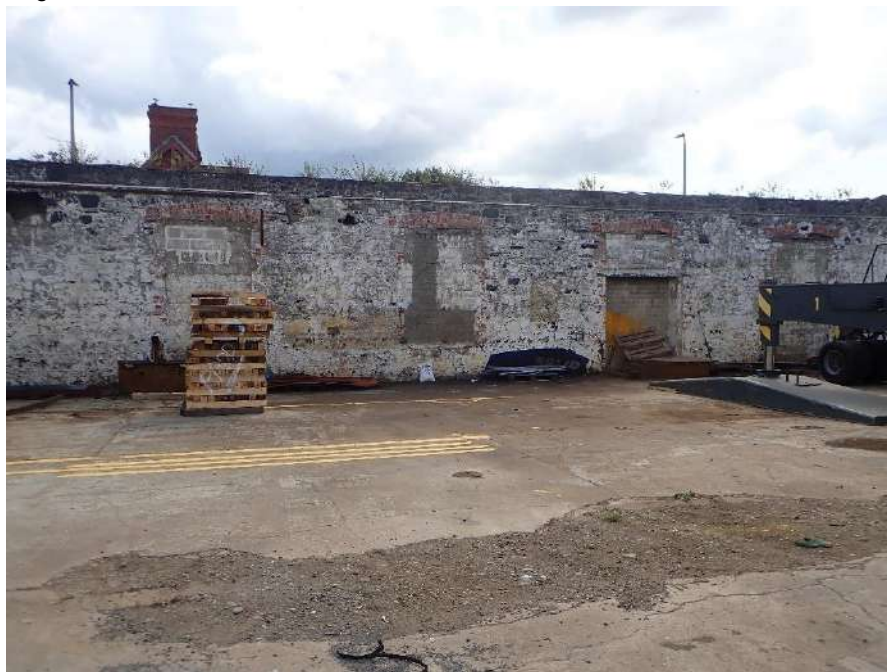
Engine Shed wall, central area, view from north.

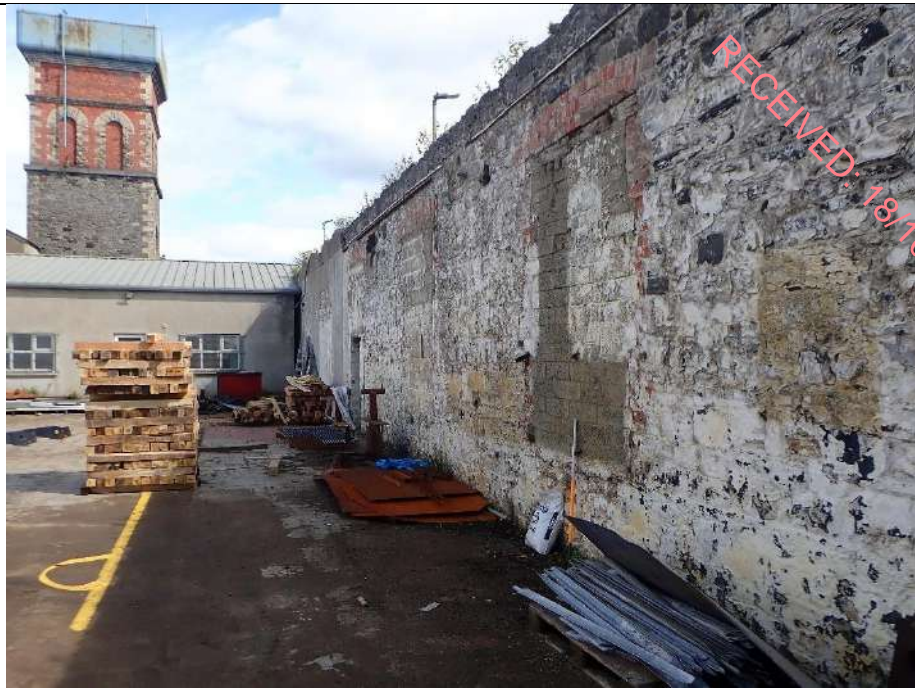
Engine Shed wall, view looking east.

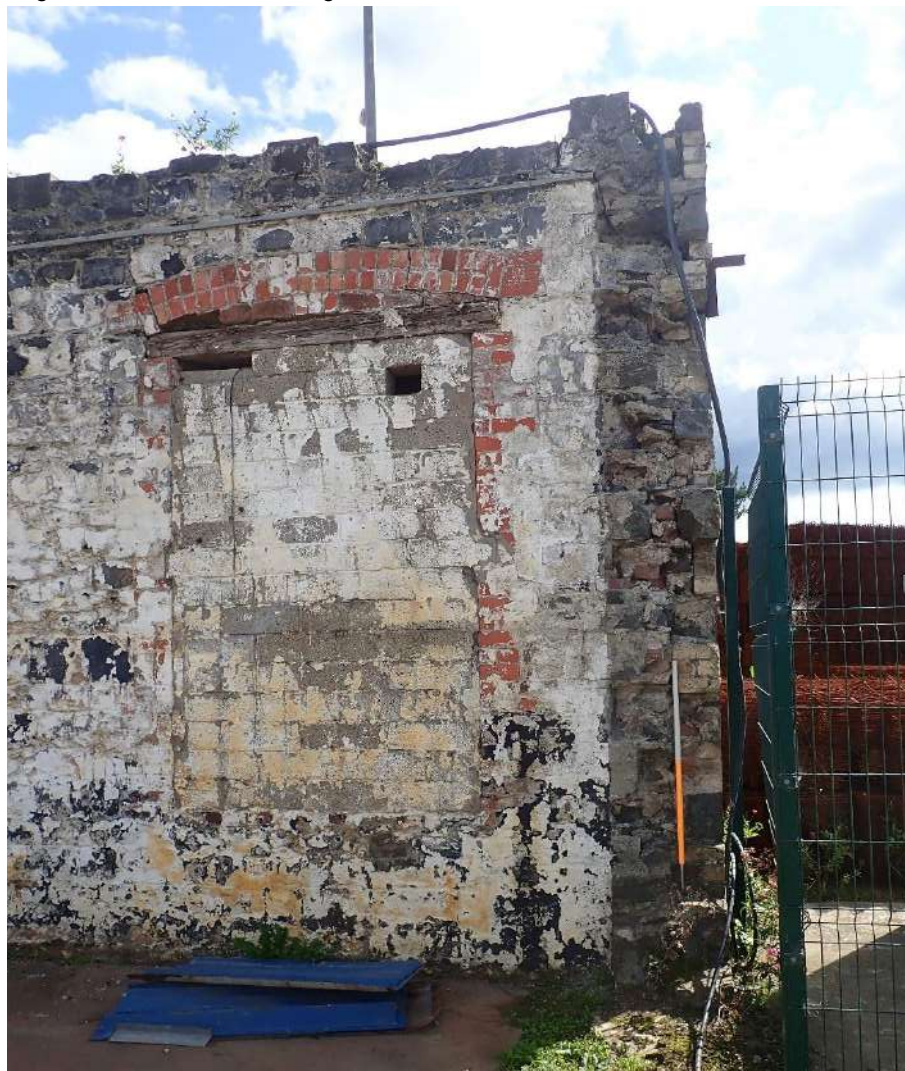
Engine Shed wall, west end showing wall end-wall fracture, view from north.
