APPENDIX 10.1

NRA CRITERIA FOR RATING THE MAGNITUDE AND SIGNIFICANCE OF IMPACTS AT EIA STAGE

VOLUME III

APPENDICES TO ENVIRONMENTAL IMPACT ASSESSMENT REPORT

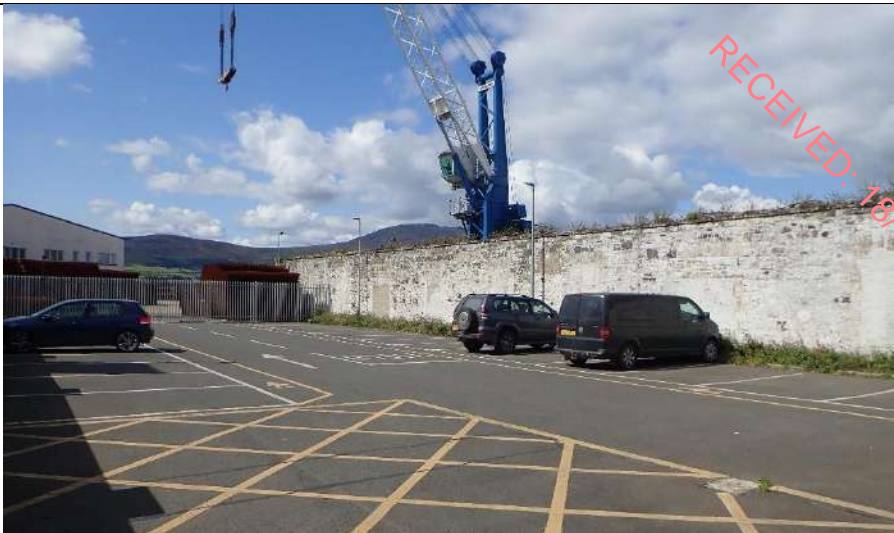
<p>Engine Shed wall view from south.</p>

Reference	Site Name	Site Type	ITM Easting	ITM Northing
ADCO 04	Engine Shed	Wall	722213	810881
Description	Wall length representing the southern long wall of the former Engine Shed recorded on the OS 1890-1900 historic map. The wall retains a series of architectural features, including a fractured wall end, six blocked-up window ope and one blocked-up doorway ope. It currently serves as a boundary between the operational area of the port to the north and Port car parking to the south.

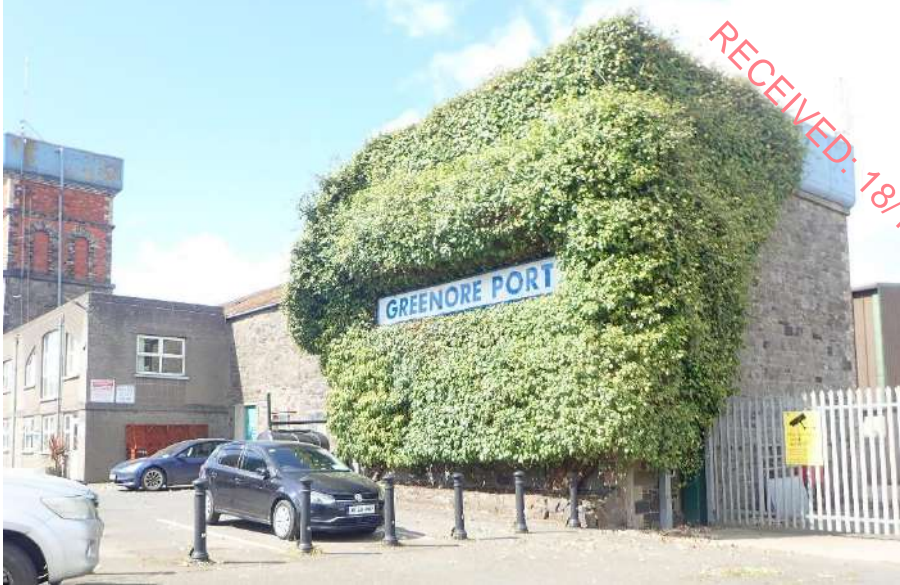
<p>View from south.</p>

Reference	Site Name	Site Type	ITM Easting	ITM Northing
ADCO 05	Building	Building	722268	810919
Description	<p>Square-planned stone building, two storeys in height, windowless on north, west and south sides, entrance door on north through rounded arch, lesser side entrance on west. Roughly cut stone laid in courses with quoins formed using yellow brick. Roof area accommodates a tank, either concrete or steel, painted blue. South façade supports Greenore Port sign and is otherwise covered in ivy. A lean-to shack was formerly appended to the north wall.</p> <p>The building is part of the railway complex associated with NIAH 13831025; RPS Lhs 009-001 and probably held a second water tower.</p>

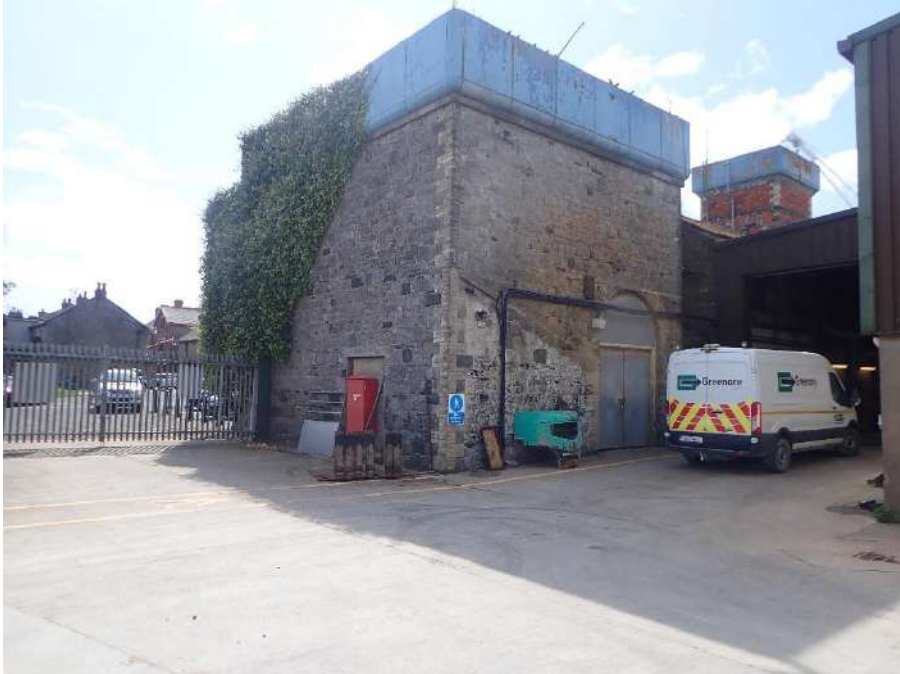
<p>View from north.</p>
Proximity to development	Within Greenore Port but outside O&M facility project area
Likely Impacts	None
Recommended Mitigation	Detailed archaeological survey to ensure a permanent record is made.

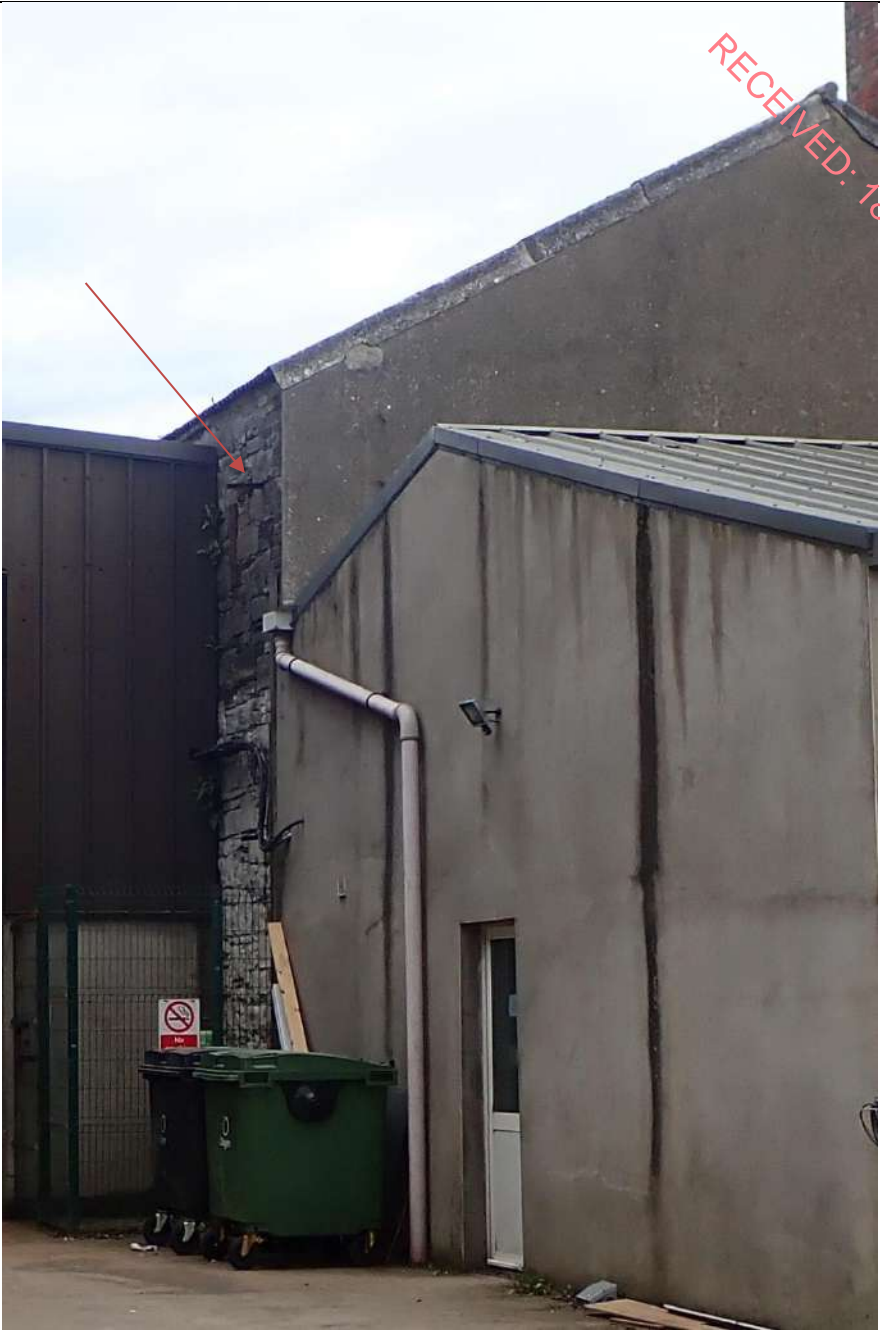
Detail showing visible section of stone wall (highlighted by red arrow) outside the shed complex.	
	Proximity to development	Within Greenore Port but outside O&M facility project area
	Likely Impacts	None
	Recommended Mitigation	Detailed archaeological survey to ensure a permanent record is made.

Reference	Site Name	Site Type	ITM Easting	ITM Northing
ADCO 06	Building wall	Wall	722239	810912
Description	Stone wall at rear of complex that houses NIAH 13831025; RPS Lhs 009-001. The wall is the north-facing long wall of a gabled building whose gable end is sheathed in concrete render and whose roof is a simple corrugated metal. Modern concrete building abuts west end and is aligned north-south. The wall is currently absorbed as part of sheds but should be regarded as part of the former railway complex abutting

and east of the Engine Shed (ADCO 04). On the OS 1890-1900 map, railway lines ran in front (north) of the building, where today there is a brown-coloured metal shed.
Image/s	  <p>View from west.</p>

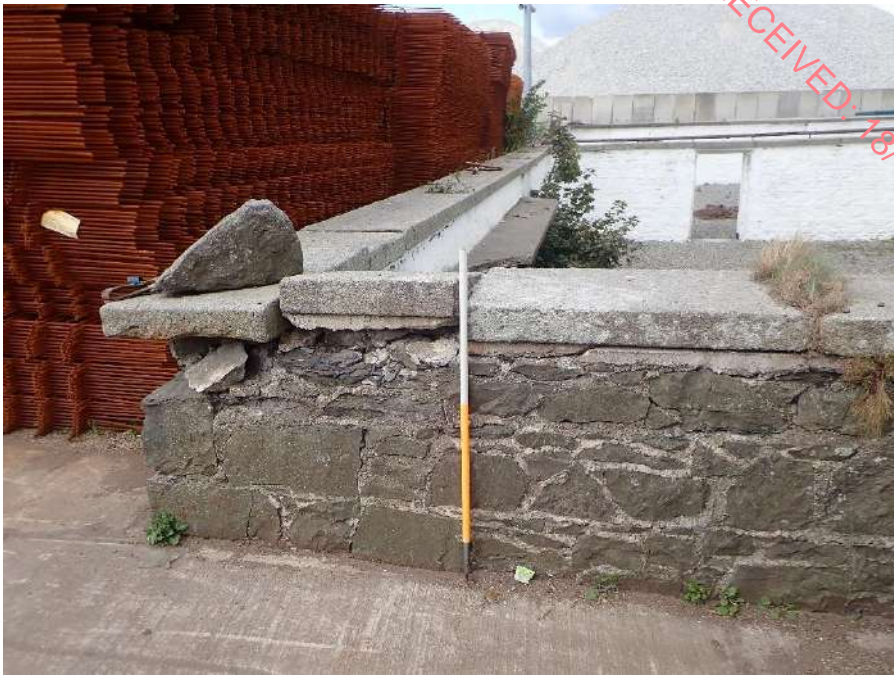
<p>View looking north.</p>

Reference	Site Name	Site Type	ITM Easting	ITM Northing
ADCO 07	Lighthouse boundary wall	Wall	722350	810982
Description	Low wall constructed with roughly shaped limestone blocks laid in courses and surmounted with granite paving that forms an elegant lintel. The southern section stands c. 800 mm above current ground level within Port area, while the northern

section is taller (c. 1.3m) and facilitated a series of lean-to sheds against the wall within the Lighthouse curtilage.
Image/s

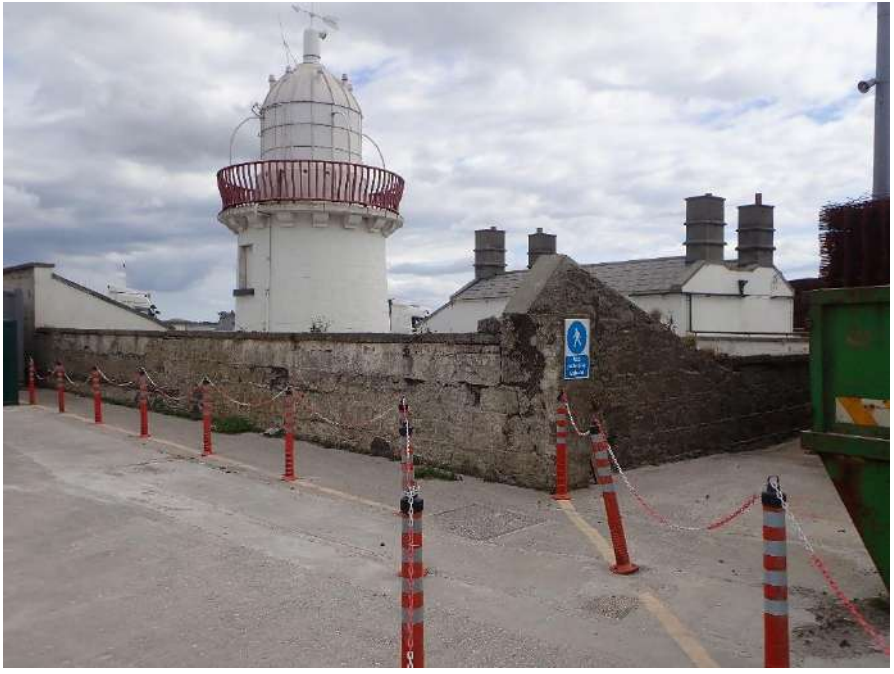
<p>View looking southeast.</p>
Proximity to development	Within Greenore Port but outside O&M facility project area
Likely Impacts	None
Recommended Mitigation	Detailed archaeological survey to ensure a permanent record is made.

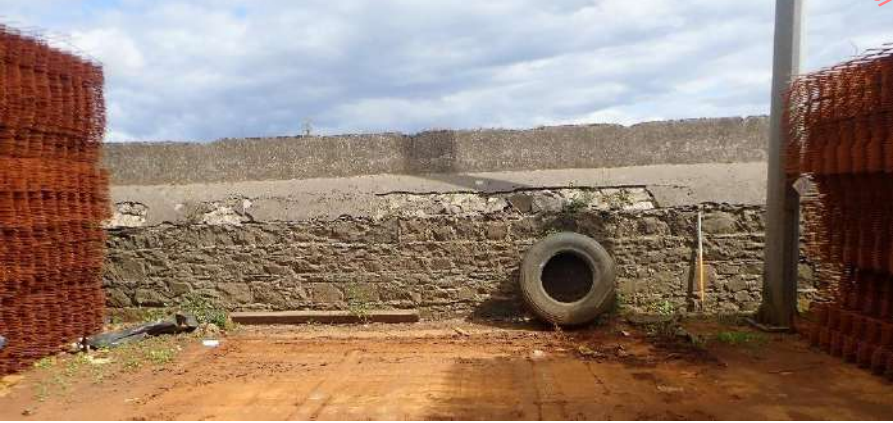
<p>View from west.</p>

Description	<p>Low wall constructed with roughly shaped limestone blocks laid in courses and standing c. 1.1 m high above ground level within Port area, and surmounted with a mortared crown of limestone. Later additions in concrete add greater height. The historic OS 25-inch map (1890-1900) shows a range of buildings standing against but outside (east) the wall, and at least one sill from those buildings was noted in the surviving wall. The wall may originally have extended over 50 in length. The southern section today has been rebuilt using concrete breeze blocks.</p>
Image/s

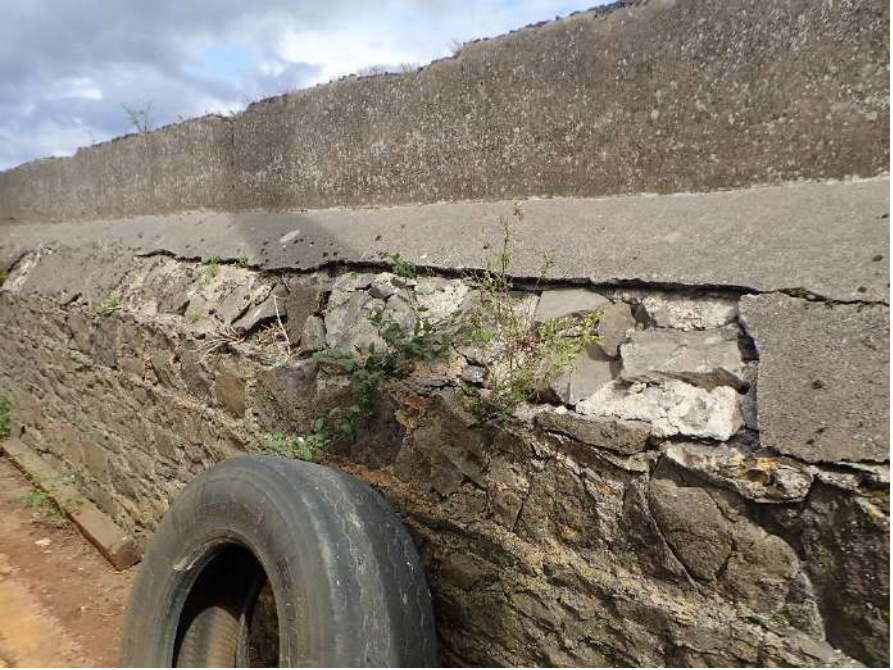
<p>View looking north.</p>

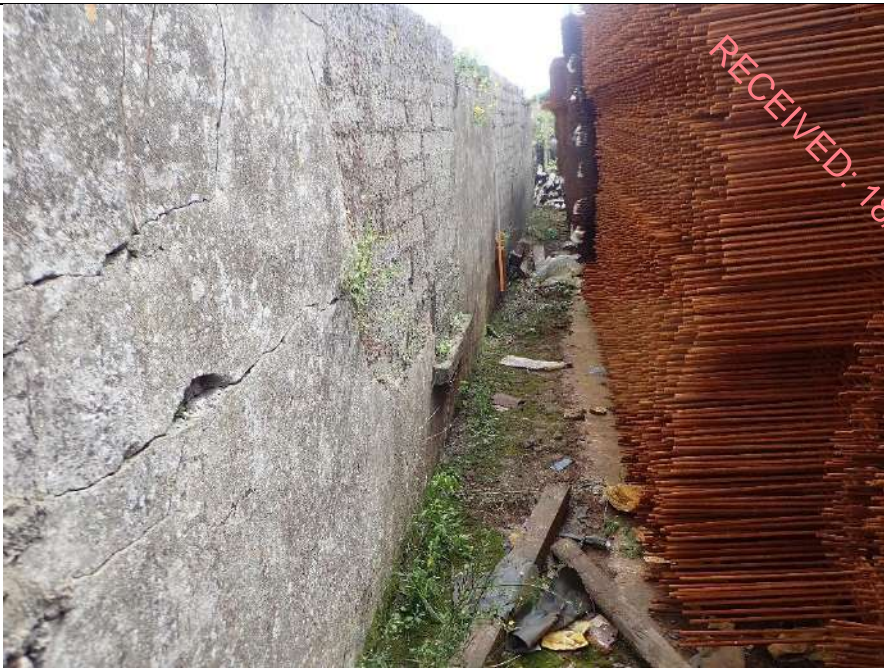
<p>View looking south and showing sill of former building extruded on wall.</p>

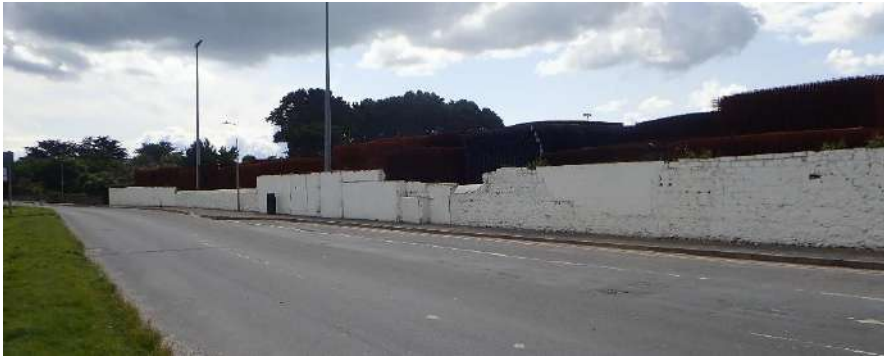
<p>View from east at boundary wall from Shore Road.</p>
Proximity to development	Within Greenore Port but outside O&M facility project area
Likely Impacts	None
Recommended Mitigation	<p>Detailed archaeological survey to ensure a permanent record is made.</p> <p>Avoid all impacts during design, construction, operation and decommissioning.</p> <p>Consider rehabilitation of wall to celebrate the nineteenth-century origins of the Port.</p>

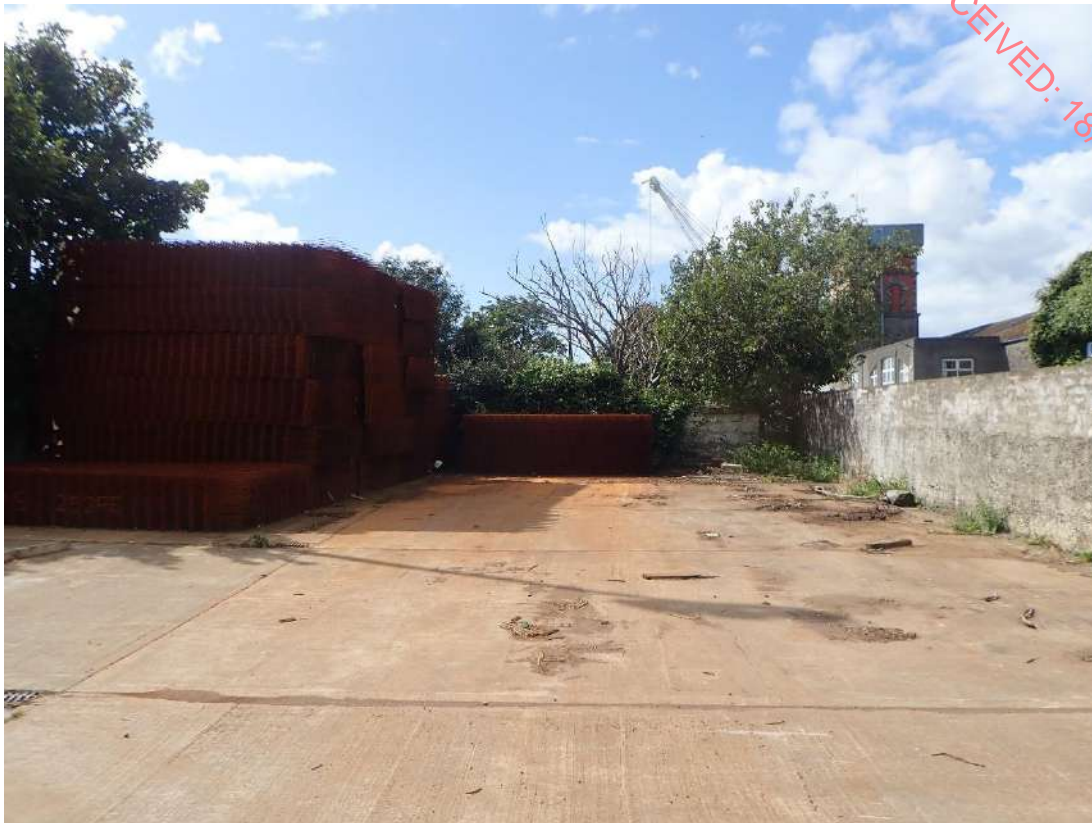
Plate 1: Area to east of Port offices where it is proposed to provide a parking area, in what is currently open-air storage.

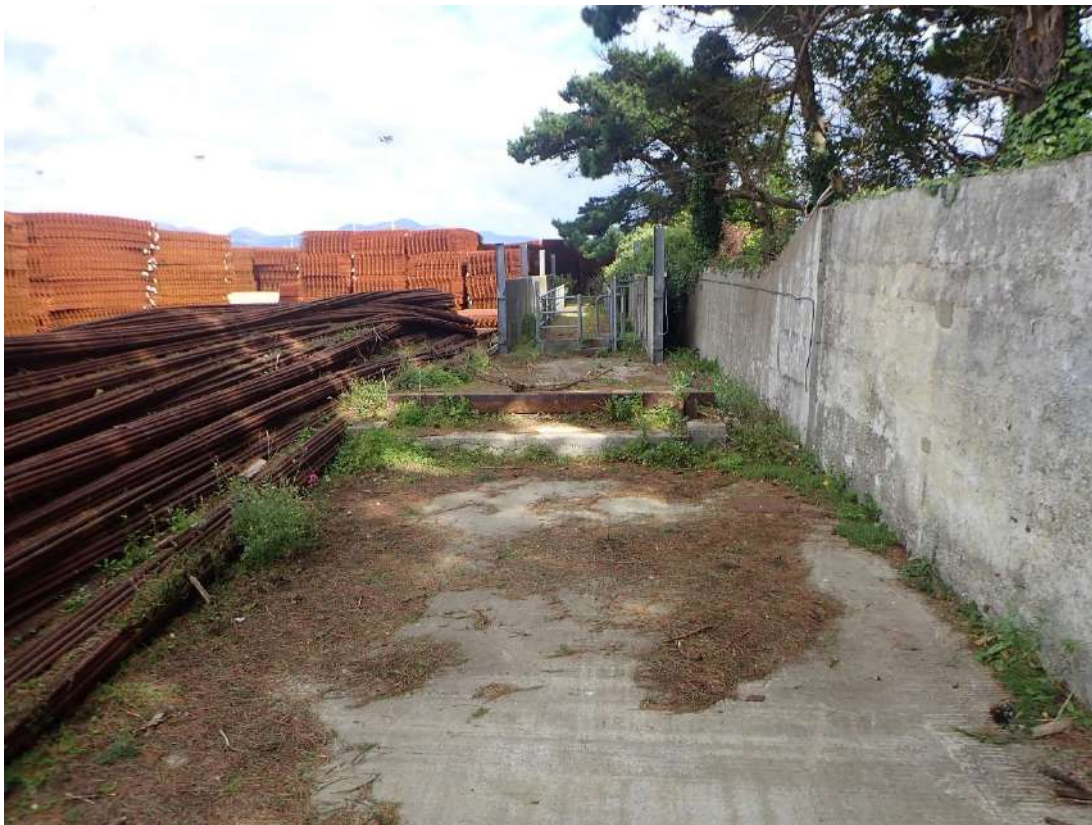
Plate 2: Southern end of new parking area east of port offices, showing nature of breeze-block boundary wall.

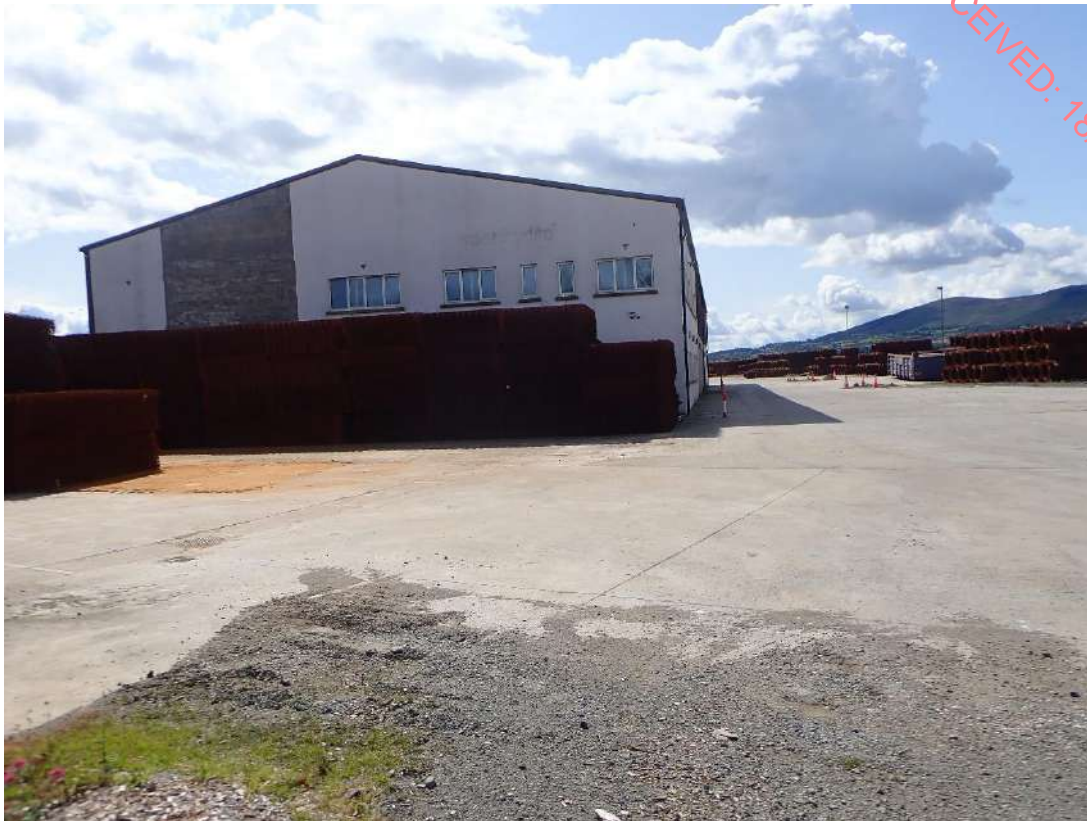
Plate 3: Operational area west of the Engine Shed (ADCO 04) site.
