# **Appendix C**

## Stage 1 Road Safety Audit & Road User Audit

This report describes the findings of a Stage 1 Road Safety Audit & Road User Audit associated with Bus Connects Galway: Dublin Road.

The Audit has been completed by Traffico Ltd. on behalf of Barry Transportation.

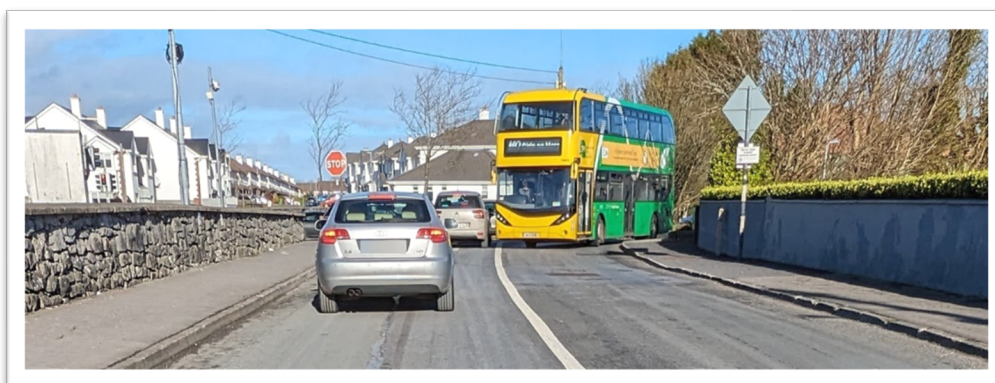
**Figure 3.5 – Left Turn into Ballyloughnane Road Appears Challenging for Buses**

**Dwg. | Location: 00004 | Left Turn into Ballyloughnane Road**

The road space available for buses and larger vehicles to turn left here appears limited. This could lead to kerb strikes, opposition type vehicle conflicts and delays during peak commuting times.

The vehicle swept path for (larger) left turning vehicles should be checked, with the geometry adjusted appropriately, if required.

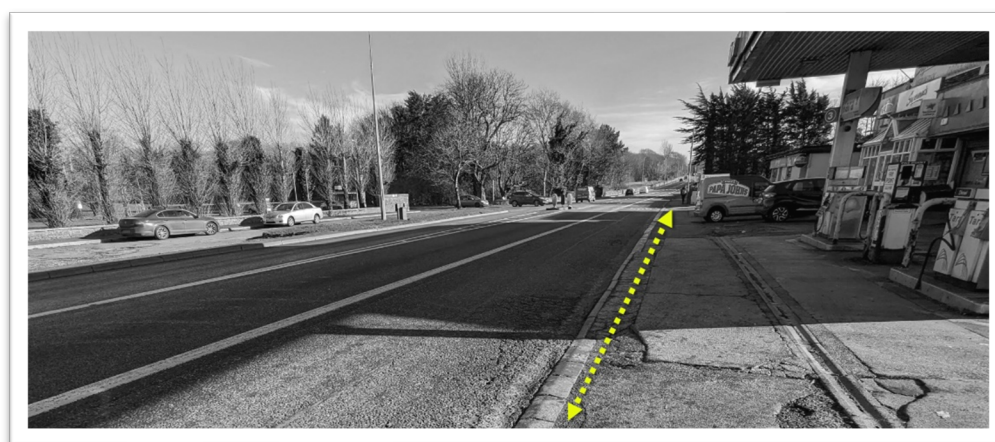
**Figure 3.6 – Vehicle Access Across Cycle Track & Footpath to Clustered Retail Site**

**Dwg. | Location: 00005 | Fast food Outlet & Petrol Station Opposite Hospital Access**

Frequent vehicle access to the fast food outlet and petrol station could place pedestrians and cyclists at an increased risk of conflict at this location.

The Designer should investigate interventions which might aggressively slow the vehicle speeds of drivers attempting to cross the cycle track and footpath at this location. This should be supplemented with measures to guide vehicles towards specific access points at each premises.

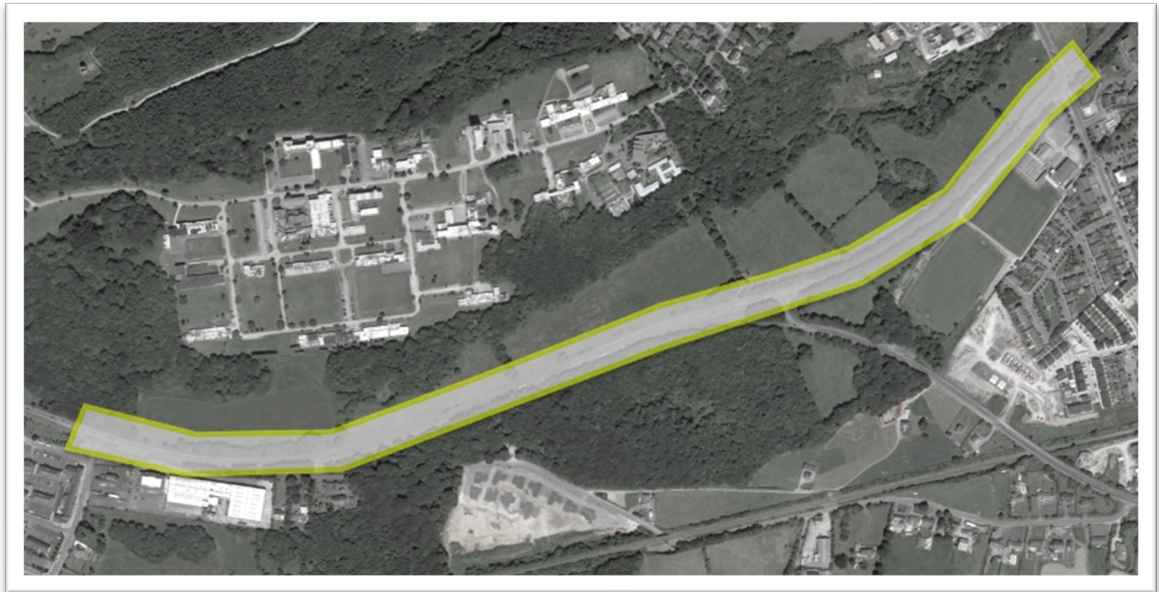
**Figure 3.7 – More Rural Section of Scheme Prone to Higher Vehicle Speeds**

**Dwg. | Location: 00006 - 00011| Galway Crystal to Doughiska Road**

The (less frequent) junction spacing and absence of development activity on this rural section of the scheme are likely to result in higher vehicle speeds. This could increase both the frequency and the severity of collision outcomes here.

Appropriate speed management measures should be set in place along this section of the scheme.
