**Environmental Impact Assessment  
Report (EIAR) Volume 3  
Quarry Extension Kilmacow, Co.  
Kilkenny**

**Roadstone Ltd  
Fortunestown, Dublin 24, Co.  
Dublin**

**Job Number: E2189**

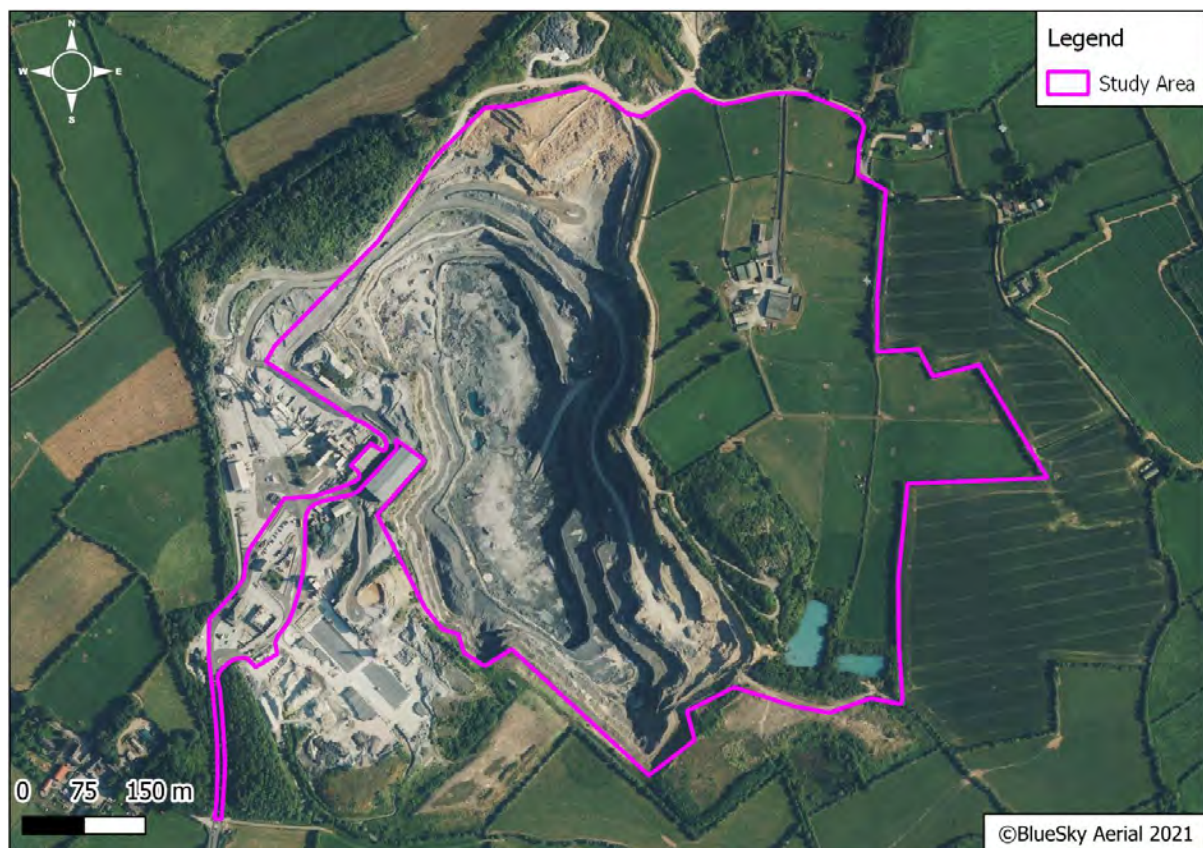
Figure 2-1: Study Area for Ecological Assessments

In order to gain a full understanding of the Site and surrounding habitats, the field-based assessment was extended to cover a larger study area as outlined in Figure 2-1 ('the Study Area'). The Study Area encompasses the full Site alongside Mr. Clohosey's landholding and the existing quarry void. The quarry void was included within the Study Area primarily as a potential peregrine falcon habitat.

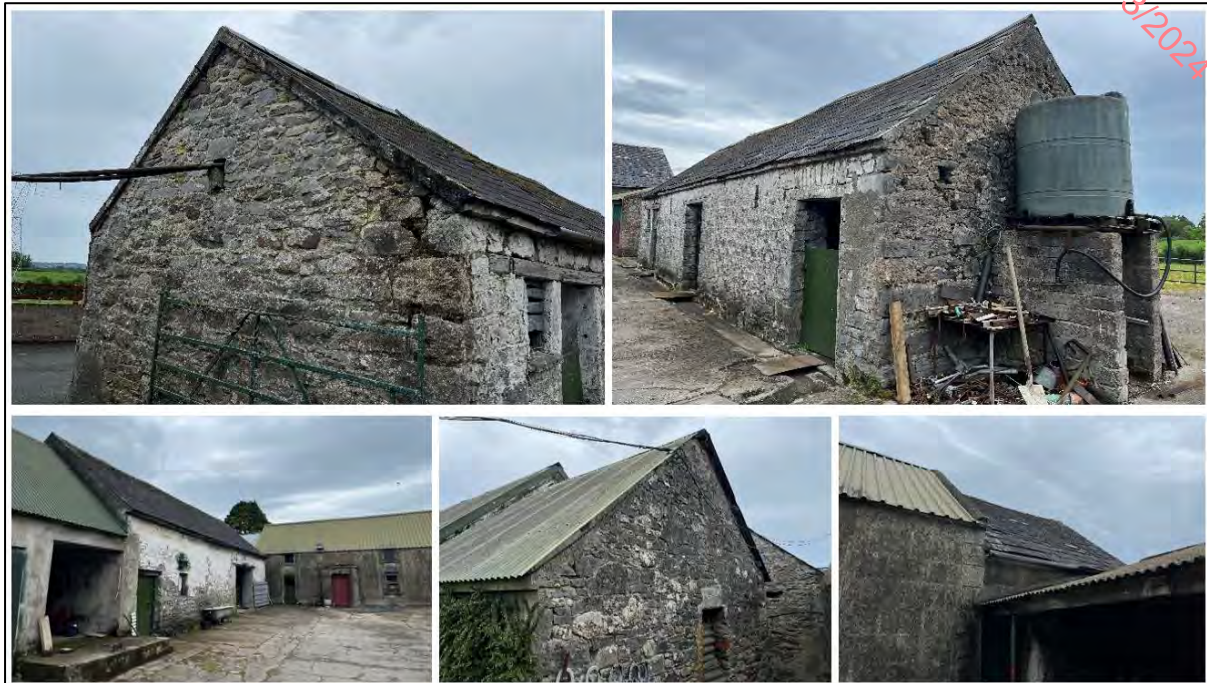
**Plate 3-1: Buildings with Potential Access Points for Bats**

It should be noted that although multiple access points were identified, no direct evidence of bats was recorded during the internal or external building inspections. The buildings considered to have moderate bat roost potential are shown in Plate 3-1 below.

All potential access points were subject to dusk emergence and dawn re-entry surveys.

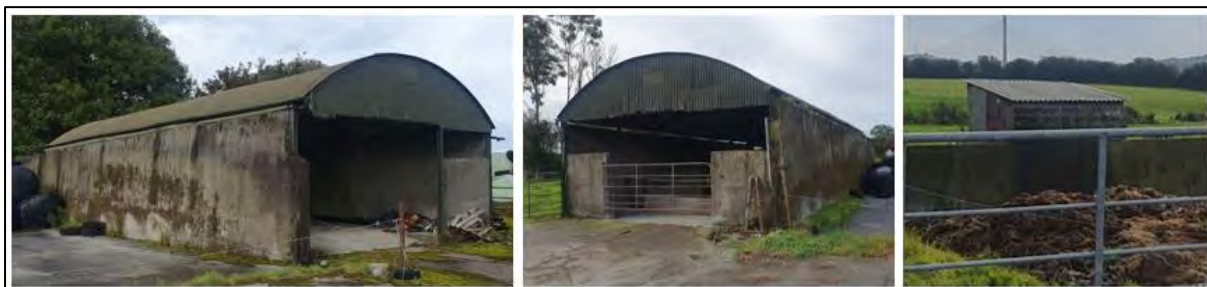
**Plate 3-2: Structures to be Removed as Part of the Proposed Development.**

The two (2No.) agricultural sheds and the pumphouse to be removed did not contain any features suitable for roosting bats nor any evidence of bat activity. These structures all have rendered walls and corrugated iron roofs. Refer to Plate 3-2 for context.

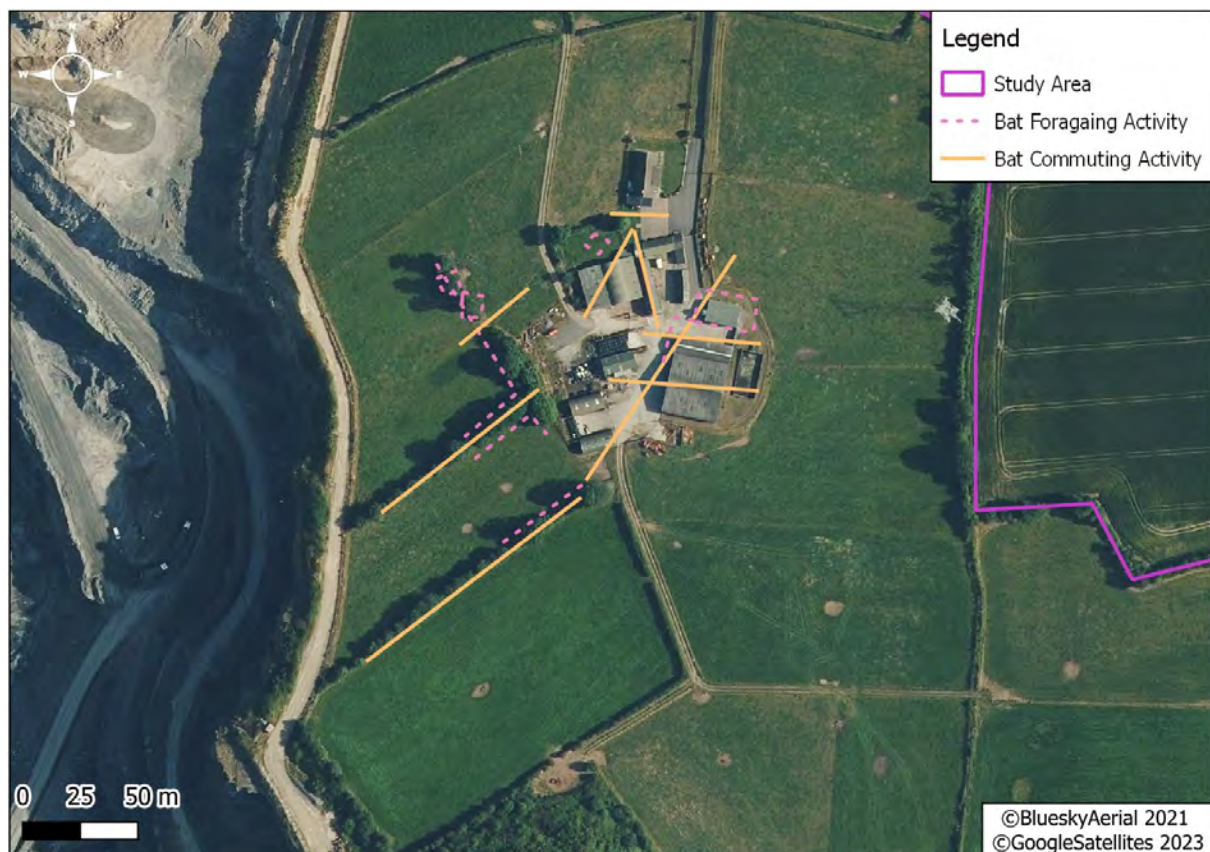
**Figure 3-3: Bat Foraging and Commuting Activity in 2022 and 2023**

Figure 3-3 below shows the foraging and commuting activity recorded during both the dusk emergence and dawn re-entry surveys conducted in 2022 and the dawn re-entry survey conducted in 2023.

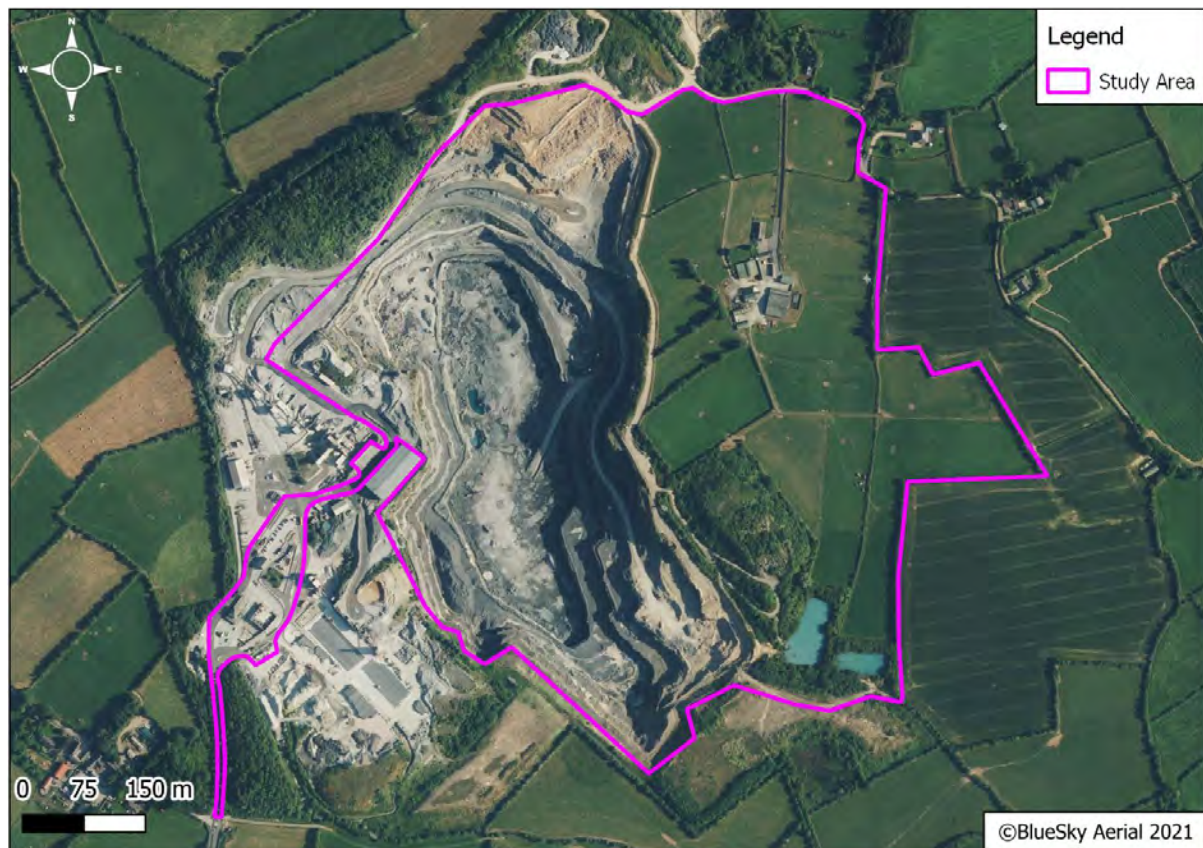
**Figure 2-1: Study Area for Ecological Assessments**

In order to gain a full understanding of the Site and surrounding habitats, the field-based assessment was extended to cover a larger study area as outlined in Figure 2-1 ('the Study Area'). The Study Area encompasses the full Site alongside Mr. Clohosey's landholding and the existing quarry void. The quarry void was included within the Study Area primarily as a potential peregrine falcon habitat.

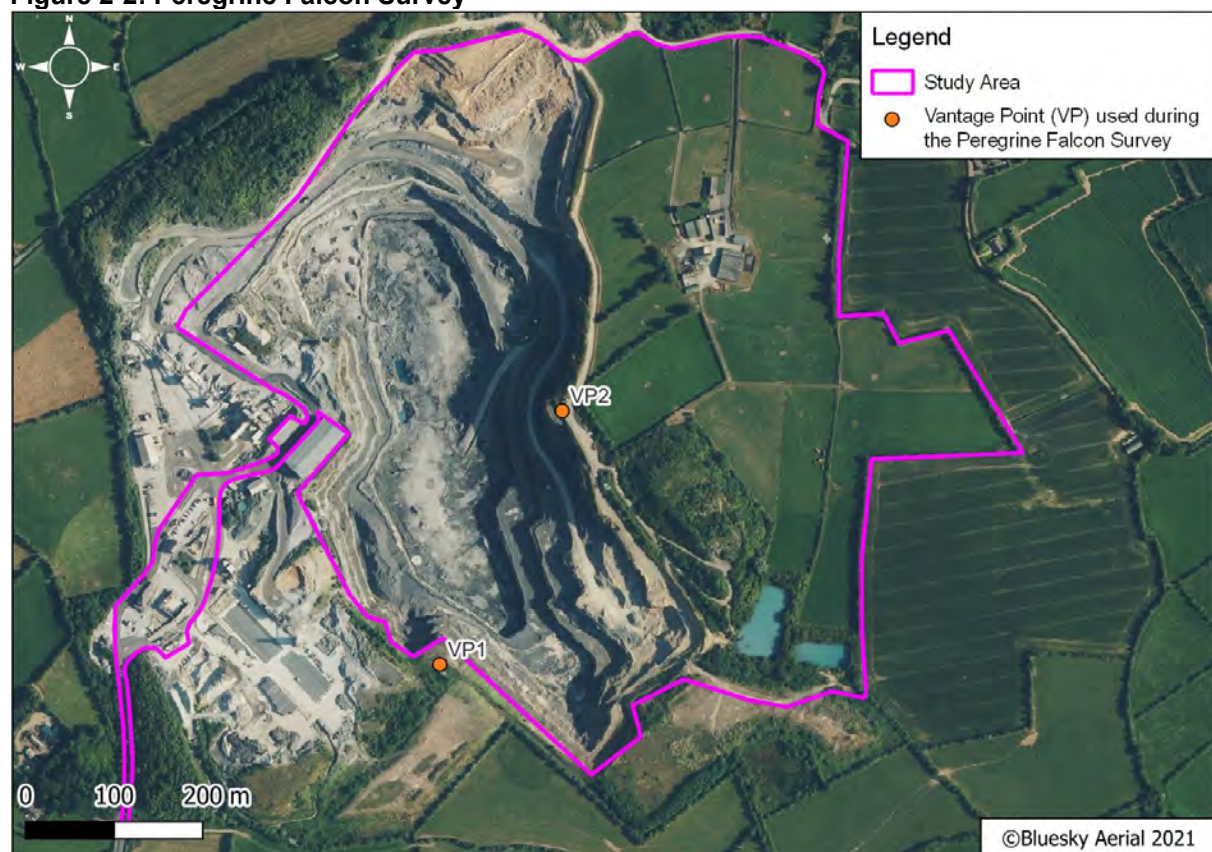
**Figure 2-2: Peregrine Falcon Survey**

The surveys were conducted over a 3-hour period and utilised designated Vantage Points (VPs), which provided appropriate views of the quarry walls within the Study Area that were noted as having potential nesting habitat for peregrine falcon (see Figure 2-2). It should be noted that VP locations were adjusted as required to get adequate views of potential nests or high activity areas identified during previous surveys. The vantage points were selected to ensure that no potential disturbance to peregrine falcon should they be present, occurred during the survey works.

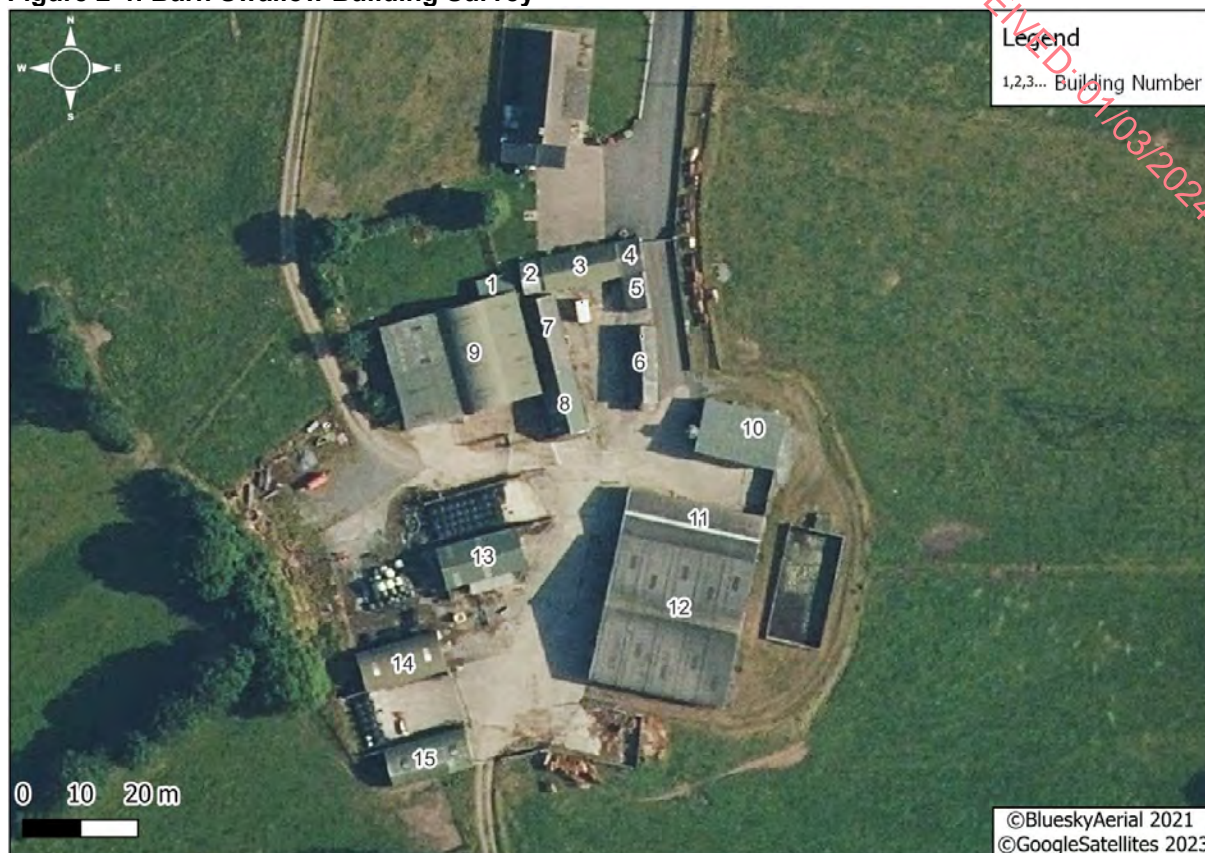
**Figure 2-4: Barn Swallow Building Survey**

Each building within the farmyard was given a reference number, refer to Figure 2-4 below for context. The surveyor recorded all species within these buildings (including any species flushed from the buildings upon entry), the behavioural activity of any species identified within the buildings was recorded using BTO breeding status codes [9], the maturity of the birds was also recorded where possible (i.e., juvenile or adult) and the number and location of nests within each building.

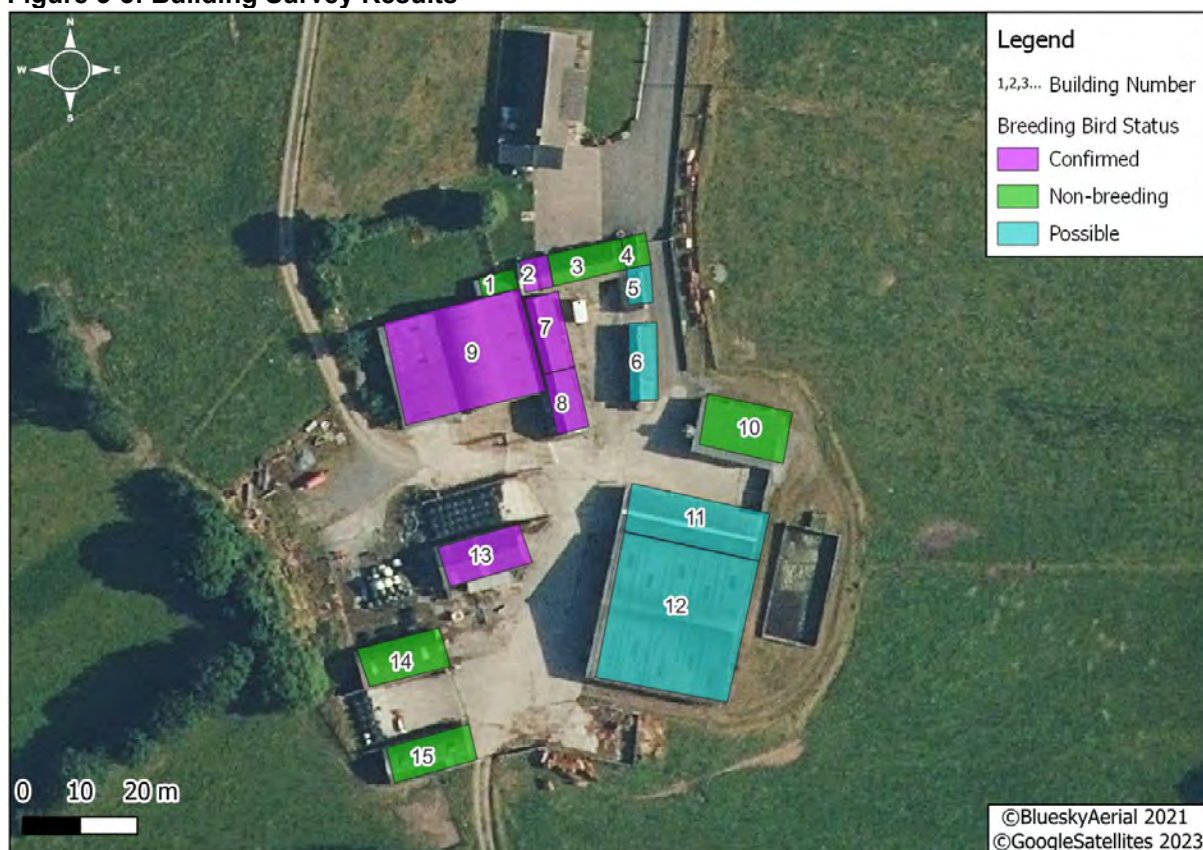
**Figure 3-3: Building Survey Results**

The results are presented in Figure 3-4 below. Also, please note that active starling nests were also identified as part of the barn swallow surveys. Records of starlings and other bird species identified during the barn swallow surveys have been included in Table 3-4 below.

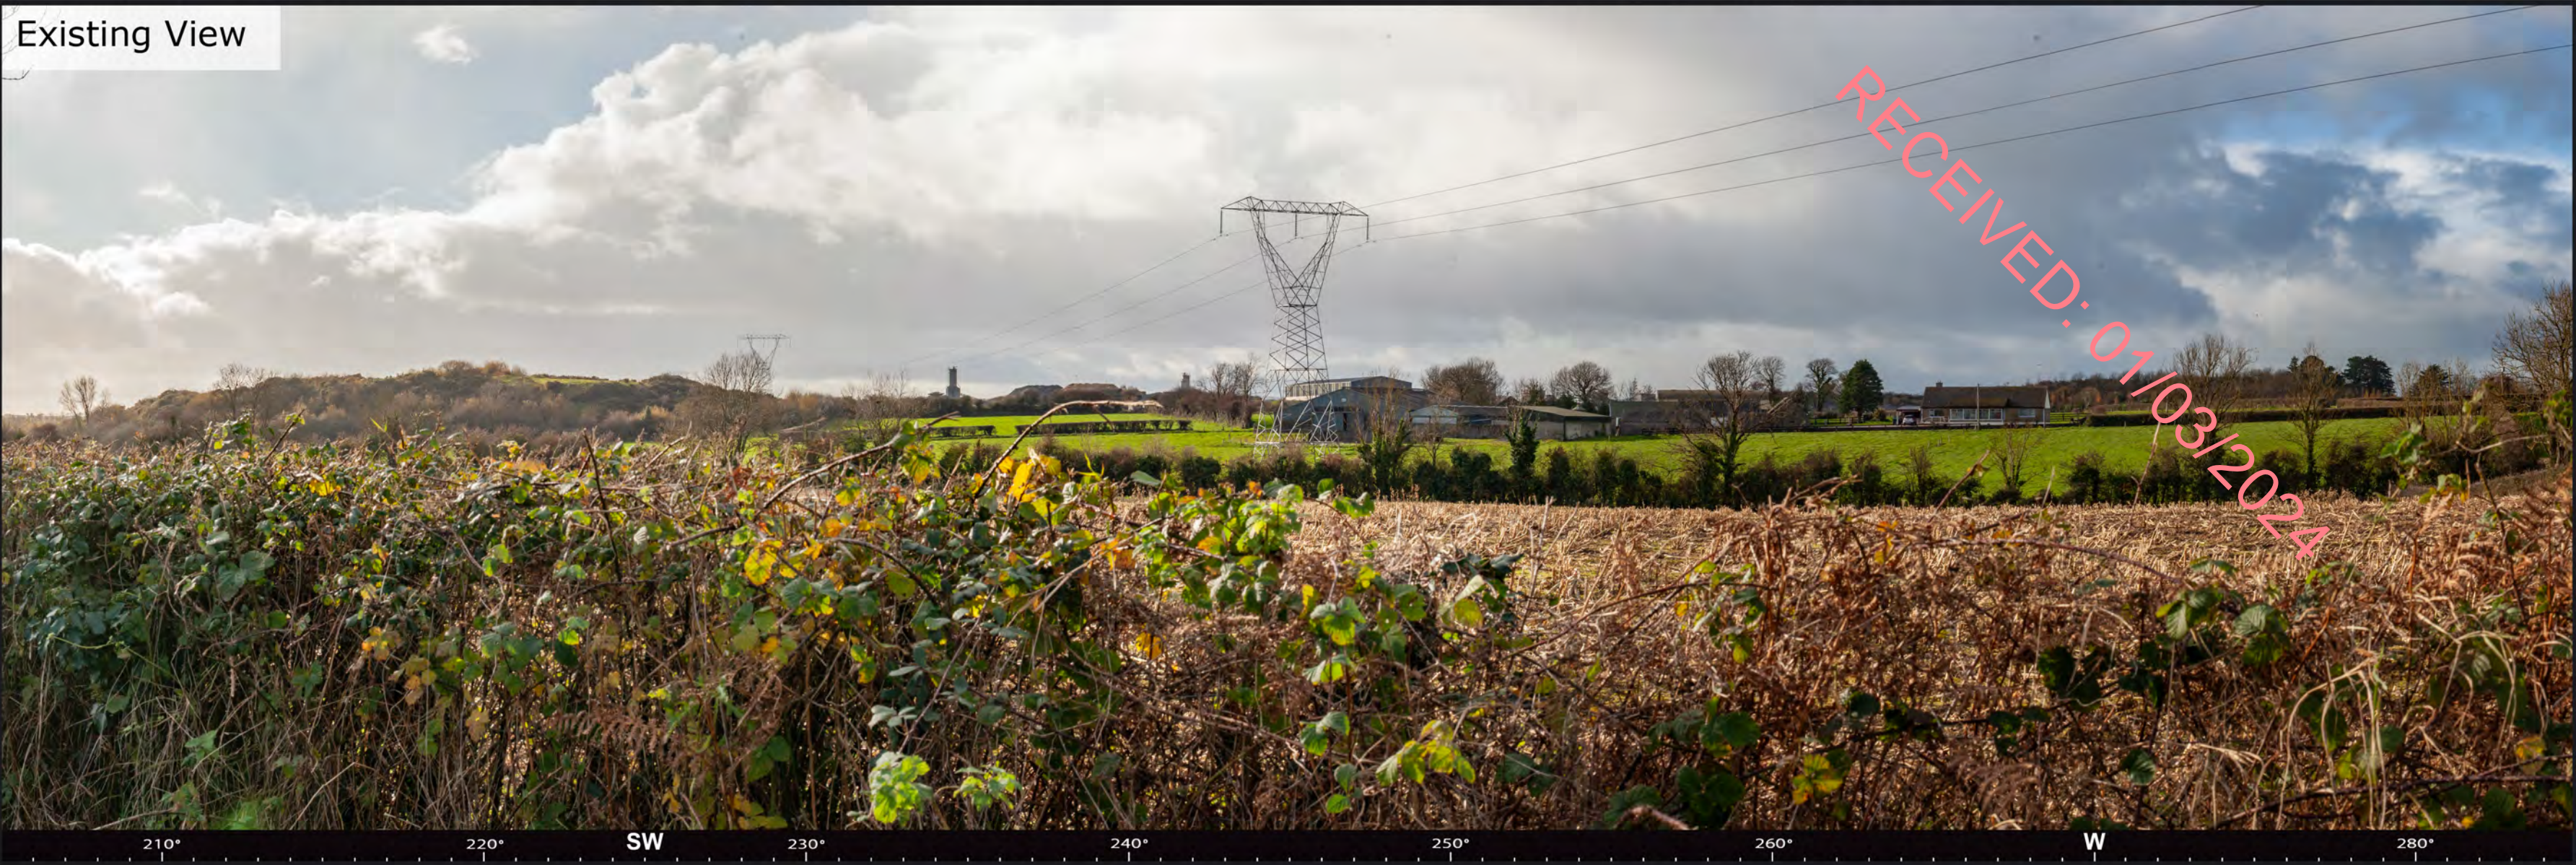
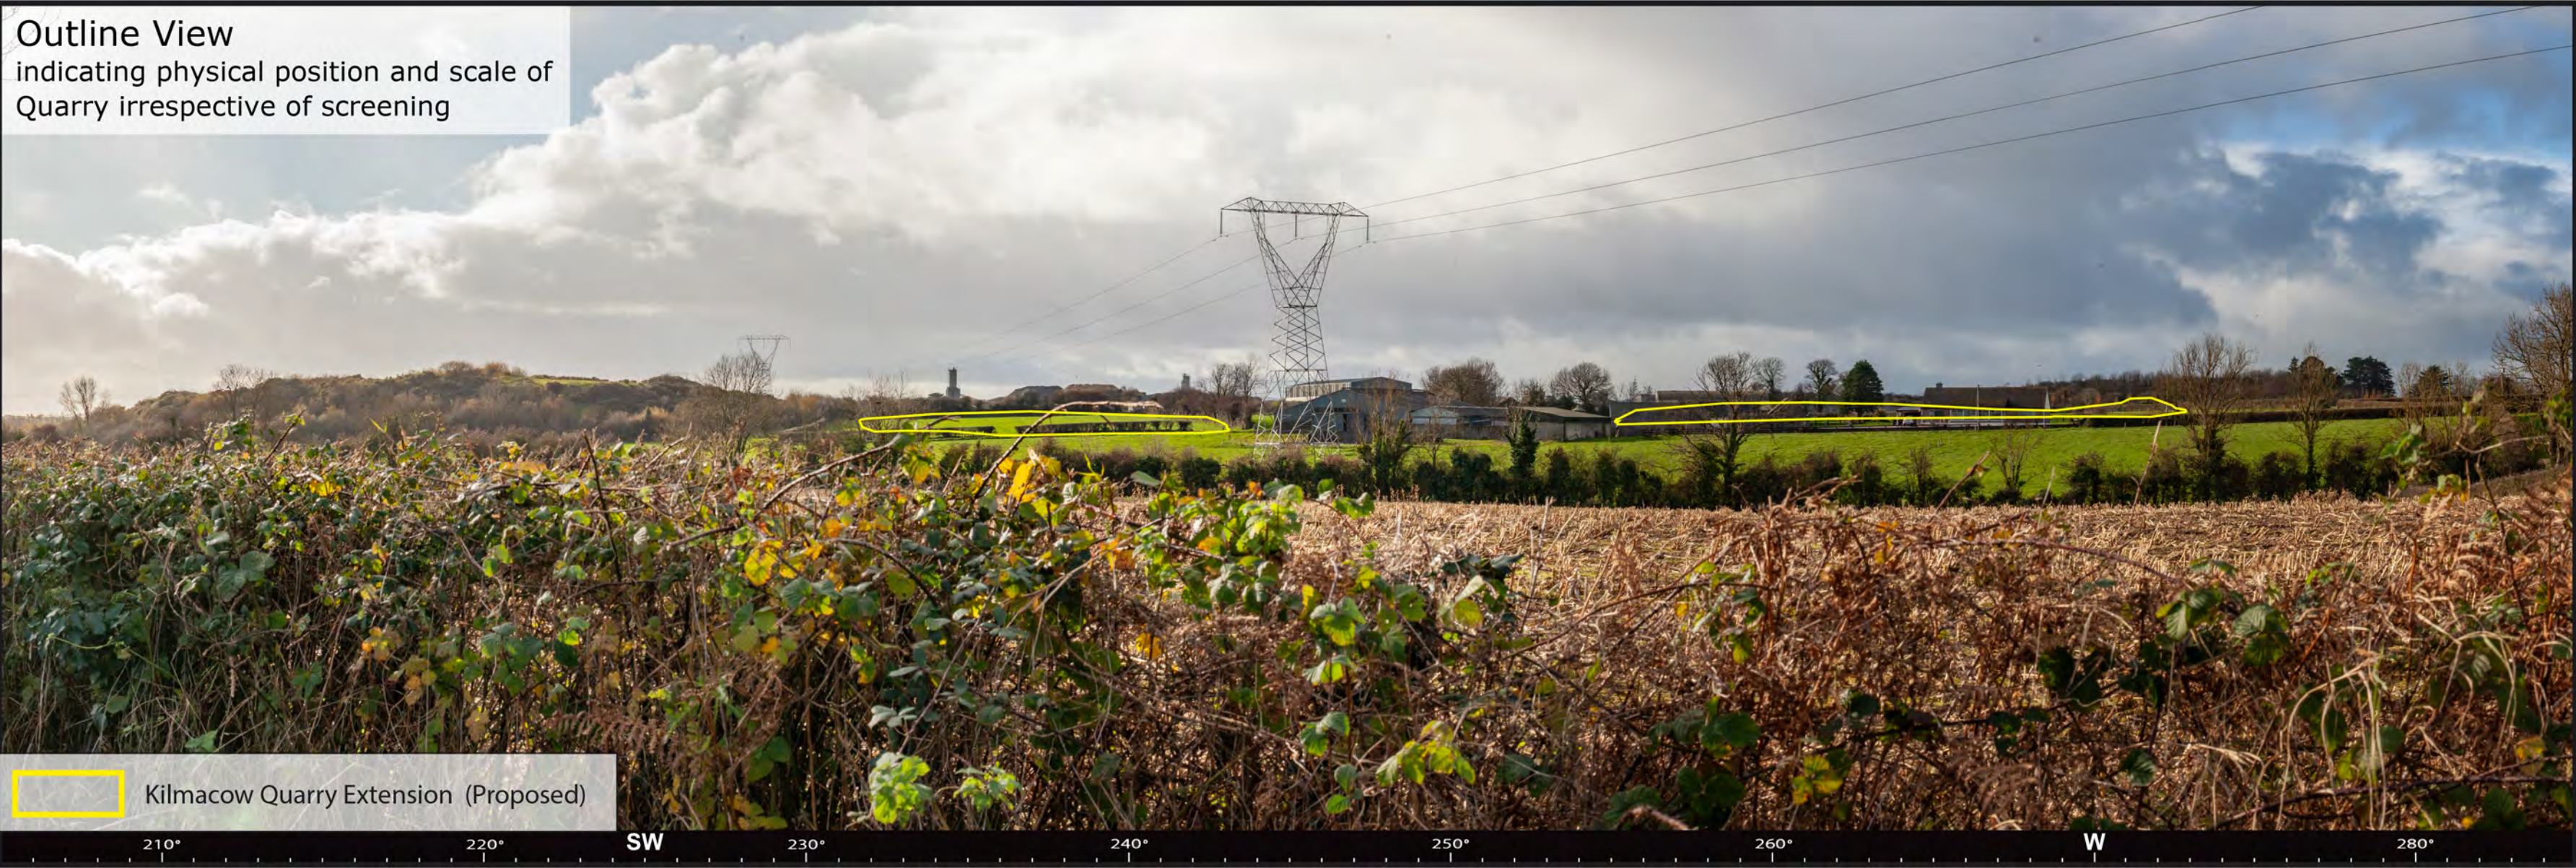
Existing View

Outline View  
indicating physical position and scale of Quarry irrespective of screening

These are 80° panoramic montages captured and presented in accordance with the guidance set by the British Landscape Institute 2011 - Advice Note 01/11.

To view these panoramas on a flat surface one must move from left to right along its length whilst maintaining a perpendicular viewing direction and the specified correct viewing distance of 30cm. To see this entire panoramic scene in reality would necessitate turning one's head through 40°.

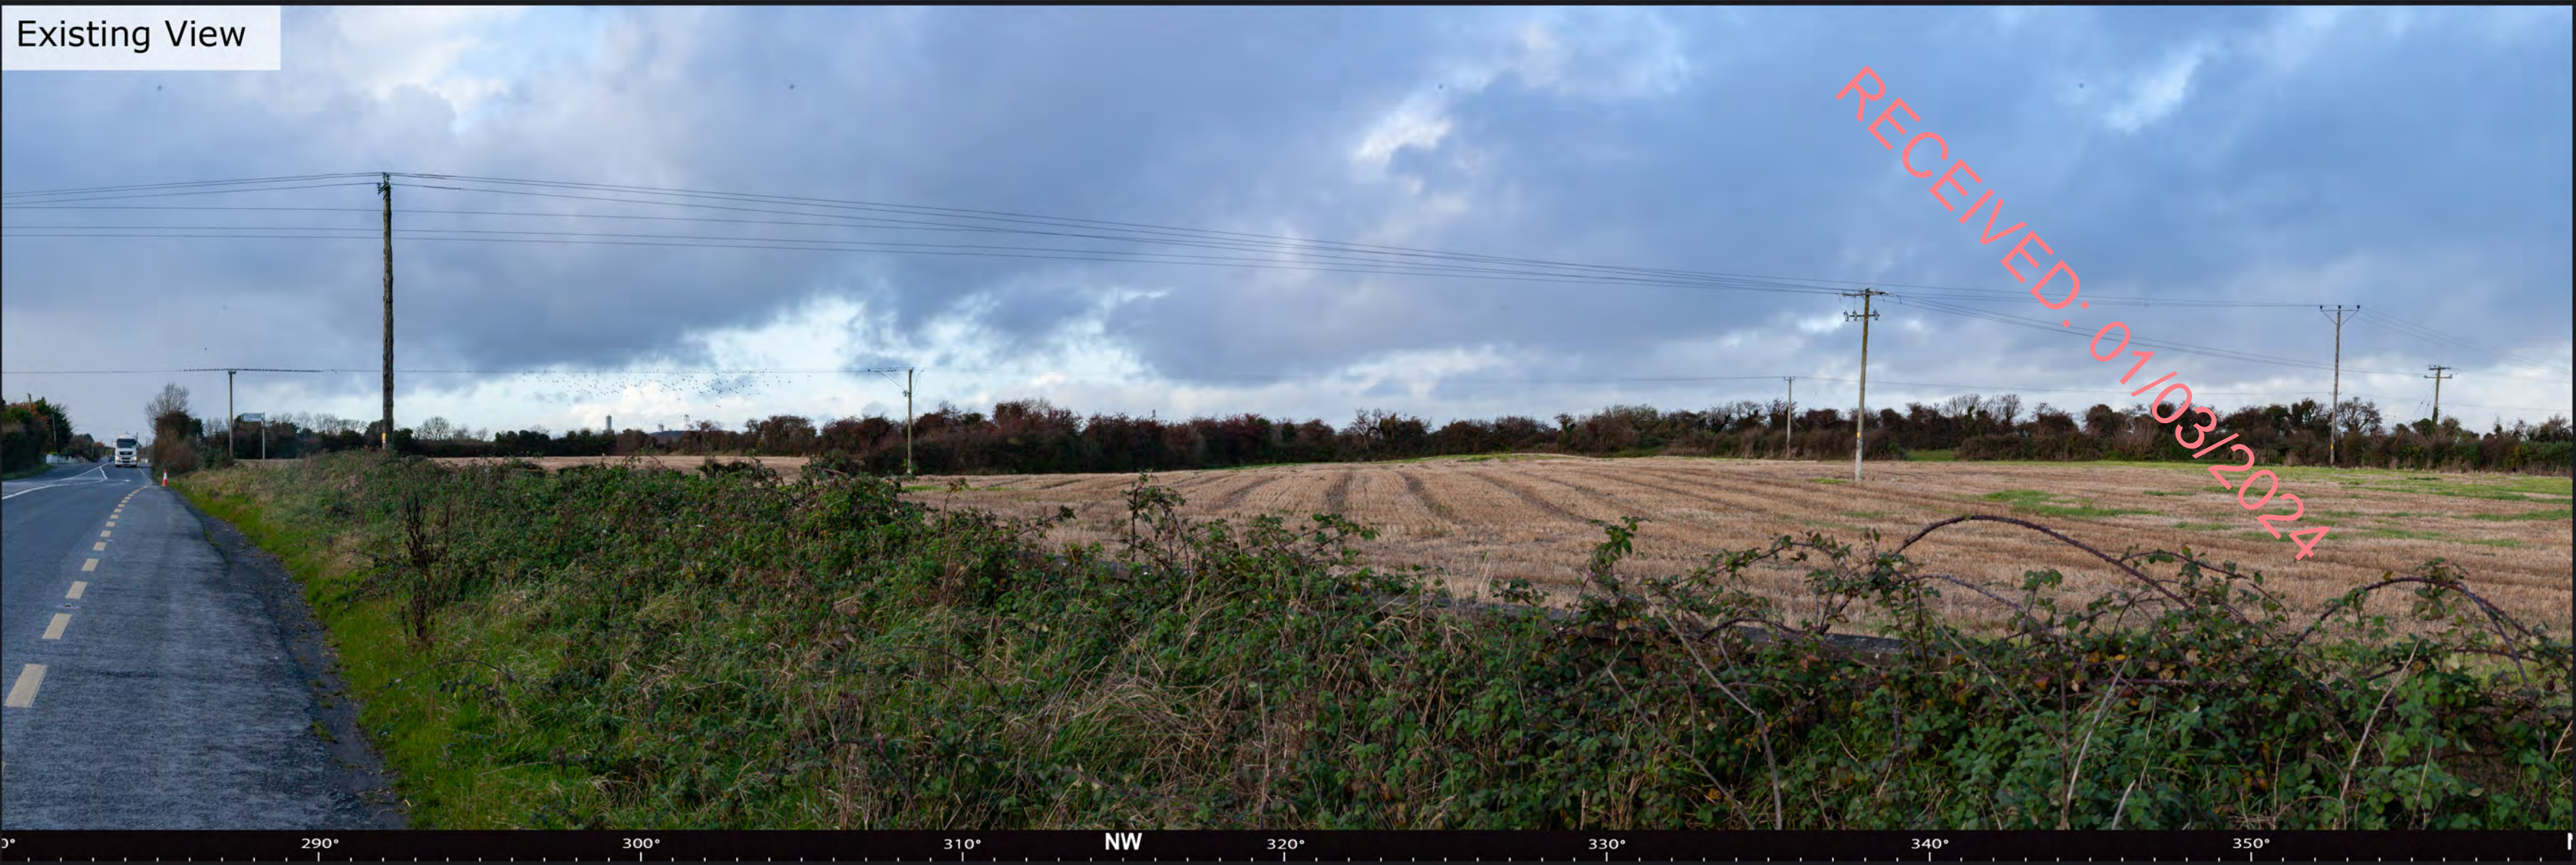
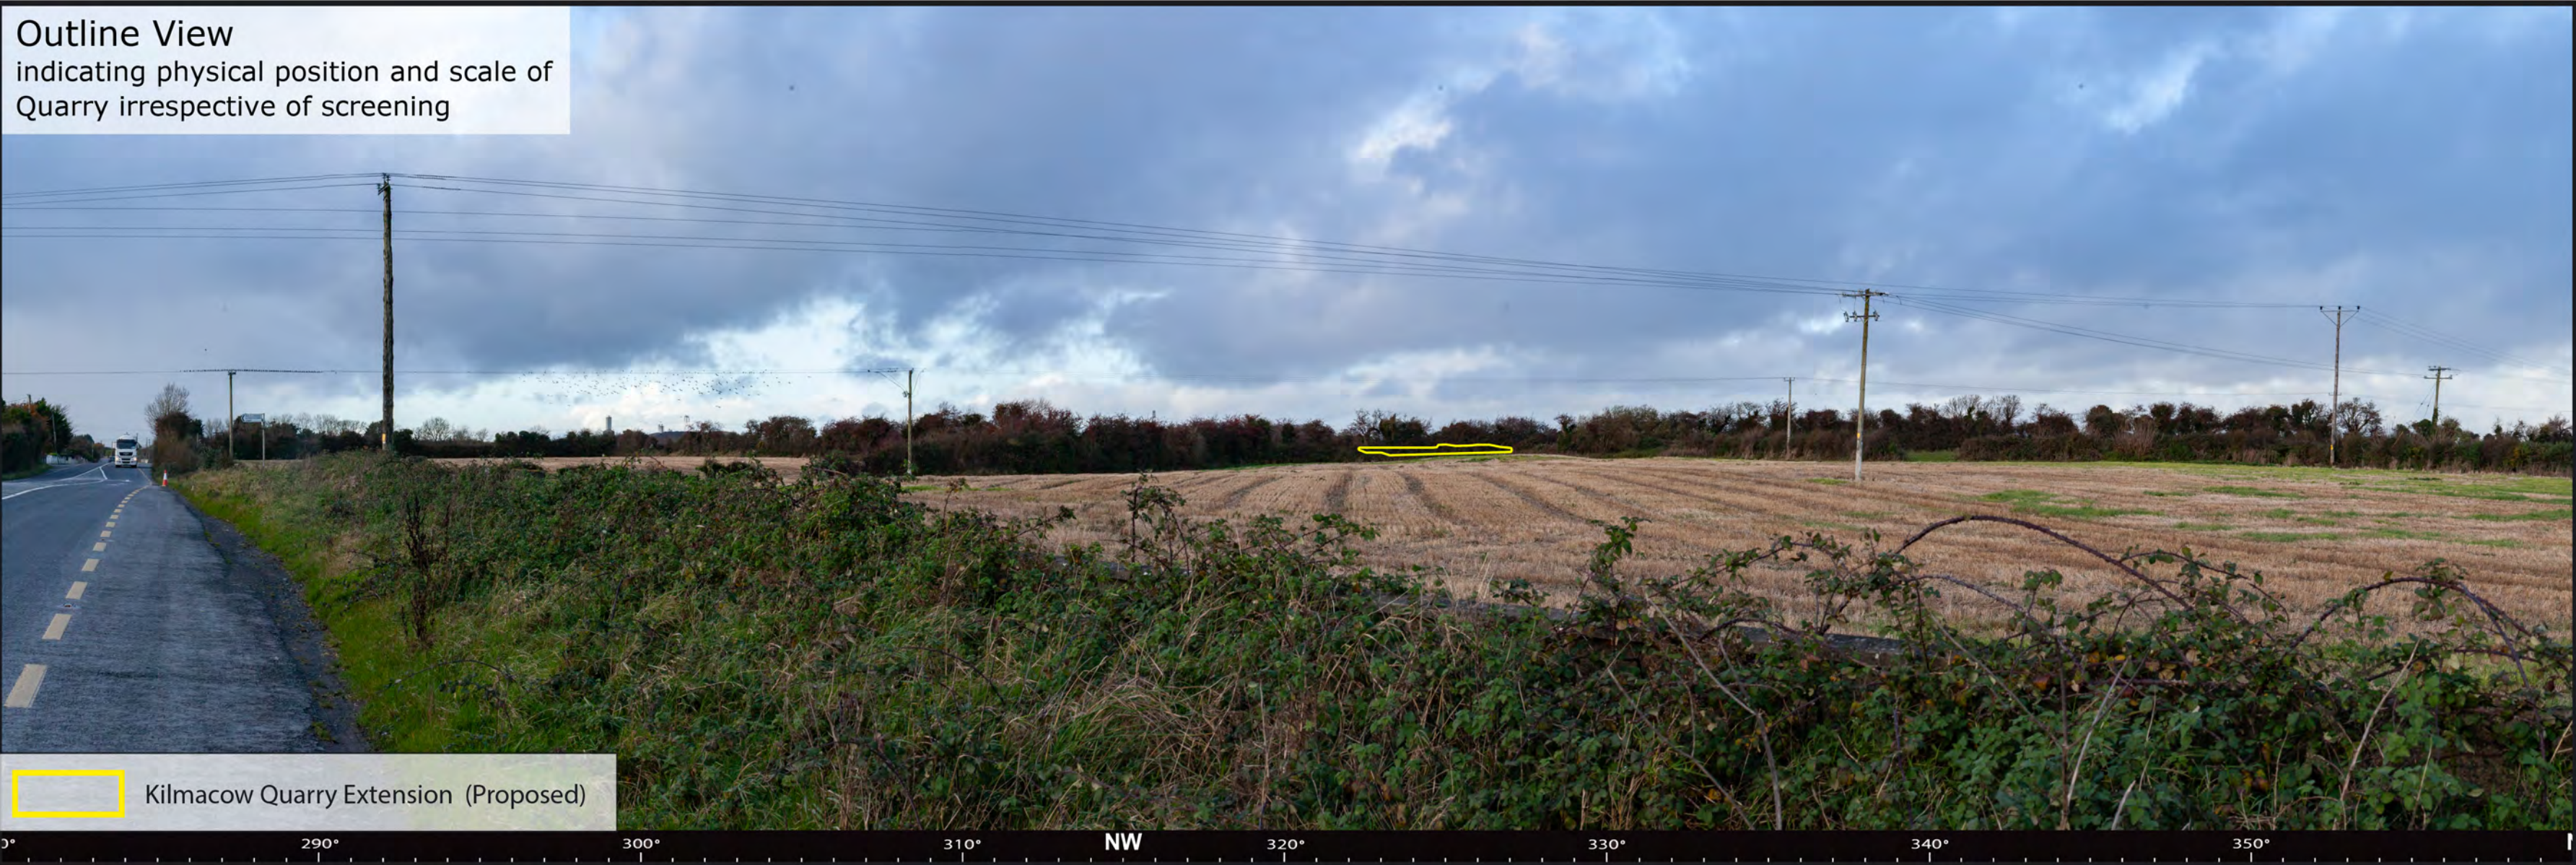
Existing View

Outline View  
indicating physical position and scale of Quarry irrespective of screening

These are 80° panoramic montages captured and presented in accordance with the guidance set by the British Landscape Institute 2011 - Advice Note 01/11.

To view these panoramas on a flat surface one must move from left to right along its length whilst maintaining a perpendicular viewing direction and the specified correct viewing distance of 30cm. To see this entire panoramic scene in reality would necessitate turning one's head through 40°.
