APPENDIX 7-1 (SPECIES LIST)

APPENDIX 7-2 (SURVEY EFFORT)

GEOTECHNICAL & PEAT STABILITY ASSESSMENT REPORT FOR CROAGH WIND FARM, CO. LEITRIM/SLIGO

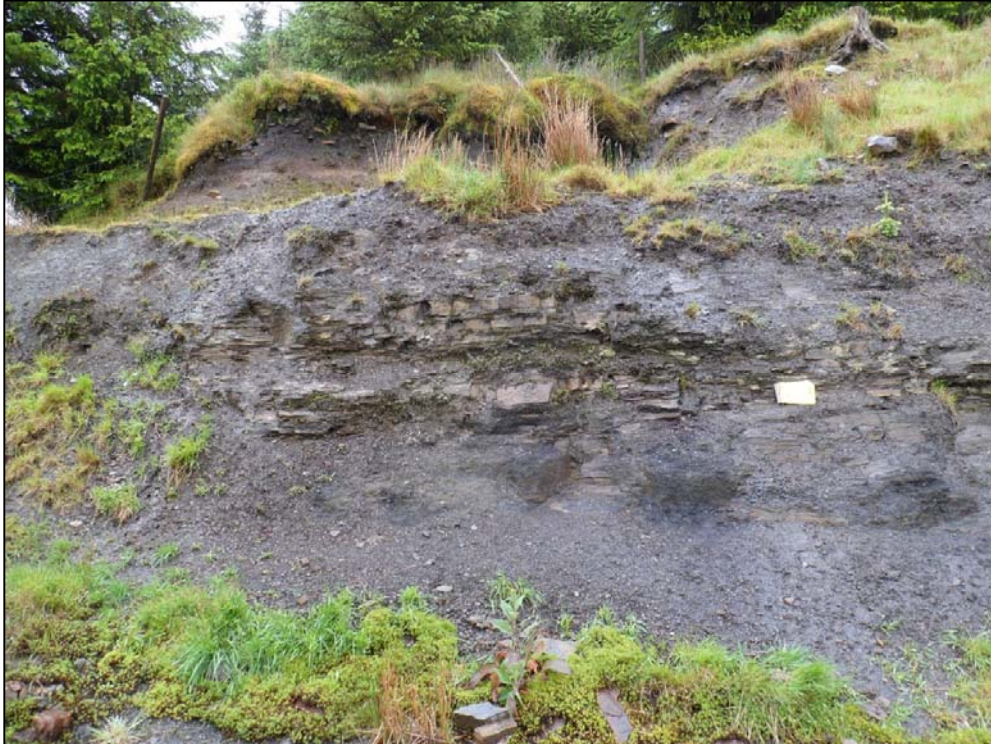
Photo 3 Example of ground profile at an existing excavation on site

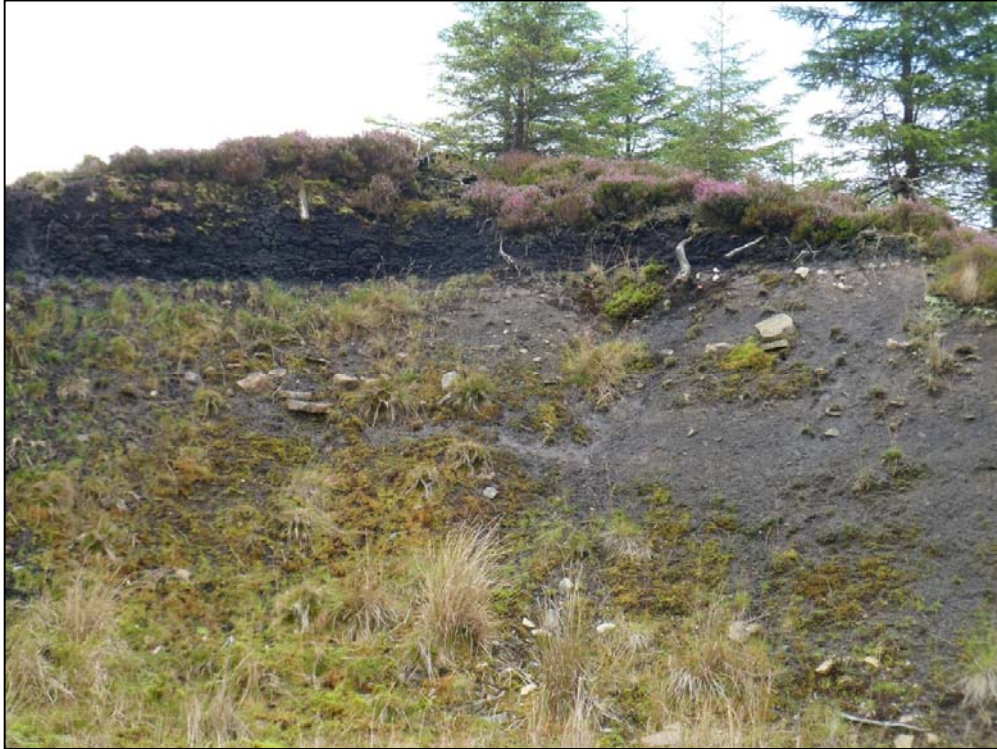
Photo 5 Example of ground conditions on site (peat overlying till)

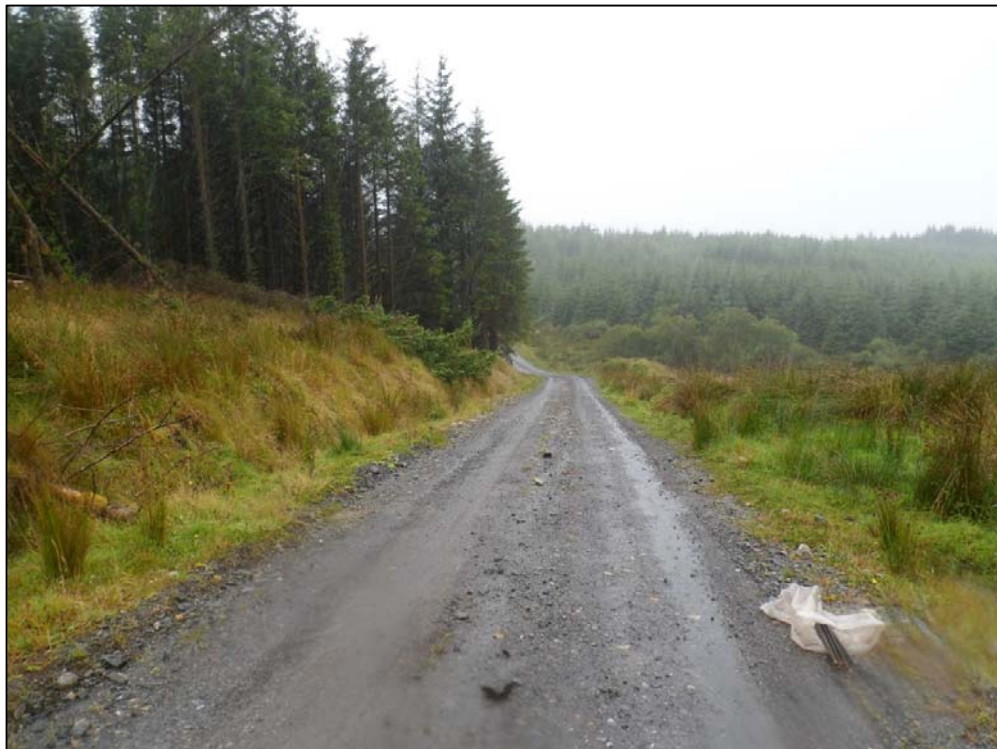
Photo 6 Example of founded access track on site

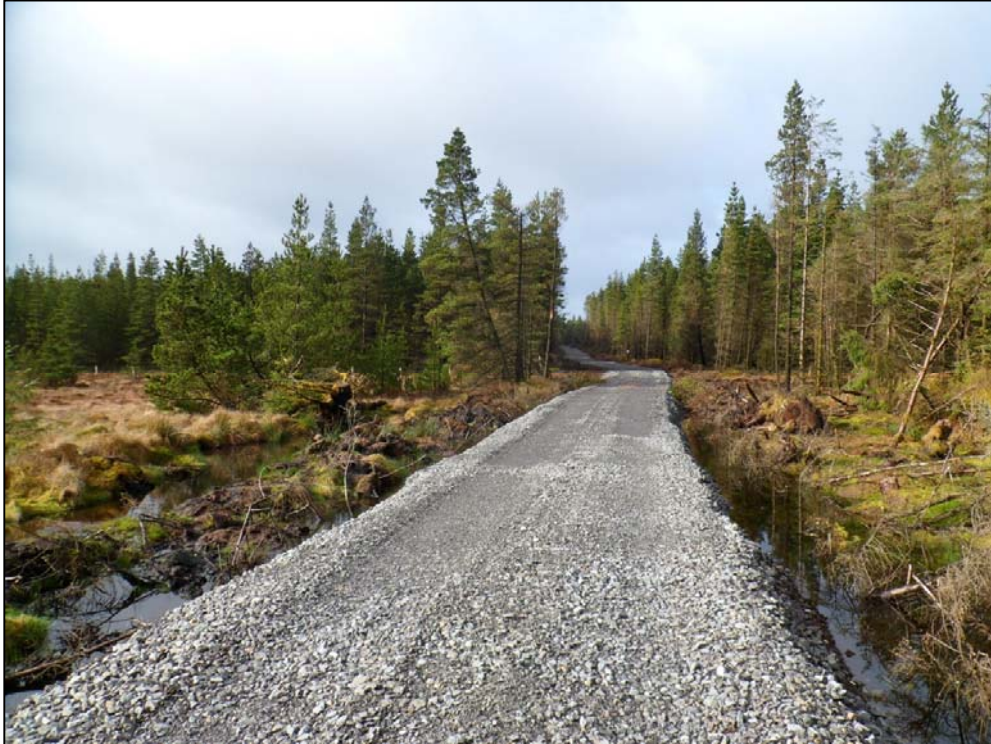
Photo 7 Example of floated access track on site

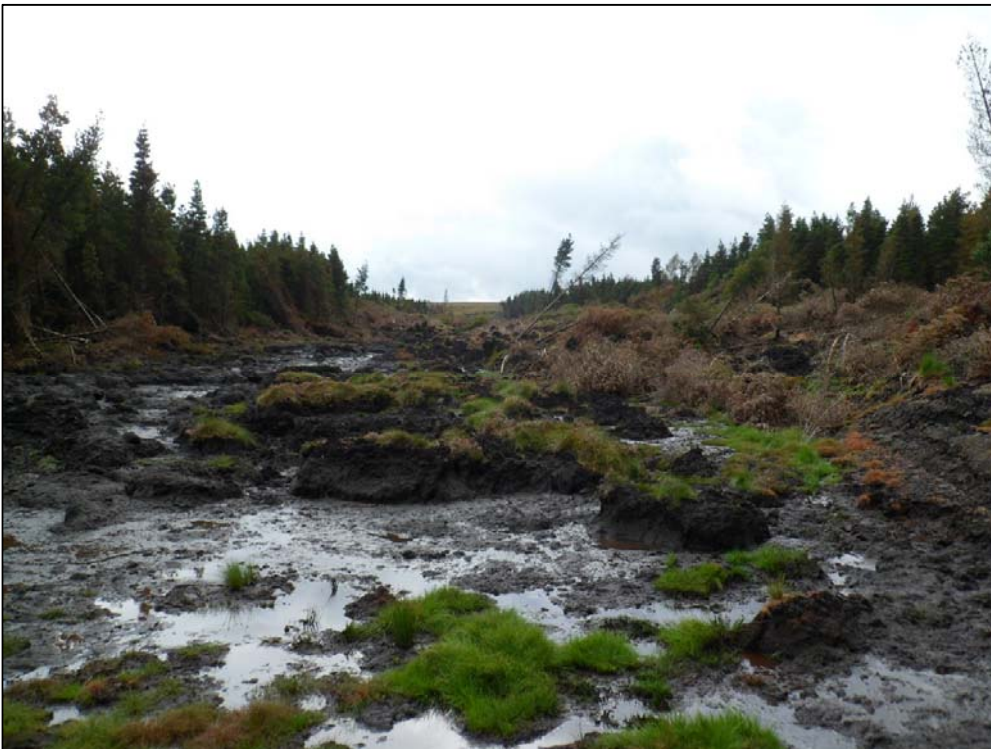
Photo 8 Overview of failure in the southwest of the site (looking south) – no development proposed for this area

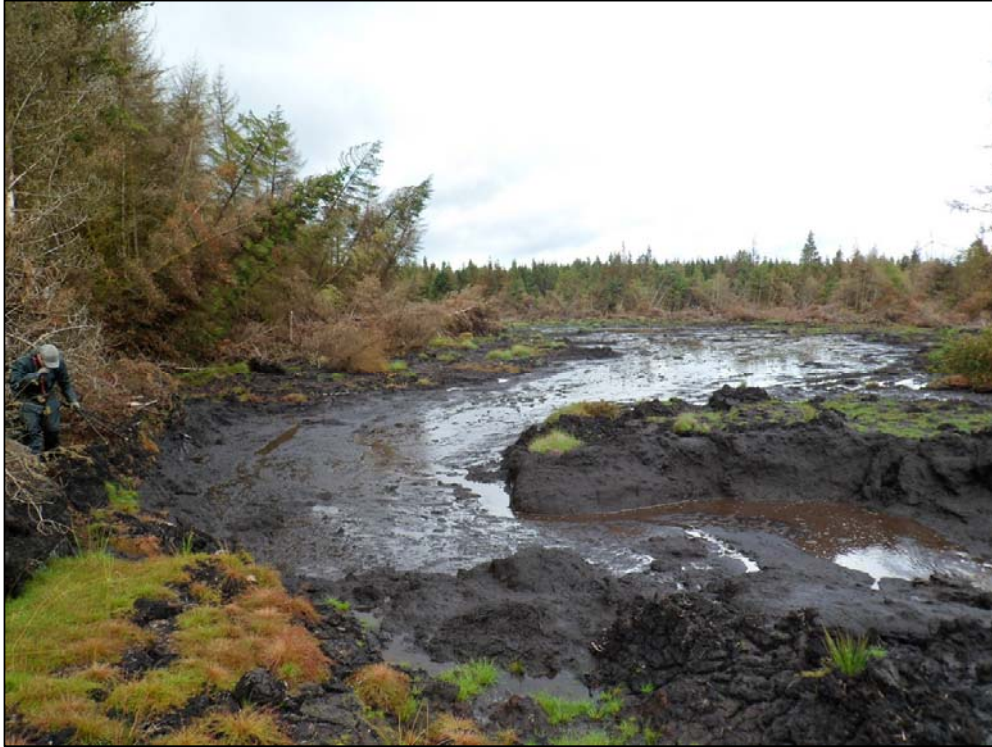
Photo 9 Overview of failure in the southwest of the site (looking north) – no development proposed for this area

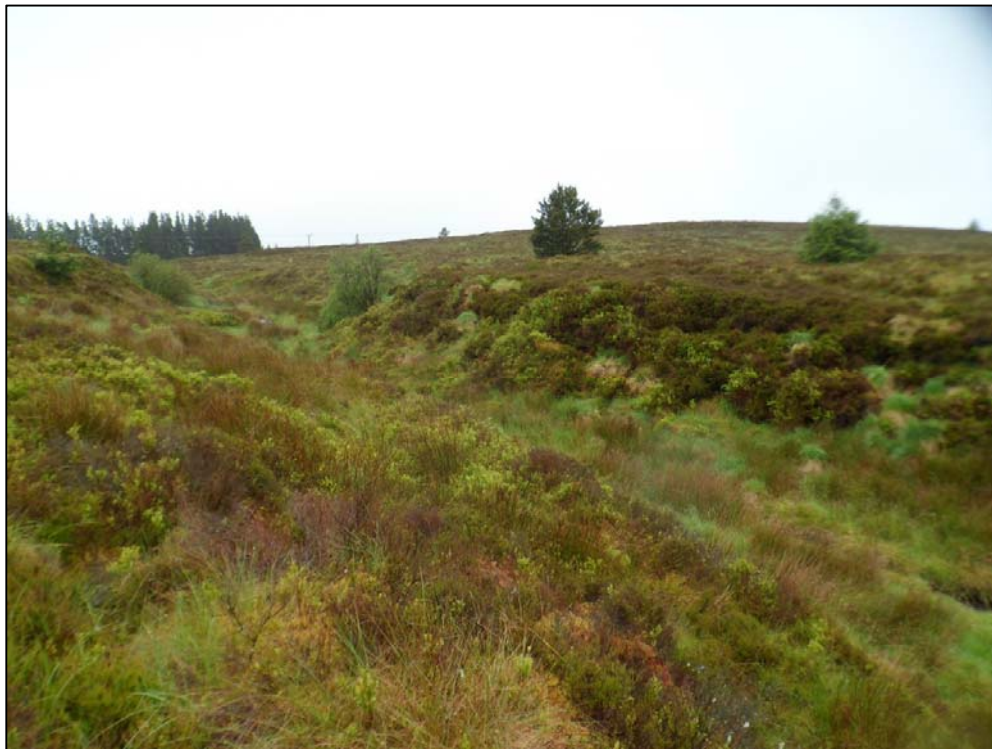
Photo 10 Watercourse crossing along proposed access route to turbine T1

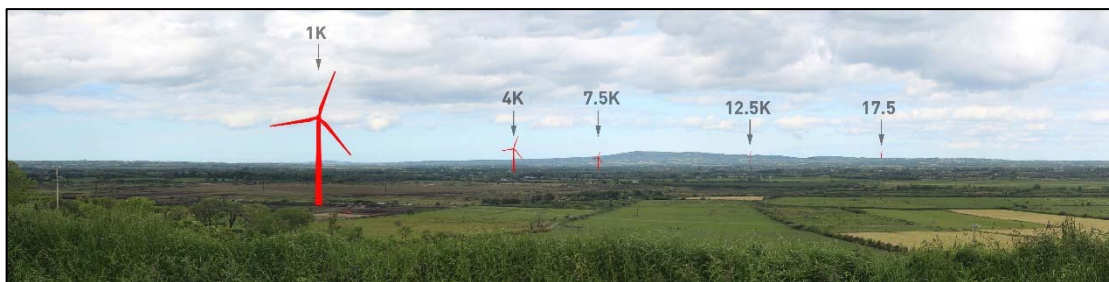
Figure 1-1 The effect of distance on visibility of wind turbines (Illustrative Purposes Only)

- The ZTV indicates areas from where a wind farm may be visible, but cannot show how it will look, nor indicate the nature or magnitude of visual impacts. The visibility of the turbines will decrease with the distance from which they are viewed, but this is not accounted for in the ZTV. Figure 11.1 below provides an illustration of the differences in view relative to the distance from a turbine.
