Remedial Environmental Impact Statement

Existing Quarry at Shannapheasteen,
Co. Galway

Project title: Connemara Granite Shannapheasteen Quarry

Document Title: Remedial Environmental Impact Statement

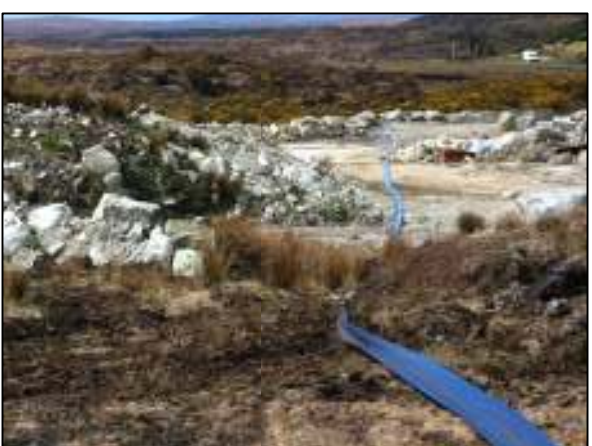
Photo 1-E
Water Discharge Pipe from
quarry floor.

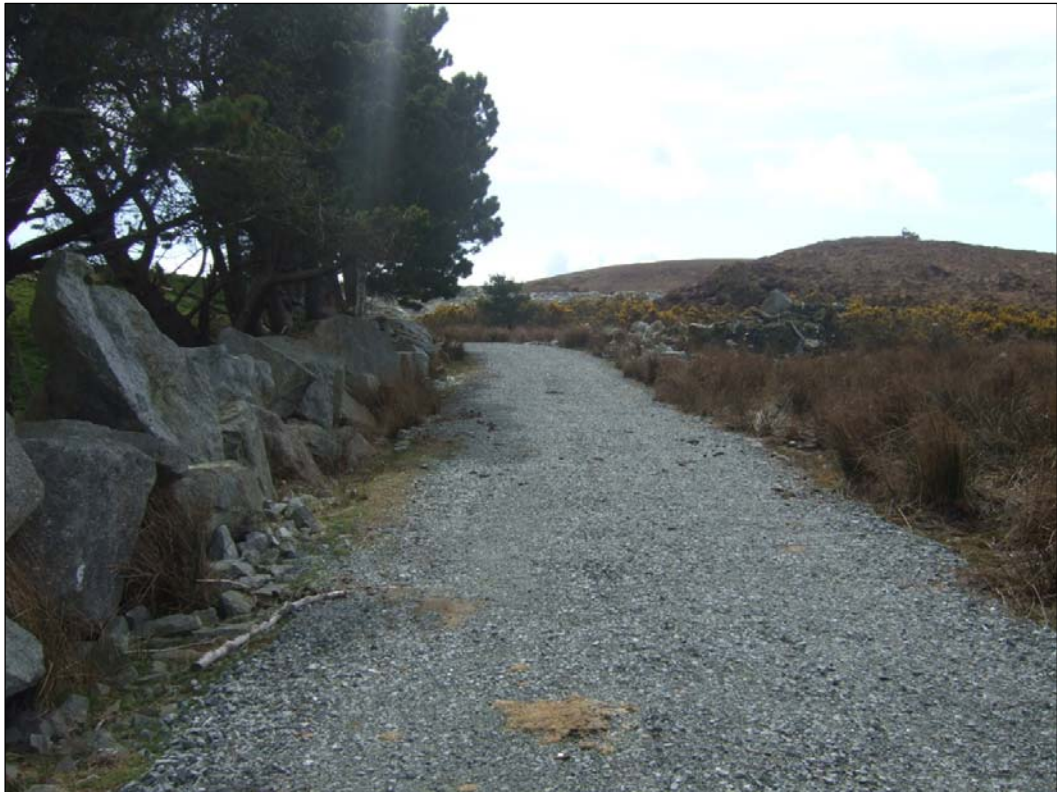
Plate 3.1 Quarry entrance road

The quarry site is accessed from the west via a junction with the L1201 local road in the townland of Shannapheasteen. The site entrance has a wide alignment easily capable of accommodating a truck entering or exiting the site. The quarry entrance roadway leading from the junction with the public road into the working area is unmettled, made up of compacted hardcore. A security gate at the site entrance prevents unauthorized entry when the site is not operational.

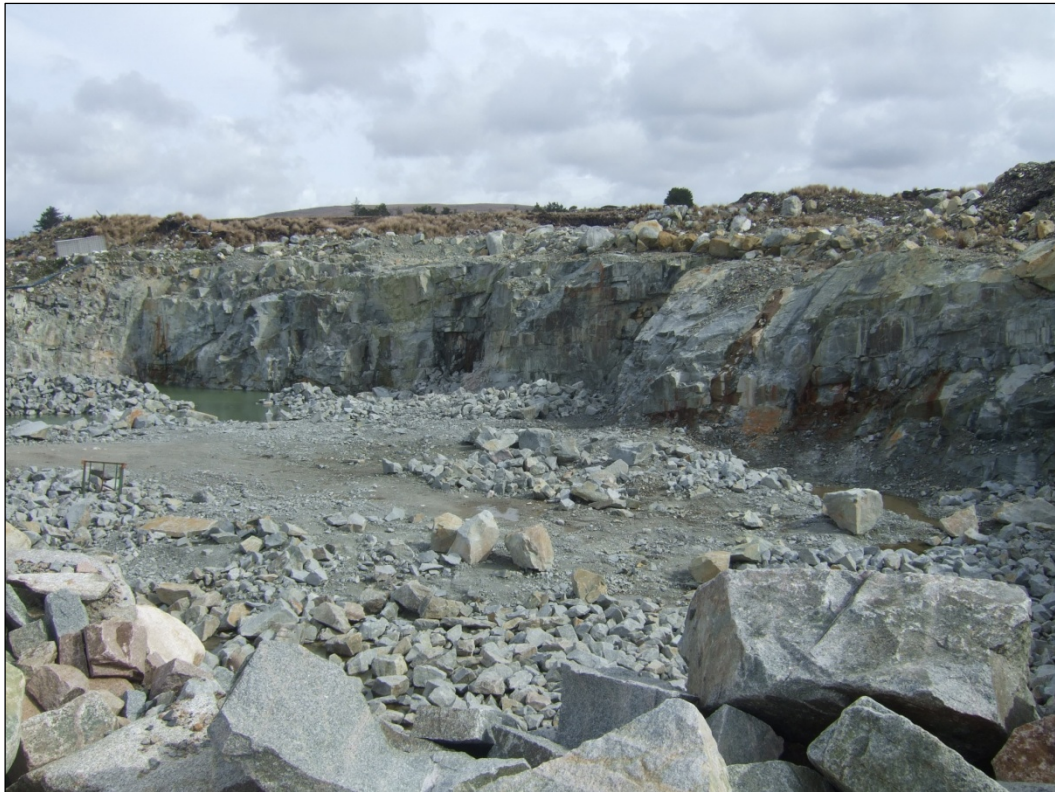
Plate 3.2 Main extraction area

The main rock area in which intensive quarrying activity has taken place in the southern area of the site, where a 0.25 hectare quarry pit and rock face has been developed, which extends to a depth approximately six metres below the surrounding land, as shown in Plate 3.2 below.

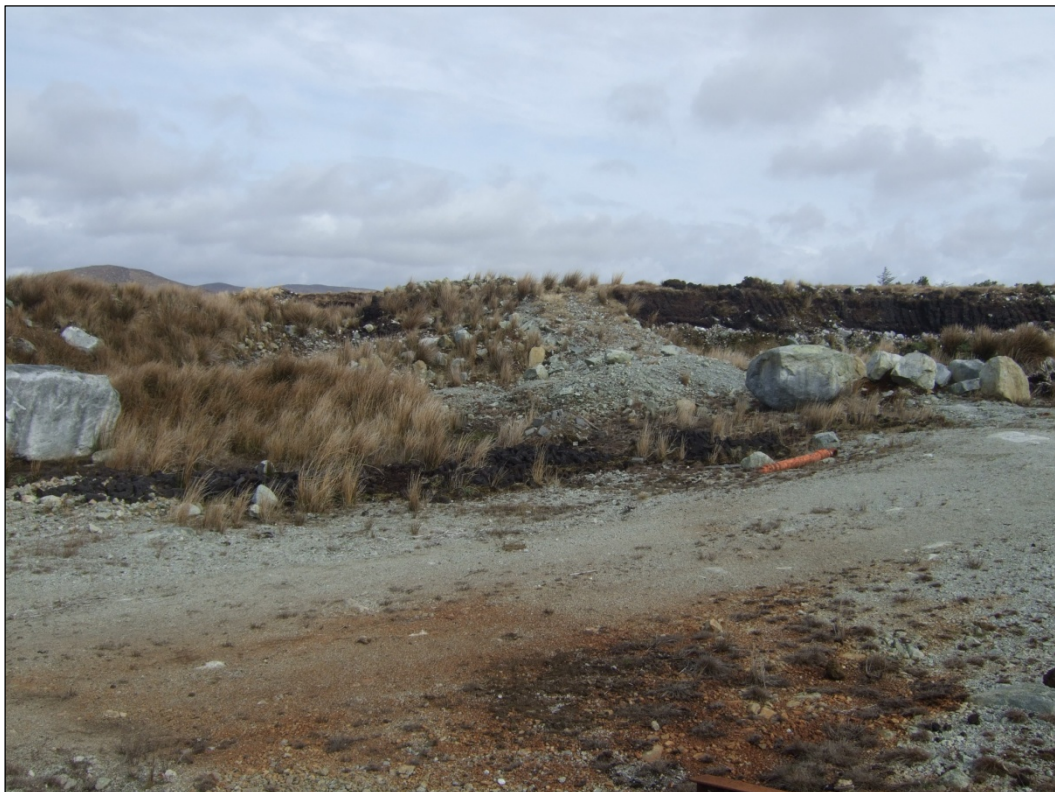
Plate 3.3 Disturbed areas where historical extraction operations were less intensive

Outside of the main extraction area, to the north and east an area measuring approximately 1 hectare was previously disturbed during the less-intensive recovery of aggregates. Work in these areas was primarily undertaken in the search for loose rock and subsoils that were used for local road building and maintenance.

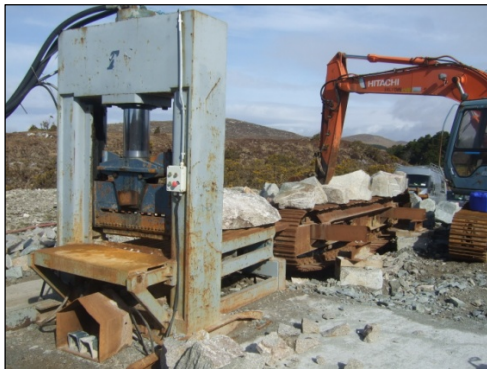
Stone from the extraction area is transported to an outdoor processing area consisting of a self-fabricated conveyor and stone guillotine. Stone is loaded onto the conveyor by an excavator, and the conveyor feeds the stone onto the guillotine table. The guillotine uses hydraulic pressure to fracture the rock into dimension stone suitable for the facing or cladding of buildings, or whatever end use is envisaged for the material. The processing of the stone to meet market demands and specifications is a time-consuming and labour intensive operation requiring considerable skill and craft.

Plate 3.4 Conveyor feeding stone guillotine

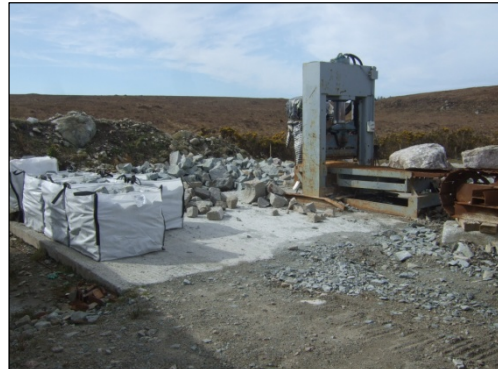
Plate 3.5 Bagged stone ready for transport

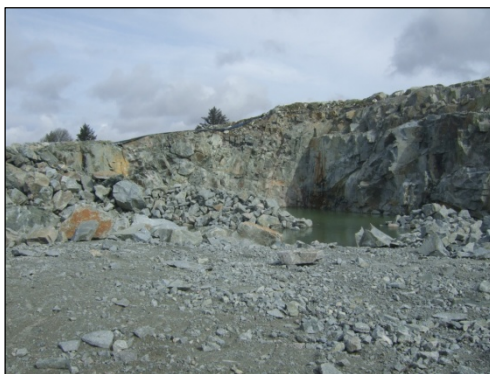
Plate 3.6 Sump in base of extraction area

The depth of excavation and current quarry floor level has not intercepted the water table, and therefore only precipitation and site runoff has to be managed within the quarry area. This is achieved by means of a sump, located in the northern portion of the main extraction area, into which most of the water from the disturbed area of the quarry drains. Water draining to the sump is allowed to settle for long periods of time, before being pumped periodically up to a filtration area where water is distributed evenly over a large, well-vegetated area of peatland as diffuse overland flow. The discharged water disperses through the vegetation which acts as a further vegetation or polishing filter, where it is largely reconverted to groundwater through infiltration of the peat.

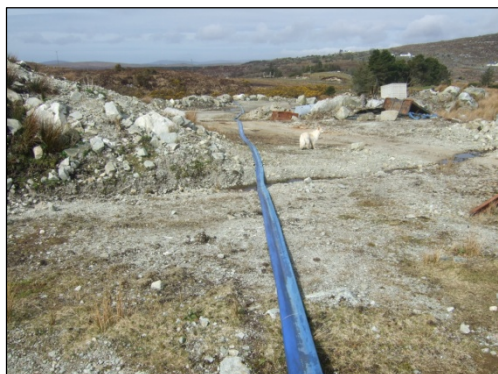
Plate 3.7 Hose running from extraction area to vegetation polishing filter

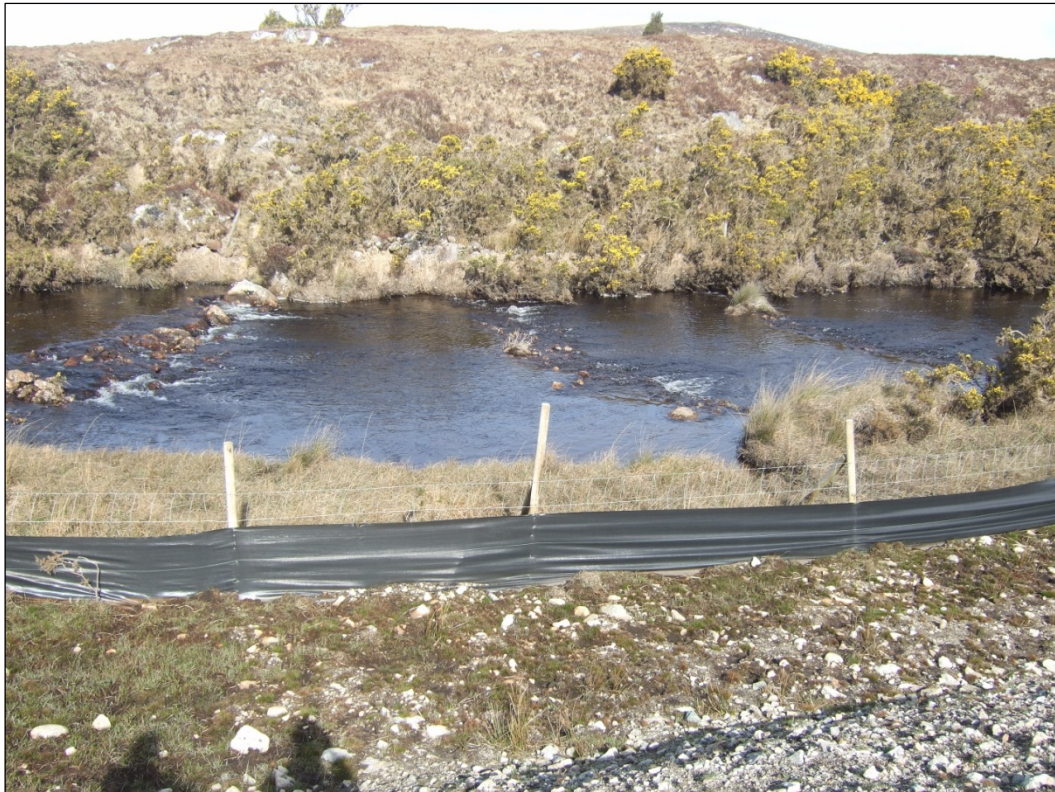
Protection is afforded to the adjacent Shannapheasteen River from potentially silt-laden run off from the exposed quarry area by means of a silt fence.

Plate 3.8 Silt fence embedded in ground and attached to wooden stakes to protect river

The existing silt fence that runs parallel to the Shannapheasteen river is to be repaired where required, and supplemented with a second fence to provide further protection to the river.

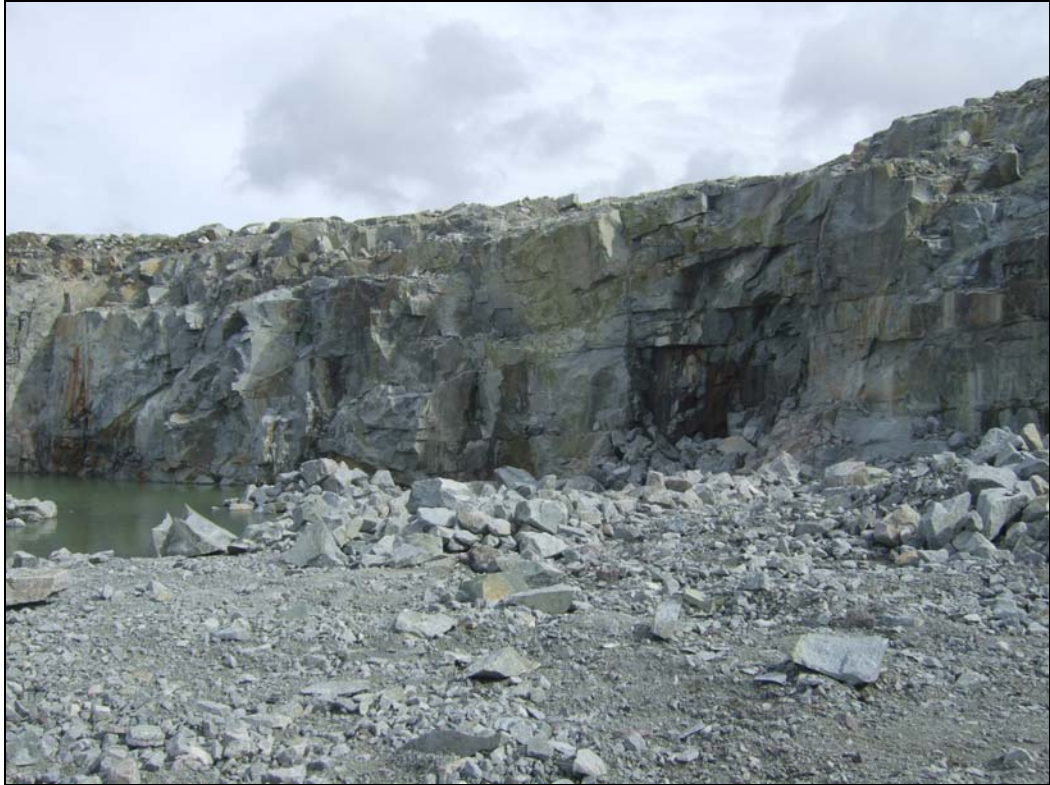
Plate 6.1 Exposed Shannapheasteen Granite bedrock at the subject quarry site

Felsic and very fine-grained facies intrude the Shannapheasteen Granite and there are aplite and almandine-spessartine aplites crossing the granite. Some of these late veins seem to grade into felsitic dykes (e.g. east of Lough Bonnamush at (M030281) but such dykes and porphyry dykes also cross the Shannapheasteen Granite. A map of the bedrock geology in the area of the site is provided in Figure 6.1. Plate 6.1 and 6.2 show photographs of the excavated bedrock taken at the quarry site.

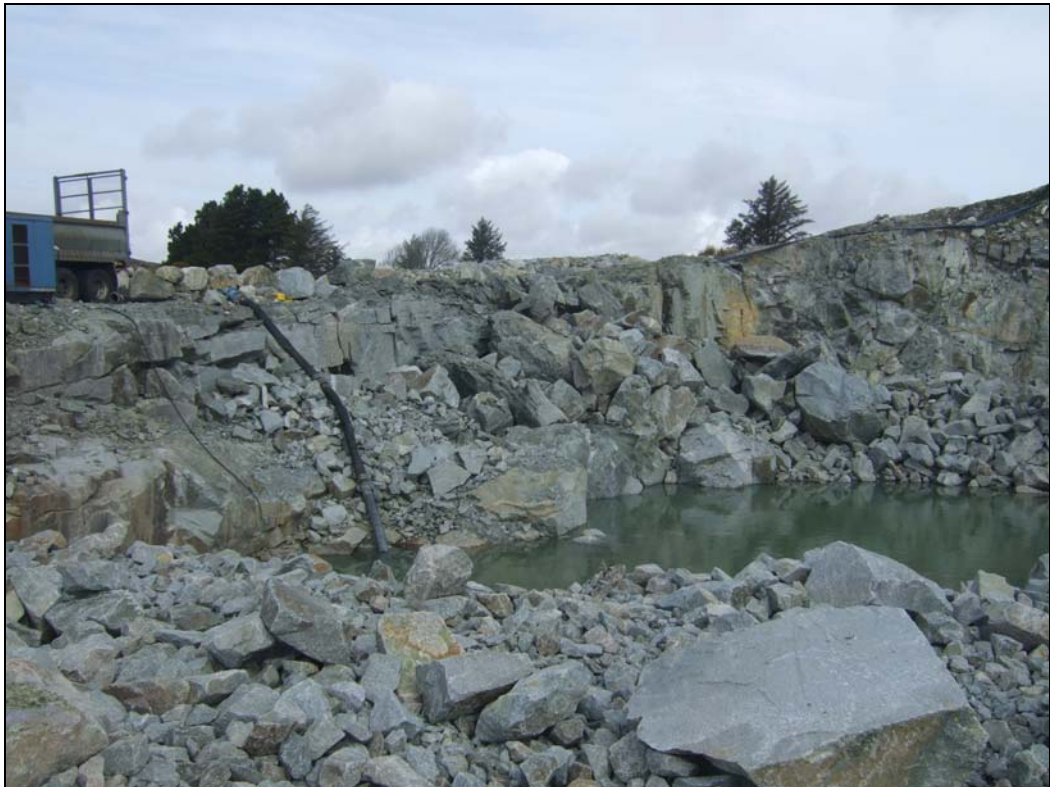
Plate 6.2 Exposed Shannapheasteen Granite bedrock at the subject quarry site

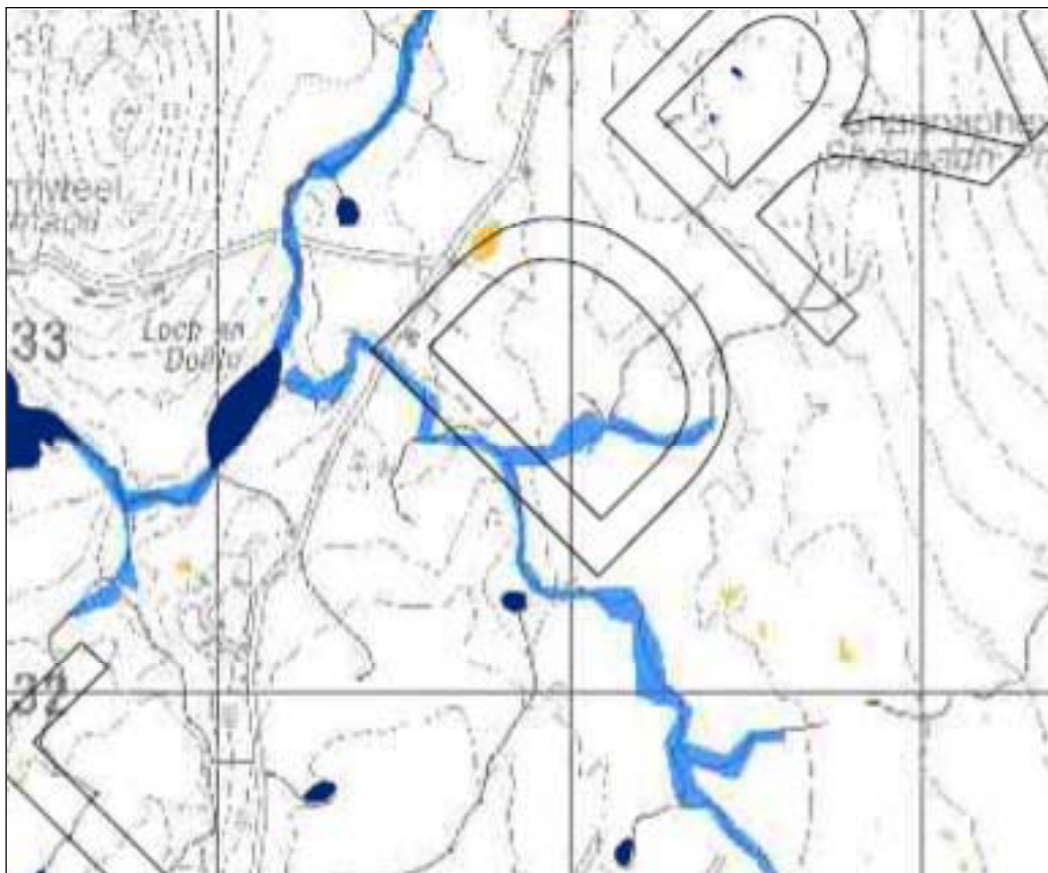
The site lies immediately adjacent the Shannapheasteen Stream. The stream channel is steep and cascades along the southern boundary before flattening out along the western boundary and crossing under the local road via a twin span concrete slab bridge with a pier in the channel. The OPW preliminary flood risk assessment mapping, as shown in Figure 7.4, correctly shows that the quarry excavation itself, whose bottom level lies several metres below the stream channel bed level, in the absence of appropriate drainage, would be at pluvial flood risk. The access road is low lying relative to the river channel and is probably at a medium flood risk.

Figure 7.4 PFRA Mapping

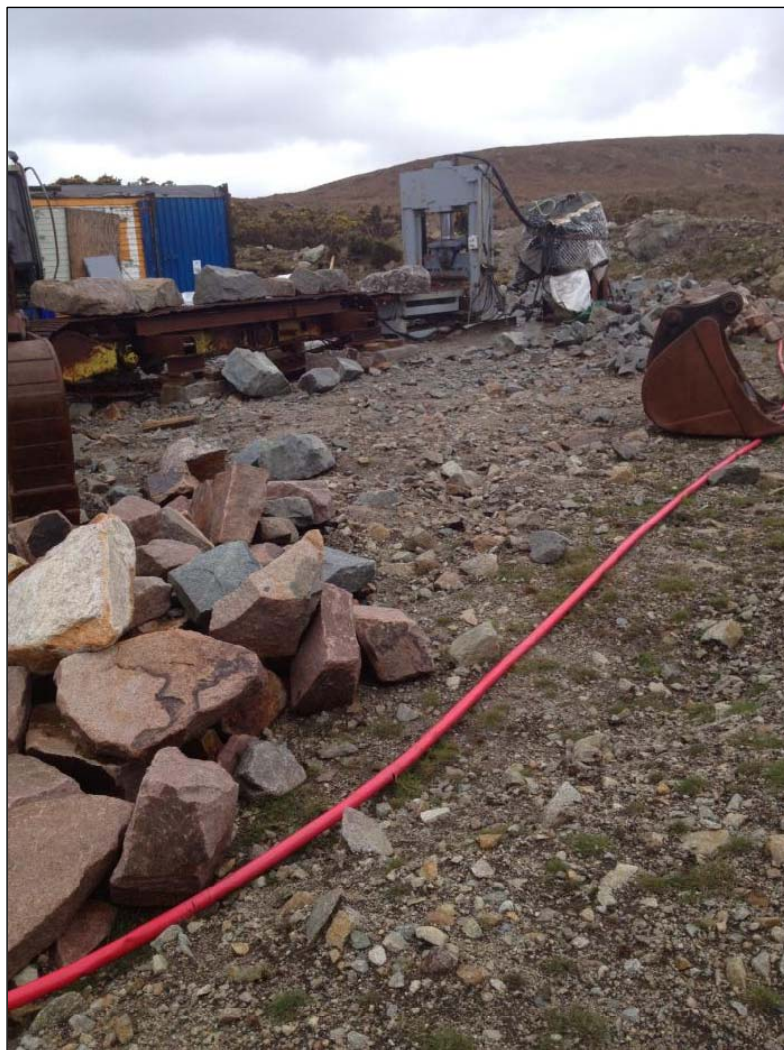
Plate 7.1 Existing Temporary Office and Stone Cutting Plant

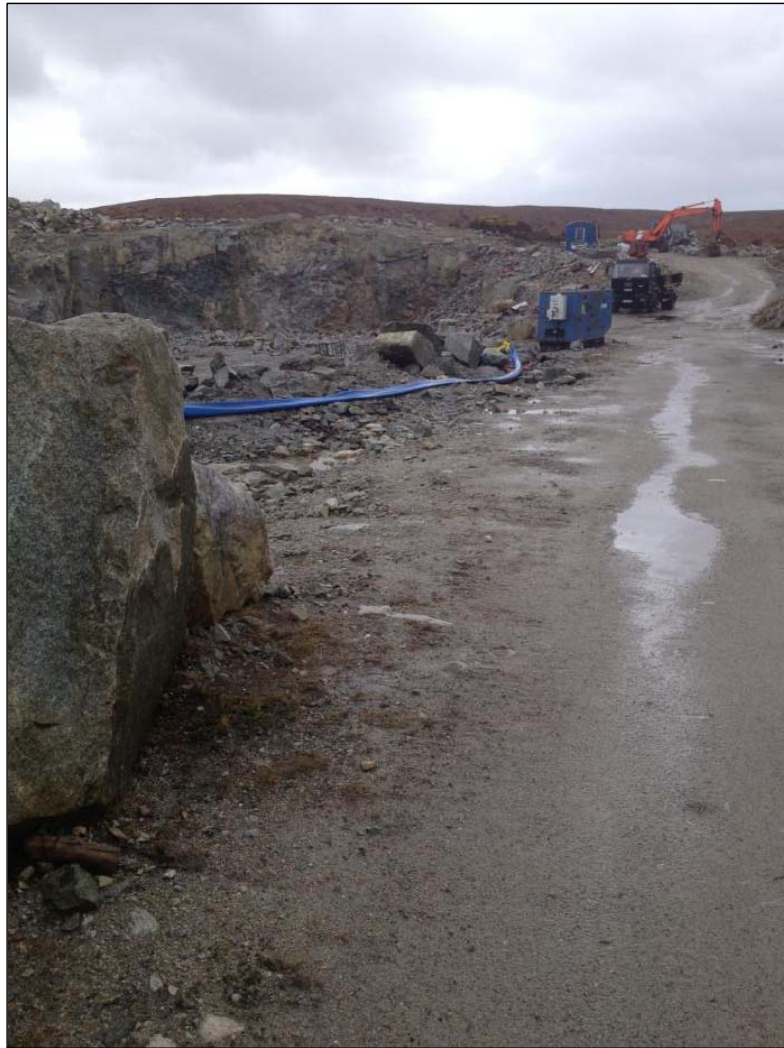
Plate 7.2 Quarry Haul road, pit and dewatering pumps

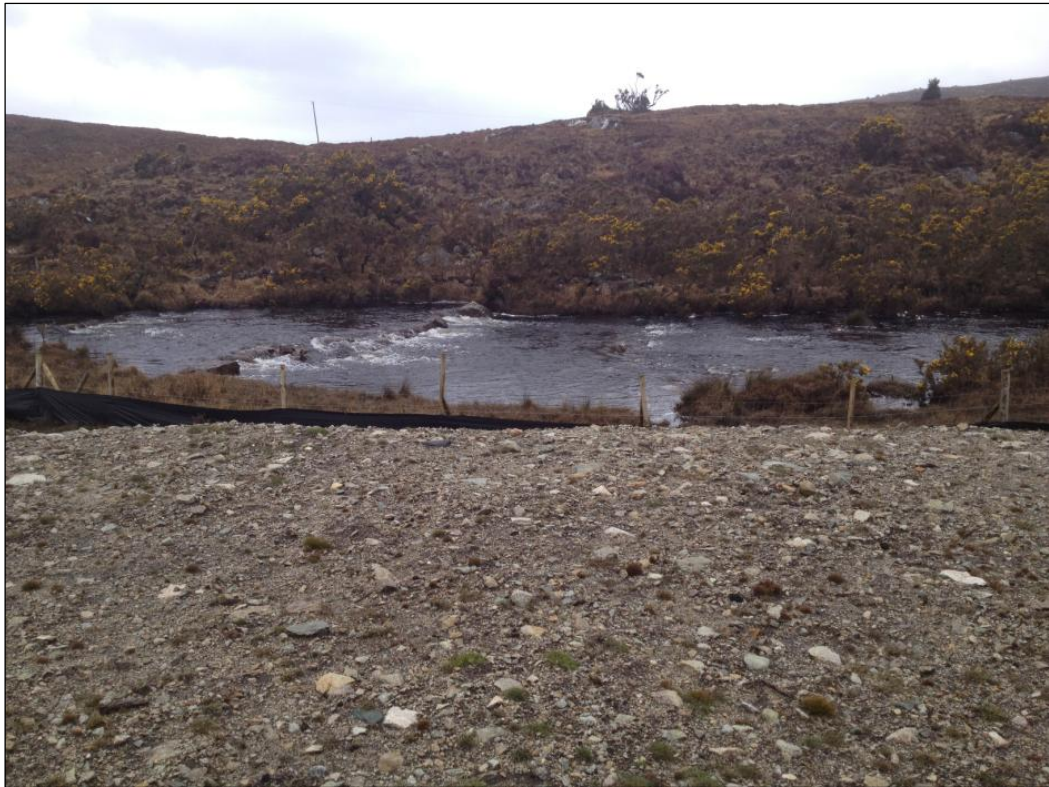
Plate 7.3-A Existing Silt Fence between Shannapheasteen Stream and the quarry haul roads

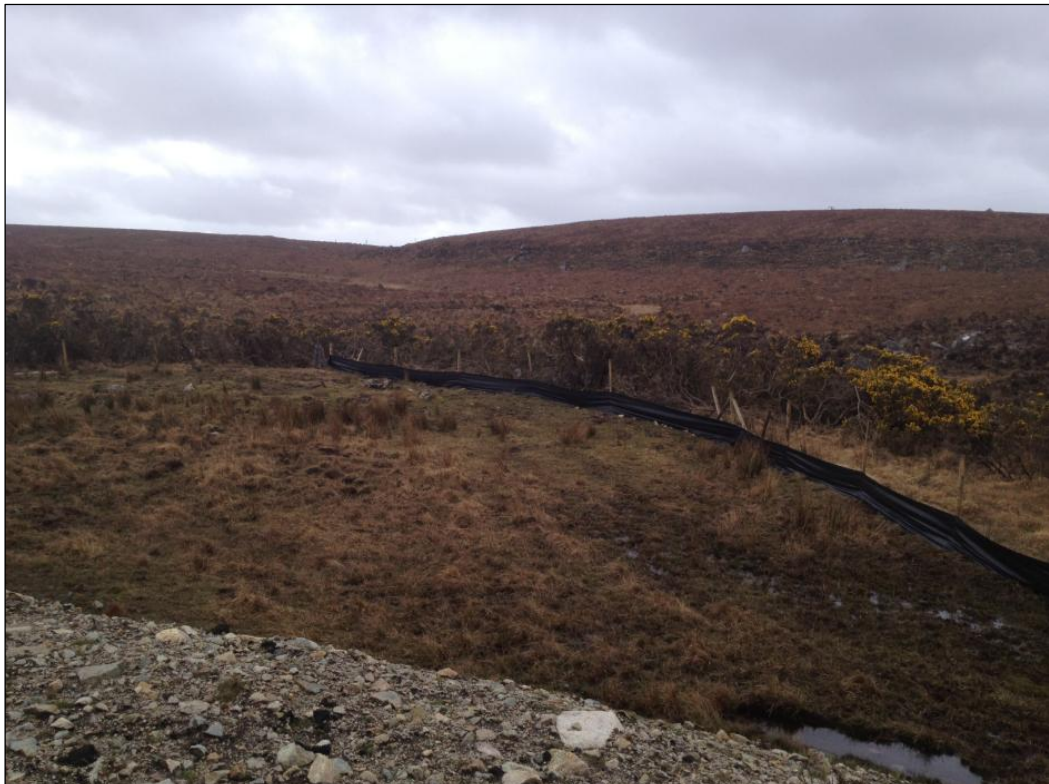
Plate 7.3-B Existing Silt Fence between Shannapheasteen Stream and the quarry haul roads

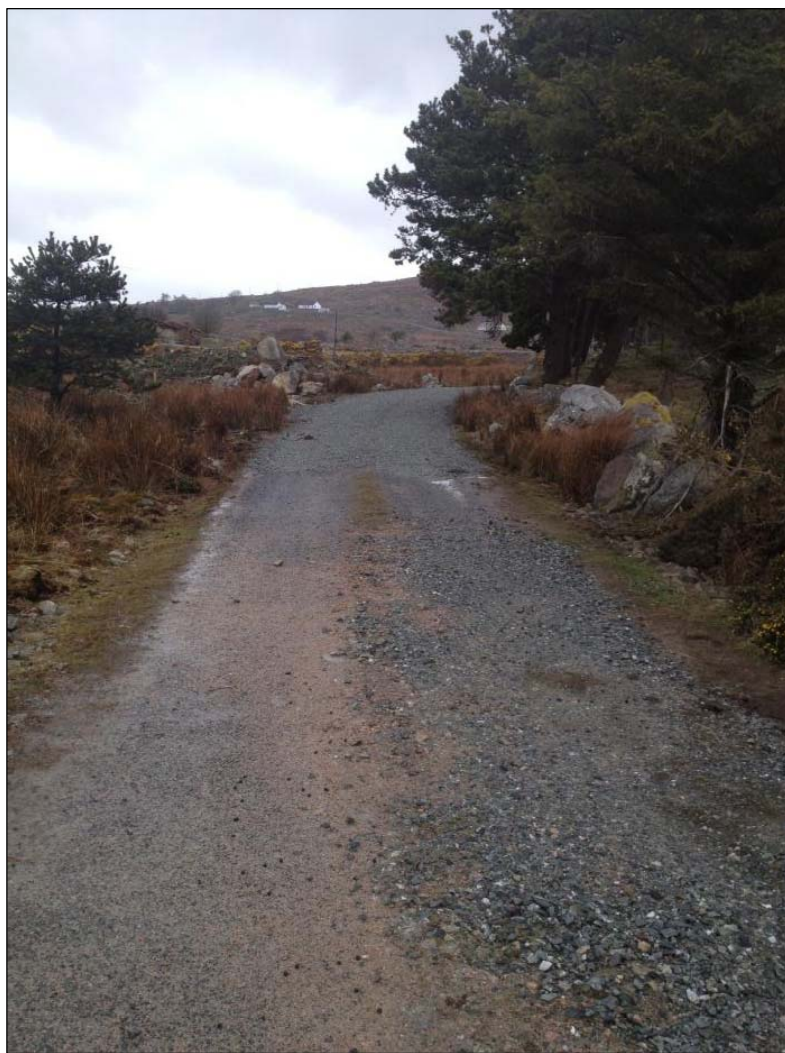
Plate 7.4 Quarry Access Road

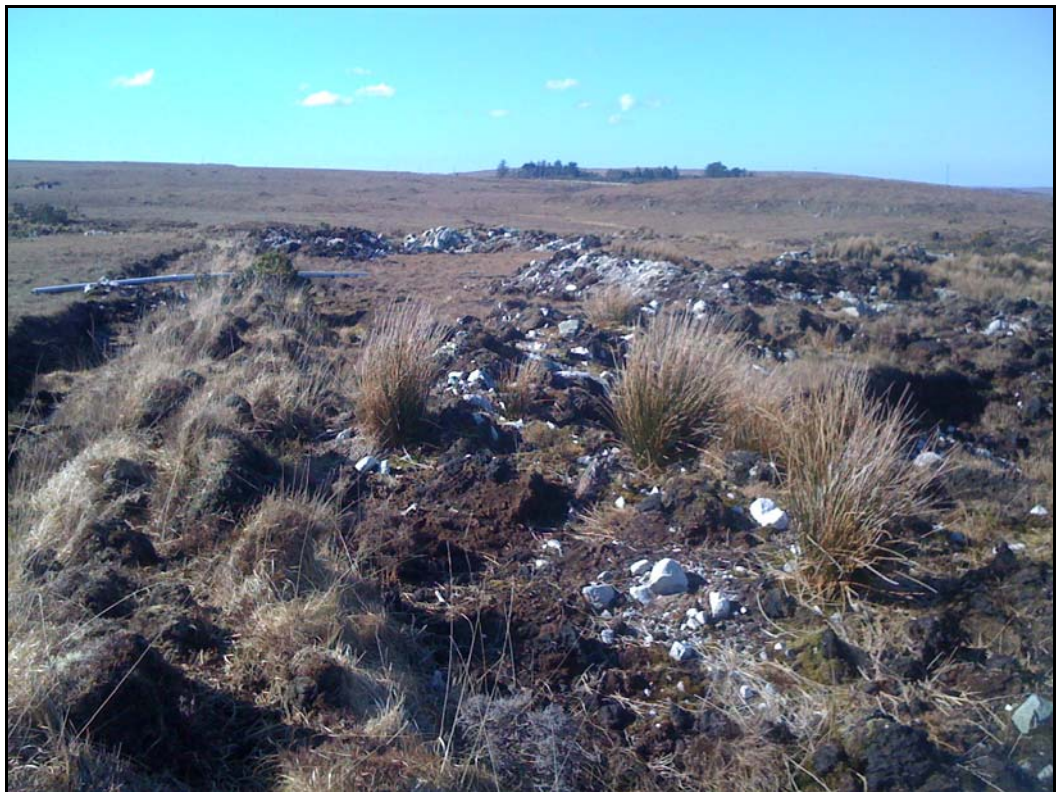
Plate 11.4 Area 2 from the south, showing disturbance of blanket bog caused by drainage works. The peat visible in sections varies in depth from 0.4 metres to over 2.0 metres.

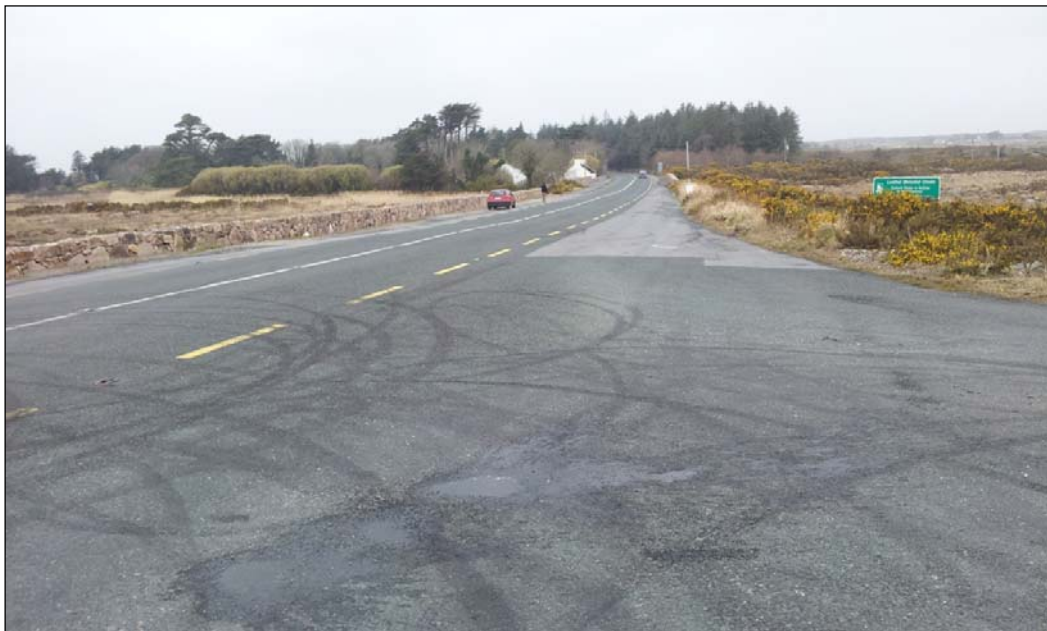
Plate 12.1 The R336 / Shannapheasteen Road junction – visibility to the northwest (right) from the Shannapheasteen Road along the R336

In the proximity of the junction with the Shannapheasteen Road the R336 is a good quality regional road typically with a speed limit of 80 kmph and a carriageway width of 7.0, as shown in Plates 12.1 and 12.2. The junction between the R336 and the Shannapheasteen Road takes the form of a standard priority junction with the local Shannapheasteen Road forming the minor arm at the junction. The geometry at this junction is adequate to accommodate all vehicle types and visibility is good for both traffic turning right onto the Shannapheasteen Road and for traffic turning left and right onto the R336.

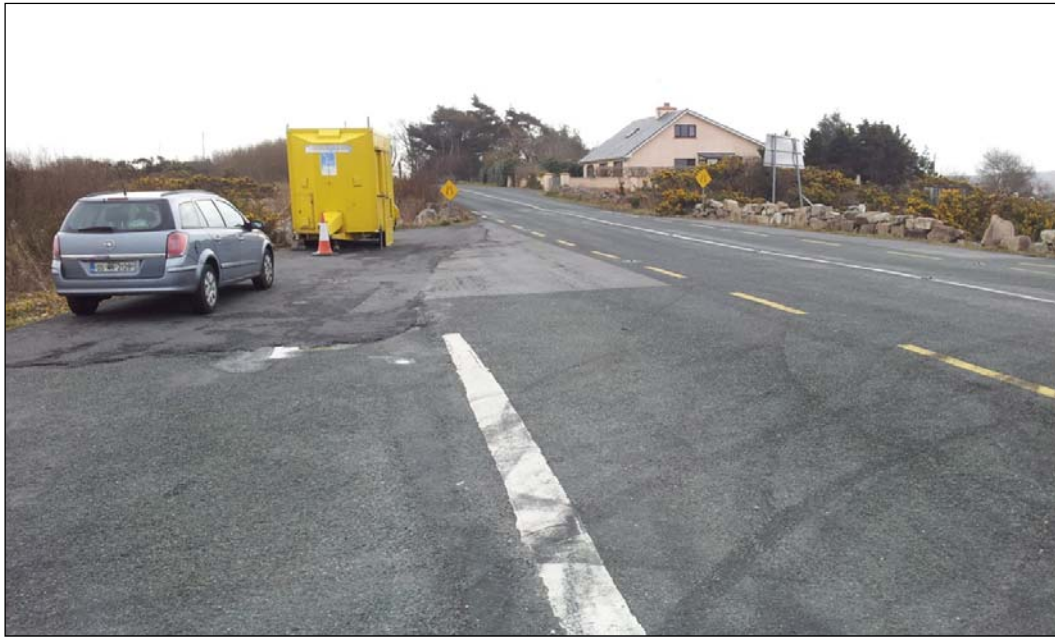
Plate 12.2 The R336 / Shannapheasteen Road junction – visibility to the southeast (left) from the Shannapheasteen Road along the R336

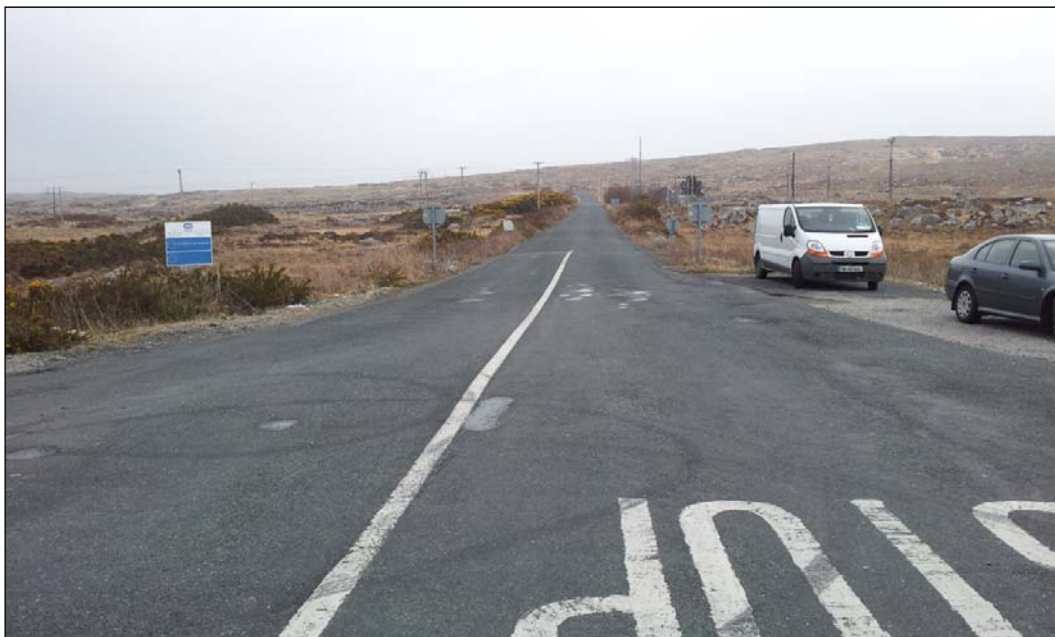
Plate 12.3 The R336 / Shannapheasteen Road junction – looking northeast along Shannapheasteen Road

The condition of the Shannapheasteen Road varies between the junction with the R336 and the access to the quarry, as shown in Plates 12.3 to 12.5. The road is typically unmarked and has a varying carriageway width averaging at approximately 4.0 metres.

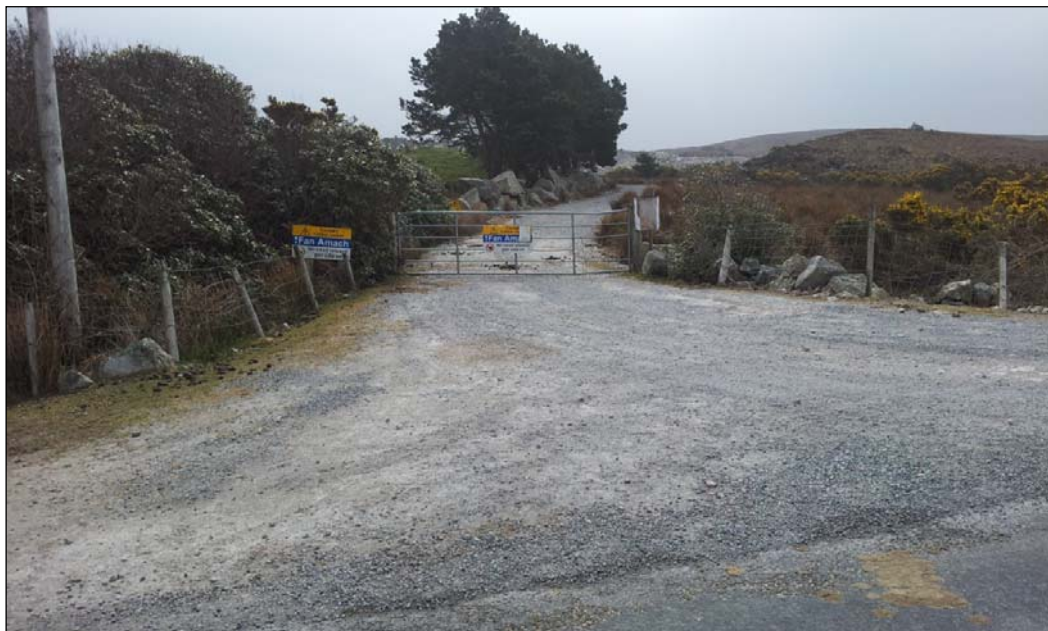
Plate 12.6 The quarry access – looking into the site from the Shannapheasteen Road

The access to the quarry is located within the default 80kph zone. The tarred surface on the Shannapheasteen Road is approximately 3.3 metres adjacent to the access which comprises of a compressed gravel road. The mouth of the access is relatively wide (15 metres) to provide for the larger vehicles that typically access the site.

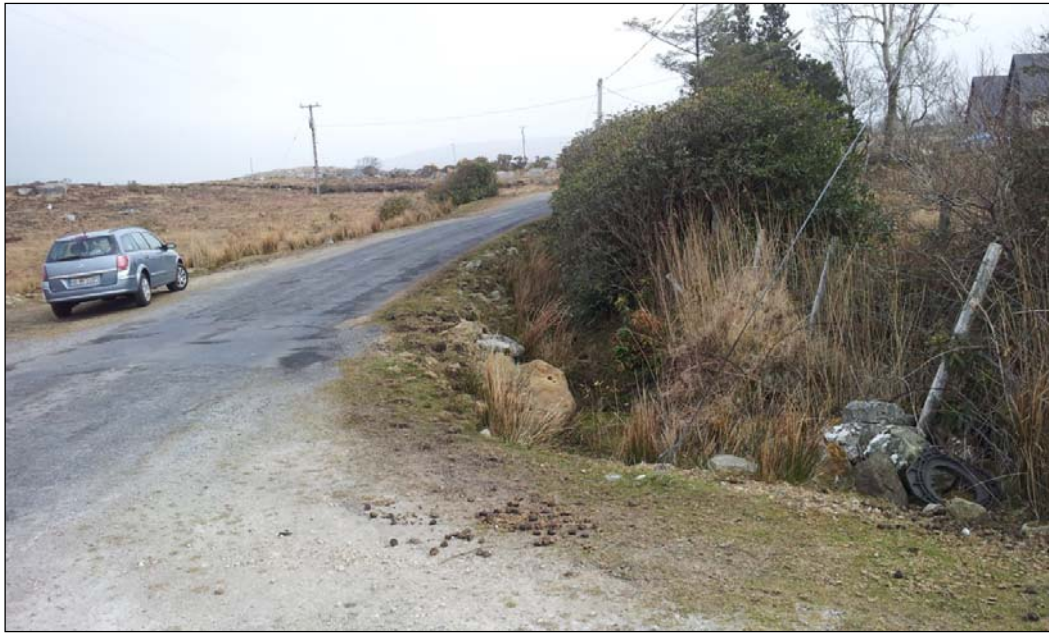
Plate 12.7 The quarry access – visibility to the northeast (right) along the Shannapheasteen Road

While the existing access junction on to the local Shannapheasteen Road appears to operate safely the existing visibility is restricted and local improvements are recommended for consideration.

Based on this assessment it is considered that the traffic generated by the existing quarry in on the Shannapheasteen Road is accommodated on the local highway network. It is recommended that local improvements are made to the existing access junction to improve visibility.

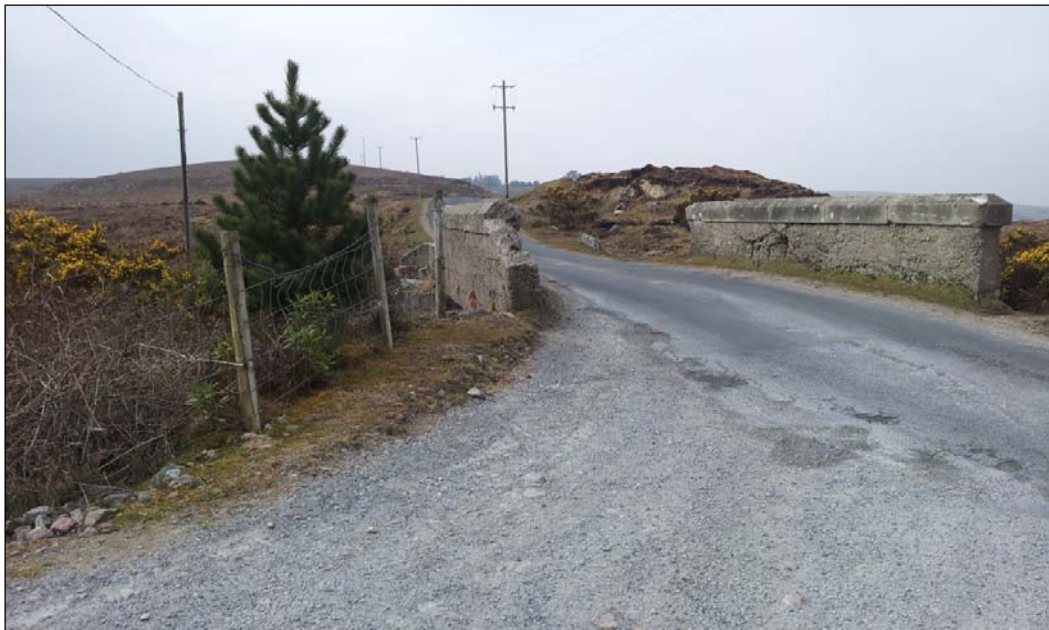
Plate 12.8 The quarry access – visibility to the southwest (left) along the Shannapheasteen Road

- To the southwest (left) sightlines are partially obscured by a bridge wall, as shown in Plate 12.8, although an oncoming vehicle can generally be seen up to a distance of approximately 90 metres, beyond which visibility is obscured by both the horizontal and vertical alignment of the road, also shown in Plate 8.

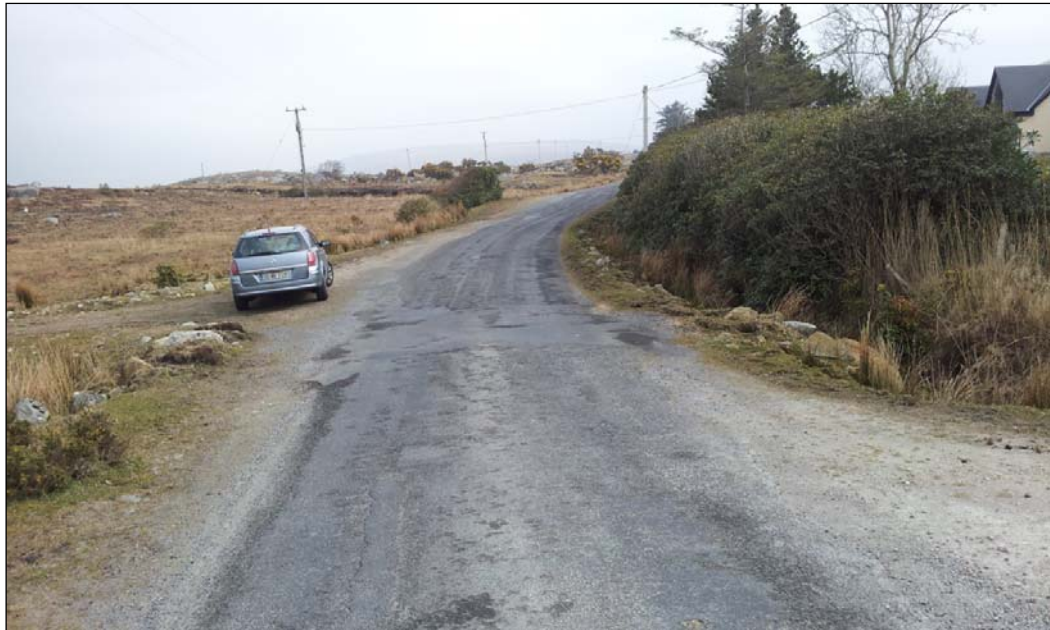
Plate 12.9 The road alignment to the north east taken from access
