5.0 BIODIVERSITY

Faith Wilson Ecological Consultant was commissioned by Birchwell Developments to prepare an Ecological Survey and Impact Assessment as part of a Large-scale Residential Development (LRD) Application for lands proposed for development on lands at Broomfield, Back Road, Malahide, Co. Dublin as shown on **Figure 5.1** below.

The proposed development subject to this Large-Scale Residential Development (LRD) application provides for the demolition of the former rugby clubhouse structure on site and the construction of 297 no. residential units comprising 211 no. houses (14 no. 2 beds, 156 no. 3 beds, 39 no. 4 beds, and 2 no. 5 beds), 46 no. duplex units (9 no. 1 beds, 14 no. 2 beds, and 23 no. 3 beds), 40 no. apartments (23 no. 1 beds, 14 no. 2 beds, and 3 no. 3 beds); 1 no. childcare facility; 1 no. café/restaurant; 1 no. retail unit; 1 no. yoga studio; and all associated site infrastructure and engineering works necessary to facilitate the development. Furthermore, the proposed development provides for a temporary pumping station situated to the southwest of the subject site, in addition to the proposed use of the existing vehicular access off Back Road (proposed ve

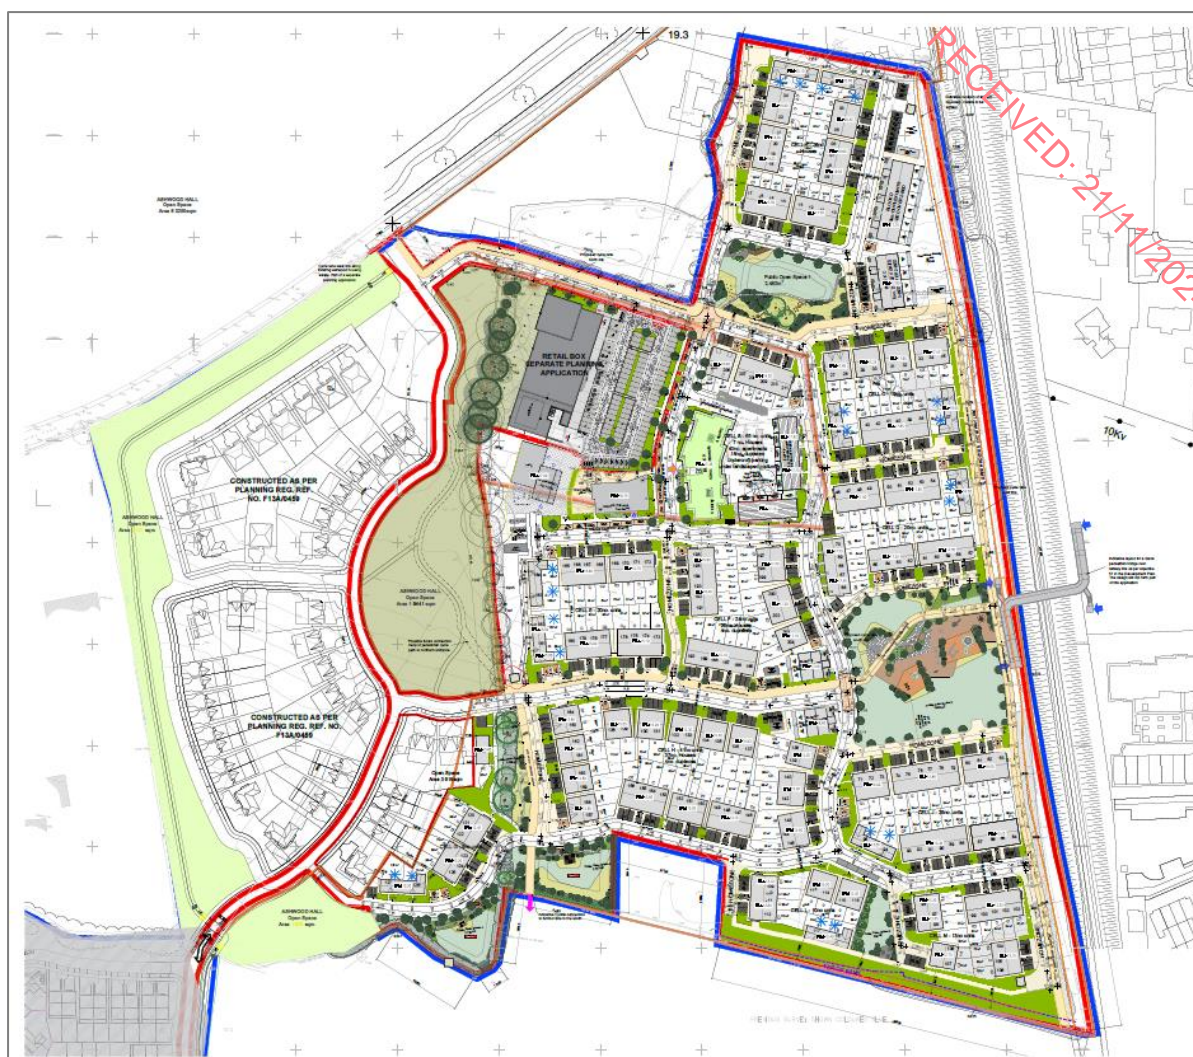
Figure 5.2 Proposed site layout for the Broomfield LRD, outlined in red at Broomfield, Malahide, Co. Dublin.

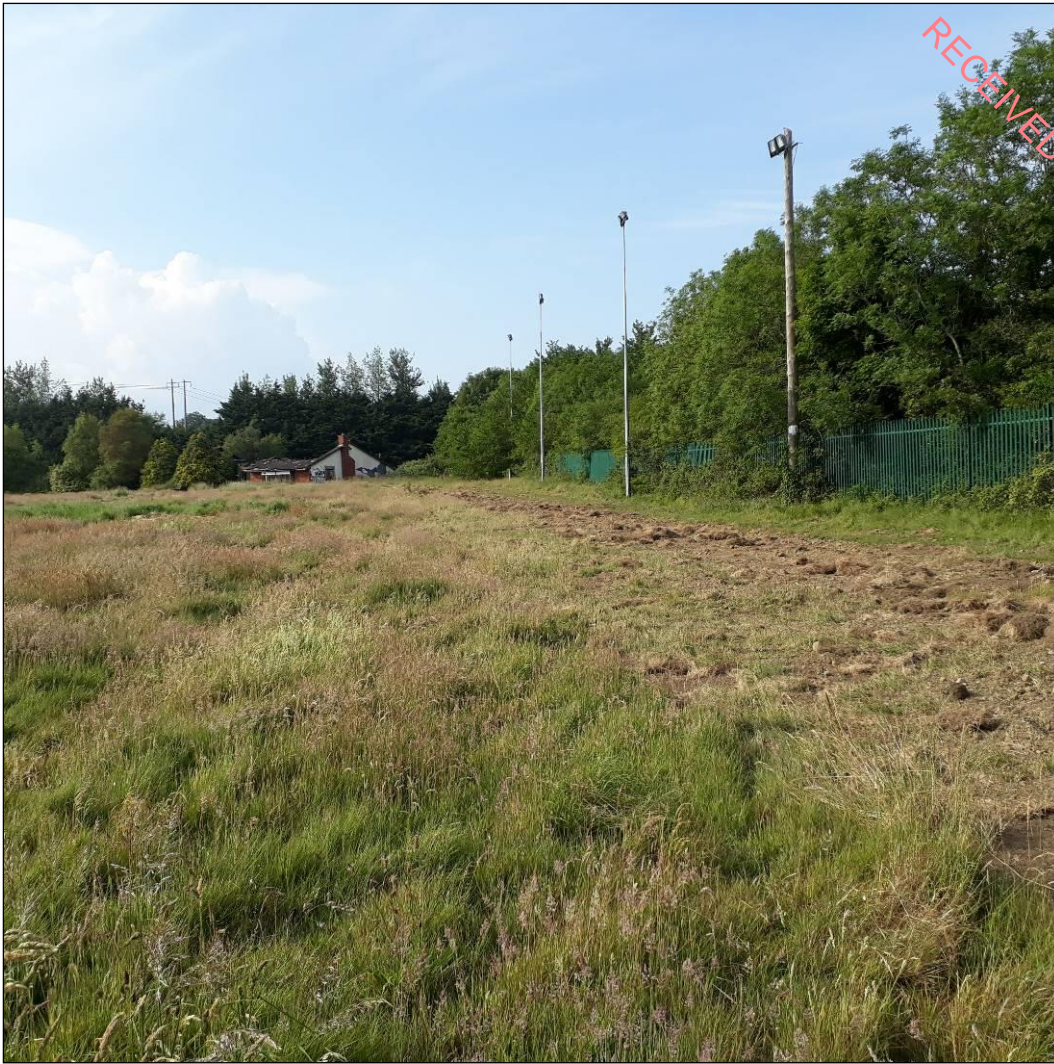
The former Rugby Club lands are bounded to the east by the Dublin – Belfast railway line. Inside the palisade fence of the railway line and extending for the length of the site to the south is a bank of ash (*Fraxinus excelsior*) oak (*Quercus robur*), hawthorn (*Crataegus monogyna*), elm (*Ulmus procera*), and sycamore (*Acer pseudoplatanus*). These trees are located offsite and provide an important visual and acoustic screen between the site and the railway line. They are described as G227 in the tree survey report.

Plate 1. Eastern boundary of the rugby club lands adjoining the railway line.

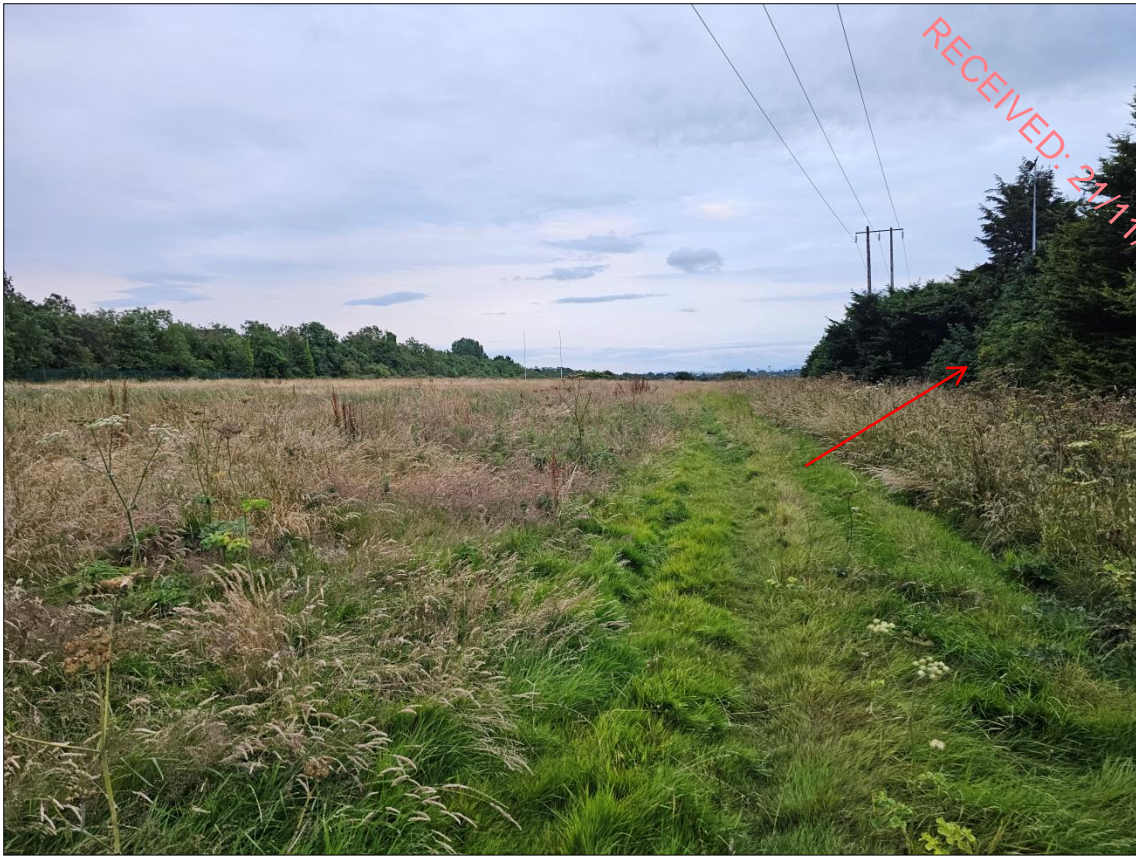
The grassland (GS2) on the former playing area is dominated by Yorkshire fog (*Holcus lanatus*), false oat-grass (*Arrhenatherum elatius*), cock's-foot grass (*Dactylis glomerata*), red fescue (*Festuca rubra*), with occasional dandelion (*Taraxacum* agg.), ribwort plantain (*Plantago lanceolata*), creeping buttercup (*Ranunculus repens*), meadow buttercup (*Ranunculus acris*) and germander speedwell (*Veronica chamaedrys*). This is becoming colonised by willows (*Salix cinerea*).

Plate 2. Looking south over the rugby club lands. Treeline G222/G223 is shown by the red arrow.

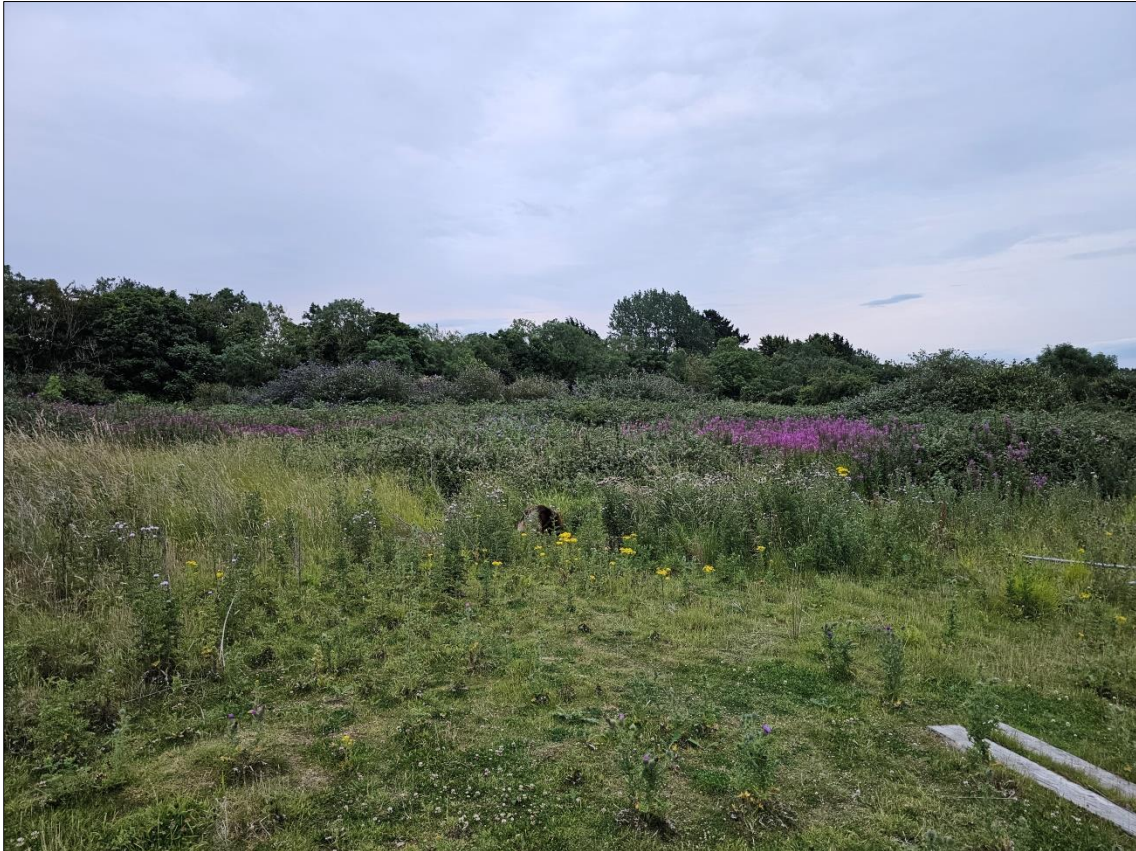
The southern portion of the former Rugby Club lands are dominated by scrub (WS1) consisting of dense tangles of bramble (*Rubus fruticosus* agg.), the non-native invasive butterfly bush (*Buddleia davidii*), and scattered immature ash (*Fraxinus excelsior*). This area is described as G226 in the tree survey report and is well used by Rabbits. Colonising species such as thistles (*Cirsium arvense*) and rosebay willowherb (*Epilobium angustifolium*) are common here as is the invasive non-native species Canadian fleabane (*Conyza canadensis*).

Plate 3. Scrub at the southern end of the rugby club lands.

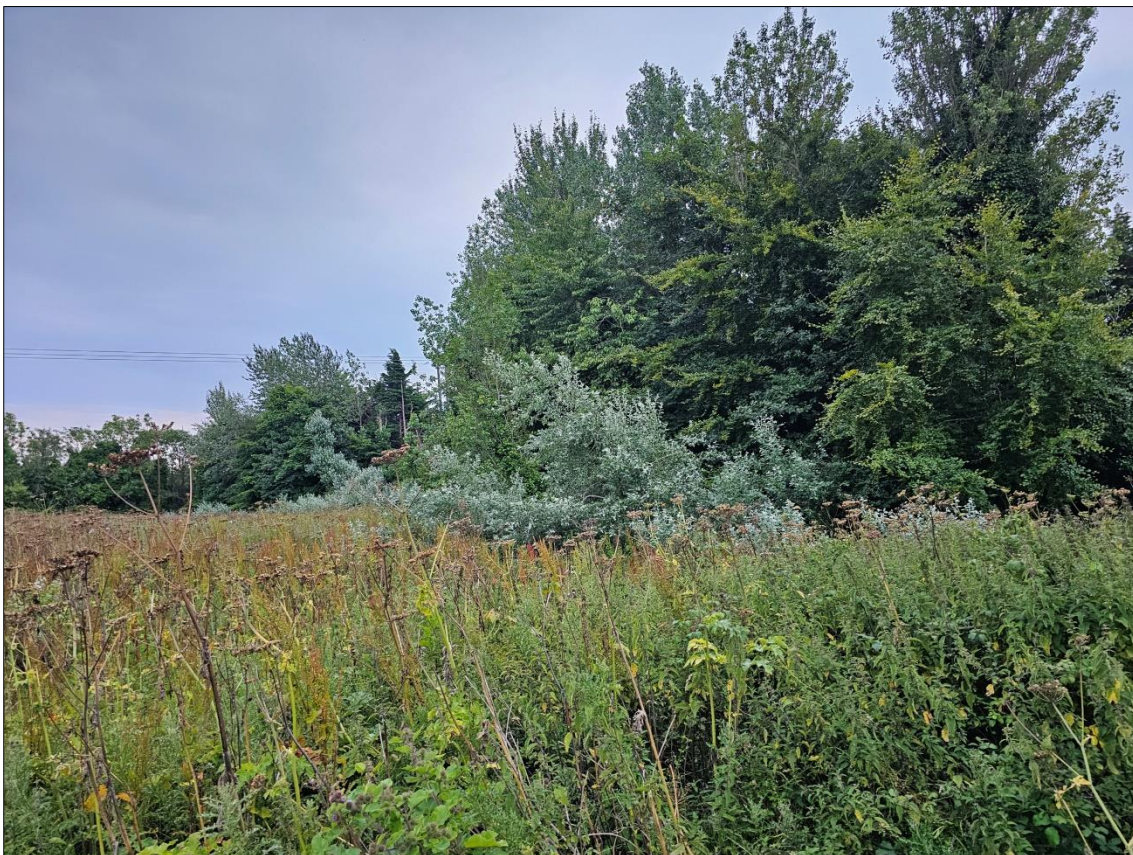
A double treeline (WL2) of Leyland cypress (*Cupressocyparis x leylandii*) (G198) separates the rugby club building from a small field to the north. A deep drainage ditch (FW4) which was dry at the time of survey is found at the base of this treeline and an old disused badger (*Meles meles*) sett, which is currently used by fox (*Vulpes vulpes*) is located here. Three rows of mixed plantings of whitebeam (*Sorbus aria*), apple (*Malus* sp.), cherry (*Prunus* sp.), sycamore, beech (*Fagus sylvatica*), hawthorn (*Crataegus monogyna*), Lombardy poplar (*Populus nigra 'italica'*) and white poplar (*Populus alba*) are found on the north side of this treeline forming an area of immature woodland (WS2) described as G200, G201 and G202 in the tree survey report. Elder, bramble and hawthorn are also present.

Plate 7. The trees between the rugby club and the northern field.

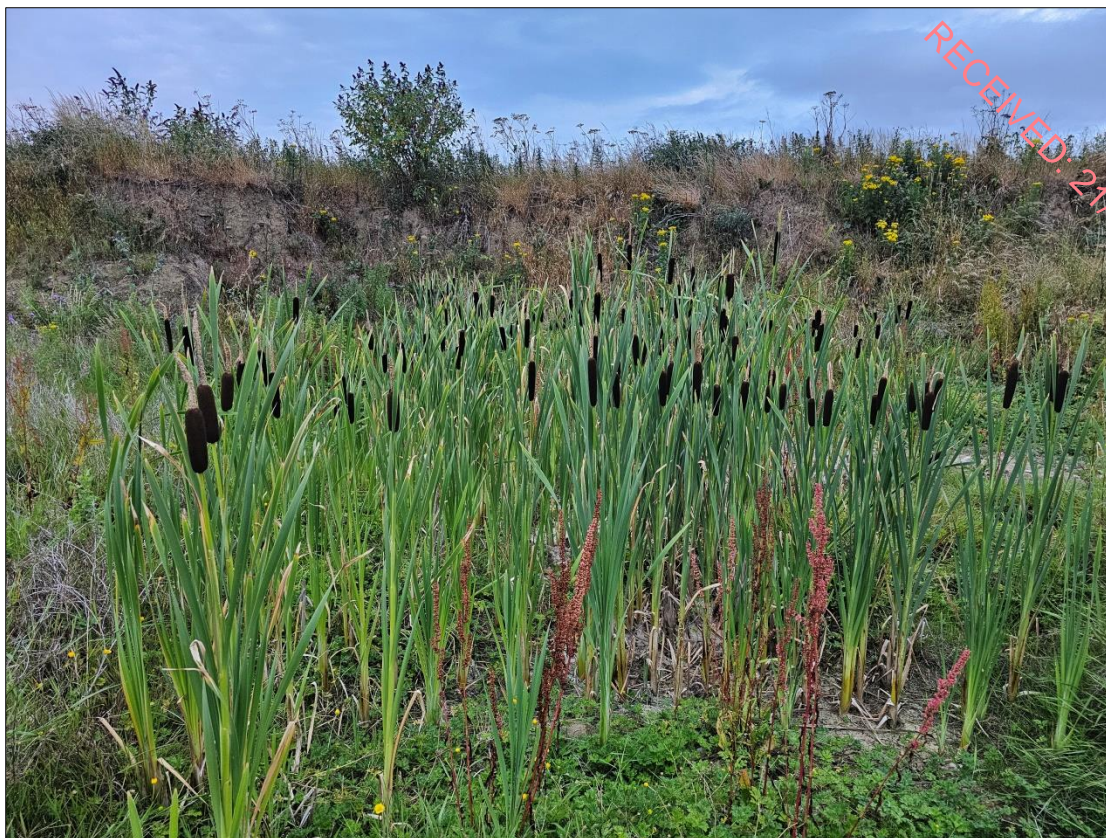
A large volume of topsoil was previously stored here from the Ashwood Hall development and this has been colonised with a variety of species including the non-native invasives Butterfly bush, Large bindweed (*Calystegia sylvatica*) and Canadian fleabane as well as bramble and thistles. A small depression at the base of the soil storage area now supports wetland plants such as reed mace (*Typha latifolia*) and hoary willowherb (*Epilobium hirsutum*). Within the grassland areas curled dock (*Rumex crispus*), white clover, creeping buttercup (*Ranunculus repens*), ribwort plantain (*Plantago lanceolata*), creeping cinquefoil (*Potentilla reptans*), weld (*Reseda luteola*), broad leaved plantain, hoary willowherb, broad-leaved willowherb (*Epilobium montanum*), ragwort (*Senecio jacobaea*), knotgrass (*Polygonum aviculare*), and wild radish (*Brassica rapa*) were frequently recorded as were willows and young oak saplings which have developed through natural succession.

Plate 11. A small wetland has formed at the base of the soil storage area.

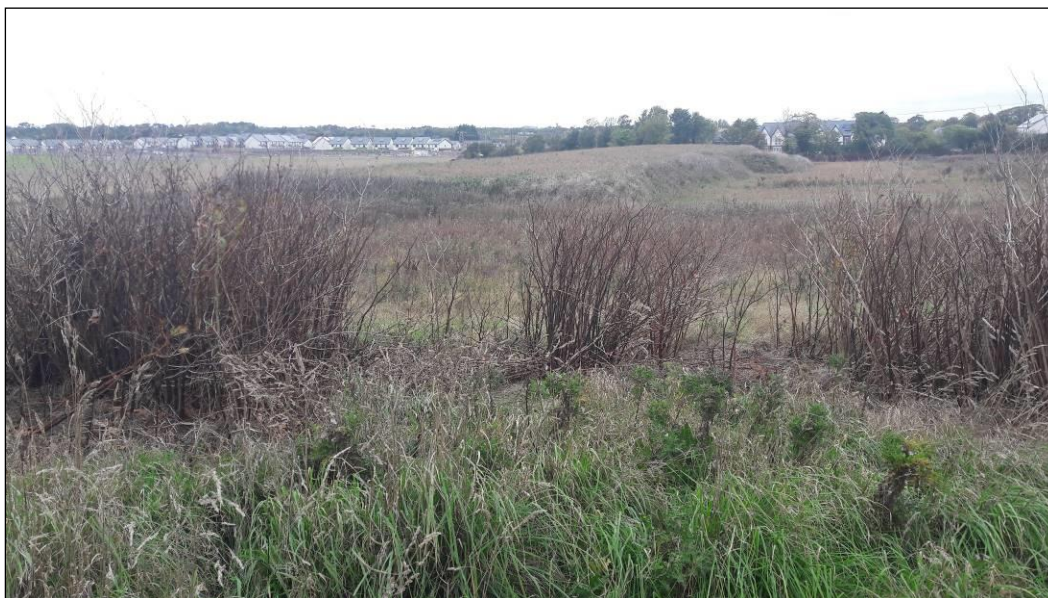
Birchwell Developments engaged a trained horticulturalist (Graeme Cahill) to begin treating the Japanese knotweed in 2017. The first treatment of the knotweed at Broomfield was on May 19th 2018. An application rate of 100ml Glyphosate:5 litres water was used. A total of 3 litres of spray was applied via a knapsack sprayer. Follow up treatment has since been conducted over many years. A detailed Japanese knotweed management plan was developed to ensure that this species is not and has not inadvertently been spread during development of the site.

Plate 12. Japanese knotweed on the former rugby club lands following treatment in 2018.

The Japanese knotweed has been the subject of ongoing treatment in situ and has not spread or become established elsewhere within the site in the intervening period.

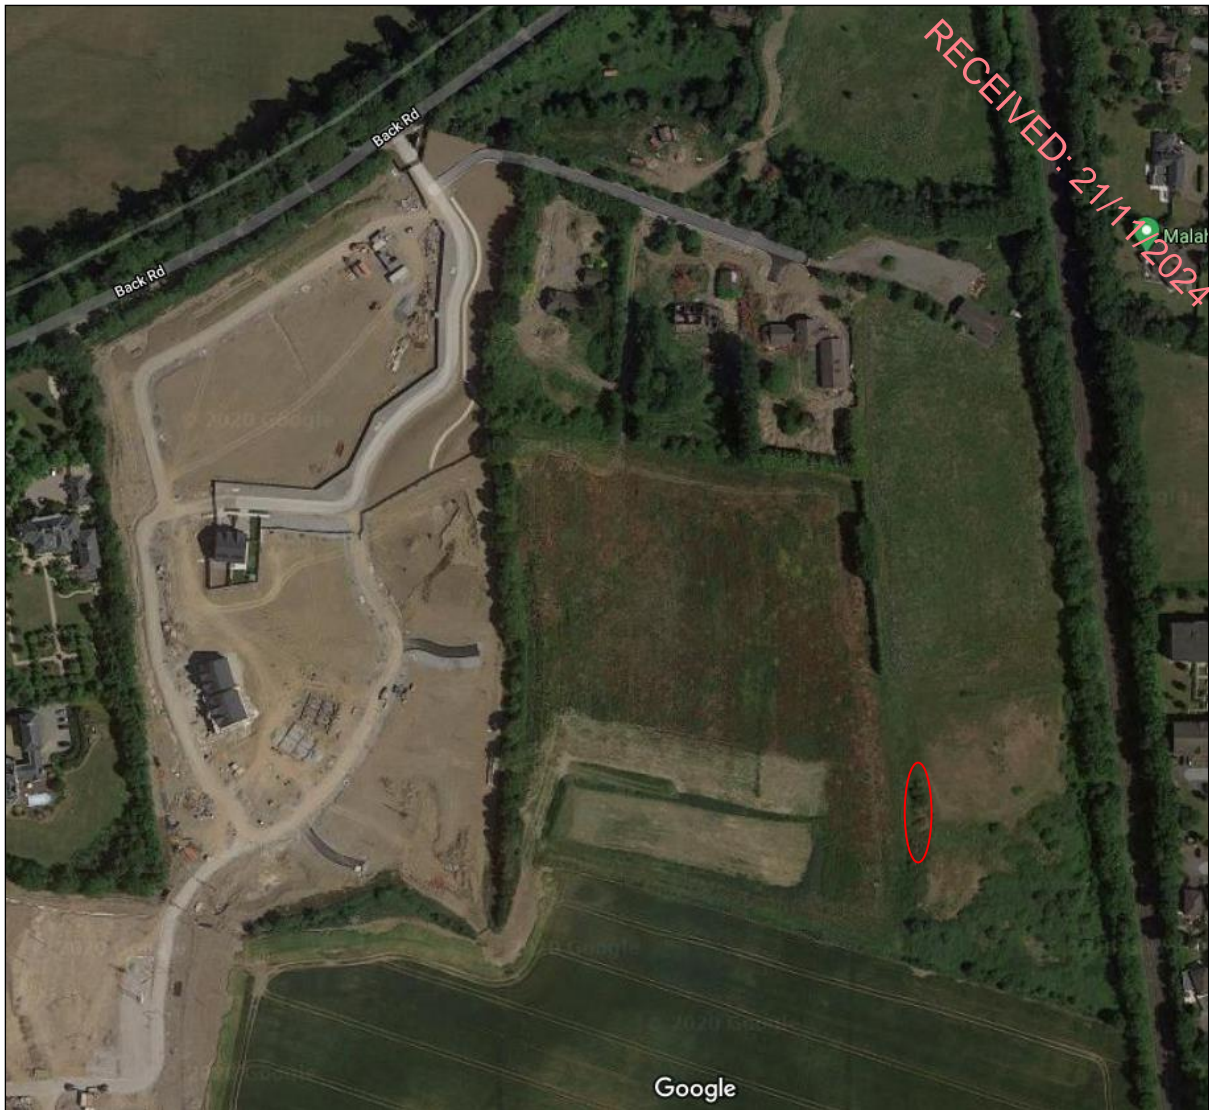
Figure 5.5. Japanese knotweed was recorded here in 2017 and has been treated on site since then by Birchwell.

The main invasive species noted in the general vicinity include stands of Japanese knotweed (*Fallopia japonica*), Canadian fleabane and butterfly bush (*Buddleia davidii*) which were found within the rugby club lands. Of these the Japanese knotweed is the only species listed under the Third Schedule of the Communities Birds and Natural Habitats Regulations 2011. The location of the Japanese knotweed stand is shown on **Figure 5.5** below.

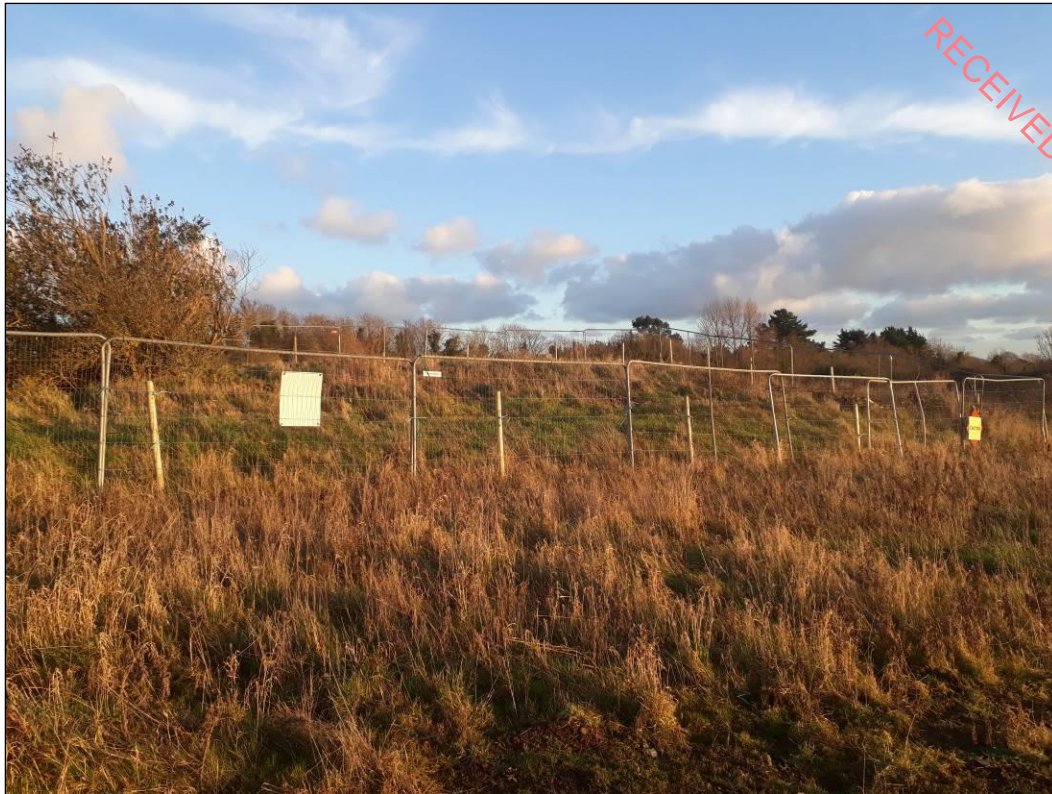
Plate 13. Japanese knotweed areas clearly demarcated and treated in January 2021.

The primary species of concern is Japanese knotweed as this is listed under the Third Schedule of the Communities Birds and Natural Habitats Regulations 2011. An invasive species management plan has been prepared to deal with the Japanese knotweed stands as shown on **Figure 5.5** above. The most recent surveys indicate that the treatment has been successful with no evidence of above ground growth of the species and no spread however a precautionary approach to the possibility for viable rhizomes to remain below the soil has been taken.

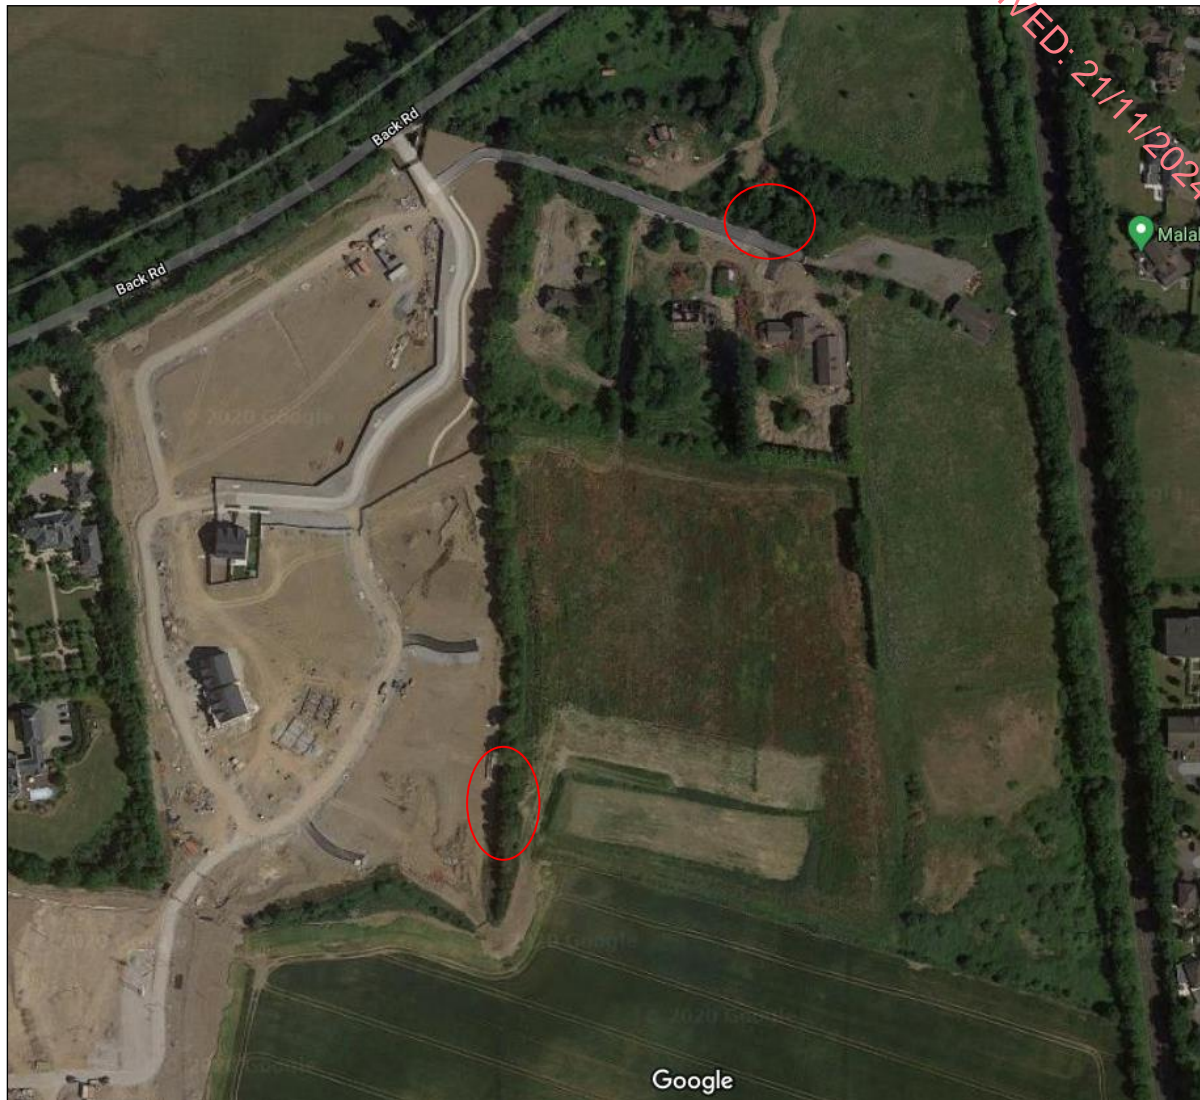
Figure 5.6. Potential badger setts within the Broomfield LRD lands.

This potential badger sett consisted of a single entrance sett, which was not active at the time of the initial or subsequent surveys. This and a number of other holes and burrows in the area are well used by rabbits but there has been no evidence of any subsequent or current use by badger in further surveys conducted since 2014. At the initial time of identification in 2014 there were feeding signs of badger noted along the southern boundary of the Broomfield Phase 1 lands and a dead badger was noted on the Back Road to the west of the entrance to Malahide Castle which triggered the suggestion that this sett was potentially used by badger.

Broomfield LRD lands were used by badgers as outlier setts to a main territory, which is located within Malahide Castle Demesne.

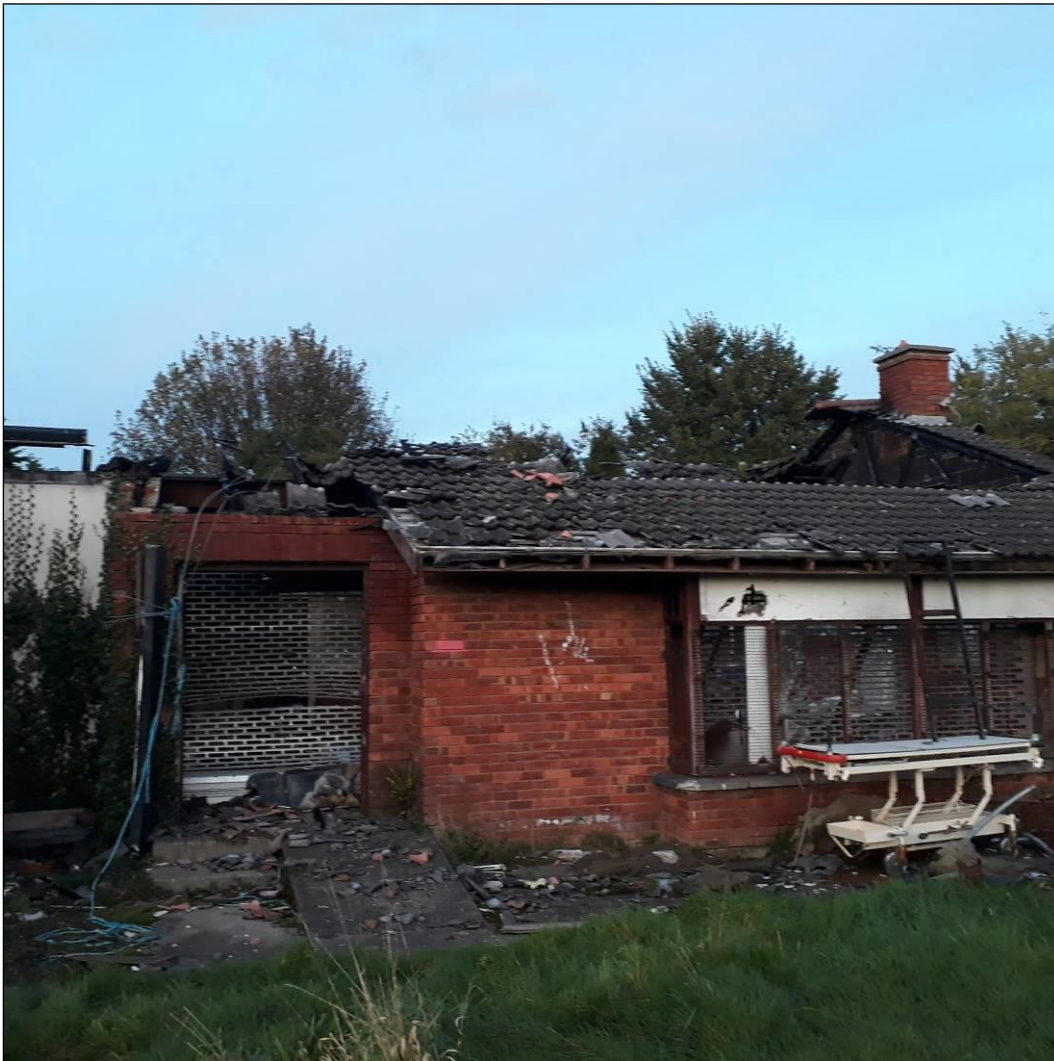
Leisler's bat was recorded foraging over the lands and over the area of scrub south of the rugby club building. The rugby club building had been the subject of arson and no longer has an intact roof/attic space. No bats were recorded emerging from this property.

Plate 14. Rugby club building destroyed by arson in 2019.

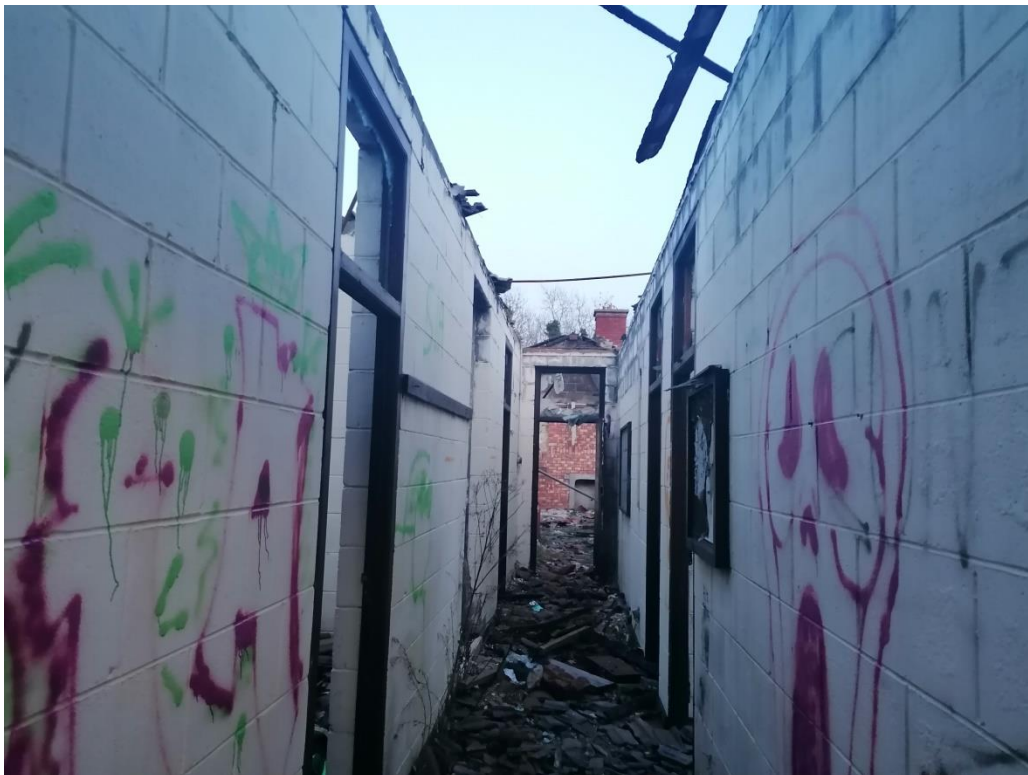
Plate 15. Rugby club building in 2022.

The rugby club building had deteriorated further in condition with fascia removed and the soffits exposed. No bats were recorded emerging from this property.

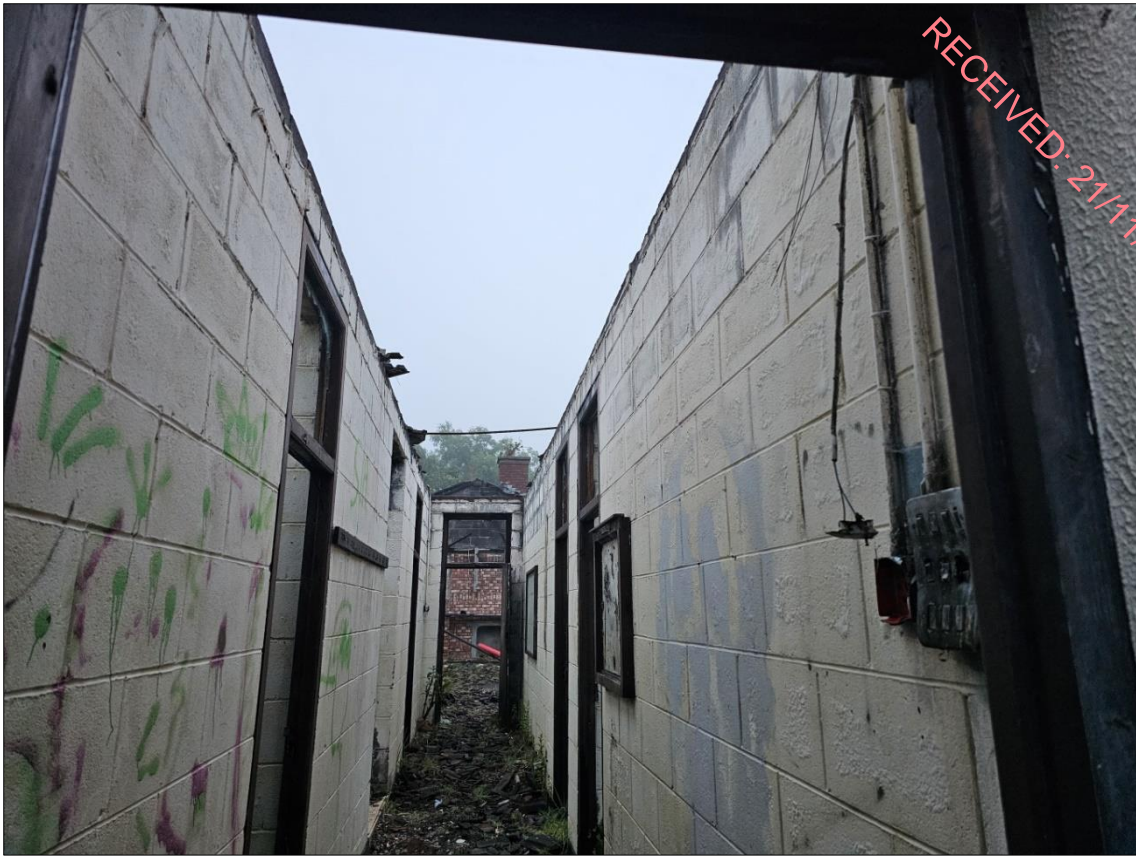
The bat survey conducted on the 9th July 2024 recorded similar activity to that in 2022. No bats were recorded emerging from the arson damaged rugby club building. The condition of this building has deteriorated further since it was last surveyed as can be seen on **Plate 16** below.

Plate 16. Former rugby club building in 2024.

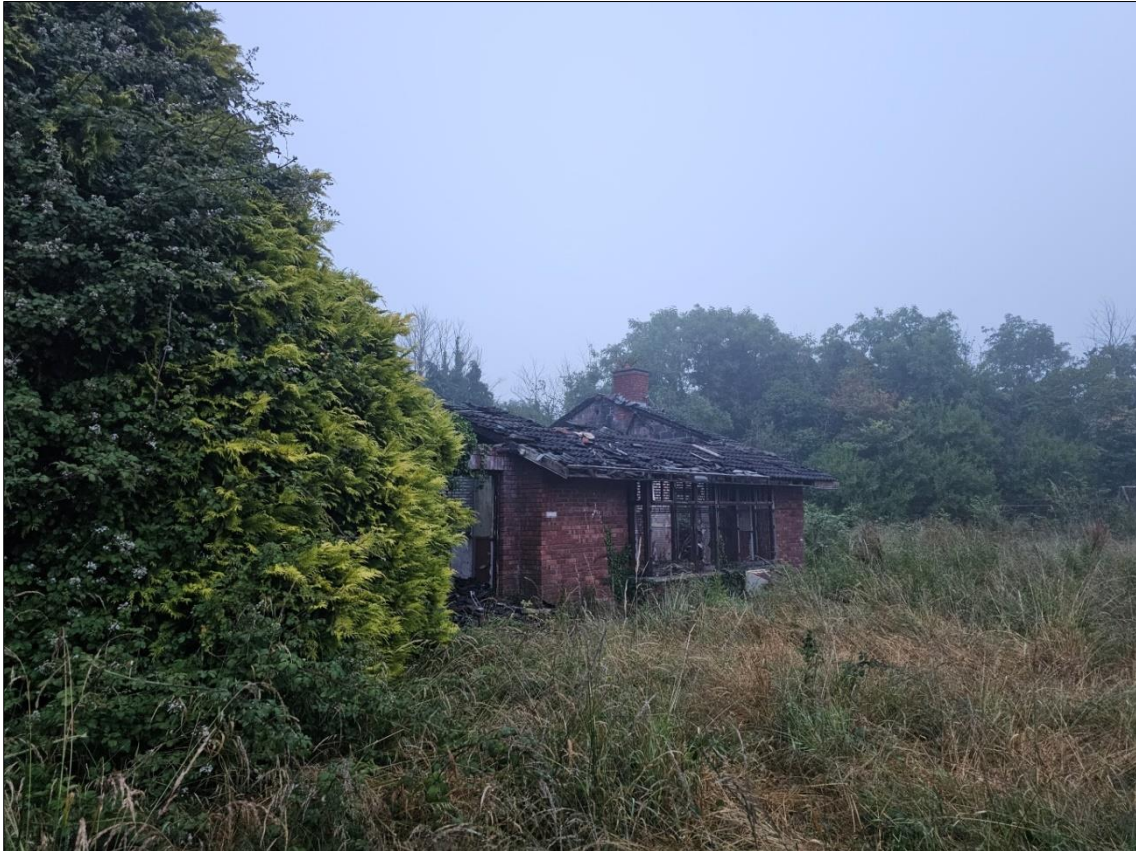
Plate 17. Former rugby club building in 2024.

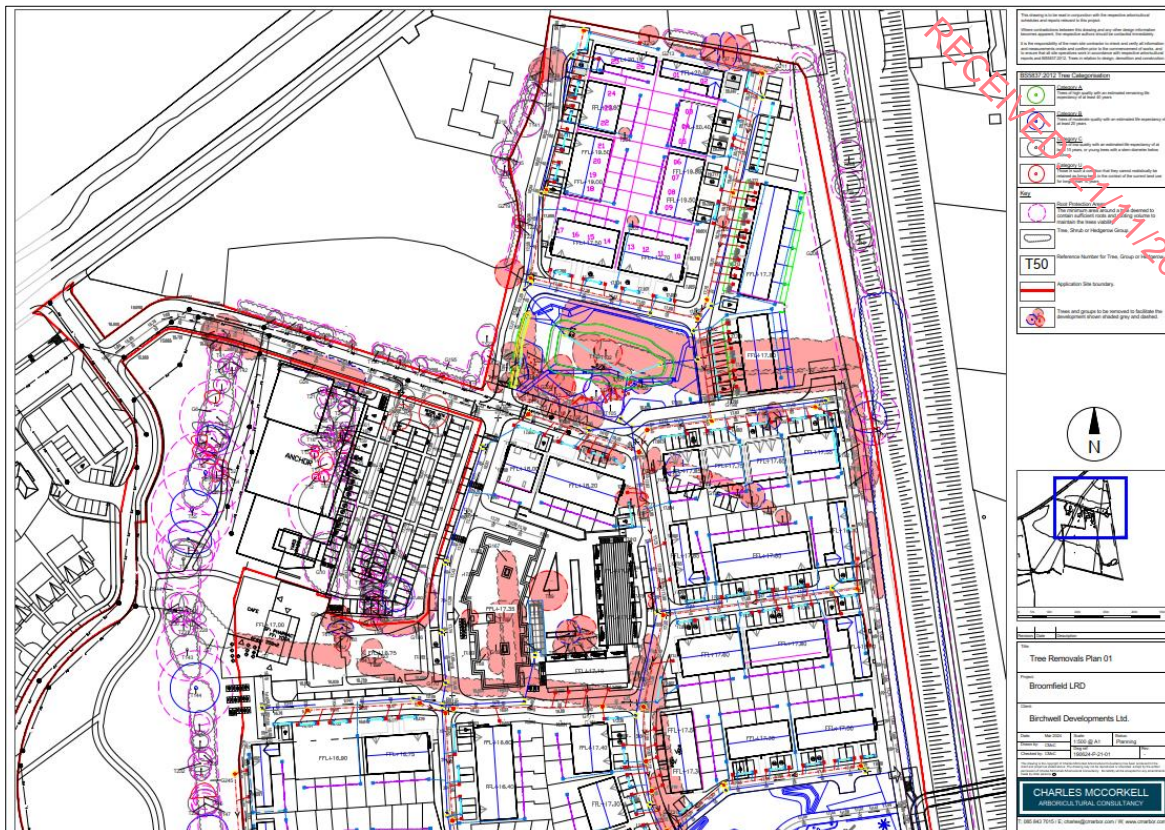
Figure 5.14. Tree removals plan (trees shown in solid pink) (Mc Corkell, 2024).

These are shown on **Figure 5.14** and **5.15** below.

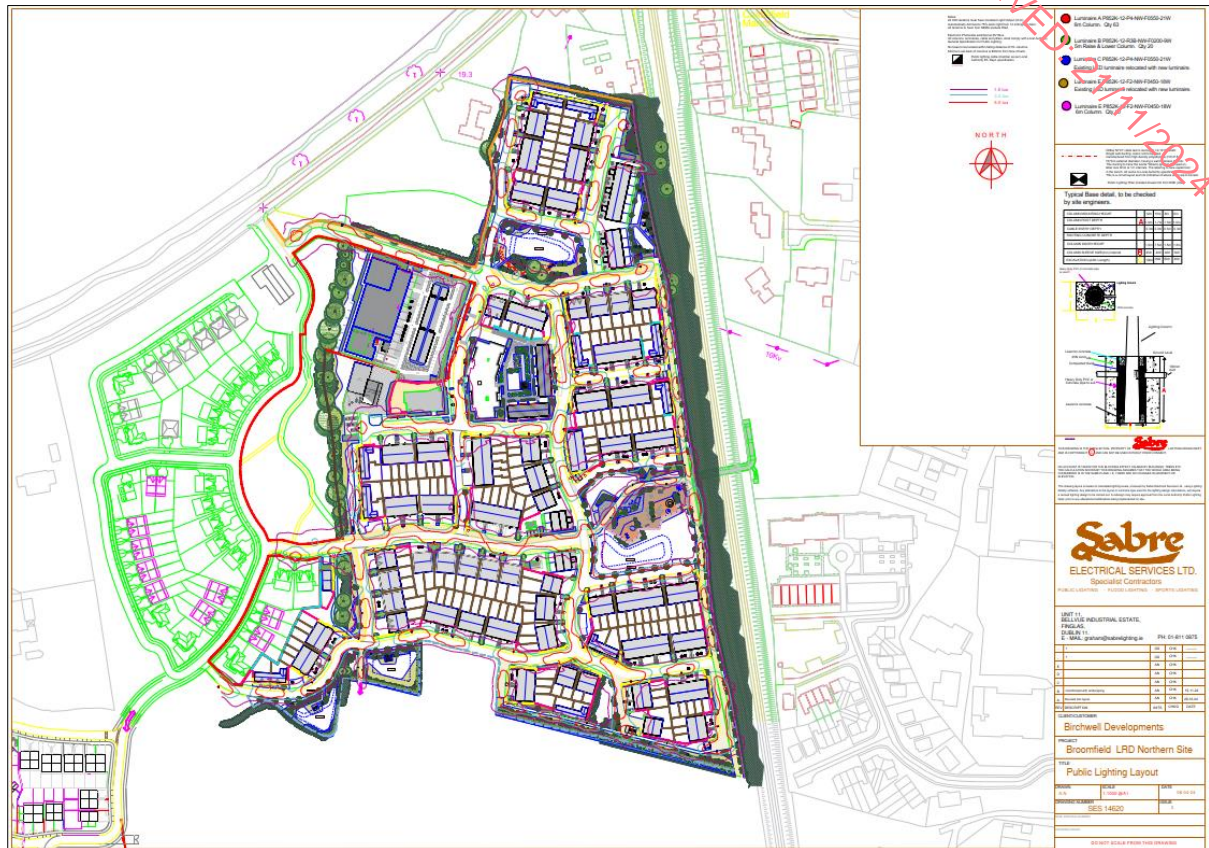
These guidelines have been implemented in the previous phases of the developments at Broomfield and in the project lighting design as set out in **Figure 5.19** below.

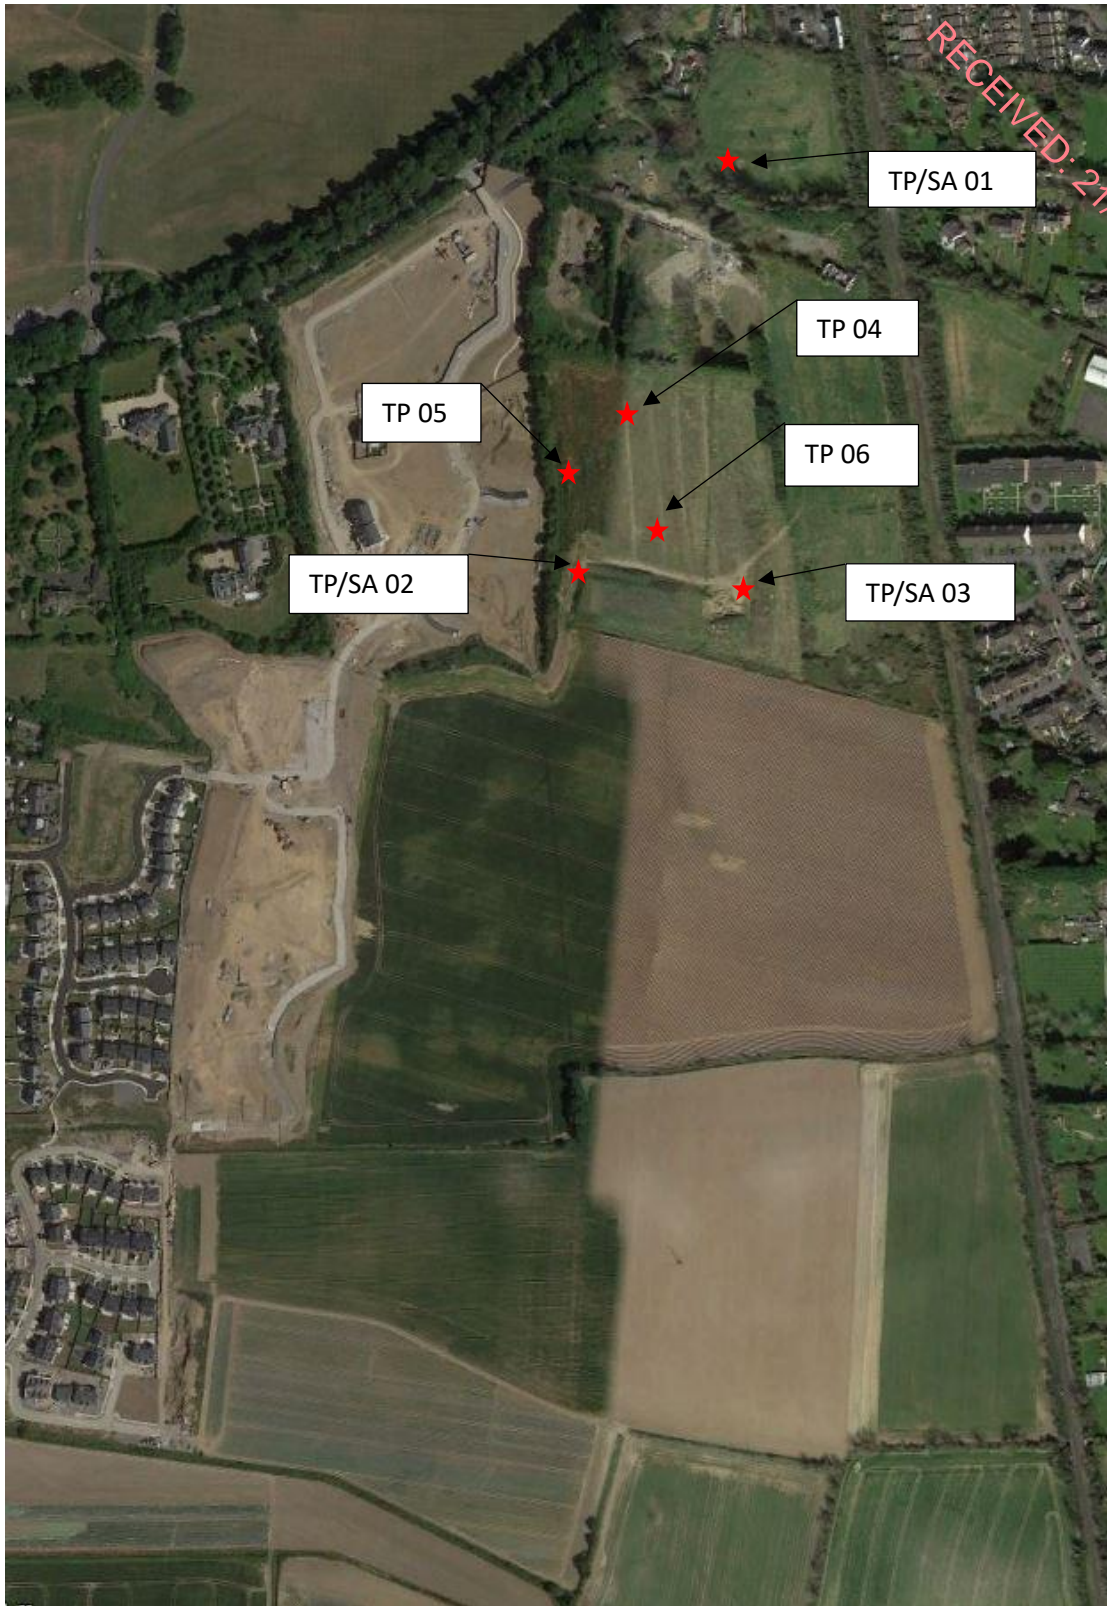
Figure 6.5 | Trial Pit (TP) & Soakaway (SA) Locations for the Subject Site Reports

Soakaway tests were also undertaken on 50% of the trial pits. The pit was filled with water and the level of groundwater recorded over time. As stipulated by BRE Special Digest 365, the pit should be filled 3 times and that the final cycle is used to provide the infiltration ratio. The time taken for the water level to fall from 75% volume to 25% volume is required to calculate the rate of infiltration. However, if the water level does not fall at a steady rate, then the test is deemed to have failed, and the area is unsuitable for stormwater percolation.

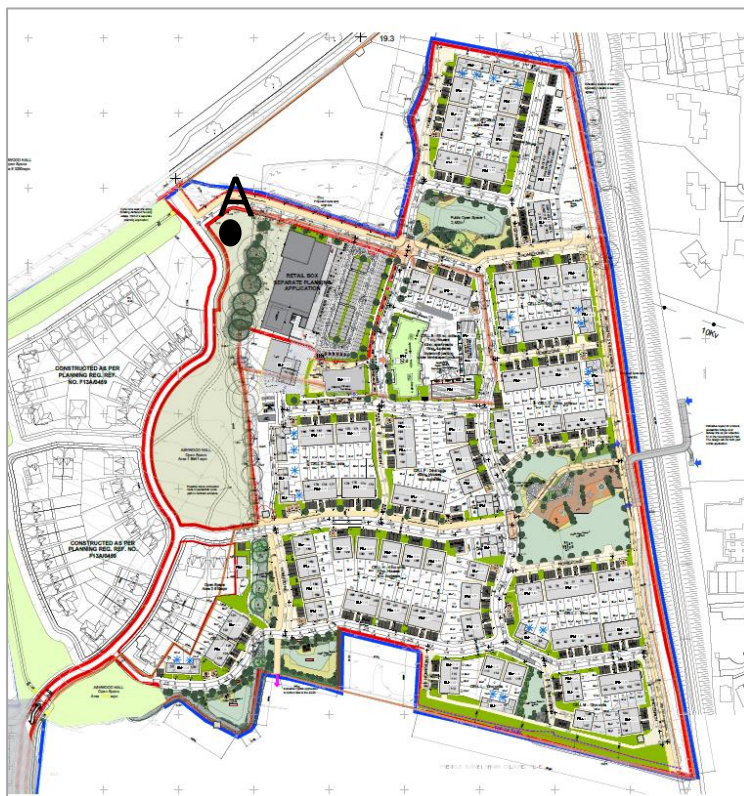
Image 8.3: Receptor location A.

Using the DMRB screening air dispersion model, pollutant concentrations in operational future years were predicted at the receptor location. In order to quantify the magnitude of change in pollutant concentrations, the descriptors in table 8.5. were used. To describe the significance of the impact, table 8.6 was then used. These descriptor tables are from the Transport Infrastructure Ireland Guidelines for the Treatment of Air Quality during the Planning and Construction of National Road Schemes which detail a methodology for determining air quality impact significance criteria for road schemes and has been adopted for this assessment. The degree of impact is determined based on both the absolute and relative impact of the proposed development. Results are compared against the 'Do-Nothing' scenario, which assumes that the proposed development is not in place in future years, in order to determine the degree of impact.

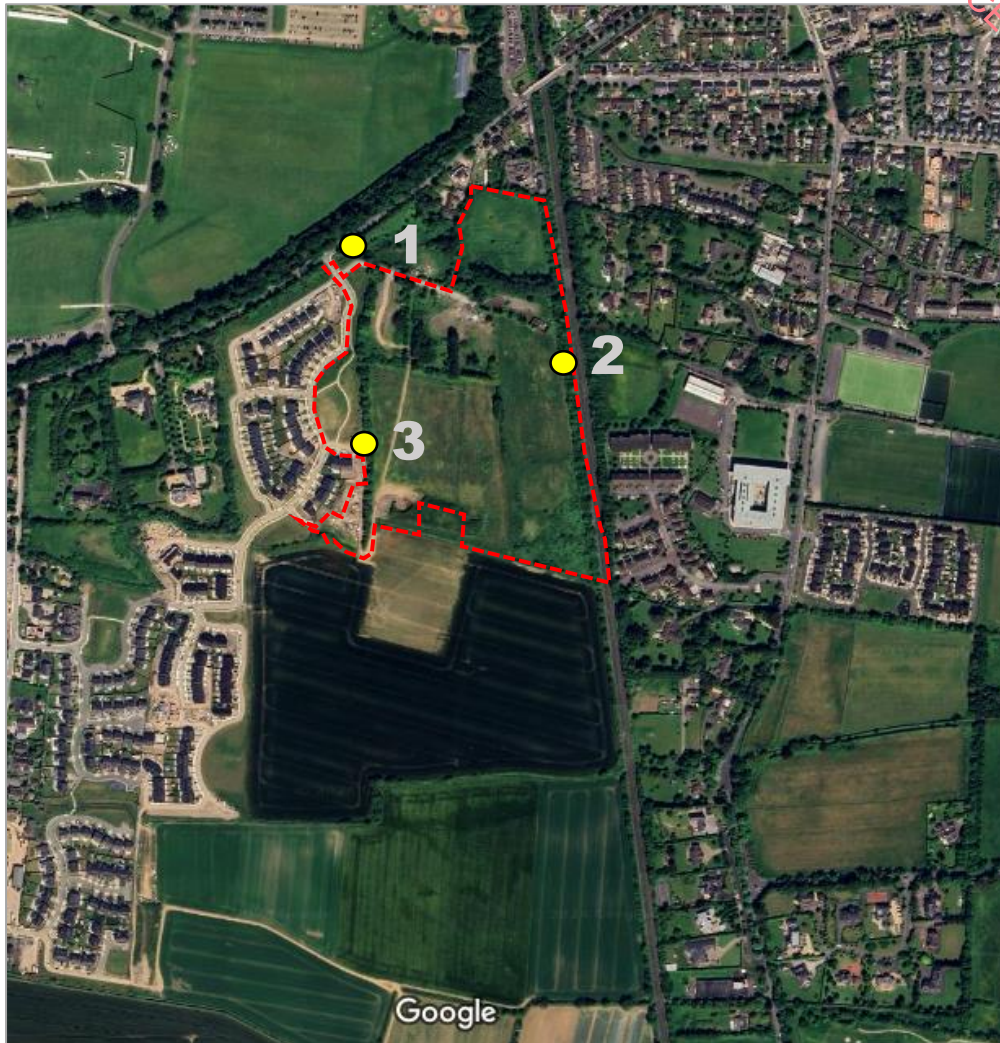
Measurement location	Location	Measurement Type	Justification
Station 1	Back Road	Unmanned	To determine back ground noise levels
Station 2	Railway line	Unmanned	To determine back ground noise levels
Station 3	Site (nearest receptor)	Unmanned	To determine back ground noise levels

Image 9.1.1: receptor locations highlighted in yellow.
