**EIAR Volume 4: Offshore Infrastructure  
Technical Appendices  
Appendix 4.3.13-4  
Archaeology Intertidal Survey  
Shanganagh, Dublin Array 21D0046,  
21R0071**

**Archaeology Intertidal Survey  
Shanganagh, Dublin Array  
21D0046, 21R0071**

**Archaeological Intertidal Survey  
Shanganagh, Dublin Array  
21D0046, 21R0071**

Subject: Dublin Array, export cable route landfall option  
Location: Shanganagh, Co. Dublin  
ITM: North limit: 725991E 723933N  
South limit: 726530E 720491N  
Status: Intertidal foreshore

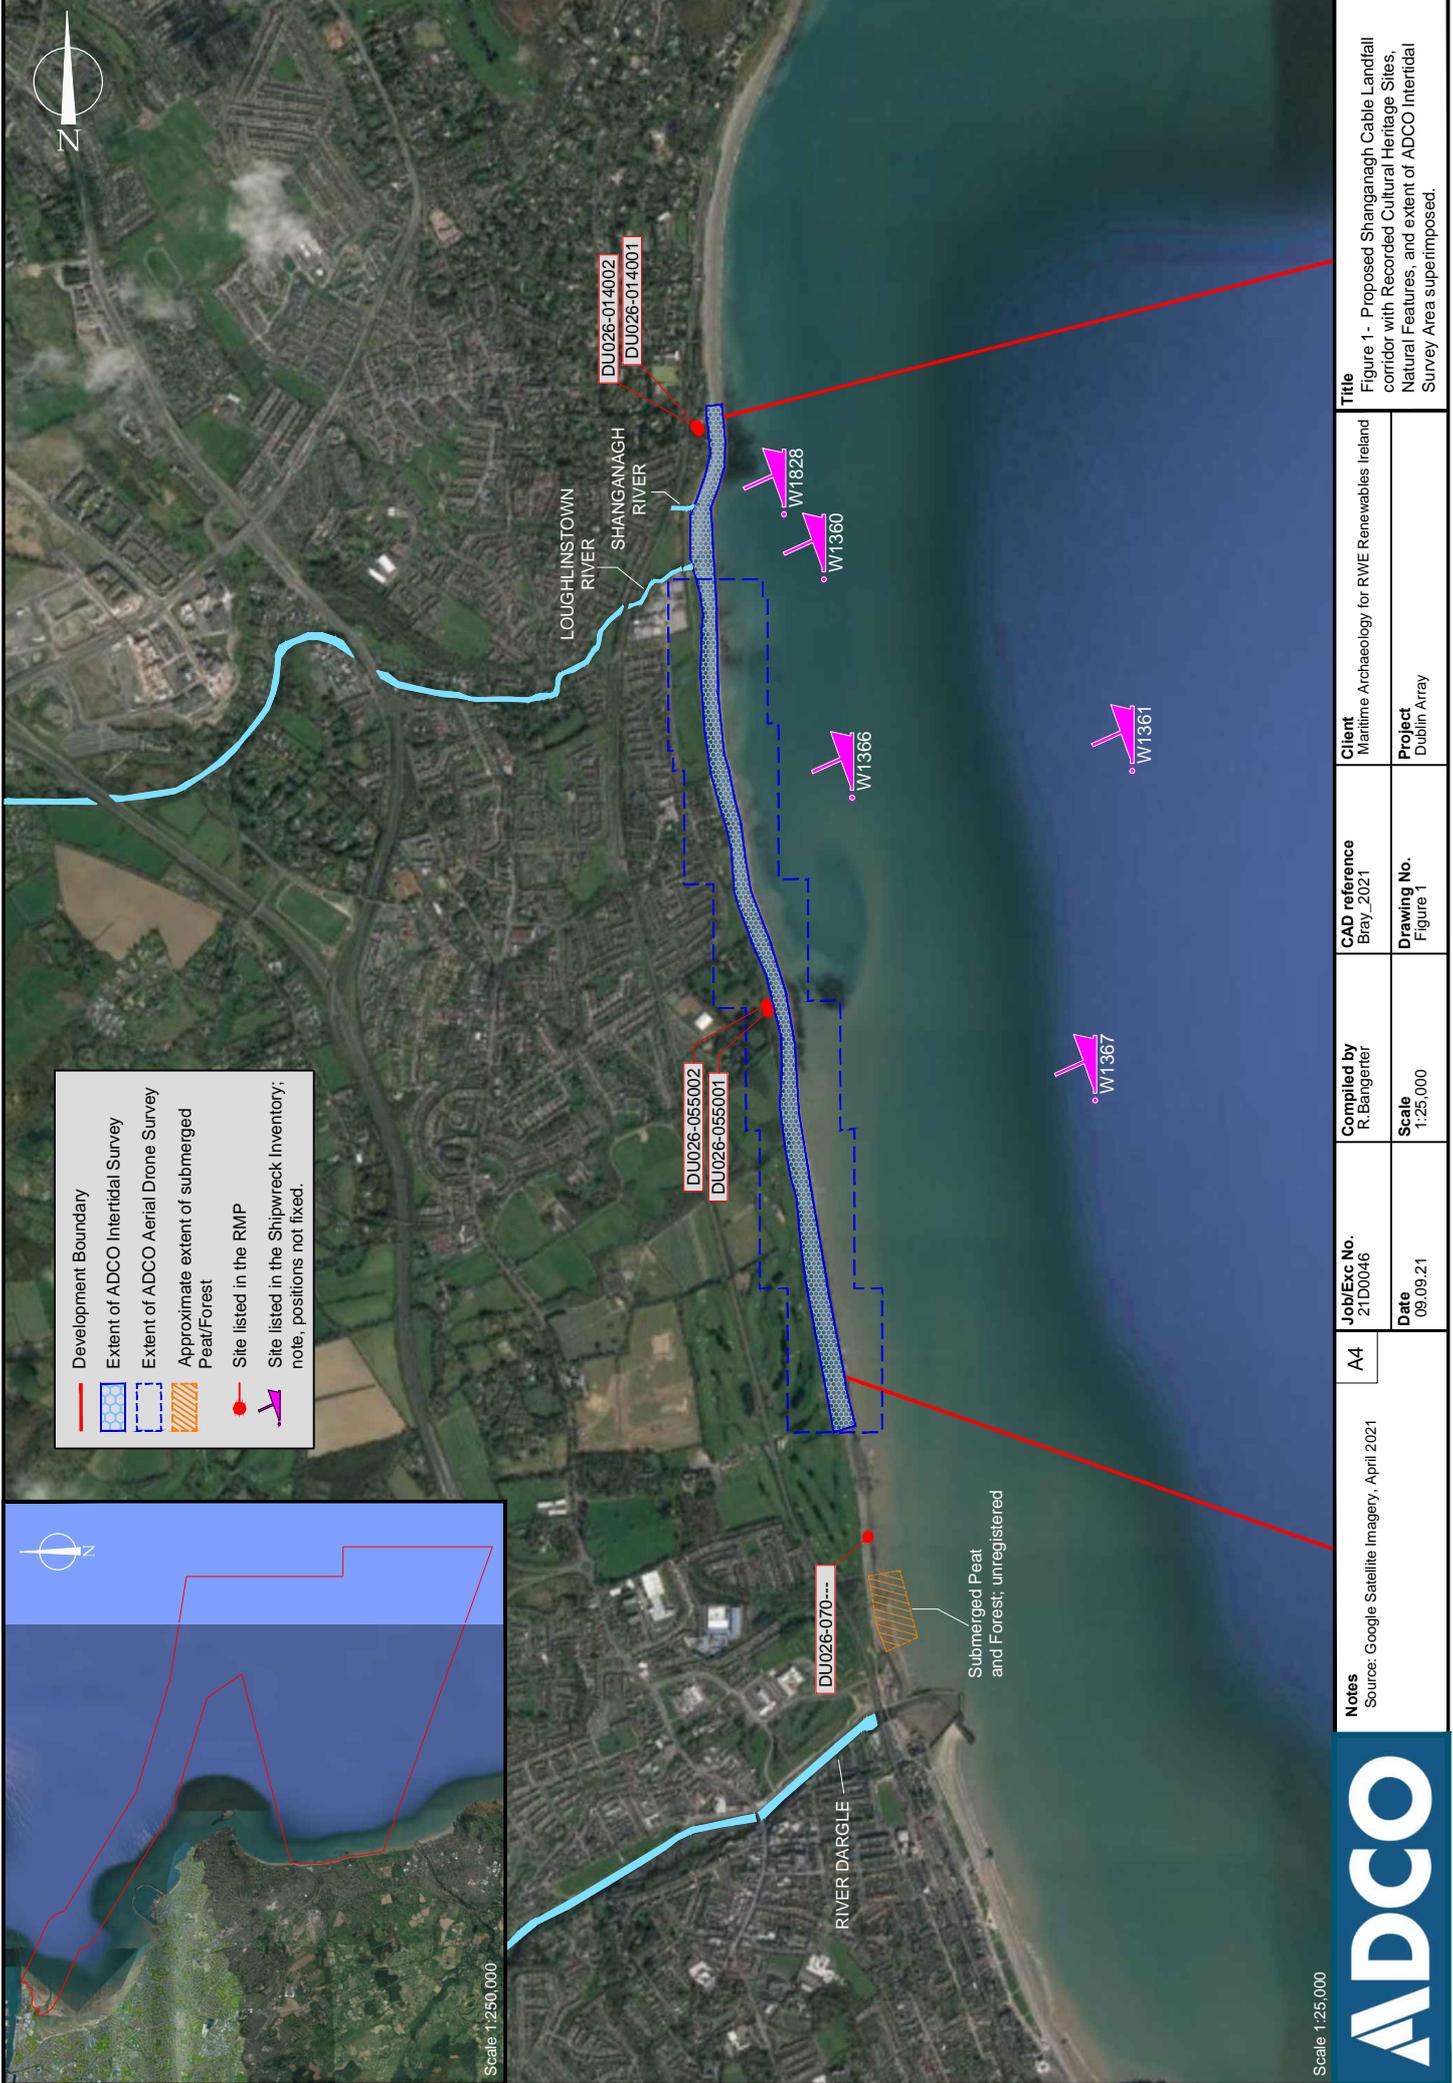
- Figure 1: Recorded cultural heritage sites and natural features at the proposed Shanganagh cable landfall corridor and showing the extent of the ADCO Intertidal Survey Area.

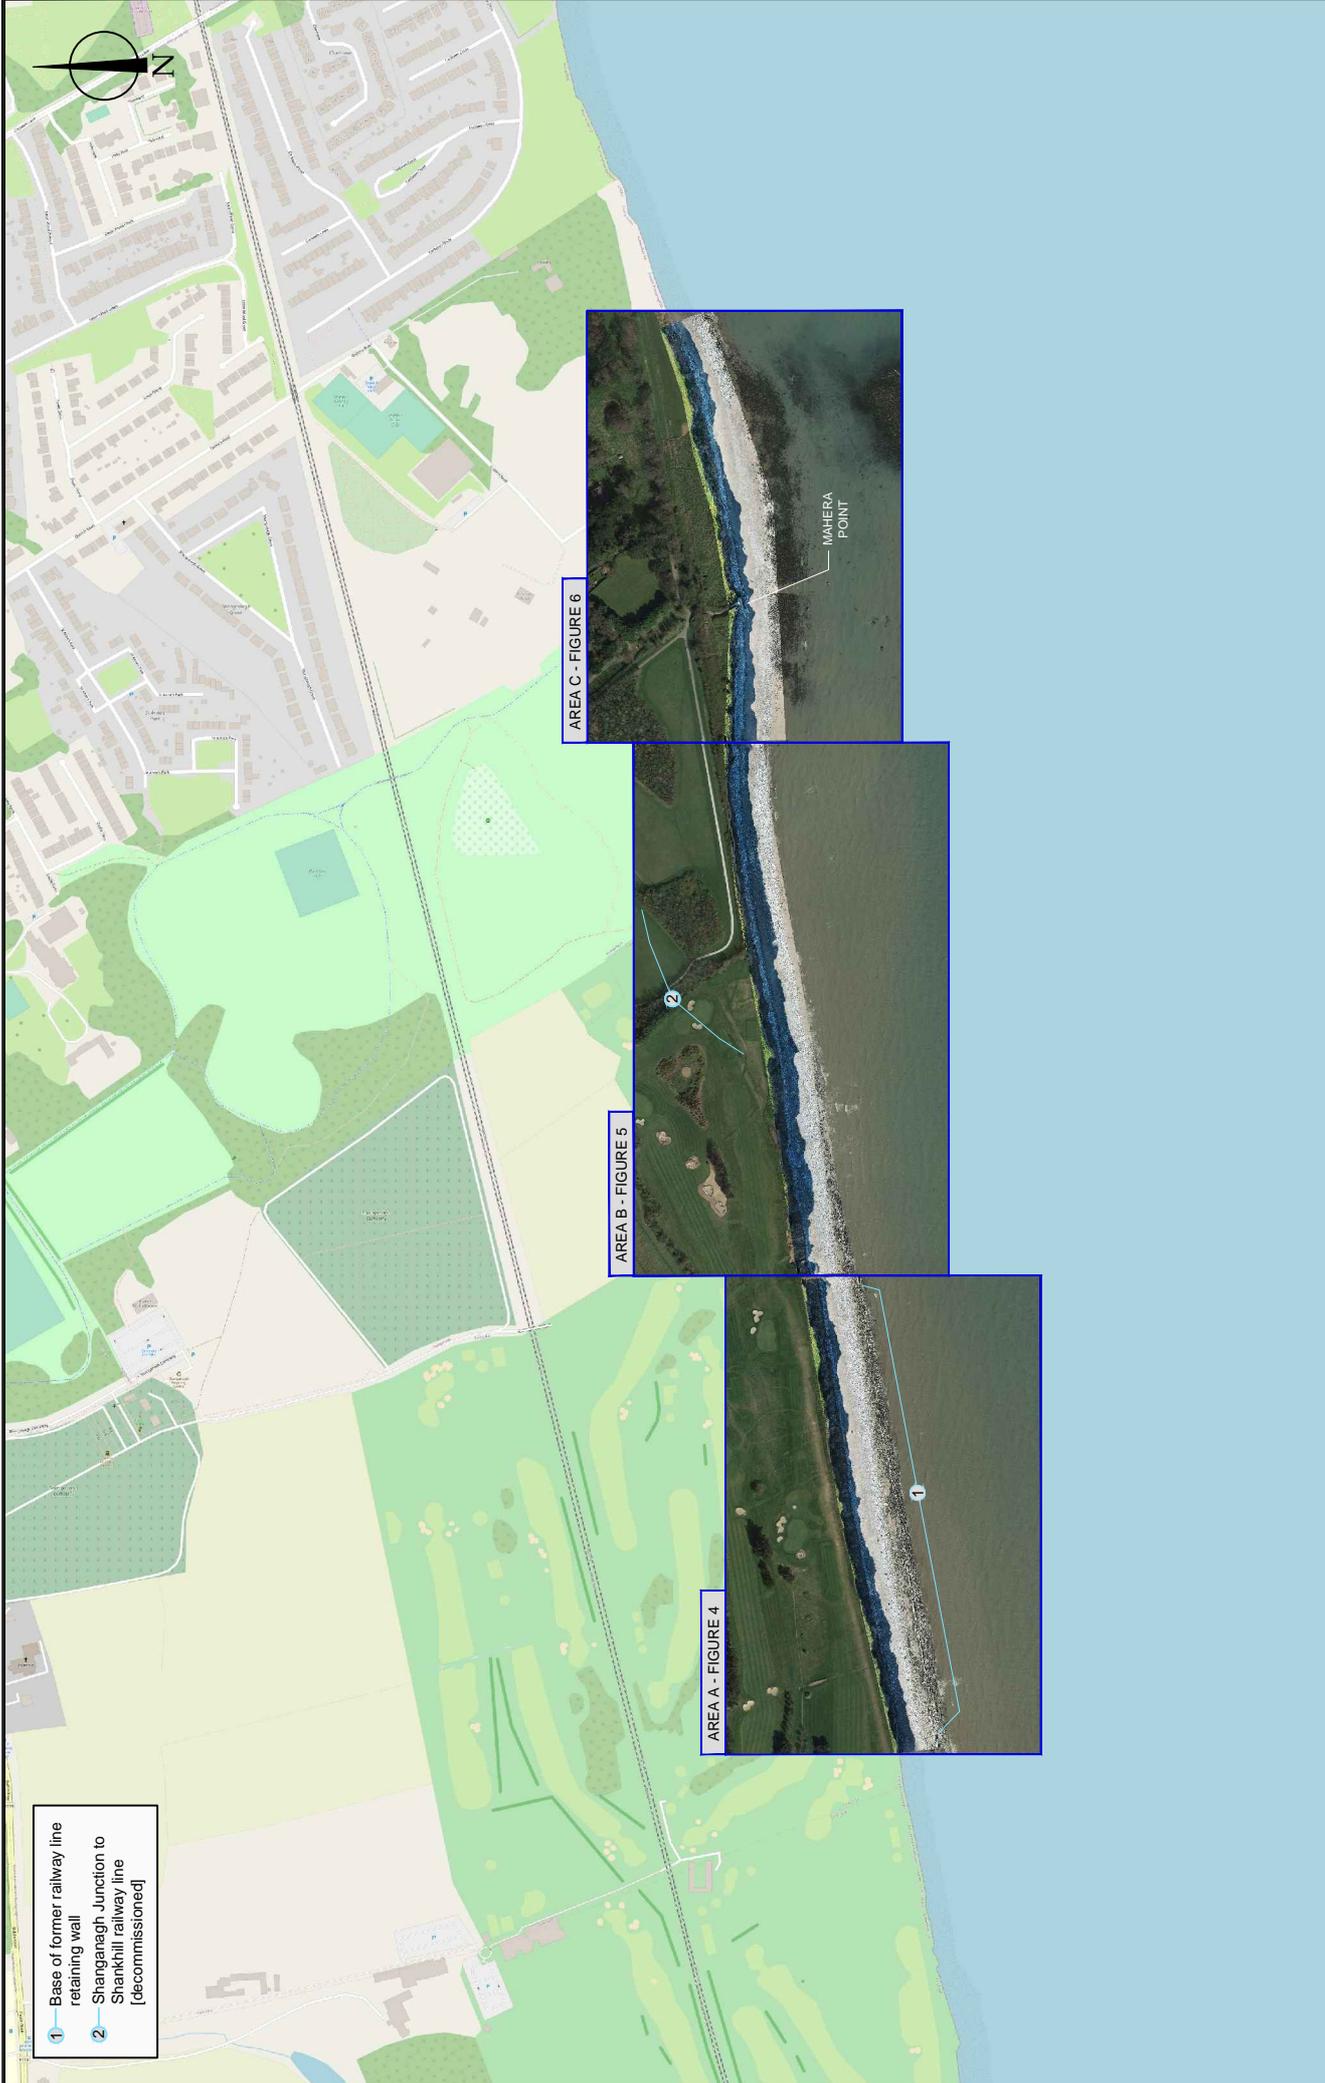
<b>Notes</b> Source: ADCO Drone Survey thumbnails superimposed upon Open Source Street Map.		<b>A4</b>	<b>Job/Exc No.</b> 21D0046	<b>Date</b> 09.09.21	<b>Compiled by</b> R. Bangerter	<b>CAD reference</b> Bray_2021	<b>Client</b> Maritime Archaeology for RWE Renewables Ireland	<b>Project</b> Dublin Array	<b>Title</b> Figure 2- Map showing location of Aerial Drone Survey Areas A-C.
				<b>Scale</b> 1:7500		<b>Drawing No.</b> Figure 2

to support the coastal route are evident on the foreshore at Low Water (Figure 2). The remains are not a registered archaeological or cultural heritage feature.

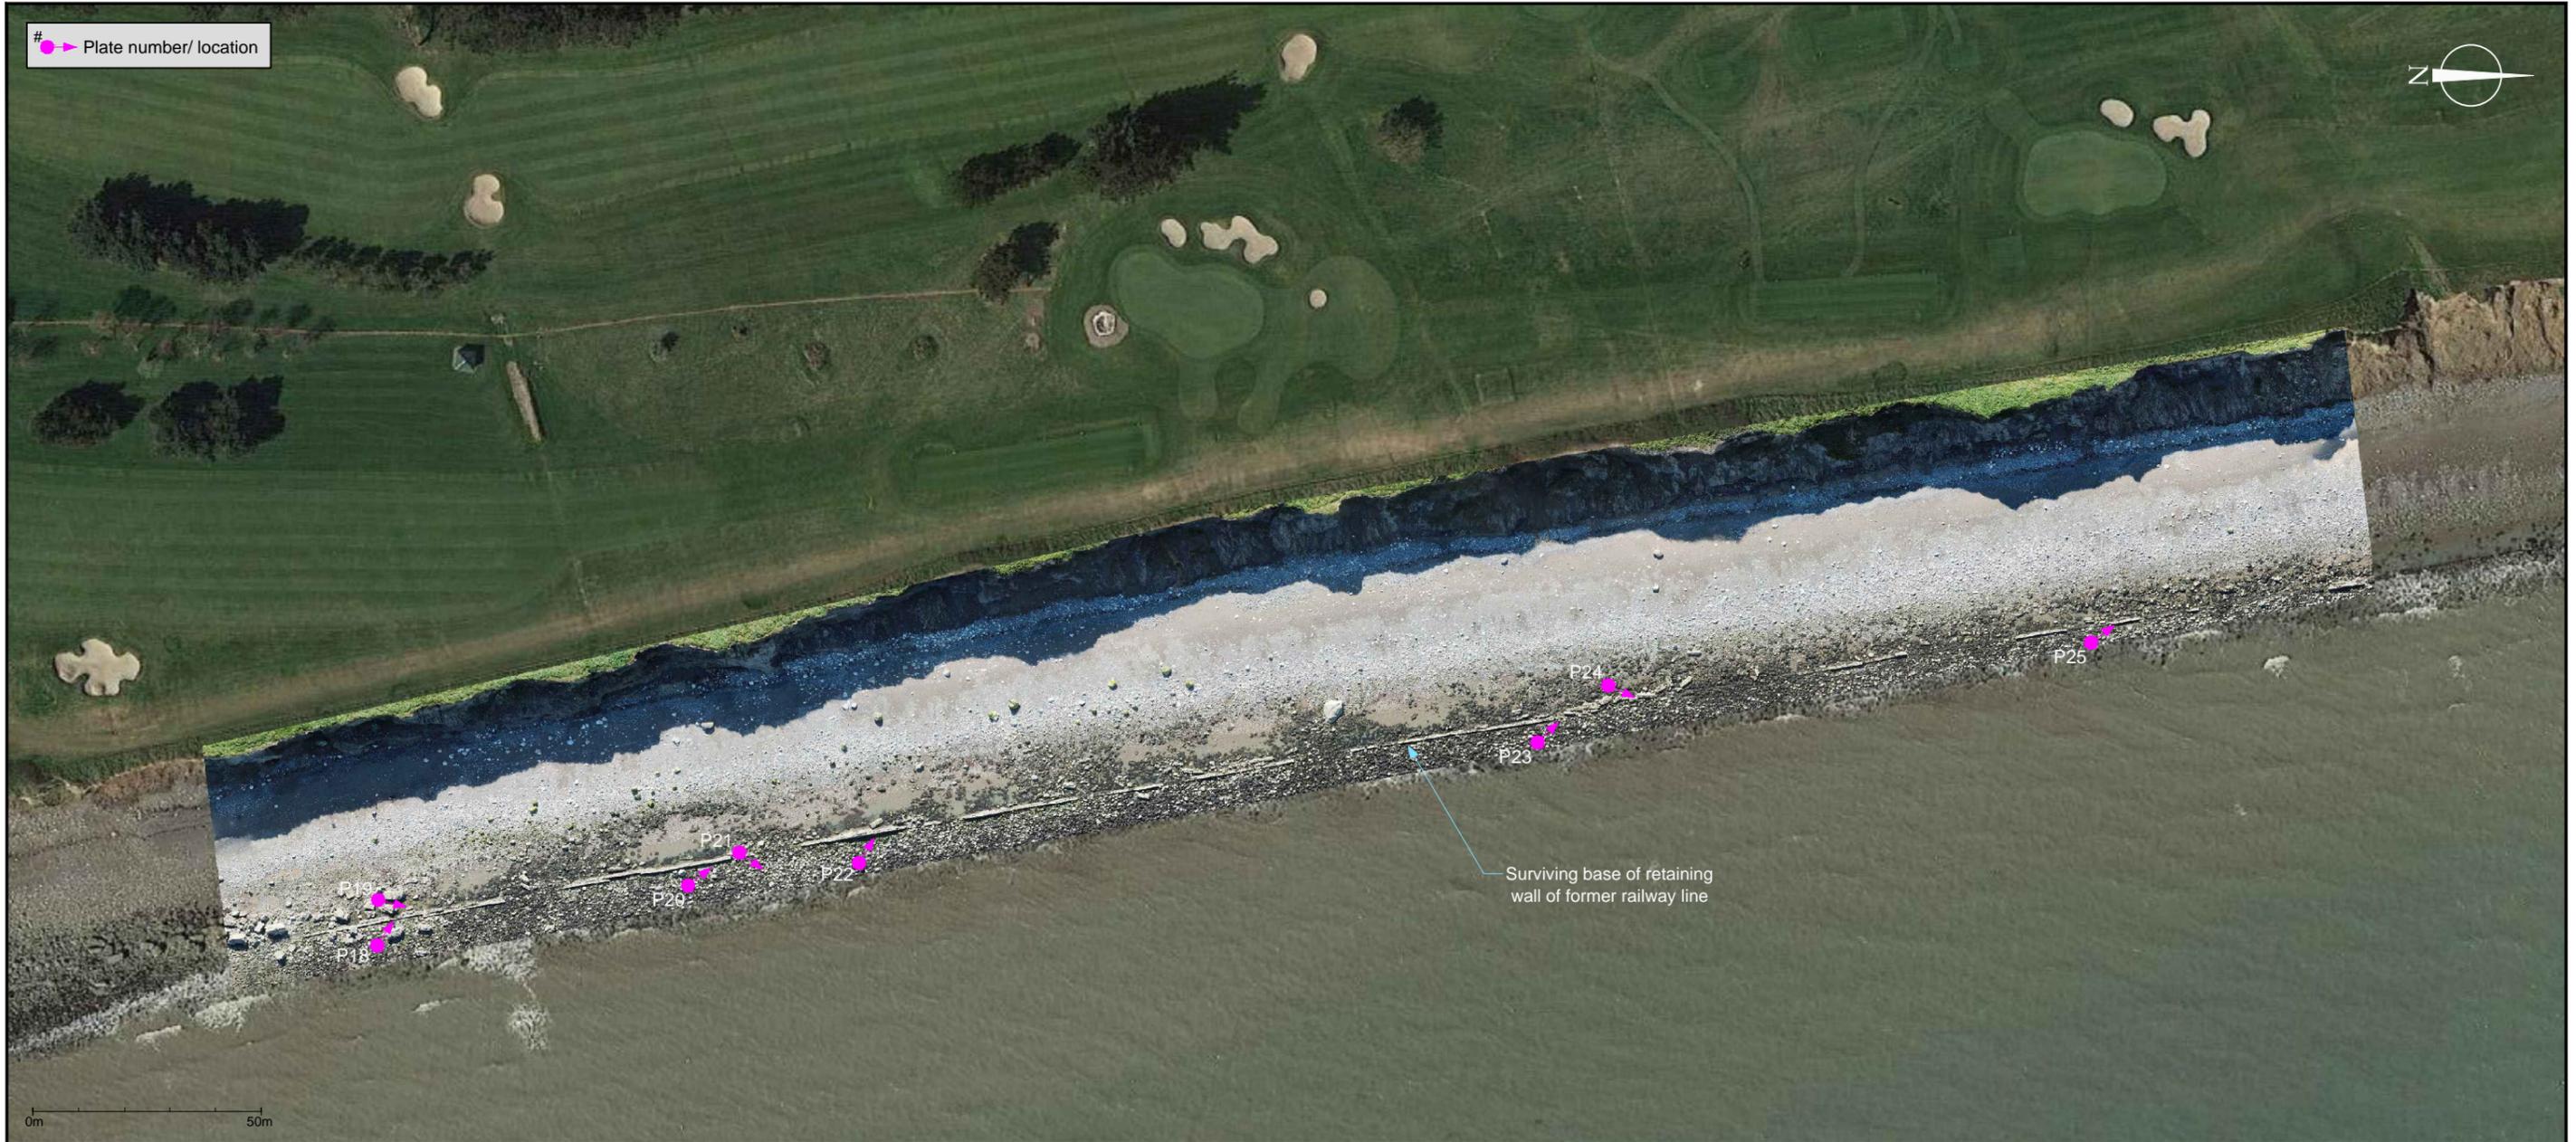
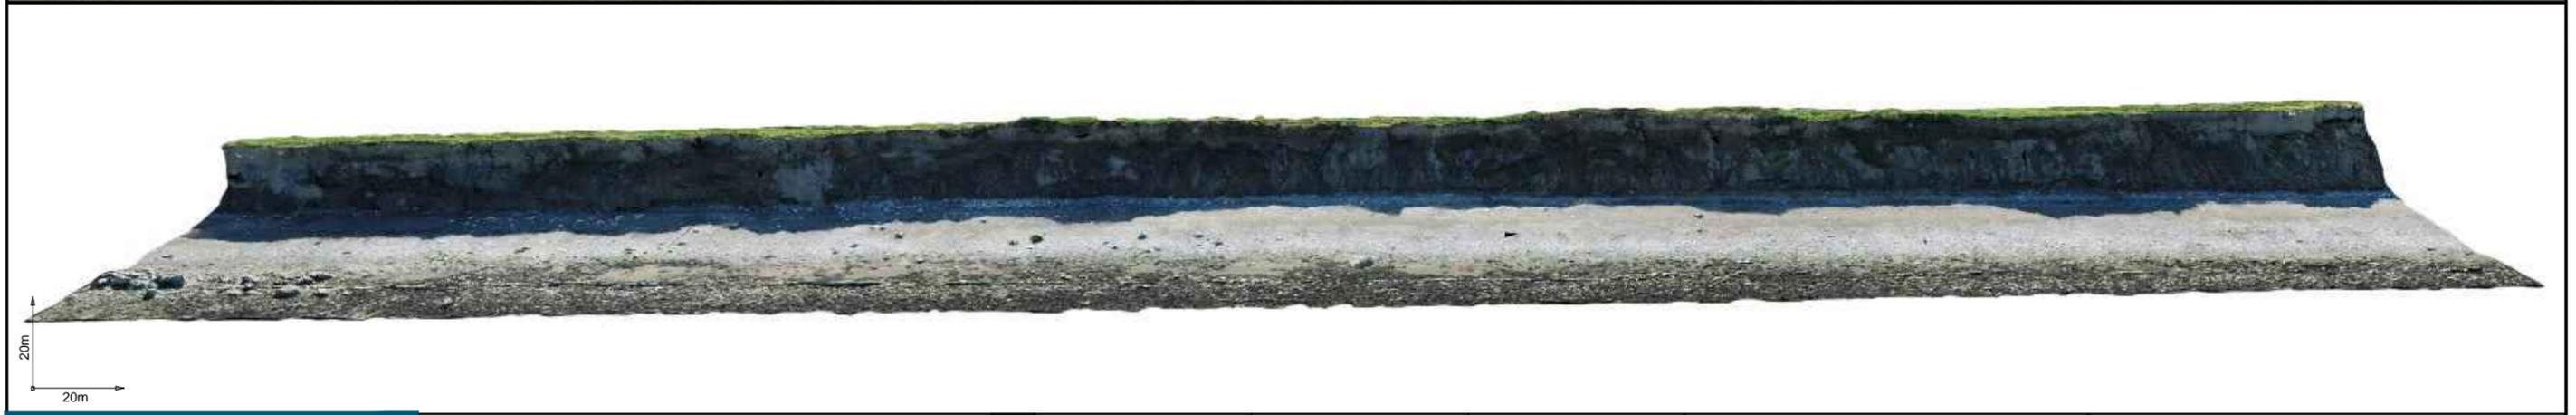
**Title**  
Figure 4- Aerial Drone Survey of a 478m section of intertidal foreshore (Section A) located 1km to the north of Bray Harbour; Plan and Isometric view.

**Notes**  
 Imagery captured by ADCO (R.Bangert/ D.Lenehan) on 17th July 2021 using an aerial drone [coordinate projection- WGS84].  
 [Plan view imagery superimposed upon Google Satellite Imagery gathered April 2021].

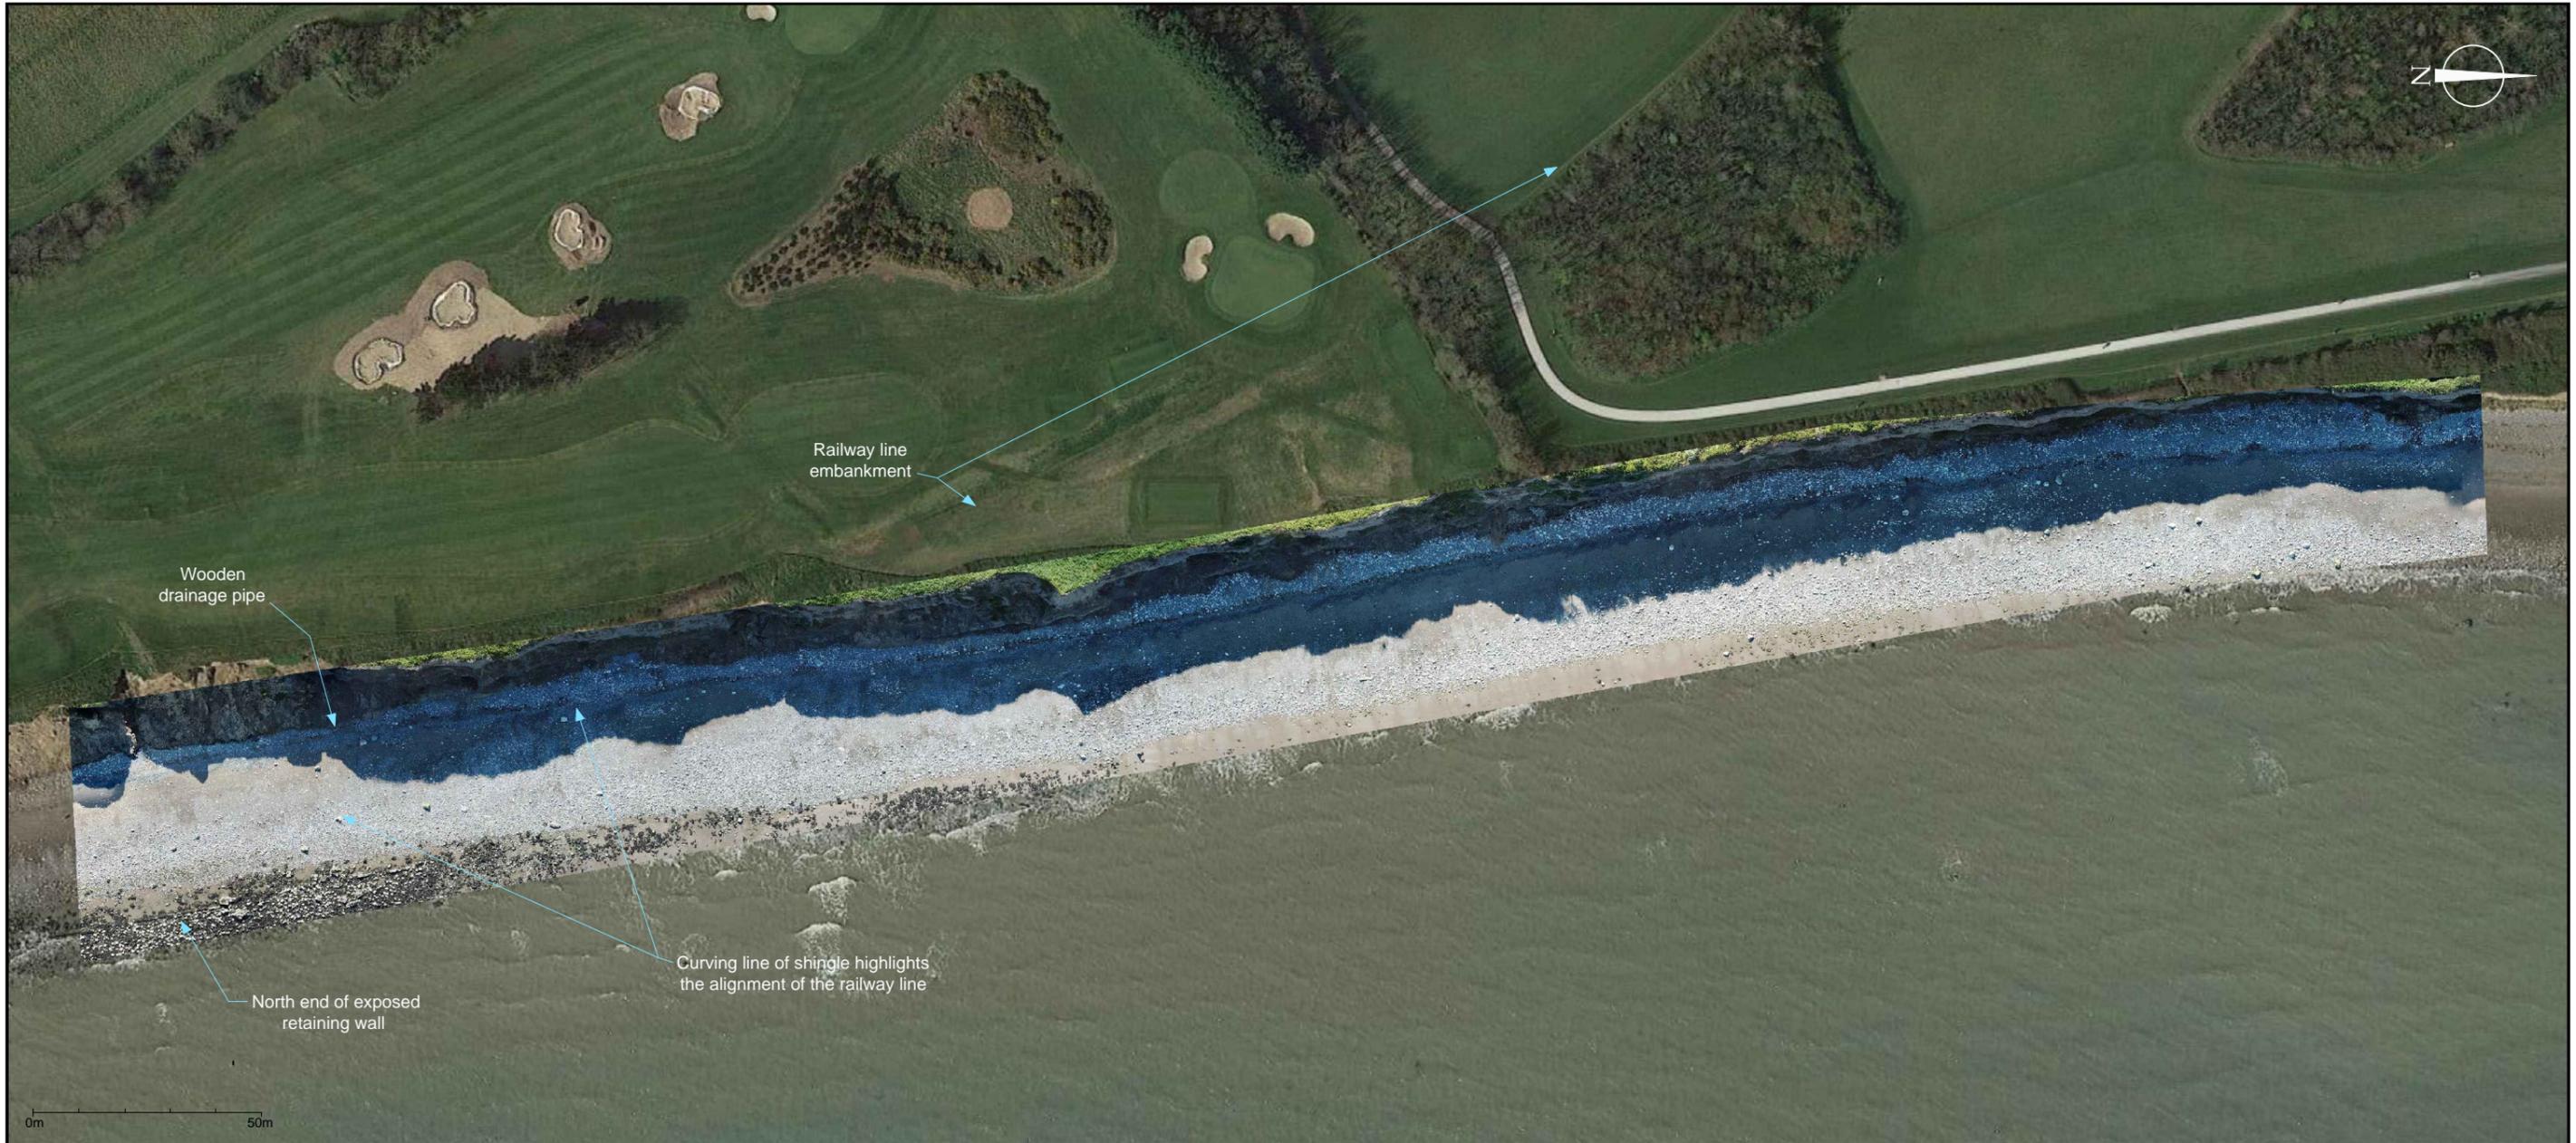
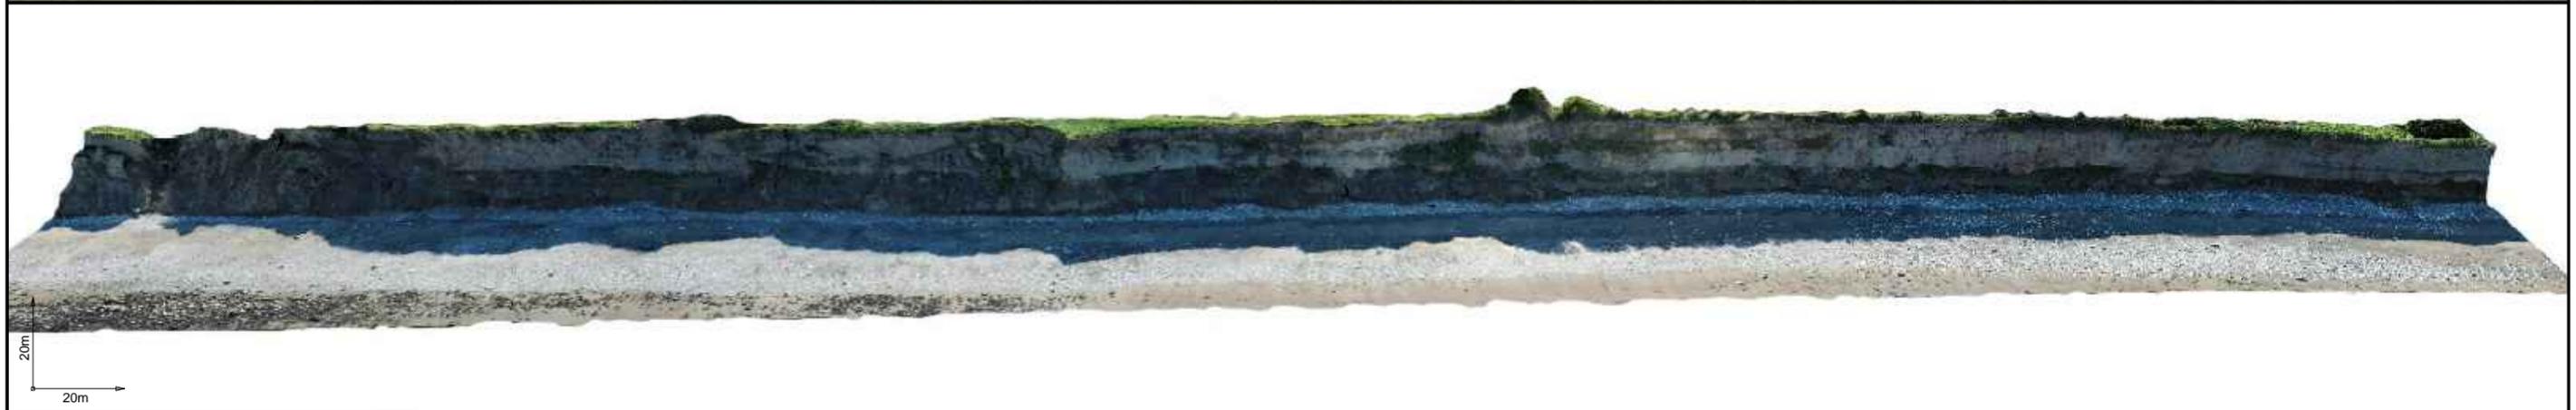
- Figure 5: Aerial Drone Survey of a 478m-long section of the intertidal foreshore (Section B) located 1.4km to the north of Bray Harbour; Plan and Isometric view.

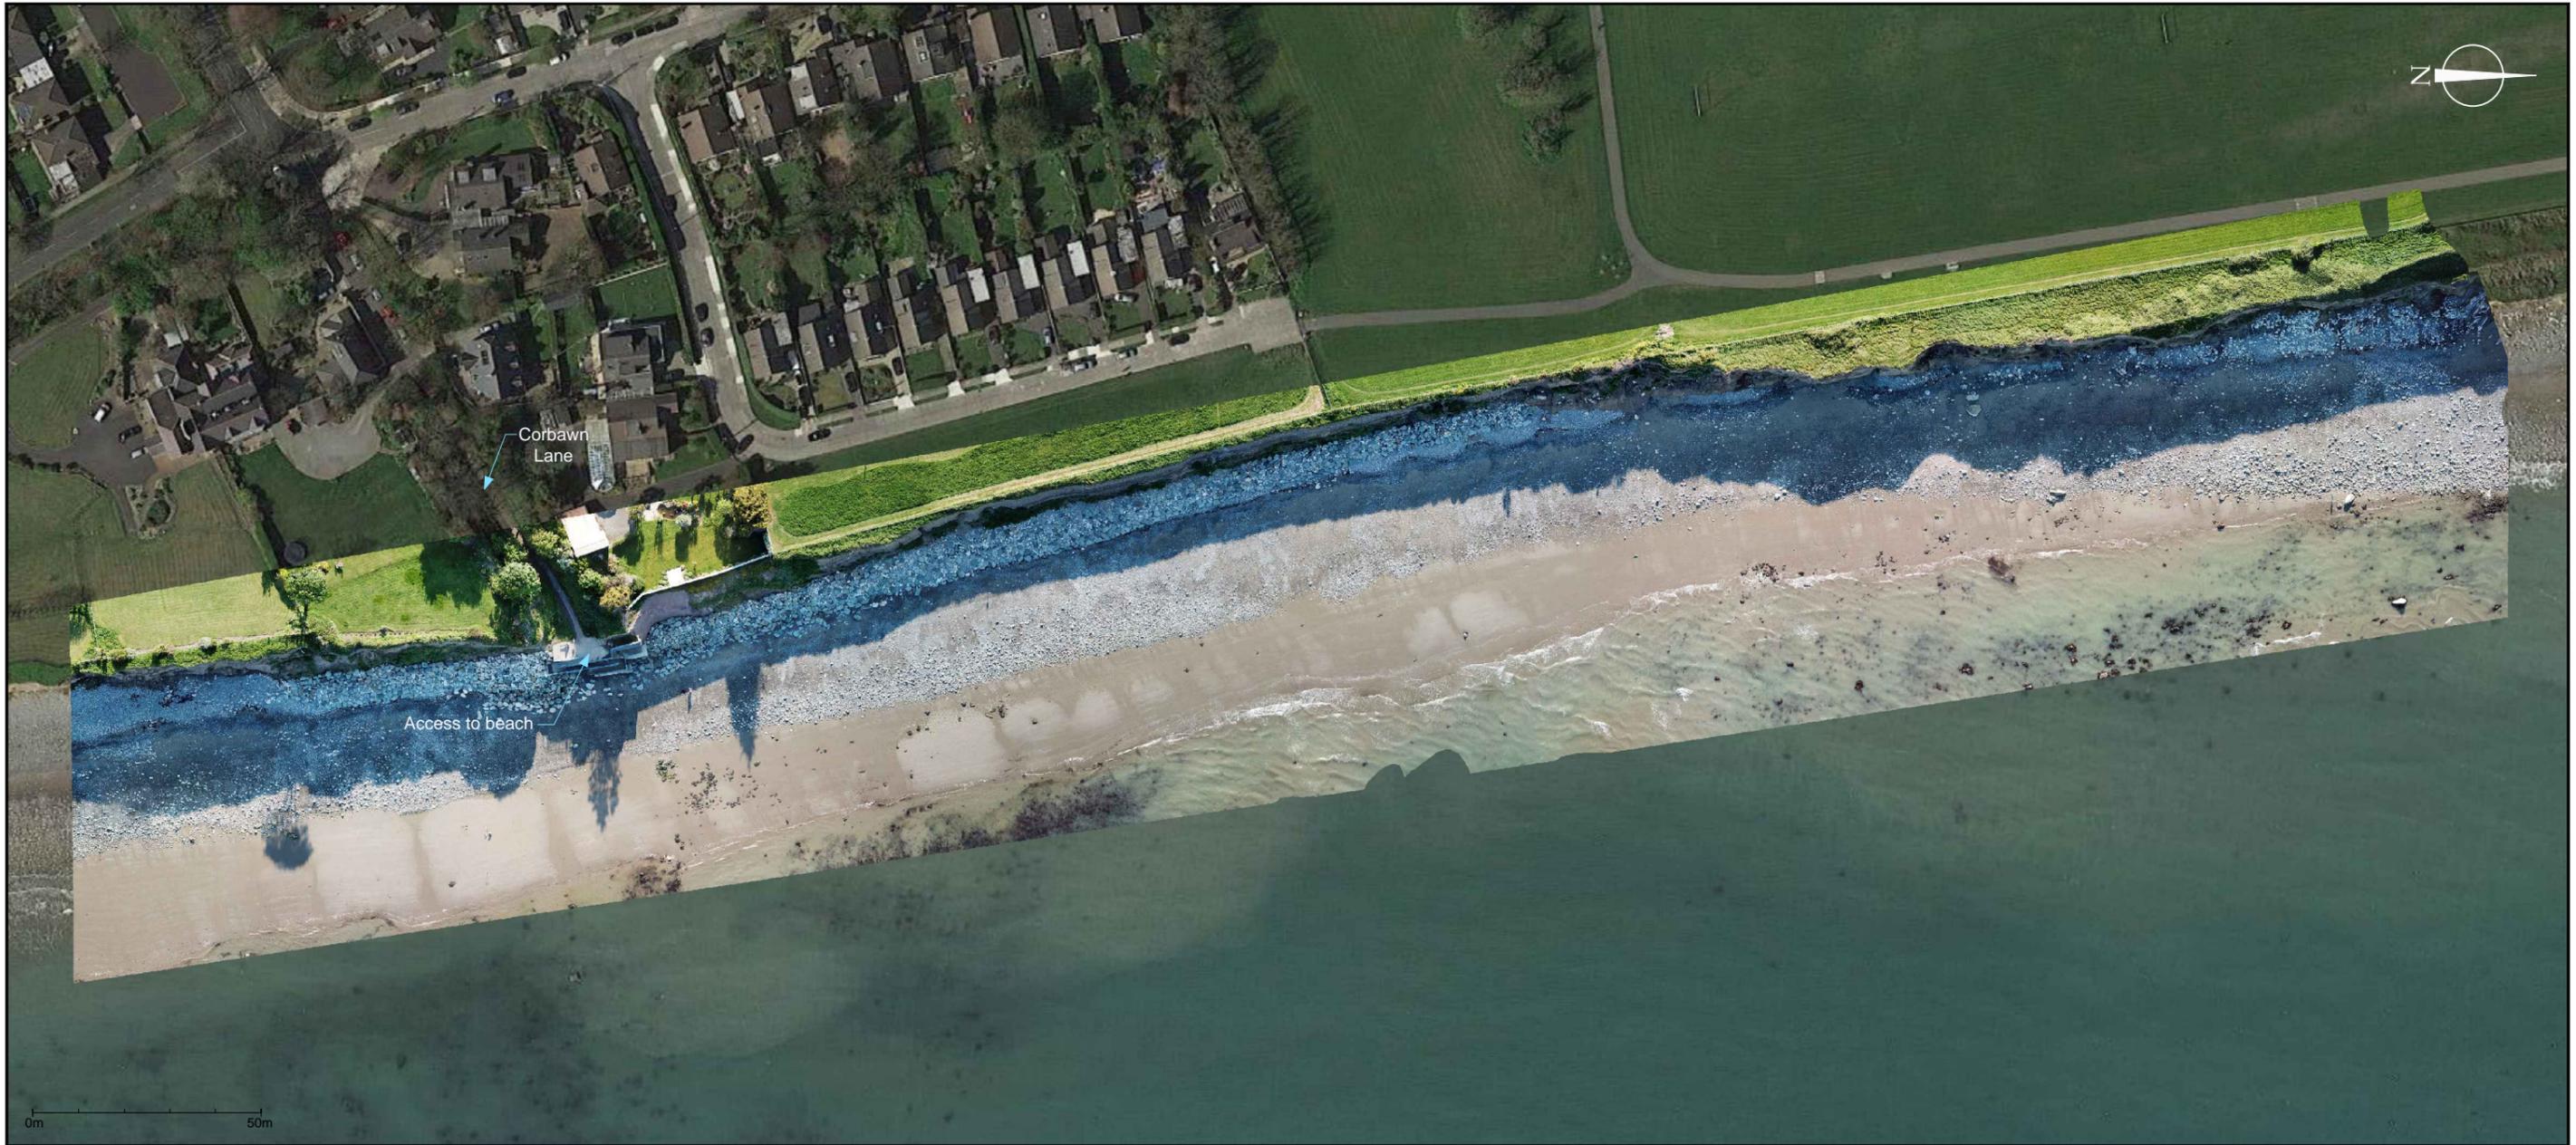
<b>Notes</b> Imagery captured by ADCO (R.Bangerter/ D.Lenehan) on 17th July 2021 using an aerial drone [coordinate projection- WGS84].  [Plan view imagery superimposed upon Google Satellite Imagery gathered April 2021].	<b>A3</b>	<b>Job/Exc No.</b> 21D0046	<b>Compiled by</b> R.Bangerter	<b>CAD reference</b> Bray_2021	<b>Client</b> Maritime Archaeology for RWE Renewables Ireland	<b>Title</b> Figure 7- Aerial Drone Survey of a 430m section of intertidal foreshore (Section D) located 2.4km to the north of Bray Harbour; Plan and Isometric view.
		<b>Date</b> 06.09.21	<b>Scale</b> 1:1400	<b>Drawing No.</b> Figure 7	<b>Project</b> Dublin Array

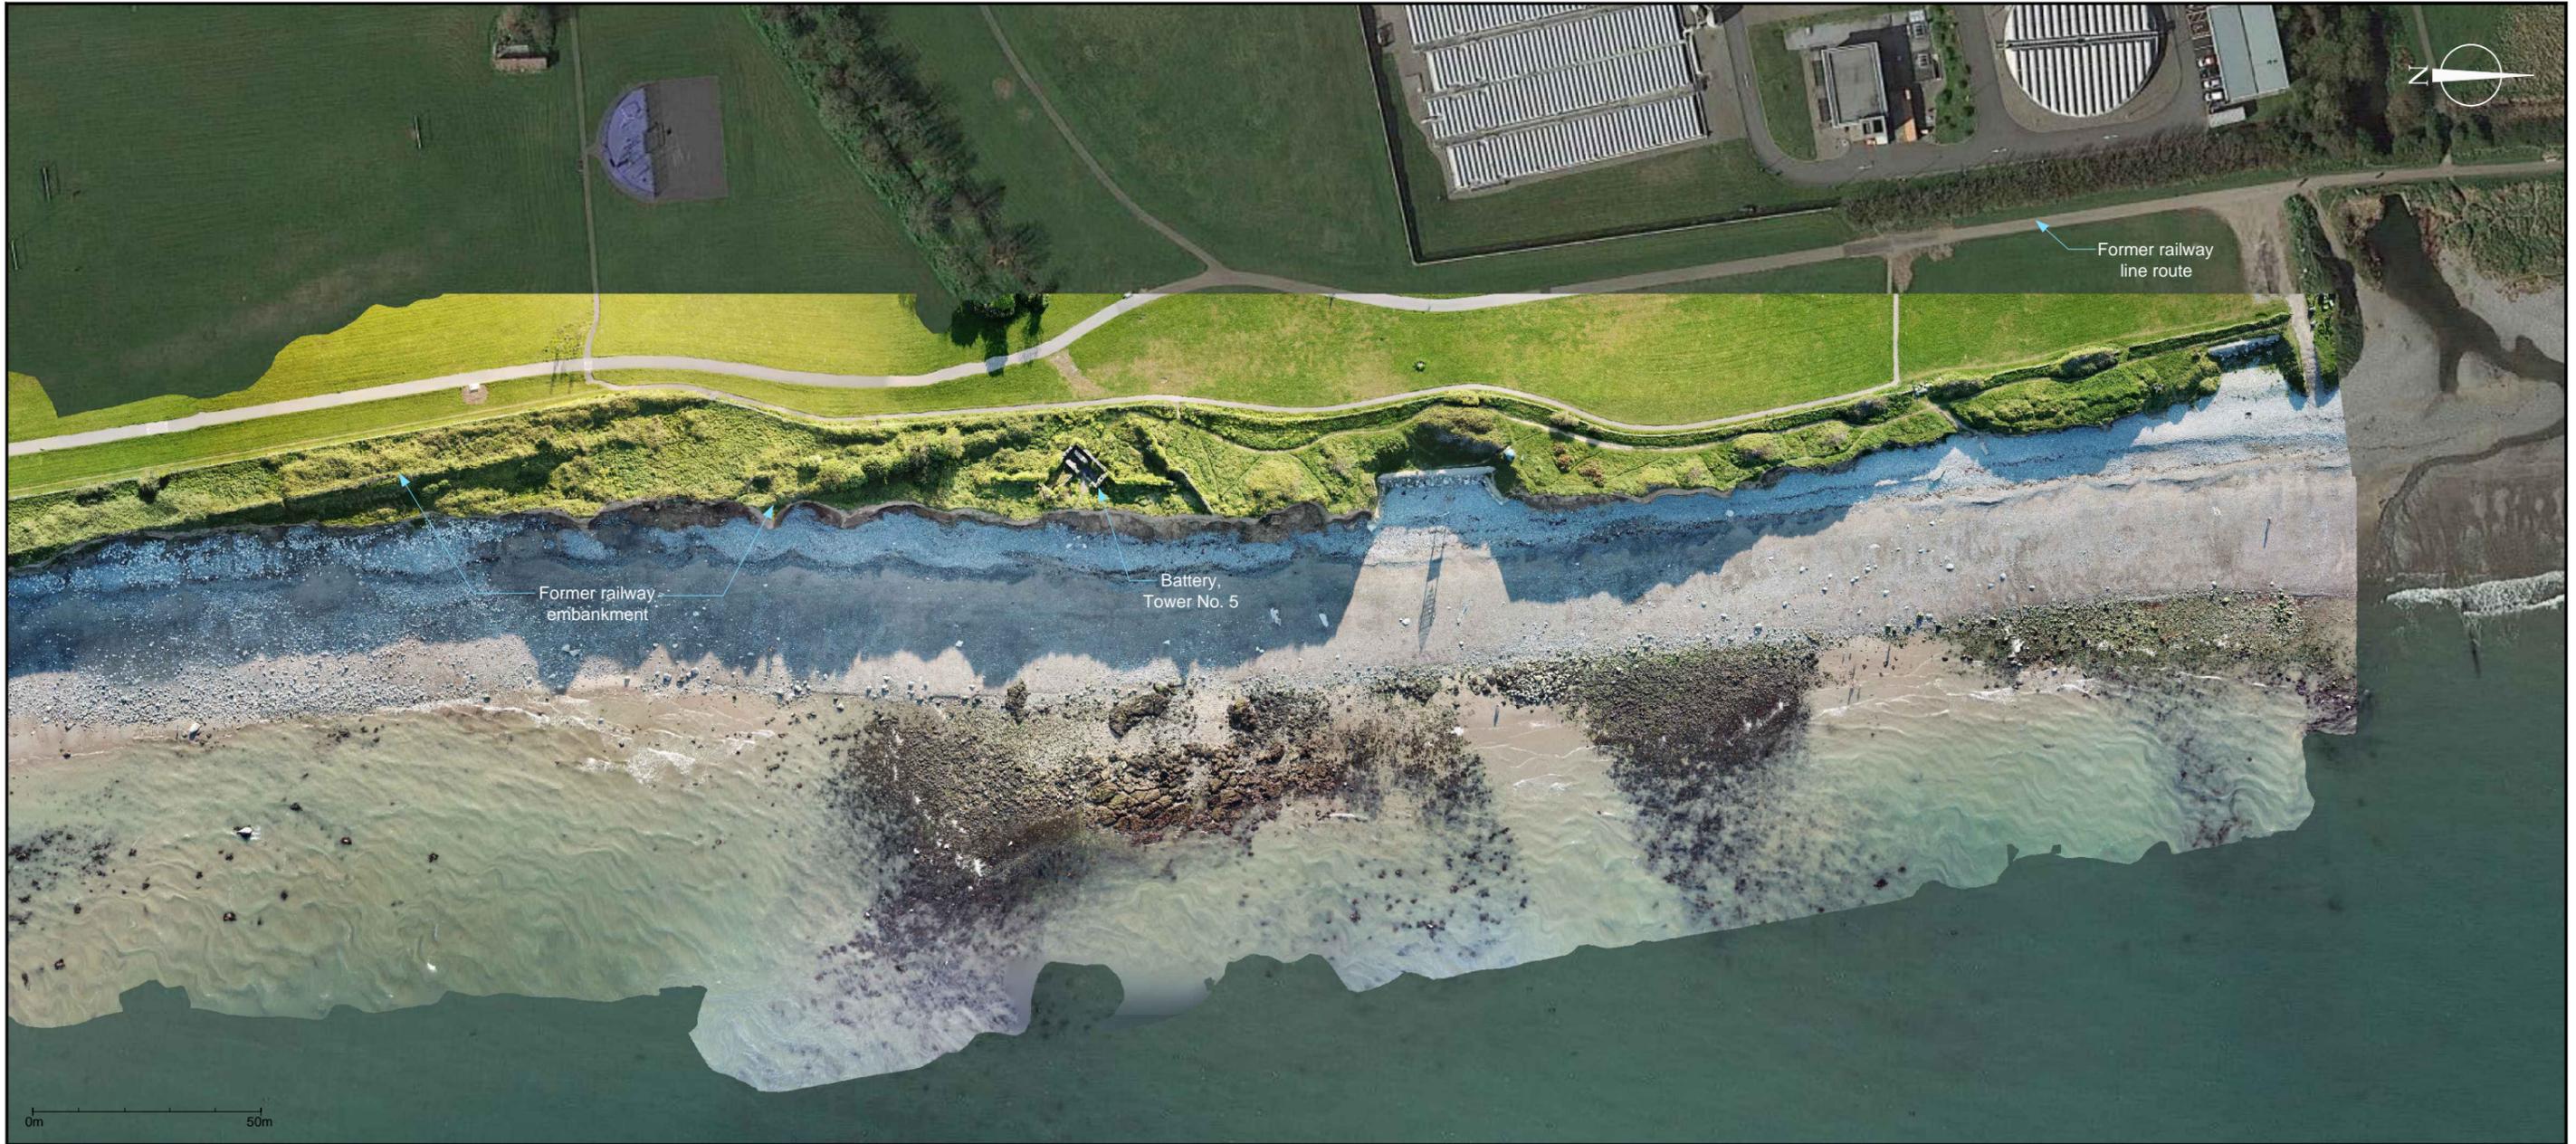
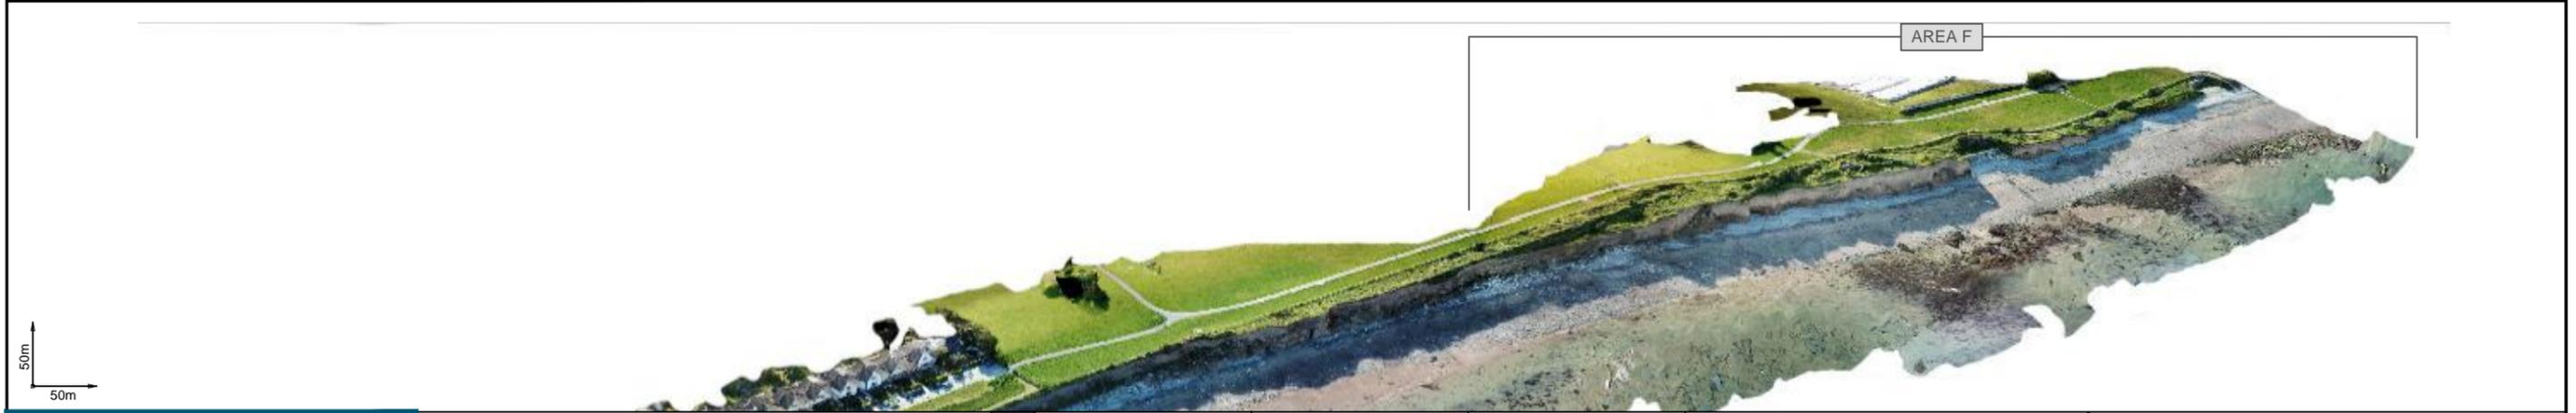
- Figure 9: Aerial Drone Survey of a 430m-long section of the intertidal foreshore (Section B) located 3.2km to the north of Bray Harbour; Plan and Isometric view.

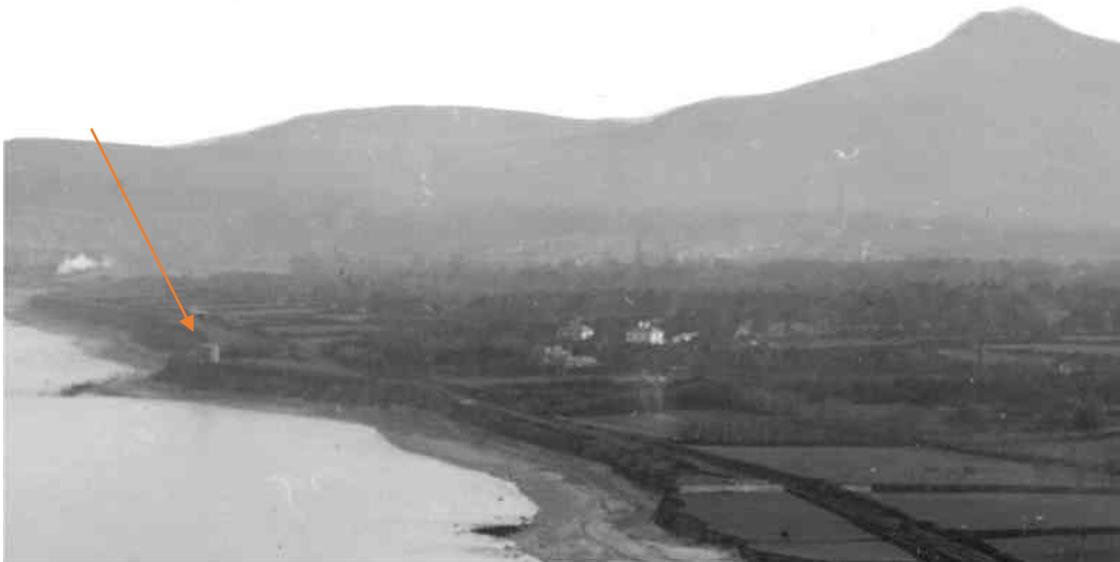
Plate 2: Historic photograph looking south from Killiney Hill along shoreline at Shanganagh, showing Martello Tower No. 4 (DU026-05501) on Mahera Point still standing, before it succumbed to destruction through coastal retreat. (Arrow added to highlight tower.)

A Martello Tower and associated defensive redoubt site were constructed further south on Mahera Point in Shanganagh townland and are registered archaeological monuments (Table 2, DU026-05501, -005502, Figures 1–2). The tower was listed as Tower No. 4 and is recorded on the First Edition Ordnance Survey six-inch map series (1843) as noted previously (Plate 1). There is a historic photograph that shows it standing (Plate 2). The complex, however, has fallen victim to coastal erosion and does not survive.<sup>4</sup>

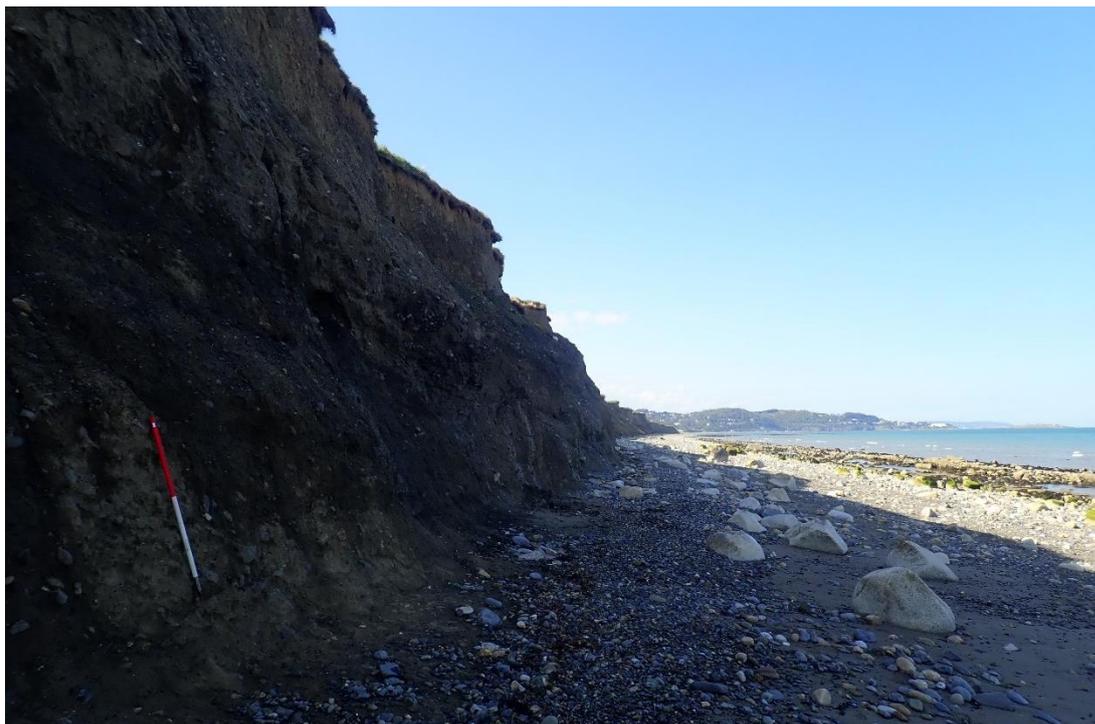
Plate 3: View looking north along shoreline at Shanganagh, showing nature of sea cliff and slumped till at its base. ITM 726505E 729481N.
