**EIAR Volume 4: Offshore Infrastructure  
Technical Appendices  
Appendix 4.3.13-4  
Archaeology Intertidal Survey  
Shanganagh, Dublin Array 21D0046,  
21R0071**

**Archaeology Intertidal Survey  
Shanganagh, Dublin Array  
21D0046, 21R0071**

**Archaeological Intertidal Survey  
Shanganagh, Dublin Array  
21D0046, 21R0071**

Subject: Dublin Array, export cable route landfall option  
Location: Shanganagh, Co. Dublin  
ITM: North limit: 725991E 723933N  
South limit: 726530E 720491N  
Status: Intertidal foreshore

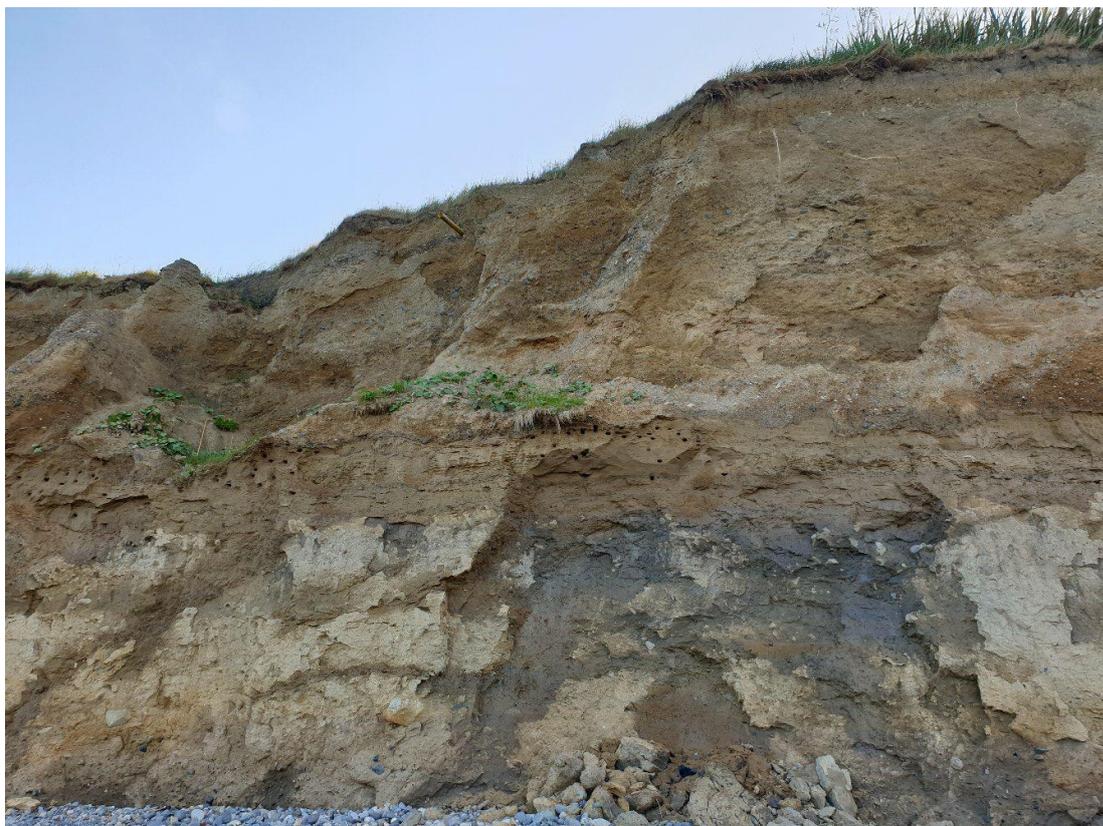
Plate 4: View facing sea cliff in Shanganagh, showing nature of exposed till and sand strata. The small holes penetrating the sand layers in the middle of the picture are created by sand martins as part of their nests.

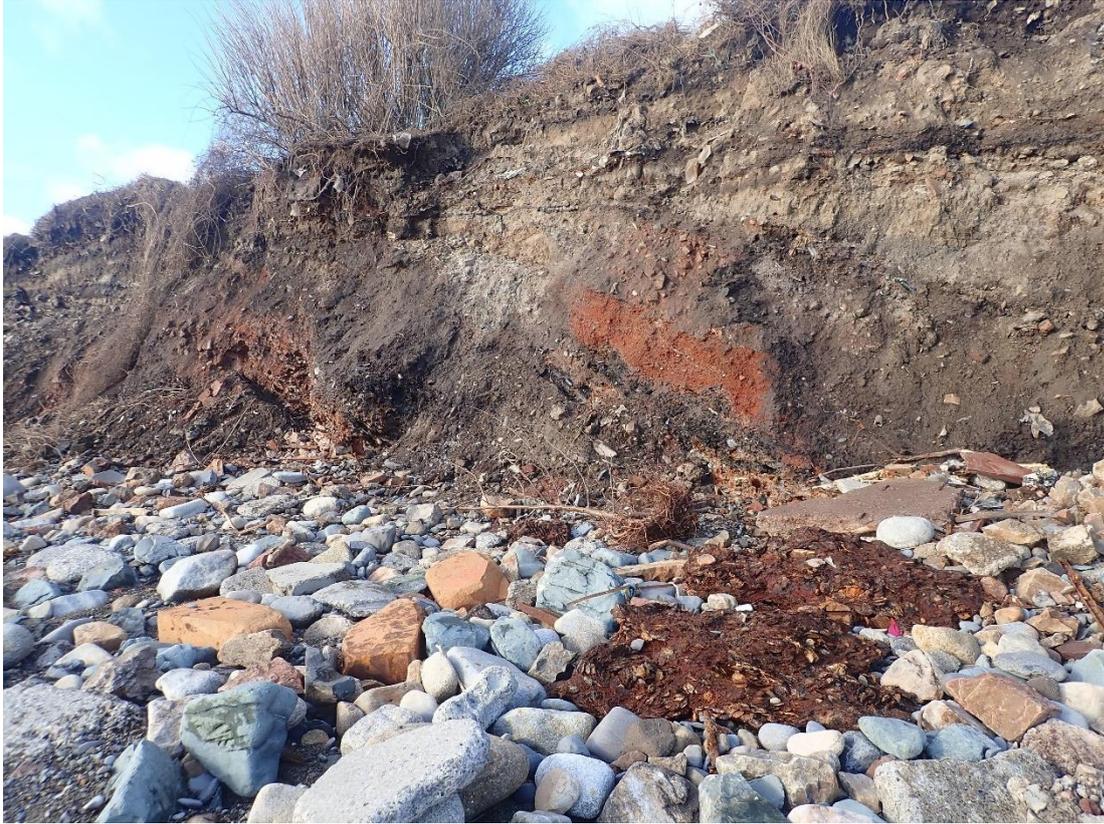
Plate 5: View of landfill site that has infilled the low-lying land area south of the project area close to Bray Harbour and creates a low cliff face of eroding debris and soil.

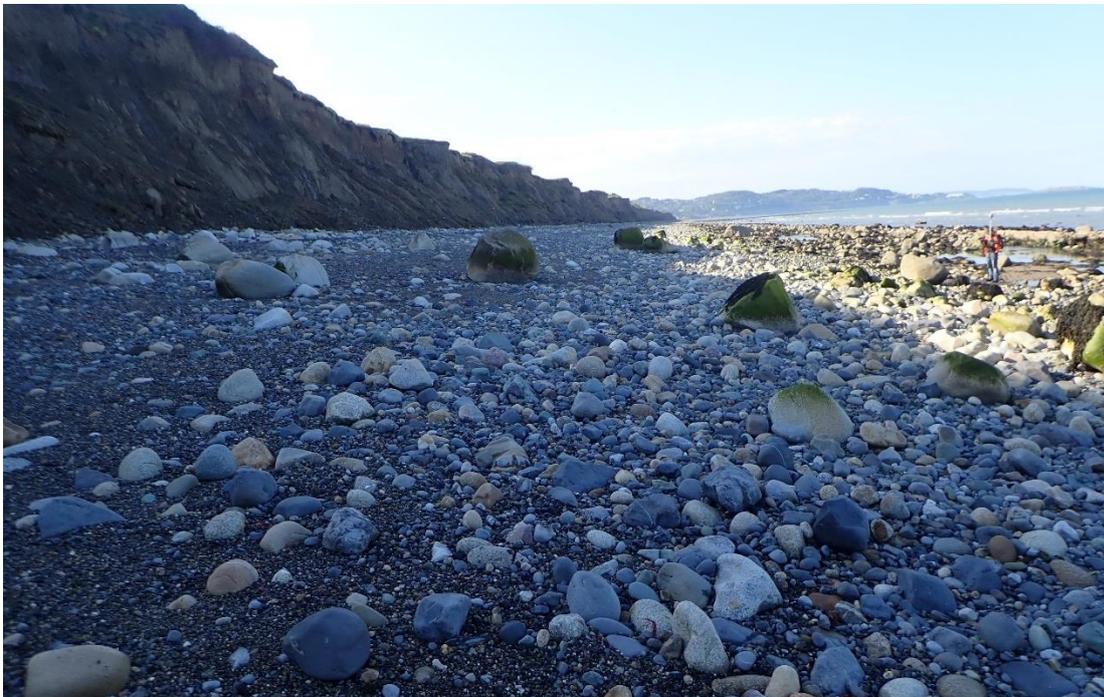
Plate 6: View looking north along Shanganagh showing boulders and rock that litter the foreshore as natural features that were probably included within the boulder clay strata before the coastline was eroded, removing the clays and lighter fractions and leaving the heavier elements to make up the foreshore.

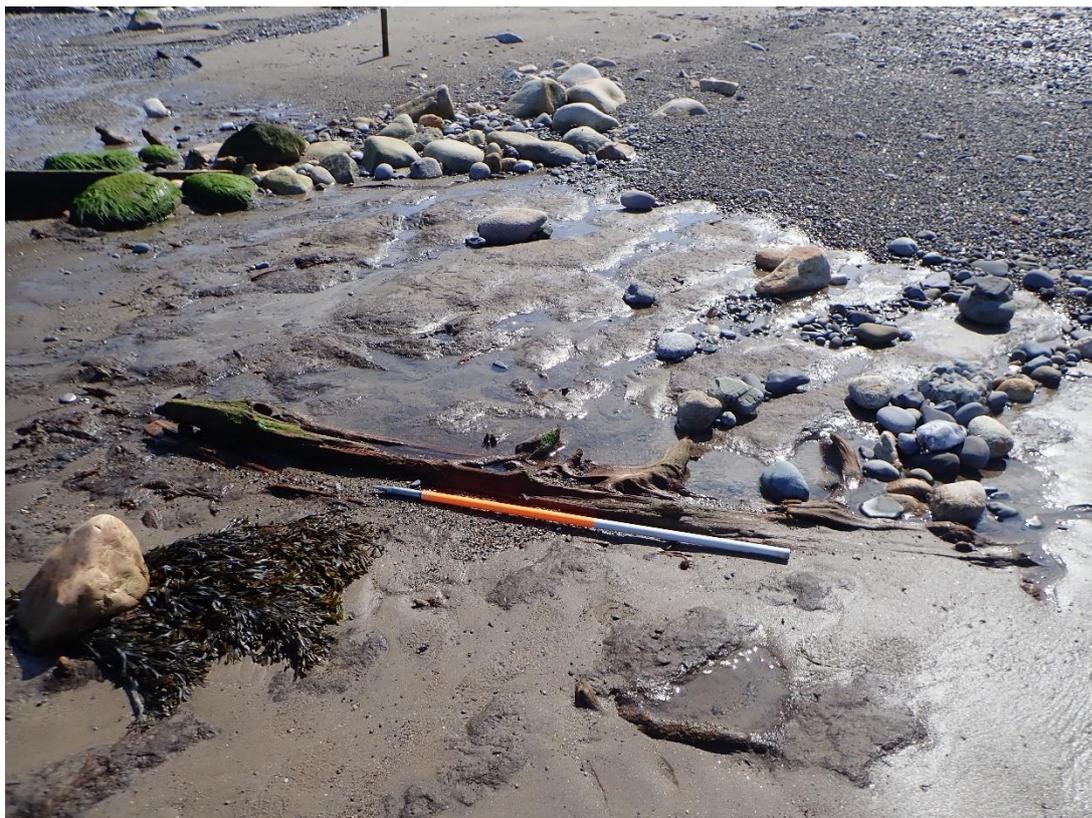
Plate 7: Example of old tree bough that is one of several timbers exposed at Low Water that reveal the presence of the submerged forest south of the project area.

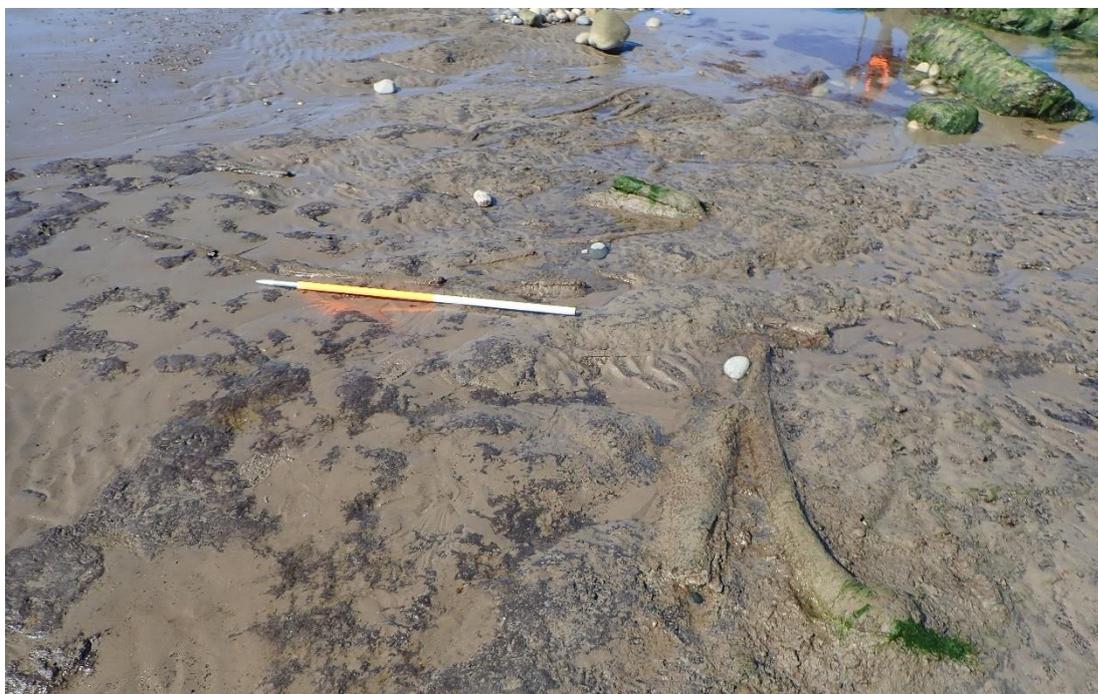
Plate 8: Elements of peat and timber from the submerged peat and forest that are exposed at Low Water south of the project area.

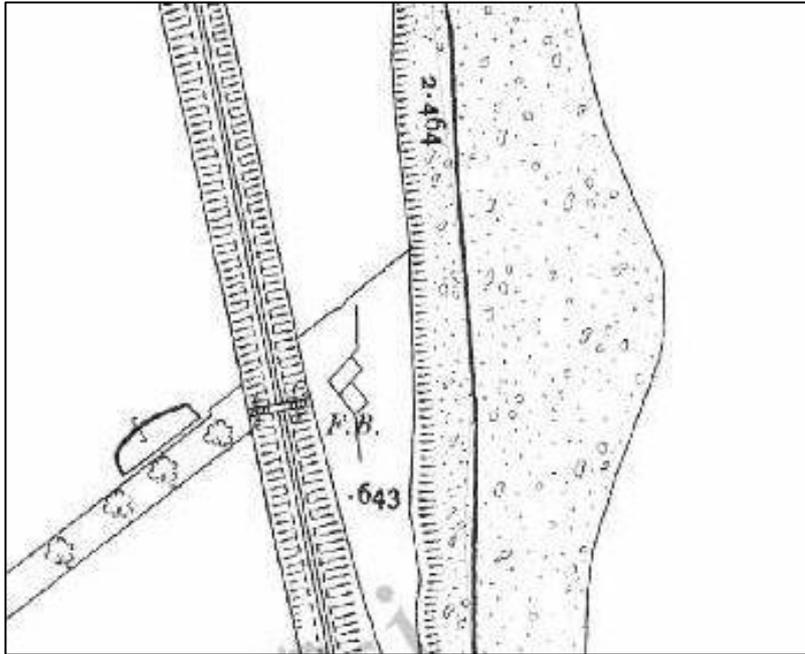
Plate 9: Extract from historic OS 25-inch map (c. 1907) showing Battery Tower No. 5 with still ample space between the complex and the cliff edge. Today the cliff edge is right against the wall (see Figure 9).

The survey highlighted the ruined battery complex (Tower No. 5) on the cliff edge in Shanganagh townland that is part of the wider Napoleonic-era coastal defence of Dublin. The battery is not a registered monument. However, the site is considered to be so, and this report recommends the site is added to the Sites and Monuments Record and is afforded statutory protection.

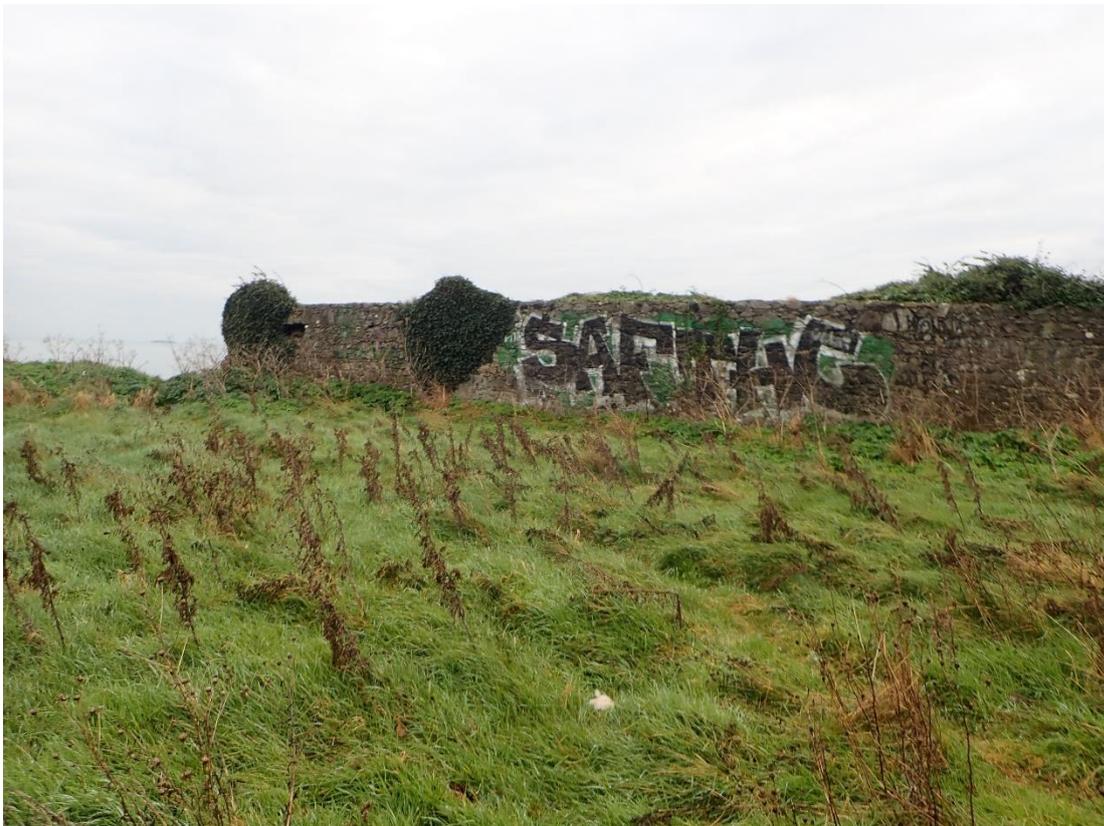
Plate 10: View from west showing the perimeter wall of the northern enclosure associated with Battery Tower No. 5, from the outside.

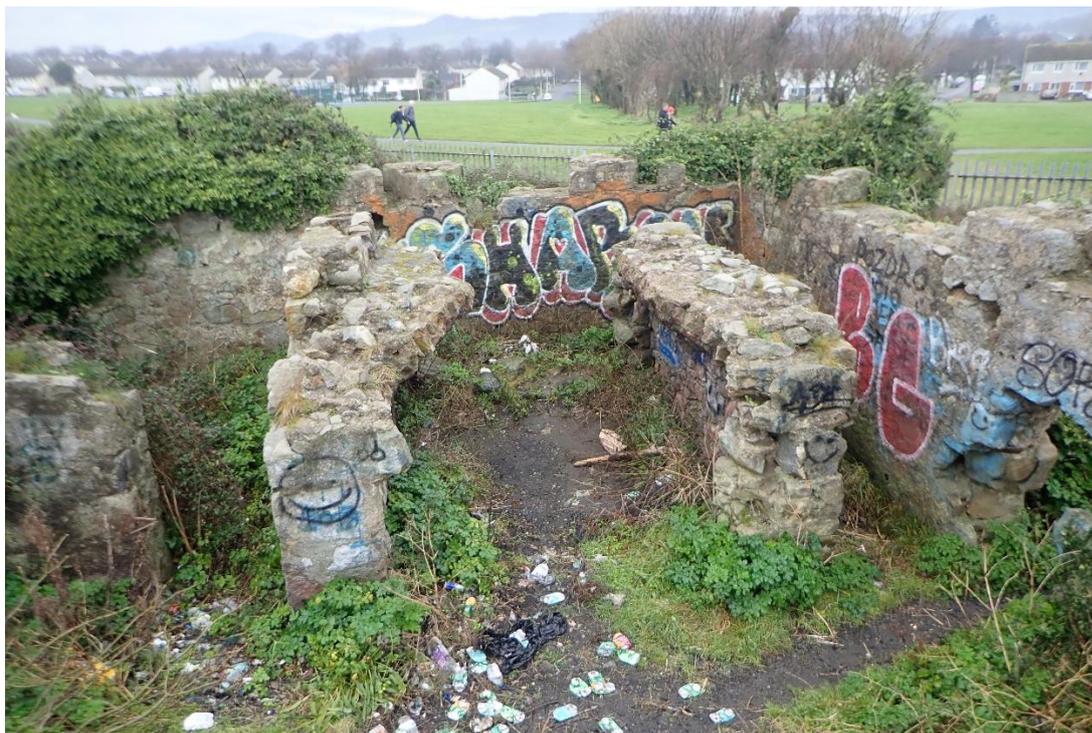
Plate 11: View looking west at squat building that supported a brick barrel vault, within the Battery enclosing wall.

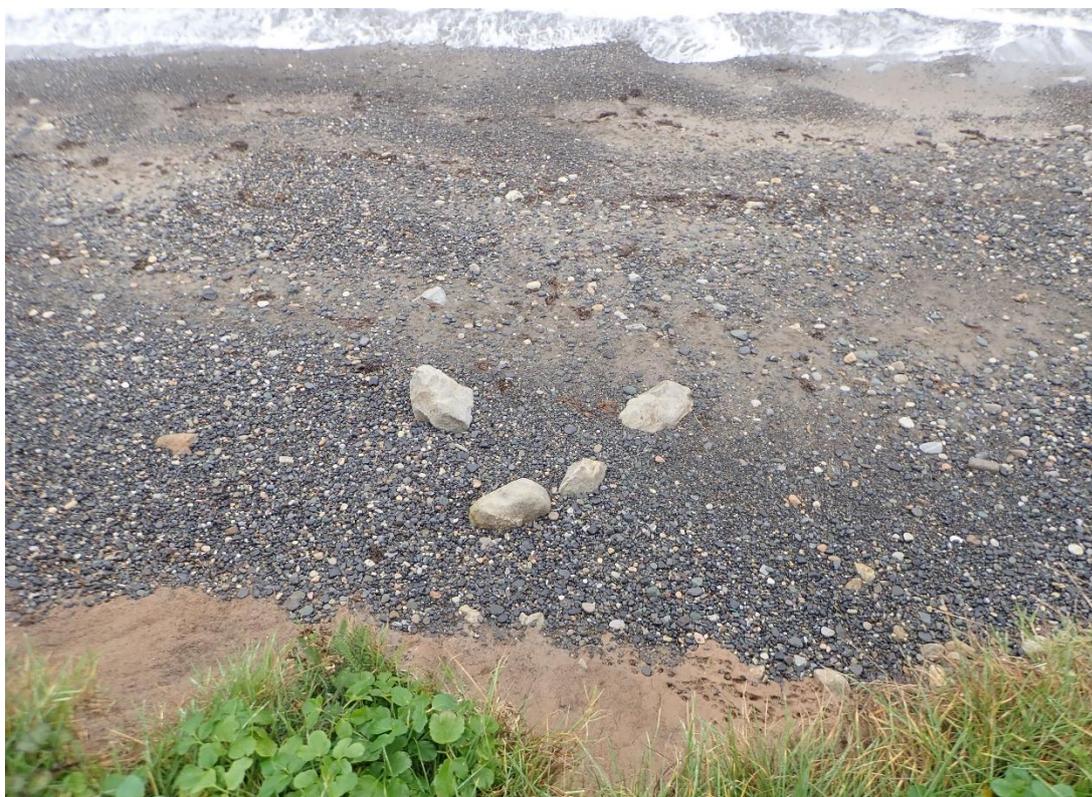
Plate 12: View looking down to the beach below the sea cliff at Battery No. 5, where there are no lengths of collapsed masonry associated with the Battery, yet.

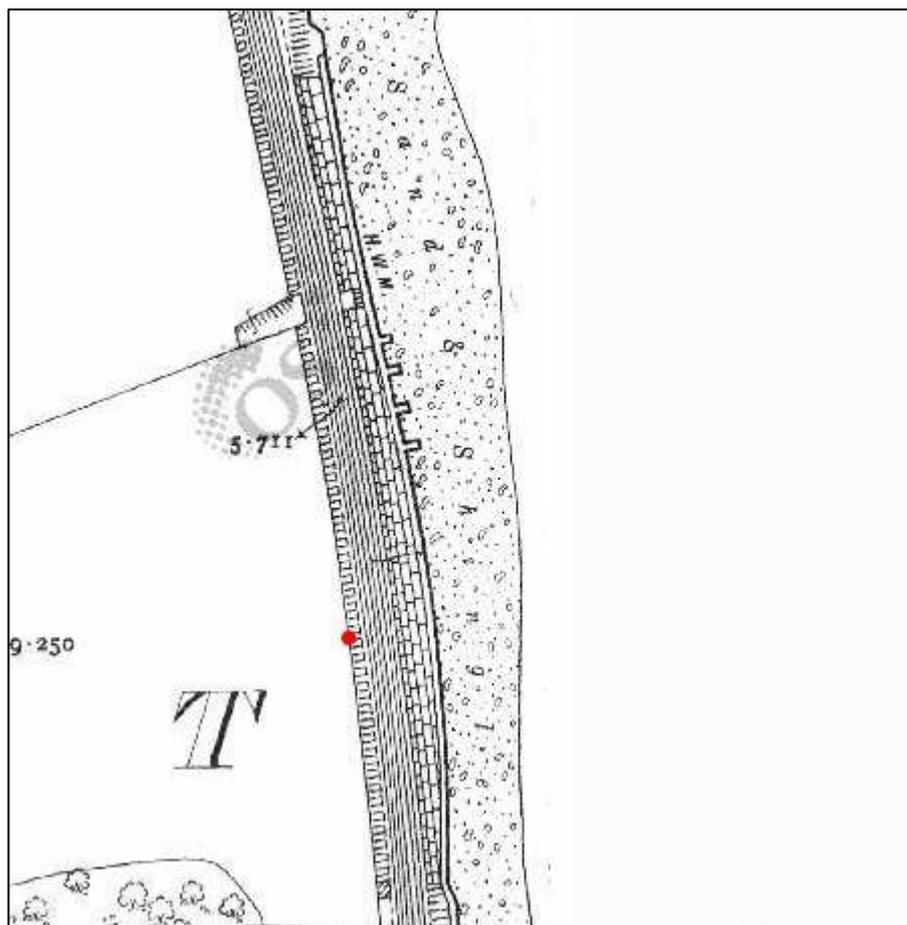
Plate 13: Extract from OS 25-inch map (c. 1907) showing a stretch of butressing to the retaining wall as it extended along Cork Great townland, south of the project area. The map includes the overlay showing the former location of Martello Tower No. 3 (DU026-070) which, along with the railway line, has fallen victim to coastal erosion.

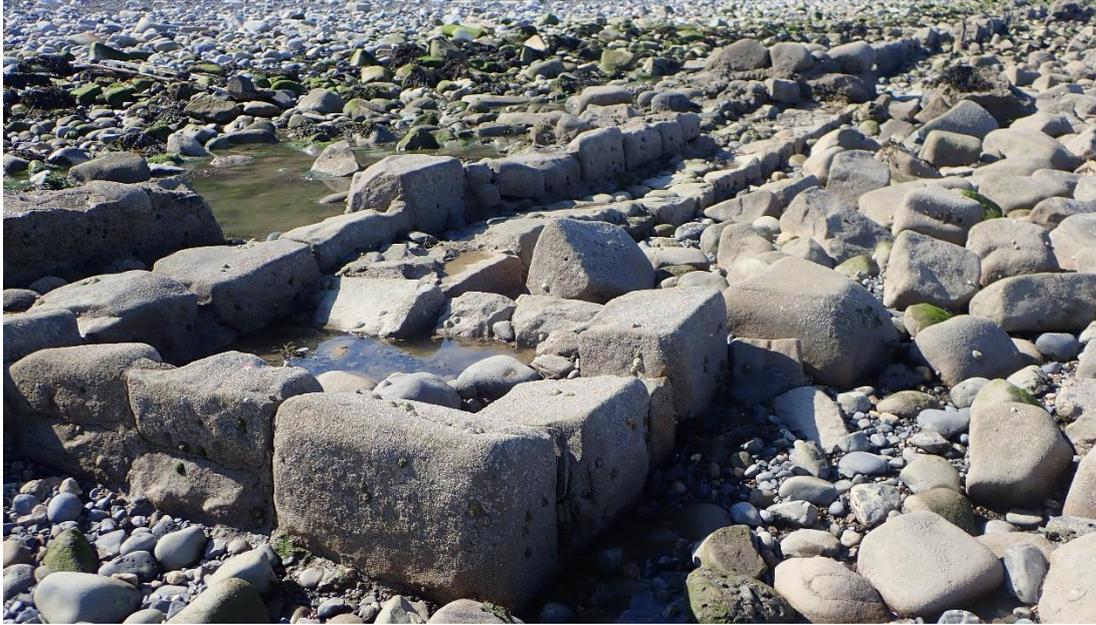
Plate 14: Example of stone butress that forms part of the retaining wall south of the project area.

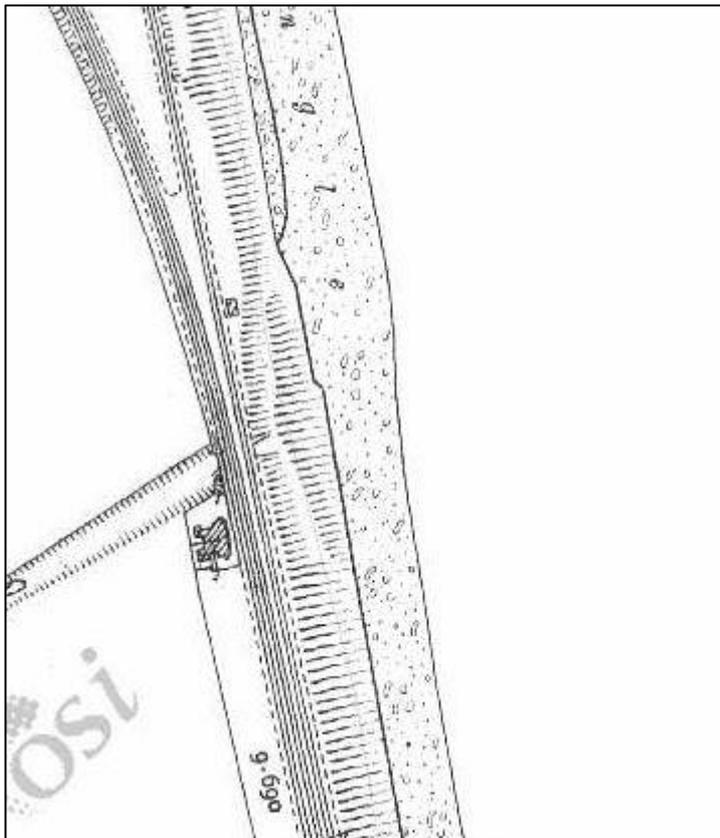
Plate 15: Extract from OS 25-inch map (c. 1907) showing where the line from Shankill merged with that from Dalkey, in Shanganagh townland close to Shanganagh Junction. The detail shows the railway line constructed inside the retaining wall and that the ground sloped down from the railway tracks to the wall.

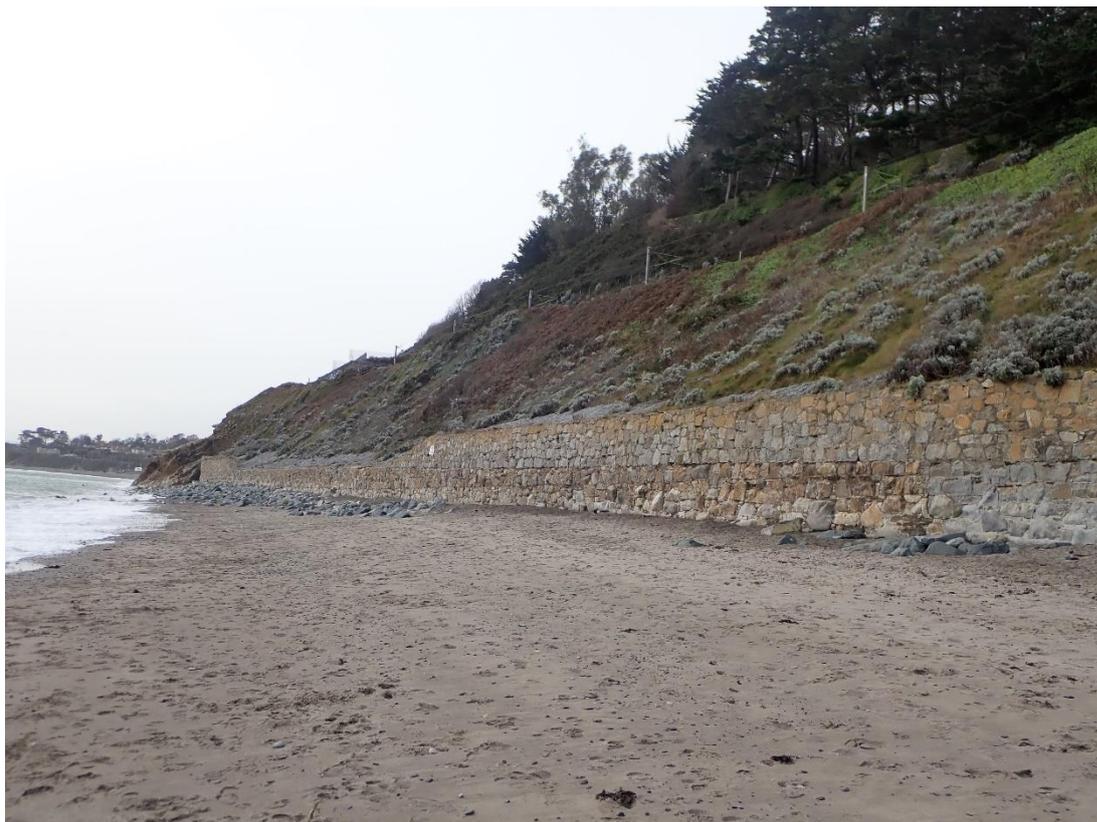
Plate 16: View of railway retaining wall at White Rock beach north of the project area. The granite-built wall retains a sloped embankment on top of which the railway line runs. It offers a comparator to what might have existed originally in Shanganagh.

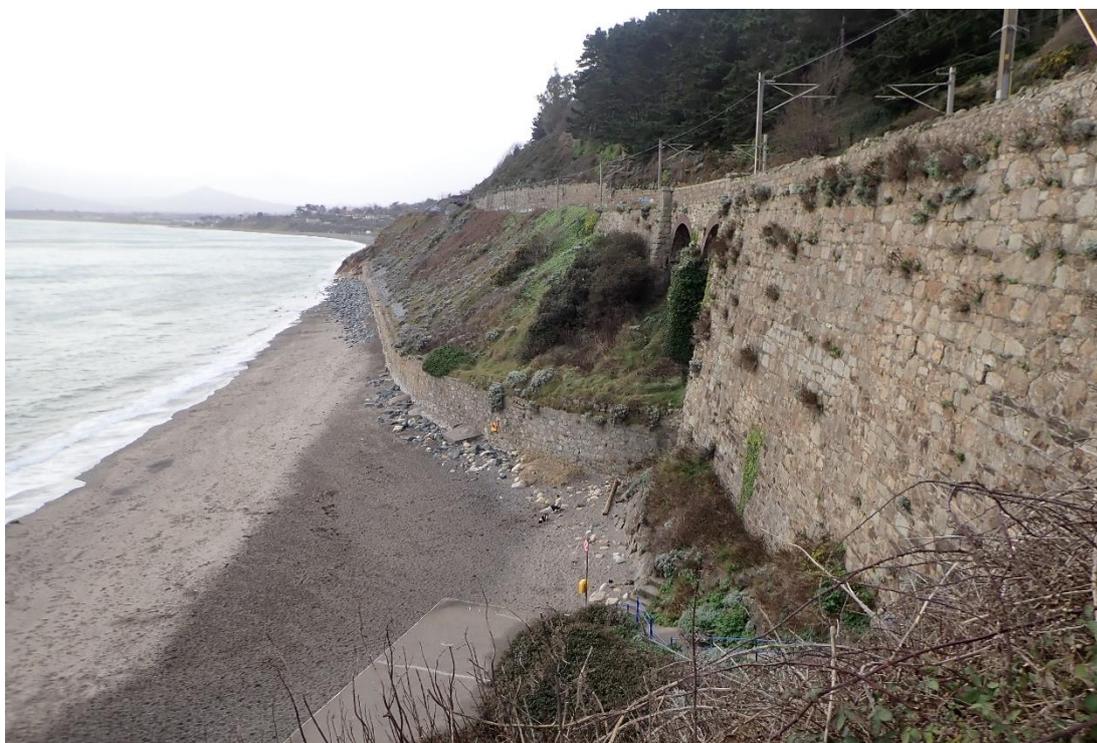
Plate 17: View of railway retaining wall and embankment at White Rock beach, north of the project area.

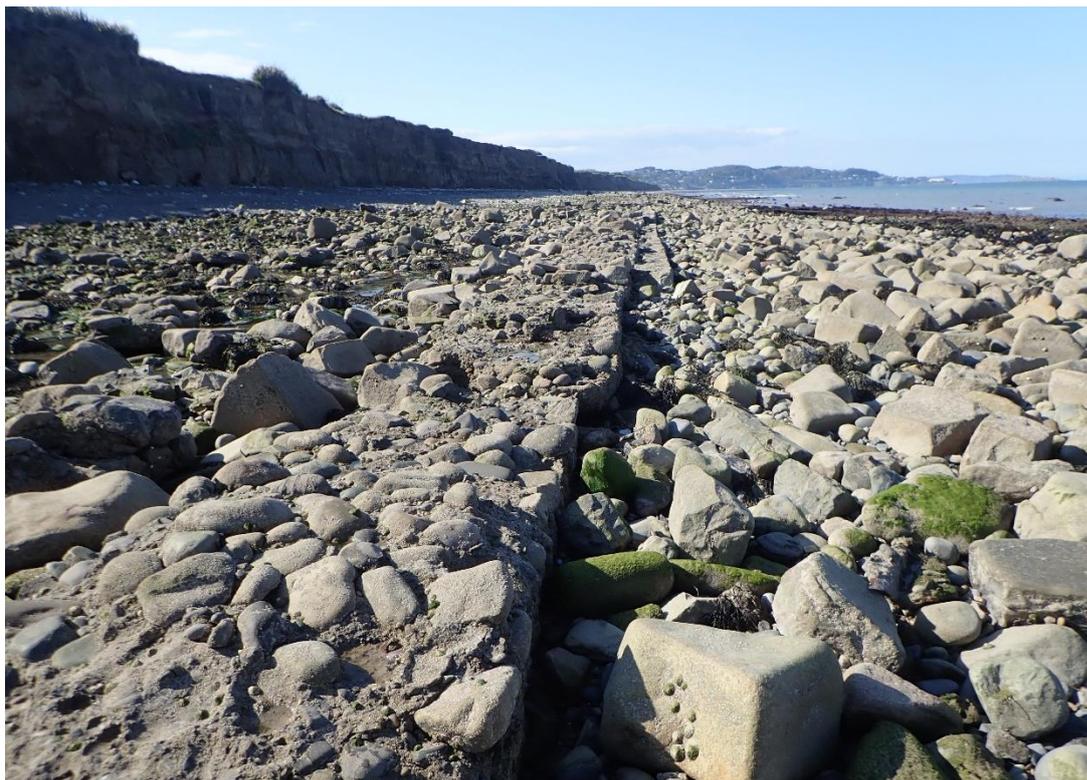
Plate 18: View looking north at base of retaining wall showing intact wall core. Position of image indicated on Figure 4.

The survey highlighted the footings of the former retaining wall for the nineteenth-century railway that are exposed along much of the southern section of the survey area in Shanganagh townland and extend into the northern section. The wall base is revealed at Low Water. It is not a registered archaeological site; however, it is a heritage asset and should be considered as such. It is recommended that the site is added to the Industrial Archaeological heritage inventory.

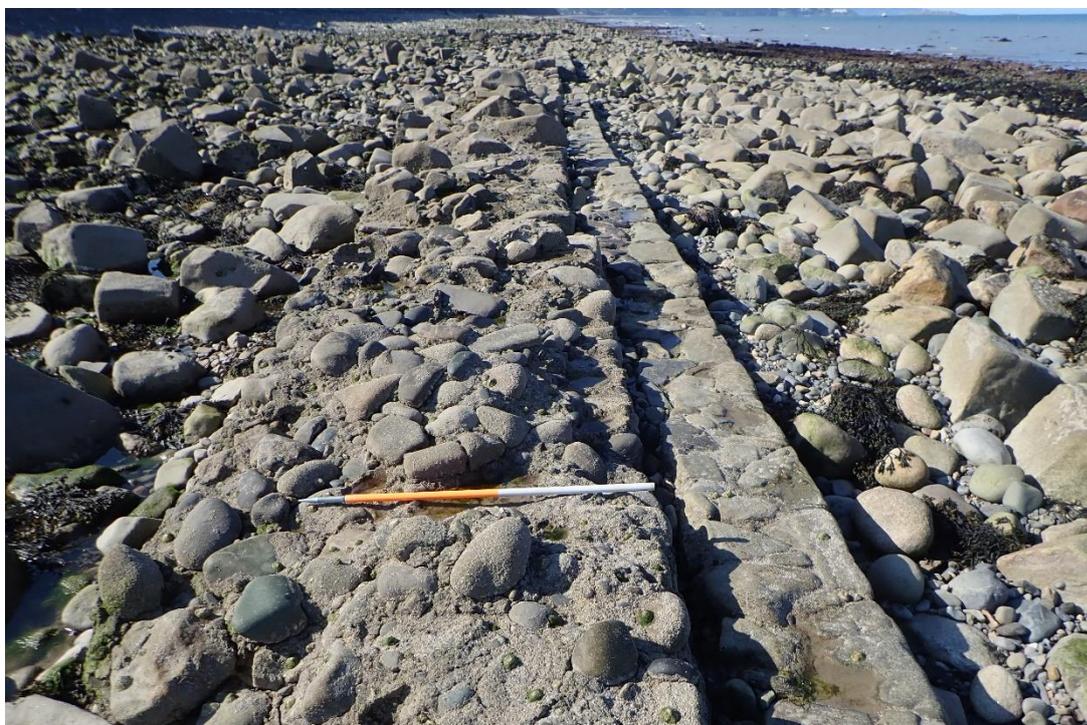
Plate 19: View looking north at base of retaining wall showing intact wall core and façade. Position of image indicated on Figure 4.

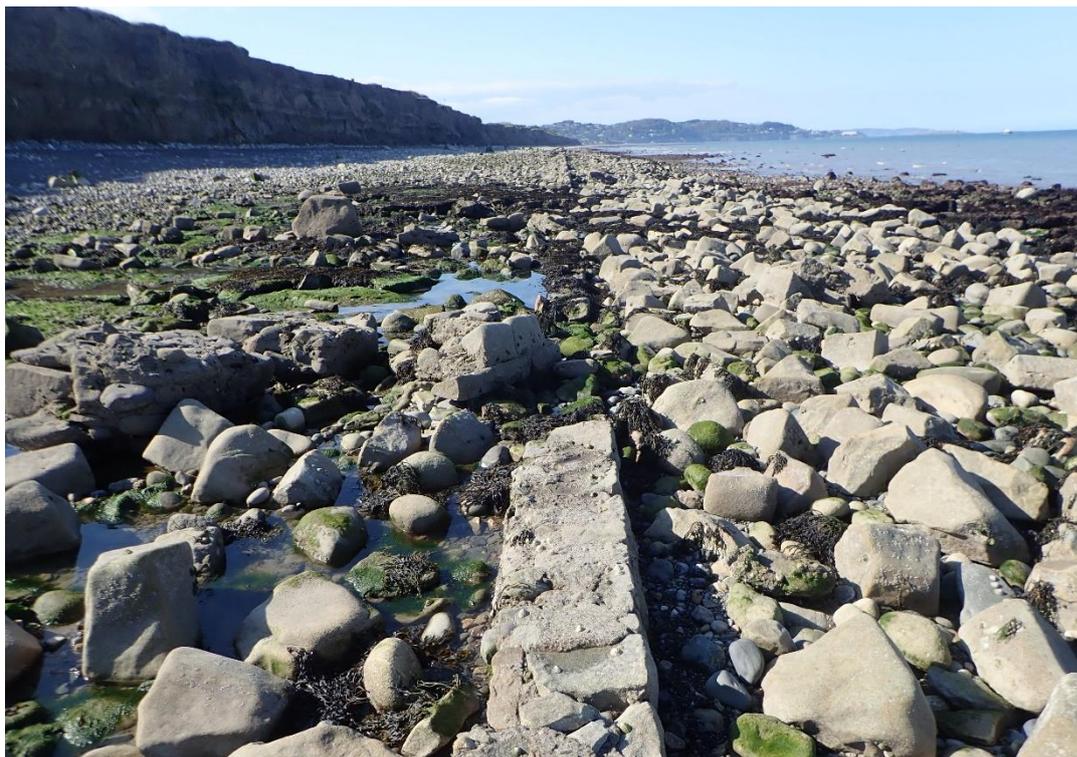
Plate 20: View looking north at base of retaining wall. Position of image indicated on Figure 4.

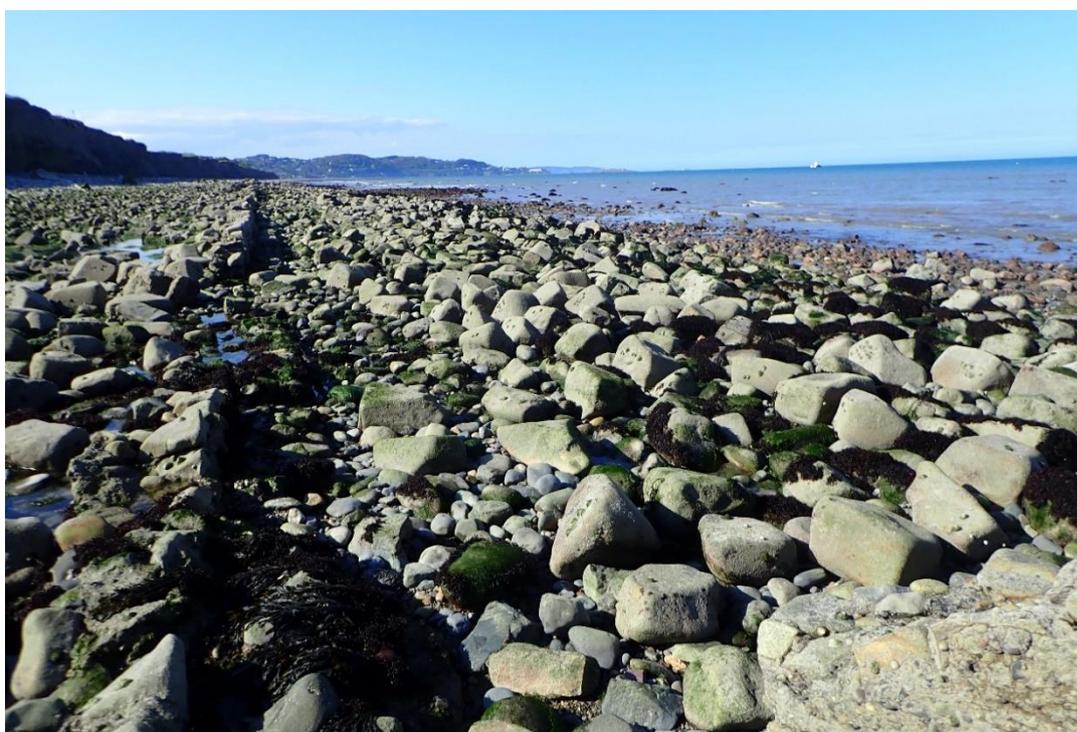
Plate 21: View looking northeast across boulder field that is established seaward of the retaining wall. The boulder field is presumably collapsed wall elements. Position of image indicated on Figure 4.

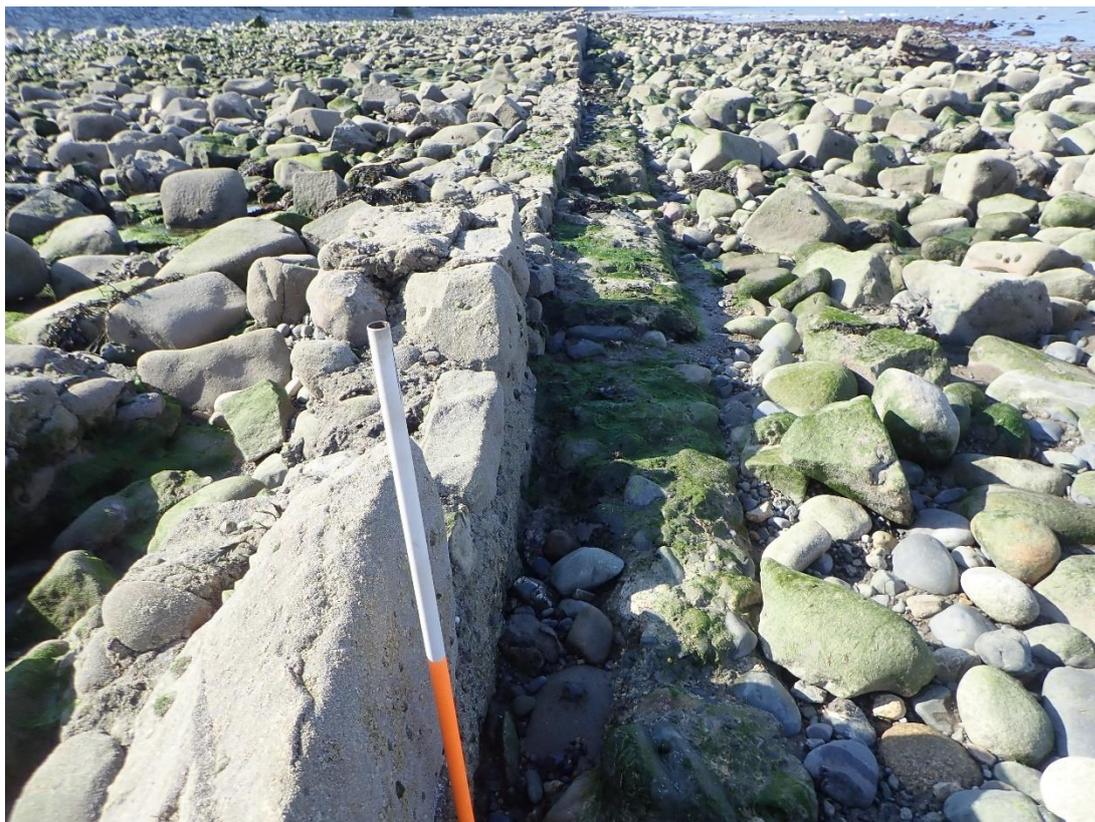
Plate 22: View looking north at base of retaining wall with external layer that might be an exposed plinth or an additional basal layer. Position of image indicated on Figure 4.

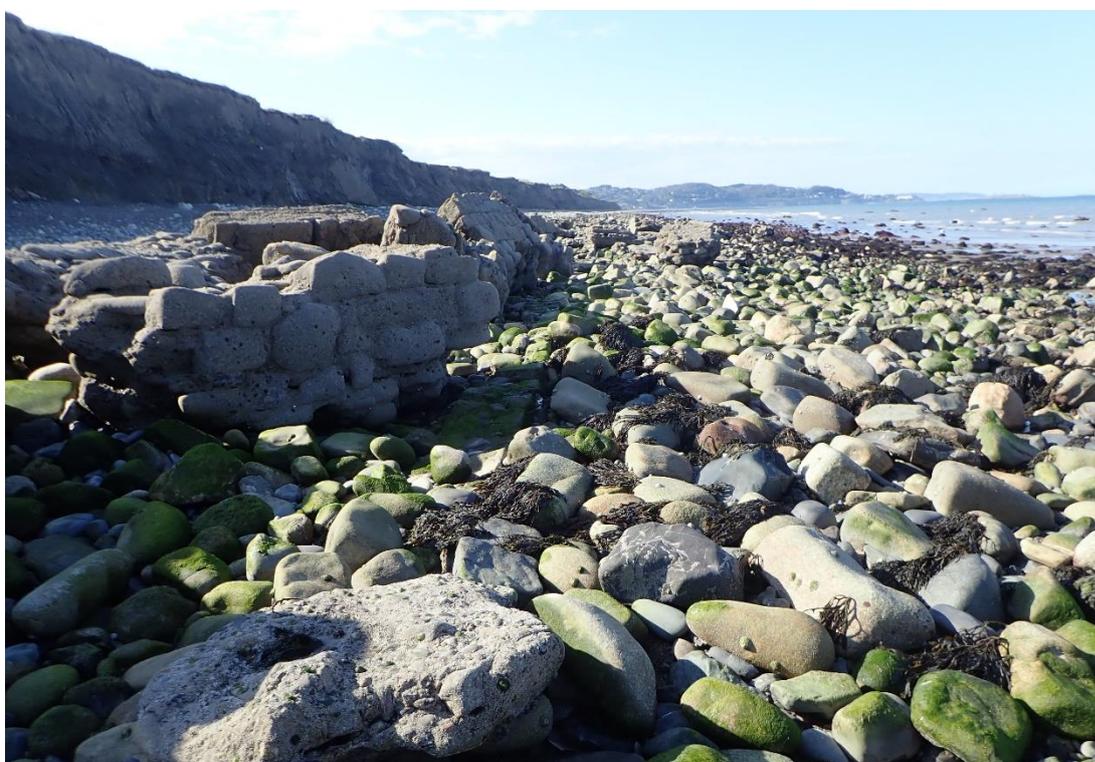
Plate 23: View looking north at base of retaining wall showing location where a chunk of the collapsed wall survives. Position of image indicated on Figure 4.

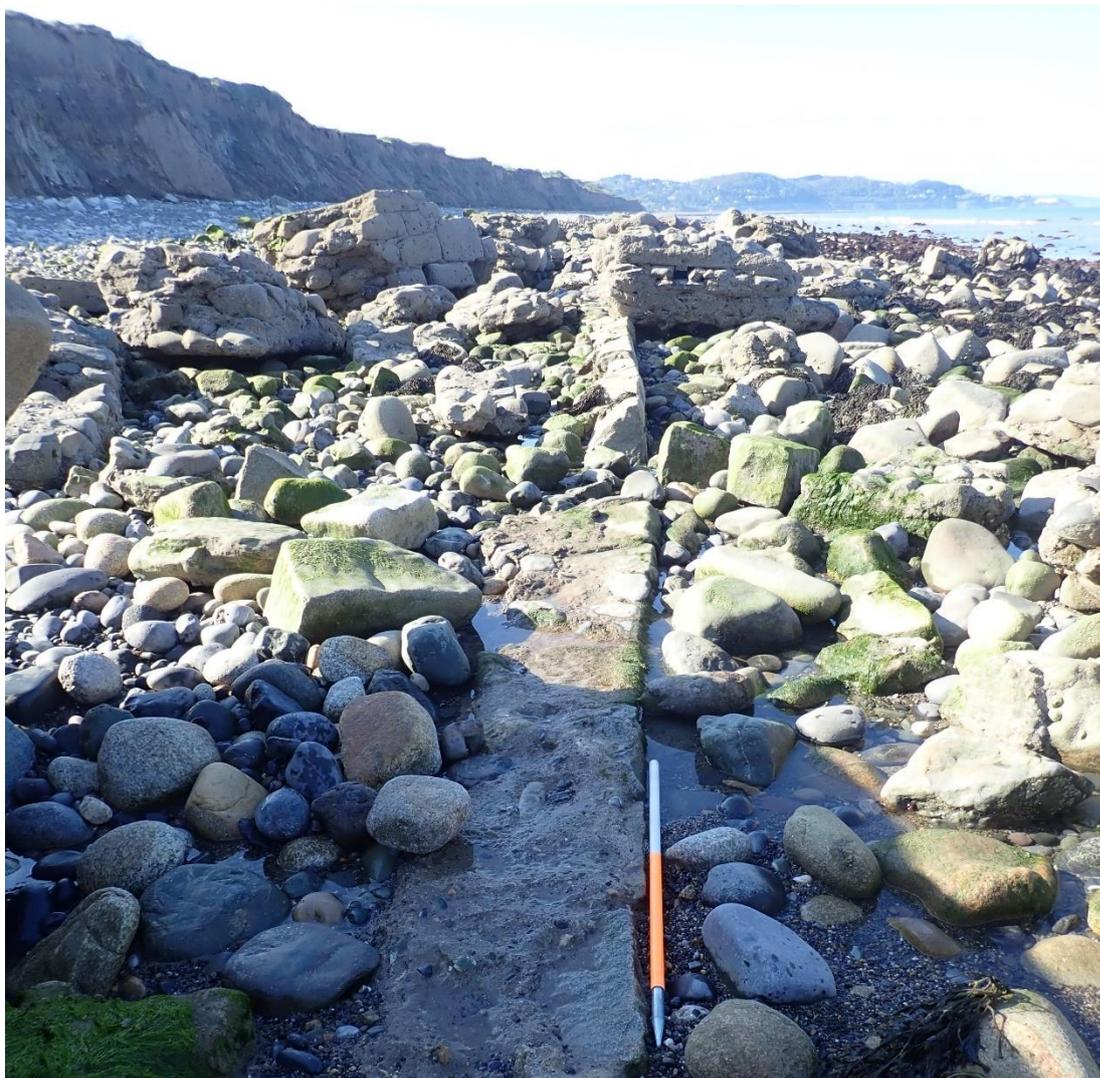
Plate 24: View looking north at base of retaining wall showing location where a further chunk of the collapsed wall survives. Position of image indicated on Figure 4.

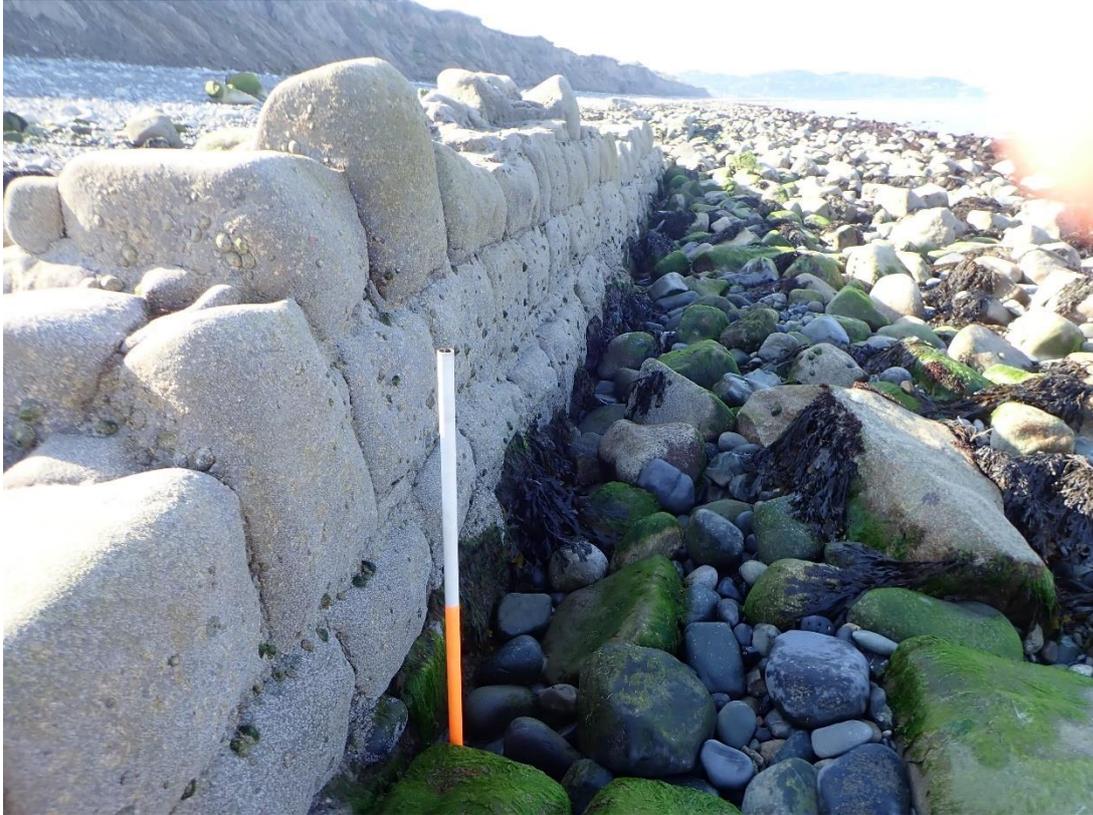
Plate 25: View looking north to where three course of stonework survive *in situ*. Position of image indicated on Figure 4.

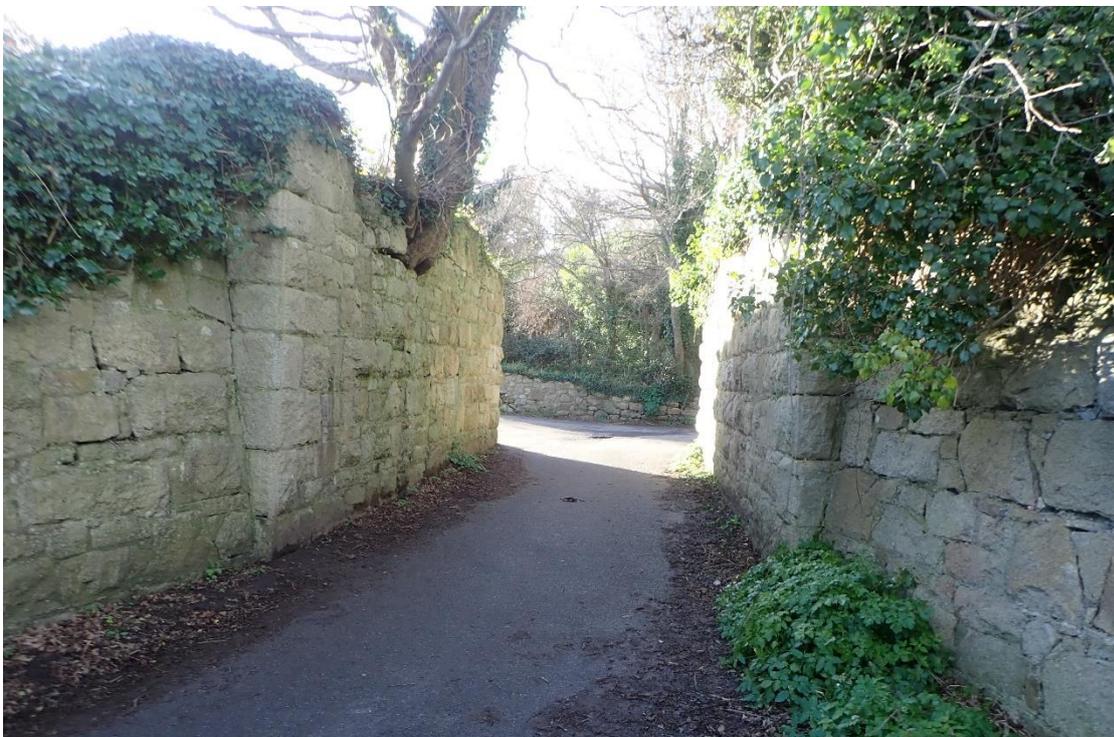
Plate 26: View looking west through granite-built underpass that formerly supported the Dalkey-to-Shanganagh Junction spur line, and which continues to provide access to the beach from Shanganagh Park.

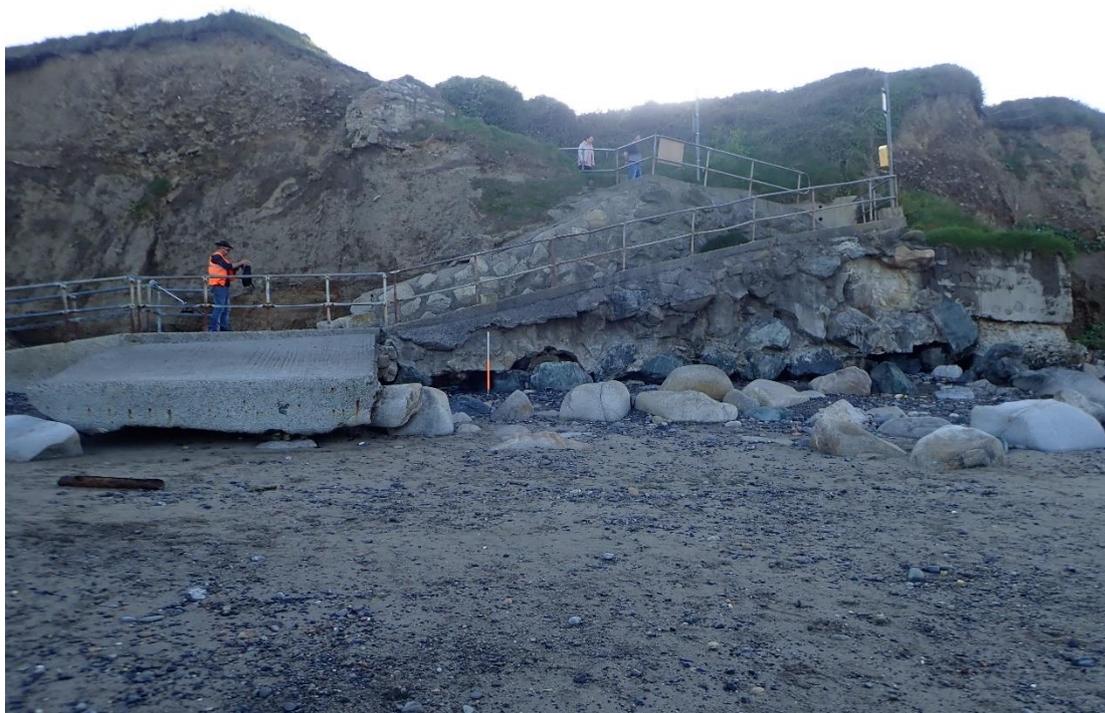
Plate 27: View looking inland from the foreshore towards the reinforced access to Shanganagh beach today. Note the modern concrete works are undercut by coastal erosion.

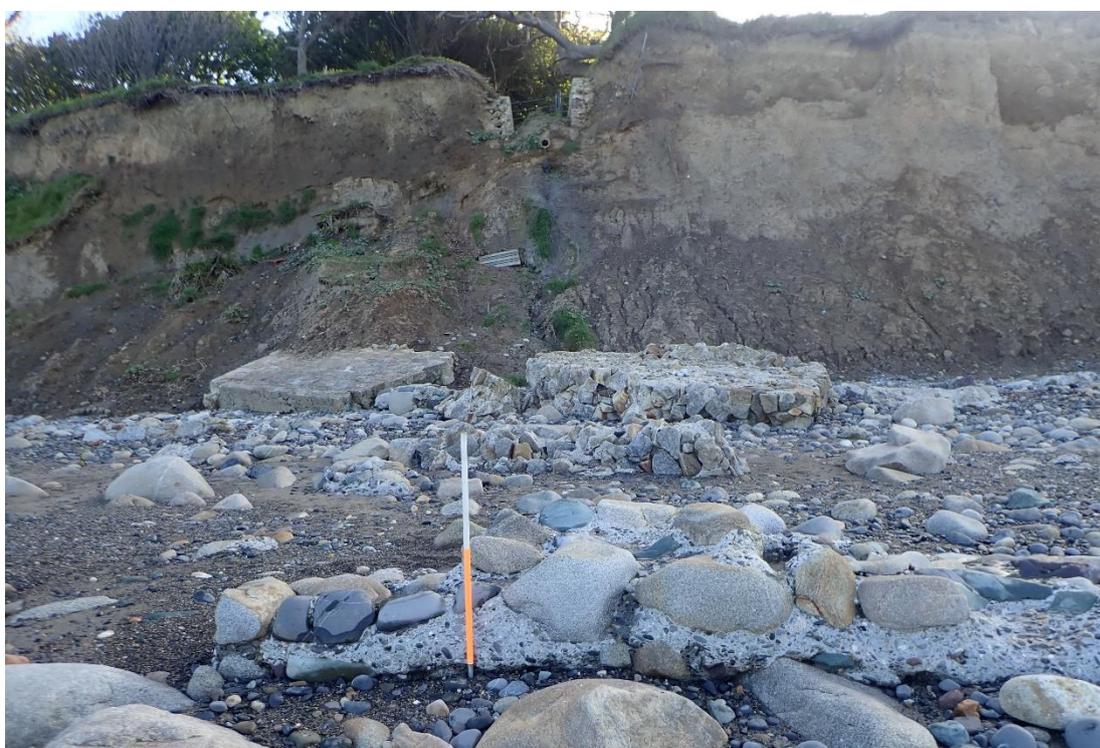
Plate 28: View looking inland from shore at ruined granite underpass that may have provided private access from Clontra House to the beach.

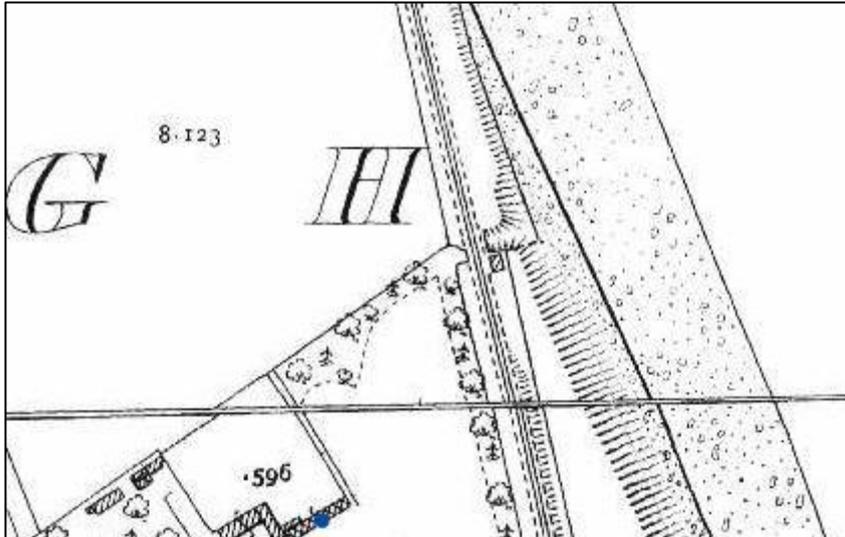
Plate 29: Extract from OS 25-inch map showing the arrangement to provide an underpass from Clontra House (NIAH60260138) on to the beach.
