**EIAR Volume 4: Offshore Infrastructure  
Technical Appendices  
Appendix 4.3.13-4  
Archaeology Intertidal Survey  
Shanganagh, Dublin Array 21D0046,  
21R0071**

**Archaeology Intertidal Survey  
Shanganagh, Dublin Array  
21D0046, 21R0071**

**Archaeological Intertidal Survey  
Shanganagh, Dublin Array  
21D0046, 21R0071**

Subject: Dublin Array, export cable route landfall option  
Location: Shanganagh, Co. Dublin  
ITM: North limit: 725991E 723933N  
South limit: 726530E 720491N  
Status: Intertidal foreshore

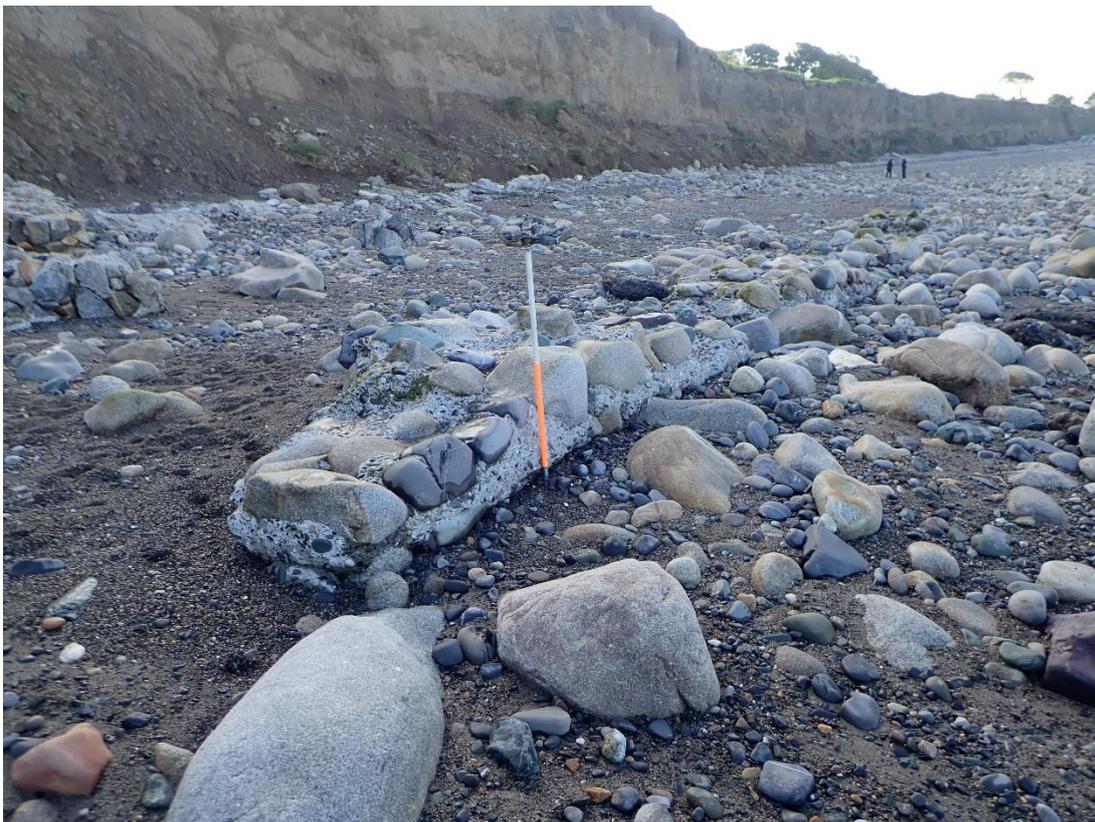
Plate 30: View looking North-northwest at the line of mortared stone that is the base of the railway retaining wall that continued north from the Clontra House underpass.

The survey highlighted the footings of the former retaining wall for the nineteenth-century railway that are exposed along much of the southern section of the survey area in Shanganagh townland and extend into the northern section. The wall base is revealed at Low Water. It is not a registered archaeological site; however, it is a heritage asset and should be considered as such. It is recommended that the site is added to the Industrial Archaeological heritage inventory.

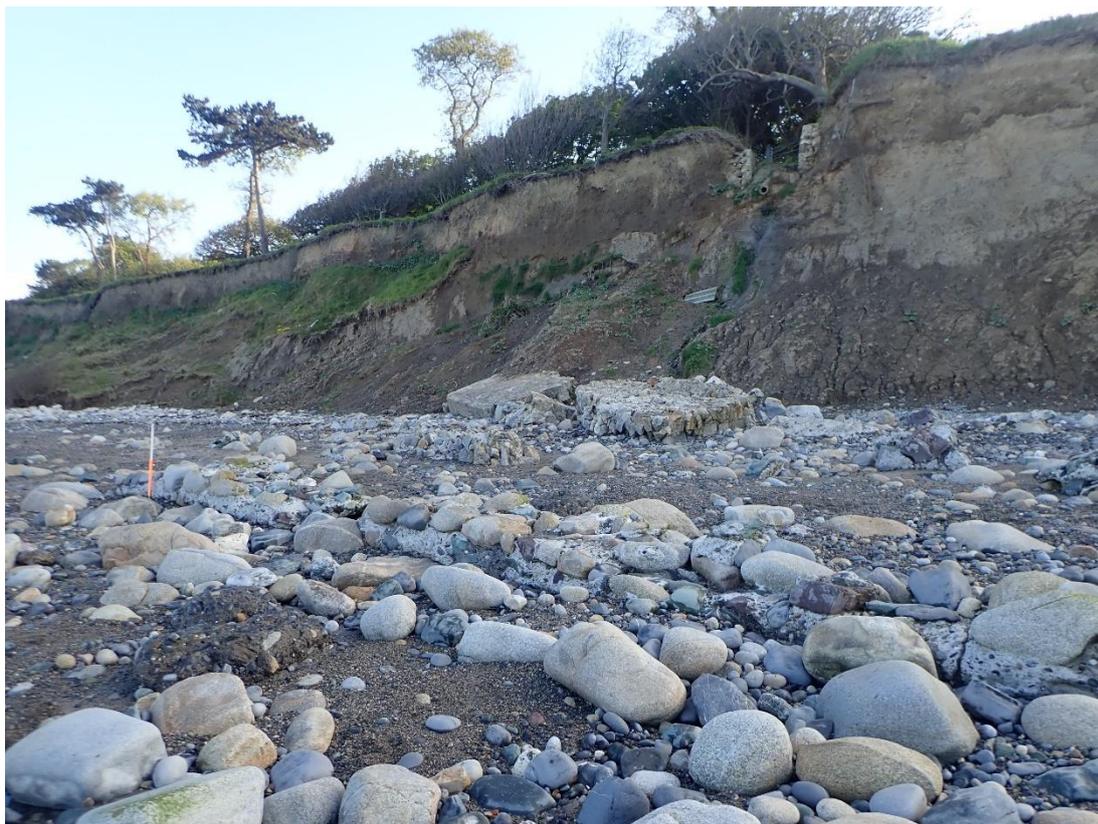
Plate 31: View looking south at the line of mortared stone that is the base of the railway retaining wall that continued north from the Clontra House underpass. The ruined underpass is visible at the cliff-top.

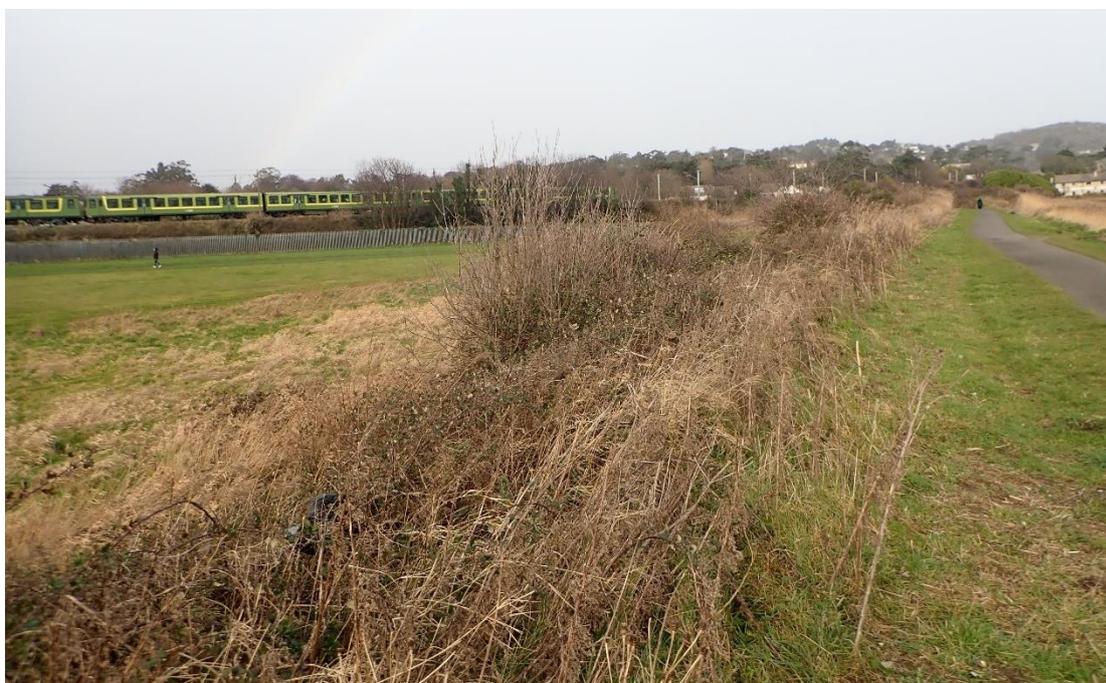
Plate 32: View looking north along former railway embankment that crosses Hackettsland townland into Killiney and is today a footpath that gives access to Killiney beach.

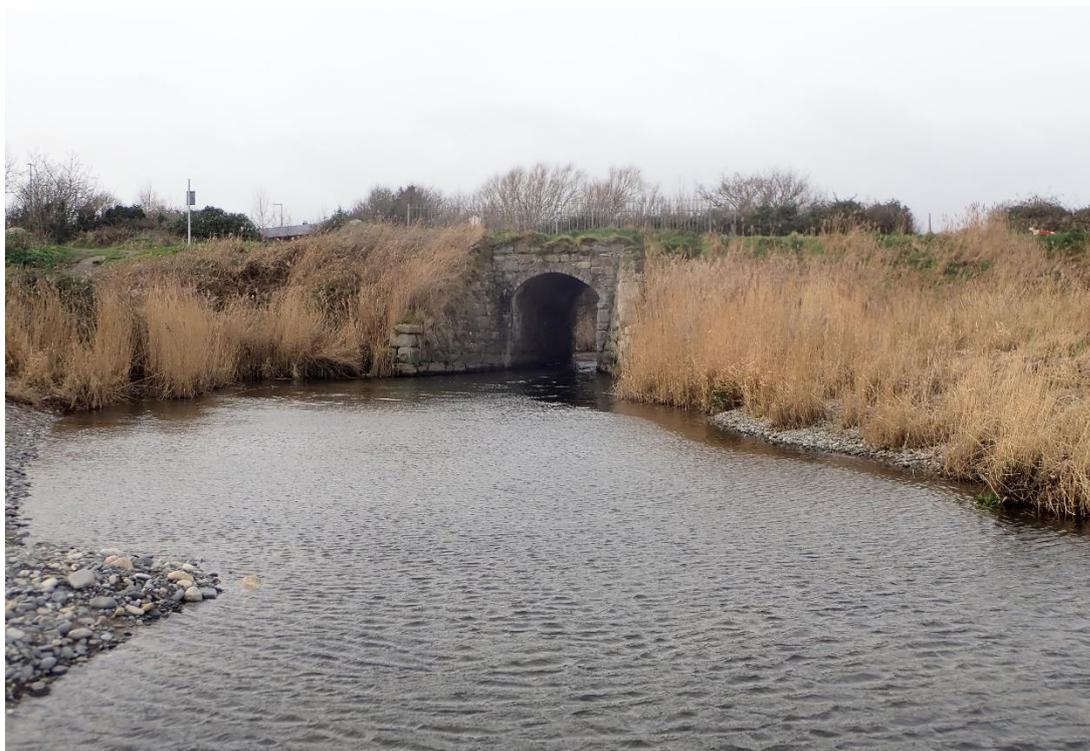
Plate 33: View looking west and upstream from the mouth of the Loughlinstown River towards a railway bridge that supported the former railway line across Hackettsland townland, and which today is footpath.

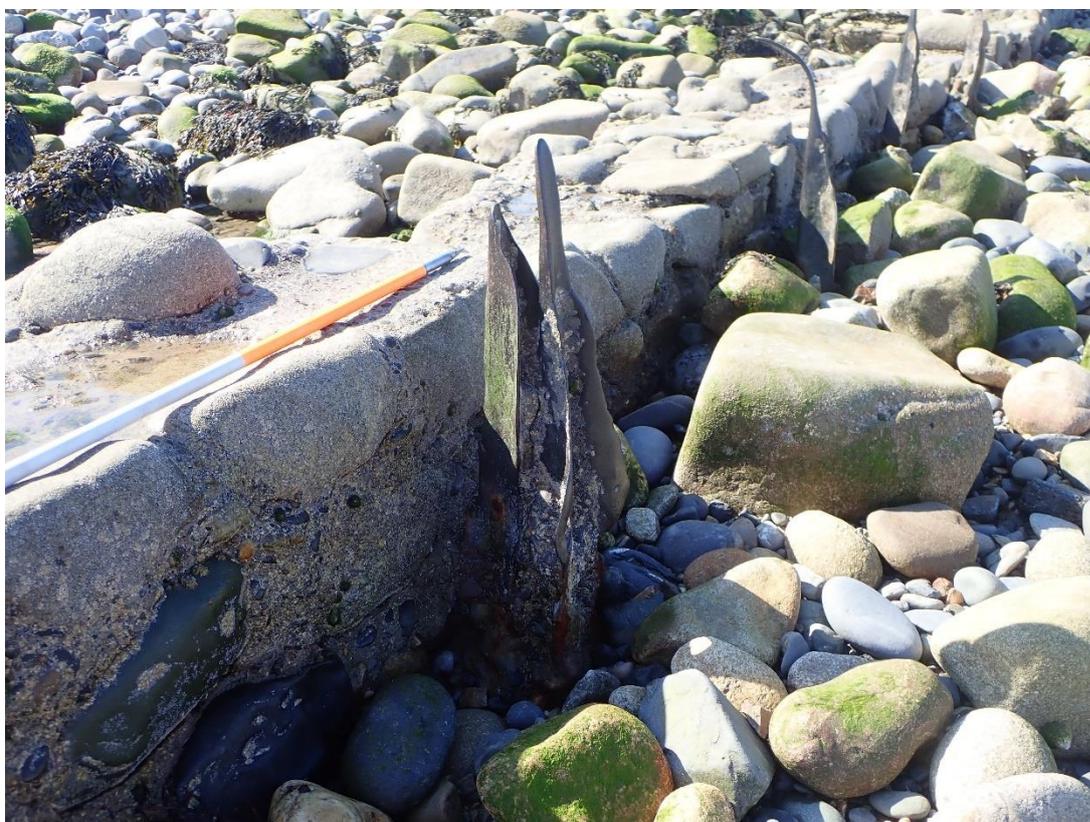
Plate 34: View of historic sheet piling that runs along exterior of railway retaining wall to the south of the project area. The steel piles are heavily eroded by coastal processes.

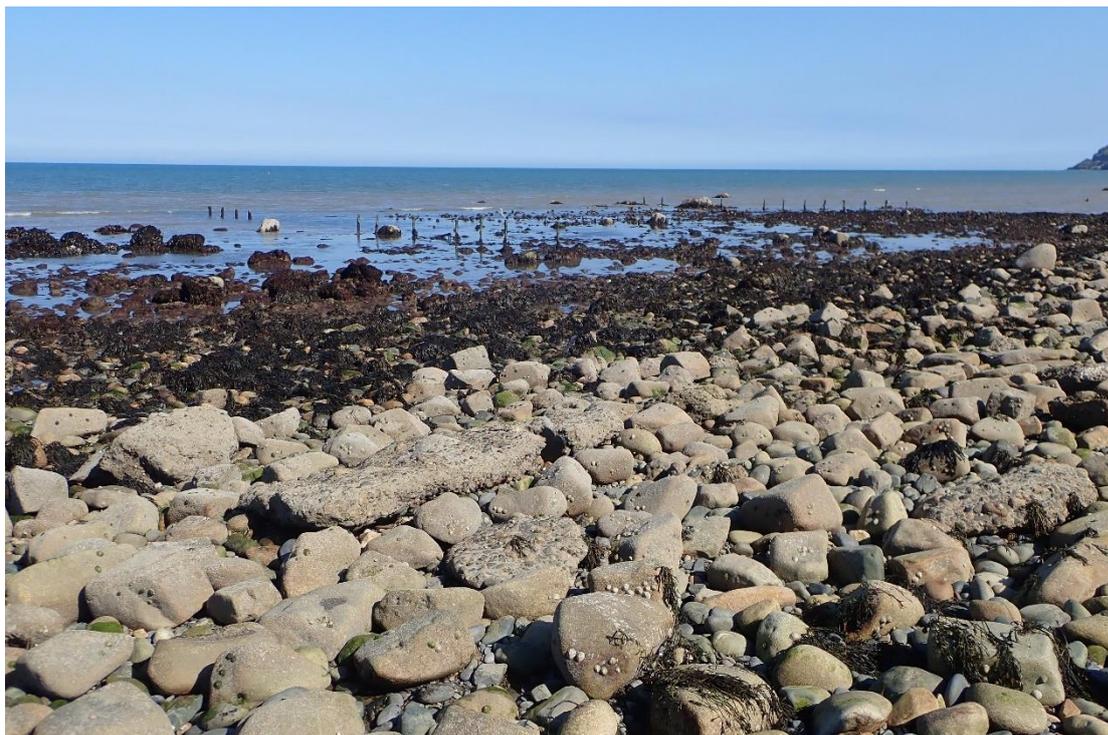
Plate 35: View looking seawards and south of the project area, where steel posts are set out at regular intervals, as the surviving anchor elements presumably groyne features to combat coastal erosion.

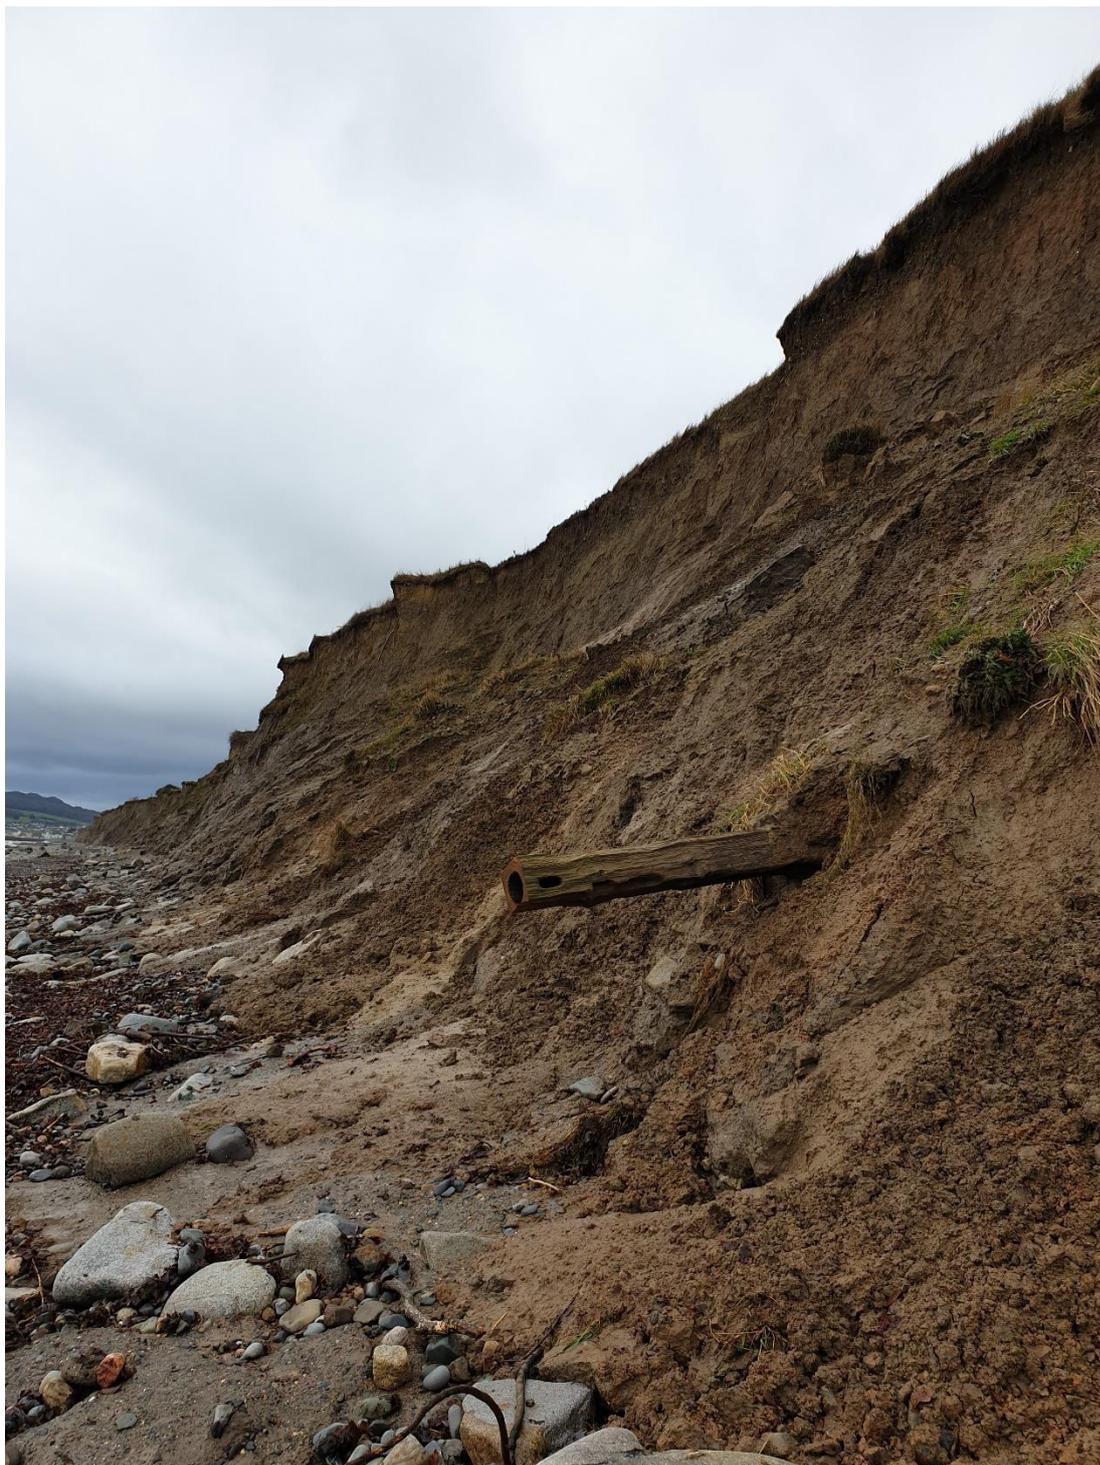
Plate 36: View from north of wooden drain that extends out of the eroding cliff face. Position is indicated on Figure 5.

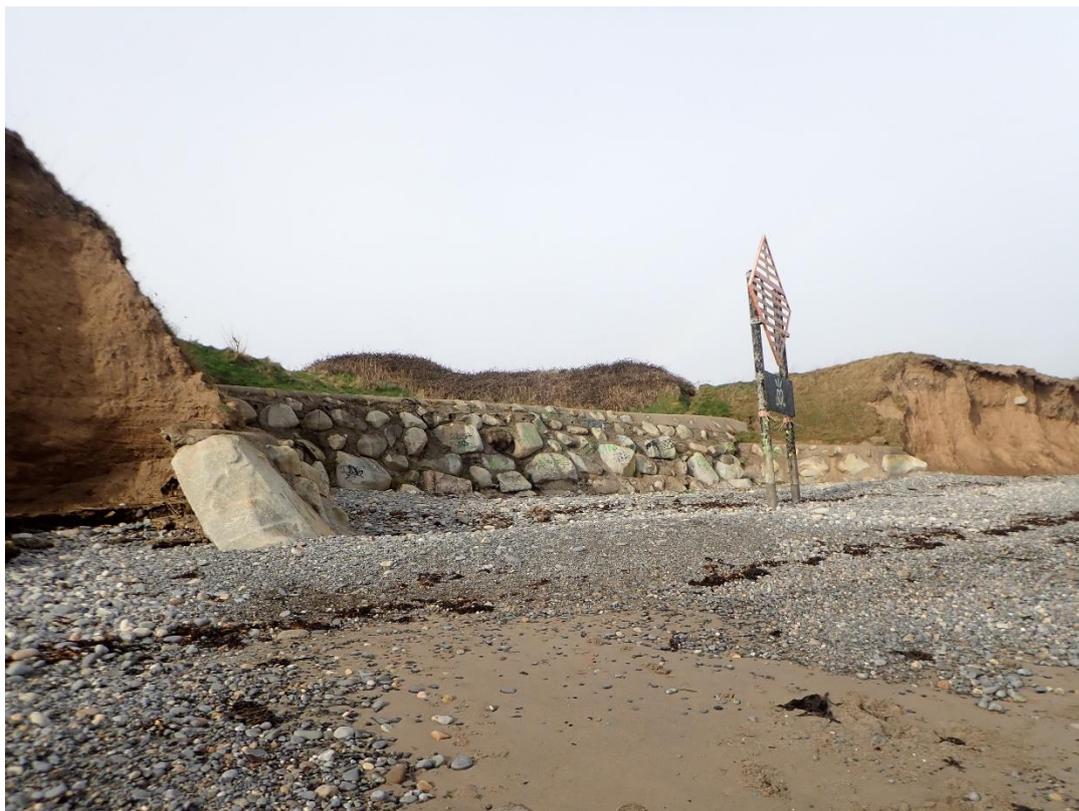
Plate 37: Landfall location of the Shanganagh Long Sea outfall. The works have cut away the sea cliff and inserted a mortared boulder barrier. The cut is clearly visible on Figure 9, as is the back-filled trench that accommodates the sewer pipe extending out to sea.
