Aquatic Baseline Report

Briskalagh Renewable
Energy Development

Project Title: **Briskalagh Renewable Energy Development**

Document Title: **Aquatic Baseline Report**

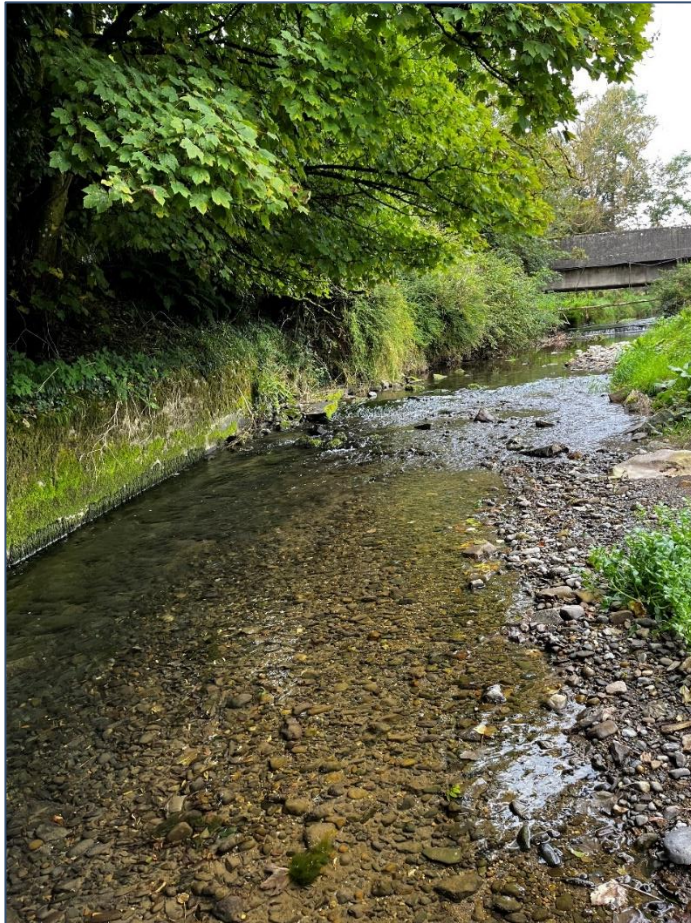
Plate 4-1 Representative picture of Survey Location WF-1

The watercourse at this survey location had low to medium flow and velocity. Water was clear and had no distinct colouration however there was a degree of siltation which was easily disturbed during the survey creating plumes of silt and fine sediment. Submerged and emergent macrophytes were uncommon with <10% percentage cover. The substrate of the watercourse was dominated by cobbles, large gravels and fine gravels. A one span road bridge and concrete apron was present at the upstream extent of the survey location. The right-hand bank (RHB) consisted of a retaining wall classified as **Buildings and artificial surfaces (BL3)** with a riparian **Treeline (WL2)** growing on the RHB and providing shade to the channel. As a result of this the channel is confined laterally and may have reduced floodplain connectivity. Species growing atop the RHB consisted predominantly of sycamore (*Acer pseudoplatanus*), ash (*Fraxinus excelsior*), bramble (*Rubus fruticosus agg*), nettle (*Urtica dioica*) and ivy (*Hedera helix*). The left-hand bank (LHB) had been historically raised and was classified as **improved agricultural grassland (GA1)**. Species present along the LHB and watercourse margin consisted of cocks foot (*Dactylis glomerata*), dock (*Rumex obtusifolius*), nettle, watercress (*Nasturtium officinale*) and willowherb (*Epilobium sp.*). Land use on the RHB consisted of a treeline and further south-west a residential dwelling while land use on the LHB consisted of agricultural pasture.

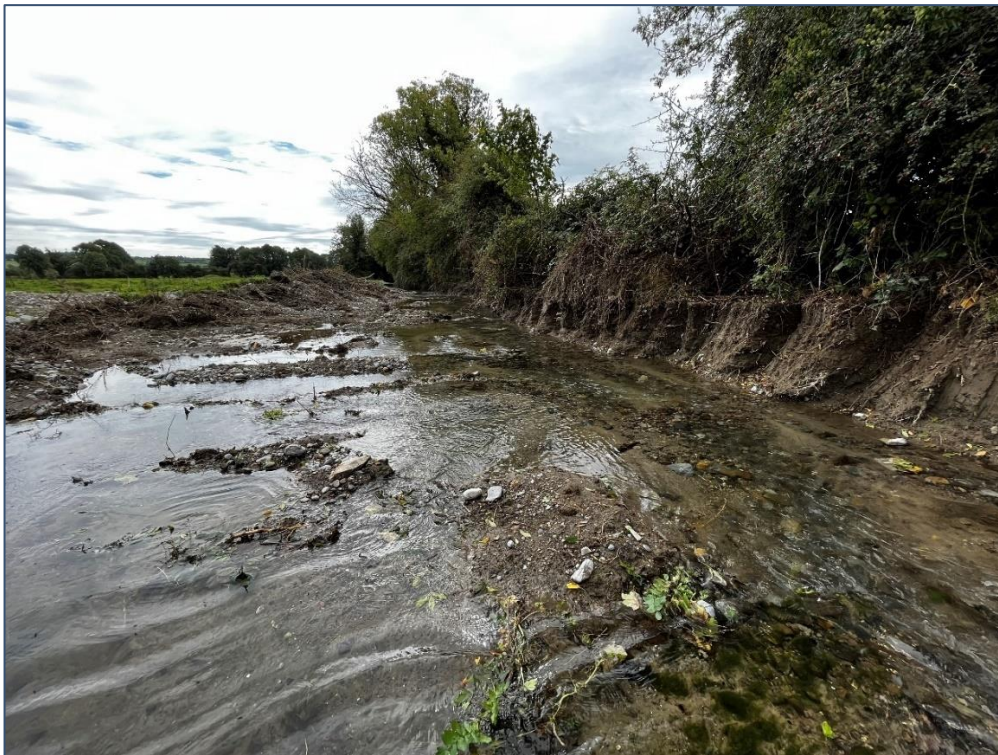
Plate 4-2 Area of altered watercourse downstream of survey location WF-1.

Downstream of the survey location point, evidence of watercourse alterations was observed on the Tullaroan Stream watercourse (Irish Grid Ref: S 38910 54596). The banks of the watercourse had been recently altered with evidence of some riverbed alterations also with bank material within the watercourse channel. This area of watercourse was heavily silted at the time of survey compared to the section immediately upstream with bank alterations likely being the cause of excess siltation.

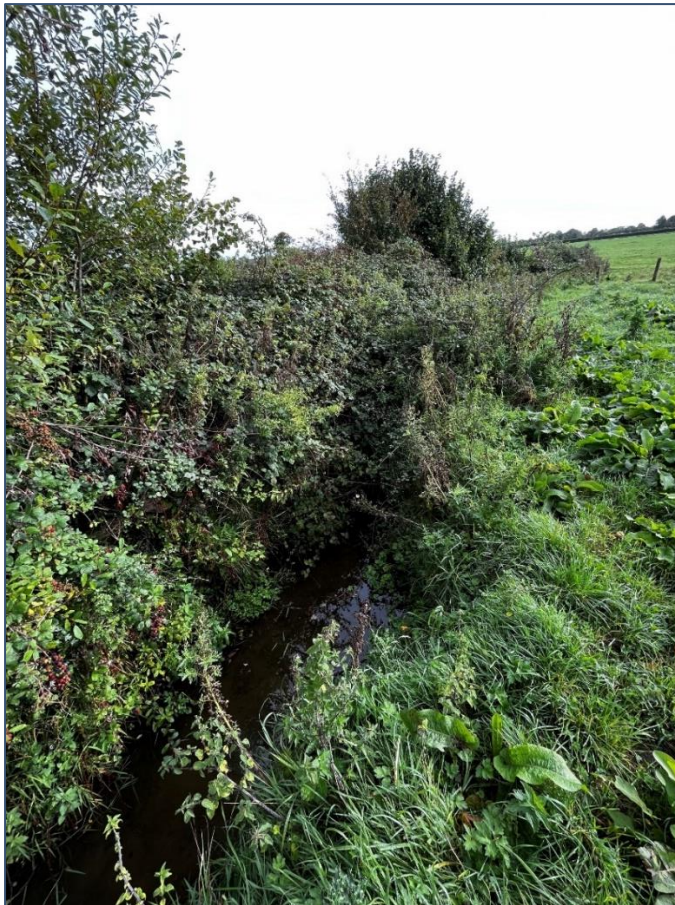
Plate 4-3 Representative picture of Survey Location WF-2

The watercourse at this survey location had low to medium flow and velocity. Water was clear and had no distinct colouration however there was a heavy degree of siltation which was easily disturbed during the survey creating plumes of silt and fine sediment that lingered in suspension. The substrate of the watercourse was dominated by cobbles, large gravels and fine gravels and silt with a contiguous silt layer also present over a high proportion of the river bed substrate. A section of the channel at the survey location is used as a crossing point between fields and as such the substrate in this area is compacted. The right-hand bank (RHB) consisted of **improved agricultural grassland (GA1)** with a field boundary **Hedgerow (WL1)** growing on the RHB and providing heavy shade to the channel. As a result sections of the channel were tunnelled and low amounts of light penetrated. Species

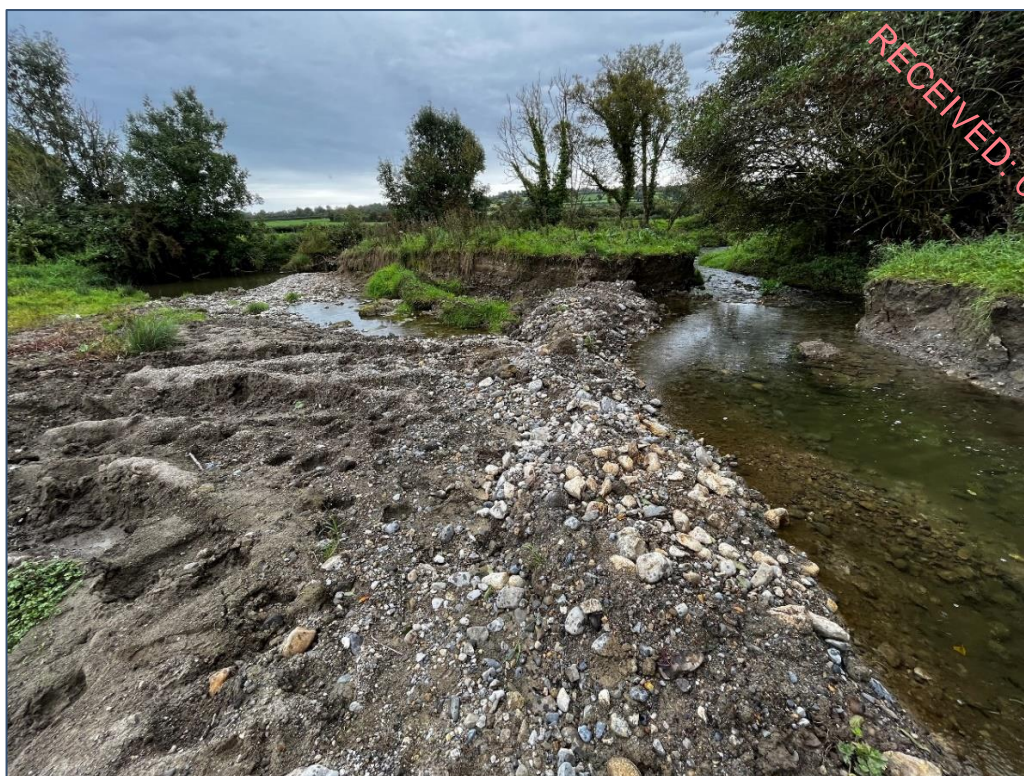
Plate 4-5 Area of altered watercourse downstream of survey location WF-3 at the confluence of the Tullaroan stream, Foylatalure and Briskalagh watercourses.

Downstream of the survey location point, evidence of watercourse alterations were observed on the confluence of the Tullaroan Stream, Foylatalure and Briskalagh watercourses (Irish Grid Ref: S 39413 53797). The banks of the watercourse had been recently altered along with evidence of some riverbed alterations and watercourse diversion. A section of the old watercourse route prior to diversion has been filled in with material. This area of watercourse was heavily silted at the time of survey with bank and riverbed alterations likely being the cause of excess siltation. Downstream of the filled in section of the old watercourse, a deep and heavily silted pool now cut off from upstream flows was present on the left hand side of the watercourse route.

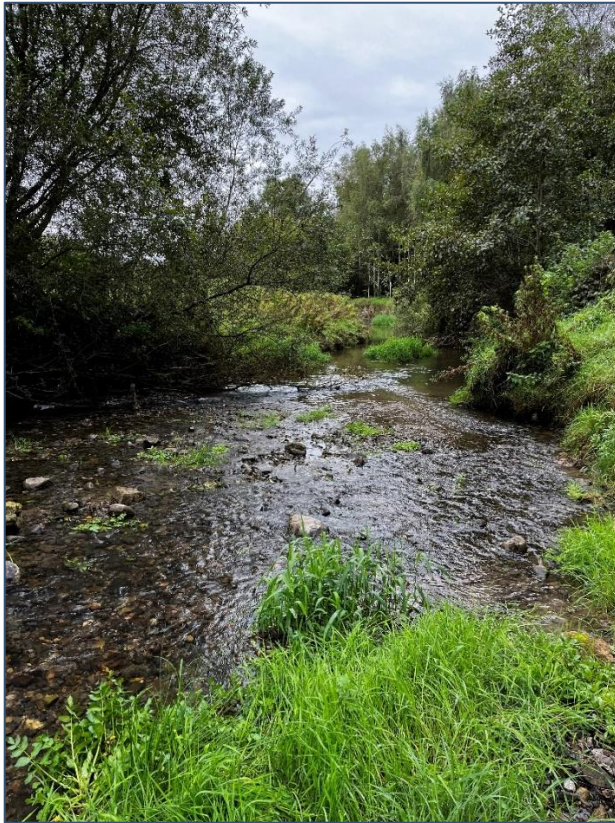
Plate 4-6 Representative picture of Survey Location WF-4

The watercourse at this survey location had low to medium flow and velocity. Water was clear with no discernible coloration but was slightly turbid within pools. There were patches of silt and light siltation in areas of the channel but also large expanses of clean courser material. Water depth increased with distance downstream of the survey location. The substrate of the watercourse was dominated by cobble, large gravels and fine gravels. The right-hand bank (RHB) consisted of **mixed broadleaved woodland (WD1)** providing moderate shade to the channel. Species characterising the woodland on the RHB consisted predominantly of alder (*alnus glutinosa*), ash, bramble, and bindweed (*Calystegia sp.*). The left-hand bank (LHB) consisted of a willow (*Salix sp.*) riparian **treeline (WL2)**. Land use on the RHB consisted of plantation forestry while land use on the LHB past the riparian treeline consisted of an area of agricultural pasture.

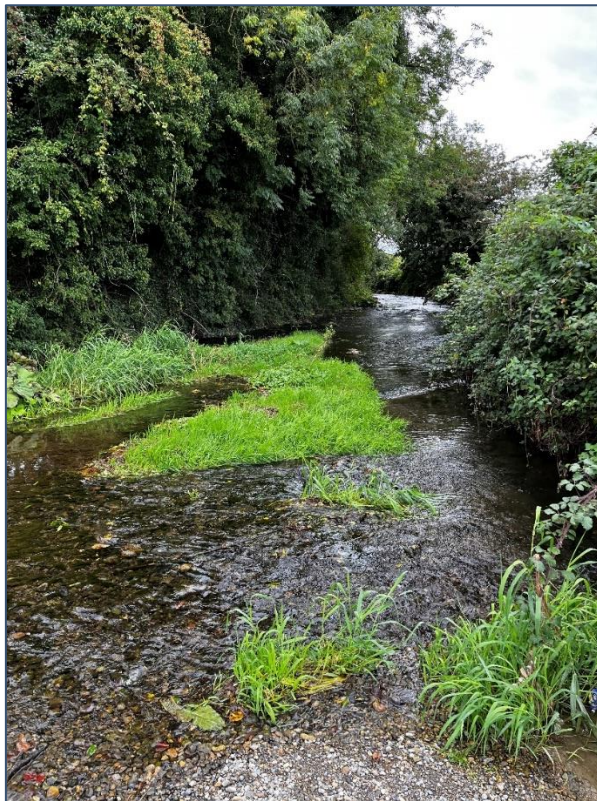
Plate 4-7 Representative picture of Survey Location WF-5

The watercourse at this survey location had low to medium flow and velocity. Water was clear with no discernible coloration. Plumes of silt were released into suspension when disturbed. The substrate of the watercourse was dominated by cobble, large gravels and fine gravels. Gravels had accumulated at the right hand bank leaving an exposed area of gravels during the flow conditions at the time of survey. A number of vegetated mid-channel gravel bars were also present within the channel in areas of shallow water. Excessive green algae growth was found on the cobbles and gravels and covered approximately 70% of the river bed substrate. A two-span bridge with a concrete apron and one support pillar within the channel was located at the upstream extent of the survey location. Flow of water was blocked through one of the spans of the bridge by a buildup of vegetated substrate and earthen deposits. The right hand bank (RHB) consisted of built land (**buildings and artificial surfaces (BL3)**) and bramble scrub (**WS1**) which quickly graded into a football pitch considered under **amenity grassland (GA2)** at the downstream extent of the survey area. The left-hand bank (LHB) consisted of a willow, ash and ivy dominated riparian **treeline (WL2)** which graded into an **agricultural grassland (GA1)** further from the bankside. Land use on the RHB consisted of urban townland and recreation while land use on the LHB past the riparian treeline consisted of an area of agricultural pasture.

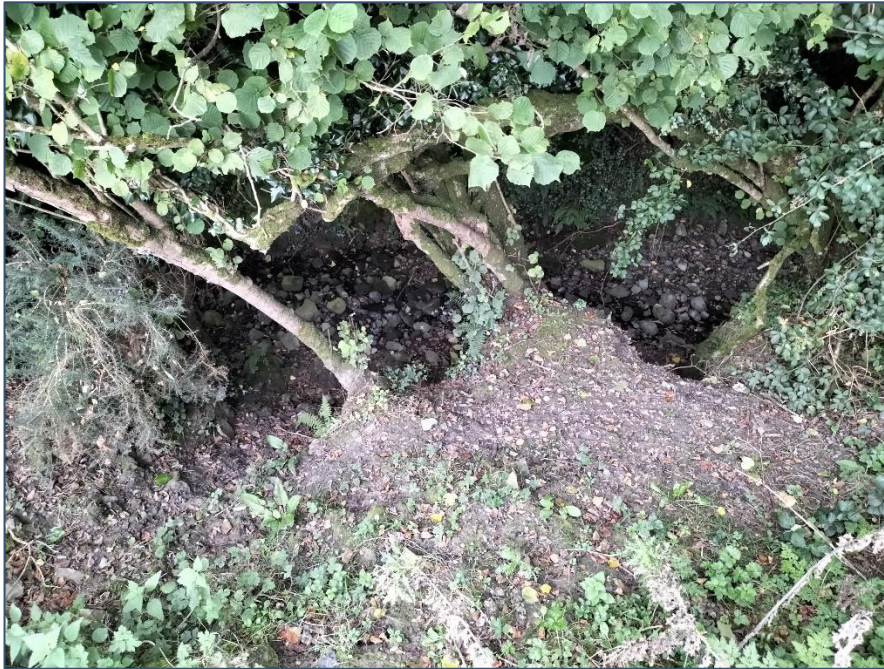
Plate 4-8 Representative picture of Survey Location WF-6

Survey site WF-6 was located on the Bregagh [Kilkenny] watercourse (IG Ref.: S 40905 54732). This section of the Bregagh [Kilkenny] watercourse was categorised as an **eroding/upland river (FW1)**. At the time of survey the survey location was dry with no water within the channel. The watercourse was trenched between two banks which had been historically raised. Bank heights were approx. 3-4m on both sides of the channel. A hazel **treeline (WL2)** grew from the bank face and tunnelled the channel providing considerable shading. The channel width was approximately 2m. Substrate consisted predominantly of cobble, gravels and fine gravels. Land use both sides of the channel consisted of **agricultural grassland (GA1)** habitat. A representative photograph of the survey location is shown in Plate 4-8.

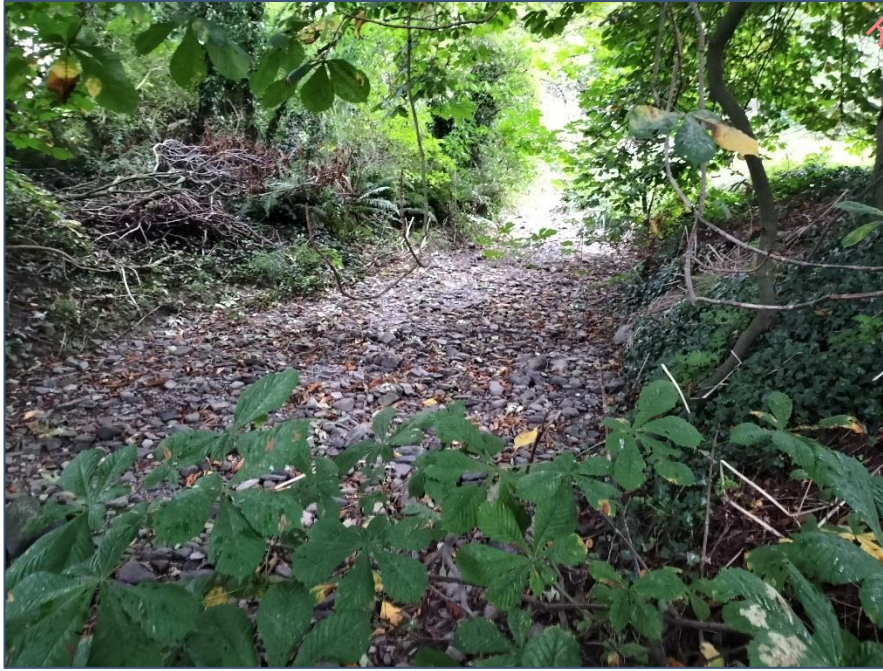
Plate 4-9 Representative picture of the attempted downstream Location (Downstream of WF-6)

Another survey location was chosen downstream on the Bregagh [Kilkenny] watercourse in order to gather baseline aquatic data however the river at this downstream location (S 43485 52988) was also dried out and further aquatic surveys were not completed. A representative photograph of the further downstream location is shown in Plate 4-7.

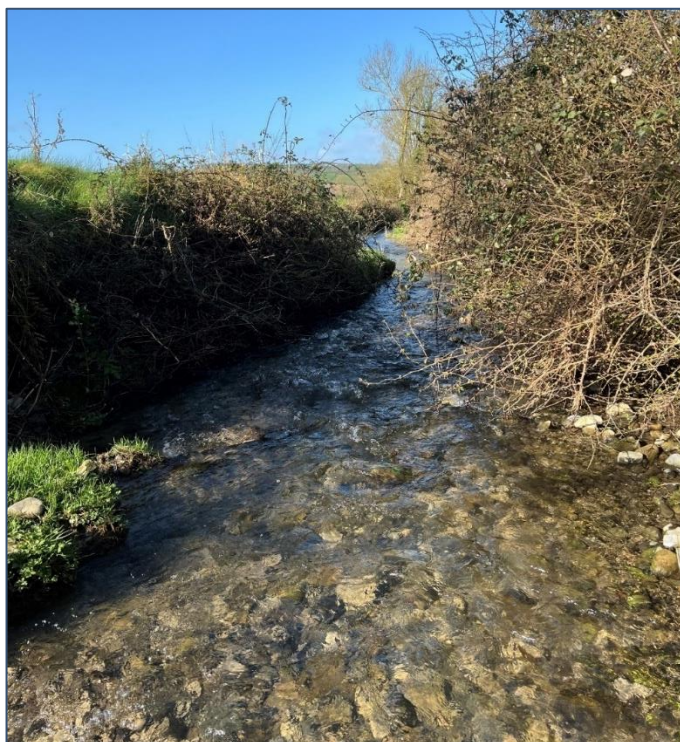
Plate 4-10 Representative picture of Sampling Point – GR-1

This section of watercourse was characterised by eroded and undercut earth banks, with large boulder and cobble substrate along the watercourse margin. Large cobble was the predominant substrate type and was semi-compacted. Water was very clear when undisturbed, with no colouration. A slight degree of siltation was observed in the watercourse during the kick-sampling process. Stream discharge was moderate, with fast water velocity. An unvegetated midpoint gravel bar was exposed in lower flow.

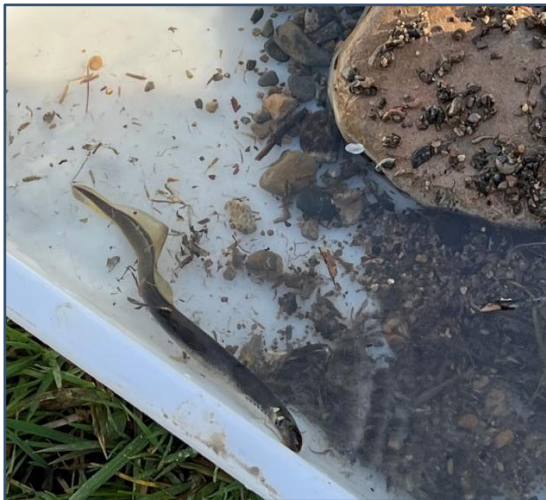
While this section of river displayed relatively clean, mobile gravel and cobble amongst transitional riffle-glides areas with accelerated flow, GR-1 was considered a moderate quality spawning ground and nursery due to the presence of an upstream barrier in the form of a raised concrete bridge apron, which separated potential salmonid and lamprey spawning grounds in areas of riffle-glide up and downstream of the bridge structure. The presence of finer, organic sediments adjacent to undercut banks away from areas of faster flow were identified as moderate lamprey *sp. ammocoete* habitat. A Brook Lamprey (*Lamprey planeri*) identified in the kick sample at GR-1 is shown in

Plate 4-11 Image of the Brook Lamprey identified in the kick-sample at Sampling Point GR-1

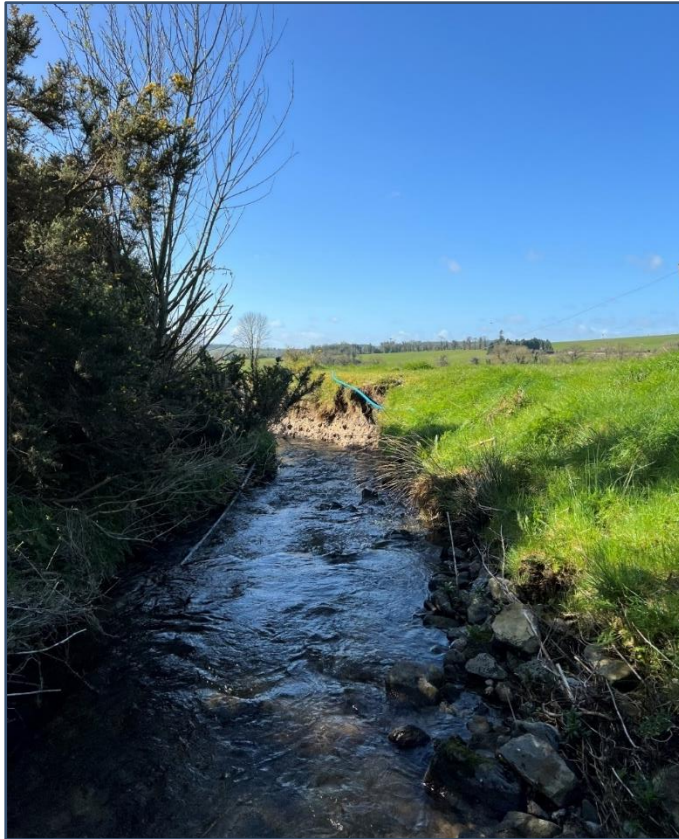
Plate 4-12 Representative picture of Sampling Point – GR-2

This section of watercourse was characterised by high, heavily eroded and undercut earth banks, with large boulders along the watercourse. Artificially reprofiled bank faces downstream of the kick-sample laterally confined the watercourse. Water was very clear when undisturbed, with no colouration. A moderate degree of siltation was observed in the watercourse during the kick-sampling process.

The kick sample was taken in areas of riffle amid a pool-riffle-glide complex. A small secondary channel which joined this section of stream was located upstream of the kick-sample location, as well as a major bridge structure with in-channel abutment support and a raised concrete apron; the presence of which created an artificial step-pool. The watercourse was culverted through one of two bridge arches, with water seemingly abstracted from the second arch via a black pipe. A secondary black pipe ran instream along the surveyed stretch of watercourse (see Plate 4-13). Stream discharge was moderate, with fast water velocity.

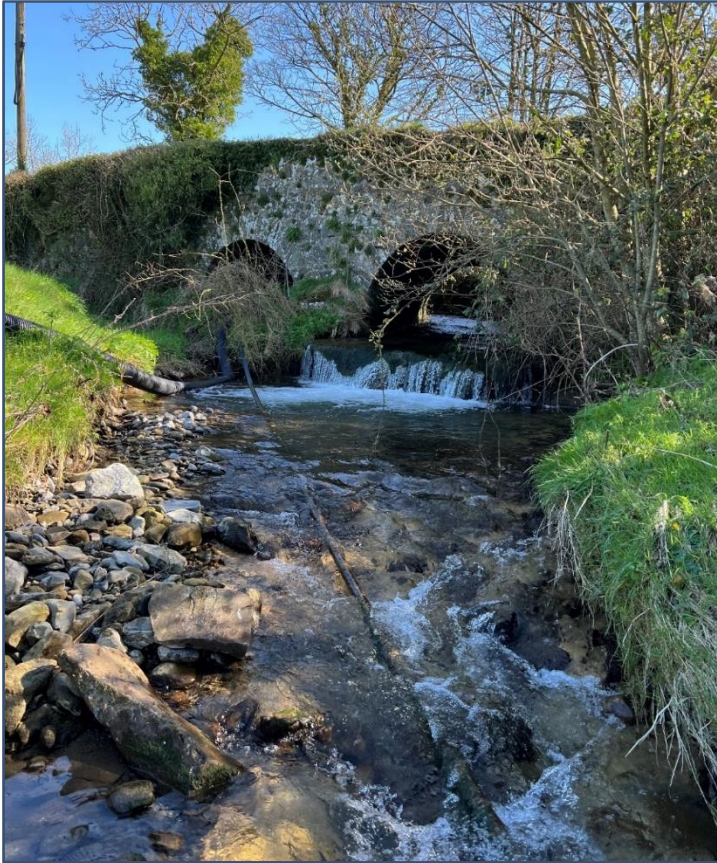
Plate 4-13 Representative picture of upstream of Sampling Point – GR-2, including the bridge structure, concrete apron and abstraction pipes

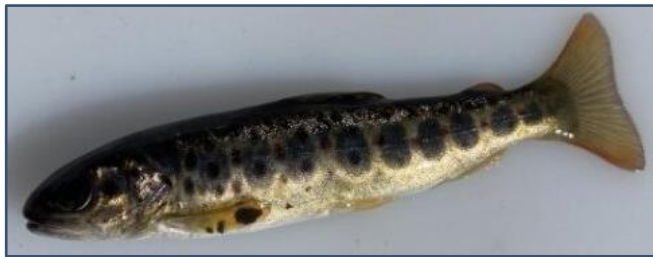
The pool-riffle-glide sequence in this section of river provided a varied river depth profile, with an area of pool downstream of the raised bridge apron providing moderate holding habitat for salmonid species. Tree canopy and scrub, as well as the raised nature of the banks, provided moderate shading to the channel margins. Despite the presence of accelerated flow, cobble and gravel substrata present were both semi-compacted with some silt deposition, most likely as a result of excessive bank erosion and reprofiling. Therefore, spawning habitat for both salmonids and lamprey were moderate. Areas of finer sediment alongside marginal refugia provided moderate habitat for *Lamprey sp.* ammocoetes. A dead salmonid parr was identified in the river (see Plate 4-14).

Plate 4-14 Image of dead salmonid parr found at Sampling Point – GR-2

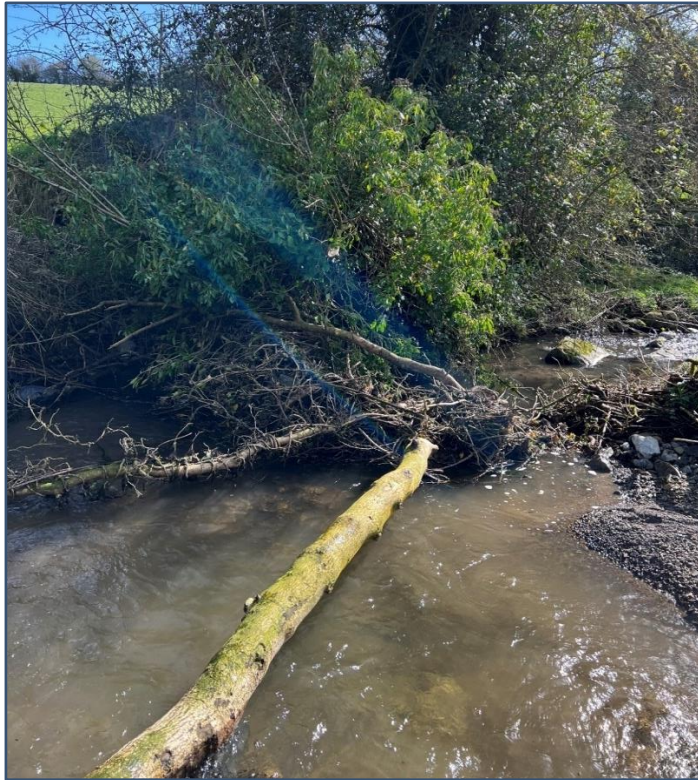
Plate 4-15 Representative picture of Sampling Point GR-3

Water was clear when undisturbed with yellow colouration, which may be attributed to a slight degree of siltation observed in the watercourse during the kick-sampling process. However, plumes of sand and silt cleared quickly. Substrate, of which cobble was the dominant types, was compacted. While bank heights immediately adjacent to the watercourse were low, steep sided **earthen embankments (BL2)** were present 5m within the riparian buffer zone. Land use for immediately adjacent to both the right- and left-hand banks featured a **treeline** of Hawthorn (*Crataegus monogyna*) and Beech (*Fagus sylvatica*) (**WL2**) and Bramble **scrub** (*Rubus fruticosus* agg.) (**WS1**), which provided moderate shading to the channel margins. Semi-natural, neutral agricultural grassland with *Festuca* spp. and *Poa* spp. grasses extended beyond the immediate riparian buffer zone (**GSI**). Moderate littering was present in and around the stream channel.

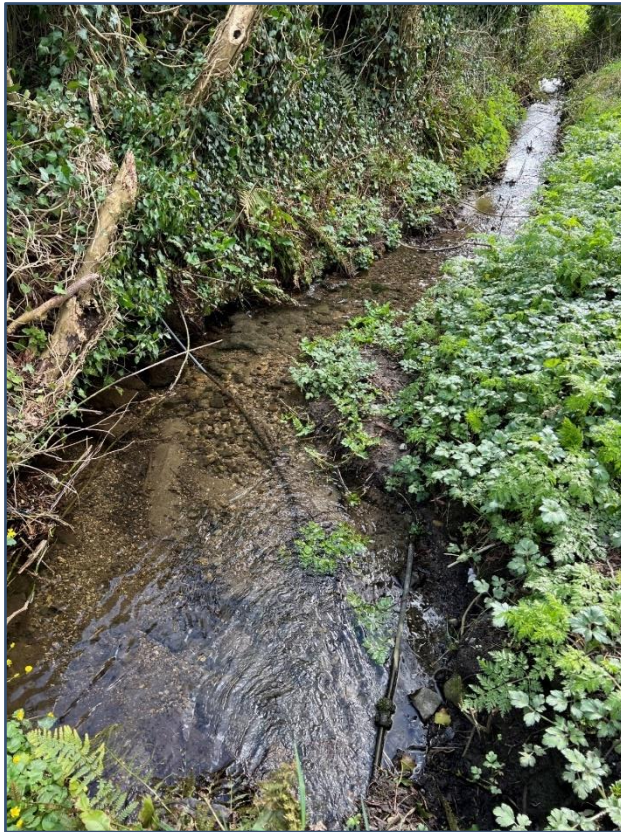
Plate 4-16 Representative picture of Sampling point – GR-4

Survey site GR-4 was located on a section of the Arigna River, a tributary of the River Nore (IG Ref.: S 38961 60218). This historically **Eroding/Upland (FW1)** stream has been both culverted and straightened, resulting in a low, slow flow pattern. The kick-sample was performed downstream of the road culvert in an area of glide. Water was slightly turbid with a heavy degree of siltation, particularly when disturbed. Yellow colouration may be attributed silt-laden water. Substrate, of which fine gravel was the dominant type, was loose. Properties of the stream at sample point GR-4 are shown in Table 4-22 and a representative photograph of the survey location is shown in Plate 4-16.

The right-hand bank was low and sloping, with some poaching (i.e. bare soil) evident at the entry point. Riparian vegetation coverage included Bracken (*Pteridium aquilinum*), Lesser Celandine (*Ficaria verna*), Cow Parsley (*Anthriscus sylvestris*), Common Nettle (*Urtica dioica*), Dock (*Rumex sp.*), Creeping Buttercup (*Ranunculus repens*) and Hart's-tongue Fern (*Asplenium scolopendrium*). The right-hand bank ran directly adjacent to a **tarmac road (BL3)**, from which two black water pipes passed through the section of stream. The left-hand bank-top, composed of an **earthen embankment (BL2)** was lined with a Hawthorn **hedgerow** (*Crataegus monogyna*) (**WL1**) with Ivy (*Hedera Hibernica*) throughout. Land use immediately behind the hedgerow on the left-hand bank was **improved agricultural grassland (GA1)** predominated by Perennial Rye-Grass (*Lolium perenne*). Instream emergent macrophytes included Fool's watercress (*Apium nodiflorum*). Sycamore trees (*Acer pseudoplatanus*) sparsely lined the opposite roadside, and shade provided by riparian vegetation was negligible.

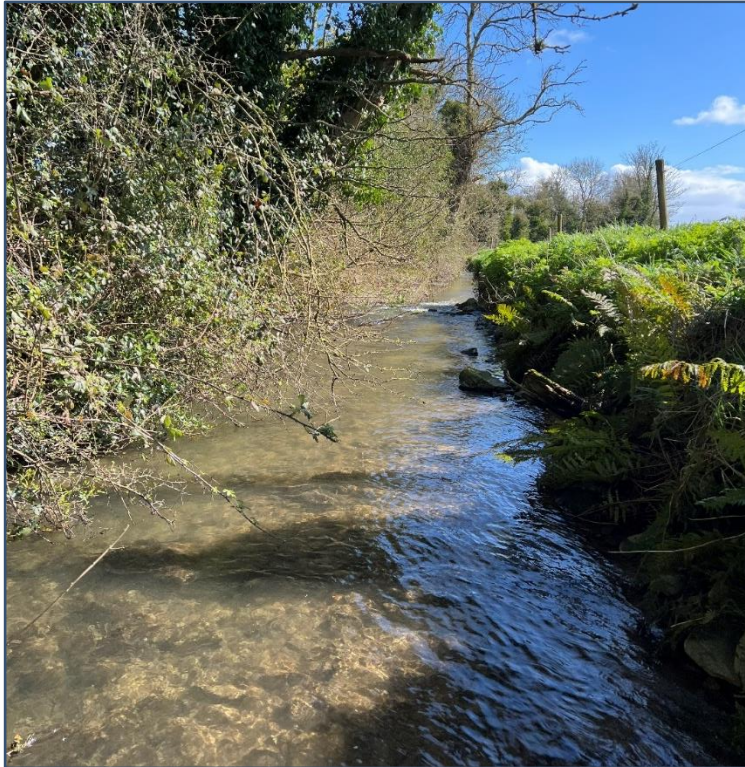
Plate 4-17 Representative picture of Sampling point – GR-5

This section of the watercourse was in moderate flow, with moderate velocity. Kick-samples were performed across sections of riffle and glide. Water was clear when undisturbed with a slight yellow colouration, which may be attributed to a slight degree of siltation observed in the watercourse during the kick-sampling process. However, plumes of sand and silt cleared quickly. Substrate, of which cobble and larger gravel were the dominant types, was semi-compacted. The section of watercourse was relatively straight, and the channel was laterally confined by raised earthen banks.

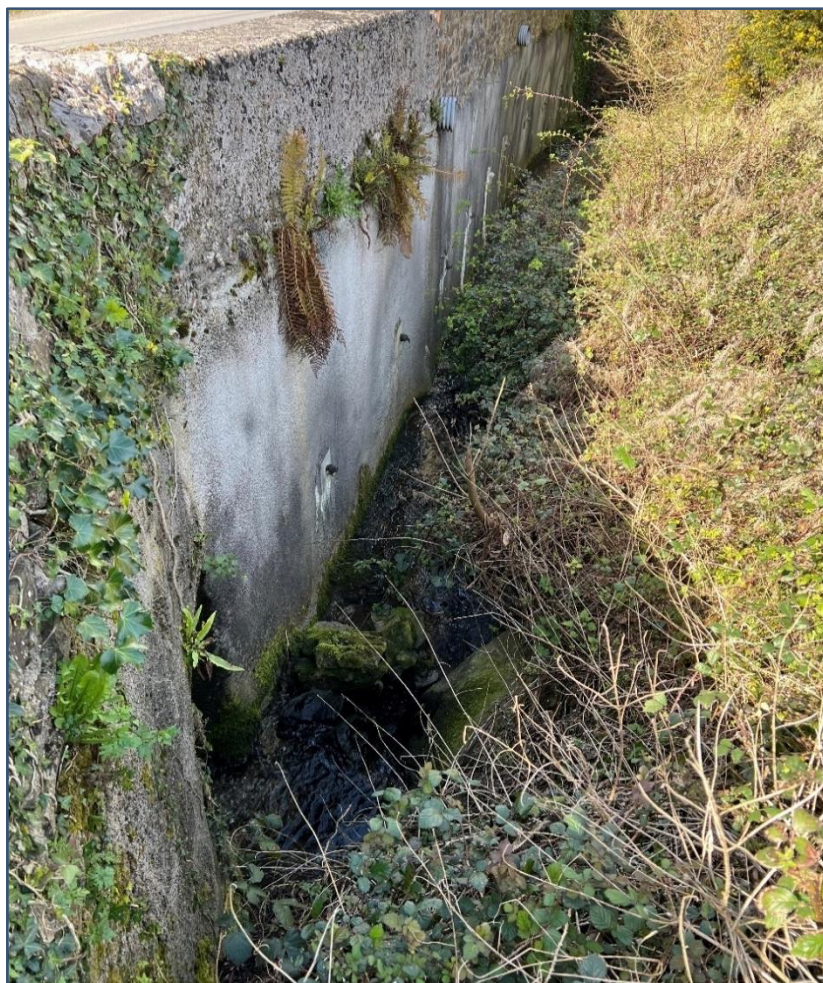
Survey site GR-6 located along Freshford Lots stream was identified as an additional watercourse along the proposed grid connection crossing (IG Ref.: S 40420 62677). However, this kick-sample site was a highly inaccessible culvert, with a steep concrete wall featuring storm drains along the left-hand bank (BL3), and a steep right-hand bank with boulder outcrops, overgrown with Bramble thicket (*Rubus fruticosus agg.*). Properties of the stream at sample point GR-6 are shown in Table 4-26 and a representative photograph of the survey location is shown in Plate 4-18.

Properties	Record			
Average Depth (m)	0.1			
Average Bank Width (m)	0.7			
Wet Width (m)	0.5			
Bank Height (m)	LHB	4	RHB	4
Flow	Low flow with moderate velocity			
Colour	No discernible colour			
Clarity	Clear			
Dominant Substrates	Streambed artificially reinforced with concrete (95%) with boulder outcrops (5%)			
Substratum Condition	Compacted

Plate 4-18 Representative picture of inaccessible Sampling Point – GR-6 (IG Ref.: S 40420 62677)

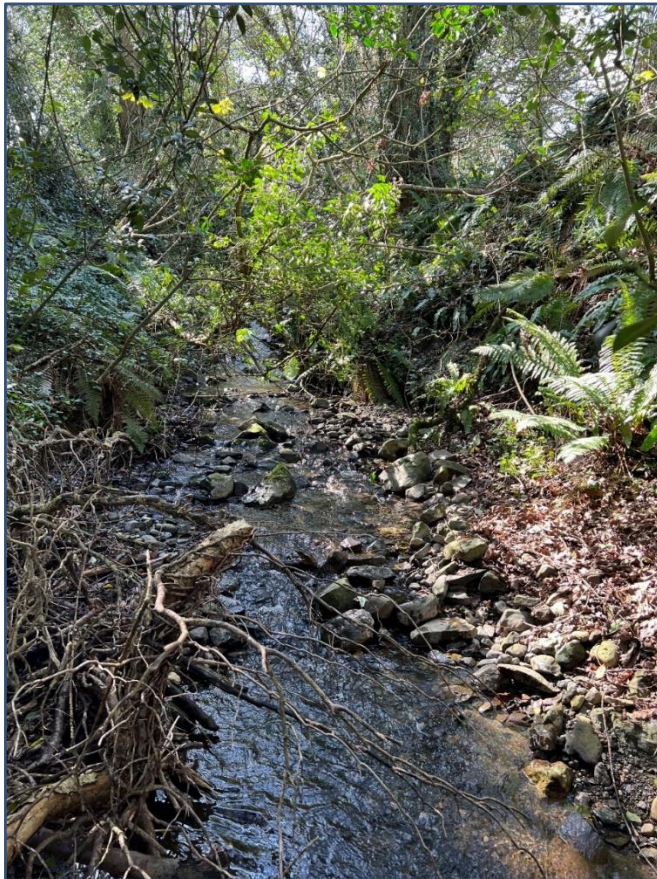
Plate 4-19 Representative picture of accessible Sampling Point – GR-6 (IG Ref.: IG Ref.: S 40495 62773)

This section of the watercourse was in low flow, with moderate velocity. Water had high clarity, no colouration and a slight degree of siltation when the streambed was disturbed. Substrate, of which gravels were the dominant kind, was semi-compacted.

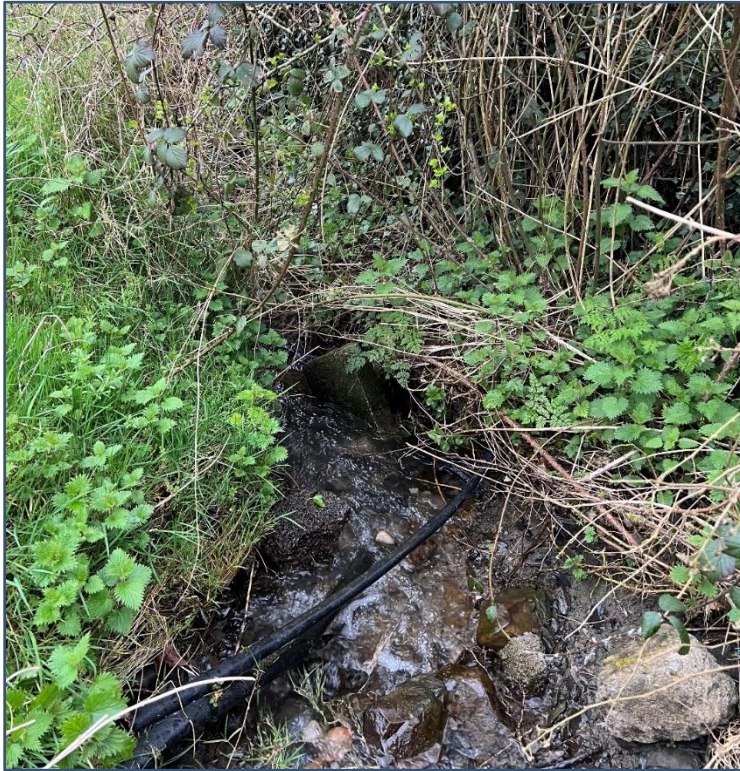
Plate 4-20 Representative picture of Sampling Point GR-7

This section of the watercourse was in moderate flow, with moderate velocity. Water was clear when undisturbed with a slight yellow colouration, which may be attributed to a moderate degree of siltation observed in the watercourse during the kick-sampling process. Substrate, of which gravel was the dominant kind, was semi-compacted. Entry to the stream and sample area was limited to a section of riffle ~20m from the road, due to fallen trees and steep, unstable earthen banks into an over-deepened, laterally confined watercourse further downstream.

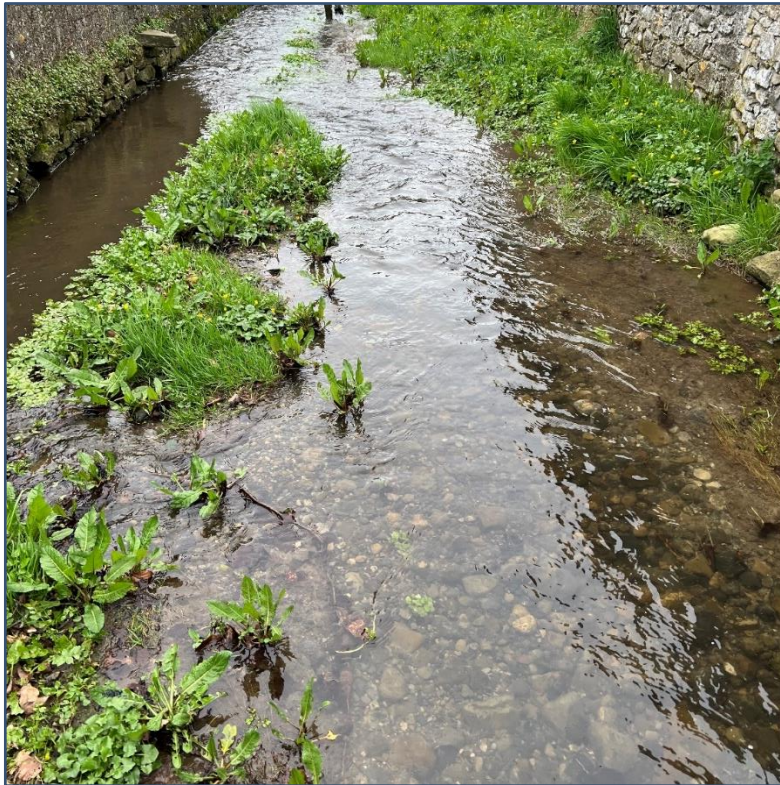
Plate 4-21 Representative picture of Sampling point GR-8

This section of the watercourse was in low flow, with slow velocity. Water had no colouration and streambed channel substrate was loosely compacted, with a moderate degree of siltation evident when disturbed.

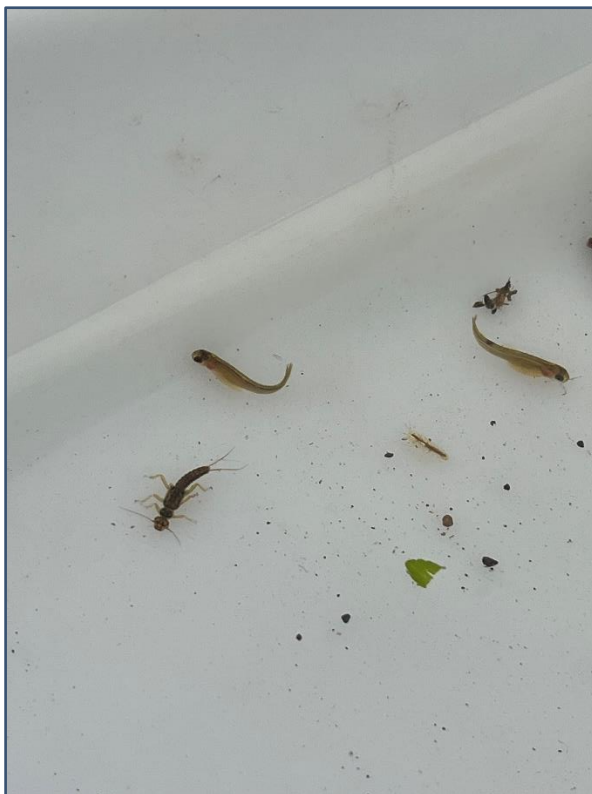
Although this stretch of stream lacked any marginal features or an adequate riparian zone to provide a source of refugia and shading to fish species, defined areas of riffle and glide alongside marginal areas of slower flow provided a water velocity difference for the sheltering and feeding habitats of salmonid fry and parr species. The narrow confined and shallow nature of the stream at this point provided poor salmonid spawning habitat. Substrate size/variability, including the presence of gravel bars, provided moderate salmonid nursery habitat, potentially limited by the moderate degree of siltation in the watercourse. Salmonid alevins were observed within the kick sample at this site (Plate 4-22). Salmonid holding, as well as general eel habitat suitability were negligible due to lack of any depth variation, pools or marginal sheltering features. While substrata present is loose, a lack of fine, organic sediment deposits meant there was poor habitat for lamprey *sp.* ammocoetes.

Plate 4-22 Salmonid alevins were observed at survey location GR-8.

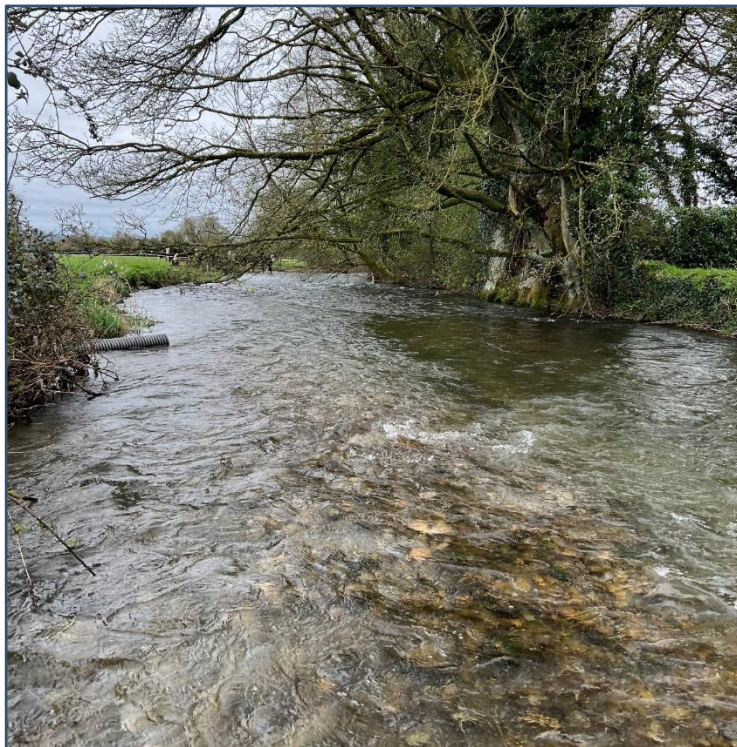
Plate 4-23 Representative picture of Sampling point GR-9

This **Depositing/Lowland section of river (FW2)** was in moderate flow, with high velocity. Water was clear with no colouration but had a slight degree of siltation upon disturbance of loosely packed riverbed substrate, of which cobble was the dominant substrate form. The section of channel at which the kick-sample was taken was straight, with a low, sloping left-hand bank and an earthen embanked right-hand bank.

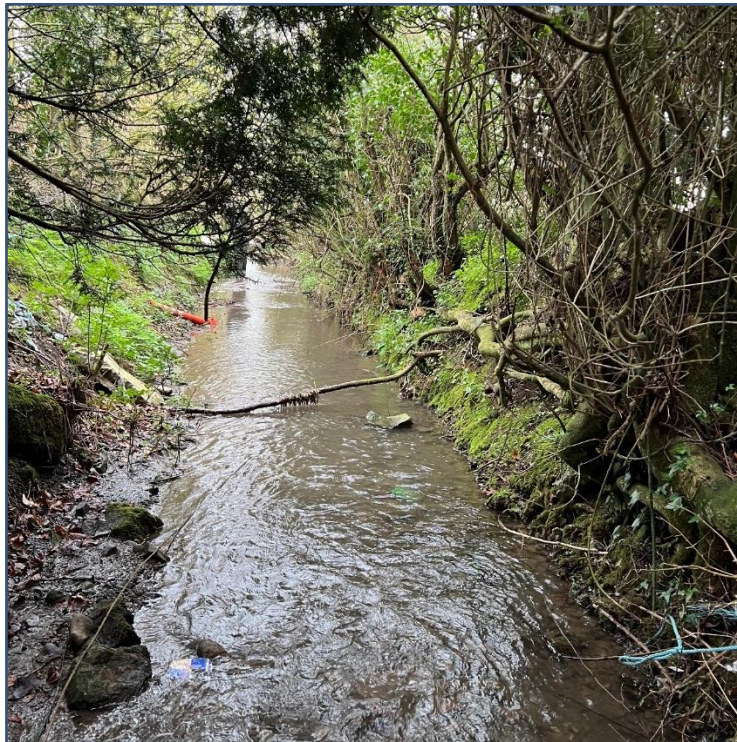
Plate 4-24 Representative picture of Sampling point GR-10

This section of highly modified **Eroding/Upland River (FW1)** was in low flow, with moderate velocity. Water was moderately turbid with no colouration but a heavy degree of siltation overlaying otherwise compacted channel substrate. The channel itself has been straightened, with high earthen embankments on both banks and sections of streambed reinforced with concrete.

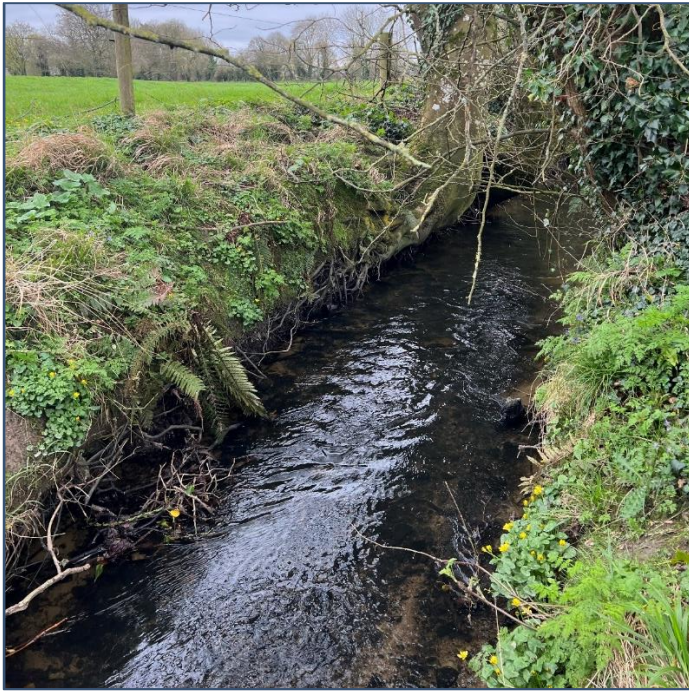
Plate 4-25 Representative picture of Sampling point GR-11

This section of **depositing/ lowland river (FW2)** was in low flow, with moderate velocity. Water was slightly turbid and yellow in colour, which may be attributed to the heavy degree of siltation. The watercourse channel is laterally confined by high, steep earthen banks.

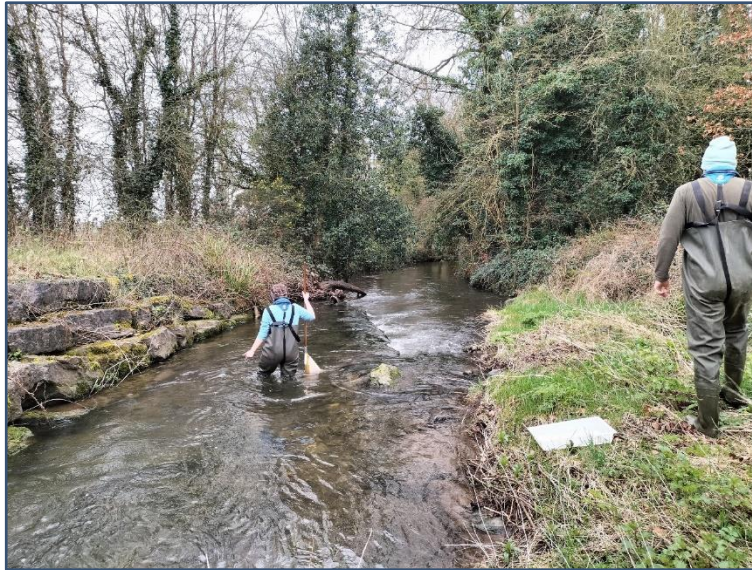
Survey site GR-12 was located on Lisdowney stream (IG Ref.: S 43638 68636). Properties of the stream at sample point GR-12 are shown in Table 4-39 and a representative photograph of the survey location is shown in Plate 4-26.

Properties	Record
Average Depth (m)	0.5
Average Bank Width (m)	4
Wet Width (m)	4
Bank Height (m)	LHB 1.5 RHB 1.2
Flow	High flow with high velocity
Colour	No perceptible colouration
Clarity	Very clear
Dominant Substrates	Boulder (> 128mm): 15% Cobble (>32–128mm): 40% Gravel (8-32mm): 20% Fine gravel (2-8mm): 20% Sand (0.25–2mm): ~2.5% Silt (<0.25mm): ~2.5%
Substratum Condition	Compacted

Plate 4-26 Representative picture of Sampling Point GR-12

This section of the watercourse was classified as **Eroding/Upland River (FW1)** with high flow and velocity. Despite a slight degree of siltation during the kick-sampling process, plumes of silt quickly cleared, and the river was determined to have very high clarity when undisturbed. This stretch of watercourse had no colouration. Both banks have been reinforced, with laid stone reinforcing banks of soil (BL1) and artificial earth embankment (BL2) along the left and right-hand banks, respectively. The channel is therefore confined laterally and may have reduced floodplain connectivity.

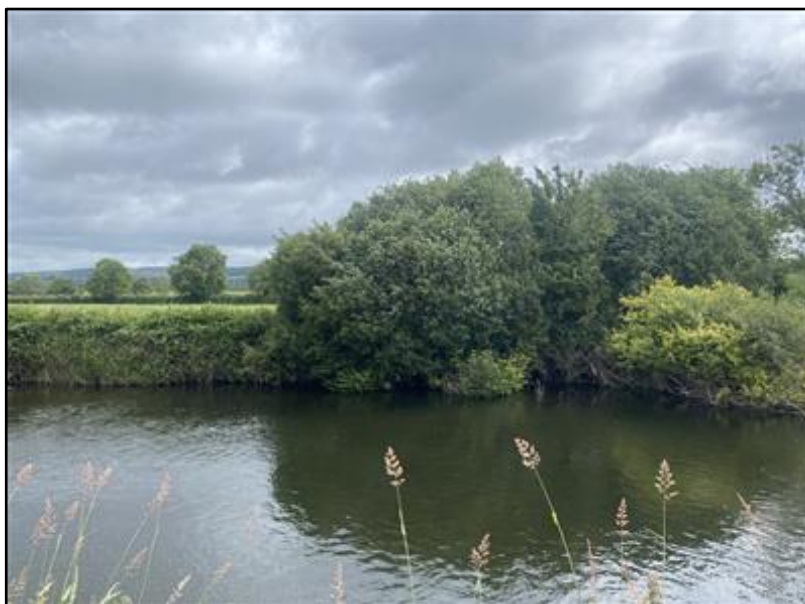
Plate 4-27 Representative picture of Sampling Point – GR-13

General fish habitat assessment was limited by the River Nore's width and depth causing visibility issues across the whole channel. Salmonid and lamprey spawning habitat was considered to be poor due to the lack of suitable conditions for spawning i.e. predominant cobble substrate, shallow well oxygenated water with clean small fine gravels. Salmonid nursery habitat was considered moderate due to the presence of some suitable habitat but also poor shading across the width of the channel and the size of the channel and depth of pools providing good habitat for predators. Some juvenile salmonids were observed at the right-hand bank sheltering behind and area of marginal vegetation. Lamprey nursery habitat was considered to be moderate due to the presence of fine sediment deposits along the bank margins and overall slow flow of the watercourse. Holding habitat for salmonids and habitat for European eel was considered to be good due to the presence of deep pools and trees overhanging the bankside providing refuges within the channel margins and shading.

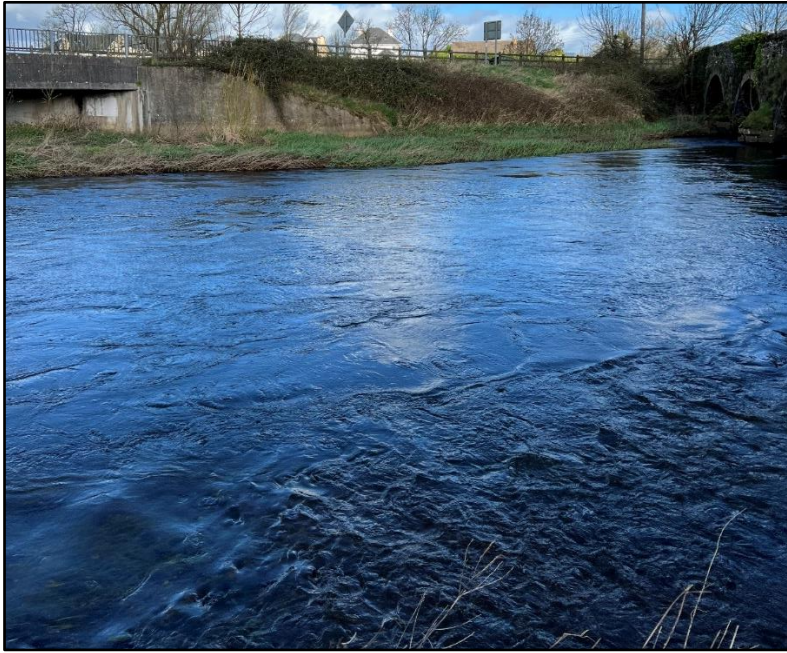
Due to water depth and unsuitable conditions for survey no Q-Value was recorded at the GR-13 survey location. However, a survey was completed downstream of this location upstream of the Ballyragget bridge at IG Ref.: S 44494 70847 (Plate 4-28). While the majority of the species recorded in the sample were pollution tolerant (66%, comprising 39 individuals), individuals that were 'very' and 'moderately pollution sensitive' species were also present. At least one Group A taxon was recorded in reasonable numbers, with seven individuals recorded for *Perla sp.* Group A taxon (~12% of the sample). The Q rating assigned to the sample location was **Q4 – Good**, based on high diversity and increased density of species (few Group B taxa, numerous Group C taxa, few Group D taxa and absent Group E taxa). The results of the kick sampling are summarised in Table 4-42.

Plate 4-28 Survey location downstream of GR-13 and upstream of the Ballyragget bridge at IG Ref.: S 44494 70847.
