# CHAPTER 7

## LAND, SOILS AND GEOLOGY

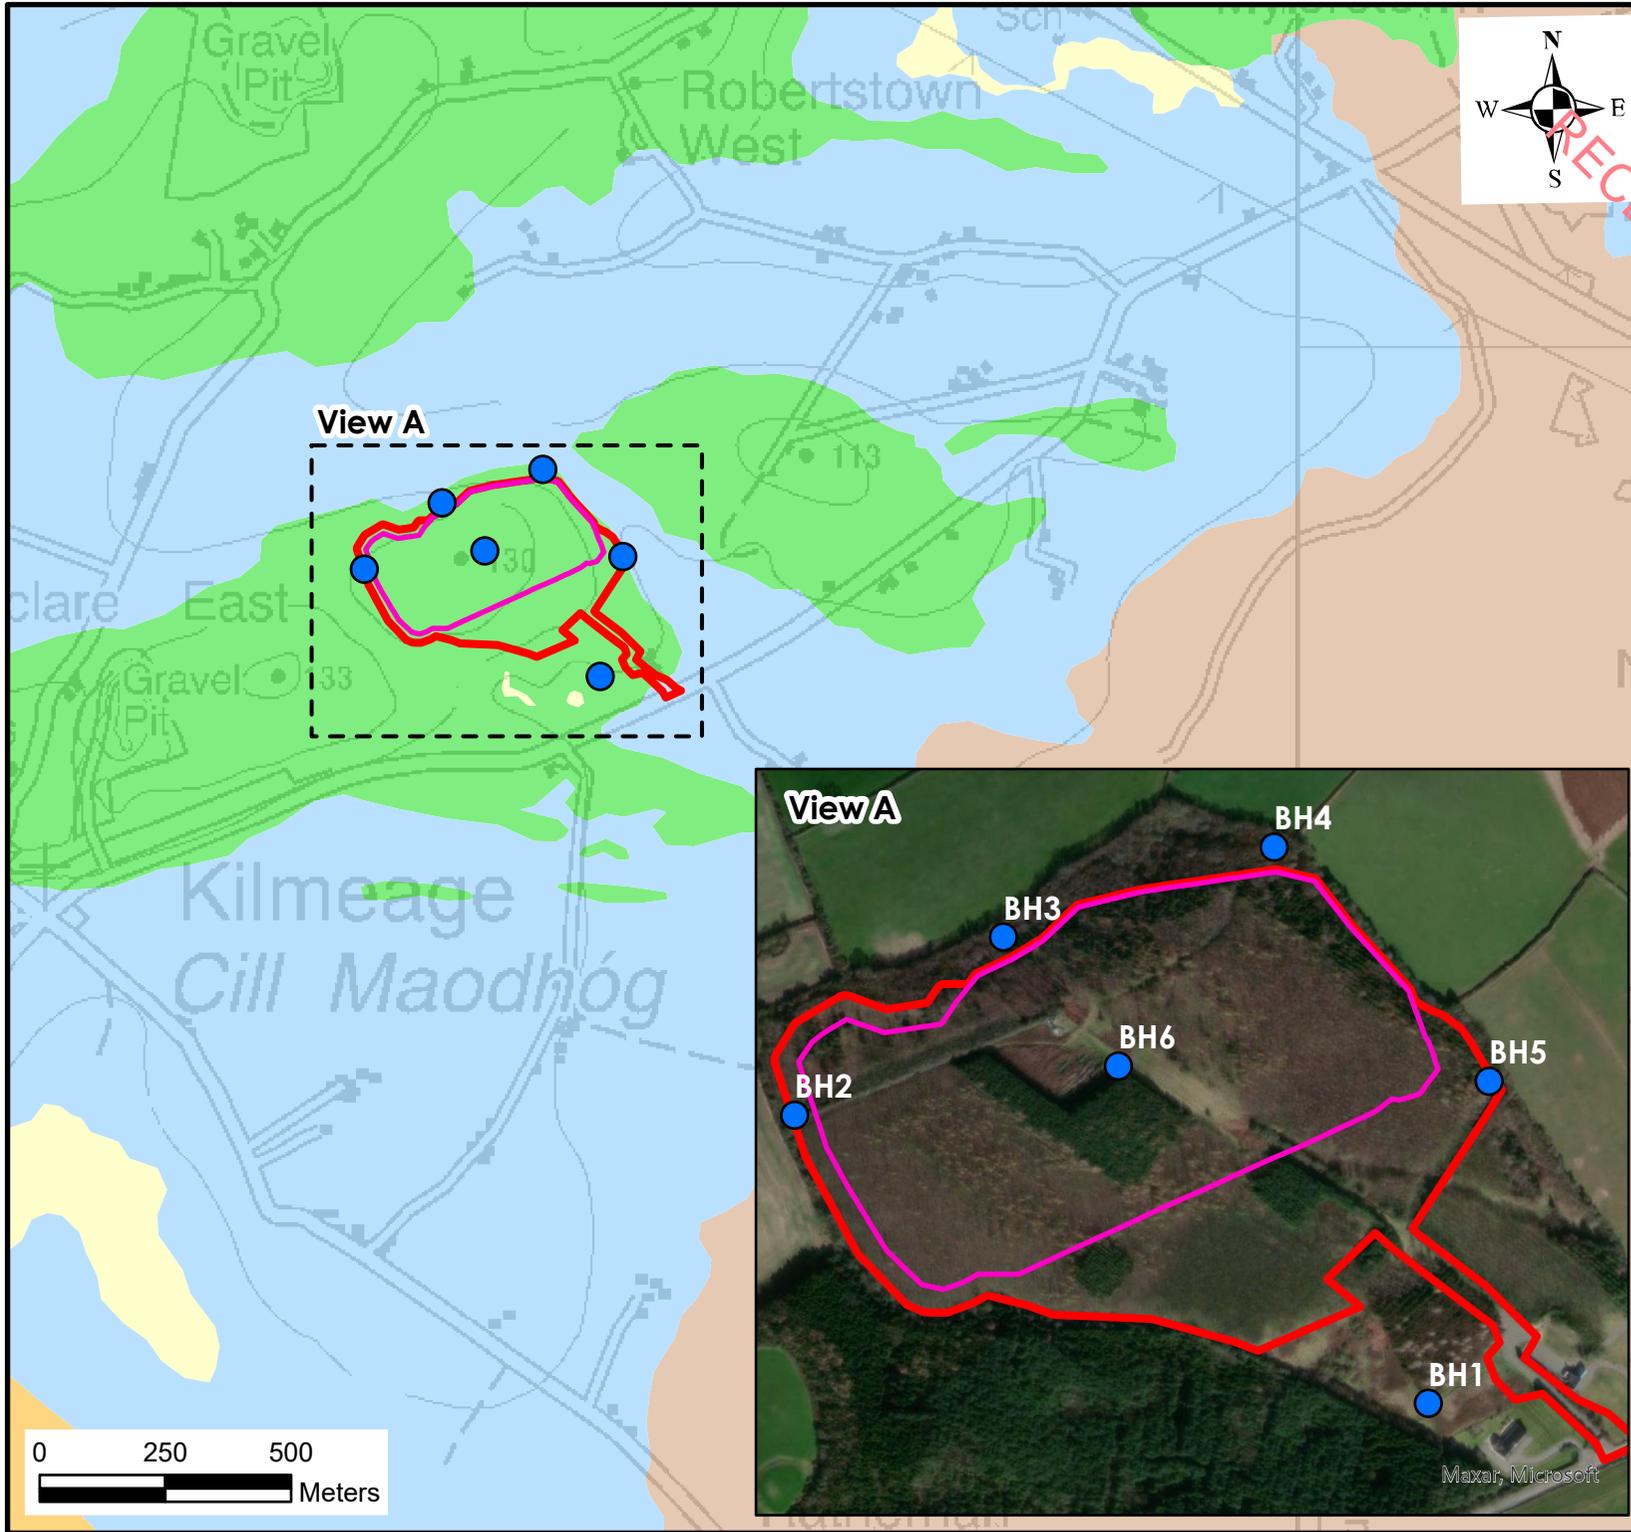
- Legend**
- Application Area
  - Extraction - Infill Area
  - Borehole locations
- Subsoils**
- A, Alluvium
  - Cut, Cut over raised peat
  - GL, Gravels derived from Limestones
  - L, Lacustrine sediments
  - TLs, Till derived from limestones

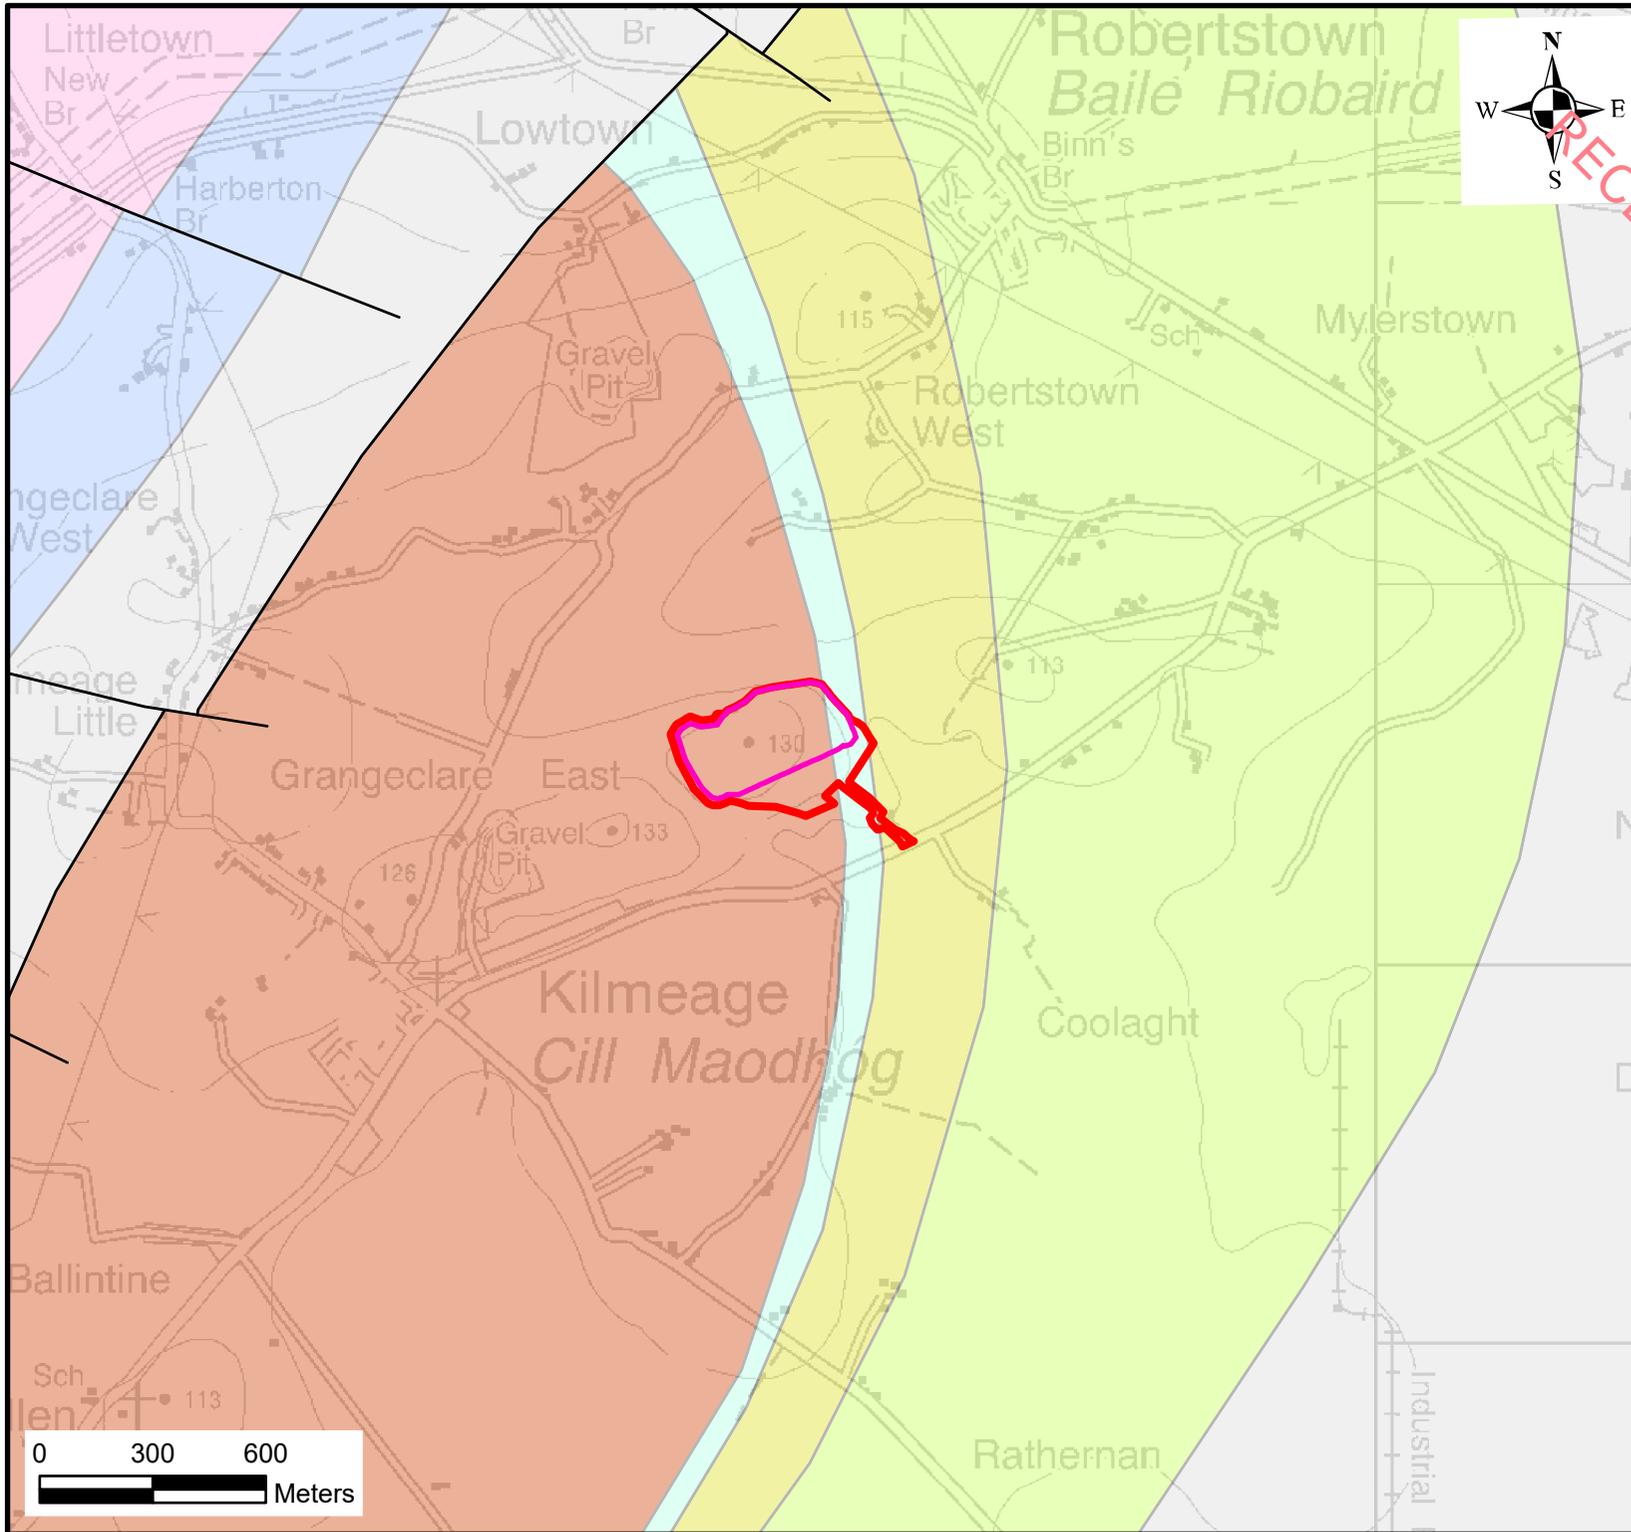
- Application Area
- Extraction - Infill Area
- Geological Linework
- Bedrock**
- Allenwood Formation
- Boston Hill Formation
- Clachan Sandstone Formation
- Feighcutten Formation
- Ferbane Mudstone Formation
- Old Red Sandstone (undifferentiated)
- Waulsortian Limestones

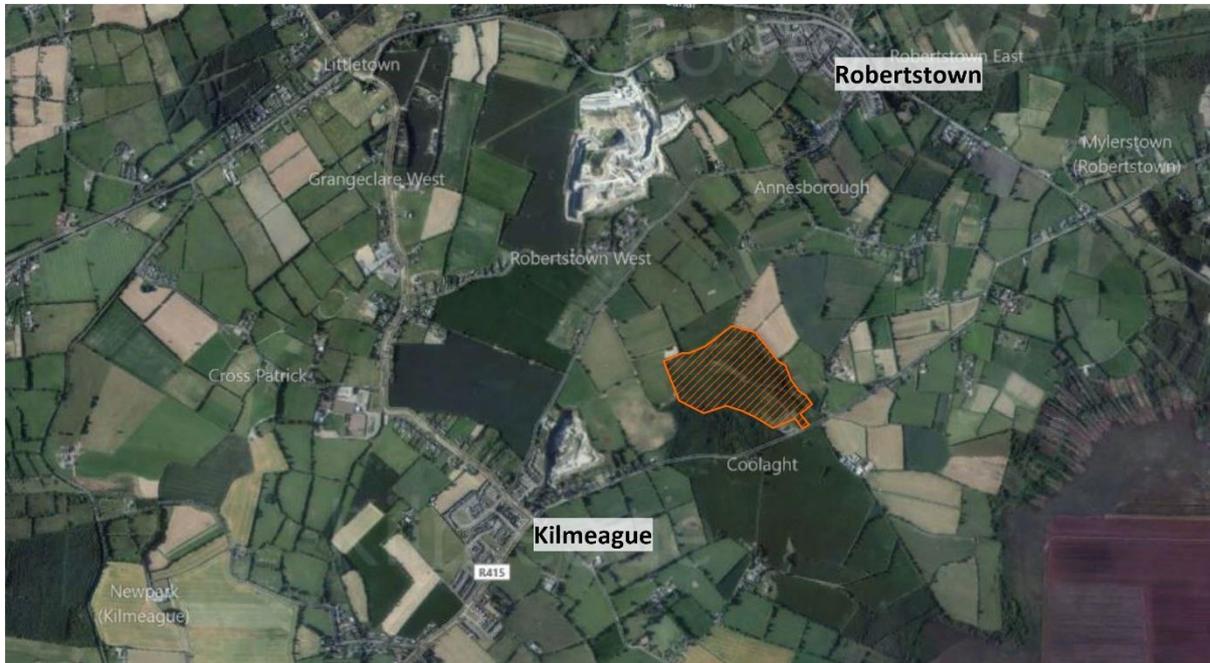
The deposit is located between Kilmeague and Robertstown (Figure 1).

Figure 1. Location of the sand and gravel deposit, outlined in orange and cross-hatched.

The deposit forms a prominent hill, rising to 131m in a generally flat area at an elevation of 100m or less.

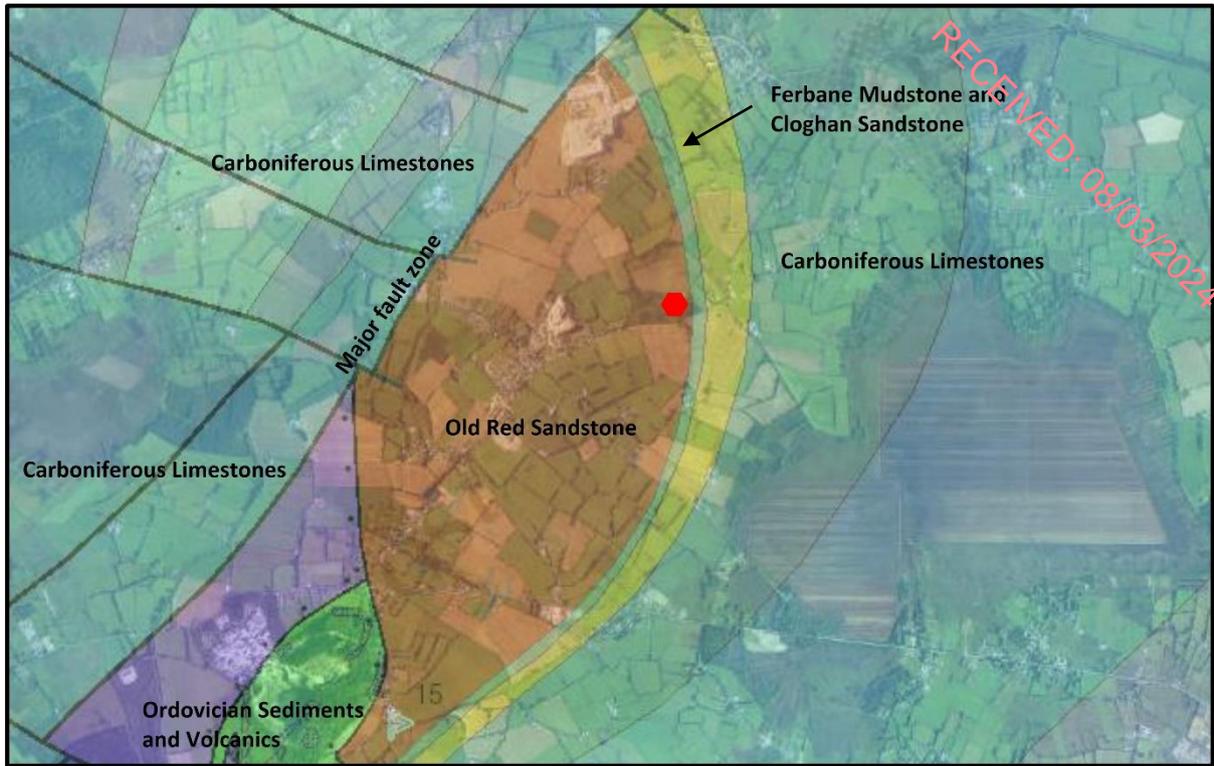
Figure 2. Bedrock Geology of the area around Kilmeague, taken from the Geological Survey of Ireland. The position of the sand and gravel site is indicated by a red octagon.

Figure 2 and figure 3 are downloaded from the Geological Survey website. The Sand and Gravel site is shown as underlain by Devonian aged Old Red Sandstone rocks. These are shown as overlain to the east by basal Carboniferous Ferbane Mudstone and Cloghan Sandstone. There is little or no bedrock exposure in the area, but the Geological Survey interpretation is remarkably accurate as proved by the well-drilling done on the site.

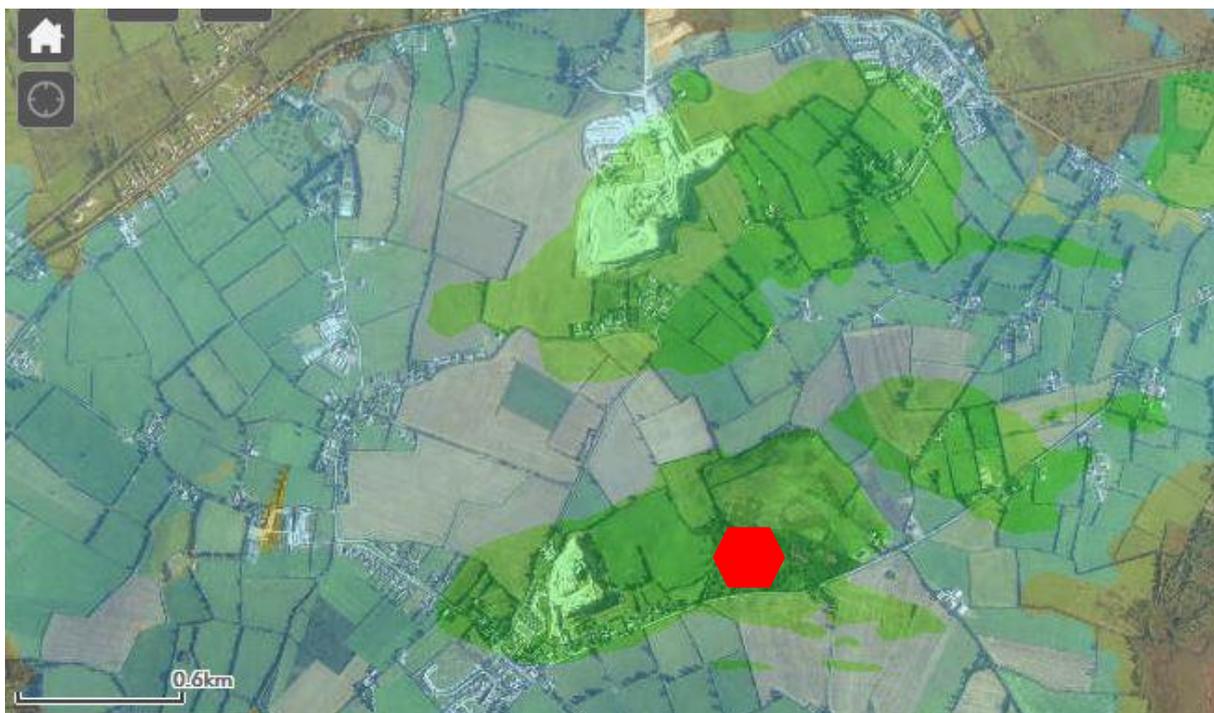
Figure 3. Quaternary Geology of the area around Kilmeague taken from the Geological Survey of Ireland. Sand and gravel deposits are in green, till in pale blue-green, and peat in brown. Note the large gravel pit (Hanlon Concrete Products) north of the site and the exhausted pit, west of the site.

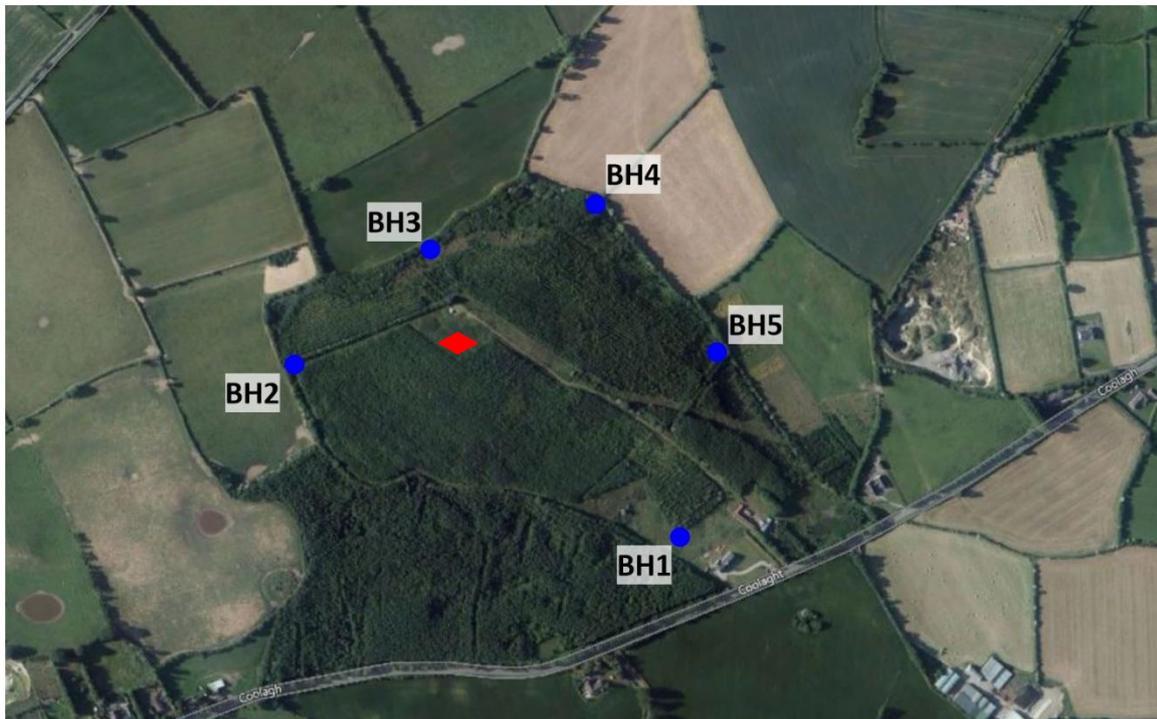
Figure 4 Borehole locations. The red diamond marks the location of the bulk sample pit.

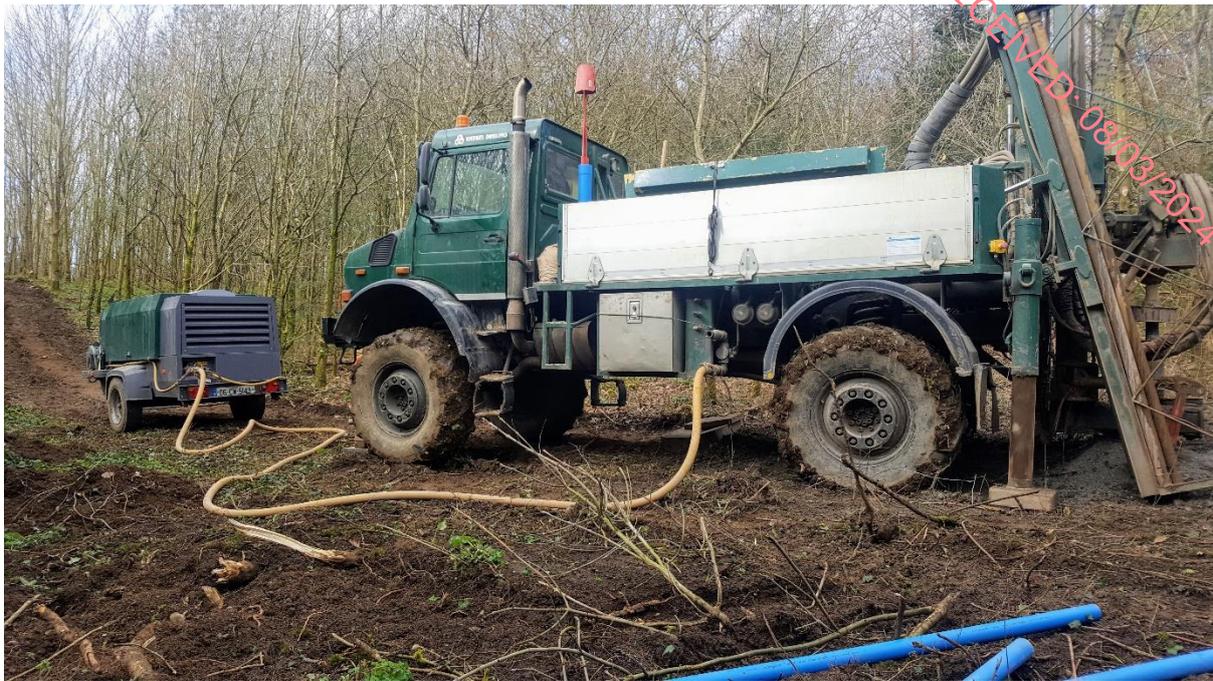
*Figure 5. Drill rig in operation on the site of BH5*

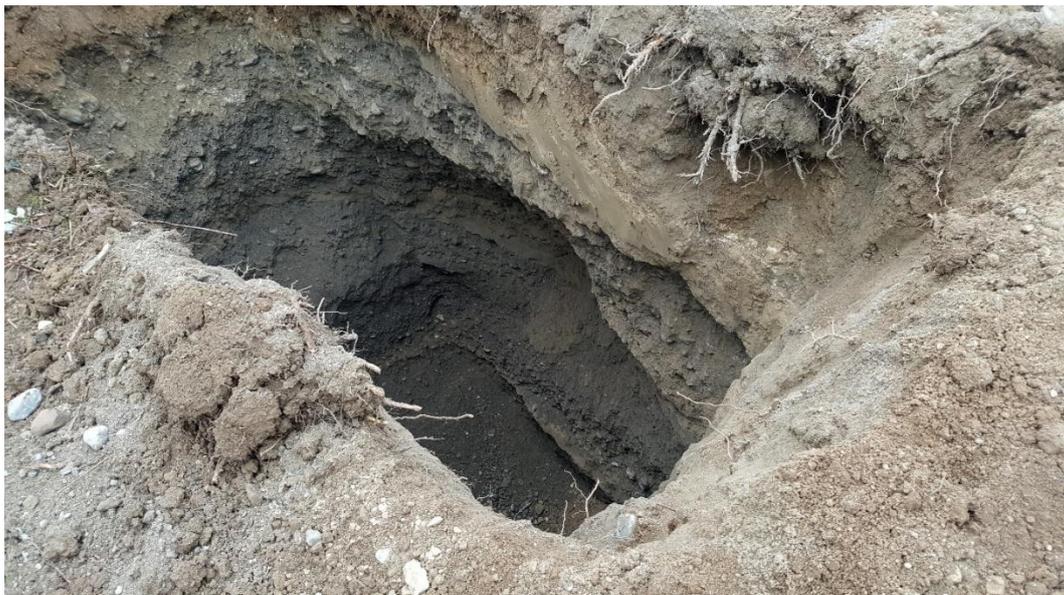
*Figure 6. Trial pit for bulk sample.*

In addition to the drilling Ger Birchall dug a pit close to the radio mast and extracted a bulk sample of the sand and gravel on 25<sup>th</sup> March 2020, site marked by red diamond, figure 4, and this bulk sample was stored with the drilled samples.

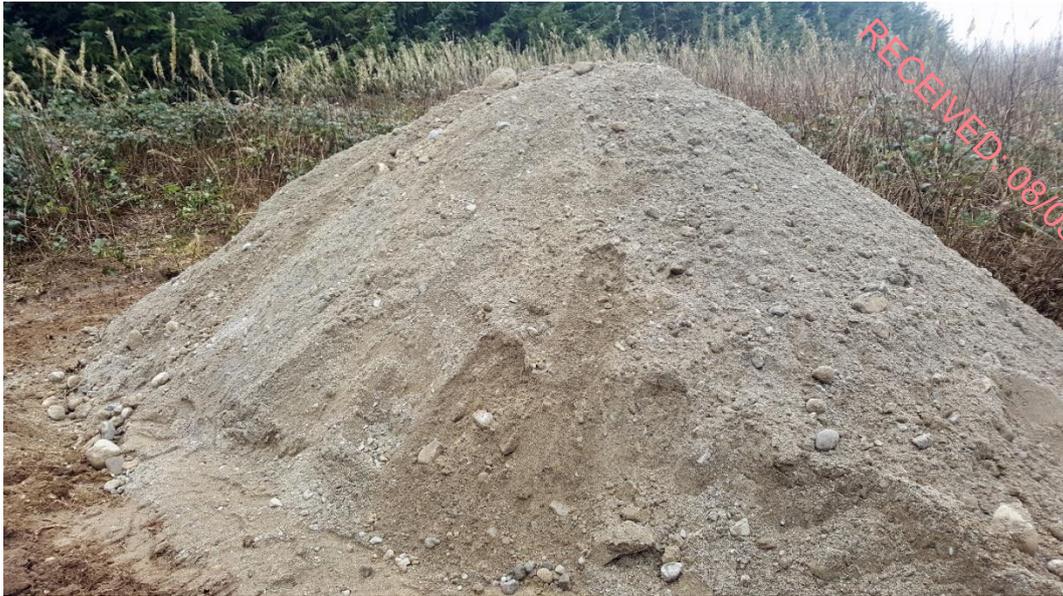
*Figure 7. Sand and gravel extracted from the trial pit.*

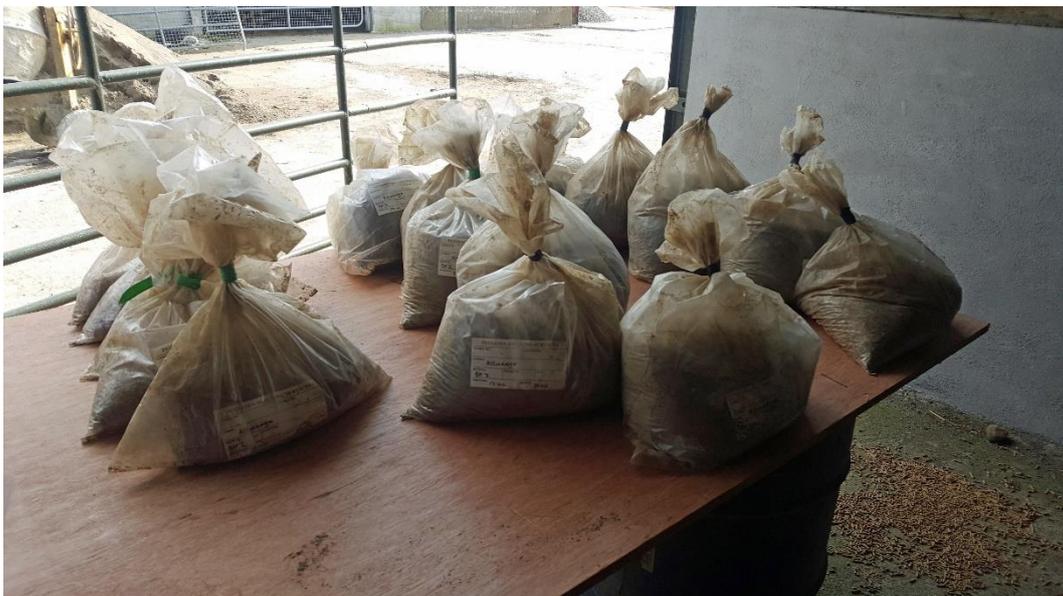
*Figure 8. Bagged and labelled samples, laid out in sequence, BH2*

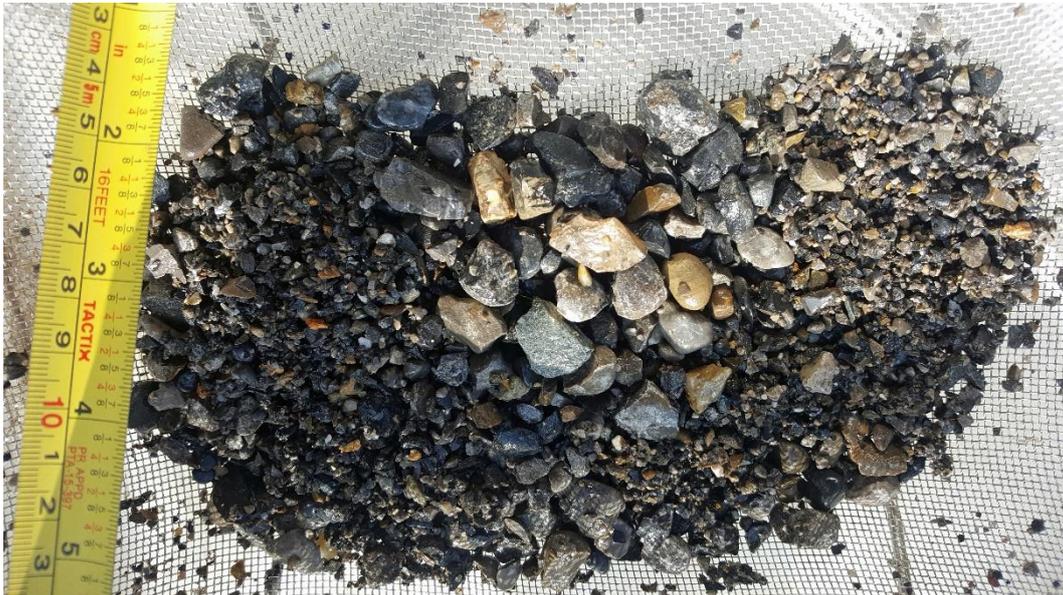
Figure 9 Washed Gravel, 9-12m BH2

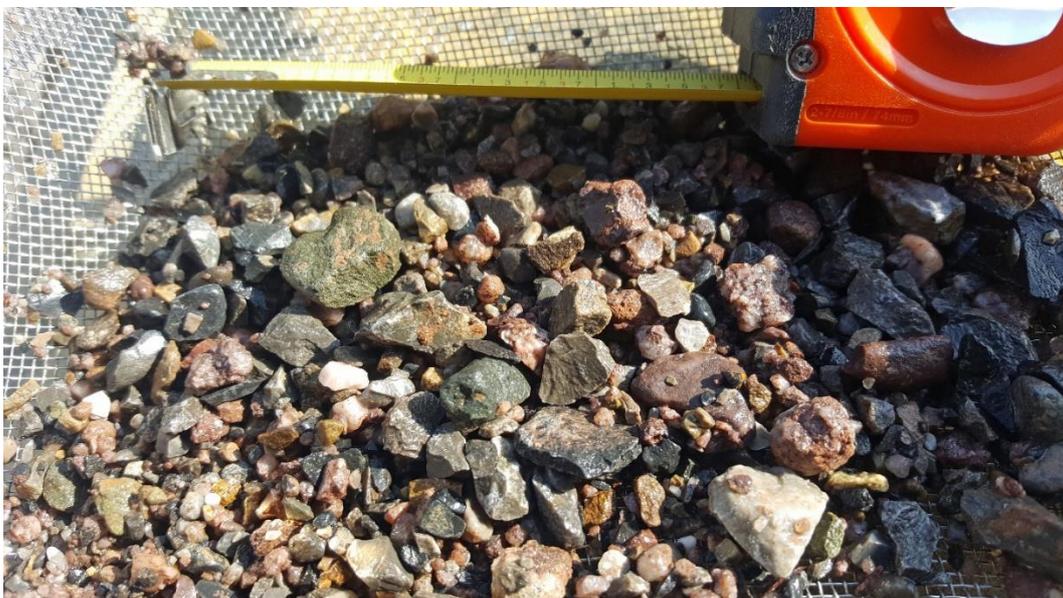
Figure 10. Washed material from 29.5m in BH2. Note pieces of red sandstone, vein quartz, and Ordovician andesite

**BH2** This is good quality sand and gravel, except for a 20cm silty lens at 13.3m. The last 3m from 29.5m is redder in colour than the overlying sand and gravel. This material contains more sandstone and less limestone than the overlying gravels and is probably locally sourced.

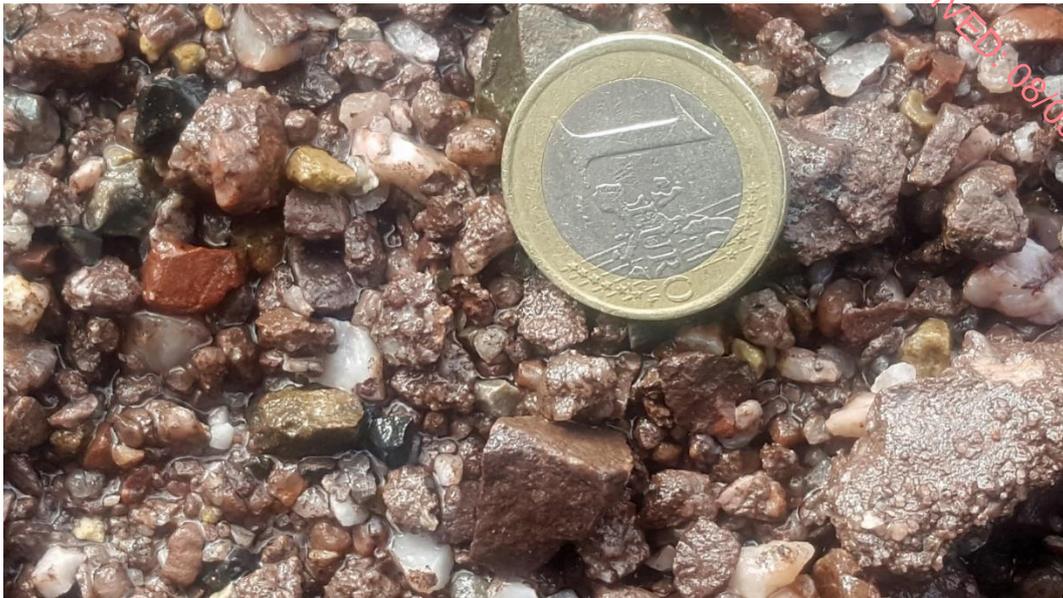
*Figure 11. Red Sandstone bedrock in BH2. There is also quite a lot of white vein quartz. A few exotic fragments including the green andesite, behind the €1 coin may have fallen down the hole.*

Bedrock in BH2 is red sandstone and is coarser grained than the red mudstone in BH1. Both lithologies are typical of the Devonian Old Red Sandstone.

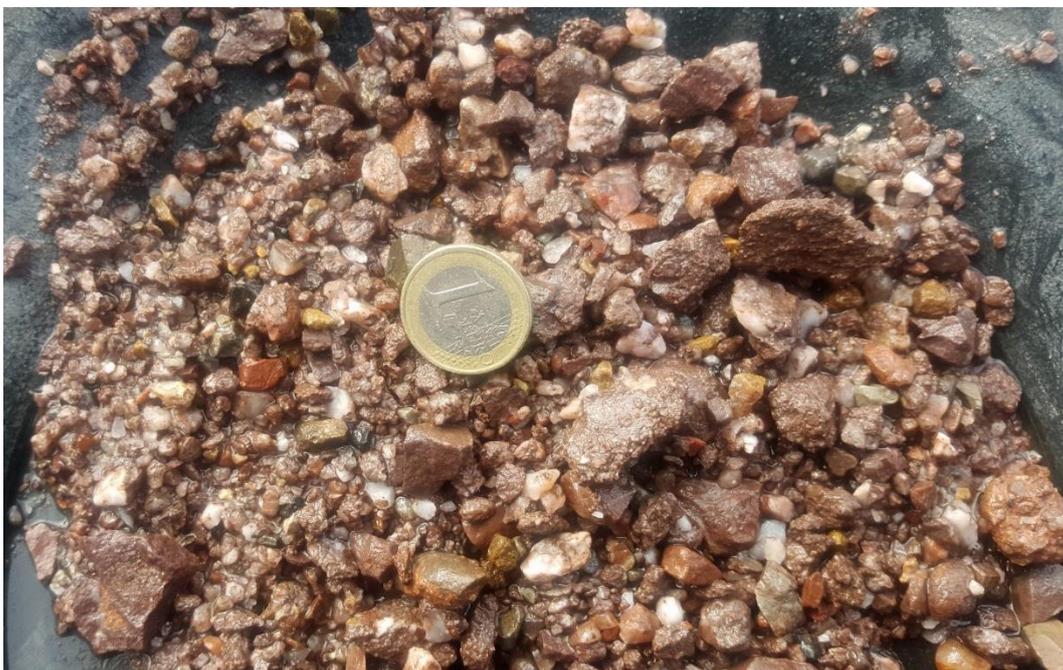
*Figure 10. Red sandstone bedrock in BH3.*

**BH3** This is good quality sand and gravel, but immediately above the bedrock from 31m down there is a reddish gravel like the material illustrated in Figure 8. Bedrock is red sandstone.

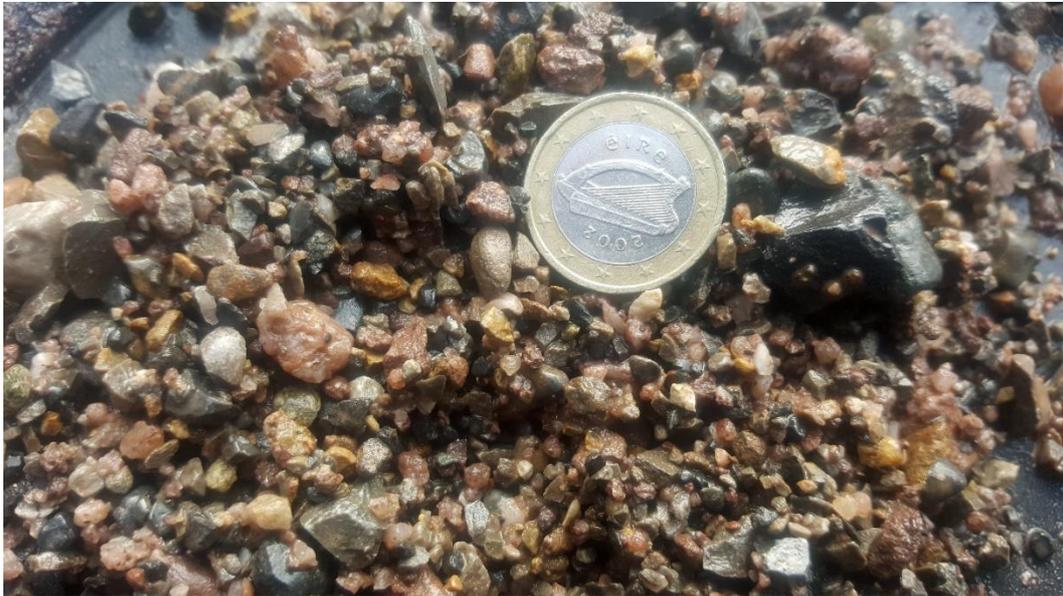
*Figure 11. Washed sand and gravel, 10m, BH5*

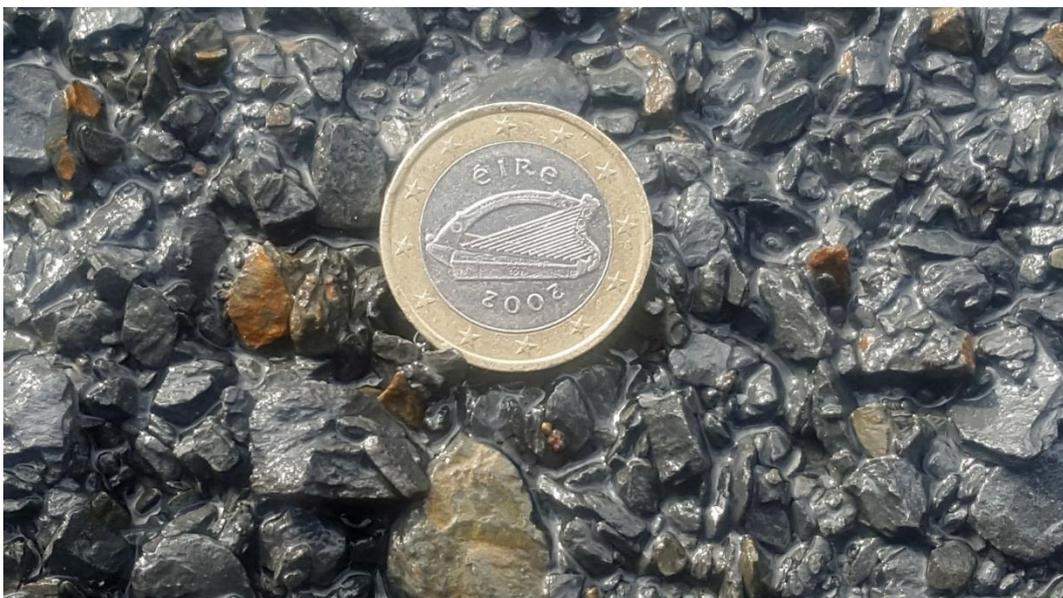
*Figure 12. Grey calcareous mudstone, BH5*

**BH5** Good sand and gravel down to 11.5m. The interval from 11.5-15.8m is described as silty sand and gravel by Stephan Petersen. This material is very silty and contains wet clay. It may not be useable, but in any case, is likely to be below the level of extraction. This borehole finishes in soft grey calcareous mudstone. This mudstone is probably the Ferbane Mudstone Formation which directly overlies the Old Red Sandstone.

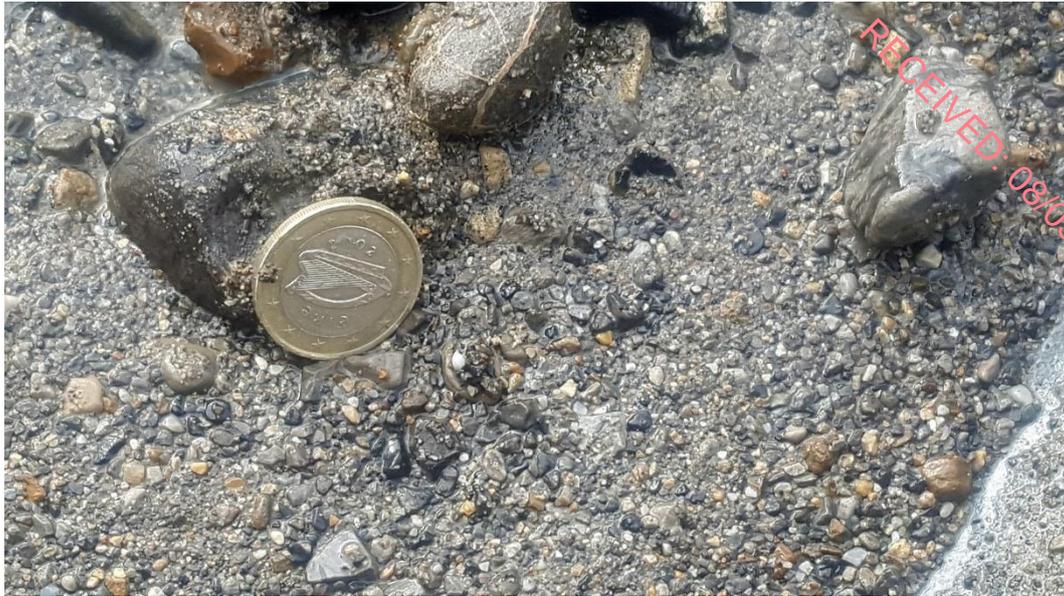
Figure 13. Washed trial pit sample

Table 1 Components in Washed Trial Pit sample	Sample %	Age
Dark grey fine-grained limestone	55%	Carboniferous
Pale grey Waulsortian Reef/ Visean Shelf/ Oolite	28%	Carboniferous
Yellow and Brown Sandstone	8%	Devonian
Andesitic volcanics	3%	Ordovician
Siltstones	3%	Carboniferous?
Calcite, quartz, chert, others	3%	
	100%

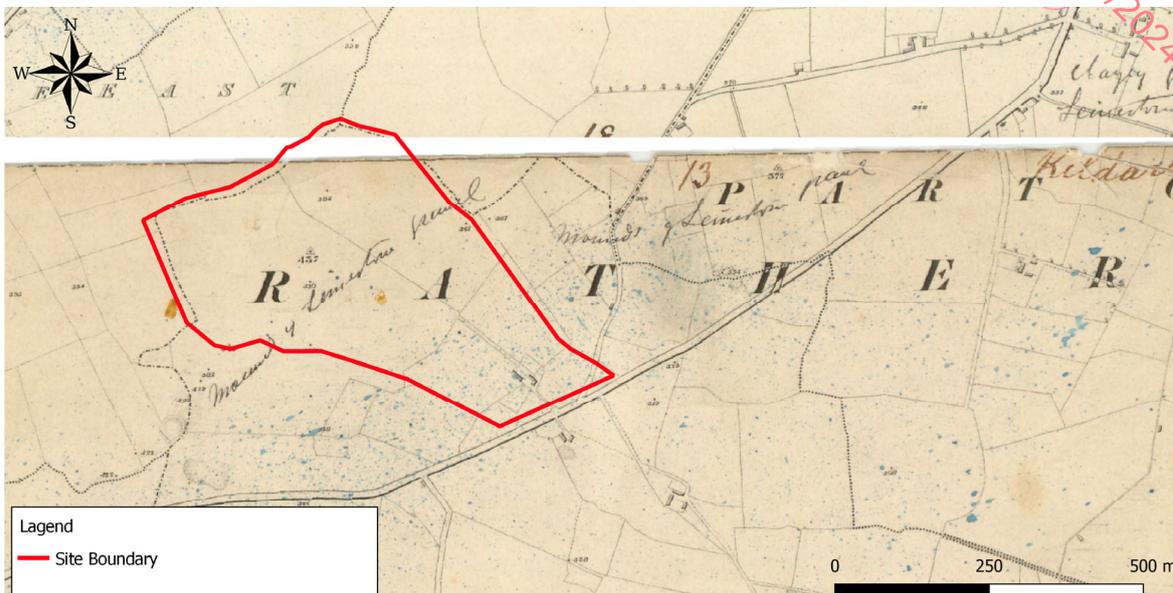
Extraction - Infill Area
  -

Application Area
  -

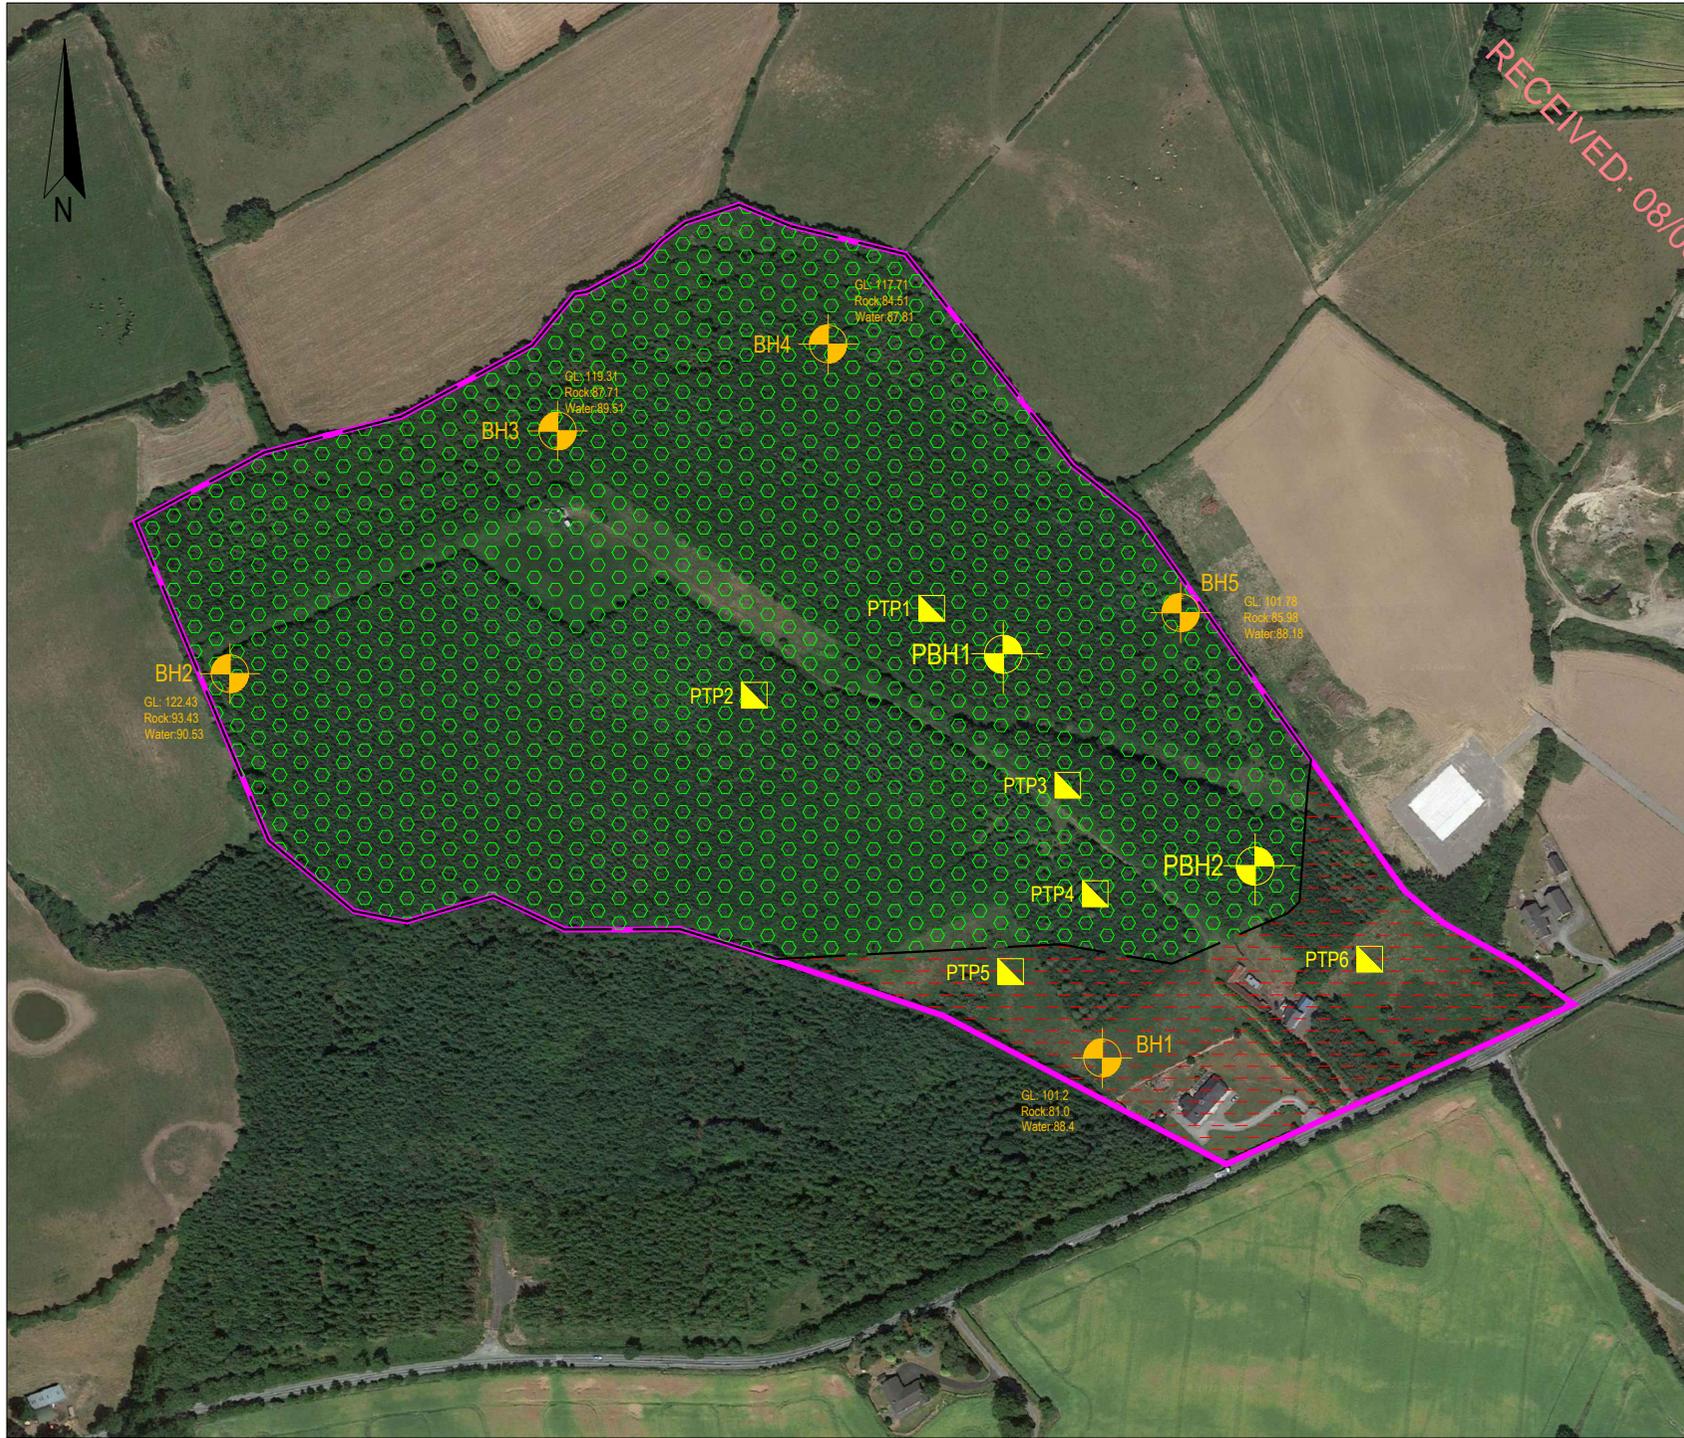
PROJECT:	KILMEAGUE LANDS GEOPHYSICAL SURVEY		
CLIENT:	QUARRY CONSULTING		
DRAWING NO:	AGP22196_01		
SCALE:	AS INDICATED @ A4		
DATE:	16-10-2023		
Version:	Date:	Drawn By:	Checked:
01	12-01-2023	YOC	POC
02	16-10-2023	YOC	TL

- Site
- 'Clean' SAND/GRAVEL & Silty SAND/GRAVEL
- Clayey SAND/GRAVEL & sandy gravelly CLAY
- Proposed borehole
- Proposed trial pit

Boreholes and trial pits to confirm the findings of the geophysical survey are recommended at the following locations:

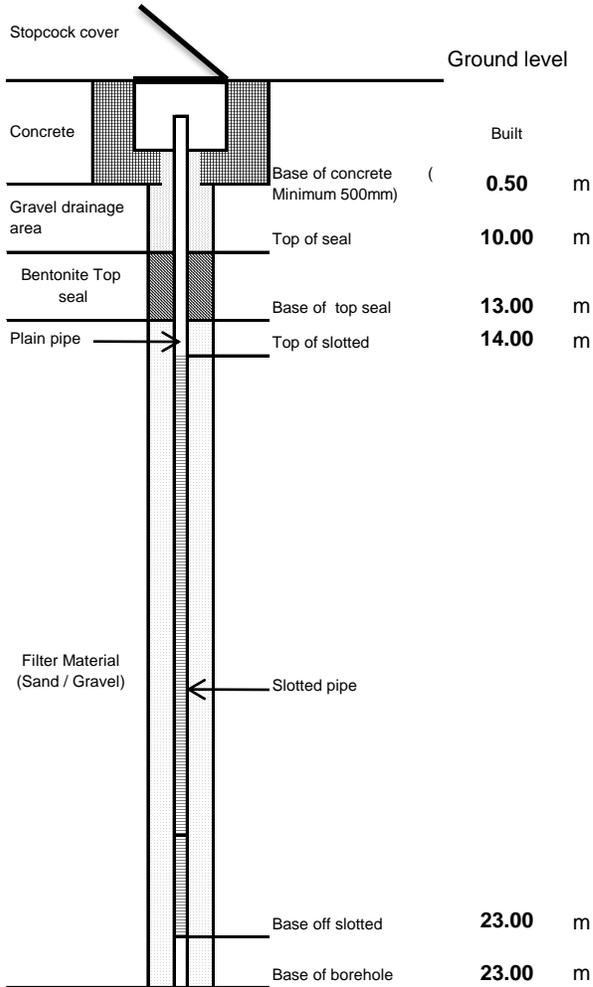
### Schematic Diagram (not to scale)

Installation Details	
Standpipe diameter (id)	50 mm
Borehole diameter	154 mm
Slot size	1 mm
Geosock	Yes
Gas tap	None
Filter type	Gravel
Type of cover	Upright
Initial reading	12.10 m
Time of Initial reading	1520 hhmm

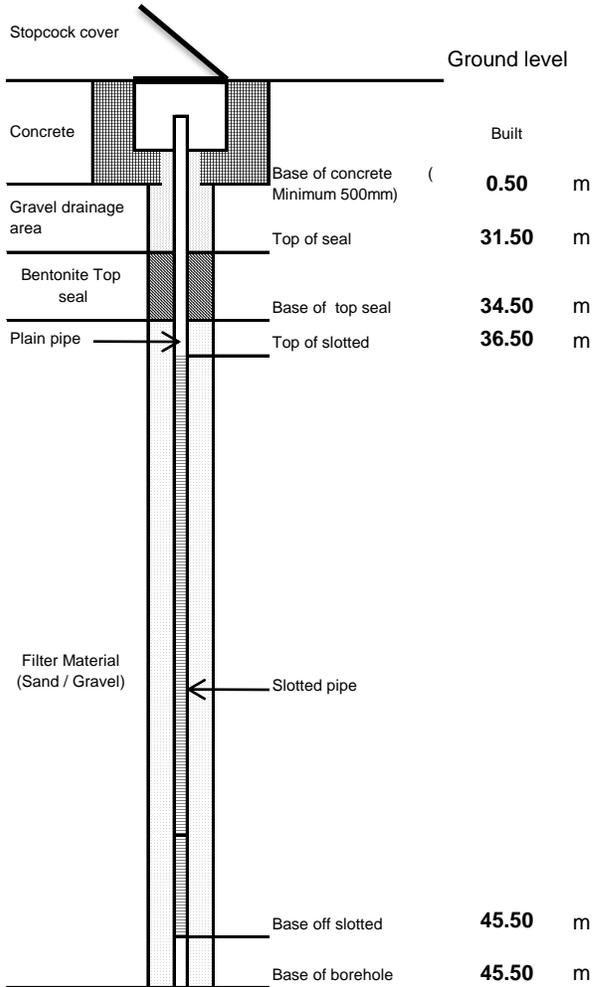
**Schematic Diagram  
(not to scale)**

Installation Details	
Standpipe diameter (id)	50 mm
Borehole diameter	120 mm
Slot size	1 mm
Geosock	Yes
Gas tap	None
Filter type	Gravel
Type of cover	Upright
Initial reading	Dry m
Time of Initial reading	1710 hhmm

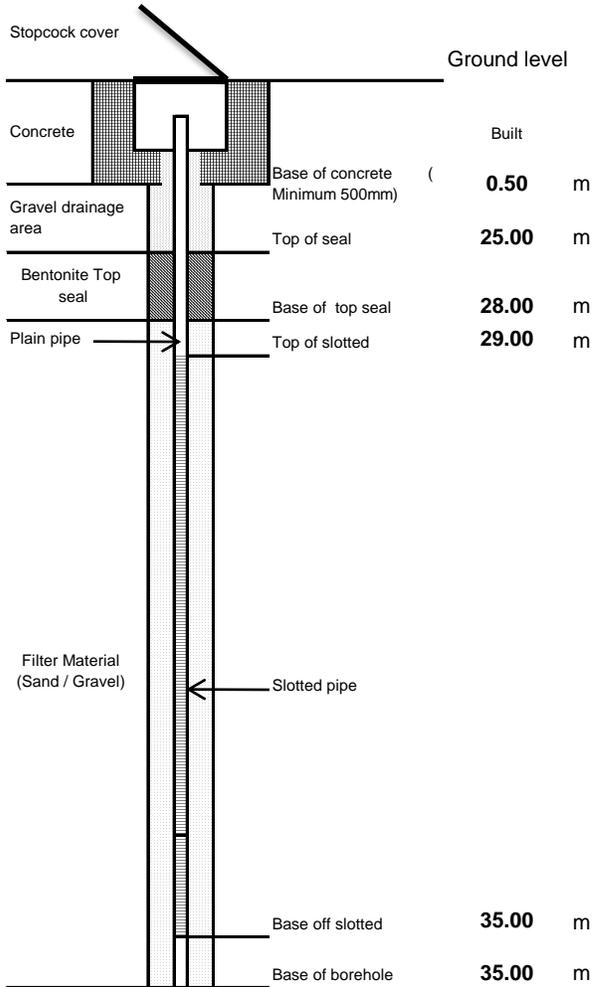
### Schematic Diagram (not to scale)

Installation Details	
Standpipe diameter (id)	50 mm
Borehole diameter	154 mm
Slot size	1 mm
Geosock	Yes
Gas tap	None
Filter type	Gravel
Type of cover	Upright
Initial reading	28.60 m
Time of Initial reading	1505 hhmm

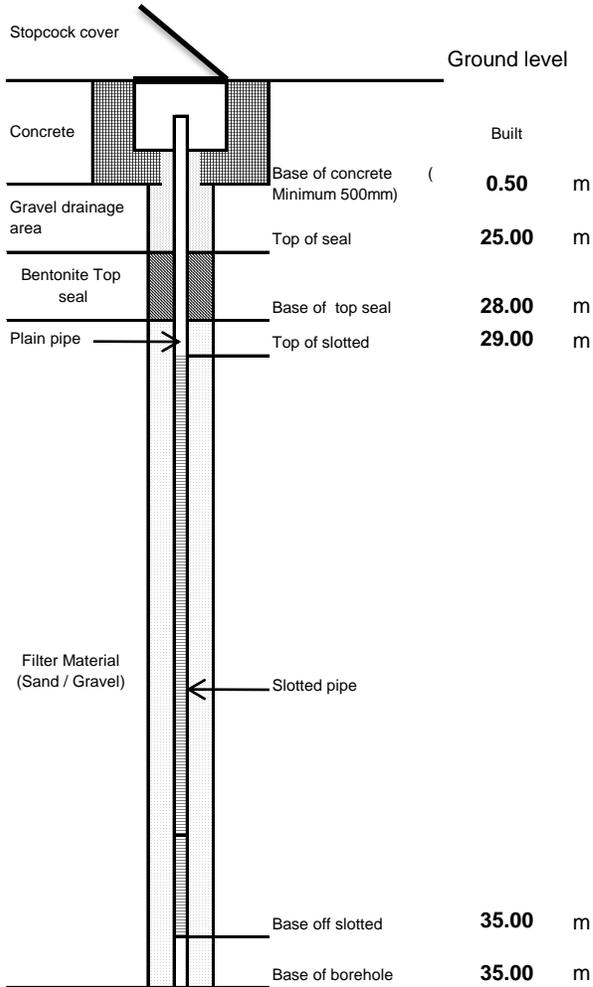
### Schematic Diagram (not to scale)

Installation Details	
Standpipe diameter (id)	50 mm
Borehole diameter	154 mm
Slot size	1 mm
Geosock	Yes
Gas tap	None
Filter type	Gravel
Type of cover	Upright
Initial reading	30.40 m
Time of Initial reading	1350 hhmm
