# CHAPTER 7

## LAND, SOILS AND GEOLOGY

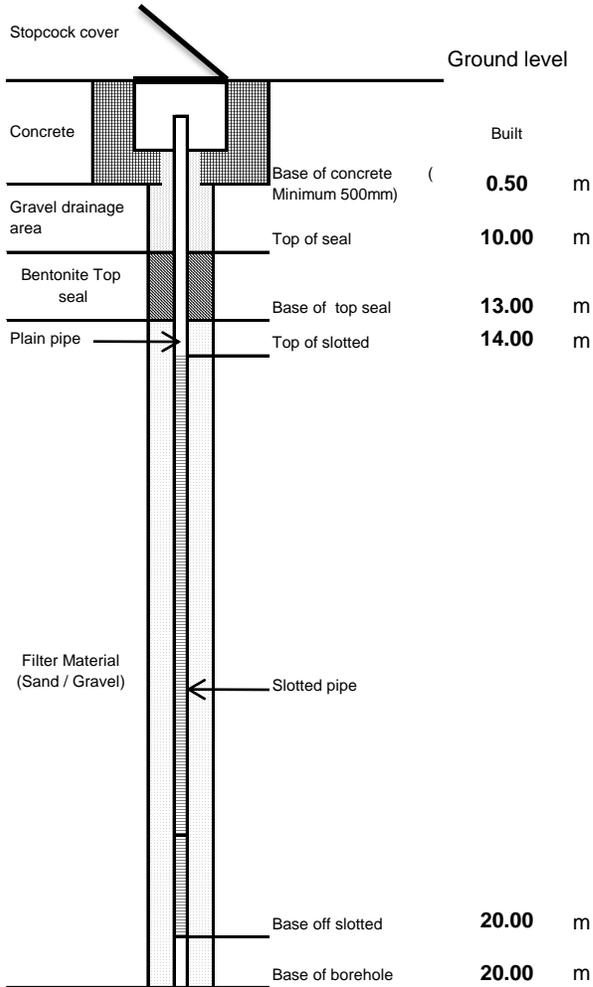
**Schematic Diagram  
(not to scale)**

Installation Details	
Standpipe diameter (id)	50 mm
Borehole diameter	120 mm
Slot size	1 mm
Geosock	Yes
Gas tap	None
Filter type	Gravel
Type of cover	Upright
Initial reading	12.30 m
Time of Initial reading	1225 hhmm
