## 1 INTRODUCTION

This document supplies the frequency analysis charts, noise summary results and the sound level meter setup photos for each monitoring event.

**Scope:** This survey was undertaken to obtain baseline acoustic conditions in the vicinity of the Murren's Quarry. The summary noise results are presented in Table 3-1 below. A map of the noise monitoring locations is presented in Figure 3-1 below.

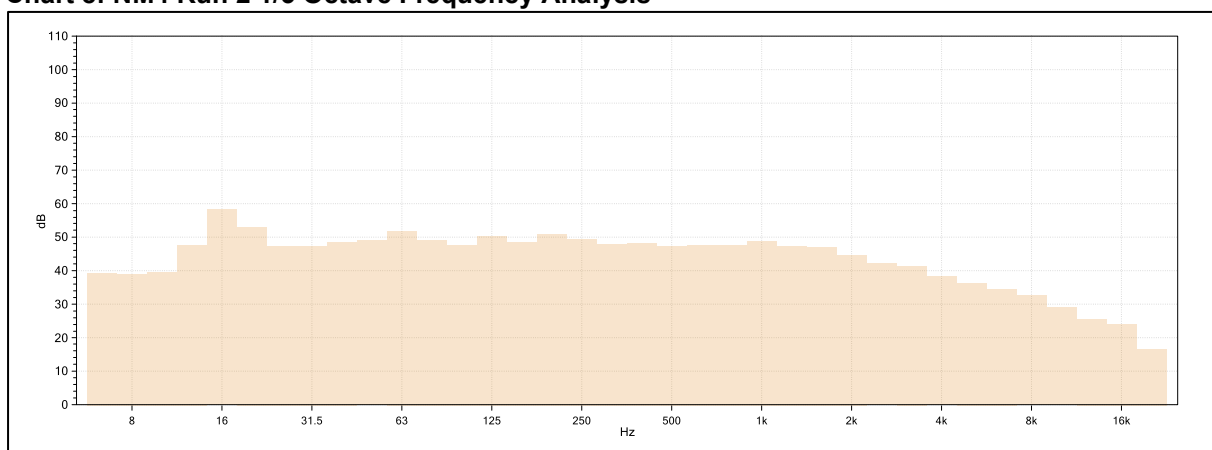
Chart 8: NM4 Run 2 1/3 Octave Frequency Analysis

| Type | Start | Elapsed Time (hh:mm:ss) | L <sub>Aeq</sub> [dB] | L <sub>90.0%</sub> [dB] | L <sub>10.0%</sub> [dB] | L <sub>AFmax</sub> [dB] | Commentary |
|---|---|---|---|---|---|---|---|
| NM4 R2 | 27/11/2024 14:37 | 00:30:00 | 57 | 29 | 46 | 88 | Dominant: Traffic on nearby road.<br>Reversing alarms on multiple occasions off-site (NW) |
