GEOTECHNICAL AND PEAT STABILITY ASSESSMENT REPORT

Seskin Wind Farm
Geotechnical Investigation Report

02 May 2024

Person responsible	Manasvi Srivastava, Liam Power
Company	AFRY Ireland Limited
Address	The Hyde Building, The Park, Carrickmines, Dublin 18, Ireland
E-mail	manasvi.srivastava@afry.com , Liam.power@afry.com
Project Number	ICPRI268
Revision Number	REV 2
Date	May 2024

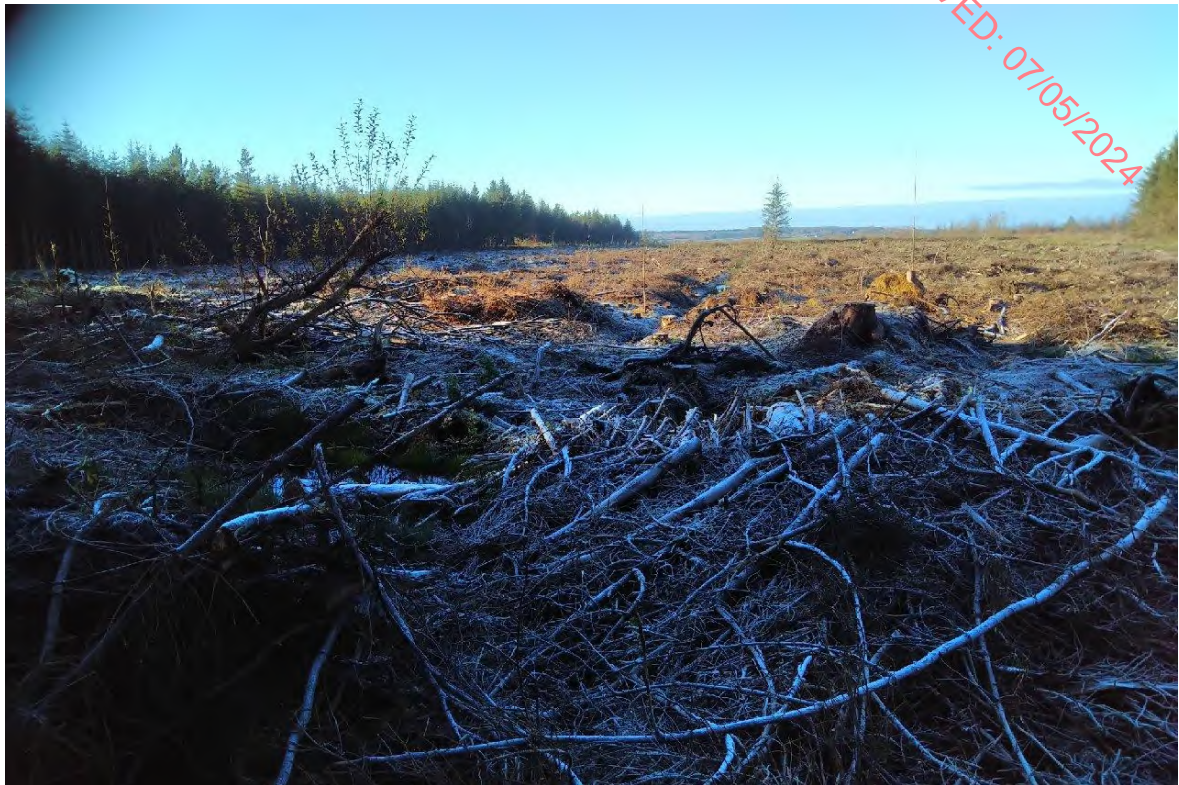
Photo 1: Access to T5 covered with brash, with uneven and soft to very soft ground surface

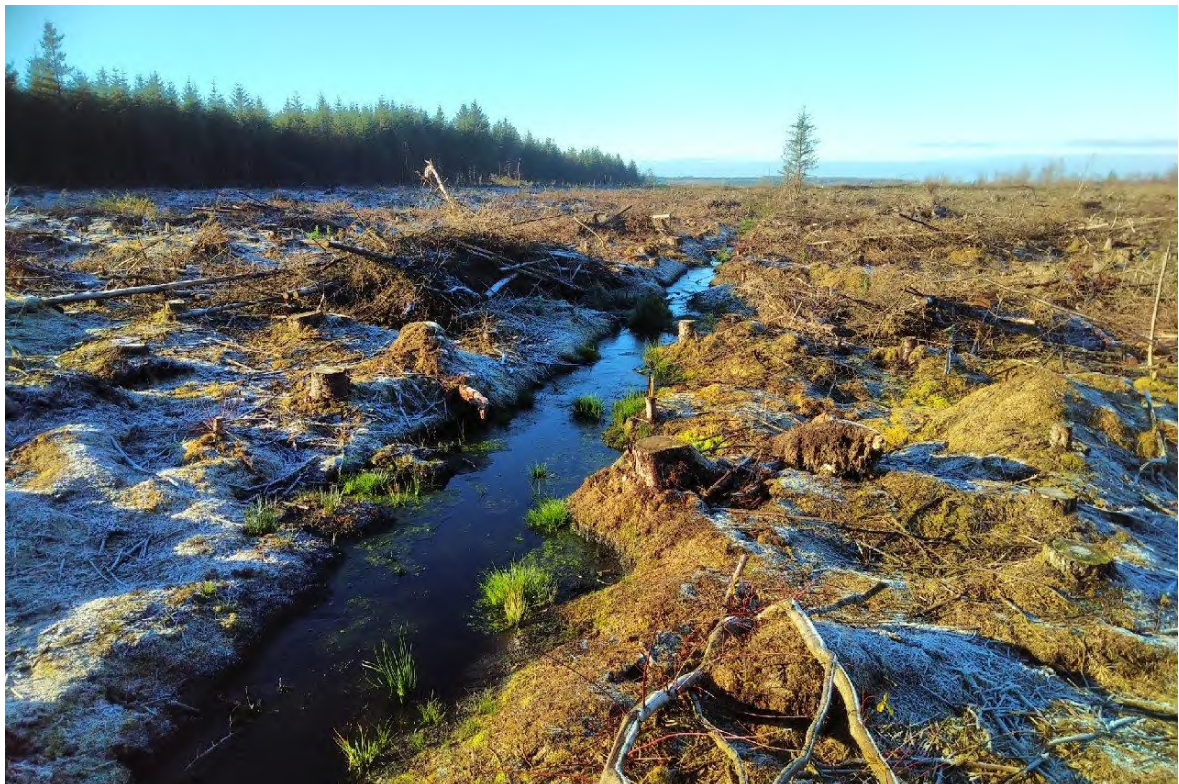
Photo 4: Access to T5 showing soft and wet ground conditions
