Figure 4.5 W5 and W6 Water Level hydrographs

Figure 5.1 St Gorman's Well & Hotwell House (imagery Google Earth March 2022)

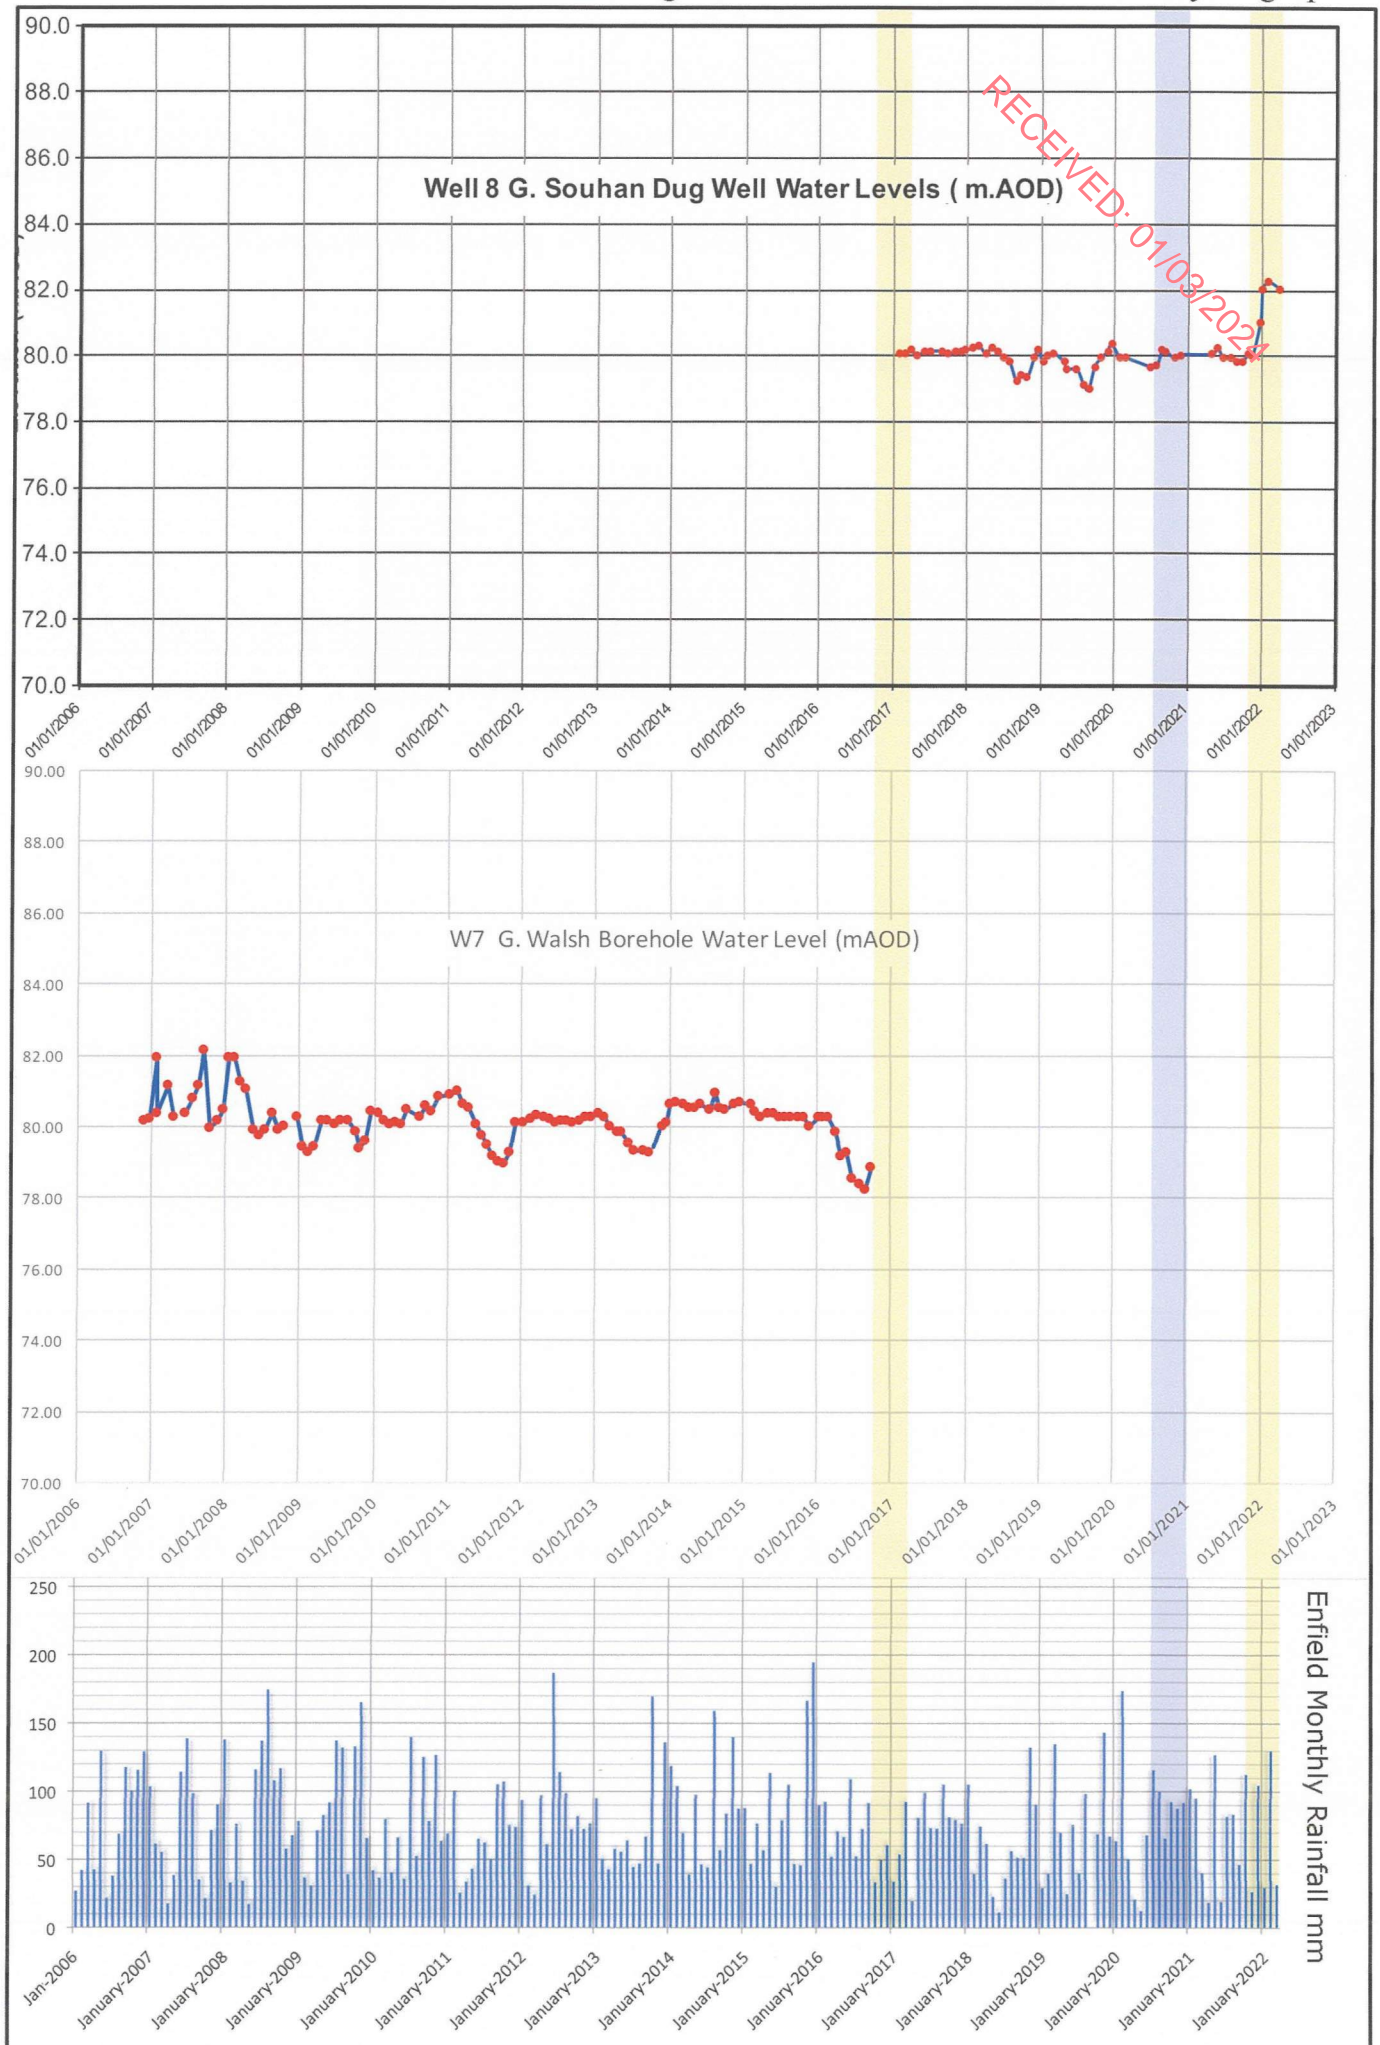
Figure 4.6 W7 and W8 Water Level hydrographs

Figure 4.6 shows the record for a borehole and a very shallow dug well. Measurements in borehole W7 were discontinued in 2016, but measurements started in the shallow well W8 across the road at the start of 2017.

Figure 4.6 shows the water levels in the borehole W7 where there appears to be a small, downward gradient in the low water levels at the end of the summer recession. The levels at the end of each summer recession appear to have gone down by 2 metres over the course of ten years. Again, the decline started over 7 years before the quarry started pumping out water. Other examples of this long term trend are discussed below.

Souhan's dug well W8 is in an extension to the house. Like W3, W5 and W6, it is shallow but productive. The water level appears to rise and fall about a metre between winter high and summer low. It does not appear to have been affected by the main long pumping test in 2020. It rose by 2 metres in November–December 2021. Given the preceding seasonal fluctuations, this appears unusual, but the Diver data from W3 also showed a rise of over 2.5 metres at the same time, though starting earlier with the heavy rain in August and October. It is possible that the generally lower water levels in W8 are mainly levels affected by pumping on the weekdays when measurements were taken, and there was perhaps a change in use of the well in the late autumn in 2021 into January 2022.

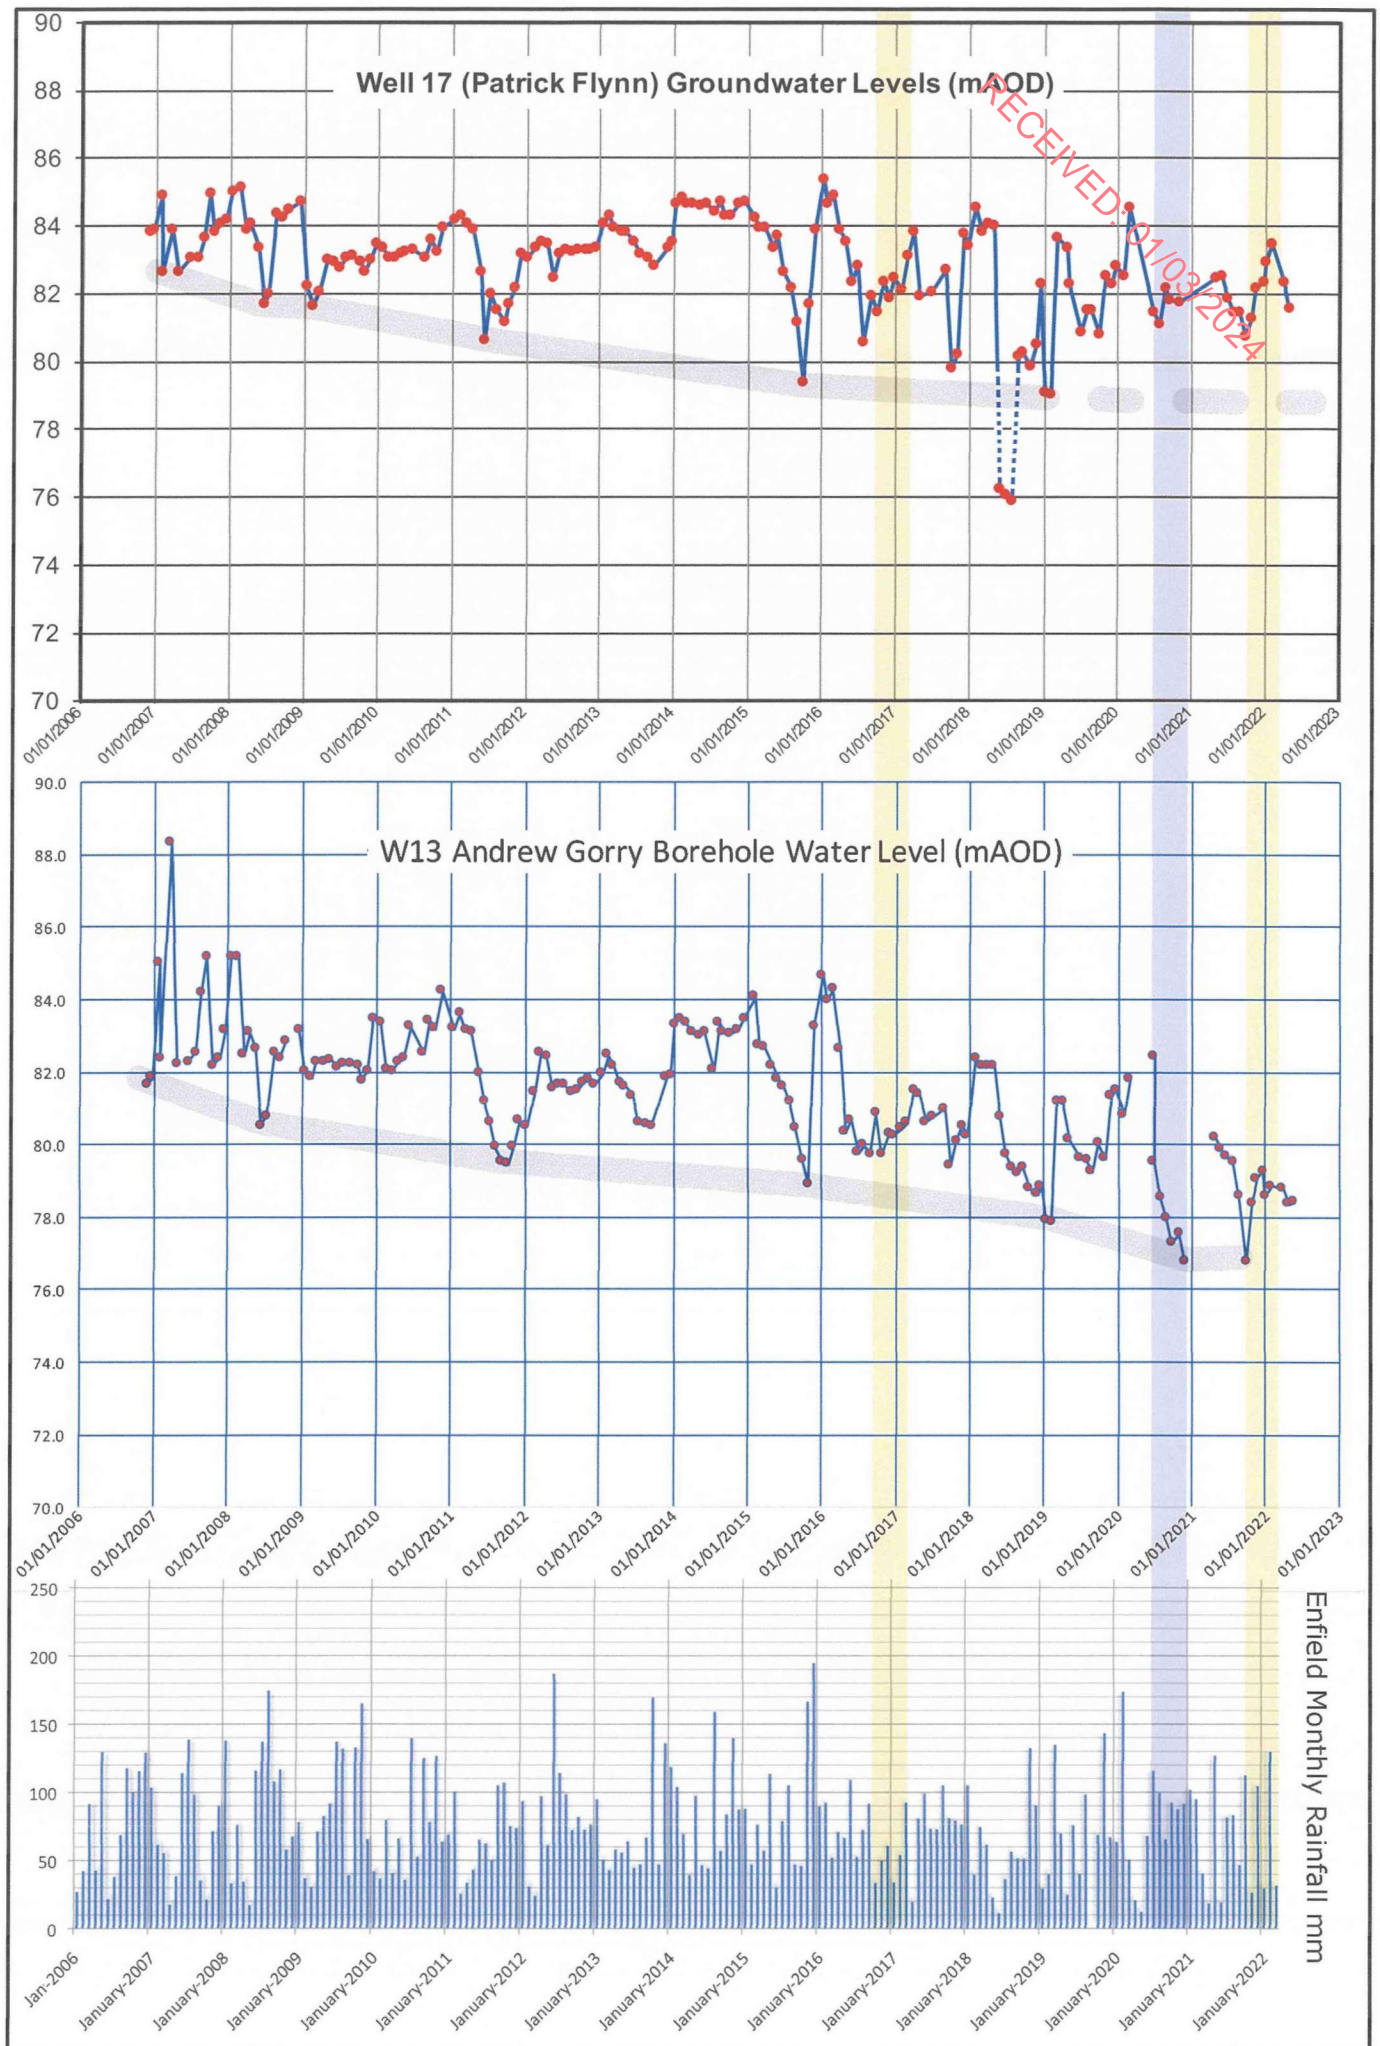
Figure 4.9 W13 and W17 Water Level hydrographs

The hydrograph for W13 is shown in Figure 4.9. The pattern of the rise of water levels in response to rainfall, and the recession of water levels in summer in borehole W13 is almost the same as the fluctuations seen in the hydrograph for W12. It is unlikely that both boreholes were being pumped at the same time, therefore the water levels that were measured are probably a real measure of the natural or static water level in the bed rock limestone.

There was a long recession throughout 2011 and other long recessions in 2015, 2016 and 2018. There was a final long recession or drawdown of water levels at the same time as the long pumping test in the quarry boreholes in 2020. Though the recession in 2020 is roughly the same magnitude as previous recessions, it is probable that the recession in 2020 was a drawdown of water levels created by the pumping of boreholes in the quarry.

The difference in response of the water levels to the pumping test in the quarry in W12. W13 and W17 probably confirms the geological interpretation in Figure 2.50. This figure shows that bedrock encountered in borehole W17 is the Lucan formation, whereas W12 and W13 appear

I have drawn a pale grey line along the end of summer recession levels for W17, for comparison with the same line on W13. The decline in water levels in W17 until 2015 is similar to W13, but thereafter the rate of decline diminishes.

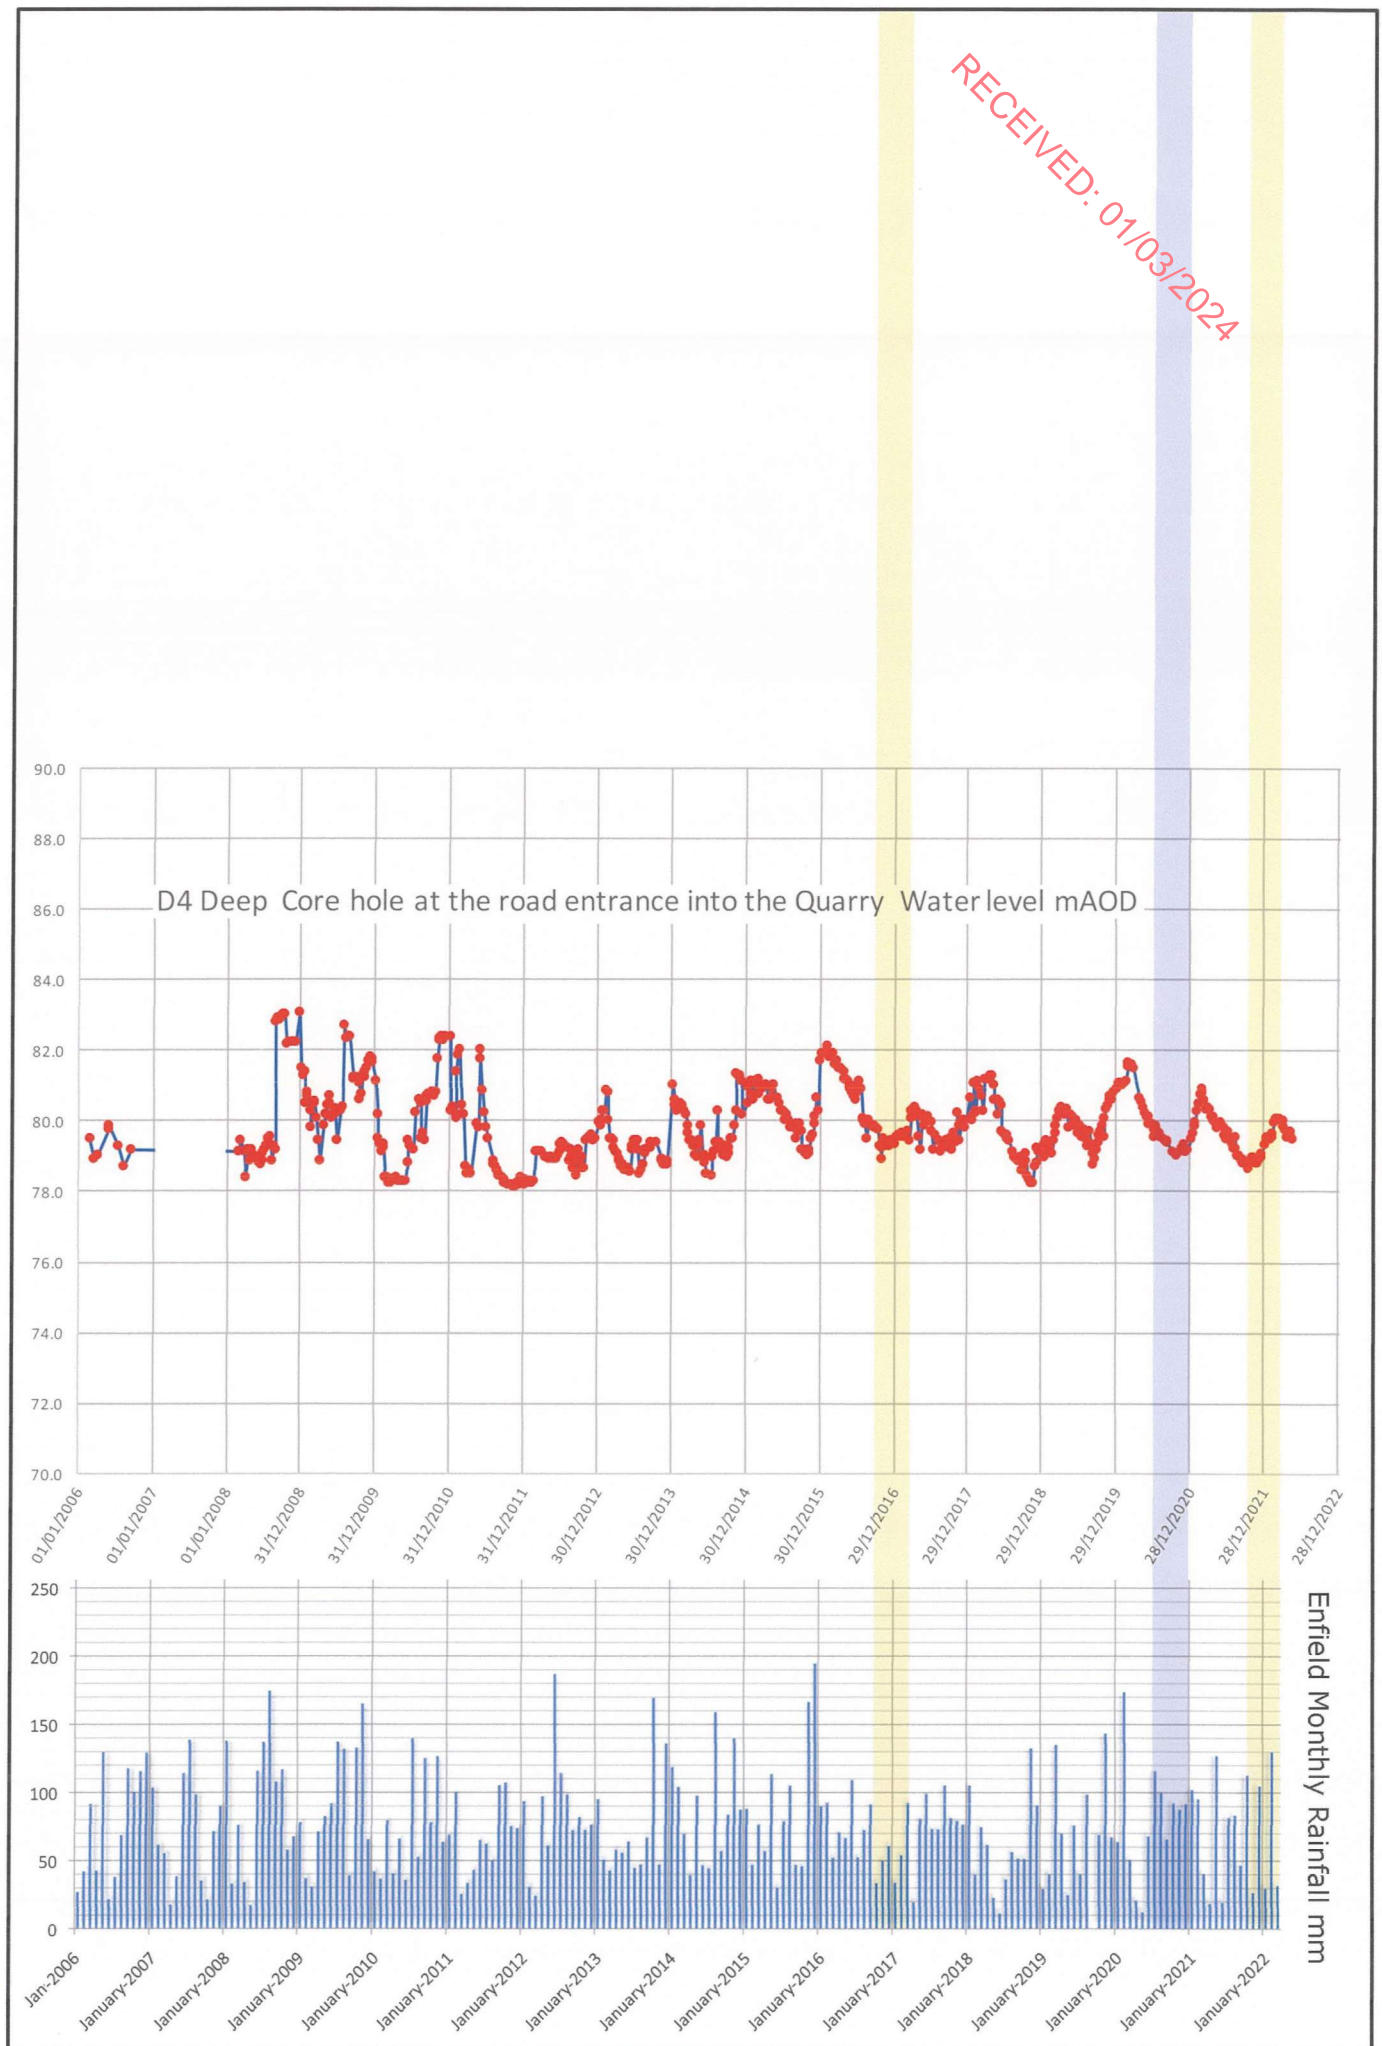
Figure 4.12 D4 Water Level hydrograph

Figure 4.12 just shows the hydrograph for core hole D4.

This core hole is at the road entrance into the quarry. The hydrograph does not show any gradual decline in water levels over the 15 year record. The fluctuating water levels stay within a relatively narrow amplitude of about four metres.

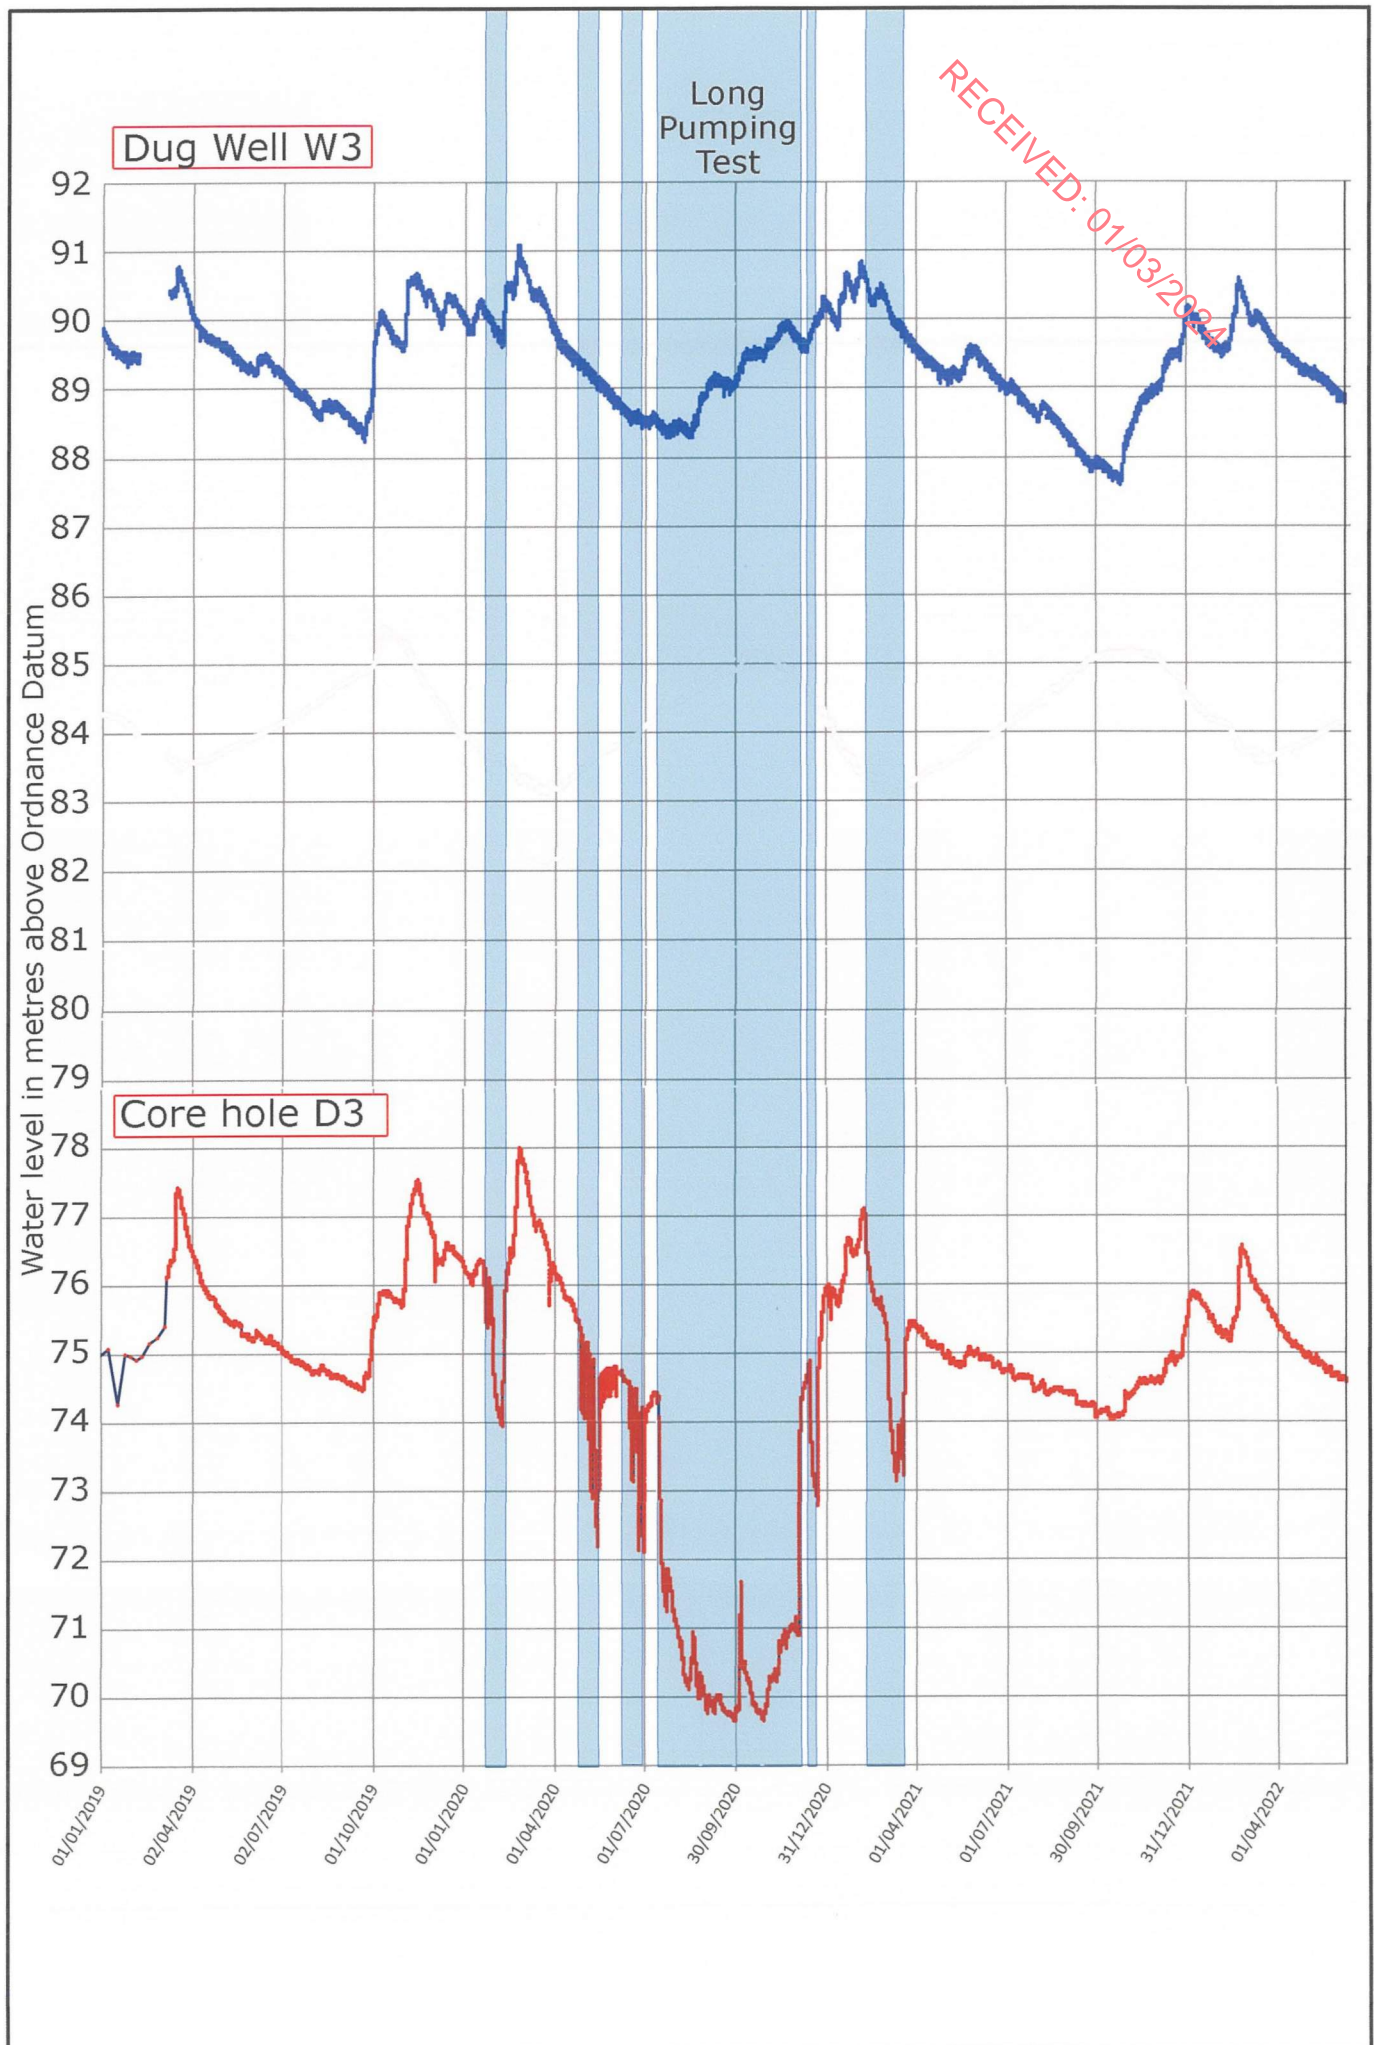
Figure 4.15 Core hole D3 and Dug well W3 Water Levels January 2019 to June 2022

Figure 4.15 brings together, for comparison, the hydrographs for dug well W3 and deep core hole D3.

Both hydrographs are on the same vertical scale in metres above Ordnance Datum. This gives an illustration of how much higher the perched water level in W3 is above the limestone bedrock water level in D3. There is a 13-14 metre difference in elevation.

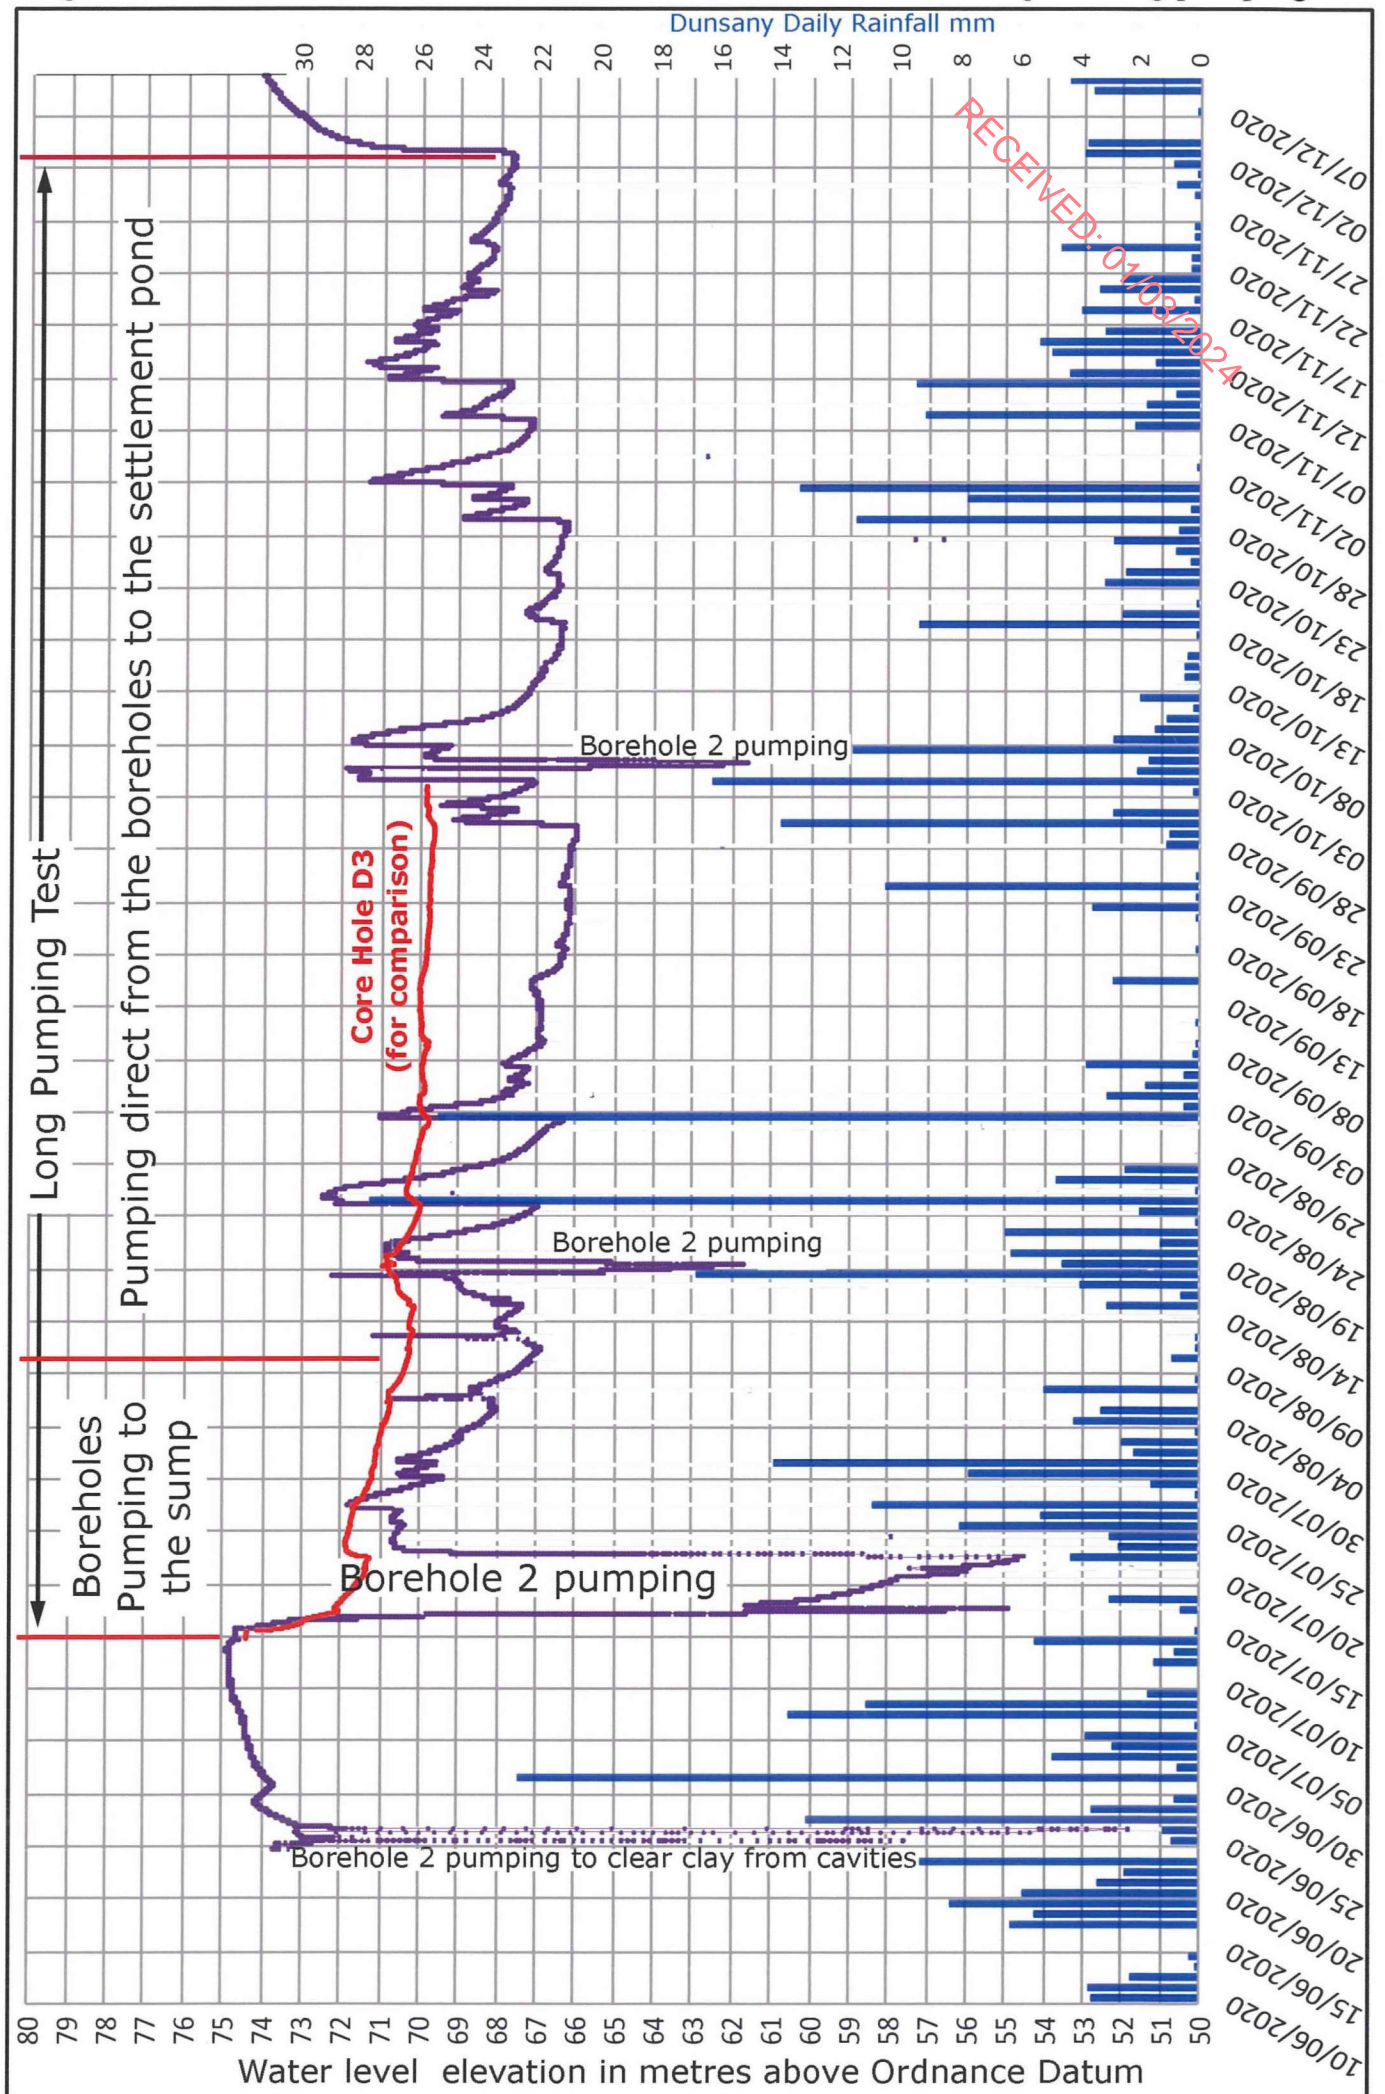
Figure 4.17 Borehole 2 Water levels June to December 2020 during the long pumping test

The hydrograph for borehole 2 shows the same response to rainfall events as the other monitoring boreholes on the quarry floor, but the drawdown, after each peak caused by the rain, is more rapid, because borehole 2 is closer to the pumping boreholes.

From the middle to the end of September, the water level in borehole 2 declined by about 10cm, as if the drawdown was approaching steady state, or equilibrium conditions.

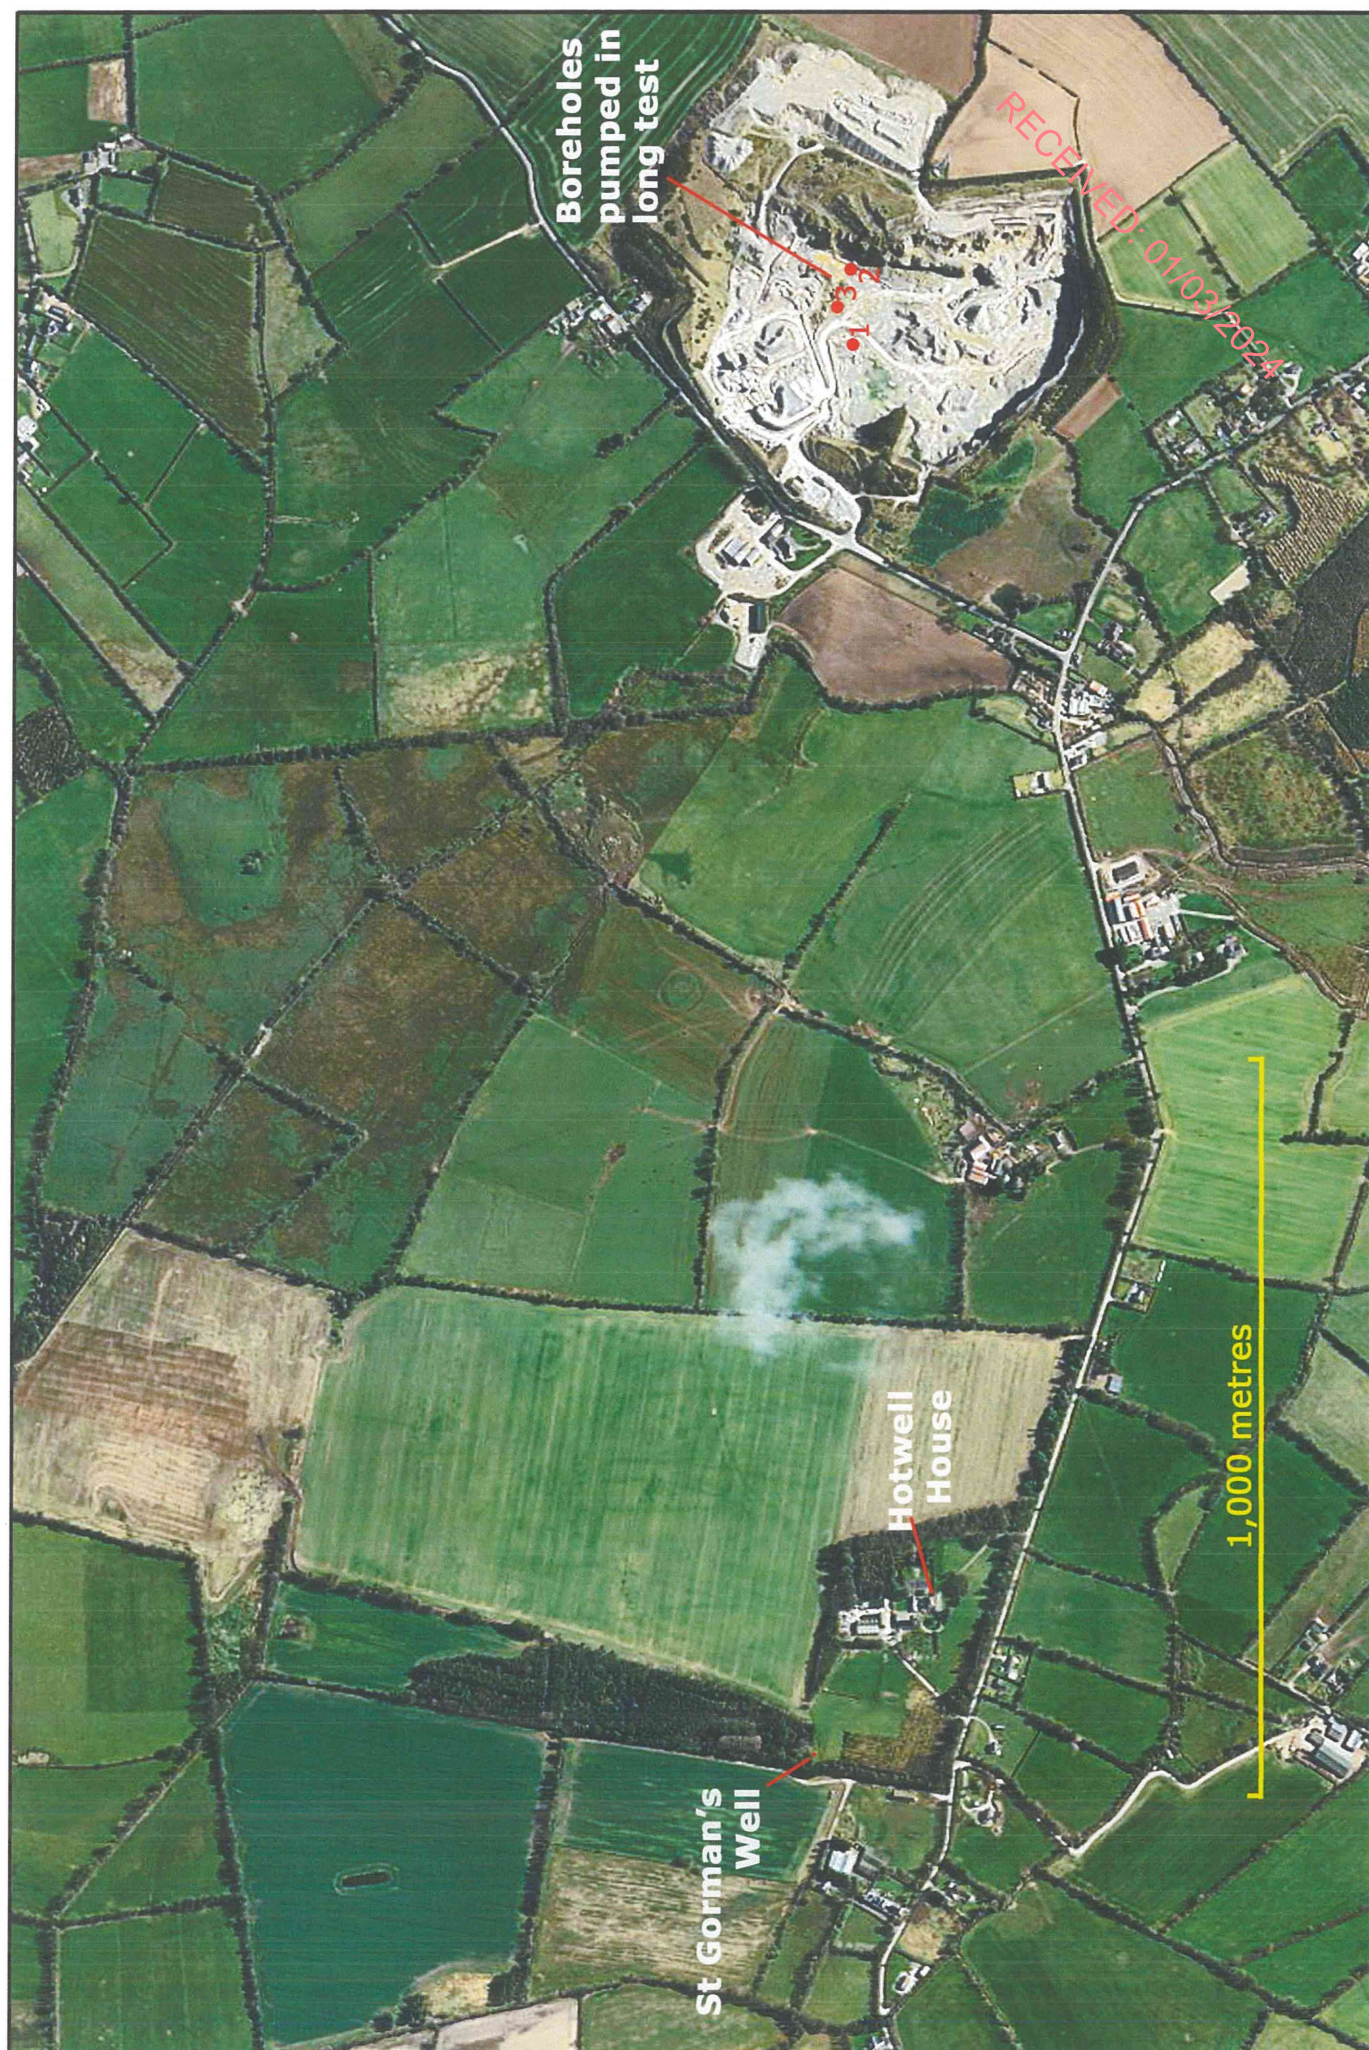
The imagery in Figure 5.1 shows arable crops growing in the adjacent fields in March 2022.

The large field, to the northeast, is up gradient of the Well, on the crest, and gentle western slope, of Ballynakill hill. It is often bare earth and stubble from September to March, with a

St Gorman's Well is located in the grounds of Hotwell House. Its location is shown on Figure 5.1, with its position relative to Rathcore quarry. The boreholes in the quarry used for the pumping tests, are also shown. The distance between the nearest pumping borehole in the quarry (No.1) and St Gorman's Well is 1.93 kilometres.

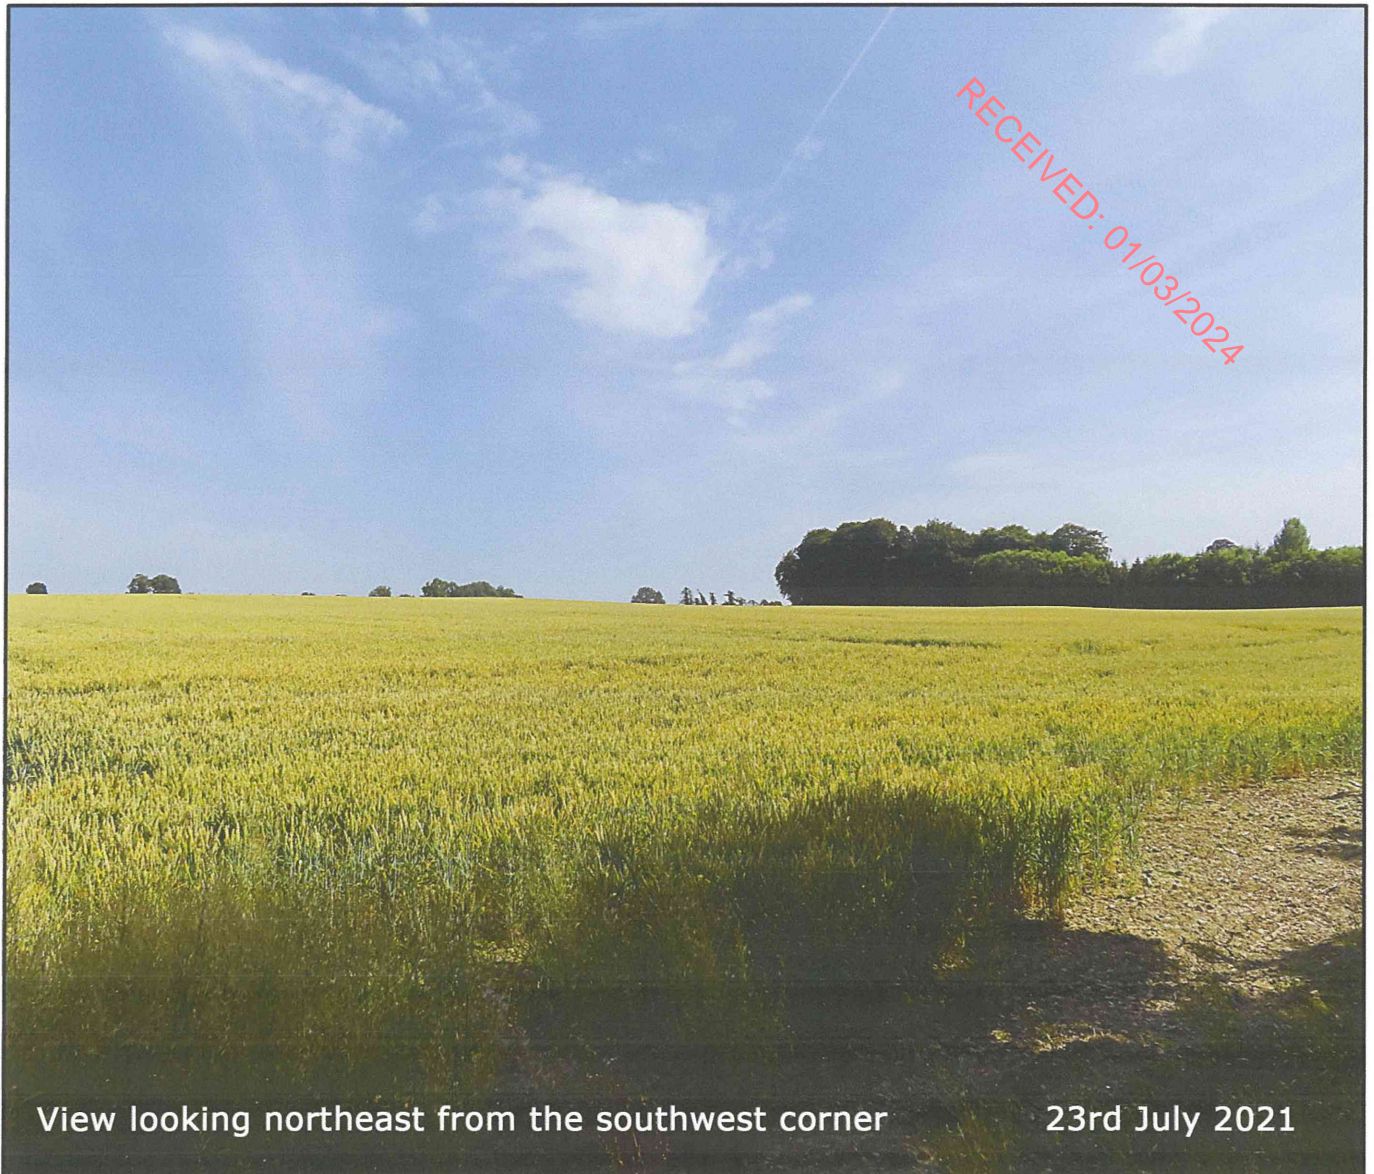
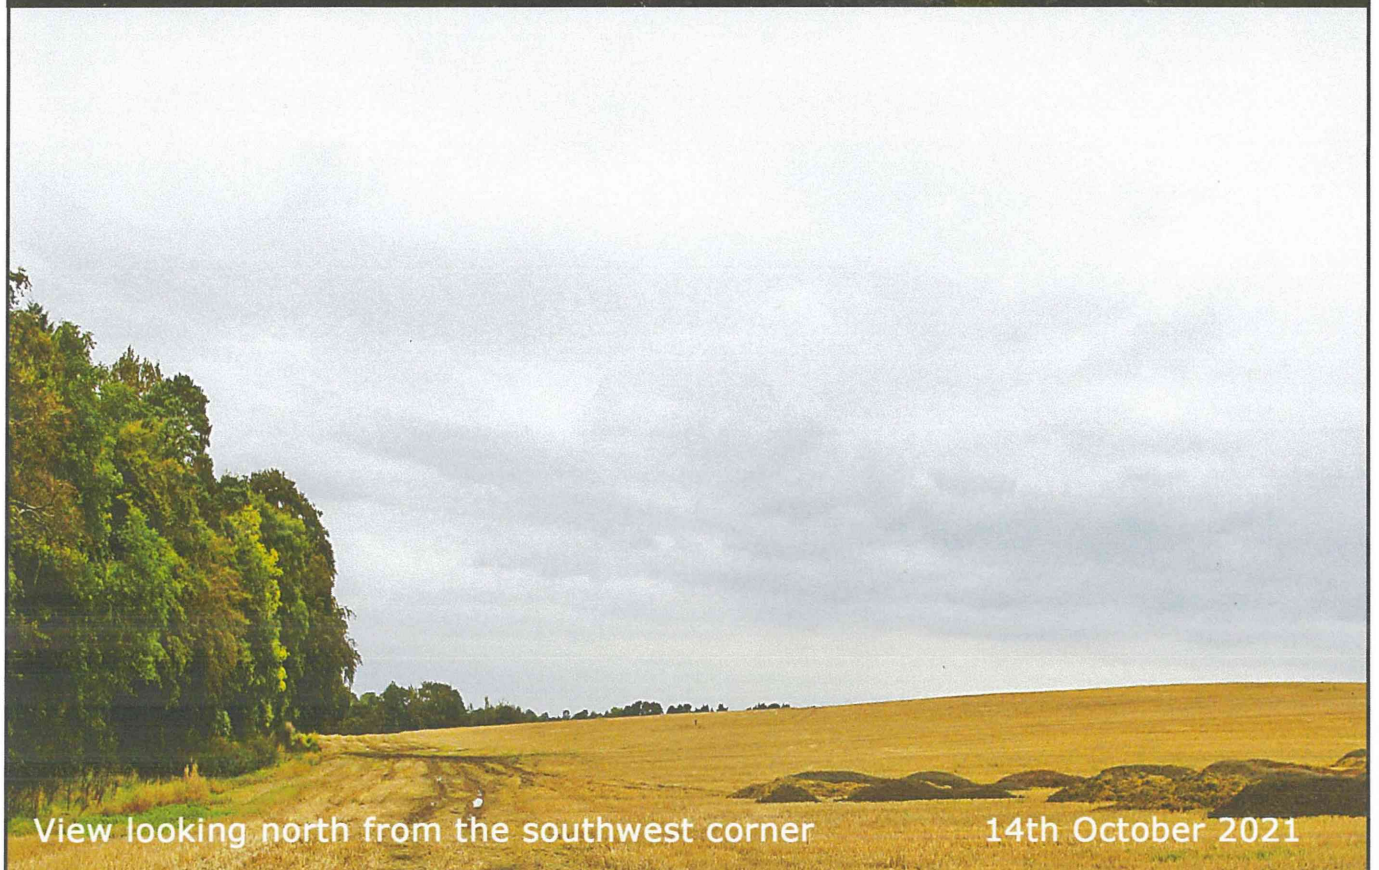
Figure 5.2 The large arable field to the northeast of St Gorman's well

winter sown arable crop. This large field is shown in summer and autumn in Figure 5.2. Rainfall can easily percolate into the soil and sandy till overburden and gravels. The rainfall will recharge both the shallow overburden and limestone bedrock groundwater system under the hill up gradient of St Gorman's Well. The large fields of pasture further to the east on Ballynakill hill, also form a recharge area above St Gorman's Well.
