Figure 4.5 W5 and W6 Water Level hydrographs

Figure 5.1 St Gorman's Well & Hotwell House (imagery Google Earth March 2022)

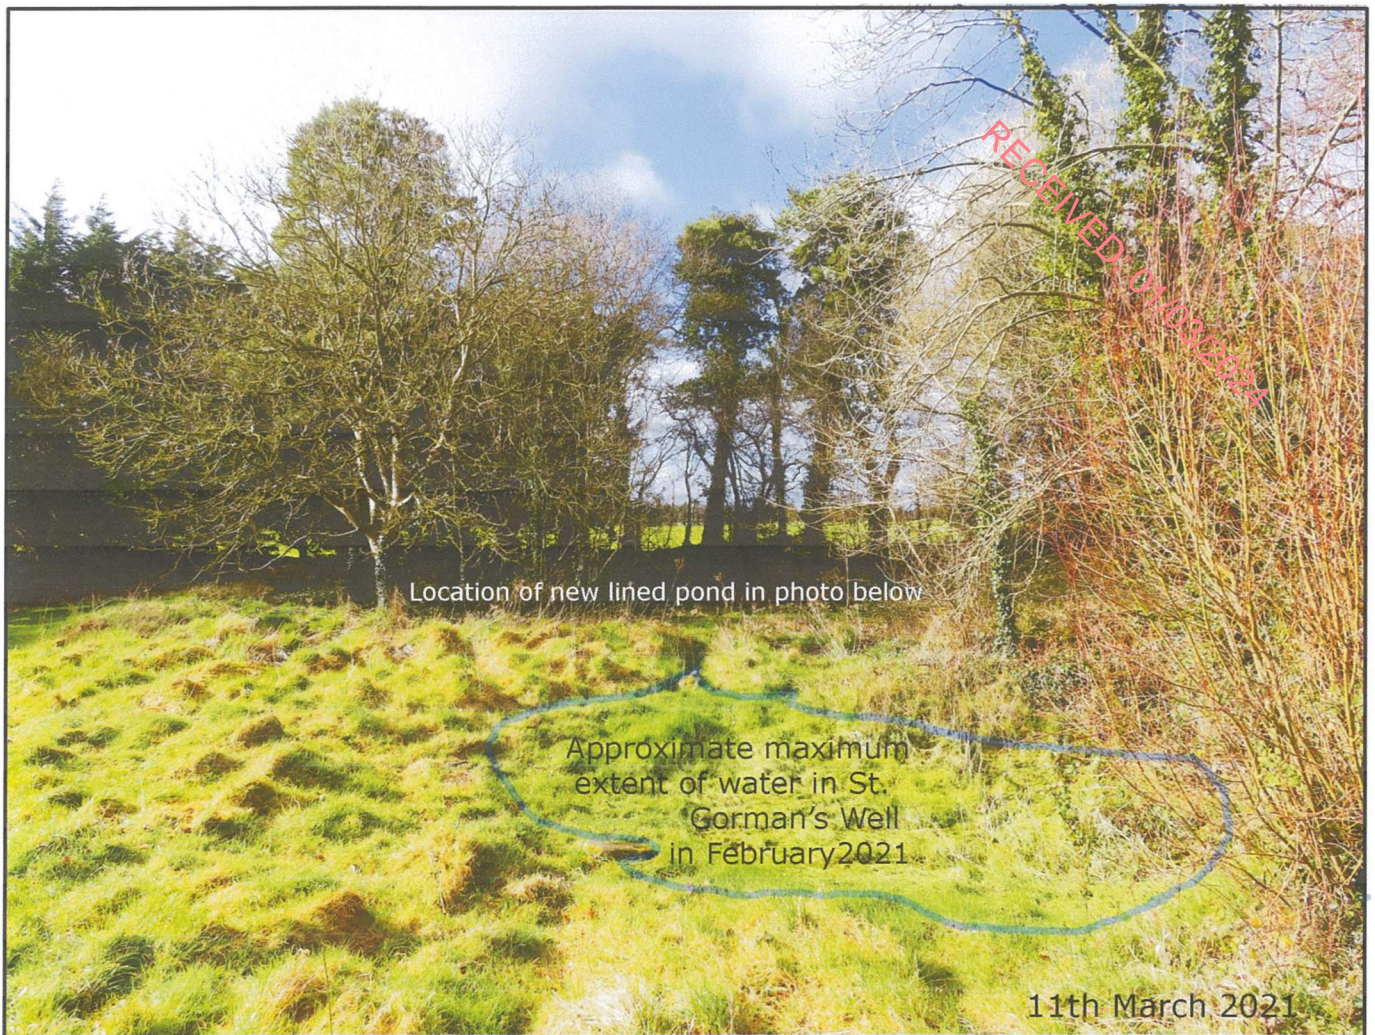
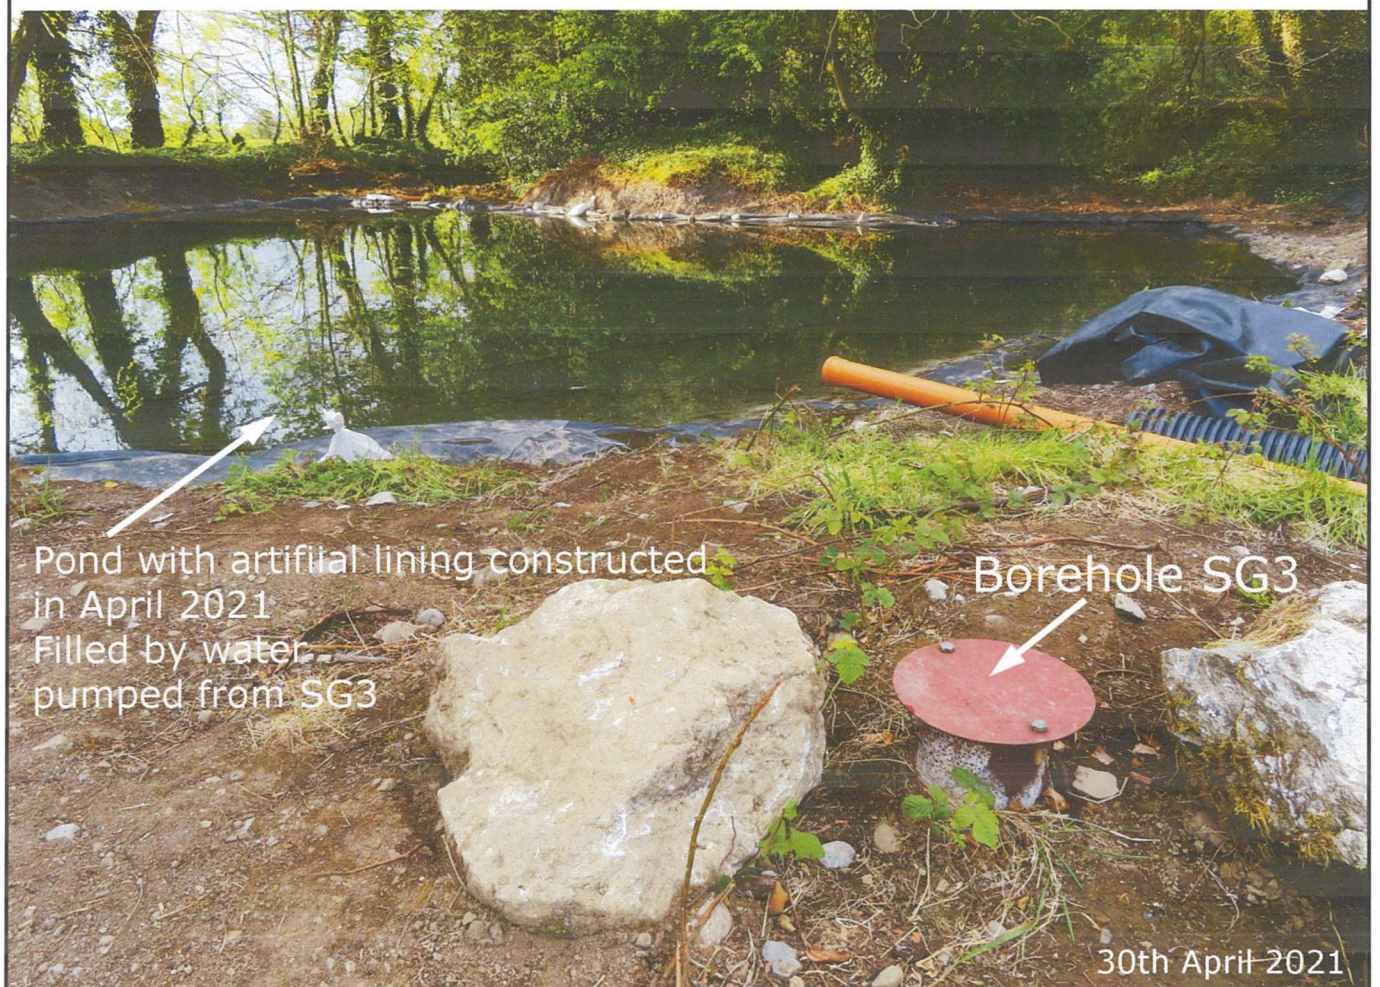
Figure 5.4 St Gorman's Well Site March and April 2021

Figure 5.4 shows St Gorman's Well in March 2021, and the recently constructed, lined pond in April 2021. The photograph showing the Well has a thin pale blue line drawn on the grass that corresponds to the maximum height and extent of the water in the Well during the previous month. A close look at the photograph will show the perimeter stones on the south side of the grassy depression.

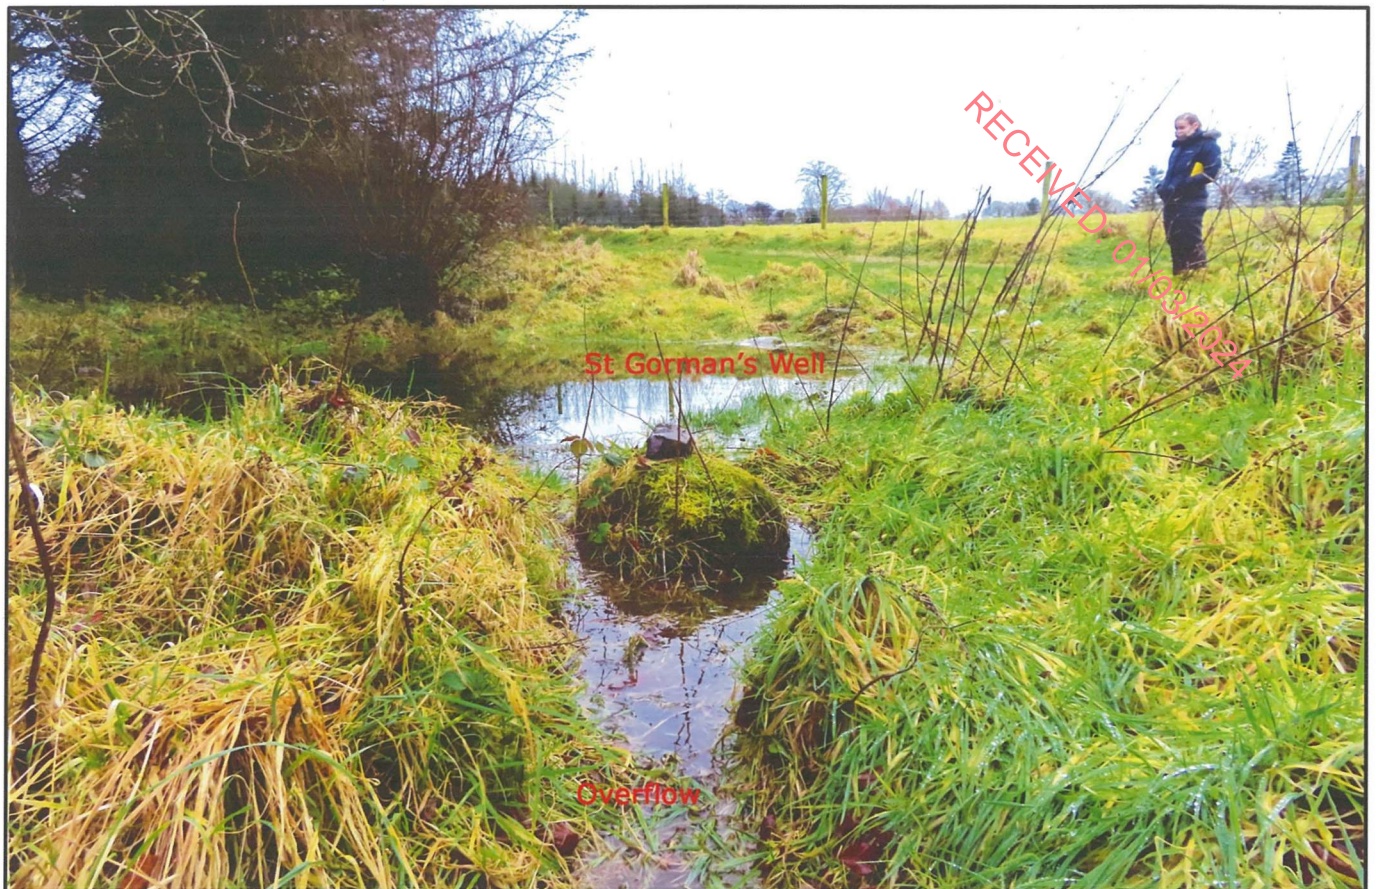
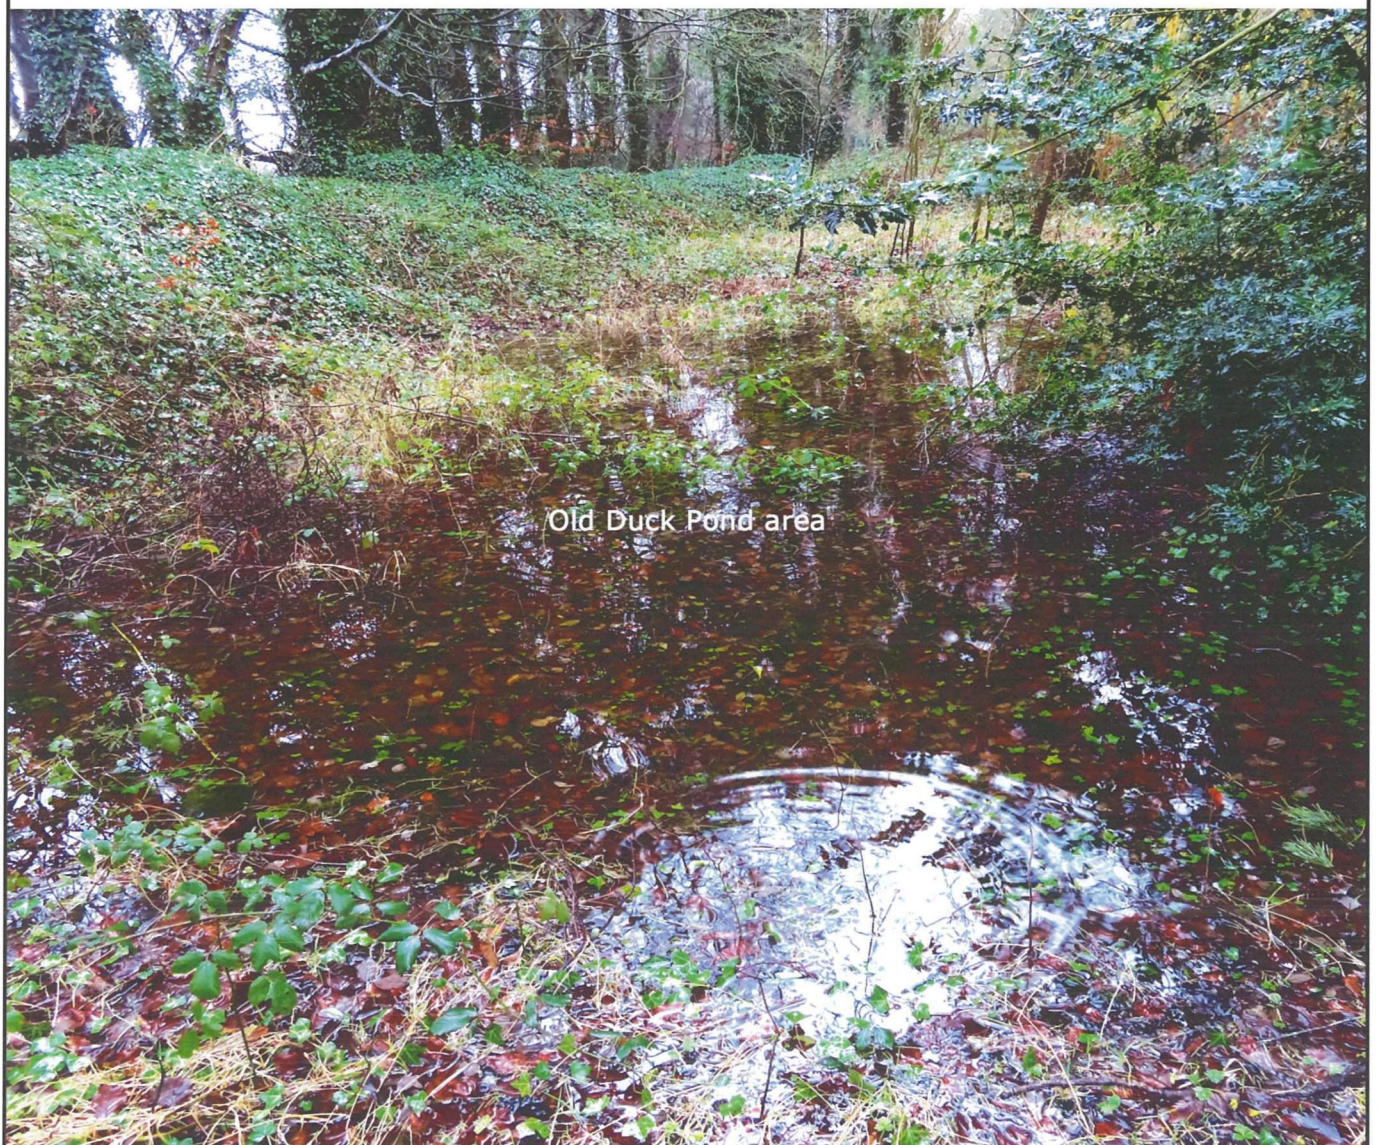
Figure 5.5 Small flow from St Gorman's Well into the old duck pond area 5/2/2021

Figure 5.5. also has two photographs. The upper shows the small flow of water out of St Gorman's well on the western side at the time of maximum water levels in early February 2021. The flow is a barely perceptible seepage in a shallow channel through the long grass. The lower photograph shows the floor of the woodland where the Duck pond had been, and which, now, is partly filled by the new lined pond. There is a 5-15cm layer of water covering the leaves on the floor. The lower photograph also shows, on the left, the embankment covered with brambles that was created with the earth excavated to create the duck pond in the 1980's. On the other side of the embankment is a steep drop, down into the drainage ditch. This ditch is a southern extension of a drainage ditch maintained by the OPW, under the Boyne Arterial Drainage Scheme.

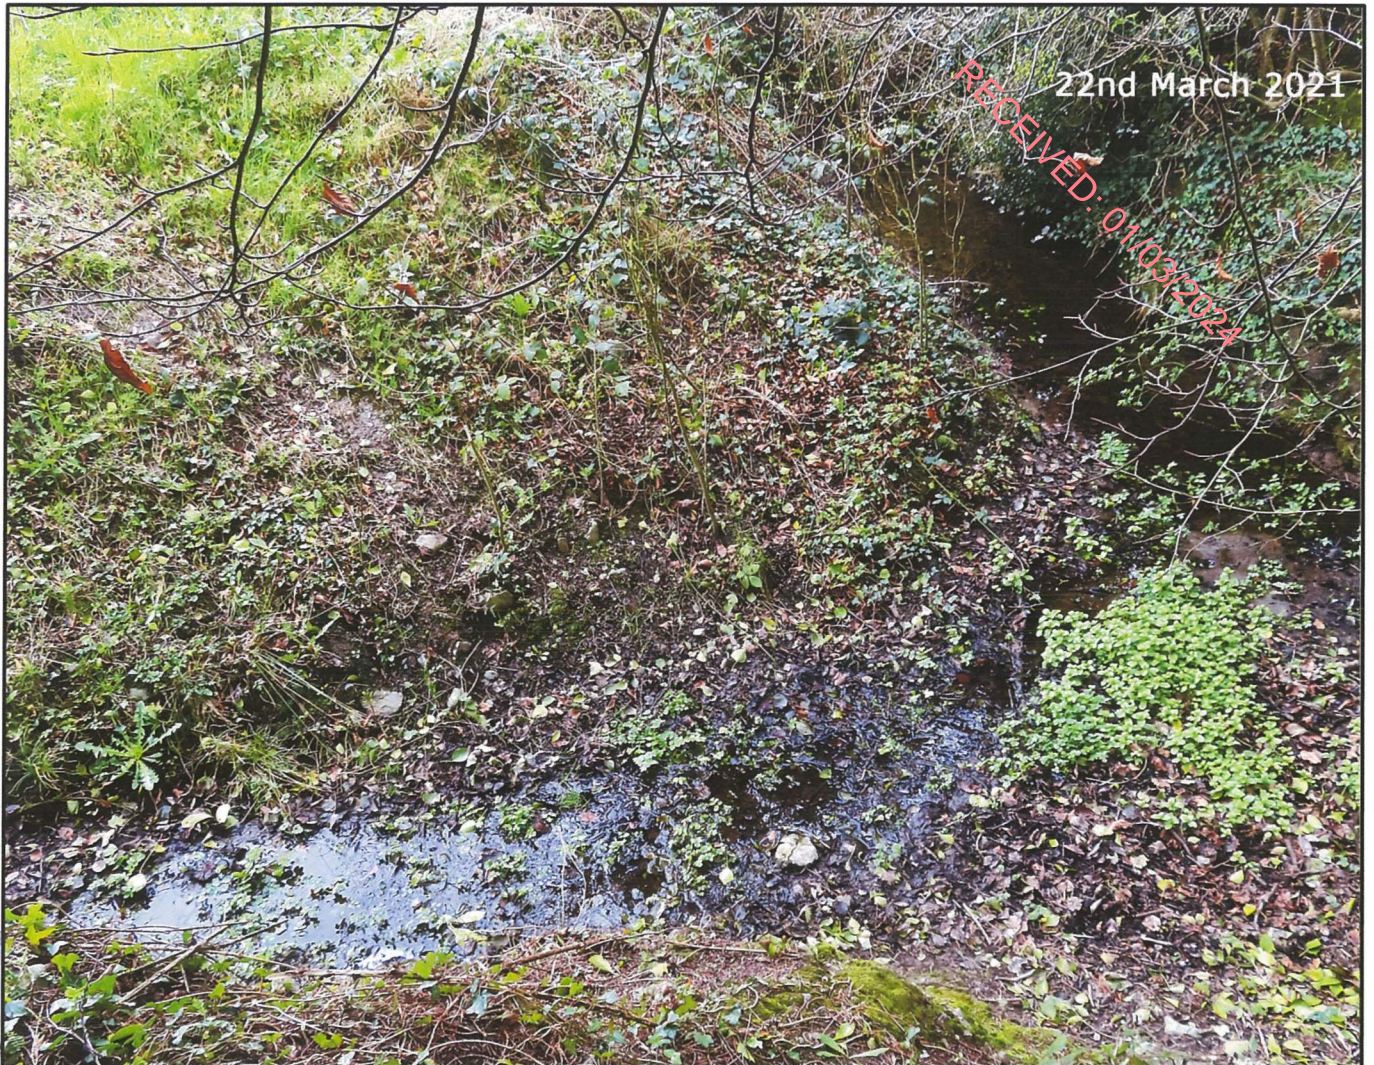
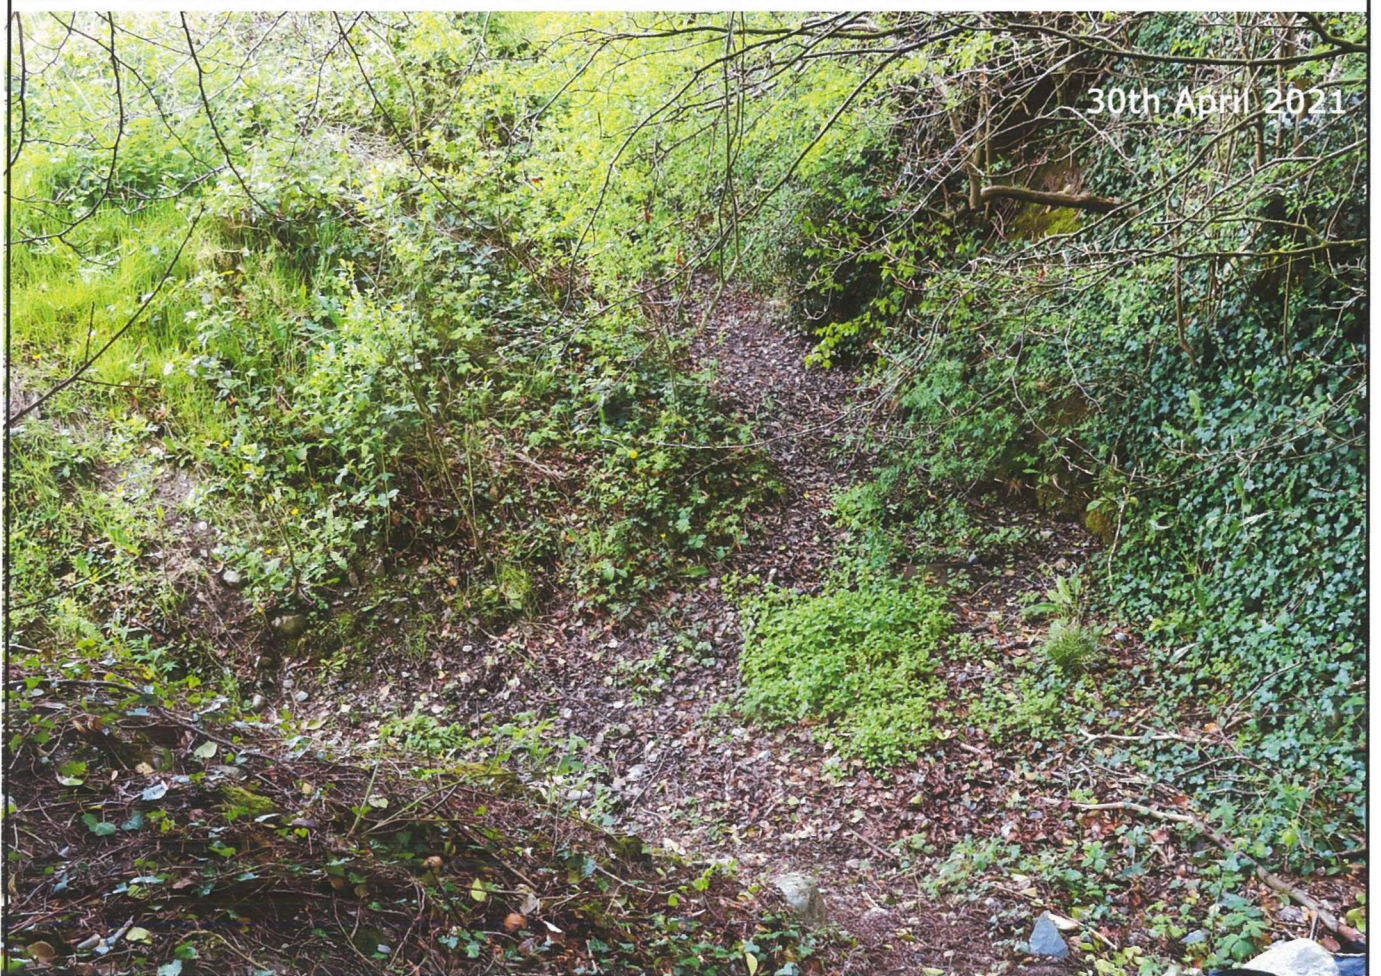
Figure 5.6 Groundwater flow and dry conditions at the confluence of the new curved drainage ditch with the original straight drainage ditch March and April 2021

Figure 5.6 shows the end of the curved drainage ditch alignment as it meets the original drain. It can be seen that the drainage ditch is deep and steep sided. The ditch up stream is short. The ditch starts at the north side of the road 200 metres to the south. Therefore, the land being drained is small.

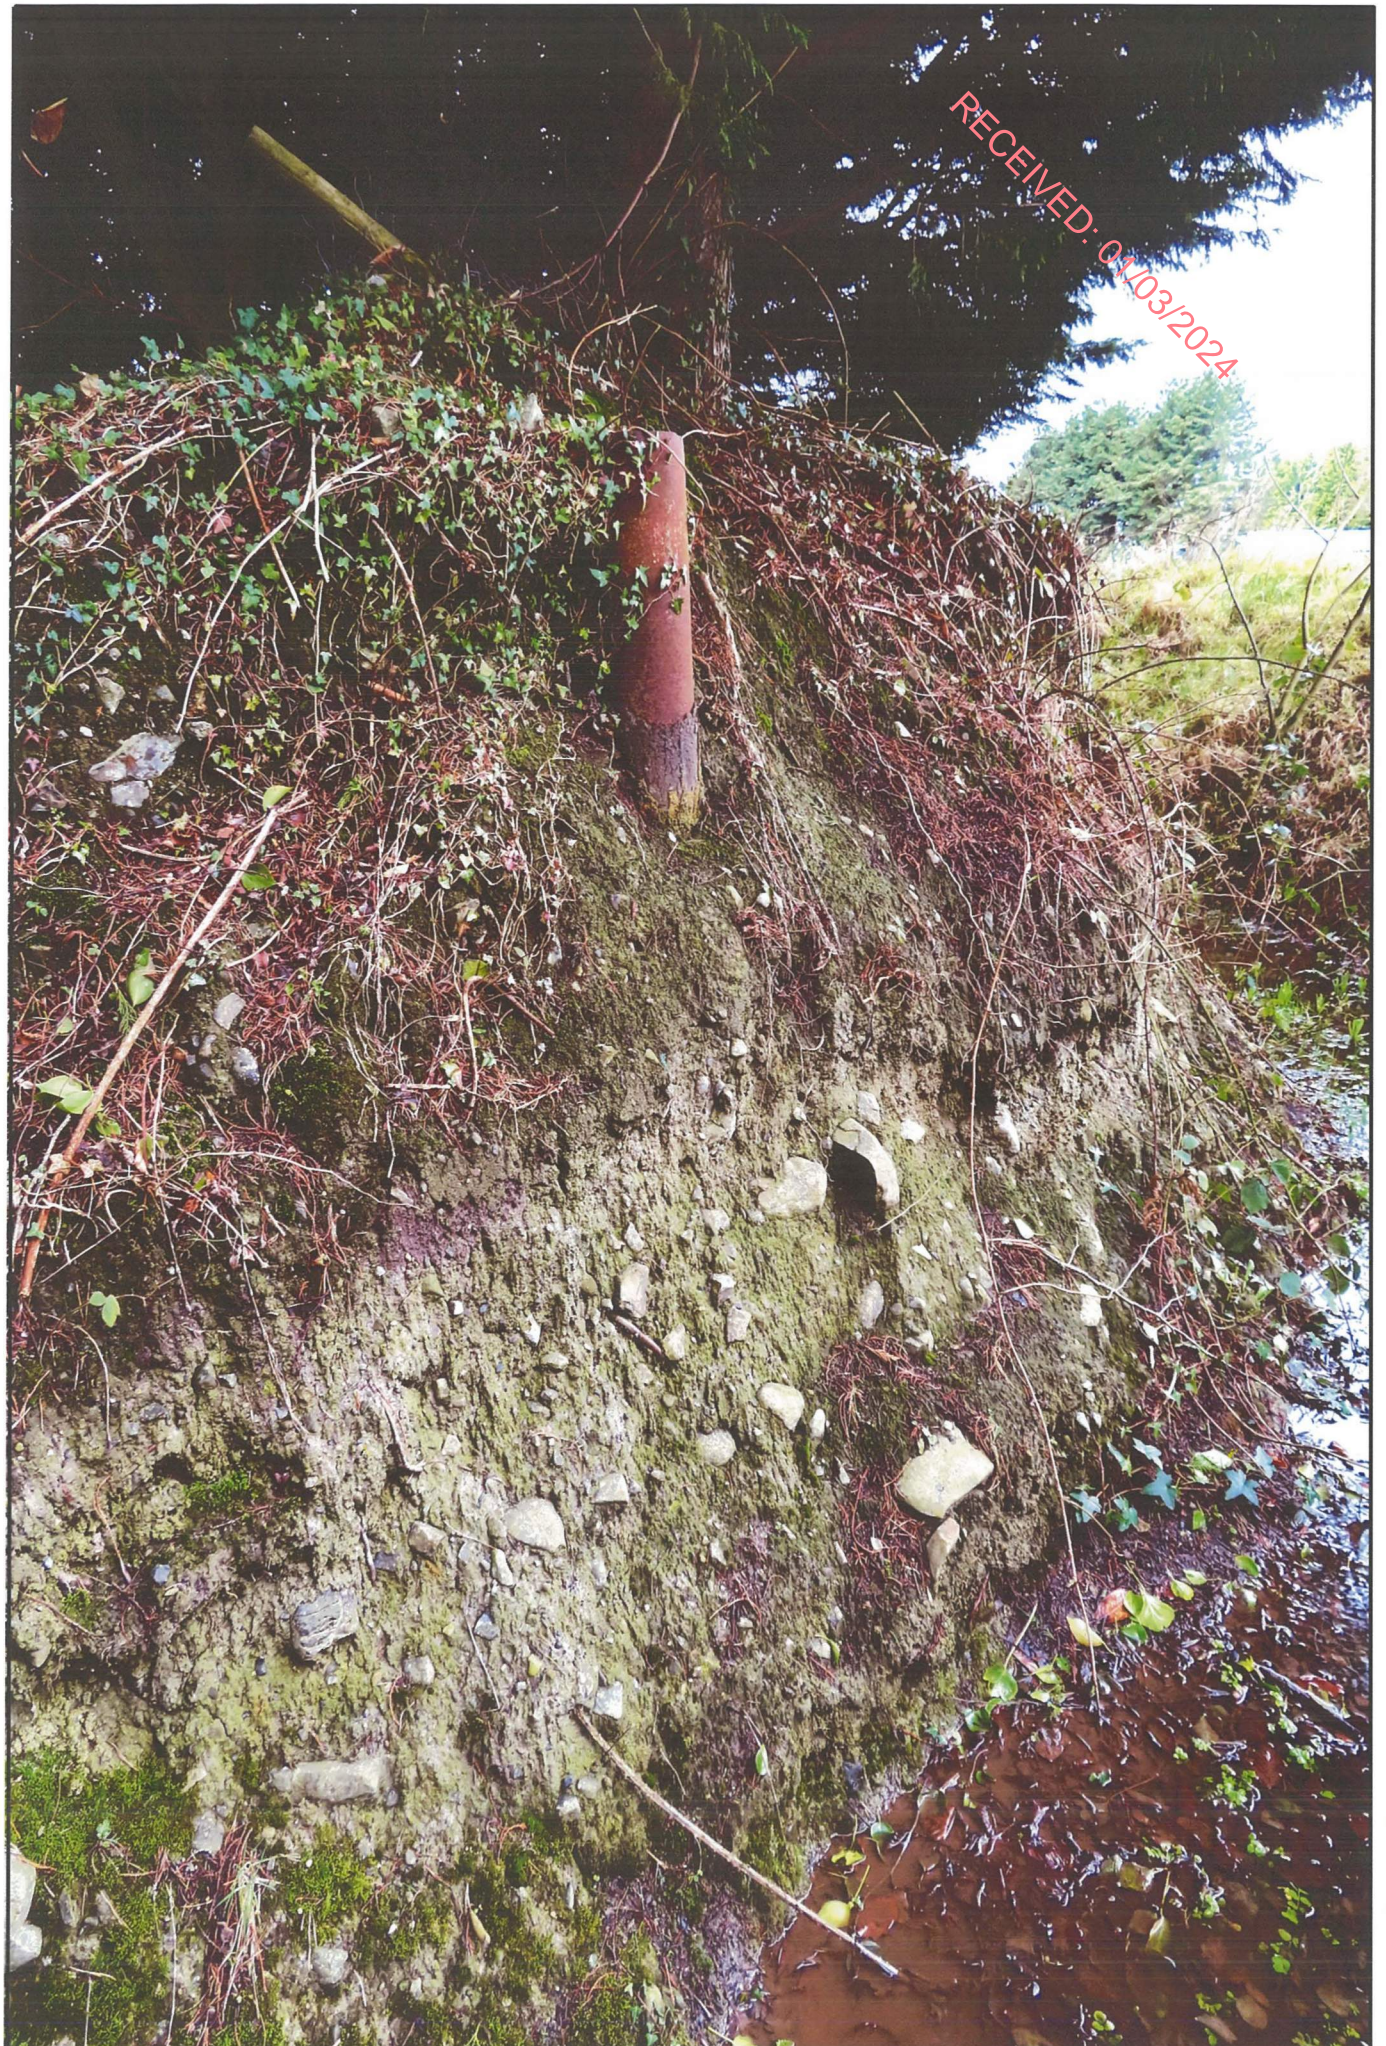
Figure 5.7 Borehole SG6, Exposure of Till and deep perimeter drain 5th February 2021

SG4, in the lower photograph, had a heavy steel cover tightly bolted onto the flange at the top of the casing at the time of the photograph. There was a rubber gasket between the cover and the casing.

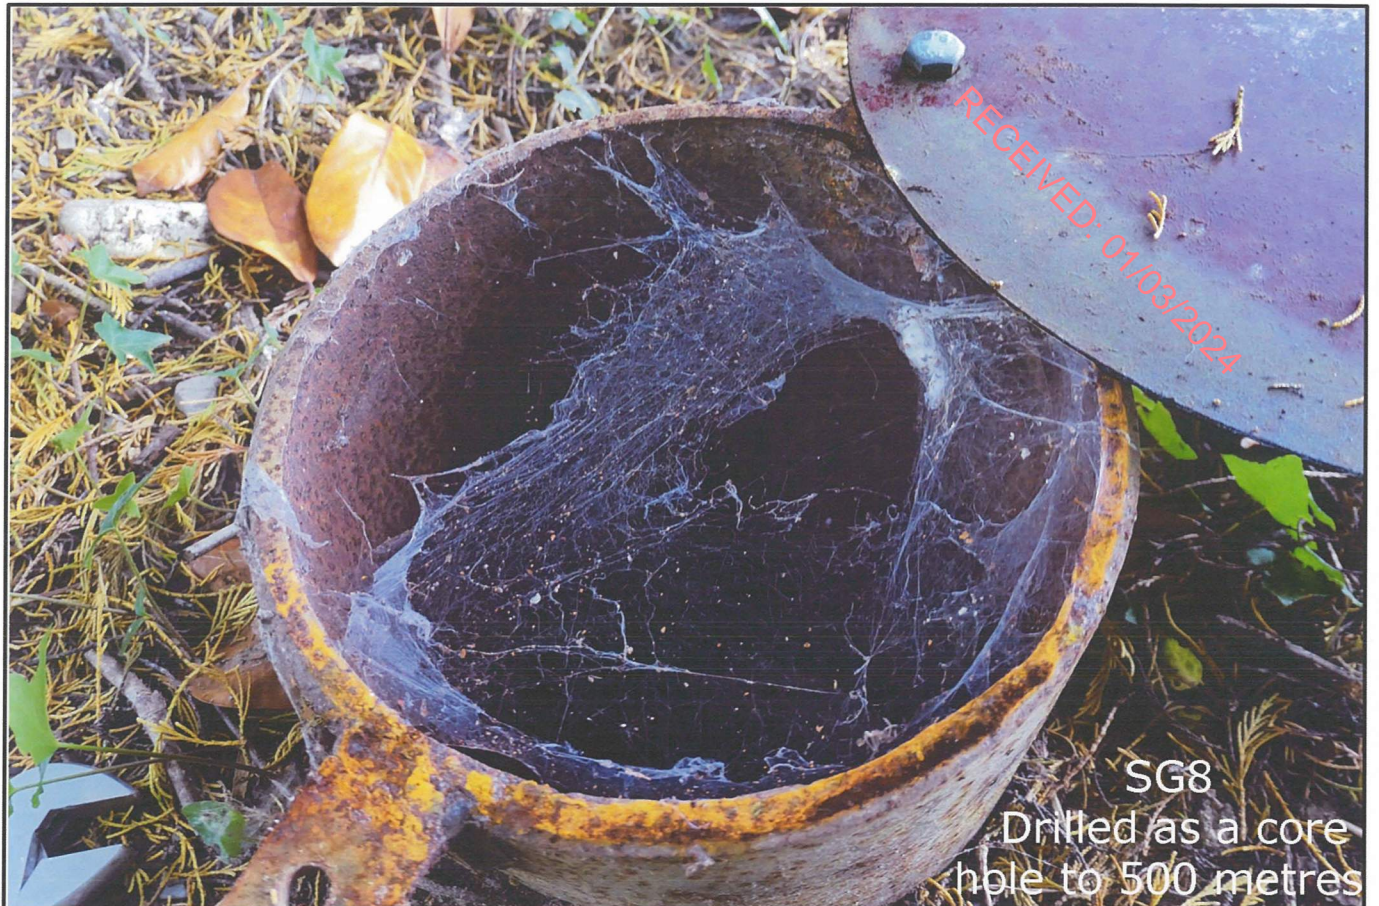
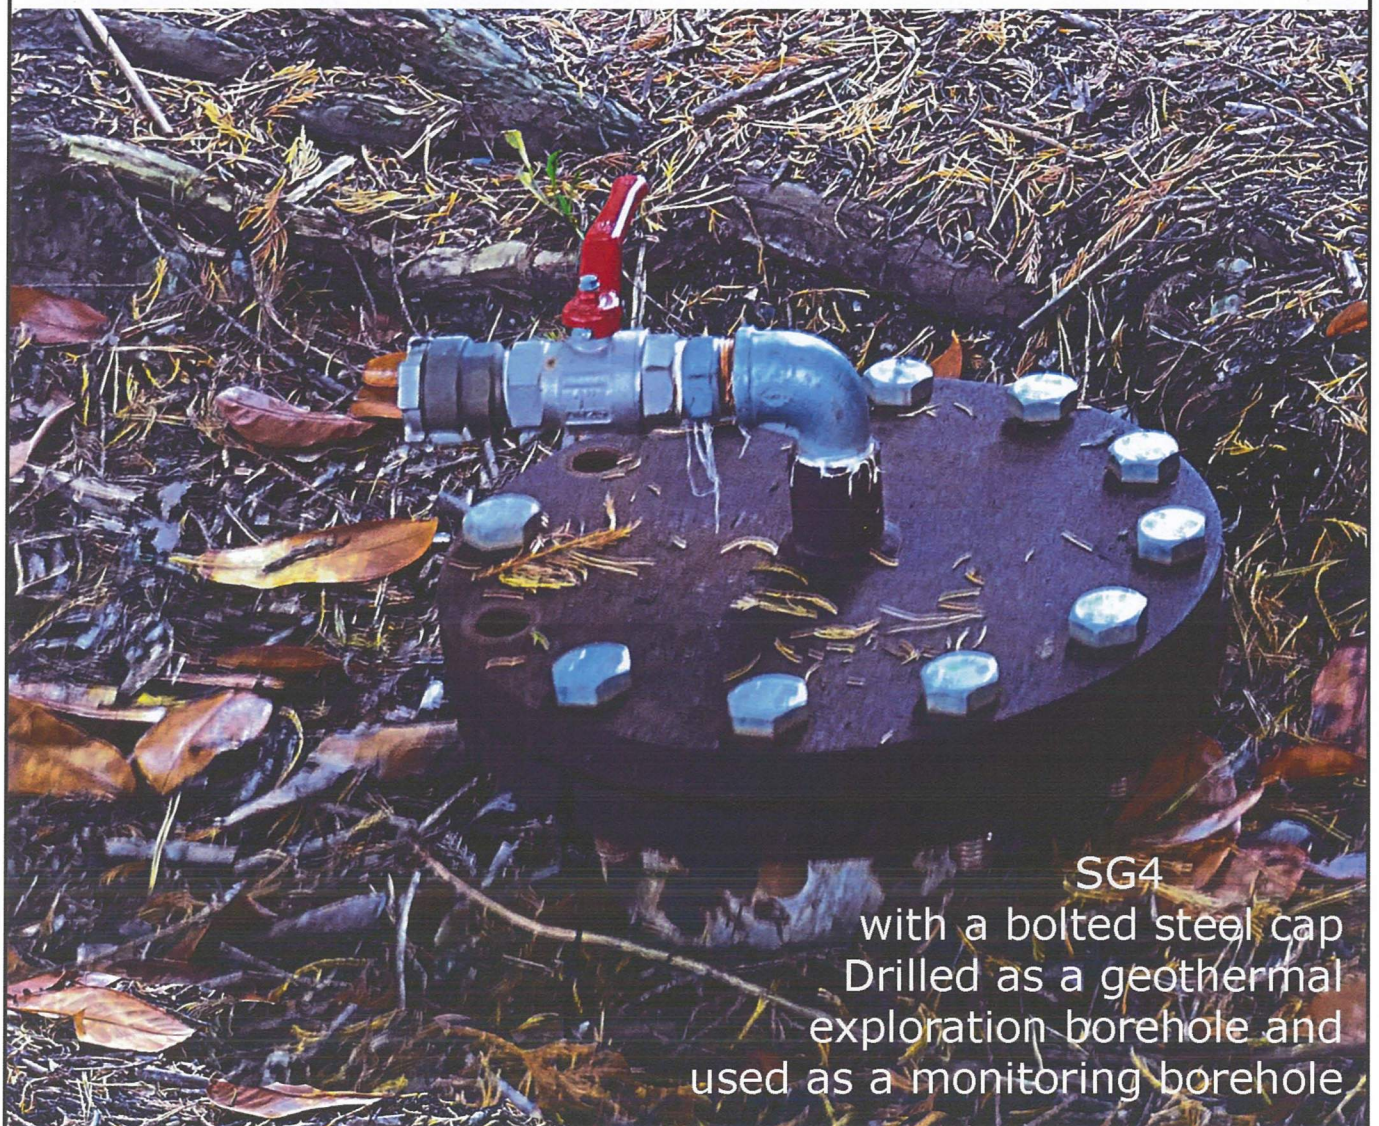
The Geological Survey of Ireland ran a video camera down the inside of the inner casing, and found that this casing extends to 54.1 metres below the wellhead. There is no record, or evidence from the surface, or the video, of a grout sealing the annulus around the inner casing. Therefore, referring back to Section 4.1, water can flow up or down the annular space outside

Figure 5.8 The Well Heads of Boreholes SG 8 and SG 4 on 1st August 2019
