### **18.3 Underwater Archaeology Impact Assessment**

# Ballina Flood Relief Scheme Underwater Archaeological Impact Assessment (UAIA)

Licence No.: 22D0081, 22R030

Date of Issue: May 2024

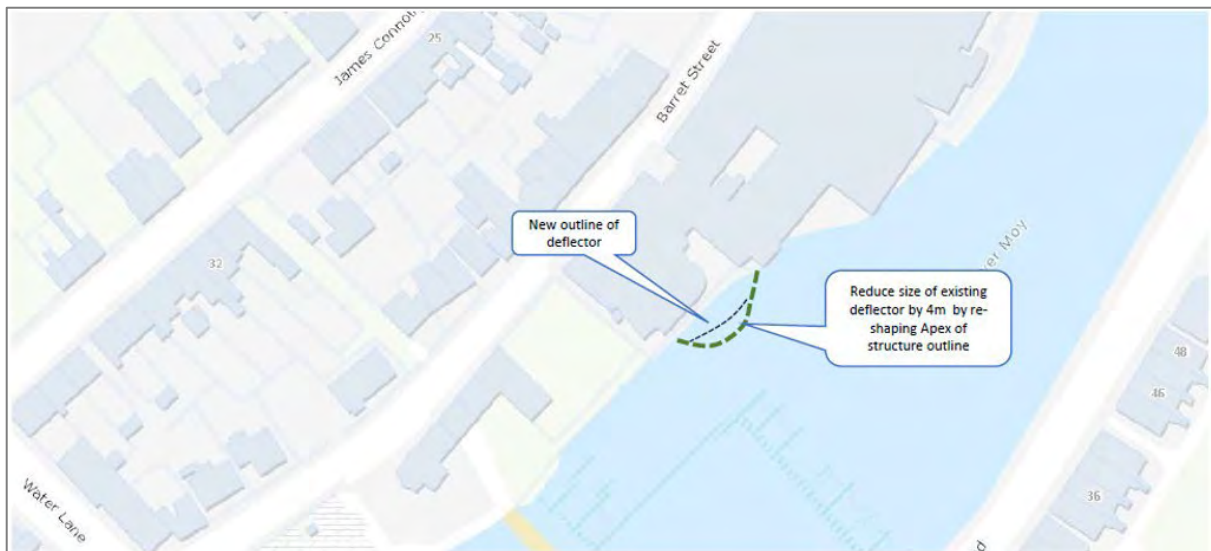
Figure 4: Proposed instream works at Ballina Manor Hotel/Apartments bank of Ridge Pool (Courtesy of RPS).

Instream works will be required for the opposite bank (at Ballina Manor Hotel/Apartments) to allow for the installation of flood walls (Figure 4). This will be accomplished by the installation of a stone ramp in front of the Weir building and warehouse to provide access to the Otters Lodge apartment building upstream of the warehouse. A cofferdam will also be constructed upstream of the ramp to allow for safe working conditions in this area. The stone ramp will be

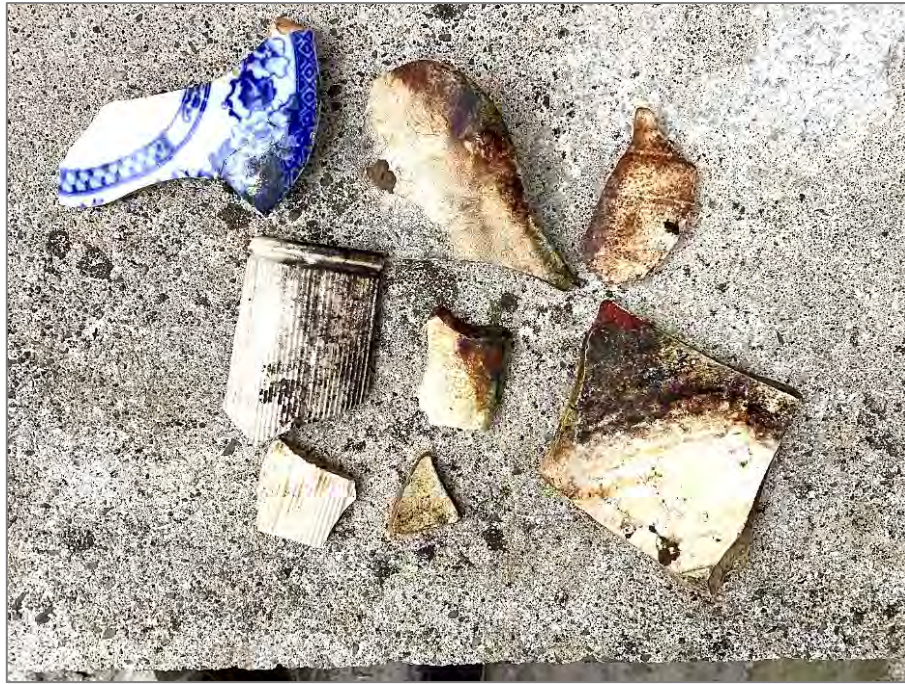
*Plate 13: Sample of post-medieval pottery found in Ridge Pool.*

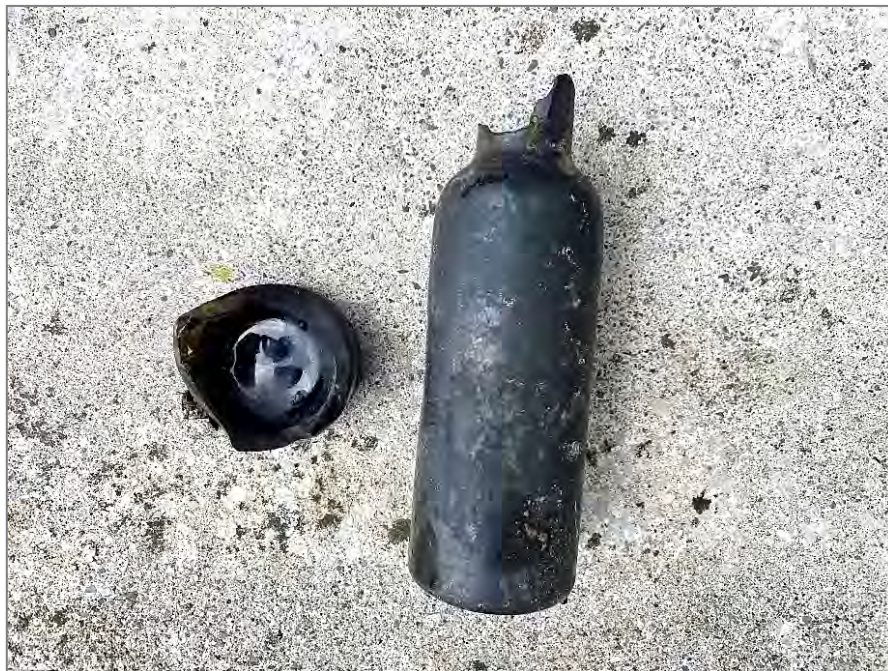
*Plate 14: Sample of glass bottles found in Ridge Pool.*

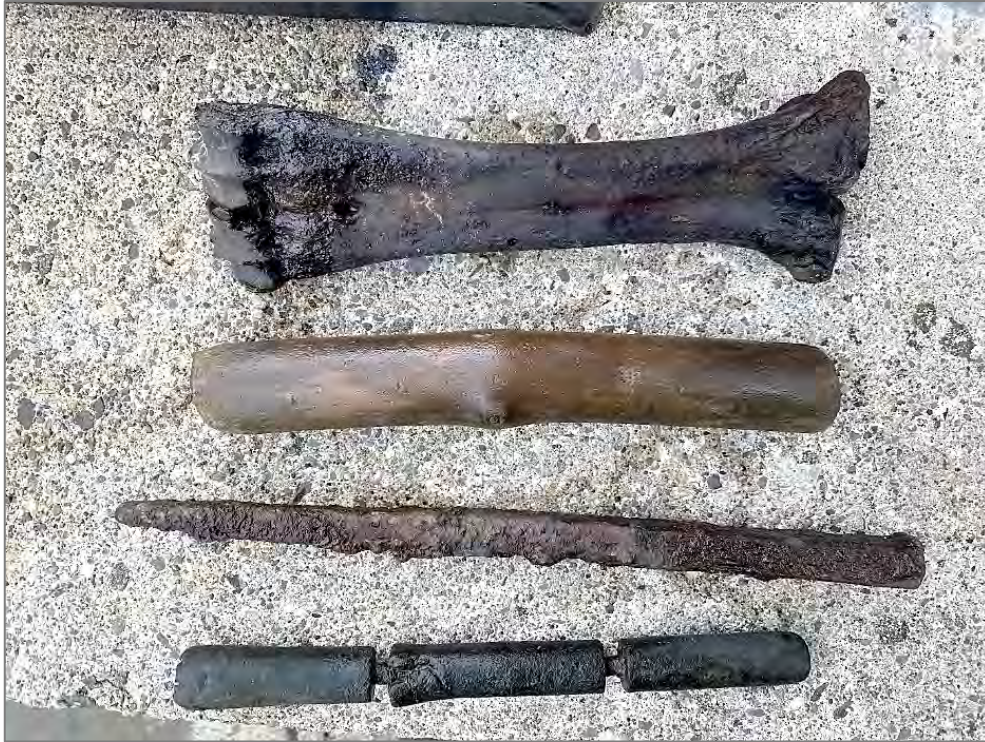
*Plate 15: Bone, shaped stick (for fishing), iron fastening, and iron hinge found in Ridge Pool.*

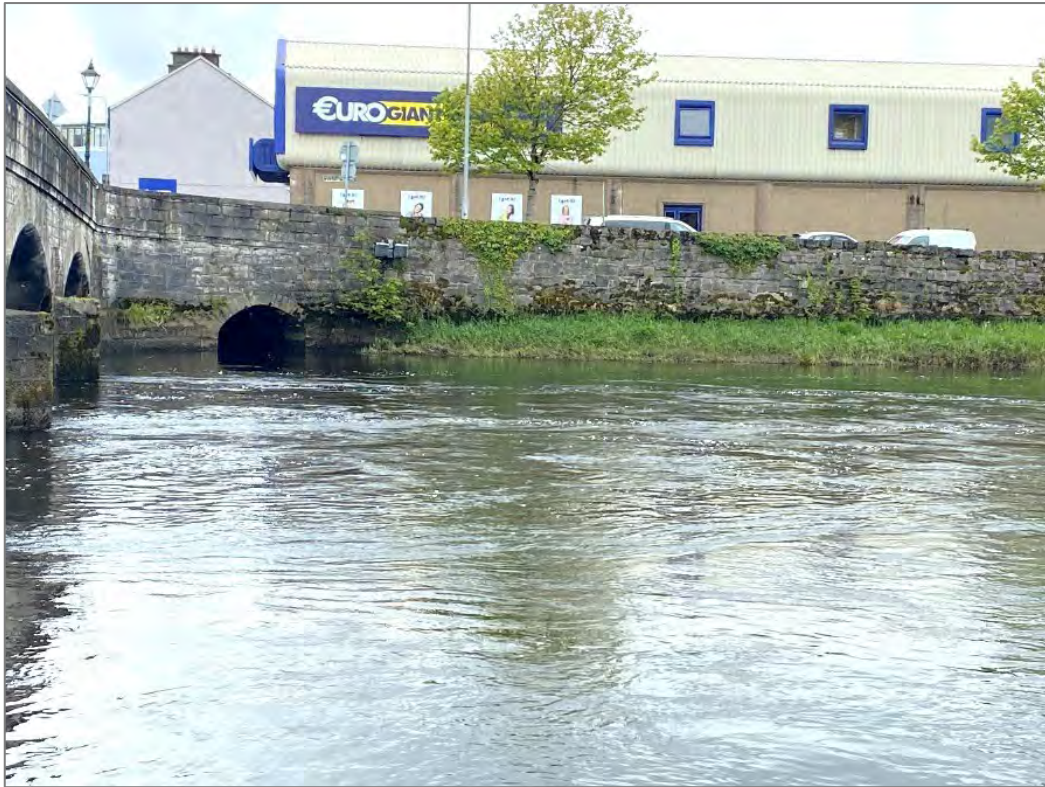
*Plate 17: Downstream Knockanelo culvert exit, in abutment to Lower Bridge beside Bachelor's Walk. Taken from east (UCH010).*

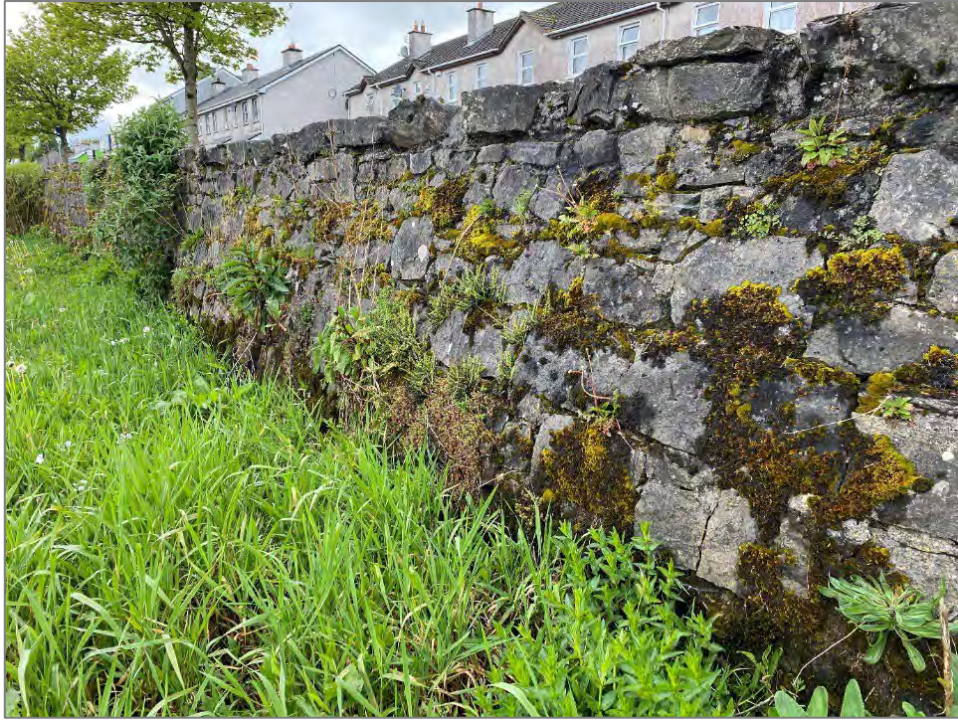
The western bank, along Bachelor's Walk, is a gently sloping vegetated silt bank, rising up to 0.80m above the water line and being up to 2m wide (Plates 18 & 19). The stone quay wall over the bank is in poor condition, being highly vegetated with stones missing along its length. It comprises roughly squared stones, which have not been set to courses. The coping comprises large, squared stones averaging 0.35m wide x 0.48m long x 0.25m thick. The mortar is concrete. The quay wall slopes down from where it meets the bridge abutment to the south (3.24m high) towards the bank (2.42m high), and has a slight batter.

*Plate 19: Detail of stone wall along Bachelor's Walk, taken from northeast.*

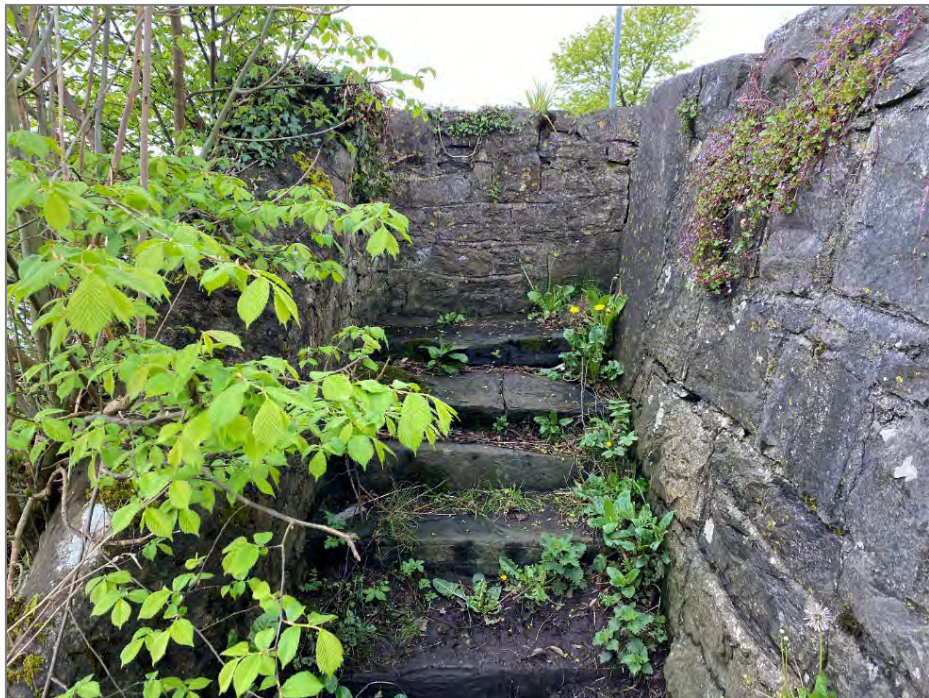
Located c. 120m northwest of Lower Bridge, there is a set of stone steps (UCH20; Plate 20)) providing access to the bank. The walling around the steps (to the southwest and southeast) is of the same construction as the quay wall. The steps themselves comprise single stone slabs, which are worn and in a poor state of repair, with several having fallen from their original position. The steps, as with the wall elsewhere, are overgrown.

*Plate 20: Stone steps (UCH17) accessing bank from Bachelor's Walk.*

UCH17	Moy River-Bachelor's Walk	Construction of flood defences- facilitated by cofferdam along southern berm from Lower Bridge to Rope Walk Lane (approx. 100m).  Access to works will be along the berm.	Access to the works along the berm has the potential to directly damage the steps, if they are not appropriately avoided by the site access traffic.	Negative  Direct  Moderate		Temporary fencing or barrier to be erected around the steps to avoid damage from access along the berm.	Negative  Direct  Slight
UCH07	River Brusna	Replacement of damaged bank and bed scour protection, extending 6m upstream and downstream of Shanaghy Heights Bridge.	There is the potential for structural remains associated with the townland boundary to exist below vegetation on the banks, which may be directly impacted by the works.	Negative  Direct  Moderate	Archaeological recording of identified features and any revealed features following clearance of vegetation.	Programme of archaeological monitoring	Negative  Direct  Slight

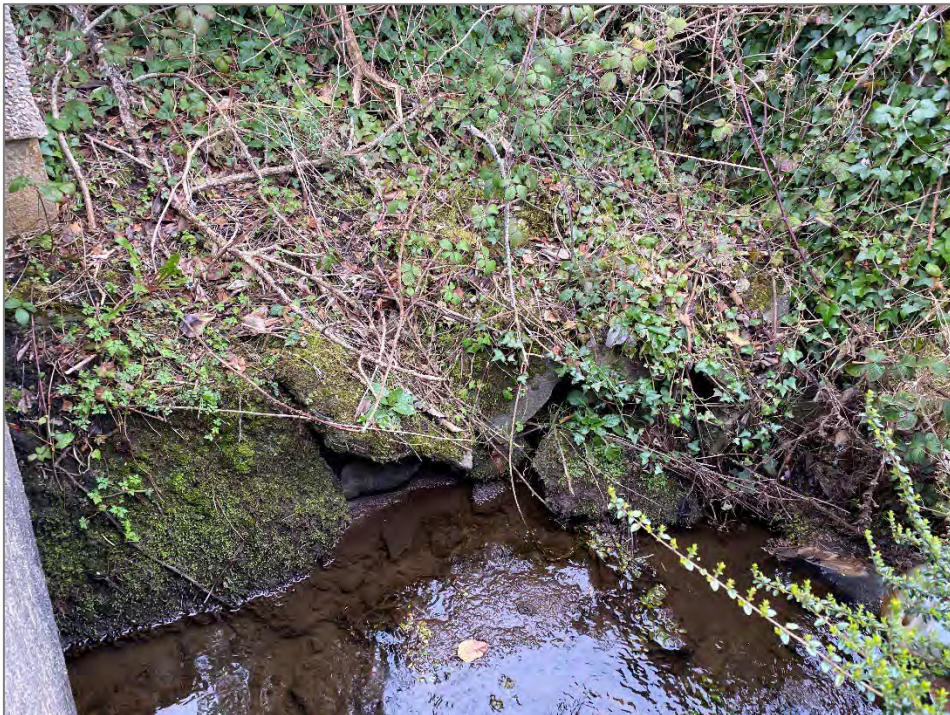
All of the culverts in this middle section are of modern construction. However, possible stone lintels from an earlier stone culvert are visible along the bank to the immediate west of one of the domestic access roads (UCH006). At least three possible collapsed lintels were visible under a covering of vegetation, measuring an average of 0.40m long x 0.60m wide x 0.04m thick. No lintels were identified to the east of the domestic access. It is possible these stones are the remains of an earlier access at the location, which was damaged and mostly removed to accommodate the present access.

*Plate 40: Possible remains of former Bunree stream access culvert. Taken from north.*

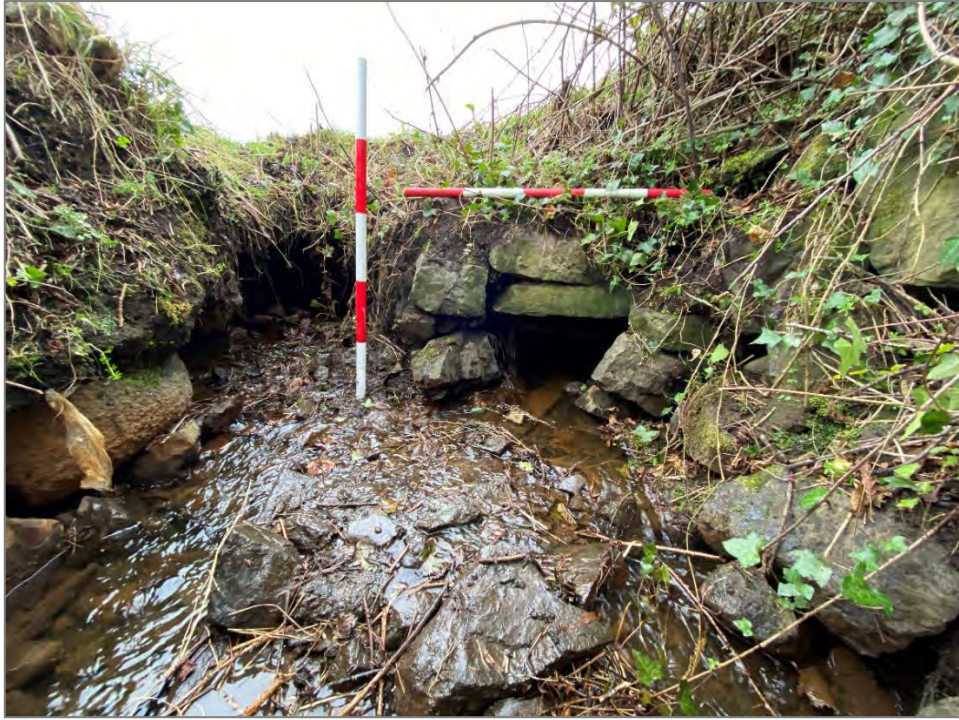
The stone culvert (UCH005; Plate 41) comprises rough squares stones (0.20 x 0.23m to 0.30 x 0.45m) with a lintel stone (0.64m x 0.09m) and a single red brick (0.06 x 0.11m), possibly from a repair. At least three types of mortar are present, indicating multiple repairs or alterations to the culvert, though all types contain cement. The interior width is 0.33m and height is 0.37m. The stream depth as it exits the culvert is 0.07m. The banks to the west of the culvert appear reinforced with stones, possibly taken from the culvert itself, and are visible in the bank up to 4m away, where a field drain empties into the stream from the south bank.

*Plate 41: Bunree stone culvert western exit, taken from east.*

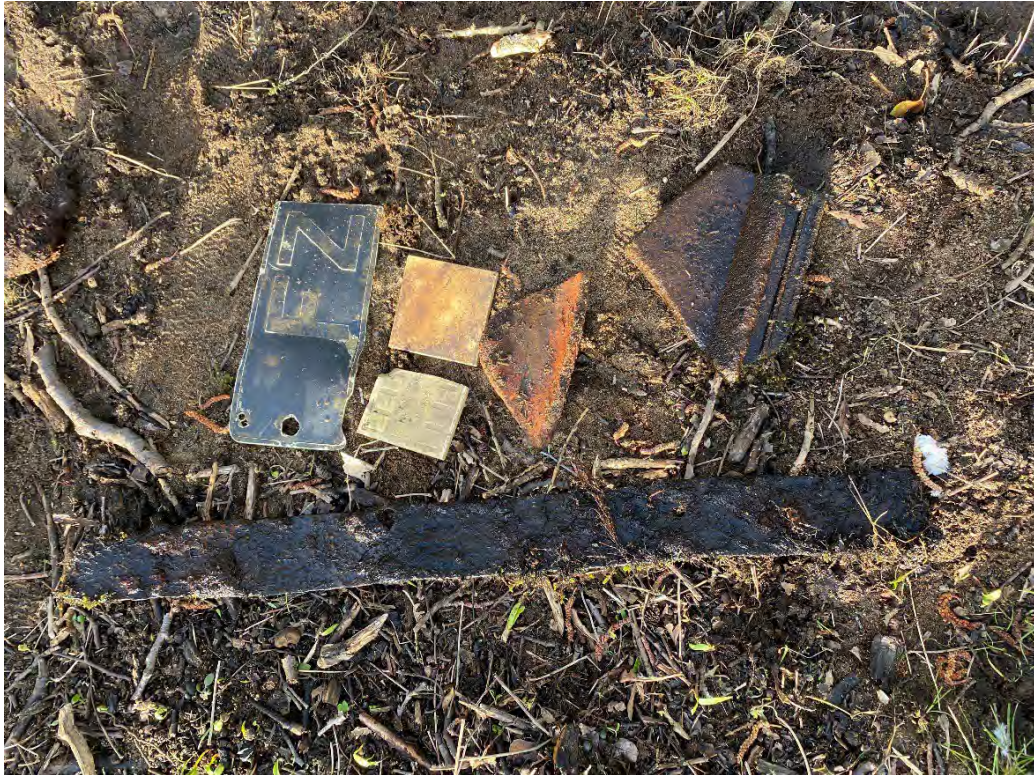
No other features were noted within the Brusna river within the survey area running between both bridges. Some very modern debris was encountered but not retained, including part of a number plate, modern tiles and iron gate fixing (Plate 43).

*Plate 43: Material found in Brusna River, including tiles and metal debris.*
