# ENVIRONMENTAL IMPACT ASSESSMENT REPORT

## VOLUME III TECHNICAL APPENDICES A-D

**PROPOSED RESIDENTIAL, RETAIL, SPORTS HALL & COMMUNITY CENTRE DEVELOPMENT**

**Athlumney, Navan, Co. Meath**

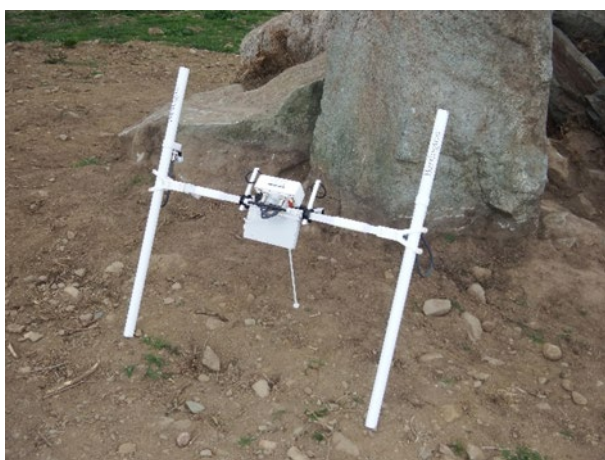
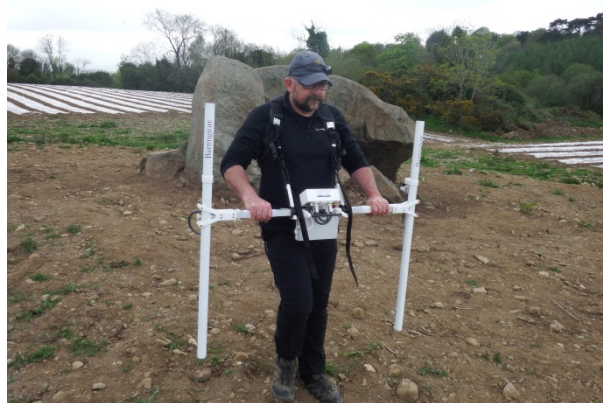
Bartington Grad 601-single axis dual sensor gradiometer.

**Fluxgate Gradiometer Survey:** Surveys are undertaken using the Bartington Grad 601-2 survey instrument which was specifically designed for archaeological prospection. It includes sensors that are highly stable, minimizing requirements for excess data processing. The instrument has a vertical 1 m sensor separation permitting finite resolution of buried archaeological features. Surveys can be undertaken in scan or detailed (zig-zag traverse) modes for reconnaissance or high-density mapping. The fluxgate enables reliable flexibility during fieldwork. Frequent realignment of the instruments and zero drift correction ensure a constant high quality of data. Extremely sensitive, these instruments can detect variations in soil magnetism to 0.1nT, affording diverse application throughout a variety of archaeological, soil morphological and geological conditions. The instrument can be employed in both commercial and research-based investigations allowing for completion of projects within short timescales. Regular grid sample densities from standard 1600 readings to 12800 readings per 20m by 20m grid are permitted. A constant high quality of data is assured by experienced field staff operating in accordance with English Heritage Research & Professional Guidelines No. 1, *Geophysical Survey In Archaeological Field Evaluation* (David 1995).

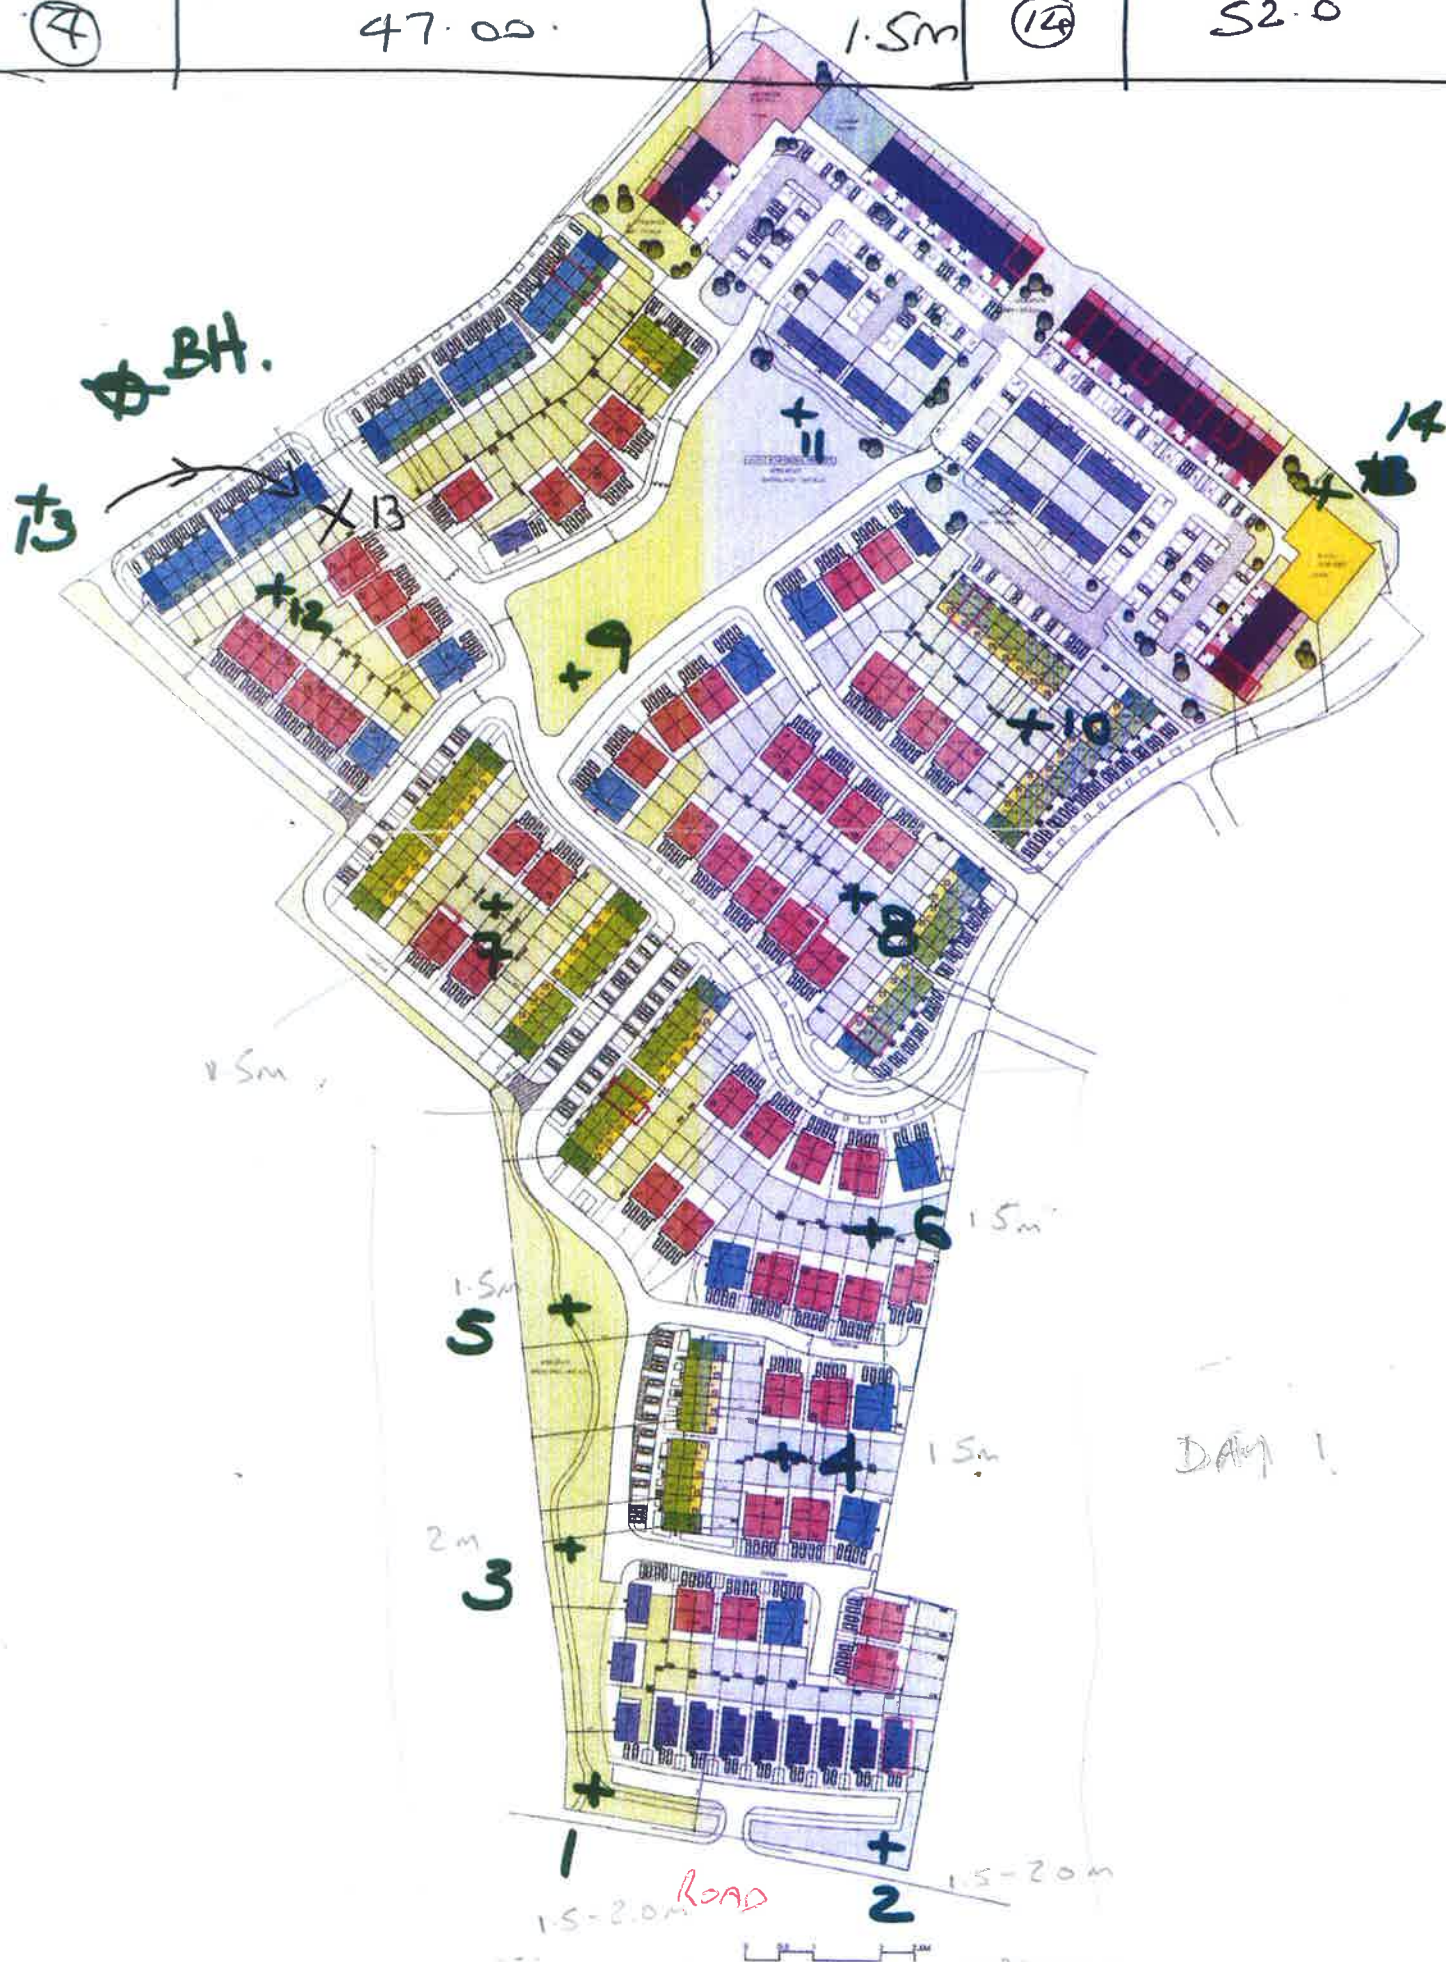
**PHASE 1**

APPROX. GROUND LEVEL	DEPTH.		APPROX GROUND LEVEL	DEPTH.
①	48.8	1.5-2m	⑧	49.5-50	1.5-2m
②	49.4	1.5-2m.	⑨	47.0	1.5-2m.
③	48.8	2m. 1.5m.	⑩	52.0	<u>3.5-4m.</u>
④	49.50		⑪	48.0	1.5-1.5m.
⑤	49.00	1.5m.	⑫	45.0	1.5m.
⑥	50.00	1.5m.	⑬	44.5	1.5m.
⑦	47.00	1.5m	⑭	52.0	1.5m.

IF PERCOLATION  
RATES ARE VERY  
POOR - EXTEND  
EXCAVATION DEEPER.  
CALL TO DISCUSS  
WHEN ON SITE. - 0868139892

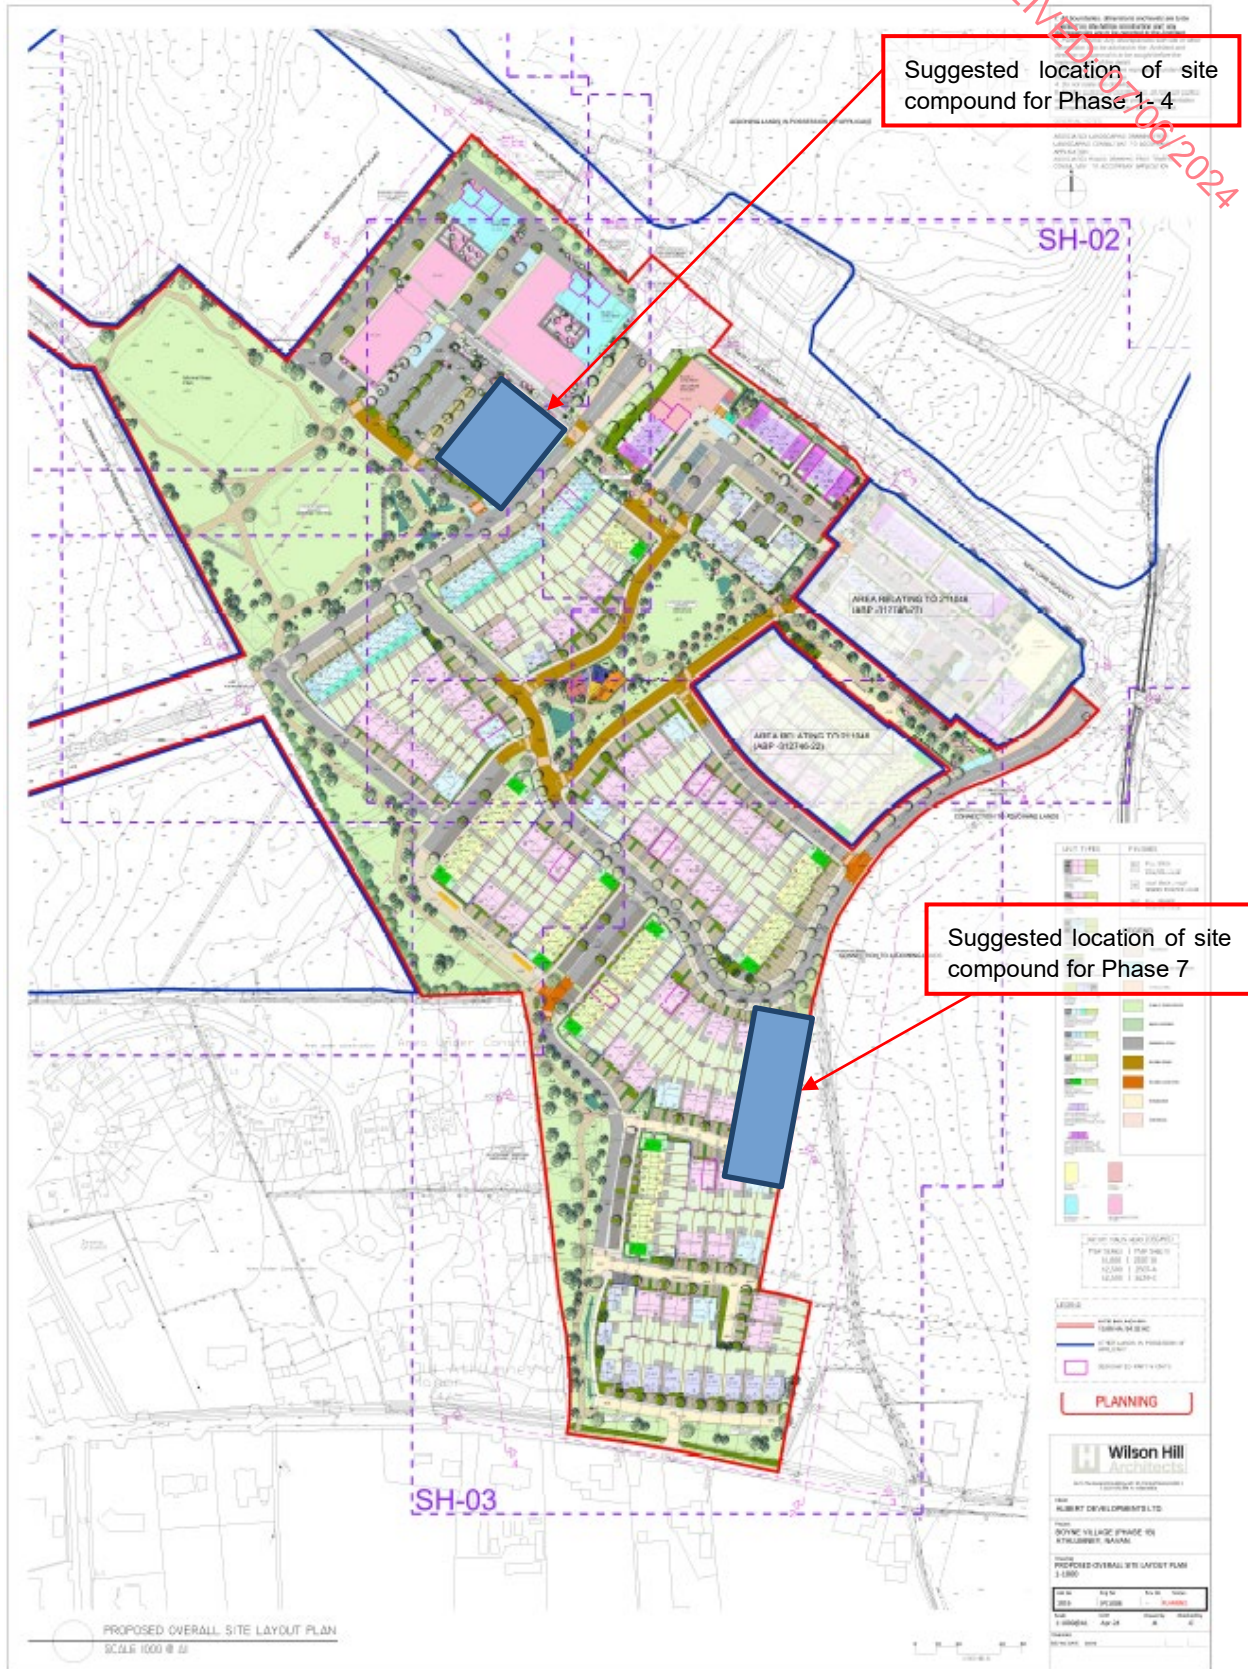
These areas will be incorporated into the development on completion of the works. Temporary buildings and containers, parking areas and material such as rubble, aggregates and un-used construction materials will be removed and disposed appropriately.

Figure 2-3: Indicative Construction Compound Location
