Dublin Street North Preliminary Geoenvironmental Risk Assessment

Project Title:	Dublin Street North PRA
Report Title:	Dublin Street North Preliminary Geoenvironmental Risk Assessment
Document Reference:	23165-PRA-001-00

Client:	McAdam Design Limited
Confidentiality	Client Confidential

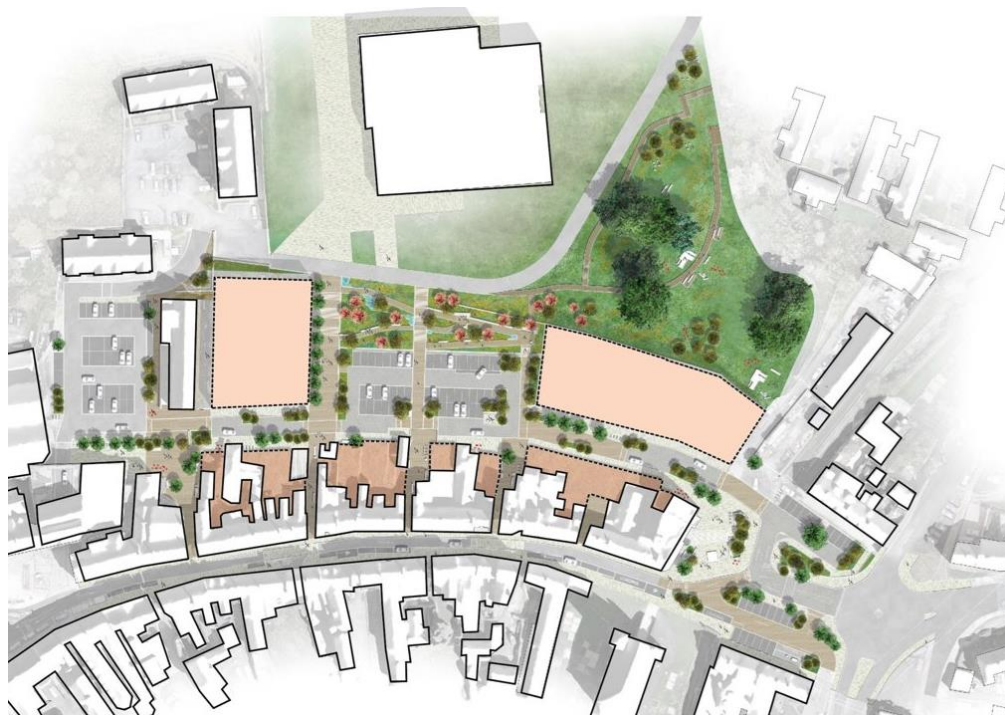
Figure 1-1 Indicative Site Plan

Gavin and Doherty Geosolutions (UK) Ltd (GDG) were commissioned by McAdam Design Ltd. to complete a Preliminary Geoenvironmental Risk Assessment (Desk Study) Report of environmental ground conditions for a proposed development site on Land North of Dublin Street, Monaghan. The site location and site boundary are outlined in Figure 1-2 and the indicative site layout, provided by the client as the Public Consultation Design - Illustrative Plan, is outlined in Figure 1-1.

The indicative site plan is proved as Figure 1-1. This report aims to assess potential contamination constraints on the site as it currently stands, and concerning the potential development, and to provide outline recommendations for additional works required to address areas of uncertainty.

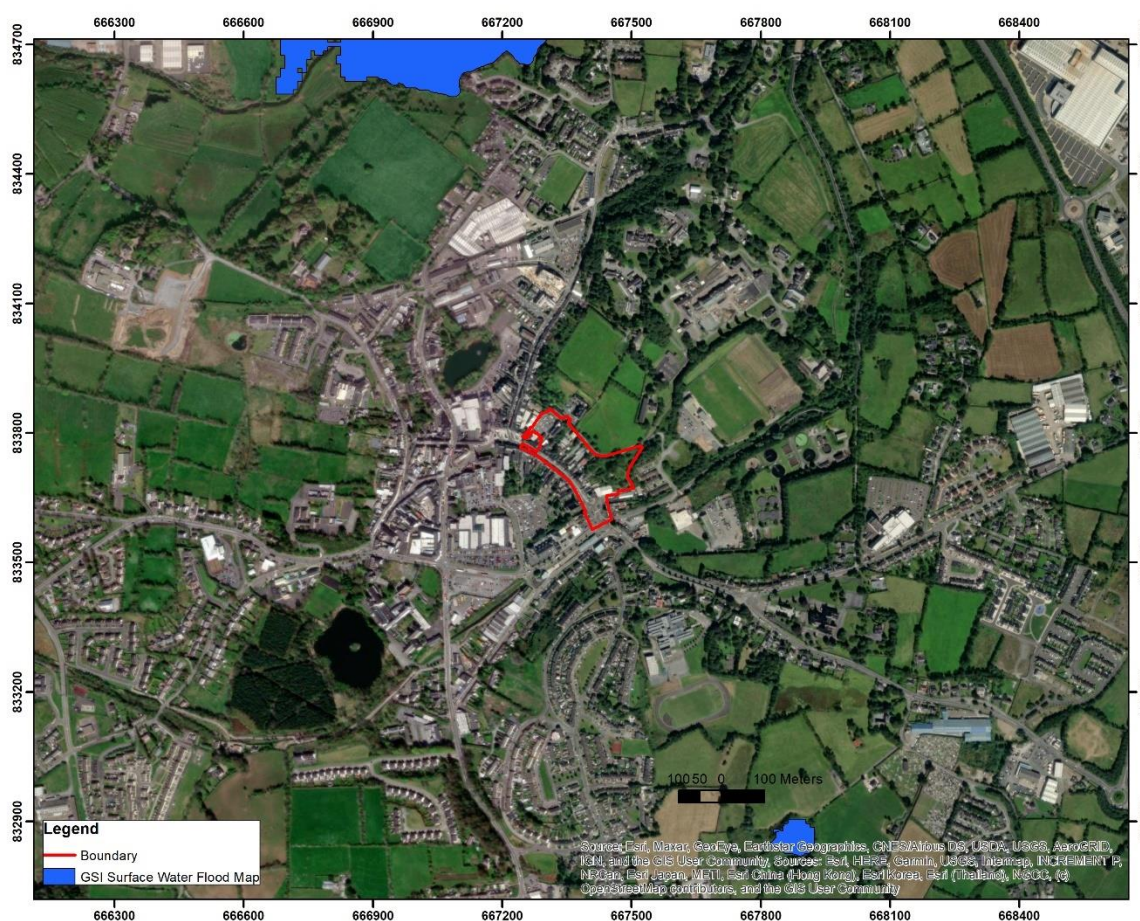
Figure 2-13 Historic Flood Maps produced (GSI, 2023)

The Historic Flood Maps produced by GSI in collaboration with Trinity College Dublin and the Institute of Technology Carlow (Figure 2-13) don't show any flood areas within 750 m of the site. However, the requirement for a flood risk assessment should be undertaken by a suitably qualified hydrologist.

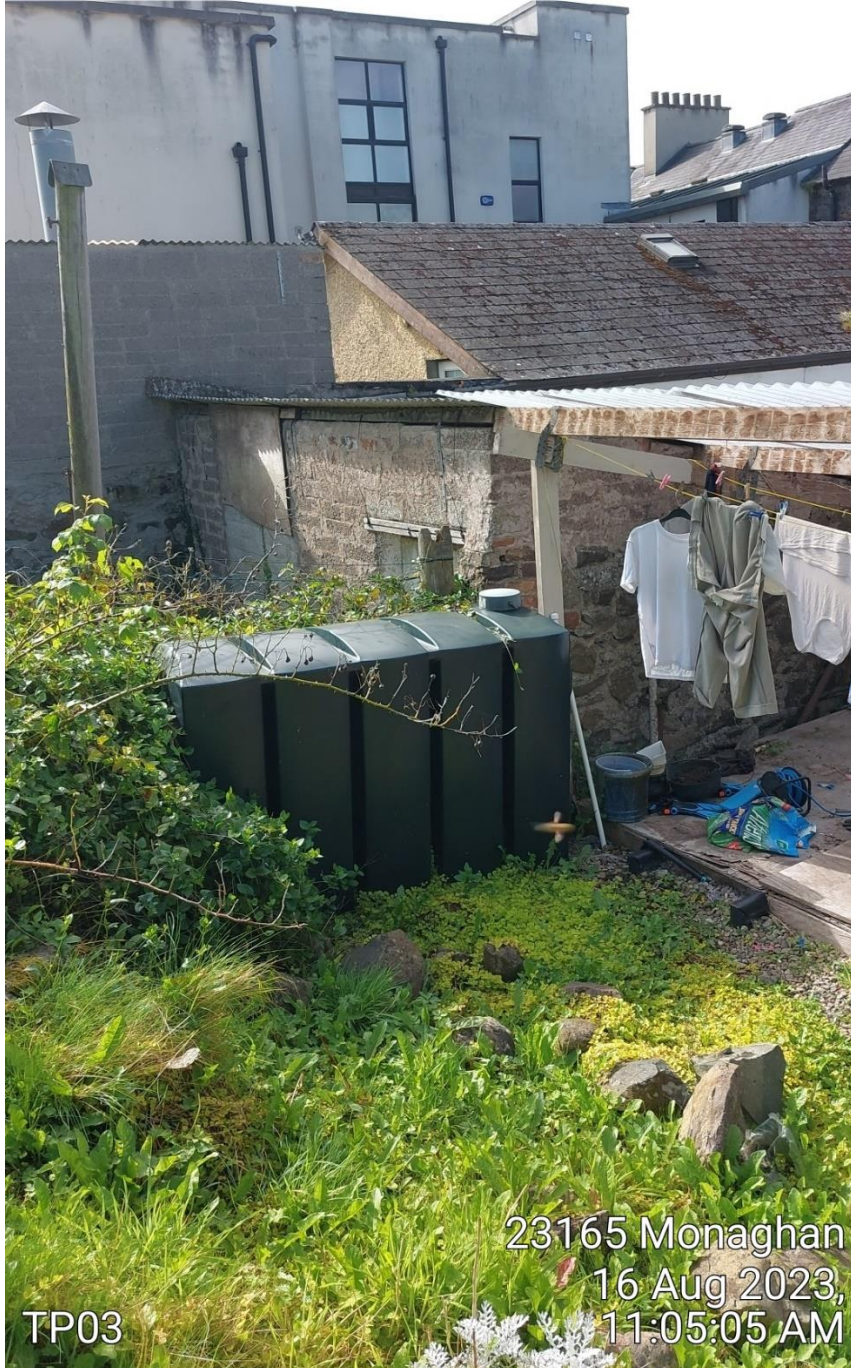
Oil tank behind private house on Dublin Street at former TP03 location.

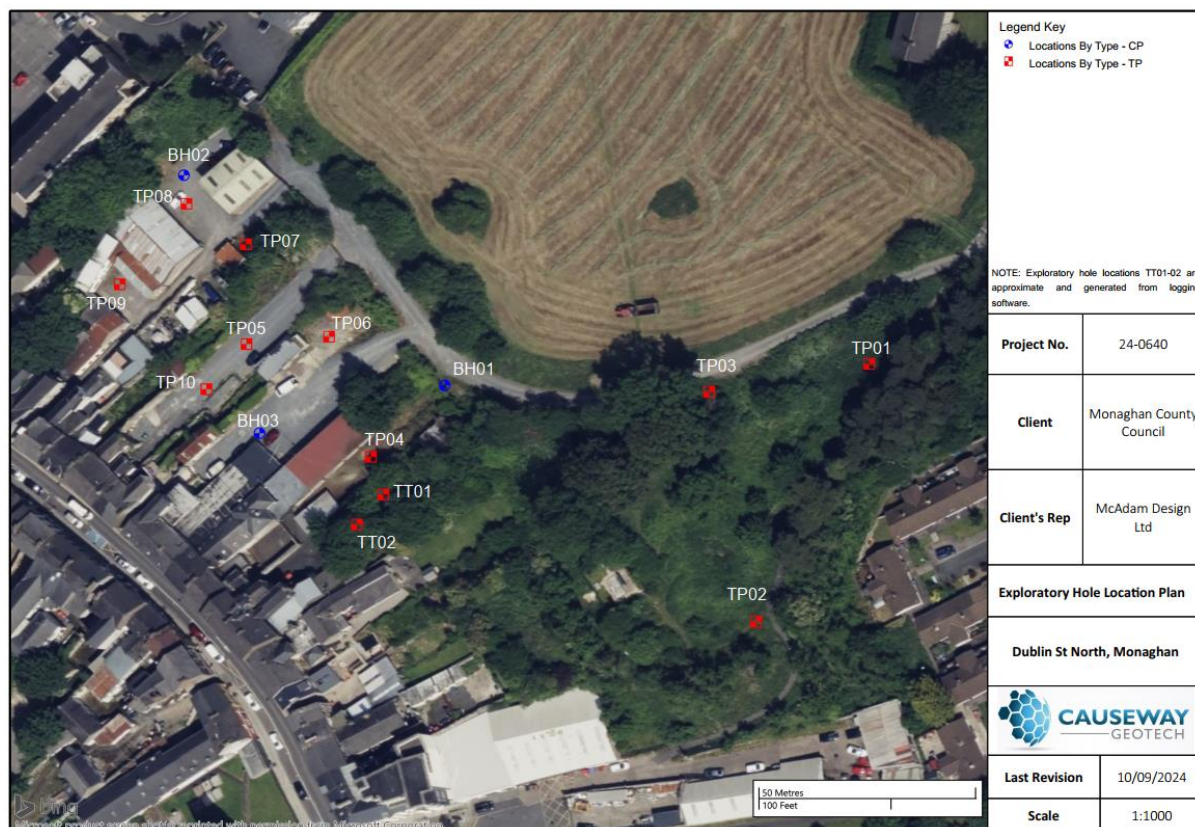
Figure 3-2: Ground investigation plan (Causeway Geotech, 2024)

The plan of the Causeway (2024) ground investigation showing the locations of exploratory holes is presented in Figure 3-2.

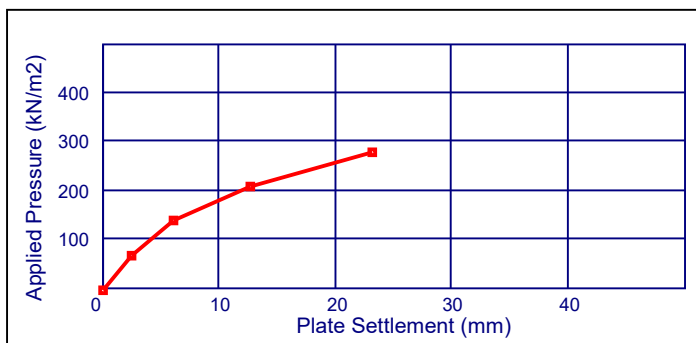
Project Client	Dublin street Monaghan County Council	Test No:	TP-08
		Lab Ref No:	24-0640
		Date Reported	27.08.24
		Weather Conditions	Dry
Technician	MMC	Air Temperature °C	20
Date Tested	13.08.24	Plate Dia (mm)	455
Location		Depth (m)	0.6
GPS Coord's		Reaction Type	14t Excavator
Material Type	Clay	App Weight (kg)	62
No Cycles	1

Plate Settlement (mm)	Applied Pressure (kN/m²)
0.00	0.0
2.44	71.2
6.04	143.3
12.63	212.7
23.12	282.9
