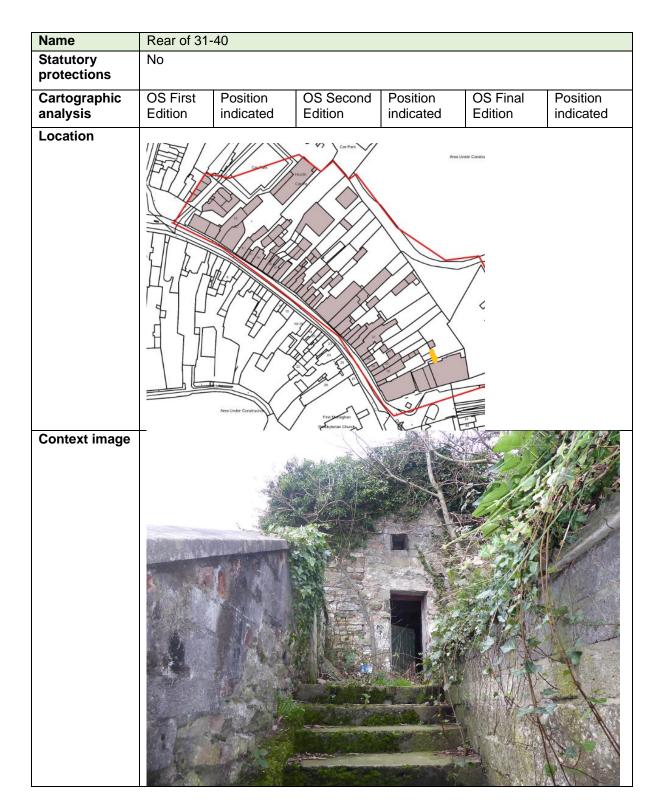
<image/>
Description	Coursed rubble flanking and retaining parapet walls to stone steps, heavily
	colonised by vegetation and height has been raised with concrete block. Historic OS maps and photograph from c.1970 indicate a lean-to building in this area, so this wall was likely at least partially internal.
Planning History	None
Other relevant information	
Consideration	Historic structure of low architectural interest.

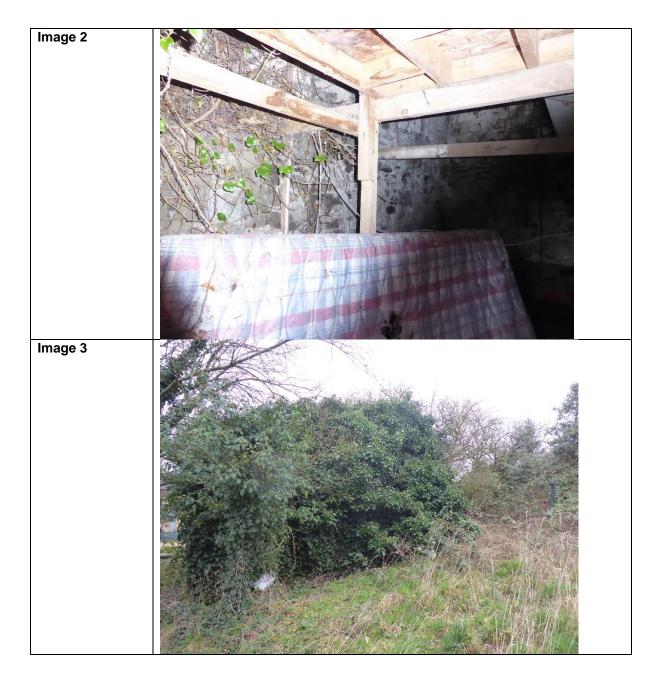
8.10 Number 32c

escription Two-storey split level pitched roof stone structure, in derelict condition and largely concealed by vegetation. Entrance in gable wall at first floor level. Access via stone steps with stone wall. Wall appears to have been raised in height with concrete block.
lanning History None found
ther relevant
iformation
onsideration Within the land take necessary for proposed Russell Row.

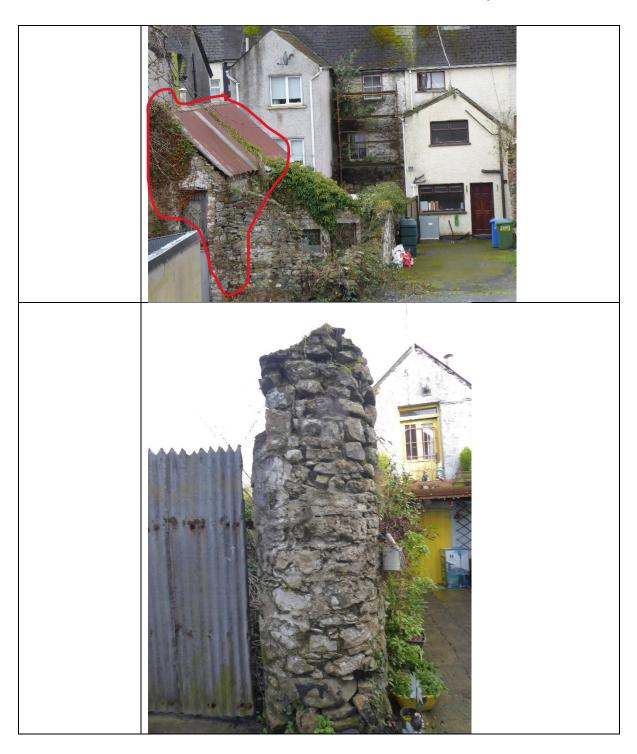
'McCarrons Shoe Repairs'	<image/>
Image 2	
Image 3

Description	Two-storey painted stone outbuilding to no.46, corrugated tin roof. Doors to both levels in front gable.
Planning History	None found
Other relevant information	Discussed with the owner on site. Lower floor was (and still is) used for storage by family. Upper level was a cobbler's workshop until the death of the cobbler c.2015. An external stair providing access to first floor entrance has since been removed.
Consideration	Outwith extents of indicative masterplan redevelopment zones. Historic structure of architectural and social interest.

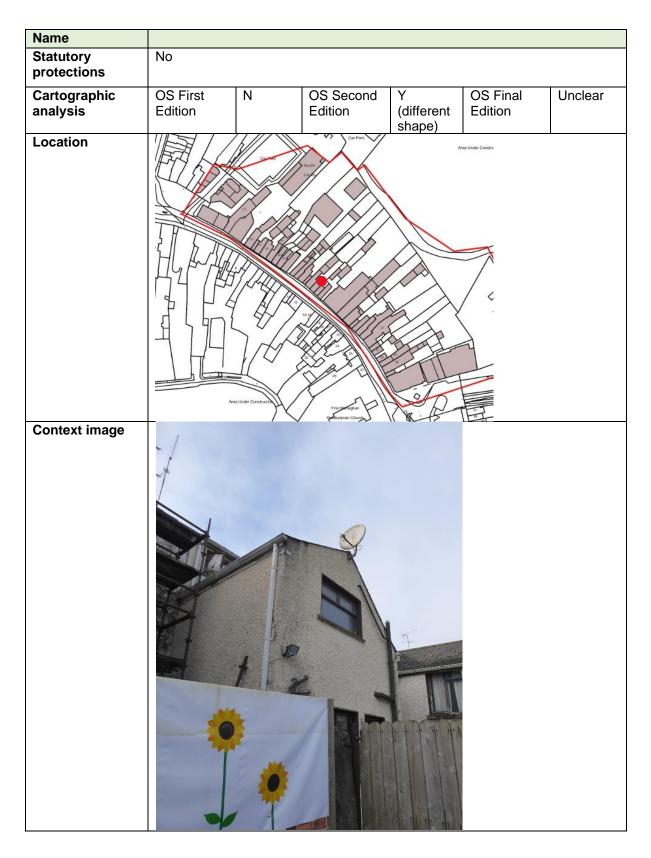
8.59 Number 48a

Image 2		
Description	Two-storey rendered rear return to no.48, likely a later replacement for an earlier structure.	
Planning History	None found	
Other relevant information		
Consideration	Outwith extents of indicative masterplan redevelopment zones.

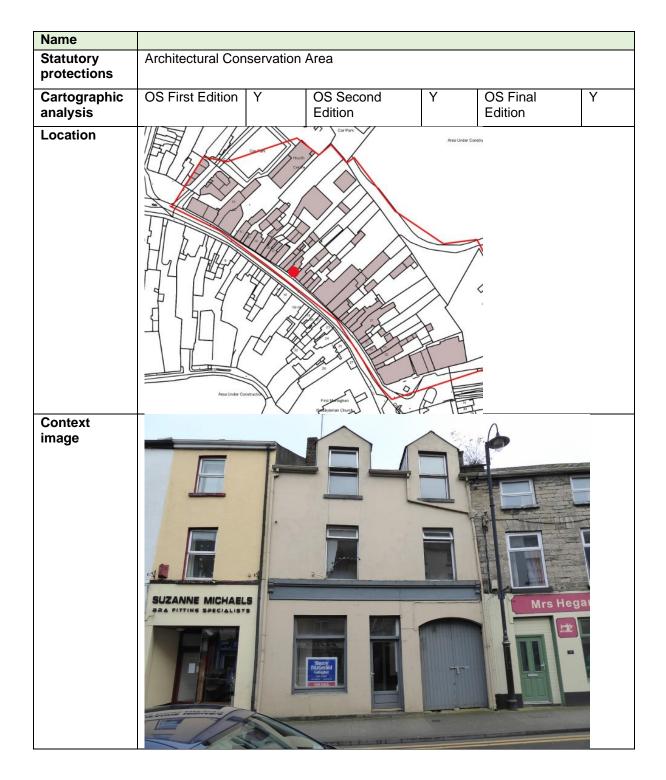
8.63 Number 50

Image 2	
Description	Three-storey two-bay building with painted render finish and carriage arch to front elevation. Coursed rubble stone finish to rear with varied window openings.
Planning History Other relevant	Reference No: 14345 Applicant Name: Paula Deery App Type: Permission Received Date: 14/11/2014 Status: Application Finalised Decision: Granted with Conditions Development Address: 50 Dublin Street, Monaghan, Co. Monaghan Development Description: for temporary permission for a period of three years to consist of change of use from a retail premises into a Tapas Bar. This will involve the removal of various partition walls and internal works, the provision of signage and all associated site works, situated in an architectural conservation area and zoned as "town centre" in the current County Development Plan.
information Consideration	Outwith extents of indicative masterplan radovalanment zonas

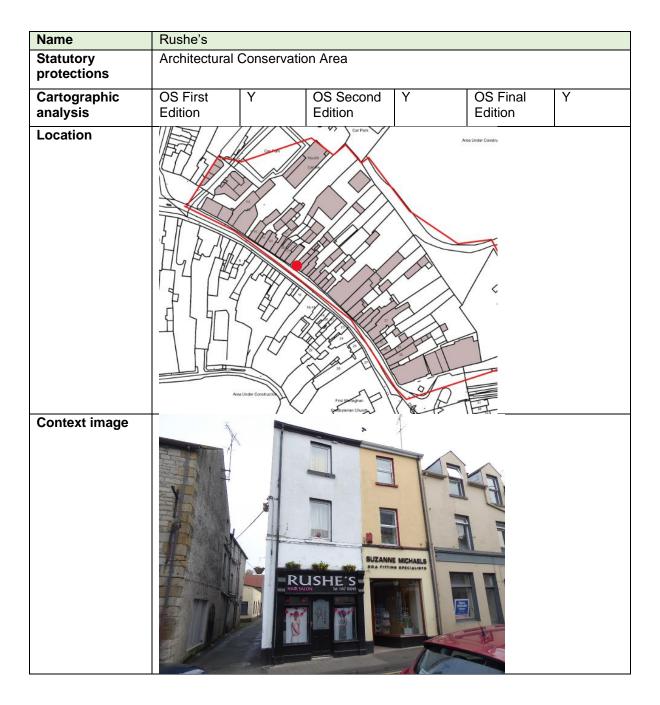
8.72 Number 52

Image 2	
Description	Three-storey single-bay painted render building. With shop front to ground floor.
Planning History	None found
Other relevant information	
Consideration	Outwith extents of indicative masterplan redevelopment zones.

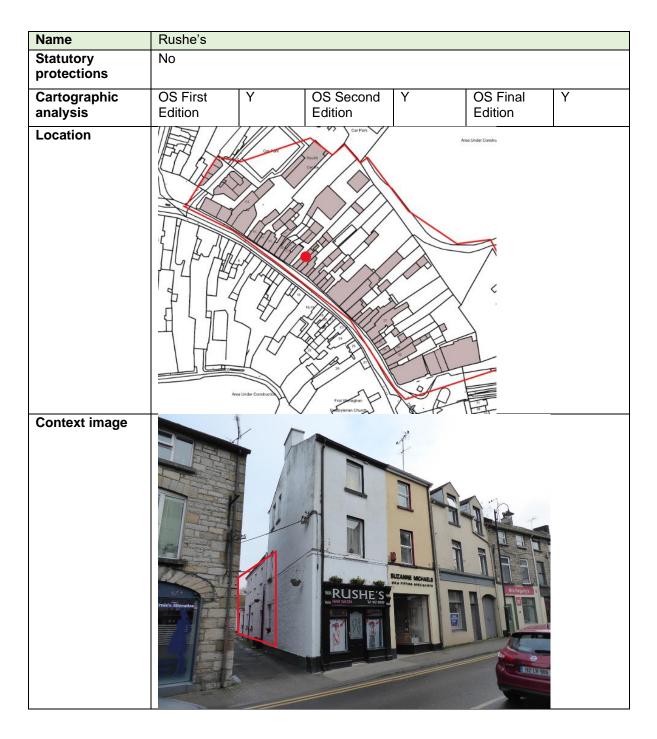
8.73 Number 52a

Description	Two-storey painted render extension to rear of no 52.
Planning History	None found
Other relevant information	
Consideration	Outwith extents of indicative masterplan redevelopment zones.

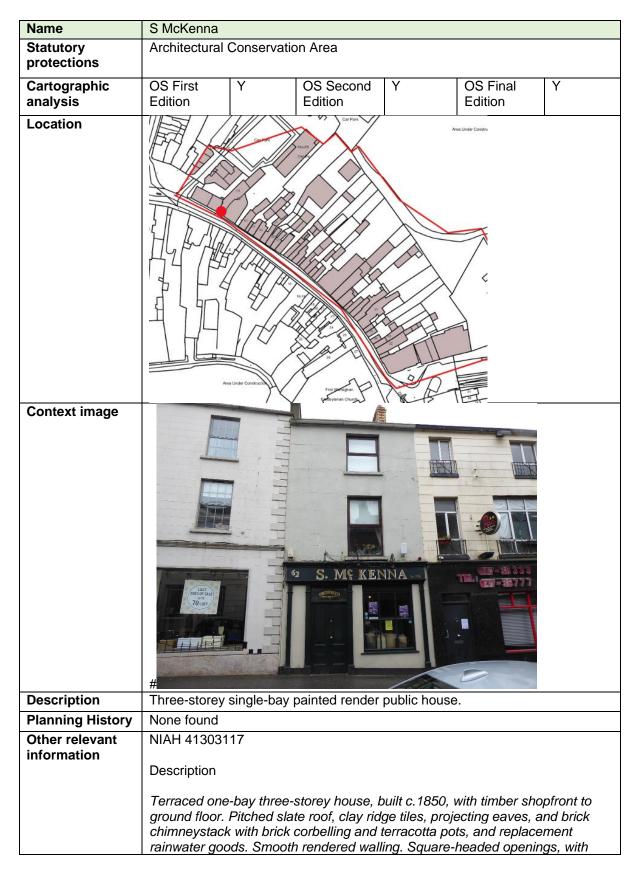
8.112 Number 62

stone sills and replacement uPVC windows. Timber shopfront comprising pilasters with plinths and simple capitals supporting plain fasciaboard with painted lettering, moulded cornice, and framing fixed square-headed six-pane timber-framed display window with fluting to frieze over window, and square- headed door opening with overlight and double-leaf timber panelled door.
	Appraisal This building is a pleasingly balanced composition of house and pub. It has a good example of a timber shopfront, with simple but appealing detailing, such as the fluted frieze over the window. The double-leaf door is typical of historic public houses. The structure and roofline also form a composite part of the curving narrow street.
Consideration	Outwith extents of indicative masterplan redevelopment zones.

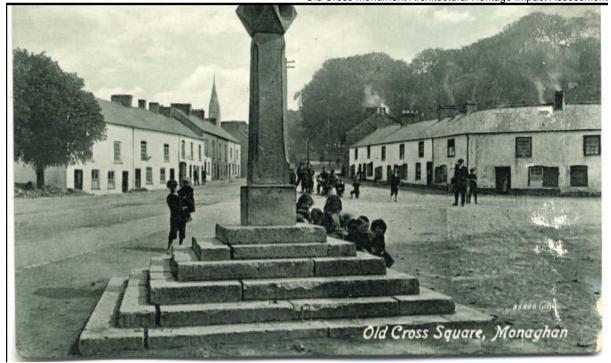
Figure 5 c. 1900, looking south – Position 2

The Monument can be seen standing in isolation (Figure 5) in Shambles Square, now with six steps (Position 2). It can be seen following the move that the space known as Shambles Square was renamed Old Cross Square by the time of the 25 inch OS map in 1908 (see Figure 6), when the Monument appears to have been moved further south towards the terrace of houses (see Figure 7)(Position 3). The image of the Pork Market (see Figure 8) shows the space in market use c.1910-14.

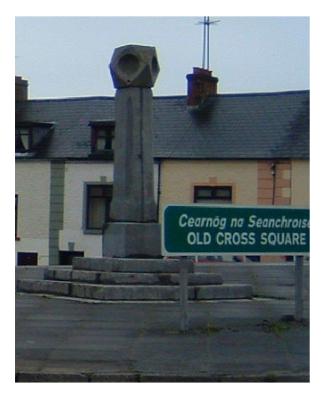
Figure 9 Undated image pre 2005 - Position 4³

Post 1914 there appear to have been two further changes in position, both times apparently to accommodate changing road layouts. The dates of the moves to Position 4 (Figure 9) and Position 5 (Figure 10) but the most recent move c.2010 to the current Position 5 (Figure 11) is well documented in the report by Dermot Nolan & Associates *Report on the Restoration of the Sundial Monument at Market Square Monaghan* dated 20th February 2011. Figure 12 provides indicative locations of each position, based on mapping and photographic sources. The proposed relocation is indicated as Position 7.

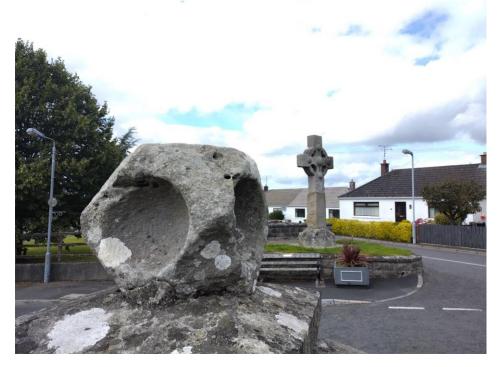
Figure 13 Sundial & Cross at Tynan⁴

The resorted Nunraw sundial in East Lothian (Figure 14) indicates how a sundial of this type may have functioned, with a metal gnomon on each face, each intended to display the time at a different location. This restoration project notes that the building of sundials was popular in Scotland in the 17th and 18th centuries. It is possible that a Scottish limestone sundial replaced an earlier limestone cross on this monument. The closest similar monument is at Tynan, co Monaghan.

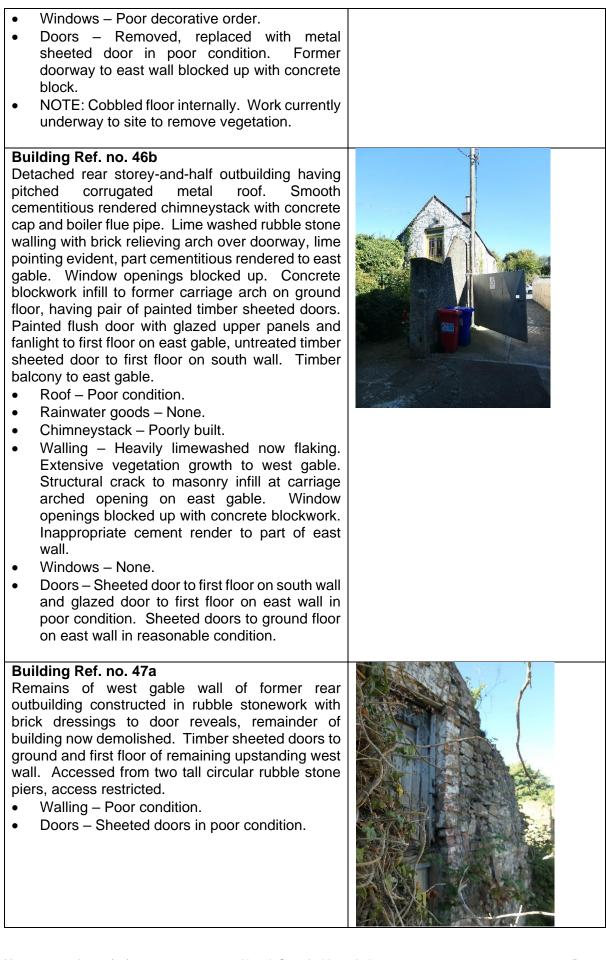
Building Ref. no. 49b Tall uncoursed rubble stone wall spanning east/west returning southwards at east end. Walling - Irregular uncapped wallhead with • vegetation and tree sapling growth. Several collapsed sections exposing wall core. Timber wallplates evident where former buildings abutted. Building Ref. no. 53 Two-storey building in commercial use. Pitched corrugated metal roof. uPVC rainwater goods. Limewashed rubble stone walling, with red brickwork to south wall having large area of concrete blockwork infill. Window boarded up on east wall. Large sliding timber sheeted door. Roof - Reasonable condition. • Rainwater goods – Inappropriate. • Heavily flaking limewash. Walling _ • Inappropriate infill material on east wall. Windows – Not accessible. • Doors – Heavily splice repaired at bottom with decay still evident. Building Ref. no. 53a Two-storey one-bay building. Pitched corrugated metal roof. uPVC rainwater goods. Limewashed rubble stone walling. uPVC casements windows and entrance door. Roof – Heavily rusted otherwise in reasonable • condition. Rainwater goods – Inappropriate. . Walling - Heavily flaking limewash structural cracks between adjoining properties on west wall. Windows - Inappropriate. Doors - Inappropriate. Building Ref. no. 53b Two-storey one-bay building. Pitched artificial slate to west range. Limewashed rubble stone to west range with segmental arched doorway opening leading to porch. Painted timber casement windows. • Roof –Inappropriate slating. Rainwater goods – Missing, timber fascia in poor condition. Walling -Heavily flaking limewash to west

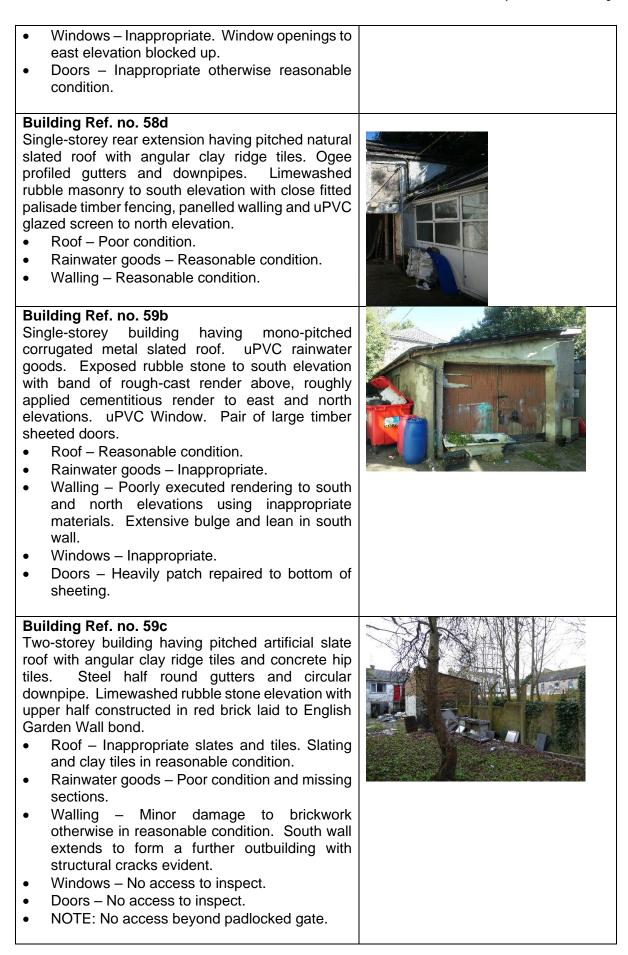
Building Ref. no. 62c

Two-storey five-bay building currently in commercial/retail use. having pitched artificial slate roof with concrete ridge tiles. Galvanised metal and uPVC rainwater goods. Coursed rubble limestone walling to south elevation with smooth render to shop front and painted smooth render to north and west elevations also having shop front, sandstone string course and window sills to south elevation. Painted timber casement windows.

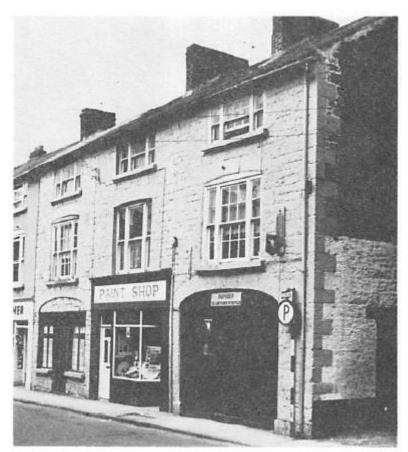
Figure 4 54,55 and 56 Dublin Street c.1970 (C.E.B. Brett)

A report carried out by C.E.B. Brett for Ulster Architectural Heritage Society and An Taisce, County Monaghan Branch (1970) *List of Historic Buildings, Groups of Buildings, Areas of Architectural Importance in the town of Monaghan*, describes the group as "An exceptionally fine group of three-storey houses of dressed stone, painted grey, with shallow triple windows under the eaves, triple windows in cambered arches at first floor level, broad segmental arches with finely-cut slating voussoirs, in Nos. 54 and 56, and most glazing bars complete". No. 54 has been modified over the last 55 years, notably the windows have been replaced (see Figure 6).

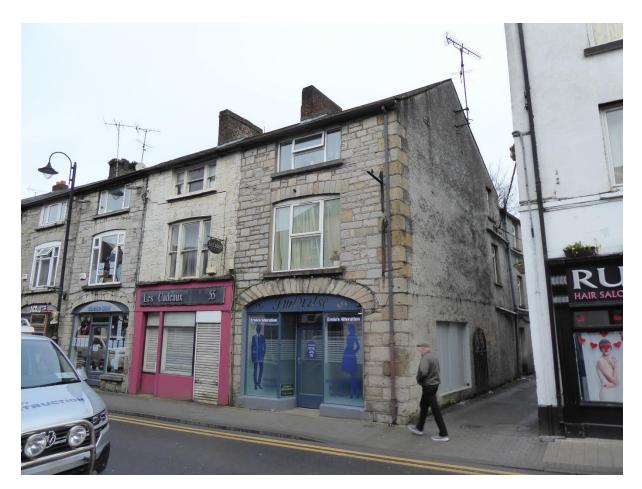
Figure 5 54,55 and 56 Dublin Street 2023

Number 54 is the southernmost of a group of four similar buildings, all on the Monaghan Record of Protected Structures (see Table 1). It is a three-storey single-bay shop with accommodation above, built c. 1815, with coursed dressed stone facing to the front façade and shop front to the ground floor (see Figure 5). Figure 4 demonstrates that the windows were originally Wyatt-style timber sliding sash windows. This style of window was particularly popular in Ireland during the period 1799-1822, coinciding with the window tax of that time which counted quantity, not size, of windows.

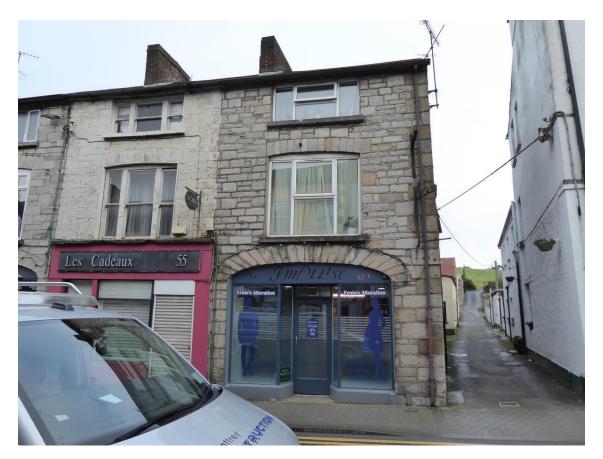
Figure 6 54 Dublin Street

A brief Building Condition report for this building is available in MAD-R016 Summary Condition of Buildings. The level of intervention and modification to this building including replacement rainwater goods and windows reduces its heritage significance.

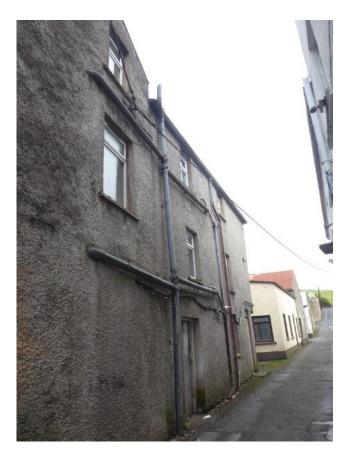
Figure 7 54A Three-storey return to no. 54

A large three-storey dashed render return to the rear (54a for the purposes of this report, see Figure 7) appears to be contemporary to the main building. A single-storey painted dash render outbuilding (54b for this report, see Figure 8) to the north-east falls partially within the redevelopment zone. Planning approval granted in 1999 does not appear to have been enacted. 54b is in separate ownership from no. 54, is not historically part of the same curtilage, and is therefore not discussed in detail within this report.

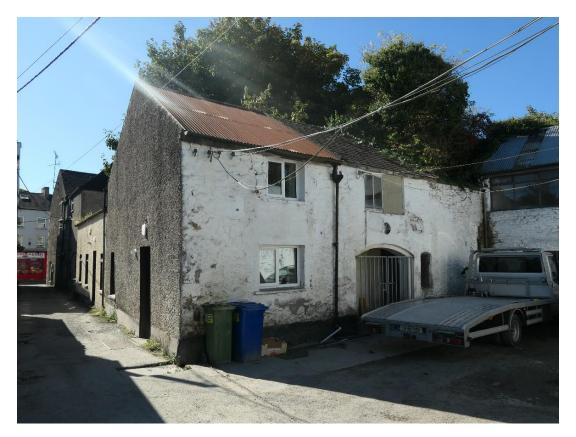
Figure 9 53a and 53b

North-east of 54b along Pump Entry are a group of buildings addressed as no. 53 Dublin Street, including a two-storey painted rubble stone outbuilding with a corrugated metal roof (see Figure 9), and a garage building 53d (see Figure 10), which are within the land take necessary for the proposed Russell Row. Number 53 and its group are historic structures of low architectural interest, having neither statutory protection nor any non-statutory record and these have been proposed for demolition in order to facilitate the proposed new road Russell Row.

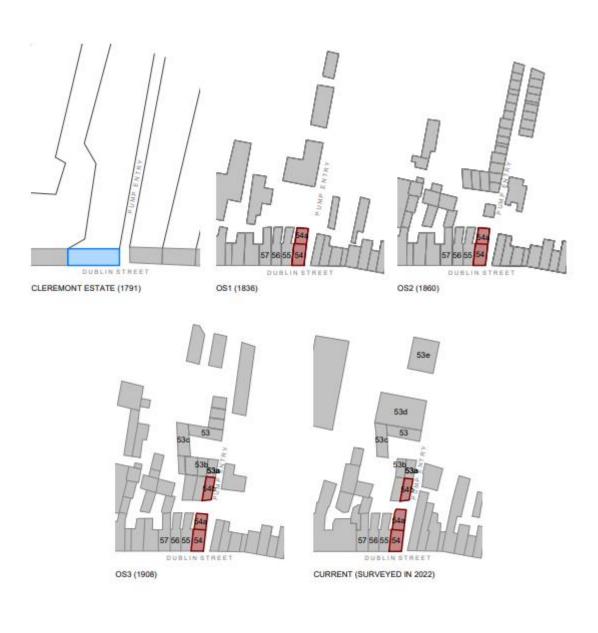
Figure 11 Cartographic Analysis

The site is shown with the Protected Structure highlighted on each of the maps in Figure 11. The earliest visible structure on the site c.1791 appears to take in all four buildings in the current group. By 1836 the footprint of each of the four matches that visible on the current map, indicating a construction date for these in the early 1800s. It can also be seen that Pump Entry has existed as a circulation route since the earliest map, and by the time of OS1 c.1836 the curtilage behind the 1791 building appears to have been split into smaller plots fronting onto Pump Entry.

OS2 c.1860 indicates these plots split further into terraces on both sides of Pump Entry, which have largely gone by OS3 c.1908. OS3 shows the first sign of the courtyard arrangement of no. 53 Dublin Street. No. 53 and 53c appear to be the same buildings visible on OS3. 53b appears to align with a footprint from OS2, suggesting it is a remainder of the earlier arrangement. 53a is a different shape on the same footprint, suggesting a different or modified building. The remainder of the terrace north-east of no. 53, visible on OS3, is no longer extant and buildings 53d and 53e are of modern construction.

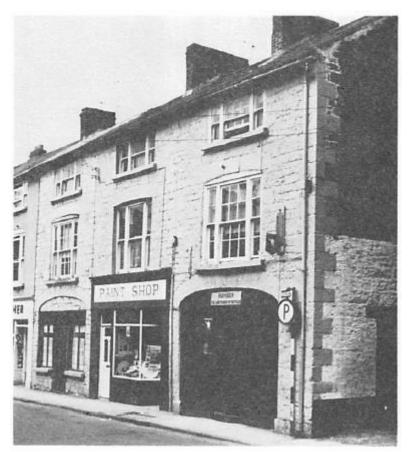
Figure 4 54,55 and 56 Dublin Street c.1970 (C.E.B. Brett)

A report carried out by C.E.B. Brett for Ulster Architectural Heritage Society and An Taisce, County Monaghan Branch. (1970) List of Historic Buildings, Groups of Buildings, Areas of Architectural Importance in the town of Monaghan, describes the group as "An exceptionally fine group of three-storey houses of dressed stone, painted grey, with shallow triple windows under the eaves, triple windows in cambered arches at first floor level, broad segmental arches with finely-cut slating voussoirs, in Nos. 54 and 56, and most glazing bars complete".

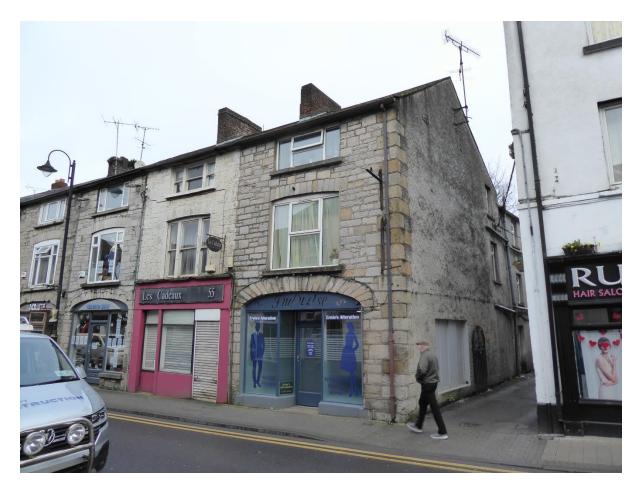
Figure 5 54,55 and 56 Dublin Street 2023

Number 55 is part of a group of four similar buildings, all on the Monaghan Record of Protected Structures (see Table 1). It is a three-storey single-bay shop with accommodation above, built c. 1815, with coursed dressed stone facing to front façade and shop front to ground floor (see Figure 5 **Error! Reference source not found.**). Figure 4 demonstrates that the windows were originally Wyatt-style timber sliding sash windows. This style of window was particularly popular in Ireland during the period 1799-1822, coinciding with the window tax of that time which counted quantity, not size, of windows.

The large glazed panes indicate modification from the smaller window panes visible to nos. 54 and 55 (see Figure 4). Whilst the shopfront has changed since the c.1970 photograph taken 55 years ago, the windows appear to be the same, albeit in poor condition. Natural slate and cast-iron rainwater goods are both present (see Figure 6). Monaghan Council has served notice on this premises as listed on the Derelict Sites Register.

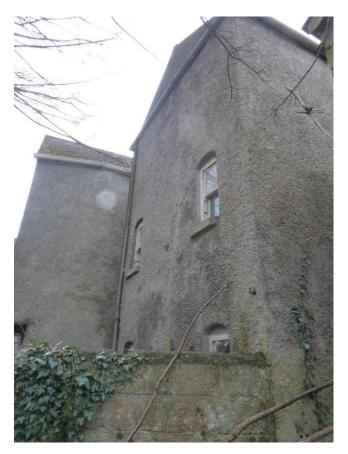
Figure 7 55a Two-storey extension to no.55

A large three-storey dashed render return (55a for the purposes of this report, see **Error! Reference source not found.**) to the rear appears to be contemporary to the main building. This return also retains a slate roof, cast-iron rainwater goods and timber sliding sash windows. The outbuilding to the rear (55b, see **Error! Reference source not found.**) was inaccessible but appears to be in poor condition and heavily overgrown with vegetation. It is currently part of the same ownership as no. 55, and appears to be part of its historic curtilage.

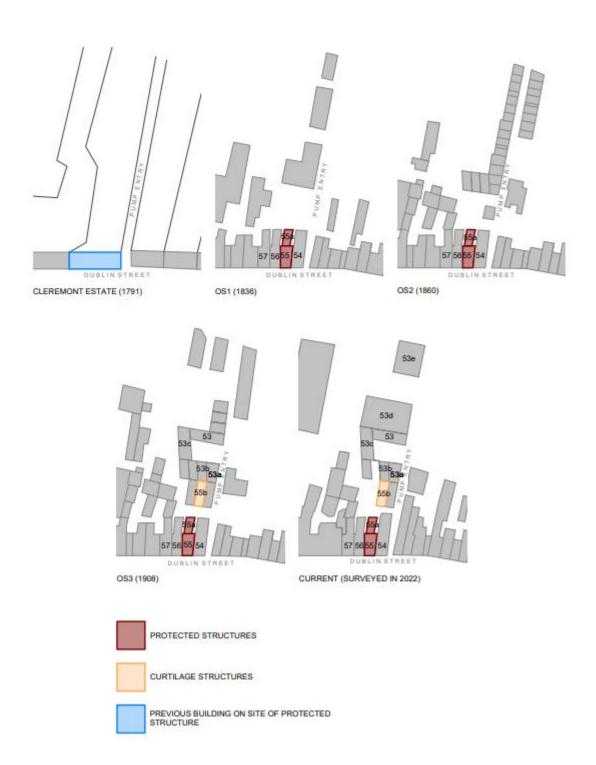
Figure 9 Cartographic Analysis

The site is shown, with the Protected Structure highlighted on each of these maps, in Figure 9. The earliest visible structure on the site c.1791 appears to take in all four buildings in the current group. By 1836 the footprint of each of the four matches that visible on the current map, indicating a construction date for these in the early 1800s. The outbuilding 55b is present on OS3, and is likely the same building currently extant on the site.

OS2 c.1860 indicates these plots split further into terraces on both sides of Pump Entry, which have largely gone by OS3 c.1908. OS3 shows the first sign of the courtyard arrangement of no. 53 Dublin Street. No. 53 and 53c appear to be the same buildings visible on OS3. 53b appears to align with a footprint from OS2, suggesting it is a remainder of the earlier arrangement. 53a is a different shape on the same footprint, suggesting a different or modified building. The remainder of the terrace northeast of no. 53, visible on OS3, is no longer extant and buildings 53d and 53e are of modern construction.

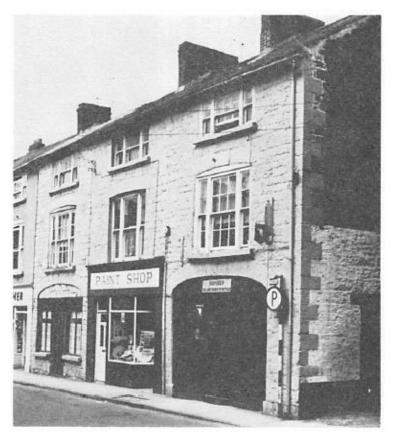
Figure 4 54,55, 56 and 57 Dublin Street c.1970 (C.E.B. Brett)

A report carried out by C.E.B. Brett for Ulster Architectural Heritage Society and An Taisce, County Monaghan Branch (1970) List of Historic Buildings, Groups of Buildings, Areas of Architectural Importance in the town of Monaghan, describes the group as "An exceptionally fine group of three-storey houses of dressed stone, painted grey, with shallow triple windows under the eaves, triple windows in cambered arches at first floor level, broad segmental arches with finely-cut slating voussoirs, in Nos. 54 and 56, and most glazing bars complete".

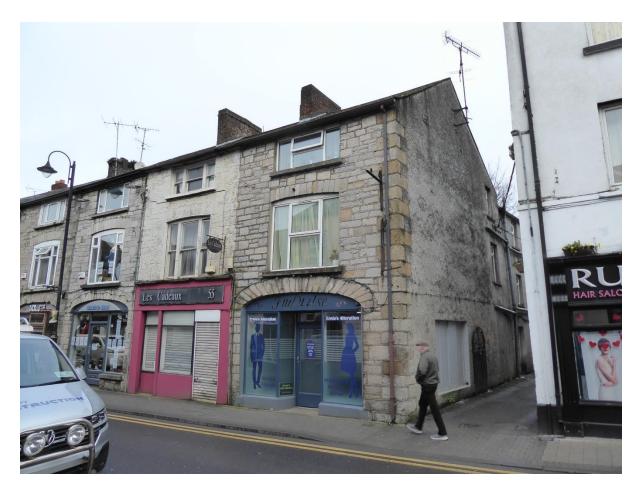
Figure 5 54,55, 56 and 57 Dublin Street 2023

Number 56 is one of a group of four similar buildings, all on the Monaghan Record of Protected Structures (see Table 1). It is a three-storey single-bay shop with accommodation above, built c. 1815, with coursed dressed stone facing to the front façade and shop front to the ground floor (see Figure 5). Figure 4 demonstrates that the windows were originally Wyatt-style timber sliding sash windows. This style of window was particularly popular in Ireland during the period 1799-1822, coinciding with the window tax of that time which counted quantity, not size, of windows.

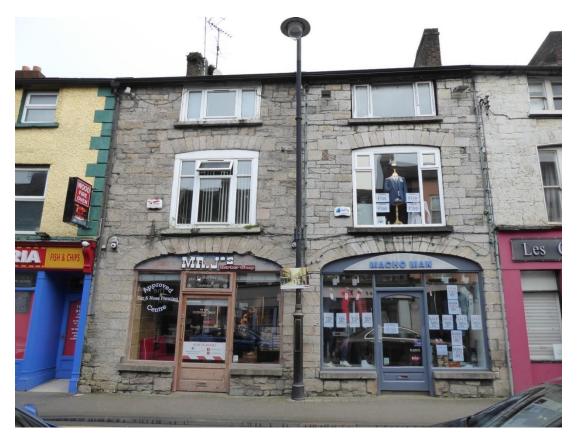
Figure 6 56 Dublin Street (right)

The building has undergone significant alterations since this photograph was taken 55 years ago (see Figure 6), with replacement uPVC windows to the upper floors. Although changes have been made to the shopfront, it is in reasonable condition.

A brief Building Condition report for this building is available in MAD-R016 Summary Condition of Buildings. The level of intervention and modification to this building including replacement rainwater goods and windows reduces its heritage significance.

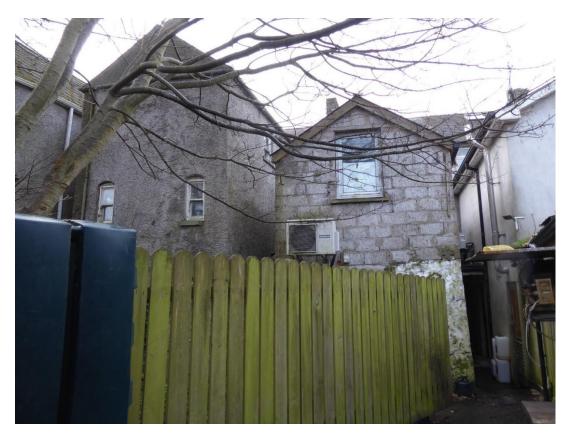
Figure 7 56A Two-storey return to rear of no.56

A two-storey return (56a for the purposes of this report, see Figure 7) is located to the rear of the main building within the historic curtilage of no. 56, and falls under its statutory protection. The ground floor is of painted rubble stone and the first floor has been modified or added to with a floor of exposed concrete blockwork walling. The building lies outside the Dublin Street Architectural Conservation Area.

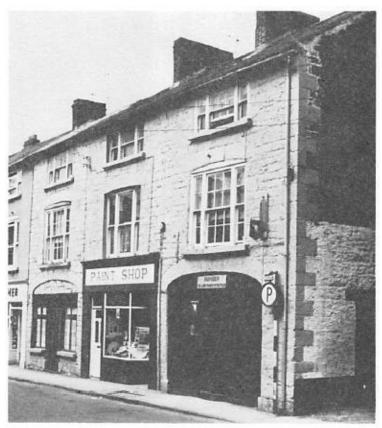
Figure 4 54,55, 56 and 57 (far left) Dublin Street c.1970 (C.E.B. Brett)

A report carried out by C.E.B. Brett for Ulster Architectural Heritage Society and An Taisce, County Monaghan Branch (1970) List of Historic Buildings, Groups of Buildings, Areas of Architectural Importance in the town of Monaghan, describes the group as "An exceptionally fine group of three-storey houses of dressed stone, painted grey, with shallow triple windows under the eaves, triple windows in cambered arches at first floor level, broad segmental arches with finely-cut slating voussoirs, in Nos. 54 and 56, and most glazing bars complete".

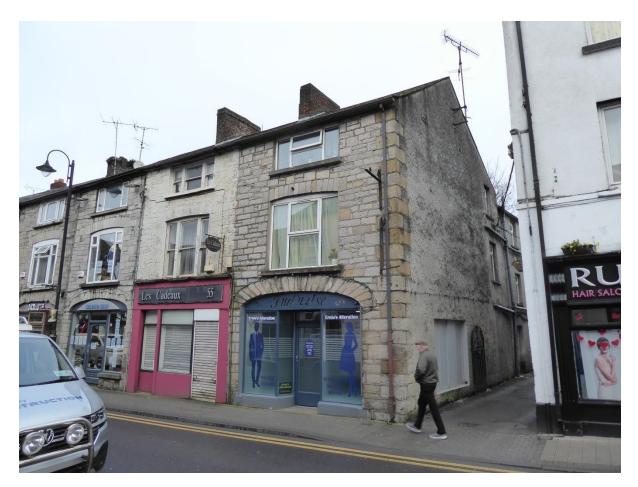
Figure 5 54,55 and 56 Dublin Street 2023

The building has undergone significant alterations since this photograph was taken 55 years ago (see Figure 5 and Figure 6), with replacement uPVC windows to the upper floors and the building has been re-roofed with artificial slate. Although changes have been made to the shopfront, it is in reasonable condition.

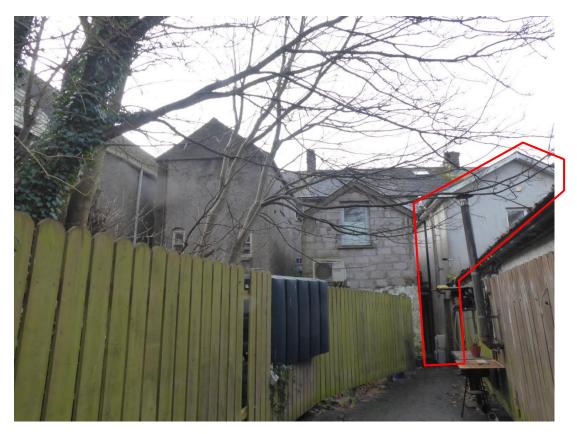
Figure 7 57A Two-storey extension to rear of no. 57

A two-storey render extension of modern construction (57a for the purposes of this report, see Figure 7) is located to the rear of the main building, likely following planning approval M.U. 29/97 in 1997.

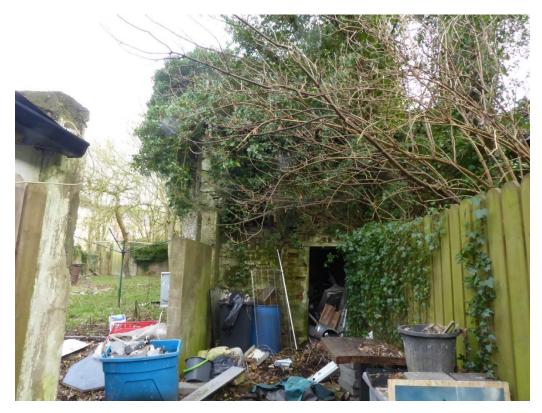
Figure 8 57c Two-storey brick and stone outbuilding to rear of no.56

To the rear of the site is a two-storey brick and stone outbuilding heavily overgrown with vegetation (57c, see Figure 8 and Figure 9). This historic structure appears to fall within the current ownership of no.57. It is therefore assumed that the Record of Protected Structures designation of no.57 should be taken into consideration when assessing the significance and sensitivity of structure 57c. The building is in very poor condition, and is proposed for demolition in order to facilitate the proposed new road Russell Row under the approved Dublin Street North Regeneration Plan. Cartographic analysis indicates that it is of later construction than no.57, and is ambiguous regarding their connection (see Section 3). This structure is not visually connected to the key views of the Protected Structure from Dublin Street and in our opinion does not contribute to the heritage significance of no.57. No. 57 derives its significance largely from the architectural style, material and relationship with nos. 54-56 Dublin Street. This structure is therefore considered to be of low architectural sensitivity (see 5.2).

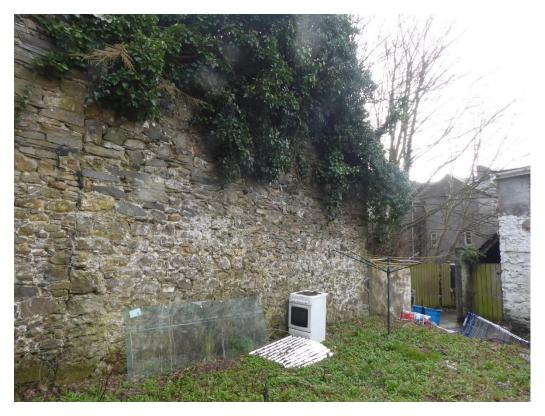
Figure 9 57c Two-storey brick and stone outbuilding to rear of no.56

Currently this structure is in very poor condition and heavily obscured by vegetation. As shown in Table 3, the proposed mitigations for no. 57c involve recording the structure pre-demolition and planning for salvage post-demolition.

The proposed demolition of the Curtilage Structure 57c will have a slight to moderate impact on the immediate environment, with noticeable changes to the character of the environment. The magnitude of the effect is noted as low, as this structure is secondary to the Recorded Protected Structure, is in poor condition and of low architectural significance, and does not contribute to the key visual identity of the Protected Structure.

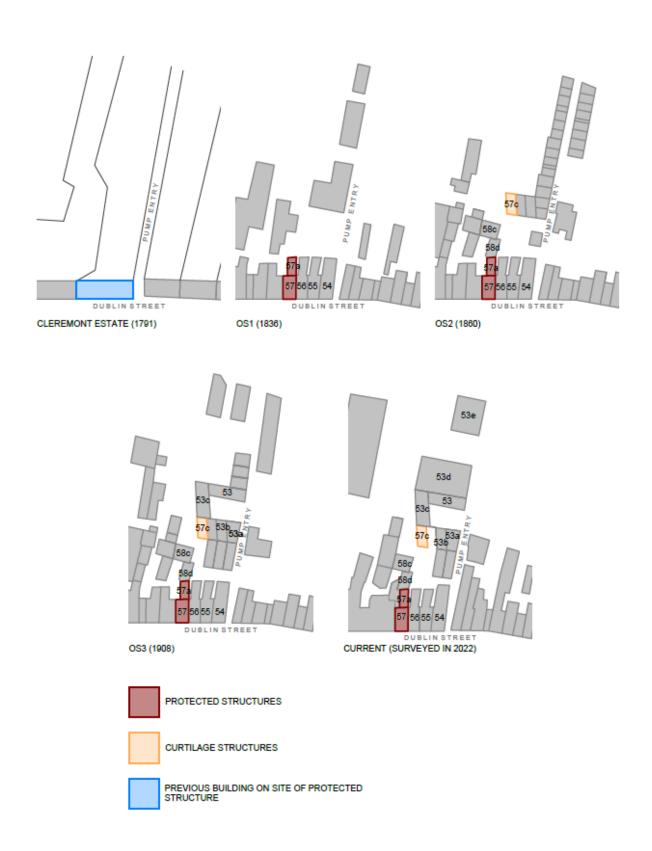
Figure 10 Cartographic Analysis

The site is shown with the Protected Structure and Curtilage Structure highlighted on each of the maps in Figure 10. The earliest visible structure on the site c.1791 appears to take in all four buildings in the current group. By 1836 the footprint of each of the four buildings matches that visible on the current map, indicating a construction date for these in the early 1800s. It can also be seen that Pump Entry has existed as a circulation route since the earliest map, and by the time of OS1 c.1836 the curtilage behind the 1791 building appears to have been split into smaller plots fronting onto Pump Entry.

By OS2 c.1860 these plots have been further subdivided into terraces, and the structure to the rear of no.58 in OS1 has been replaced by a number of buildings occupying approximately the same footprint by OS2 c.1860. It can be seen in this map that No. 58c is linked to no.57 and its return no. 57a by an additional structure 58d. OS3 c.1908 shows the terraces flanking Pump Entry have largely gone and have been replaced by the first instance of a courtyard arrangement at no. 53 Dublin Street.
