**BLESSINGTON DEMESNE LRD**

**ENVIRONMENTAL IMPACT ASSESSMENT REPORT**

**VOLUME III APPENDICES**

**Bat Fauna Impact Assessment for the  
Proposed Blessington Demesne Town Park & Residential Development**

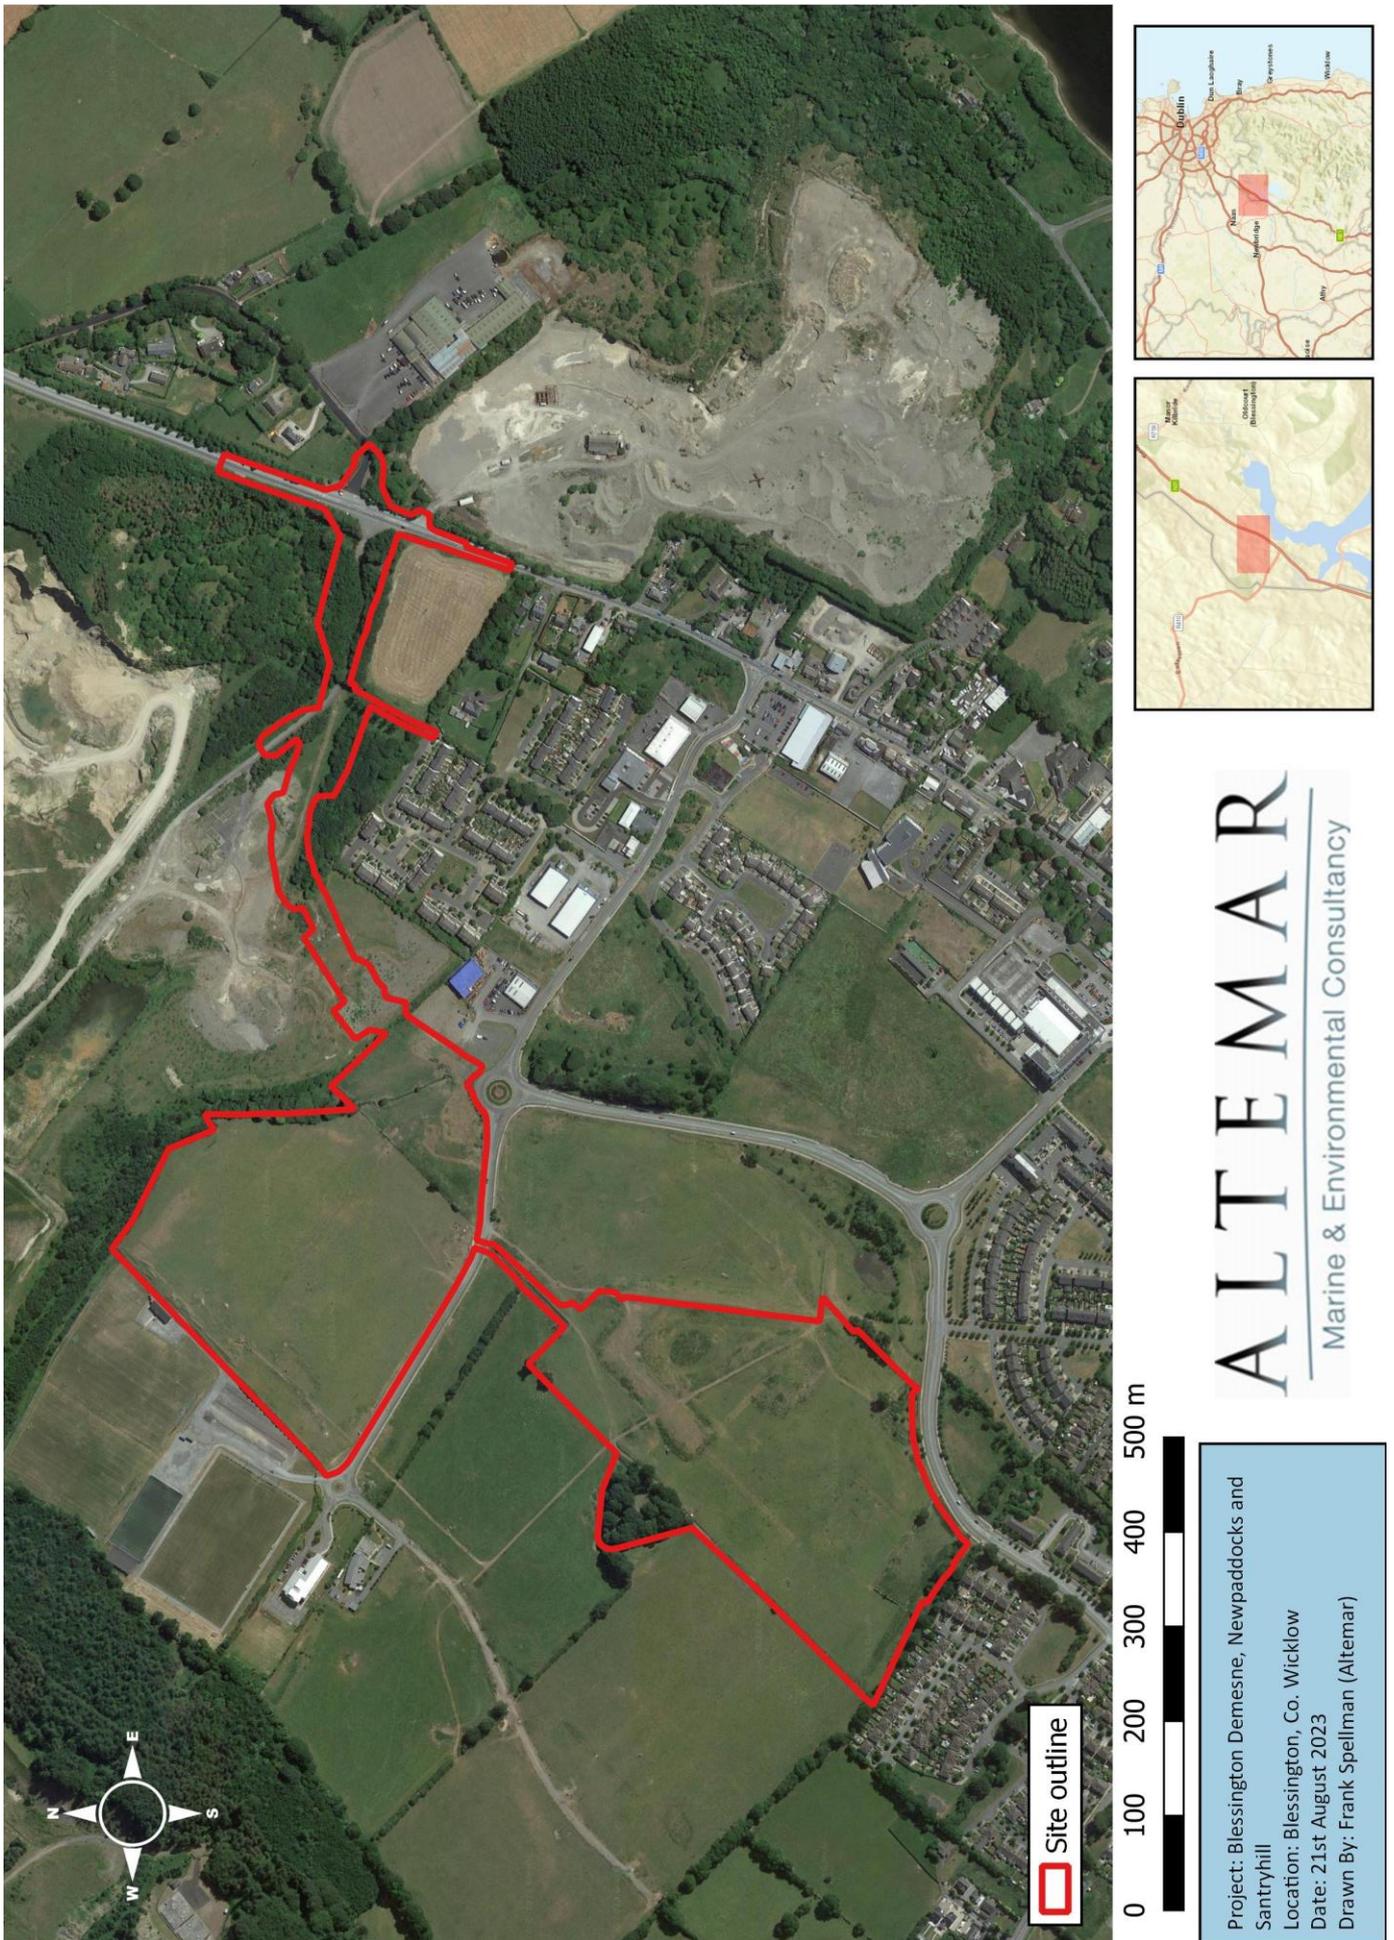
Figure 1. Proposed site outline and location

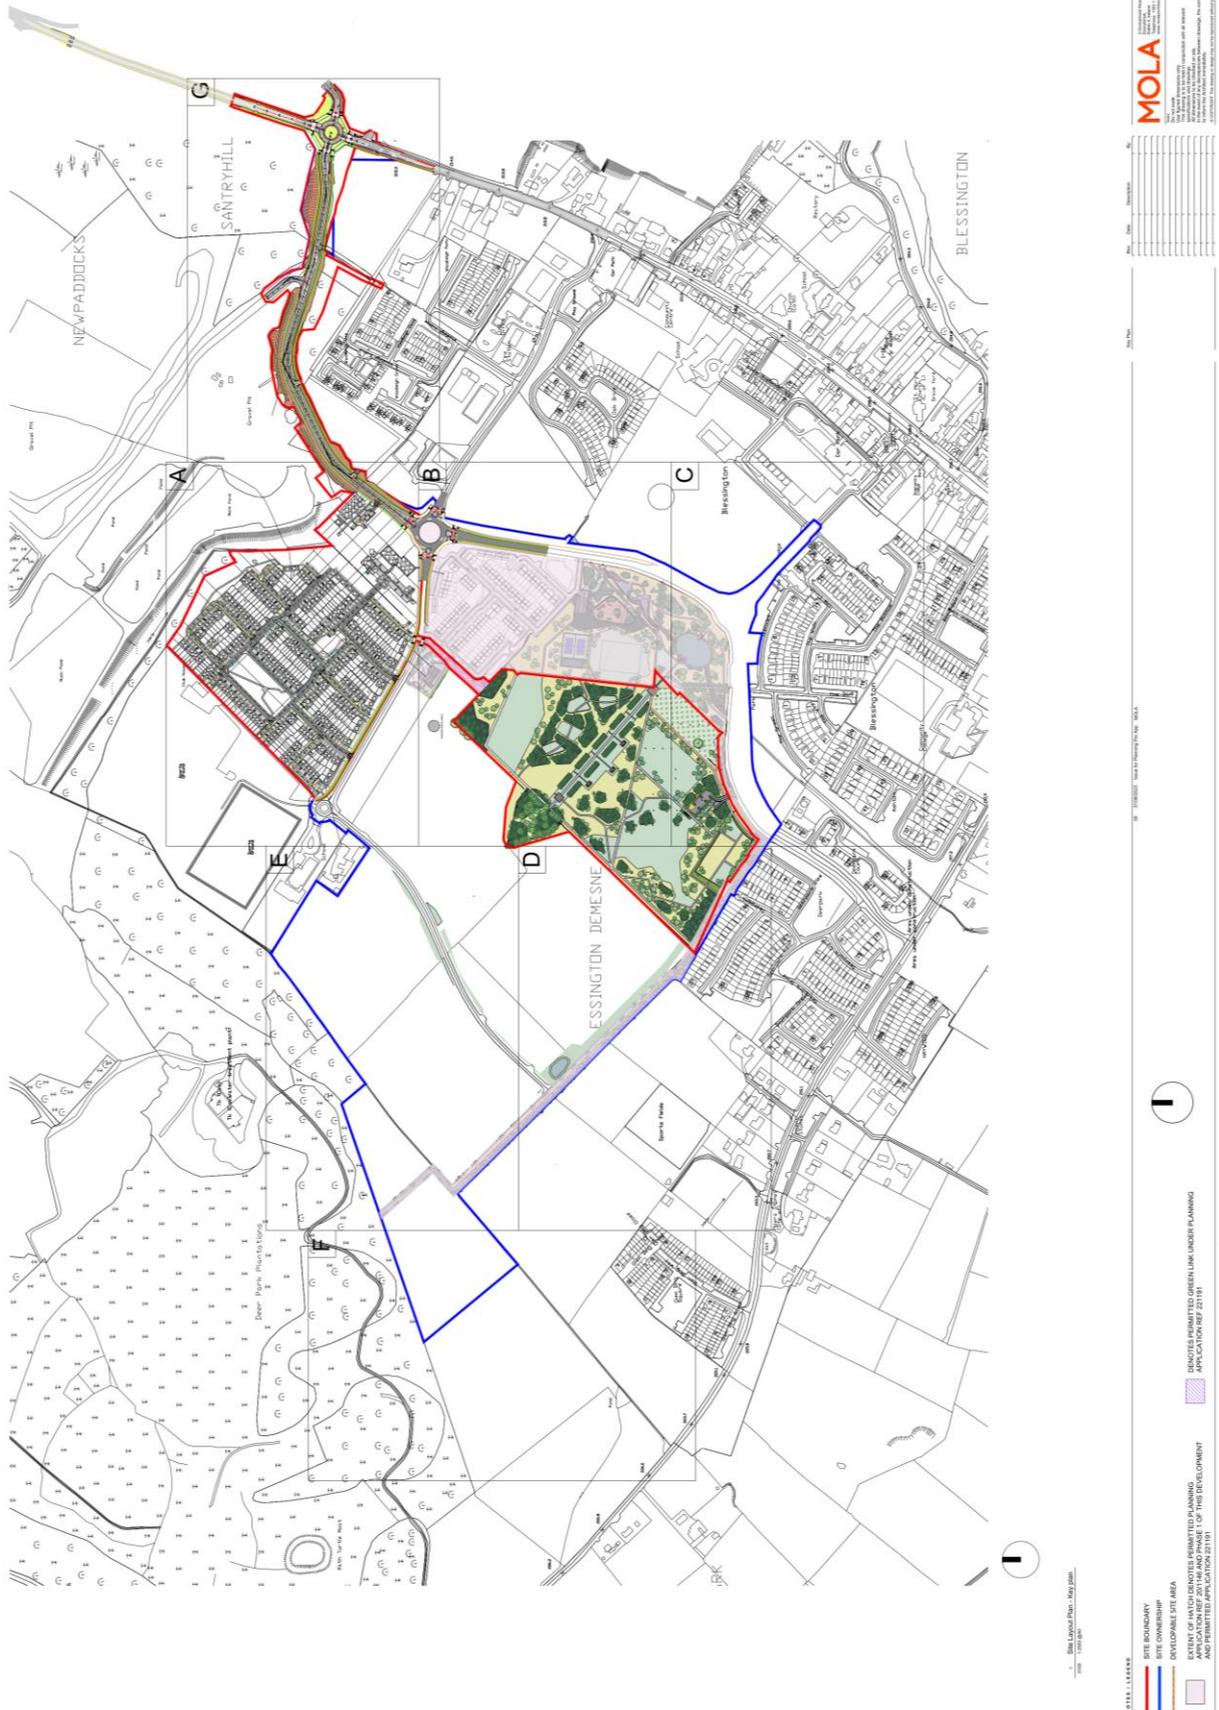
Figure 2. Site Layout Plan

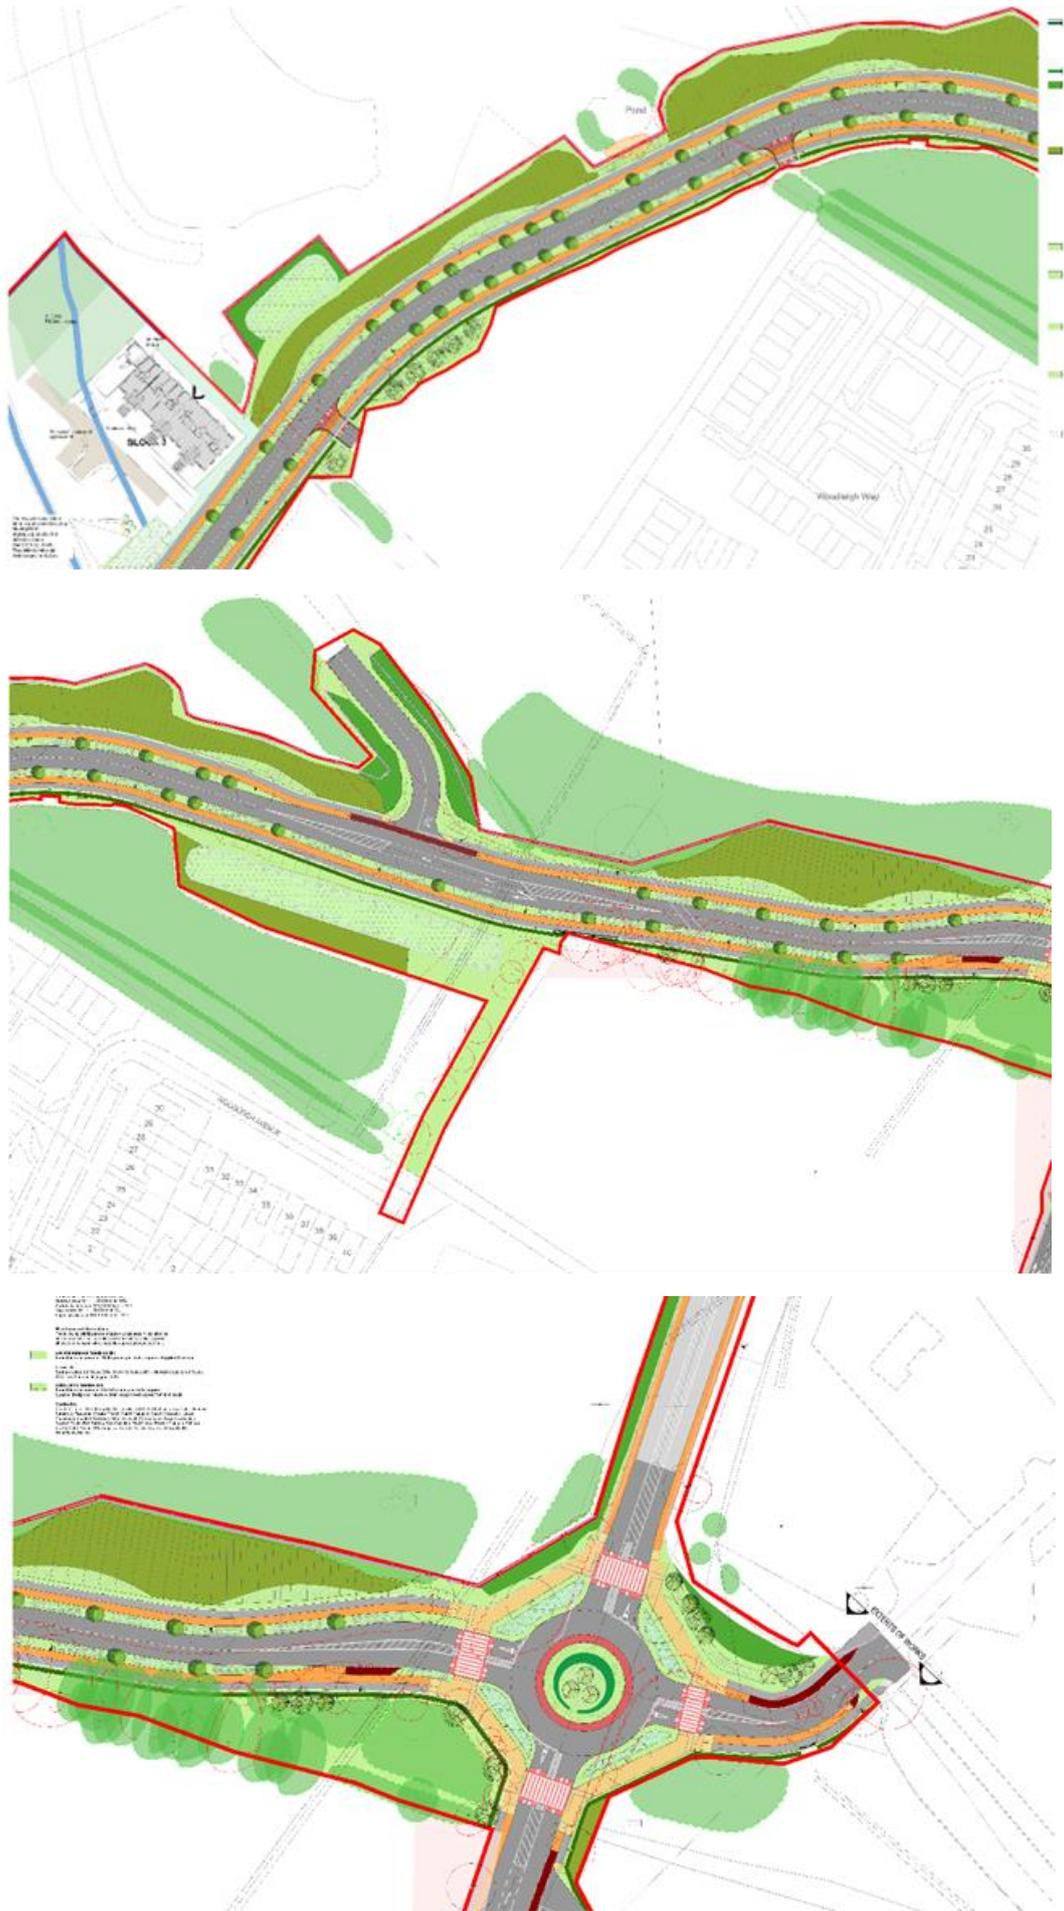
Figures 5a-5c. Proposed landscape masterplan (Blessington Inner Link Street)

The landscape strategy for the Blessington Inner Link Street elements of the proposed development has been prepared by Cunnane Stratton Reynolds to accompany this planning application. The proposed landscape masterplan (Blessington Inner Link Street) is demonstrated in Figure 5.

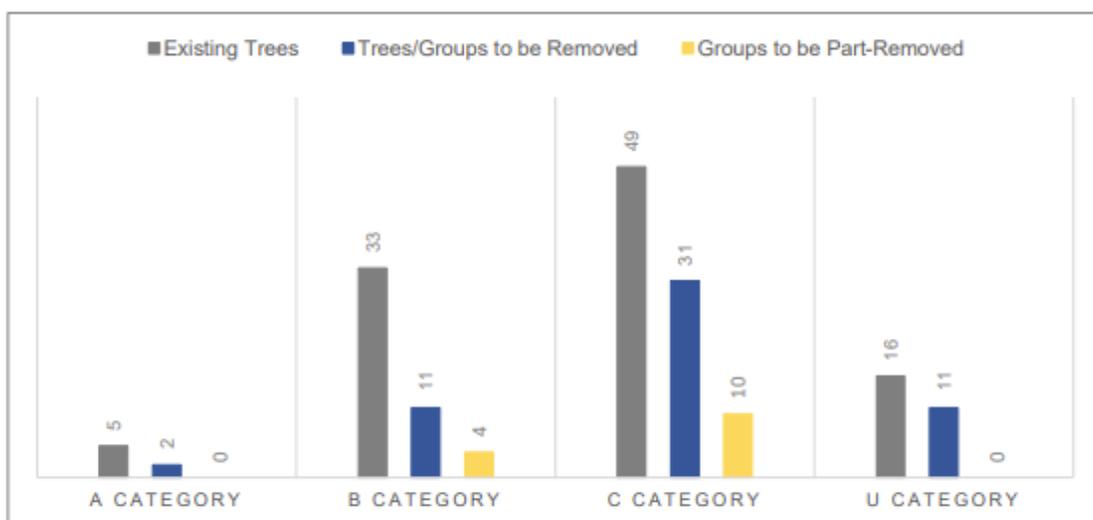
**Figure 3: Breakdown of tree removal required as part of the development.**

Of the 69 survey entries proposed to be removed or partially removed, 2 trees are of high quality and value (A Category), 11 trees, 1 hedgerow and 3 woodlands are of moderate quality and value (B Category) and 29 trees, 9 groups of trees, 2 woodlands and 1 hedgerow are of low quality and value (C Category) and 11 trees are of poor quality (U Category). A breakdown of trees and groups to be removed / partially removed according to their BS5837:2012 category is outlined in Figure 3.

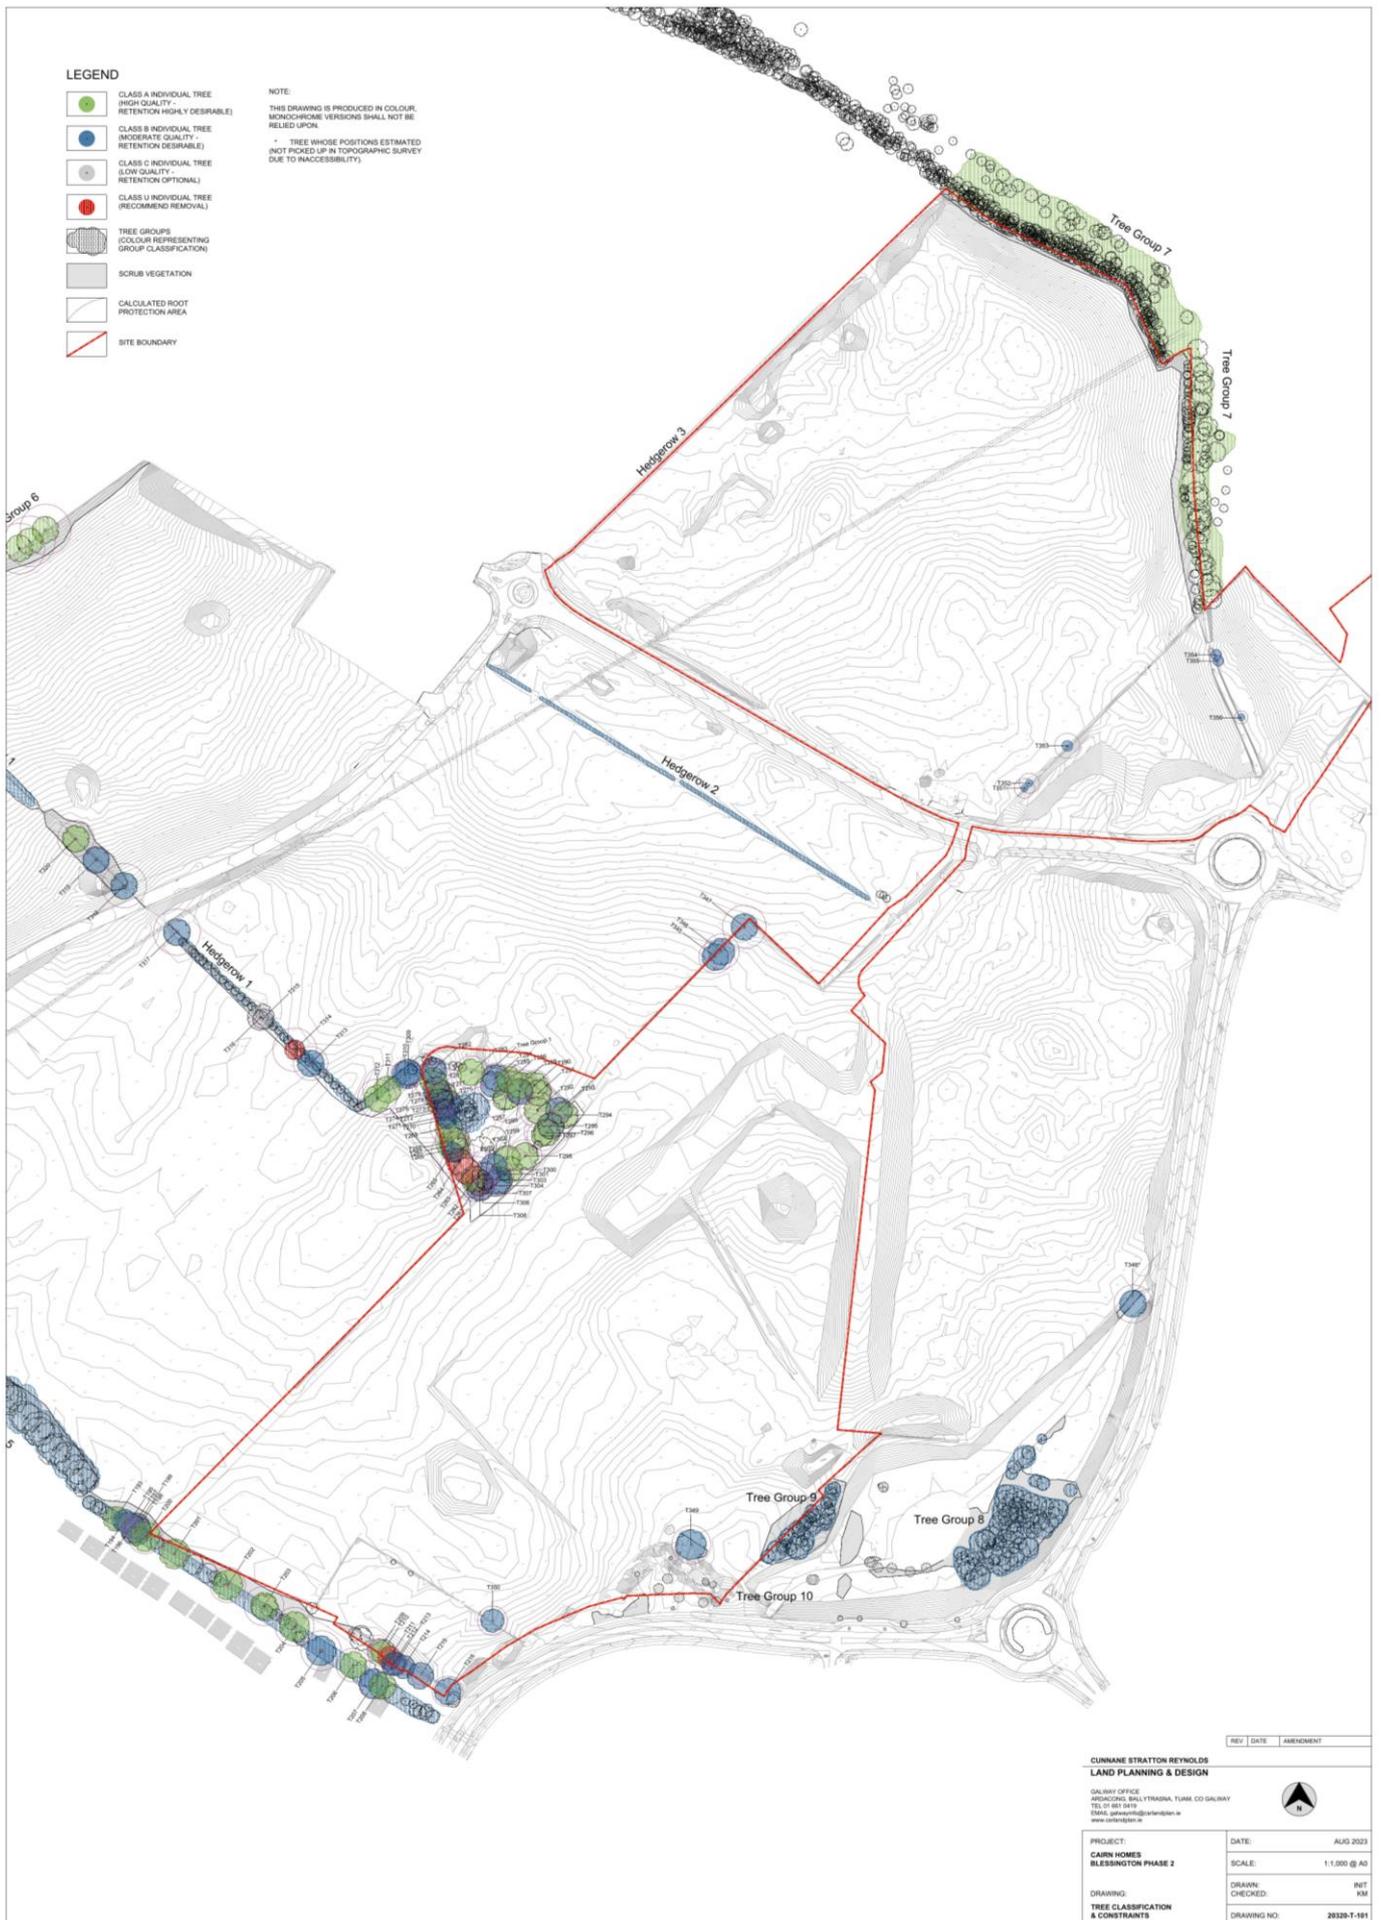
Figure 6. Tree Classification & Constraints

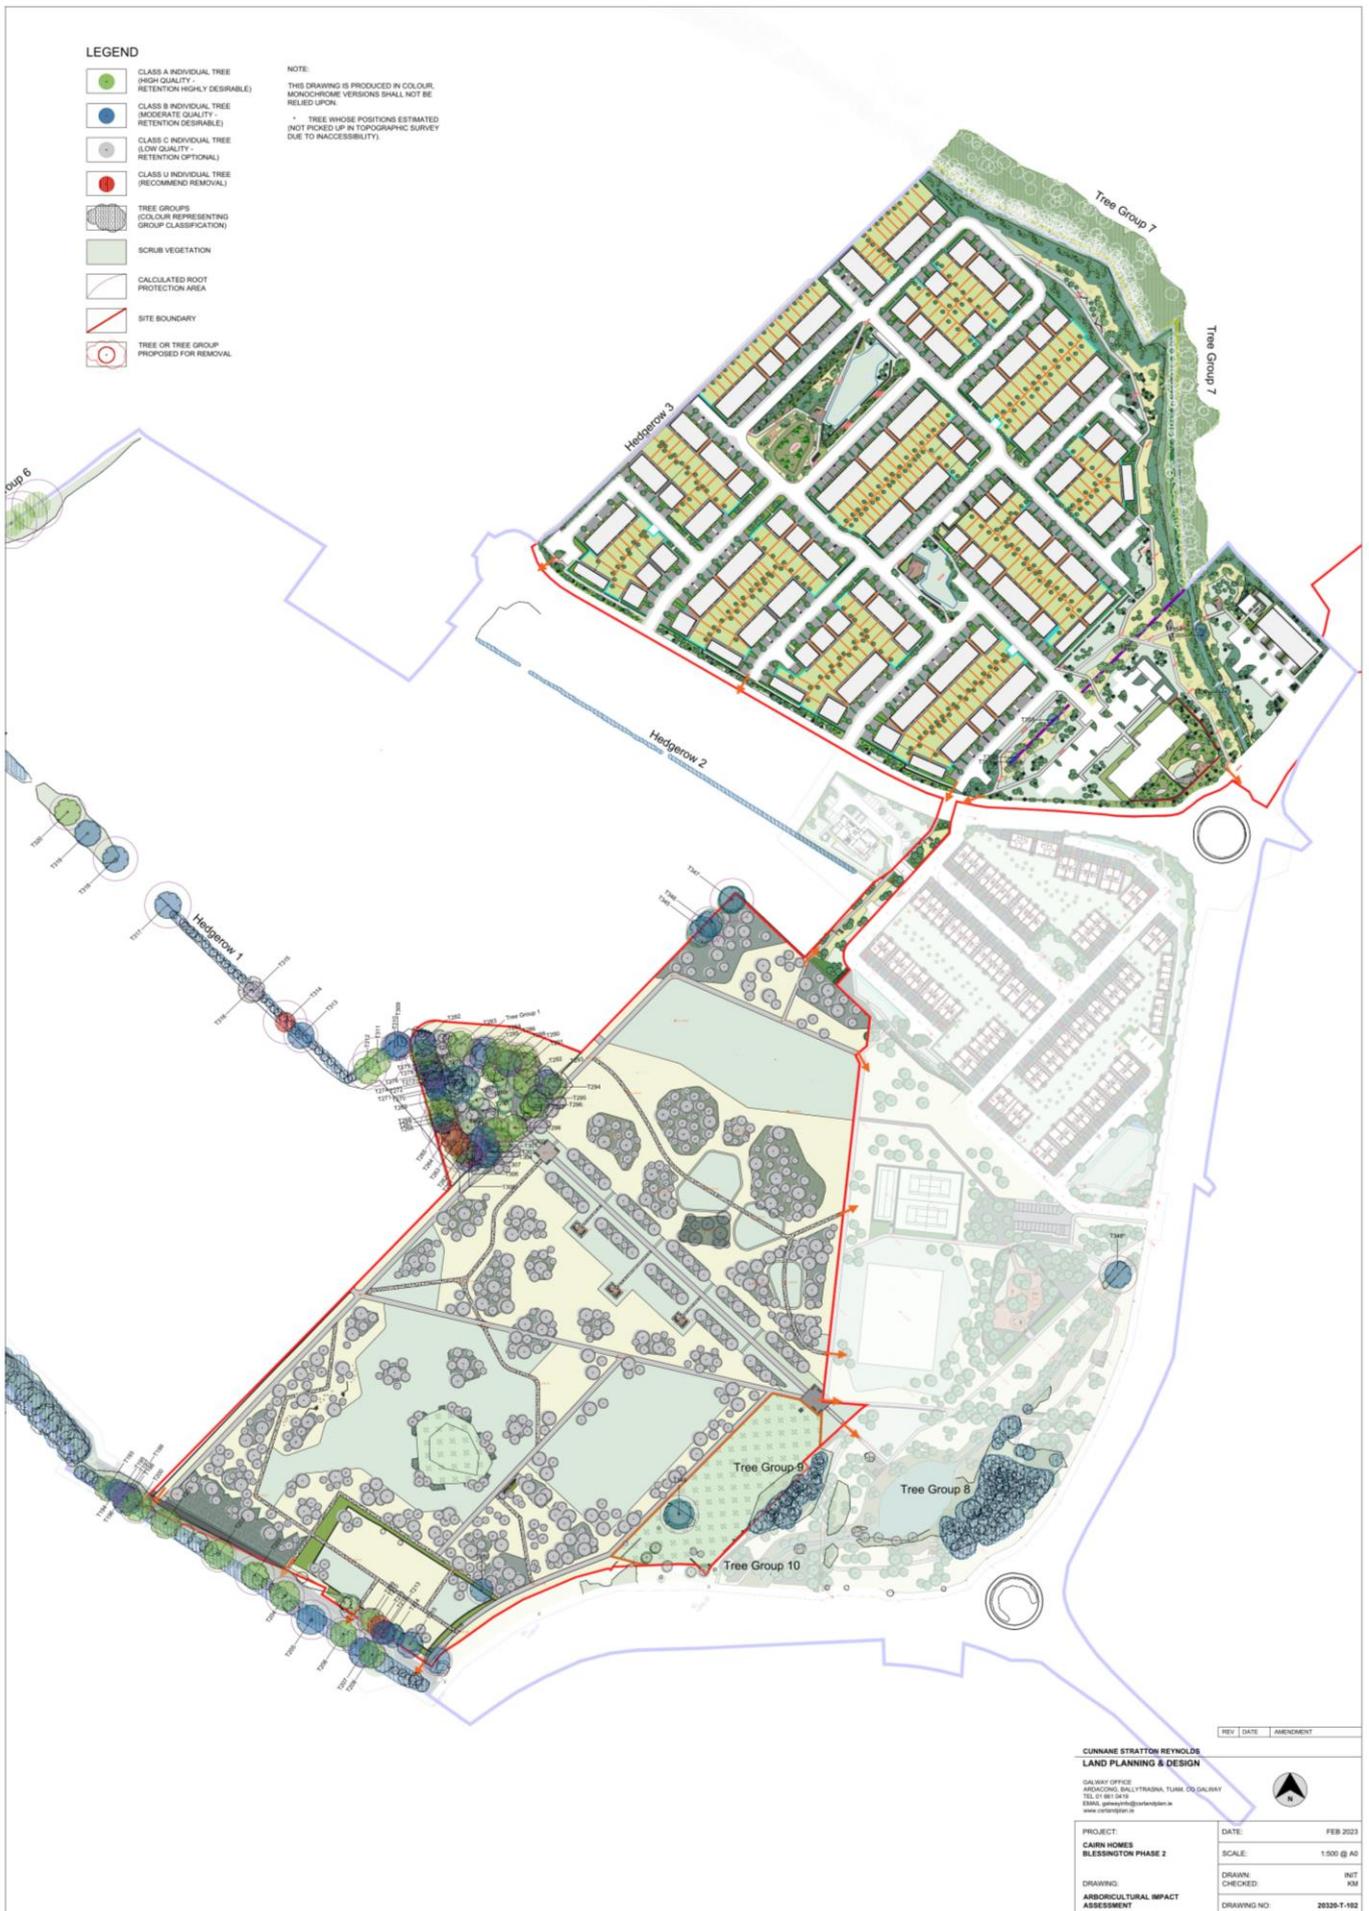
Figure 7. Arboricultural Impact Assessment

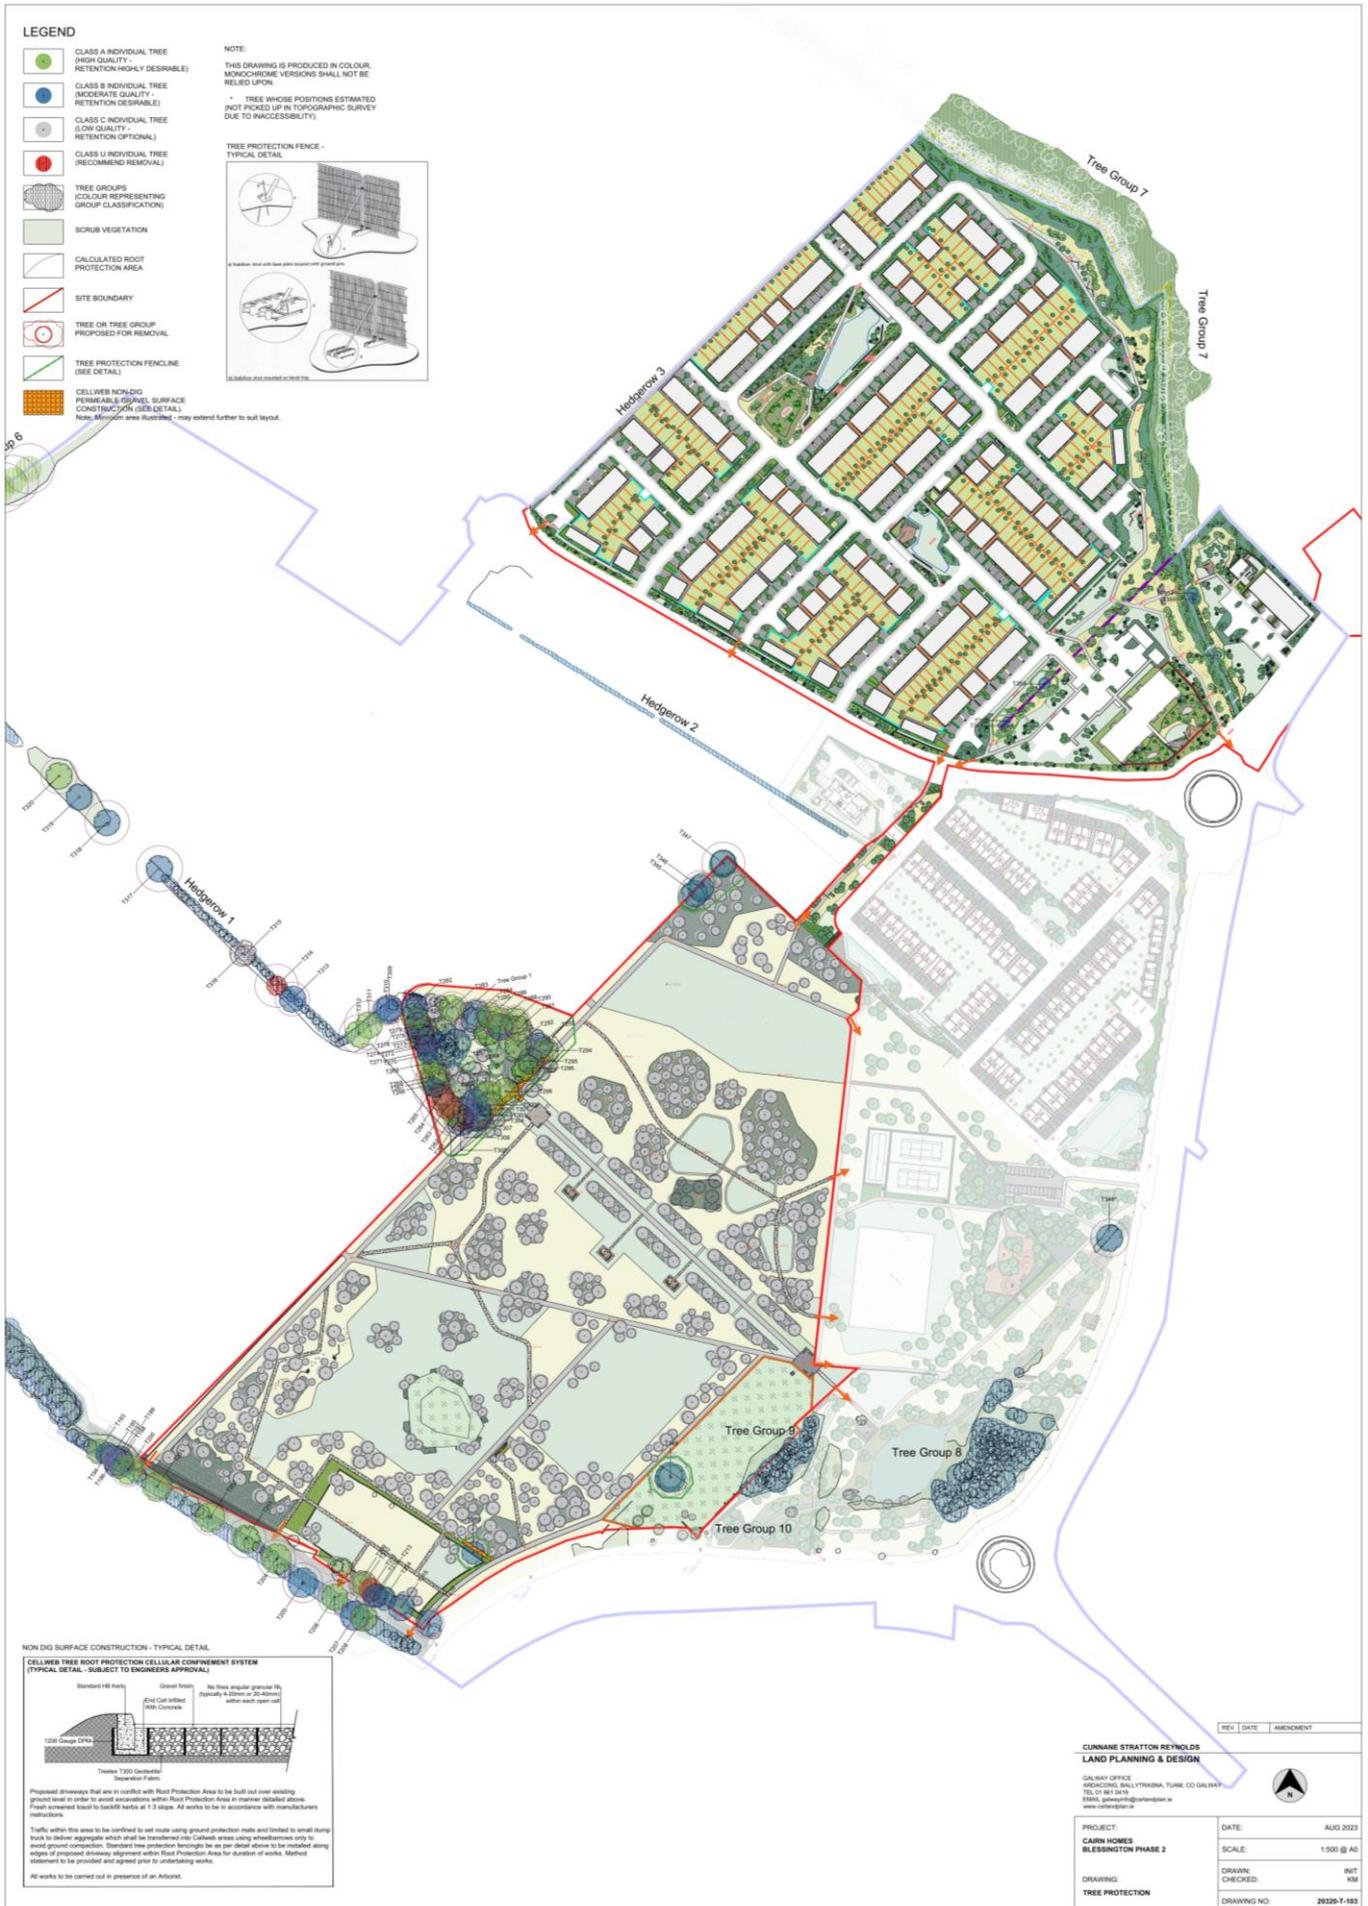
Figure 8. Tree Protection Plan

**Tree protection measures** – All retained trees can be successfully protected during the proposed development works by using robust fencing measures which comply with the recommendations outlined within BS 5837:2012. The location and specification of all tree protection measures are highlighted on the Tree Protection Plan at Appendix B.'

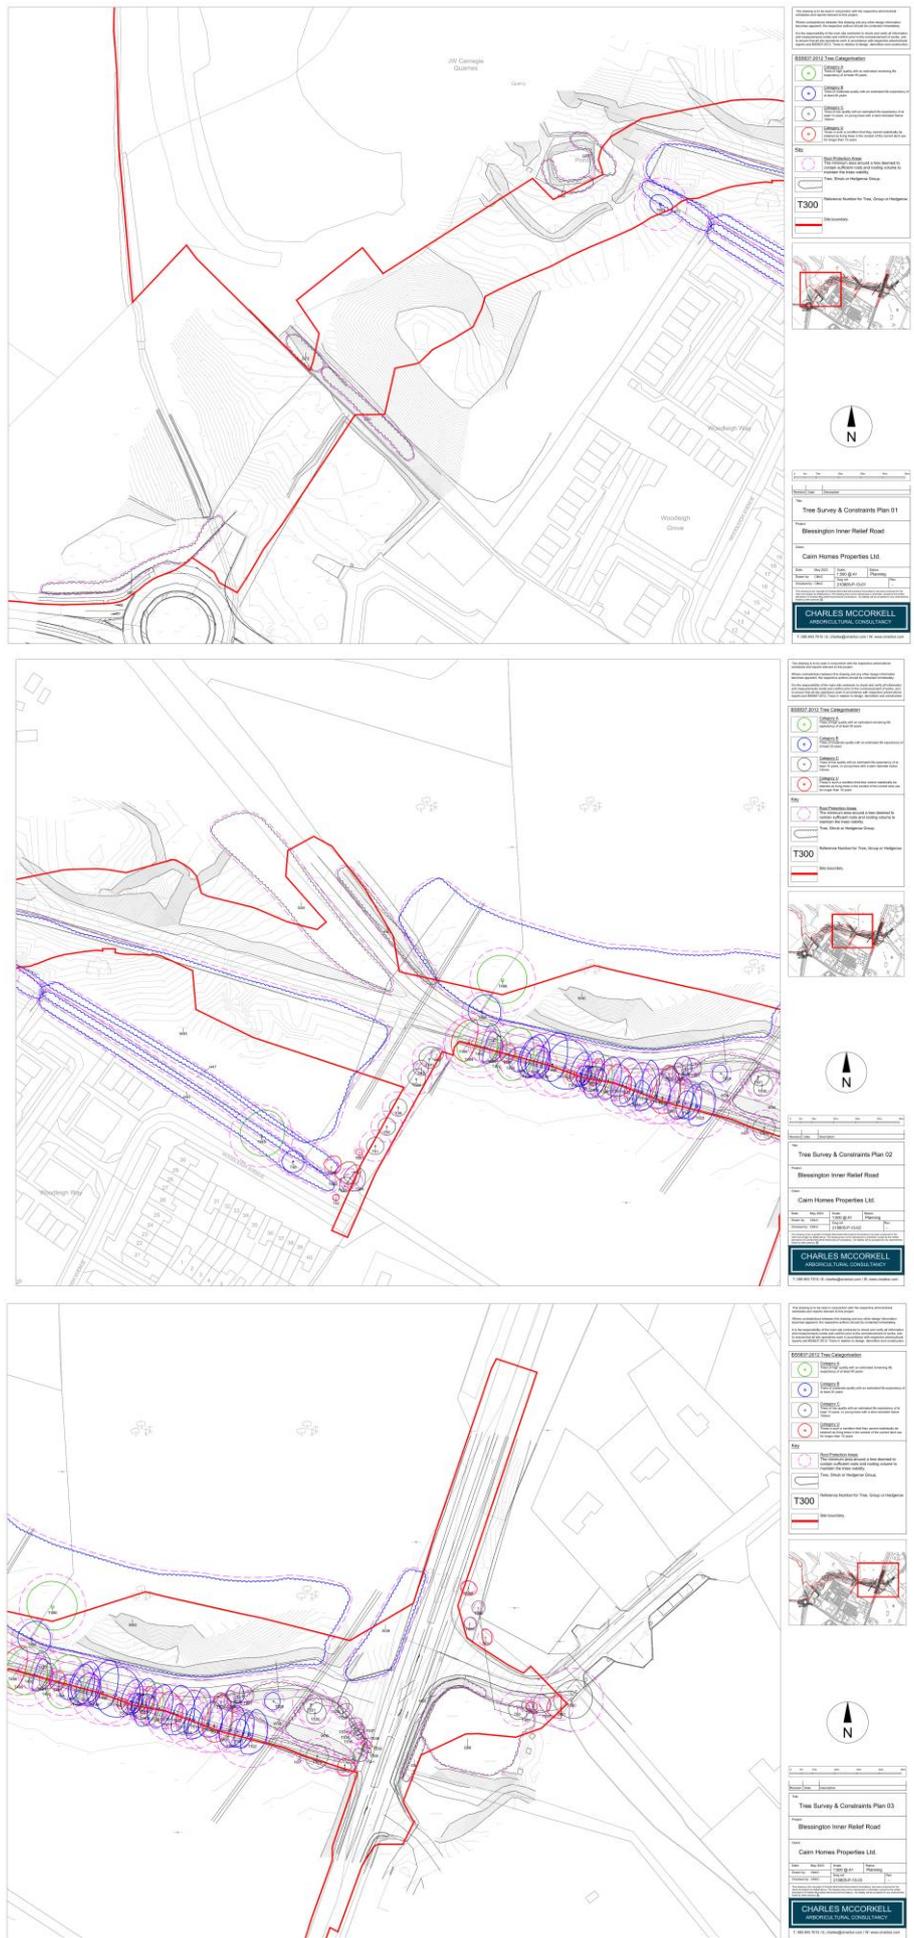
Figures 9a-9c. Tree Survey & Constraints (Sheets 1-3)

The tree classification & constraints plan, tree removals plan, and tree protection plan are demonstrated in Figures 9-11.

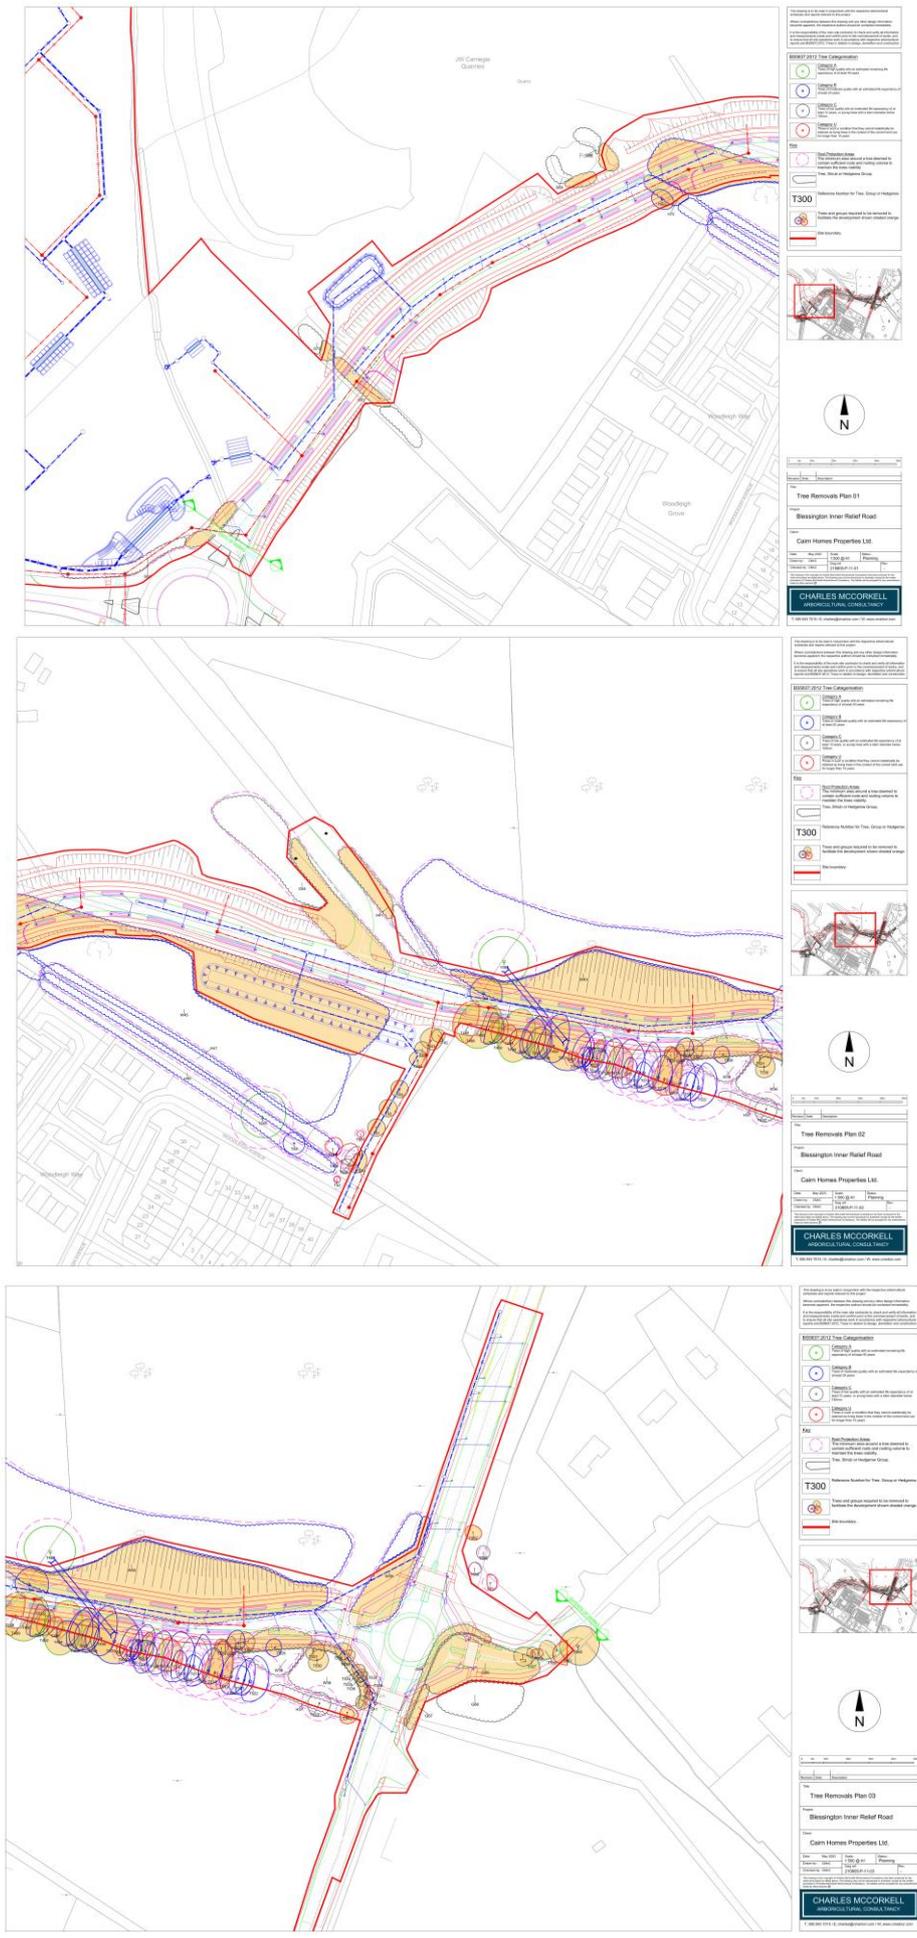
Figures 10a-10c. Tree Removals Plan (Sheets 1-3)

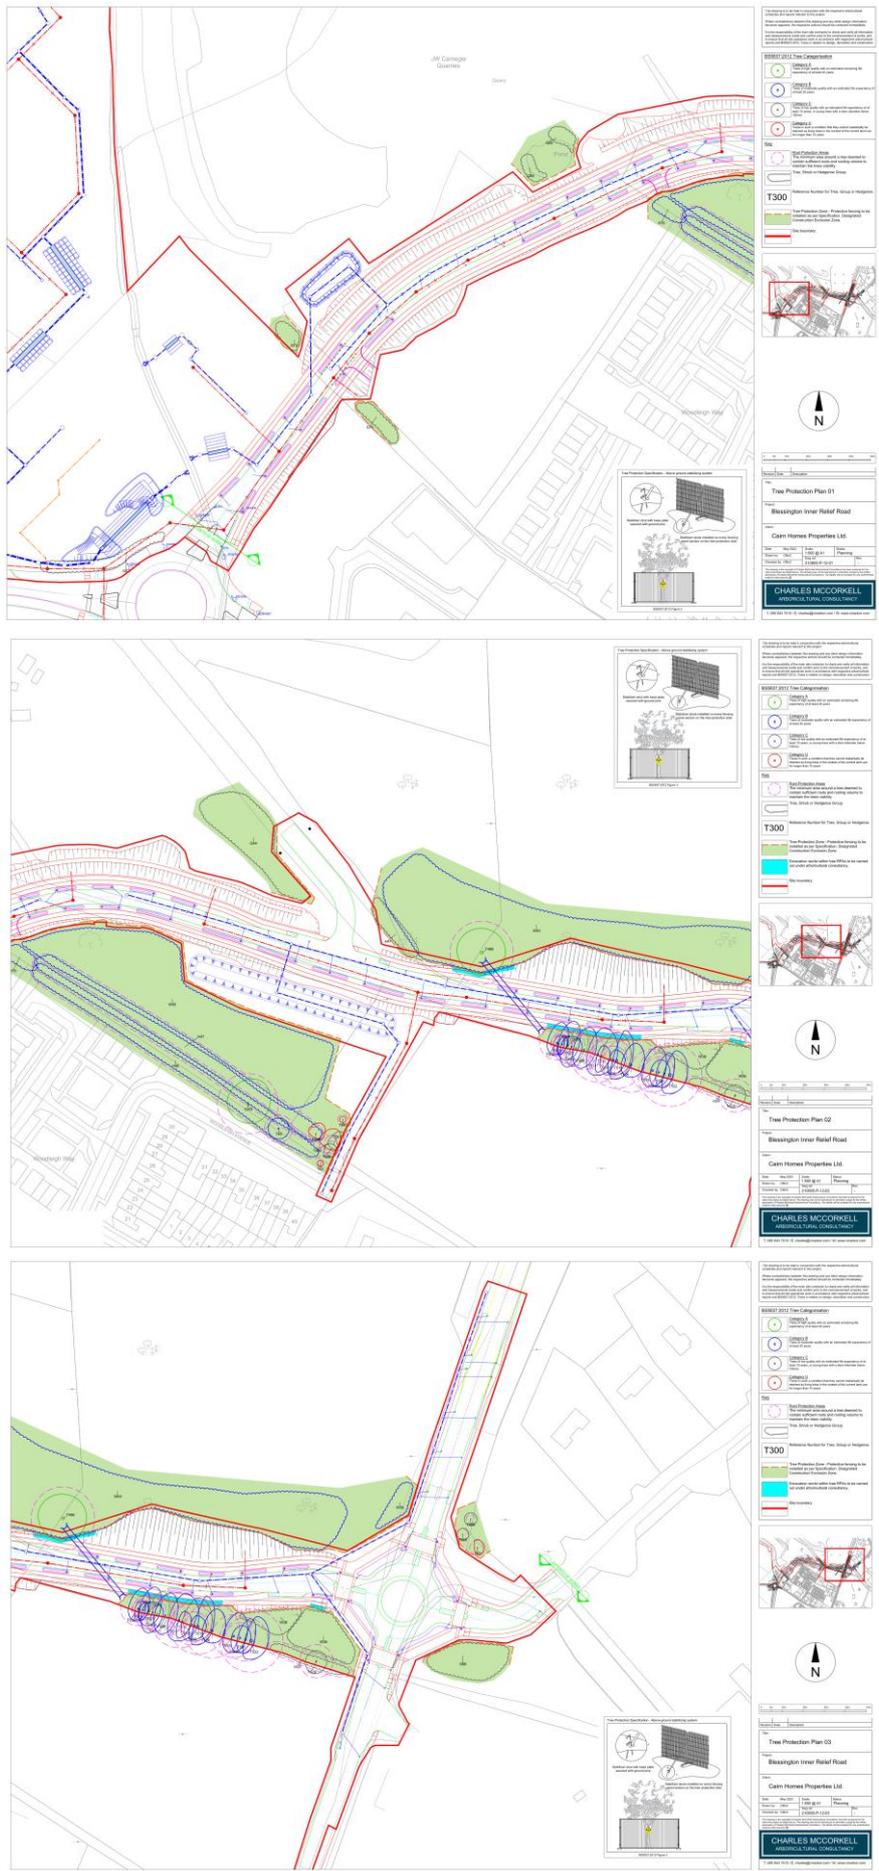
Figures 11a-11c. Tree Protection Plan (Sheets 1-3)
