**BLESSINGTON DEMESNE LRD**

**ENVIRONMENTAL IMPACT ASSESSMENT REPORT**

**VOLUME III APPENDICES**

**Bat Fauna Impact Assessment for the  
Proposed Blessington Demesne Town Park & Residential Development**

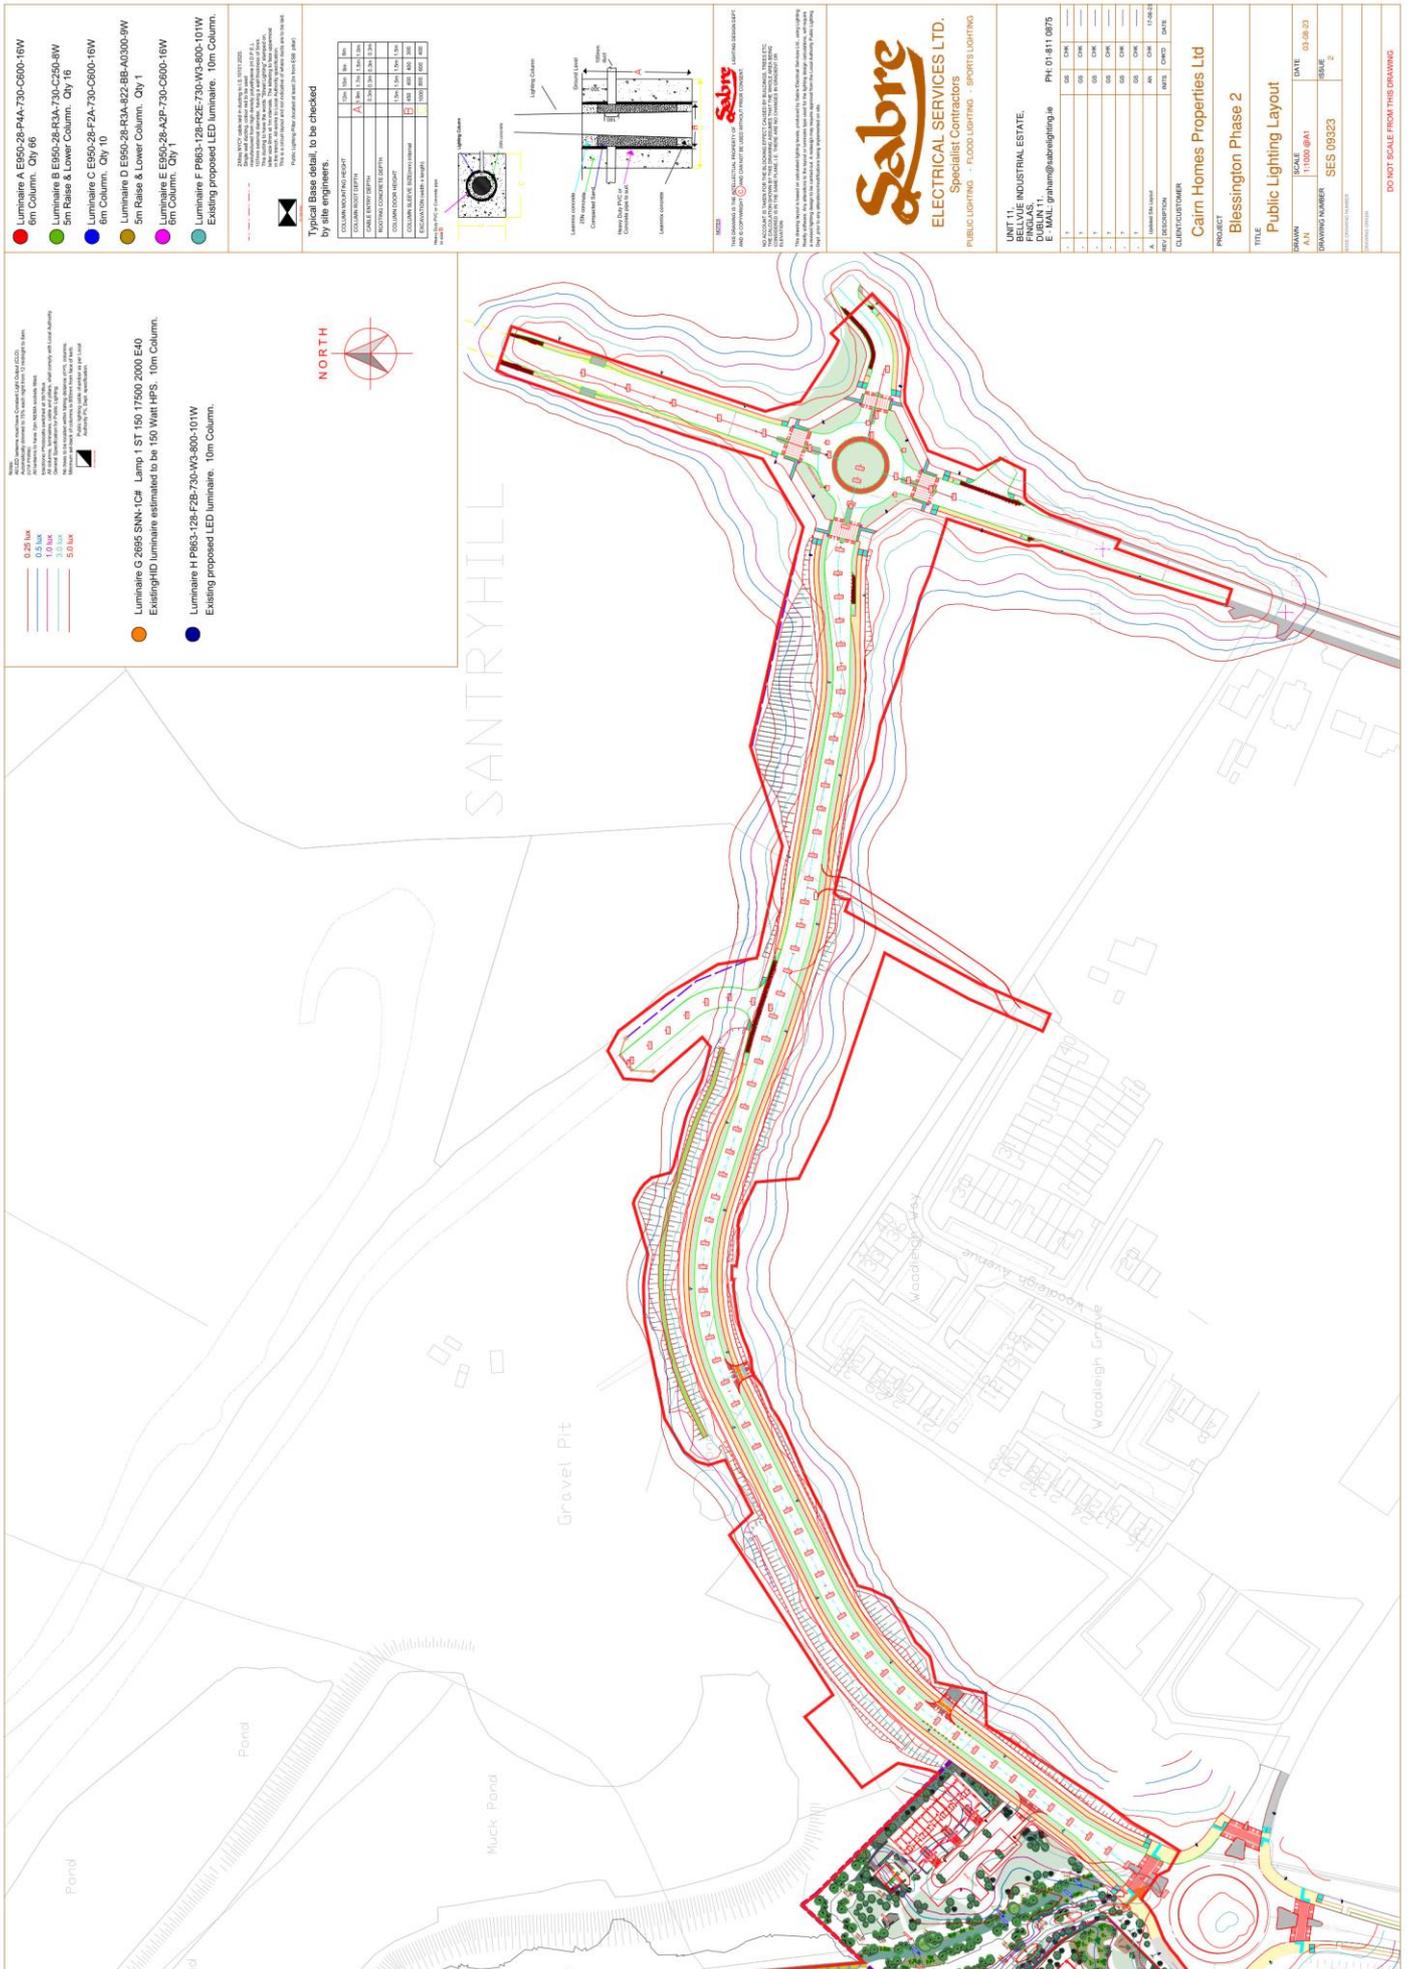
Figure 13. Public Lighting Layout (Sheet 2)

The proposed public lighting layout is demonstrated in Figures 12 & 13.

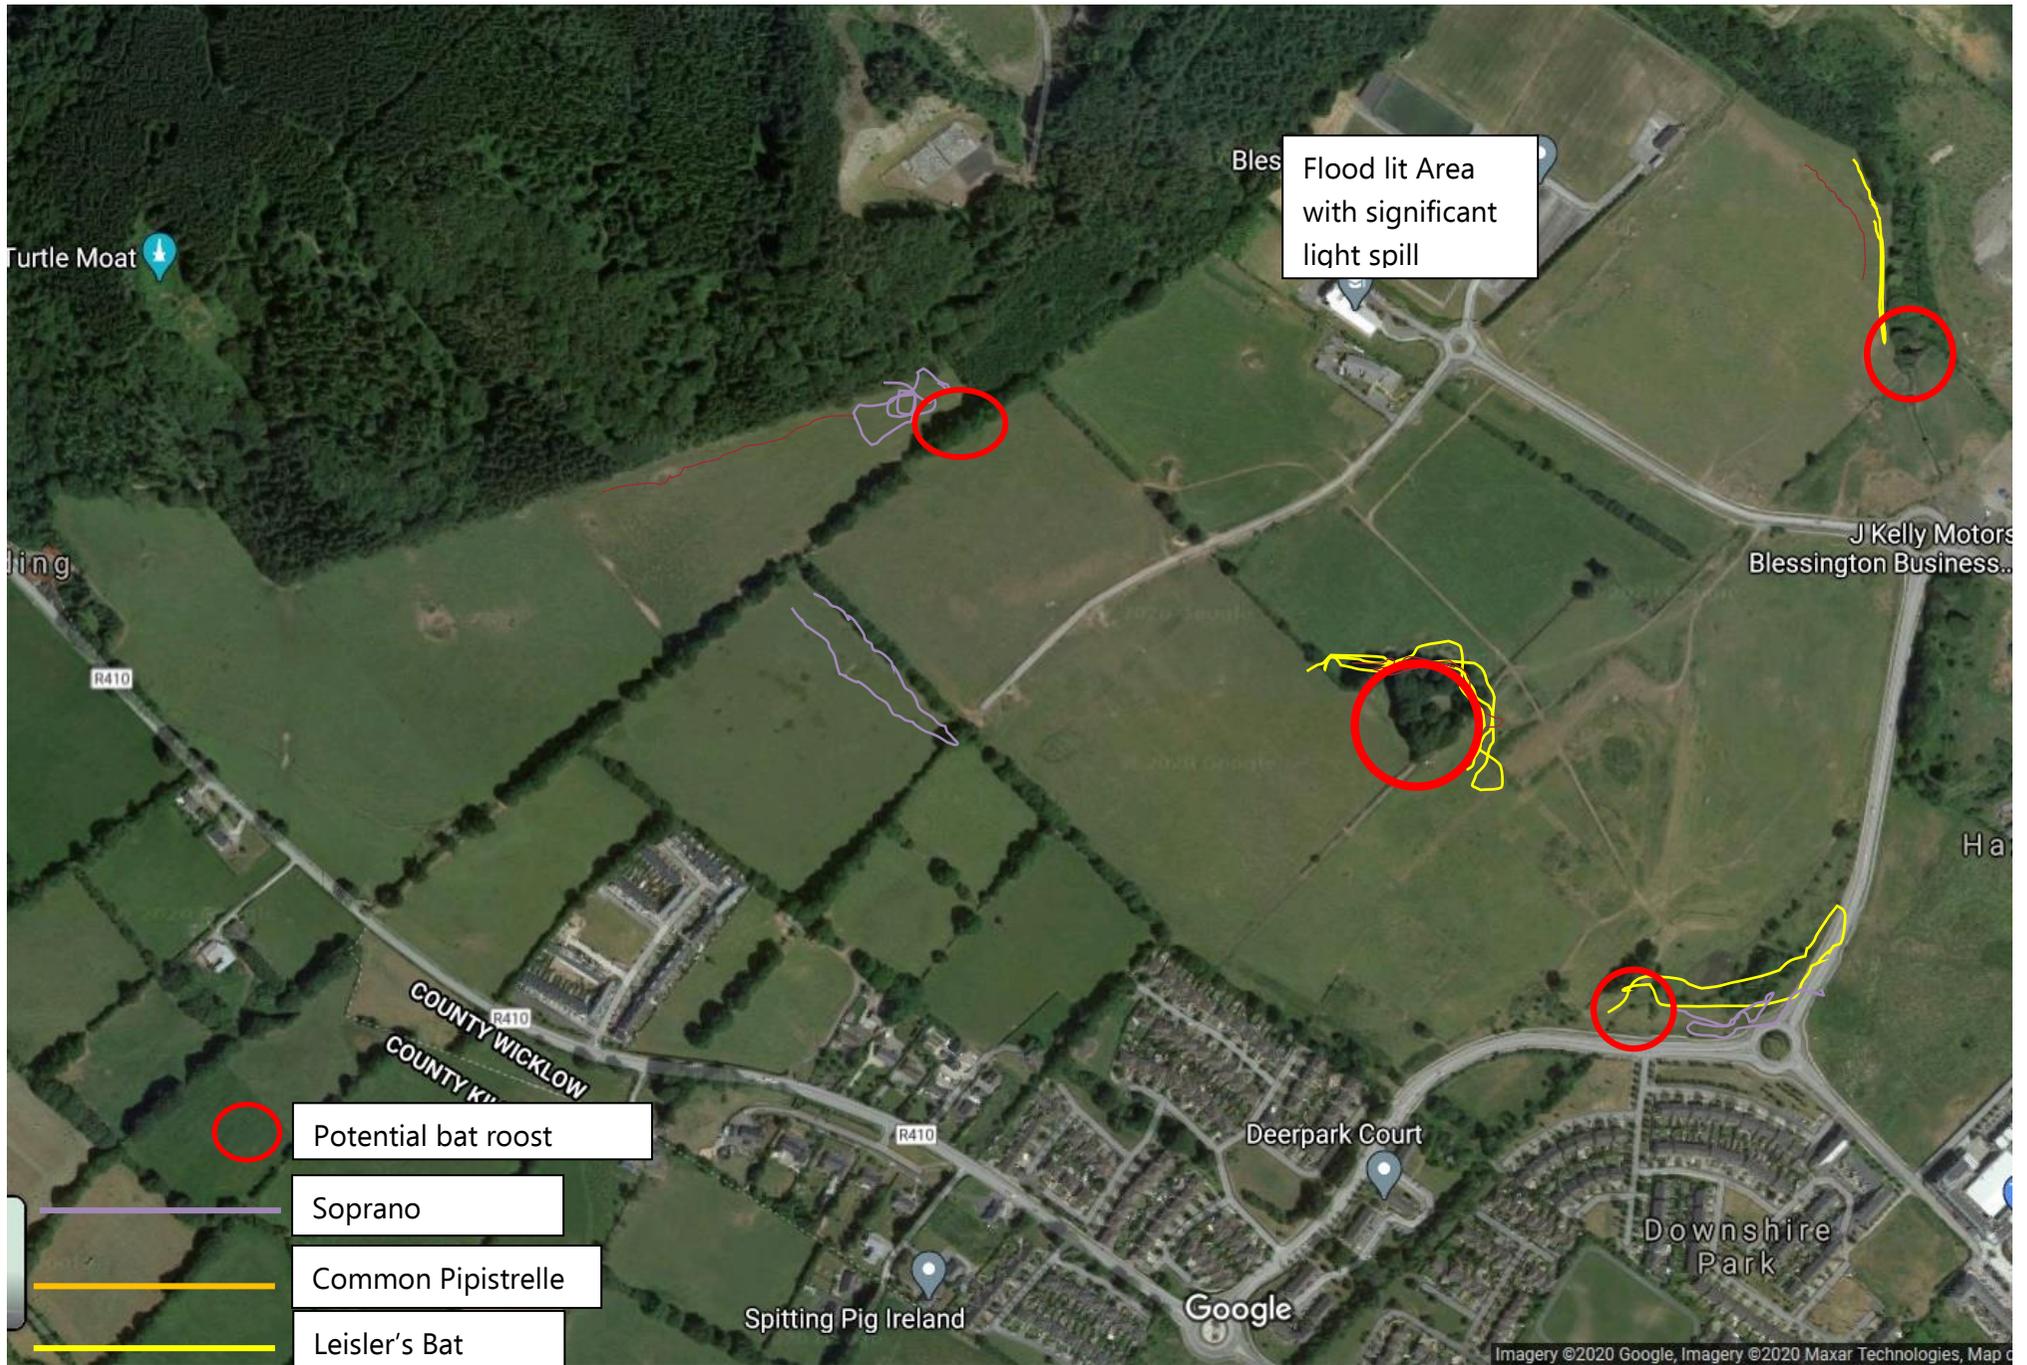
**Figure 14.** Soprano pipistrelle (blue) and Leisler's bat (yellow) feeding activity and main area of bat roosting potential (orange). Potential Leisler's Bat roost (single red circle) (August 2020 survey).

As seen in Figures 14-16 bat activity on site was relatively high in specific places where insects are likely to be plentiful and have the ability to swarm. Three species were noted on site :

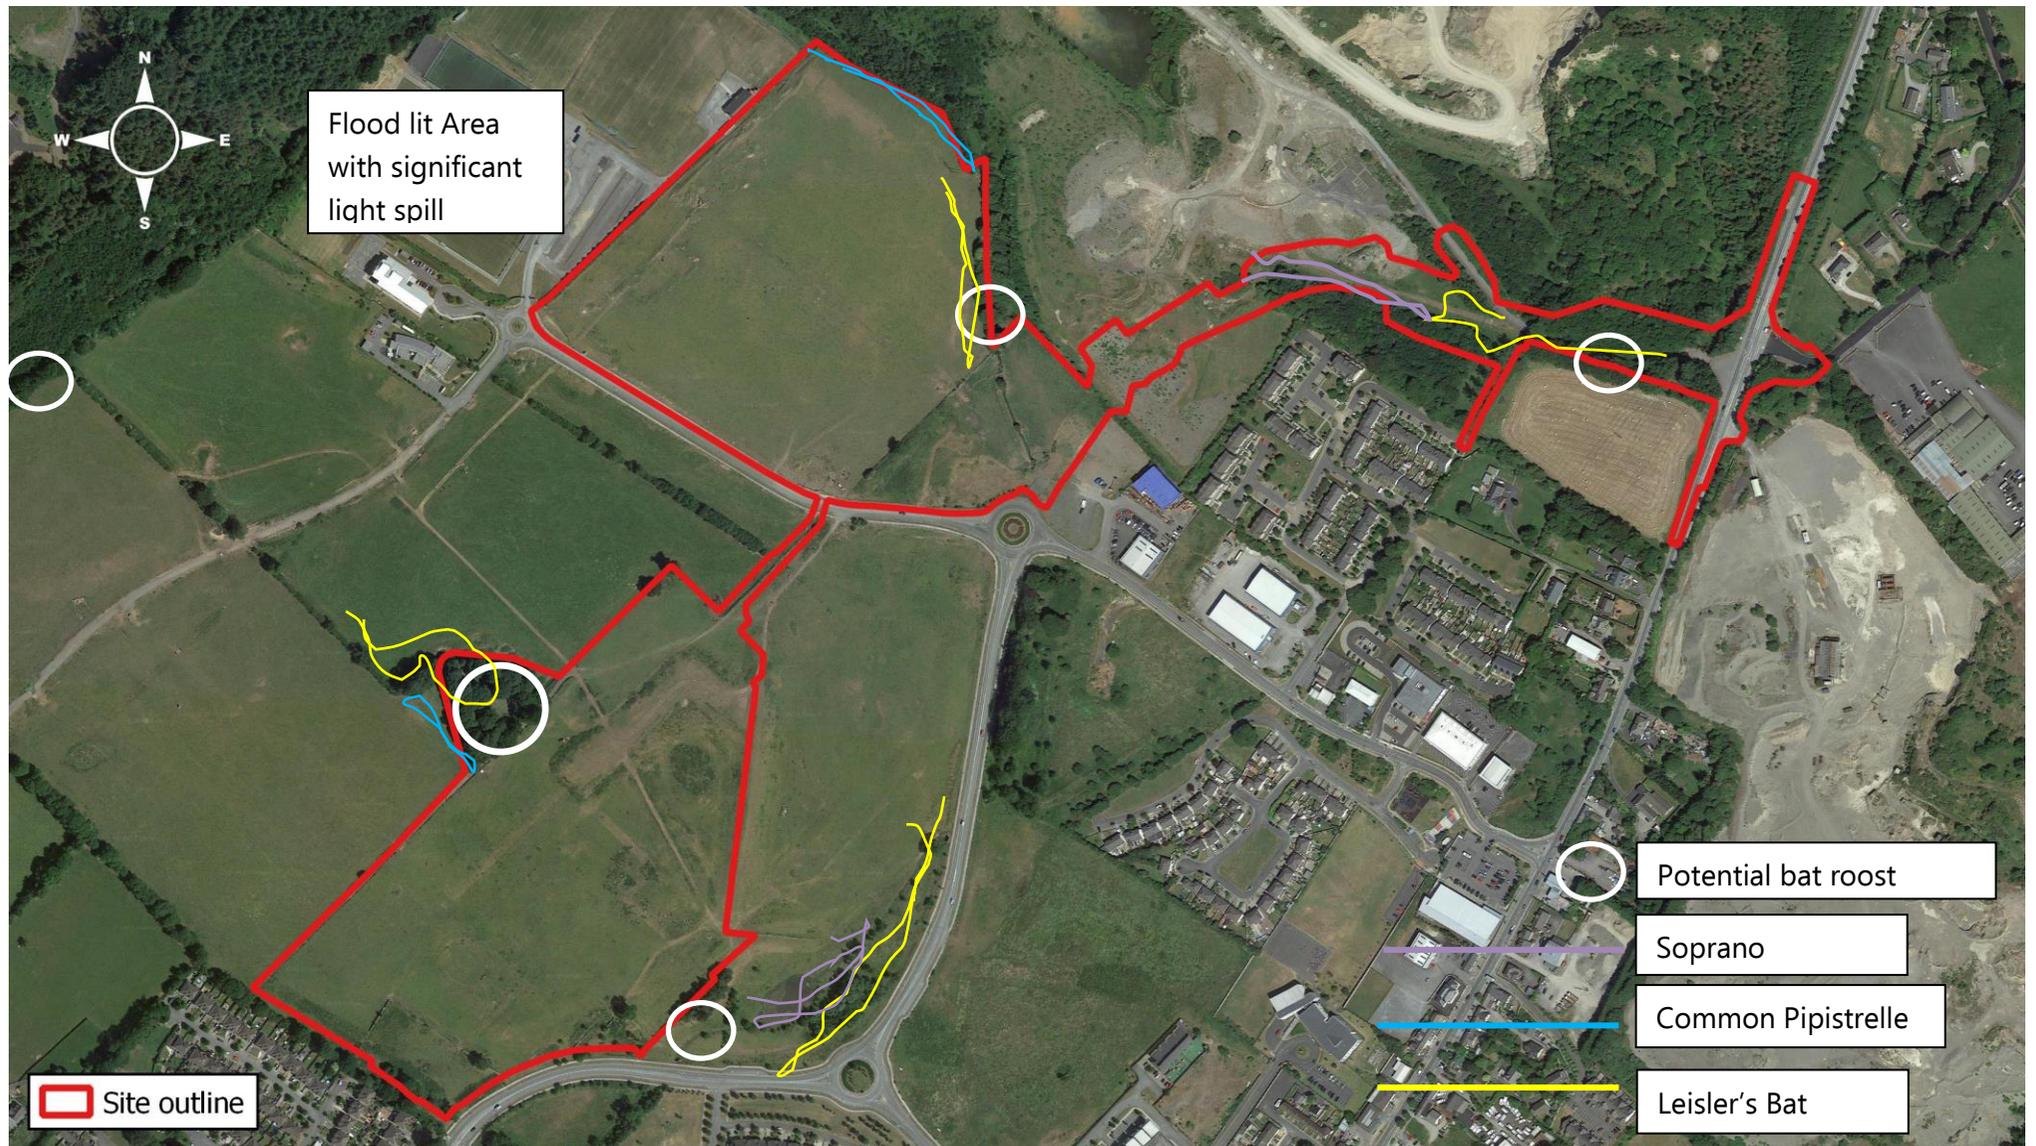
**Figure 15.** Soprano pipistrelle(blue) and Leisler's bat (yellow) feeding activity and main area of bat roosting potential (orange). Potential Leisler's Bat roost (single blue circle) (9<sup>th</sup> September 2022 survey)

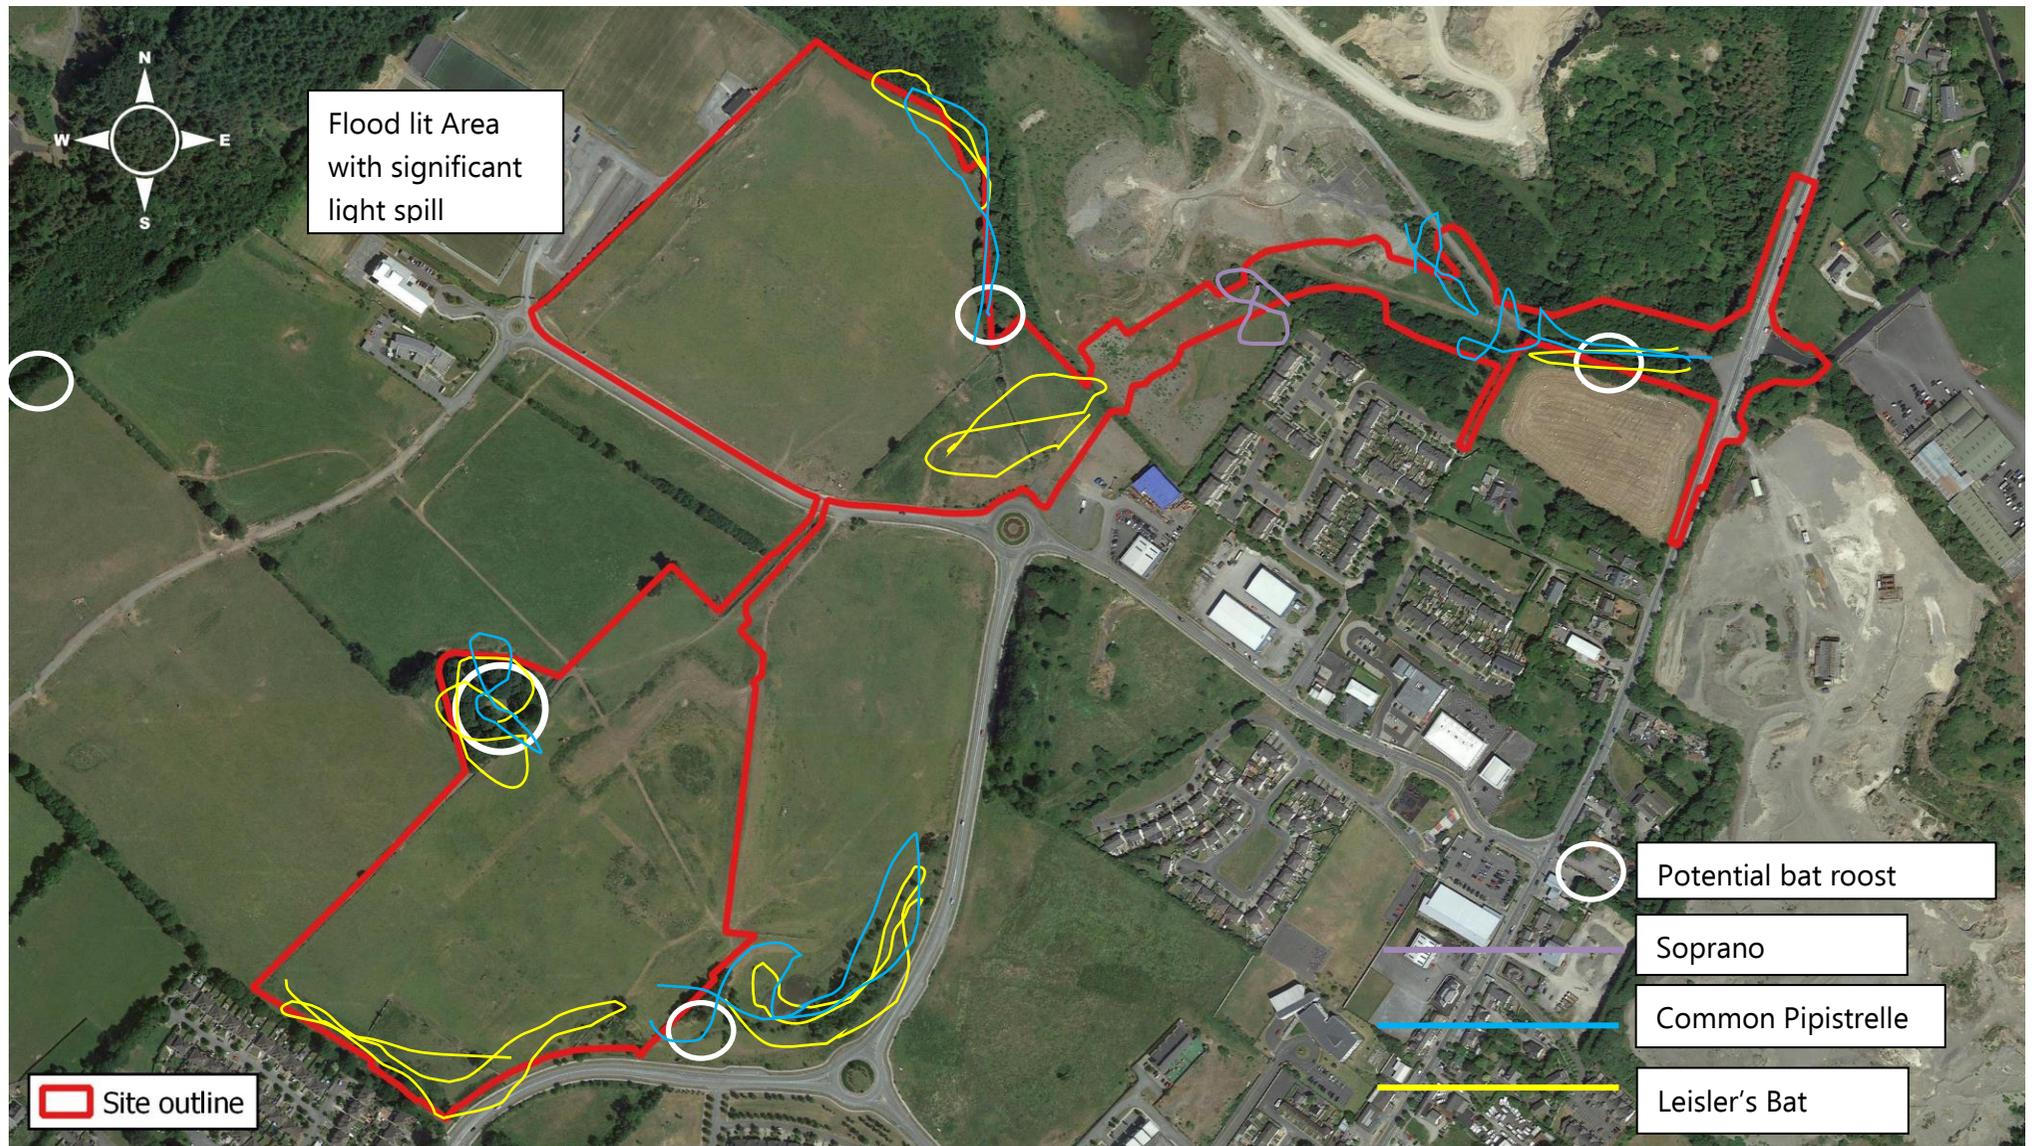
**Figure 16.** Soprano pipistrelle(blue) and Leisler's bat (yellow) feeding activity and main area of bat roosting potential (orange). Potential Leisler's Bat roost (single blue circle) (August 2023 survey)

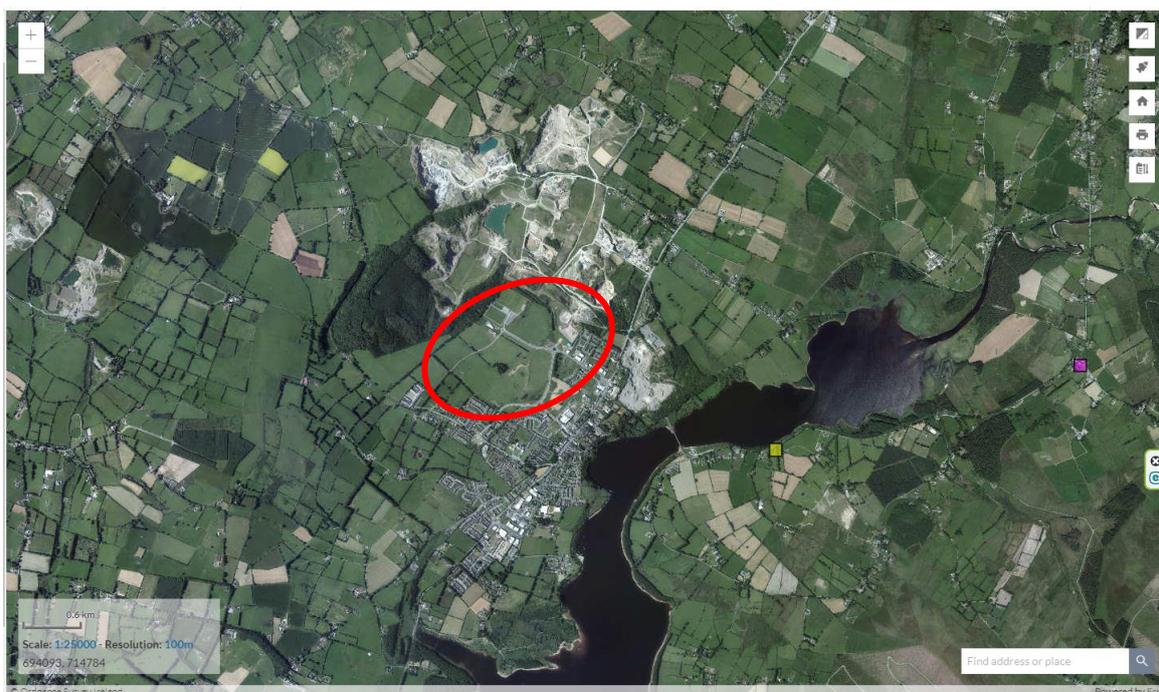
**Figure 17.** Daubenton’s Bat (*Myotis daubentonii*) (yellow) and Brown Long-eared Bat (*Plecotus auritus*) (purple) (Source NBDC) (Site location – red circle)

The review of existing bat records (sourced from Bat Conservation Ireland’s National Bat Records Database) within the 2km<sup>2</sup> grids (Reference grids N91S & N91X) encompassing the study area reveals that four of the nine known Irish species have been observed locally (Table 1). The National Biodiversity Data Centre’s online viewer was consulted in order to determine whether there have been recorded bat sightings in the wider area. This is visually represented in Figures 17 & 18. The following species were noted in the wider area: Brown Long-eared Bat (*Plecotus auritus*), Soprano Pipistrelle (*Pipistrellus pygmaeus*), Daubenton’s Bat (*Myotis daubentonii*), and Lesser Noctule (*Nyctalus leisleri*) (Figures 17 & 18).

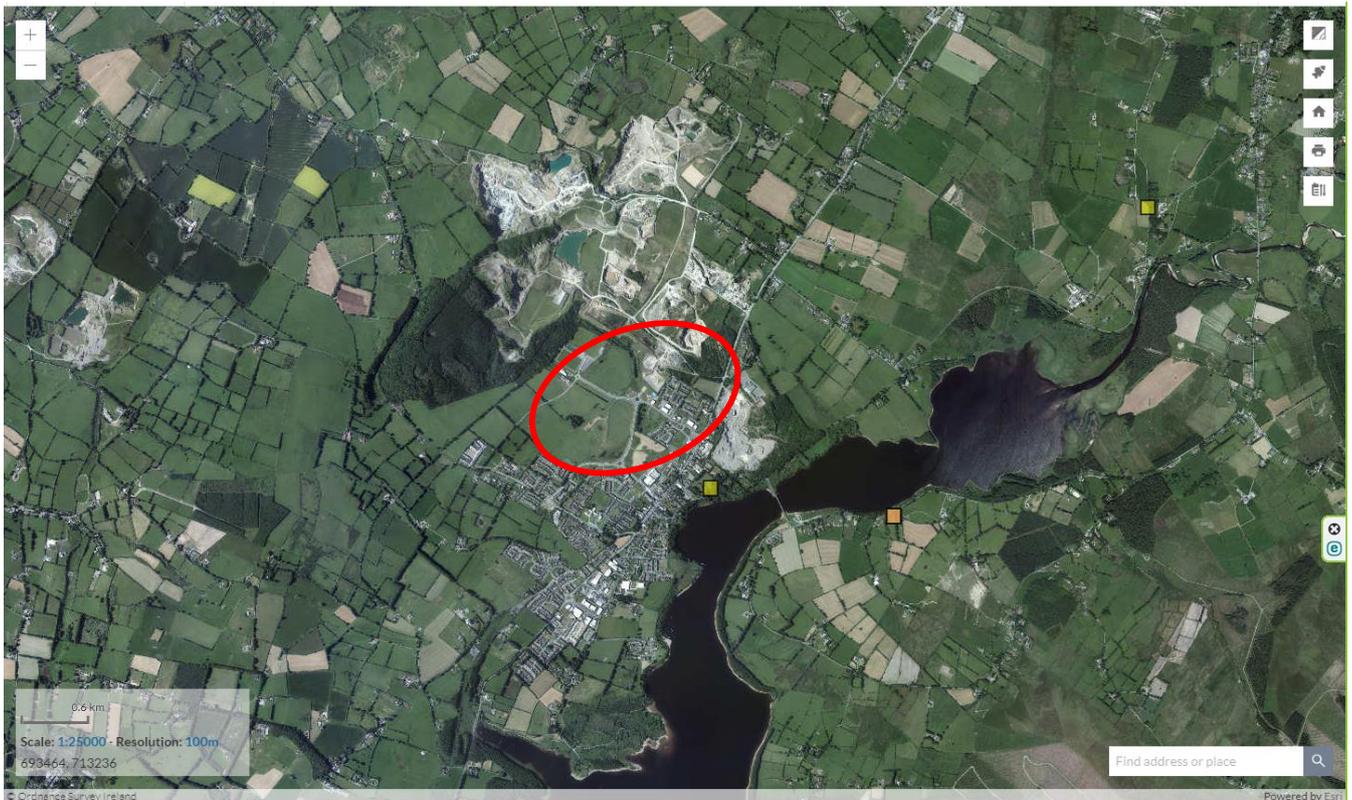
**Figure 18.** Soprano Pipistrelle (*Pipistrellius pygmaeus*) (yellow), Lesser Noctule (*Nyctalus leisleri*) (purple), and both Leisler's Bat and Soprano Pipistrelle (orange) (Source NBDC) (Site location – red circle)

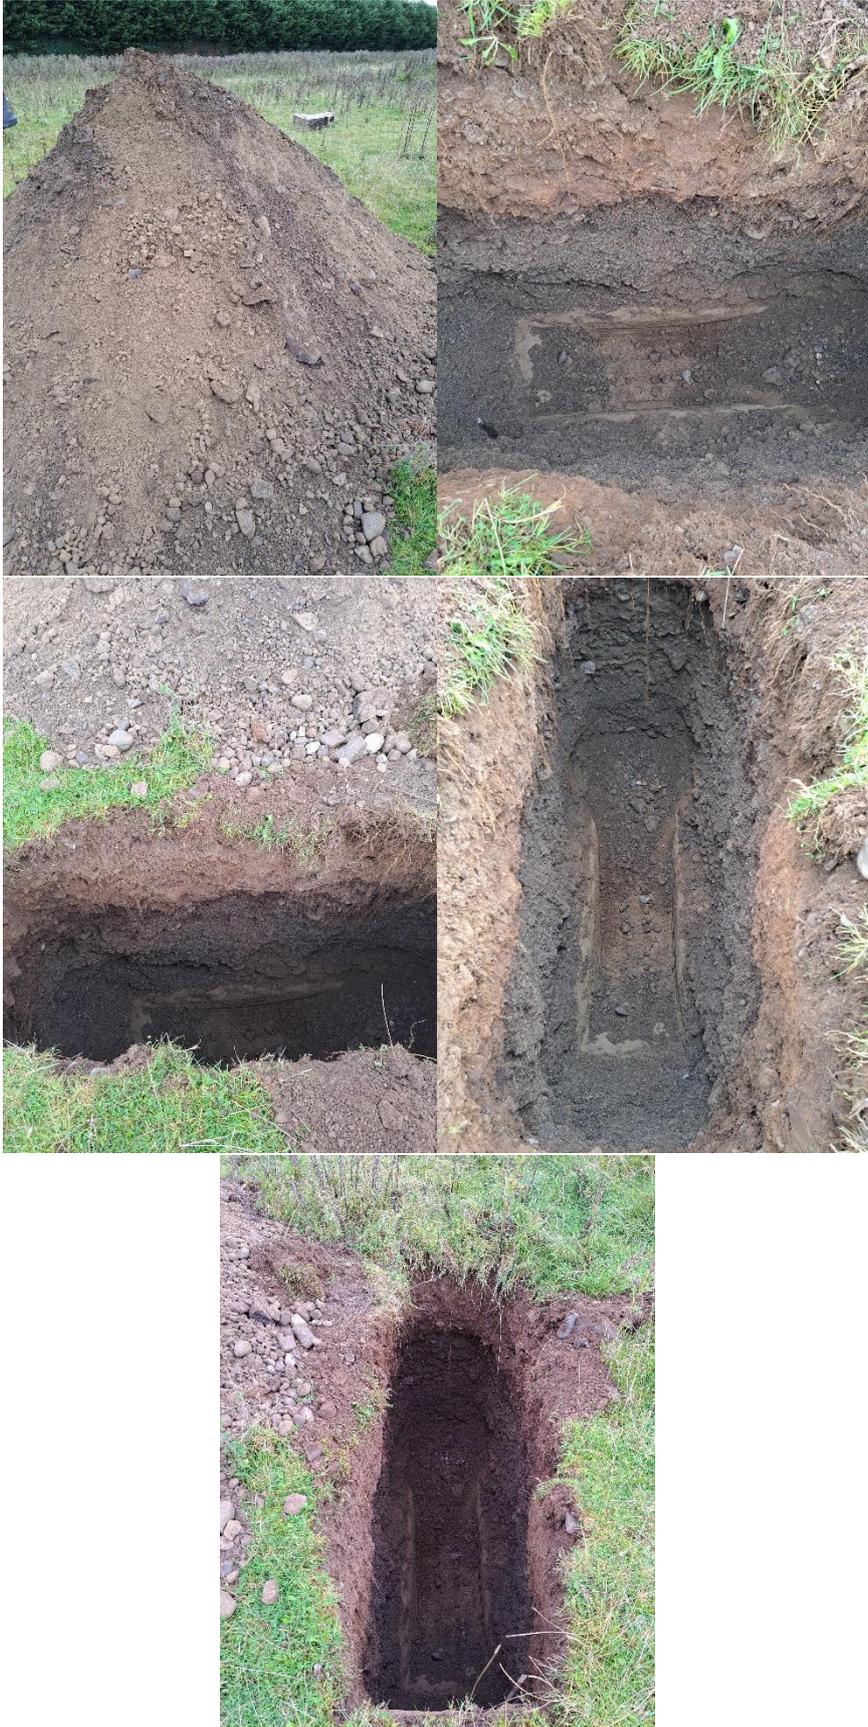
TP-01

Machine : 6T Excavator Method : Trial Pit		Dimensions (2.00m x 0.70m x 3.00m) (Lx W x D)	Ground Level (mOD)	Client Cairn Homes	Job Number 12122-08-22
		Location (Handheld GPS) 697745 E 715382 N	Dates 28/09/2022- 29/09/2022	Project Contractor Ground Investigations Ireland	Sheet 1/1

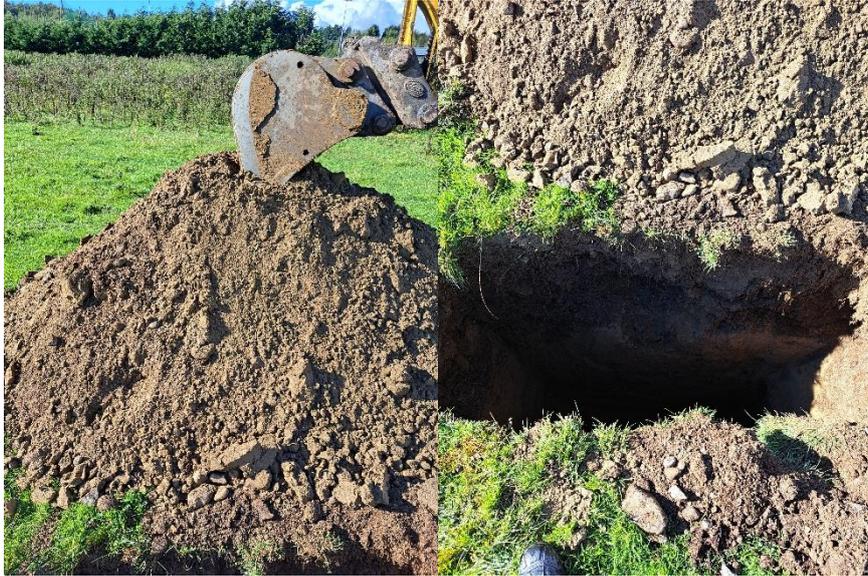
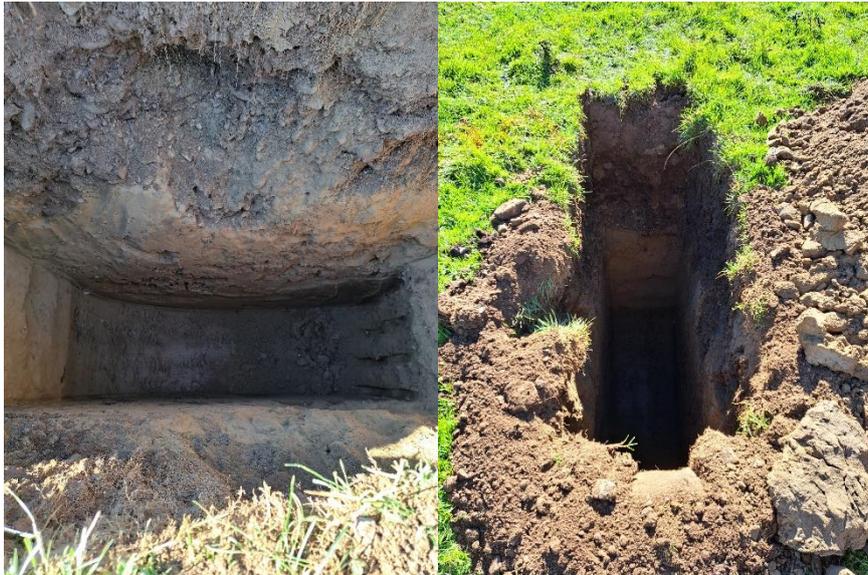
TP-02

<b>Plan</b> . . . . . . . . . .	<b>Remarks</b>  Pit complete at 3.00m No groundwater encountered Trial pit stable Trial pit backfilled upon completion					
	<table border="1"> <tr> <td>Scale (approx)</td> <td>Logged By</td> <td>Figure No.</td> </tr> <tr> <td>1:25</td> <td>MK</td> <td>12122-08-22.TP02</td> </tr> </table>	Scale (approx)	Logged By	Figure No.	1:25	MK
Scale (approx)	Logged By	Figure No.				
1:25	MK	12122-08-22.TP02

Machine : 6T Excavator Method : Trial Pit	Dimensions (1.80m x 0.60m x 3.00m) (Lx W x D)	Ground Level (mOD)	Client Cairn Homes	Job Number 12122-08-22
	Location (Handheld GPS) 697785 E 715457 N	Dates 28/09/2022- 29/09/2022	Project Contractor Ground Investigations Ireland	Sheet 1/1

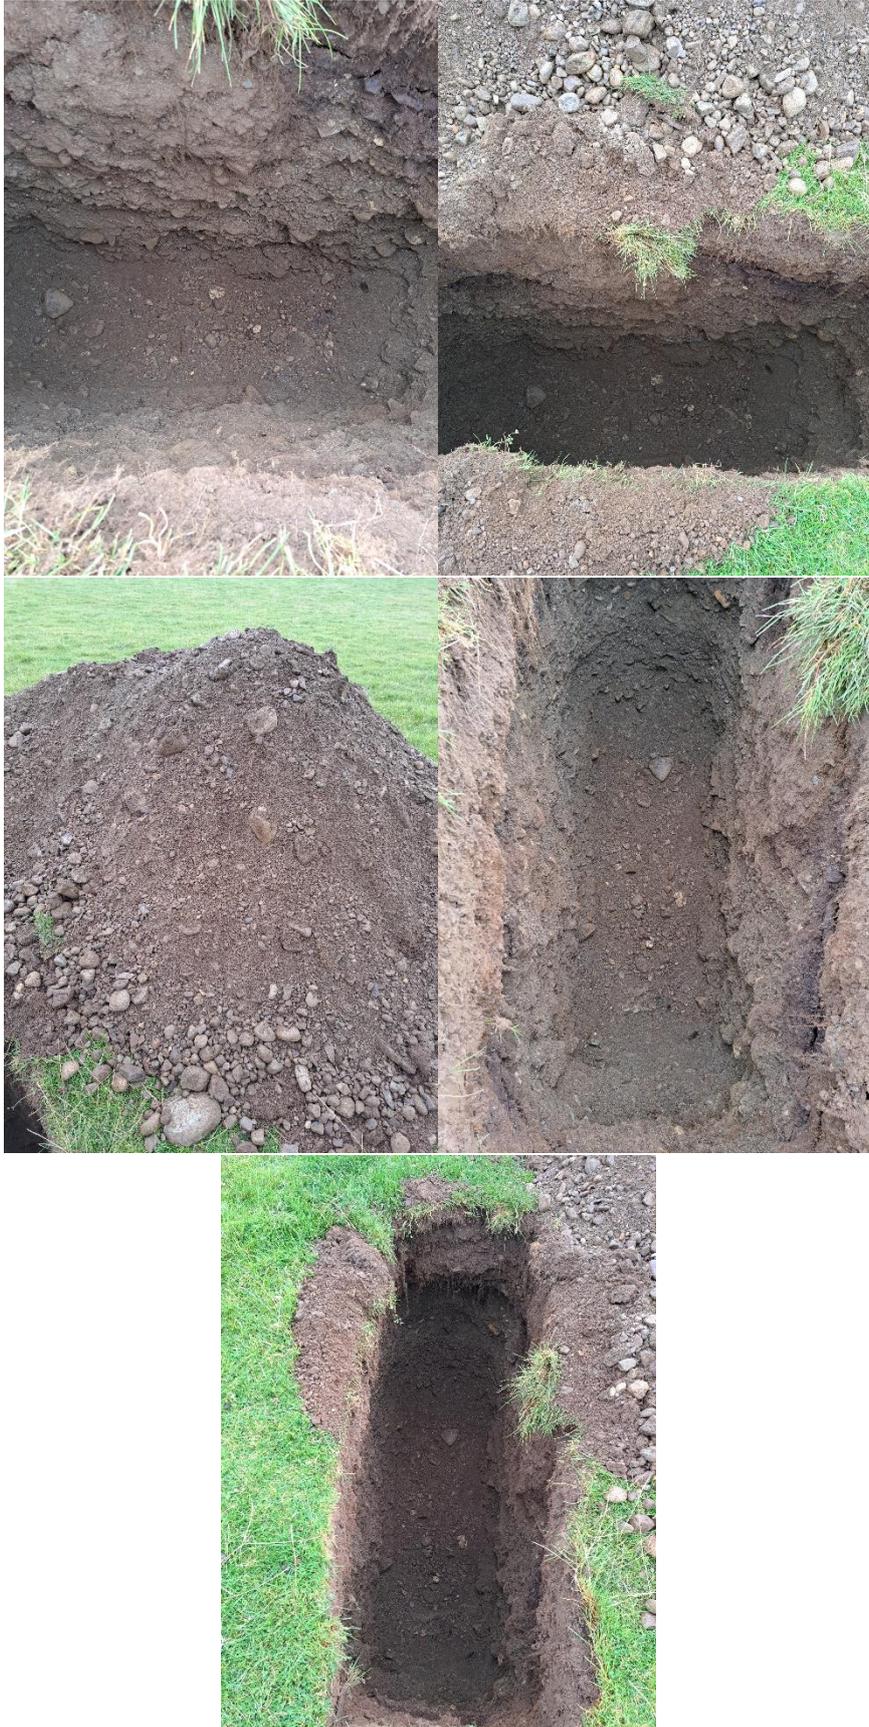
TP-03

<b>Machine</b> : 6T Excavator <b>Method</b> : Trial Pit	<b>Dimensions</b> (2.30m x 0.80m x 3.00m) (Lx W x D)	<b>Ground Level (mOD)</b>	<b>Client</b> Cairn Homes	<b>Job Number</b> 12122-08-22
	<b>Location</b> (Handheld GPS) 697707 E 715278 N	<b>Dates</b> 28/09/2022- 29/09/2022	<b>Project Contractor</b> Ground Investigations Ireland	<b>Sheet</b> 1/1

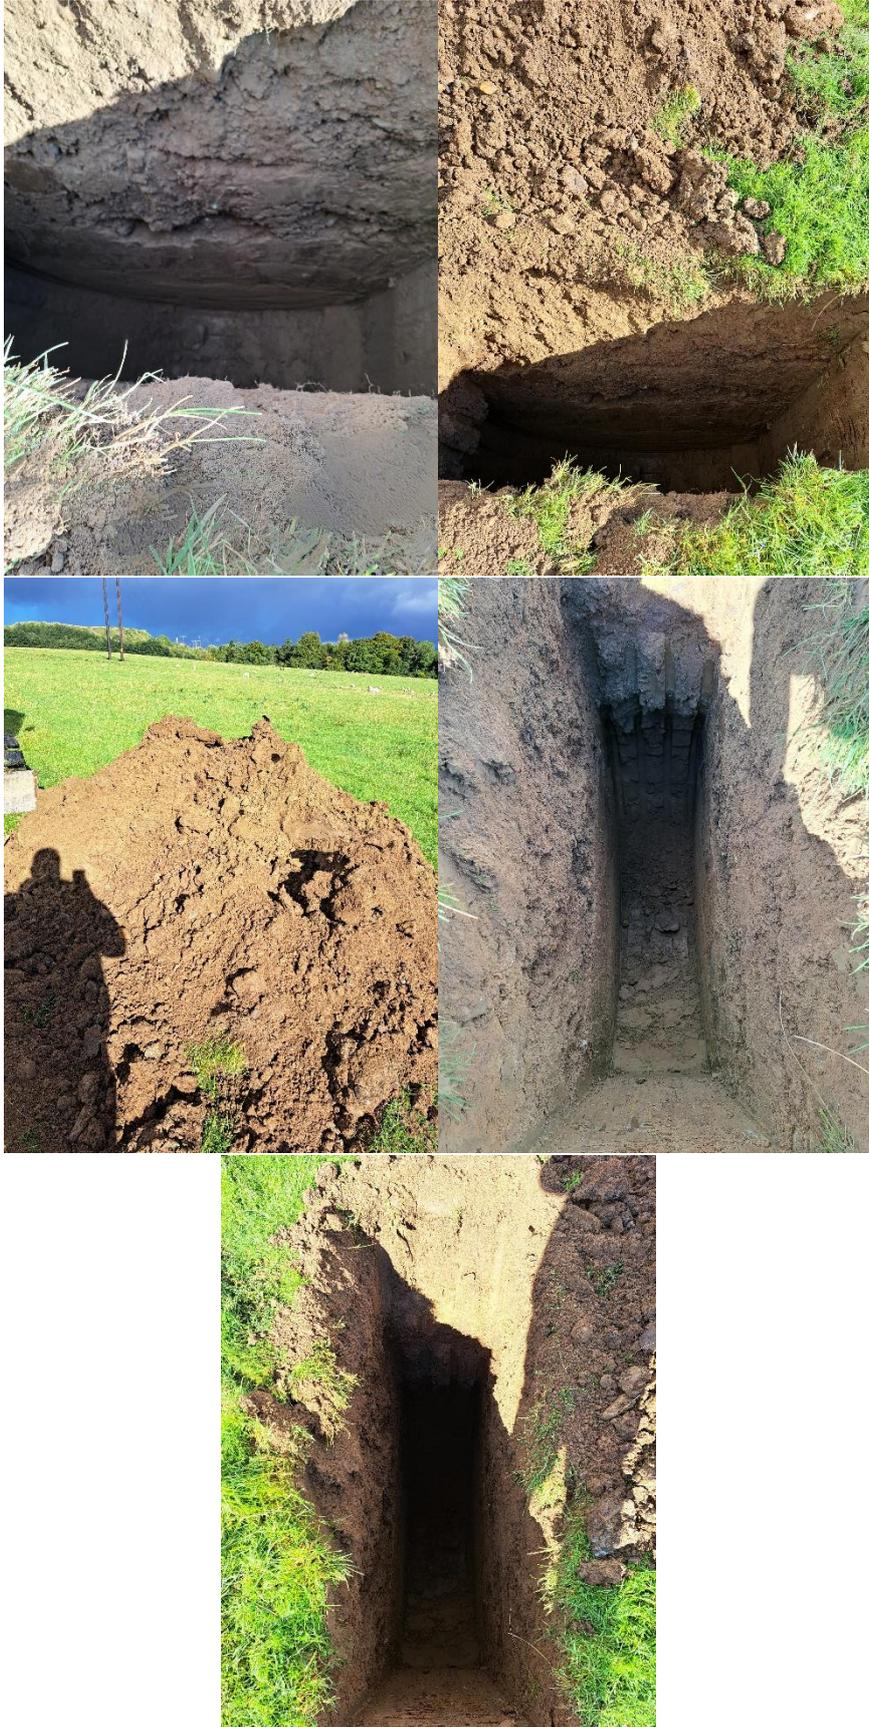
TP-04

<b>Plan</b>	<b>Remarks</b>		
.	Pit complete at 3.00m		
.	No groundwater encountered		
.	Trial pit stable		
.	Trial pit backfilled upon completion		
.	<b>Scale (approx)</b>	<b>Logged By</b>	<b>Figure No.</b>
.	1:25	MK	12122-08-22.TP04

Machine : 6T Excavator Method : Trial Pit	Dimensions (2.30m x 0.80m x 3.00m) (L x W x D)	Ground Level (mOD)	Client Cairn Homes	Job Number 12122-08-22
	Location (Handheld GPS) 697757 E 715184 N	Dates 28/09/2022- 29/09/2022	Project Contractor Ground Investigations Ireland	Sheet 1/1

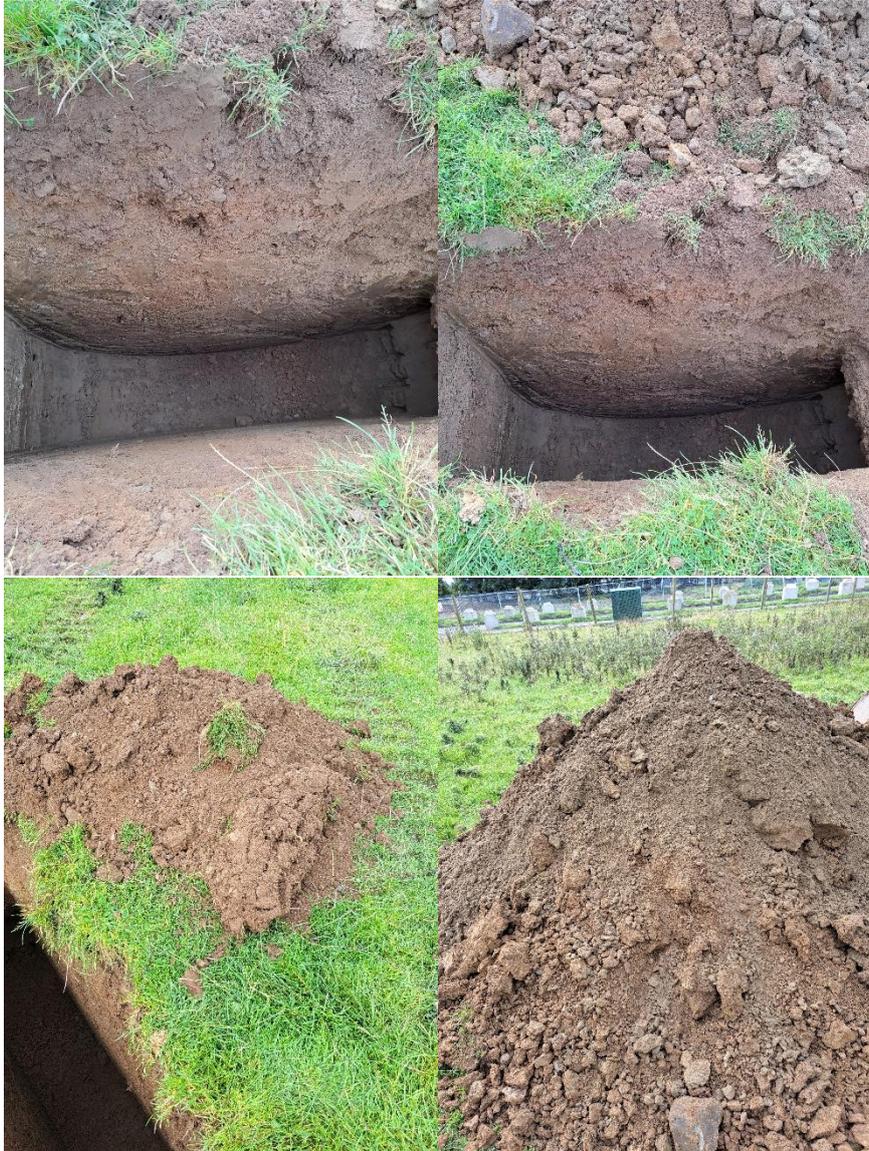
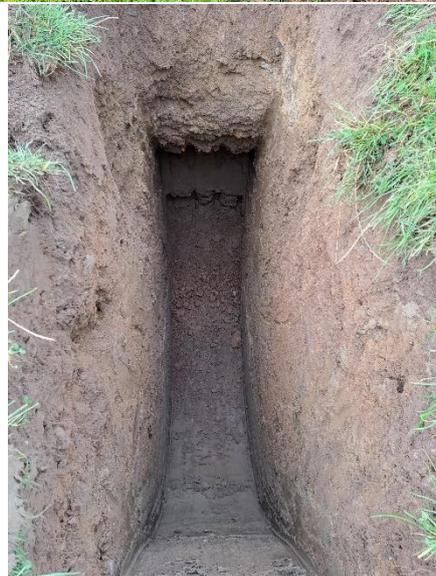
TP-05

<b>Plan</b> .	<b>Remarks</b> Pit complete at 3.00m No groundwater encountered Trial pit stable Trial pit backfilled upon completion	
		<b>Scale (approx)</b> 1:25

Machine : 6T Excavator Method : Trial Pit		Dimensions (1.80m x 0.60m x 3.00m) (Lx W x D)	Ground Level (mOD)	Client Cairn Homes	Job Number 12122-08-22
		Location (Handheld GPS) 697780 E 715263 N	Dates 28/09/2022- 29/09/2022	Project Contractor Ground Investigations Ireland	Sheet 1/1

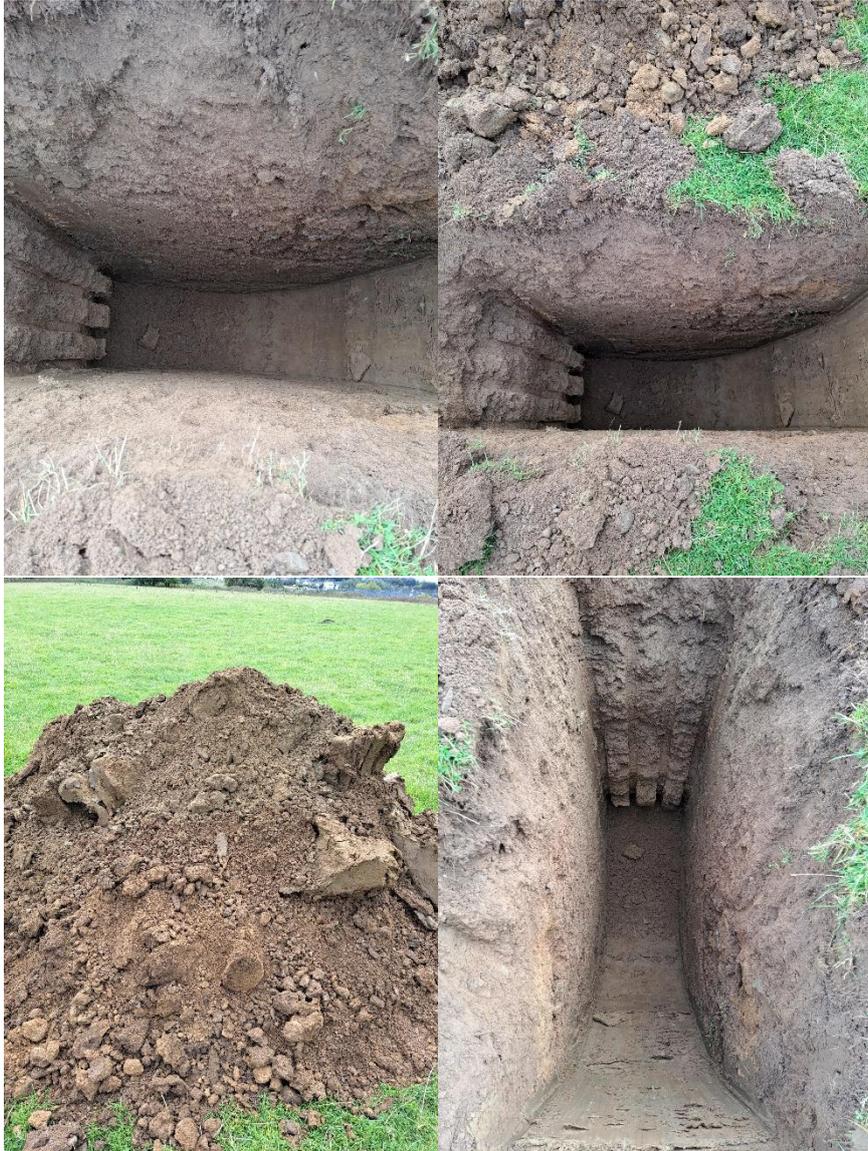
TP-06

<b>Plan</b> . . . . . . . . . .	<b>Remarks</b> Pit complete at 3.10m No groundwater encountered Trial pit stable Trial pit backfilled upon completion					
	<table border="1"> <tr> <td>Scale (approx)</td> <td>Logged By</td> <td>Figure No.</td> </tr> <tr> <td>1:25</td> <td>MK</td> <td>12122-08-22.TP06</td> </tr> </table>	Scale (approx)	Logged By	Figure No.	1:25	MK
Scale (approx)	Logged By	Figure No.				
1:25	MK	12122-08-22.TP06

Machine : 6T Excavator Method : Trial Pit	Dimensions (1.90m x 0.60m x 3.00m) (Lx W x D)	Ground Level (mOD)	Client Cairn Homes	Job Number 12122-08-22
	Location (Handheld GPS) 697836 E 715341 N	Dates 28/09/2022- 29/09/2022	Project Contractor Ground Investigations Ireland	Sheet 1/1

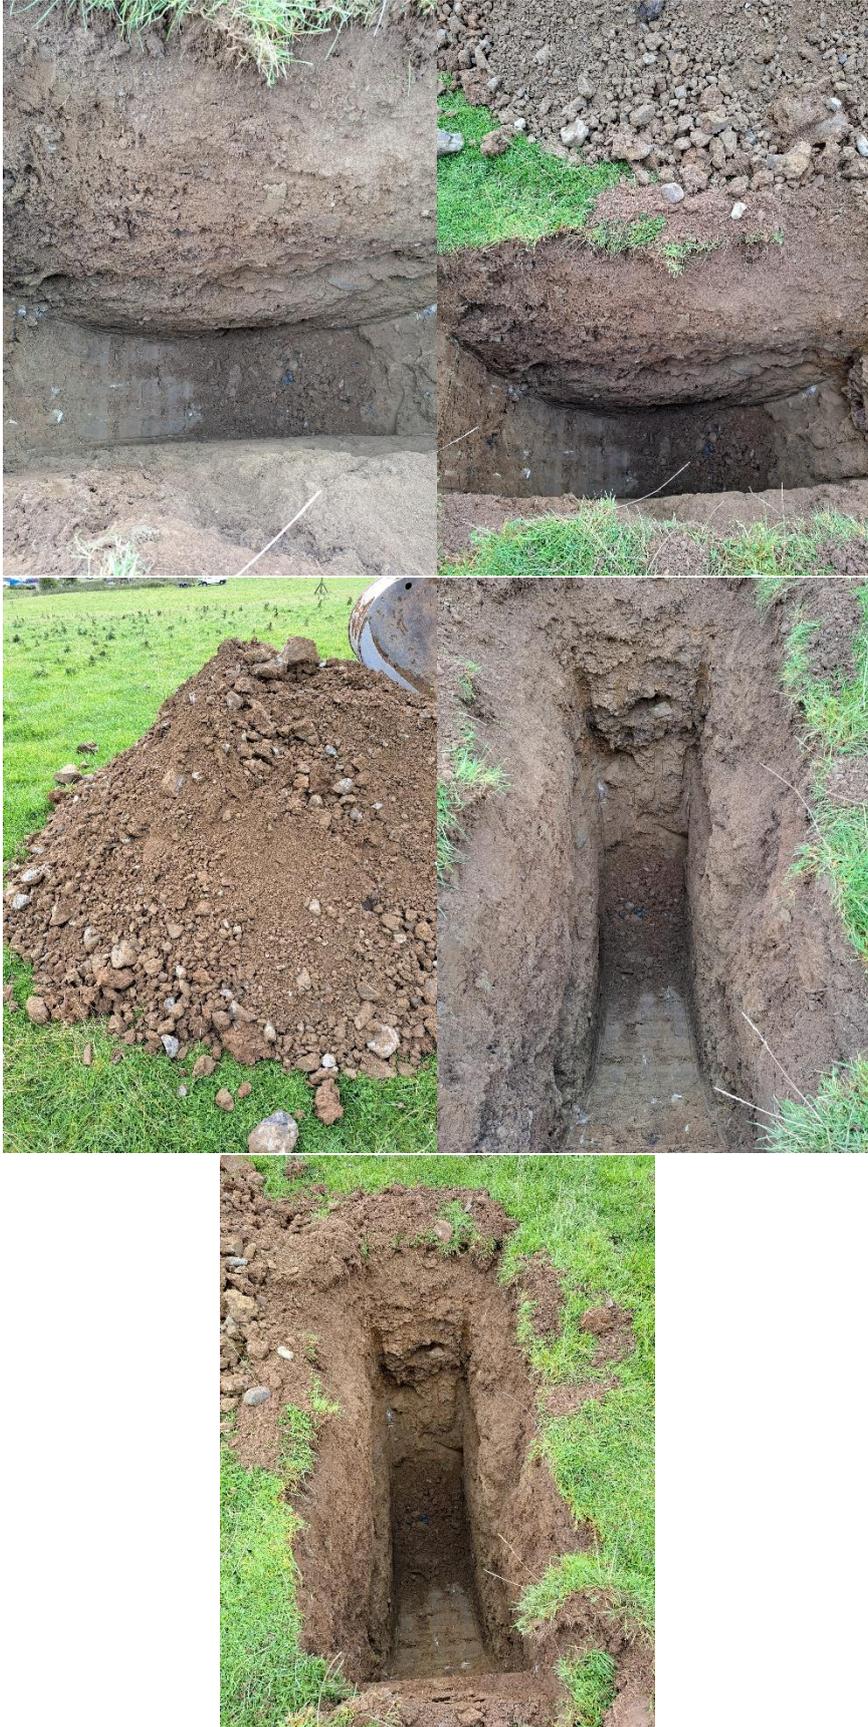
TP-07

<b>Plan</b> . . . . . . . . . .	<b>Remarks</b>  Pit complete at 3.00m No groundwater encountered Trial pit stable Trial pit backfilled upon completion	
		<b>Scale (approx)</b> 1:25

Machine : 6T Excavator Method : Trial Pit	Dimensions (2.20m x 0.60m x 3.00m) (Lx W x D)	Ground Level (mOD)	Client Cairn Homes	Job Number 12122-08-22
	Location (Handheld GPS) 697896 E 715341 N	Dates 28/09/2022- 29/09/2022	Project Contractor Ground Investigations Ireland	Sheet 1/1
