**BLESSINGTON DEMESNE LRD**

**ENVIRONMENTAL IMPACT ASSESSMENT REPORT**

**VOLUME III APPENDICES**

**Bat Fauna Impact Assessment for the  
Proposed Blessington Demesne Town Park & Residential Development**

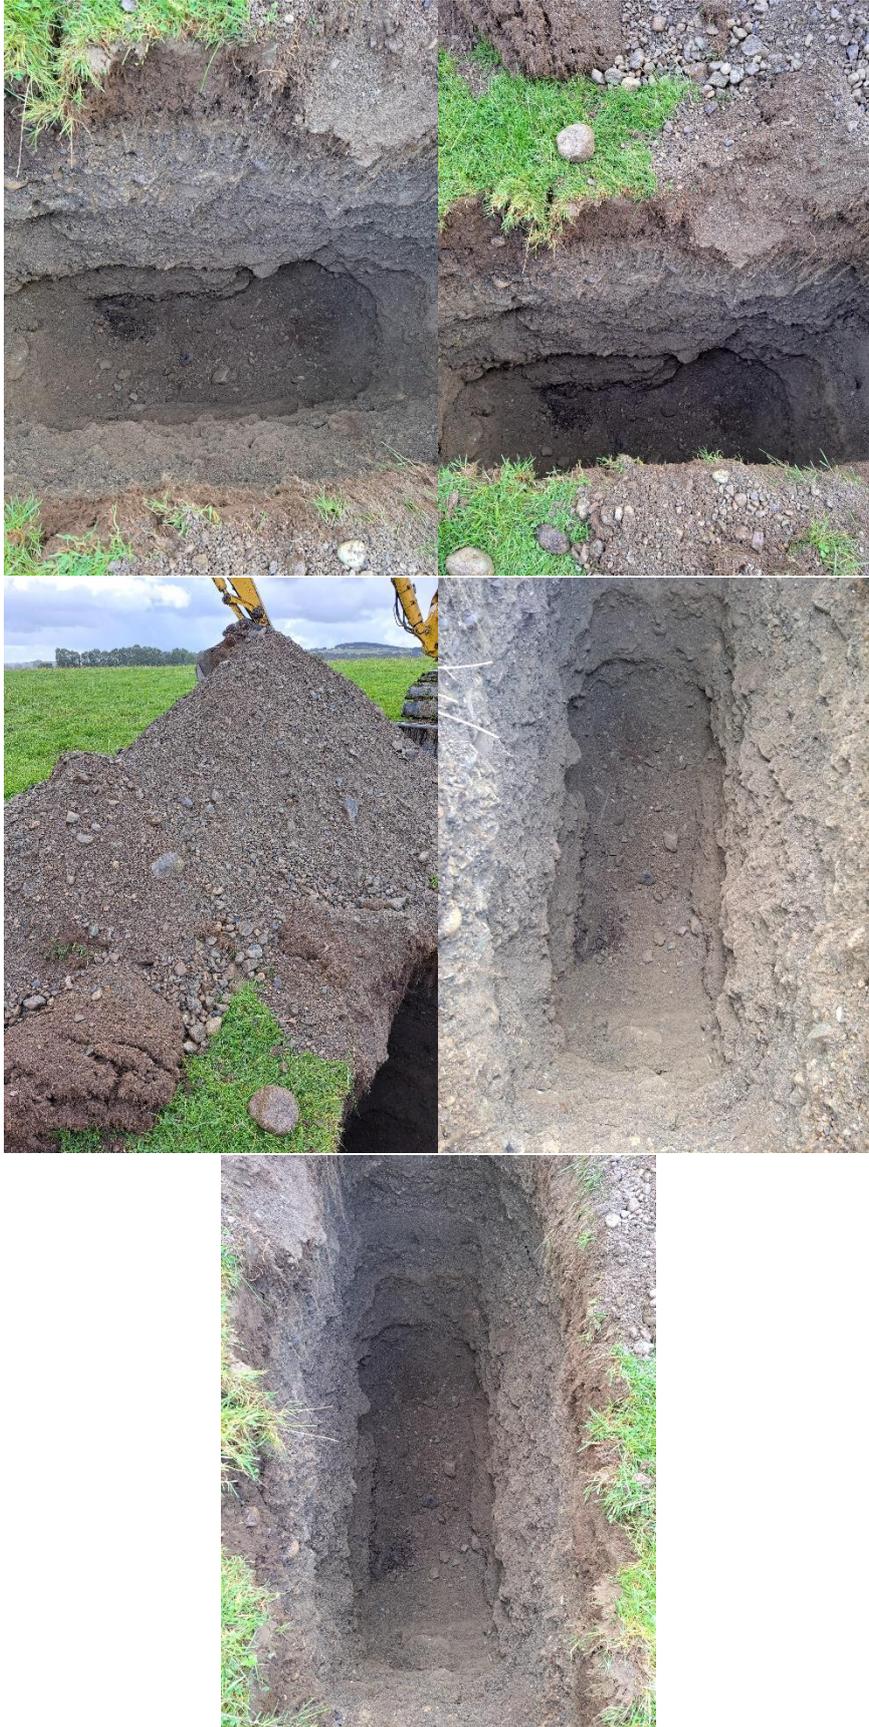
TP-08

<b>Plan</b> . . . . . . . . . .	<b>Remarks</b>  Pit complete at 3.00m No groundwater encountered Trial pit stable Trial pit backfilled upon completion					
	<table border="1"> <tr> <td>Scale (approx)</td> <td>Logged By</td> <td>Figure No.</td> </tr> <tr> <td>1:25</td> <td>MK</td> <td>12122-08-22.TP08</td> </tr> </table>	Scale (approx)	Logged By	Figure No.	1:25	MK
Scale (approx)	Logged By	Figure No.				
1:25	MK	12122-08-22.TP08

<b>Machine</b> : 6T Excavator <b>Method</b> : Trial Pit	<b>Dimensions</b> (2.00m x 0.80m x 3.00m) (Lx W x D)	<b>Ground Level (mOD)</b>	<b>Client</b> Cairn Homes	<b>Job Number</b> 12122-08-22
	<b>Location</b> (Handheld GPS) 697867 E 715184 N	<b>Dates</b> 28/09/2022- 29/09/2022	<b>Project Contractor</b> Ground Investigations Ireland	<b>Sheet</b> 1/1

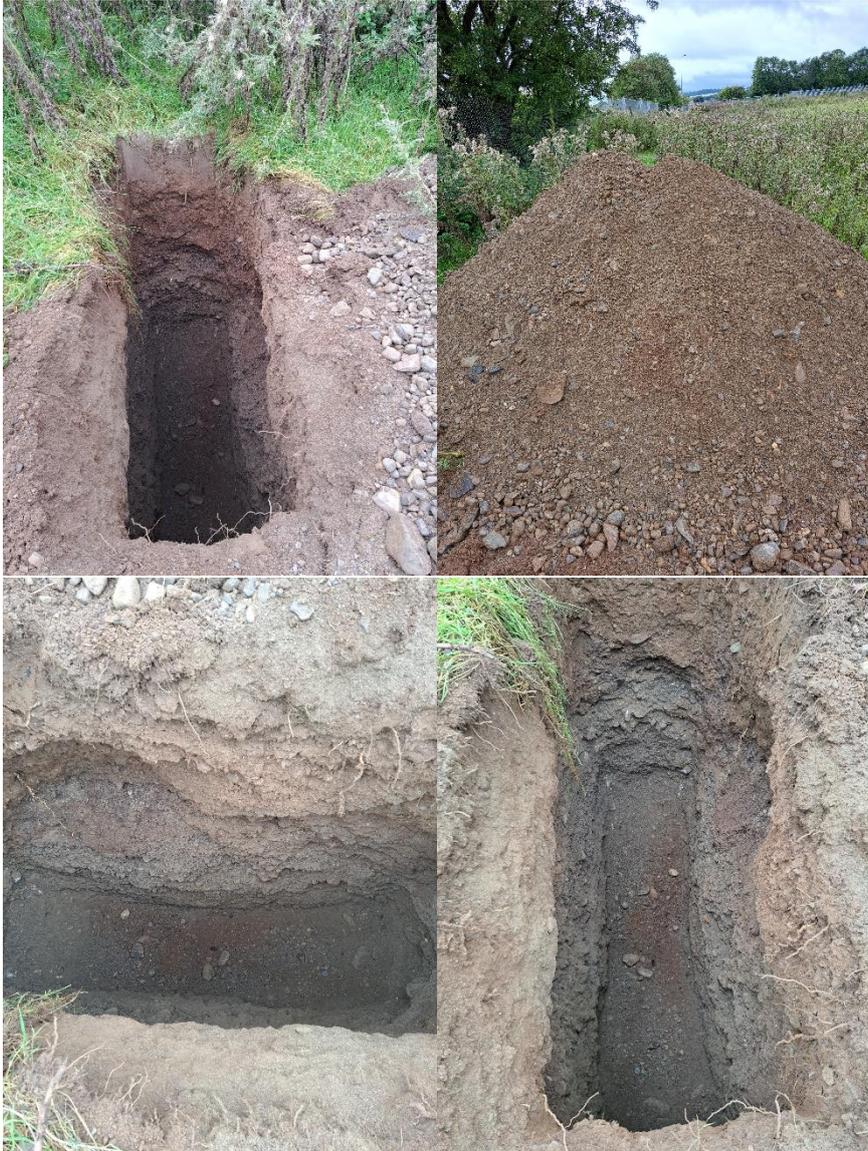
TP-09

<b>Plan</b>	<b>Remarks</b>		
.	Pit complete at 3.00m		
.	No groundwater encountered		
.	Trial pit stable		
.	Trial pit backfilled upon completion		
.			
.			
.			
.			
.			
	<b>Scale (approx)</b>	<b>Logged By</b>	<b>Figure No.</b>
	1:25	MK	12122-08-22.TP09

Machine : 6T Excavator Method : Trial Pit		Dimensions (2.10m x 0.70m x 3.10m) (Lx W x D)	Ground Level (mOD)	Client Cairn Homes	Job Number 12122-08-22
		Location (Handheld GPS) 697962 E 715187 N	Dates 28/09/2022- 29/09/2022	Project Contractor Ground Investigations Ireland	Sheet 1/1

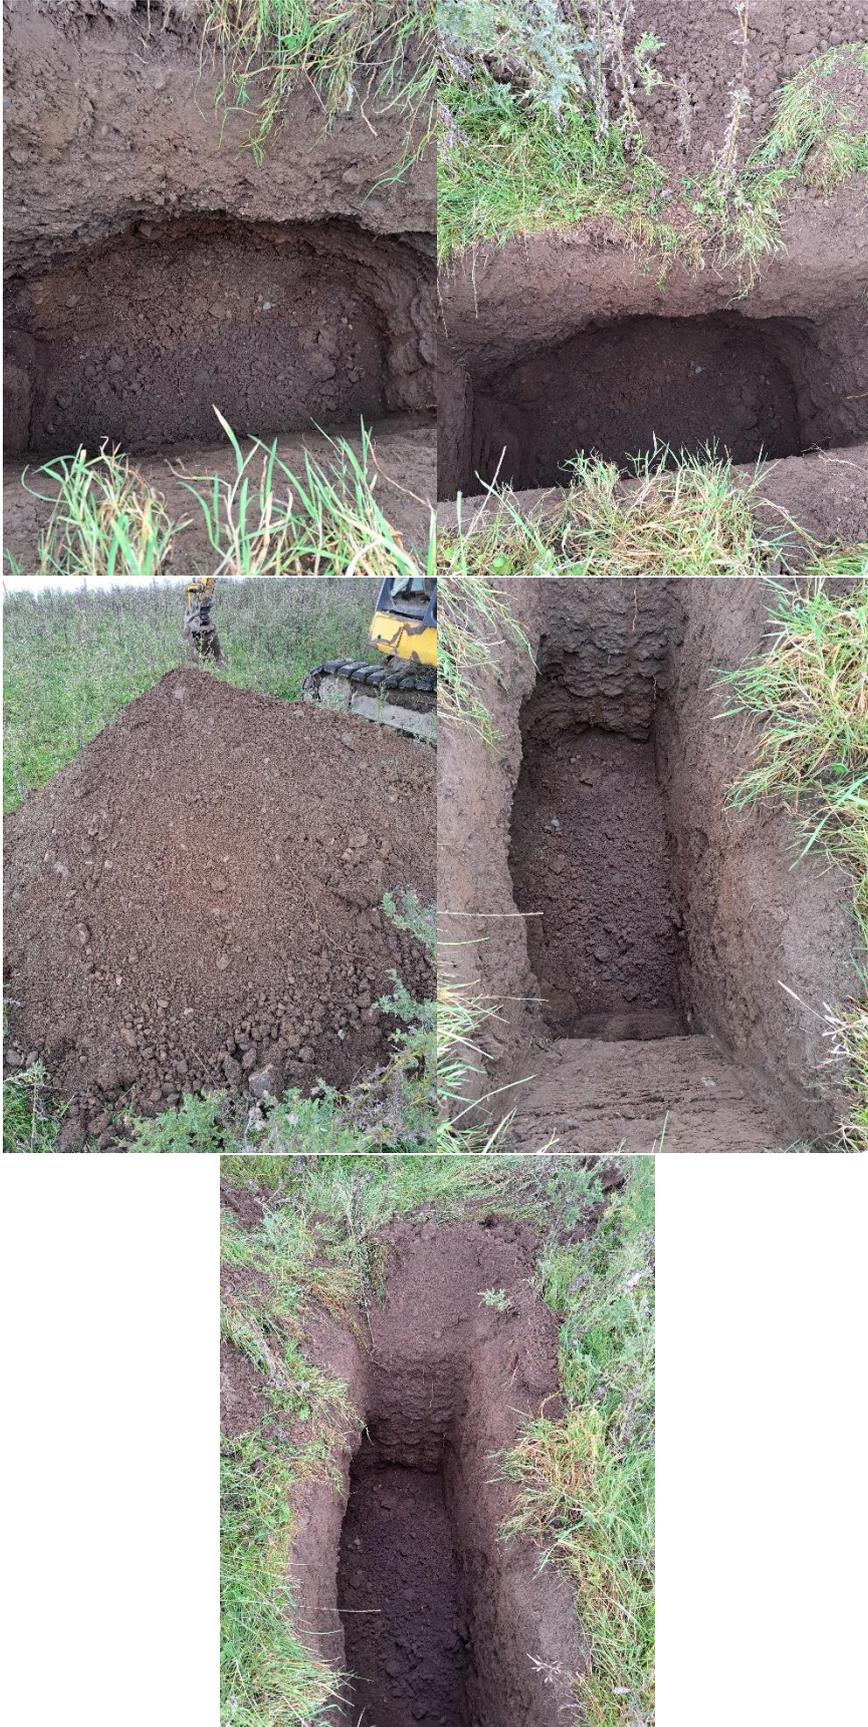
TP-10

<b>Plan</b> . . . . . . . . . .	<b>Remarks</b>  Pit complete at 3.10m No groundwater encountered Trial pit stable Trial pit backfilled upon completion					
	<table border="1"> <tr> <td>Scale (approx)</td> <td>Logged By</td> <td>Figure No.</td> </tr> <tr> <td>1:25</td> <td>MK</td> <td>12122-08-22.TP10</td> </tr> </table>	Scale (approx)	Logged By	Figure No.	1:25	MK
Scale (approx)	Logged By	Figure No.				
1:25	MK	12122-08-22.TP10

Machine : 6T Excavator Method : Trial Pit	Dimensions (2.90m x 0.60m x 3.00m) (Lx W x D)	Ground Level (mOD)	Client Cairn Homes	Job Number 12122-08-22
	Location (Handheld GPS) 697992 E 715237 N	Dates 28/09/2022- 29/09/2022	Project Contractor Ground Investigations Ireland	Sheet 1/1

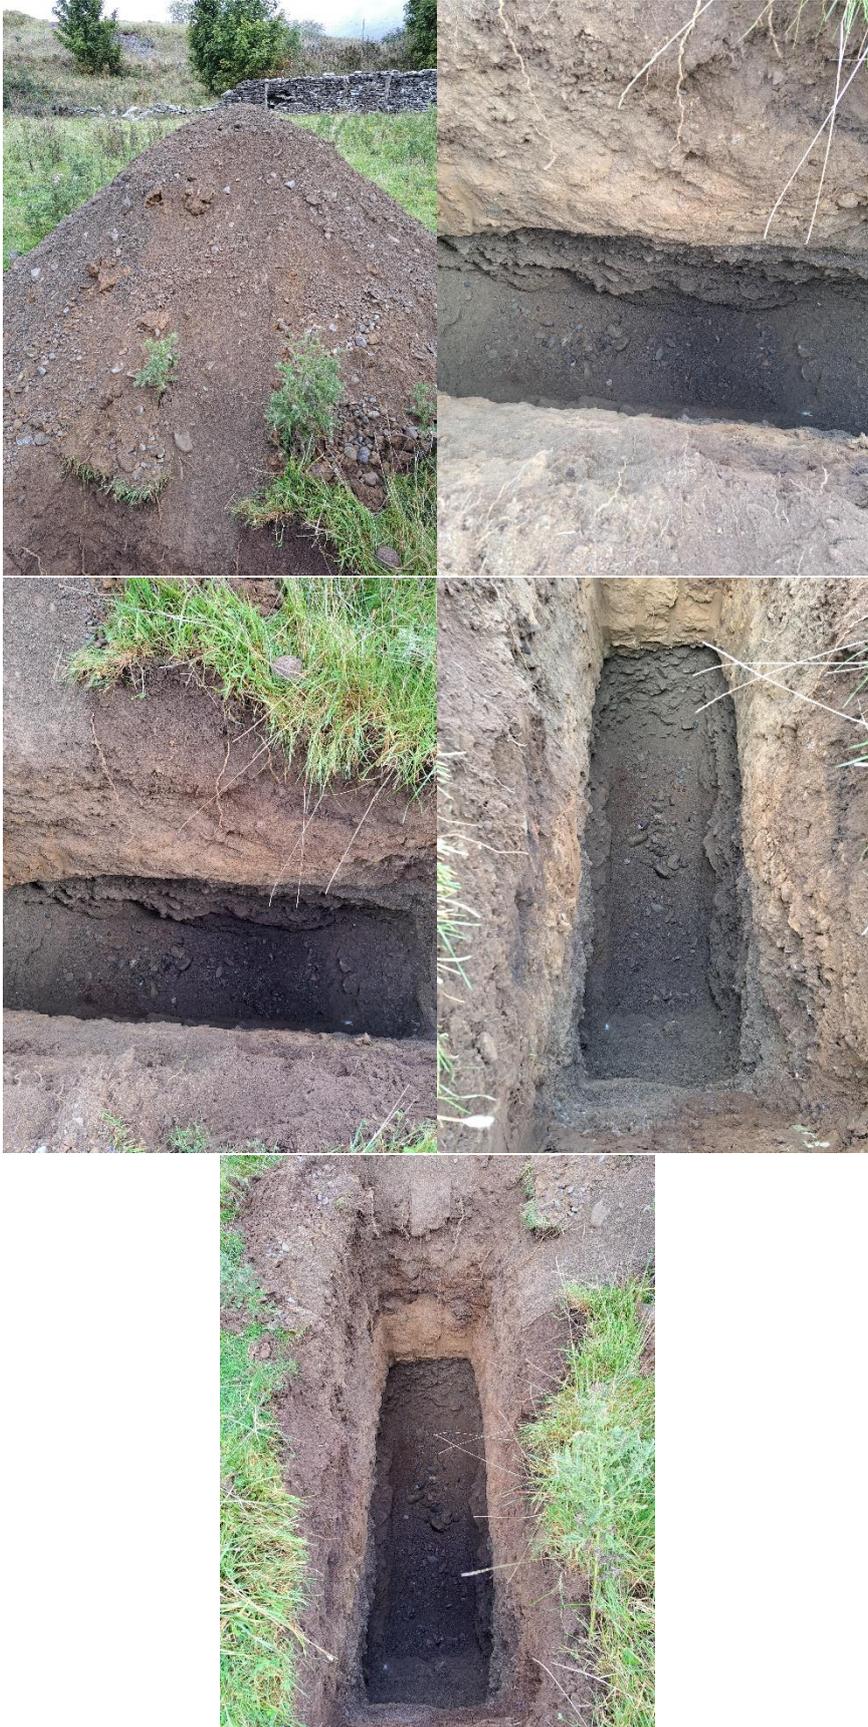
TP-11

<b>Plan</b> .	<b>Remarks</b>  Pit complete at 3.00m No groundwater encountered Trial pit stable Trial pit backfilled upon completion	
		<b>Scale (approx)</b> 1:25

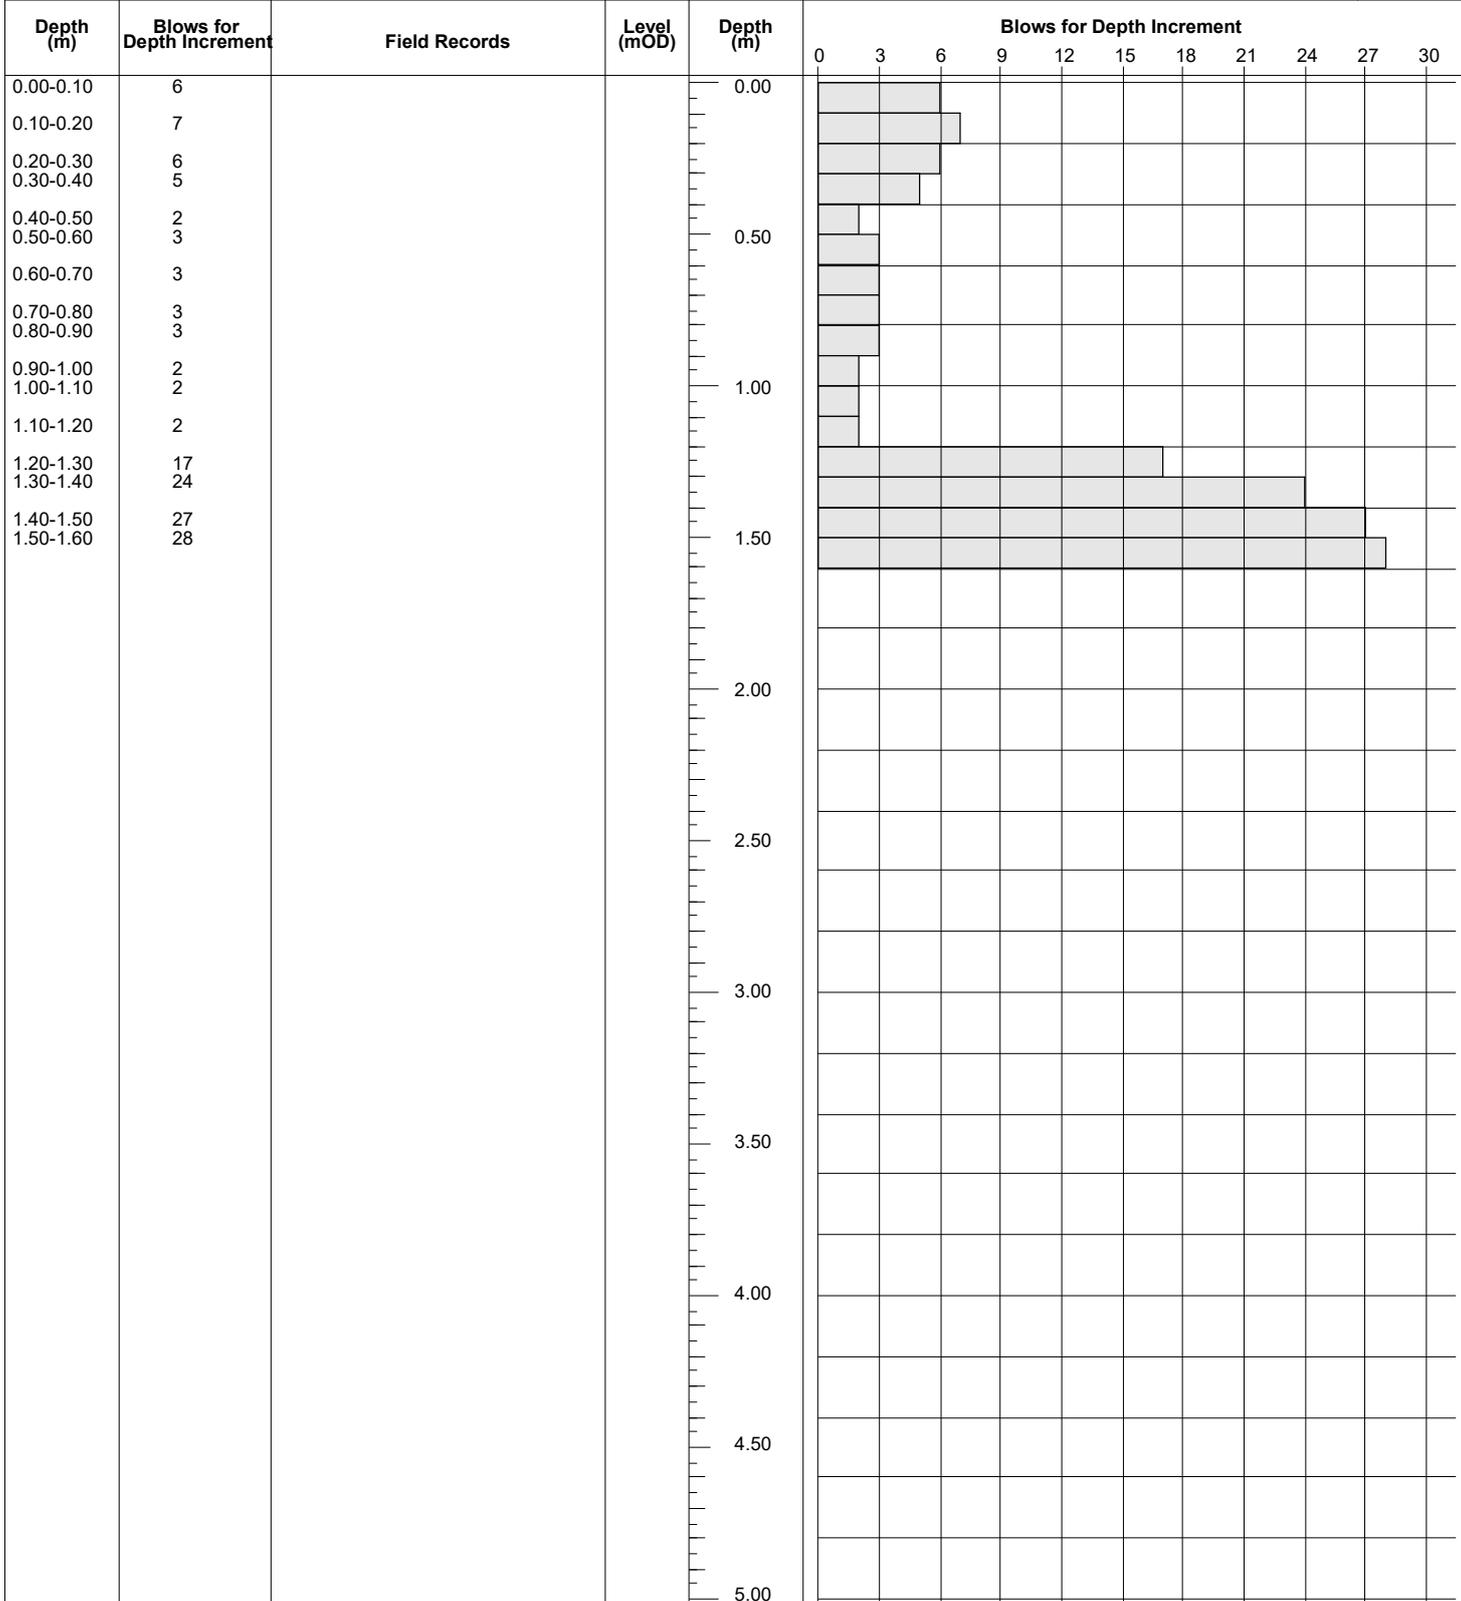
<b>Remarks</b>	<b>Scale (approx)</b> 1:25	<b>Logged By</b> AG
	<b>Figure No.</b>	
	12122-08-22.DPH-01

<b>Method</b> Dynamic Pobe Heavy (DPH) Hammer Drop Height 500mm Hammer Weight 50Kg	<b>Cone Dimensions</b> Diameter 43.7mm, Angle 90°	<b>Ground Level (mOD)</b>	<b>Client</b> Cairn Homes	<b>Job Number</b> 12122-08-22
	<b>Location (Handheld GPS)</b>	<b>Dates</b> 28/09/2022- 29/09/2022	<b>Engineer</b> DBFL Consulting Engineers	<b>Sheet</b> 1/1

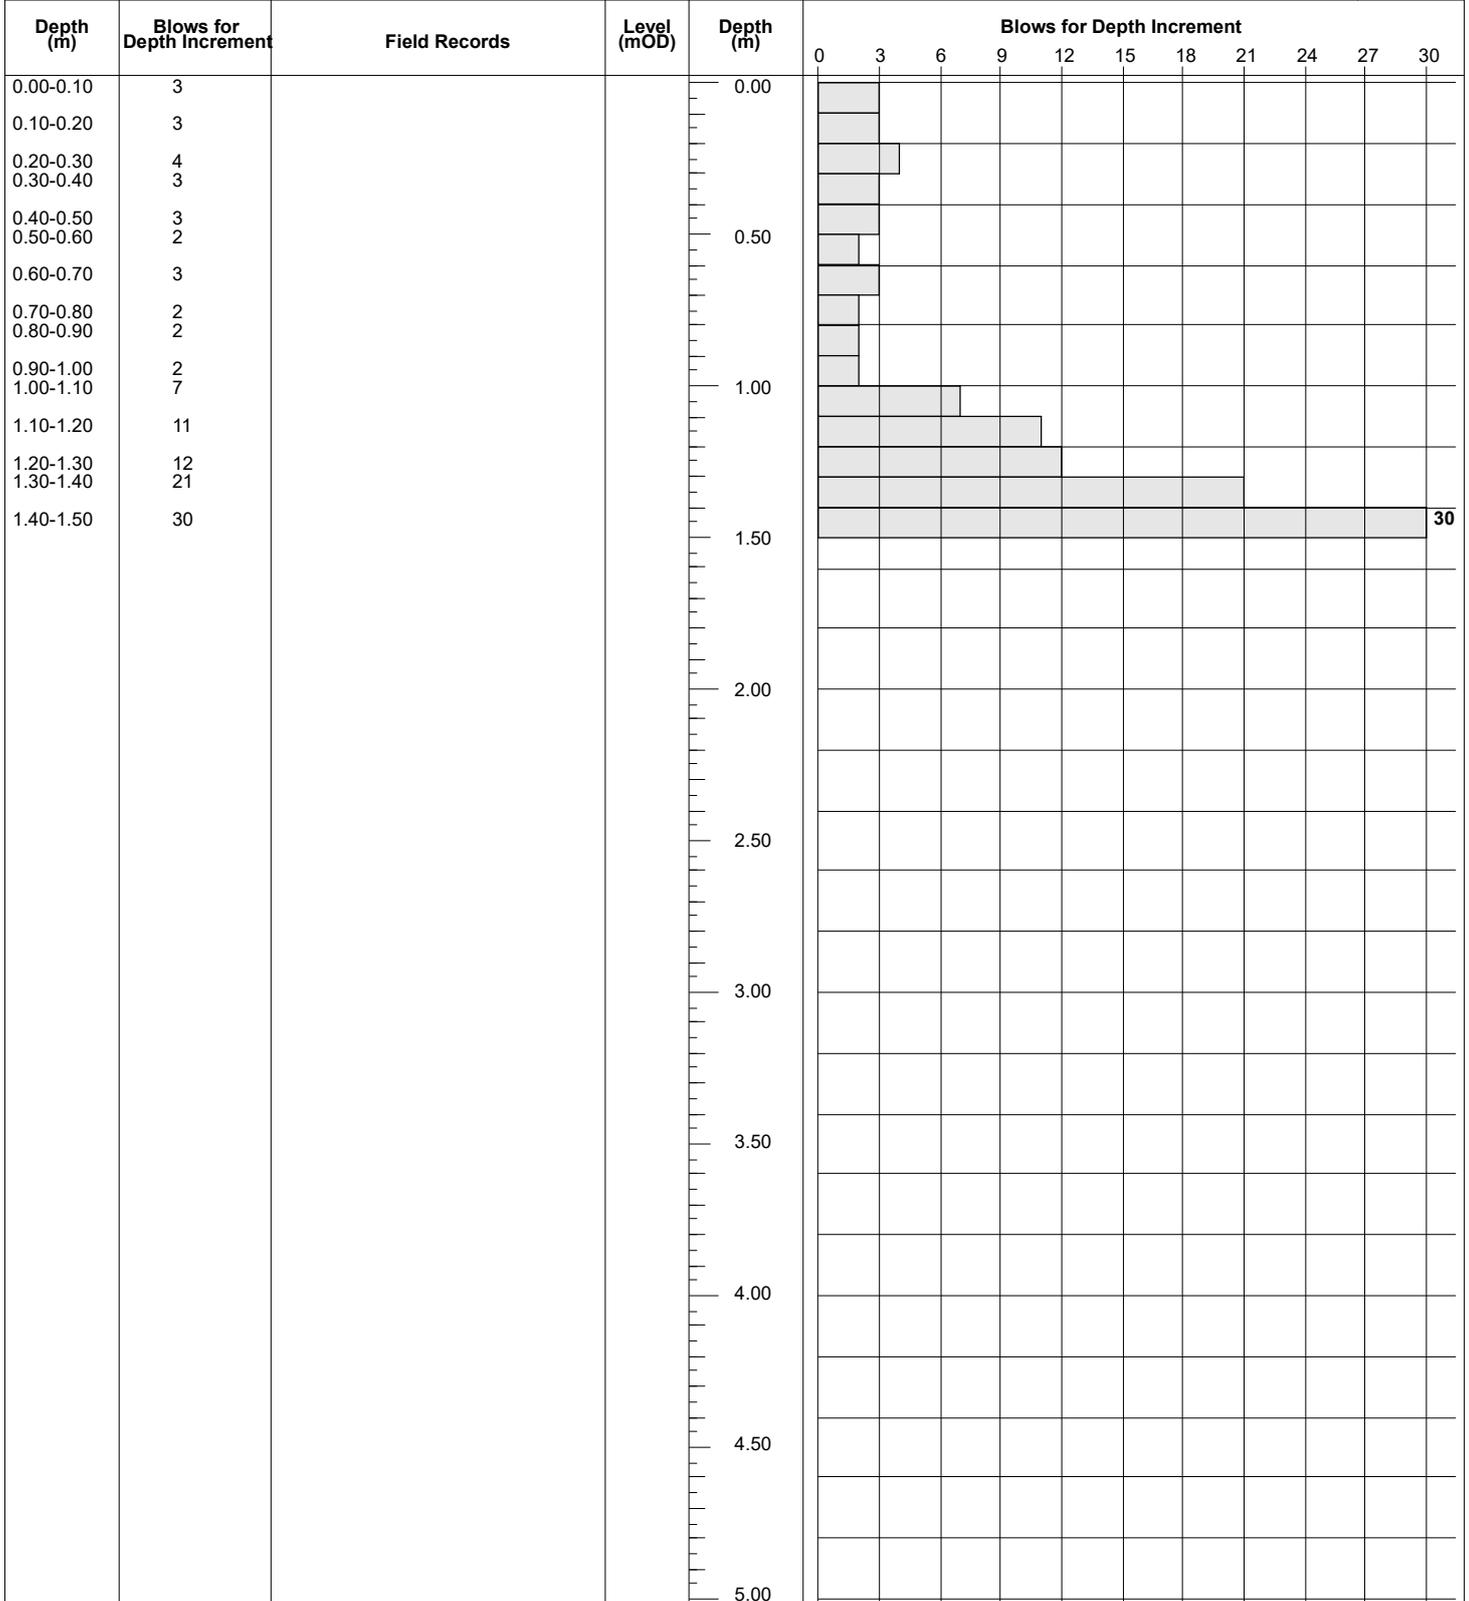
Remarks	Scale (approx)	Logged By
	1:25	AG
	Figure No.	
12122-08-22.DPH-03

<b>Method</b> Dynamic Pobe Heavy (DPH) Hammer Drop Height 500mm Hammer Weight 50Kg	<b>Cone Dimensions</b> Diameter 43.7mm, Angle 90°	<b>Ground Level (mOD)</b>	<b>Client</b> Caim Homes	<b>Job Number</b> 12122-08-22
	<b>Location (Handheld GPS)</b>	<b>Dates</b> 28/09/2022- 29/09/2022	<b>Engineer</b> DBFL Consulting Engineers	<b>Sheet</b> 1/1

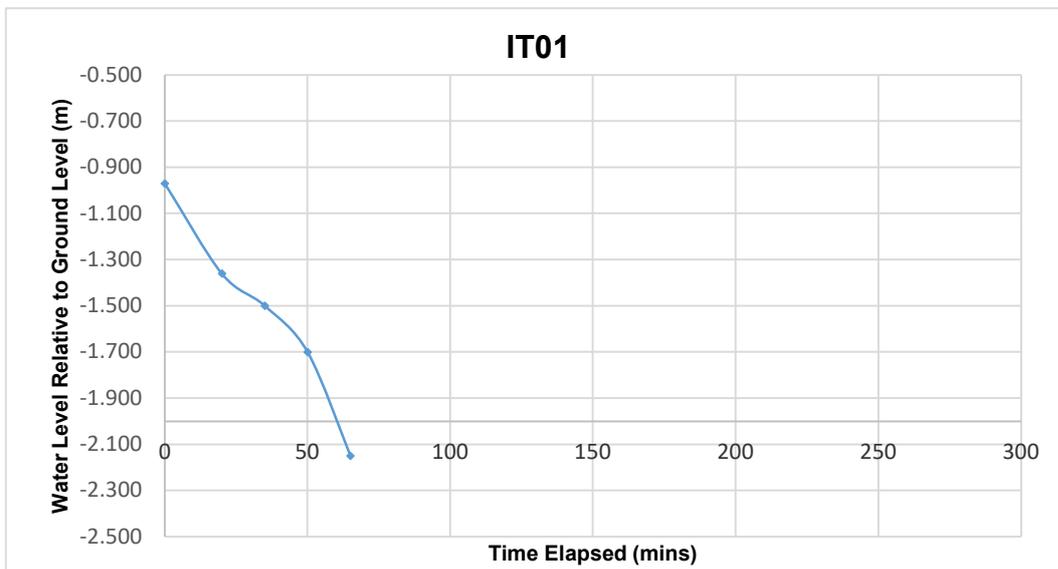
<b>Start depth</b> 0.97	<b>Depth of Pit</b> 3.000	<b>Diff</b> 2.030	<b>75% full</b> 1.4775	<b>25%full</b> 2.4925
Length of pit (m)	Width of pit (m)		75-25Ht (m)	Vp75-25 (m3)
1.900	0.700		1.015	1.35
Tp75-25 (from graph) (s)	<b>2400</b>		50% Eff Depth	ap50 (m2)
<b>f =</b>	<b>8.512E-05</b>	<b>m/s</b>	1.015	6.608

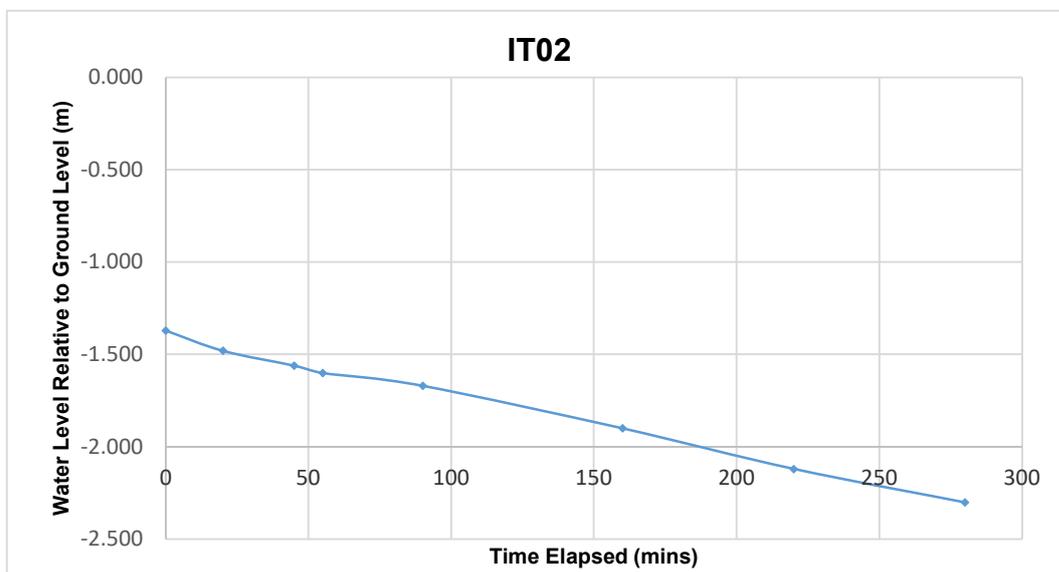
<b>Start depth</b> 1.37	<b>Depth of Pit</b> 3.000	<b>Diff</b> 1.630	<b>75% full</b> 1.7775	<b>25%full</b> 2.5925
Length of pit (m)	Width of pit (m)		75-25Ht (m)	Vp75-25 (m3)
2.500	0.700		0.815	1.43
Tp75-25 (from graph) (s)	<b>7800</b>		50% Eff Depth	ap50 (m2)
			0.815	6.966
<b>f =</b>	<b>2.625E-05</b>	<b>m/s</b>

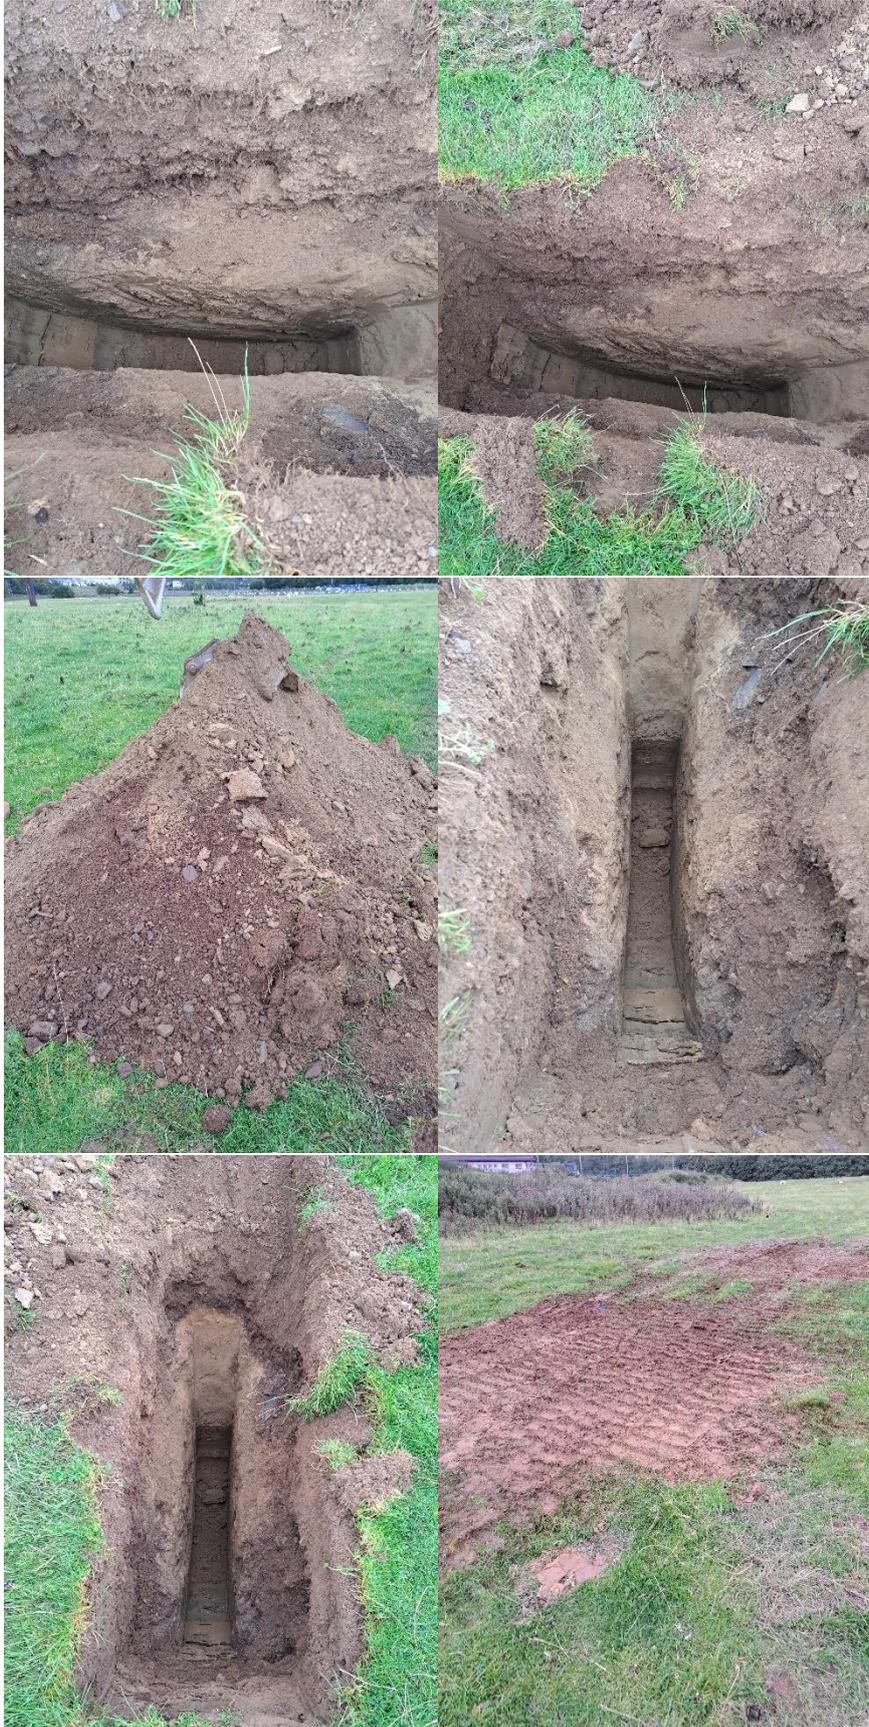
IT-02

Machine : 6T Excavator Method : Trial Pit	Dimensions (2.20m x 0.70m x 3.00m) (Lx W x D)	Ground Level (mOD)	Client Cairn Homes	Job Number 12122-08-22
	Location (Handheld GPS) 697780 E 715263 N	Dates 28/09/2022- 29/09/2022	Project Contractor Ground Investigations Ireland	Sheet 1/1

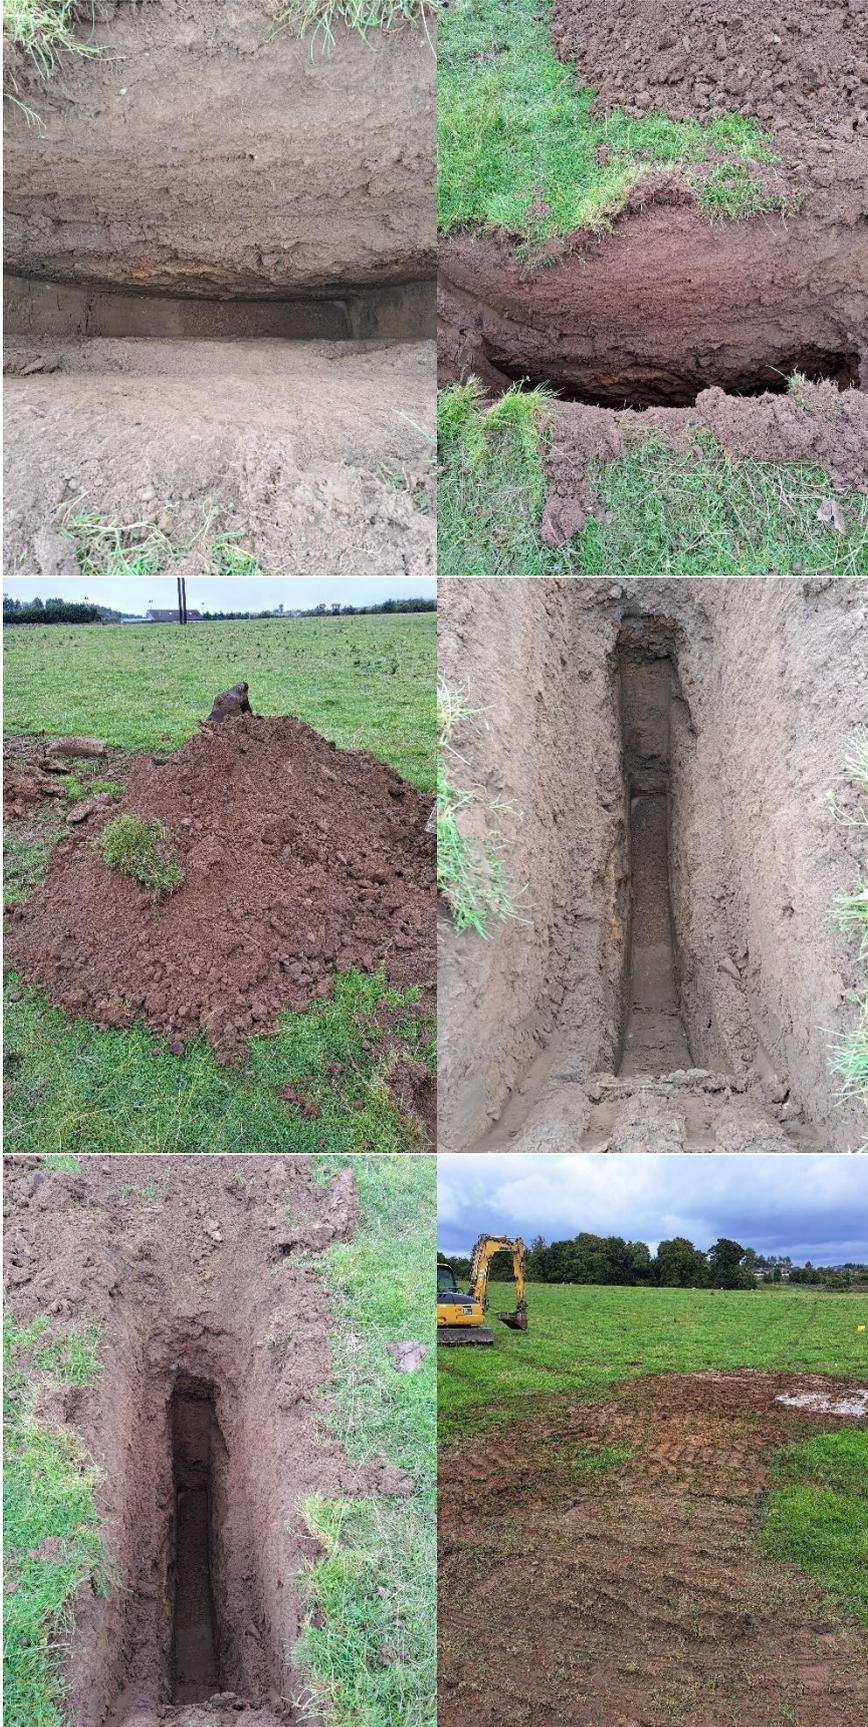
IT-03

Machine : 6T Excavator Method : Trial Pit	Dimensions (2.20m x 0.70m x 3.00m) (Lx W x D)	Ground Level (mOD)	Client Cairn Homes	Job Number 12122-08-22
	Location (Handheld GPS) 697836 E 715318 N	Dates 28/09/2022- 29/09/2022	Project Contractor Ground Investigations Ireland	Sheet 1/1

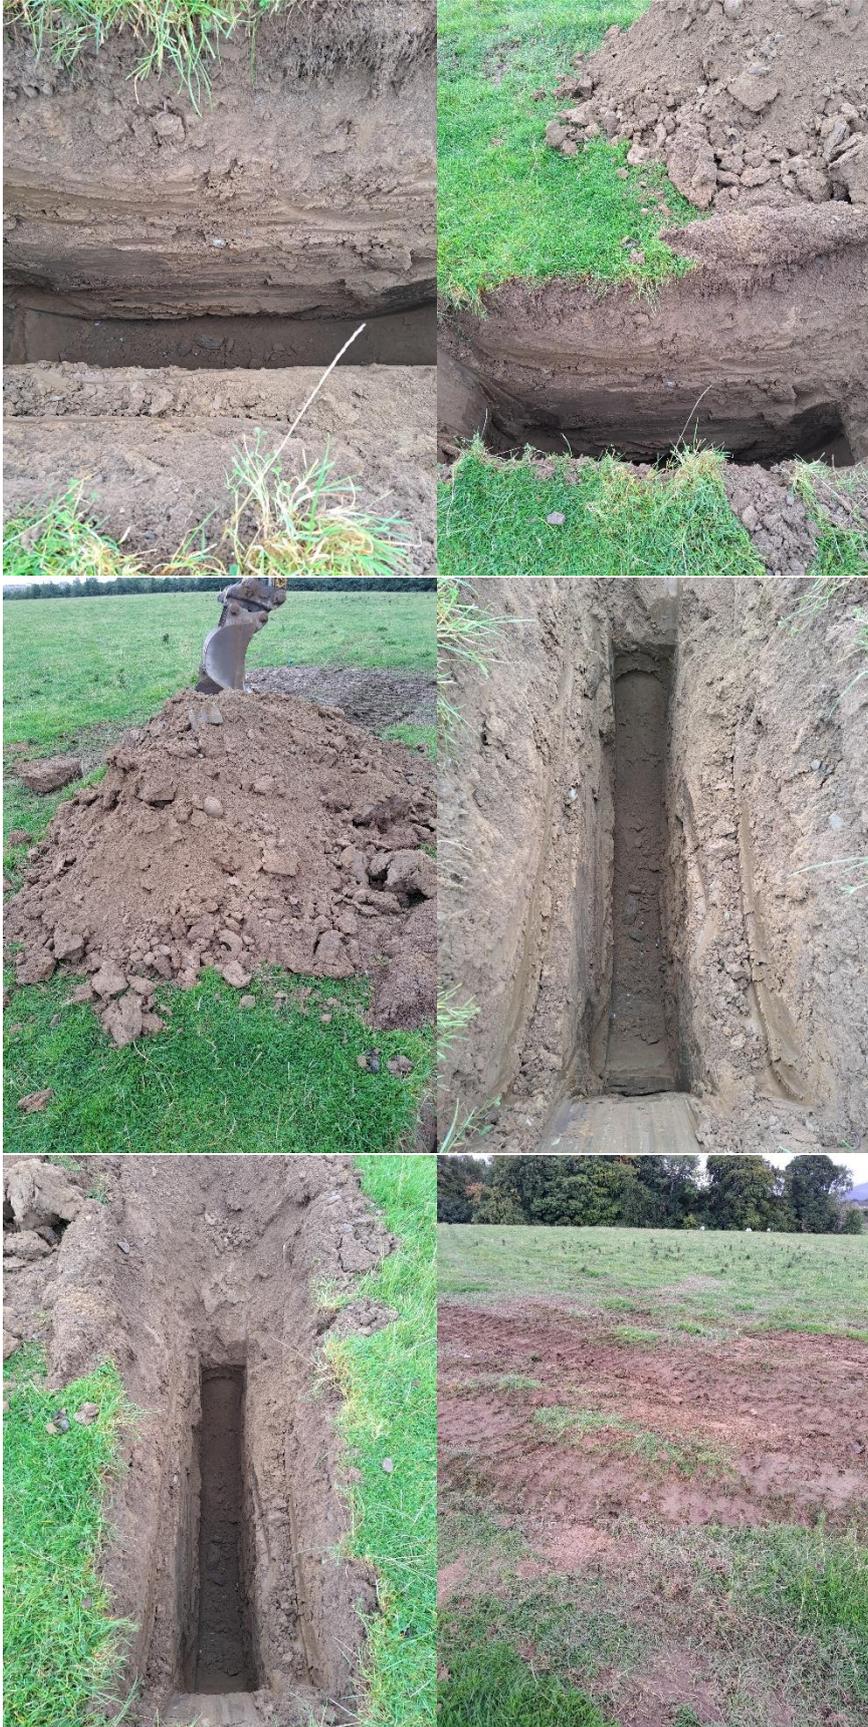
IT-04

<b>Plan</b> . . . . . . . . . .	<b>Remarks</b> Pit complete at 3.00m No groundwater encountered Trial pit stable Trial pit backfilled upon completion					
	<table border="1"> <tr> <td>Scale (approx)</td> <td>Logged By</td> <td>Figure No.</td> </tr> <tr> <td>1:25</td> <td>MK</td> <td>12122-08-22.IT04</td> </tr> </table>	Scale (approx)	Logged By	Figure No.	1:25	MK
Scale (approx)	Logged By	Figure No.				
1:25	MK	12122-08-22.IT04

Machine : 6T Excavator Method : Trial Pit		Dimensions (2.30m x 0.70m x 3.00m) (Lx W x D)	Ground Level (mOD)	Client Cairn Homes	Job Number 12122-08-22
		Location (Handheld GPS) 697896 E 715341 N	Dates 28/09/2022- 29/09/2022	Project Contractor Ground Investigations Ireland	Sheet 1/1

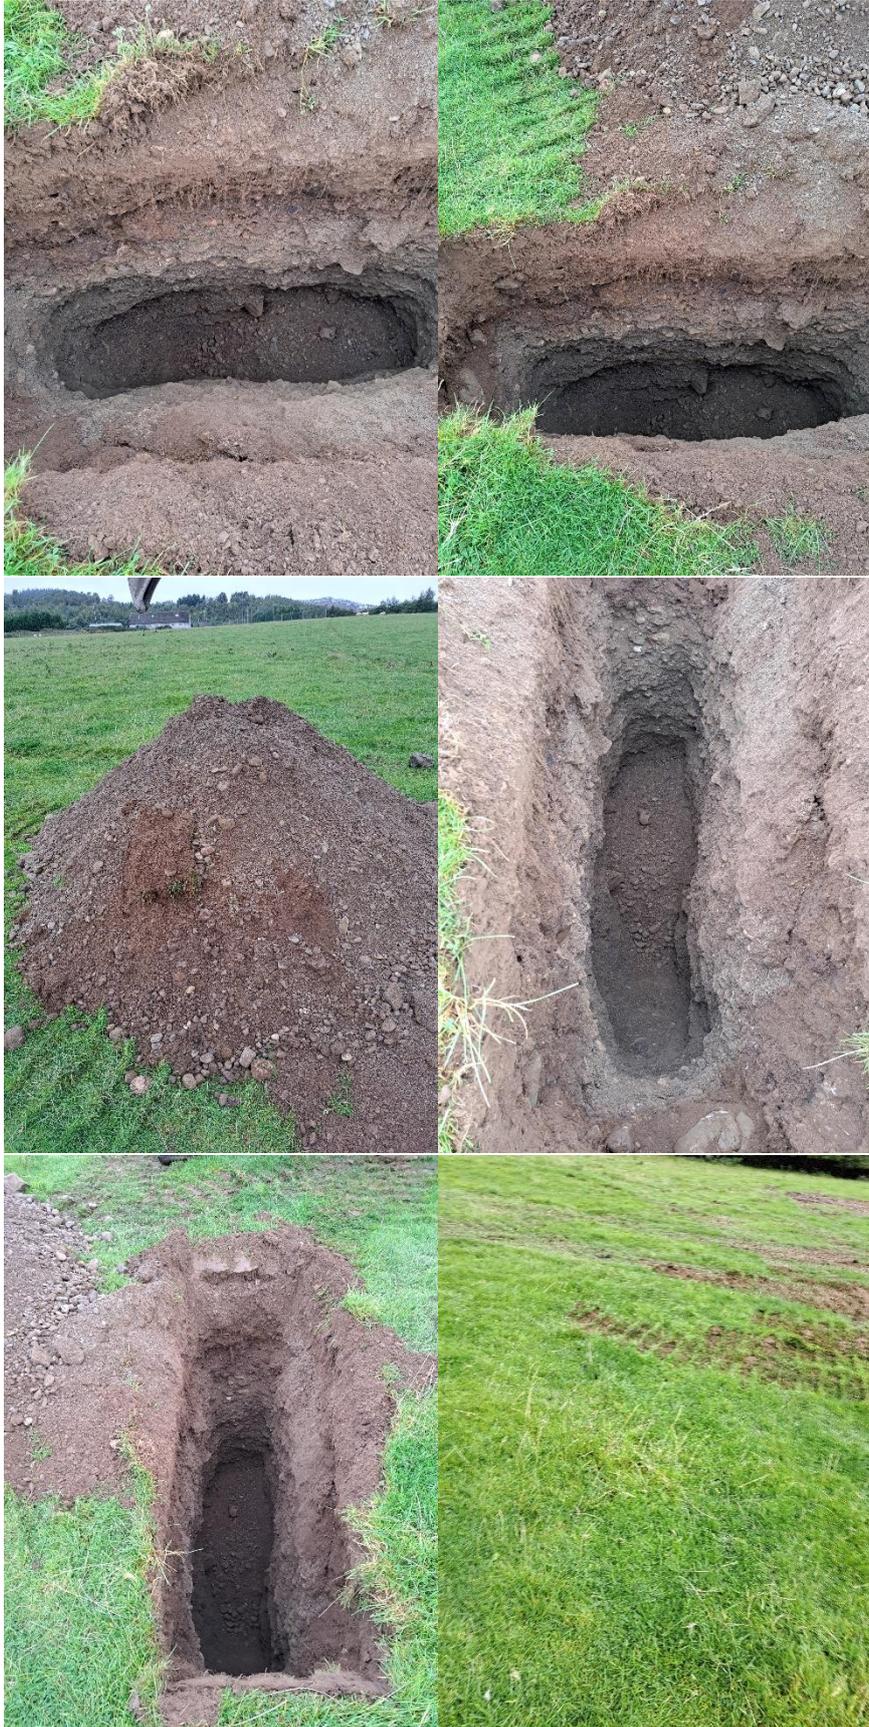
IT-05

<b>Plan</b> . . . . . . . . . .	<b>Remarks</b> Pit complete at 3.00m No groundwater encountered Trial pit stable Trial pit backfilled upon completion					
	<table border="1"> <tr> <td>Scale (approx)</td> <td>Logged By</td> <td>Figure No.</td> </tr> <tr> <td>1:25</td> <td>MK</td> <td>12122-08-22.IT05</td> </tr> </table>	Scale (approx)	Logged By	Figure No.	1:25	MK
Scale (approx)	Logged By	Figure No.				
1:25	MK	12122-08-22.IT05

Machine : 6T Excavator Method : Trial Pit		Dimensions (2.10m x 0.70m x 3.00m) (Lx W x D)	Ground Level (mOD)	Client Cairn Homes	Job Number 12122-08-22
		Location (Handheld GPS) 697867 E 715318 N	Dates 28/09/2022- 29/09/2022	Project Contractor Ground Investigations Ireland	Sheet 1/1

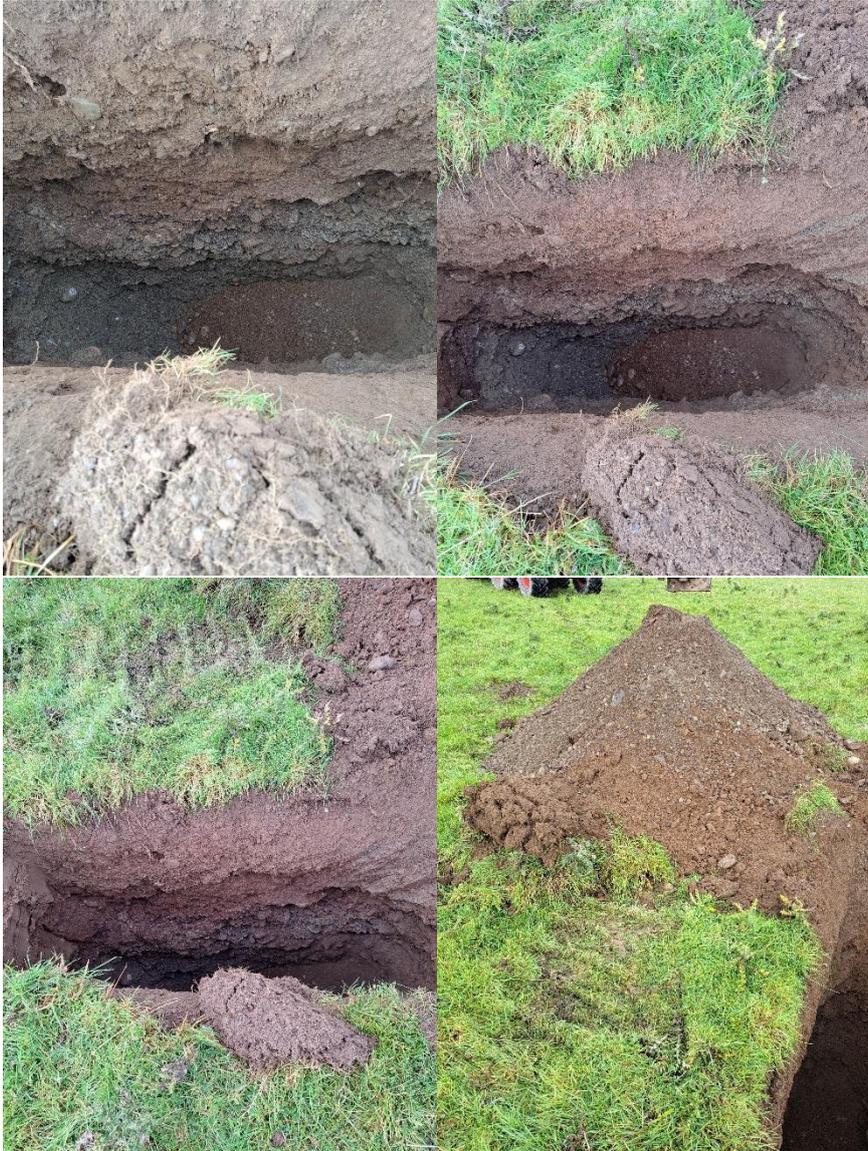
IT-06

<b>Plan</b> . . . . . . . . . .	<b>Remarks</b>  Pit complete at 3.00m No groundwater encountered Trial pit stable Trial pit backfilled upon completion					
	<table border="1"> <tr> <td>Scale (approx)</td> <td>Logged By</td> <td>Figure No.</td> </tr> <tr> <td>1:25</td> <td>MK</td> <td>12122-08-22.IT06</td> </tr> </table>	Scale (approx)	Logged By	Figure No.	1:25	MK
Scale (approx)	Logged By	Figure No.				
1:25	MK	12122-08-22.IT06
