# **Environmental Impact Assessment Report**

**KILLALA DATA CENTRE DEVELOPMENT**

**MULLAFARRY AND TAWNAGHMORE UPPER,  
KILLALA, CO. MAYO**

## **Volume 3 - EIA Report Appendix**

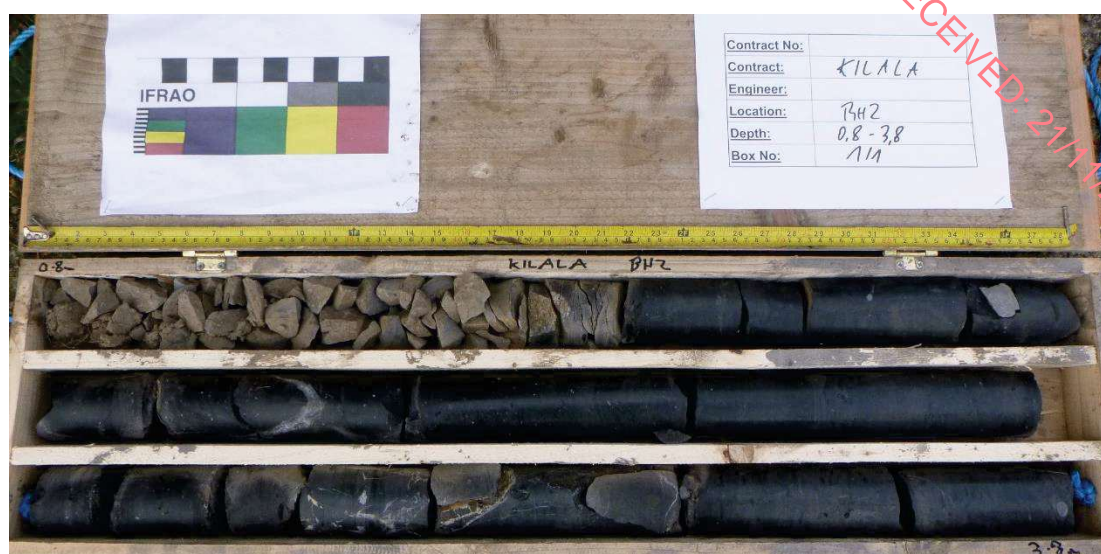
BH02 Box 1 of 1

Bedrock was encountered at 0.80mbgl and 0.50mbgl at BH02 and BH03 respectively and although highly fractured core was initially encountered, the bedrock was logged as a strong grey muddy LIMESTONE, with calcite veins and fossils recorded and is part of the Ballina Limestone Formation. The core quality improved at 1.35mbgl and 1.90mbgl in the coreholes and they were terminated after 3m of core was recovered.

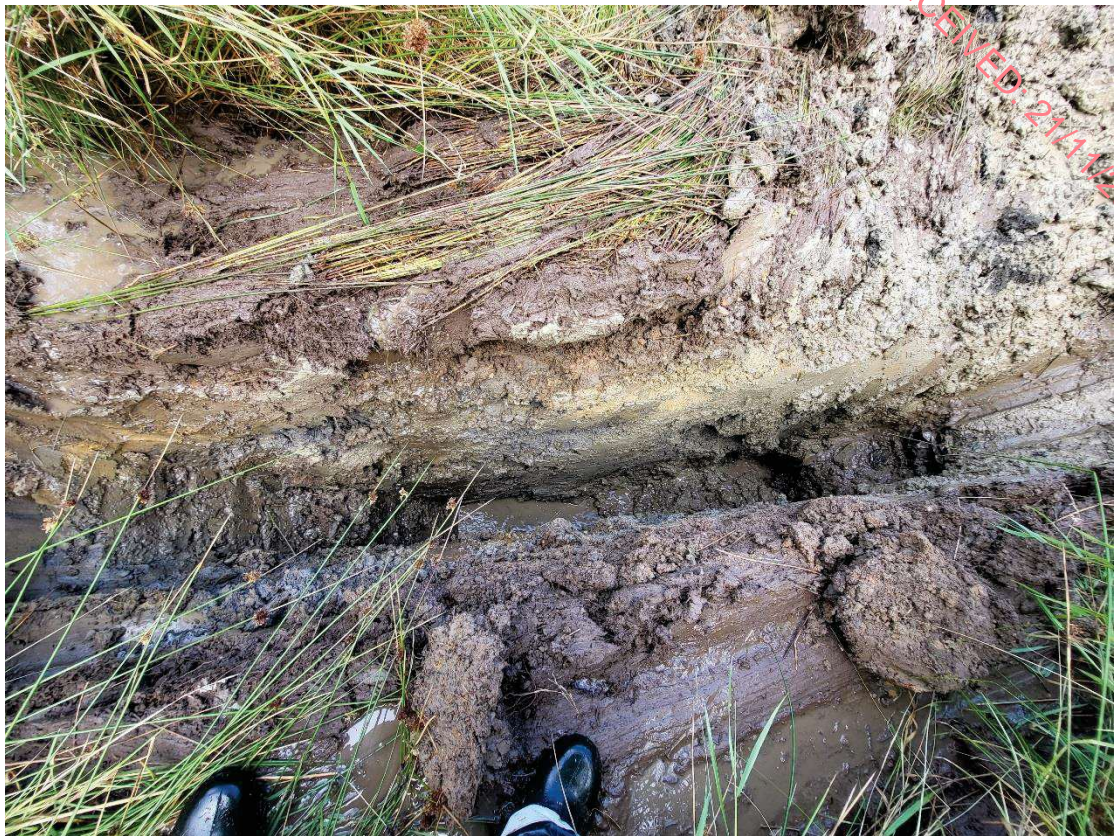
**TP01 Sidewall**

The natural ground conditions are dominated by brown sandy slightly gravelly silty CLAY with cobbles. The locations to the south east of the site achieved depths greater than 1.00mbgl, with TP01 achieving 1.80m depth before terminating.
