**Clonburris
Phase 3**

**Ground Investigation &
Geotechnical
Interpretative Report**

Project No. 25279A

August 2024

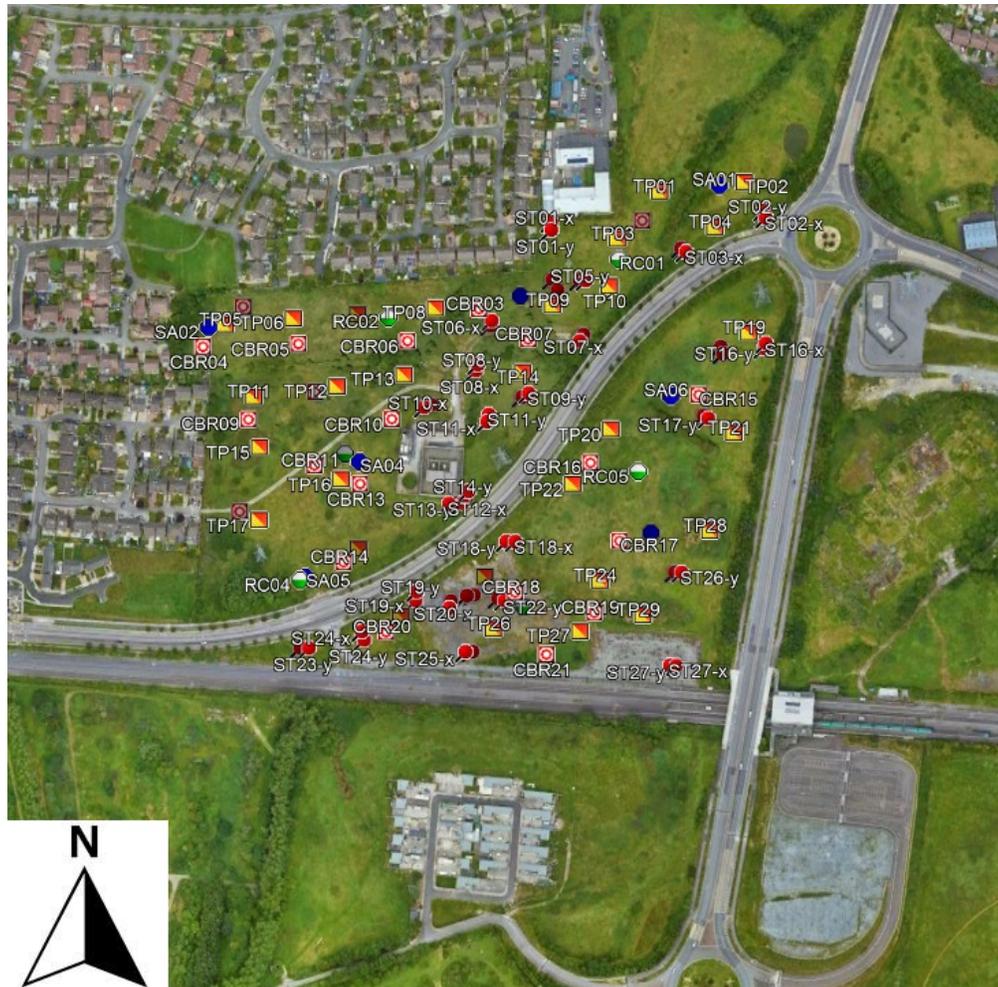
Figure 1 – Site Location Plan – intrusive locations plotted

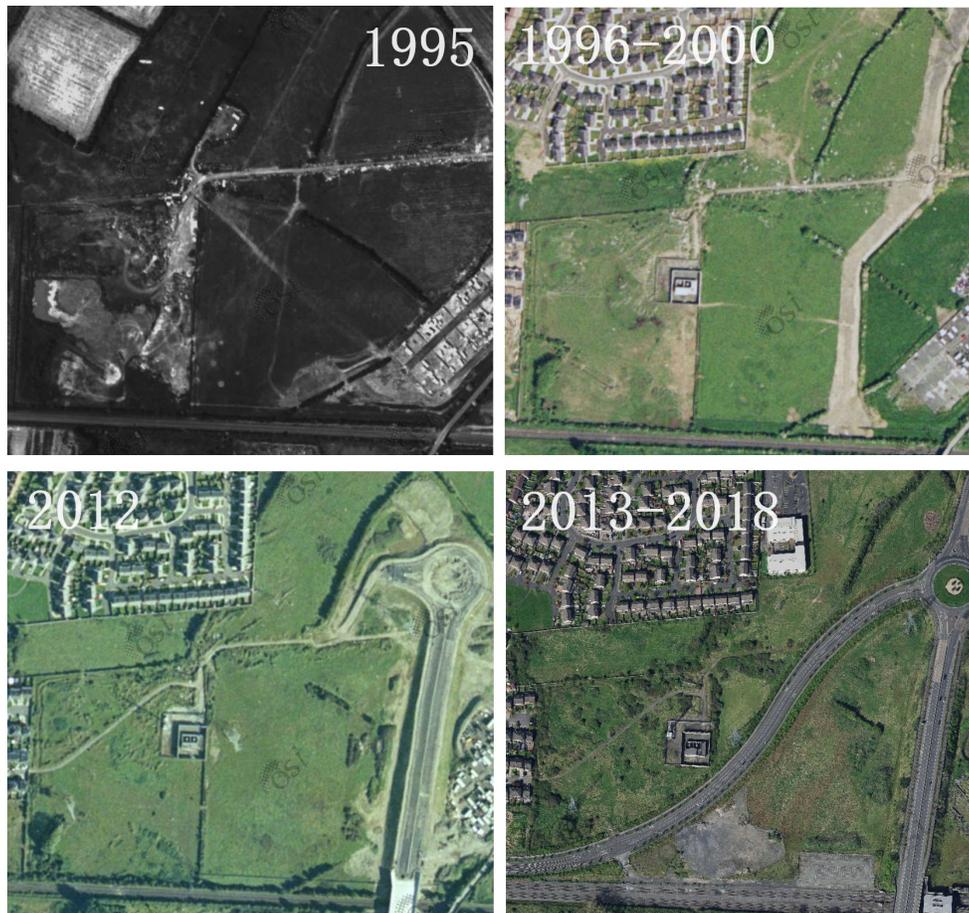
Figure 5 –OSI aerial orthophotographs for the Kishoge site 1995 - 2018 (Tailte Éireann)

Aerial orthophotography reveals an interesting development from 1995 (See Figure 5). A trackway crosses east-west across the site which leads to an area of apparent tipping / stockpiling. The area of disturbed ground persists into the colour imagery dating from 1996-2000. The Balgaddy 38kV Substation also appears in the image as does the linear scar of trenchwork resulting from works on a 900mm diameter gas transmission main.

The drawings from 2012 show the Outer Orbital Route under construction. The R136 roundabout is in place but spurs to both Balgaddy / Neillstown to the east and Ballyowen / Lucan to the north are as yet undeveloped. Soil stockpiling is again noted, this time to the west and northwest of the newly constructed R136 roundabout. The current road network, including Adamstown Avenue can be viewed in the more recent 2013-2018 orthophotograph.

- Given the recent disturbance documented in the aerial orthophotographs from 1995 (See Figure 5), the existence of Made Ground soils in the stratigraphy is not unexpected.

- Extensive CLAY fill was uncovered in TP02. TP02 lies in an area flagged as having soil disturbance dating from the period of R136 road construction (See Figure 5). Dark brown and dark grey sandy gravelly CLAY soils extended to 1.70m (56.67m OD) where a greyish brown CLAY/SILT was unearthed. This was remarked as containing organic matter. Although classed pitside as Made Ground, this may be a buried topsoil / organic subsoil deposit. This extended to 2.30m (56.07m OD) at which point natural stiff soils were logged.

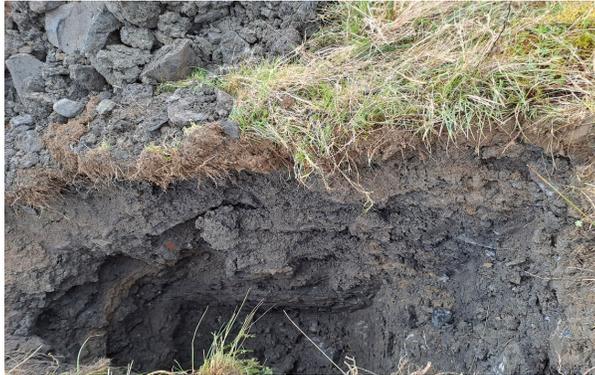
Fig 6A TP04, positioned ca. 2m higher than nearby trial pits, found dark grey slightly sandy slightly gravelly CLAY (MADE GROUND) to 2.50m bgl (57.66m OD). Rare plastic / rubbish and steel combined with a strong organic odour were noted.

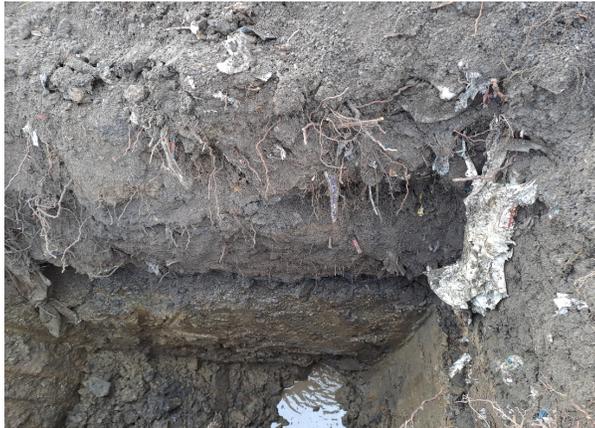
Fig 6B At TP13, >2% plastic / rubbish was recorded in the Clay Made Ground to a depth of 1.40m (56.02m OD).

- Rare plastic / rubbish is observed in the topsoil excavated at TP12 to a depth of 0.35m bgl.
- The most extensive collection of rubbish / plastic was logged in TP13. It was measured from ground level to 1.40m bgl. Anthropogenic content was >2% in this area, being rare to occasional. The dig location is linked with the historical soil disturbance noted from 1995 coupled with being proximal to the construction of the adjacent Balgaddy substation. Stiff clay was viewed from 1.40m to the pit base at 2.50m. For the same reasons as TP13, the uppermost soils in nearby TP16 also contained Made Ground to 0.60m. With an absence of rubbish / plastic, the soil disturbance is more likely to relate to construction activity at the time of the substation construction.

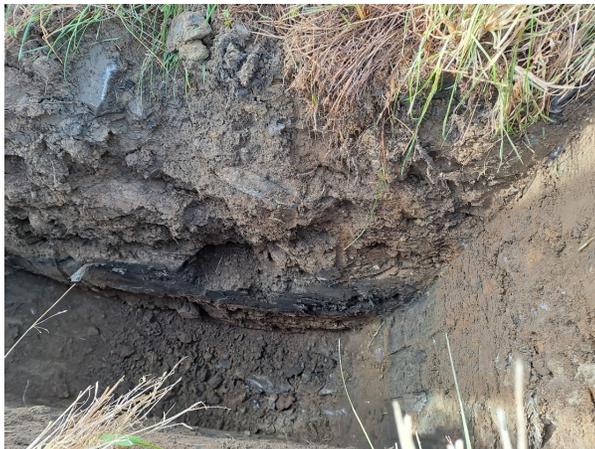
Fig 6C At TP22, Topsoil overlies a dark brown to brown sandy gravelly CLAY with rare plastic and cobble-sized concrete blocks. Possible Made Ground continues to 1.50m with an organic signature. This is thought to be buried topsoil / subsoil.

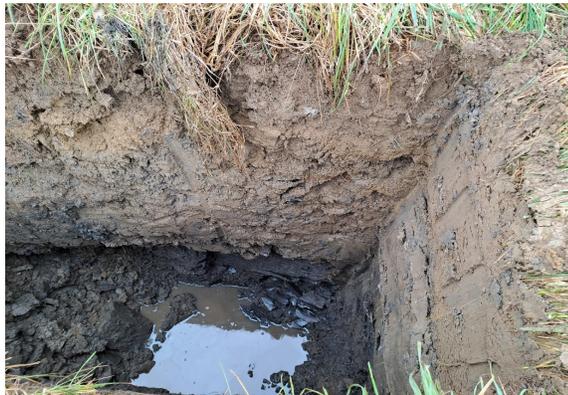
Figures 7A – 7B – Natural ground sidewall profiles photographed during trial pitting. Fig 7A TP05 with topsoil overlying firm to stiff and stiff brown mottled grey & light brown sandy gravelly CLAY with cobbles to 1.30m. Stiff grey blue sandy gravelly silty CLAY to 1.70m. A possible highly weathered rockhead recovered as clayey/silty GRAVEL from 1.70m to the pit base at 2.0m. Slow water entry at 1.70m.

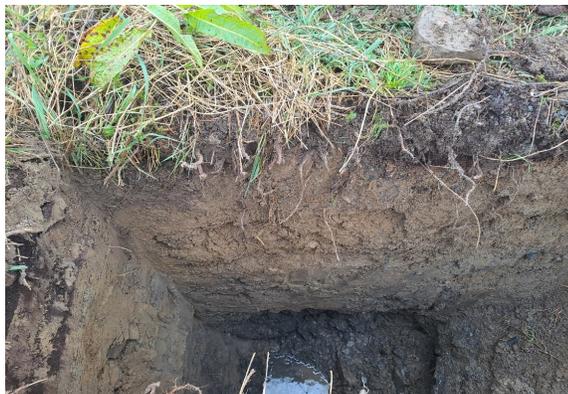
Fig 7B At TP07, topsoil was found overlying a firm brown slightly sandy slightly gravelly SILT/CLAY with rare anthropogenic content. Stiff grey sandy gravelly silty CLAY persisted from 1.10m to 1.80m. From 1.80m to the pit base at 2.50m, possible highly weathered rock was recovered as clayey/silty GRAVEL. Again, as with TP05, a moderate water strike was recorded towards the base of the pit at 2.30m.

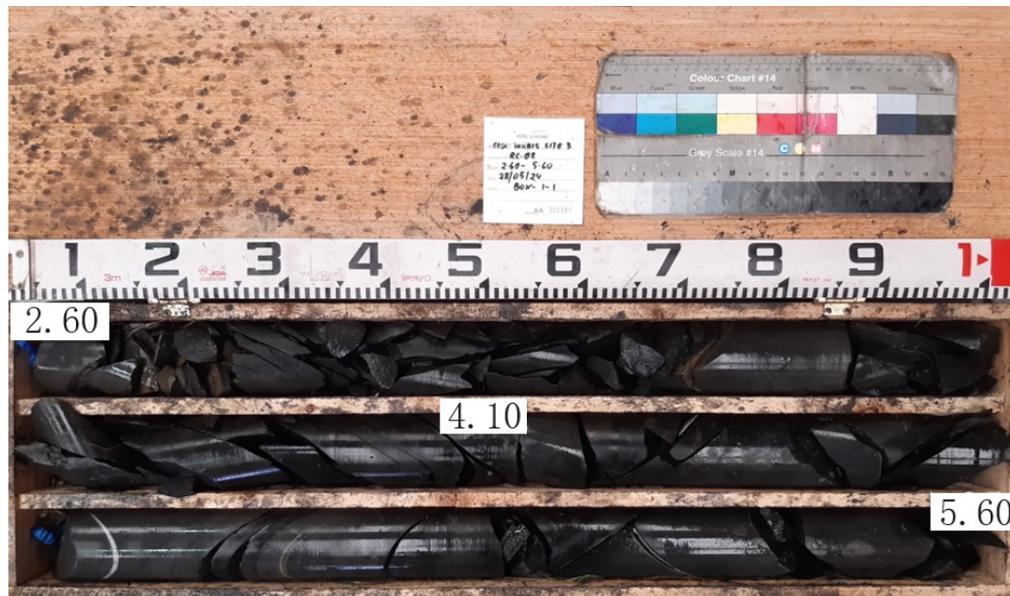
Figure 9 - Cores in RC02 from 2.60m bgl to 5.60m

The recovered cores were logged as weak to strong, medium to thinly bedded (to thinly laminated where fissile mudstone/shale), grey/dark grey/black, fine-grained, LIMESTONE. The rock was further described as predominantly argillaceous limestone with layers of calci-siltite limestone, local stylolites and with pyrite present. The rock mass was slightly weathered to moderately weathered at fissile mudstone/shale zones.

Discontinuity spacings in the rotary cores generally ranged from medium (200 to 600mm) to closely spaced (60 to 200mm), rarely widely (600 to 2000mm) spaced. The discontinuity surfaces were typically smooth to locally rough, planar to locally curvilinear. Apertures were tight to locally partly open with local clay smearing. Discontinuities host calcite veinfill (from 1-20mm thick). Dips are subhorizontal, 10° to 15°, rarely 40° to 45° and very locally 70°.
