16 CULTURAL HERITAGE (ARCHAEOLOGICAL & ARCHITECTURAL)

16.1 INTRODUCTION

The following chapter details an archaeological and cultural heritage assessment undertaken in advance of three proposed residential developments (known as Sites 3, 4, 5) at Grange, Esker South, Kishoge and Balgaddy, in Clonburris, Co. Dublin. The assessment aims to ascertain any potential likely and significant impacts that the proposed developments may have on the existing cultural heritage resource.

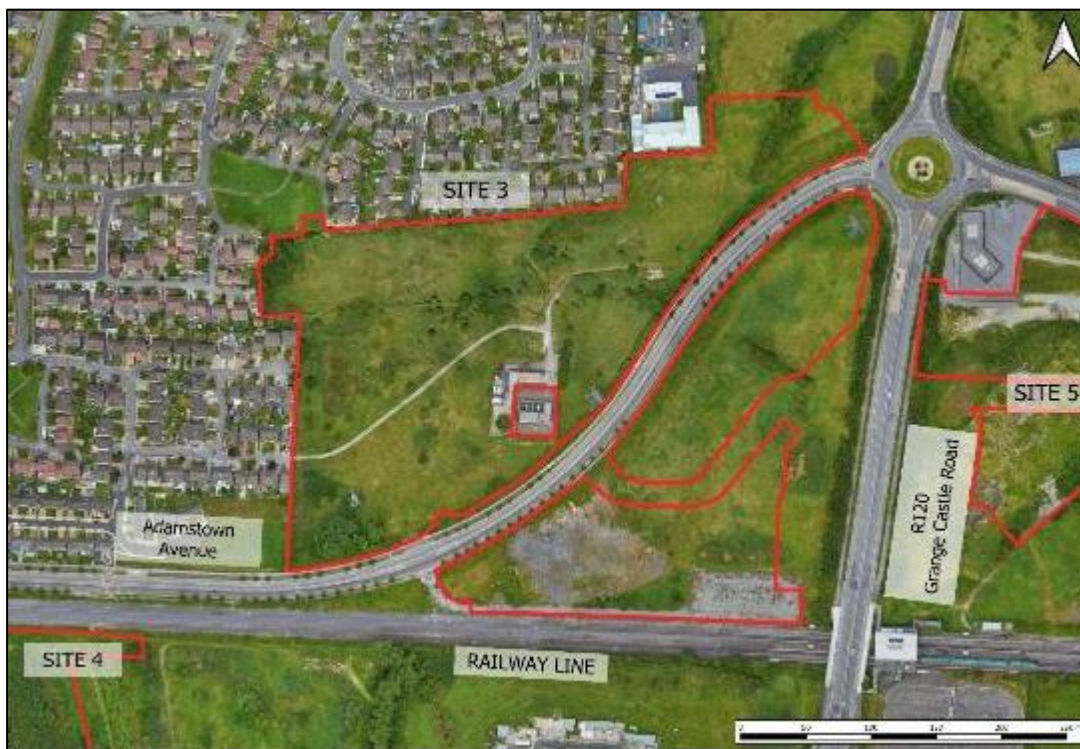
Figure 16.2: Extract from Google Earth showing site boundary of Site 3

Site 3 is the central of the three sites. The majority of Site 3 falls within the townland of Kishoge, though small areas on the western periphery encroach into Esker South. Site 3 is not a contiguous area but rather consists of three portions (Figure 16.2). The largest of these portions is situated immediately northwest of the L1058 road (Adamstown Avenue). It is an area of rough grassland containing scattered trees, a number of electricity pylons, access tracks and the Balgaddy 38kV substation. The substation is excluded from the development area by an internal redline.

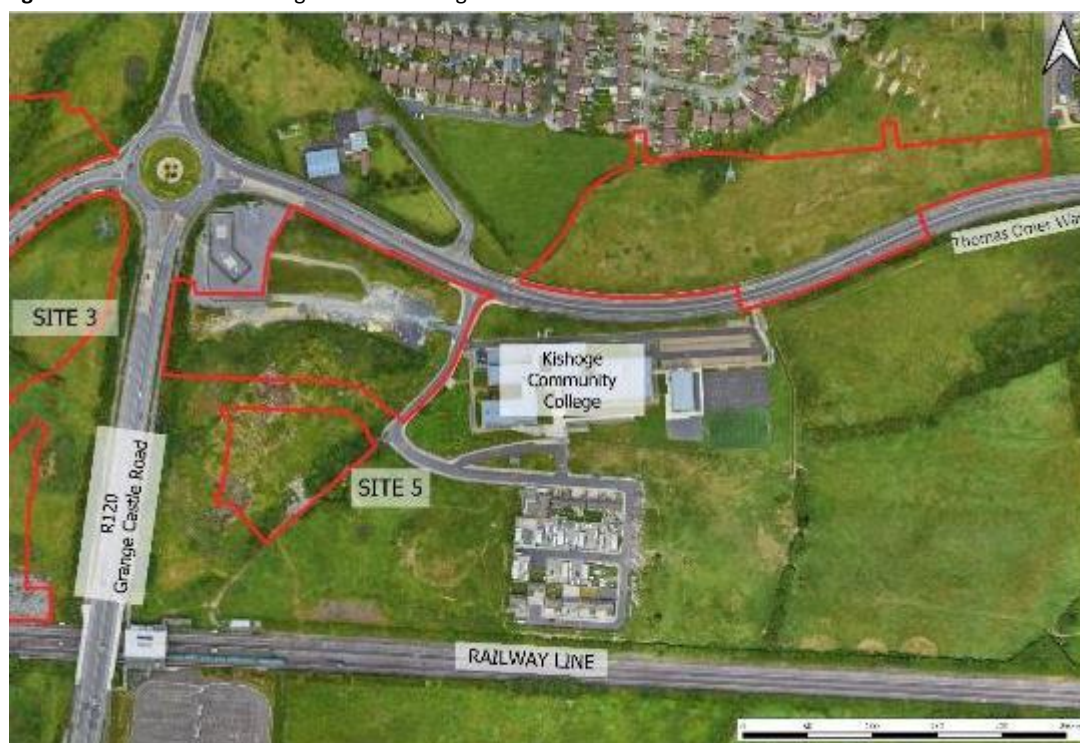
Figure 16.9: Extract from Google Earth showing of Site 5

Site 5 comprises three smaller areas (Figure 16.9) located to the west and north of the Kishoge Community College, within the townlands of Kishoge and Balgaddy. The northern portion comprises an area of rough greenfield to the immediate north of Thomas Omer Way. Part of Thomas Omer Way is included within the site boundary. The Kishoge-Balgaddy townland boundary runs through the site, and a treeline follows part of this boundary. The southern and central portions comprise highly disturbed sites to the immediate east of the R136, with the Kishoge Community College located to the east.
