# Appendix 9.2

**Lisheen Mine Closure, Restoration and Aftercare  
Management Plan 2016**

**CLOSURE, RESTORATION &  
AFTERCARE MANAGEMENT PLAN -  
C.R.A.M.P**

**April 2016**

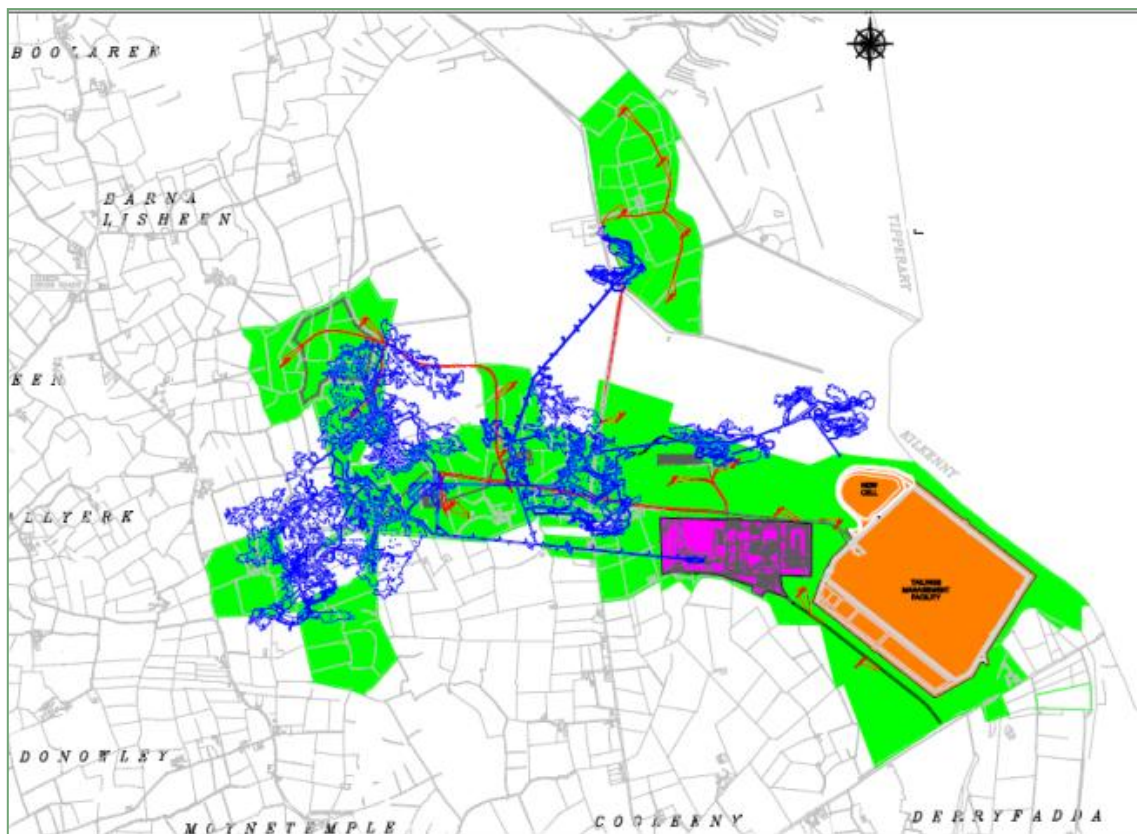
Figure 3.1: Overall site layout including Mine workings

The drawing below includes the Mine workings (IPCL boundary and land holding is shown in green).

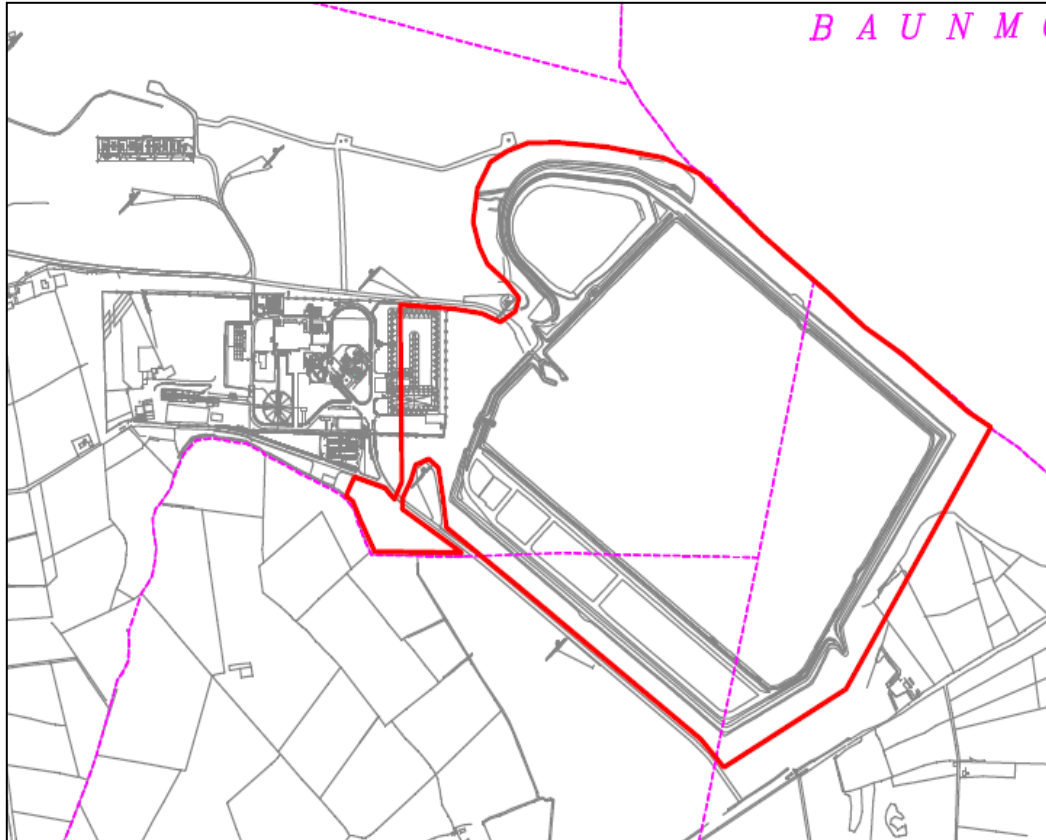
It is planned that Lisheen will get permission, through a technical amendment of the IPCL, to reduce the site boundary significantly to only include the TMF. This will only be permitted by the EPA following an independent closure audit to demonstrate that there are no potential environmental issues remaining.

Figure 3.2: Predicted reduced IPCL boundary (in red) surrounding the TMF

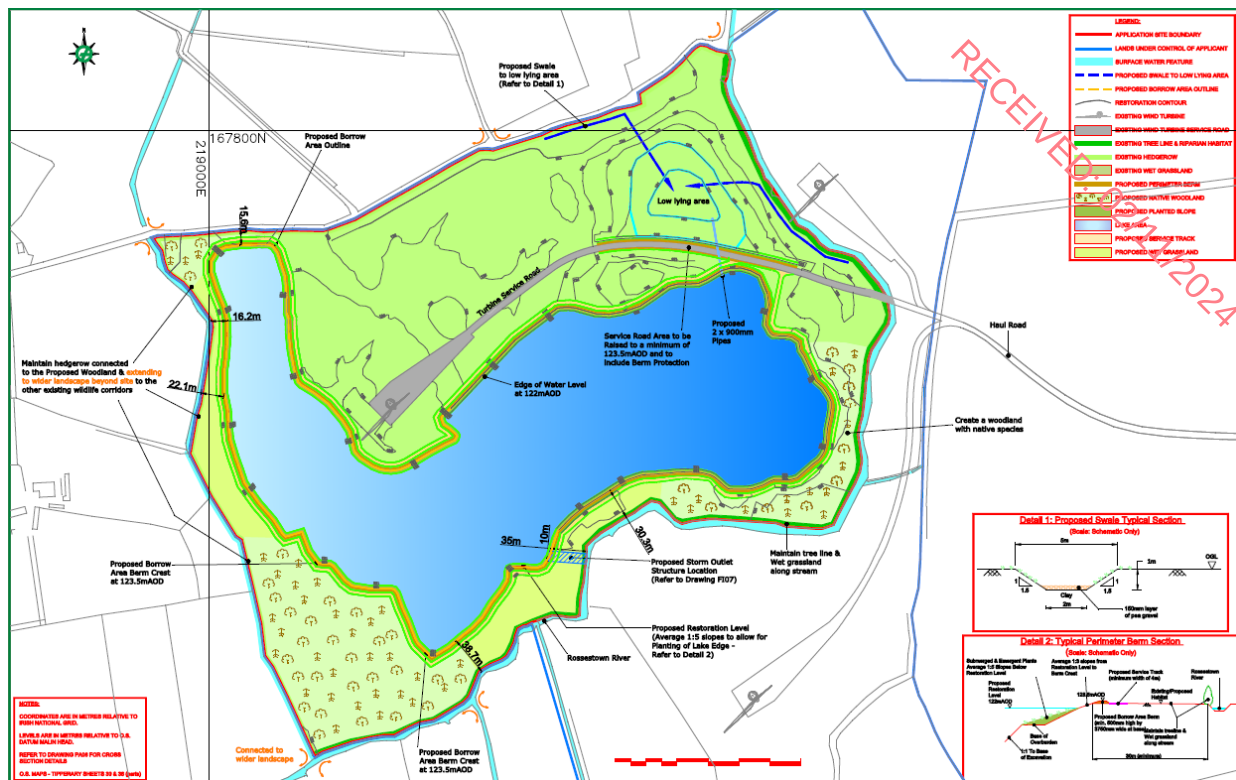
Figure 3.3: Rehabilitation plan for Carrick Hill Borrow pit

Figure 4 below shows the restoration plan for Carrick Hill.

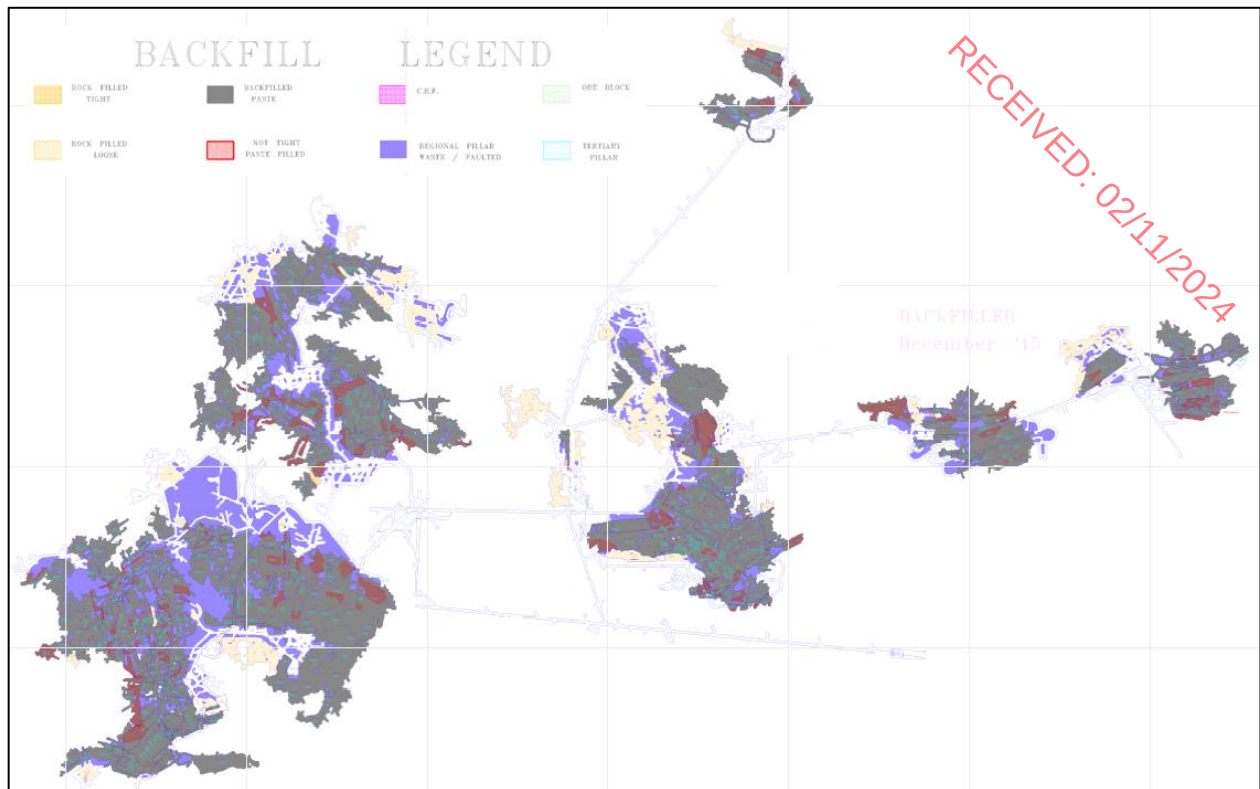
Figure 3.4: Complete backfill placement (December 2015)

The extent of paste backfill on closure and the Mine workings is as indicated in below.

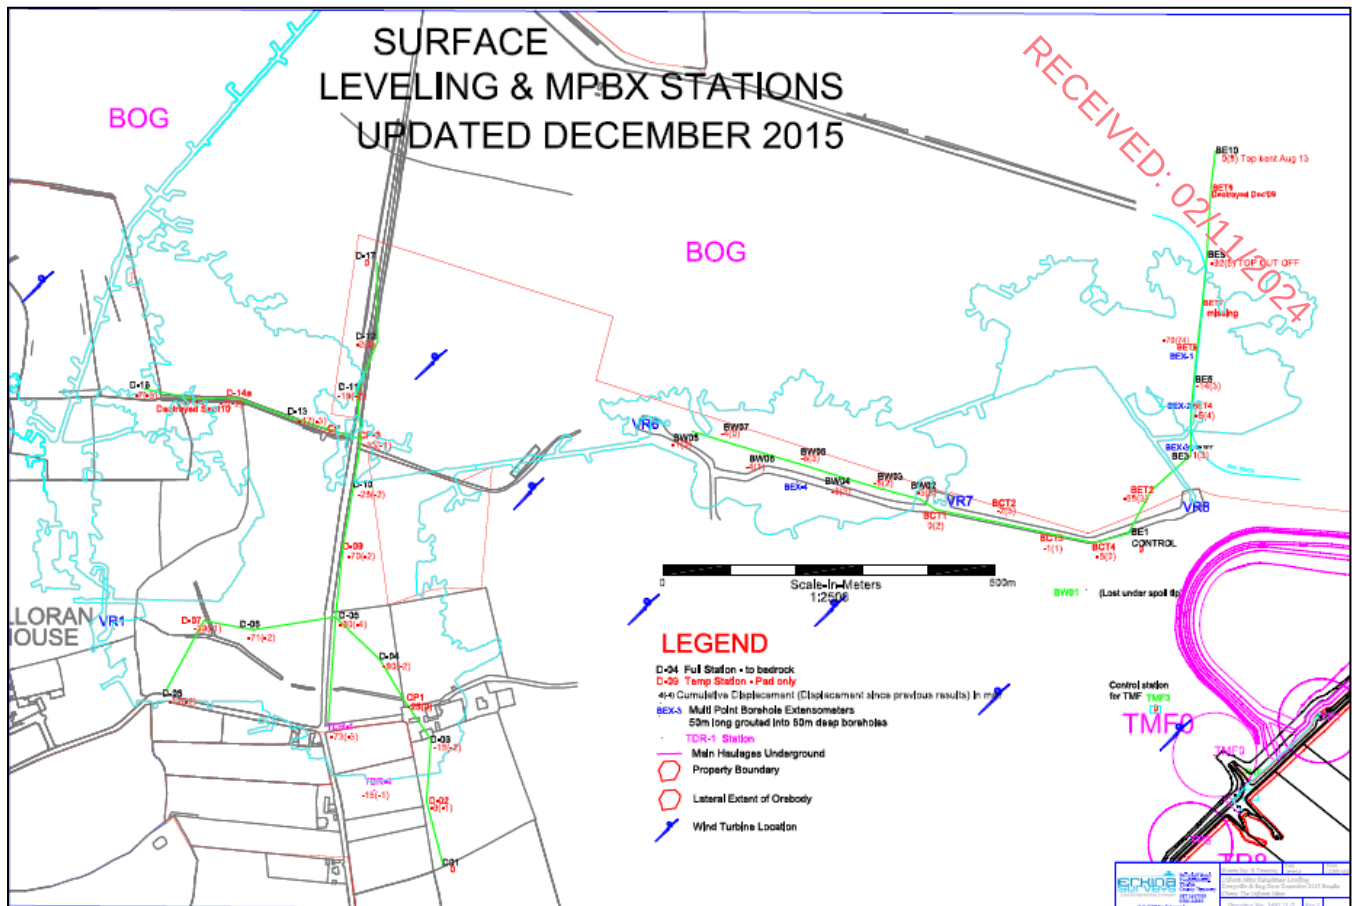
*Figure 3.5: Settlement Monitoring Stations*

Monitoring for regional settlement is carried out at the Lisheen Mine site on a quarterly basis. The monitoring station locations are illustrated in below.

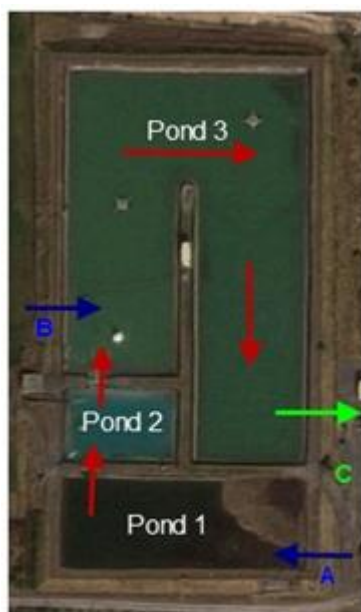
There are 3 distinct water ponds that make up the conditioning ponds.

It would be possible to add water in the first pond and batch release into the other ponds to ensure that solids were managed correctly.

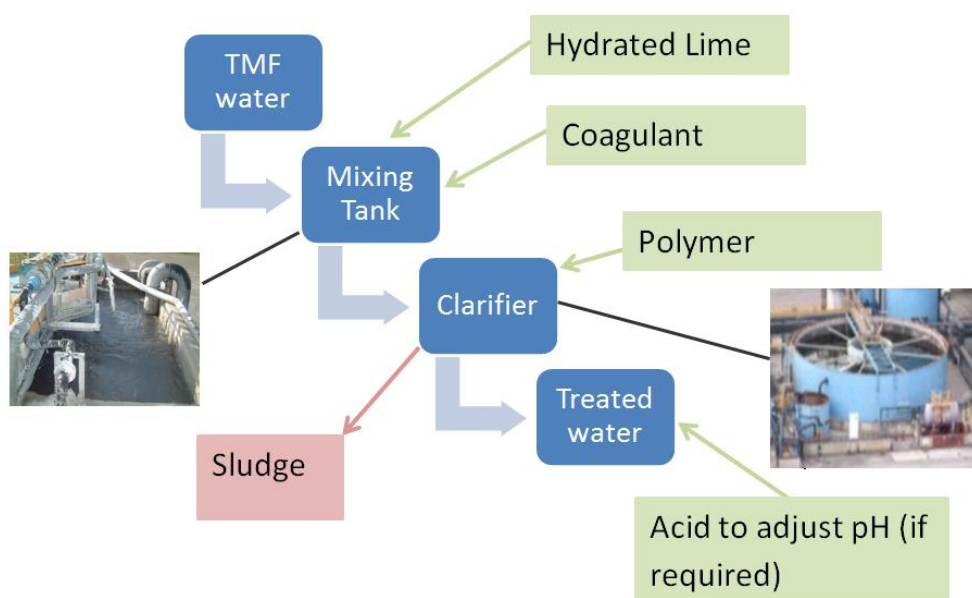
Existing MWTP arrangement:

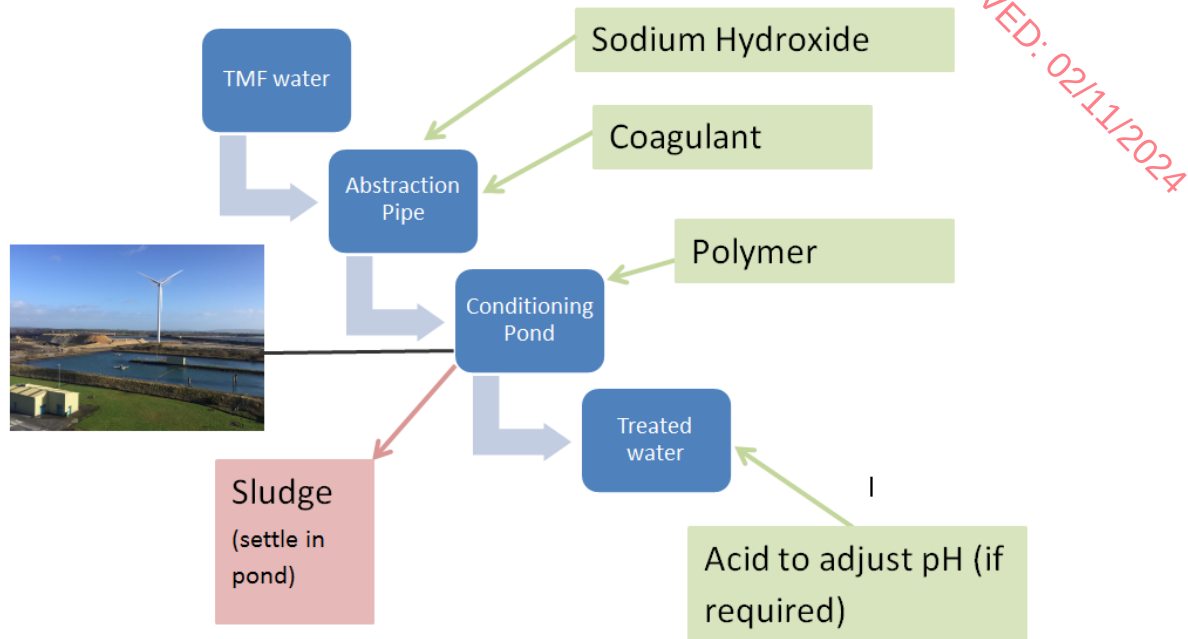
In the modified water treatment arrangement the pH agent and coagulant is added at the beginning of the water abstraction pipeline and the pipe line essentially takes the place of the mixing tank.

Solids will settle in the conditioning ponds in place of the clarifier (the ponds have a retention time far in excess of the existing clarifiers). Any precipitate formed will settle out in the conditioning ponds.

Proposed water treatment arrangement to facilitate batch treatment of TMF water:

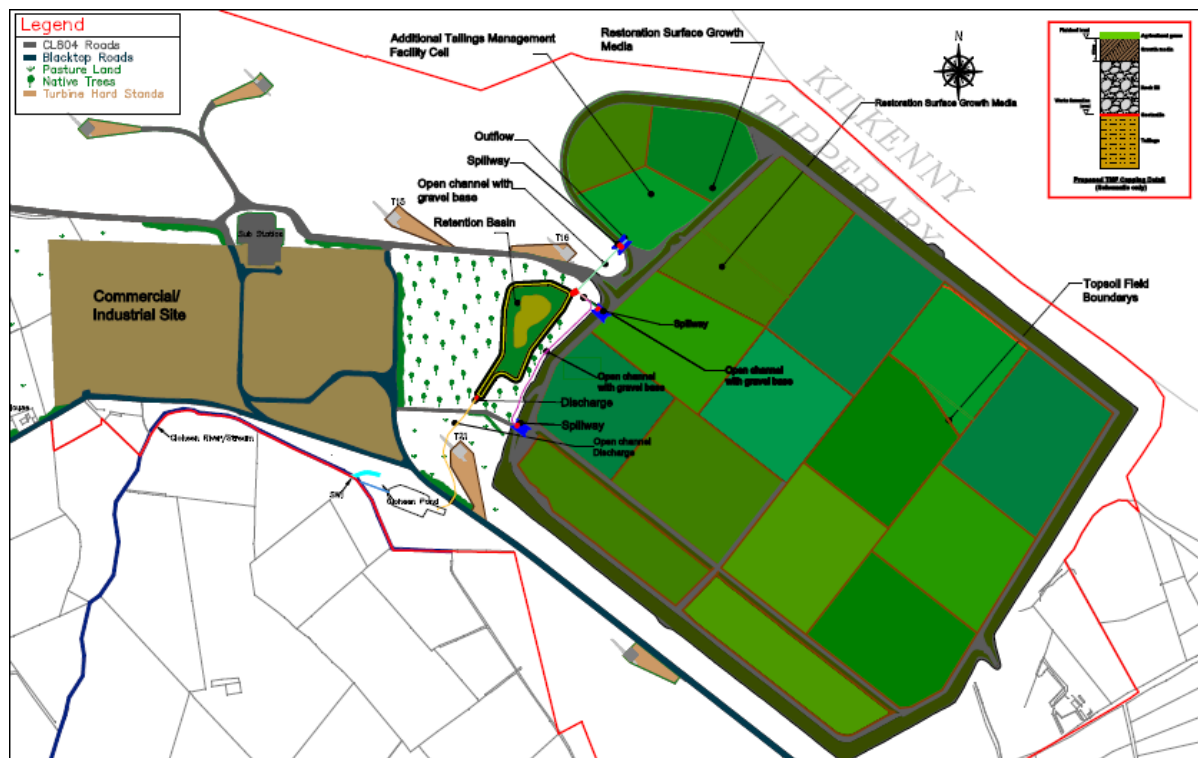
Figure 4.1: Final restoration plan for Lisheen

The final restoration concept for the Lisheen TMF is shown below depicting a landscape of pasture grassland.

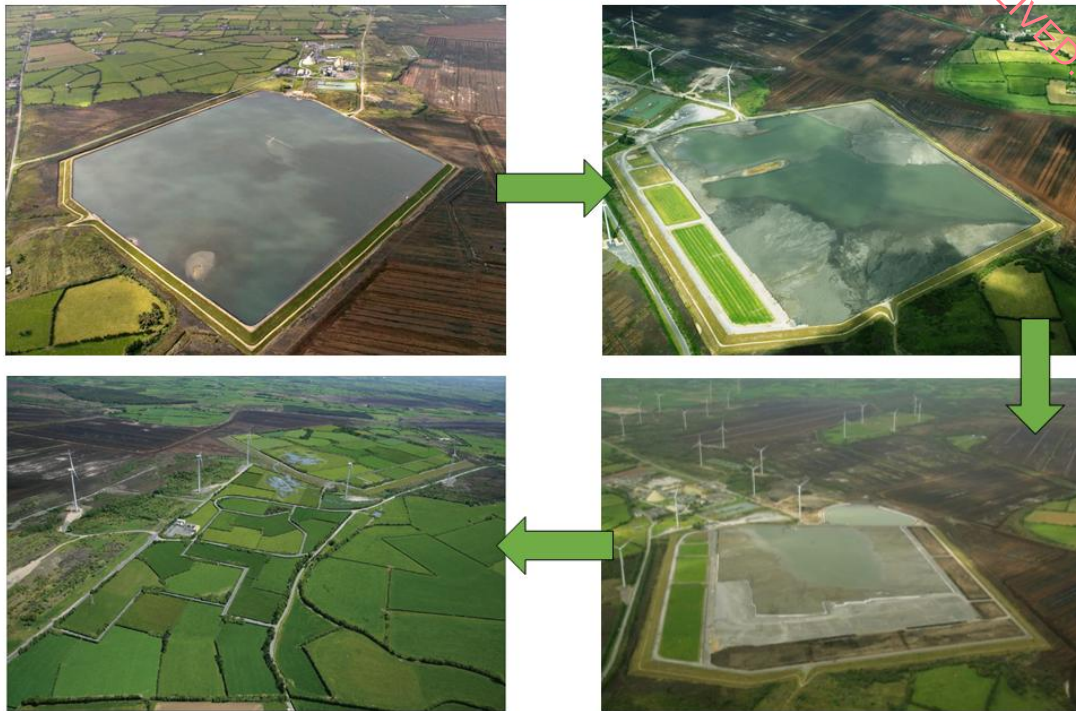
## TMF – Progressive Rehabilitation

The progressive capping strategy commenced from the walls of the facility moving inwards and the direction of the water take off location (reclaim pumps). The reclaim pumps will be replaced by a spillway to an engineered wetland that will be created on the downstream side of the TMF dam.

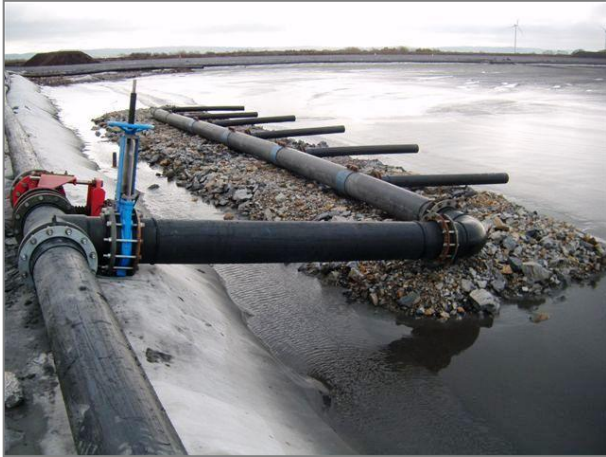
*Figure 4.2 - Spigot pipe system*

The initial tailings beach creation is achieved by locally surcharging the tailings level by deposition from the TMF margin with a system of spigot pipes, as shown in Figure 1 below. The formed tailings beach is allowed to dry for up to nine weeks to dewater before rock cap construction. The drying time can vary depending on weather conditions and the time of year. The tailings beach is formed by tailings deposition to a maximum level of 1 metre below the dam wall crest height.

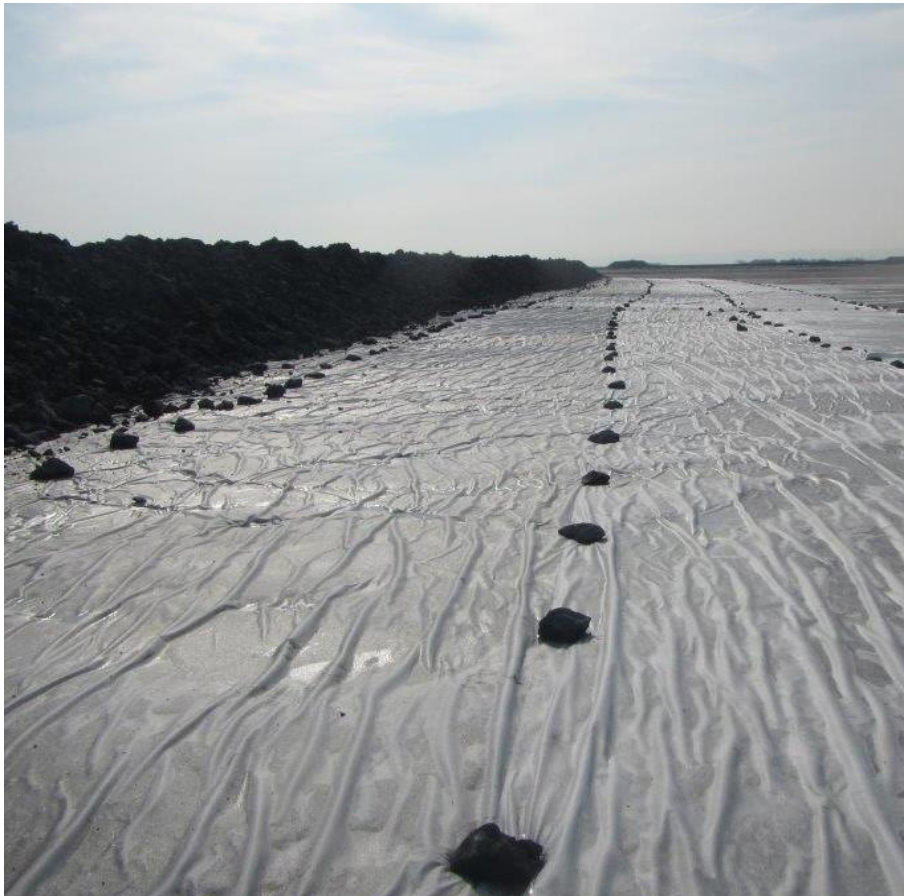
*Figure 4.3 – Placement of geotextile*

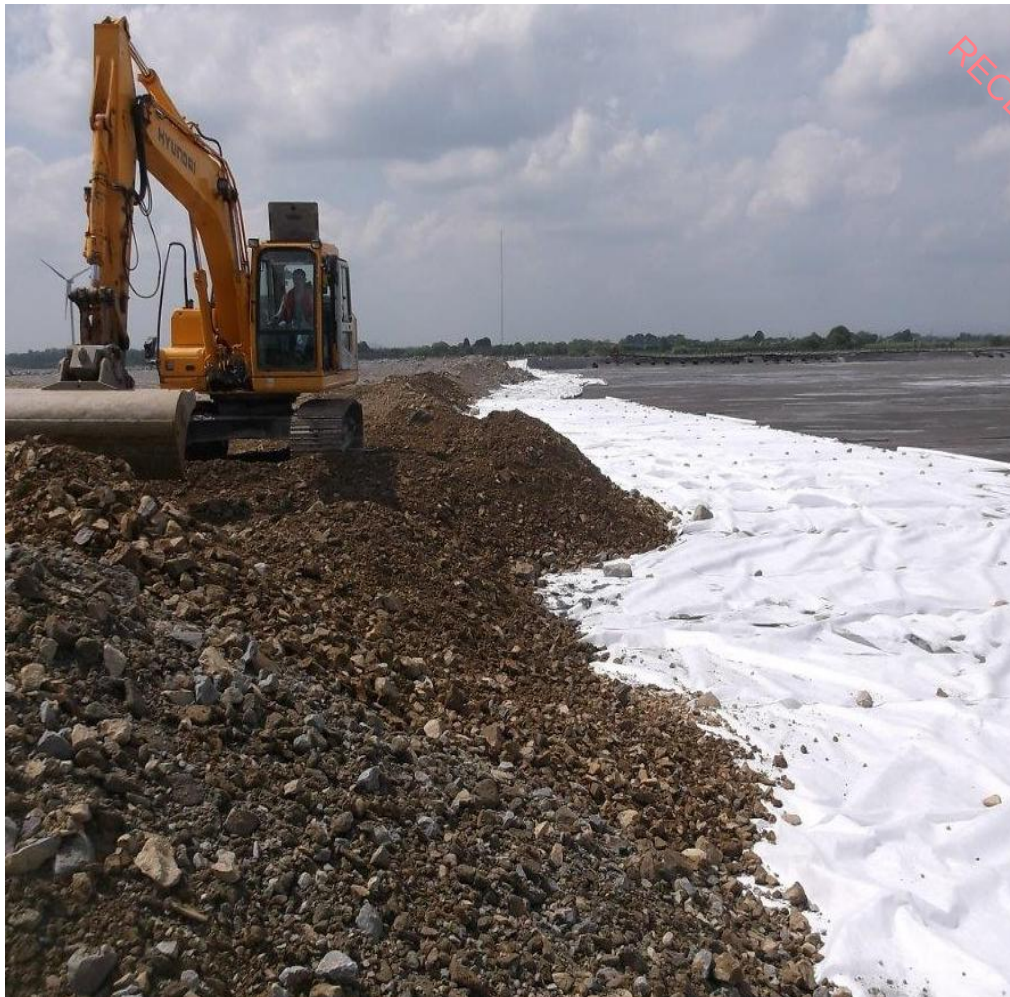
*Figure 4.4 – Placement of rock cap*

The rock cap specification as shown in Figure 4.4 comprises the following key elements:

- Terram 1000 or equivalent non-woven geotextile placed directly onto the dried tailings beach with a lap length of at least 750mm;
- 700mm deep layer of limestone rock with a maximum particle size of 300mm along its long axis;
- 300mm growth medium which is made up of a 50/50 blend of glacial till and peat.

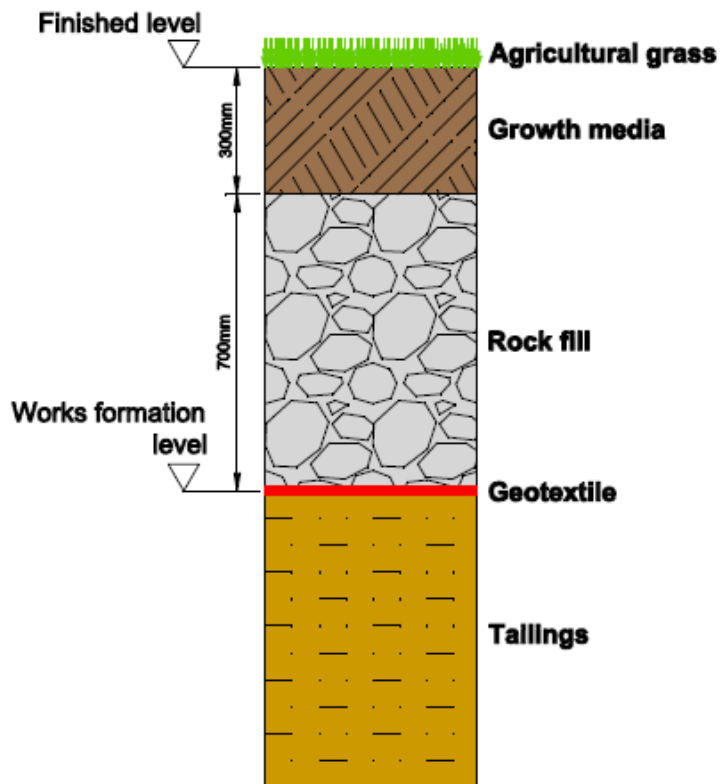
Figure 4.5 - TMF Cap Cross Section detail

When forming the cap along exposed liner the liner has to be protected from potential punctures. This is done by firstly placing a 500gsm non-woven geotextile (or stronger) directly onto the liner, with a minimum lap length of 750mm, and extending this geotextile onto the tailings beach by 2m. A terram 1000 or equivalent non-woven geotextile, again with a lap length of 750mm, is then placed on the 500gsm fabric and extended onto the exposed tailings beach. A 300mm layer of granular gravel material with a maximum particle size of 75mm is then placed on top of the dam wall prior to placement of the larger limestone rock and the advancement of the rock cap.

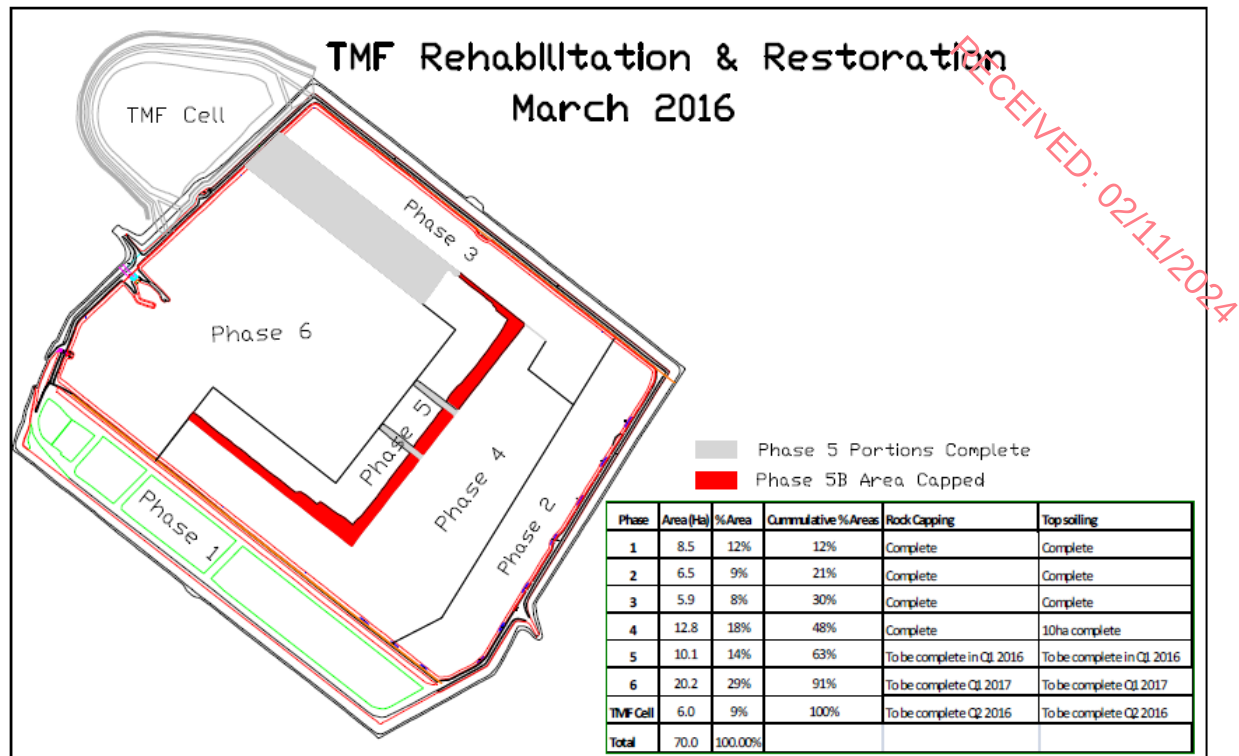
Figure 4.6: TMF Rehabilitation and Restoration Progress March 2016

To date approximately 38 hectares of the TMF has been rock capped with approximately 29 hectares of this area been fully rehabilitated and restored to pasture grassland. All works have been carried out under separate contracts for the areas defined as Phases 1, 2, 3 and 4 which cover areas of 8.5, 6.5, 5.9, and 12.8 hectares respectively. Approximately 3.5 hectares of Phase 5 was completed before cessation of the Mine. The remaining portion of Phase 5 and Phase 6 and 7 will be completed post closure. 59% of the main TMF facility was rock capped prior to the closure of the Mine.

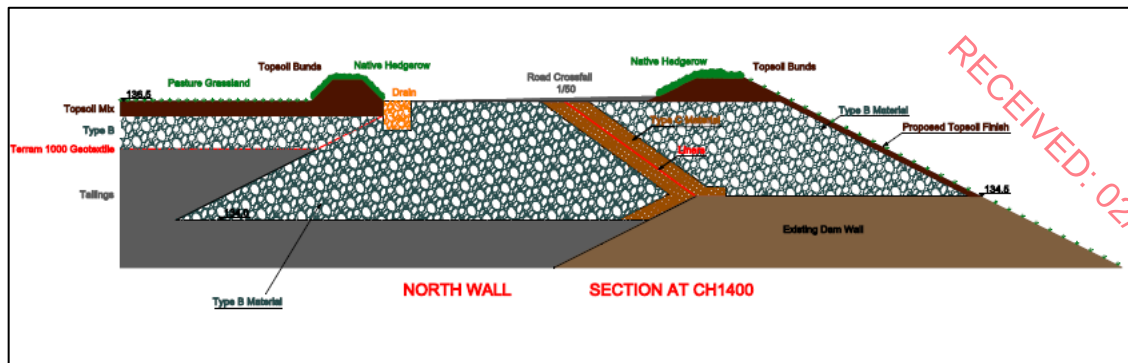
Figure 4.7:

Figures 4.7 and 4.8 below depicted the additional works to be carried out as part of the completion of the TMF rehabilitation. These works include the following;

- Perimeter Road and drainage - creation of a cross fall and a drainage channel from the outer edge of the TMF

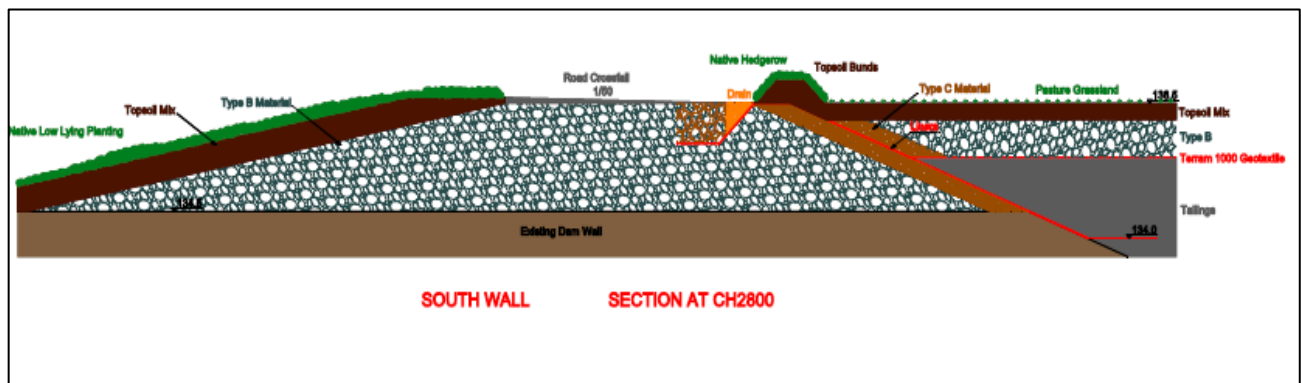
Figure 4.8:

- Remove Outer Rock Fill Bund - removal of the outer rock fill bund along the edge of the TMF
- Topsoil to Outer Embankment - installation of a top soil layer (including seeding) along the raised section of the main TMF
- Topsoil bund to Outer Embankment - installation of a top soil bund (including seeding) in-lieu of the removal of the rock fill bund
- Topsoil to south wall embankment - installation of a top soil layer (including seeding) to a depth of 500mm along the 850 metres of the raised section of the south wall
- Remove till bunds to the Phase 1 paddocks
- Remove Demo Wetland Cell
- Topsoil between existing TMF paddocks and areas on Phase 1 - installation of a top soil layer (including seeding) to a depth of 300mm between the existing TMF paddocks along Phase 1
- Hedge row planting - planting of native species to the TMF bund.
