Graffy Wind Park

GRAFFY WIND PARK Environmental Impact Assessment Report (EIAR) VOLUME 3A: APPENDICES 7-10

GRAFFY WIND PARK, GLENTIES, COUNTY DONEGAL

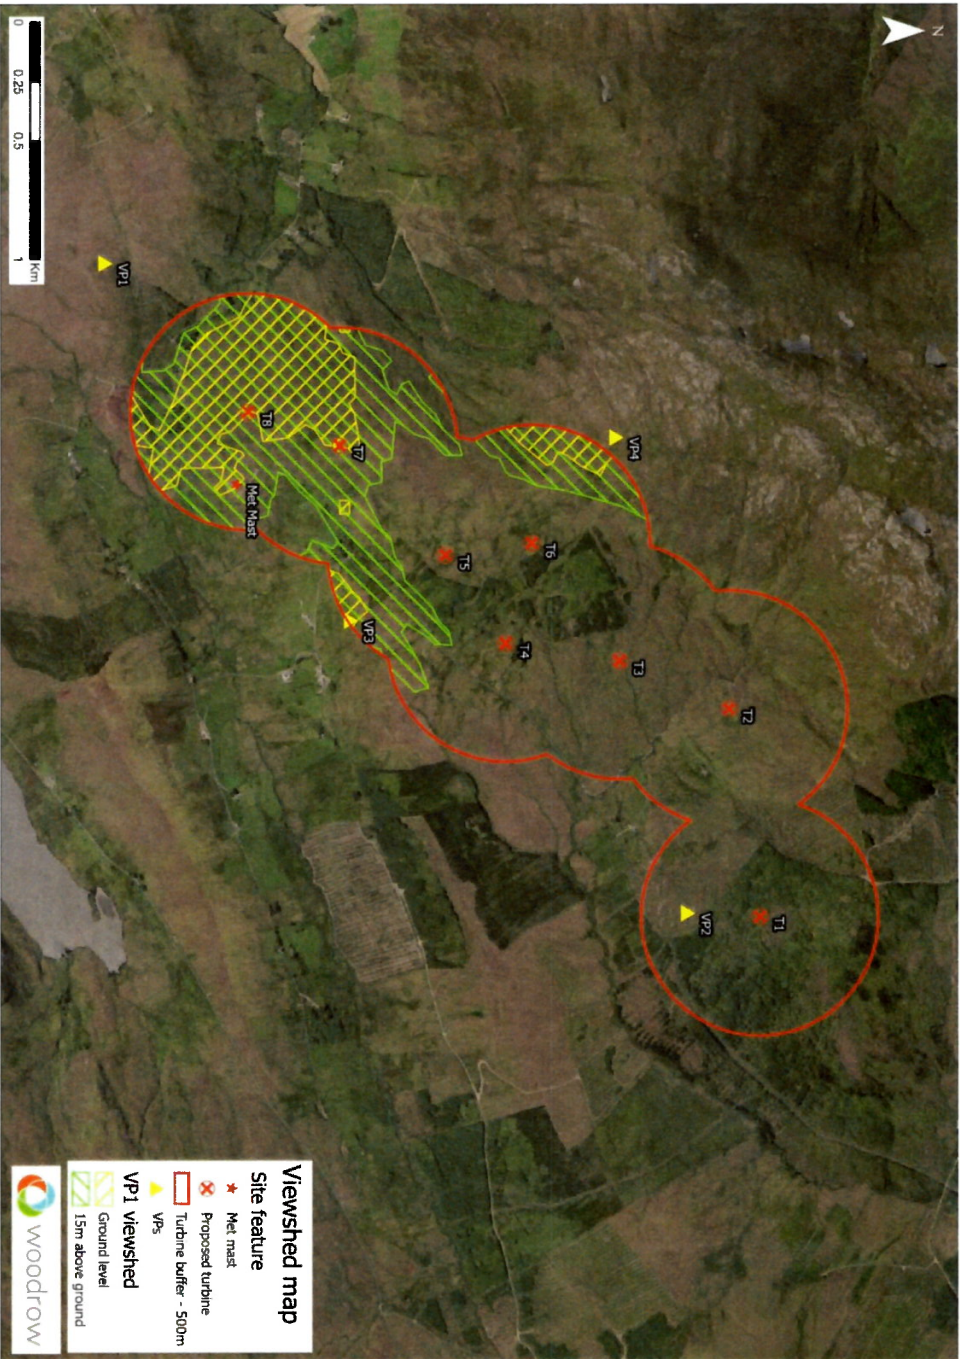
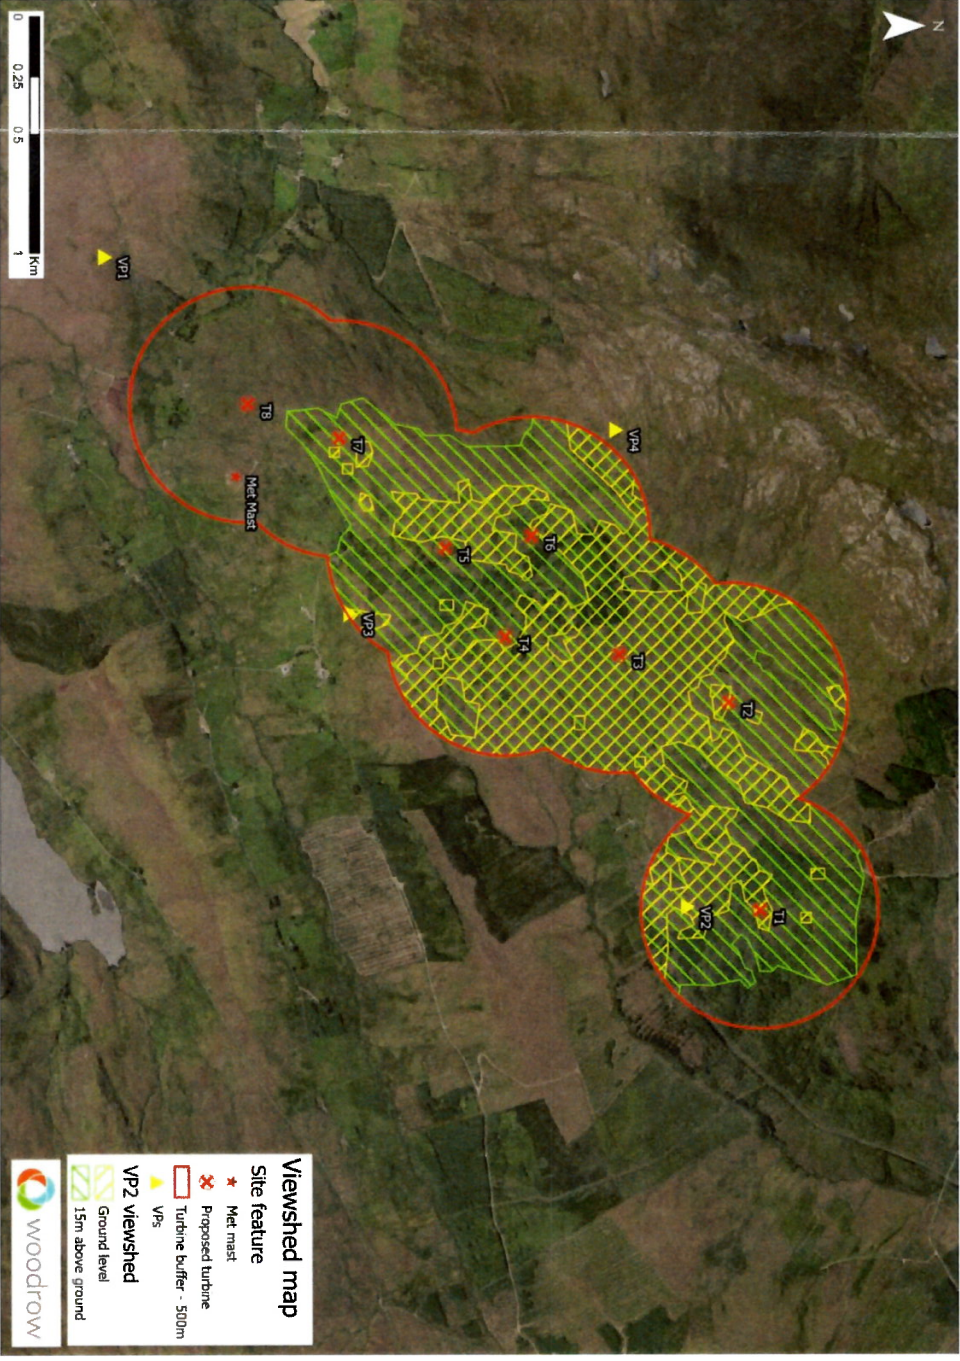
Figure 4. Ground level & 15 m above ground viewsheds for each VP within 500 m turbine buffer

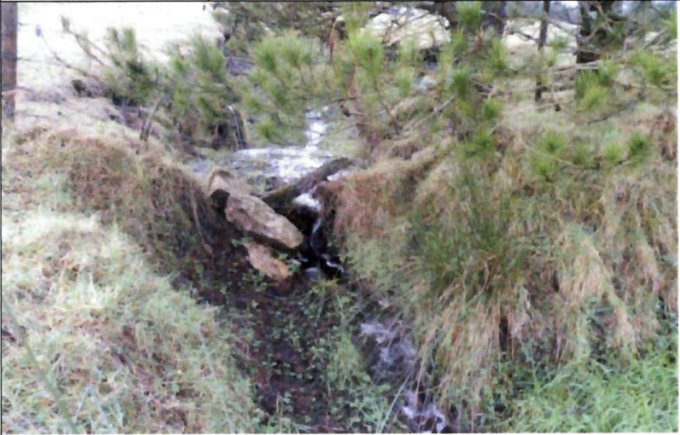
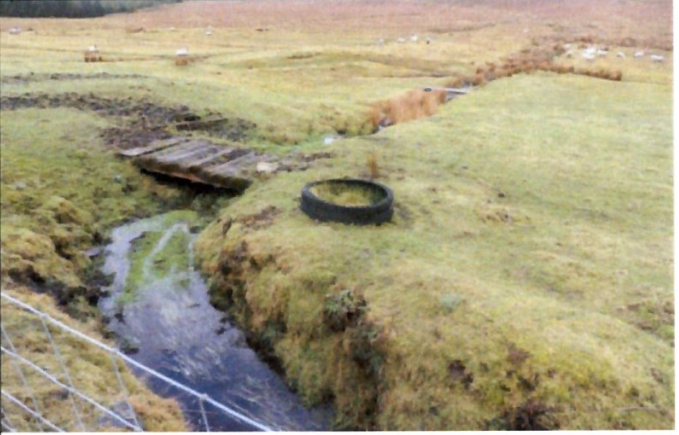
View upstream over very steep terrain where the channel cuts through rough sheep grazing		View downstream to poor quality steep vegetated channel with extensive sheep grazing and bank erosion leading to in-channel siltation

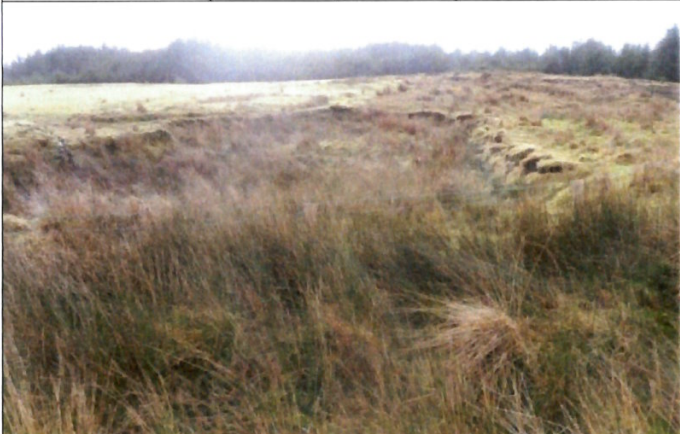
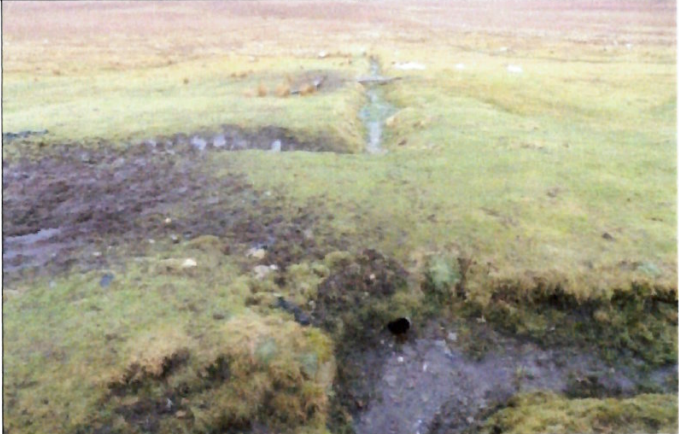
View upstream over very steep terrain where the ill-defined channel seeps from rough sheep pasture and rushes		View downstream to very poor quality, arrow, shallow and steep channel with extensive sheep grazing and in-channel siltation

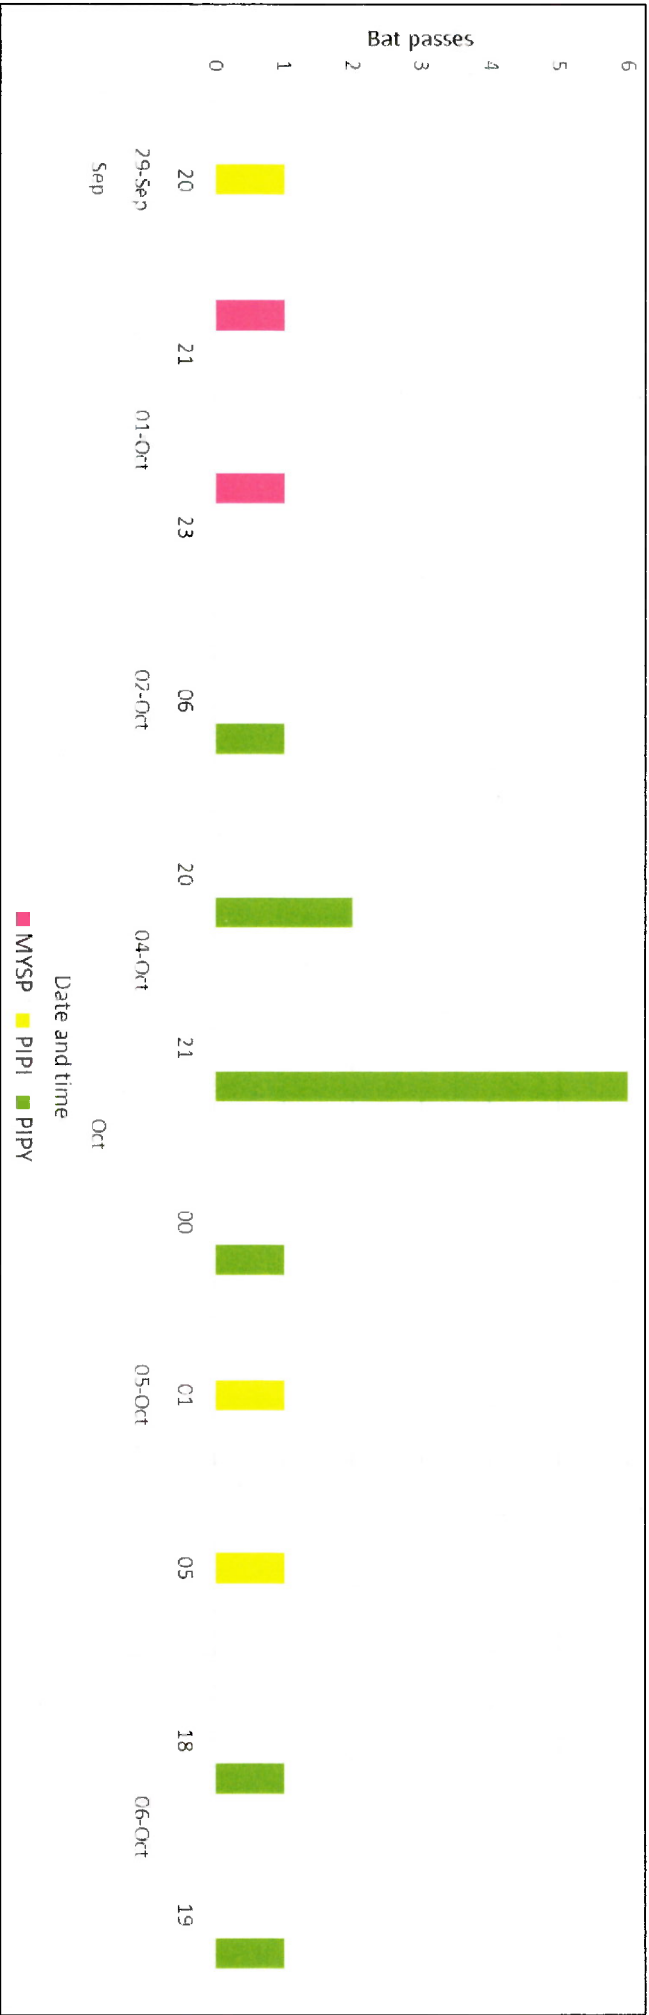
Figure 15. Autumn - Bat passes over time: 29-Sep to 06-Oct-2019 for D.05: unit near T5

Figure 15 shows the data for the D.05 deployment covering a position close to the final location of T5, which bring the turbine closer to the conifer plantation a feature potentially utilised by bats. As for the summer deployment, **Figure 15** illustrates the low (0 to 6 passes per night) and sporadic usage of area by different species of bat over the autumn.

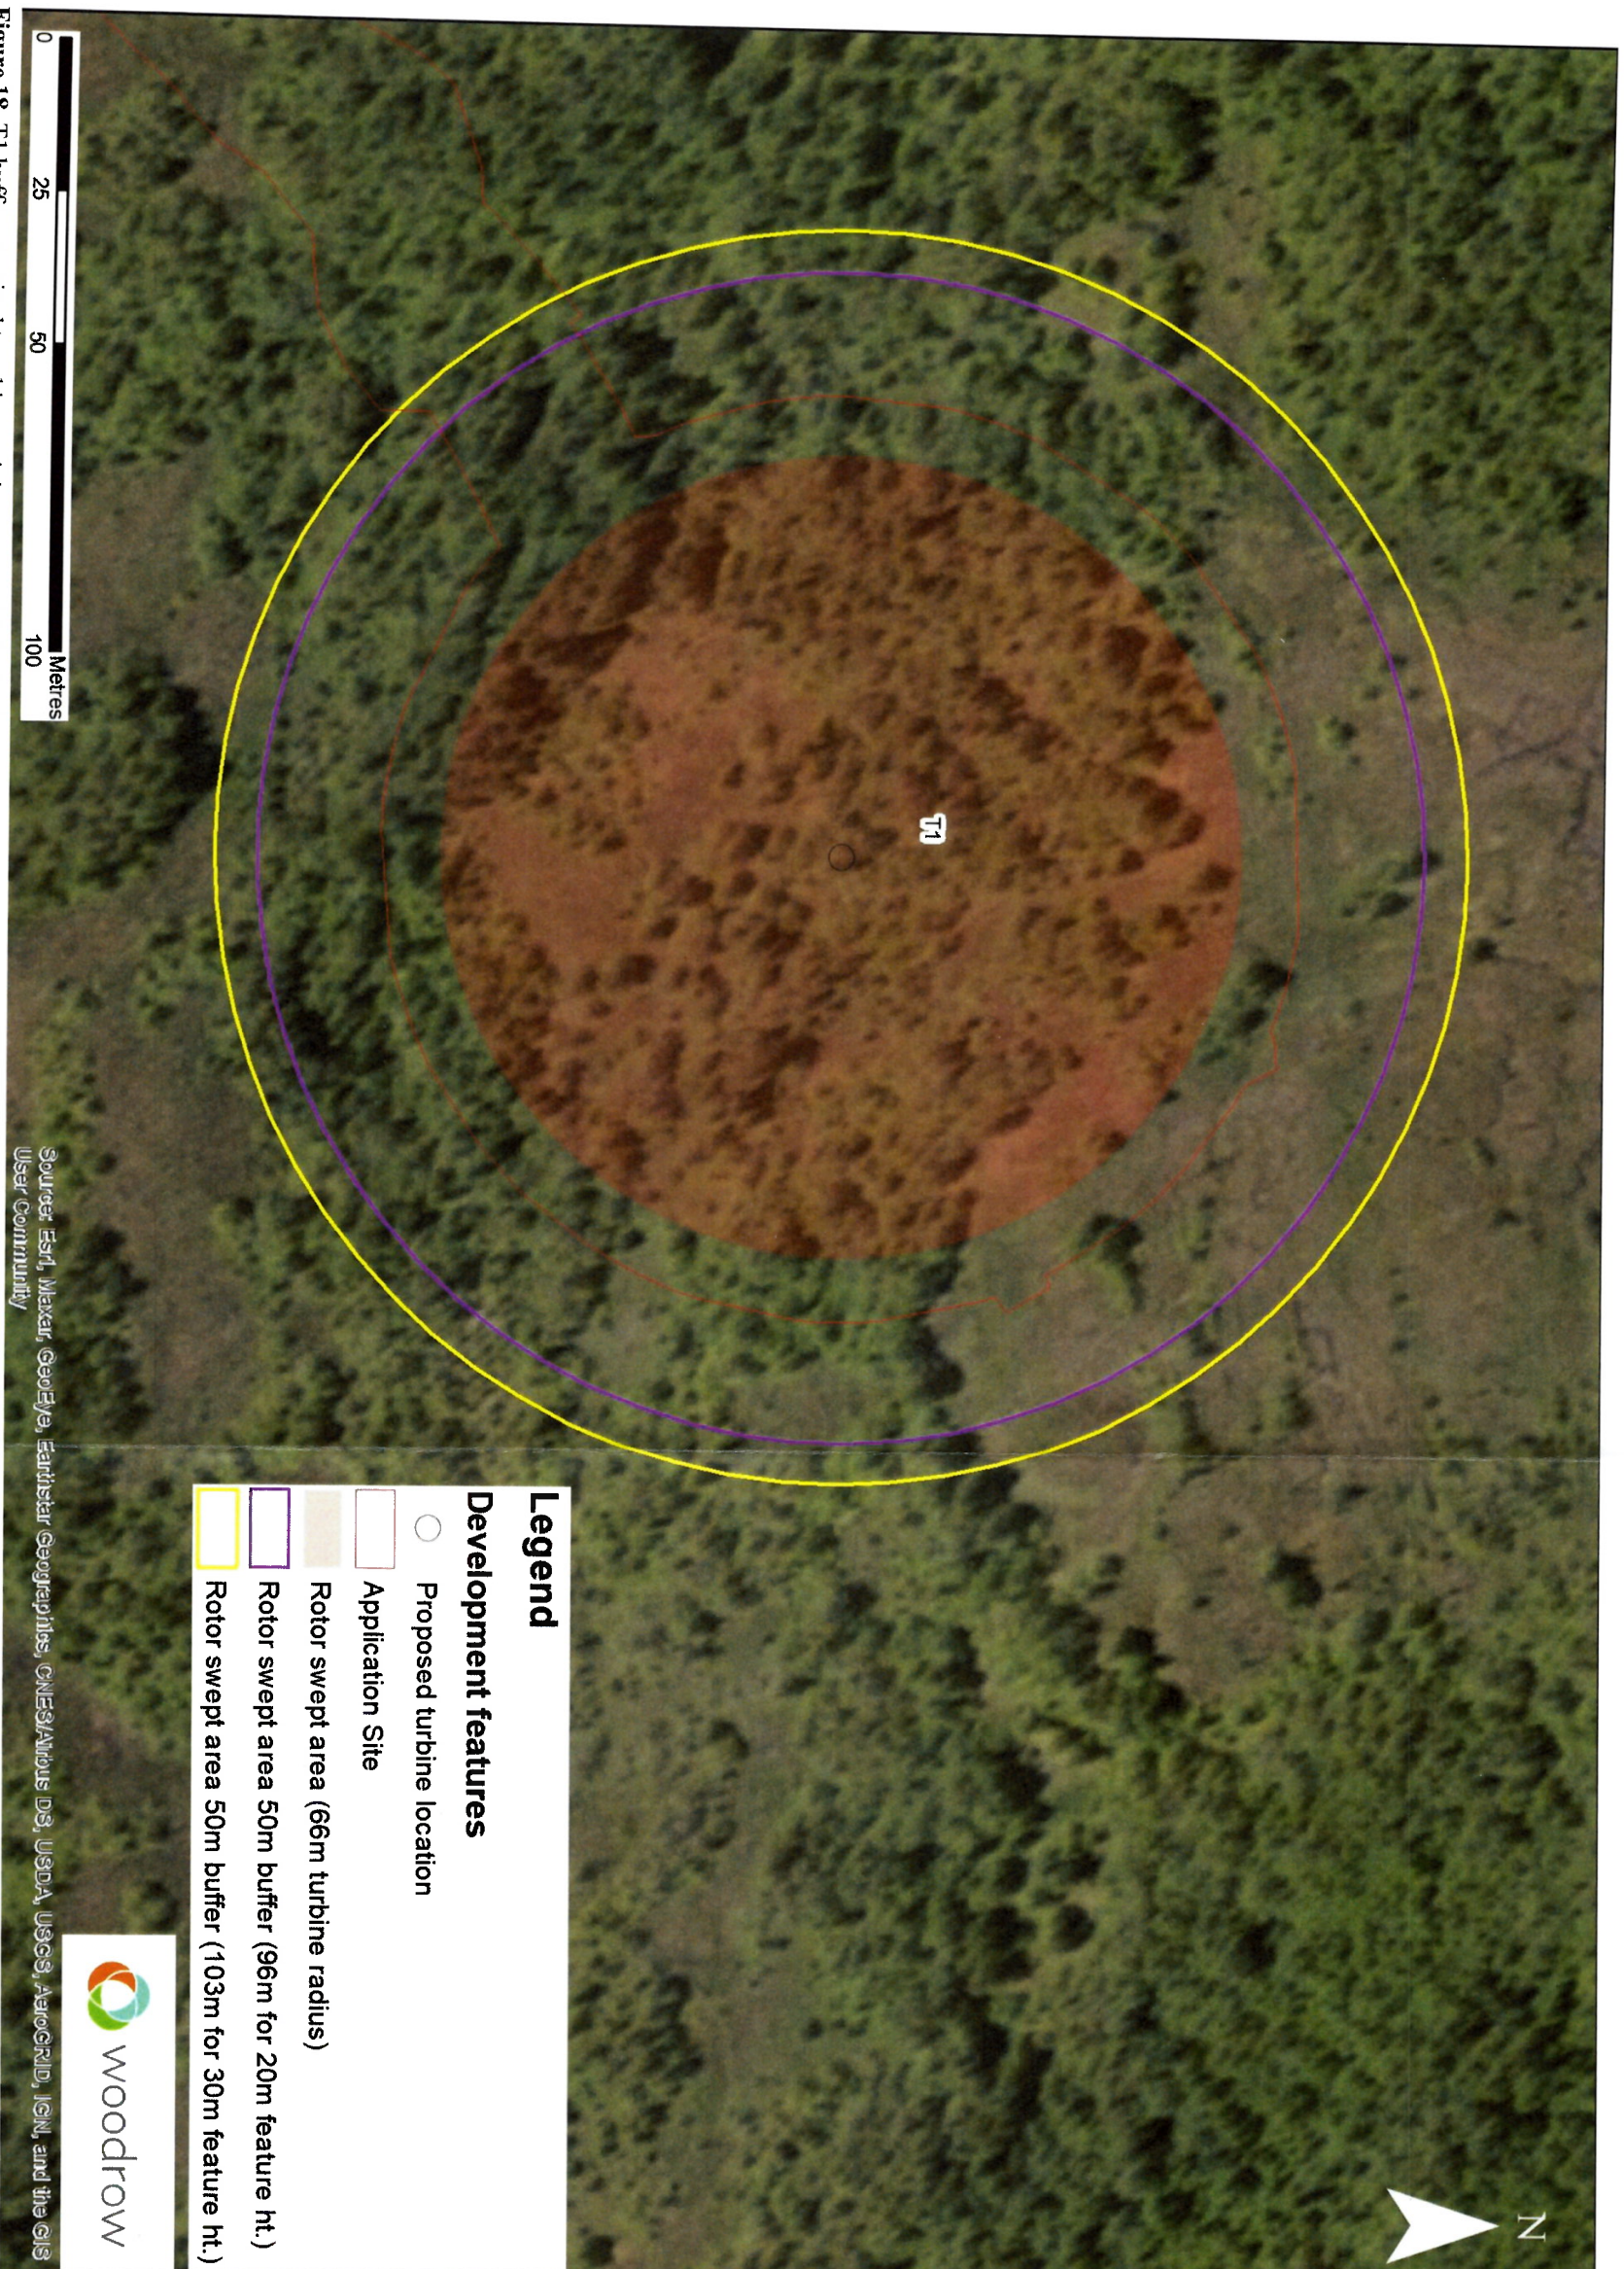
Figure 18. T1 buffers required to achieve minimum 50 m blade tip-feature separation distances

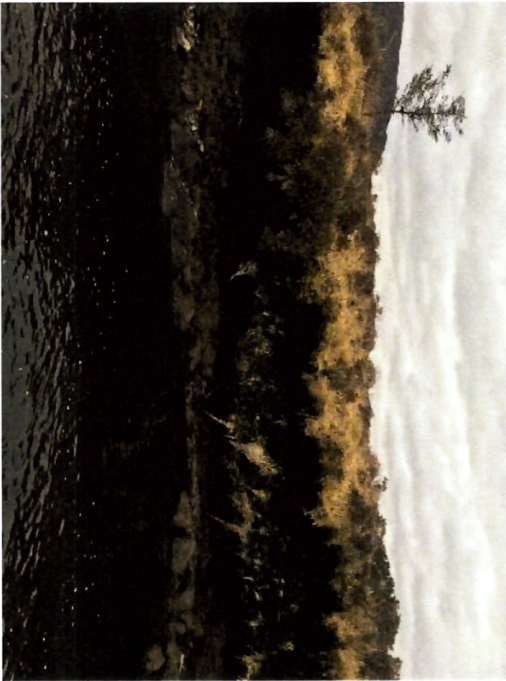
Stracashel section 1 with significant bank undercutting at d/s end of reach
Stracashel	2	Owenea	G8430 9646 – G84390 9650	Frequent occurrence (41–300/100m) Suitable habitat but poor to fair quality due to an abundance of fine materials and considerable fine fragmented peat, and silt. The riparian zone was dominated by grasses with little tree cover and extensive bank collapse due to erosion.

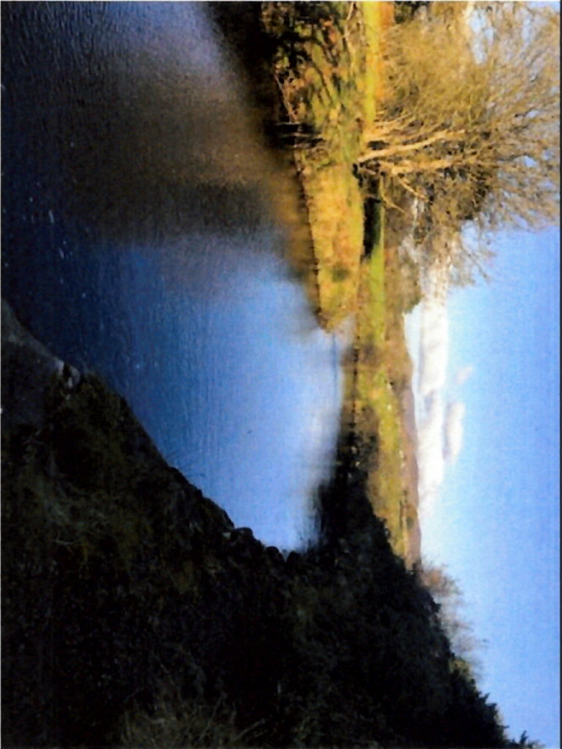
<p><i>Revetment along the left bank of the main channel</i></p>
