CLONASLEE FLOOD RELIEF SCHEME

Appendix 16.2: Inventory of Cultural Heritage Assets and Receptors within the Study Area

MDW0867
S5 P01
19 May 2025

CHAPTER 16 CULTURAL HERITAGE

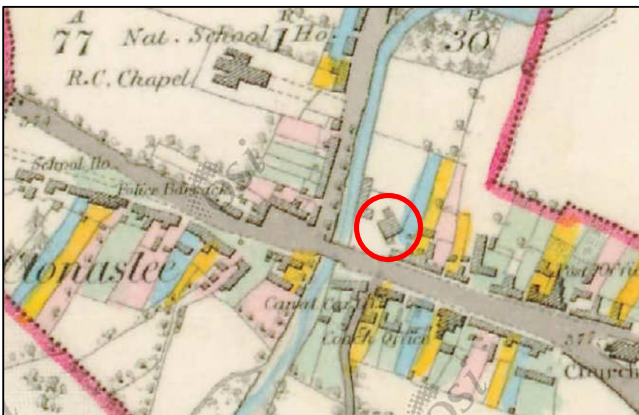
Receptor No.	CH-001
Site Type:	Structure
Status:	Listed on SMR (note – shown as delisted on RMP map but at a different location; see description below).
Reference:	LA002-010----
Image:

Townland:	Clonaslee
Coordinates (ITM):	631798, 711024
Approximate Distance:	20m (from edge of building shown on historical OS map)
Description:	<p>Originally listed in the SMR of Laois as a possible castle site located to S of the Roman Catholic church at Clonaslee. However, the structure located on the lands of Mr. John Moran was recorded by Henry Wheeler, Inspector of Monuments with the Office of Public Works in 1967 and was described as follows:</p> <p>'On E bank of Clodiagh River. Piece of wall 2 ft. (0.6m) thick at existing top, height at present 3' 6"-4' (1.2m). Two offsets at base. Masonry of indeterminate character runs NW-SE. Visible for about 15' (4.5m). A pit has been dug for a tank just outside it (full of water to a depth of several inches). Traces of two other walls roughly at right angles in the yard of the owner. If so, the exposed wall would be the N.E. side of a rectangular block. Owner thinks sides are c. 45' (13.7m) long, but I could not readily verify this. Bears no relationship to village street of Clonaslee or to oldish farm buildings at back which must be c.150 years old. These overlie it and are different buildings. Wall is a bit thin for a castle. Water gushed from inside it. ? Water mill. 1839 edition of 6" OS map shows what seems to be this building: no indication of its purpose. It was roughly square, with small annexes at NW & SE corners: no building on street front: apparently a yard there' (SMR File 17 May 1967).</p> <p>The structure recorded in 1967 was deemed not to be the site of a castle and was delisted from the SMR for Co. Laois and was not listed in the RMP for Co. Laois. The site report from Henry Wheeler stated that it was located on the east bank of the Clodiagh River on the grounds of property owned by John Moran which is the site immediately adjoining the Clodiagh River to the N of the main street. Compiled and revised by: Caimin O'Brien. Date of upload/revision: 28 June 2022.</p> <p>Reference: Comerford, Rev. M. 1883-6. <i>Collections relating to the dioceses of Kildare and Leighlin</i>, 3 vols. Dublin: James Duffy and Sons.</p>

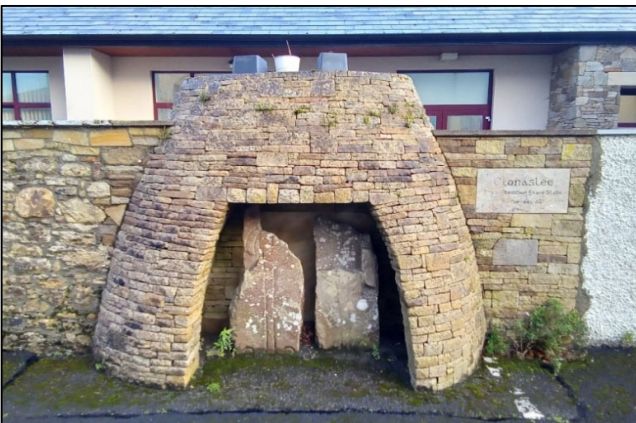
Receptor No.	CH-004
Site Type:	Cross-slab (present location)
Status:	Listed on SMR/Recorded Monument
References:	SMR LA002-012002---/RMP LA002-012---
Image:

Townland:	Clonaslee
Coordinates (ITM):	631708, 711161 (walkover survey). Note: recorded HEV ITM for SMR LA002-012002--- is 631704, 711121, which differs by approximately 39m to location noted during walkover survey.
Approximate Distance:	81m (from cross slab); 55m (from edge of SMR ZoN); 18m (from edge of RMP constraints area).
Description:	<p>HEV Record for SMR LA002-012002---</p> <p>[One of] two [surviving] rectangular shaped sandstone slabs both with incised simple crosses set against N wall of Clonaslee Catholic churchyard. A third much smaller incised cross-slab is illustrated by Leask as Carrigeen no. 1 (JKAS 1937, 108) and has been incorporated into the fabric of the boundary wall of the RC church at Clonaslee. This slab could not be precisely located within the churchyard wall. The remaining two cross-slabs, Carrigeen no. 2 and no. 3 (LA002-012001-/LA002-012---) are illustrated as being completely intact but both now have at least 1/3 of the W upper portions missing. Originally these cross-slabs (LA002-013003-/006-/007-) came from Carrigeen graveyard (LA002:013001-) in the townland of Ballynahown (JRSAI 1916, 166; JKAS 1939, 187). One of a group of three cross-slabs (LA002-013003-/006-/007-) which were moved from this graveyard to the RC church at Clonaslee. Compiled by: Caimin O'Brien Date of upload: 17 December 2007.</p> <p>HEV Record RMP LA002-012---</p> <p>Two rectangular-shaped sandstone slabs both with incised simple crosses set against N wall of Clonaslee Catholic churchyard. A third much smaller slab is illustrated by Leask as Carrigeen no. 1 (JKAS 1937, 108) but could not be found. The remaining two cross-slabs (Carrigeen no. 2 and no. 3) are illustrated as being completely intact, but both now have at least 1/3 of the W upper portions missing. Originally these cross-slabs (LA002-013003-/006-/007-) came from Carrigeen graveyard (LA002:013001-) Ballynahown. (JRSAI 1916, 166; JKAS 1939, 187).</p>

Receptor No.	CH-004
	<p>Carrigeen no. 1 [is depicted] by Leask in 1939 and described as a 'pillar slab, 5 ft. 4 ins. Long by 1 ft. 4 ins. Wide at broadest part; some parts spalled off. An incised Greek cross in a circle occupies central position. The upper arm of cross is two lined and starts from a curved double pot-hook line - roughly concentric with central circle and hooked at extremities and finish in a half round expansion. The lower member shaft is of two lines and finishes in the same way but diverges near the circle into two short curves concentric with it' (Leask 1939, 187).</p> <p>The above description is derived from the published 'Archaeological Inventory of County Laois' (Dublin Stationery Office, 1995) compiled by P. David Sweetman, Olive Alcock and Bernie Moran. In certain instances, the entries have been revised and updated in the light of recent research. Date of upload: 17 December 2007.</p>

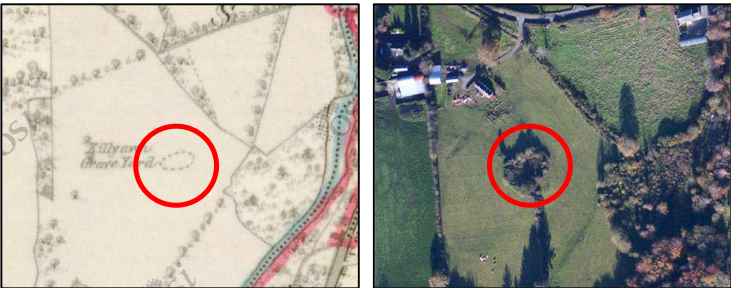
Receptor No.	CH-005
Site Type:	Children's burial ground
Status:	Recorded Monument/listed on SMR
Reference:	LA002-019----
Images:

Townland:	Brittas
Coordinates (ITM):	631492, 710685
Approximate Distance:	103m (from site); 84m (from edge of SMR ZoN); 53m (from edge of RMP constraints area).
Description:	<p>Possible killeen consisting of a flat subcircular area enclosed by a modern hedge and iron railings; no surface evidence of grave-markers, stonework etc. which might indicate the exact type of site. The above description is derived from the published 'Archaeological Inventory of County Laois' (Dublin Stationery Office, 1995) compiled by P. David Sweetman, Olive Alcock and Bernie Moran. Date of upload: 17 December 2007.</p>
Sources:	<p>RMP; HEV (see permalink below). https://heritagedata.maps.arcgis.com/apps/webappviewer/index.html?id=0c9eb9575b544081b0d296436d8f60f8&query=18a4b61b268-layer-9%2CSMRS%2CLA002-019----</p>

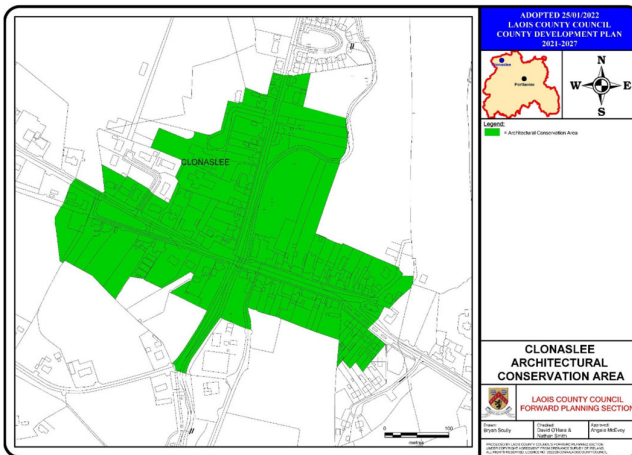
Townland:	Clonaslee; Capparogan; Brittas
Coordinates (ITM):	631750, 711020 (at main crossroad in Clonaslee)
Approximate Distance:	0m
Description:	<p>The ACA is focused on the historic core of Clonaslee which comprises the Main Street [R422], the Green and the Tullamore Road [L2006].</p> <p>[...] The Clodiagh River runs along the Tullamore Road enclosed by a stone wall and under the Main Street [...] and contributes to the special character of the village. The streetscape of Main Street is cohesive, incorporating a strong building line defining the edge of the street, the buildings are mostly two-storey, with wide frontages, gable-pitched roofs, large chimney stacks and vertical emphasis windows, are orientated towards and open directly onto the Main Street.</p> <p>Gaps between the buildings provide shared access to back lands though a few integral carriageways exist also. Most of the buildings have no elevational decoration, some are decorated with painted raised plasterwork to the doorways and faux quoins to the edges. Elevational finishes include roughcast, lime render and cement renders. Much of the original building fabric such as doors, sliding sash windows, roof tiles and rainwater goods have been replaced. Chimney stacks and pots generally survive. A small number of shopfronts of architectural quality survive.</p> <p>The roof heights and pitches vary along the Main Street within a small range. More generally the streetscape comprises a linear form, designed vistas and views and some fine individual buildings including the Church of Ireland which now functions as a Heritage Centre, the Lodge and Hickey's Public House with their decorative timber fascia boards, the defunct Courthouse overlooking the Green. The Swan Public House, though not of architectural interest, is a prominent building by reason of its siting.</p> <p>Open spaces make an important contribution to the character of the village and comprise the Green and the open space to the front of Hickey's Public House known as the Square. Buildings along the western side [of] Tullamore Road are more informally arranged becoming single-storey cottages from the village and are generally of a lower architectural order. The cottages along this road contribute to the special character of the ACA. The buildings and open spaces of the village are generally well-maintained.</p> <p>See permalink below for further details.</p>

Receptor No.	CH-006
Importance of Receptor:	High
Description of Impact:	Potential indirect negative effect (visual impact) to ACA resulting from the construction of a flood wall.
Magnitude of Impact:	Medium
Significance of Effect:	Each element within the ACA is assessed individually to avoid double-counting
Proposed Mitigation:	Mitigation for each element within the ACA impacted is provided
Residual Impact:	Slight, short-term, Neutral

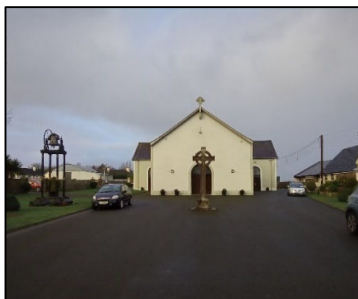
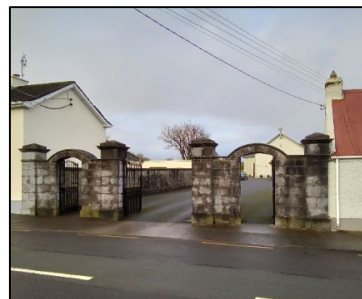
Church and entranceway (CH-007)

Townland:	Clonaslee
Coordinates (ITM):	631695, 711147 (church, CH-007) 631687, 711130 (stile, CH-007.1) 631688, 711125 (memorial wall, CH-007.2) 631728, 711124 (bell, CH-007.3)
Approximate Distance:	5m (from entranceway of church, CH-007); 65m (from church, CH-007) 93m (from stile, CH-007.1) 91m (from memorial wall, CH-007.2) 52m (from bell, CH-007.3)
Description:	Detached Catholic church, dated 1813, on a T-shaped plan with sacristy projection to rear. Interior retains some original fittings. Plaque inscribed: "This Chapel was Erected Anno Dom 1813 The Revd Thaddaeus Dunne Pastor".

Receptor Nos.	CH-007 CH-007.1 to CH-007.3 (associated sub-numbers)
Sources:	Walkover survey (November 2023); Laois County Development Plan, Appendix 1: 26 https://laois.ie/wp-content/uploads/Appendix-1-RPS-of-Adopted-LCDP-2021-2027.pdf NIAH (Building Survey) https://www.buildingsofireland.ie/buildings-search/building/12800201/saint-manmans-catholic-church-clonaslee-clonaslee-laois
Importance of Receptor:	High (church) Medium (stile, memorial wall and bell)
Description of Impacts:	Potential direct negative effect to receptor's entranceway (pictured above, to the right) due to close proximity of construction works, which could result in unintentional/accidental damage. Potential indirect negative effect (visual impact) to the receptor's entranceway resulting from the construction of a flood wall.
Magnitude of Impact:	Medium
Significance of Effect:	Moderate
Proposed Mitigation:	Use of protective barriers where necessary to avoid accidental damage to receptors within the ACA; Use of appropriate materials and appropriate wall height to (1) ensure the flood wall fits in with the surrounding character of Clonaslee and (2) to ensure the river remains an integral part of the village and is not severed/disconnected from the streetscape due to inappropriate wall height/materials.

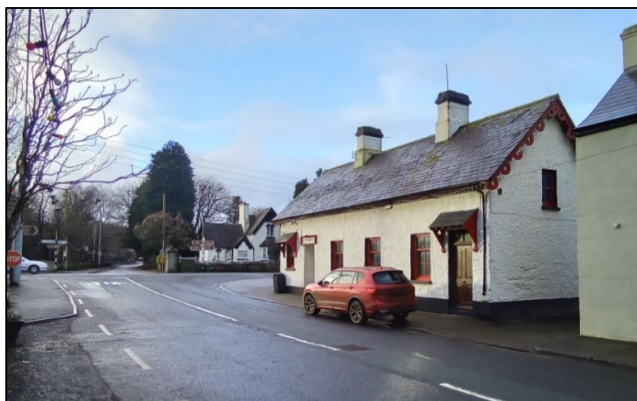
Receptor No.	CH-009
Site Type:	Façade of public house
Status:	Protected Structure
Reference:	RPS 343

Townland:	Clonaslee
Coordinates (ITM):	631744, 711045
Approximate Distance:	5m
Description:	Façade of M.D. Hickey Pub, The Square. No further details provided in RPS.
Sources:	Walkover survey (November 2023); Laois County Development Plan, Appendix 1: 27 https://laois.ie/wp-content/uploads/Appendix-1-RPS-of-Adopted-LCDP-2021-2027.pdf
Importance of Receptor:	High
Description of Impact:	Potential direct negative effect to receptor's façade due to close proximity of construction works, which could result in unintentional/accidental damage. Potential indirect negative effect (visual impact) to receptor's façade resulting from the construction of a flood wall.
Magnitude of Impact:	Low
Significance of Effect:	Moderate
Proposed Mitigation:	Use of appropriate protective measures such as the installation of barriers where considered necessary; Use of appropriate materials and appropriate wall height to fit with the character of the townscape/ACA.

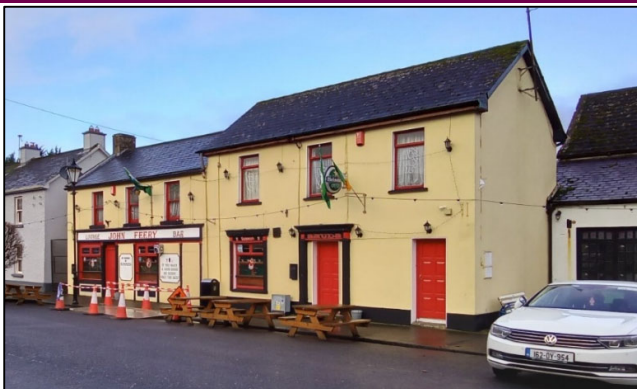
**Townland:** Clonaslee**Coordinates (ITM):** 631844, 711007**Approximate Distance:** 80m**Description:** Façade of John Feery Pub, Main Street.
No further details provided in RPS.**Sources:** Walkover survey (November 2023); Laois County Development Plan, Appendix 1: 27
<https://laois.ie/wp-content/uploads/Appendix-1-RPS-of-Adopted-LCDP-2021-2027.pdf>**Importance of Receptor:** High**Description of Impact:** None**Magnitude of Impact:** N/A**Significance of Effect:** N/A**Proposed Mitigation:** N/A**Residual Impact:** N/A**Receptor No. CH-011****Site Type:** House**Status:** Protected Structure**Reference:** RPS 963**Image:**

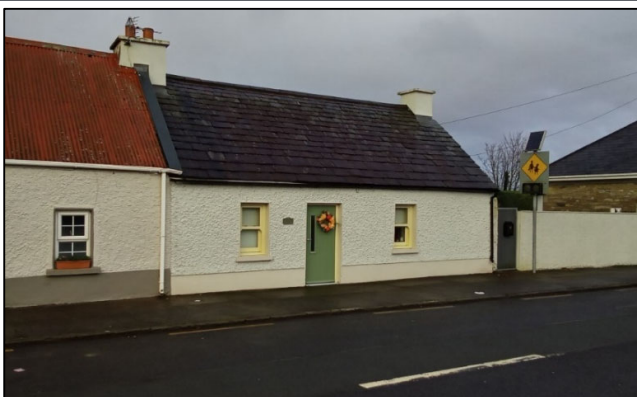
**Townland:** Clonaslee**Coordinates (ITM):** 631774, 711138**Approximate Distance:** 5m**Description:** House, Chapel Lane, Clonaslee. No further details provided in RPS.

Receptor No.	CH-011
Sources:	Walkover survey (November 2023); Laois County Development Plan, Appendix 1: 97 https://laois.ie/wp-content/uploads/Appendix-1-RPS-of-Adopted-LCDP-2021-2027.pdf
Importance of Receptor:	High
Description of Impact:	Potential direct negative effect to receptor due to close proximity of construction works, which could result in unintentional/accidental damage. Potential indirect negative effect (visual impact) to the receptor resulting from the construction of a flood wall.
Magnitude of Impact:	Medium
Significance of Effect:	Moderate
Proposed Mitigation:	Use of appropriate protective measures such as the installation of barriers where considered necessary; Use of appropriate materials and appropriate wall height to fit with the character of the townscape/ACA.
Residual Impact:	Slight, Short-Term, Neutral

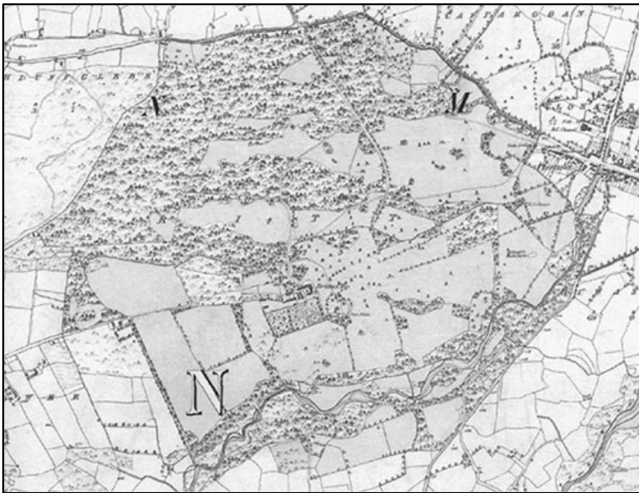
Townland:	Brittas; Scarroon; Gorrage Lower; Bunastick
Coordinates (ITM):	630810, 710742 (approximate centre point)
Approximate Distance:	0m
Description:	Brittas House historic demesne – extent is shown on historical OS maps.
Sources:	Walkover survey (November 2023); NIAH Garden Survey (see permalink below); wade and metal detection survey (Melia 2024). https://www.buildingsofireland.ie/buildings-search/site/126/brittas-house-kilmanman-co-laois
Importance of Receptor:	Medium
Description of Impact:	As the Brittas Wood walking trails occur within the former demesne of Brittas House, works within this area constitute a direct impact on the demesne itself. However, positive effects will be seen through heightened accessibility via introduction of flood defence measures.
Magnitude of Impact:	Medium

Receptor No.	CH-012
Significance of Effect:	Medium
Proposed Mitigation:	Moderate
Residual Impact:	Slight, Longterm, Positive.

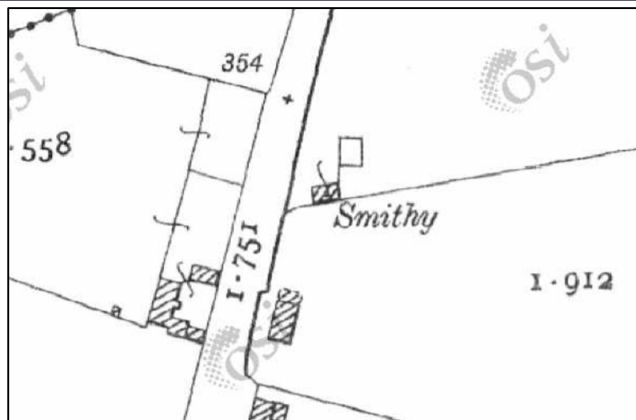
Receptor No.	CH-013
Site Type:	Smithy (site of)
Status:	Undesignated
Reference:	N/A

Townland:	Clonaslee
Coordinates (ITM):	631850, 711311
Approximate Distance:	19.5m
Description:	Appears on the first-edition six-inch OS map (1841) as a roofed rectangular structure with its gable fronting towards the local road. A longer north-south orientated building (possible dwelling?) is located immediately to the north, both buildings are conjoined by a wall. By the time of survey of the 25-inch OS map, the former possible dwelling is depicted much smaller in scale, and as un-roofed. The building to the south is annotated as 'smithy'. The wall conjoining both structures survives in situ.
Sources:	Six-inch OS map (1841); 25-inch OS map (1909)
Importance of Receptor:	Unknown
Description of Impact:	None
Magnitude of Impact:	N/A
Significance of Effect:	N/A
Proposed Mitigation:	N/A
Residual Impact:	N/A

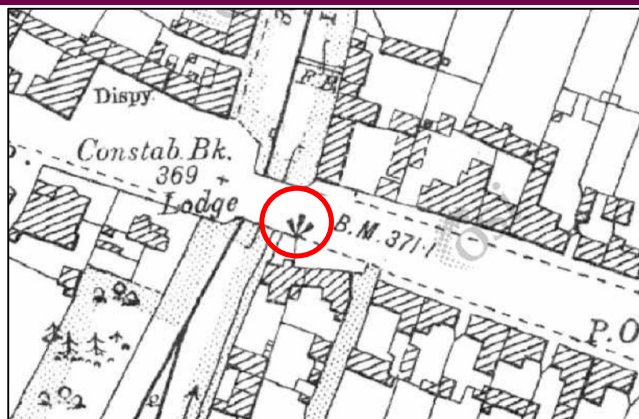
**Townland:** Clonaslee**Coordinates (ITM):** 631772, 711010**Approximate Distance:** 19m**Description:** Benchmark annotated on 25-inch OS map (1909).**Source:** 25-inch OS map (1909)**Importance of Receptor:** Unknown**Description of Impact:** None**Magnitude of Impact:** N/A**Significance of Effect:** N/A**Proposed Mitigation:** N/A**Residual Impact:** N/A
Receptor Nos. CH-015
CH-015.1 and CH-015.2 (associated sub-numbers)
Site Type: Lodge and front garden boundary wall (CH-015)
 Stone walls associated with lodge (CH-015.1 and CH015.2)
Status: Undesignated
Reference: Potentially associated with Brittas House Protected Structure (RPS 432) and historical demesne (CH-012: NIAH Site ID 126)
Image:

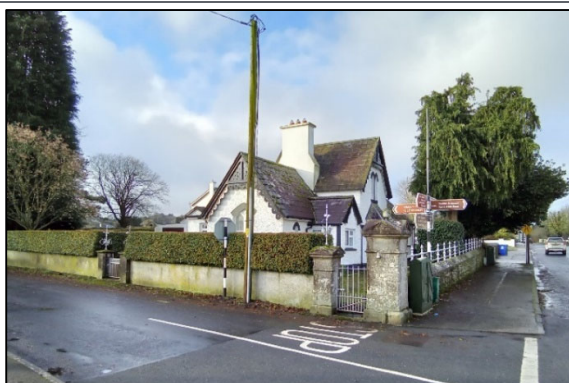
Lodge and front garden boundary wall, CH-015

Townland:	Clonaslee
Coordinates (ITM):	631728, 711011 (lodge and front garden boundary wall CH-015) 631727, 710977 (stone wall CH-015.1) 631687, 710905 (stone wall CH-015.2)
Approximate Distance:	11m (from gated boundary wall of lodge CH-015) 34m (from stone wall CH-015.1) 0m (stone wall CH-015.2; part of the wall runs along perimeter of proposed Brittas Wood site compound)
Description:	CH-015, CH-015.1 and CH-015.2 comprise a low road-side boundary wall built with a combination of coursed and random uncoursed mainly sandstone blocks, some of which are angular and dressed. Some evidence for lime mortar survives, but sections of this wall are dry-stone, and there is phasing evident in sections of the wall also. The wall survives to a height of c 1.2m, and is capped along its course with 'cow and calf' style masonry. The dressed stone appears to be re-used, and it was initially assessed that this material may have been part of a mill or mill buildings what may have existed in this area in the past. The wall was not built at the time of survey for the first-edition six-inch OS map (1841), but the road was constructed by 1909 and it is likely that the roadside boundary wall was constructed around the same time.

Receptor Nos.	CH-015 CH-015.1 and CH-015.2 (associated sub-numbers)
Significance of Effect:	Not Significant to Slight
Proposed Mitigation:	Use of appropriate protective measures such as the installation of barriers; Use of appropriate materials and appropriate wall height to fit with the character of the townscape/ACA. Rebuild with like-for-like materials if any section will need to be temporarily widened.
Residual Impact:	Not Significant to Slight, Short term.

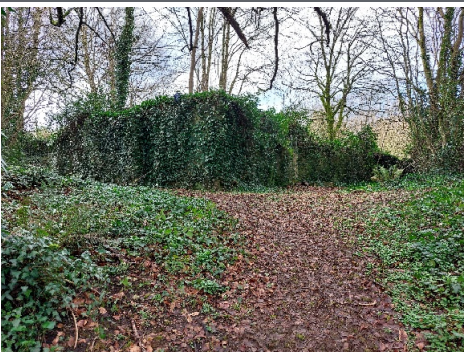
<p>Lodge CH-016</p>
Townland:	Bunastick
Coordinates (ITM):	631658, 710622
Approximate Distance:	37m
Description:	Very heavily ivy-clad single storey structure which appears to have similar facades on each side. Stone built and rendered with evidence of blue paint surviving on the west-facing façade. Evidence for windows/opes surviving in the northern and western facades, and the doorway being in a central position in the west face. A culvert runs below the southern side of the building and appears to be designed to allow water funnel under the building and south westwards towards the Clodiagh river. Evidence for substantial earthworks and creation of pathways from this building to the river (in a zig-sag formation to accommodate the steep river bank/slope to the river) suggest that there may have been some industrial function to this building. The building is depicted on both the first-edition six-inch map (1841) and the 25-inch OS map (1909) and is annotated as 'lodge' on the latter, presumably a lodge of Brittas Demesne.

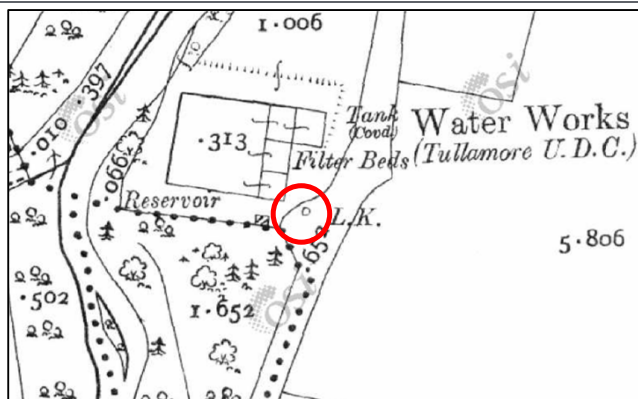
Receptor No.	CH-017
Site Type:	Lime kiln (site of)
Status:	Undesignated

Description:	Depicted on the 25-inch OS map (1909) with the circular symbology denoting a kiln, and with the letters L.K.(lime kiln) beside it.
---------------------	--

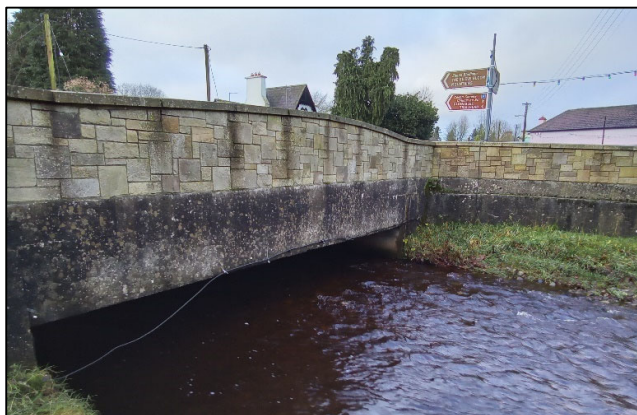
Receptor No.	CH-018
---------------------	---------------

Receptor No.	CH-018
Description:	Modern bridge crossing the Clodiagh, of concrete construction with stone-faced concrete parapets. Built c. 2012. Replaced earlier bridge depicted on first-edition six-inch OS (1841) and later editions. Some potential survives for abutments of the earlier bridge to survive in the banks either side of the river.
Sources:	First edition six-inch OS map (1841); 25-inch OS map (1909); walkover survey (November 2023)
Importance of Receptor:	Low
Description of Impact:	Negligible
Magnitude of Impact:	Low
Significance of Effect:	Not Significant
Proposed Mitigation:	Archaeological monitoring in the vicinity of the former bridge
Residual Impact:	Not Significant, long term positive

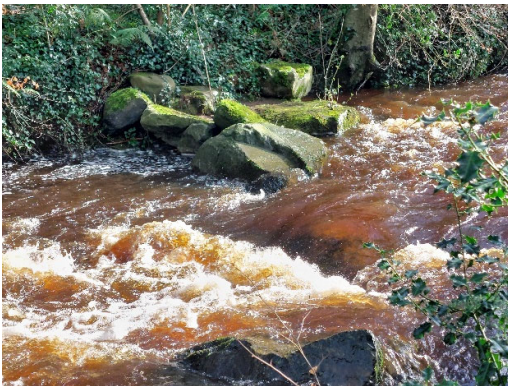
<p>River Clodiagh CH-019 in full flow in Brittas Wood</p>
Townlands:	Clonaslee; Ballynakill
Coordinates (ITM):	631807, 711168
Approximate Distance:	0m (located immediately adjacent to proposed works)
Description:	River Clodiagh
Sources:	Historical OS maps; walkover survey; wade and metal survey (Melia 2024)
Importance of Receptor:	Low
Description of Impact:	Direct, negative
Magnitude of Impact:	Low
Significance of Effect:	Slight
Proposed Mitigation:	Archaeological monitoring of all in-stream works and works along the banks of the river during construction
Residual Impact:	Short term, neutral

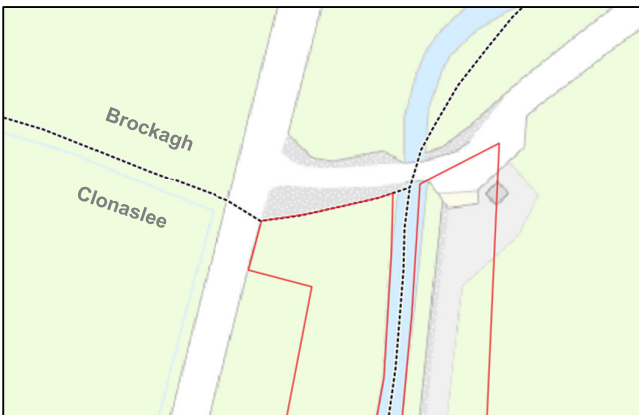
Townlands:	Clonaslee; Brockagh
Coordinates (ITM):	631907, 711692
Approximate Distance:	0m (part of the townland boundary runs along the perimeter of the proposed Tullamore Road site compound).
Description:	Townland boundary which has been disturbed through the construction of the wetland facility to the east. However, some evidence for older sections surviving in situ are evident, with crab-apples being identified close to the gate to the wetland facility.
Sources:	Historical OS maps; aerial imagery
Importance of Receptor:	Low
Description of Impact:	Low
Magnitude of Impact:	Low
Significance of Effect:	Slight
Proposed Mitigation:	Protective barriers: Advance works townland boundary survey and archaeological testing to ascertain the nature and potential age of the boundary feature within the planning application boundary extents. Further archaeological works such as resolution and/or monitoring may also be required.

Residual Impact:	Slight

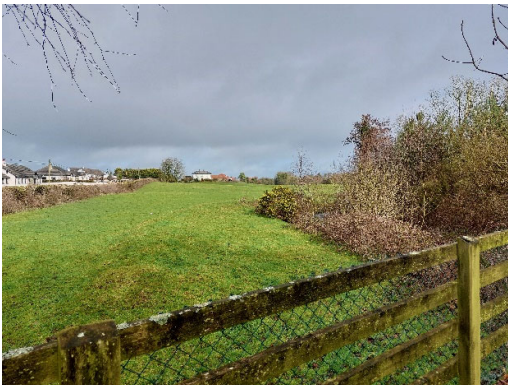
Receptor No.	CH-021
Townlands:	Brockagh; Ballynakill
Coordinates (ITM):	632020, 711743
Approximate Distance:	2m
Description:	Townland boundary which extends along the perimeter of the proposed Tullamore Road site compound. Has been subject to previous disturbance during earlier development works and now is marked with a post-and-rail fence along the roadside. The boundary broadly aligns with the course of the river as depicted on the first-edition six-inch OS map (1841). Some disturbance has been evidenced in the construction of the wetland facility to the east, but otherwise the boundary retains the line of that shown on the early historic mapping.
Sources:	Historical OS maps; aerial imagery. Walkover survey.
Reference:

<p>CH-021 Post and rail fence along the northern side of the road with the Clodiagh to the right of view</p>
Importance of Receptor:	Low
Description of Impact:	Potential direct negative

Magnitude of Impact:	Low
Significance of Effect:	Slight
Proposed Mitigation:	Protective barriers: Advance works townland boundary survey and archaeological testing to ascertain the nature and potential age of the boundary feature within the planning application boundary extents. Further archaeological works such as resolution and/or monitoring may also be required.
Residual Impact:	Slight

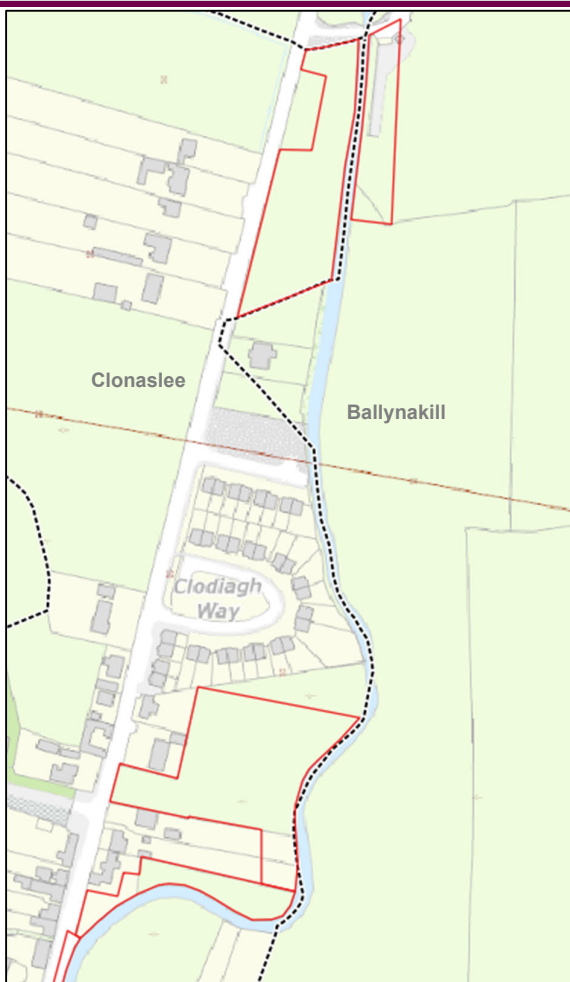
Townlands:	Clonaslee; Ballynakill
Coordinates (ITM):	631945, 711397
Approximate Distance:	0m (part of the townland boundary runs along the perimeter of the proposed Chapel Street site compound and at the proposed location of the Tullamore Road embankment/ ICW wall at the northern end of the scheme)
Description:	Townland boundary between Clonaslee and Ballynakill largely formed by the River Clodiagh within the study area, with a small section off the line of the river in the vicinity of the proposed Tullamore Road site compound and to the south of the proposed Chapel Street site compound.
Sources:	Historical OS maps; aerial imagery
Importance of Receptor:	Low
Description of Impact:	Potential direct negative
Magnitude of Impact:	Low
Significance of Effect:	Slight
Proposed Mitigation:	Protective barriers; Advance works townland boundary survey and archaeological testing to ascertain the nature and potential age of the boundary feature within the planning application boundary extents. Further archaeological works such as resolution and/or monitoring may also be required.

Receptor No. CH-022**Residual Impact:** Slight, Short-term, Neutral.**Receptor No. CH-023****Site Type:** Iron gates**Status:** Undesignated**Reference:** N/A**Image:**

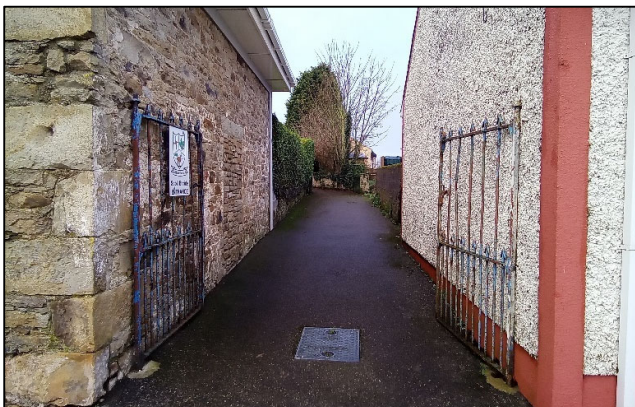
**Townland:** Clonaslee**Coordinates (ITM):** 631787, 711169**Approximate Distance:** 7m**Description:** Possible wrought iron gates of a vernacular style that add to the character of the ACA in Clonaslee. Note the position of these gates in relation to a smithy (CH-013) depicted on the historic mapping.**Source:** Walkover survey**Importance of Receptor:** Low**Description of Impact:** None**Magnitude of Impact:** N/A**Significance of Effect:** N/A**Proposed Mitigation:** N/A**Residual Impact:** N/A**Receptor Nos. CH-024****CH-024.1 to CH024.3 (associated sub-numbers)****Site Type:** Stone wall (CH-024)
Stiles (CH-024-1; CH024-2); bench (CH-024-3)**Status:** Undesignated**Reference:** N/A

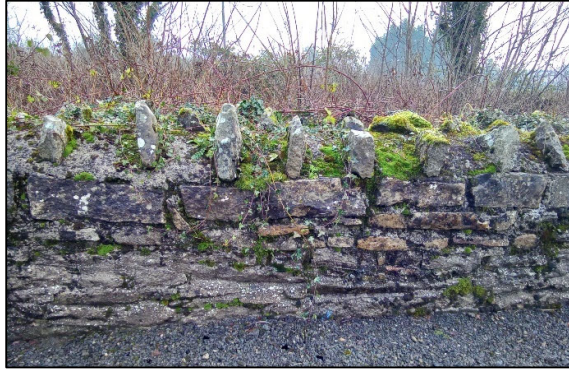
Stone wall, CH-024

Receptor Nos.	CH-024 CH-024.1 to CH024.3 (associated sub-numbers)
Townland:	Clonaslee
Coordinates (ITM):	631780, 711099 (stone wall, CH-024) 631789, 711134 (stile, CH-024-1) 631771, 711071 (stile, CH-024-2) 631765, 711042 (bench, CH-024-3)
Approximate Distance:	0m
Description:	Low stone wall forming the roadside boundary and riverbank wall on the western side of the Cloidagh, on the Tullamore Road side of the Proposed Scheme. Comprises sections of possible original wall construction, interspersed with modern sections and several features (styles, bench, steps providing river access) of built heritage interest throughout. Random coursed and uncoursed masonry, mainly sandstone, with cow and calf style coping stones throughout. Some sections of the wall are clearly bonded and capped with cementitious material, but other sections appear to be of dry-stone construction. A simple stone bench is a notable feature close to (the north of) the main bridge in Clonaslee, as are two styles which allow access through the wall to steps down to the river behind the wall itself. This wall adds to the character of the ACA, and as direct impacts are unavoidable, it is recommended that the proposed flood defence wall is faced with similar stone masonry.

Source:	Walkover survey
Importance of Receptor:	Low
Description of Impact:	Direct, negative
Magnitude of Impact:	High
Significance of Effect:	Moderate
Proposed Mitigation:	Built heritage survey of stone wall and associated features prior to works; use of appropriate materials and re-building like-for-like.
Residual Impact:	Slight, Longterm, Positive

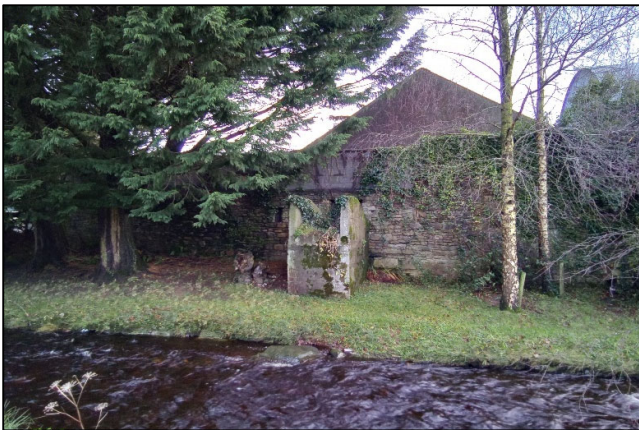
Townland:	Clonaslee
Coordinates (ITM):	631779, 711056
Approximate Distance:	7.5m (on opposite side of river to proposed works)
Description:	Stone wall which is the west-facing gable wall of an outbuilding to the rear of a property fronting onto Main Street. This building is shown on the first-edition six-inch OS map (1841) as part of a possible range flanking the eastern side of the Clodiagh. Remnants of a probable foot-bridge abutment which is adjoining the wall is of concrete construction. This foot bridge is shown on the 25-inch OS map (1909) annotated with F.B. (foot bridge) and is of likely late nineteenth or early twentieth century construction.
Source:	Walkover survey
Importance of Receptor:	Low
Description of Impact:	None
Magnitude of Impact:	N/A
Significance of Effect:	N/A
Proposed Mitigation:	N/A

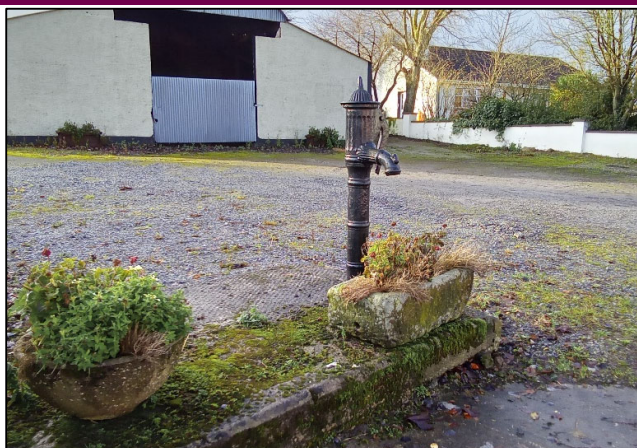
Receptor No. CH-028**Image:**

Townland:	Clonaslee
Coordinates (ITM):	631703, 711032
Approximate Distance:	51m
Description:	Cast-iron water pump with fluted domed cap and simple finial, fluted upper column with cows-tail style pump handle at the western side. There is a carved stone trough at the base of the spout and this sits on a simple concrete plinth.
Source:	Walkover survey
Importance of Receptor:	Low
Description of Impact:	None
Magnitude of Impact:	N/A
Significance of Effect:	N/A
Proposed Mitigation:	N/A
Residual Impact:	N/A

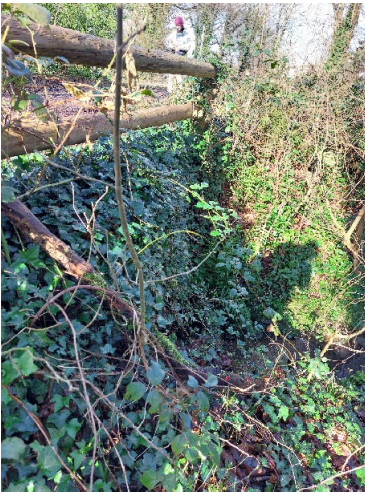
Receptor No.	CH-030
Site Type:	Culvert
Status:	Undesignated
Reference:	N/A
Image:

Townland:	Brittas
Coordinates (ITM):	631673, 710755
Approximate Distance:	0m
Description:	This culvert is at a location on the Brittas Wood walk where a ditch from the west empties into the Clodiagh to the east. It is a stone structure, but very occluded by ivy and dense vegetation so an accurate description was not feasible during walkover survey.
Sources:	25-inch OS map (1909); walkover survey; wade and metal detection survey

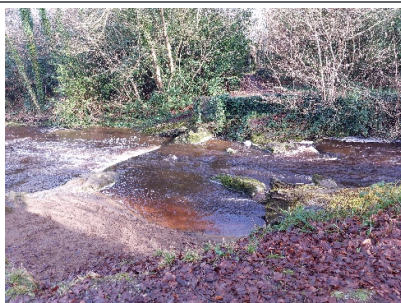
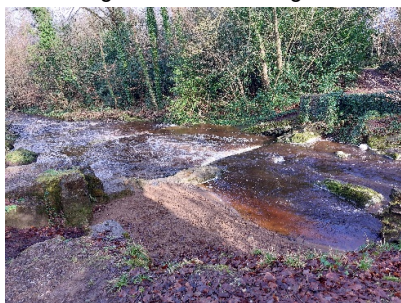
Remaining abutment and fragments of former footbridge CH-33 looking southeast

Abutment on west side of river and showing fragments of former footbridge CH-33 looking southeast.

Townland:	Bunastick; Brittas
Coordinates (ITM):	631657, 710686
Approximate Distance:	2m
Description:	Abutments, pier remnants and large slabs of concrete and stone in the river channel which represent the remains of the former footbridge at this location.
Sources:	25-inch OS map (1909); walkover survey; wade survey
Importance of Receptor:	Low
Description of Impact:	Potential direct negative
Magnitude of Impact:	Low
Significance of Effect:	Low
Proposed Mitigation:	Ensure the area is avoided during construction
Residual Impact:	Not Significant, Short term, Neutral

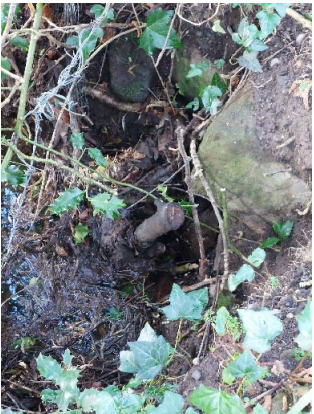
Receptor No.	CH-034
Site Type:	Relict Culvert
Status:	Undesignated
Reference:	N/A
Image:

<p>Image taken of CH-34 looking down from the edge of the walking path at a stone-built culvert allowing water to pass below the path from the west towards the River Clodiagh to the east. This culvert was otherwise inaccessible from the western side.</p>
Townland:	Bunastick; Brittas
Coordinates (ITM):	631654, 710689
Approximate Distance:	2m
Description:	Stone-built culvert draining water from the west to the river Clodiagh, passing below the Brittas Wood path at this location.
Sources:	25-inch OS map (1909); walkover survey; wade survey
Importance of Receptor:	Low
Description of Impact:	Potential direct negative
Magnitude of Impact:	Low
Significance of Effect:	Not Significant
Proposed Mitigation:	Ensure area is avoided during construction works
Residual Impact:	Not Significant, Short term, Neutral

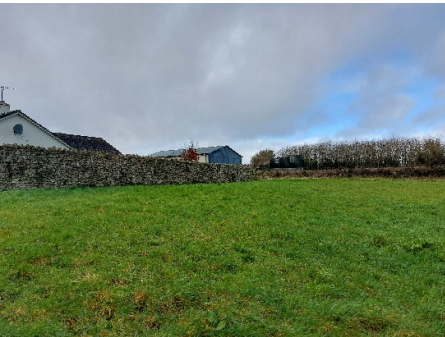
Townlands:	Brittas; Clonaslee

Sources:	Historical OS maps; walkover survey
Importance of Receptor:	Low
Description of Impact:	Potential direct negative
Magnitude of Impact:	Low
Significance of Effect:	Slight
Proposed Mitigation:	Protective barriers; Advance works townland boundary survey and archaeological testing to ascertain the nature and potential age of the boundary feature within the planning application boundary extents. Further archaeological works such as resolution and/or monitoring may also be required.
Residual Impact:	Slight, Short term, Neutral

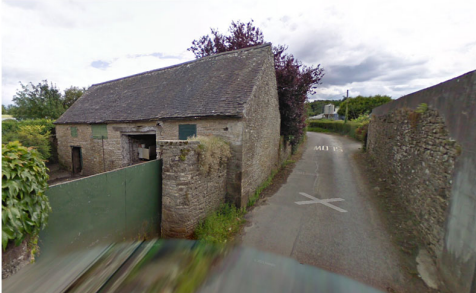
<p>CH-036 looking south; image © Google satellite</p>
Townland:	Clonaslee
Coordinates (ITM):	631782, 710979
Approximate Distance:	45m
Description:	Stone walled and slated and outbuilding along the L2002, immediately south of the R422 road. Structure comprises a one-and-a-half storey outbuilding with the western half accessed via a large rectangular opening with a window to the west (resembling entrance to a hay loft) at first floor level. The eastern side of the building has a smaller pedestrian doorway at ground floor level and two window openings above. All of the window openings are boarded up and painted green. The roof is slated and in good condition with all of the ridge tiles in place; the west facing gable clearly shows that the roof pitch was raised at some time during the lifespan of the building. The gate is modern, but the gate piers have distinct rounded edges incorporated into the wall. Phasing evident throughout. Located within the ACA.

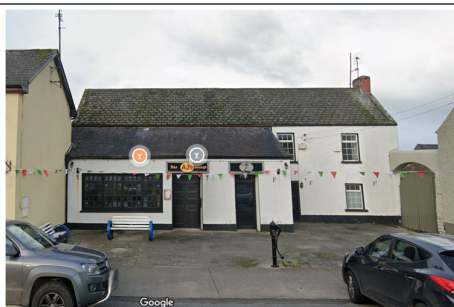
CH-037 A.J.'s Bar and Lounge, looking south. Image © Google

Townland:	Clonaslee
Coordinates (ITM):	631860, 711003
Approximate Distance:	98m
Description:	A.J.'s Bar & Lounge at eastern edge of study area. Within the ACA. Set back from the street front in contrast with it's neighbours at either side. The façade of a large two-storey building is occluded by a single storey extension to the front of the building which includes a large multi-paned window in four sections; some of the glass is bulls-eye type, but it is suggested that this is modern rather than of any considerable age. The roof is slated, and the chimney stack is rendered, occluding the underlying building fabric. There is a narrow barge extending from the chimney stack to the eaves on the western side
Source:	Walkover survey
Importance of Receptor:	Low
Description of Impact:	None
Magnitude of Impact:	N/A
Significance of Effect:	N/A
Proposed Mitigation:	N/A
Residual Impact:	N/A

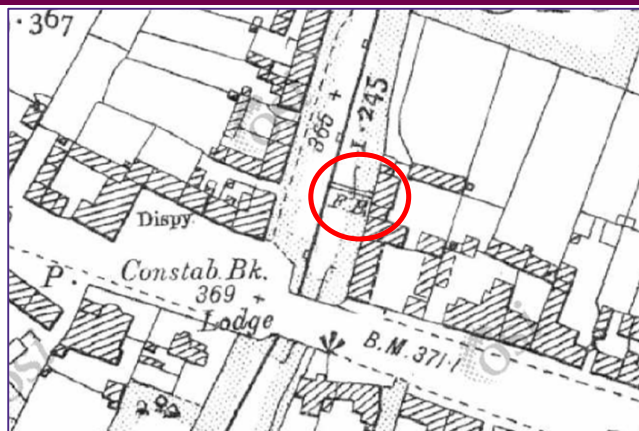
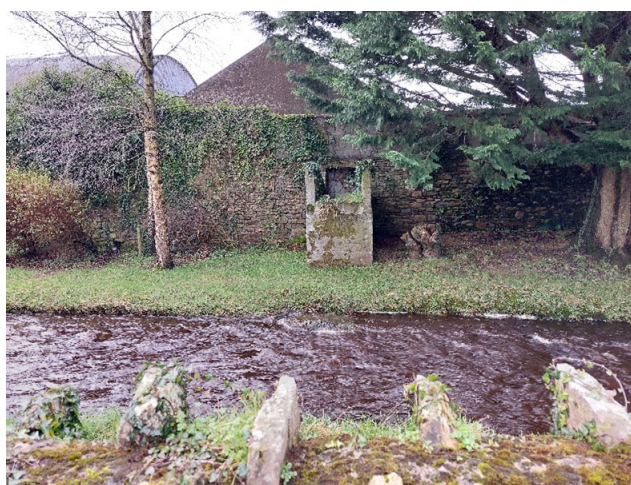
Remnant of the pier of former footbridge CH-040 looking east

Townland:	Clonaslee
Coordinates (ITM):	631773, 711052
Approximate Distance:	0m
Description:	Former footbridge marked on the 25-inch OS map (1909). The base of the bridge pier survives <i>in situ</i> at the eastern side riverbank, with concrete rather than stone pier surviving at the eastern side also. The bridge pier appears to abut the west-facing gable of a building (shown also on the first-edition six-inch OS map) which seems to be part of a range of buildings flanking the eastern side of the Clodiagh since at least that time (1841). The bridge would appear to be not as old.
Source:	25-inch OS map (1909)
Importance of Receptor:	Low. Local
Description of Impact:	Potential direct negative
Magnitude of Impact:	Low
Significance of Effect:	Slight
Proposed Mitigation:	Archaeological monitoring during construction
Residual Impact:	Not Significant, Temporary, Negative
