CLONASLEE FLOOD RELIEF SCHEME

Appendix 16.6: Wade Survey

Report on Wade and Metal Detection Survey at Clonaslee, Co. Laois

June 2024

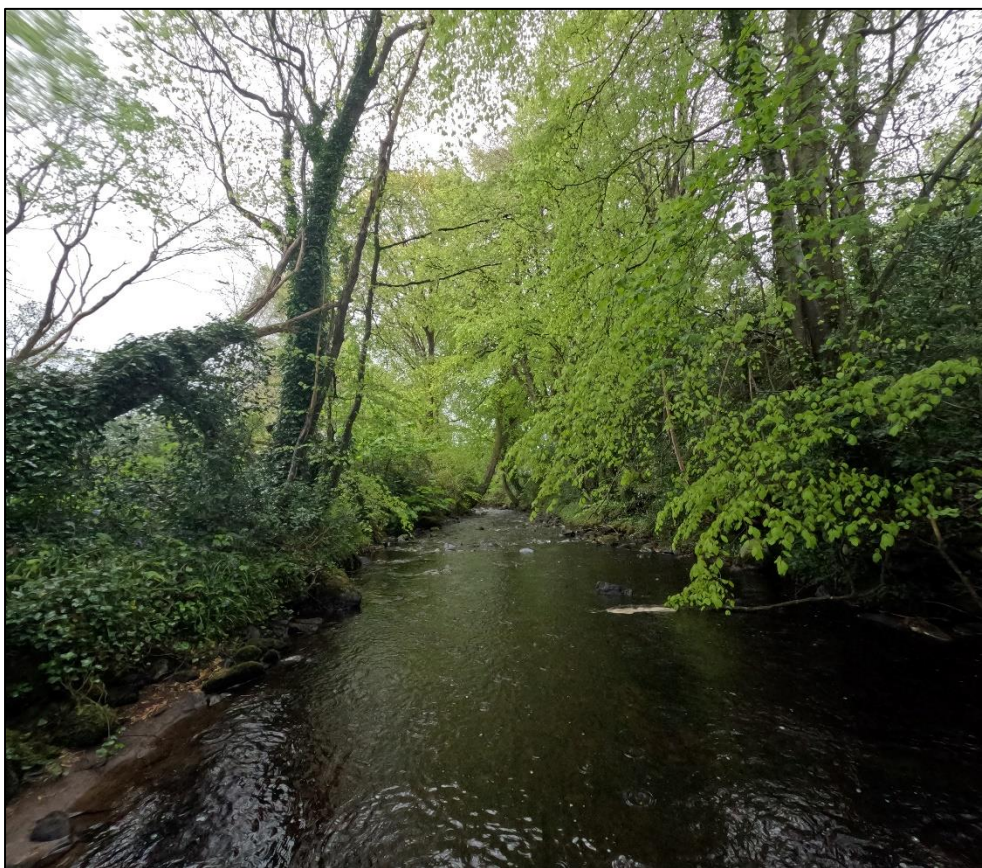
At the time of the survey, the Clodiagh River was not in spate. The river averaged 5.5m wide and was up to 0.4m deep within the Survey Area (Plate 1). The riverbed was uneven and was composed of stones, cobbles and boulders of varying sizes. Due to natural turbidity exacerbated by sediment unavoidably kicked up by the archaeologist walking in the river, underwater visibility was very limited. However, all ferrous anomalies found in the course of the 100%-coverage metal detecting in the river were investigated and retrieved by hand. Only modern objects (iron fittings and sheeting as well as aluminium drink cans) were found during in-stream metal detecting, but nothing of cultural heritage interest (Plate 2).

Plate 1. The Clodiagh River within the wade and metal detection Survey Area, looking north.

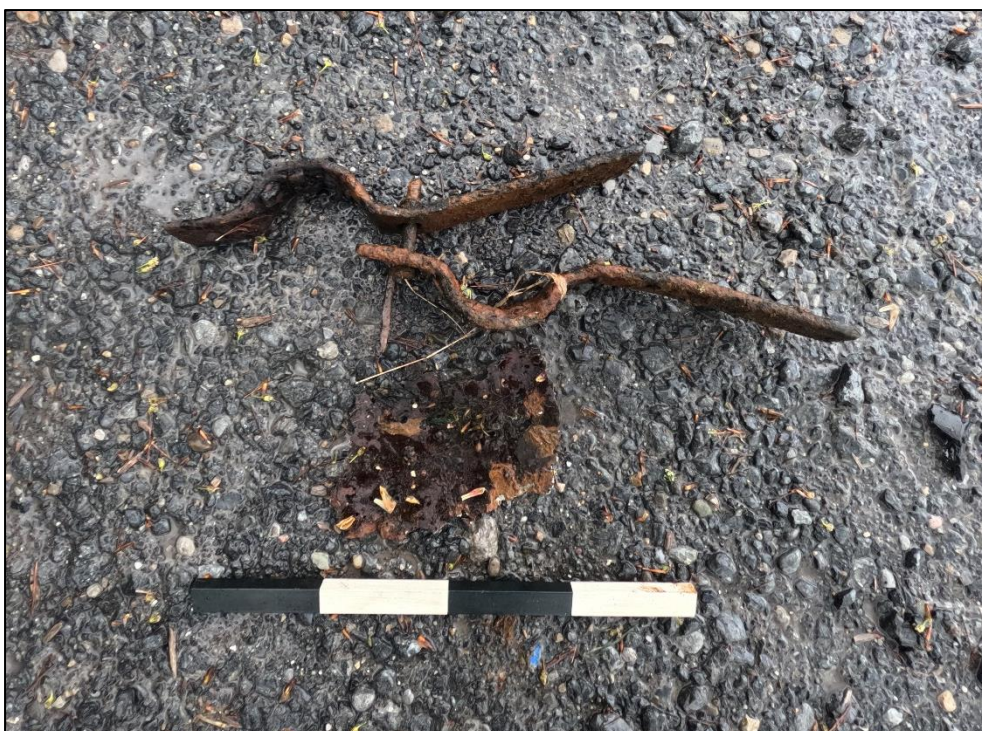
Plate 2. Modern iron fittings and sheeting found during metal detecting in the Clodiagh River.

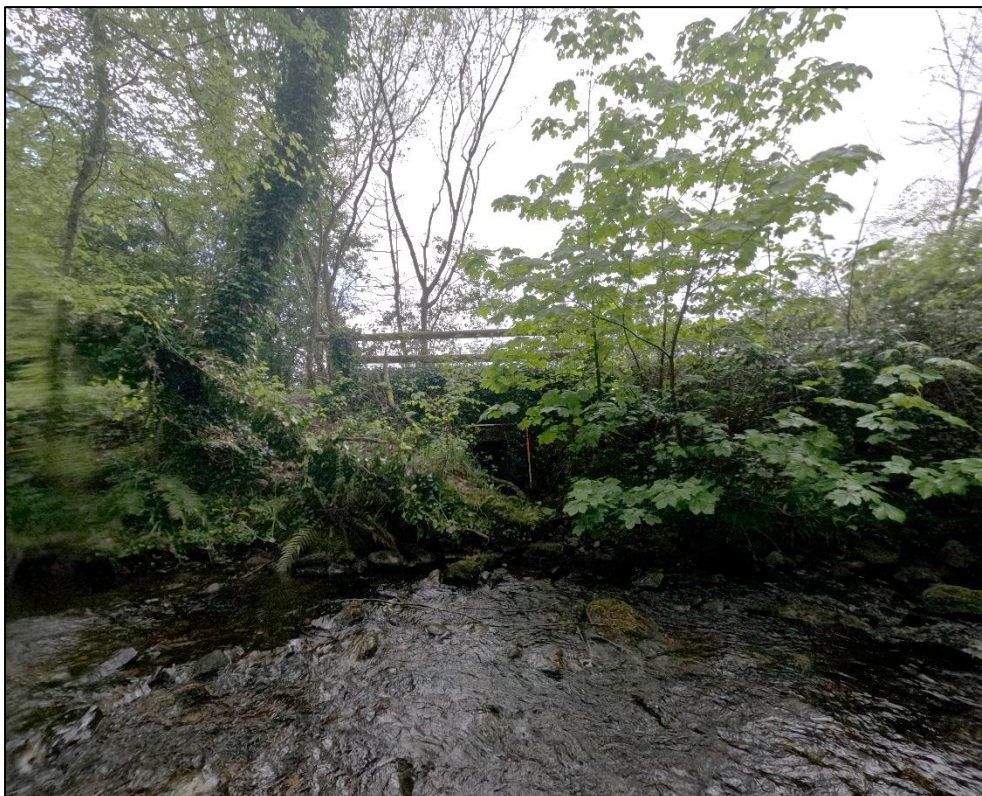
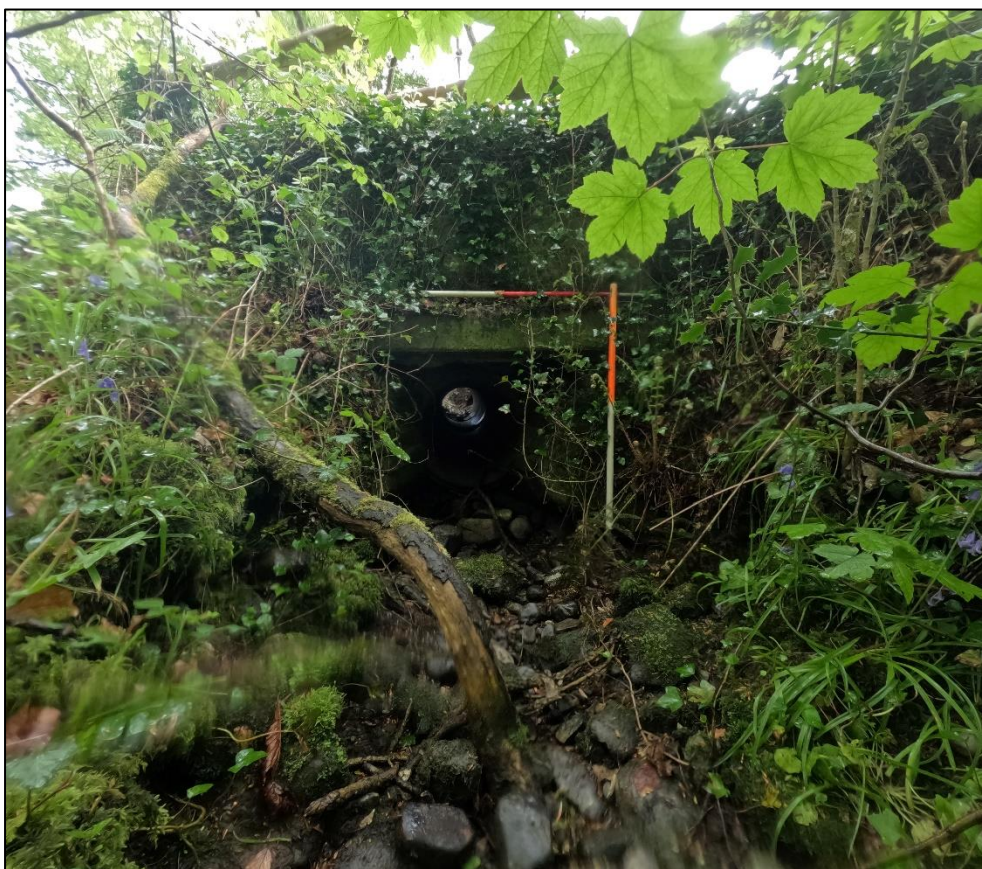
Cut into the west bank of the Clodiagh River midway along the Survey Area (ITM 631673, 710755) is a stone and concrete culvert running NE–SW, providing drainage from the field ditch to the west (Plate 3; Figure 7). The riverside footpath is built over the culvert, with railings as protection for pedestrians. The culvert's riverside opening (int. dims. 1m wide, 0.75m high) has a stone lintel. A concrete pipe (int. diam. c.0.6m) runs through the culvert (Plate 4). This culvert is modern in date.

Plate 3. Location of the in-use culvert on the west bank of the Clodiagh River within the Survey Area, looking west.

Plate 4. Eastern opening of the culvert, looking west.

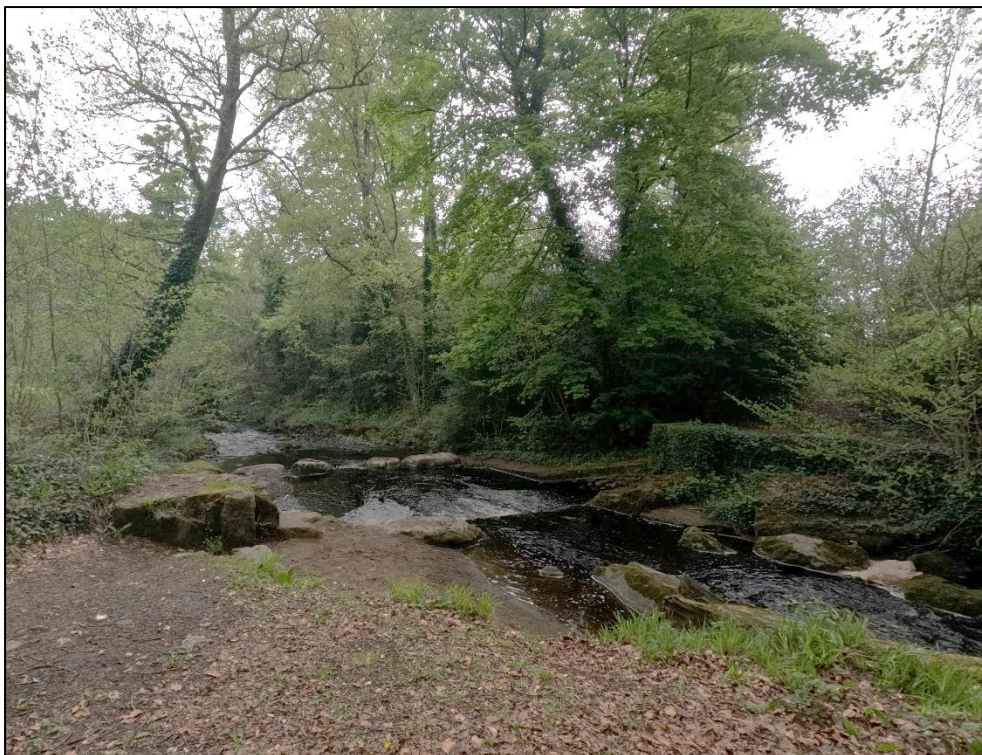
Approximately 35m to the south of the Survey Area are the relict remains of a former footbridge (drawn and labelled on the 1909 OS 25-inch map [Figure 5 & Figure 6]). These remains include the footings of the bridge abutments, a weir, and several other structural features on the west and east bank of the river (Plate 5–Plate 8).

Only the footings of the footbridge abutments have survived. These are rectangular in plan (each c.2m long, 1.1–1.3m wide) and are built of concrete and rubble. The weir running between the downstream corners of the bridge abutment footings is also built of concrete, and is c.1.1m wide and c.0.8m deep

Plate 5. Site of footbridge, looking northeast.

In construction and maintenance of the proposed embankment, it is recommended that care be taken to avoid damaging or visually impeding these cultural heritage features. This will be best managed by barriers during works, and an adequate distancing of the embankment's base from any cultural heritage features.

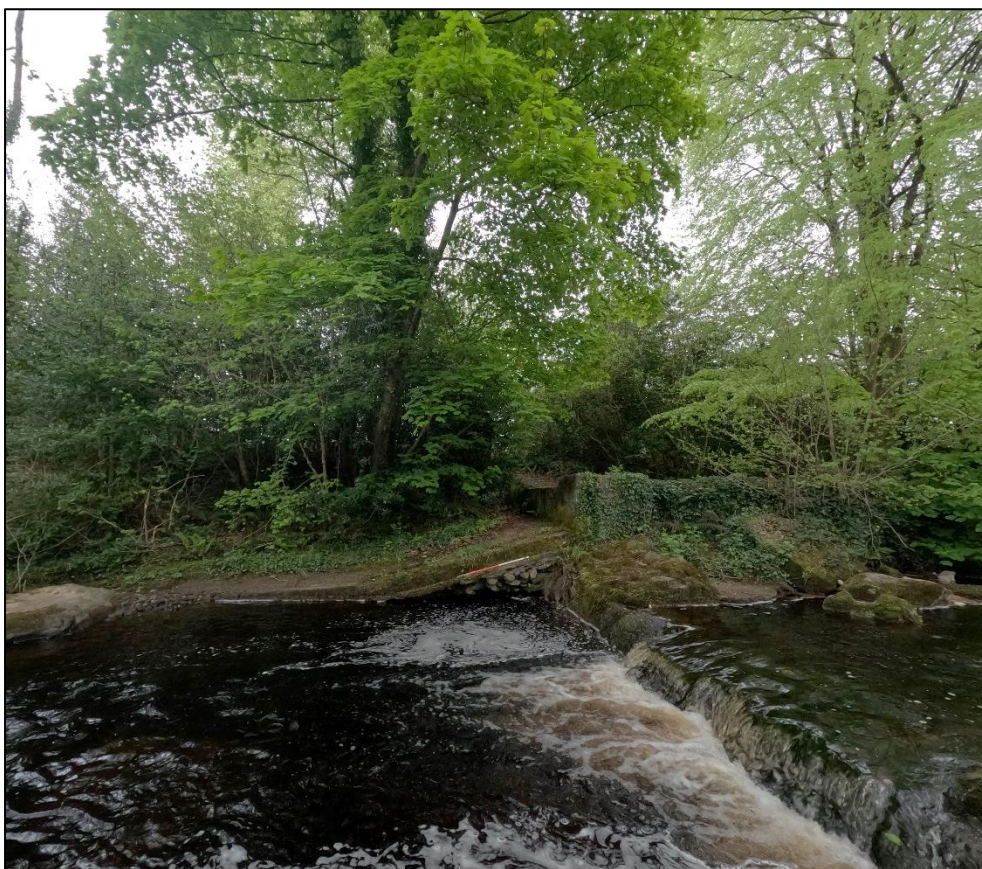
On the east side of the river, abutting the south side of the footbridge footing, is a stone wall which supports the riverside bridle-path (Plate 6). The upper portion of this wall has collapsed down onto the riverbank. Immediately downstream (i.e., north) from the bridge footing is a rubble and concrete quay-like riverside access platform with a smooth level surface (for fishing in the weir pool?), accessed via a ramp (stone base, concrete cap) running down from the riverside path immediately to the east of the footbridge footing. The bridle-path runs south from the footbridge along the river bank, with access also to the ruins of a lodge structure (drawn on labelled on the 25-inch OS map) set back from the river on higher ground c.50m to the south.

Plate 6. East bank at site of footbridge, looking east.

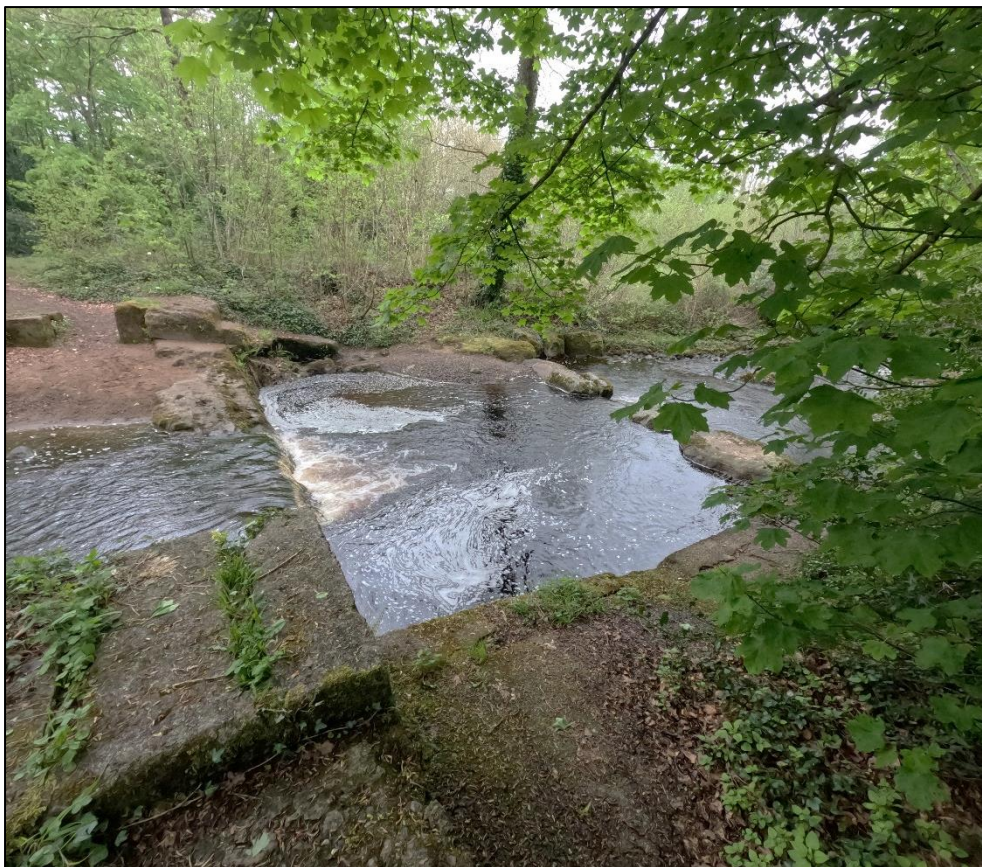
Plate 7. Footbridge site, looking west, with wall visible at back left.

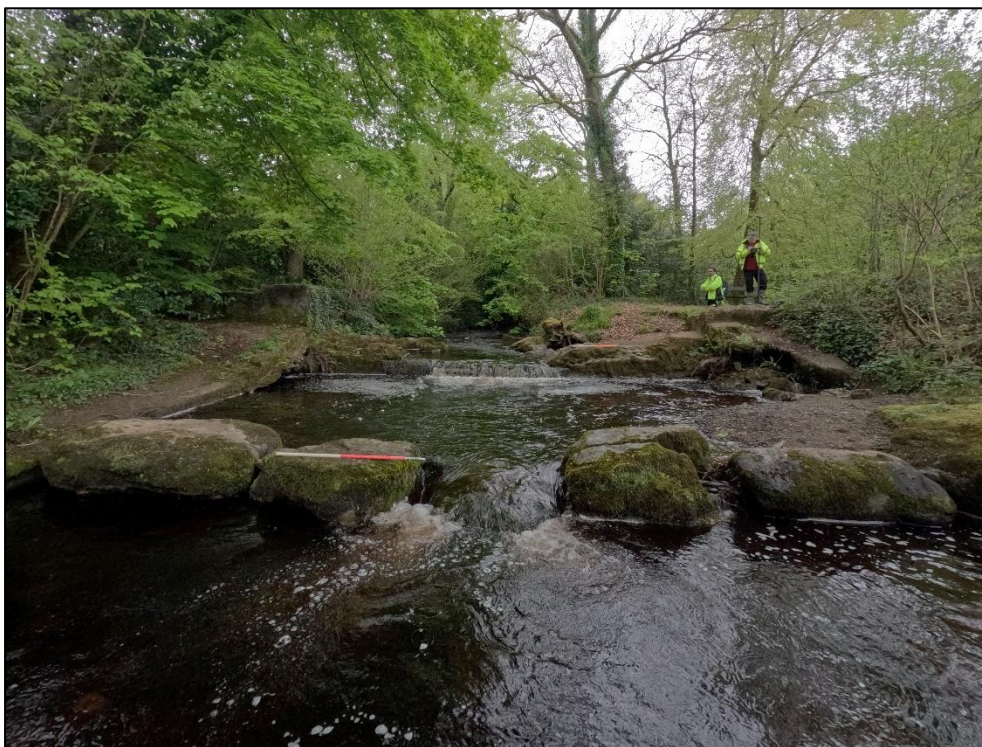
A linear arrangement of four large, flat-topped but not visibly worked boulders (1.2–1.9m long, 0.8–1.1m wide, 0.6m high) ran across the Clodiagh River c.15m downstream from the footbridge, with a 1m-wide gap between the boulders in the middle of the river (Plate 8; Figure 7). These boulders provided some protection to migrating fish during spate conditions and helped to limit erosion downstream from the bridge and weir, by defining and maintaining the weir pool.

Plate 8. Site of former footbridge, looking south, with relict culvert at back right, and boulder groynes in foreground.

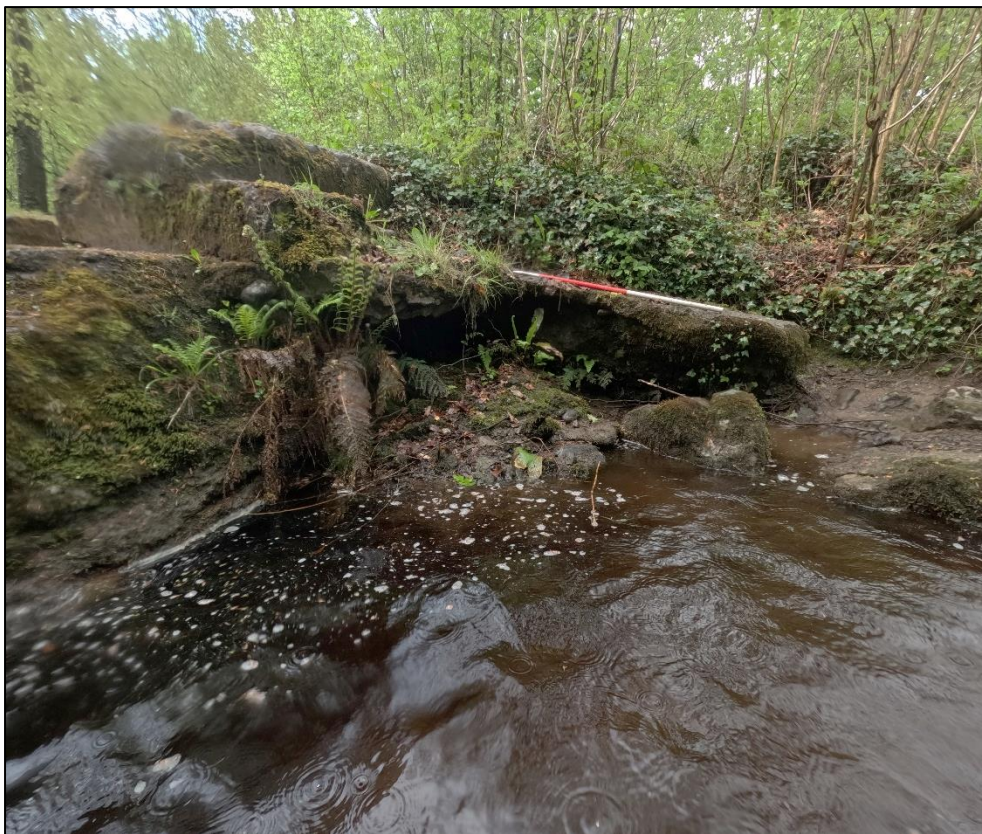
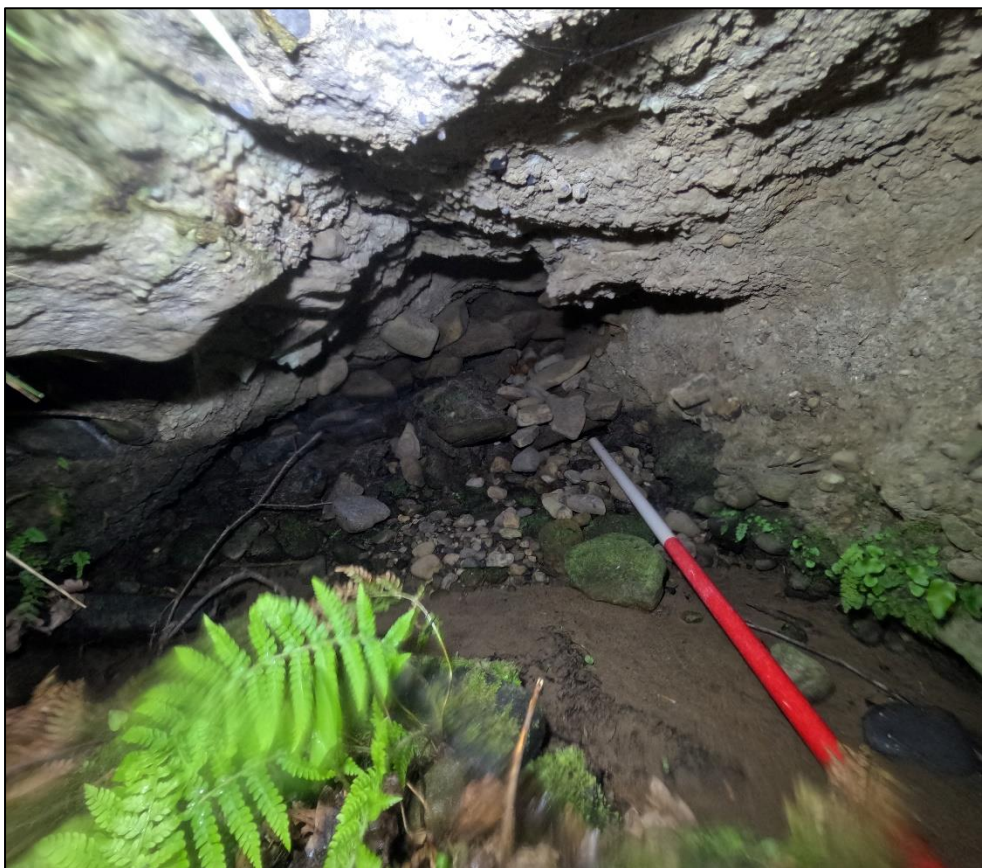
As well as the footbridge abutment, other structural features on the west bank of the river at the former footbridge include: a relict culvert (int. dims. c.1.2m wide, 0.6m high to top of basal collapse) of concrete with a rubble core (also marked and labelled on the 25-inch OS map) which is now mostly full of rubble (Plate 9 & Plate 10; Figure 7); and the lower course of a cut-block wall in which there is a 1.1m-wide gap in the wall lined by blocks with central jambs (Plate 7 & Plate 11). A loose cut-stone block (0.8 x 0.55 x 0.4m) on the western bank of the river may be associated with the wall here.

Plate 9. Relict culvert adjacent to footbridge in west bank of Clodiagh River, looking west.

Plate 10. Interior of relict culvert at site of former footbridge.
