Stage 1: Remedial Appropriate Assessment - Screening and Stage 2: Natura Impact Statement

**Substitute Consent Application
at**

**Ballymagroarty Quarries, Ballintra,
Co. Donegal, Ireland**

**On behalf of
Patrick McCaffrey & Sons Ltd**

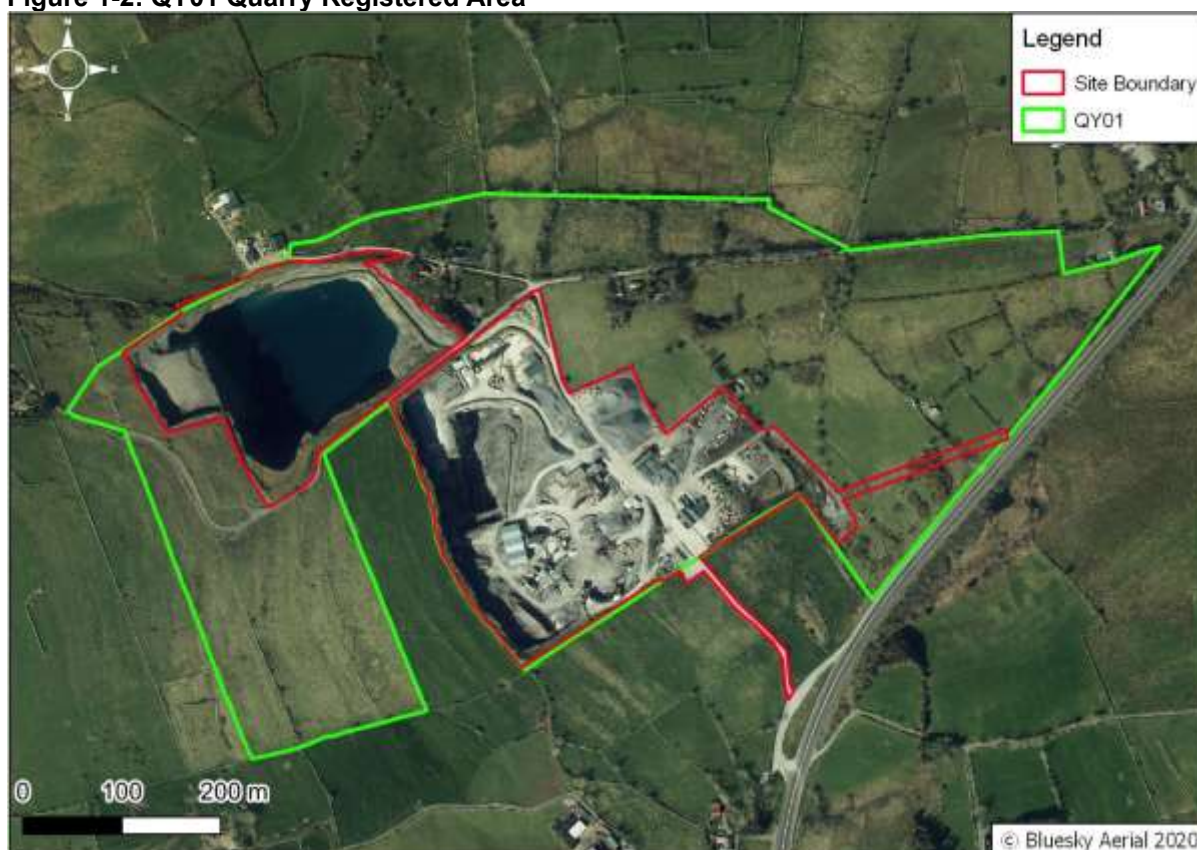
Figure 1-2: QY01 Quarry Registered Area

The Site was registered under Section 261 in 2005 and was provided with the reference number of QY01 by the competent authority ('Donegal County Council'). There are several structures on-site, including a concrete plant, macadam plant, blockmaking slab / shed, silos and offices. The extent of the Registered Area is shown in Figure 1-2 below.

This rNIS assesses the lands that have undergone development, shown in red Figure 1-2 above. This includes the north quarry, south quarry and ancillary works.

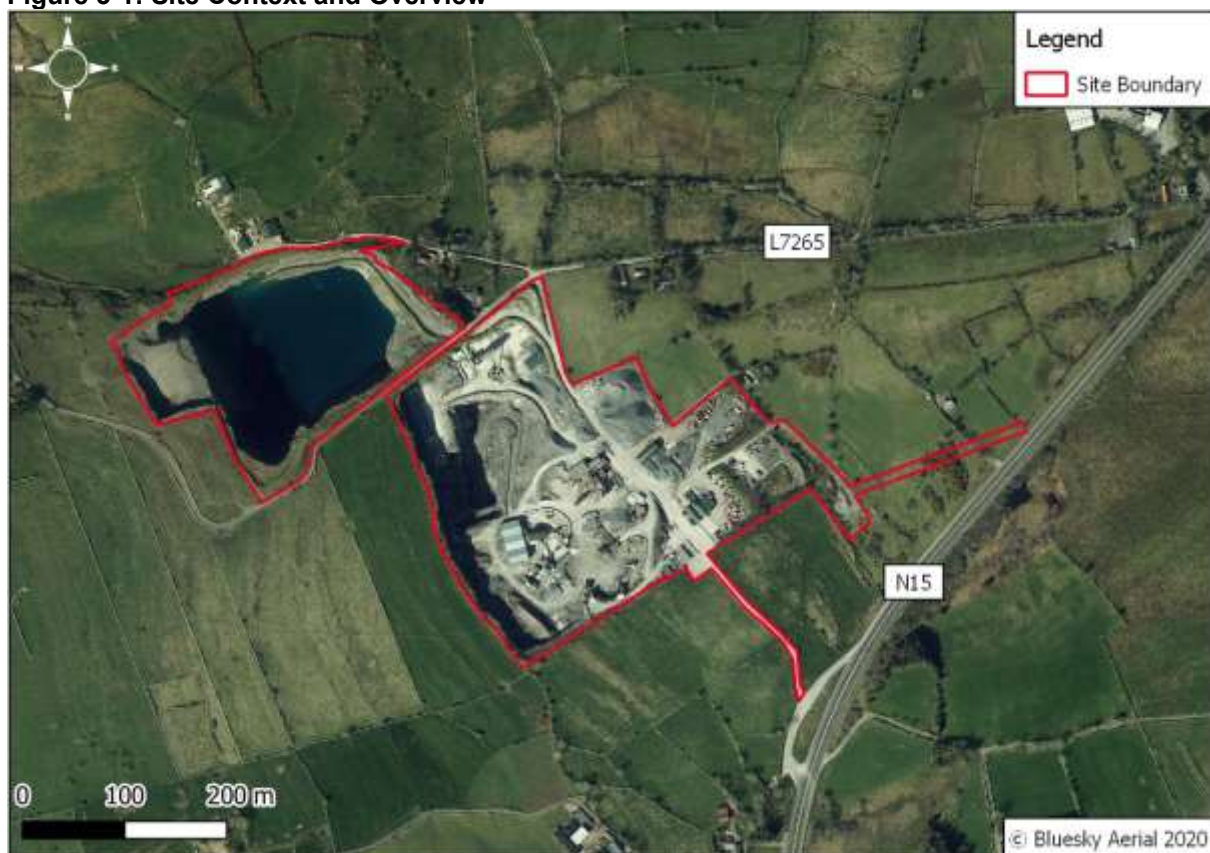
Figure 3-1: Site Context and Overview

- Site office;
- Mobile plant and vehicle parking;
- Laboratory;
- Workshop;
- Staff welfare facilities;
- Weighbridge;
- Block production area;
- Wheel wash; and,
- Associated settlement ponds.

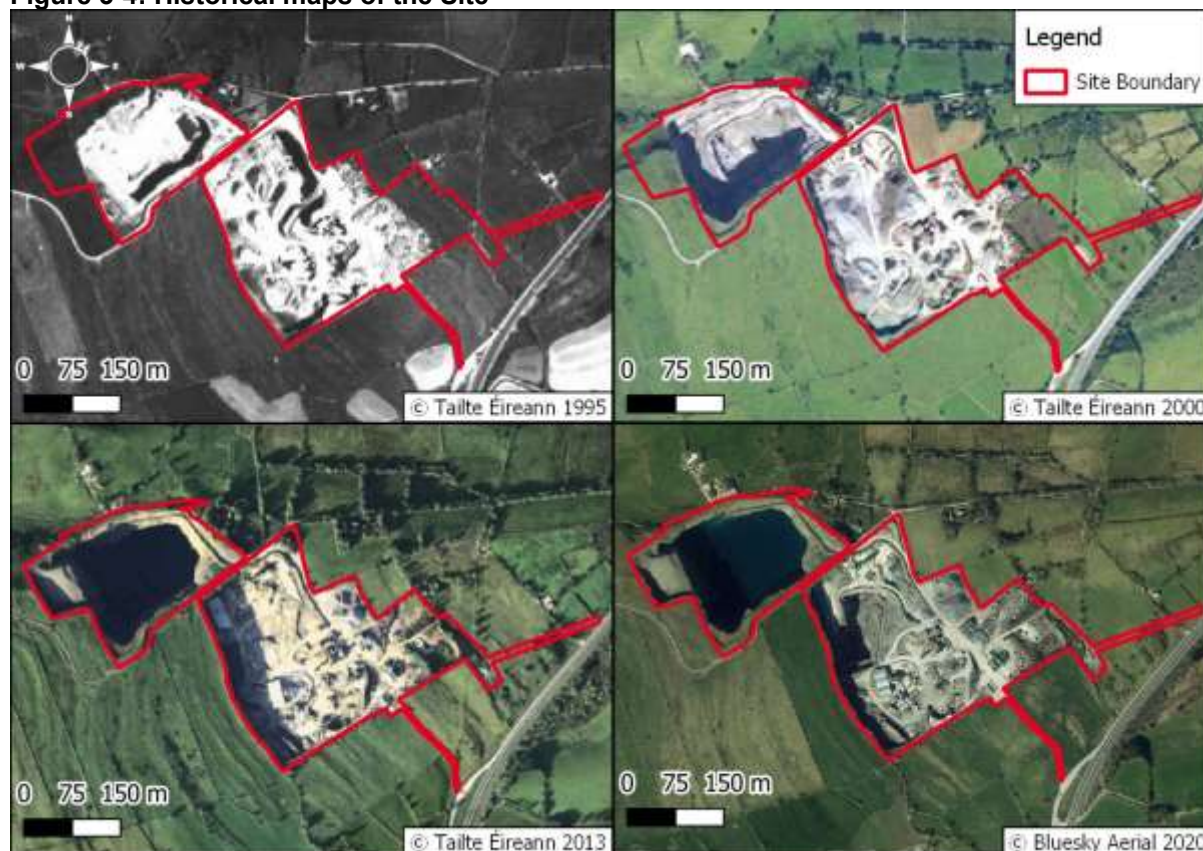
Figure 3-4: Historical maps of the Site

In previous years, the excavated and processed volumes of aggregates from the Site reached up to 250,000 tonnes per annum, with additional volumes of imported rock processed (other limestone and high PSV rock).

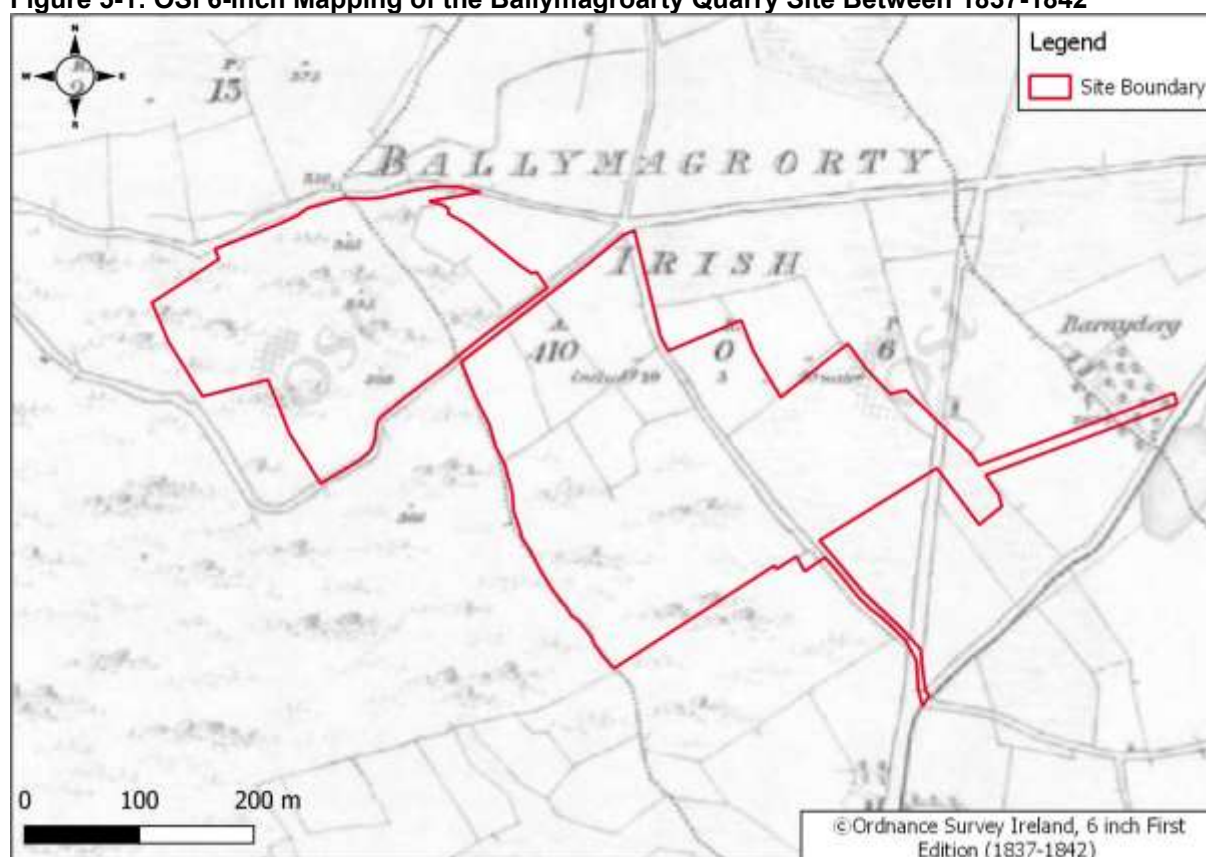
Figure 5-1: OSI 6-inch Mapping of the Ballymagroarty Quarry Site Between 1837-1842

The field east of the Site appears to have been rough pasture at this time. It is not known if this land was used for growing arable crops or was grazing pasture for livestock, Refer to Figure 5-1.

The OSI 6-inch maps available were dated from 1837–1842, and the 25-inch maps dated from 1888–1913. The descriptions of historical habitats and ecologically significant features identified from these maps, as shown in Figures 5-1 and 5-2, reflect a period before the introduction of modern classification systems, such as the Fossitt habitat codes in 2000. The descriptions below are based on historical mapping data and traditional land-use practices and are outlined further in Appendix C – OSI Characteristic Sheet for Maps on a scale of 6 inches to 1 Mile and 25.344 inches to 1 Mile. [28]

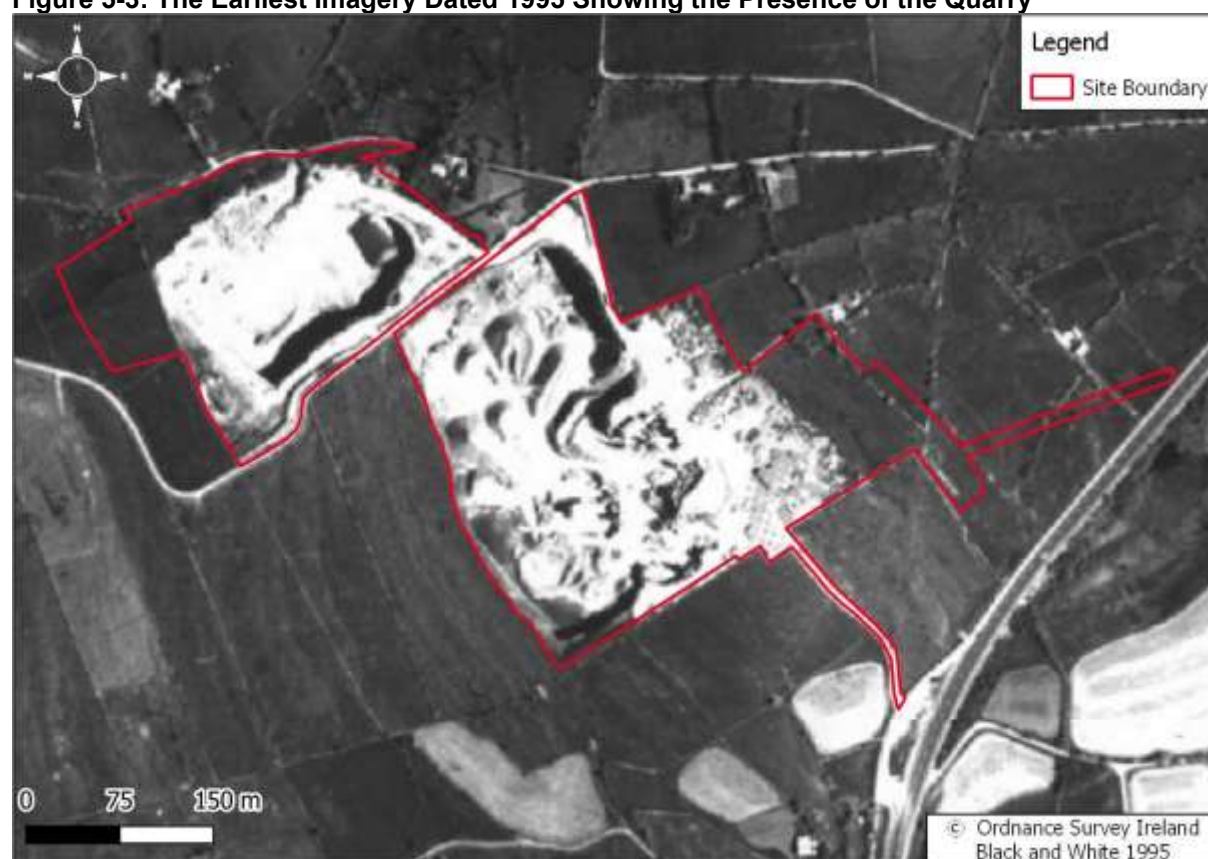
Figure 5-3: The Earliest Imagery Dated 1995 Showing the Presence of the Quarry

The hedgerows and treelines previously dividing the two improved agricultural fields in 1995 (detailed above), ca.175m of this hedgerow / treeline has been removed, and it is evident in the 1996/2001 imagery ca. 140m of the L-shaped hedgerow / treeline remain intact. It is considered that this habitat would be of high local ecological value.

Aerial imagery from 1995, 1996, 2001, 2008, 2010, 2011, and 2013 provides evidence of the quarry's change, with corresponding loss and replacement of natural habitats by quarrying activities. Through a desktop study of these images, the habitats present during each year were identified and analysed and showed a consistent reduction of vegetated areas and their replacement with quarry infrastructure, exposed rock, and stockpiles. Refer to Figures 5-3, 5-4, 5-5, 5-6, 5-7, 5-8 and 5-9 below for context.

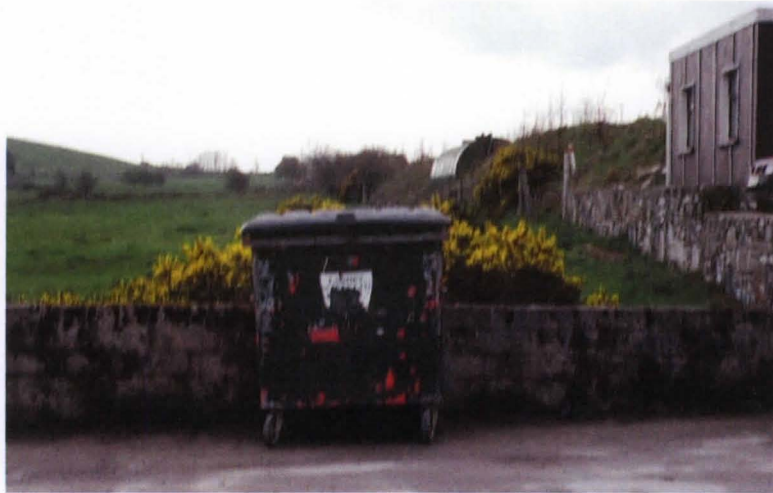
P. Mc Caffrey & Sons Ltd employs a wheelie bin service on a contract basis for general waste from the site such as canteen waste. The waste is collected on a weekly basis by Laghey Waste Ltd, Donegal who dispose of the waste appropriately.

Figure 1. One of the many Wheelie bins located throughout the quarry

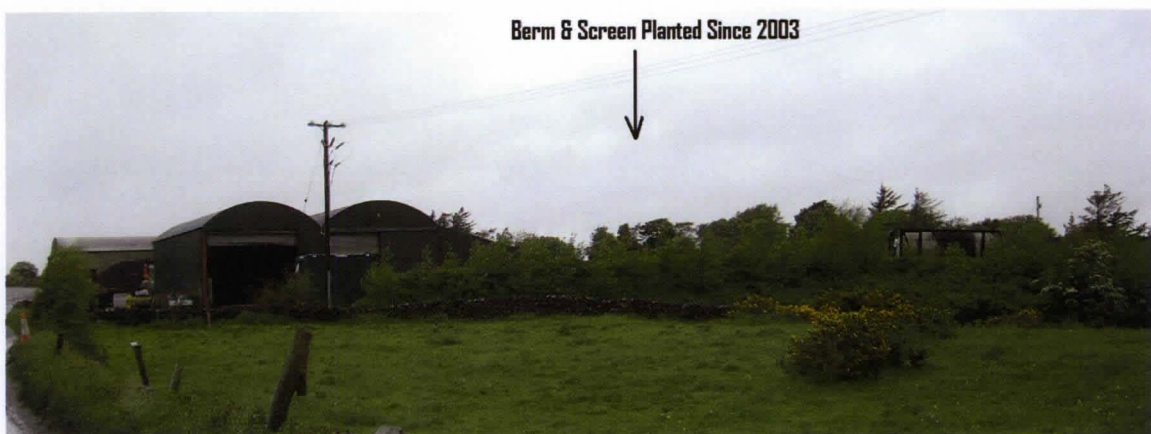
The overall appearance of the quarry has been improved by the development of physical screens such as tree and hedge planting. P. McCaffrey & Sons Ltd. propose to further alleviate this impact by the additional planting and landscaping of the boundary to the site and the establishment of landscaped screening mounds around the site. Plantation of these areas will commence in March and April during the planting season. It is also proposed that the aluminum roofs of the buildings at the quarry site will be painted green to aid in their camouflage in the area.

Figure 2: Planted Berm and Screen.

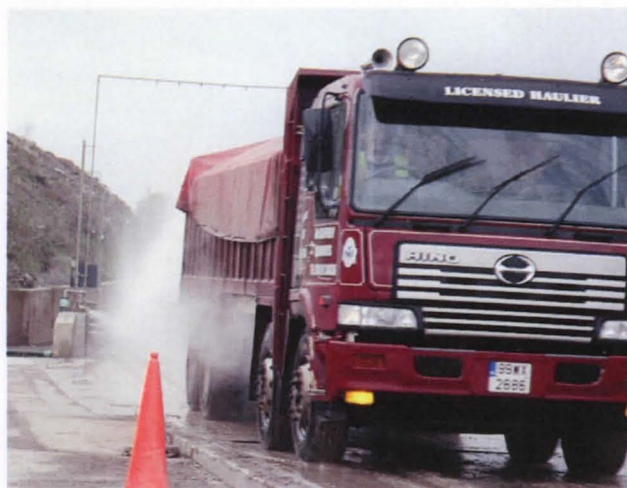
Figure 3: Wheel wash in operation at the quarry

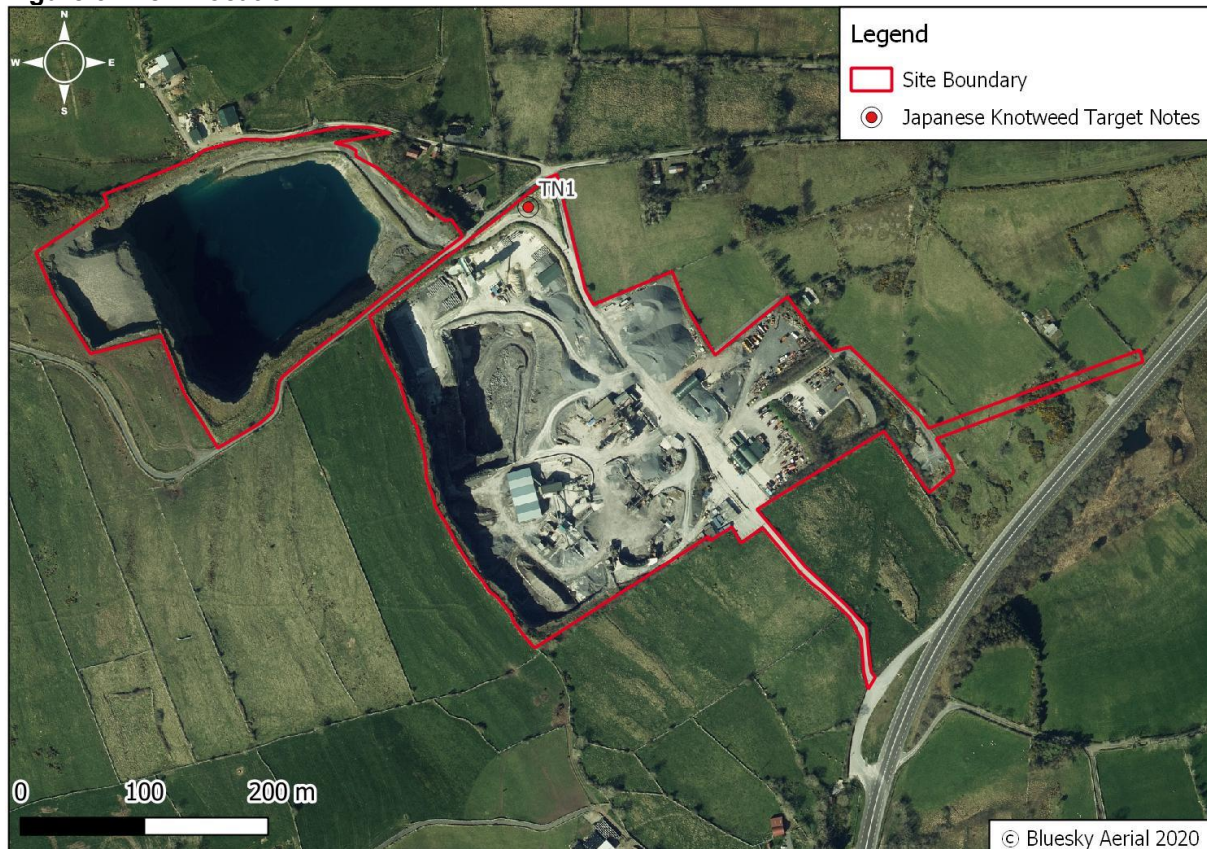
Figure 3-1: JK Location

It is understood that no formal treatment of the mature JK stand was carried out prior to the ground disturbance in this area. The presence of emerging JK growth confirms that the species remains active at this location.

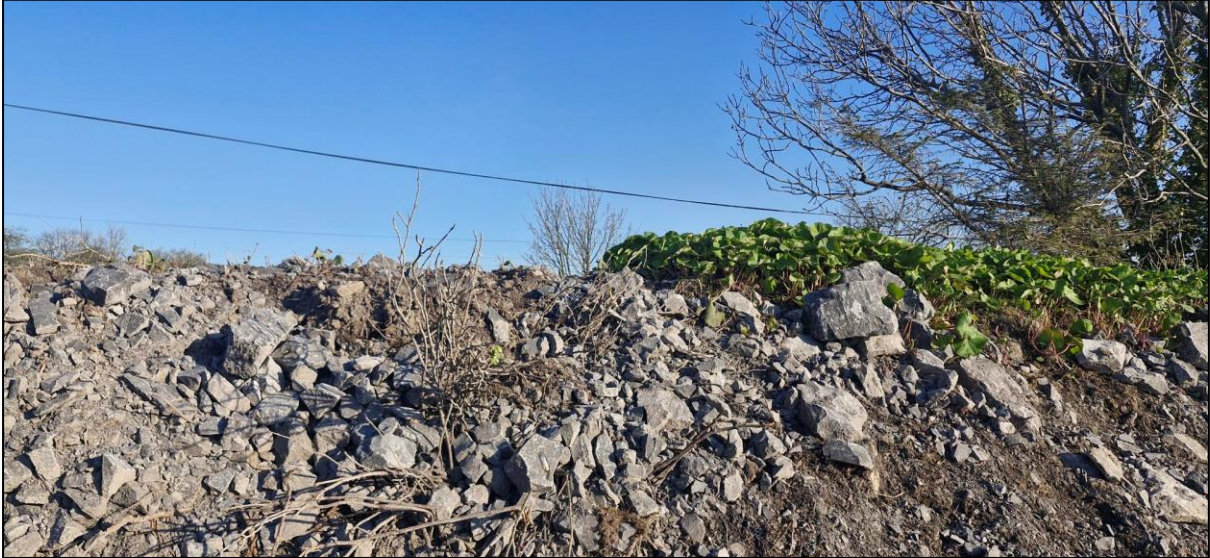
Plate 3-1: Disturbed Berm with Excess Materials (4th April 2025)

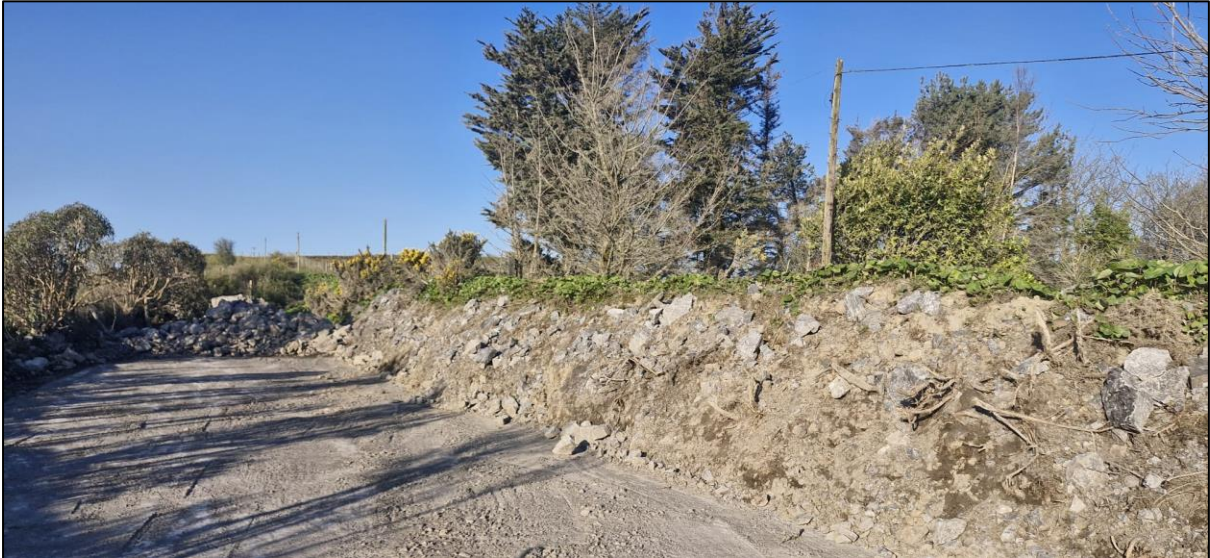
Plate 3-2: Wide View of Area which previously contained the Mature JK Stand. Additional Material on Berm Visible (4th April 2025)

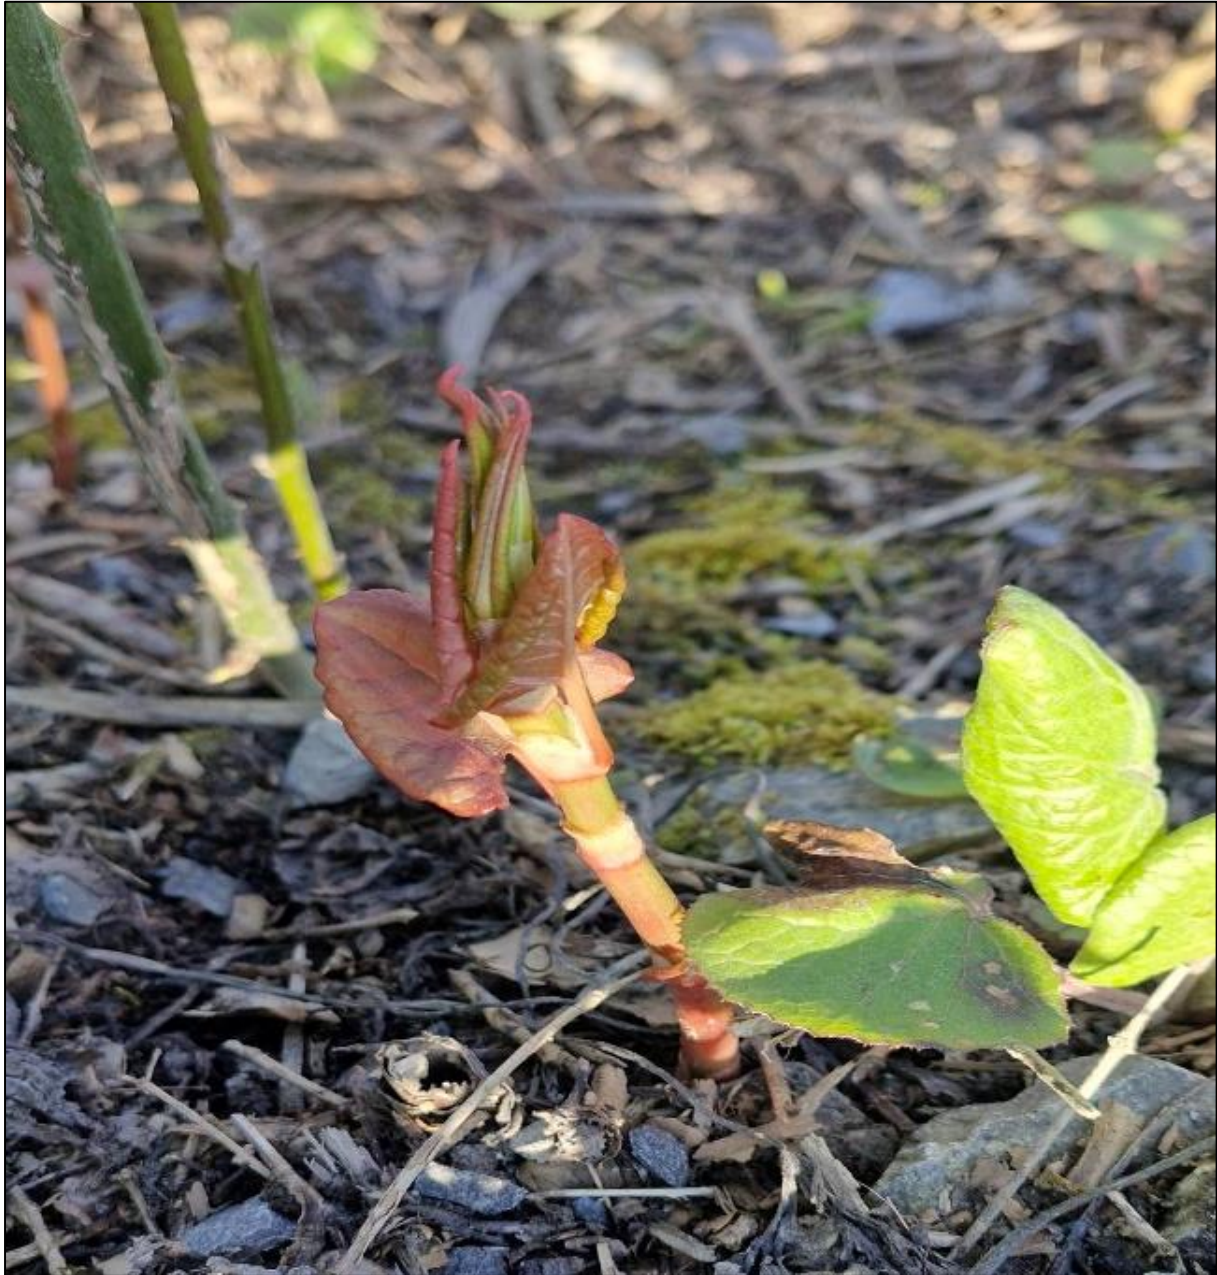
Plate 3-3: New JK Shoots Identified on 4th April 2025
