# Fisheries assessment of Moanmore wind farm, Co. Clare

Prepared by Triturus Environmental Ltd. for

AQUAFACT International Services Ltd.

**October 2023**

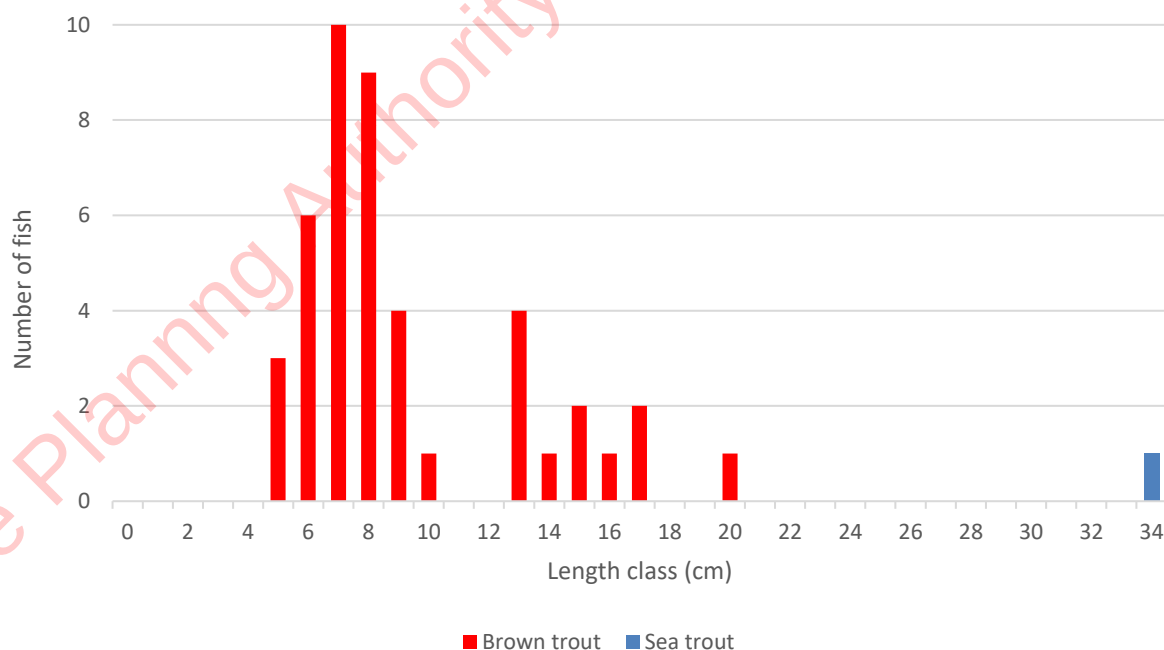
**Figure 3.1** Length frequency distribution recorded via electro-fishing at site M1 on the Moyasta River, September 2023

Brown trout ( $n=44$ ) and sea trout ( $n=1$ ) (both *Salmo trutta*) were the only fish species recorded via electro-fishing at site M1 (**Figure 3.1**). The site was of high value for salmonids, supporting a healthy mixed cohort population of brown trout in addition to a low density of migratory sea trout. Despite some moderate suitability for European eel, none were recorded. The high energy, spate channel was unsuitable for lamprey with soft sediment deposits compacted and unsuitable for ammocoete burial.

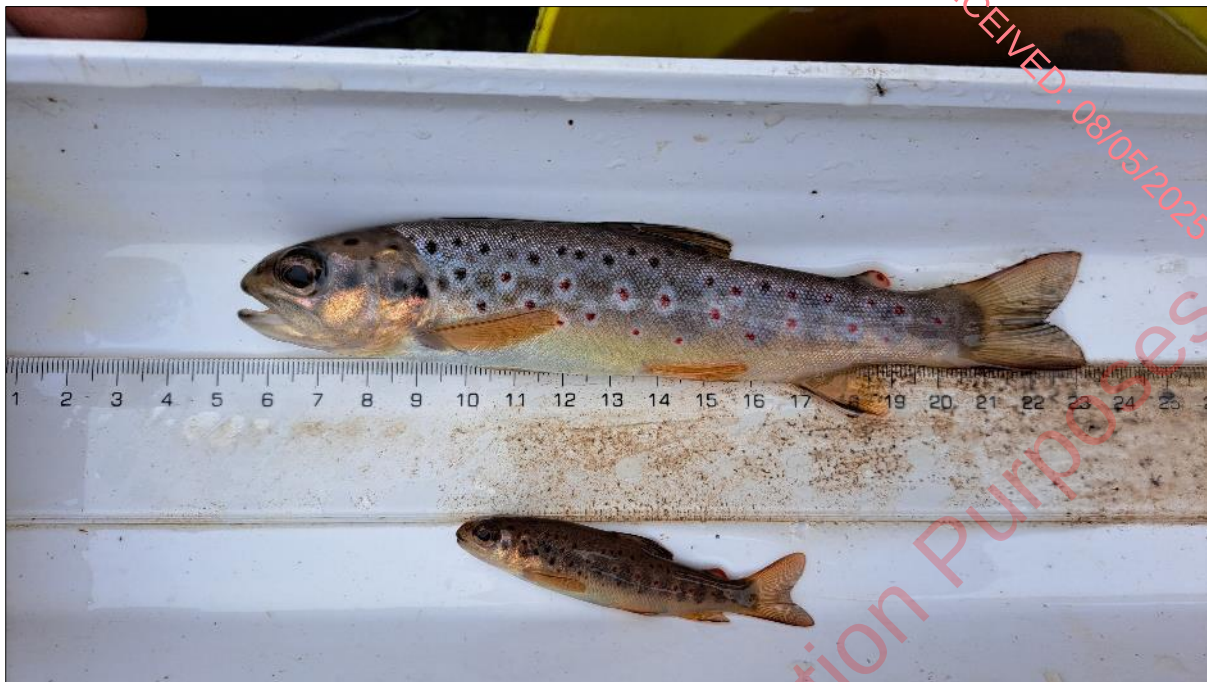
**Plate 3.1** Adult and juvenile brown trout recorded at site M1 on the Moyasta River, September 2023

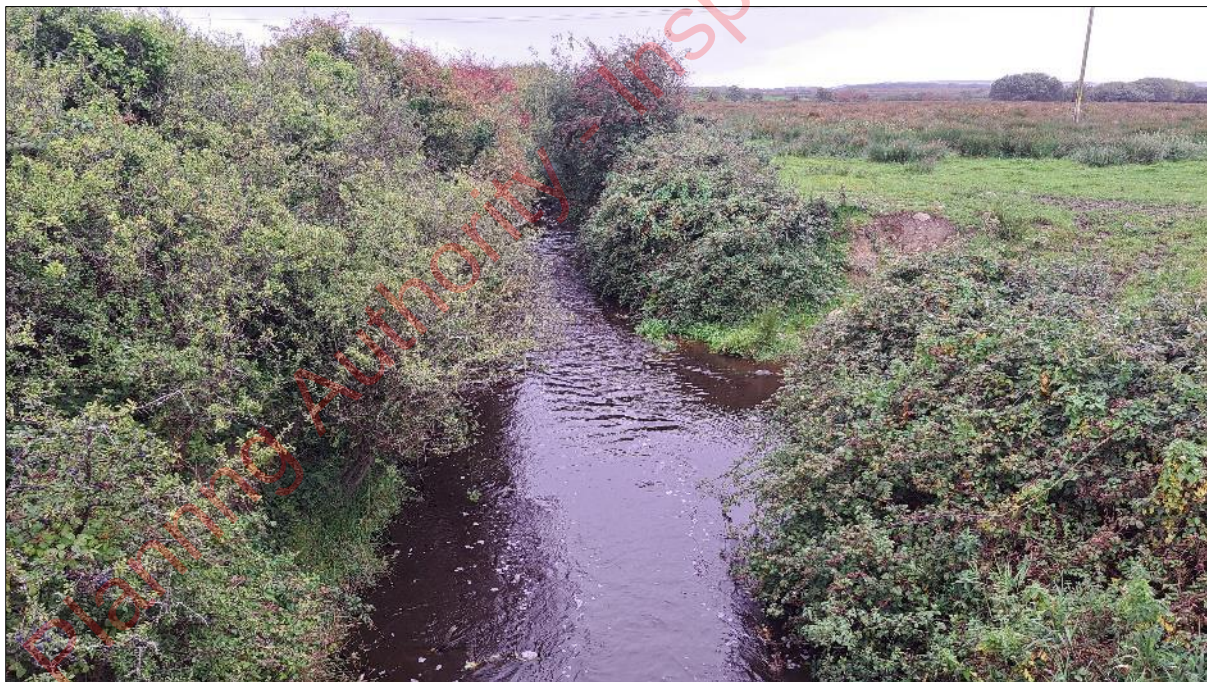
**Plate 3.2** Representative image of site M1 on the upper reaches of the Moyasta River, September 2023

Site M1 was located on the Moyasta River (27M04) at the L2034 road crossing. The upland eroding spate river (FW1; Fossitt, 2000) had been straightened and deepened historically but demonstrated some instream recovery. The river averaged 7-8m wide and 0.2-0.4m deep with localised deeper areas to 1m. The profile comprised a series of riffle, glide and pools with deeper glide predominating downstream. The substrata were dominated by compacted cobble with frequent boulder and localised areas of sand and mixed gravels. Siltation was moderate overall (higher than expected for river type). Macrophyte growth was sparse with only localised fool's watercress (*Apium nodiflorum*), watercress (*Nasturtium officinale*) and water pepper (*Persicaria hydropiper*) along the littoral areas. Cover of aquatic bryophytes was moderate with frequent *Leptodictyum riparium* on larger substrata. The riparian areas featured dense scrub supporting blackthorn (*Prunus spinosa*), hawthorn (*Crataegus monogyna*), grey willow (*Salix cinerea*) and ash (*Fraxinus excelsior*) with localised tunnelling (which provided valuable thermal refugia for fish populations). The site was bordered by semi-improved pasture (GA1) and wet grassland (GS4).

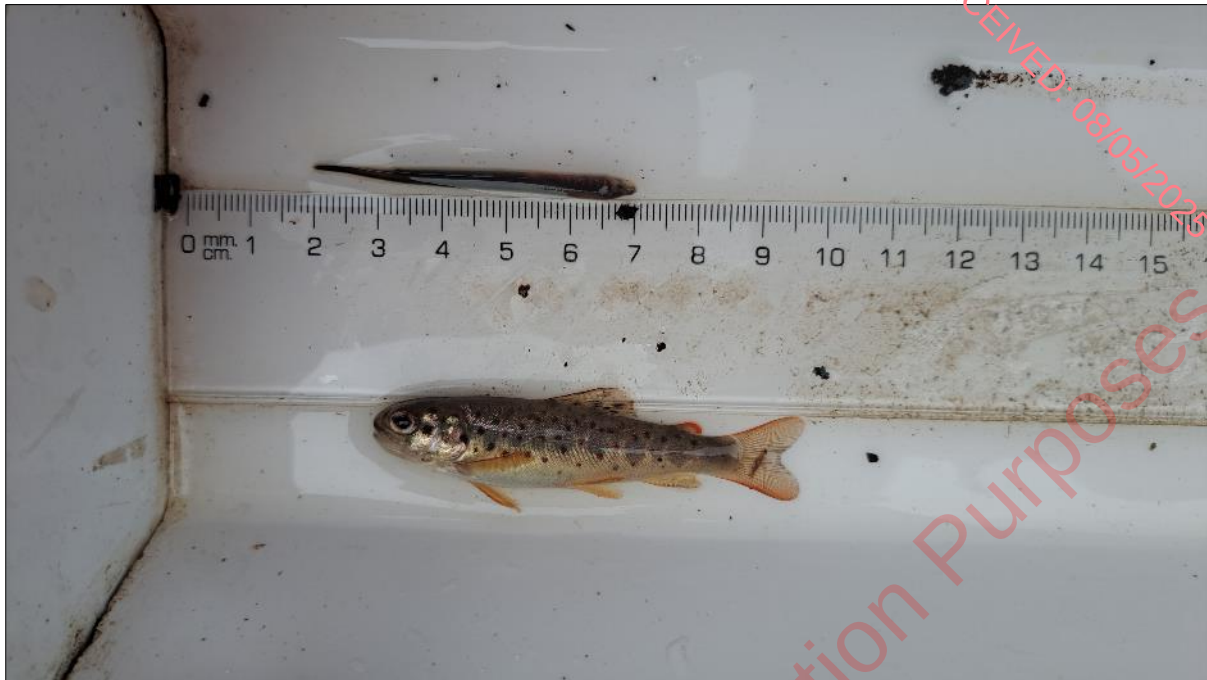
**Plate 3.3** *Lampetra* sp. ammocoete and juvenile brown trout recorded at site M2 on the Moyasta River, September 2023

Brown trout ( $n=33$ ), lamprey (*Lampetra* sp.; Gardiner, 2003) ( $n=2$ ) and three-spined stickleback (*Gasterosteus aculeatus*) ( $n=1$ ) were recorded via electro-fishing at site M2 (**Figure 3.2**). As per site M1 upstream, the site was of high value for salmonids, supporting a healthy mixed cohort population of brown trout and was a good quality nursery despite modifications and siltation pressures. Good quality spawning habitat for both salmonids and lamprey was present (cobble & mixed gravels) but such areas were localised. Deeper glide, pools and scours provided some good holding opportunities for adult salmonids. These areas also provided moderate suitability for European eel, although none were recorded. *Lampetra* sp. ammocoetes were present in marginal soft sediment accumulations although densities were low given (1 per m<sup>2</sup>).

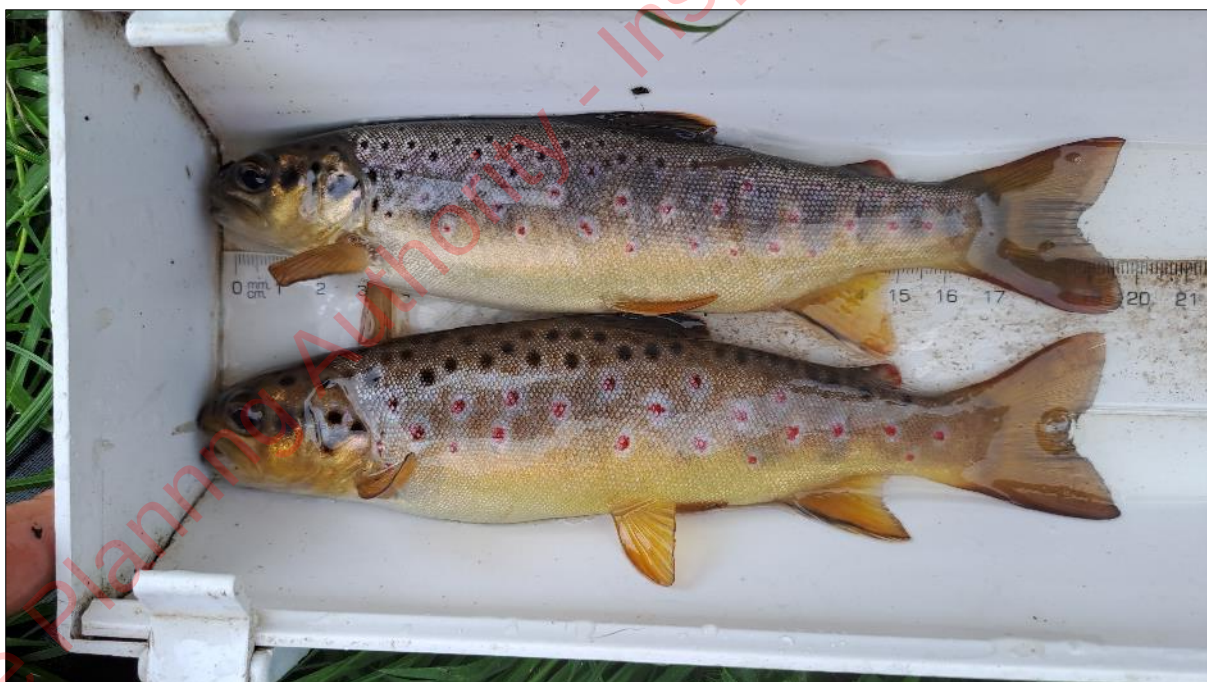
**Plate 3.4** Adult brown trout recorded at site M2 on the Moyasta River, September 2023

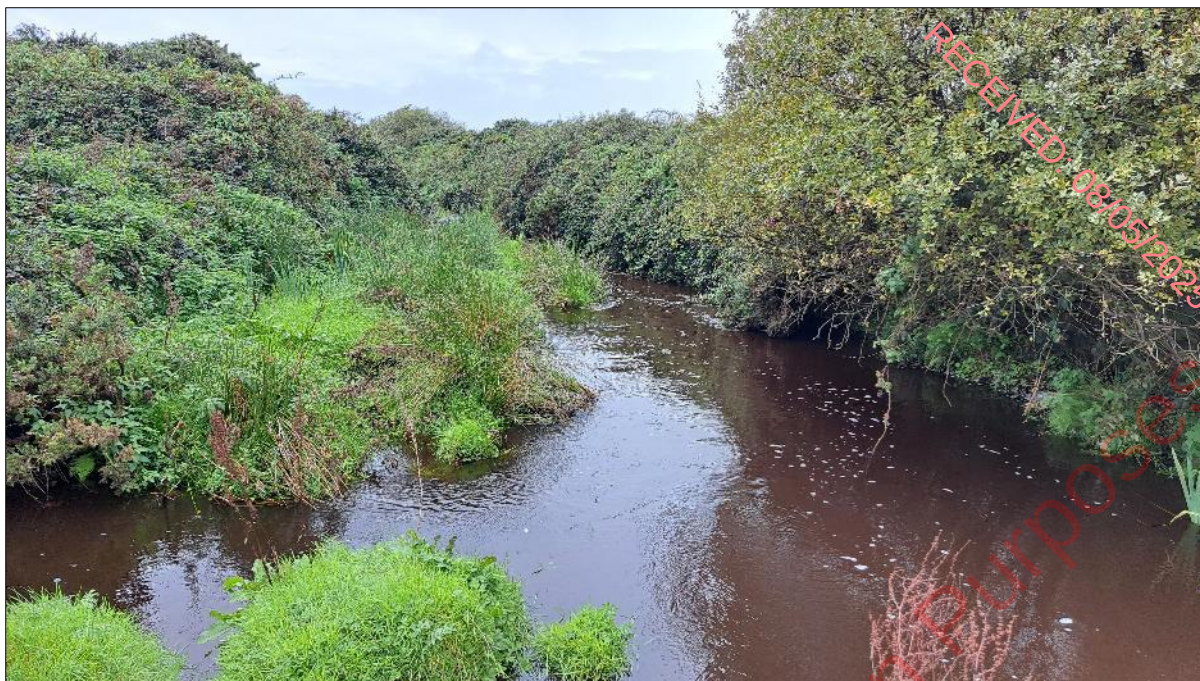
**Plate 3.5** Representative image of site M2 on the Moyasta River, September 2023 (at small stream confluence)

Site M2 was located on the Moyasta River at an unmapped stream confluence approximately 400m downstream of site M1. The upland eroding spate river (FW1) had been straightened and deepened historically but demonstrated some instream recovery. The river averaged 6-7m wide and 0.2-0.5m deep with localised deeper areas to 1.2m. The profile comprised swift glide and riffle with localised pool. The substrata were dominated by compacted cobble with scattered boulder and locally frequent patches of sand and mixed gravels. Soft sediment accumulations were present along the channel margins but were typically compacted. Siltation was moderate overall (higher than expected for river type). Macrophyte growth was sparse with only localised fool's watercress and watercress with localised instream stands of iris (*Iris psuedacorus*). Cover of aquatic bryophytes was low with only occasional *Leptodictyum riparium*. The riparian areas supported dense scrub dominated by grey willow, bramble (*Rubus fruticosus* agg.), gorse (*Ulex europaeus*) and hedge bindweed (*Calystegia sepium*). The site was bordered by wet grassland (GS4) and semi-improved pasture (GA1) with some livestock poaching pressures.

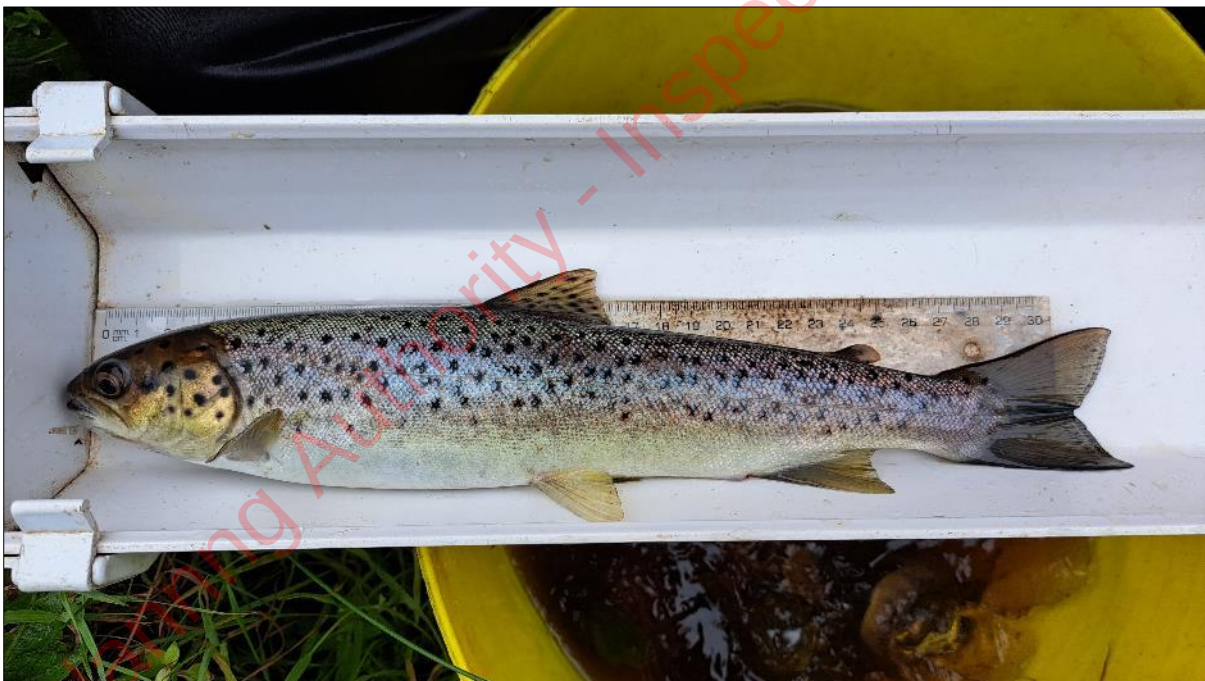
**Plate 3.6** Sea trout recorded at site M3 on the Moyasta River, September 2023

Brown trout ( $n=12$ ) and sea trout ( $n=1$ ) were the only fish species recorded via electro-fishing at site M3 (**Figure 3.3**). The site was of highest value as a holding habitat for both resident and migratory salmonids given the predominance of deep glide and pool, with widespread flow refugia by way of undercut/scoured banks. The site was of relatively poor value as a nursery and salmonid spawning habitat. Despite some good suitability for European eel, none were recorded. The soft sediment accumulations present were compacted and thus unsuitable for lamprey although some very limited spawning substrata were present.

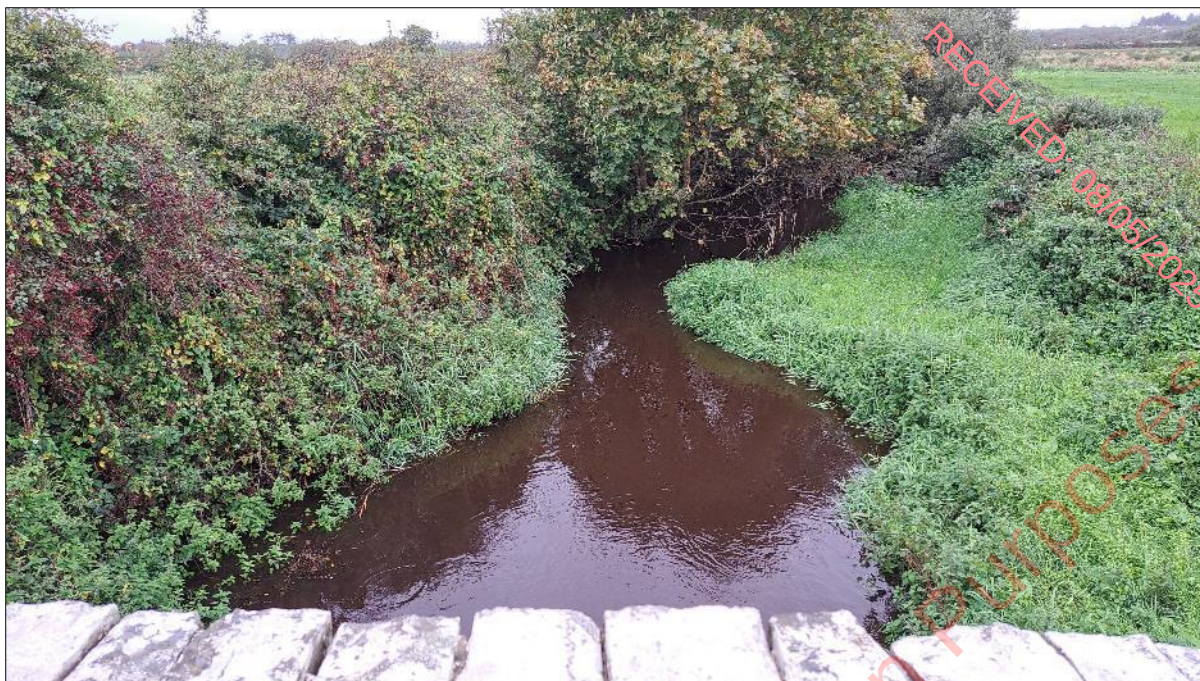
**Plate 3.7** Representative image of site M3 on the Moyasta River, September 2023

Site M3 was located on the Moyasta River at the L2036 road crossing. The upland spate channel (FW1) had been straightened and deepened locally but demonstrated some good instream recovery. The river averaged 5-7m wide and >0.5m deep, with localised deeper areas to 1.3m. The profile comprised deep glide and pool (no riffle). The substrata were dominated by compacted cobble and mixed gravels with localised accumulations of sand. The steep marginal slopes featured compacted silt. Boulder was rare. The banks were typically undercut/scoured (characteristic of a spate channel). Given the high average depth, macrophytes were limited to occasional fool's watercress and water mint (*Mentha aquatica*). The aquatic bryophyte *Leptodictyum riparium* was occasional on instream structure. The banks supported abundant reed canary grass (*Phalaris arundinacea*) with abundant bramble, hawthorn, gorse and nettle (*Urtica dioica*). Mature sycamore (*Acer psuedoplatanus*) and grey willow heavily shaded the river downstream of the bridge. The site was bordered by semi-improved pasture (GA1) and wet grassland (GS4) with coniferous afforestation (WD4) bordering the river upstream of the bridge.

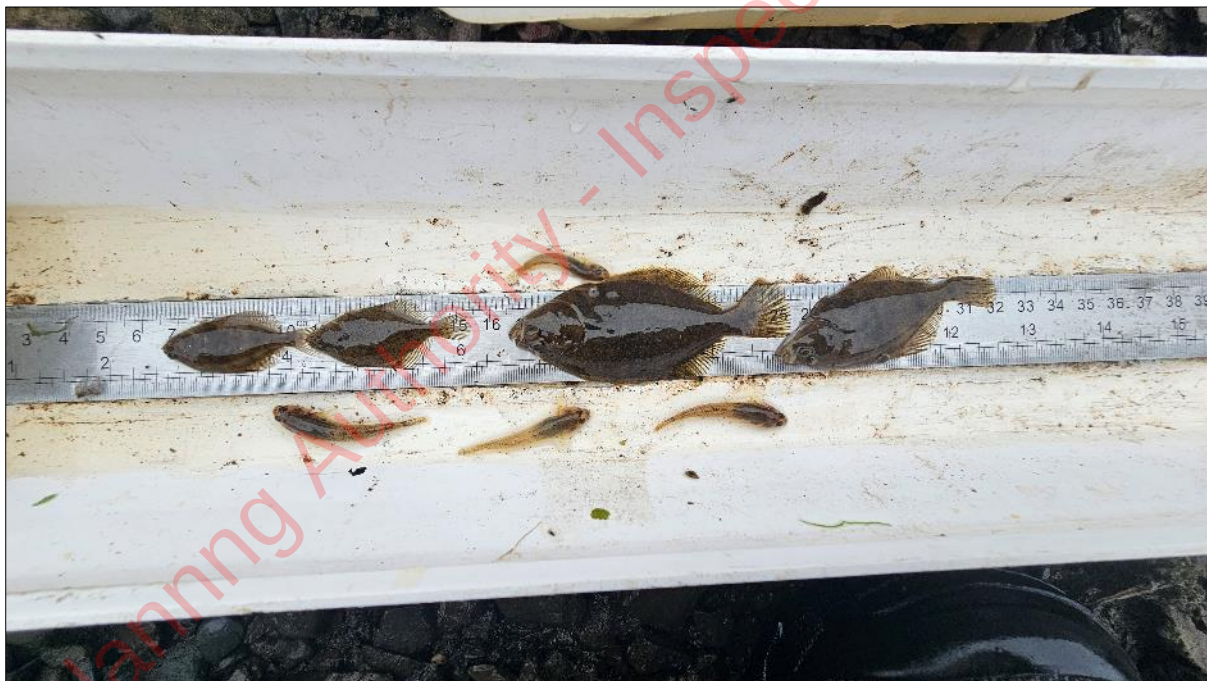
**Plate 3.8** Sand goby and juvenile flounder recorded at site M4 on the tidal Moyasta River, September 2023

European eel (*Anguilla anguilla*) ( $n=4$ ), flounder (*Platichthys flesus*) ( $n=15$ ), sand goby (*Pomatoschistus minutus*) ( $n=16$ ) and three-spined stickleback ( $n=2$ ) were recorded via electro-fishing at site M4 (**Figure 3.4**). The tidal site was of high value as a European eel nursery, as well as other transitional species including flounder. Deeper pool (e.g. under road bridge) provided good quality holding areas for adult European eel and migratory salmonids. The site was not of value as a salmonid or lamprey spawning habitat and the silt accumulations present were unsuitable for lamprey ammocoetes.

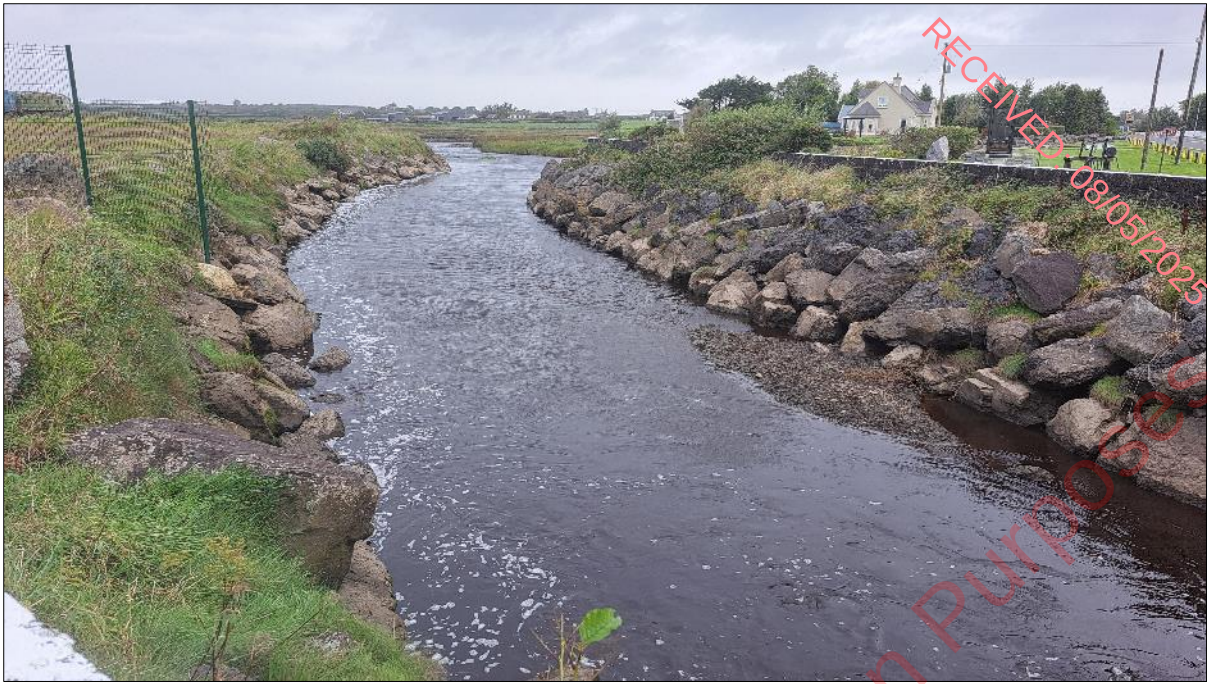
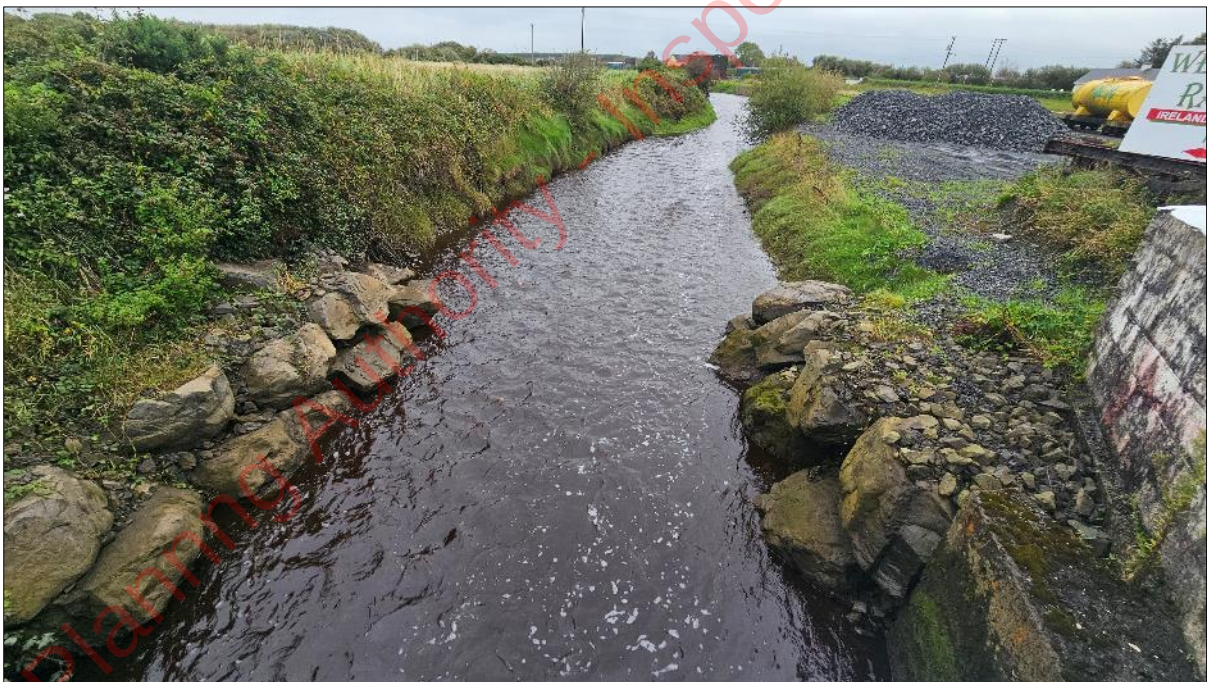
**Plate 3.9** Representative image of site M4 on the Moyasta River, September 2023 (downstream of road crossing)

**Plate 3.10** Representative image of site M4 on the Moyasta River, September 2023 (upstream of road crossing)

Site M4 was located on the lowermost reaches of the Moyasta River at the N67 road crossing. The tidal river (CW2) had been modified in vicinity of the bridge with boulder revetment along both banks. The channel averaged 6-8m wide and varied from 0.1m to 0.6m deep at low tide. The profile was dominated by tidal glide and riffles with localised pool. The substrata comprised a mix of bedded cobble, gravels and estuarine muds. Given the transitional, modified environment, freshwater macrophytes or aquatic bryophytes were not recorded. The modified banks supported low-lying scrub vegetation and rank grasses.

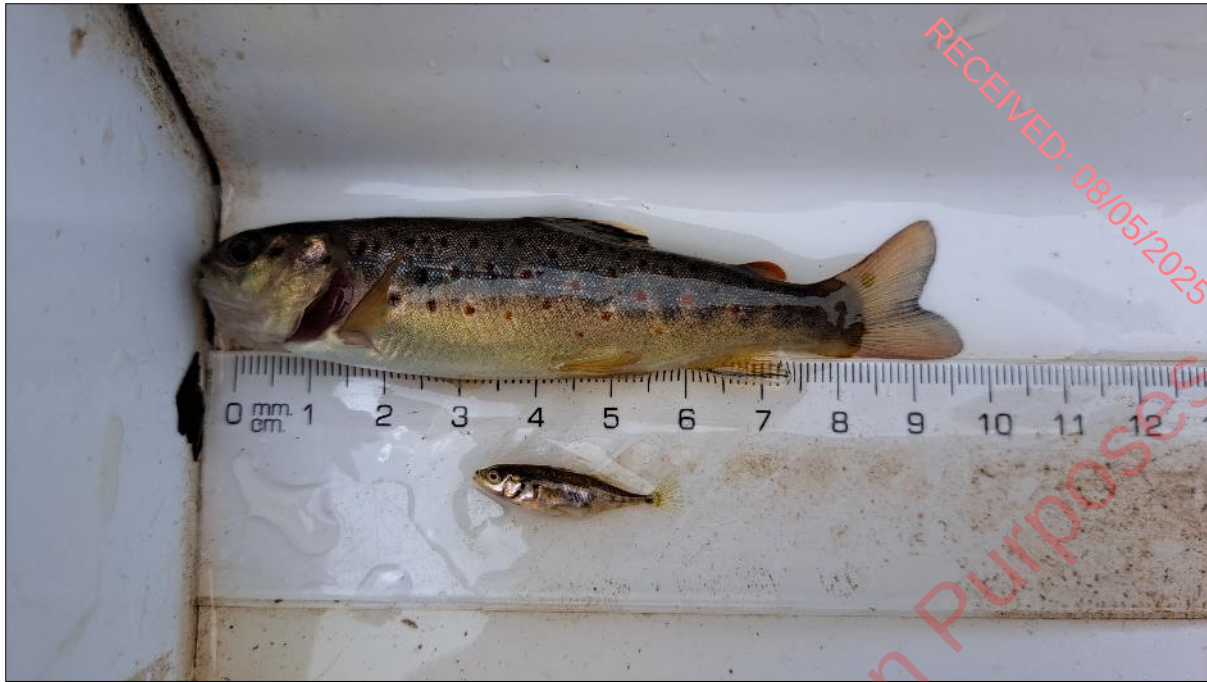
**Plate 3.11** Brown trout and three-spined stickleback recorded at site M5 on the Moanmore South River, September 2023

Brown trout ( $n=2$ ) and three-spined stickleback ( $n=7$ ) were the only fish species recorded via electro-fishing at site M5 (Figure 3.5). The site was of poor fisheries value given extensive historical modifications and the generally shallow, heavily silted nature of the river at this location. Whilst a low density of brown trout was recorded, salmonid spawning and nursery habitat was of poor quality. The narrow channel was not of value as a holding habitat for adult salmonids. Despite some low suitability for European eel, none were recorded. The upland site was unsuitable for lamprey.

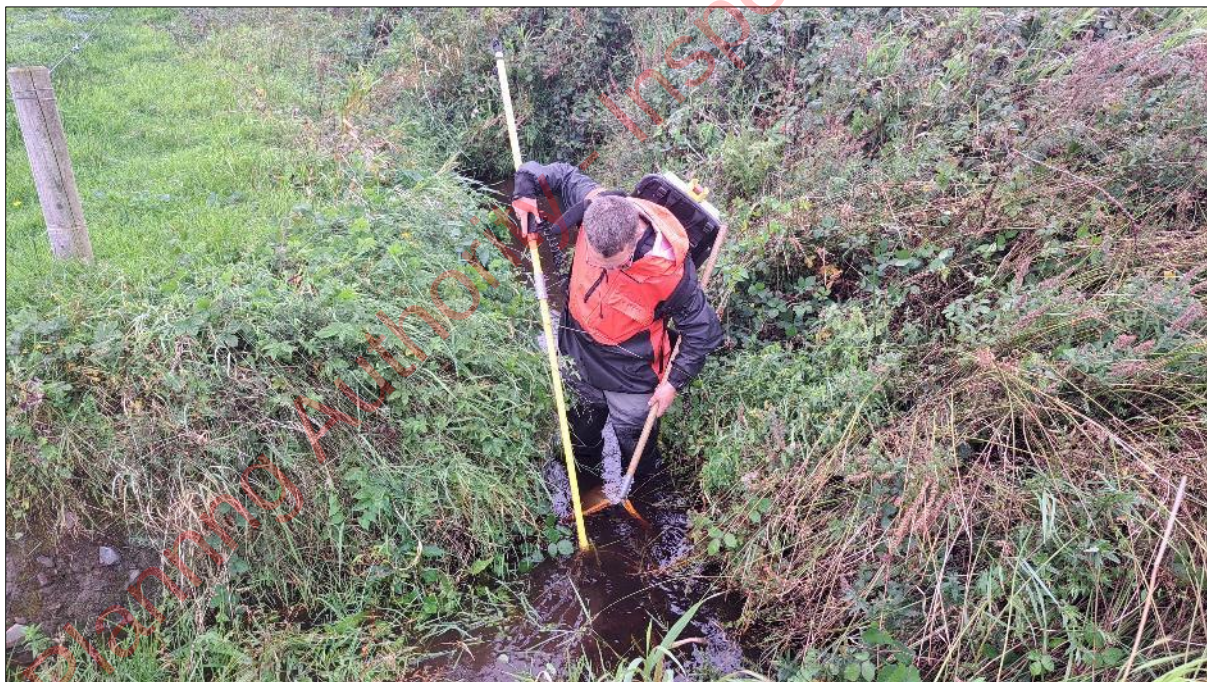
**Plate 3.12** Representative image of site M5 on the Moanmore South River, September 2023

Site M5 was located on the upper reaches of the Moanmore South River (27M14), a tributary of the Moyasta River, adjacent to turbine T3 (Moanmore wind farm). The small upland river (FW1) had been historically straightened and deepened resulting in a narrow, steep-sided channel with poor hydromorphology. The river averaged <1m wide and 0.2-0.3m deep. The profile comprised shallow glide and riffle with occasional pool. The substrata were dominated by compacted gravels and cobble with abundant silt deposits. Several recently excavated/cleared field drains adjoined the river and were contributing to the silt load. The narrow channel supported only sparse macrophyte growth with occasional common duckweed (*Lemna minor*) and rare fool's watercress. Aquatic bryophytes were not recorded. The historically cleared banks supported low-lying scrub vegetation with scattered bramble, iris and hawthorn. The site was bordered by wet semi-improved pasture (GA1) which had been drained.
