# Appendix 12-1

**Road Safety Report**

## Rinn Rua Hotel & Leisure Park, Co. Kerry

# Stage 1 & 2 Road Safety Audit

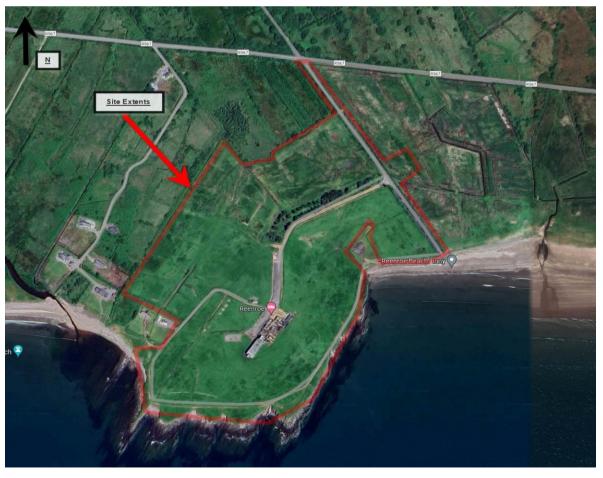
Figure 1.2 - Site Extents

See Figure 1.1 Site Location Map. Figure 1.2 shows the site extents on aerial photography and Figure 1.3 shows the site layout for the proposed junction alterations.

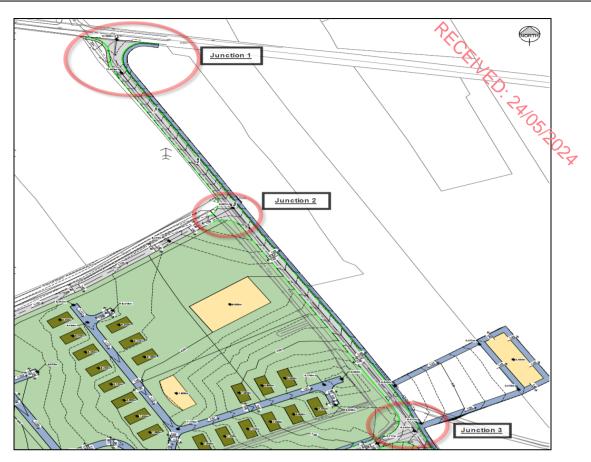
Figure 1.3 -Proposed Development Layout

The site is currently served by a singular access point from the local road. This local road also serves the public beach and a single dwelling house. It is proposed the new development will be served by 2 vehicular access roads and a dedicated pedestrian access to the south along the edge of the cliff. The proposed development also included the realignment of the junction of the local road and the R567. This audit considers the development access points onto the Local road, the upgraded local road and the realigned junction.

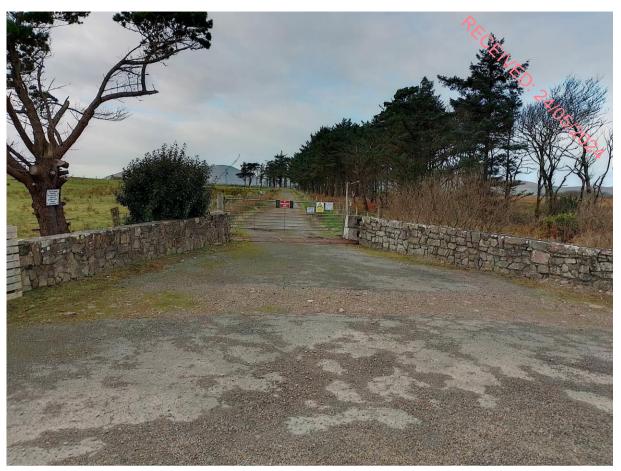
Photo A1: Existing Entrance to the site (Junction 3)

No specific pedestrian facilities have been shown linking between the development footpath at Junction 2 and the proposed footpath on the local access road. Failure to provide dedicated pedestrian access at this location could lead to pedestrians walking onto trafficked lanes to access the public road and potentially coming into conflict with vehicles leading to potential collisions. Refer to Fig 2.1 & Photo A1.

The designer should consider including a footpath at this location linking the development to footpaths in the area. The design team should ensure that an adequate pedestrian crossing is also provided at the location.

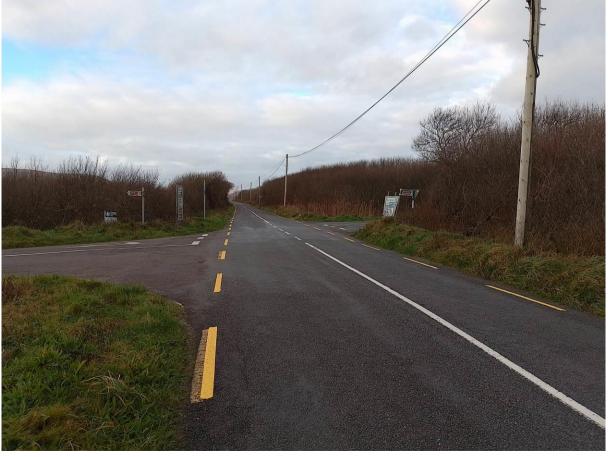
Photo A2: Sightlines to the west at realigned junction location (Junction 1)

The audit team acknowledges that the realigned Junction of the local road and R567 is an improvement to the current arrangement. However, no details have been provided to the audit team as to the proposed sightlines to be provided at Junction 1. Inadequate sight lines at an entrance may lead to collisions between vehicles passing by on R567 and vehicles exiting the local road. Refer to Fig 2.2 & Photos A2 & A3.

A junction arrangement with an adequate visibility envelope is required, in accordance with the relevant standards for the road design speed. The visibility envelope should be kept clear of all obstructions such as wall, hedges, fences, signs etc and vegetation over 600mm in height.

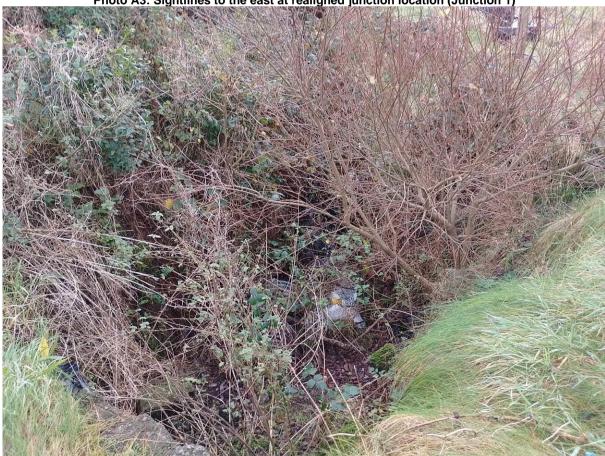
Photo A4: Existing water course crossing under the local road

The audit team observed that it is proposed to install a roadside kerb and footpath on the eastern side of the local road. This kerb is replacing the exiting verge at the edge of the road. No road surface water drainage proposals are shown on the drawings provided to the audit team. Lack of road surface drainage could lead to surface water ponding and could lead to collisions between vehicles or vehicles and pedestrians due to aquaplaning on water ponds following periods of heavy rainfall. Refer to Photos A4, A5 & A6

Provide road surface water drainage at both the realigned junction and the widened local road. The design team should also consider the existing land drainage and open ditches in any proposed designs.
