CAMROSS S & G PIT DEVELOPMENT  
ENVIRONMENTAL IMPACT  
ASSESSMENT REPORT  
BAT ACTIVITY SURVEY RESULTS

CAMROSS S & G PIT DEVELOPMENT  
ENVIRONMENTAL IMPACT  
ASSESSMENT REPORT

# Aquatic & fisheries baseline report for the continued operation and development of a quarry at Mounthall, Co. Laois

# EIAR Extract

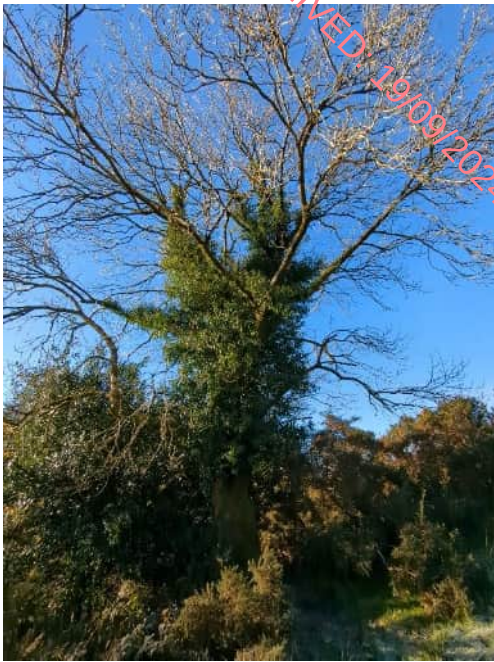
| Ref. | Description | Evaluation | Overall assessment | Photograph |
|---|---|---|---|---|
| Tree 1 | Tree 1 comprised a semi-mature ash located within the woodland/scrub mosaic to the south of the Site at approximate ITM co-ordinates 626722, 698044. | There were no PRFs identified on this tree. However, the main stem was covered in partially detached ivy with stem diameters in excess of 50 mm. It may be possible that PRFs exist within the obscured areas of the tree. It is anticipated that any potential PRFs within the stem would be suitable for crevice-dwelling and void-dwelling bats. | <b>Low bat roosting potential</b> | |

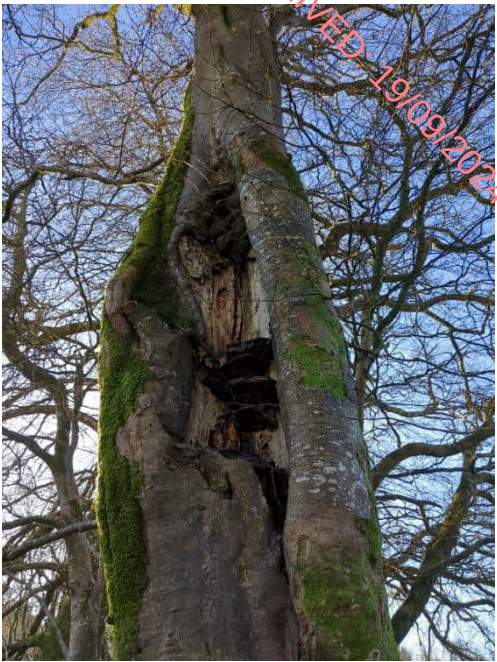
| Ref. | Description | Evaluation | Overall assessment | Photograph |
|---|---|---|---|---|
| Tree 3 | Tree 3 (TN3) comprised a mature beech located along a treeline at approximate ITM co-ordinates 626813, 698045. | There is a large trunk cavity with located approximately 3 m up the main stem. This has vertical linear crevices leading to potential roosting for numerous crevice-dwelling bats. There are also gaps leading behind deadwood into a potential trunk cavity. | <b>Moderate bat roosting potential</b> | |

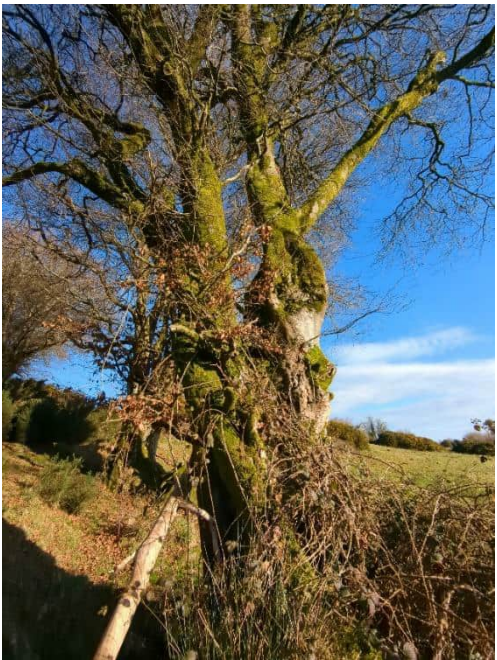
| Ref. | Description | Evaluation | Overall assessment | Photograph |
|---|---|---|---|---|
| Tree 4 | Tree 4 comprised a mature beech located along a treeline within the southern field at approximate ITM co-ordinates 626849, 698135. | There are minor crevices for single bats located throughout the main stem up to approximately 8 m in height. These are shallow and do not go deep enough to support numerous bats. | <b>Low bat roosting potential</b> | |

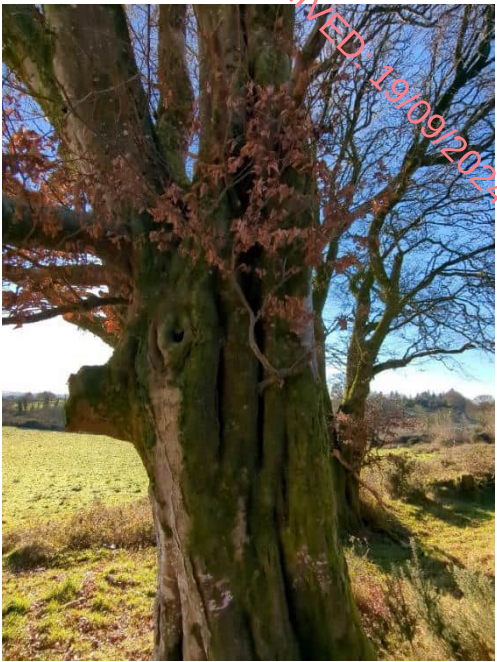
| Ref. | Description | Evaluation | Overall assessment | Photograph |
|---|---|---|---|---|
| Tree 5 | Tree 5 comprised a mature beech located within treeline at approximate ITM co-ordinates 626859, 698145. | There were many shallow crevices located along the main stem which were not deep enough to support numerous bats. | <b>Low bat roosting potential</b> | |

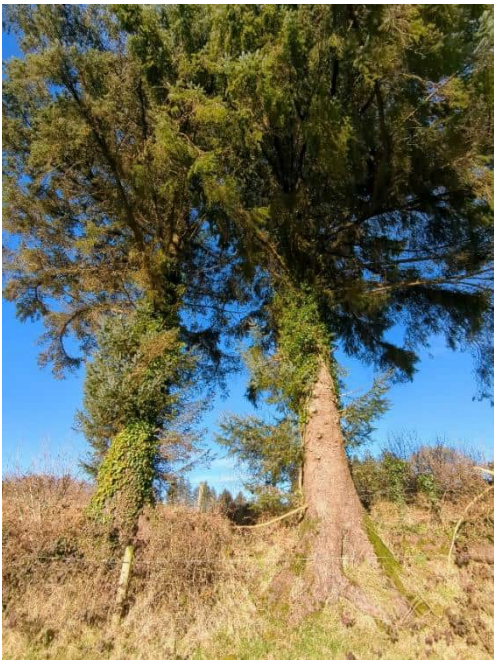
| Ref. | Description | Evaluation | Overall assessment | Photograph |
|---|---|---|---|---|
| Tree 8 | Tree 8 comprised of two mature spruces located within a treeline located to the north of the Site between the existing S&G pit and the northern field at approximate ITM co-ordinates 626608, 698339. | No PRFs were identified, and these trees were only given a low assessment rather than a negligible assessment due to the dense canopy obscuring parts of the stem. However, based on the good health and semi-mature ages of the trees, it was considered unlikely to support features that would support larger numbers of bats. | <b>Low bat roosting potential</b> | |

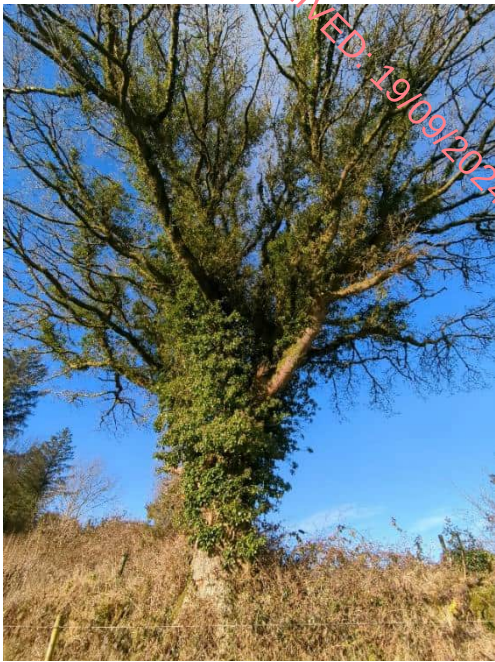
| Ref. | Description | Evaluation | Overall assessment | Photograph |
|---|---|---|---|---|
| Tree 9 | Tree 9 was located to the north of the Site, bordering the northern field at approximate ITM co-ordinates 626548, 698314. | There were no PRFs identified on this tree. However, the main stem was covered in partially detached ivy with stem diameters in excess of 50 mm. It may be possible that PRFs exist within the obscured areas of the tree. It is anticipated that any potential PRFs within the stem would be suitable for crevice-dwelling and void-dwelling bats. | <b>Low bat roosting potential</b> | |

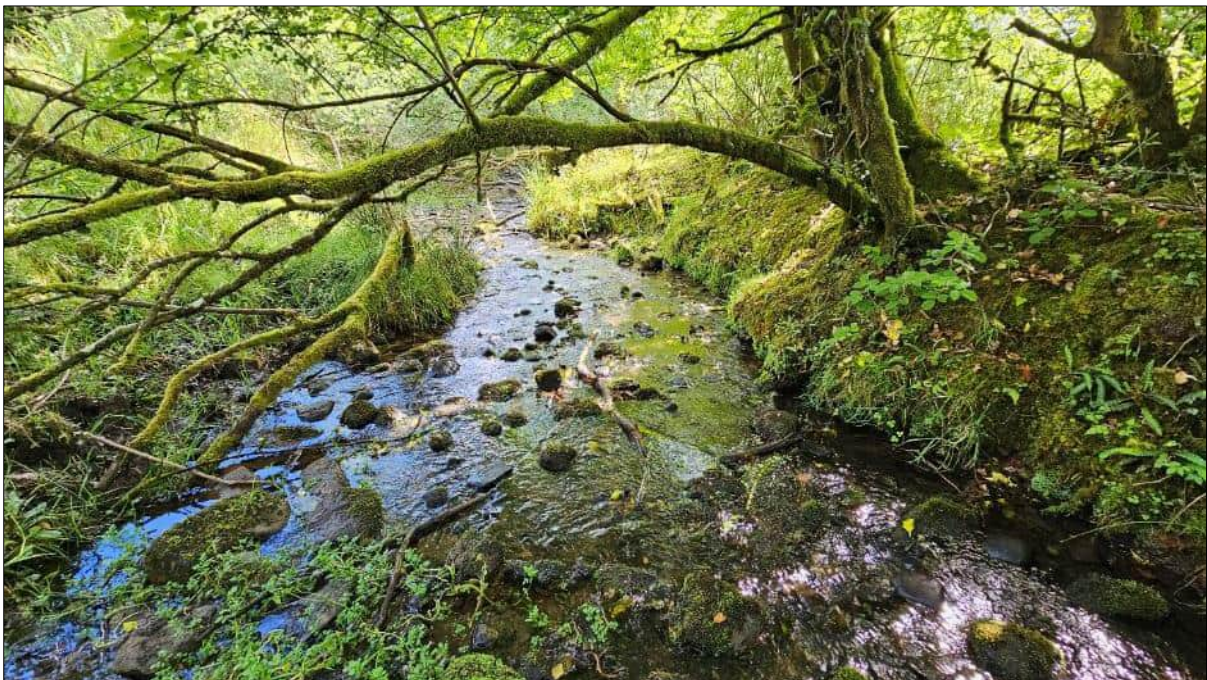
**Plate 4.1** Representative image of the unnamed tributary of the Killeen River (Site A1)

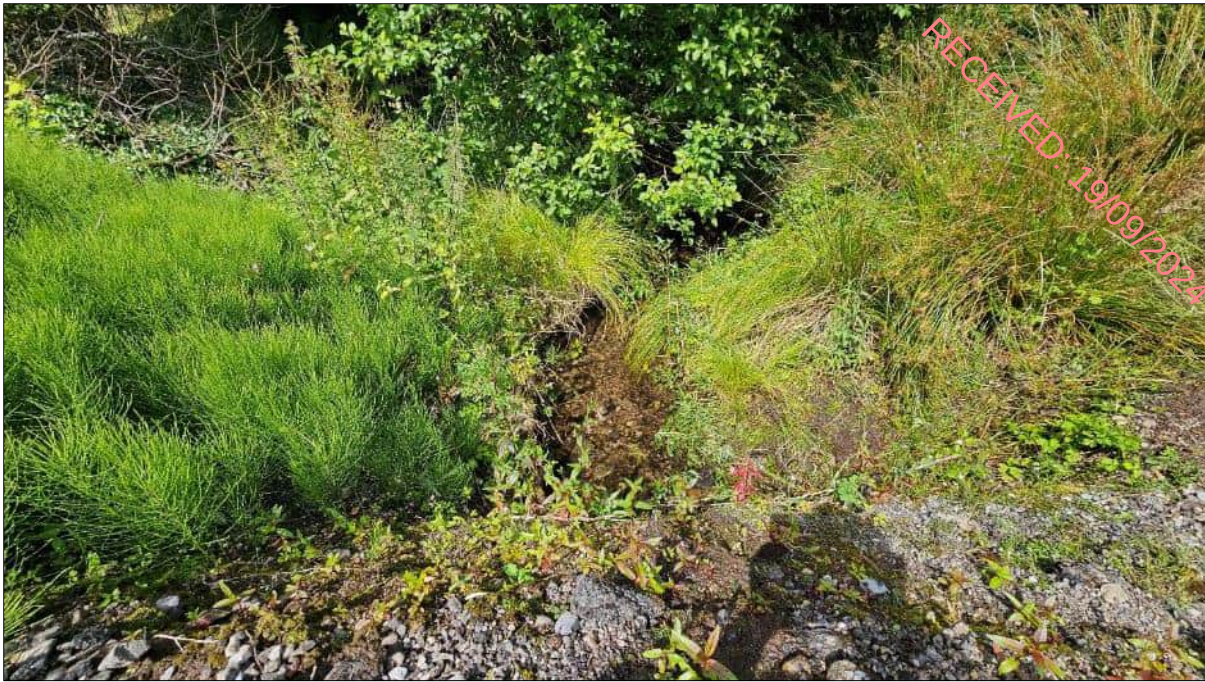
**Plate 4.4** Representative image of site A2 on the unnamed tributary of the Killeen Stream

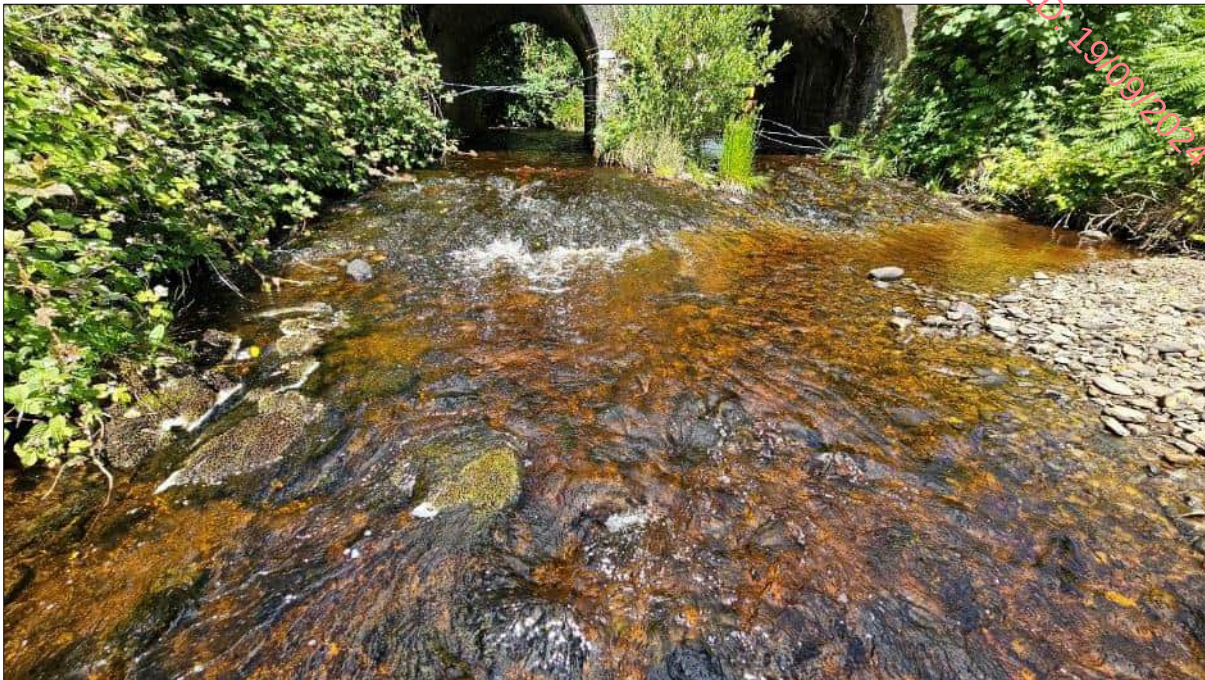
**Plate 4.11** Representative image of site B2 on the Killeen River

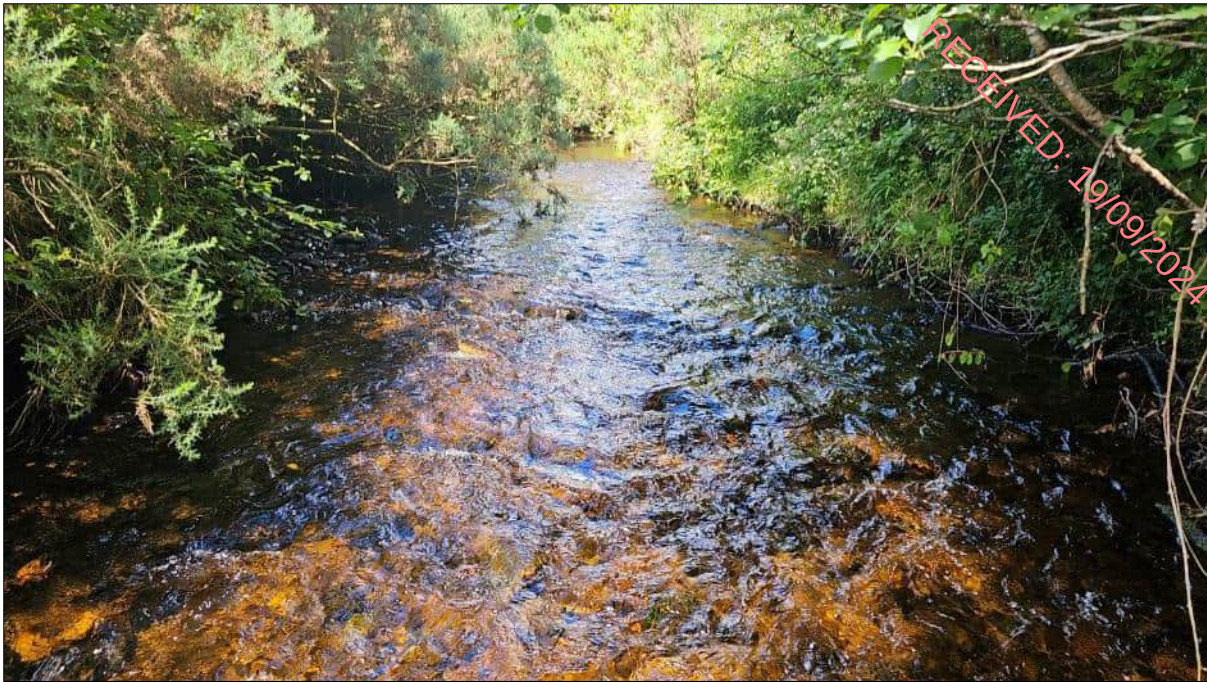
**Plate 4.13** Representative image of site B3 on the Killeen River, July 2024

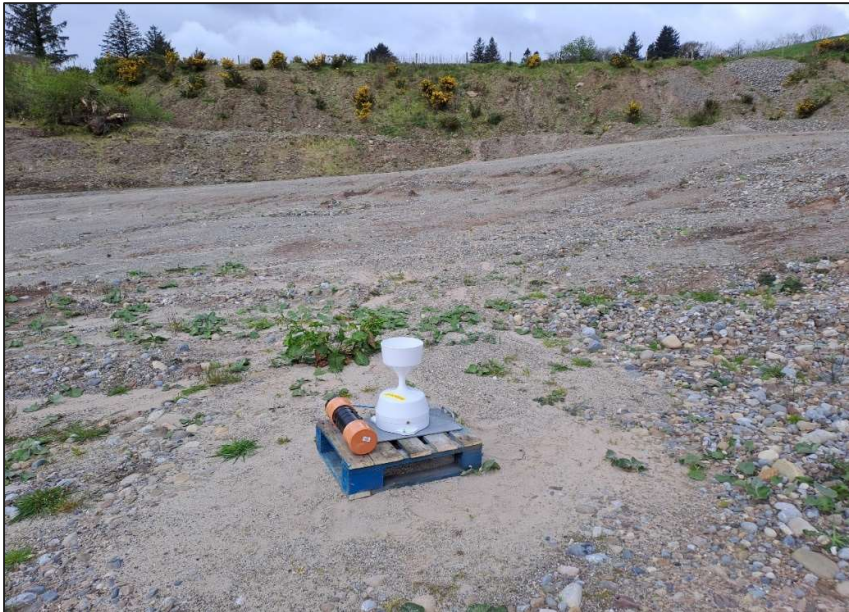
**Plate 7-1:** Site Rain Gauge

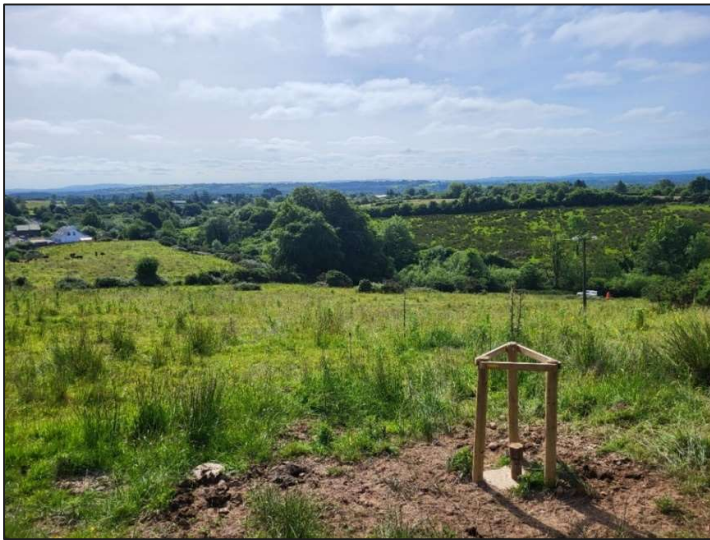
**Plate 7-3:** BH08, located on higher ground

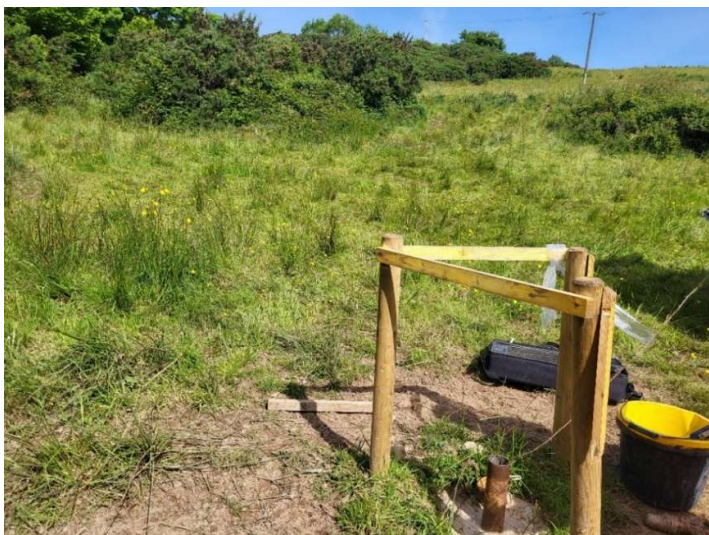
**Plate 7-4:** BH06, located on lower ground
