GEOTECHNICAL & PEAT STABILITY ASSESSMENT REPORT

LEMANAGHAN WIND FARM, CO. OFFALY

Geotechnical & Peat Stability Assessment Report

P20-216

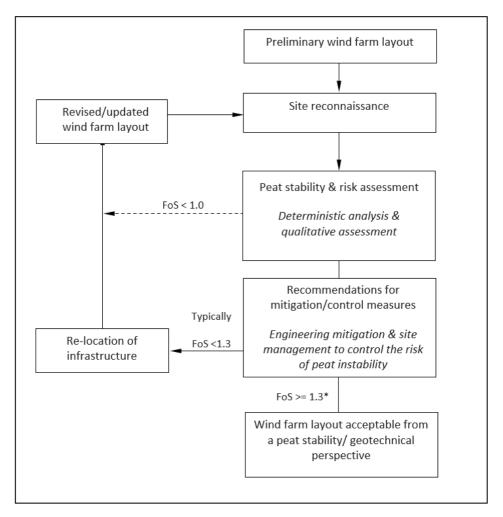
Figure 2-1: Methodology for Peat Stability Assessment

A flow diagram showing the general methodology for the peat stability assessment is shown in Figure 2-1. The methodology illustrates the optimisation of the wind farm layout based on the findings from the site reconnaissance and stability analysis and subsequent feedback.

^{*}An FoS of between 1.0 and 1.3 does not mean that a failure will occur, but that the area requires attention. Mitigation measures can be provided for areas with an FoS of between 1.0 and 1.3 to reduce the risk of failure.

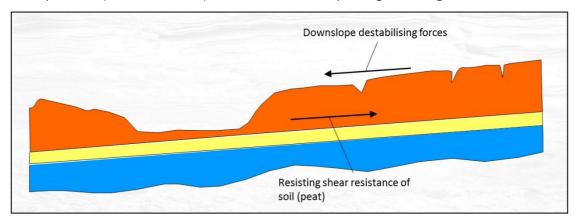
Figure 2-2: Peat Slope Showing Balance of Forces to Maintain Stability

The FoS is a measure of the stability of a particular slope. For any slope, the degree of stability depends on the balance of forces between the weight of the soil/peat working downslope (destabilising force) and the inherent strength of the peat/soil (shear resistance) to resist the downslope weight, see Figure 2-2.

The FoS provides a direct measure of the degree of stability of a slope and is the ratio of the shear resistance over the downslope destabilising force. Provided the available shear resistance is greater than the downslope destabilising force then the FoS will be greater than 1.0 and the slope will remain stable. If the FoS is less than 1.0 the slope is unstable and liable to fail. The acceptable factor of safety for assessment purposes is 1.3 (BS6031, 1981).

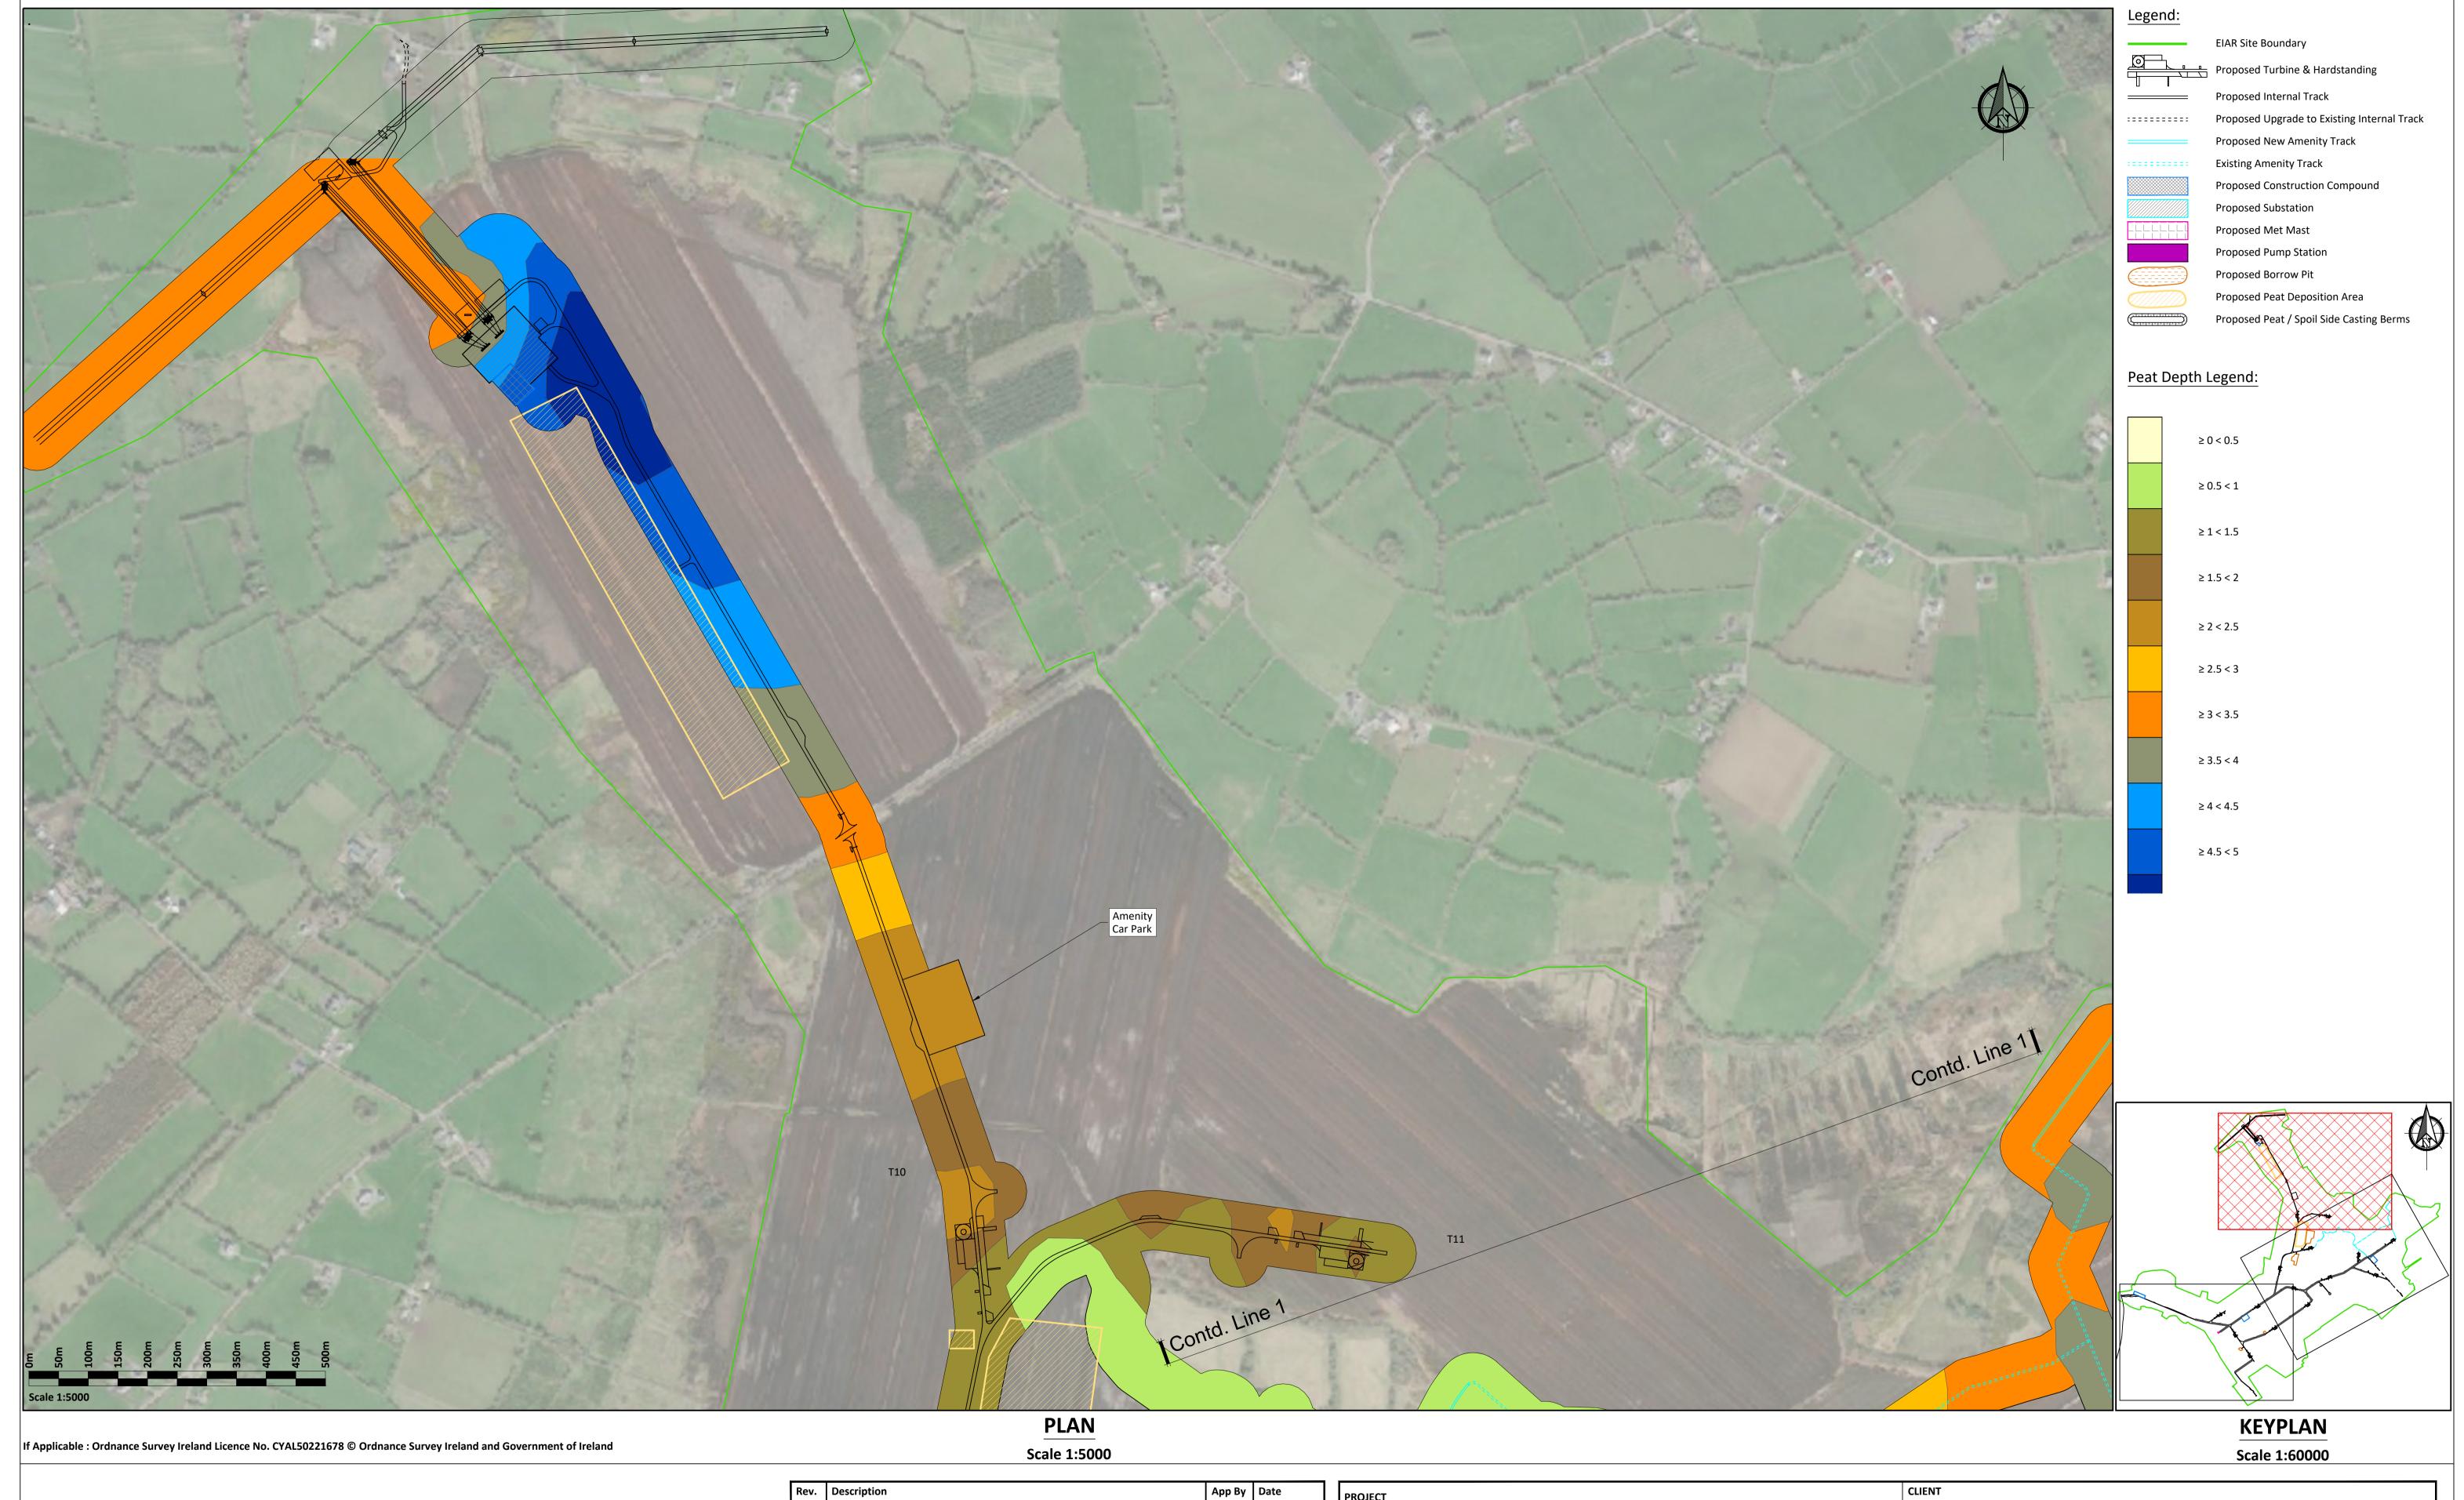
4	PROJECT		CLIENT				
		LEMANAGHAN WIND FARM, CO. OFFALY			МКО		
	SHEET		Date	22.07.25	Project number P20-216	Scale (@ A1) 1:5000	
		PEAT DEPTH CONTOUR PLAN SHEET 1 OF 3	Drawn by	POR	Drawing Number		Rev
			Checked by	AC	P20-216-0600-0001 (Sheet set subset 0600)		В
	O:\ACAD\2020\P20-	-216\P20-216-0600-0001

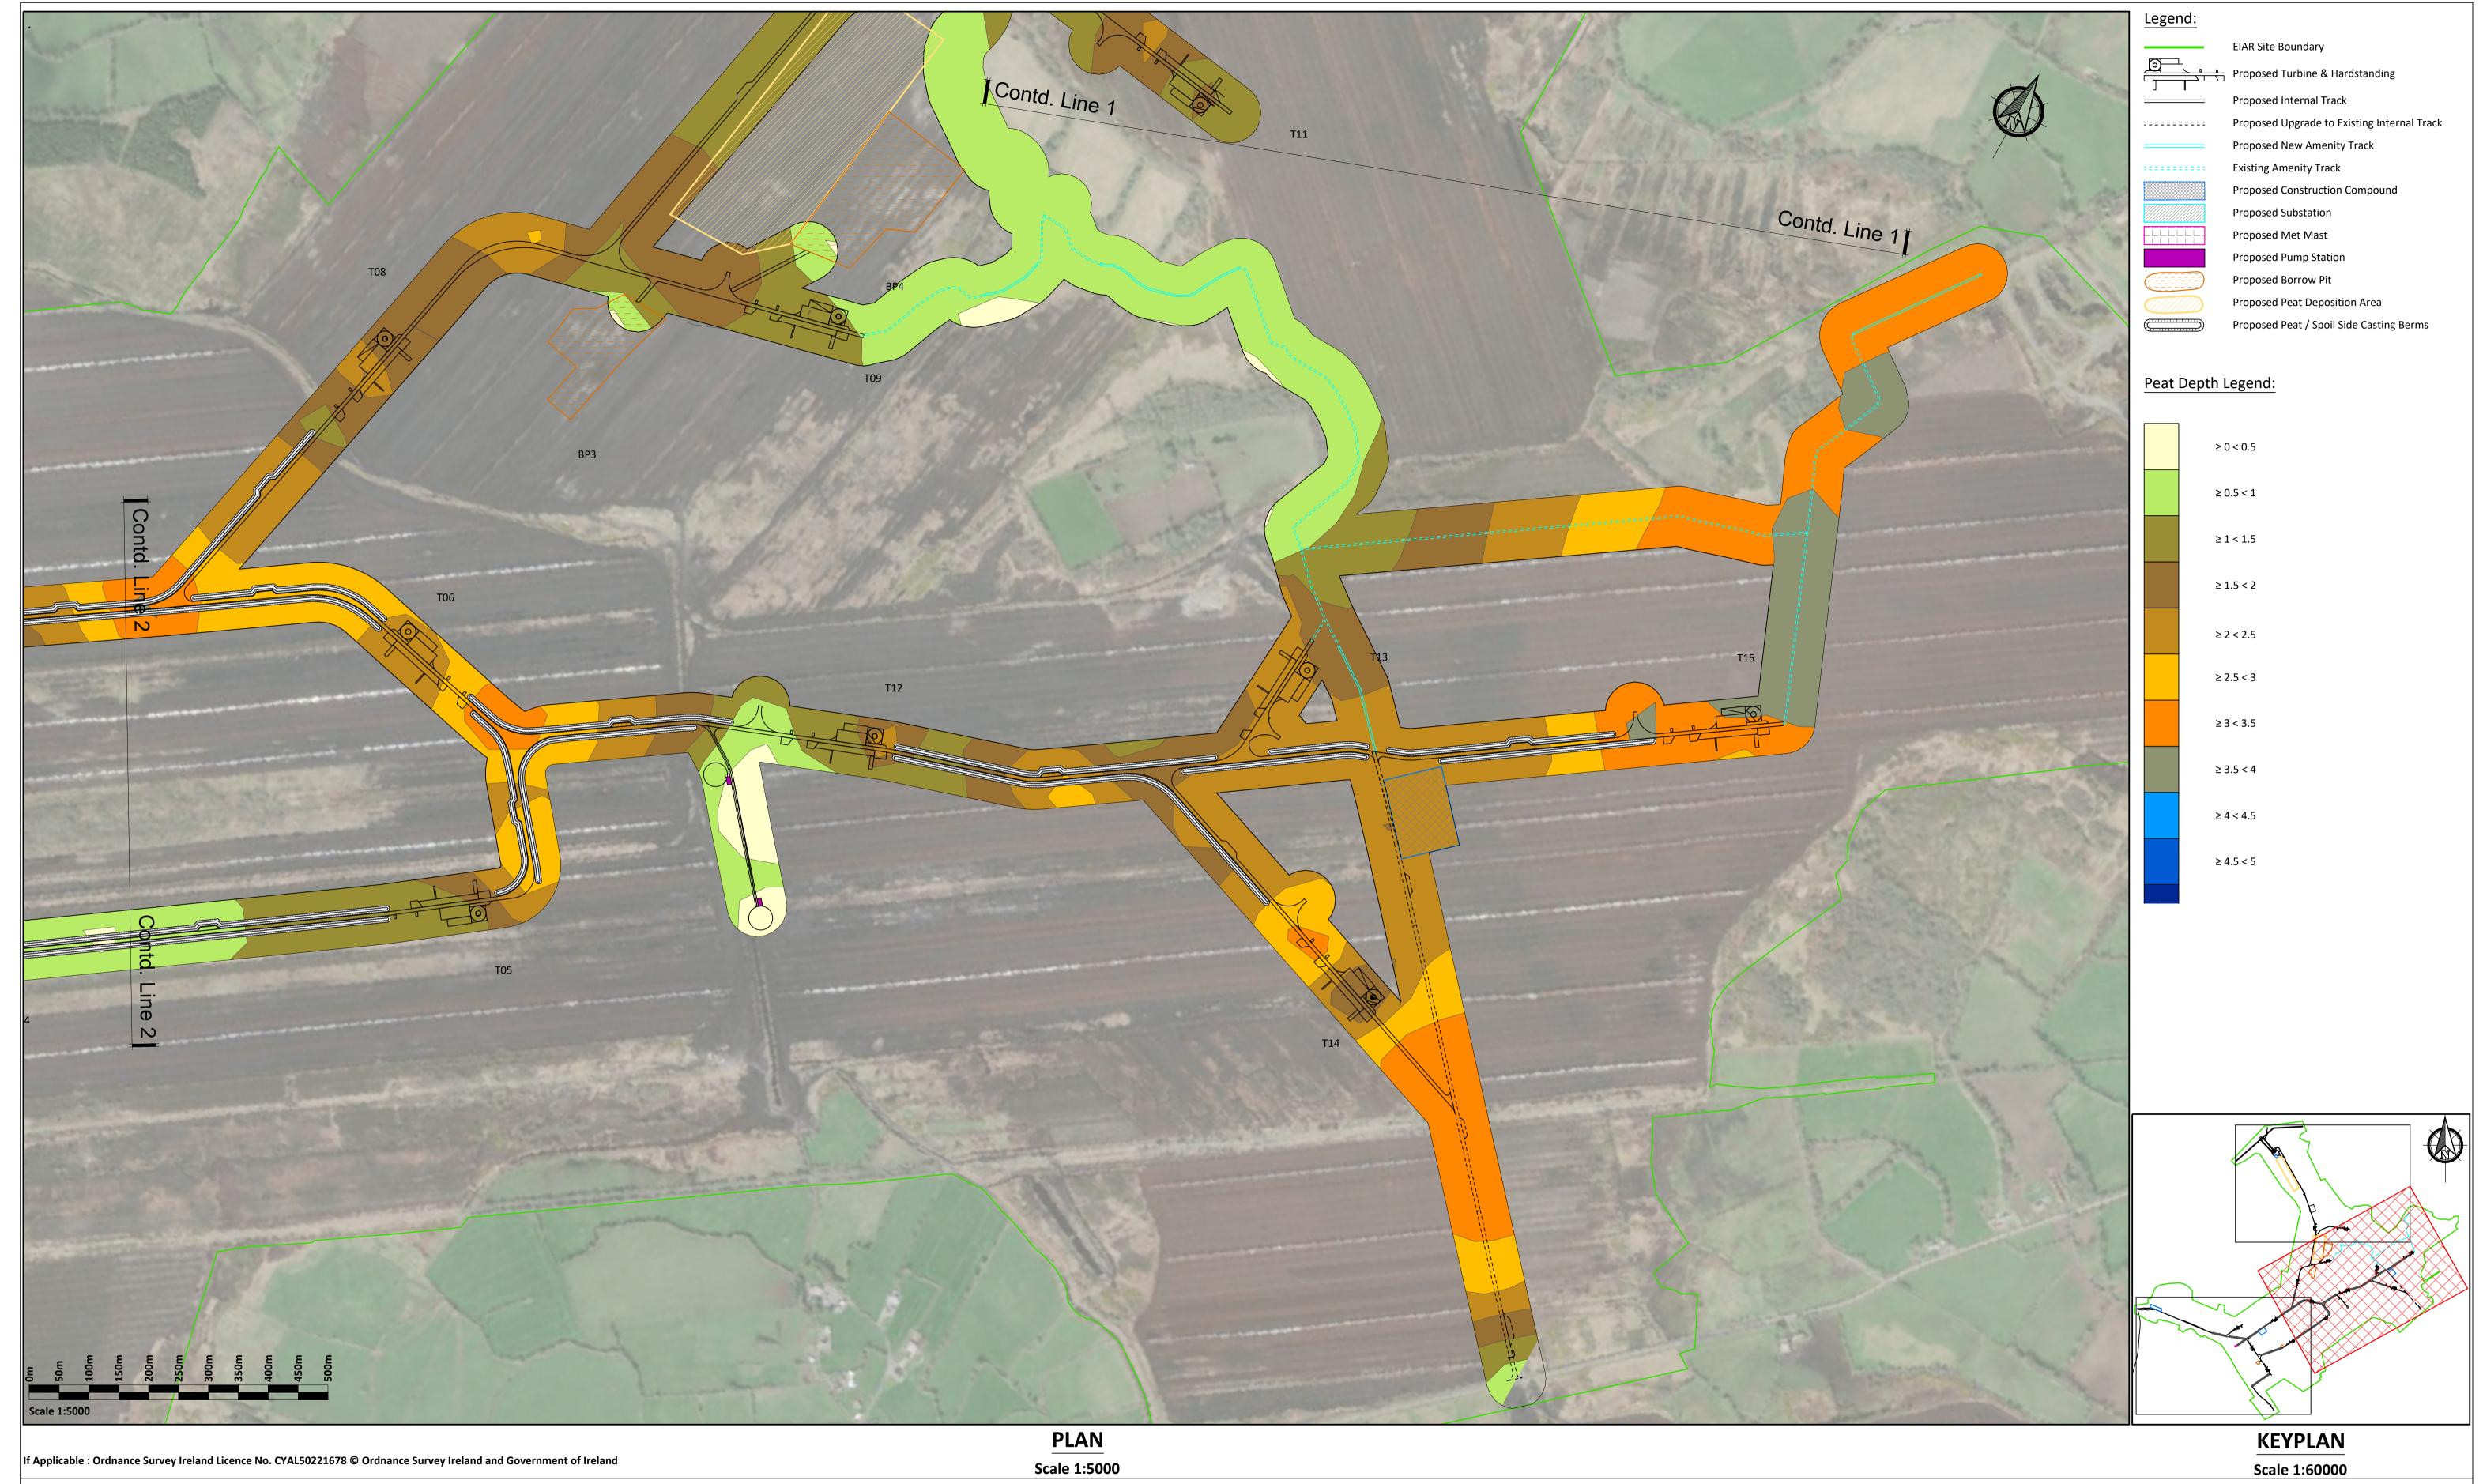
PROJECT	CLI	LIENT				
		MKO					
	LEMANAGHAN WIND FARM, CO. OFFALY						
	SHEET	Dat		22.07.25	Project number P20-216 Scale 1:500	(@ A1) 00	
	PEAT DEPTH CONT	OUR PLAN SHEET 2 OF 3	rawn by	POR	Drawing Number		Rev
			hecked by	AC	P20-216-0600-0002 (Sheet set subset 0600)		В
	O:\ACAD\2020\P20-216\P20-216-0600-0002

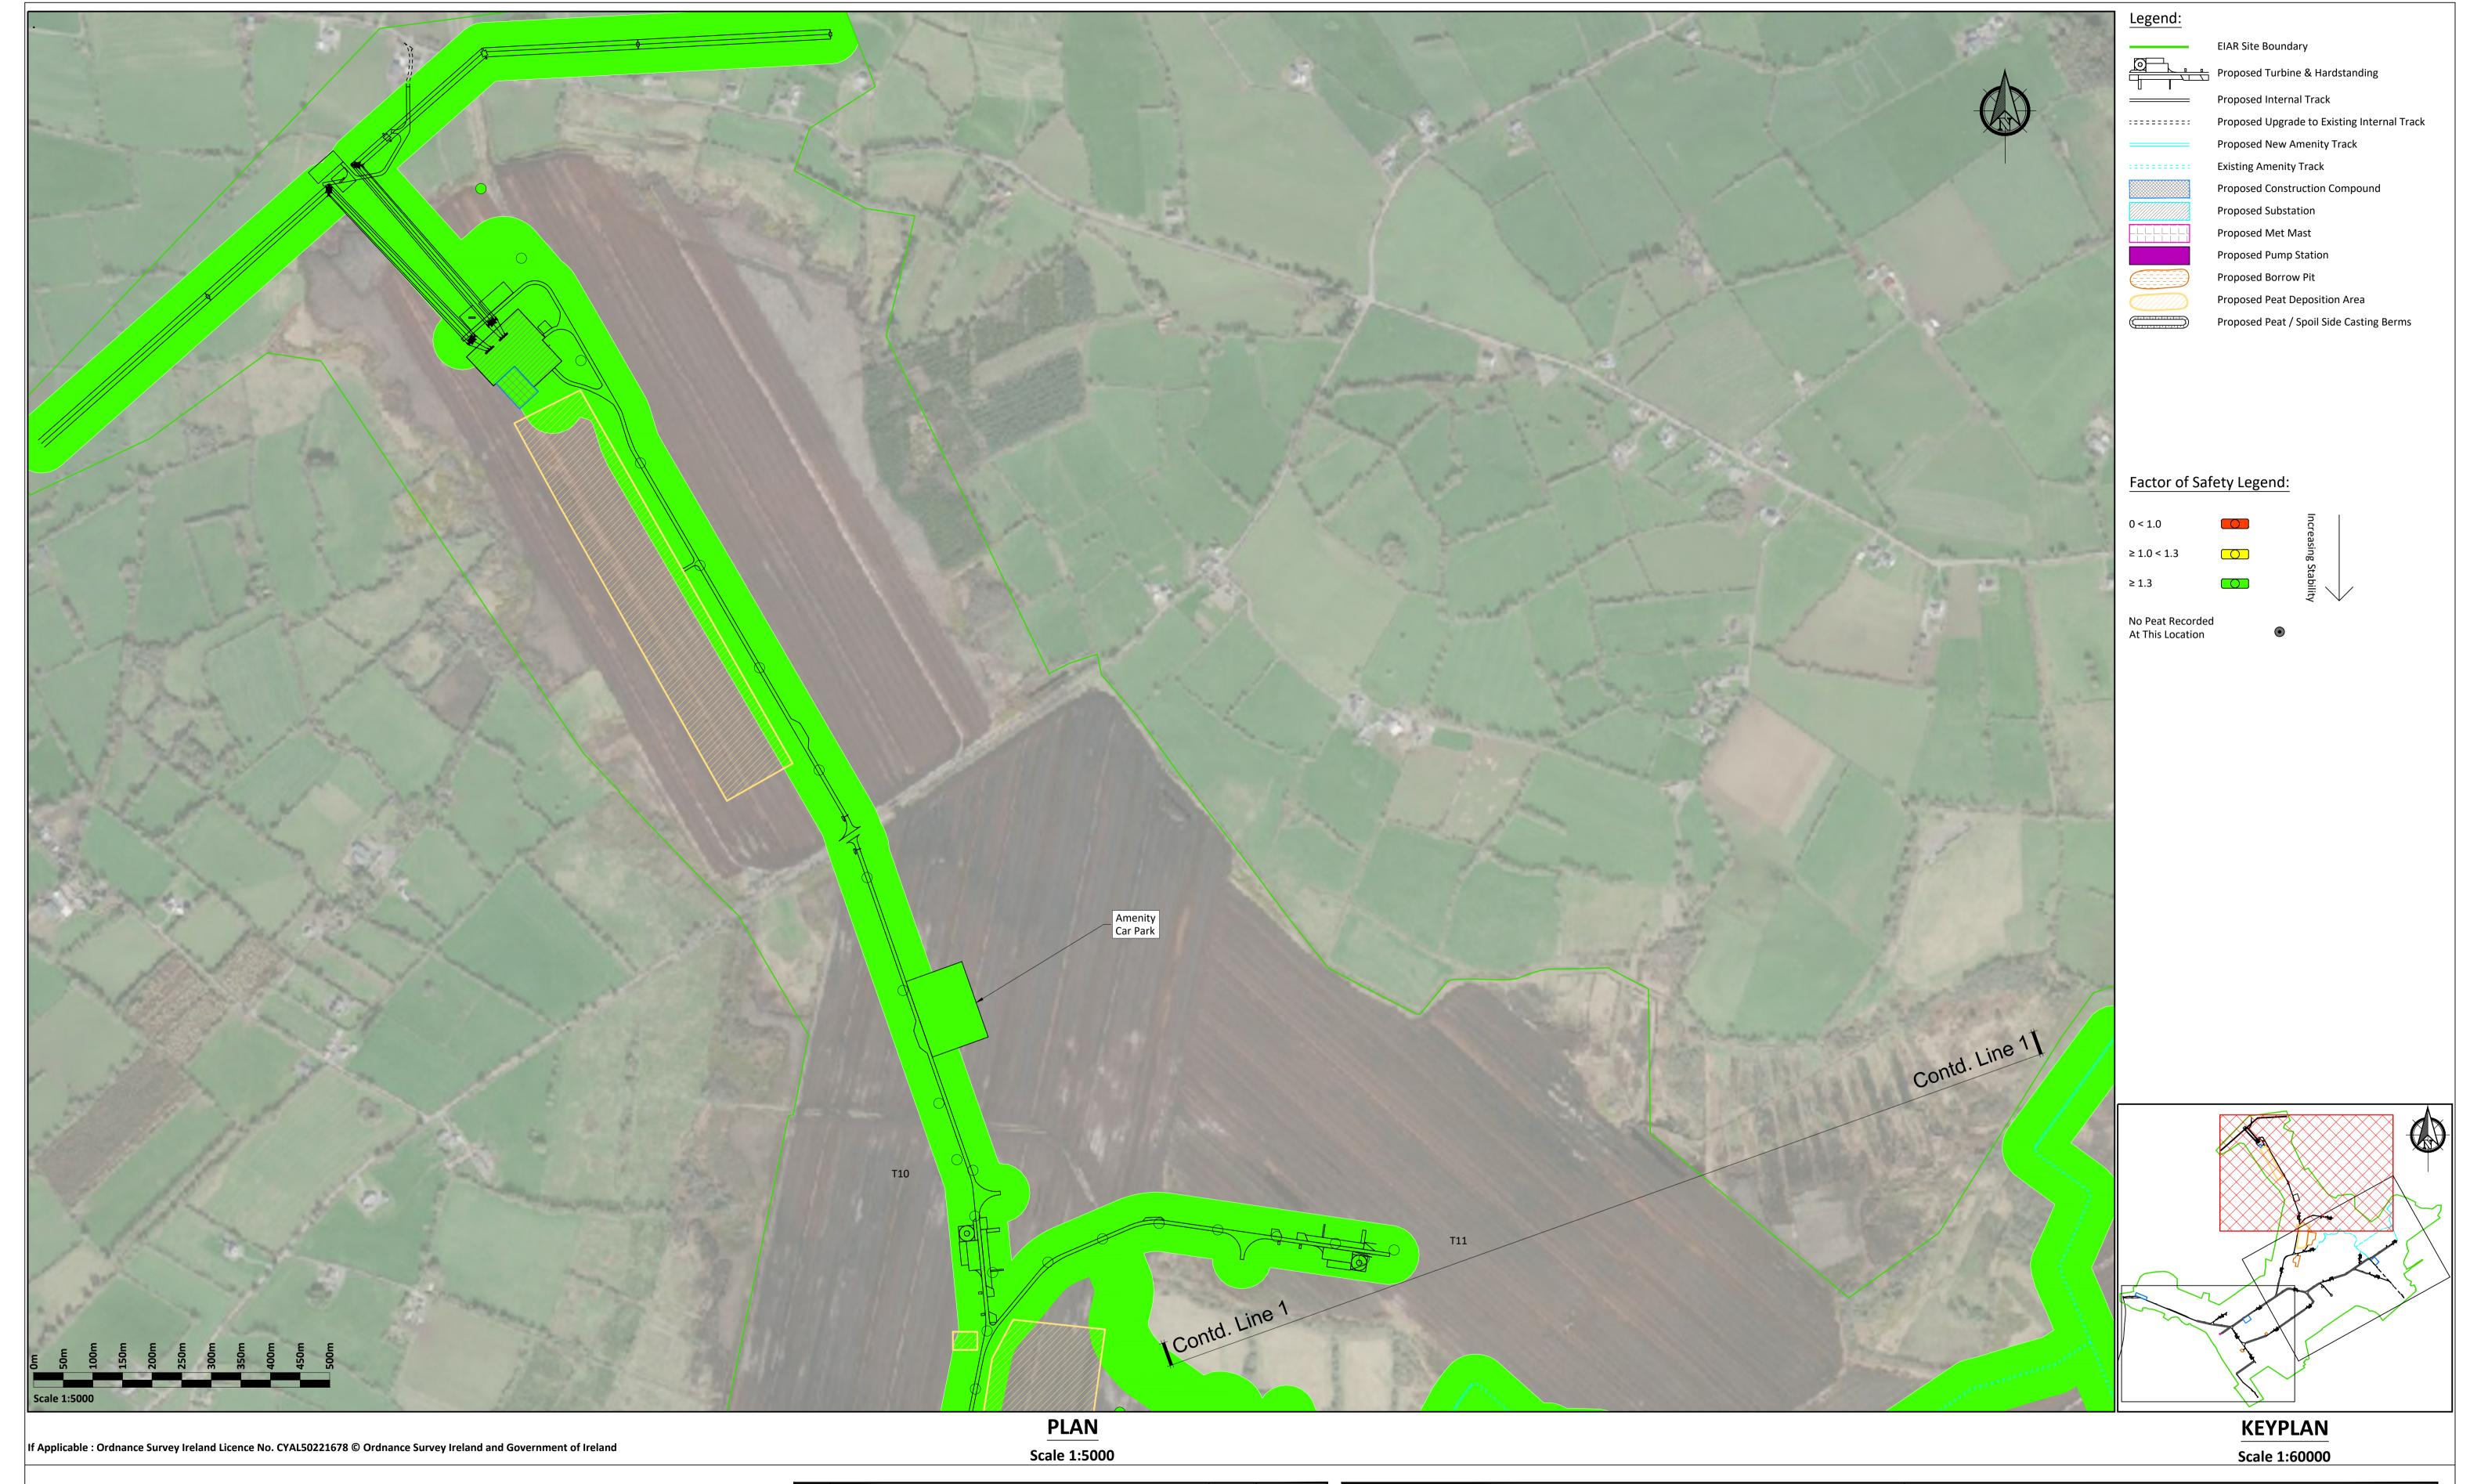
PROJECT	CLIENT				
	LEMANAGHAN WIND FARM, CO. OFFALY			D 41/O		
				MKO		
	FACTOR OF SAFETY PLAN – SHORT TERM CRITICAL CONDITION 2 (UNDRAINED) SHEET 1 OF 3	Date	22.07.25	Project number Scale (@ 1:5000	A1)	
		Drawn by	POR	Drawing Number	F	Rev
		Checked by	AC	P20-216-0600-0010 (Sheet set subset 0600)		В
	O:\ACAD\2020\P20-216\P20-216-0600-0010

- 5. Factor of safety plan compiled for the short-term critical condition (undrained) for 281 no. FoS points analysed along the proposed infrastructure envelope on site.

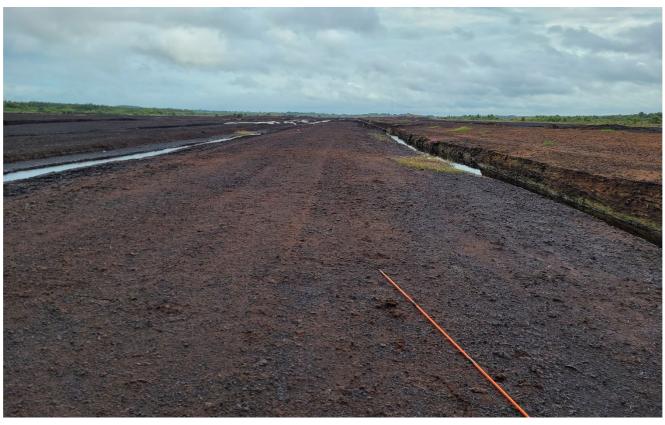
Figure A- 1 Open worked peat

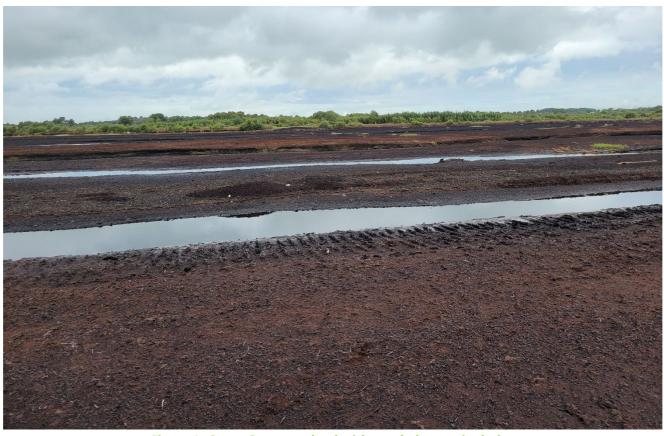
Figure A- 2 Open peatland with ponded water in drains

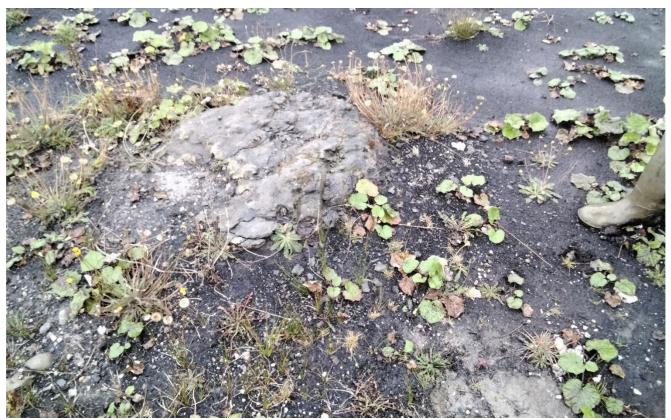
Figure A-3 Possible Rock outcrop at location of proposed borrow pit

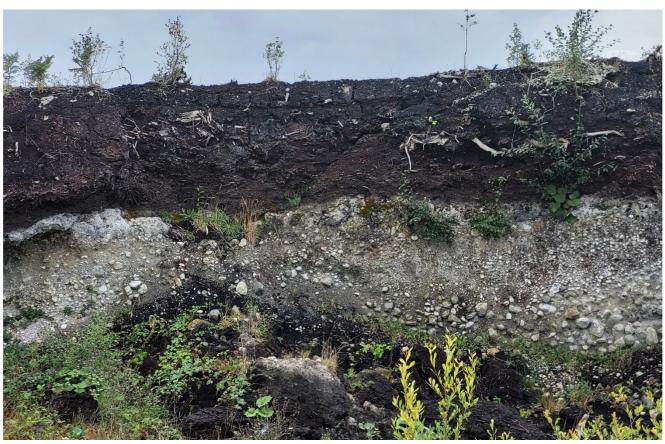
Figure A- 4 Soil Profile of Peat overlying Glacial Till.
